# SydneyStrataReport

## STRATA REPORT

| Address of property | Unit 303/446-448 Bunnerong Road,<br>Matraville, NSW. |
| Strata Plan | SP 97139 |

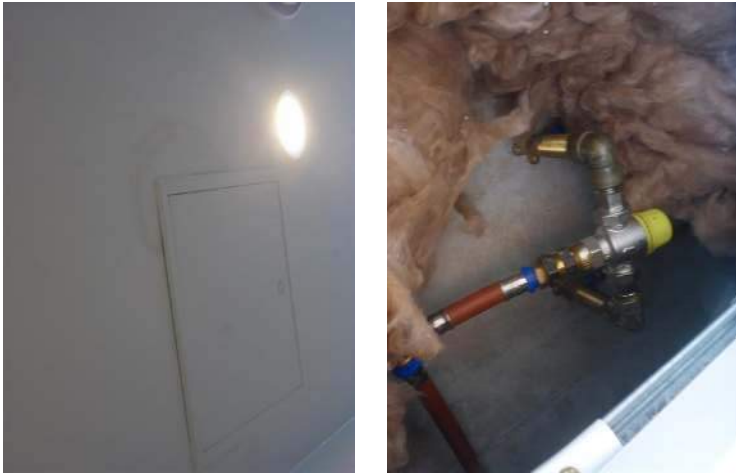
| ITEM | COMMENTARY | PHOTOGRAPH |
|---|---|---|
| A | <p><b>Location &amp; Description</b><br/> Bathroom:<br/> Evidence of water penetration in the form of staining to the plasterboard ceiling lining adjacent to the manhole.<br/> A joint in the water reticulation pipework and a tempering valve is located above.</p> | |
| B | <p><b>Cause(s)</b><br/> ➤ Failure of the joints in the water reticulation pipework.</p> | |

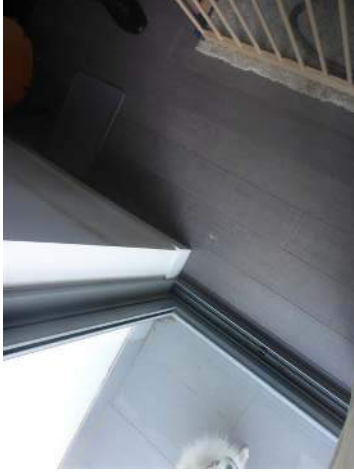
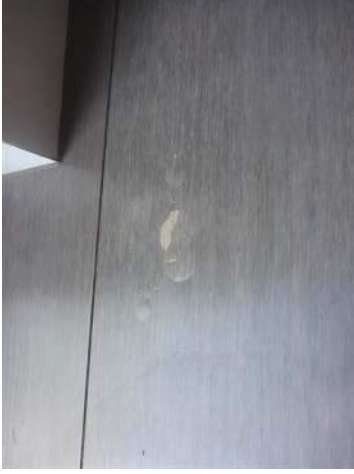
| ITEM | COMMENTARY | PHOTOGRAPH |
|---|---|---|
| A | <p><b>Location &amp; Description</b><br/>Living room:<br/>Isolated warping and blistering of the finish on the timber laminate flooring adjacent to the southern end of the southern, east-facing sliding door.<br/>Elevated moisture meter readings to the flooring in this location.</p> | |
| B | <p><b>Cause(s)</b></p> <ul style="list-style-type: none"> <li>➤ Cannot conclusively establish the cause of the reported defect, further investigation required</li> <li>➤ Possible manufacturing defect with the timber laminate flooring.</li> <li>➤ Possible damage to the timber laminate flooring.</li> <li>➤ Possible water penetration through the adjacent sliding door to the courtyard</li> </ul> | |
| C | <p><b>Breach(es)</b><br/>To be confirmed – Pending further investigations.</p> <p>If the builder has failed to adequately waterproof the external wall and/or sliding door, an unsatisfactory standard of workmanship has been executed.</p> <p>If the builder has damaged the flooring during installation, an unsatisfactory standard of workmanship has been executed.</p> <p>Possible breach of <i>Performance Requirement FP1.4</i> of the Building Code of Australia, which requires that <i>a roof or external wall (including openings around windows and doors) must prevent the penetration of water.</i></p> <p>Accordingly, under Section 18B (a), and (c) of the Home Building Act 1989 (NSW):</p> <ul style="list-style-type: none"> <li>(a) Failure to perform work with due care and skill.</li> <li>(c) Failure to perform work that complies with the Home Building Act.</li> </ul> | |

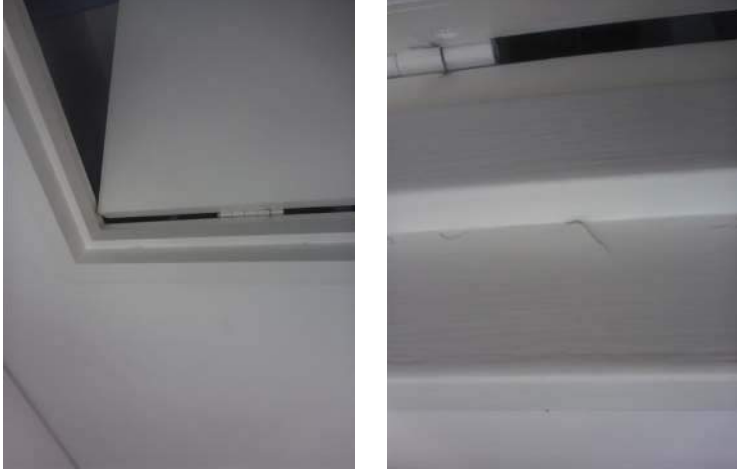
| ITEM | COMMENTARY | PHOTOGRAPH |
|---|---|---|
| A | <p><b>Location &amp; Description</b><br/>Bedroom 1:<br/>Isolated areas of flaking paint on the hinge side of the steel door frame.</p> | |
| B | <p><b>Cause(s)</b></p> <ul style="list-style-type: none"> <li>➤ Inadequate preparation of the steel door frame prior to painting.</li> <li>➤ Inadequate workmanship during painting of the steel bedroom door frame.</li> </ul> | |

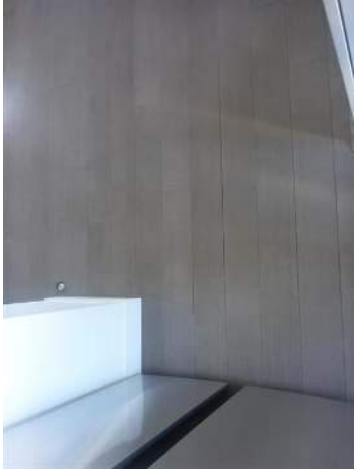
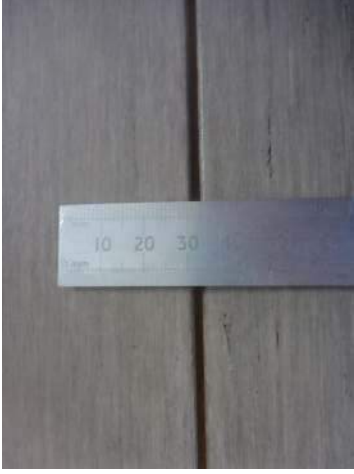
| ITEM | COMMENTARY | PHOTOGRAPH |
|---|---|---|
| A | <p><b>Location &amp; Description</b><br/>Timber floor:<br/>The gaps between the timber laminate floor boards are inconsistent and excessive (up to ~ 3-4mm in width). Affected areas are located in the kitchen and adjacent to the bathroom</p> | |
| B | <p><b>Cause(s)</b></p> <ul style="list-style-type: none"> <li>➤ Differential movement of the timber laminate flooring</li> <li>➤ Poorly executed workmanship during installation of floating floor (inadequate movement provisions).</li> <li>➤ Floating timber flooring may not have been site-acclimatised correctly prior to installation.</li> <li>➤ Possible water damage.</li> </ul> | |
| C | <p><b>Breach(es)</b><br/>In failing to adequately install the timber laminate flooring with adequate allowance for movement, an unsatisfactory standard of workmanship has been executed.</p> <p>Section 14.03 Gaps in exposed timber flooring in the Office of Fair Trading 'Guide to standards and tolerances' dated 2007 stipulates that <i>flooring is defective if it has a gap of more than 2mm between adjacent boards that extend for more than 1m and that flooring is defective if it has gaps of more than 5mm in total of gaps between four consecutive boards.</i></p> <p>Accordingly, under Section 18B (a) and (c) of the Home Building Act 1989 (NSW):</p> <p>(a) Failure to perform work with due care and skill.<br/>(c) Failure to perform work that complies with the Home Building Act.</p> | |

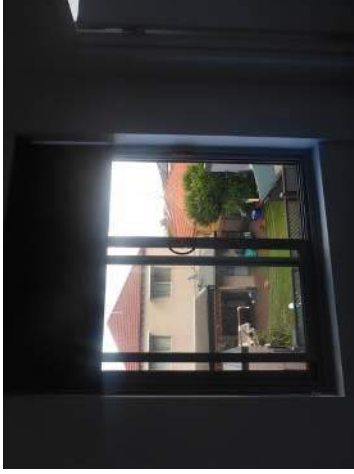
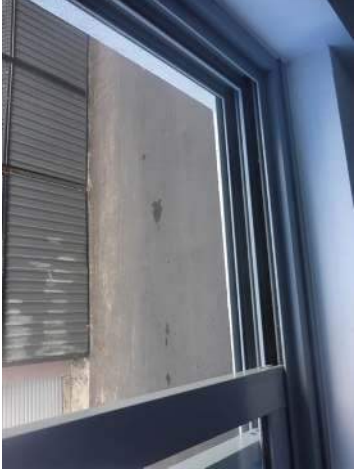
| ITEM | COMMENTARY | PHOTOGRAPH |
|---|---|---|
| A | <p><b>Location &amp; Description</b><br/>Bedroom 1:<br/>The sliding window opens more than 125mm.<br/>Instructed by the occupant that a restrictor has not been removed from the window.</p> <p>Note: it is understood that the Construction Certificate application was made after 1<sup>st</sup> May 2014.<br/>Note: it is assumed that the window has not been modified since occupation (i.e. the original restrictors were not removed after construction).</p> | |
| B | <p><b>Cause(s)</b></p> <ul style="list-style-type: none"> <li>➤ Possible oversight or incomplete works (i.e. restrictors not installed).</li> </ul> | |
| C | <p><b>Breach(es)</b></p> <p>In failing to install a suitable window restrictor in the bedroom, an unsatisfactory standard of workmanship has been executed.</p> <p>Non-compliance with D2.24 <i>Protection of openable windows</i> in the Building Code of Australia, which stipulates that <i>a window opening must be provided with protection, if the floor below the window is 2m or more above the surface beneath in a bedroom in a Class 2 building.</i></p> <p><i>Where the lowest level of the window opening is less than 1.7m above the floor, the openable portion of the window must be protected with a device capable of restricting the window opening.</i></p> <p><i>A restrictor must not permit a 125mm sphere to pass through the window opening.</i></p> <p>In failing to install window restrictors, an unsatisfactory standard of workmanship has been executed.</p> | |

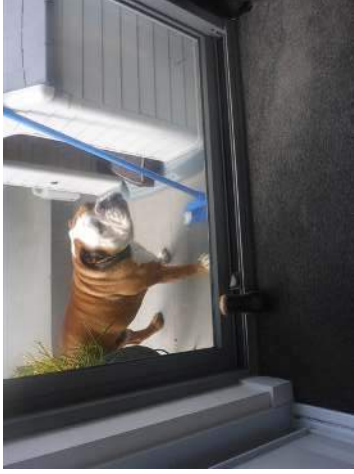
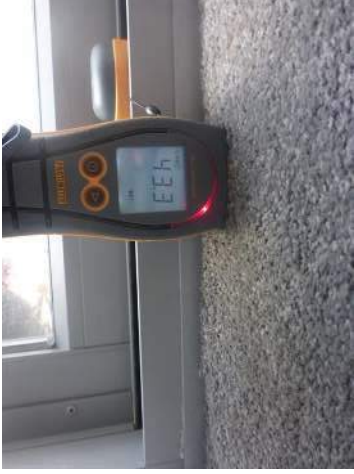
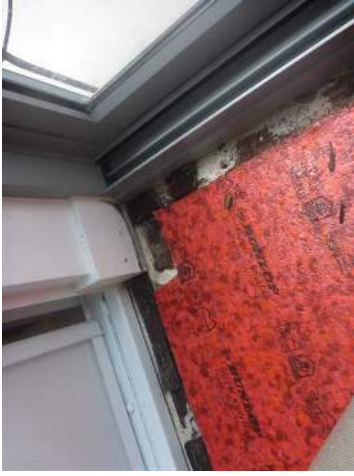
| ITEM | COMMENTARY | PHOTOGRAPH |
|---|---|---|
| A | <p><b>Location &amp; Description</b><br/>Bedroom 2:<br/>Instructed by the occupants of water penetration adjacent to the bottom left-hand side of the courtyard sliding door. High moisture meter readings and deteriorated smooth edge in the nominated area. This is the fixed-pane end of the sliding door assembly.</p> | |
| B | <p><b>Cause(s)</b></p> <ul style="list-style-type: none"> <li>➤ Cannot conclusively establish the cause of the reported defect, further investigation required.</li> <li>➤ Possible failure of the waterproofing of the aluminium framed sliding door.</li> <li>➤ Possible failure of the waterproofing upturn for the courtyard.</li> </ul> | |
| C | <p><b>Breach(es)</b><br/>In failing to adequately construct the building to resist water ingress, an unsatisfactory standard of workmanship has been executed.</p> <p>Breach of Performance Requirement FP1.4 of the Building Code of Australia, which requires that <i>a roof or external wall (including openings around windows and doors) must prevent the penetration of water that could cause:</i></p> <ul style="list-style-type: none"> <li>(a) <i>Unhealthy conditions, and a loss of amenity for occupants; and</i></li> <li>(b) <i>Undue dampness and deterioration of building elements.</i></li> </ul> <p>Accordingly, breach of Section 18B (a) and (c) of the Home Building Act 1989 (NSW):</p> <ul style="list-style-type: none"> <li>(a) Failure to perform work with due care and skill.</li> <li>(c) Failure to perform work in accordance with the Home Building Act 1989 (NSW).</li> </ul> | |

| ITEM | COMMENTARY | PHOTOGRAPH |
|---|---|---|
| D | <p><b>Recommended Scope of Works/ Method of Repair</b></p> <ol style="list-style-type: none"> <li>1. Protect all adjoining surfaces around work area.</li> <li>2. Direct water against the adjacent sliding door, sill flashings and external wall to simulate rain and identify any waterproofing failures with same.</li> <li>3. Detailed scope of works to be determined based on the outcome of the above investigations.</li> <li>4. Rectify any waterproofing failures identified.</li> <li>5. Water test the repairs to verify the success of same.</li> <li>6. Replace water damaged internal skirtings, underlay and carpet as required.</li> <li>7. Repaint affected internal surfaces to match the existing with a suitable interior paint system in accordance with the manufacturer's recommendations.</li> <li>8. Clean up and make good work area.</li> </ol> | |

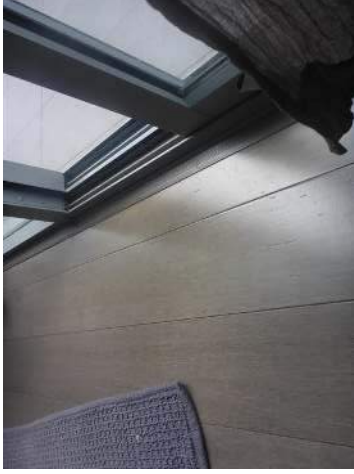
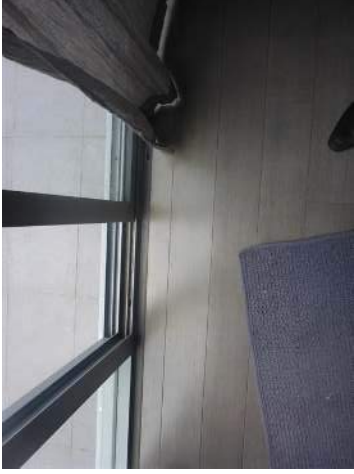
| ITEM | COMMENTARY | PHOTOGRAPH |
|---|---|---|
| A | <p><b>Location &amp; Description</b><br/>Living room:<br/>Isolated discolouration of the timber laminate flooring adjacent to the east-facing courtyard doors.<br/>Two (2) boards affected.</p> | |
| B | <p><b>Cause(s)</b></p> <ul style="list-style-type: none"> <li>➤ Possible sun damage.</li> <li>➤ Possible failure to install flooring with suitable durability for the conditions of service.</li> </ul> | |
| C | <p><b>Breach(es)</b><br/>If the builder has failed to install flooring with adequate durability for the conditions of service, an unsatisfactory standard of workmanship has been executed.</p> <p>Accordingly, under Section 18B (a) and (c) of the Home Building Act 1989 (NSW):</p> <ul style="list-style-type: none"> <li>(a) Failure to perform work in a proper and workmanlike manner.</li> <li>(c) Failure to perform work that complies with the Home Building Act.</li> </ul> | |

| ITEM | COMMENTARY | PHOTOGRAPH |
|---|---|---|
| D | <p><b>Recommended Scope of Works/ Method of Repair</b></p> <ol style="list-style-type: none"> <li>1. Set up work area and protect all surrounding surfaces.</li> <li>2. Flooring manufacturer to inspect and comment on the discolouration of the timber laminate flooring.</li> <li>3. Scope of works to be determined based on the outcome of the above inspection by the manufacturer (i.e. re-finishing or replacement).</li> <li>4. Scope of works to be referred to the original builder for action</li> <li>5. Clean up and make good work area.</li> </ol> | |

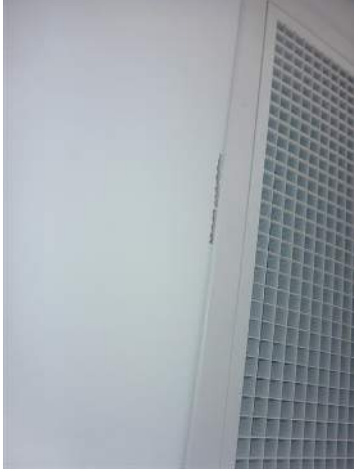
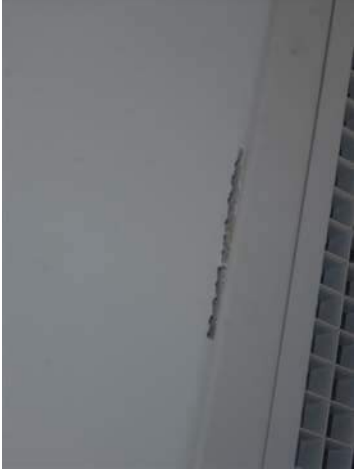
| ITEM | COMMENTARY | PHOTOGRAPH |
|---|---|---|
| A | <p><b>Location &amp; Description</b><br/>Hallway:<br/>Isolated separation ~1.0mm in width between the air conditioning return air grill and the plasterboard ceiling lining.</p> | |
| B | <p><b>Cause(s)</b></p> <ul style="list-style-type: none"> <li>➤ Differential building movement.</li> <li>➤ Failure to adequately make good opening in the ceiling for the return air grill.</li> </ul> | |
| C | <p><b>Breach(es)</b></p> <p>In failing to make good the plasterboard ceiling lining, an unsatisfactory standard of workmanship has been executed.</p> <p>Section 10.01 <i>Gaps associated with internal fixing</i> in the Office of Fair Trading 'Guide to Standards and Tolerances' 2007 stipulates that gaps between mouldings and other fixtures are defects if they exceed 1mm in the first year and are visible from a normal viewing position or if they exceed 2mm after the first year.</p> <p>Although this gap is not involving a moulding, the same tolerance has been applied between the ceiling and the ventilation grill.</p> <p>Accordingly, under Section 18B (a), and (c) of the Home Building Act 1989 (NSW):</p> <p>(a) Failure to perform work with due care and skill.<br/>(c) Failure to perform work that complies with the Home Building Act.</p> | |

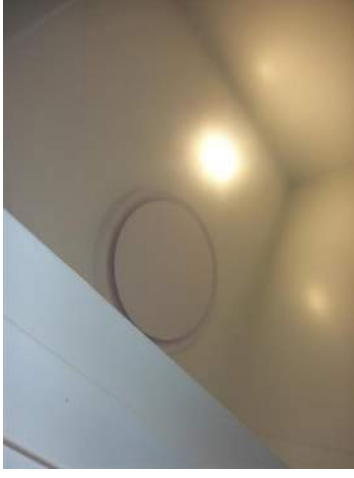
| ITEM | COMMENTARY | PHOTOGRAPH |
|---|---|---|
| A | <p><b>Location &amp; Description</b><br/>Wet area fans:<br/>Instructed by the occupant that the wet area fans do not draw sufficient air. Steam accumulates in the wet areas as a result of same.</p> | |
| B | <p><b>Cause</b></p> <ul style="list-style-type: none"> <li>➤ Cannot conclusively establish the cause of the reported defect, further investigation required.</li> <li>➤ Possible failure to adequately install and commission the mechanical ventilation system.</li> <li>➤ Possible installation of a defective ventilation fan.</li> </ul> | |

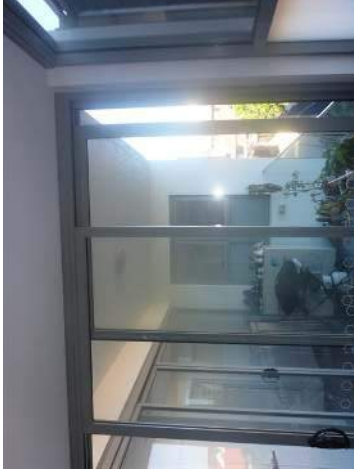
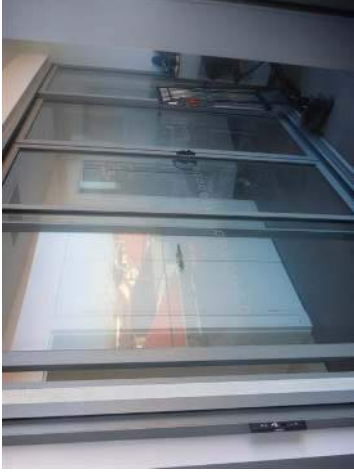
| ITEM | COMMENTARY | PHOTOGRAPH |
|---|---|---|
| A | <p><b>Location &amp; Description</b><br/>Living room:<br/>The “fixed” panels within the sliding door assemblies have not been fixed in position and can be moved.</p> | |
| B | <p><b>Cause(s)</b></p> <ul style="list-style-type: none"> <li>➤ Possible manufacturing defect.</li> <li>➤ Possible incomplete work during the assembly and/or installation of the sliding doors.</li> </ul> | |
| C | <p><b>Breach(es)</b><br/>In failing to adequately install the sliding doors in accordance with the manufacturer’s recommendations, an unsatisfactory standard of workmanship has been executed.<br/><br/>Accordingly, under Section 18B (a), and (c) of the Home Building Act 1989 (NSW):</p> <p>(a) Failure to perform work with due care and skill.<br/>(c) Failure to perform work that complies with the Home Building Act.</p> | |

| ITEM | COMMENTARY | PHOTOGRAPH |
|---|---|---|
| D | <p><b>Recommended Scope of Works/ Method of Repair</b></p> <ol style="list-style-type: none"> <li>1. Protect all adjoining surfaces around work area.</li> <li>2. Engage the door manufacturer to return to site and re-fix the door panels as required.</li> <li>3. Make good the balcony sliding doors and ensure adequate waterproofing.</li> <li>4. Clean-up and make good work area.</li> </ol> | |

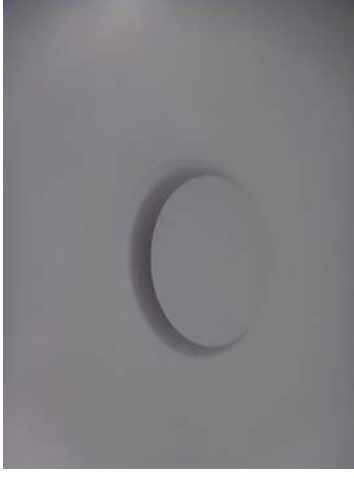
| ITEM | COMMENTARY | PHOTOGRAPH |
|---|---|---|
| A | <p><b>Location &amp; Description</b><br/>Wet area fans:<br/>Instructed by the occupant that the wet area fans do not draw sufficient air. Steam accumulates in the wet areas as a result of same.</p> | |
| B | <p><b>Cause</b></p> <ul style="list-style-type: none"> <li>➤ Cannot conclusively establish the cause of the reported defect, further investigation required.</li> <li>➤ Possible failure to adequately install and commission the mechanical ventilation system.</li> <li>➤ Possible installation of a defective ventilation fan.</li> </ul> | |

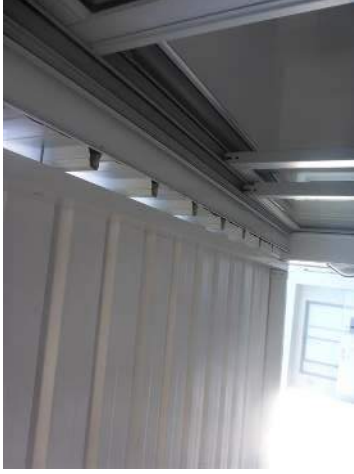
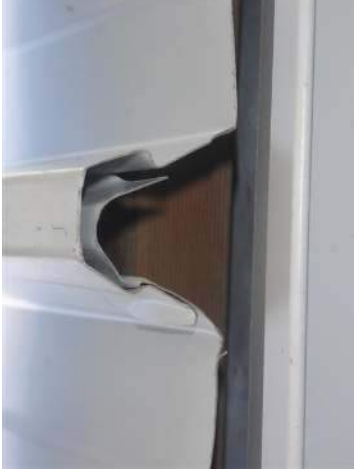
| ITEM | COMMENTARY | PHOTOGRAPH |
|---|---|---|
| A | <p><b>Location &amp; Description</b><br/>Northern balcony:<br/>Instructed by the occupant of water emanating from the interface between the awning above the sliding door and the Colorbond wall cladding. Significant gaps were observed between the awning and the wall cladding. Further instructed that the builder previously agreed to rectify this item.</p> <p>The timber framing for the external wall can be seen though gaps behind the external metal cladding above the doorway.</p> | |
| B | <p><b>Cause(s)</b></p> <ul style="list-style-type: none"> <li>➤ Failure to adequately install the awning and associated flashings.</li> <li>➤ Failure to complete agreed remedial works.</li> </ul> | |
| C | <p><b>Breach(es)</b></p> <p>If the builder has failed to install the awning, external cladding and/or associated flashings in accordance with the plans and specifications, an unsatisfactory standard of workmanship has been executed.</p> <p>In failing to complete agreed remedial works, an unsatisfactory standard of workmanship has been executed.</p> <p>Accordingly, under Section 18B (a), and (c) of the Home Building Act 1989 (NSW):</p> <p>(a) Failure to perform work with due care and skill.<br/>(c) Failure to perform work that complies with the Home Building Act.</p> | |

| ITEM | COMMENTARY | PHOTOGRAPH |
|---|---|---|
| D | <p><b>Recommended Scope of Works/ Method of Repair</b></p> <ol style="list-style-type: none"> <li>1. Protect all adjoining surfaces around work area.</li> <li>2. Supply and install suitable flashings at the interface between the wall cladding and the awning roof.</li> <li>3. Install suitable foam infill behind the wall cladding to conceal the cavity and timber framing in accordance with the manufacturer's recommendations.</li> <li>4. Clean-up and make good work area.</li> </ol> | |

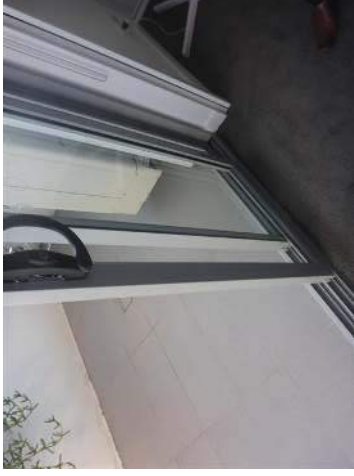
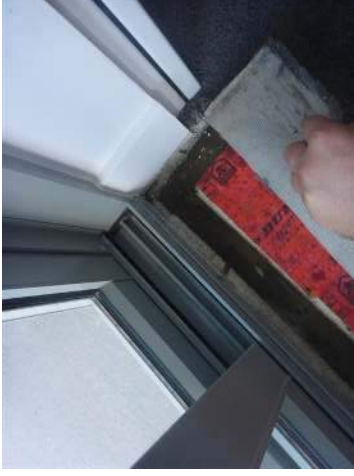
| ITEM | COMMENTARY | PHOTOGRAPH |
|---|---|---|
| A | <p><b>Location &amp; Description</b><br/>Bedroom 2:<br/>Instructed by the occupant of water penetration emanating through the south-facing balcony sliding door. Deteriorated smooth edge, carpet and underlay observed adjacent to the sliding door.</p> | |
| B | <p><b>Cause(s)</b></p> <ul style="list-style-type: none"> <li>➤ Further investigation required to determine the cause(s) of the reported building defect.</li> <li>➤ Possible failure of the waterproofing of the aluminium framed sliding door.</li> <li>➤ Possible failure of the waterproofing upturn for the balcony.</li> <li>➤ Possible failure / inadequacy of the flashings for the external wall cladding.</li> </ul> | |
| C | <p><b>Breach(es)</b><br/>Breach of <i>Performance Requirement FP1.4</i> of the Building Code of Australia, which requires that <i>a roof or external wall (including openings around windows and doors) must prevent the penetration of water that could cause:</i></p> <p>(a) <i>Unhealthy conditions, and a loss of amenity for occupants; and</i><br/>(b) <i>Undue dampness and deterioration of building elements.</i></p> <p>In failing to adequately construct the building to resist water ingress, an unsatisfactory standard of workmanship has been executed.</p> <p>Accordingly, breach of Section 18B (a) and (c) of the Home Building Act 1989 (NSW):</p> <p>(a) Failure to perform work with due care and skill.<br/>(c) Failure to perform work in accordance with the Home Building Act 1989 (NSW).</p> | |

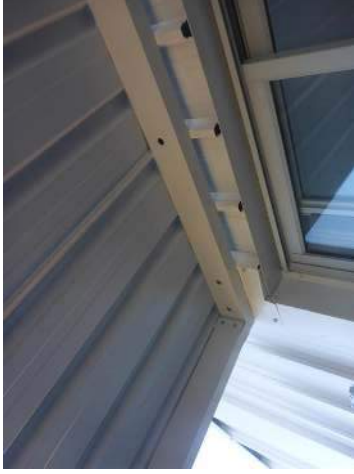
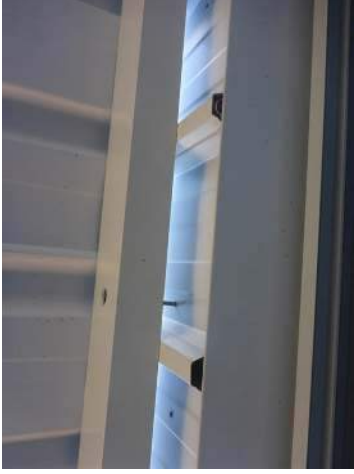
| ITEM | COMMENTARY | PHOTOGRAPH |
|---|---|---|
| A | <p><b>Location &amp; Description</b><br/>Southern balcony:<br/>Instructed by the occupant of water emanating from the interface between the awning above the sliding door and the Colorbond wall cladding. Significant gaps were observed between the awning and the wall cladding.<br/>Further instructed that the builder previously agreed to rectify this item.</p> | |
| B | <p><b>Cause(s)</b></p> <ul style="list-style-type: none"> <li>➤ Failure to adequately install the awning and associated flashings.</li> <li>➤ Failure to complete agreed remedial works.</li> </ul> | |
| C | <p><b>Breach(es)</b><br/>If the builder has failed to install the awning, external cladding and/or associated flashings in accordance with the plans and specifications, an unsatisfactory standard of workmanship has been executed.<br/><br/>Accordingly, under Section 18B (a), and (c) of the Home Building Act 1989 (NSW):<br/><br/>(a) Failure to perform work with due care and skill.<br/>(c) Failure to perform work that complies with the Home Building Act.</p> | |

| ITEM | COMMENTARY | PHOTOGRAPH |
|---|---|---|
| D | <p><b>Recommended Scope of Works/ Method of Repair</b></p> <ol style="list-style-type: none"> <li>1. Protect all adjoining surfaces around work area.</li> <li>2. Supply and install suitable flashings at the interface between the wall cladding and the awning roof.</li> <li>3. Install suitable foam infill behind the wall cladding to conceal the cavity and timber framing in accordance with the manufacturer's recommendations.</li> <li>4. Clean-up and make good work area.</li> </ol> | |

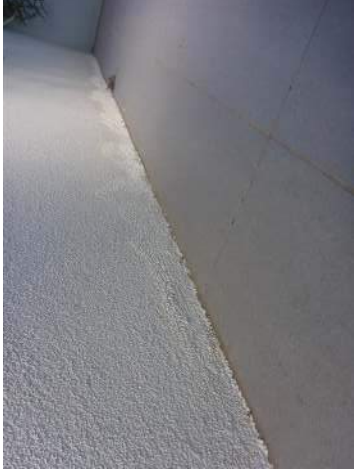
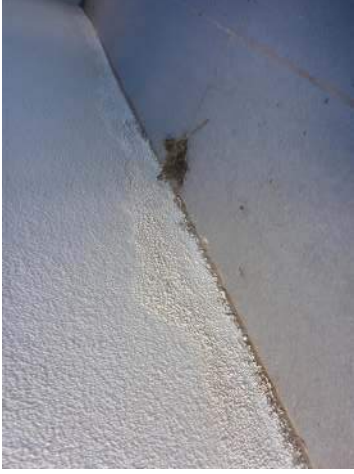
| ITEM | COMMENTARY | PHOTOGRAPH |
|---|---|---|
| A | <p><b>Location &amp; Description</b><br/>Southern balcony:<br/>Isolated blistering, flaking and discoloured paint at the base of the rendered balustrade throughout.</p> | |
| C | <p><b>Breach(es)</b><br/>In failing to use compatible materials in contact with one another, an unsatisfactory standard of workmanship has been executed.</p> <p>Breach of the Office of Fair Trading "Guide to Standards &amp; Tolerances", Section 12.02 Surface finish of paintwork: which states that "Paintwork is defective if application defects or blemishes and other irregularities in the surface are visible from a normal viewing position."</p> <p>Accordingly, under Section 18B (a) and (c) of the Home Building Act 1989 (NSW):</p> <p>(a) Failure to perform work with due care and skill.<br/>(c) Failure to perform work that complies with the Home Building Act and other laws (i.e. the Building Code of Australia).</p> | |

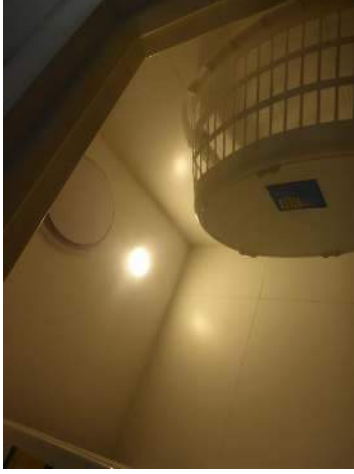
| ITEM | COMMENTARY | PHOTOGRAPH |
|---|---|---|
| A | <p><b>Location &amp; Description</b><br/>Wet area fans:<br/>Instructed by the occupant that the wet area fans do not draw sufficient air. Steam accumulates in the wet areas as a result of same.</p> | |

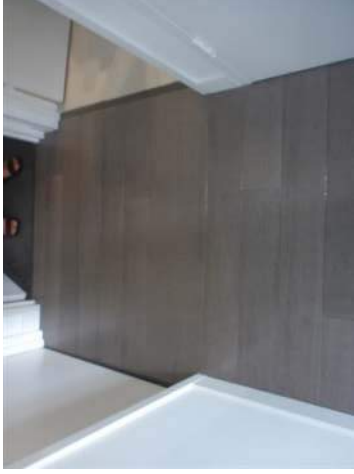
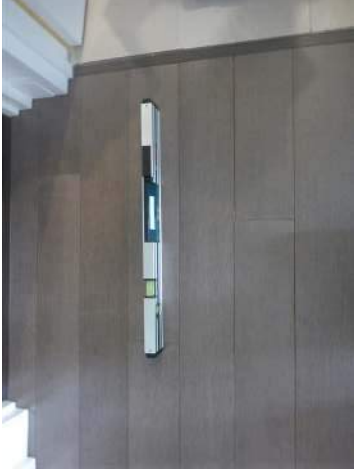
| ITEM | COMMENTARY | PHOTOGRAPH |
|---|---|---|
| A | <p><b>Location &amp; Description</b><br/>Hallway:<br/>Isolated warping and “bounce” in the timber laminate flooring adjacent to the main bedroom and bathroom.<br/>Low moisture meter readings registered in the affected areas.</p> | |
| B | <p><b>Cause(s)</b></p> <ul style="list-style-type: none"> <li>➤ Possible warping of floor due to expansion (i.e. inadequate perimeter movement joints around flooring to accommodate expansion).</li> <li>➤ There may be unfilled or unlevelled voids or other irregularities in the concrete floor surface beneath the timber floor.</li> </ul> | |

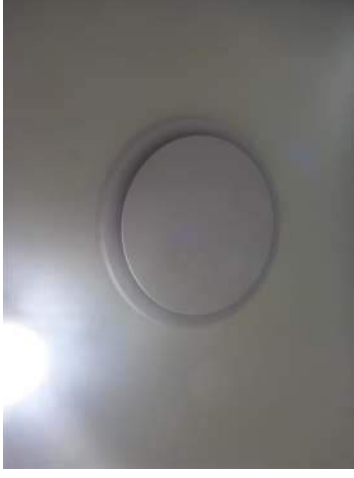
| ITEM | COMMENTARY | PHOTOGRAPH |
|---|---|---|
| A | <b>Location &amp; Description</b><br>Bathroom:<br>Instructed by the occupant that the bathroom fan does not draw sufficient air.<br>Steam accumulates in the bathroom as a result of same. | |

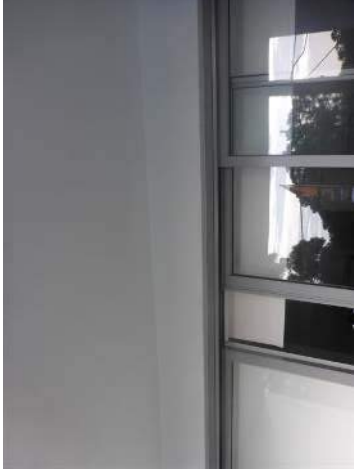
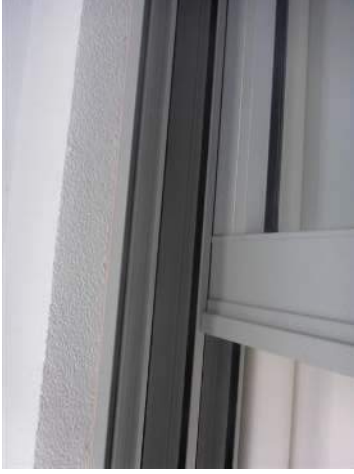
| ITEM | COMMENTARY | PHOTOGRAPH |
|---|---|---|
| A | <p><b>Location &amp; Description</b><br/> Eastern balcony:<br/> The northern sliding pane within the balcony door binds on the head of the door frame.</p> | |
| C | <p><b>Breach(es)</b><br/> In failing to adequately install the sliding balcony door, an unsatisfactory standard of workmanship has been executed.<br/> Accordingly, under Section 18B (a), and (c) of the Home Building Act 1989 (NSW):</p> <ul style="list-style-type: none"> <li>(a) Failure to perform work with due care and skill.</li> <li>(c) Failure to perform work that complies with the Home Building Act.</li> </ul> | |

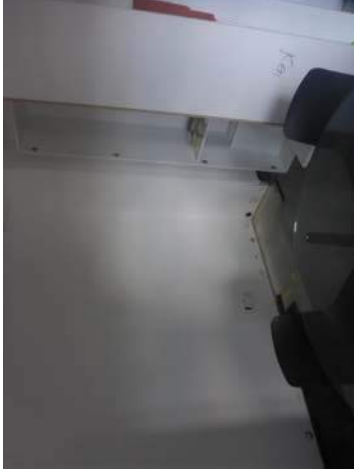
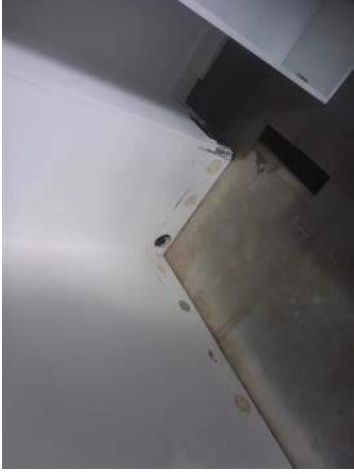
| ITEM | COMMENTARY | PHOTOGRAPH |
|---|---|---|
| A | <p><b>Location &amp; Description</b></p> <p>Dining area:<br/>Instructed by occupants of water penetration to the floor adjacent to the southern wall.<br/>The floor finishes have been removed from the affected area and inspection openings cut in the adjacent service riser.</p> <p>The affected area is located immediately below item # 14.1</p> | |
| C | <p><b>Breach(es)</b></p> <p>In failing to adequately construct the building to resist water ingress, an unsatisfactory standard of workmanship has been executed.</p> <p>Breach of <i>Performance Requirement FP1.4</i> of the Building Code of Australia, which requires that <i>a roof or external wall (including openings around windows and doors) must prevent the penetration of water that could cause:</i></p> <ul style="list-style-type: none"> <li>(a) <i>Unhealthy conditions, and a loss of amenity for occupants; and</i></li> <li>(b) <i>Undue dampness and deterioration of building elements.</i></li> </ul> <p>Accordingly, under Section 18B (a) and (c) of the Home Building Act 1989 (NSW):</p> <ul style="list-style-type: none"> <li>(a) Failure to perform work in a proper and workmanlike manner.</li> <li>(c) Failure to perform work that complies with the Home Building Act.</li> </ul> | |

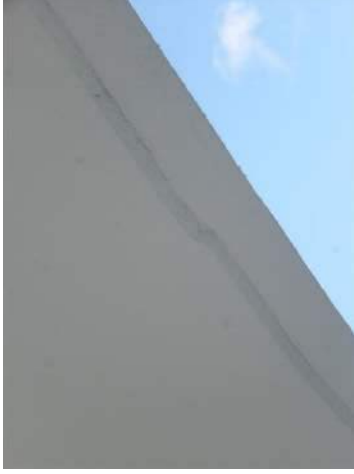
| ITEM | COMMENTARY | PHOTOGRAPH |
|---|---|---|
| A | <p><b>Location &amp; Description</b><br/>Western balcony:<br/>The drip groove above the balcony has not been formed straight and even.</p> | |

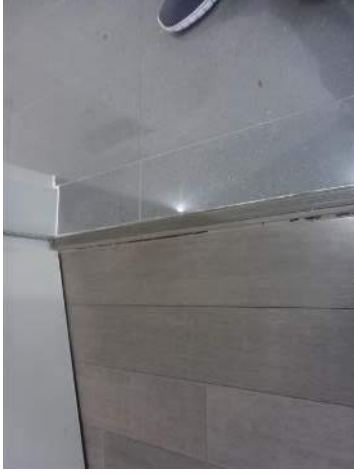
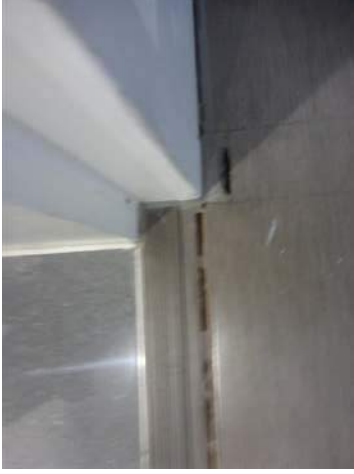
| ITEM | COMMENTARY | PHOTOGRAPH |
|---|---|---|
| A | <p><b>Location &amp; Description</b><br/>Entry door:<br/>Excessive separation of the joint in the timber laminate flooring adjacent to the trim strip.<br/>Gaps up to approximately 5-7mm in width to same.</p> | |
| C | <p><b>Breach(es)</b><br/>In failing to adequately install the timber laminate flooring with adequate allowance for movement, an unsatisfactory standard of workmanship has been executed.</p> <p>Section 14.03 <i>Gaps in exposed timber flooring</i> in the Office of Fair Trading 'Guide to standards and tolerances' dated 2007 stipulates that <i>flooring is defective if it has a gap of more than 2mm between adjacent boards that extend for more than 1m and that flooring is defective if it has gaps of more than 5mm in total of gaps between four consecutive boards.</i></p> <p>Accordingly, under Section 18B (a) and (c) of the Home Building Act 1989 (NSW):</p> <p>(a) Failure to perform work with due care and skill.<br/>(c) Failure to perform work that complies with the Home Building Act.</p> | |

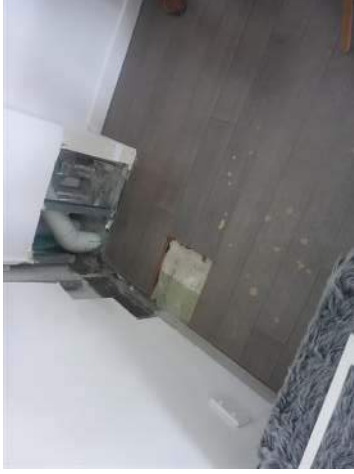
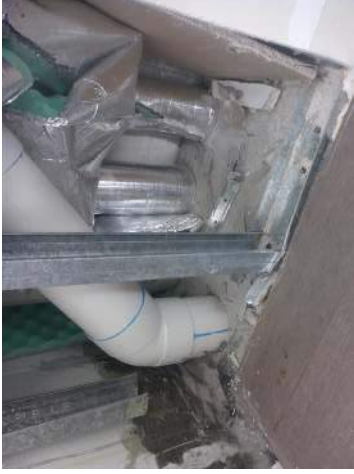
| ITEM | COMMENTARY | PHOTOGRAPH |
|---|---|---|
| A | <p><b>Location &amp; Description</b><br/>Dining room:<br/>Evidence of water penetration emanating from the base of the southern wall in the form of staining to the concrete floor.<br/>Evidence of previous inspections in the form of inspection opening in the service riser in the south-western corner.<br/>Isolated timber laminate flooring has been removed from the affected area.</p> <p>Instructed of previous isolated remedial works by the original builder and ongoing water penetration following same.<br/>Photographs of the exterior of the wall and ongoing water penetration (following our inspection) were provided by the lot owner.</p> | |
| C | <p><b>Breach(es)</b></p> <p>In failing to adequately construct the building to resist water ingress, an unsatisfactory standard of workmanship has been executed.</p> <p>Breach of <i>Performance Requirement FP1.4</i> of the Building Code of Australia, which requires that <i>a roof or external wall (including openings around windows and doors) must prevent the penetration of water that could cause:</i></p> <ul style="list-style-type: none"> <li>(a) <i>Unhealthy conditions, and a loss of amenity for occupants; and</i></li> <li>(b) <i>Undue dampness and deterioration of building elements.</i></li> </ul> <p>Accordingly, under Section 18B (a) and (c) of the Home Building Act 1989 (NSW):</p> <ul style="list-style-type: none"> <li>(a) Failure to perform work in a proper and workmanlike manner.</li> <li>(c) Failure to perform work that complies with the Home Building Act.</li> </ul> | |

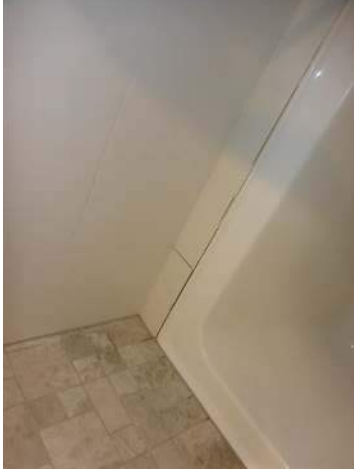
| ITEM | COMMENTARY | PHOTOGRAPH |
|---|---|---|
| A | <p><b>Location &amp; Description</b><br/>Bathroom:<br/>Separation up to approximately 1.0mm in width between the bathtub and tiled hob opposite the shower rose.</p> | |

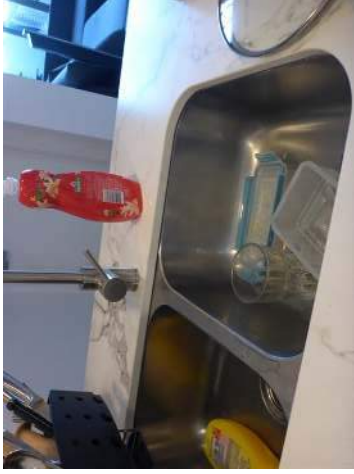
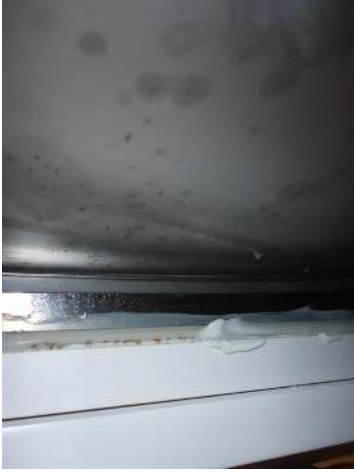
| ITEM | COMMENTARY | PHOTOGRAPH |
|---|---|---|
| A | <p><b>Location &amp; Description</b><br/> Kitchen:<br/> Instructed by the occupant of water penetration around the perimeter of the sink into the cabinet below. Isolated water staining on the underside of the benchtop at the interface with the sink and sealant works.</p> | |
| C | <p><b>Breach(es)</b><br/> In failing to install the sink in a manner that would prevent water penetration to the cupboard below, an unsatisfactory standard of workmanship has been executed.<br/> Accordingly, under Section 18B (a) and (c) of the Home Building Act 1989 (NSW):<br/> (a) Failure to perform work in a proper and workmanlike manner.<br/> (c) Failure to perform work that complies with the Home Building Act and other laws (i.e. the National Construction Code).</p> | |

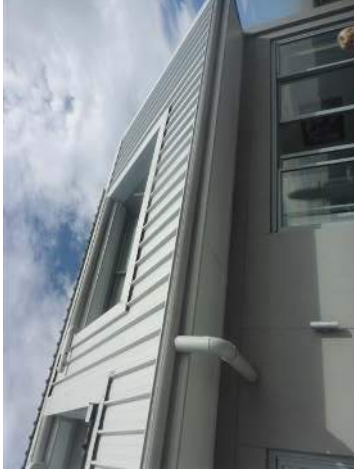
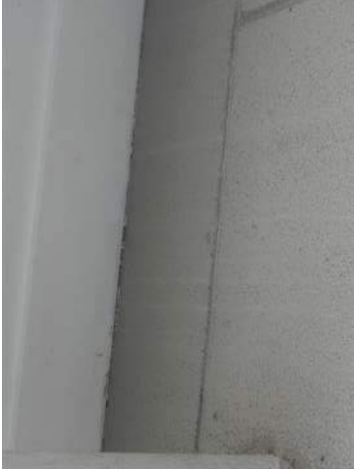
| ITEM | COMMENTARY | PHOTOGRAPH |
|---|---|---|
| A | <p><b>Location &amp; Description</b><br/> Eastern Balcony:<br/> Water seepage emanating from the interface between the external AFS wall and the eaves lining.<br/> Streaming staining visible on the exterior of the walls.<br/> A dormer window is located above the affected area.</p> | |
| C | <p><b>Breach(es)</b><br/> In failing to adequately install the flashings for the gutter and/or rooftop, an unsatisfactory standard of workmanship has been executed.</p> <p>Accordingly, under Section 18B (a) and (b) of the Home Building Act 1989 (NSW):</p> <p>(a) Failure to perform work in a proper and workmanlike manner.<br/> (b) Failure to supply materials that are good and suitable for the purpose for which they are used.</p> | |

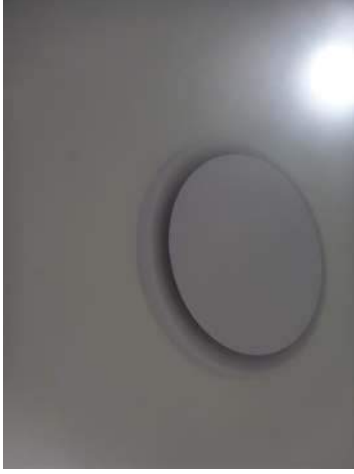
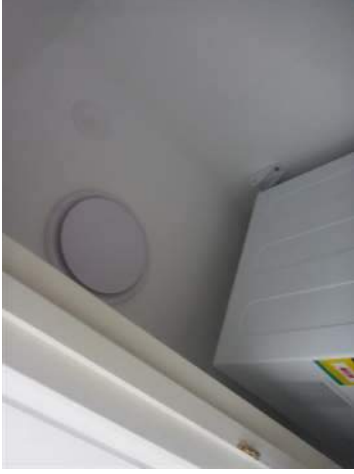
| ITEM | COMMENTARY | PHOTOGRAPH |
|---|---|---|
| A | <p><b>Location &amp; Description</b><br/>Wet area fans:<br/>Instructed by the occupant that the wet area fans do not draw sufficient air. Steam accumulates in the wet areas as a result of same.</p> | |
| C | <p><b>Breach(es)</b><br/>To be confirmed, Pending further investigation by qualified ventilation consultant.</p> <p>If the builder has failed to adequately install and commission the ventilation system, an unsatisfactory standard of workmanship has been executed.</p> <p>Accordingly, under Section 18B (a), and (c) of the Home Building Act 1989 (NSW):</p> <p>(a) Failure to perform work with due care and skill.<br/>(c) Failure to perform work that complies with the Home Building Act.</p> | |

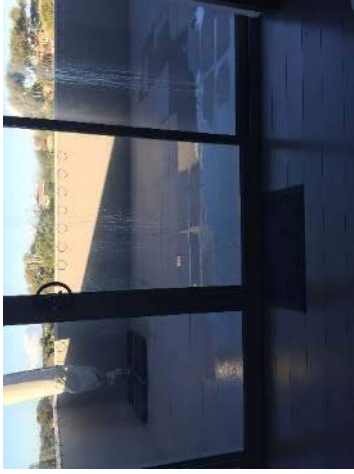
| ITEM | COMMENTARY | PHOTOGRAPH |
|---|---|---|
| A | <p><b>Location &amp; Description</b><br/>Balcony:<br/>Instructed by the occupant of streaming staining on the glass balcony doors that cannot be cleaned.</p> | <p>Photograph provided by the lot Owner</p> |

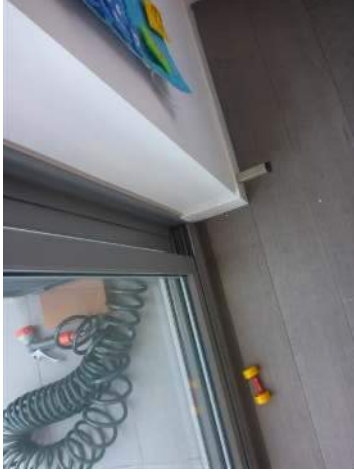
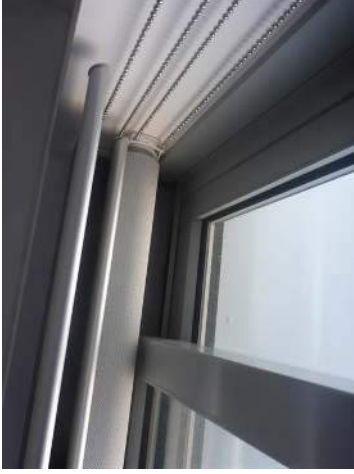
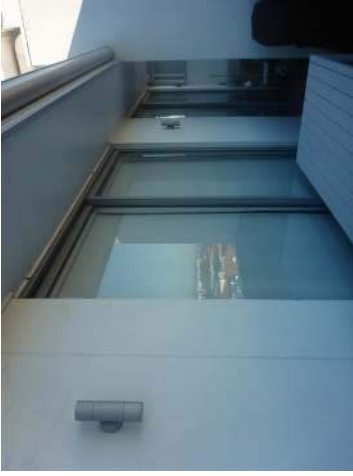
| ITEM | COMMENTARY | PHOTOGRAPH |
|---|---|---|
| A | <p><b>Location and description</b></p> <p>Balconies:<br/>Instructed by the occupants of water penetration through both the northern and southern balcony doors during periods of wind-driven rain affecting the floors.<br/>No visible evidence of water damage to the timber laminate flooring during the inspection.</p> | |
| C | <p><b>Breach(es)</b></p> <p>To be confirmed – Pending further investigations</p> <p>If the builder has failed to adequately construct the building to resist water ingress, an unsatisfactory standard of workmanship has been executed.</p> <p>Possible breach of <i>Performance Requirement FP1.4</i> of the Building Code of Australia, which requires that <i>a roof or external wall (including openings around windows and doors) must prevent the penetration of water that could cause:</i></p> <p>(a) <i>Unhealthy conditions, and a loss of amenity for occupants; and</i><br/> (b) <i>Undue dampness and deterioration of building elements.</i></p> <p>Accordingly, breach of Section 188 (a) and (c) of the Home Building Act 1989 (NSW):</p> <p>(a) Failure to perform work with due care and skill.<br/> (c) Failure to perform work in accordance with the Home Building Act 1989 (NSW).</p> | |

| ITEM | COMMENTARY | PHOTOGRAPH |
|---|---|---|
| D | <p><b>Recommended Scope of Works/ Method of Repair</b></p> <ol style="list-style-type: none"> <li>1. Protect all adjoining surfaces around work area.</li> <li>2. Direct water against the sliding doors and walls to simulate rain and identify any waterproofing failures with same.</li> <li>3. Inspect rooftop flashings (and flood test if required) to identify any waterproofing failures with same.</li> <li>4. Detailed scope of works to be determined based on the outcome of the above testing.</li> <li>5. Rectify any waterproofing failures identified during the testing above.</li> <li>6. Water test the repairs to verify the success of same.</li> <li>7. Replace water damaged internal skirtings, underlay and carpet as required.</li> <li>8. Clean up and make good work area.</li> </ol> | |

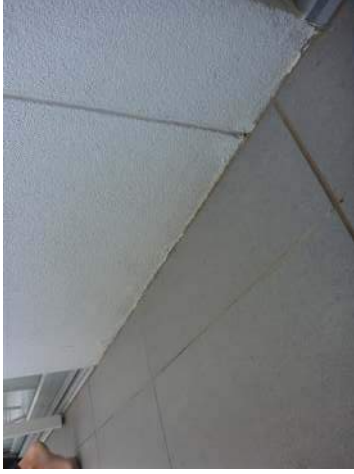
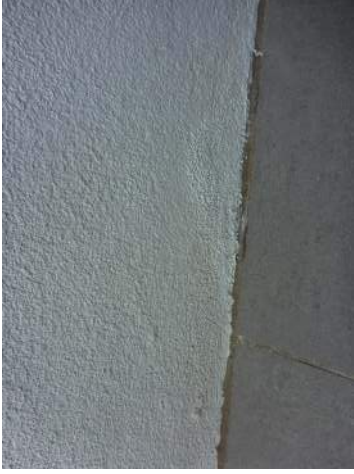
| ITEM | COMMENTARY | PHOTOGRAPH |
|---|---|---|
| A | <p><b>Location and description</b></p> <p>Balconies:<br/>Isolated blistering, flaking and discoloured paint at the base of the rendered balustrade and building walls throughout. Instructed by the occupants of increased blistering of the paint during periods of rainfall.</p> | |
| C | <p><b>Breach(es)</b></p> <p>In failing to use compatible materials in contact with one another, an unsatisfactory standard of workmanship has been executed.</p> <p><i>Section 12.02 Surface finish of paintwork: of the Office of Fair Trading "Guide to Standards &amp; Tolerances" states that "Paintwork is defective if application defects or blemishes and other irregularities in the surface are visible from a normal viewing position."</i></p> <p>Accordingly, under Section 18B (a) and (c) of the Home Building Act 1989 (NSW):</p> <p>(a) Failure to perform work with due care and skill.<br/>(c) Failure to perform work that complies with the Home Building Act and other laws (i.e. the Building Code of Australia).</p> | |

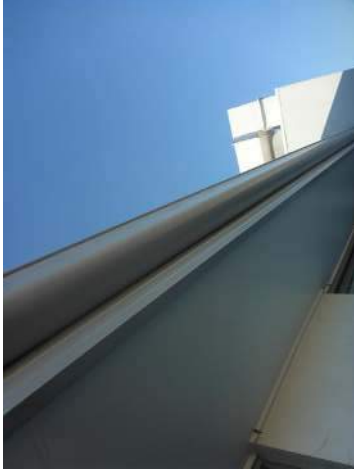
| ITEM | COMMENTARY | PHOTOGRAPH |
|---|---|---|
| A | <p><b>Location and description</b><br/> Balconies:<br/> Instructed by the occupants that water emanates from the interface between the fascias and the gutters.<br/> Streaming staining visible on the fascias below the gutters.</p> | |

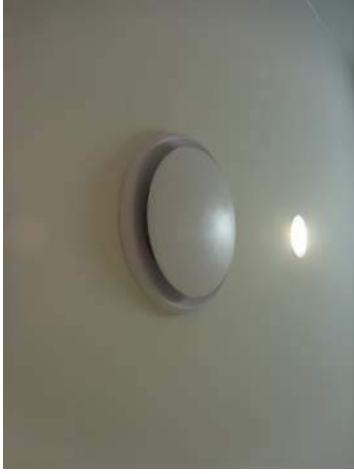
| ITEM | COMMENTARY | PHOTOGRAPH |
|---|---|---|
| A | <p><b>Location &amp; Description</b><br/>Wet area fans:<br/>Instructed by the occupant that the wet area fans do not draw sufficient air. Steam accumulates in the wet areas as a result of same.</p> | |

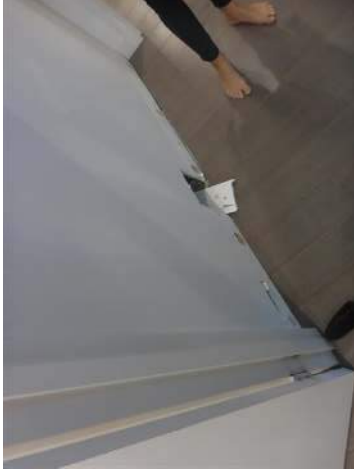
| ITEM | COMMENTARY | PHOTOGRAPH |
|---|---|---|
| A | <p><b>Location &amp; Description</b><br/>Hallway:<br/>Incomplete repair to the timber laminate flooring.<br/>Skirtings have not been reinstated throughout the unit.<br/>Inspection opening in the plasterboard wall has not been made good.</p> | |

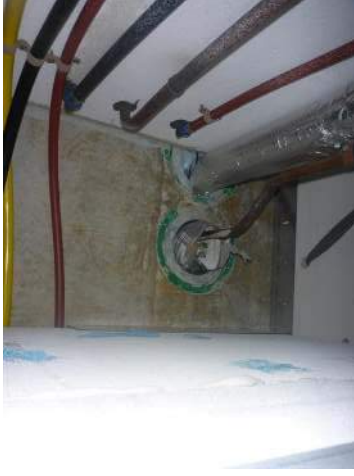
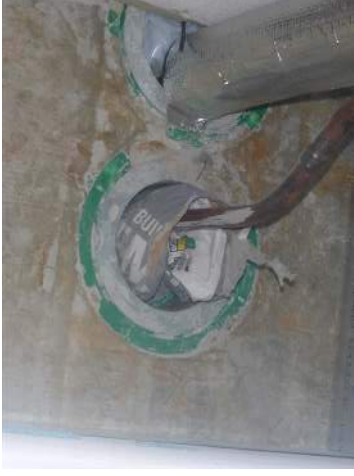
| ITEM | COMMENTARY | PHOTOGRAPH |
|---|---|---|
| A | <p><b>Location and description</b><br/> Eastern building, Level 1 – Hot water cupboard:<br/> The fire collars forming the slab penetrations have been plugged with newspaper.<br/> Cannot confirm the adequacy of the fire separation materials and construction.</p> | |
| C | <p><b>Breach(es)</b></p> <p>To be confirmed – Pending further investigation by a qualified fire services consultant.</p> <p>If the builder has failed to incorporate adequate fire separation between the floors, an unsatisfactory standard of workmanship has been executed.</p> <p>Possible breach of <i>Section C – Fire resistance</i> in the National Construction Code.</p> | |

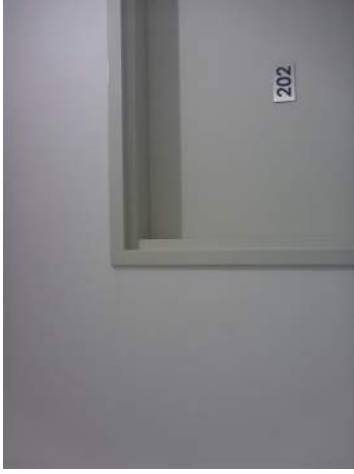
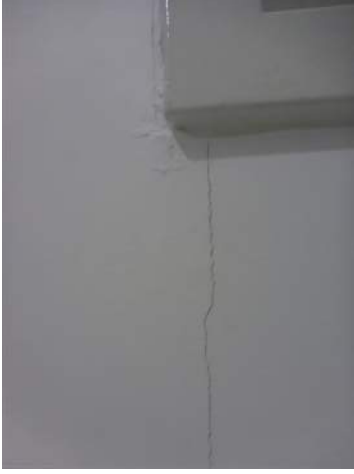
| ITEM | COMMENTARY | PHOTOGRAPH |
|---|---|---|
| A | <p><b>Location and description</b><br/>Eastern building, Level 2:<br/>Hairline separation of the horizontal joint in the plasterboard wall adjacent to the top left hand corner of the door to Unit 202.</p> | |
| C | <p><b>Breach(es)</b><br/>In failing to install the plasterboard linings to accommodate normal building movement, an unsatisfactory standard of workmanship has been executed.</p> <p>Breach of AS 2589 – 2007 <i>Gypsum Linings – Application and finishing, Clause 4.3.4 Edge Openings</i> which states:</p> <p><i>To avoid cracking of vertical joints at openings such as windows and doorways, vertical joints shall not coincide with the edge of openings and the sheets shall be laid so that the vertical joint falls a minimum of 200 mm from the edge of the opening</i></p> <p>Breach of Section 9.15 <i>Cracking in plasterboard, hard plaster and other plaster elements</i> in the Office of fair trading “Guide to standards and tolerances” dated 2007 which states that cracking in recessed or butt joints is a defect if visible from a normal viewing position.</p> <p>Accordingly, under Section 18B (a) and (c) of the Home Building Act 1989 (NSW):</p> <p>(a) Failure to perform work in a proper and workmanlike manner.<br/>(c) Failure to perform work that complies with the Home Building Act.</p> | |

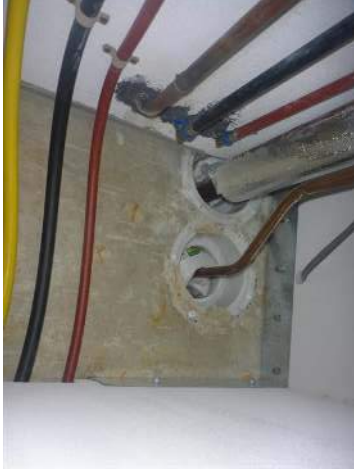
| ITEM | COMMENTARY | PHOTOGRAPH |
|---|---|---|
| A | <p><b>Location and description</b><br/> Eastern building, Level 2 – Hot water cupboard:<br/> The fire collars forming the slab penetrations have been plugged with newspaper.<br/> Cannot confirm the adequacy of the fire separation materials and construction.</p> | |

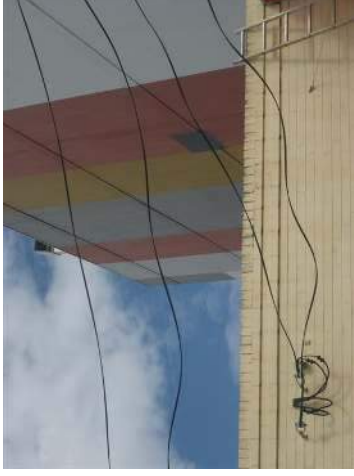
| ITEM | COMMENTARY | PHOTOGRAPH |
|---|---|---|
| A | <p><b>Location &amp; Description</b><br/> Southern Elevation – Eastern building:<br/> Isolated repairs have not been painted to match the existing on the 3<sup>rd</sup> floor slab edge.<br/> Area of unpainted façade at the 2<sup>nd</sup> floor slab edge.<br/> Elevation partially obscured by neighbouring building.</p> | |

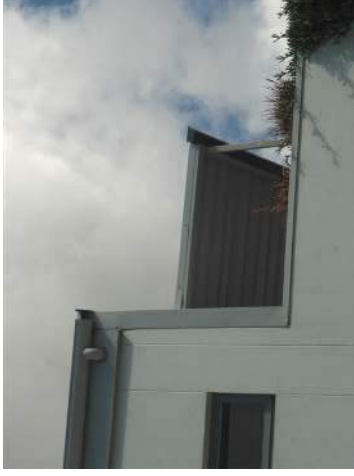
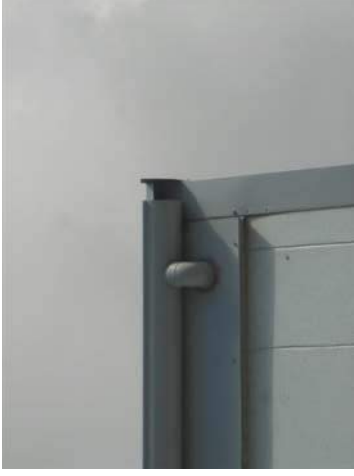
| ITEM | COMMENTARY | PHOTOGRAPH |
|---|---|---|
| A | <p><b>Location &amp; Description</b><br/> Eastern Elevation – Western building:<br/> The gutter servicing the rooftop has been finished short of the northern end of the building.<br/> A gap is visible between the end of the gutter and the adjacent fascia.</p> | |
| C | <p><b>Breach(es)</b><br/> In failing to adequately install the gutter for the full length of the rooftop, an unsatisfactory standard of workmanship has been executed.<br/> Accordingly, under Section 18B (a) and (c) of the Home Building Act 1989 (NSW):<br/> (a) Failure to perform work in a proper and workmanlike manner.<br/> (c) Failure to perform work that complies with the Home Building Act.</p> | |

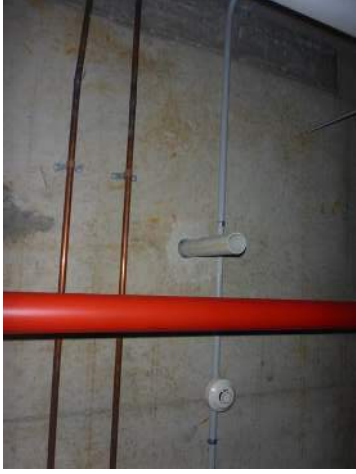
| ITEM | COMMENTARY | PHOTOGRAPH |
|---|---|---|
| C | <p><b>Breach(es)</b><br/>In failing to adequately install the PVC pipework and/or cap / remove redundant pipework, an unsatisfactory standard of workmanship has been executed.</p> <p>Accordingly, under Section 18B (a) and (c) of the Home Building Act 1989 (NSW):</p> <p>(a) Failure to perform work with due care and skill.<br/>(c) Failure to perform work that complies with the Home Building Act.</p> | |
