# SydneyStrataReport

## STRATA REPORT

| Address of property | Unit 303/446-448 Bunnerong Road,<br>Matraville, NSW. |
| Strata Plan | SP 97139 |

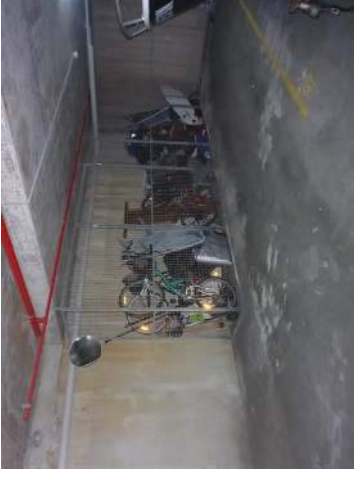
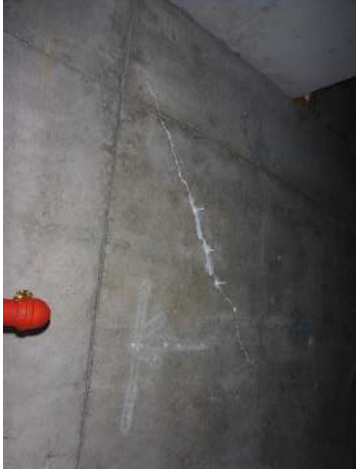
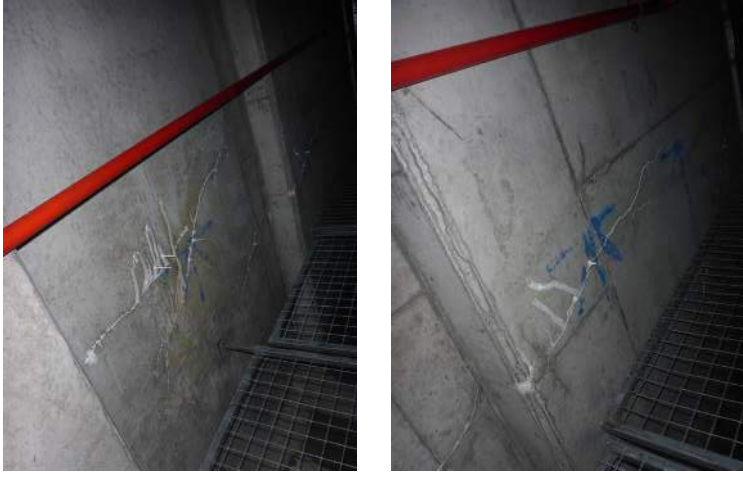
| ITEM | COMMENTARY | PHOTOGRAPH |
|---|---|---|
| A | <p><b>Location &amp; Description</b><br/> Basement carpark – Level 1:<br/> No perimeter drains have been installed to control water ingress from the concrete blockwork walls.<br/> A number of storage cages are located around the perimeter of the basement carpark, and thus are affected by water penetration.</p> | |

| ITEM | COMMENTARY | PHOTOGRAPH |
|---|---|---|
| C | <p><b>Breach(es)</b></p> <p>The water penetration emanating through the concrete slab is undermining the use and amenity of the car spaces. The minerals emanating through the cracks will permanently damage the paintwork on vehicles parked below. The car spaces therefore have not been constructed 'fit for purpose'.</p> <p>Breach of <i>Performance Requirement</i> FP1.4 of the Building Code of Australia, which requires that <i>a roof and external wall must prevent the penetration of water that could cause:</i></p> <ul style="list-style-type: none"> <li>(a) <i>Unhealthy conditions, and a loss of amenity for occupants; and</i></li> <li>(b) <i>Undue dampness and deterioration of building elements.</i></li> </ul> <p>It is noted that although the basement carpark is defined as a Class 7 building in the Building Code of Australia, there is a necessity for compliance with FP1.4 due to the damage that the water penetration can inflict on parked vehicles.</p> <p>Accordingly, under Section 18B (a) and (c) of the Home Building Act 1989 (NSW):</p> <ul style="list-style-type: none"> <li>(a) Failure to perform work in a proper and workmanlike manner.</li> <li>(c) Failure to perform work that complies with the Home Building Act and other laws (i.e. Building Code of Australia).</li> </ul> | |

| ITEM | COMMENTARY | PHOTOGRAPH |
|---|---|---|
| D | <p><b>Recommended Scope of Works/ Method of Repair</b></p> <ol style="list-style-type: none"> <li>1. Establish a safe, mobile work platform to access the concrete slab soffit.</li> <li>2. Protect adjoining surfaces.</li> <li>3. Mechanically chase into the concrete slab soffit along the cracks.</li> <li>4. Apply a suitable cementitious plugging mortar into the chases in accordance with the manufacturer instructions.</li> <li>5. Apply a suitable cementitious over-coat membrane on the plugging mortar in accordance with the manufacturer instructions.</li> <li>6. Clean up and make good work areas.</li> </ol> | |

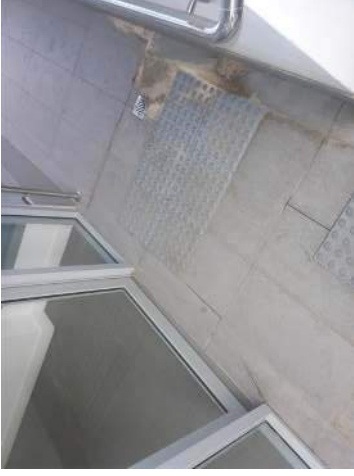
| ITEM | COMMENTARY | PHOTOGRAPH |
|---|---|---|
| C | <p><b>Breach(es)</b></p> <p>In failing to install sufficient drainage for the central courtyard, an unsatisfactory standard of workmanship has been executed.</p> <p>Accordingly, under Section 18B (a) and (c) of the Home Building Act 1989 (NSW):</p> <p>(a) Failure to perform work in a proper and workmanlike manner.</p> <p>(c) Failure to perform work that complies with the Home Building Act.</p> | |

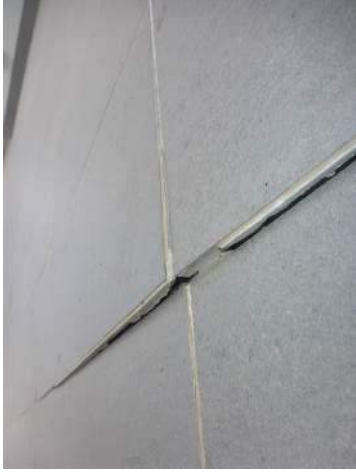
| ITEM | COMMENTARY | PHOTOGRAPH |
|---|---|---|
| C | <p><b>Breach(es)</b></p> <p>In failing to install adequate movement joints in the courtyard floor tiling, an unsatisfactory standard of workmanship has been executed.</p> <p>In accordance with the NSW Office of Fair Trading – Guide to Standards &amp; Tolerances 2007, <i>Section 11.02 Floor and wall tiling where the builder supplied the tiles:</i></p> <p><i>Where the supply and laying of the tiles is by the builder as part of the building contract, the failure of the tiles, substrate, adhesive or grout is a defect.</i></p> <p>In accordance with the NSW Office of Fair Trading – Guide to Standards &amp; Tolerances 2007, <i>Section 11.05</i> which stipulates that</p> <p><i>After handover, tiles are defective when caused by the builder's workmanship, they become cracked, pitted, chipped, loose or drummy and such in more than five per cent of the tiled area within 24 months of completion.</i></p> | |
