SydneyStrataReport

STRATA REPORT

Client	Andrew C. So
Address of property	Unit A603/2 Sunders Close, Macquarie Park, NSW.
Lot	62
Strata Plan	SP 89124
Name of Strata Management Co.	Bright & Duggan
Telephone Number of Strata Agent	9902 7100
Report Date	4 September 2023

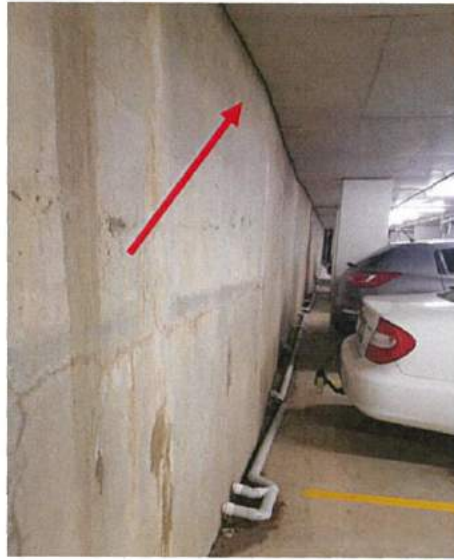
Photo 1: Photo showing a significant bow in the boundary wall on B3.

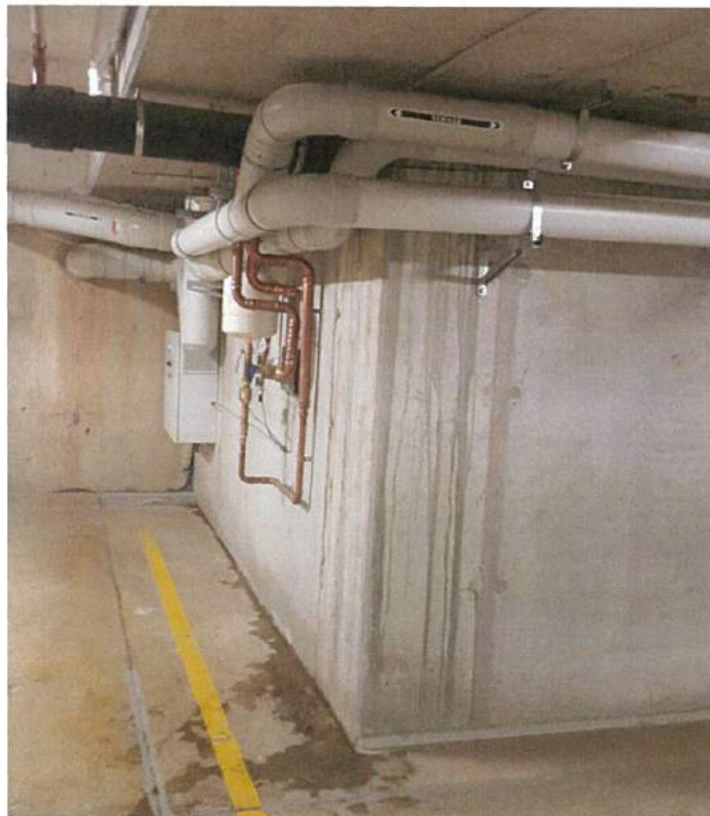
Photo 2: Leak at storm water drainage line entry point to retention tank on B1.

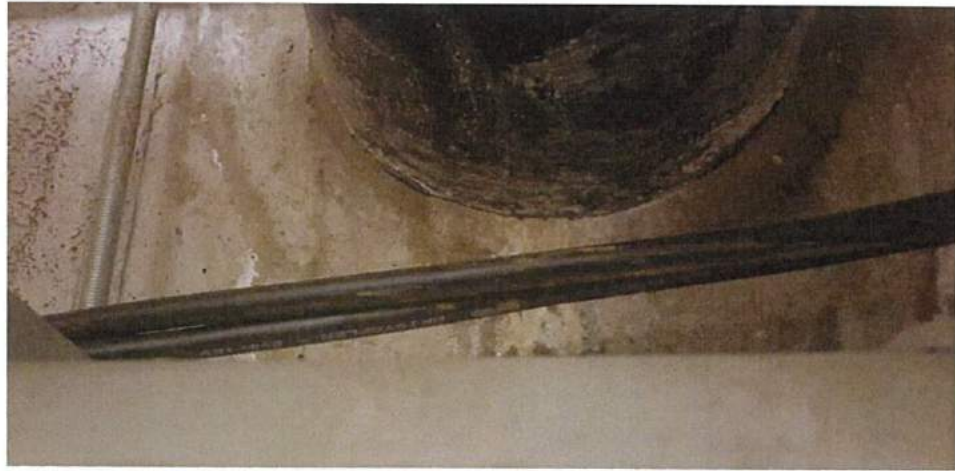
Photo 3: Closer view of the leaking junction between the cast iron pipe and concrete wall of the retention tank, this is a close up of the leak shown in Photo 2 above.

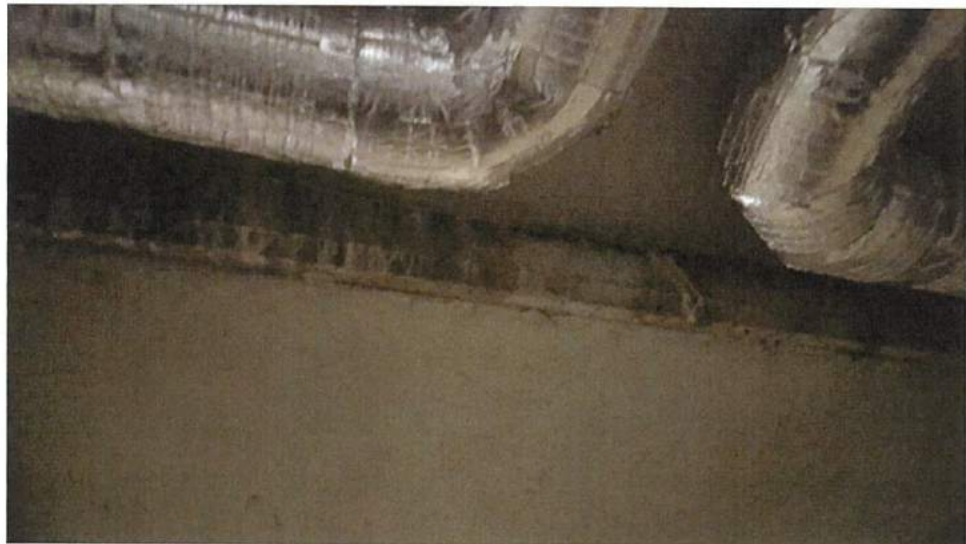
Photo 4: Leak at cold joint between floor slab and south side of elevator structure.

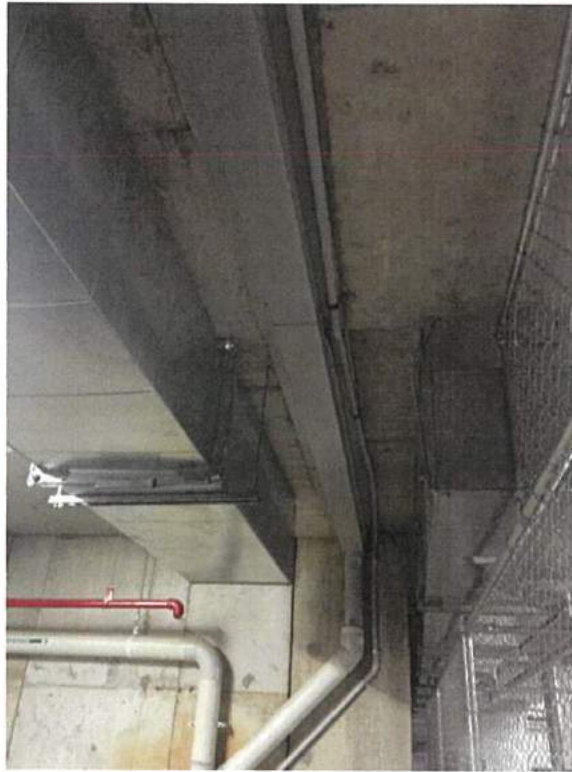
Photo 5: Sheet metal catch drain fitted to construction joint between the ground floor slabs of buildings A and B on B1. This drain was found to be leaking.

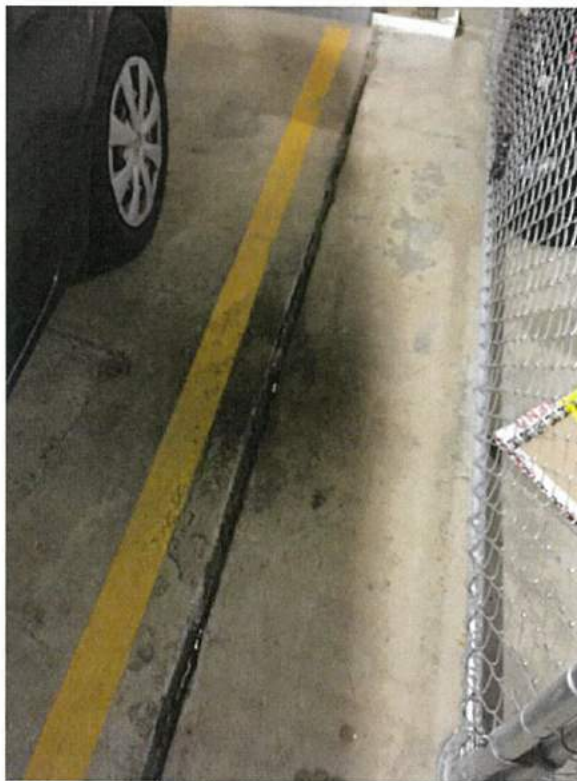
Photo 6: Moisture on surface of slab at construction joint between the B1 floor slab of buildings A and B. Photo taken immediately below location of photo 5.

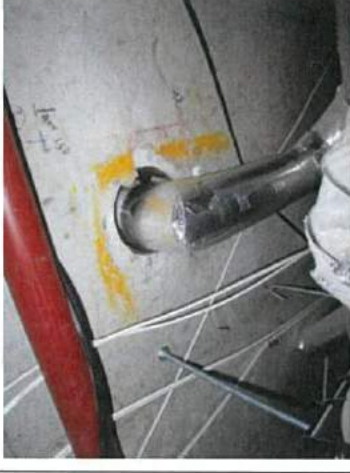
2.	Unit G06 There is a 50mm uPVC pipe located within a 100mm penetration. The penetration is protected with a fire collar. A fire collar is generally not tested for this scenario.	TBC

Toga propose to surround the penetration with a fire rated board and install a fire rated collar. Methodology and materials yet to be provided.

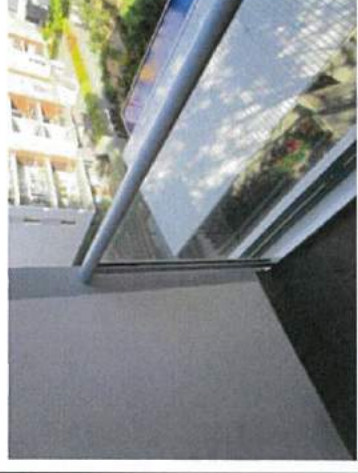
3.	Unit 510 The balcony balustrade exhibits excessive displacement when lateral force is applied. The balustrade returns are not adequately fixed into the adjacent external walls.	TBC

Toga have advised that the Owners Corporations Expert (Peter Karsai) is in discussion with an independent testing authority to satisfy testing methodology compliant with the Australian Standards. To be discussed between BCA Logic and Toga.

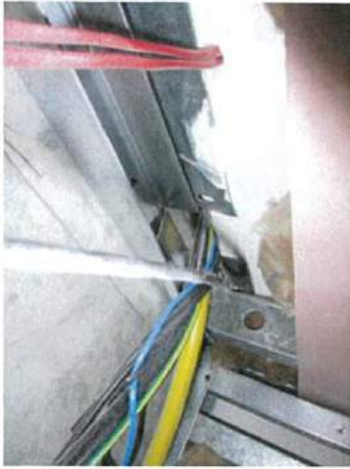
5.	Unit 905 Unsealed electrical penetrations through the bounding wall above the entry door. Electrical penetrations pass through the head stud of the Hebel wall. This allows the passage of smoke along the top of the head stud.	1. Appropriately seal around the electrical penetrations with an approved fire rated mastic in accordance with the manufacturers recommendations to maintain the FRL. 2. Suitably repair the large voids within the Hebel wall in strict accordance with the manufacturer's rectification methods to maintain the FRL of the wall.

Toga will reseal the penetration with Promat Promaseal AN Acrylic Sealant Test Report A-13-816

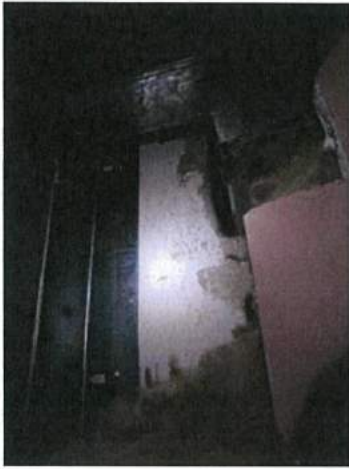
7.	<p>Unit 905</p> <p>A number of Air conditioning pipes penetrate through the bounding wall with lagging. The penetration is square and is lined with a steel casing that projects approximately 75mm out of the wall. The casing is infilled with an intumescent Grafitex like material.</p> <p>The perimeter of the steel casing is not suitably at the Hebel interface.</p> <p>Query is raised to the adequate sealing of the penetration and whether the grafitex material is located within the Hebel wall itself and not just the mouth of the casing. It is noted that the penetration requiring protection is within the wall and therefore sealing the mouth of the casing is not sufficient.</p>	TBC

<p>Toga propose to surround the penetration with a fire rated board and install a Promat flexi wrap system.</p> <p>Methodology and materials yet to be provided.</p>

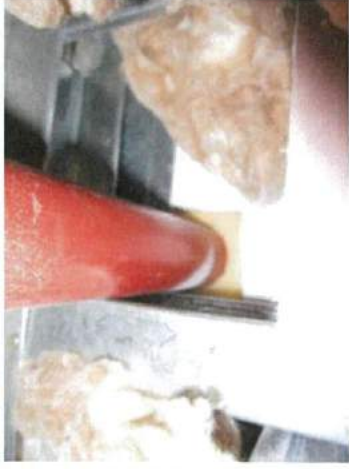
Item No.	Description and Location of the Defect	Agreed Scope of Works	BCA Logic Photograph	Defect Status and Photograph
8.	Unit 905 Unsealed sprinkler pipework through the bounding wall above the entry door. Large square penetration.	TBC

Toga propose to surround the penetration with a fire rated board and seal with Promat Promaseal AN Acrylic Sealant. Methodology and materials yet to be provided.
9.	Unit 1010 Unsealed electrical penetrations through the bounding wall above the kitchen.	1. Appropriately seal around the electrical penetrations with an approved fire rated mastic in accordance with the manufacturers recommendations to maintain the FRL.

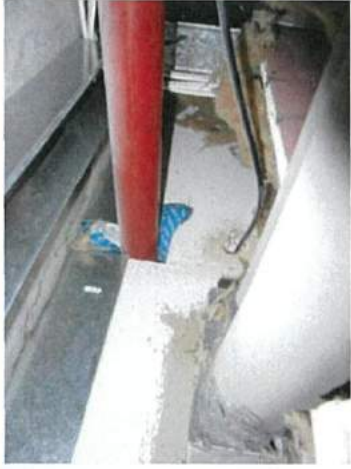
Item No.	Description and Location of the Defect	Agreed Scope of Works	BCA Logic Photograph	Defect Status and Photograph
11.	Unit 1010 Poorly sealed sprinkler pipework through the bounding wall above the kitchen. No evidence of mastic. Fire pillow installed within penetration. Large square penetration through the head stud of the Hebel wall. This allows the passage of smoke along the top of the head stud.	TBC

Toga propose to surround the penetration with a fire rated board and seal with Promat Promaseal AN Acrylic Sealant. Methodology and materials yet to be provided.

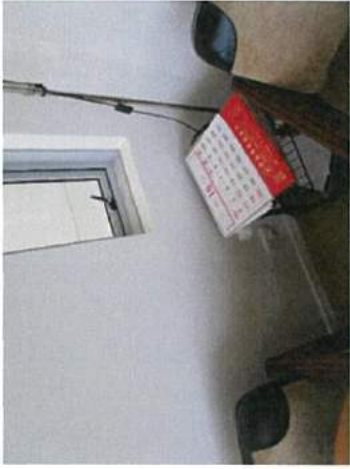
12.	Unit 1010 The barrier below the openable window is 795mm measured from the finished floor level. The window has no opening restriction. <u>Consequence:</u> There is risk of a person(s) falling from the window.	Defect - Advised PCA instructed for a window restrictor to be provided at time of construction. Agreed BCA Logic to review and provide further comment. We have reviewed PCA comments and BCA Clause D2.16 of BCA2011. Any window opening below a 4m fall measured from the internal floor finish has a concession applicable to not provide a barrier in accordance with BCA Clause D2.16(a). However, where there is a fall of more than 4m, BCA Clause D2.16(g)(C) requires a barrier at a height of 865mm beneath an openable window. It is noted that the window in the closed position is a barrier in itself. There are provisions in other parts of this clause that permit openings to be restricted to 125mm to maintain DTS compliance. It is also noted that the existing windows do not have any climbable elements within 150mm and 760mm. Based on these 3

Toga have advised all windows with a sill height less than 865mm will be checked for a restricting device. Where a restricting device is removed or not evident, Toga shall install one.

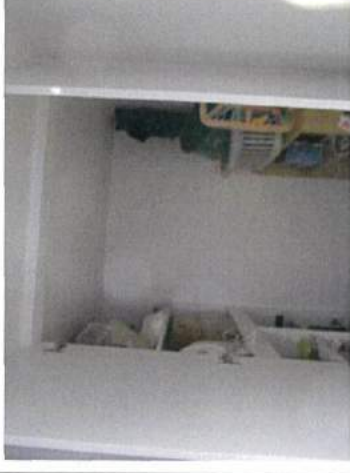
13.	<p>Unit 1010</p> <p>The laundry is provided with a sectioned off storage area. Two doors are provided to segregate the laundry from the storage cupboard. No sprinkler head is located within this large storage cupboard. The storage cupboard was measured to be approximately 1.67m wide x 1.01m deep x 2.3m high.</p>	<p>1. Engage a hydraulic engineer/contractor to review the existing sprinkler system and provide an additional sprinkler head within the storage room.</p> <p>2. Alternatively, permanently remove the doors to the storage room to allow a fire to activate the laundry sprinkler head within the original designed timeframe.</p>

<p>Advised works completed. Awaiting inspection and sign-off from BCA Logic</p>

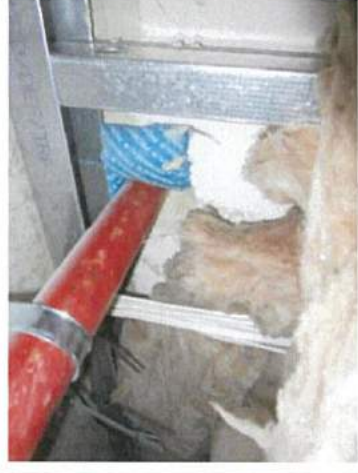
14.	<p>Unit 1102</p> <p>Poorly sealed sprinkler pipework through the bounding wall above the kitchen. No evidence of mastic. Fire pillow installed within penetration.</p> <p>Large square penetration through the head stud of the Hebel wall. This allows the passage of smoke along the top of the head stud.</p>	TBC

<p>Toga propose to surround the penetration with a fire rated board and seal with Promat Promaseal AN Acrylic Sealant.</p> <p>Methodology and materials yet to be provided.</p>

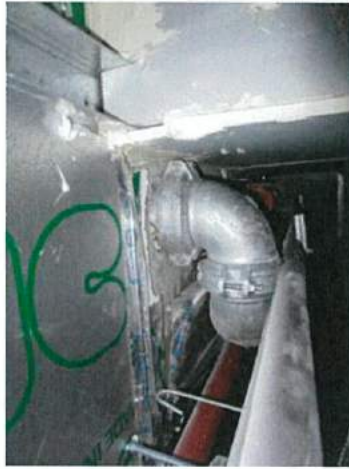
19.	<p>Unit 1201</p> <p>Unsealed hydrant pipework penetrating through the slab above the bathroom.</p>	<ol style="list-style-type: none"> 1. Appropriately seal around the hydrant pipework with an approved fire rated mastic in accordance with the manufacturers recommendations to maintain the FRL.

<p>Toga will reseal the penetration with Promat Promaseal AN Acrylic Sealant</p> <p>Test Report A-13-816</p>

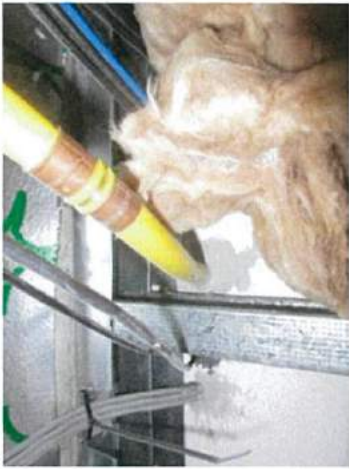
21.	Unit 1201 No fire collar to electrical conduit and PEX gas pipe through the bounding wall above the entry door. We note that the conduit and PEX pipe are sealed with a mastic.	1. Supply and install an approved fire collar such as a Promat conduit collar to the conduit and PEX pipe penetrations on both sides of the wall in accordance with the manufacturers recommendations to maintain the FRL.

Toga propose to use two Promat CFC 32 Uni Collars joined together. Methodology yet to be provided. Test Report Number A-12-163d

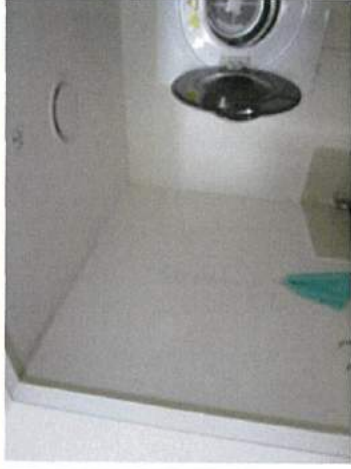
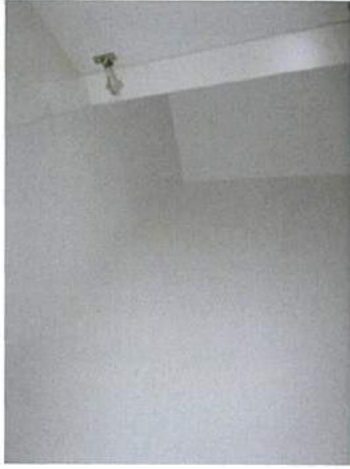
Item No.	Description and Location of the Defect	Agreed Scope of Works	BCA Logic Photograph	Defect Status and Photograph
23.	<p>Unit 1201</p> <p>The laundry is provided with a sectioned off storage area. Two doors are provided to segregate the laundry from the storage cupboard.</p> <p>No sprinkler head is located within this large storage cupboard.</p> <p>The storage cupboard was measured to be approximately 1.7m wide x 0.5m deep x 2.33m high.</p>	<ol style="list-style-type: none"> 1. Engage a hydraulic engineer/contractor to review the existing sprinkler system and provide an additional sprinkler head within the storage room. 2. Alternatively, permanently remove the doors to the storage room to allow a fire to activate the laundry sprinkler head within the original designed timeframe.

<p>Advised works completed. Awaiting inspection and sign-off from BCA Logic</p>

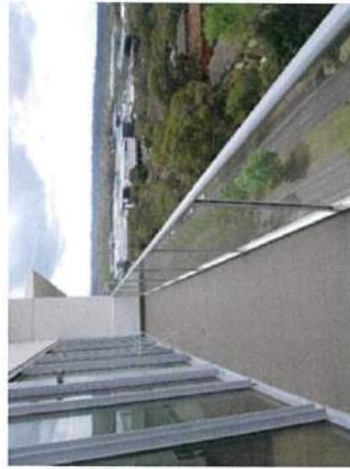
24.	<p>Unit 1201</p> <p>The balcony balustrade exhibits excessive displacement when lateral force is applied.</p> <p>The balustrade is continuous and extends approximately 16m.</p> <p>The balustrade returns are not adequately fixed into the adjacent external walls.</p>	<ol style="list-style-type: none"> 1. Engage a structural engineer to review the existing balustrade system and; determine and test the required loads. 2. Provide vertical structural stiffeners at intervals recommended by the structural engineer.

<p>Toga have advised that the Owners Corporations Expert (Peter Karsai) is in discussion with an independent testing authority to satisfy testing methodology compliant with the Australian Standards.</p> <p>To be discussed between BCA Logic and Toga.</p>

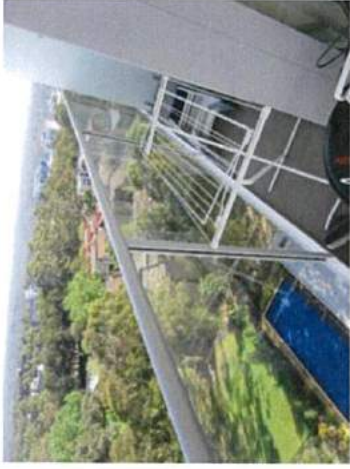
Item No.	Description and Location of the Defect	Agreed Scope of Works	BCA Logic Photograph	Defect Status and Photograph
25.	Unit 1203 The balcony balustrade exhibits excessive displacement when lateral force is applied. The balustrade is continuous and extends across 4 balconies. The balustrade returns are not adequately fixed into the adjacent external walls.	<ol style="list-style-type: none"> 1. Engage a structural engineer to review the existing balustrade system and; determine and test the required loads. 2. Provide vertical structural stiffeners at intervals recommended by the structural engineer. 3. Provide a fixing mechanism between the individual balcony privacy screens and handrail. Ensure the fixing mechanism does not facilitate climbing.

Toga have advised that the Owners Corporations Expert (Peter Karsai) is in discussion with an independent testing authority to satisfy testing methodology compliant with the Australian Standards. To be discussed between BCA Logic and Toga.

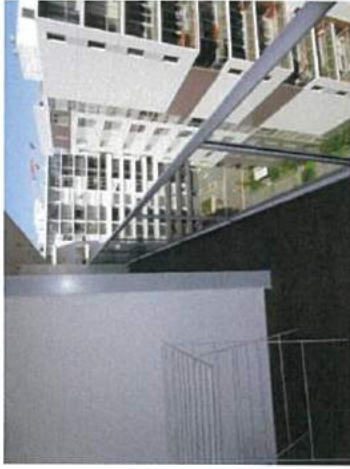
26.	Unit 1206 The balcony balustrade exhibits excessive displacement when lateral force is applied. The balustrade is continuous and extends across 4 balconies. The balustrade returns are not adequately fixed into the adjacent external walls.	<ol style="list-style-type: none"> 1. Engage a structural engineer to review the existing balustrade system and; determine and test the required loads. 2. Provide vertical structural stiffeners at intervals recommended by the structural engineer. 3. Provide a fixing mechanism between the individual balcony privacy screens and handrail. Ensure the fixing mechanism does not facilitate climbing.

Toga have advised that the Owners Corporations Expert (Peter Karsai) is in discussion with an independent testing authority to satisfy testing methodology compliant with the Australian Standards. To be discussed between BCA Logic and Toga.

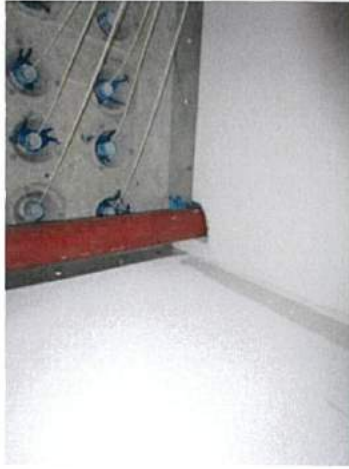
58.	<p>Level 9 – NBN Cupboard</p> <p>Unsealed sprinkler pipework through bounding wall.</p>	<p>1. Appropriately seal the sprinkler pipe with an approved fire rated mastic in accordance with the manufacturer's recommendations.</p>

<p>Toga to reseal with Promat Promaseal AN Acrylic Sealant</p> <p>Test Report A-13-816</p>
