# SydneyStrataReport

## STRATA REPORT

Client	Infinity Property Agents
Address of property	Unit 107/361-362 Military Road, Mosman, NSW.
Lot	13
Strata Plan	SP 92834
Name of Strata Management Co.	Executive Strata
Telephone Number of Strata Agent	1300 984 186
Report Date	22 April 2020

Mixed Use Residential Apartment at  
363 Military Road,  
Mosman, NSW

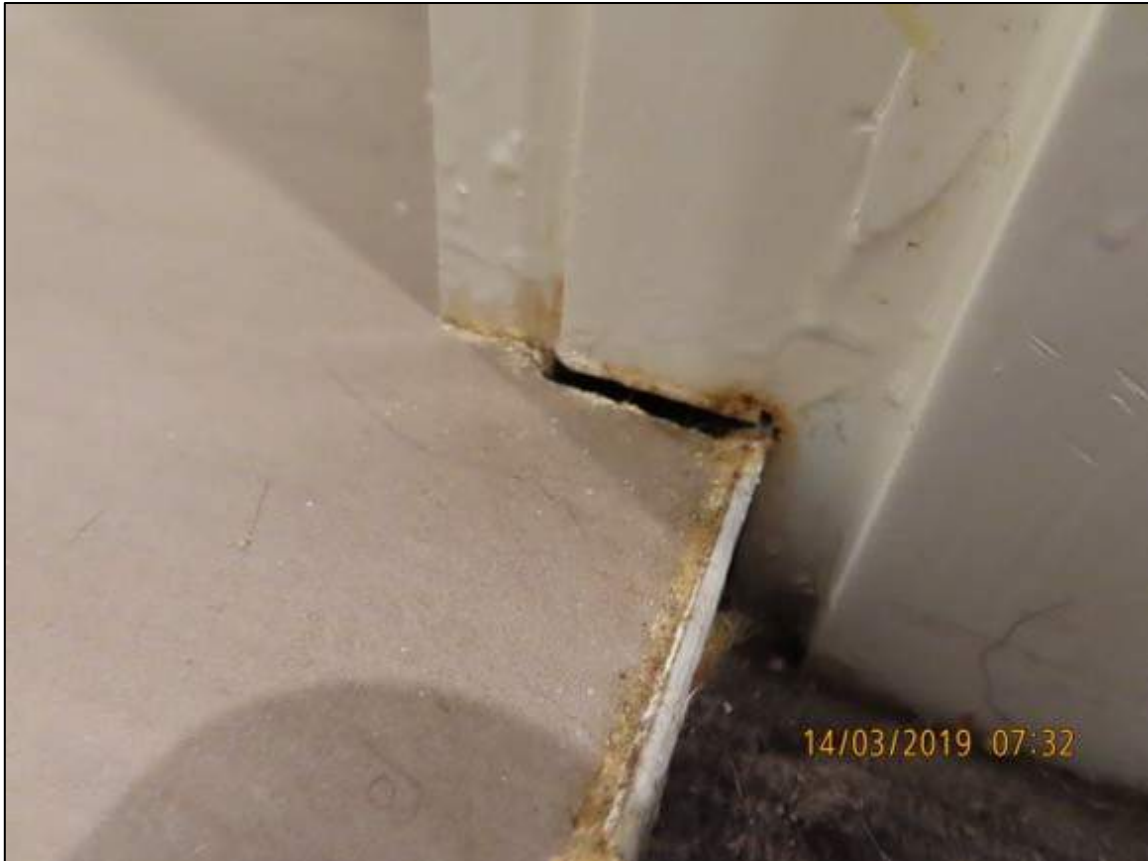
**Photograph 3:** Showing unsightly gap at threshold of Ensuite in Unit 4.

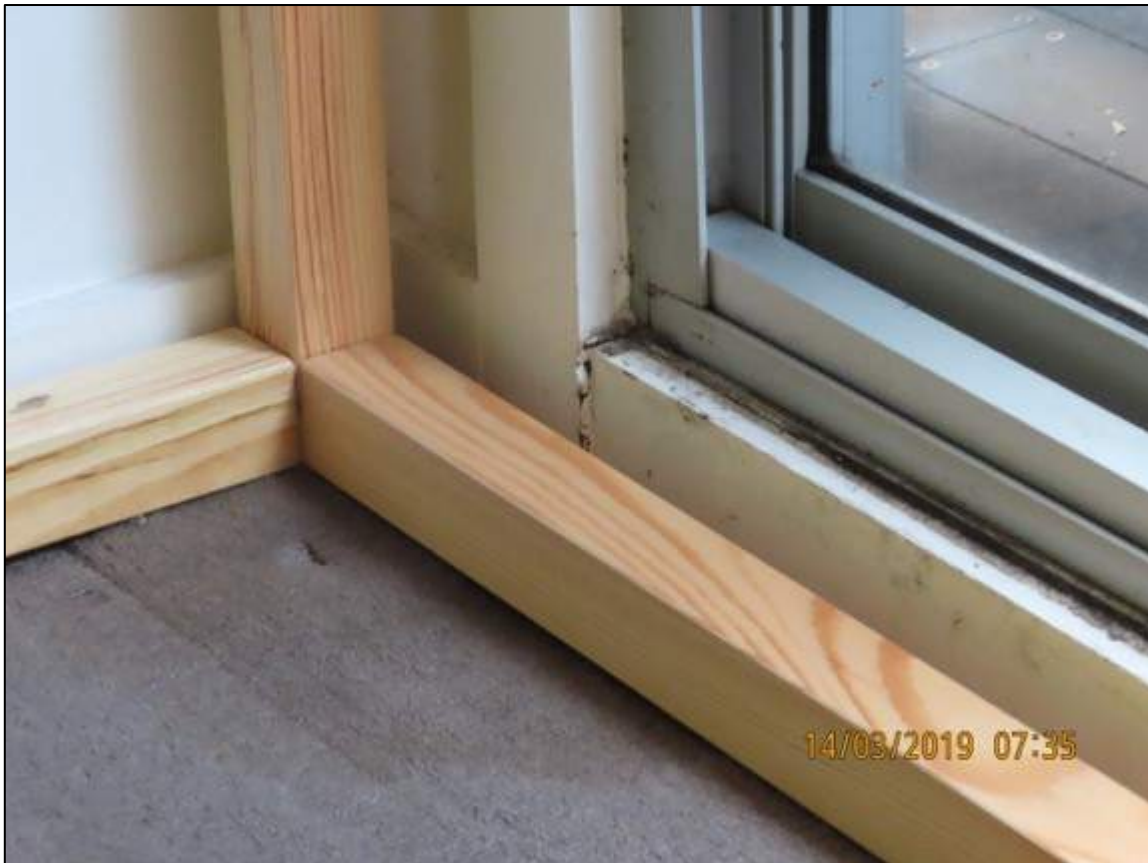
**Photograph 4:** Showing application of sealant to the threshold of Ensuite in Unit 4.

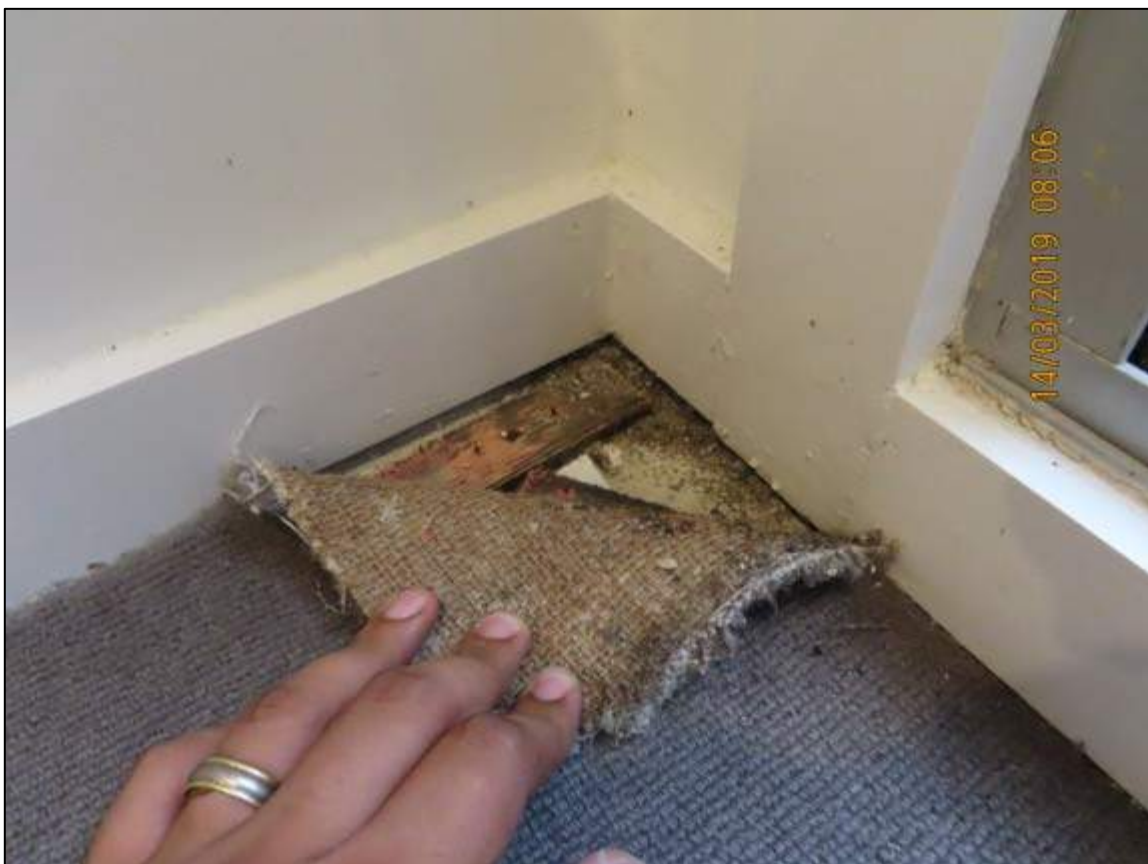
**Photograph 5:** Showing wet carpet and water staining adjacent to courtyard sliding door of Bedroom 2 in Unit 4.

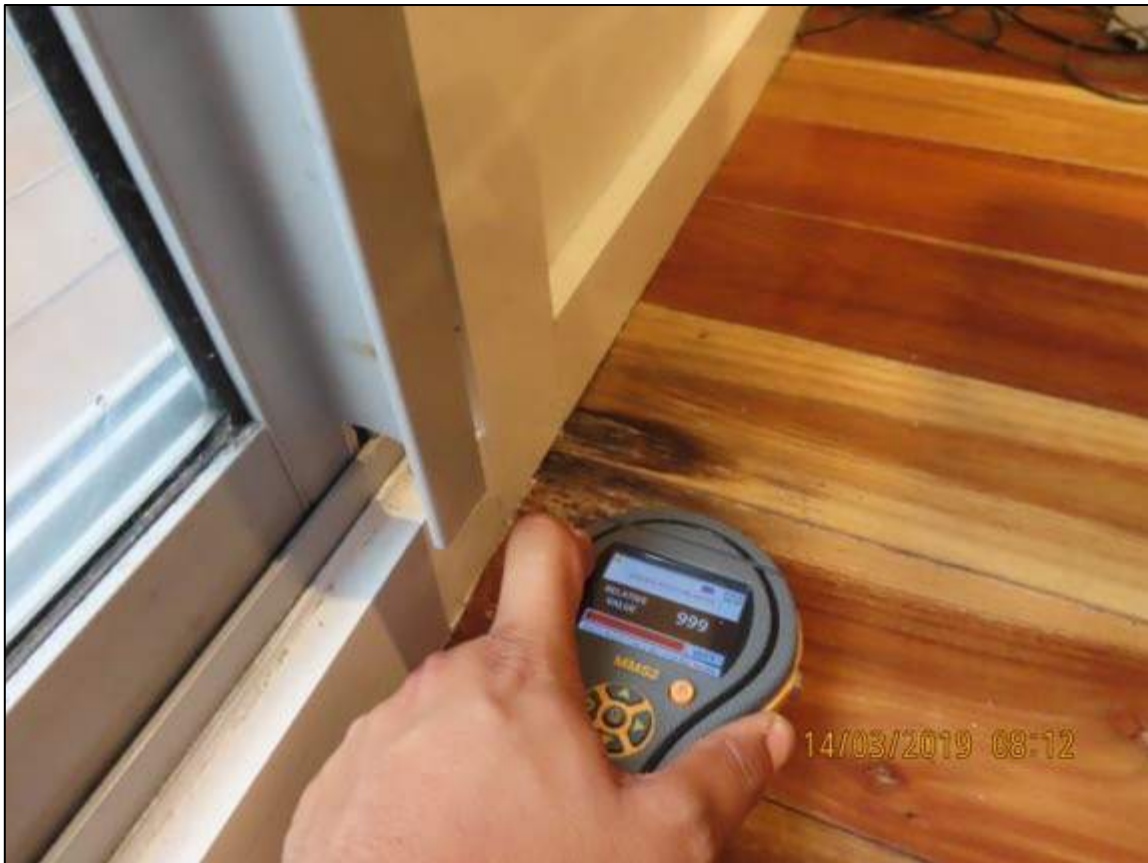
**Photograph 7:** Showing consequential damages in form of water damage to timber floorboards of Living Room in Unit 5.

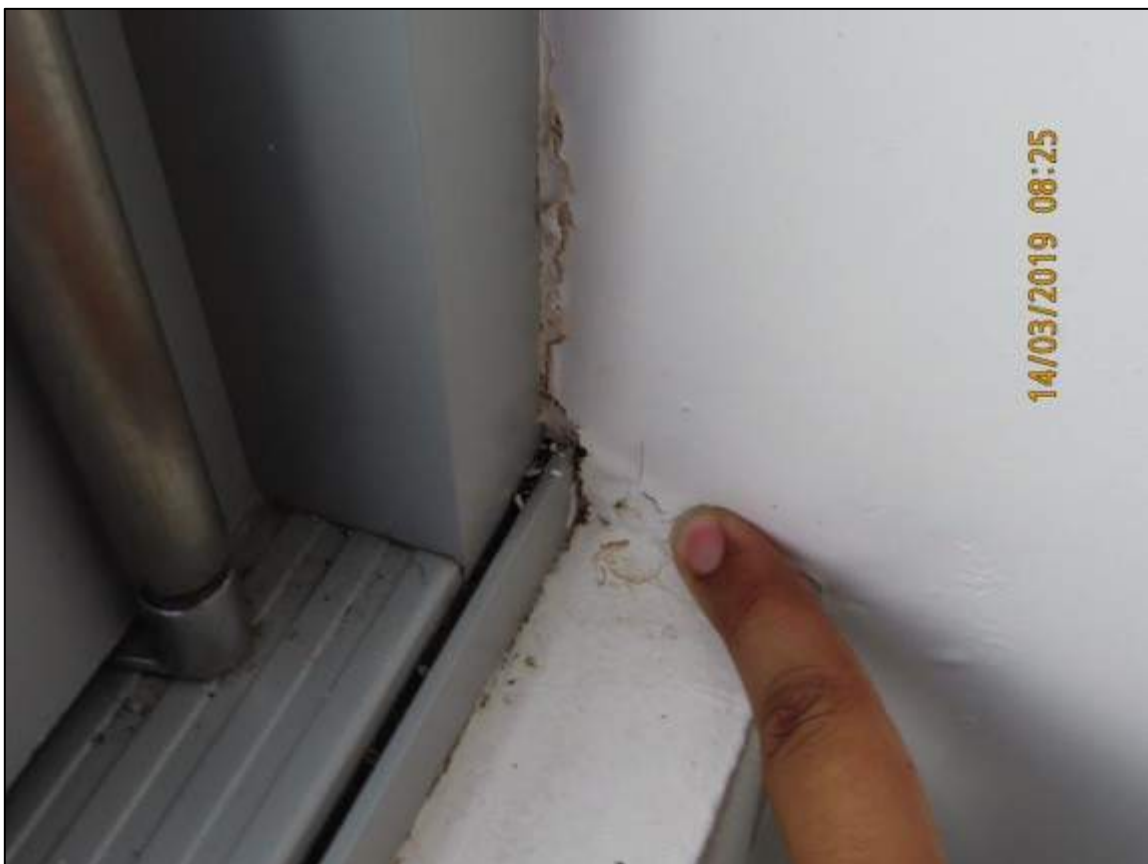
**Photograph 8:** Showing elevated moisture readings adjacent to courtyard sliding door in Living Room of Unit 5.

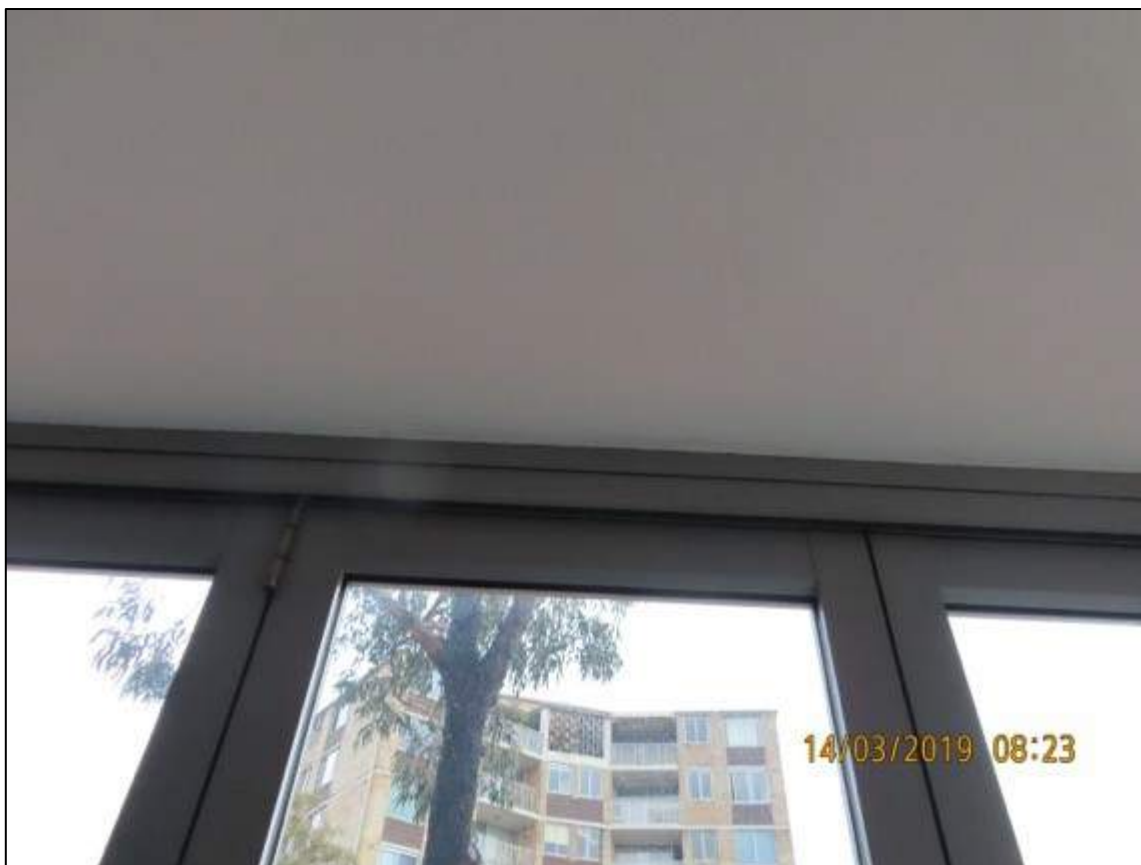
**Photograph 9:** Showing blistering plasterboard wall and water damage adjacent to the Enclosed balcony windows in Unit 8.

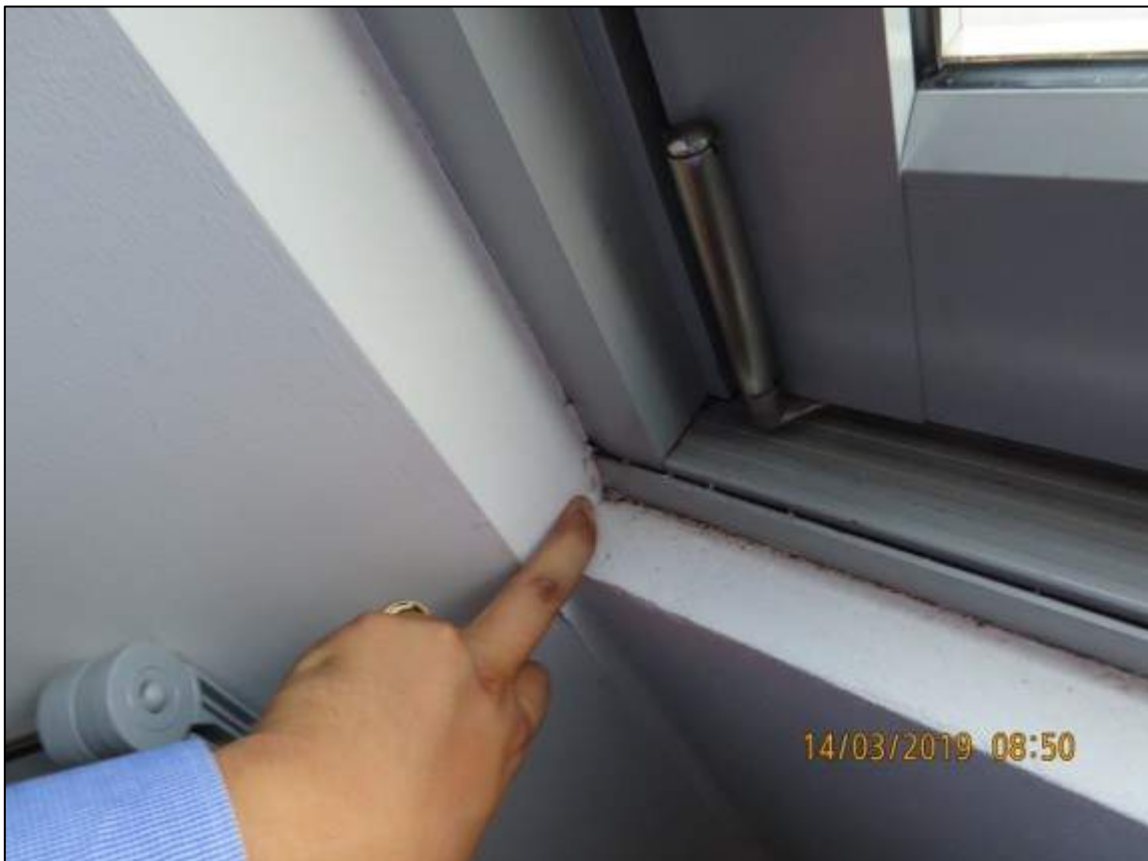
**Photograph 12:** Showing water damage adjacent to Bedroom window in Unit 8.

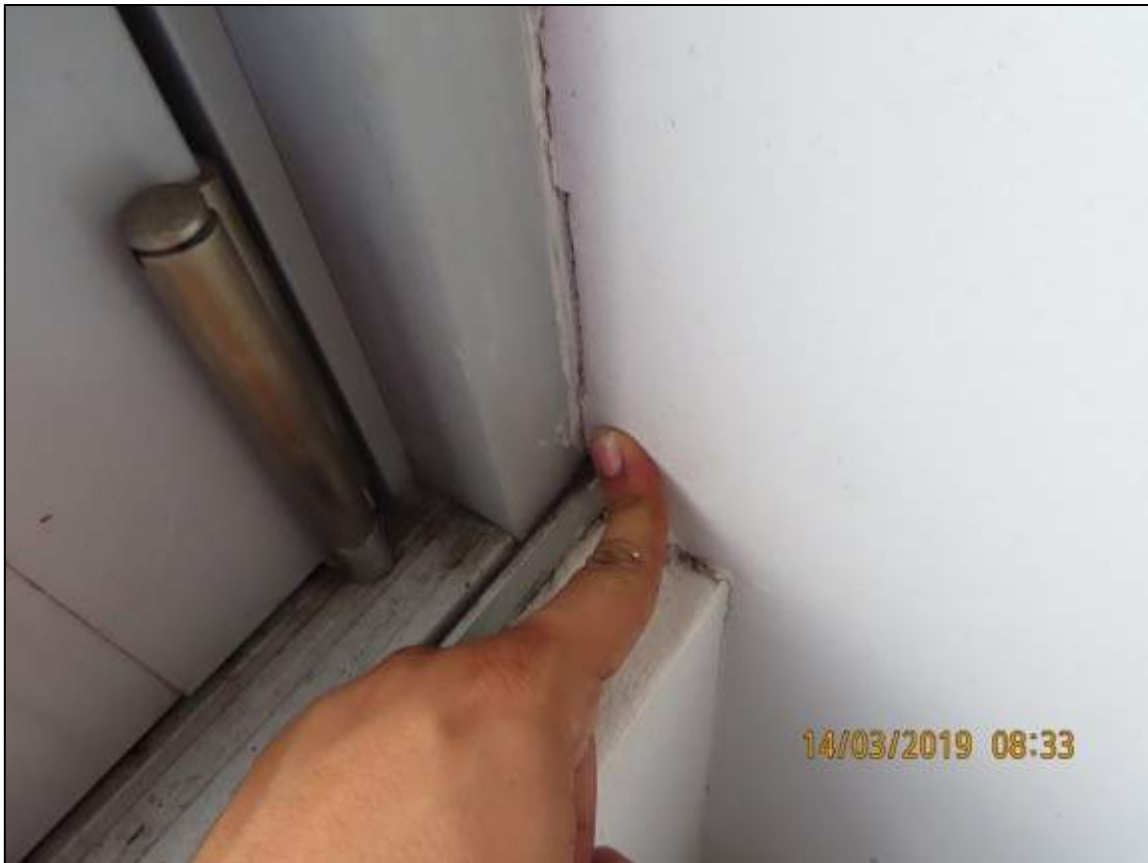
**Photograph 13:** Showing water damage and blistering plasterboard adjacent to Enclosed balcony window of Unit 9.

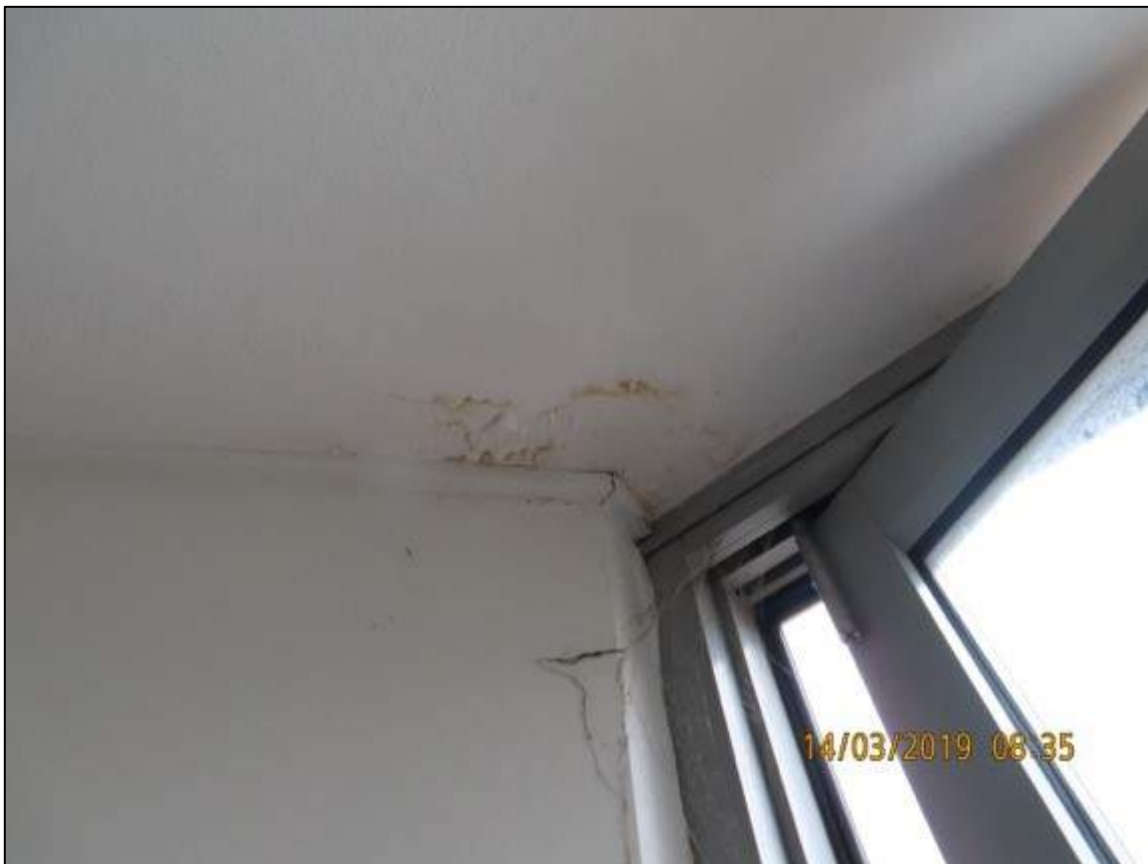
**Photograph 14:** Showing water damage adjacent to Enclosed balcony windows of Unit 10.

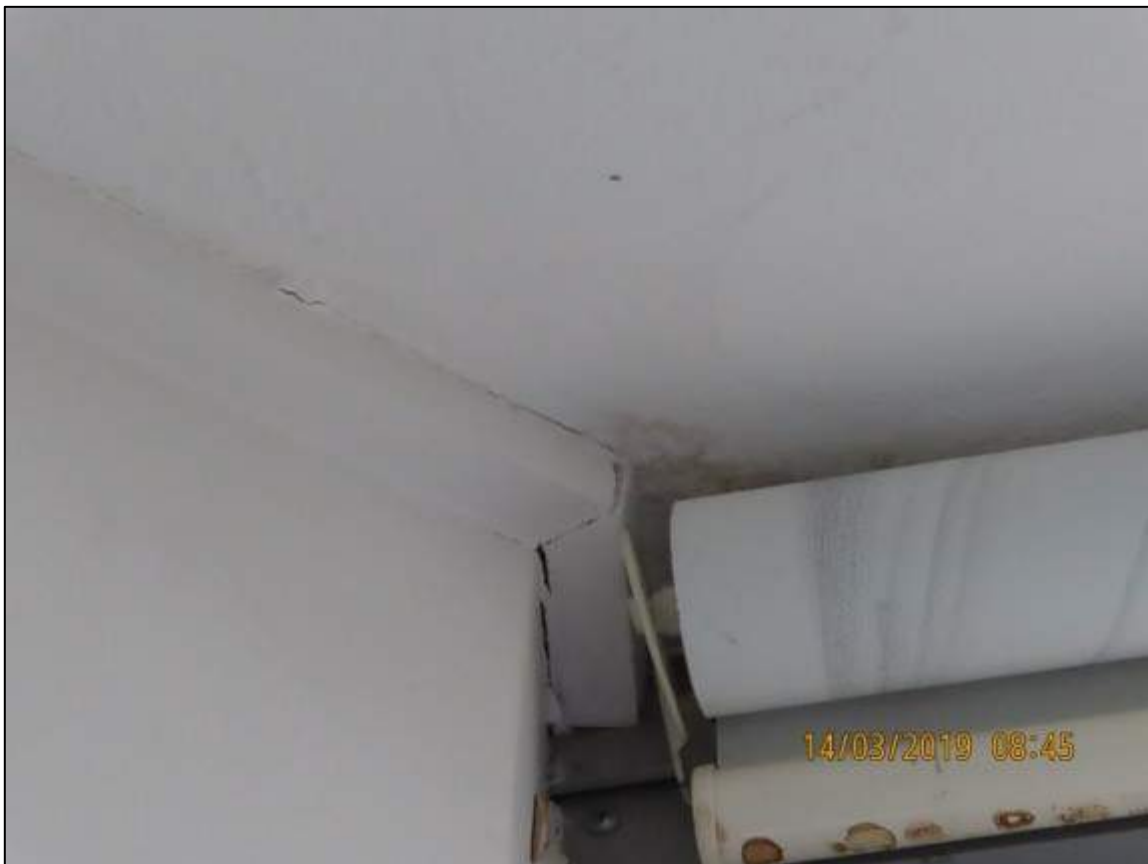
**Photograph 18:** Showing delamination of plasterboard adjacent to Enclosed balcony window of Unit 13.

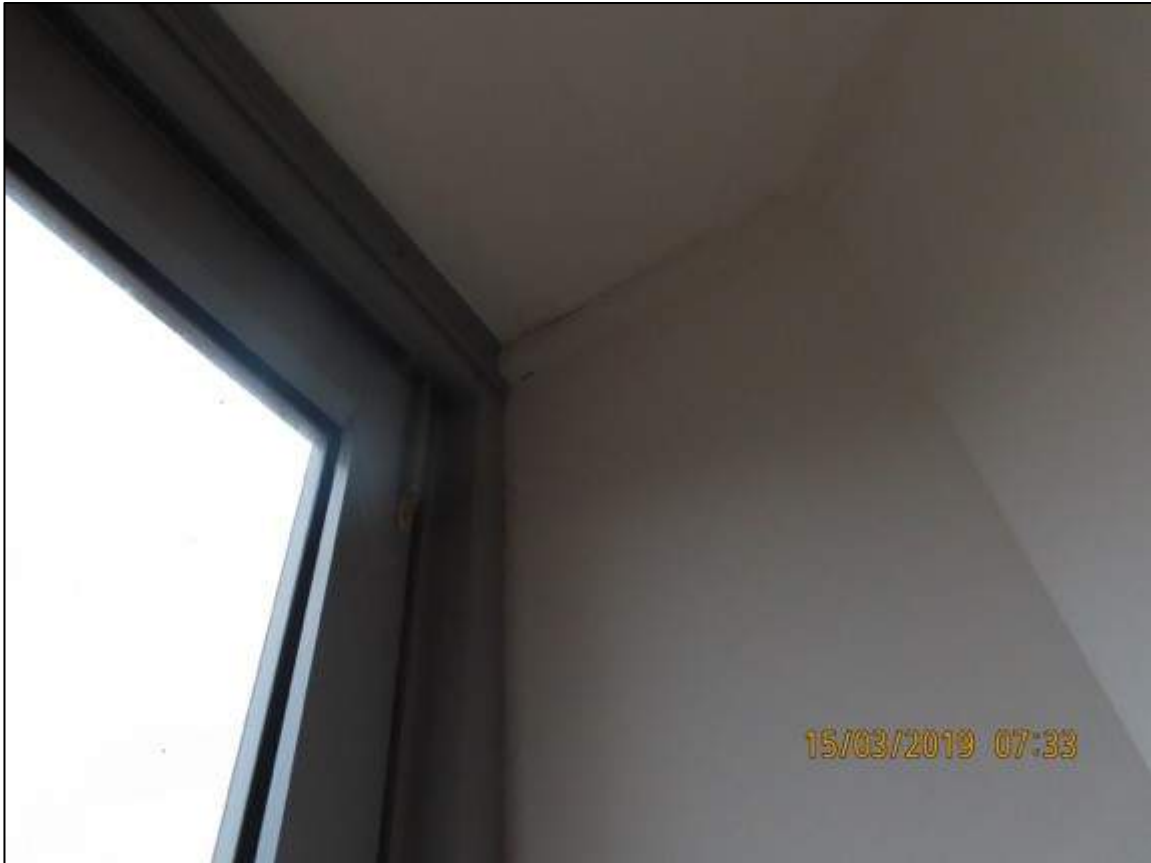
**Photograph 23:** Showing water staining to ceiling of Bathroom in Unit 15.

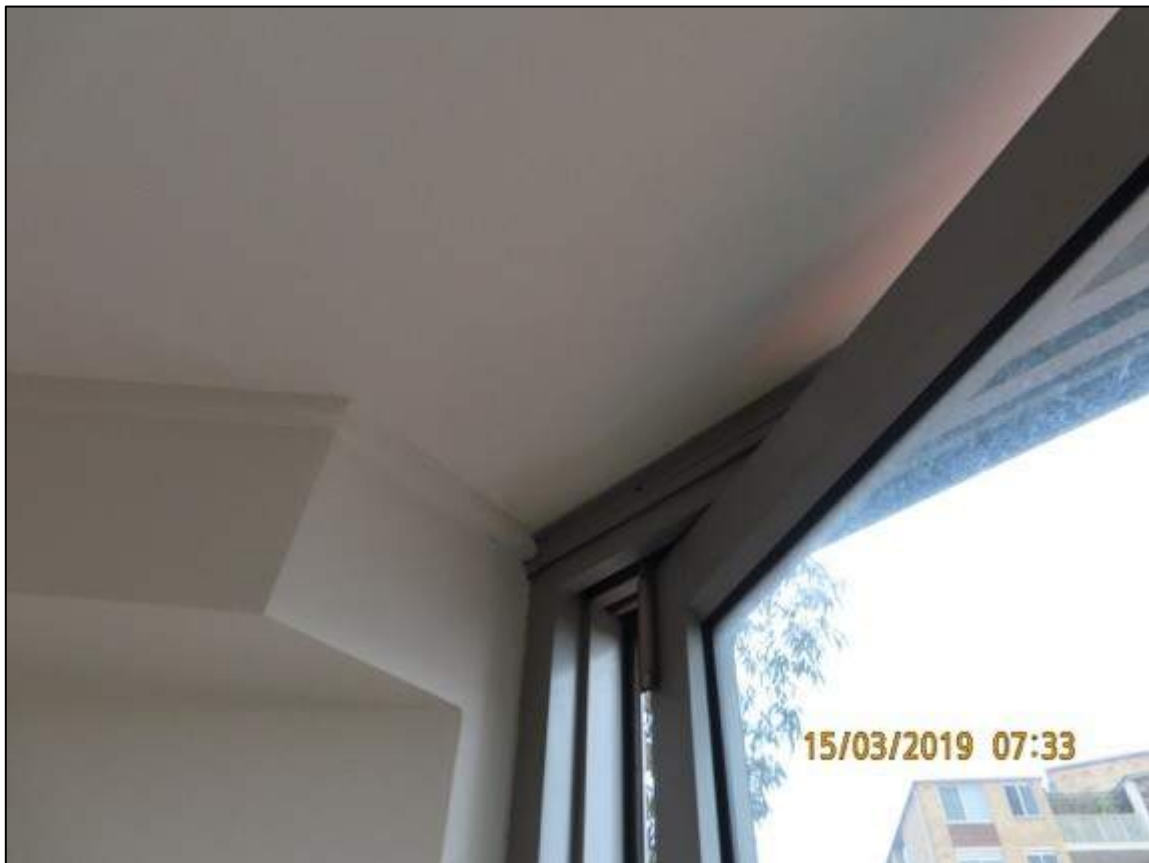
**Photograph 24:** Showing water staining and damage adjacent to head of Enclosed Balcony windows of Unit 17.

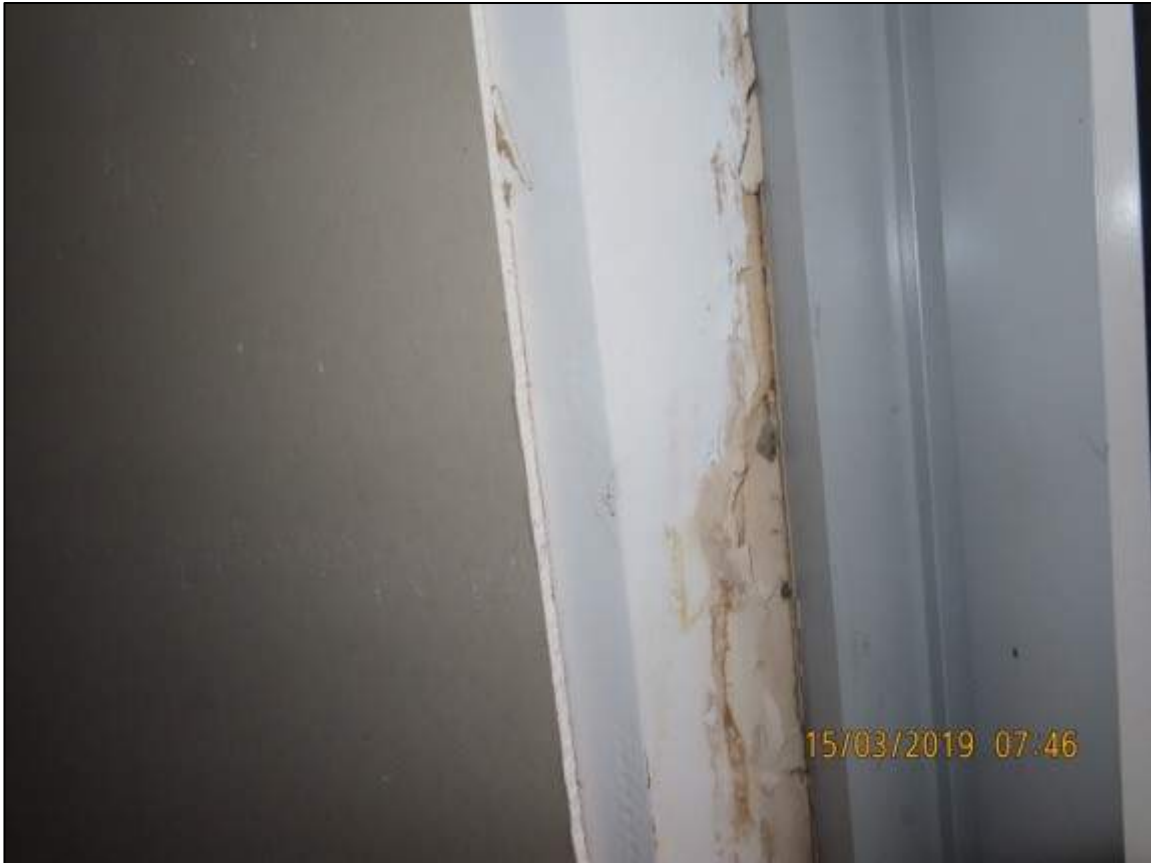
**Photograph 25:** Showing water staining adjacent to head of Enclosed Balcony windows of Unit 17.

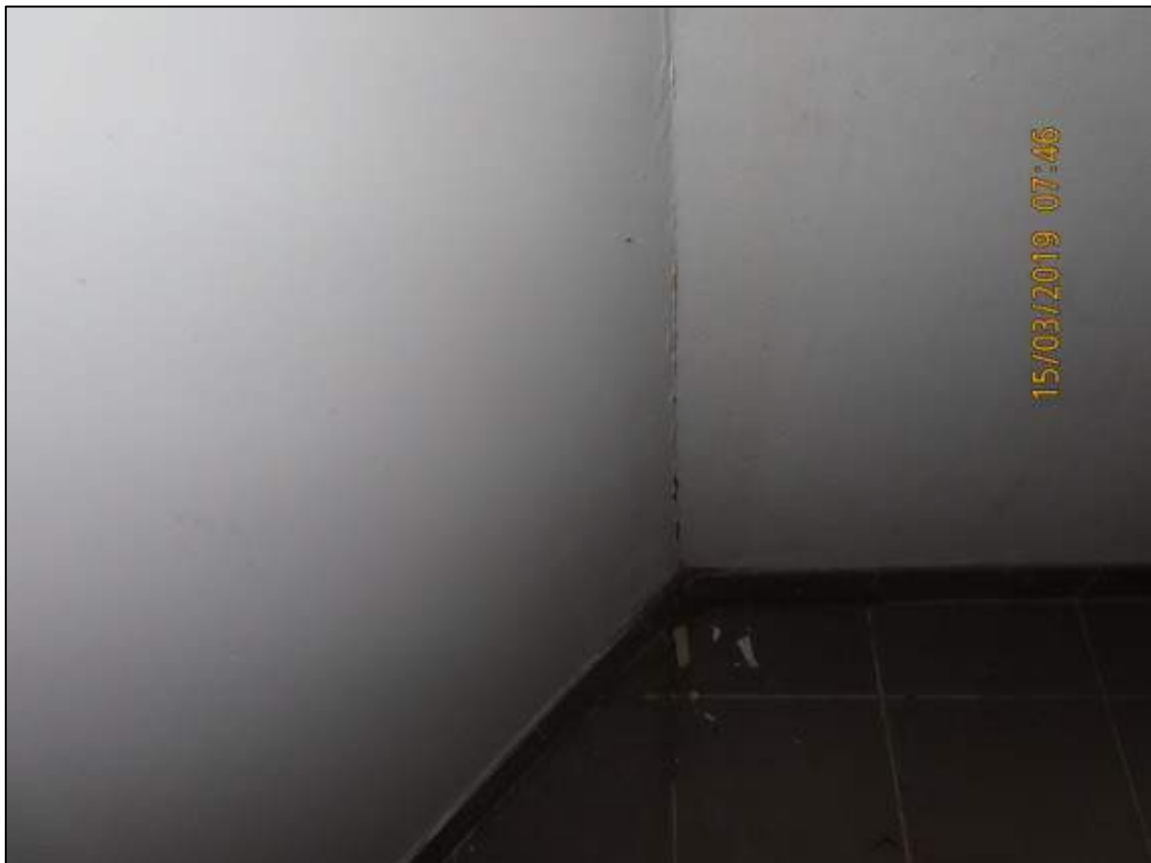
**Photograph 26:** Showing water damage adjacent to Enclosed Balcony windows of Unit 18.

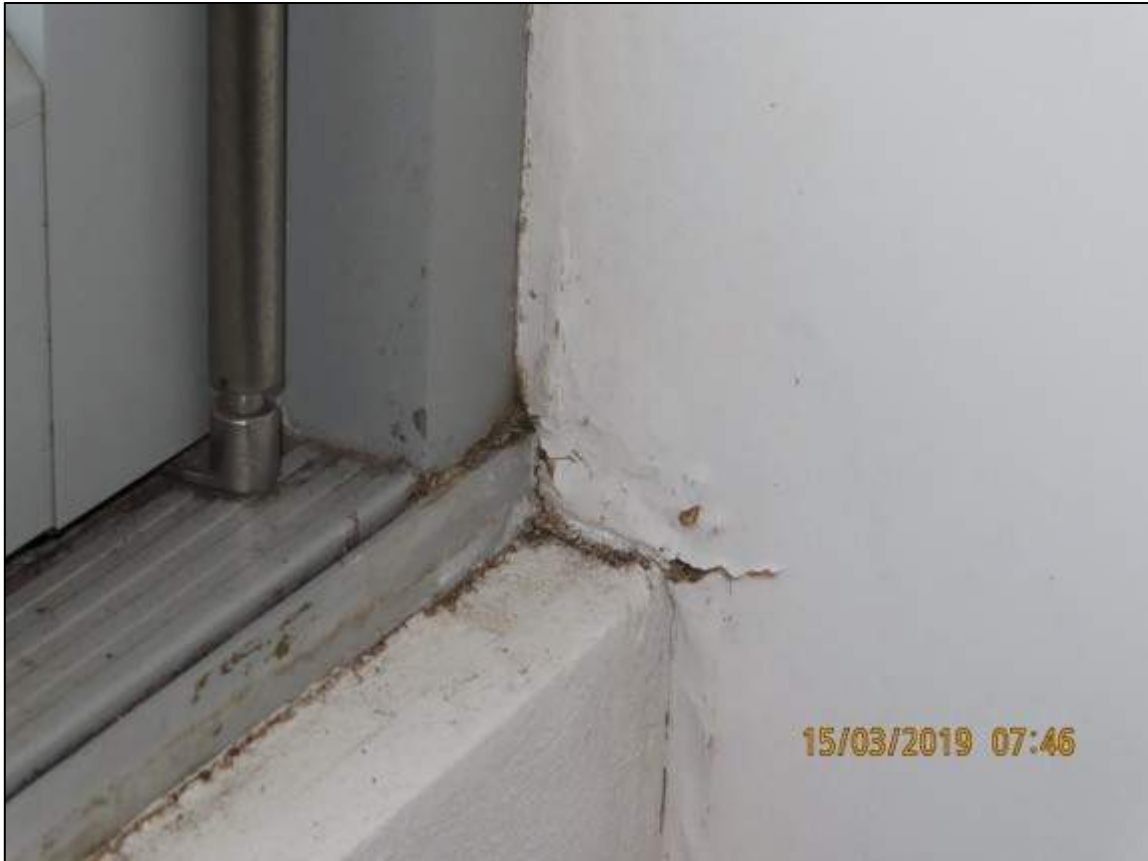
**Photograph 27:** Showing blistering plasterboard below Enclosed Balcony windows of Unit 18.

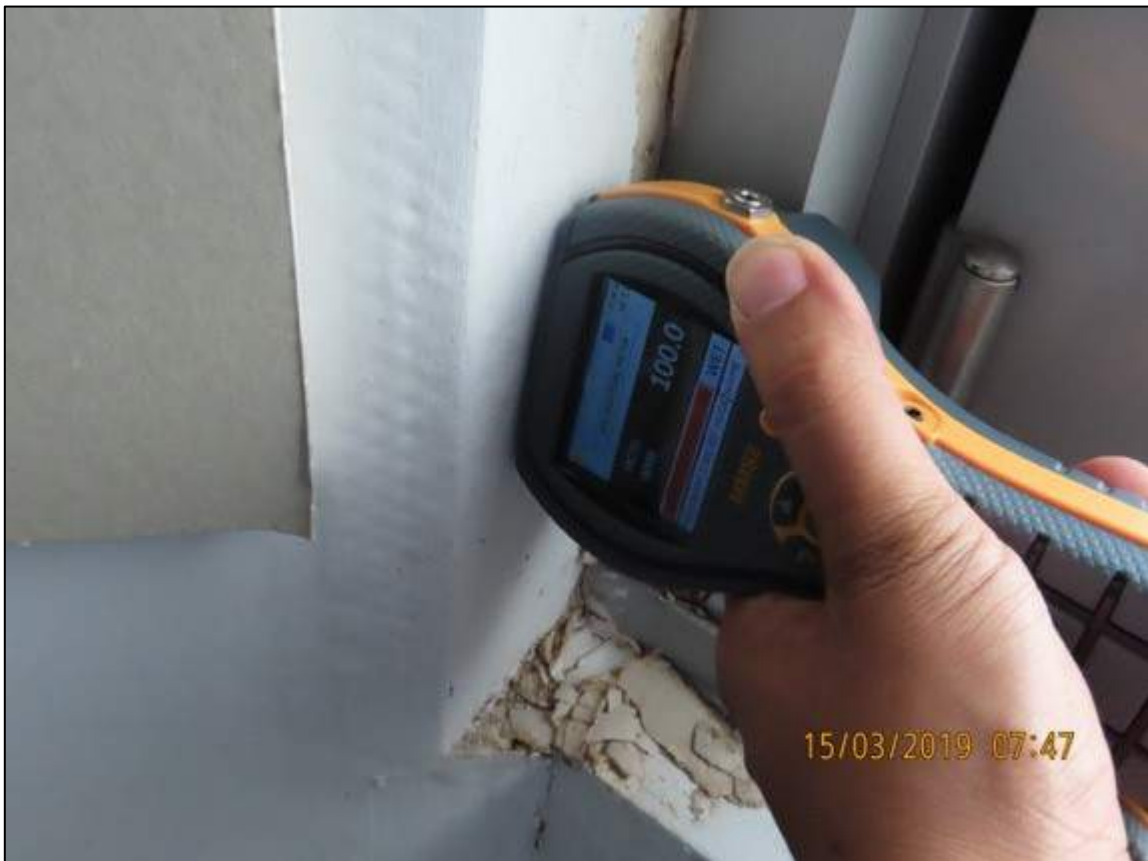
**Photograph 28:** Showing water damage adjacent to Enclosed Balcony windows of Unit 18.

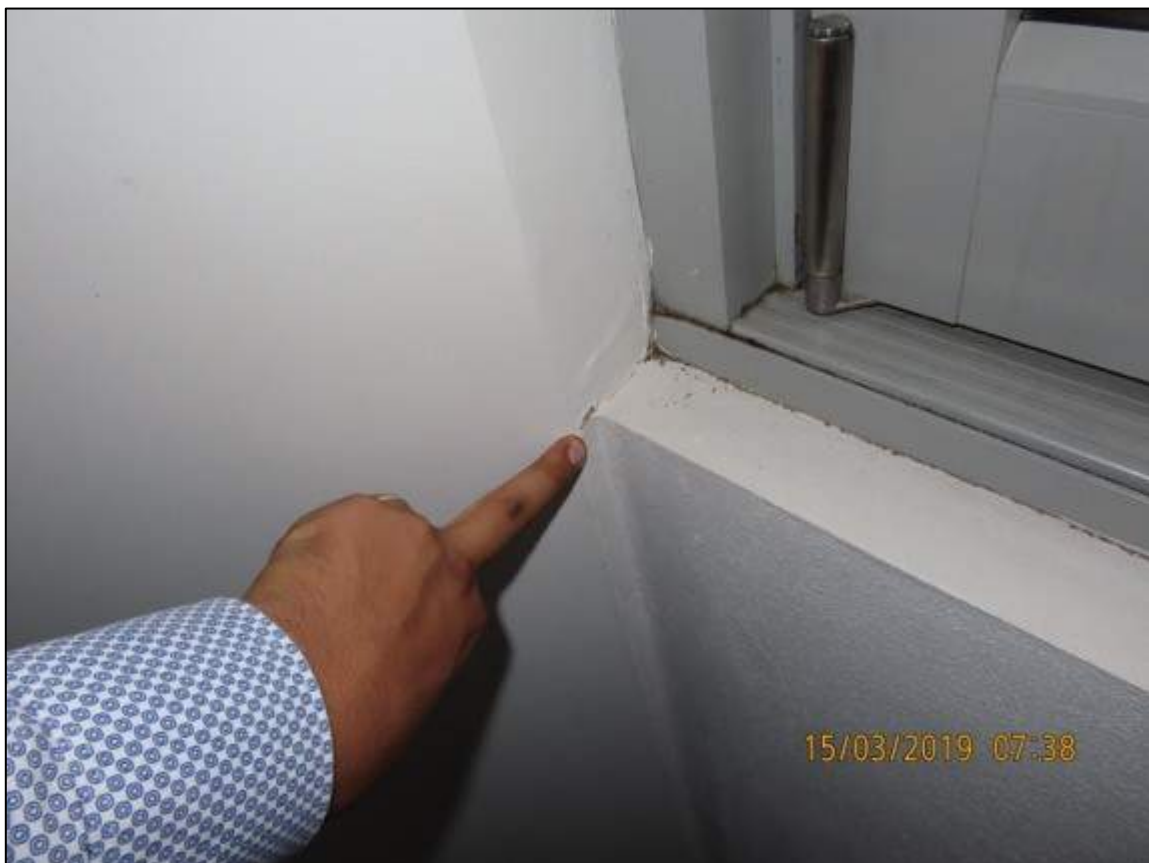
**Photograph 32:** Showing elevated moisture readings adjacent to Enclosed Balcony windows of Unit 19.

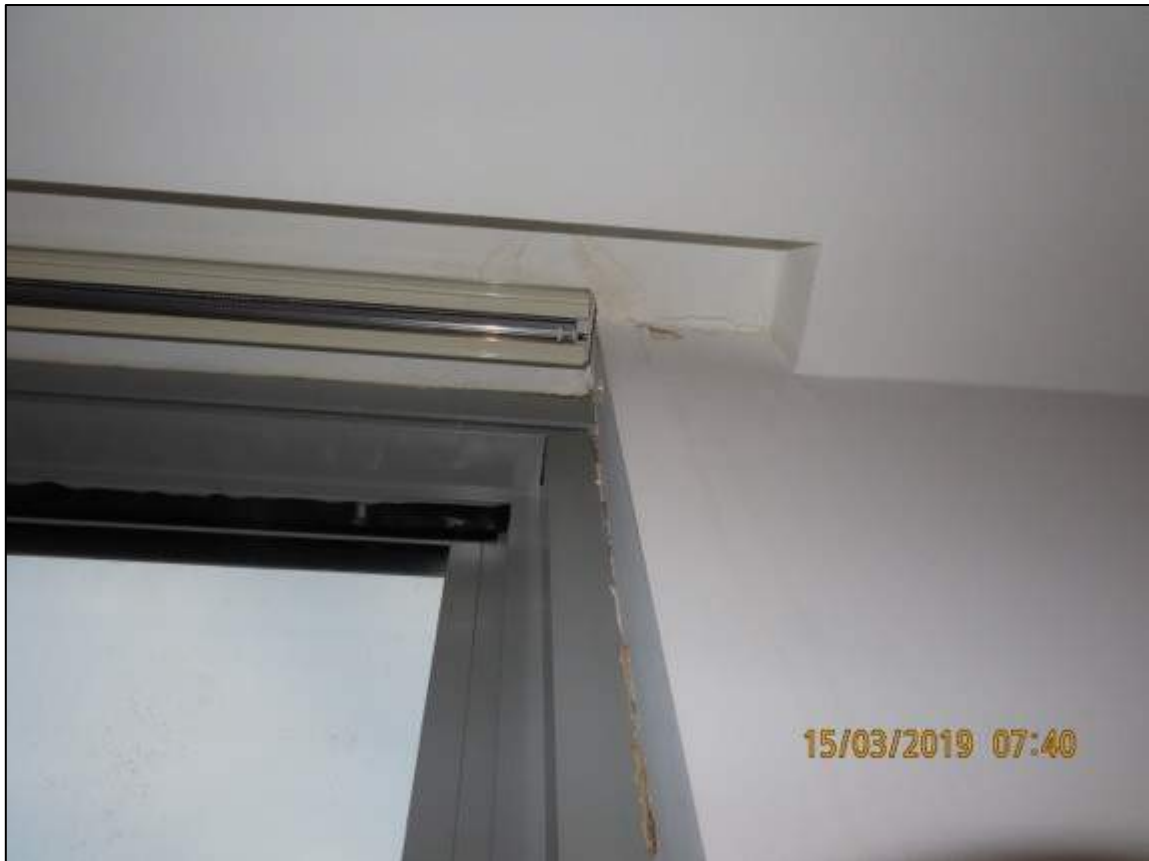
**Photograph 33:** Showing water damage adjacent to Enclosed Balcony windows of Unit 19.

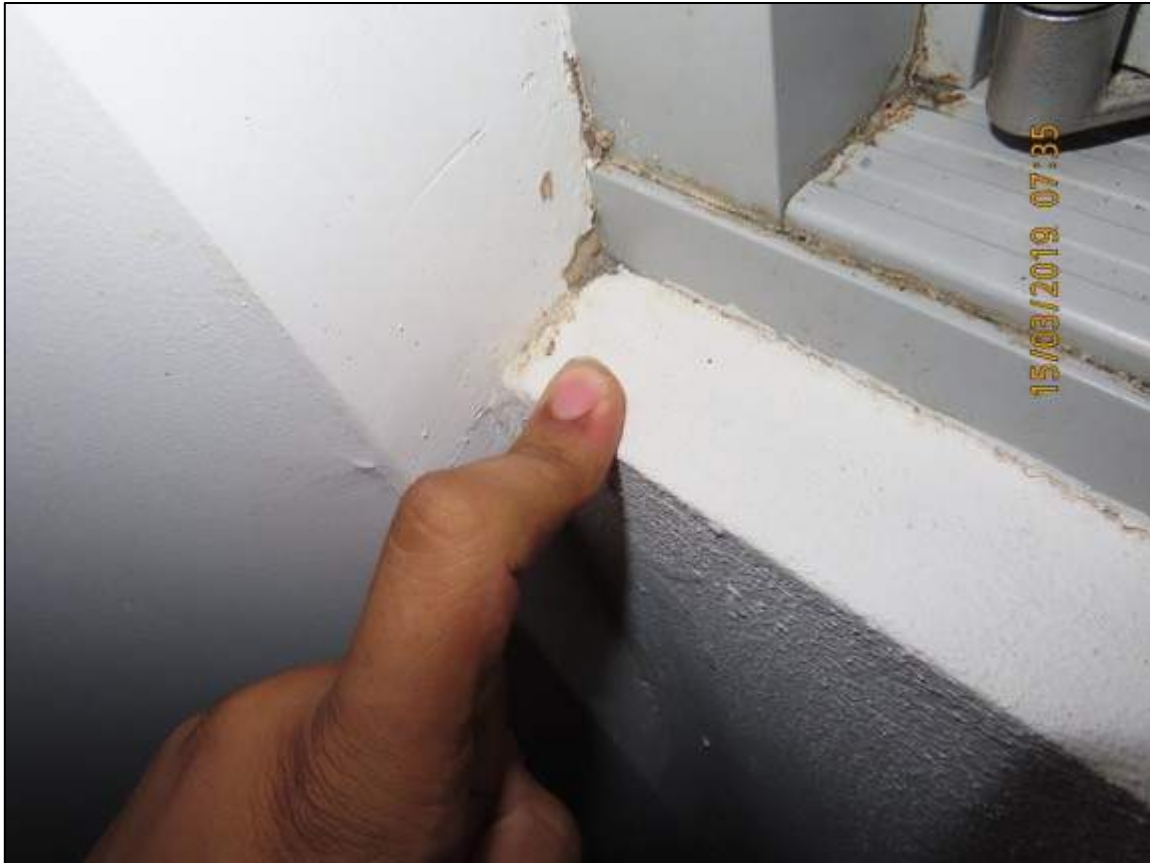
**Photograph 37:** Showing water damage and staining adjacent to Bedroom window of Unit 20.

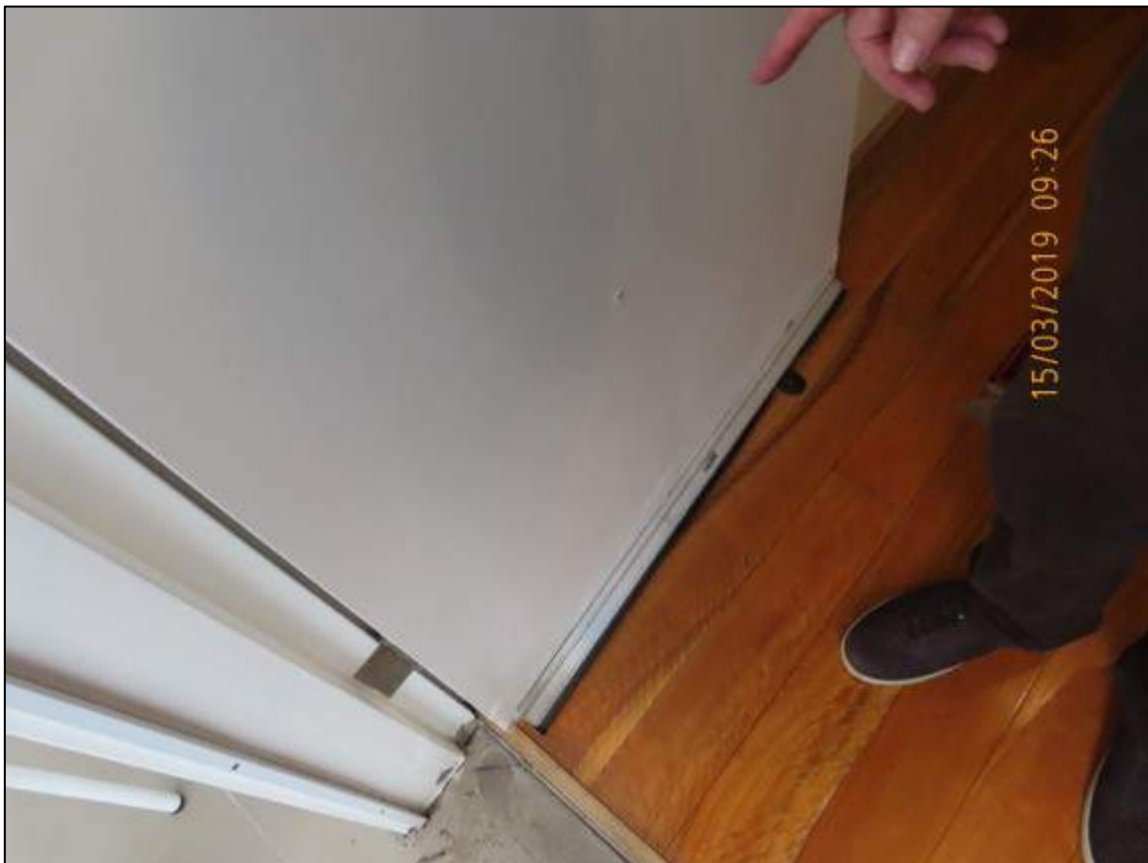
**Photograph 40:** Showing water damage to entry door of Unit 22.

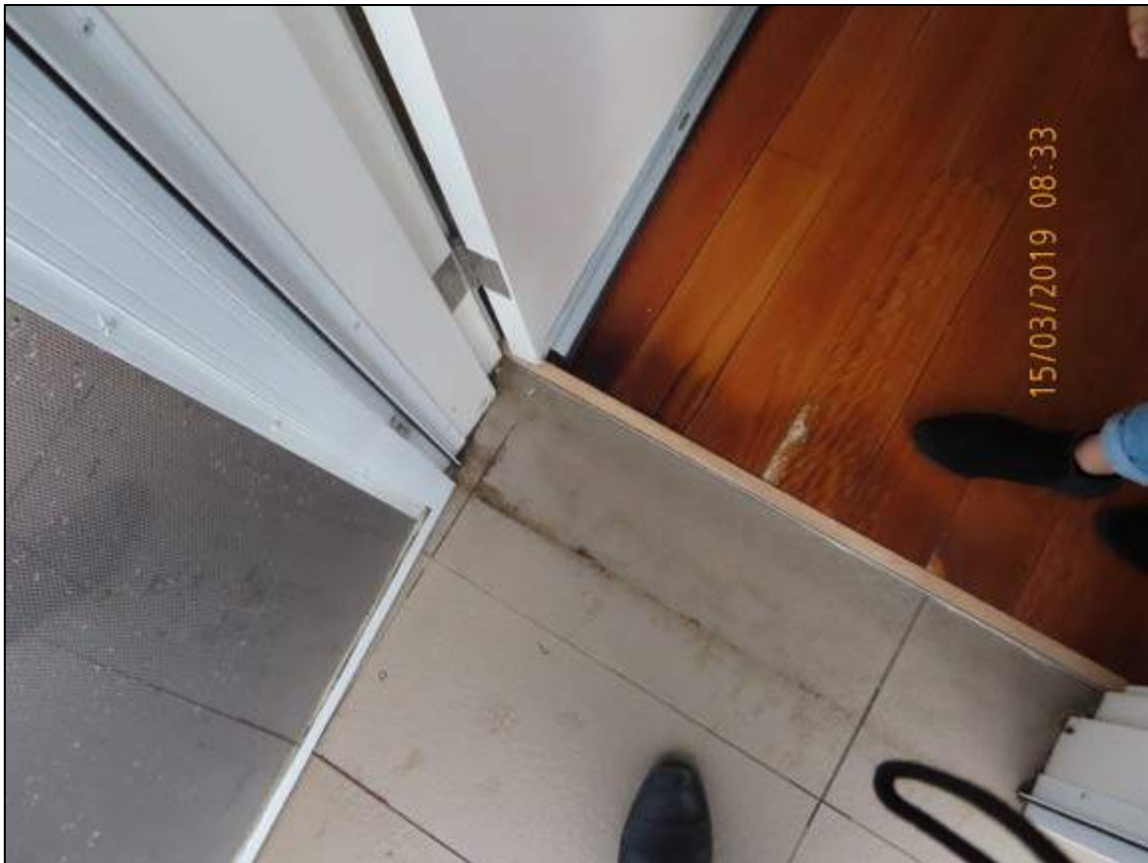
**Photograph 41:** Showing water damage to entry door of Unit 23.

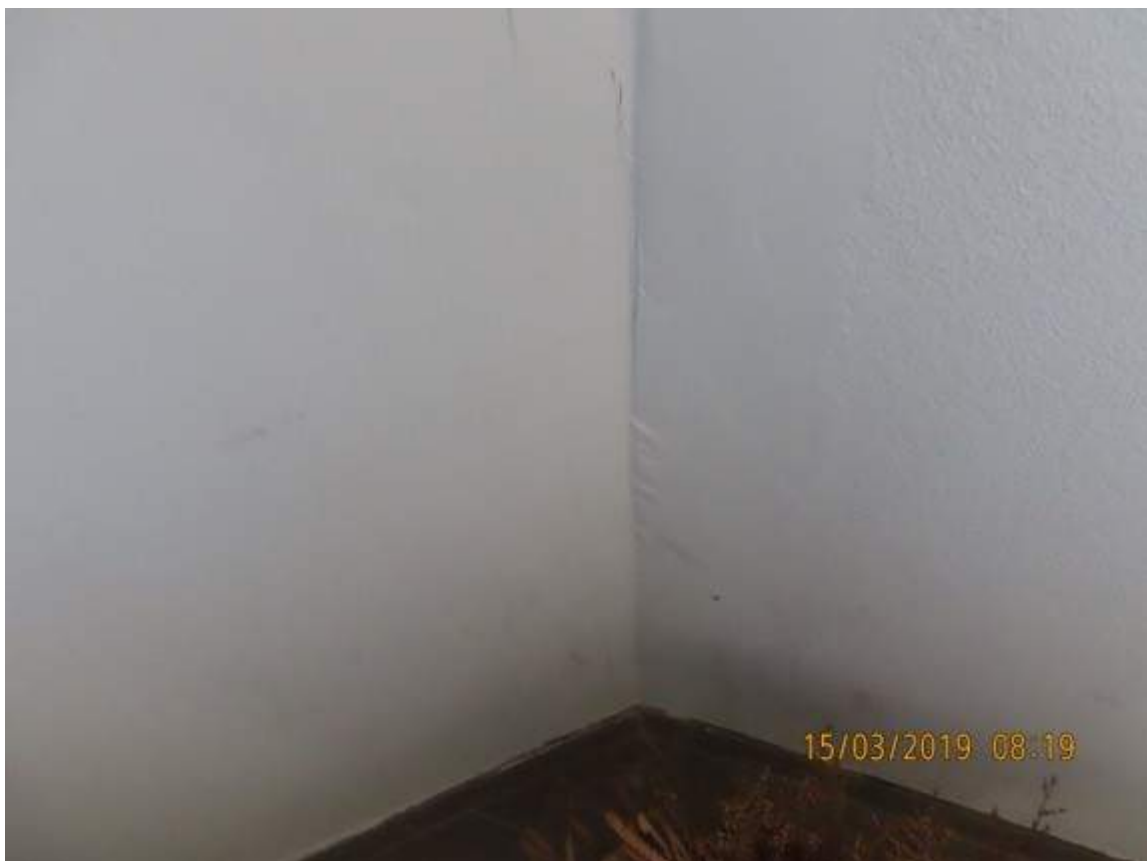
**Photograph 44:** Showing delaminating plasterboard below Enclosed Balcony windows of Unit 28.
