# SydneyStrataReport

## STRATA REPORT

Client	Infinity Property Agents
Address of property	Unit 107/361-362 Military Road, Mosman, NSW.
Lot	13
Strata Plan	SP 92834
Name of Strata Management Co.	Executive Strata
Telephone Number of Strata Agent	1300 984 186
Report Date	22 April 2020

Mixed Use Residential Apartment at  
363 Military Road,  
Mosman, NSW

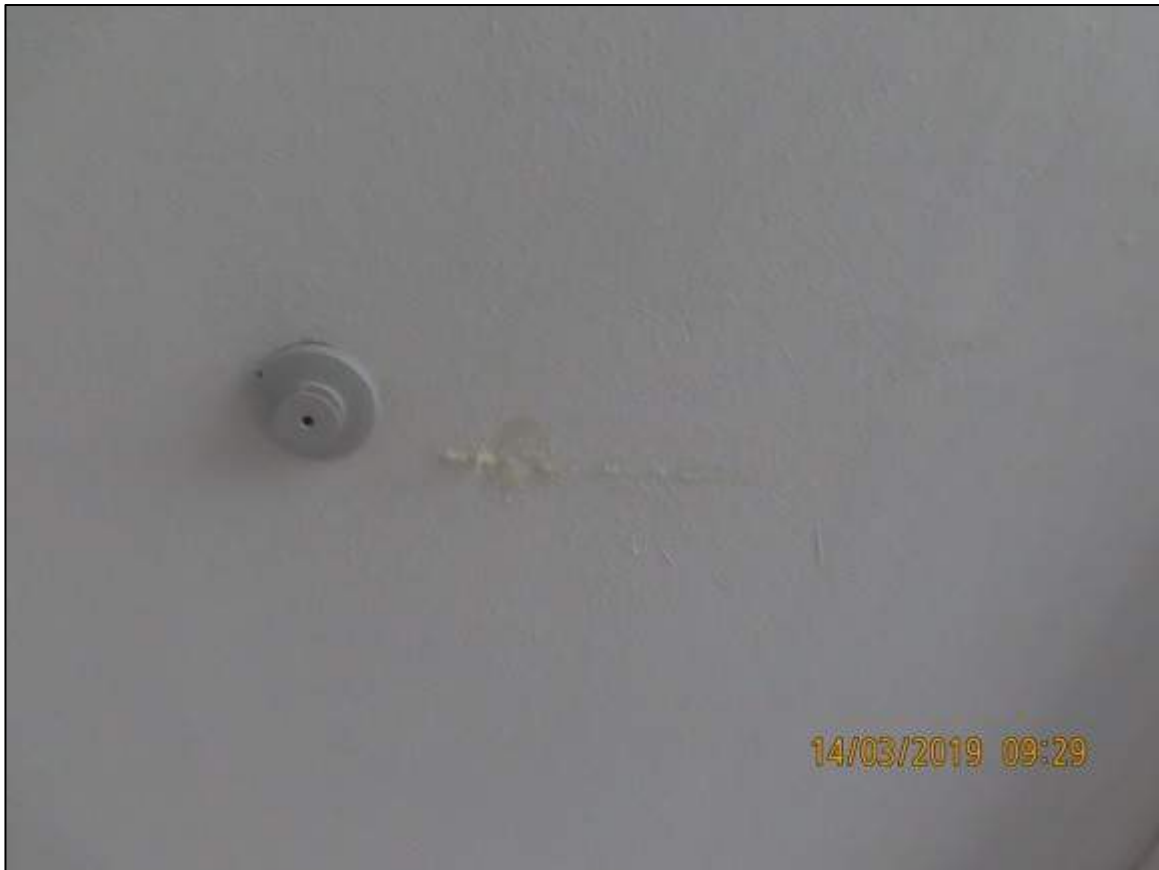
**Photograph 45:** Showing water damage below Enclosed Balcony windows of Unit 28.

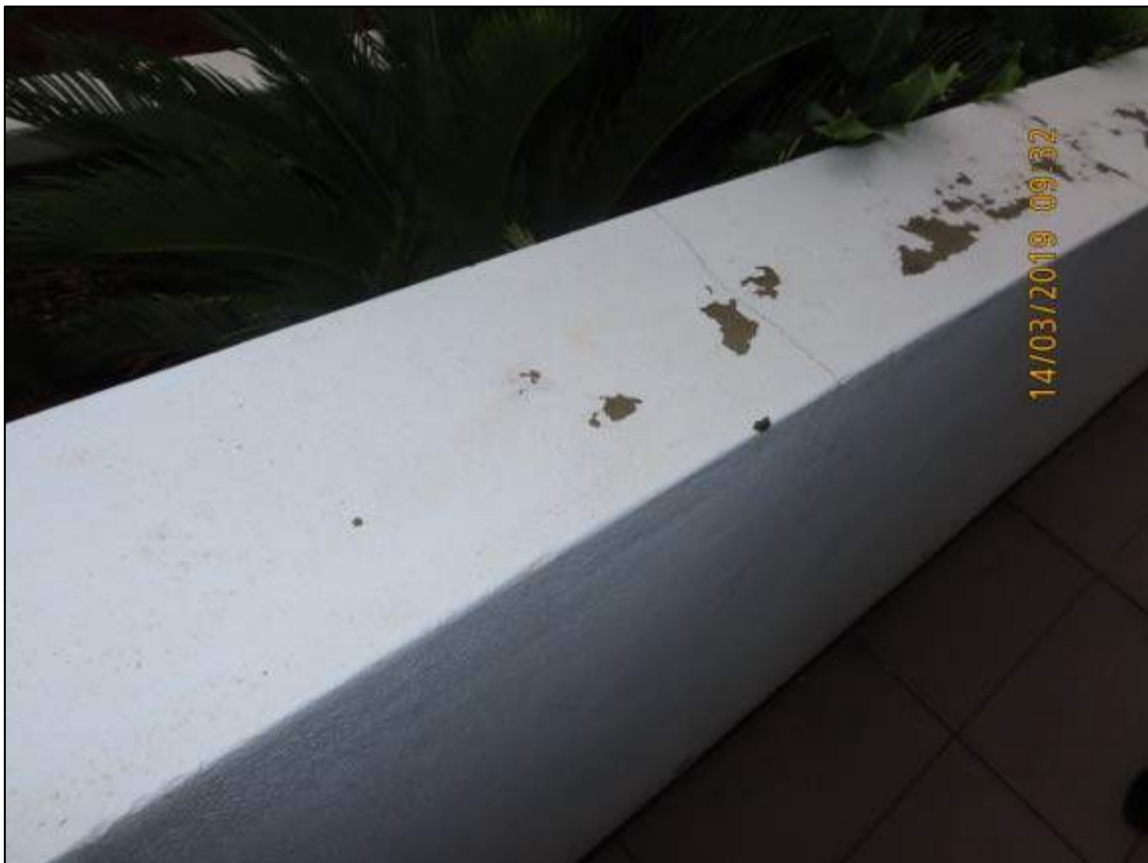
**Photograph 54:** Showing cracking and corrosion to Level 3 external common area planterboxes.

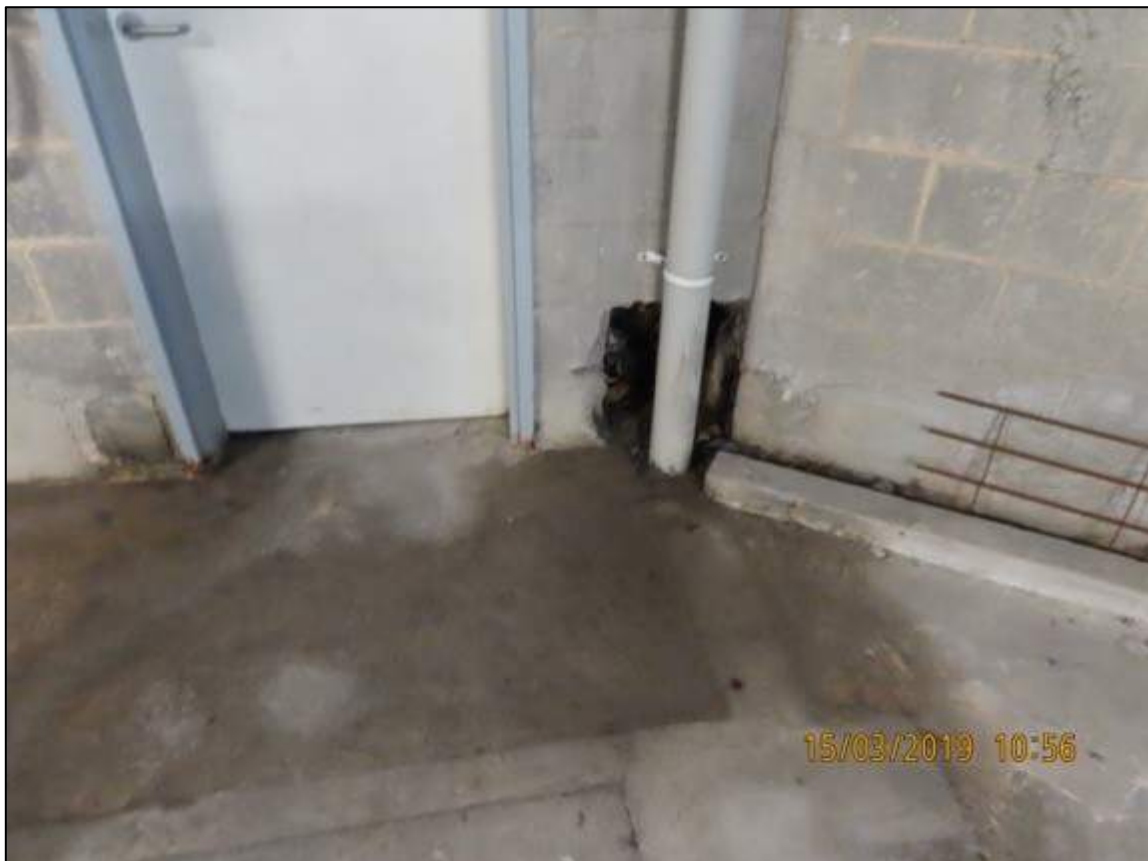
**Photograph 58:** Showing further view of water ponding opposite northern fire stairs entry of Level 3 basement.

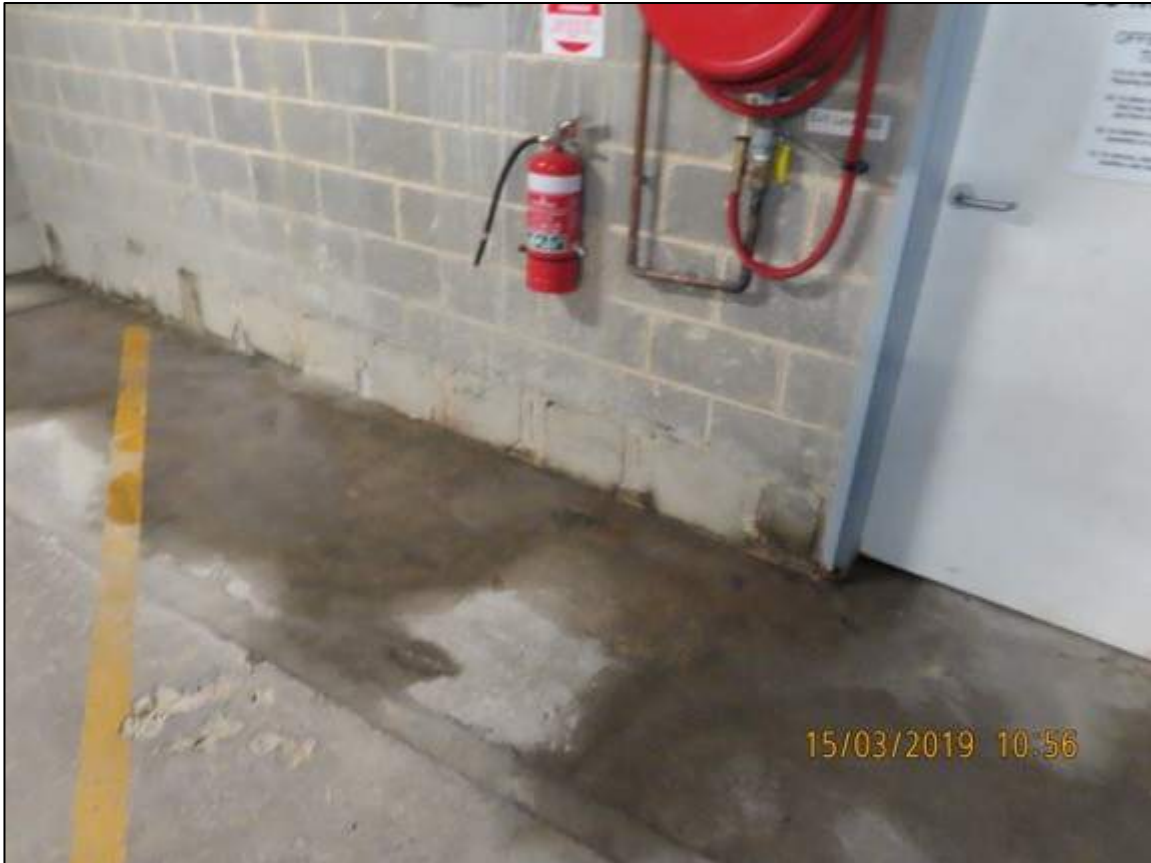
**Photograph 59:** Showing water ponding and corrosion to entry doors of northern fire stairs on Level 3 basement.

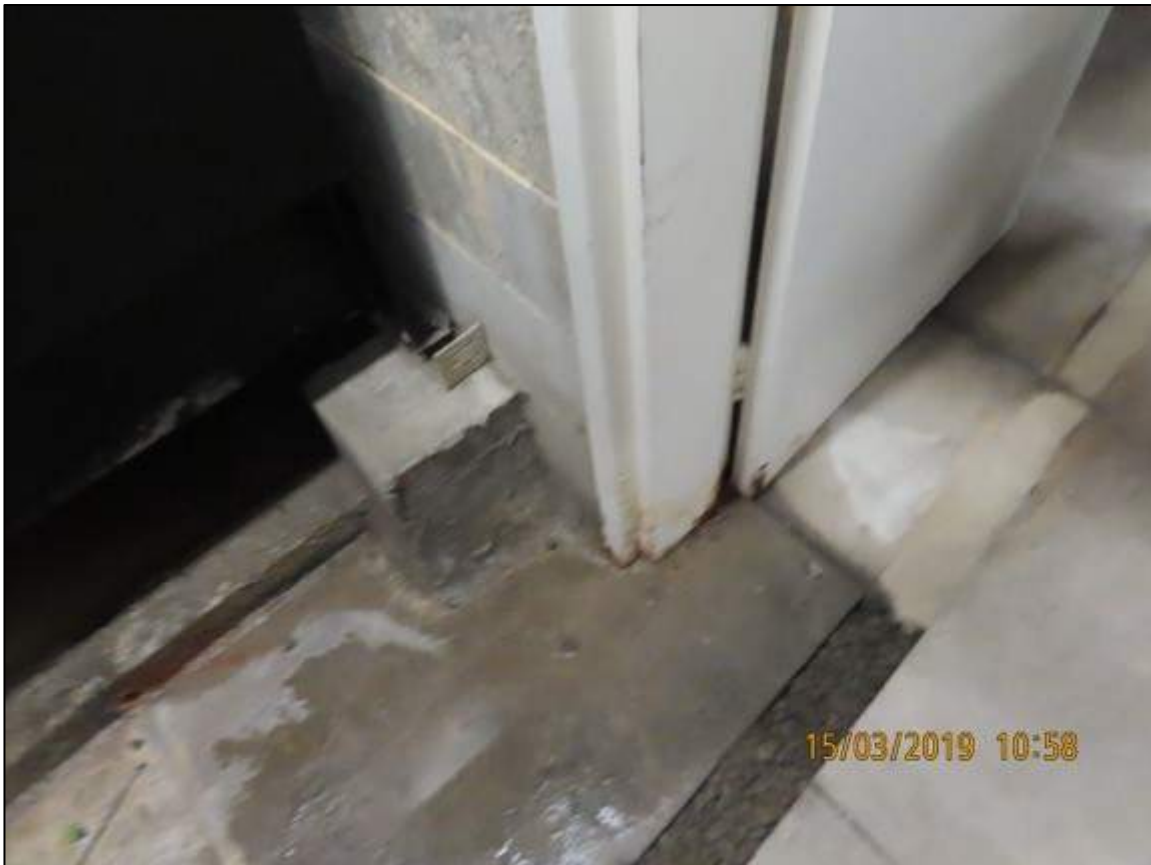
**Photograph 61:** Showing overflow of water in perimeter hob in northern fire stairs on Level 3 basement.

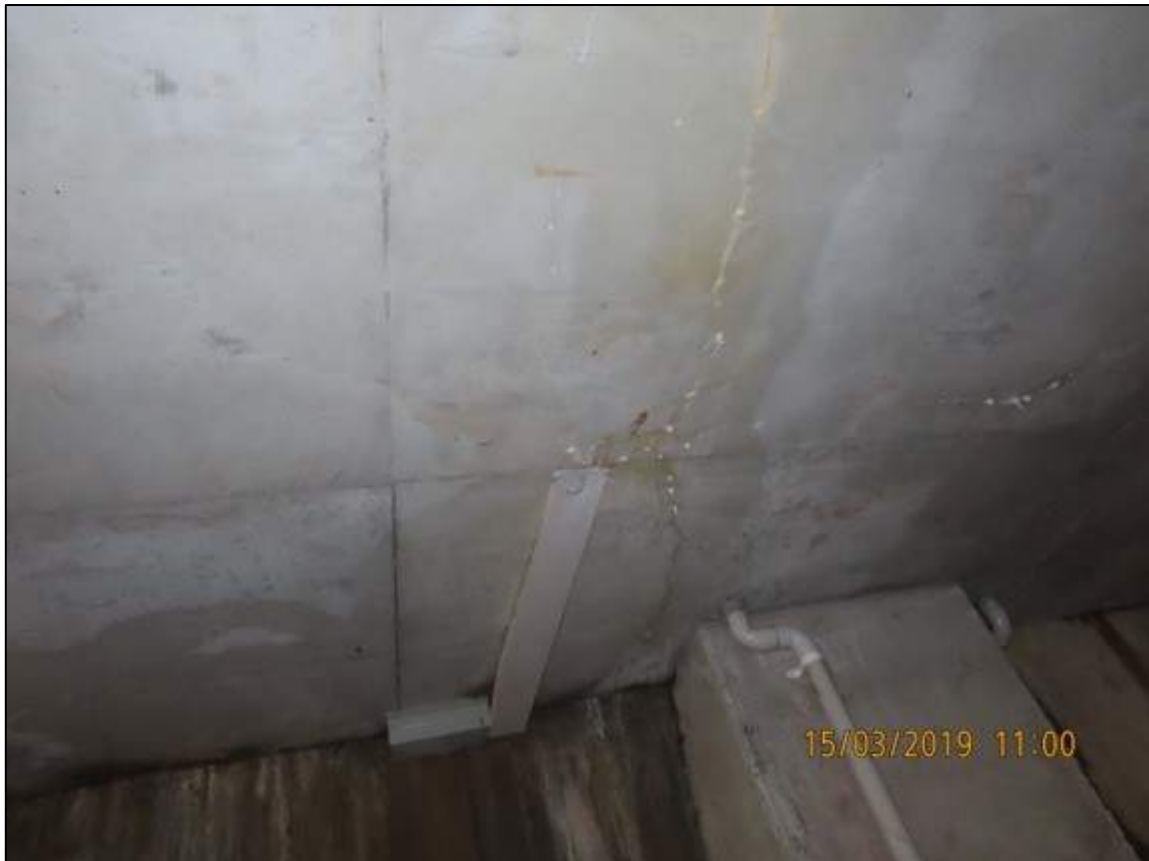
**Photograph 63:** Showing efflorescence emanating from cracking to soffit above car spaces 27 and 28.

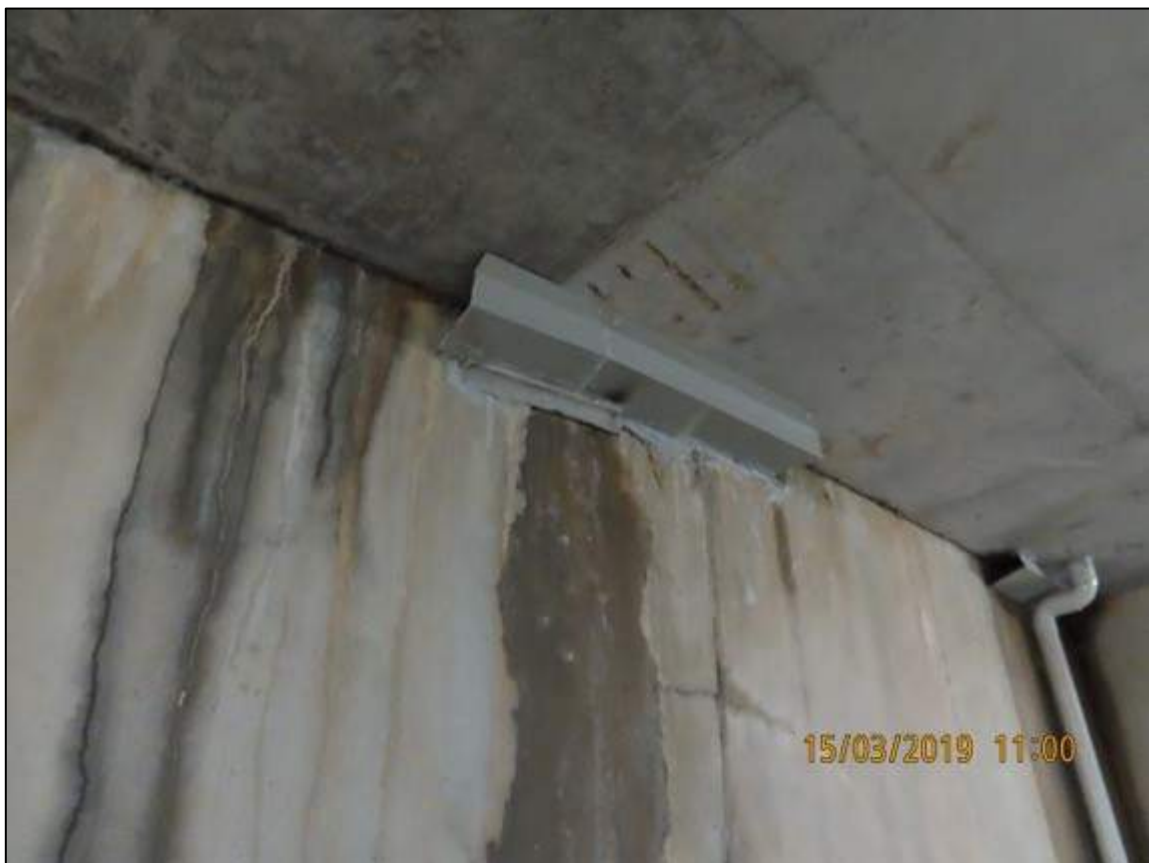
**Photograph 64:** Showing further view of efflorescence emanating out of cracking of soffit.

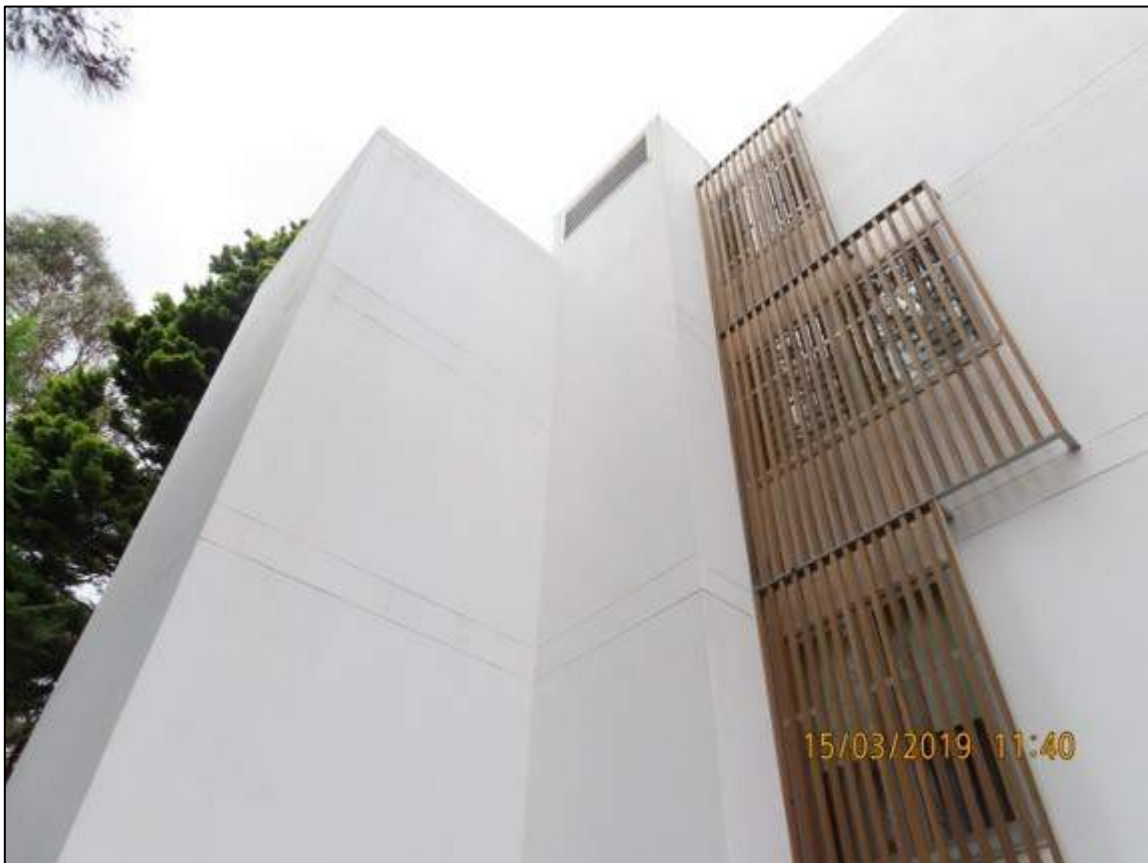
**Photograph 66:** Showing stepped cracking to eastern rooftop wall.

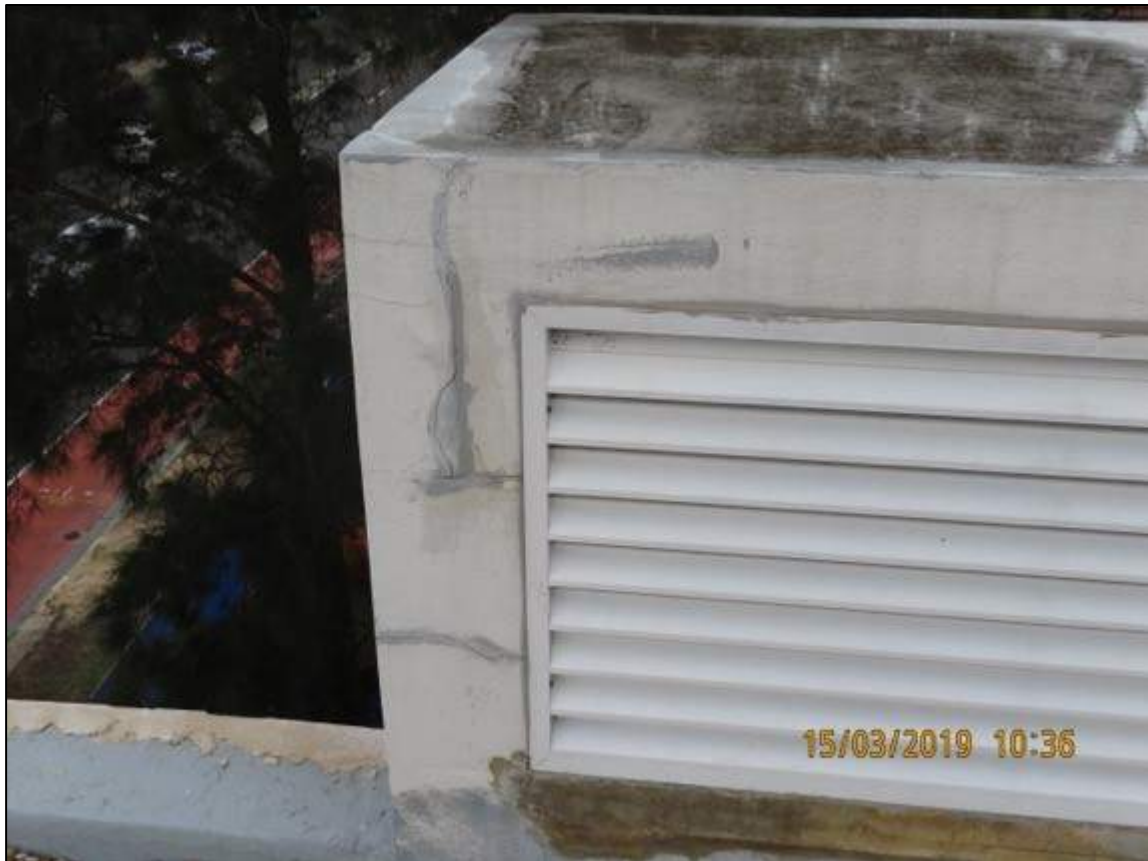
**Photograph 71:** Showing application of sealant to rooftop perimeter capping.

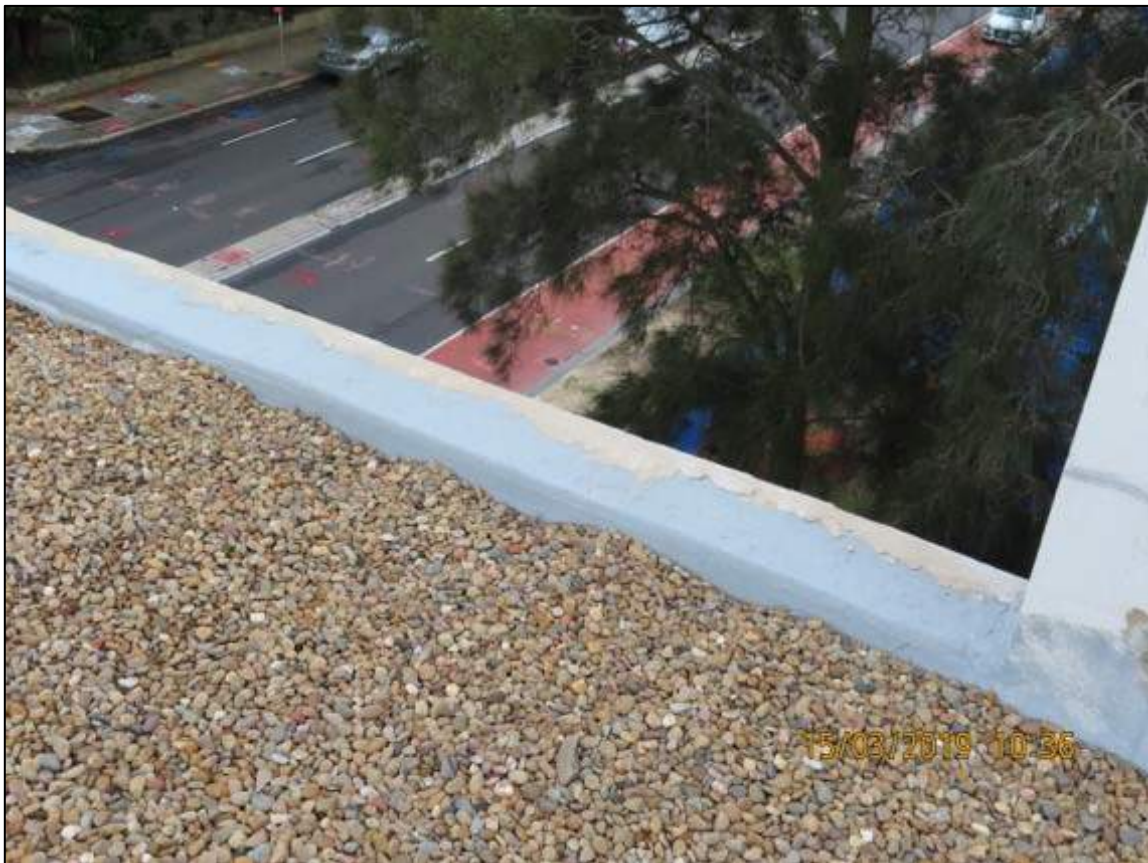
**Photograph 72:** Showing evidence of previous patch repairs to rooftop façade wall.

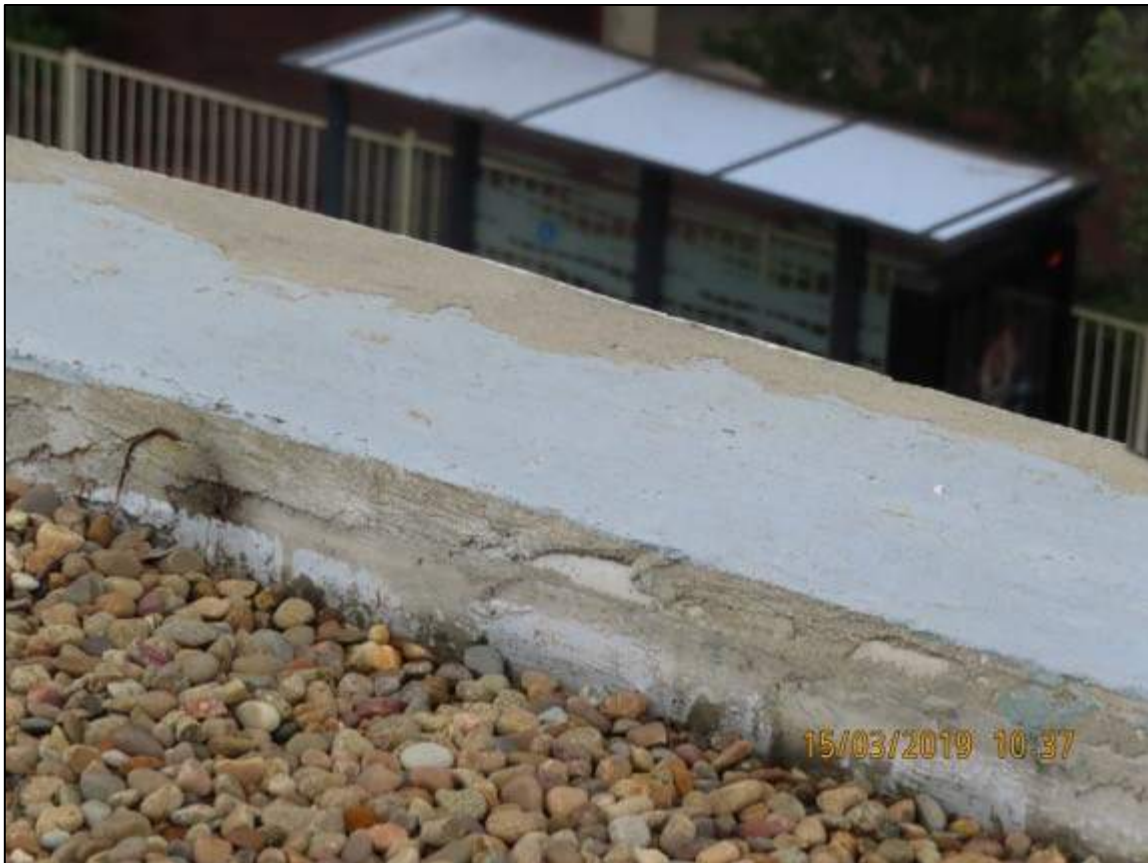
**Photograph 73:** Showing delamination of waterproofing membrane to perimeter edge.

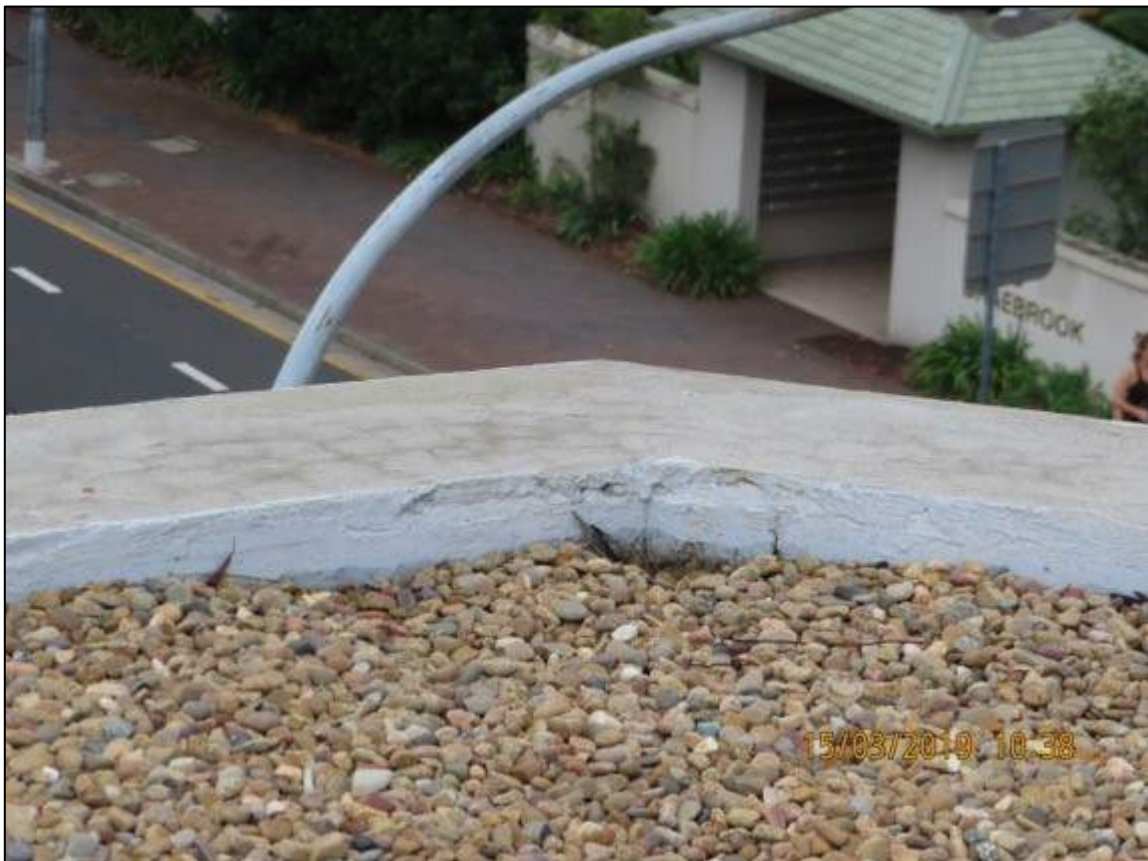
**Photograph 74:** Showing further view of degradation of waterproofing membrane to perimeter edge.

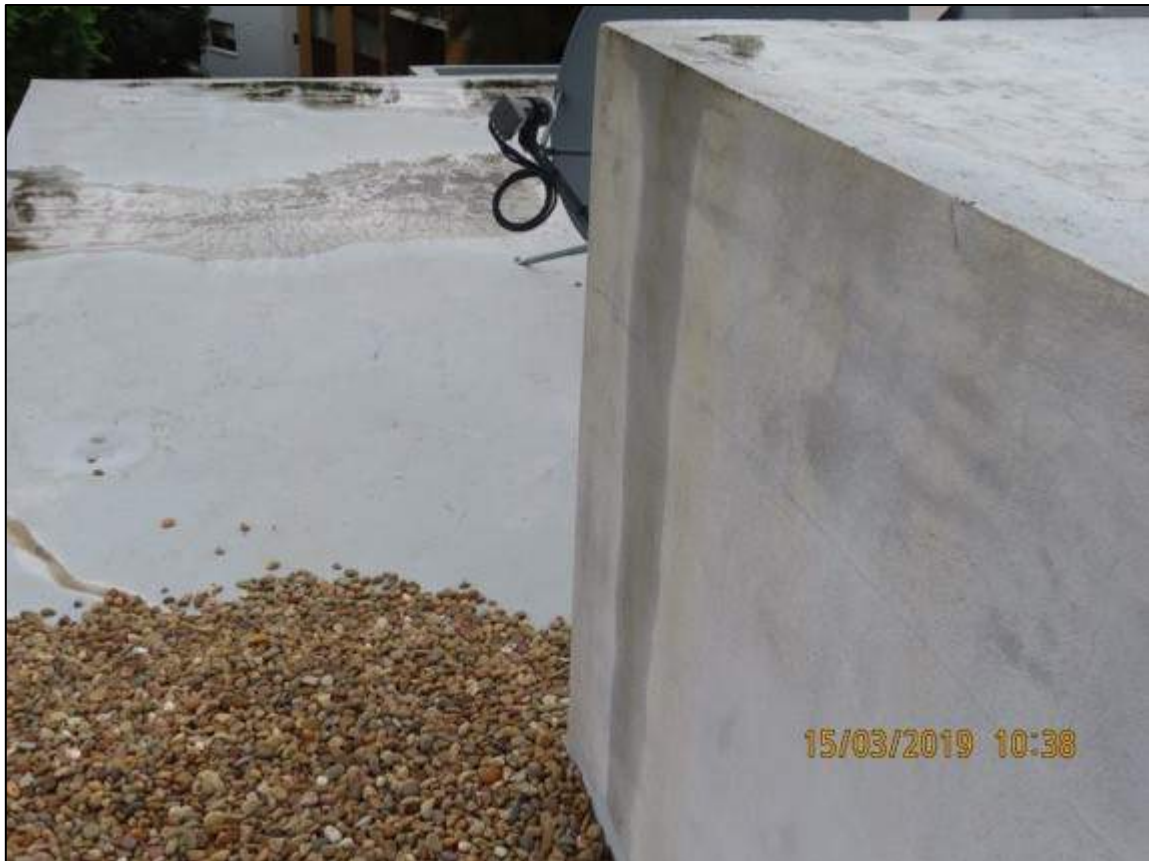
**Photograph 75:** Showing exposed perimeter edge of the rooftop.

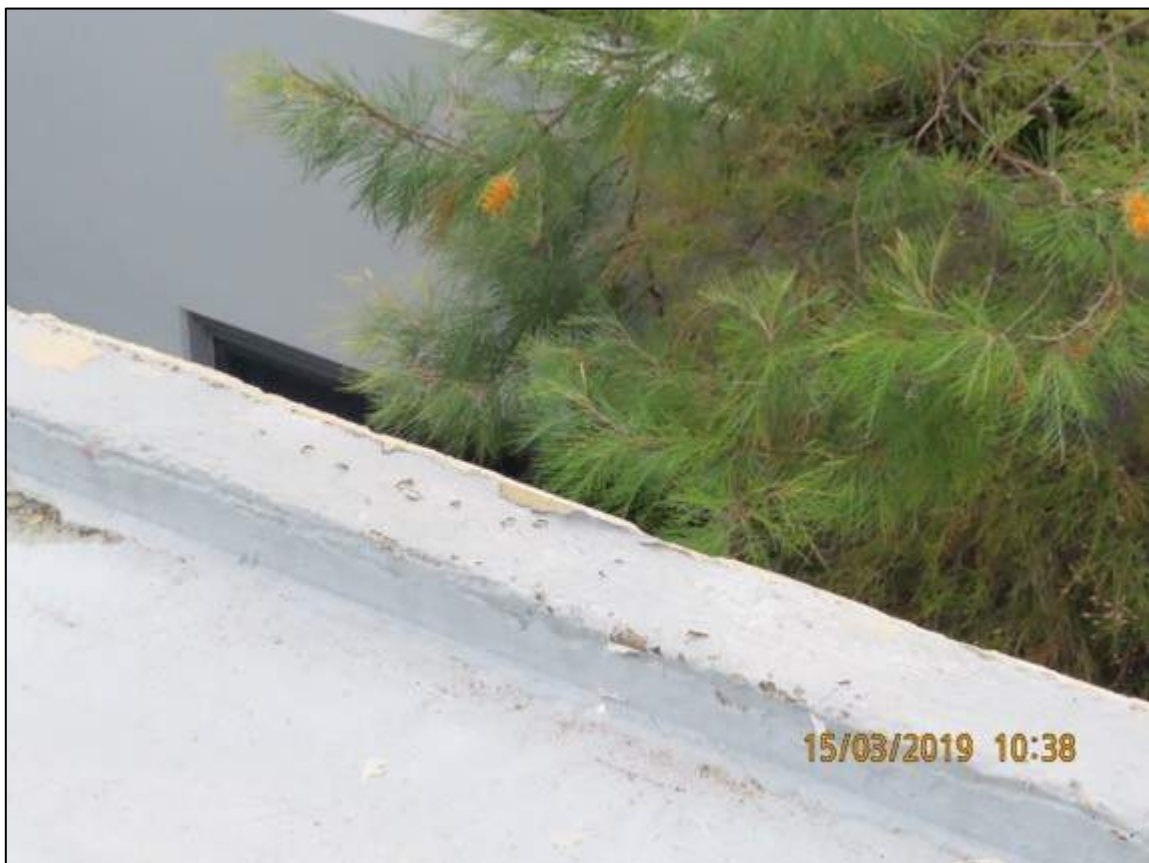
**Photograph 76:** Showing craze cracking to rooftop façade wall.

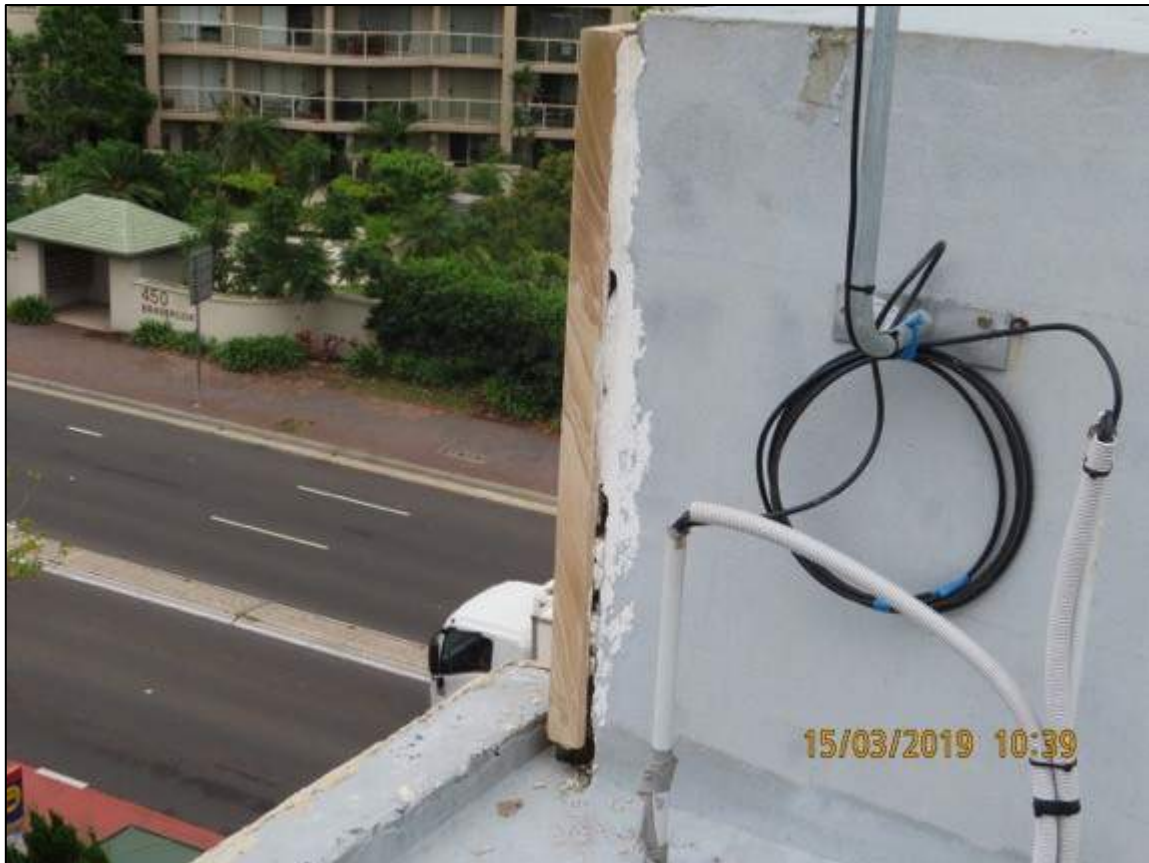
**Photograph 77:** Showing blistering membrane to perimeter edge of rooftop.

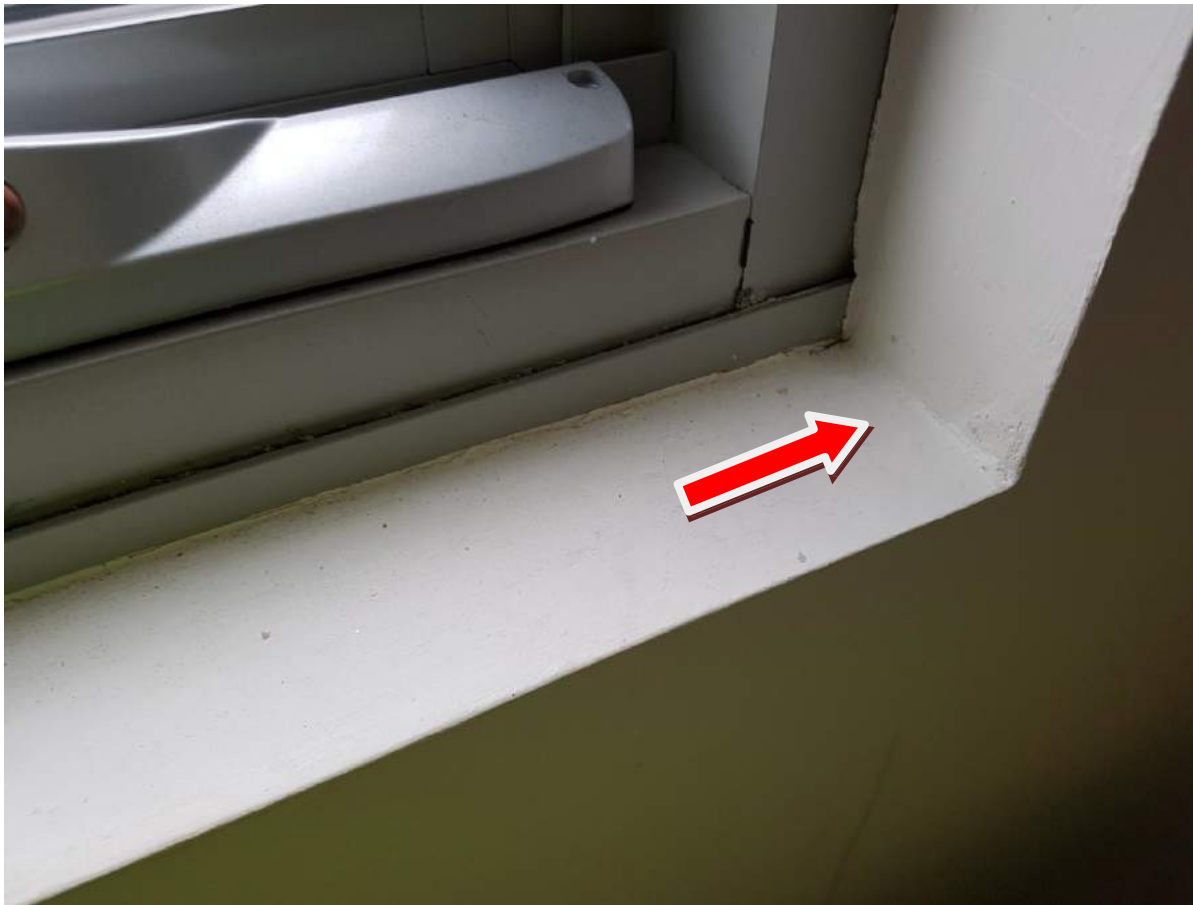
Water appears to be leaking around the window frame.

Water is seeping in from the top of the window frame and making its way down.

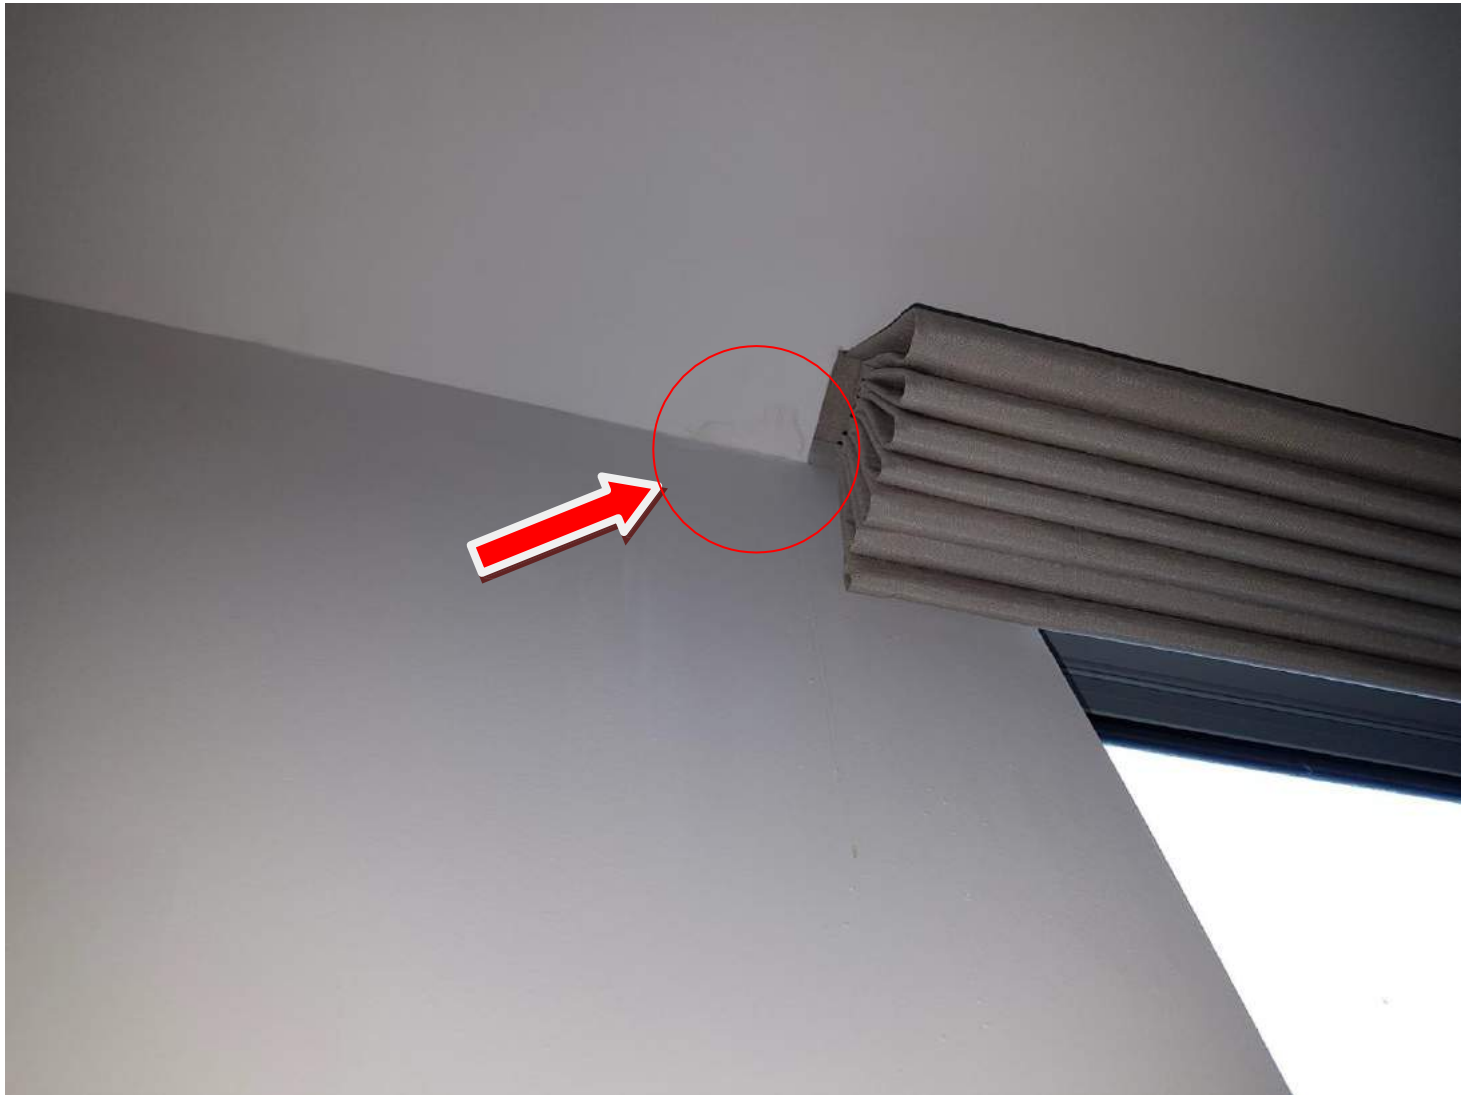
Water appears to be leaking around the window frame.

Water is seeping in from the top of the window frame and making its way down.

Recommended that; further inspection is required. Above unit 15 to view the window seal externally.

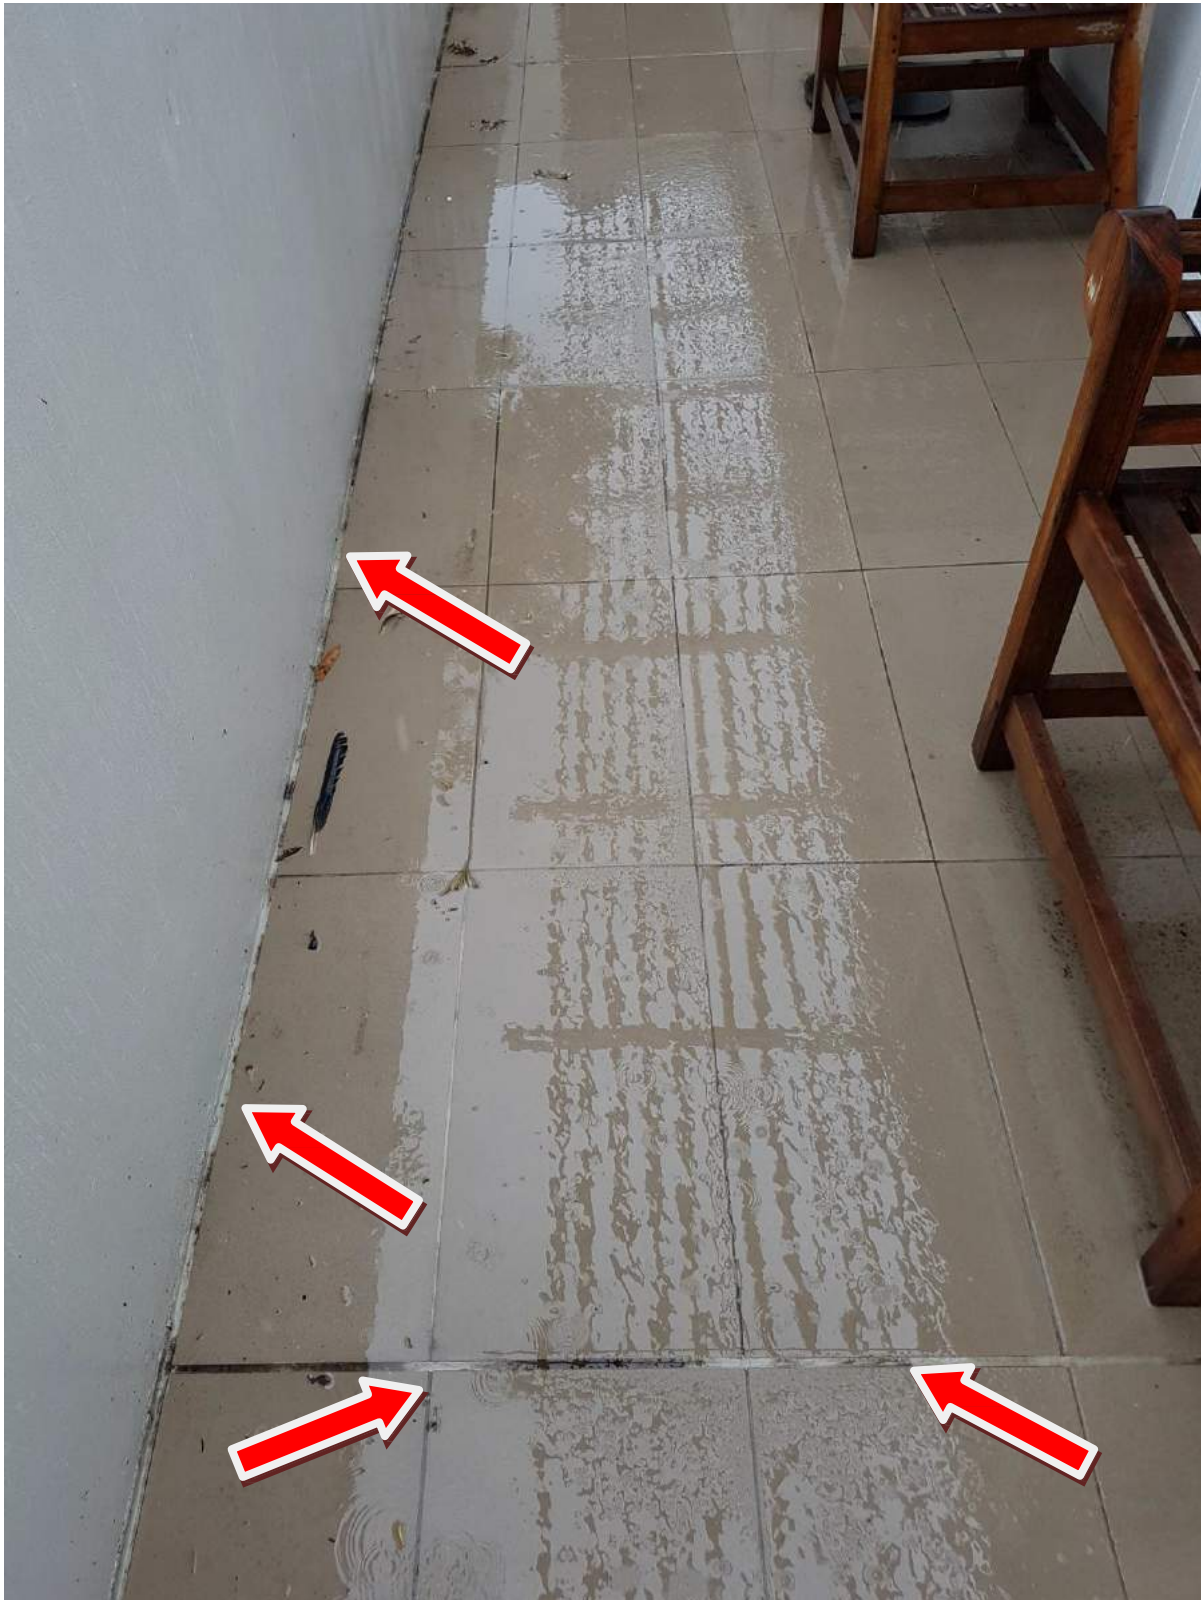
Expansion joints  
require re-caulking  
due to poor  
preparation and  
caulking

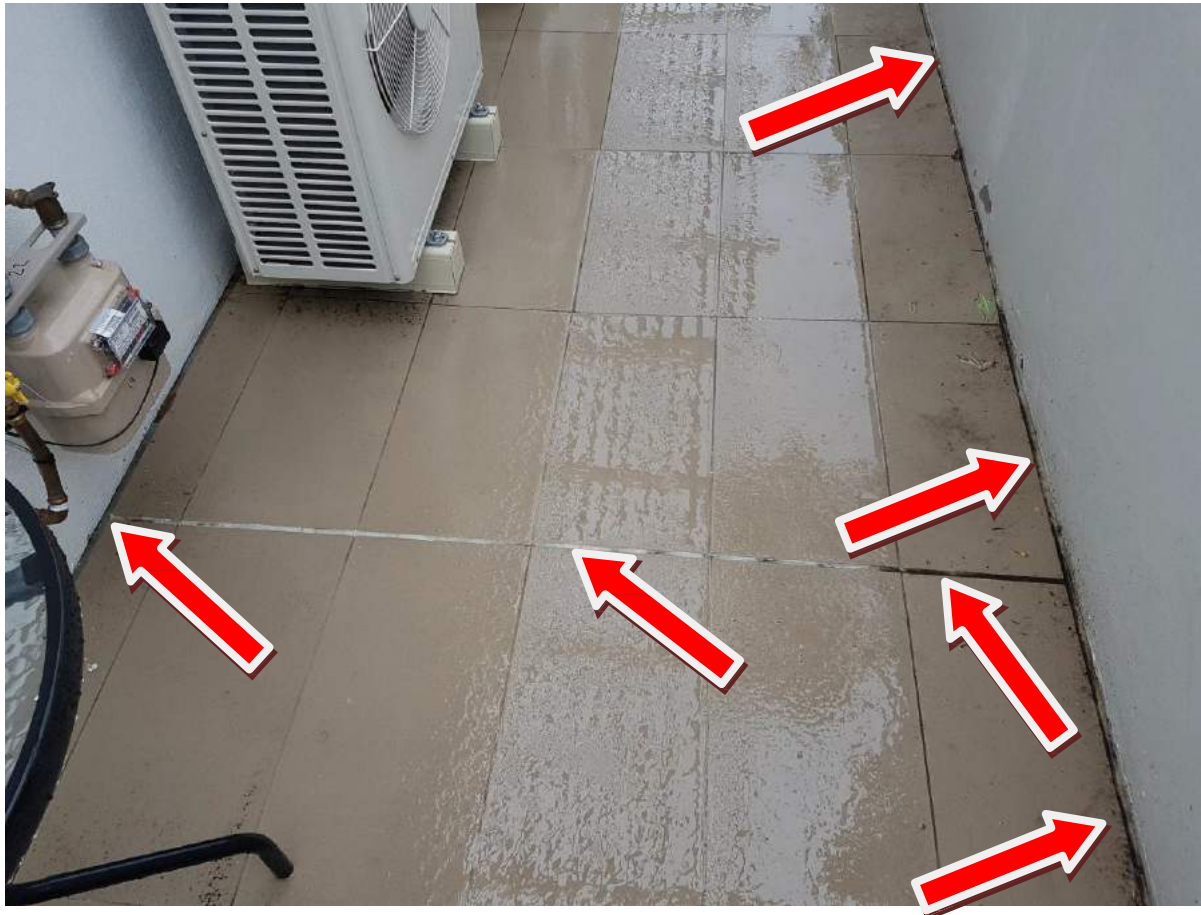
Expansion joints  
require re-caulking  
due to poor  
preparation and  
caulking.  
Also, planter box  
requires repairs to  
the cracks.

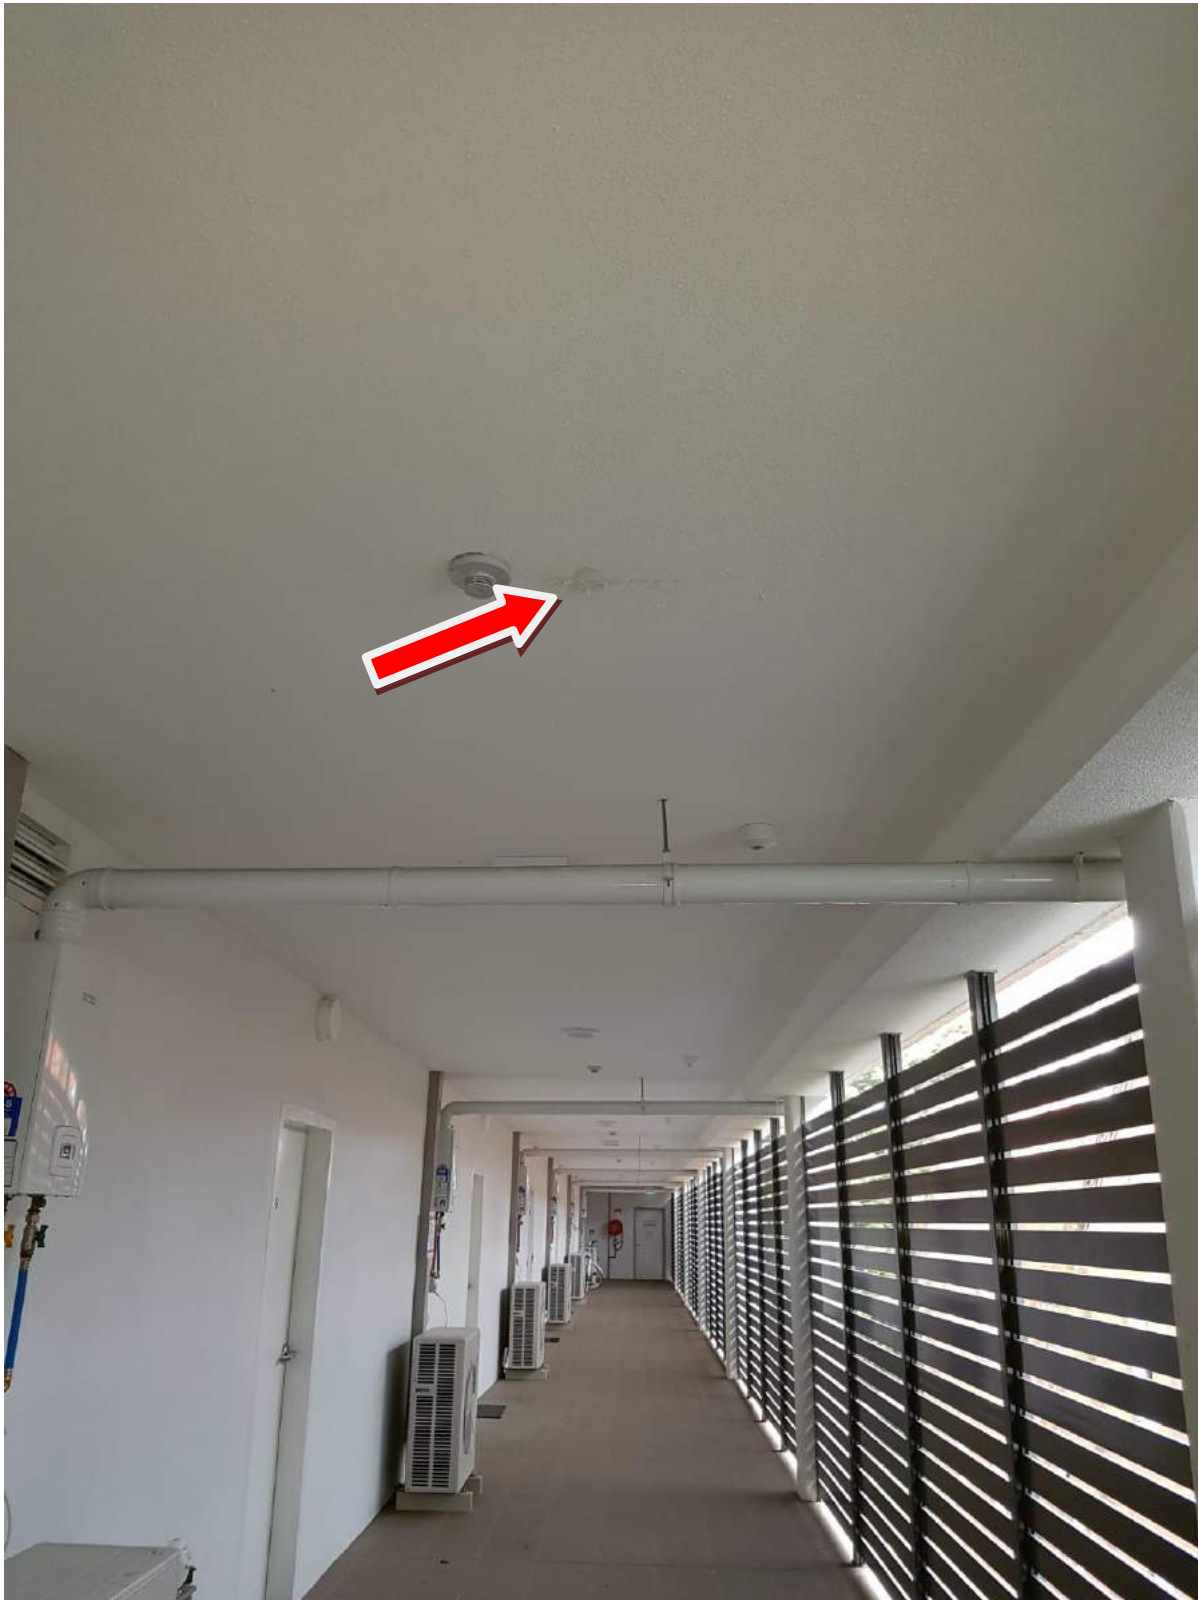
Due to the tiles on the upper level seeping water. Water has leaked causing efflorescence on the ceiling.
