SydneyStrataReport

STRATA REPORT

Client	Church Street Parramatta Property Pty Ltd
Address of property	Unit 3303/330 Church Street, Parramatta, NSW.
Lot	359
Strata Plan	SP 94469
Name of Strata Management Co.	NSW Strata
Telephone Number of Strata Agent	8980 1841
Report Date	15 February 2024

BUILDING DEFECTS REPORT Part 1/2

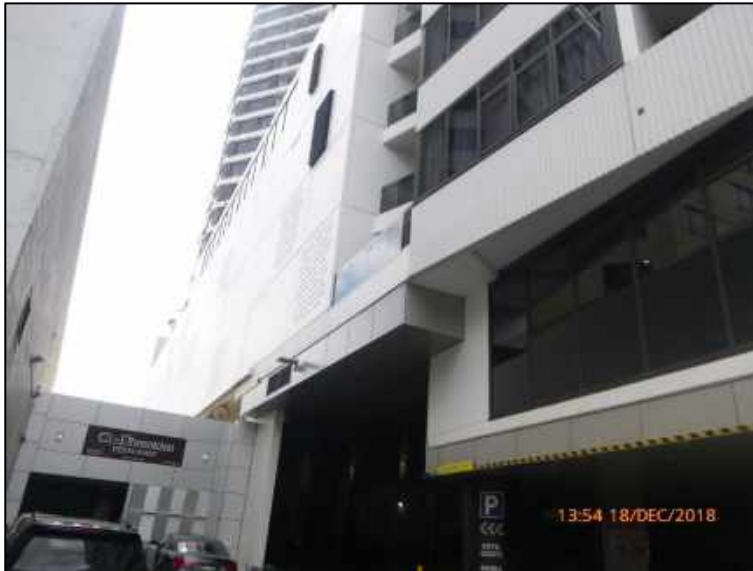
Photograph 1 – Presence of cladding on the eastern elevation

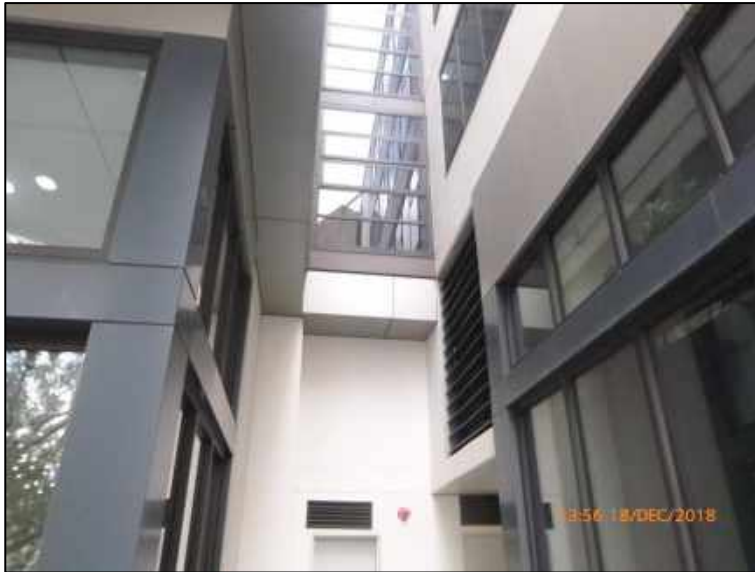
Photograph 4 – Cladding panels identify on the facade on the northern elevation of the building.

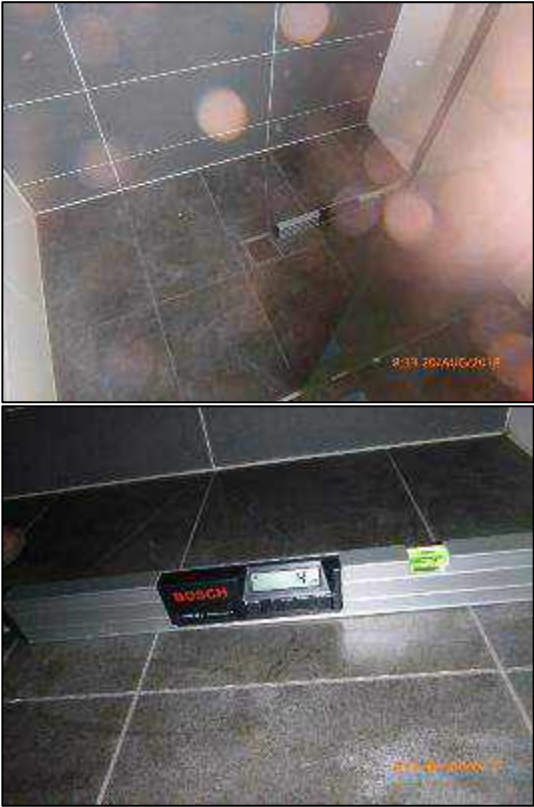
Item	Location	Defect Description and Breach	Rectification	Photograph (if applicable)
35	Main bedroom ensuite	See section 5.1.1 Falls (mm); 6/1000	See section 5.1.2

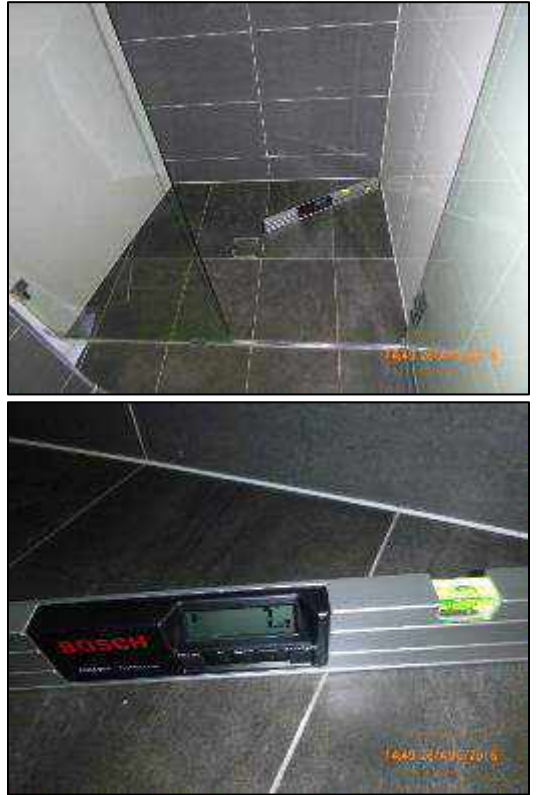
Item	Location	Defect description and Breach	Rectification	Photograph (if applicable)
976	Main bedroom ensuite	See section 5.1.1 Falls (mm); 1/1000	See section 5.1.2

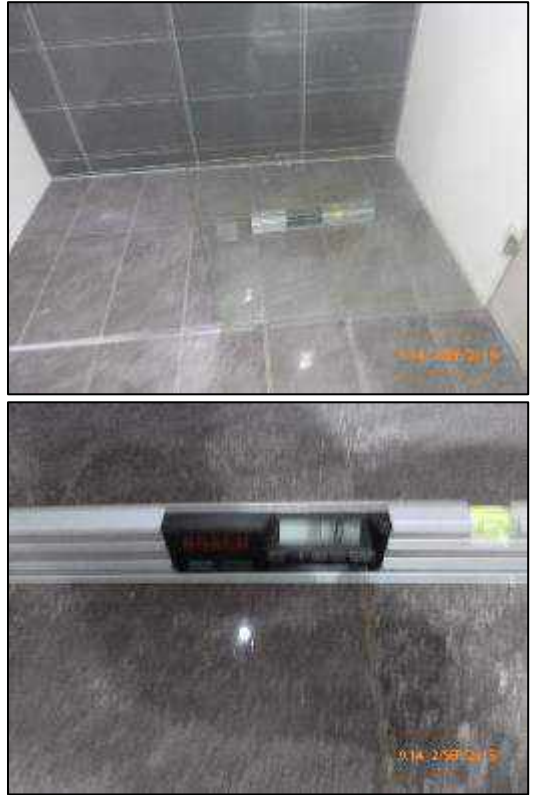
Item	Location	Defect description and Breach	Rectification	Photograph (if applicable)
1062	Balcony	See section 5.2.1 Falls (mm); 4/1000	See section 5.2.2

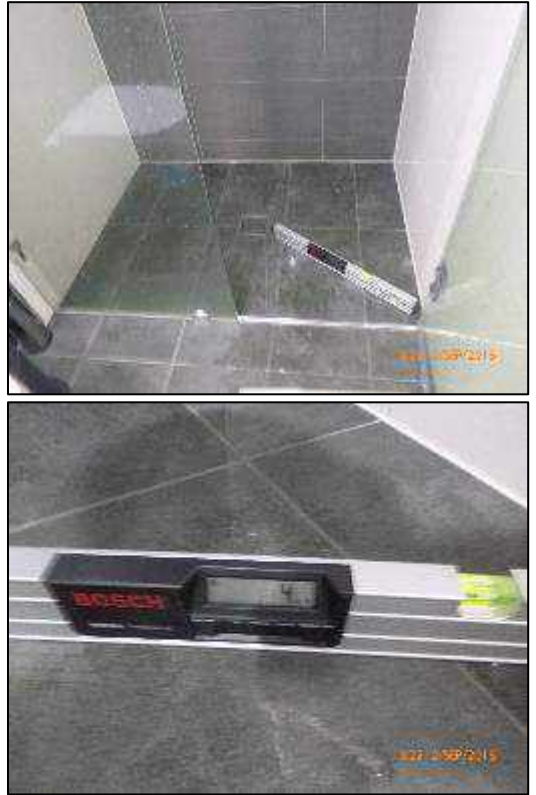
Item	Location	Defect description and Breach	Rectification	Photograph (if applicable)
1327	Main bedroom ensuite	See section 5.1.1 Falls (mm); 0/1000	See section 5.1.2

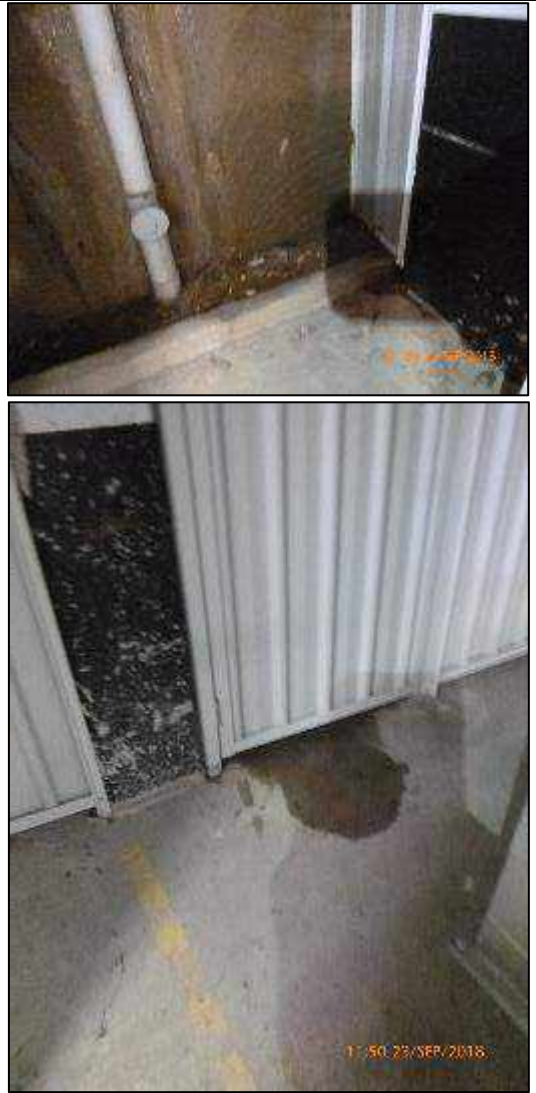
Item	Location	Defect description and Breach	Rectification	Photograph (if applicable)
2184	Soffit of slab in cage of unit 1505.	<p>Water seepage observed through the soffit of slab.</p> <p>Home Building Act (NSW) 1989</p> <ul style="list-style-type: none"> Part 2C, 18B (a) and (c). <p>AS 4654 – 2012 Waterproofing membranes for external use</p> <p>Falls in finishes shall ensure water drains to the drainage outlet. Water shall not be retained on the finished surface with the exception of residual water remaining due to surface tension.</p> <p>The fall shall be in the structural substrate, or formed by a screed over the structural substrate.</p> <p>NOTE: Falls for surface drainage should be no flatter than 1 in 100.</p> <p>Guide to Standards and Tolerances 2017</p> <ul style="list-style-type: none"> Section 14.7 Ponding on waterproof decks and balconies/ <p>This is a defect because 'water ponds or does not drain' as outlined in Section 14.7 of the Guide to Standards and Tolerances 2017.</p>	<ol style="list-style-type: none"> 1. Remove existing tiles and screed in wet areas above drainage pipe. 2. Remove waterproofing back to bare concrete; 3. Apply suitable waterproofing with correct penetration, drainage, upturns and wall opening detailing. 4. Apply graded sand and cement screed with moisture retarder, achieve minimum fall requirements as per the B.C.A and AS 4654; 5. Waterproof over bedding before retiling; 6. Seal appropriately around all slab penetrations; 7. Apply tiles to screed with adequate quantity of adhesive to ensure sound bond; 8. Clean and make good.

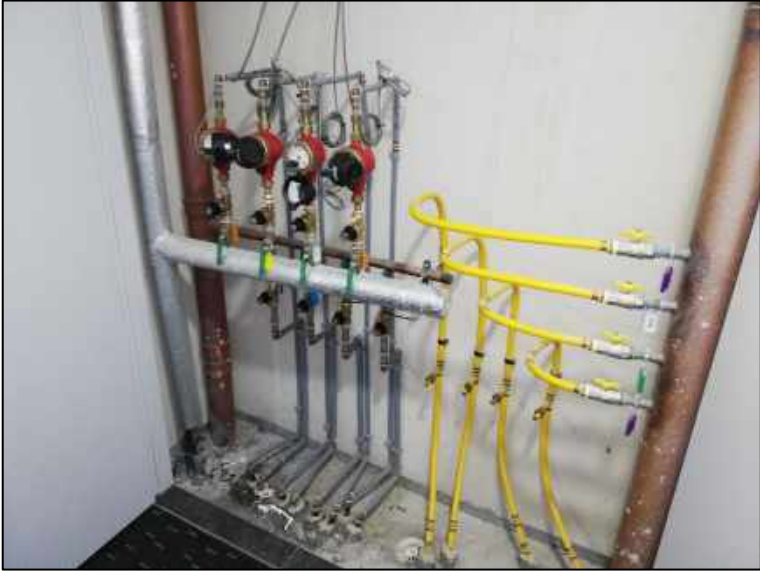
ITEM	1
Photo 1

Photo 1 comments	<ol style="list-style-type: none"> 1. Typical image of a hydraulic services riser cupboard with individual apartment hot water meters, cold water and gas isolation valves. 2. Hydraulic services installation has been installed in a tradesman like manner with no obvious defects visible.

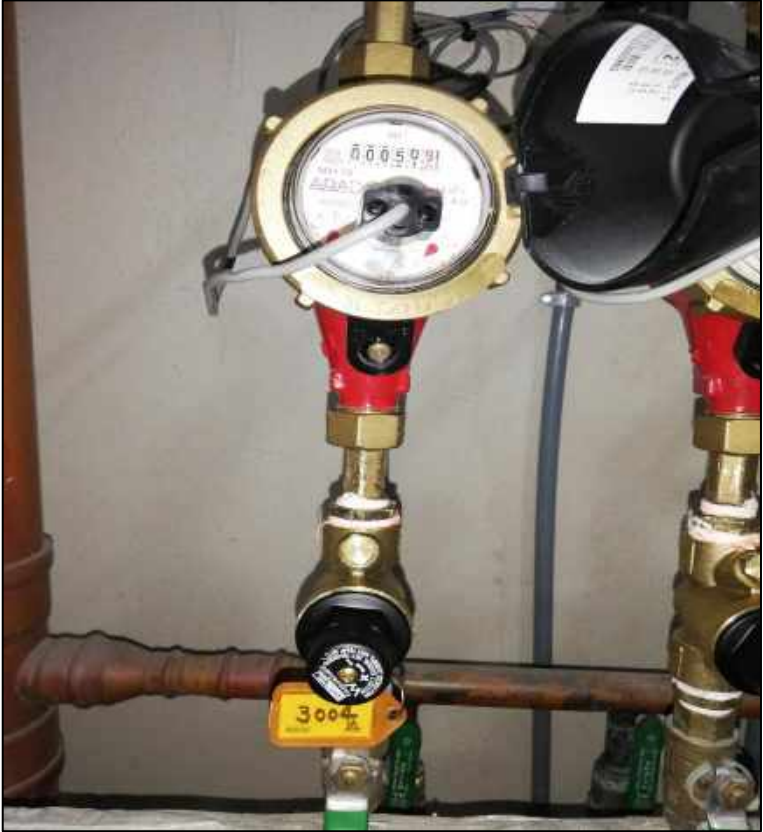
Photo 2 Comments	<p>Multiple residents within the complex reported excessive billing, particularly gas usage was is connected to the hot water system. Noviiion engineering was engaged to assess Unit 3004 to assess the installation of the hot water meters and if the meters had been labelled incorrectly. Noviiion carried out tests on apartment 3004 to identify any abnormal items that could contribute to the reported expensive hot water bills. The items tested with the following results;</p> <ol style="list-style-type: none"> 1. The waiting time for hot water delivery to the main shower rose took approximately 25 seconds. This is a typically normal for low flow water efficient showers roses. 2. The hot water temperature was record at the shower rose of 47 degrees Celsius. This temperature is acceptable and within the current regulations, with the maximum being 50 degrees Celsius. 3. On one of the suspect apartments we witnessed, the hot water meter correctly reading the water being used for apartment 3004. 4. The hot water meter at the time of the inspection show a reading of 50.9m3 (50,900 litres) and the unit has been occupied for approximately 12 months. An estimate of the approximate water usage based 365 days equates to 139.5 litres per day for two people living in a one-bedroom apartment. The recorded usage is considered to be above average usage for hot water usage in a one-bedroom apartment. This estimate could change based on the actual number of occupied days and occupations. <p>Furthermore, there are two items that could be contributing to high hot water bills which could be;</p> <ol style="list-style-type: none"> 1. the wiring that interconnects the hot water meter to the database could be incorrectly assigned to a different apartment. It is recommended that the relevant utility authority be engaged to confirm this. 2. The utility rate for hot water usage could be higher compared with other retailers. It could be in the owner's best interest to seek quotes from other retailers for hot water supply rates, and/or negotiate with the current retailer.
