# SydneyStrataReport

## STRATA REPORT

| Address of property | Unit 303/446-448 Bunnerong Road,<br>Matraville, NSW. |
| Strata Plan | SP 97139 |

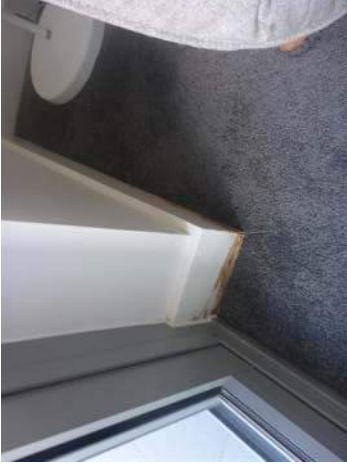
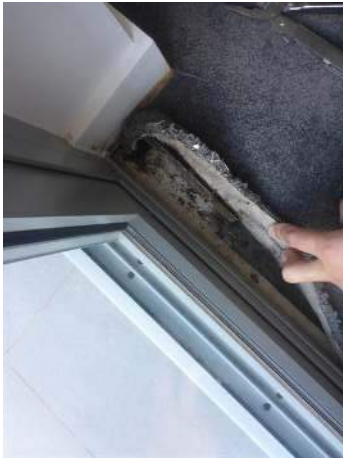
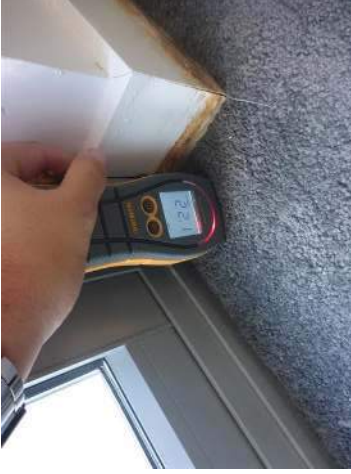
| ITEM | COMMENTARY | PHOTOGRAPH |
|---|---|---|
| A | <p><b>Location &amp; Description</b><br/>Bedroom 2:<br/>Evidence of water penetration in the form of staining to the floor and skirting on the southern side of the east-facing sliding door.<br/>Deteriorated smooth edge under the carpet in this location.</p> | |
| B | <p><b>Cause(s)</b></p> <ul style="list-style-type: none"> <li>➤ Further investigation required to determine the cause(s) of the reported building defect.</li> <li>➤ Possible failure of the waterproofing of the aluminium framed sliding door.</li> <li>➤ Possible failure of the waterproofing upturn for the courtyard.</li> </ul> | |
| C | <p><b>Breach(es)</b><br/>Breach of Performance Requirement FP1.4 of the Building Code of Australia, which requires that a roof or external wall (including openings around windows and doors) must prevent the penetration of water that could cause:</p> <p>(a) Unhealthy conditions, and a loss of amenity for occupants; and<br/>(b) Undue dampness and deterioration of building elements.</p> <p>In failing to adequately construct the building to resist water ingress, an unsatisfactory standard of workmanship has been executed.</p> <p>Accordingly, breach of Section 18B (a) and (c) of the Home Building Act 1989 (NSW):</p> <p>(a) Failure to perform work with due care and skill.<br/>(c) Failure to perform work in accordance with the Home Building Act 1989 (NSW).</p> | |

| ITEM | COMMENTARY | PHOTOGRAPH |
|---|---|---|
| D | <p><b>Recommended Scope of Works/ Method of Repair</b></p> <ol style="list-style-type: none"> <li>1. Set up work area and protect all adjoining surfaces and elements around the work area.</li> <li>2. Direct water against the sliding door to simulate rain and identify the source(s) of water penetration.</li> <li>3. Scope of works to be determined based on the outcome of the above investigations.</li> <li>4. Rectify any failures / deficiencies with the sliding door as required.</li> <li>5. Water test the repairs to verify their success.</li> <li>6. Replace water damaged internal skirtings, underlay and carpet as required.</li> <li>7. Clean up and make good work area.</li> </ol> | |

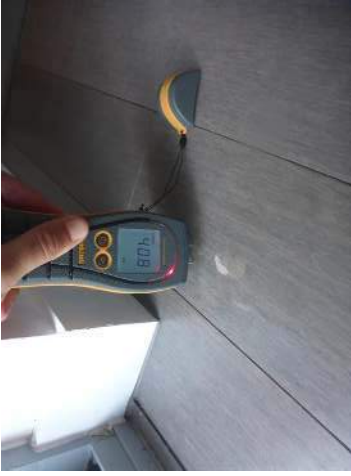
| ITEM | COMMENTARY | PHOTOGRAPH |
|---|---|---|
| A | <p><b>Location &amp; Description</b><br/>Living room:<br/>Isolated warping and blistering of the finish on the timber laminate flooring adjacent to the southern end of the southern, east-facing sliding door.<br/>Elevated moisture meter readings to the flooring in this location.</p> | |
| B | <p><b>Cause(s)</b></p> <ul style="list-style-type: none"> <li>➤ Cannot conclusively establish the cause of the reported defect, further investigation required</li> <li>➤ Possible manufacturing defect with the timber laminate flooring.</li> <li>➤ Possible damage to the timber laminate flooring.</li> <li>➤ Possible water penetration through the adjacent sliding door to the courtyard</li> </ul> | |
| C | <p><b>Breach(es)</b><br/>To be confirmed – Pending further investigations.</p> <p>If the builder has failed to adequately waterproof the external wall and/or sliding door, an unsatisfactory standard of workmanship has been executed.</p> <p>If the builder has damaged the flooring during installation, an unsatisfactory standard of workmanship has been executed.</p> <p>Possible breach of <i>Performance Requirement FP1.4</i> of the Building Code of Australia, which requires that <i>a roof or external wall (including openings around windows and doors) must prevent the penetration of water.</i></p> <p>Accordingly, under Section 18B (a), and (c) of the Home Building Act 1989 (NSW):</p> <ul style="list-style-type: none"> <li>(a) Failure to perform work with due care and skill.</li> <li>(c) Failure to perform work that complies with the Home Building Act.</li> </ul> | |

| ITEM | COMMENTARY | PHOTOGRAPH |
|---|---|---|
| D | <p><b>Recommended Scope of Works/ Method of Repair</b></p> <ol style="list-style-type: none"> <li>1. Protect all adjoining surfaces around work area.</li> <li>2. Direct water against the sliding door to simulate rain and identify the source(s) of water penetration.</li> <li>3. Scope of works to be determined based on the outcome of the above investigations.</li> <li>4. Rectify any waterproofing failures identified.</li> <li>5. Remove skirtings in the affected area to allow the replacement of the timber laminate flooring.</li> <li>6. Replace the damaged timber laminate flooring to match the existing in accordance with the manufacturer's recommendations.</li> <li>7. Reinstall skirtings where required to match the existing.</li> <li>8. Repaint skirtings and affected walls etc. to match the existing with a suitable interior paint system in accordance with the manufacturer's recommendations.</li> <li>9. Clean-up and make good work area.</li> </ol> | |

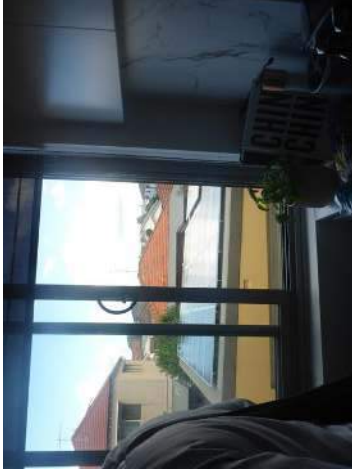
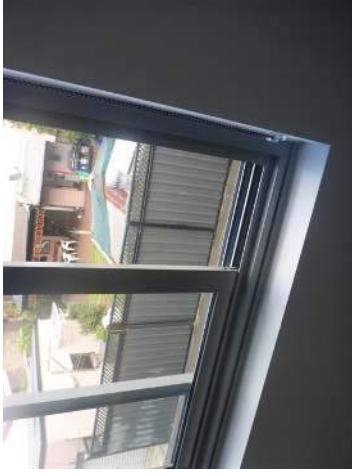
| ITEM | COMMENTARY | PHOTOGRAPH |
|---|---|---|
| A | <p><b>Location &amp; Description</b><br/>Dining room / kitchen:<br/>The sliding windows in the western wall opens more than 125mm<br/>Instructed by the occupant that restrictors were not removed.</p> <p>Note: it is understood that the Construction Certificate application was made after 1<sup>st</sup> May 2014.<br/>Note: it is assumed that the window has not been modified since occupation (i.e. the original restrictors were not removed after construction).</p> | |
| B | <p><b>Cause(s)</b></p> <ul style="list-style-type: none"> <li>➤ Possible oversight or incomplete works (i.e. restrictors not installed).</li> </ul> | |
| C | <p><b>Breach(es)</b></p> <p>In failing to install a suitable window restrictor in the bedroom, an unsatisfactory standard of workmanship has been executed.</p> <p>Non-compliance with D2.24 <i>Protection of openable windows</i> in the Building Code of Australia, which stipulates that <i>a window opening must be provided with protection, if the floor below the window is 2m or more above the surface beneath in a bedroom in a Class 2 building.</i></p> <p><i>Where the lowest level of the window opening is less than 1.7m above the floor, the openable portion of the window must be protected with a device capable of restricting the window opening.</i></p> <p><i>A restrictor must not permit a 125mm sphere to pass through the window opening.</i></p> <p>In failing to install window restrictors, an unsatisfactory standard of workmanship has been executed.</p> | |

| ITEM | COMMENTARY | PHOTOGRAPH |
|---|---|---|
| C | <p><b>Breach(es) Cont.</b><br/>Accordingly, under Section 18B (a) and (c) of the Home Building Act 1989 (NSW):</p> <p>(a) Failure to perform work with due care and skill.<br/>(c) Failure to perform work that complies with the Home Building Act.</p> | |

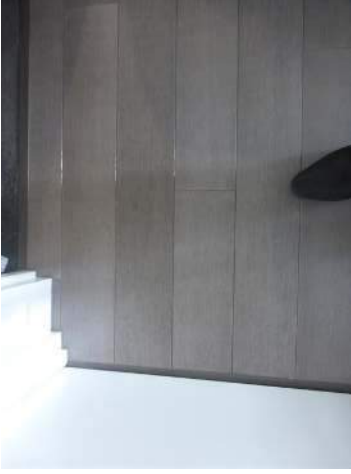
| ITEM | COMMENTARY | PHOTOGRAPH |
|---|---|---|
| C | <p><b>Breach(es)</b><br/>In failing to install the floating timber floor with suitable provisions to accommodate movement, an unsatisfactory standard of workmanship has been executed.</p> <p>In failing to ensure the surface of the concrete floor slab was uniform prior to the installation of the floating timber floor an unsatisfactory standard of workmanship has been executed.</p> <p>Accordingly, under Section 18B (a), and (c) of the Home Building Act 1989 (NSW):</p> <p>(a) Failure to perform work with due care and skill.<br/>(c) Failure to perform work that complies with the Home Building Act.</p> | |

| ITEM | COMMENTARY | PHOTOGRAPH |
|---|---|---|
| D | <p><b>Recommended Scope of Works/ Method of Repair</b></p> <ol style="list-style-type: none"> <li>1. Set up work area and protect all adjoining surfaces and other elements surrounding the work area.</li> <li>2. Carefully remove skirting around the affected sections of the floating timber floor.</li> <li>3. Carefully remove the affected sections of the floating timber floor.</li> <li>4. Fill any voids or other irregularities in the concrete floor slab.</li> <li>5. Reinstate the floating timber floor in accordance with the manufacturer's instructions.</li> <li>6. Reinstate skirting to match existing.</li> <li>7. Touch-up paint skirting and adjoining plasterboard wall lining sheets as required.</li> <li>8. Clean up and make good work area.</li> </ol> | |

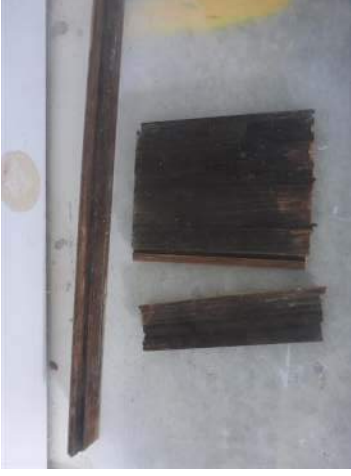
| ITEM | COMMENTARY | PHOTOGRAPH |
|---|---|---|
| C | <p><b>Breach(es)</b></p> <p>In failing to adequately construct the building to resist water ingress, an unsatisfactory standard of workmanship has been executed.</p> <p>Breach of <i>Performance Requirement FP1.4</i> of the Building Code of Australia, which requires that <i>a roof or external wall (including openings around windows and doors) must prevent the penetration of water that could cause:</i></p> <ul style="list-style-type: none"> <li>(a) <i>Unhealthy conditions, and a loss of amenity for occupants; and</i></li> <li>(b) <i>Undue dampness and deterioration of building elements.</i></li> </ul> <p>Accordingly, under Section 18B (a) and (c) of the Home Building Act 1989 (NSW):</p> <ul style="list-style-type: none"> <li>(a) Failure to perform work in a proper and workmanlike manner.</li> <li>(c) Failure to perform work that complies with the Home Building Act.</li> </ul> | |

| ITEM | COMMENTARY | PHOTOGRAPH |
|---|---|---|
| D | <p><b>Recommended Scope of Works/ Method of Repair</b></p> <ol style="list-style-type: none"> <li>1. Protect all adjoining surfaces around work area.</li> <li>2. Establish safe access to the exterior of the wall.</li> <li>3. Visually inspect the full height of the wall, with emphasis on the joints in same and attempt to identify the source(s) of the water penetration.</li> <li>4. Direct water against the wall to simulate rain and attempt to reproduce the water penetration.</li> <li>5. Detailed scope of works to be determined based on the outcome of the above investigations.</li> <li>6. Rectify any failures / deficiencies identified. It is anticipated that the works may involve one or more of the following: <ul style="list-style-type: none"> <li>• Re-sealing of the joints between the AFS wall sections.</li> <li>• Re-application of the external waterproof coating system.</li> <li>• Re-sealing of the joints in the adjacent box gutter.</li> <li>• Repair / replacement of the flashings for the adjacent box gutter / southern wall.</li> </ul> </li> <li>7. Replace water damaged flooring, wall linings, skirtings etc to match the existing in accordance with the manufacturer's recommendations.</li> <li>8. Repaint the dining area to match existing with a suitable interior paint system in accordance with the manufacturer's recommendations.</li> <li>9. Reinstate the built-in cupboards previously removed as part of the investigation works.</li> <li>10. Clean-up and make good work area.</li> </ol> | |

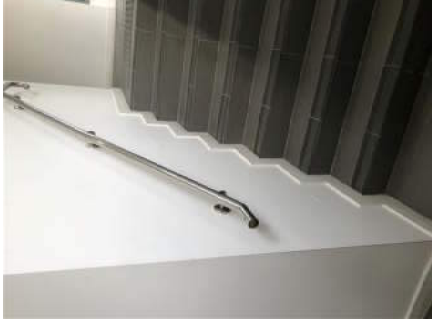
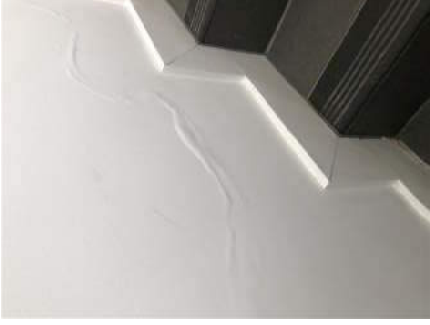
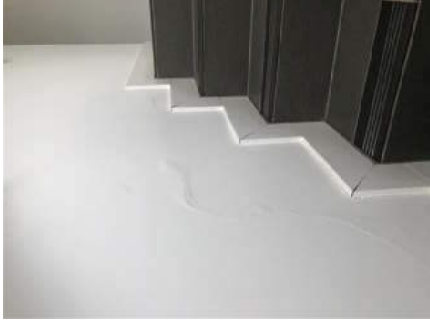
| ITEM | COMMENTARY | PHOTOGRAPH |
|---|---|---|
| A | <p><b>Location and description</b><br/> <u>Eastern building, Ground floor:</u><br/> The owner of Unit 301 reported blistering paint on the rendered southern wall of the stairs between ground and upper ground floors during a period of rainfall.<br/> This wall forms part of the lift shaft.</p> <p><b>Photographs provided by the Owner of Unit 301.</b></p> | |
| B | <p><b>Cause(s)</b></p> <ul style="list-style-type: none"> <li>➤ Could not conclusively establish the cause of the reported defect. Further investigation required.</li> <li>➤ Possible water penetration from the adjacent common courtyard.</li> <li>➤ Possible water penetration to the lift shaft.</li> <li>➤ Possible failure to adequately install the interior paintwork to the lift shaft.</li> </ul> | |
| C | <p><b>Breach(es)</b></p> <p>If the builder has failed to adequately construct the building to resist water ingress, an unsatisfactory standard of workmanship has been executed.</p> <p>Breach of <i>Performance Requirement FP1.4</i> of the Building Code of Australia, which requires that <i>a roof or external wall (including openings around windows and doors) must prevent the penetration of water that could cause:</i></p> <ul style="list-style-type: none"> <li>(a) <i>Unhealthy conditions, and a loss of amenity for occupants; and</i></li> <li>(b) <i>Undue dampness and deterioration of building elements.</i></li> </ul> <p>If the builder has failed to adequately install the interior paintwork, an unsatisfactory standard of workmanship has been executed.</p> | |

| ITEM | COMMENTARY | PHOTOGRAPH |
|---|---|---|
| C | <p>Section 12.02 Surface finish of paintwork: of the Office of Fair Trading “Guide to Standards &amp; Tolerances” states that “Paintwork is defective if application defects or blemishes and other irregularities in the surface are visible from a normal viewing position.”</p> <p>Accordingly, under Section 18B (a) and (c) of the Home Building Act 1989 (NSW):</p> <p>(a) Failure to perform work with due care and skill.</p> <p>(c) Failure to perform work that complies with the Home Building Act and other laws (i.e. the Building Code of Australia).</p> | |

| ITEM | COMMENTARY | PHOTOGRAPH |
|---|---|---|
| D | <p><b>Recommended Scope of Works/ Method of Repair</b></p> <ol style="list-style-type: none"> <li>1. Set up work area and protect all adjoining surfaces and other elements surrounding the work area.</li> <li>2. Establish safe access to the area above the lift shaft.</li> <li>3. Inspect the top of the lift shaft for any waterproofing failures / deficiencies. Undertake isolated flood testing where required to verify any source(s) of water penetration.</li> <li>4. Undertake flood testing of the adjacent courtyard / planter boxes etc to identify any water penetration from same.</li> <li>5. Scope of works to be determined based on the outcome of the above investigations.</li> <li>6. If the defect is deemed the responsibility of the original builder, the above scope of works should be referred to them for rectification.</li> <li>7. Coat the affected wall with a suitable epoxy coating system in accordance with the manufacturer’s recommendations.</li> <li>8. Repaint the affected wall with a suitable interior paint system to match the existing in accordance with the manufacturer’s recommendations</li> <li>9. Clean up and make good work area.</li> </ol> | |

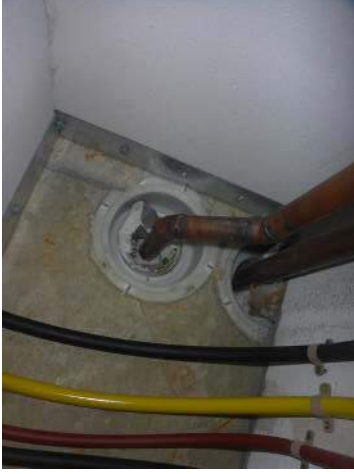
| ITEM | COMMENTARY | PHOTOGRAPH |
|---|---|---|
| A | <p><b>Location and description</b><br/> Eastern building, Level 2 – Hot water cupboard:<br/> The fire collars forming the slab penetrations have been plugged with newspaper.<br/> Cannot confirm the adequacy of the fire separation materials and construction.</p> | |
| B | <p><b>Cause(s)</b></p> <ul style="list-style-type: none"> <li>➤ Incomplete work – failure to remove temporary material after the construction of the floor slab.</li> <li>➤ The redundant penetration has not been filled with an appropriate fire-resistant material.</li> </ul> | |
| C | <p><b>Breach(es)</b></p> <p>To be confirmed – Pending further investigation by a qualified fire services consultant.</p> <p>If the builder has failed to incorporate adequate fire separation between the floors, an unsatisfactory standard of workmanship has been executed.</p> <p>Possible breach of <i>Section C – Fire resistance</i> in the National Construction Code.</p> | |

| ITEM | COMMENTARY | PHOTOGRAPH |
|---|---|---|
| D | <p><b>Recommended Scope of Works/ Method of Repair</b></p> <ol style="list-style-type: none"> <li>1. Set up work area and protect all adjoining surfaces and other elements surrounding the work area.</li> <li>2. Engage a qualified fire services consultant to inspect the service cupboards and confirm the apparent defect.</li> <li>3. Scope of works to be determined based on the outcome of this inspection.</li> <li>4. If the defect is deemed the responsibility of the original builder, the above scope of works should be referred to them for rectification.</li> <li>5. Clean up and make good work area.</li> </ol> | |

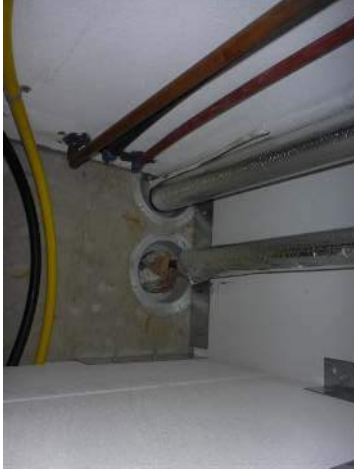
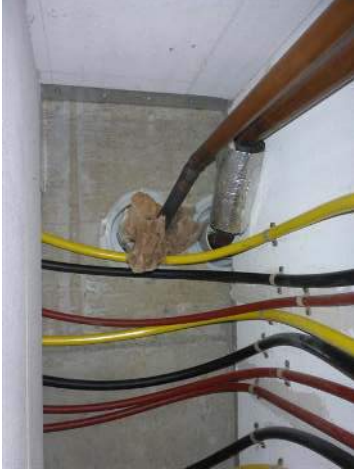
| ITEM | COMMENTARY | PHOTOGRAPH |
|---|---|---|
| A | <p><b>Location and description</b><br/> Eastern building, Level 3 – Hot water cupboard:<br/> The fire collars forming the slab penetrations have been plugged with paper.<br/> Cannot confirm the adequacy of the fire separation materials and construction.</p> | |
| B | <p><b>Cause(s)</b></p> <ul style="list-style-type: none"> <li>➤ Incomplete work – failure to remove temporary material after the construction of the floor slab.</li> <li>➤ The redundant penetration has not been filled with an appropriate fire-resistant material.</li> </ul> | |
| C | <p><b>Breach(es)</b><br/> To be confirmed – Pending further investigation by a qualified fire services consultant.</p> <p>If the builder has failed to incorporate adequate fire separation between the floors, an unsatisfactory standard of workmanship has been executed.</p> <p>Possible breach of <i>Section C – Fire resistance</i> in the National Construction Code.</p> | |

| ITEM | COMMENTARY | PHOTOGRAPH |
|---|---|---|
| D | <p><b>Recommended Scope of Works/ Method of Repair</b></p> <ol style="list-style-type: none"> <li>1. Set up work area and protect all adjoining surfaces and other elements surrounding the work area.</li> <li>2. Engage a qualified fire services consultant to inspect the service cupboards and confirm the apparent defect.</li> <li>3. Scope of works to be determined based on the outcome of this inspection.</li> <li>4. If the defect is deemed the responsibility of the original builder, the above scope of works should be referred to them for rectification.</li> <li>5. Clean up and make good work area.</li> </ol> | |

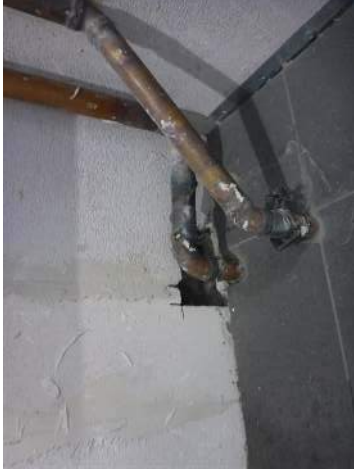
| ITEM | COMMENTARY | PHOTOGRAPH |
|---|---|---|
| A | <p><b>Location and description</b><br/> Eastern building, Level 4 – Hot water cupboard:<br/> Sections at the base of the rear <i>Hebel</i> wall have been cut away to provide clearance for the service pipework.<br/> Cannot confirm the adequacy of the fire rating for the modified Hebel wall.</p> | |
| B | <p><b>Cause</b></p> <ul style="list-style-type: none"> <li>➤ Modification of the Hebel wall to accommodate pipework.</li> </ul> | |
| C | <p><b>Breach(es)</b><br/> TBC - further investigation required by qualified fire consultant and/or the wall manufacturer.<br/> Possible breach of Section C2.7 <i>Separation by fire walls</i> &amp; Spec 1.1 of the Building Code of Australia.<br/> If the builder has failed to adequately protect against the spread of fire, an unsatisfactory standard of workmanship has been executed.<br/> Accordingly, under Section 18B (a) and (c) of the Home Building Act 1989 (NSW):<br/> (a) Failure to perform work in a proper and workmanlike manner.<br/> (c) Failure to perform work that complies with the Home Building Act and other laws (i.e. Building Code of Australia).</p> | |

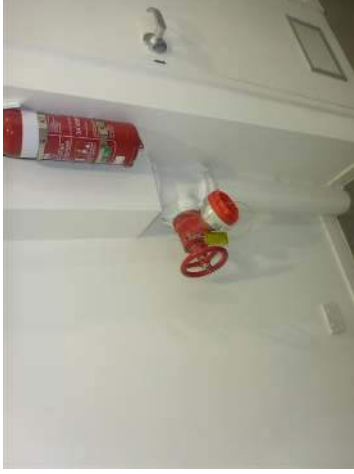
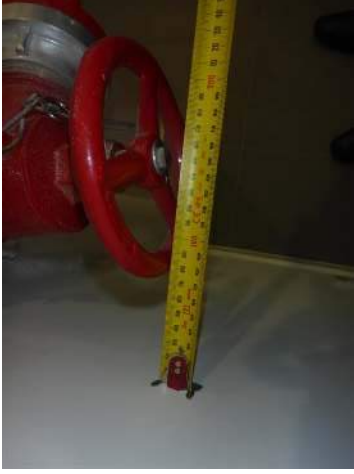
| ITEM | COMMENTARY | PHOTOGRAPH |
|---|---|---|
| A | <p>Western building, stairwell:</p> <p>The fire hydrant handle on the 1<sup>st</sup> floor is approximately 75mm clear of the wall. This is less than the 100mm clearance required under AS2419.</p> | |
| B | <p><b>Cause(s)</b></p> <ul style="list-style-type: none"> <li>➤ Failure to install the hydrant handwheels with sufficient clearances.</li> </ul> | |
| C | <p><b>Breach(es)</b></p> <p>AS2419.1:2005 <i>Fire hydrant installation</i> Section 3.5.2 <i>Clearance</i> states that "For a fully open fire hydrant valve, there shall be not less than 100mm clearance around the valve handwheel".</p> <p>Accordingly, under Section 18B (a) and (c) of the Home Building Act 1989 (NSW):</p> <p>(a) Failure to perform work with due care and skill.</p> <p>(c) Failure to perform work that complies with the Home Building Act and other laws (i.e. the Building Code of Australia).</p> | |

| ITEM | COMMENTARY | PHOTOGRAPH |
|---|---|---|
| D | <p><b>Recommended Scope of Works/ Method of Repair</b></p> <ol style="list-style-type: none"> <li>1. Set up work area and protect all adjoining surfaces and elements around the work area.</li> <li>2. Decommission and drain the hydrant system.</li> <li>3. Loosen the retaining clamps for the hydrant outlet handwheels.</li> <li>4. Realign the hydrant handwheels with sufficient clearances and re-tighten clamps.</li> <li>5. Commission and charge the hydrant system.</li> <li>6. Clean up and make good work area.</li> </ol> | |

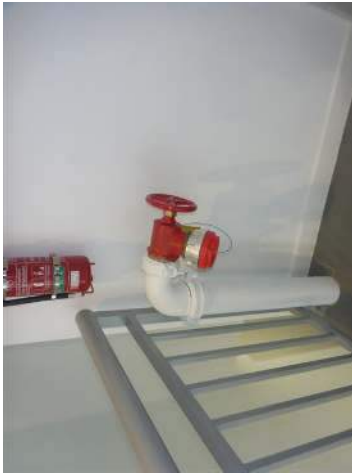
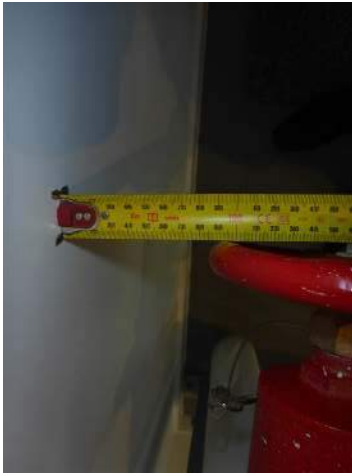
| ITEM | COMMENTARY | PHOTOGRAPH |
|---|---|---|
| A | Western building, stairwell:<br>The fire hydrant handle on the 2 <sup>nd</sup> floor is approximately 85mm clear of the wall.<br>This is less than the 100mm clearance required under AS2419. | |
| B | <b>Cause(s)</b><br>➤ Failure to install the hydrant handwheels with sufficient clearances. | |
| C | <b>Breach(es)</b><br>AS2419.1:2005 <i>Fire hydrant installation</i> Section 3.5.2 <i>Clearance</i> states that "For a fully open fire hydrant valve, there shall be not less than 100mm clearance around the valve handwheel".<br>Accordingly, under Section 18B (a) and (c) of the Home Building Act 1989 (NSW):<br>(a) Failure to perform work with due care and skill.<br>(c) Failure to perform work that complies with the Home Building Act and other laws (i.e. the Building Code of Australia). | |

| ITEM | COMMENTARY | PHOTOGRAPH |
|---|---|---|
| D | <b>Recommended Scope of Works/ Method of Repair</b><br>1. Set up work area and protect all adjoining surfaces and elements around the work area.<br>2. Decommission and drain the hydrant system.<br>3. Loosen the retaining clamps for the hydrant outlet handwheels.<br>4. Realign the hydrant handwheels with sufficient clearances and re-tighten clamps.<br>5. Commission and charge the hydrant system.<br>6. Clean up and make good work area. | |

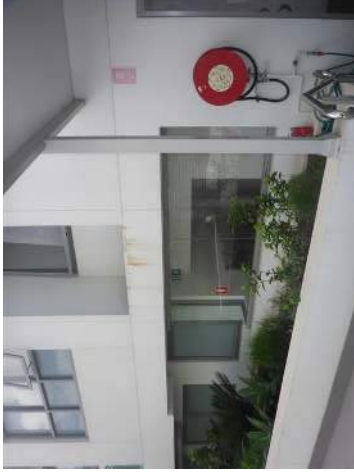
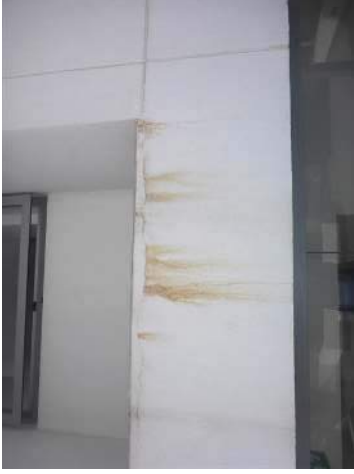
| ITEM | COMMENTARY | PHOTOGRAPH |
|---|---|---|
| A | <p><b>Location &amp; Description</b><br/>Western Elevation – Eastern building:<br/>Leaching emanating from the slab edge at the first floor level adjacent to the northern side of the eastern foyer entry.</p> | |
| B | <p><b>Cause(s)</b></p> <ul style="list-style-type: none"> <li>➤ Differential building movement</li> <li>➤ Inadequate joint provisions incorporated into render. This has made the render more susceptible to cracking as a result of differential movement.</li> <li>➤ Leaching is due to the water penetration through the render on the slab edge.</li> </ul> | |
| C | <p><b>Breach(es)</b><br/>In failing to adequately prevent moisture ingress and therefore control leaching from the building's exterior, an unsatisfactory standard of workmanship has been executed.</p> <p>Accordingly, under Section 18B (a) and (c) of the Home Building Act 1989 (NSW):</p> <p>(a) Failure to perform work in a proper and workmanlike manner.<br/>(c) Failure to perform work that complies with the Home Building Act.</p> | |

| ITEM | COMMENTARY | PHOTOGRAPH |
|---|---|---|
| D | <p><b>Recommended Scope of Works/ Method of Repair</b></p> <ol style="list-style-type: none"> <li>1. Set up work area and protect all adjoining surfaces and other elements surrounding the work area.</li> <li>2. Establish safe access to the areas of the works.</li> <li>3. Clean and remove leaching from the building's facade.</li> <li>4. Grind out the cracking, clean and prepare substrate.</li> <li>5. Supply and install a suitable flexible sealant to the cracking in accordance with the manufacturer's recommendations.</li> <li>6. Repaint the affected areas and any other disturbed adjoining surfaces to the nearest breaks to match existing using an appropriate multiple-coat exterior paint system.</li> <li>7. Clean up the work area.</li> </ol> | |

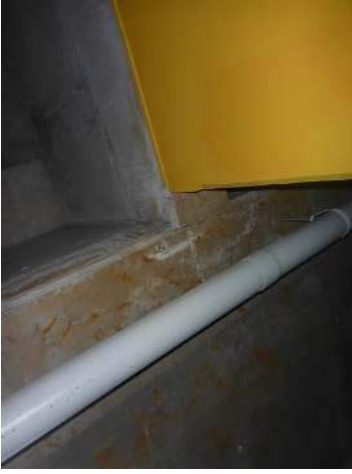
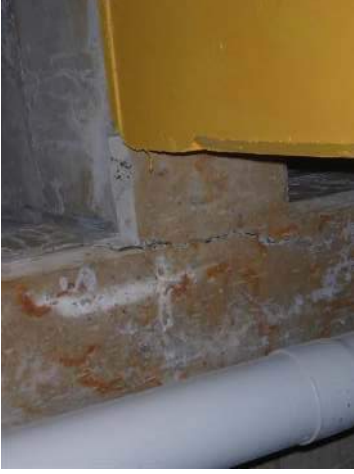
| ITEM | COMMENTARY | PHOTOGRAPH |
|---|---|---|
| A | <p><b>Location and description</b><br/>Car space 26:<br/>Cracking approximately 3.0mm in width to the reinforced concrete drop beam adjacent to the rear of the car space.</p> | |
| B | <p><b>Cause(s)</b></p> <ul style="list-style-type: none"> <li>➤ Differential building movement</li> <li>➤ Cracking of <i>cold-joint</i> in the concrete beam.</li> </ul> | |
| C | <p><b>Breach(es)</b><br/>In failing to adequately prevent the formation of cracking in the concrete beam, an unsatisfactory standard of workmanship has been executed.</p> <p>Breach of the Office of fair trading “<i>Guide to standards and tolerances</i>” Section 2.10 <i>Cracks in concrete slabs</i> which states that “Cracks greater than 2.0mm in width are defects.”</p> <p>Accordingly, under Section 18B (a) and (c) of the Home Building Act 1989 (NSW):</p> <p>(a) Failure to perform work with due care and skill.<br/>(c) Failure to perform work that complies with the Home Building Act and other laws (i.e. Building Code of Australia).</p> | |

| ITEM | COMMENTARY | PHOTOGRAPH |
|---|---|---|
| D | <p><b>Recommended Scope of Works/ Method of Repair</b></p> <ol style="list-style-type: none"> <li>1. Protect all adjoining surfaces around work area.</li> <li>2. Refer cracking to original engineers for comment.</li> <li>3. Establish suitable elevated work platform to undertake the works.</li> <li>4. Depending on the further advice from the original engineers;</li> <li>5. Grind out the cracking in the concrete beam.</li> <li>6. Clean all dust and other debris from the crack.</li> <li>7. Supply and install a suitable flexible sealant to the cracking in accordance with the manufacturer’s recommendations and tool flush.</li> <li>8. Clean-up and make good work area.</li> </ol> | |

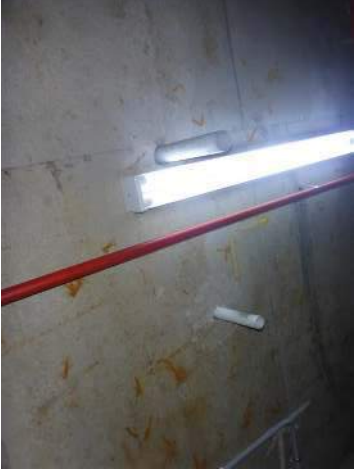
| ITEM | COMMENTARY | PHOTOGRAPH |
|---|---|---|
| A | <p><b>Location and description</b><br/>Basement level 1:<br/>Numerous PVC pipes penetrating through the slab have not been terminated or directed to a suitable discharge point. Issue is evident throughout the carpark.</p> | |
| B | <p><b>Cause(s)</b></p> <ul style="list-style-type: none"> <li>➤ Failure to direct the PVC pipework to a suitable outlet.</li> <li>➤ Failure to cap / remove redundant pipework</li> </ul> | |
| C | <p><b>Breach(es)</b><br/>In failing to adequately install the PVC pipework and/or cap / remove redundant pipework, an unsatisfactory standard of workmanship has been executed.</p> <p>Accordingly, under Section 18B (a) and (c) of the Home Building Act 1989 (NSW):</p> <p>(a) Failure to perform work with due care and skill.<br/>(c) Failure to perform work that complies with the Home Building Act.</p> | |

| ITEM | COMMENTARY | PHOTOGRAPH |
|---|---|---|
| D | <p><b>Recommended Scope of Works/ Method of Repair</b></p> <ol style="list-style-type: none"> <li>1. Protect all adjoining surfaces around work area.</li> <li>2. Establish suitable elevated work platform to undertake the works.</li> <li>3. Trim and cap any redundant PVC pipework as required and/or</li> <li>4. Extend the PVC pipework to an appropriate discharge as required.</li> <li>5. Clean-up and make good work area.</li> </ol> | |

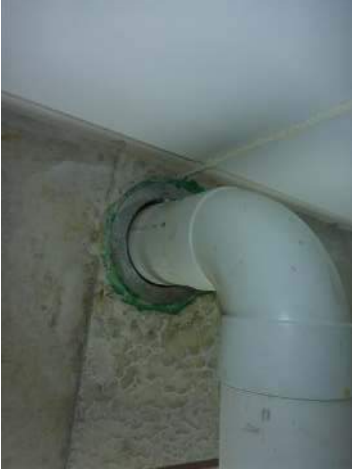
| ITEM | COMMENTARY | PHOTOGRAPH |
|---|---|---|
| A | <p><b>Location &amp; Description</b><br/>Basement carpark – Toilet:<br/>Leaching emanating from the soffit of the slab above adjacent to the pipework penetration.</p> | |
| B | <p><b>Cause(s)</b></p> <ul style="list-style-type: none"> <li>➤ There are inadequate waterproofing provisions on or in the concrete slab to inhibit water penetration.</li> </ul> | |
| C | <p><b>Breach(es)</b></p> <p>The water penetration emanating through the concrete slab is undermining the use and amenity of the toilet. The area therefore has not been constructed 'fit for purpose'.</p> <p>Breach of <i>Performance Requirement FP1.4</i> of the Building Code of Australia, which requires that <i>a roof and external wall must prevent the penetration of water that could cause:</i></p> <p>(a) <i>Unhealthy conditions, and a loss of amenity for occupants; and</i></p> <p>(b) <i>Undue dampness and deterioration of building elements.</i></p> <p>Accordingly, under Section 18B (a) and (c) of the Home Building Act 1989 (NSW):</p> <p>(a) Failure to perform work in a proper and workmanlike manner.</p> <p>(c) Failure to perform work that complies with the Home Building Act and other laws (i.e. Building Code of Australia).</p> | |

| ITEM | COMMENTARY | PHOTOGRAPH |
|---|---|---|
| D | <p><b>Recommended Scope of Works/ Method of Repair</b></p> <ol style="list-style-type: none"> <li>1. Establish a safe, mobile work platform to access the concrete slab soffit.</li> <li>2. Protect adjoining surfaces.</li> <li>3. Apply a suitable cementitious negative side waterproof membrane in accordance with the manufacturer instructions.</li> <li>4. Clean up and make good work areas.</li> </ol> | |

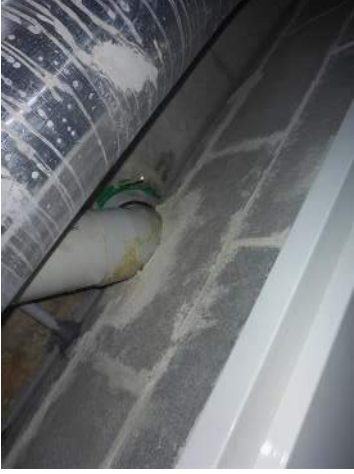
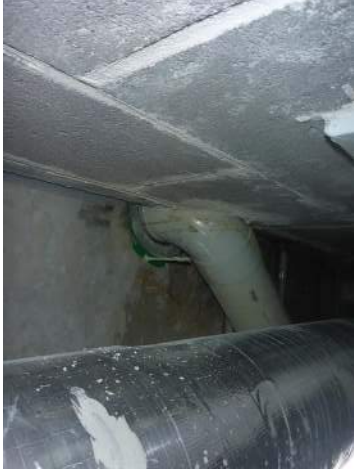
| ITEM | COMMENTARY | PHOTOGRAPH |
|---|---|---|
| A | <p><b>Location &amp; Description</b><br/> Basement carpark – ground level:<br/> Leaching emanating from the soffit of the slab above adjacent to the pipework penetration above the entry to the western fire stairwell.</p> | |
| B | <p><b>Cause(s)</b></p> <ul style="list-style-type: none"> <li>➤ There are inadequate waterproofing provisions on or in the concrete slab to inhibit water penetration.</li> </ul> | |
| C | <p><b>Breach(es)</b></p> <p>The water penetration emanating through the concrete slab can create a slip hazard for people exiting the carpark in an emergency. The area therefore has not been constructed 'fit for purpose'.</p> <p>Breach of <i>Performance Requirement FP1.4</i> of the Building Code of Australia, which requires that <i>a roof and external wall must prevent the penetration of water that could cause:</i></p> <p>(a) <i>Unhealthy conditions, and a loss of amenity for occupants; and</i><br/> (b) <i>Undue dampness and deterioration of building elements.</i></p> <p>Accordingly, under Section 18B (a) and (c) of the Home Building Act 1989 (NSW):</p> <p>(a) Failure to perform work in a proper and workmanlike manner.<br/> (c) Failure to perform work that complies with the Home Building Act and other laws (i.e. Building Code of Australia).</p> | |

| ITEM | COMMENTARY | PHOTOGRAPH |
|---|---|---|
| D | <p><b>Recommended Scope of Works/ Method of Repair</b></p> <ol style="list-style-type: none"> <li>1. Establish a safe, mobile work platform to access the concrete slab soffit.</li> <li>2. Protect adjoining surfaces.</li> <li>3. Apply a suitable cementitious negative side waterproof membrane in accordance with the manufacturer instructions.</li> <li>4. Clean up and make good work areas.</li> </ol> | |

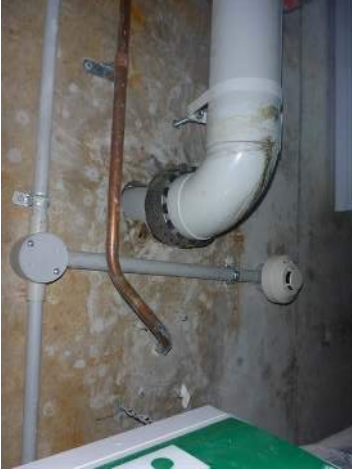
| ITEM | COMMENTARY | PHOTOGRAPH |
|---|---|---|
| A | <p><b>Location &amp; Description</b><br/> Basement carpark – ground level:<br/> The slab penetration adjacent to the entry for the western fire stairs has been fitted with a retrofit fire collar.<br/> A section of concrete is missing above this.<br/> It is unclear whether this complies with the manufacturer's recommendations.</p> | |
| B | <p><b>Cause(s)</b></p> <ul style="list-style-type: none"> <li>➤ Incomplete work/oversight (i.e. redundant slab penetration not grouted).</li> <li>➤ It is strongly recommended that this issue is assessed by a specialist fire safety/building regulations consultant.</li> </ul> | |
| C | <p><b>Breach(es)</b><br/> N/A pending further investigations.</p> <p>Possible breaches under Section C Fire Resistance in the Building Code of Australia.</p> <p>Accordingly, under Section 18B (a) and (c) of the Home Building Act 1989 (NSW):</p> <ul style="list-style-type: none"> <li>(a) Failure to perform work with due care and skill.</li> <li>(c) Failure to perform work that complies with the Home Building Act and other laws (i.e. Building Code of Australia).</li> </ul> | |

| ITEM | COMMENTARY | PHOTOGRAPH |
|---|---|---|
| D | <p><b>Recommended Scope of Works/ Method of Repair</b></p> <ol style="list-style-type: none"> <li>1. Establish a safe, mobile work platform to access the concrete slab soffit.</li> <li>2. Protect adjoining surfaces.</li> <li>3. The Owners Corporation should engage a qualified fire safety/building regulations consultant to assess this issue.</li> <li>4. As required grout the slab penetration and/or undertake works as recommended by the fire safety consultant.</li> <li>5. Clean up and make good work areas.</li> </ol> | |

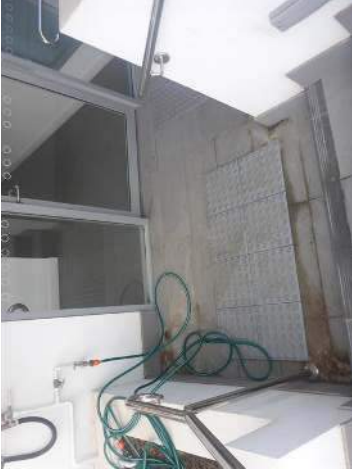
| ITEM | COMMENTARY | PHOTOGRAPH |
|---|---|---|
| A | <p><b>Location &amp; Description</b></p> <p>Floor tiling – adjacent to entry:</p> <p>Instructed by numerous occupants of ponding water on the floor tiles adjacent to the entry door to the eastern building. Further instructed of water penetration into the adjacent foyer under the door.</p> <p>A single floor waste is located at the base of the disabled ramp.</p> <p>The floor tiling was measured and found to be falling towards the existing drainage outlet.</p> <p>There is no hob under the door from the foyer to prevent water ingress.</p> | |
| B | <p><b>Cause(s)</b></p> <ul style="list-style-type: none"> <li>➤ Inadequate drainage to accommodate the surface water from the courtyard during heavy rainfall.</li> <li>➤ Possible failure to comply with the plans and specifications.</li> </ul> | |
| C | <p><b>Breach(es)</b></p> <p>In failing to install sufficient drainage for the central courtyard, an unsatisfactory standard of workmanship has been executed.</p> <p>Accordingly, under Section 18B (a) and (c) of the Home Building Act 1989 (NSW):</p> <p>(a) Failure to perform work in a proper and workmanlike manner.</p> <p>(c) Failure to perform work that complies with the Home Building Act.</p> | |

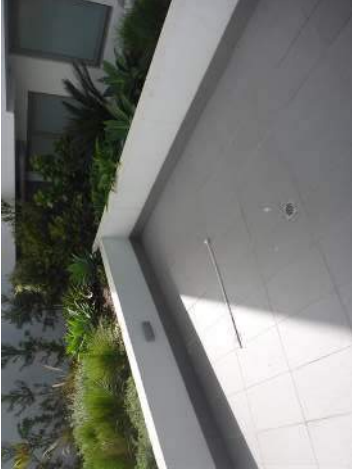
| ITEM | COMMENTARY | PHOTOGRAPH |
|---|---|---|
| A | <p><b>Location &amp; Description</b></p> <p>Floor tiles:<br/> Numerous drummy and delaminated floor tiles throughout the central courtyard area.<br/> Significant vertical displacement of the tiles in the narrow area on the southern side of the foyer entries.<br/> No intermediate expansion joints visible in the floor tiles.</p> | |
| B | <p><b>Cause(s)</b></p> <ul style="list-style-type: none"> <li>➤ Failure to adequately prepare the substrate prior to tiling.</li> <li>➤ Failure to install adequate perimeter and intermediate joints in the floor tiling.</li> <li>➤ Poor workmanship during the installation of the courtyard floor tiling.</li> </ul> | |
| C | <p><b>Breach(es)</b></p> <p>In failing to install adequate movement joints in the courtyard floor tiling, an unsatisfactory standard of workmanship has been executed.</p> <p>In accordance with the NSW Office of Fair Trading – Guide to Standards &amp; Tolerances 2007, <i>Section 11.02 Floor and wall tiling where the builder supplied the tiles:</i></p> <p><i>Where the supply and laying of the tiles is by the builder as part of the building contract, the failure of the tiles, substrate, adhesive or grout is a defect.</i></p> <p>In accordance with the NSW Office of Fair Trading – Guide to Standards &amp; Tolerances 2007, <i>Section 11.05</i> which stipulates that</p> <p><i>After handover, tiles are defective when caused by the builder's workmanship, they become cracked, pitted, chipped, loose or drummy and such in more than five per cent of the tiled area within 24 months of completion.</i></p> | |
