SydneyStrataReport

STRATA REPORT

Client	Andrew C. So
Address of property	Unit A603/2 Sunders Close, Macquarie Park, NSW.
Lot	62
Strata Plan	SP 89124
Name of Strata Management Co.	Bright & Duggan
Telephone Number of Strata Agent	9902 7100
Report Date	4 September 2023

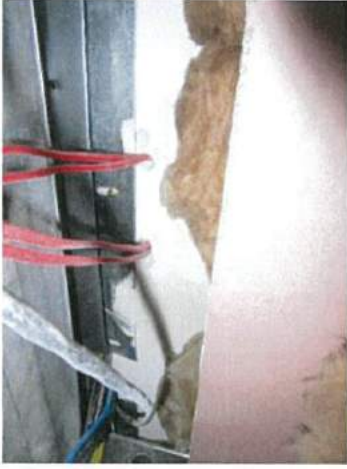
Item No.	Description and Location of the Defect	Agreed Scope of Works	BCA Logic Photograph	Defect Status and Photograph
4.	Unit 905 Redundant penetration within Hebel bounding wall.	1. Appropriately seal around the redundant penetration with an approved fire rated mastic in accordance with the manufacturers recommendations to maintain the FRL.

Toga will reseal the penetration with Promat Promaseal AN Acrylic Sealant Test Report A-13-816

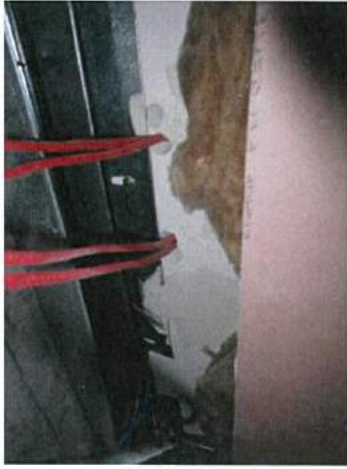
5.	Unit 905 Unsealed electrical penetrations through the bounding wall above the entry door. Electrical penetrations pass through the head stud of the Hebel wall. This allows the passage of smoke along the top of the head stud.	1. Appropriately seal around the electrical penetrations with an approved fire rated mastic in accordance with the manufacturers recommendations to maintain the FRL. 2. Suitably repair the large voids within the Hebel wall in strict accordance with the manufacturer's rectification methods to maintain the FRL of the wall.

Toga will reseal the penetration with Promat Promaseal AN Acrylic Sealant Test Report A-13-816

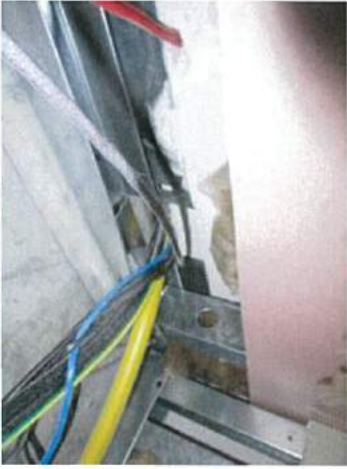
Item No.	Description and Location of the Defect	Agreed Scope of Works	BCA Logic Photograph	Defect Status and Photograph
6.	<p>Unit 905</p> <p>No fire collar to the PEX gas pipe through the bounding wall above the entry door. The PEX pipe passes through the head stud of the Hebel wall.</p> <p>We note that the PEX pipe is not sealed with a mastic.</p>	<ol style="list-style-type: none"> Supply and install an approved fire collar such as a Promat conduit collar to the conduit and PEX pipe penetrations on both sides of the wall in accordance with the manufacturers recommendations to maintain the FRL. Suitably repair the large voids within the Hebel wall in strict accordance with the manufacturer's rectification methods to maintain the FRL of the wall.

<p>Toga propose to use two Promat CFC 32 Uni Collars joined together.</p> <p>Methodology yet to be provided.</p> <p>Test Report Number A-12-163d</p>

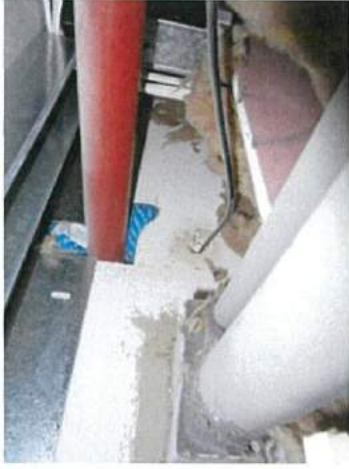
Toga propose to surround the penetration with a fire rated board and seal with Promat Promaseal AN Acrylic Sealant. Methodology and materials yet to be provided.
9.	Unit 1010 Unsealed electrical penetrations through the bounding wall above the kitchen.	1. Appropriately seal around the electrical penetrations with an approved fire rated mastic in accordance with the manufacturers recommendations to maintain the FRL.

Toga will seal the penetration with Promat Promaseal AN Acrylic Sealant Test Report A-13-816

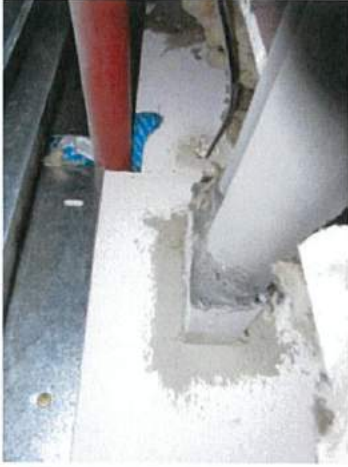
Item No.	Description and Location of the Defect	Agreed Scope of Works	BCA Logic Photograph	Defect Status and Photograph
10.	<p>Unit 1010</p> <p>A number of Air conditioning pipes penetrate through the bounding wall with lagging. The penetration is square and is lined with a steel casing that projects approximately 75mm out of the wall. The casing is infilled with an intumescent Graftex like material.</p> <p>The perimeter of the steel casing is not suitably at the Hebel interface.</p> <p>Query is raised to the adequate sealing of the penetration and whether the graftex material is located within the Hebel wall itself and not just the mouth of the casing.</p> <p>It is noted that the penetration requiring protection is within the wall and therefore sealing the mouth of the casing is not sufficient.</p>	TBC

<p>Toga propose to surround the penetration with a fire rated board and install a Promat flexi wrap system.</p> <p>Methodology and materials yet to be provided.</p>

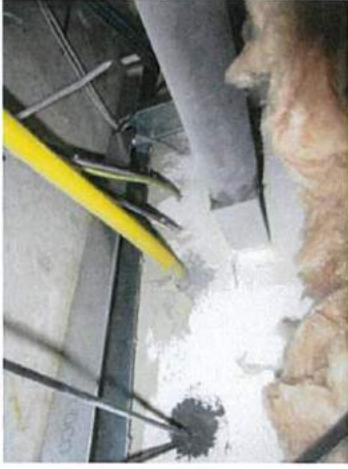
Item No.	Description and Location of the Defect	Agreed Scope of Works	BCA Logic Photograph	Defect Status and Photograph
15.	Unit 1102 No fire collar to PEX gas pipe through the bounding wall. We note that the PEX pipe is sealed with a mastic.	1. Supply and install an approved fire collar such as a Promat conduit collar to the PEX pipe penetration on both sides of the wall in accordance with the manufacturers recommendations to maintain the FRL.

Toga propose to use two Promat CFC 32 Uni Collars joined together. Methodology yet to be provided. Test Report Number A-12-163d

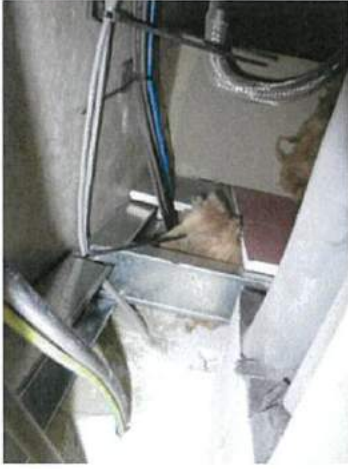
16.	Unit 1201 A number of Air conditioning pipes penetrate through the bounding wall with lagging. The penetration is square and is lined with a steel casing that projects approximately 75mm out of the wall. The casing is infilled with an intumescent Grafitex like material. Query is raised to the adequate sealing of the penetration and whether the grafitex material is located within the Hebel wall itself and not just the mouth of the casing. It is noted that the penetration requiring protection is within the wall and therefore sealing the mouth of the casing is not sufficient.	TBC

Toga propose to surround the penetration with a fire rated board and install a Promat flexi wrap system. Methodology and materials yet to be provided.

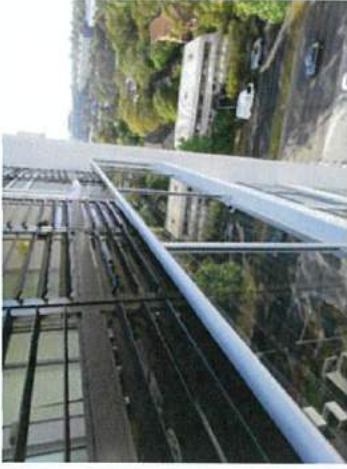
Item No.	Description and Location of the Defect	Agreed Scope of Works	BCA Logic Photograph	Defect Status and Photograph
17.	<p>Unit 1102</p> <p>The balcony balustrade exhibits excessive displacement when lateral force is applied.</p> <p>The balustrade returns are not adequately fixed into the adjacent external walls.</p>	<ol style="list-style-type: none"> 1. Engage a structural engineer to review the existing balustrade system and; determine and test the required loads. 2. Provide vertical structural stiffeners at intervals recommended by the structural engineer.

<p>Toga have advised that the Owners Corporations Expert (Peter Karsai) is in discussion with an independent testing authority to satisfy testing methodology compliant with the Australian Standards.</p> <p>To be discussed between BCA Logic and Toga.</p>

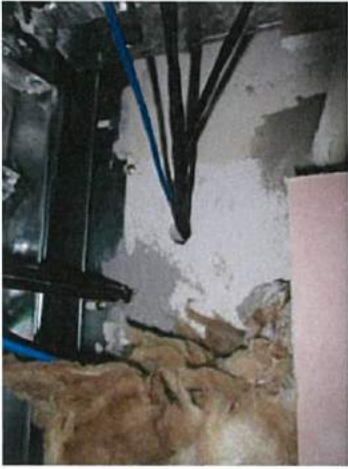
Item No.	Description and Location of the Defect	Agreed Scope of Works	BCA Logic Photograph	Defect Status and Photograph
20.	Unit 1201 Unsealed electrical penetrations through the bounding wall above the entry door.	1. Appropriately seal around the electrical penetrations with an approved fire rated mastic in accordance with the manufacturers recommendations to maintain the FRL.

Toga will reseal the penetration with Promat Promaseal AN Acrylic Sealant Test Report A-13-816

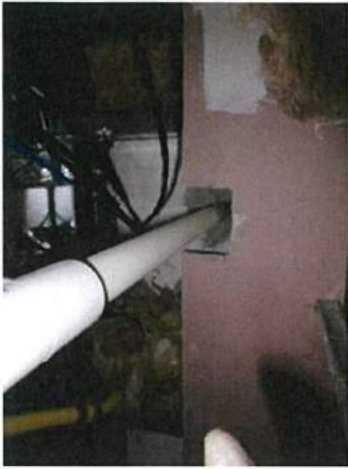
21.	Unit 1201 No fire collar to electrical conduit and PEX gas pipe through the bounding wall above the entry door. We note that the conduit and PEX pipe are sealed with a mastic.	1. Supply and install an approved fire collar such as a Promat conduit collar to the conduit and PEX pipe penetrations on both sides of the wall in accordance with the manufacturers recommendations to maintain the FRL.

Toga propose to use two Promat CFC 32 Uni Collars joined together. Methodology yet to be provided. Test Report Number A-12-163d

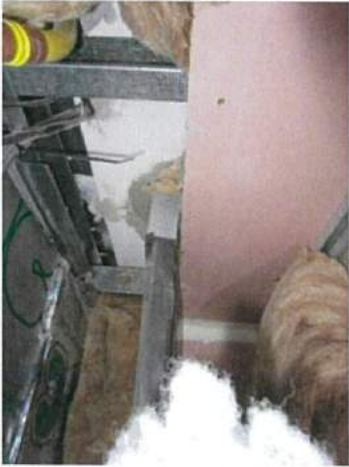
Item No.	Description and Location of the Defect	Agreed Scope of Works	BCA Logic Photograph	Defect Status and Photograph
22.	<p>Unit 1201</p> <p>A number of Air conditioning pipes penetrate through the bounding wall with lagging. The penetration is square and is lined with a steel casing that projects approximately 75mm out of the wall. The casing is infilled with an intumescent Grafitex like material.</p> <p>Query is raised to the adequate sealing of the penetration and whether the grafitex material is located within the Hebel wall itself and not just the mouth of the casing.</p> <p>It is noted that the penetration requiring protection is within the wall and therefore sealing the mouth of the casing is not sufficient.</p>	TBC

<p>Toga propose to surround the penetration with a fire rated board and install a Promat flexi wrap system.</p> <p>Methodology and materials yet to be provided.</p>

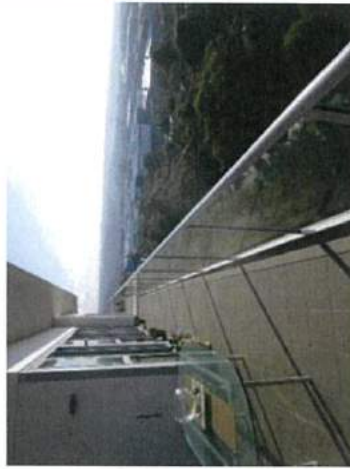
27.	Unit 1208 The balcony balustrade exhibits excessive displacement in excess of 40mm when lateral force is applied. The balustrade is continuous extends across the balcony for a length of 18m. The balustrade returns are not adequately fixed into the adjacent external walls.	<ol style="list-style-type: none"> 1. Engage a structural engineer to review the existing balustrade system and; determine and test the required loads. 2. Provide vertical structural stiffeners at intervals recommended by the structural engineer.

Toga have advised that the Owners Corporations Expert (Peter Karsai) is in discussion with an independent testing authority to satisfy testing methodology compliant with the Australian Standards. To be discussed between BCA Logic and Toga.

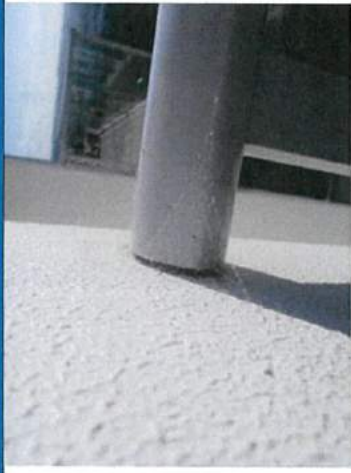
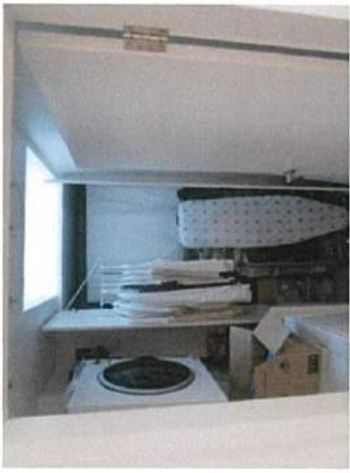
Item No.	Description and Location of the Defect	Agreed Scope of Works	BCA Logic Photograph	Defect Status and Photograph
28.	<p>Unit 1208</p> <p>The laundry is provided with a sectioned off storage area. Two doors are provided to segregate the laundry from the storage cupboard.</p> <p>No sprinkler head is located within this large storage cupboard.</p> <p>The storage cupboard was measured to be approximately 1.03m wide x 1.63m deep and 2.33m high.</p>	<p>1. Engage a hydraulic engineer/contractor to review the existing sprinkler system and provide an additional sprinkler head within the storage room.</p> <p>2. Alternatively, permanently remove the doors to the storage room to allow a fire to activate the laundry sprinkler head within the original designed timeframe.</p>

<p>Advised works completed. Awaiting inspection and sign-off from BCA Logic</p>

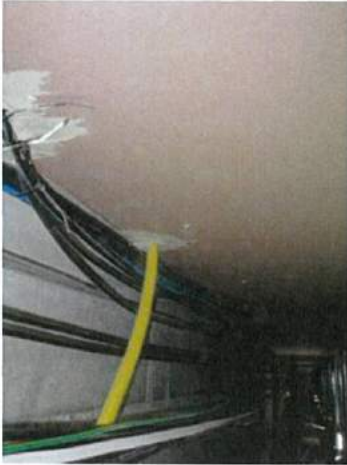
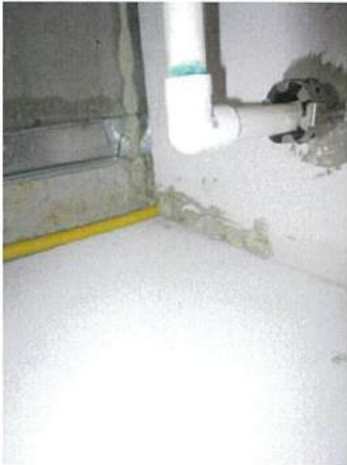
Item No.	Description and Location of the Defect	Agreed Scope of Works	BCA Logic Photograph	Defect Status and Photograph
29.	<p>General</p> <p>We observed the gas PEX pipes throughout the foyer levels to have no fire collars installed. It is noted that in various instances the gas PEX pipes have been sealed with a mastic.</p> <p>This was observed in the following locations:</p> <ul style="list-style-type: none">- Ground Floor- Level 1- Level 2- Level 3- Level 5- Level 6- Level 7- Level 8- Level 9- Level 10- Level 11- Level 12- Level 1 – above U110- Level 1 – above 105- Level 1 – above 102- Level 1 – above 101- Level 2 – NBN cupboard- Level 3 – NBN cupboard- Level 5 – NBN cupboard- Level 6 – NBN cupboard- Level 7 – NBN cupboard- Level 8 – NBN cupboard	<p>1. Supply and install an approved fire collar such as a Promat conduit collar to the PEX pipe penetrations on both sides of the wall in accordance with the manufacturers recommendations to maintain the FRL.</p>

<p>Toga propose to use two Promat CFC 32 Uni Collars joined together.</p> <p>Methodology yet to be provided.</p> <p>Test Report Number A-12-163d</p>

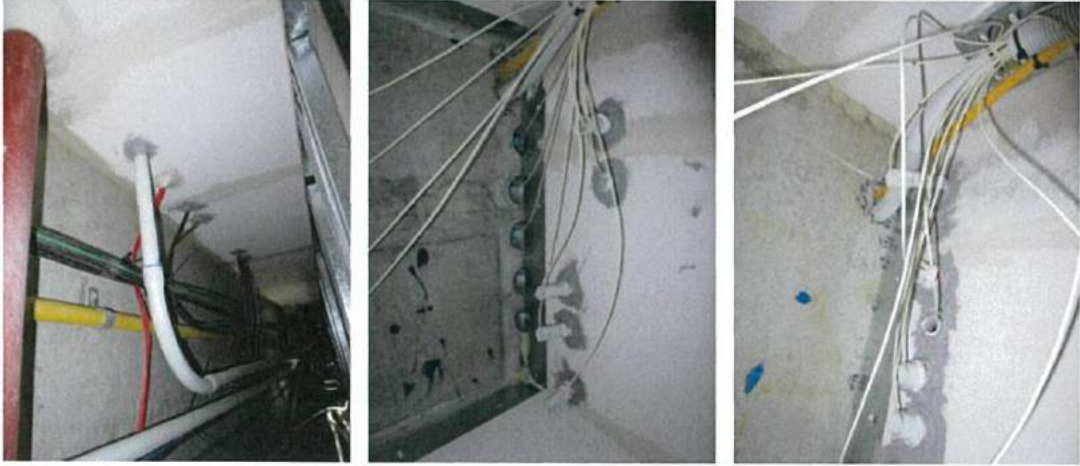
Item No.	Description and Location of the Defect	Agreed Scope of Works	BCA Logic Photograph	Defect Status and Photograph
30.	<p>General</p> <p>We observed electrical conduits and NBN conduits pipes throughout the foyer levels to have no fire collars installed.</p> <p>It is noted that in various instances the conduits have been sealed with a mastic.</p> <p>This was generally observed in the following locations:</p> <ul style="list-style-type: none"> - Ground Floor - Level 1 - Level 2 - Level 3 - Level 5 - Level 6 - Level 7 - Level 8 - Level 9 - Level 10 - Level 11 - Level 12 - Ground Floor – within riser into U3 - Ground Floor – within riser into slab above - Level 3 – U302 - Level 5 – NBN Cupboard x5 through bounding wall - Level 6 – NBN Cupboard x5 through bounding wall - Level 7– NBN Cupboard x5 through bounding wall - Level 8– NBN Cupboard x5 through bounding wall 	<p>1. Supply and install an approved fire collar such as a Promat conduit collar to the conduit penetrations on both sides of the wall in accordance with the manufacturers recommendations to maintain the FRL.</p>

<p>Toga propose to use two Promat CFC 32 Uni Collars joined together.</p> <p>Methodology yet to be provided.</p> <p>Test Report Number A-12-163d</p>

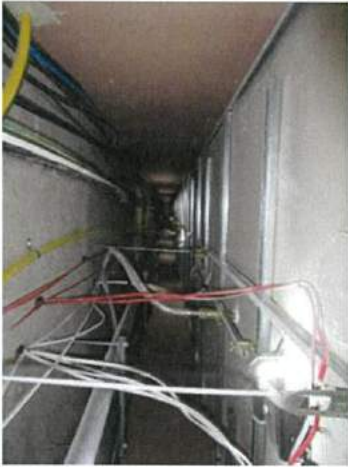
Item No.	Description and Location of the Defect	Agreed Scope of Works	BCA Logic Photograph	Defect Status and Photograph
35.	<p>General</p> <p>We noted that there are no sprinkler heads located within the ceiling voids throughout.</p> <p>The ceiling voids varied in height between each level with the ground floor measured to be 600mm high.</p> <p>Level 6 was measured at 360mm high.</p> <p>Level 12 was measured at 460mm high.</p> <p>This was observed in the following locations:</p> <ul style="list-style-type: none">- Ground Floor- Level 1- Level 2- Level 3- Level 5- Level 6- Level 7- Level 8- Level 9- Level 10- Level 11- Level 12	<ol style="list-style-type: none">1. Supply and install a compliant sprinkler system throughout the ceiling voids in accordance with AS2118.1-1999.2. Alternatively, provide fire and draft stops every 15m in accordance with Clause 5.6.1 of AS2118.1-1999.

<p>Toga to install draft stops in ceiling void at 15m intervals.</p>

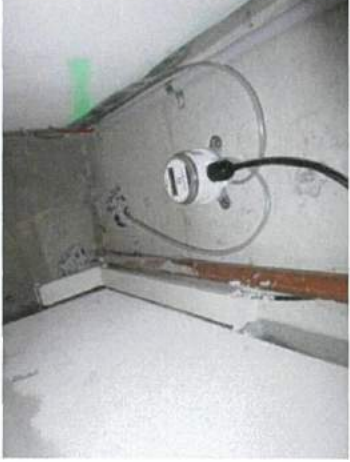
Item No.	Description and Location of the Defect	Agreed Scope of Works	BCA Logic Photograph	Defect Status and Photograph
36.	<p>General</p> <p>We identified a number of Magnasense differential pressure transmitters installed within service cupboards adjacent to the fire isolated stairs.</p> <p>The small clear plastic tubing penetrating the fire isolated stairs was not sealed.</p> <p>This affected all levels and fire stair wells.</p>	<ol style="list-style-type: none"> 1. Due to the nature of the plastic tubing, there is an unknown product that would be suitable for this application. 2. Therefore, we recommend a passive fire consultant is engaged to provide advice on a suitable system. 3. Based on the flexibility of the tubing, it may prove useful to use a Promat Grafitex or Hilti intumescent Mastic coned out around the pipe. This will allow for the mastic to expand and seal the penetration and collapse the pipe.

<p>Toga to install Hilti Sealant CP 611A</p> <p>Test Report RIR 27912900.3</p>

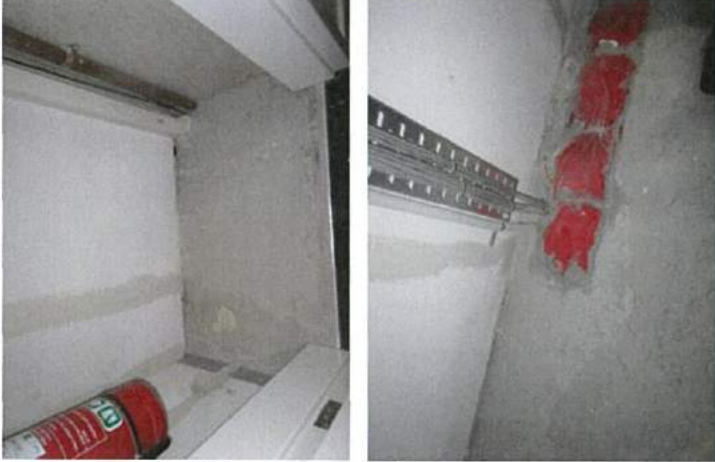
37.	<p>General</p> <p>Electrical cupboards and fire hose reel cupboards</p> <p>The junctions between the Hebel panels and floor slab bounding the SOU's have not been adequately sealed.</p> <p>This was observed in the following locations:</p> <ul style="list-style-type: none"> - Ground Floor - Level 1 - Level 2 - Level 3 - Level 5 - Level 6 - Level 7 - Level 8 - Level 9 - Level 10 - Level 11 - Level 12 	<ol style="list-style-type: none"> 1. Appropriately seal the Hebel wall and slab junctions with an approved fire rated mastic in accordance with the manufacturer's recommendations.

<p>Toga to reseal with CSR Fireseal.</p>

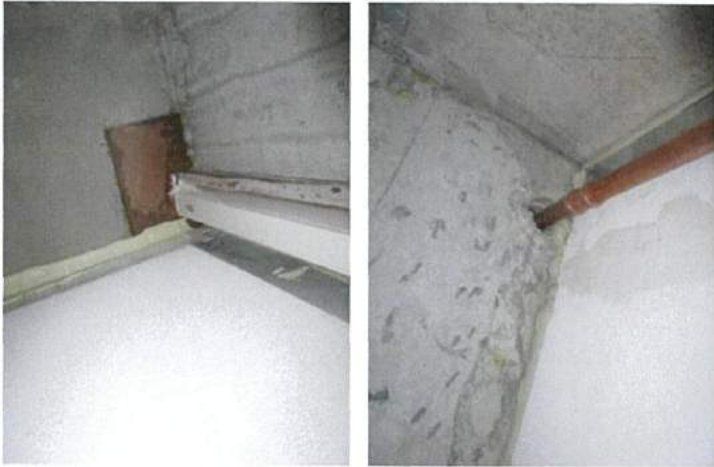
Item No.	Description and Location of the Defect	Agreed Scope of Works	BCA Logic Photograph	Defect Status and Photograph
38.	<p>General</p> <p>Fire hose reel cupboards</p> <p>Unsealed copper pipes and data cables through the slab above.</p> <p>This was observed in the following locations:</p> <ul style="list-style-type: none">- Level 5- Level 6- Level 7- Level 8- Level 9- Level 10- Level 11- Level 12	<p>1. Appropriately seal the copper pipe and data cable with an approved fire rated mastic in accordance with the manufacturer's recommendations.</p>

<p>Toga to reseal with Promat Promaseal AN Acrylic Sealant</p> <p>Test Report A-13-816</p>

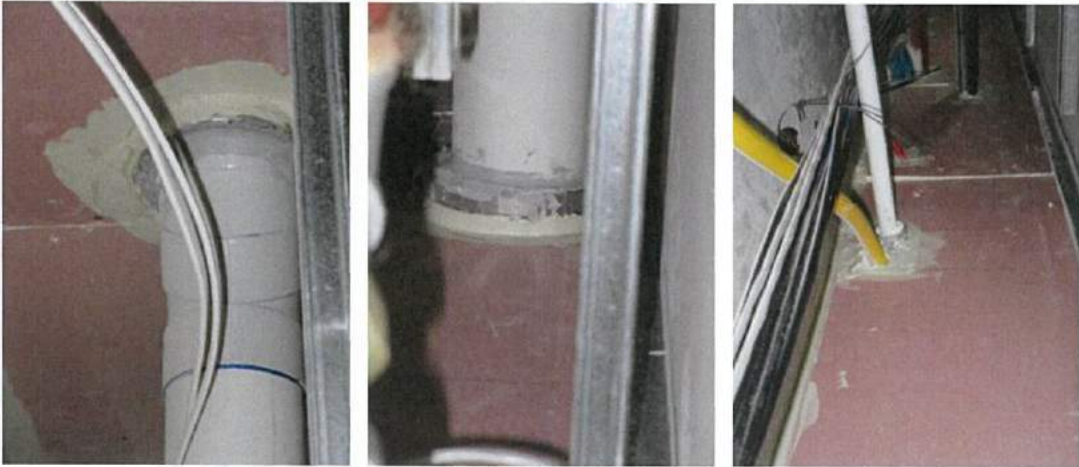
Item No.	Description and Location of the Defect	Agreed Scope of Works	BCA Logic Photograph	Defect Status and Photograph
39.	<p>We observed a number of uPVC pipes with retro fit fire collars installed.</p> <p>The junction between the fire collar and pipe has been sealed.</p> <p>This covers the intumescent material.</p> <p>This was observed in the following locations:</p> <ul style="list-style-type: none">- Level 1 – x2 PVC pipes- Level 2 – U213 PVC pipe- Level 2 – Garbage room PVC pipe- Level 3- Level 5- Level 6- Level 7- Level 8- Level 9- Level 10- Level 11- Level 12	<ol style="list-style-type: none">1. Gain access to the affected fire collars.2. Remove the mastic obstructing the intumescent ring.

<p>Toga propose to remove the fire rated mastic.</p>

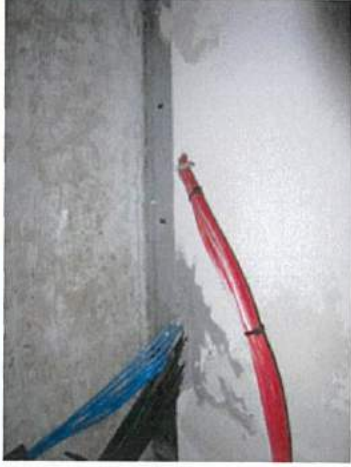
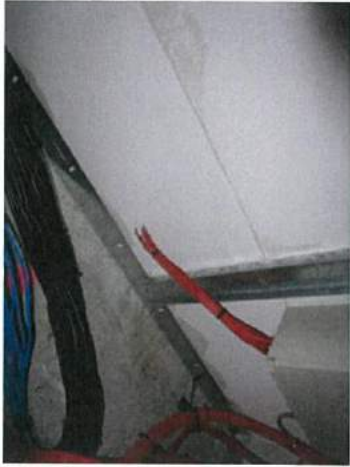
Item No.	Description and Location of the Defect	Agreed Scope of Works	BCA Logic Photograph	Defect Status and Photograph
40.	<p>Electrical/Communications cupboard</p> <p>We identified a number of unsealed electrical, communications and data cables penetrating through the corridor walls.</p> <p>This was observed in the following locations:</p> <ul style="list-style-type: none"> - Ground Floor - Level 1 - Level 2 - Level 3 - Level 5 - Level 6 - Level 7 - Level 8 - Level 9 - Level 10 - Level 11 - Level 12 	<ol style="list-style-type: none"> 1. Appropriately smoke seal around the electrical/communications/data cable(s) with a fire rated mastic in strict accordance with the manufacturer's recommendations. 2. Where there is an excessive sized penetration, suitably smoke seal with a non-combustible product.

<p>Toga to reseal with Promat Promaseal AN Acrylic Sealant</p> <p>Test Report A-13-816</p>

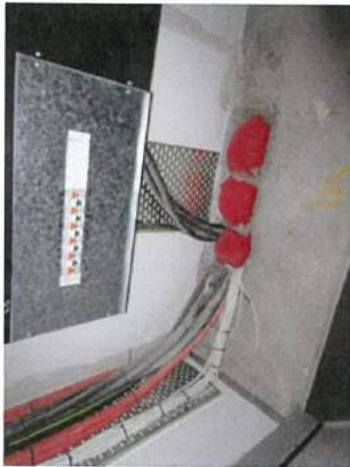
41.	<p>Electrical/Communications cupboard</p> <p>We noted that the floor penetrations where electrical, communications and data cables pass through are pre-formed voids infilled with fire rated pillows and sealed with fire rated mastic.</p> <p>We note that generally the cable bundles at each floor level vary between 100mm and 150mm and located to one side of the void.</p>	<ol style="list-style-type: none"> 1. Remove the existing fire pillows and all mastic. 2. Cut back any electrical conduits passing through the void for the thickness of the pillows or that are located within the slab. 3. Suitably bundle the electrical, communications and data cables into bundles no greater than 50mm. 4. Separate the newly formed bundles in accordance with the fire pillow manufactures recommendations. 5. Reinstall the existing fire rated pillows in a vertically stacked manner within the pre-formed void. The pillow

<p>As per BCA Logic Scope.</p>

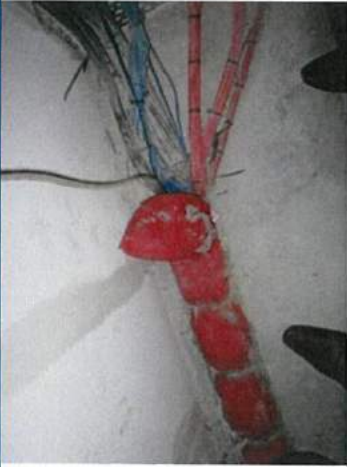
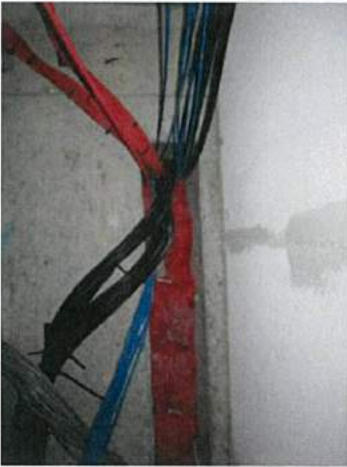
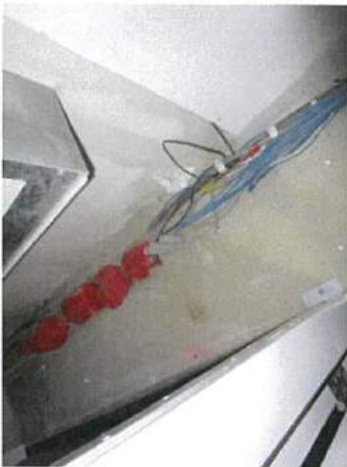
Item No.	Description and Location of the Defect	Agreed Scope of Works	BCA Logic Photograph	Defect Status and Photograph
	<p>The cable bundles are poorly sealed. There are large gaps between fire pillows.</p> <p>We note that the fire pillows are located at the top of the penetration and protrude above the finished floor slab. The pillows have been installed horizontally.</p> <p>It is noted that the pillows have been sealed from the top only.</p> <p>Furthermore, we noted a number of electrical conduits passing through the pillows or floor slab with no fire collars or smoke seals to their openings.</p> <p>This was observed in the following locations:</p> <ul style="list-style-type: none">- Ground Floor- Level 1- Level 2- Level 3- Level 5- Level 6- Level 7- Level 8- Level 9- Level 10- Level 11- Level 12	<p>should extend within the penetration so it does not protrude above or below the void.</p> <p>6. Provide additional pillows as required to fill the void.</p> <p>7. Seal the perimeter junctions and junctions between pillows with a fire rated mastic in strict accordance with the fire pillow tested details. Confirm with manufacturer if sealing from the top only is compliant with the tested system.</p> <p>8. Fire pillow system and fire rated mastic in strict accordance with the manufacturer's recommendations.</p> <p>9. Where conduits are cut back through the slab, appropriately seal around the conduit with a fire rated mastic in strict accordance with the manufacturer's recommendations from below.</p> <p>Installation recommendation (trafalgarfire.com.au)</p>

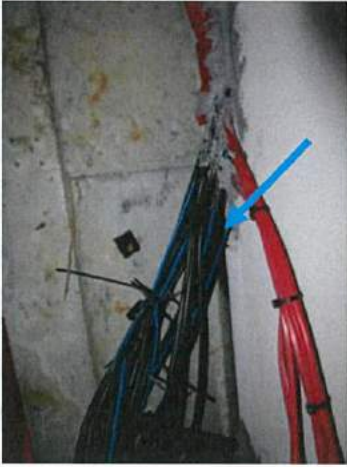
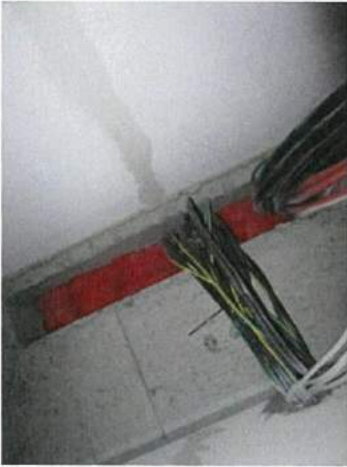
Item No.	Description and Location of the Defect	Agreed Scope of Works	BCA Logic Photograph	Defect Status and Photograph
42.	<p>Electrical/Communications cupboard</p> <p>We identified a number of unsealed electrical, communications and data cables penetrating through the bounding walls of the adjoining units.</p> <p>There were a number of redundant penetrations through the bounding walls.</p> <p>This was observed in the following locations:</p> <ul style="list-style-type: none">- Ground Floor – x2 cables- Level 1 – unsealed void- Level 2- Level 3- Level 5- Level 6- Level 7- Level 8- Level 9 – x1 cable- Level 9 – x1 redundant- Level 10- Level 11 – x2 cables- Level 12	<ol style="list-style-type: none">1. Appropriately seal around the electrical/communications/data cable(s) and any redundant penetration with a fire rated mastic in strict accordance with the manufacturer's recommendations.2. Where there is an excessive sized penetration or oversized redundant penetration, supply and install an approved Magnesium silicate board (Such as Trafalgar Maxilite system) around the penetration and secure to the wall in accordance with the manufacturers recommendations.

<p>Toga to reseal with Promat Promaseal AN Acrylic Sealant</p> <p>Test Report A-13-816</p>

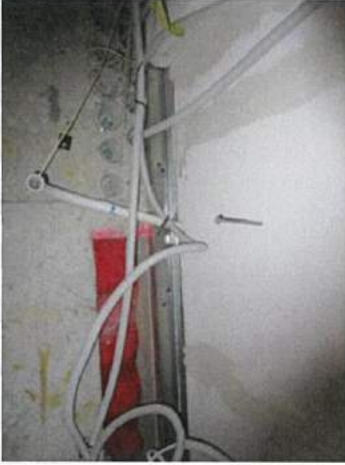
Item No.	Description and Location of the Defect	Agreed Scope of Works	BCA Logic Photograph	Defect Status and Photograph
43.	<p>Electrical/Communications cupboard</p> <p>We observed a number of conduits with no fire collars penetrating through the bounding walls.</p> <p>This was observed in the following locations:</p> <ul style="list-style-type: none"> - Ground Floor - x1 conduit - Level 1 - Level 2 - Level 3 - Level 5 - Level 6 - Level 7 - Level 8 - Level 9 - Level 10 - Level 11 - Level 12 	<ol style="list-style-type: none"> Supply and install a suitable retro-fit fire collar such as a Promat conduit collar to the conduit penetrations in accordance with the manufacturers recommendations to maintain the FRL.

<p>Toga propose to use two Promat CFC 32 Uni Collars joined together.</p> <p>Methodology yet to be provided.</p> <p>Test Report Number A-12-163d</p>

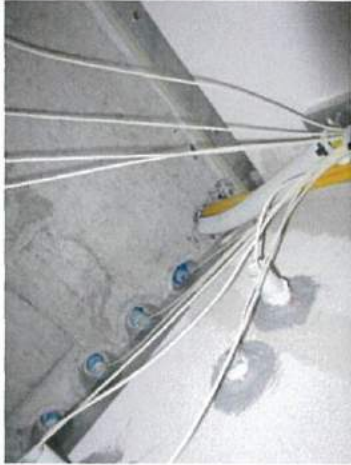
44.	<p>NBN Cupboard</p> <p>Electrical cables and conduit located half within the corridor and half within adjacent Unit bounding wall. This was observed in the following locations:</p> <ul style="list-style-type: none"> - Level 2 - Level 3 - Level 5 - Level 6 - Level 7 - Level 8 - Level 9 - Level 10 - Level 11 - Level 12 	<ol style="list-style-type: none"> Box out the electrical conduit with an approved two way fire rated system such as Trafalgar Maxilite board to maintain an FRL of -/60/60. Supply and install a new retro-fit conduit collar to electrical conduit in strict accordance with the manufacturer's recommendations.

<p>Toga propose to surround the penetration with a fire rated board and install a Promat Uni collar.</p> <p>Methodology and materials yet to be provided.</p>

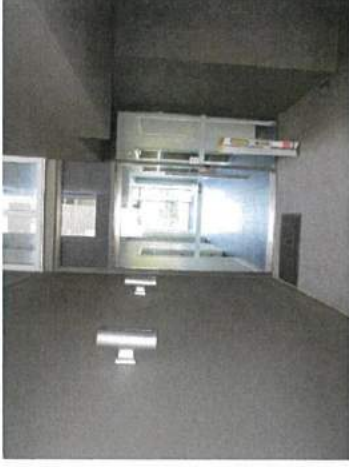
Item No.	Description and Location of the Defect	Agreed Scope of Works	BCA Logic Photograph	Defect Status and Photograph
46.	<p>Ground Floor</p> <p>The final glass discharge doors from ground floor to a road or open space are electronically operated.</p> <p>We noted that the doors open inwards.</p> <p>There is a metal 'L' bracket at the top of the door restricting it from opening inwards.</p> <p>Furthermore, we note that the Final Fire Safety Measures listed in the CC also includes Fail safe devices. It is assumed that this relates to these doors.</p>	<ol style="list-style-type: none"> 1. Based on the configuration of the door being restricted from opening in the direction of egress, this defect would be impractical to fix, we recommend that an Alternative Solution be explored for the door opening inwards based on the low population and fire isolated exits available. 2. Engage the maintenance contractor to undertake a fire trip test of the buildings emergency services and confirm if the automatic door has a fail-safe device fitted. 3. Provide a failsafe device interconnected with the sprinkler system as required subject to fire trip.

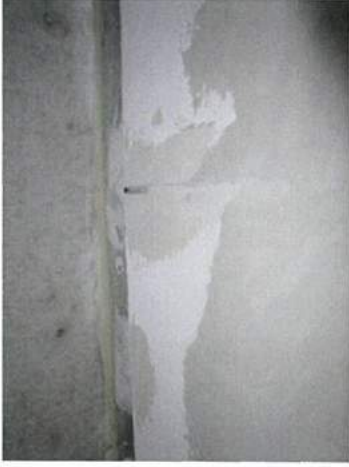
47.	<p>Level 2 - Southern Fire hose reel Cupboard</p> <p>The junctions between the Hebel panels and floor slabs both top and bottom bounding the SOU have not been adequately sealed.</p>	<ol style="list-style-type: none"> 1. Appropriately seal the Hebel wall and slab junctions with an approved fire rated mastic in accordance with the manufacturer's recommendations.

Toga to reseal with CSR Fireseal.

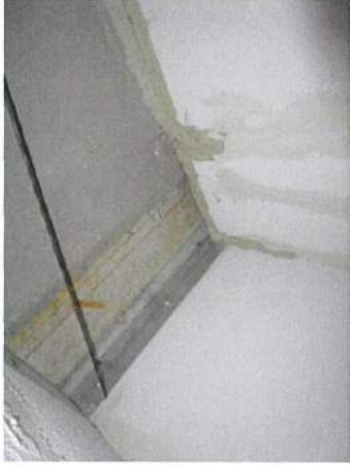
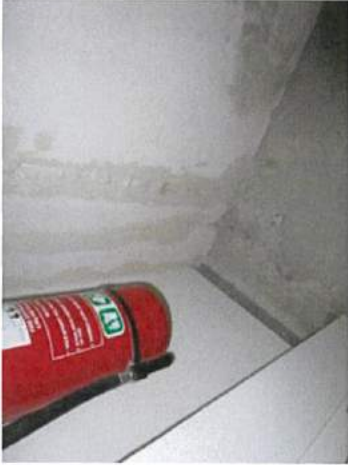
Item No.	Description and Location of the Defect	Agreed Scope of Works	BCA Logic Photograph	Defect Status and Photograph
48.	<p>Level 2</p> <p>The junctions between the Hebel panels and floor slabs both top and bottom bounding the SOU have not been adequately sealed.</p> <p>There is no head channel supporting the top of the Hebel wall panel bounding U 205.</p> <p>There are 2 redundant penetrations within the Hebel wall panels with a large damaged section adjacent.</p>	<ol style="list-style-type: none"> 1. Remove the Hebel wall panels. 2. Supply and install a Hebel head track secured to the slab soffit. 3. Supply and install new Hebel wall panels in accordance with the manufacturer's recommendations. 4. Appropriately seal the Hebel wall and slab junctions with an approved fire rated mastic in accordance with the manufacturer's recommendations.

As per BCA Logic Scope.

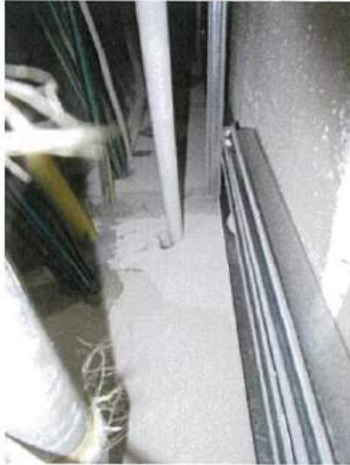
49.	<p>Level 2</p> <p>The corridors to all levels are provided with smoke doors and walls.</p> <p>We noted an unsealed electrical conduit penetrating through the smoke wall.</p>	<ol style="list-style-type: none"> 1. Appropriately seal the conduit with an approved smoke/fire rated mastic in accordance with the manufacturer's recommendations

<p>Toga to reseal with Promat Promaseal AN Acrylic Sealant</p> <p>Test Report A-13-816</p>

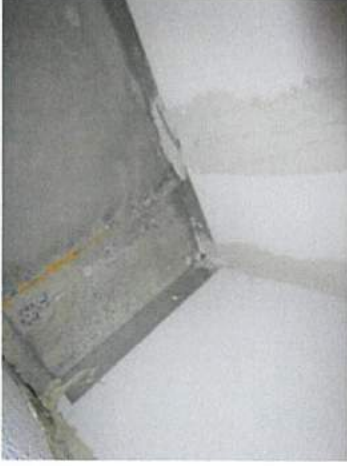
Item No.	Description and Location of the Defect	Agreed Scope of Works	BCA Logic Photograph	Defect Status and Photograph
50.	Level 5 - Southern Fire hose reel Cupboard The junctions between the Hebel panels and floor slabs both top and bottom bounding the SOU have not been adequately sealed.	1. Appropriately seal the Hebel wall and slab junctions with an approved fire rated mastic in accordance with the manufacturer's recommendations.

Toga to reseal with CSR Fireseal.

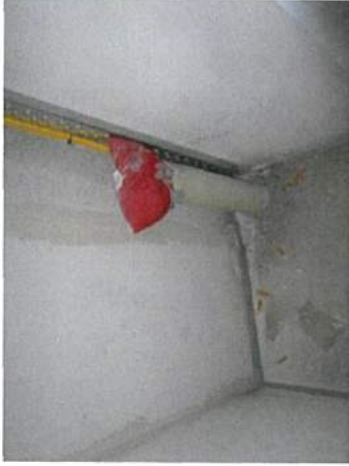
51.	Level 5 fire hose reel cupboard There is an isolated PVC Pipe that is smoke sealed from the top in which is approximately 400mm from the floor slab. The penetration requires protection at the point of penetration.	1. Gain access to the area below. 2. Supply and install an approved retro fit fire collar around the PVC pipe in accordance with the manufacturer's recommendations. 3. Cut the pipe flush with the floor slab and reinstate the existing pillow to provide a smoke barrier. Suitably smoke seal the pillow in place.

As per BCA Logic scope.

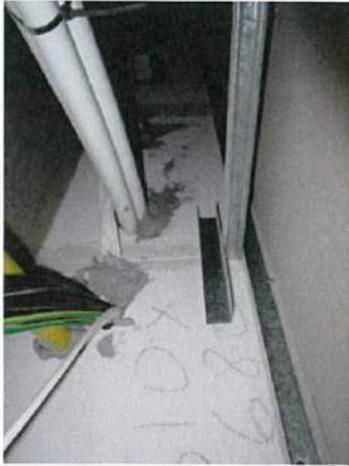
52.	Level 6 The corridors to all levels are provided with smoke doors and walls. We noted poorly sealed electrical cables conduit penetrating through the smoke wall.	1. Appropriately seal the conduit with an approved smoke/fire rated mastic in accordance with the manufacturer's recommendations

Toga to reseal with Promat Promaseal AN Acrylic Sealant Test Report A-13-816

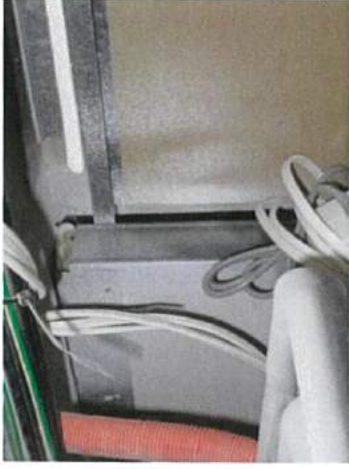
Item No.	Description and Location of the Defect	Agreed Scope of Works	BCA Logic Photograph	Defect Status and Photograph
53.	Level 6 The garbage room wall and corridor are not sealed to maintain the required FRL's at the external wall/garbage room/corridor interface.	<ol style="list-style-type: none"> 1. Gain access to the junction within both the corridor and ceiling void. 2. Engage a qualified passive fire consultant to provide a fire stopping system to maintain the FRL's of the bounding walls.

As per BCA Logics Scope of works.

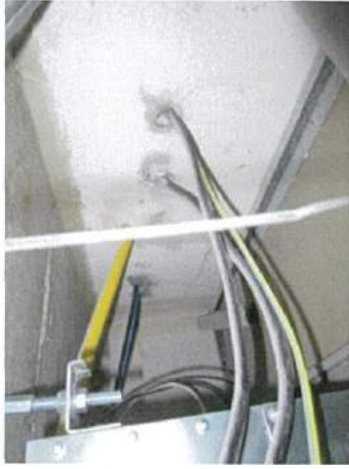
54.	Level 6 – Southern foyer Unsealed data cables through the bounding wall of Unit 602.	<ol style="list-style-type: none"> 1. Appropriately seal the data cables with an approved fire rated mastic in accordance with the manufacturer's recommendations.

Toga to reseal with Promat Promaseal AN Acrylic Sealant Test Report A-13-816

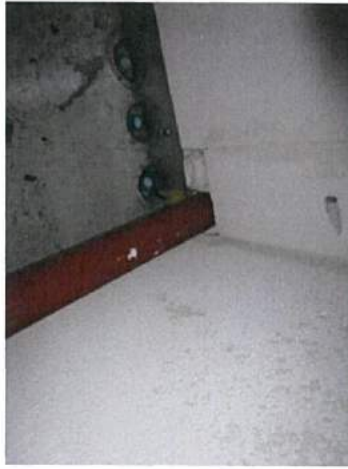
55.	Level 8 – NBN Cupboard Unsealed sprinkler pipework through bounding wall.	<ol style="list-style-type: none"> 1. Appropriately seal the sprinkler pipe with an approved fire rated mastic in accordance with the manufacturer's recommendations.

Toga to reseal with Promat Promaseal AN Acrylic Sealant Test Report A-13-816

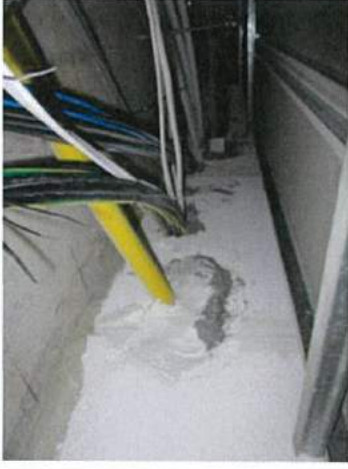
Item No.	Description and Location of the Defect	Agreed Scope of Works	BCA Logic Photograph	Defect Status and Photograph
56.	<p>Level 9</p> <p>The corridors to all levels are provided with smoke doors and walls.</p> <p>We noted poorly sealed electrical cables conduit penetrating through the smoke wall.</p>	<p>1. Appropriately seal the conduit and electrical cables with an approved smoke/fire rated mastic in accordance with the manufacturer's recommendations</p>

<p>Toga to reseal with Promat Promaseal AN Acrylic Sealant</p> <p>Test Report A-13-816</p>

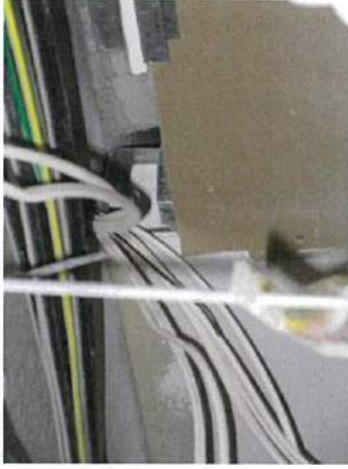
57.	<p>Level 9</p> <p>The garbage room wall and corridor are not sealed to maintain the required FRL's at the external wall/garbage room/corridor interface.</p>	<p>1. Gain access to the junction within both the corridor and ceiling void.</p> <p>2. Engage a qualified passive fire consultant to provide a fire stopping system to maintain the FRL's of the bounding walls.</p>

<p>As per BCA Logics scope of works.</p>

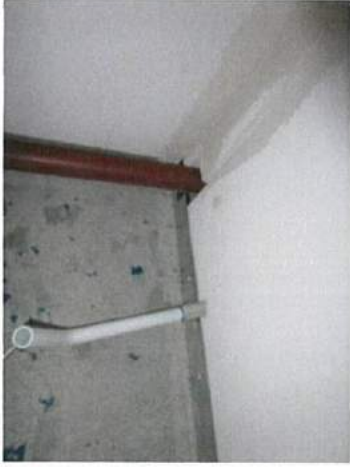
Item No.	Description and Location of the Defect	Agreed Scope of Works	BCA Logic Photograph	Defect Status and Photograph
59.	Level 10 – NBN Cupboard Unsealed sprinkler pipework through bounding wall.	1. Appropriately seal the sprinkler pipe with an approved fire rated mastic in accordance with the manufacturer's recommendations.

Toga to reseal with Promat Promaseal AN Acrylic Sealant Test Report A-13-816

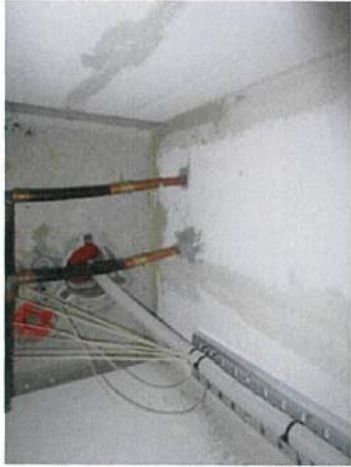
60.	Level 11 – NBN Cupboard X2 poorly sealed copper pipework through bounding wall of Unit 1102.	1. Appropriately seal the copper pipe with an approved fire rated mastic in accordance with the manufacturer's recommendations.

Toga to reseal with Promat Promaseal AN Acrylic Sealant Test Report A-13-816

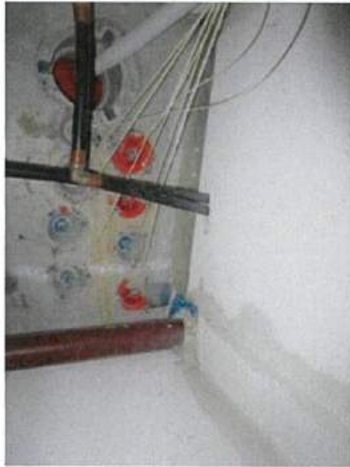
61.	Level 11 – NBN Cupboard There are x2 plastic water pipes penetrating through the bounding wall of Unit 1101 with no fire collar installed.	1. Gain access into the ceiling space as required. 2. Supply and fix an approved retrofit fire collar suitable for plastic pipework in accordance with the manufacturers recommendations.

Toga propose to use two Promat CFC 32 Uni Collars joined together. Methodology yet to be provided. Test Report Number A-12-163d

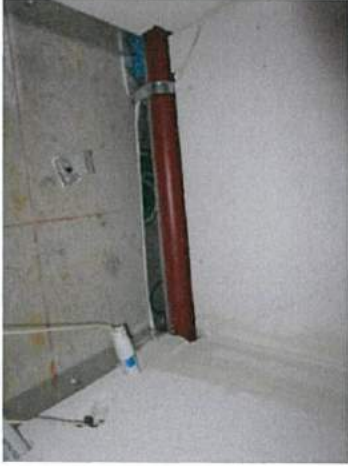
Item No.	Description and Location of the Defect	Agreed Scope of Works	BCA Logic Photograph	Defect Status and Photograph
62.	Level 12 - NBN Cupboard Sprinkler pipework is located half within the corridor and half within adjacent Unit bounding wall.	1. Box out the sprinkler pipework with an approved two way fire rated system such as Trafalgar Maxilite board to maintain an FRL of -/60/60.

As per BCA Logics scope of works.

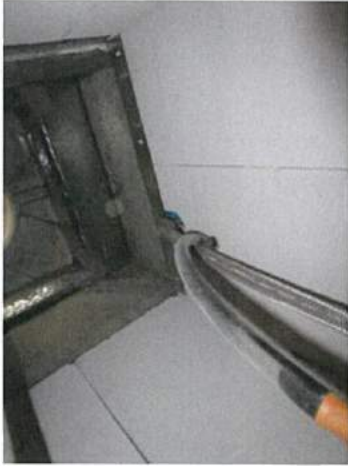
63.	Level 12 – Garbage Room Unsealed flexible sprinkler pipework through garbage shaft.	1. Appropriately seal the sprinkler pipe with an approved fire rated mastic in accordance with the manufacturer's recommendations.

Toga to reseal with Promat Promaseal AN Acrylic Sealant Test Report A-13-816

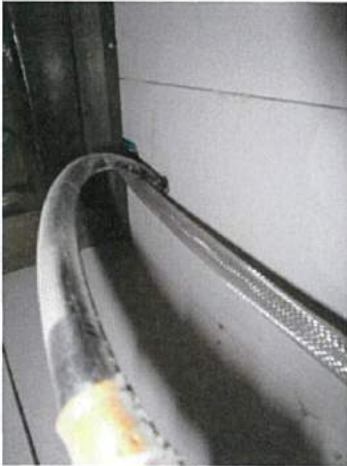
64.	Level 12 – Garbage Room Unprotected plastic water pipe penetrating through the garbage room shaft with no fire collar installed.	1. Supply and fix an approved retrofit fire collar suitable for plastic pipework in accordance with the manufacturers recommendations.

Toga propose to use two Promat CFC 32 Uni Collars joined together. Methodology yet to be provided. Test Report Number A-12-163d

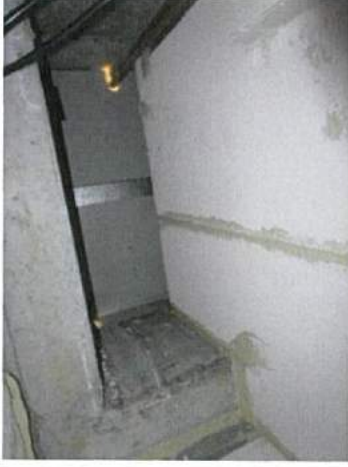
Item No.	Description and Location of the Defect	Agreed Scope of Works	BCA Logic Photograph	Defect Status and Photograph
65.	<p>Level 12 – Garbage Room</p> <p>The garbage chute riser finishes short of the roof. The shaft lid is required to maintain an FRL or continue above the roof.</p> <p>There is a large void above the shaft between the adjoining SOU.</p>	<ol style="list-style-type: none"> 1. Gain access to the roof. 2. Remove the existing weatherproof capping. 3. Supply and install a lightweight fire rated lid between the shaft and SOU to maintain the required FRL or continue the shaft through above the roof lining. 4. Provide a new weatherproof capping to support the shaft projection.

<p>Toga propose to enclose the top of the shaft with a fire rated board.</p> <p>Methodology yet to be provided.</p>

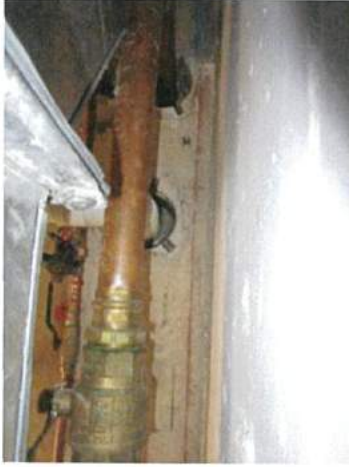
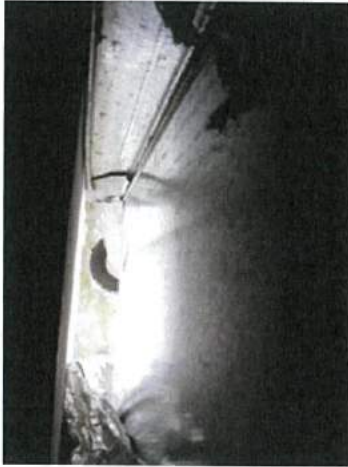
66.	<p>Ground floor – Garbage room</p> <p>There are various PVC pipes penetrating through the floor slabs and walls with no fire collars.</p> <p>There are a number of 50mm pipes located in 100mm slab block outs with no protection.</p> <p>There were approximately 5 instances within the garbage room.</p>	<ol style="list-style-type: none"> 1. Where the penetration is too large, surround the PVC with a tight fitting calcium silicate board (such as Trafalgar Maxilite board, or equivalent) so that the entire opening in the wall is covered with an overlap of not less than 100mm. Fix and seal to maintain a FRL of not less than 2 hours. 2. Seal between the pipe and the board with an acrylic fire rated sealant (such as Trafalgar Fyreflex, or equivalent). 3. Provide a retrofit fire collar to each PVC pipe (such as a Promat Retrofit Fire Collar), installed in accordance with the manufacturers specifications.

<p>As per BCA Logics scope of works.</p>

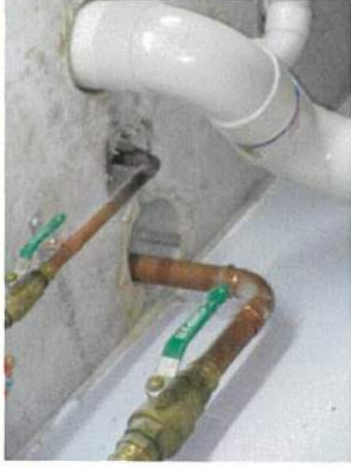
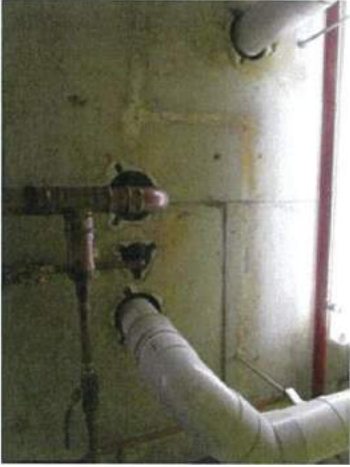
Item No.	Description and Location of the Defect	Agreed Scope of Works	BCA Logic Photograph	Defect Status and Photograph
67.	<p>Ground floor – Garbage room</p> <p>There are various copper pipes penetrating through the floor slabs with no fire stopping.</p> <p>There are a number of pipes located in 100mm slab block outs with no protection.</p> <p>There were approximately 6 instances within the garbage room.</p>	<ol style="list-style-type: none"> Where the penetration is too large, surround the PVC with a tight fitting calcium silicate board (such as Trafalgar Maxilite board, or equivalent) so that the entire opening in the wall is covered with an overlap of not less than 100mm. Fix and seal to maintain a FRL of not less than 2 hours. Seal between the pipe and the board with an acrylic fire rated sealant (such as Trafalgar Fyreflex, or equivalent).

<p>Toga will surround the oversized penetration with a fire rated board.</p> <p>Toga to reseal with Promat Promaseal AN Acrylic Sealant</p> <p>Test Report A-13-816</p>

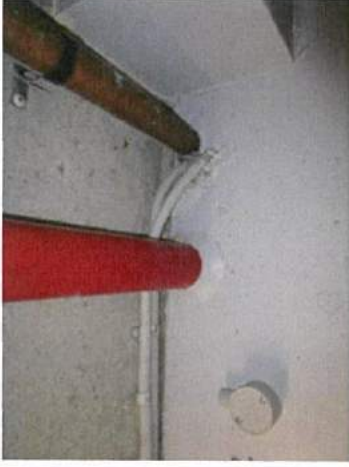
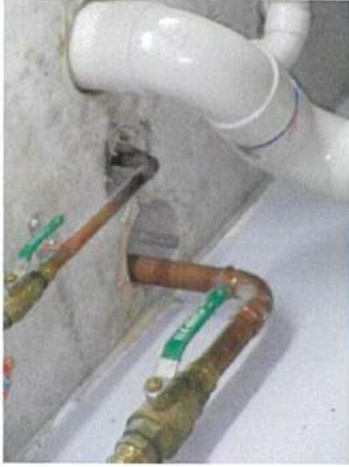
Item No.	Description and Location of the Defect	Agreed Scope of Works	BCA Logic Photograph	Defect Status and Photograph
68.	<p>Ground floor – Garbage room</p> <p>There are various PVC pipes penetrating through fire rated elements with no fire collars installed.</p> <p>This was observed in the following locations:</p> <ul style="list-style-type: none"> - Above the garbage room door – x2 conduits - PVC pipes throughout slab above – x3 - PVC pipes throughout boxed out bulkheads – x5 	<p>1. Provide a retrofit fire collar to each PVC pipe (such as a Promat Retrofit Fire Collar), installed in accordance with the manufacturers specifications.</p>

As per BCA Logics scope of works.

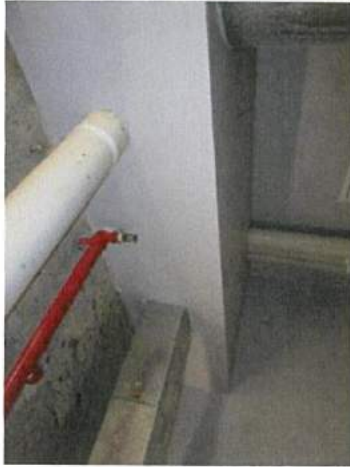
69.	<p>Ground floor – Garbage room</p> <p>There is an individual sprinkler pipe obstructed by a boxed out section to the ceiling lining adjacent the garbage chute.</p>	<p>1. Engage a hydraulic contractor to relocate the sprinkler pipe so that it is located within the bulkhead and above the bin area.</p>

TBC

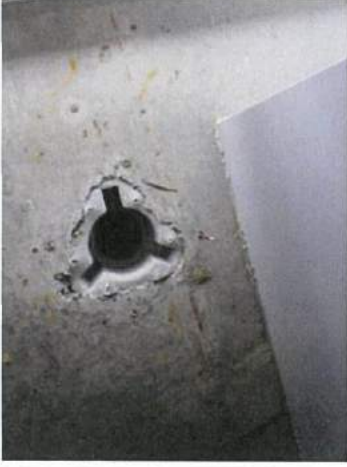
Item No.	Description and Location of the Defect	Agreed Scope of Works	BCA Logic Photograph	Defect Status and Photograph
70.	Ground floor – Garbage room There is a single redundant penetration located within the slab above.	<ol style="list-style-type: none"> 1. Gain access to the area above and infill the penetration and provide a high density mortar such as Promat Promastop Cement that maintains the required FRL. 2. Alternatively, provide a fire pillow system from within redundant pipe and suitably smoke seal to maintain the required FRL.

As per BCA Logics scope of works.

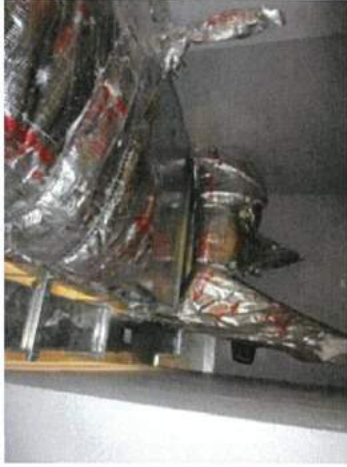
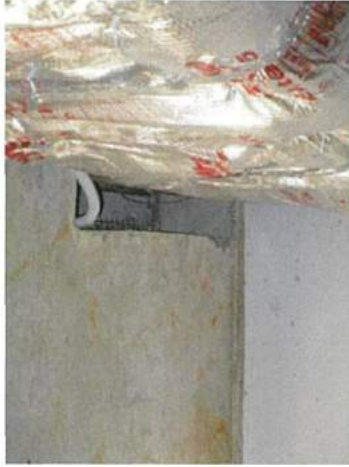
71.	Ground floor – Garbage room The Café exhaust ducting runs from the south eastern corner to the north western corner of the garbage room. The exhaust ducting is wrapped in Trafalgar Fyrewrap and maintains an FRL of -/120/120. The Fyrewrap has been poorly installed and is not installed correctly. Sections of the wrapping have detached. Furthermore, the penetration of the exhaust duct into the shaft is not suitably fire rated. There is a large unsealed perimeter gap.	<ol style="list-style-type: none"> 1. Surround the bottom of the shaft where the duct enters with a tight fitting calcium silicate board (such as Trafalgar Maxilite board, or equivalent) so that the entire opening is covered with an overlap of not less than 100mm. Fix and seal to maintain a FRL of not less than 2 hours. 2. Engage a Trafalgar representative to attend site to remove and replace the Fyrewrap in strict accordance with their recommendations. 3. Trafalgar to provide certification as required.

As per BCA Logics scope of works.

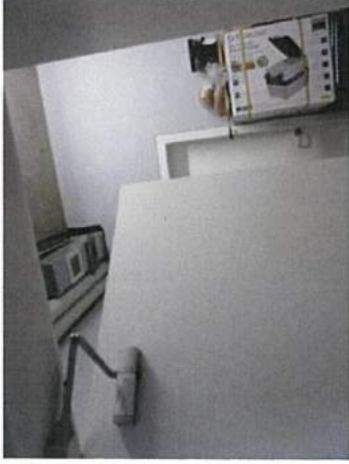
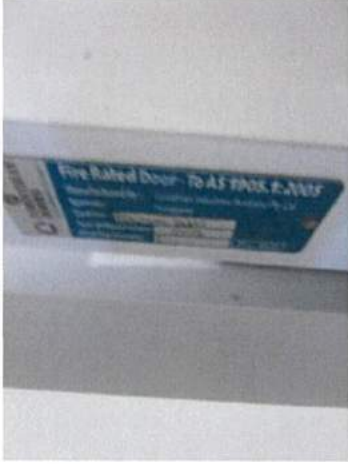
Item No.	Description and Location of the Defect	Agreed Scope of Works	BCA Logic Photograph	Defect Status and Photograph
72.	<p>Ground floor – Garbage room</p> <p>The door and frame separating the Class 6 retail (café) and the garbage room are tagged with an FRL of -/120/30.</p> <p>The Class 6 portion is required to have a firewall with an FRL of 180/180/180.</p>	<ol style="list-style-type: none"> 1. Remove the existing fire door and fire rated frame between the Class 6 and Class 2 portion. 2. Supply and install a new self-closing fire door and fire rated frame that maintains an FRL of -/180/30.

As per BCA Logics scope of works.

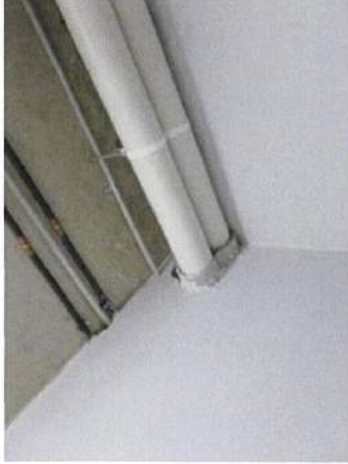
73.	<p>Ground floor – Garbage room</p> <p>There are two PEX water pipes and an electrical conduit penetrating through the eastern Garbage room wall into the Class 6 café (from within the retail storage area) with no fire collar installed.</p>	<ol style="list-style-type: none"> 1. Provide a retrofit fire collar to each PEX pipe and conduit (such as a Promat Retrofit conduit Collar), installed in accordance with the manufacturers specifications.

TBC
