SydneyStrataReport

STRATA REPORT

Client	Andrew C. So
Address of property	Unit A603/2 Sunders Close, Macquarie Park, NSW.
Lot	62
Strata Plan	SP 89124
Name of Strata Management Co.	Bright & Duggan
Telephone Number of Strata Agent	9902 7100
Report Date	4 September 2023

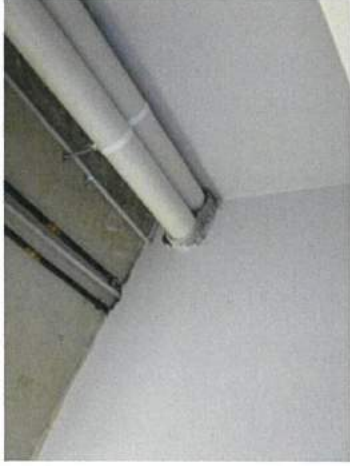
Item No.	Description and Location of the Defect	Agreed Scope of Works	BCA Logic Photograph	Defect Status and Photograph
74.	<p>Ground floor – Garbage room</p> <p>There are two uPVC pipes penetrating through the eastern Garbage room wall into the Class 6 café (from within the retail storage area) with a single retro-fit fire collar incorrectly installed.</p> <p>Only one retro fit collar per pipe is permitted.</p>	<ol style="list-style-type: none"> 1. Remove the existing fire collar. 2. Provide a retrofit fire collar to each uPVC pipe (such as a Promat Retrofit fire Collar), installed in accordance with the manufacturers specifications.

<p>As per BCA Logics scope of works.</p>

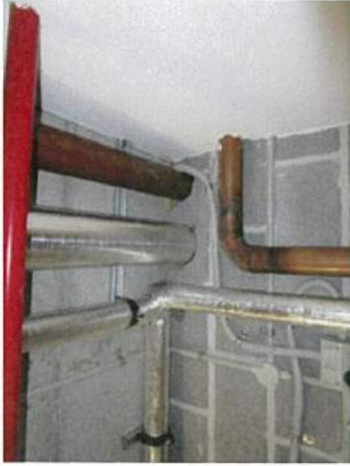
75.	<p>Hot water boiler room</p> <p>There are x3 unsealed copper pipe with lagging penetrating through the wall bounding the fire isolate passageway.</p>	<ol style="list-style-type: none"> 1. Cut back any lagging penetrating through the wall. 2. Appropriately seal around the copper pipework with an approved fire rated mastic in accordance with the manufacturers recommendations to maintain the fire wall FRL.

<p>Toga to reseal with Promat Promaseal AN Acrylic Sealant</p> <p>Test Report A-13-816</p>

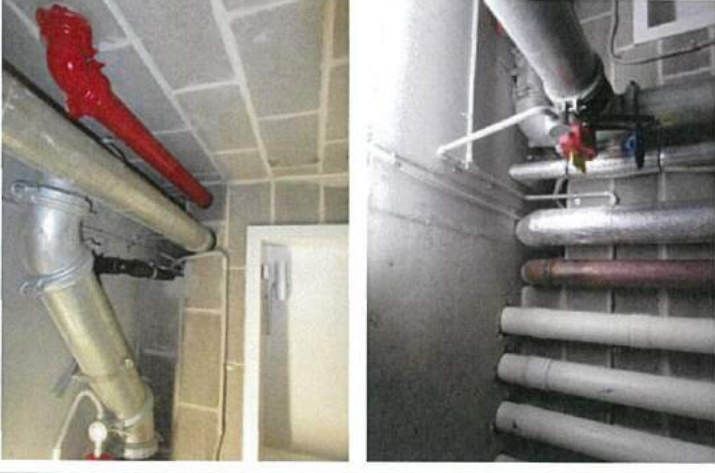
Item No.	Description and Location of the Defect	Agreed Scope of Works	BCA Logic Photograph	Defect Status and Photograph
76.	<p>Sprinkler tank room</p> <p>There are unsealed services throughout penetrating through the wall bounding the fire isolated passageway. The sprinkler tank room is required to maintain an FRL to separate the two areas.</p> <p>We observed the following:</p> <ul style="list-style-type: none"> - Large voids at the head of the wall. - Unsealed copper pipework passing through the wall. - Unsealed lagged copper pipework penetrating through the wall. - Unsealed sprinkler pipework passing through the wall. - Unsealed Hydrant pipework passing through the wall. - No fire collars to PVC pipework passing through the wall. 	<ol style="list-style-type: none"> 1. Supply and install an approved Magnesium silicate board (Such as Trafalagar Maxilite system) around the penetrations to enclose the large voids and secure to the wall in accordance with the manufacturers recommendations. 2. Cut back any lagging to the copper pipework prior to sealing. 3. Appropriately seal around metal pipework with an approved fire rated mastic in accordance with the manufacturers recommendations to maintain the fire wall FRL. 4. Supply and install suitable retro fit fire collars to PVC pipework as required in accordance with the manufacturers recommendations to maintain the fire wall FRL.

<p>Toga will surround the oversized penetration with a fire rated board.</p> <p>Toga to reseal with Promat Promaseal AN Acrylic Sealant</p> <p>Test Report A-13-816</p>

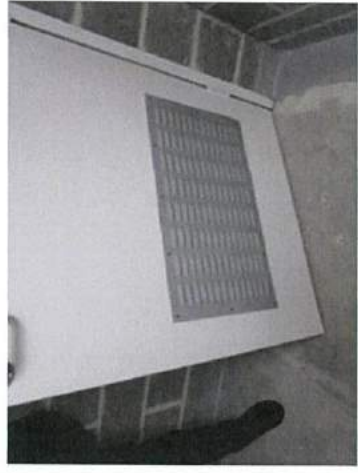
77.	<p>Security Room</p> <p>No airlock is provided to the security room.</p> <p>Access is directly via the Fire Isolated passageway that shares an exit door with the roof.</p>	<ol style="list-style-type: none"> 1. Provide a suitable airlock at roof level to maintain compliance with this clause and ensure that the security room does not open directly into the fire isolated passageway. 2. Alternatively, engage a qualified fire engineer to prepare an alternative Solution to address this issue.

TBC

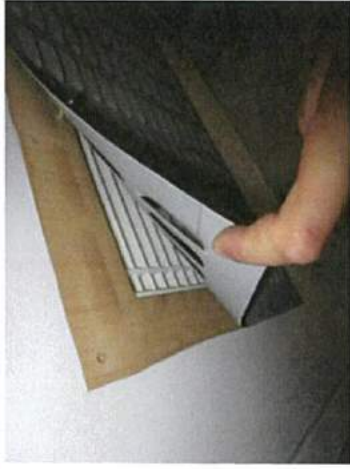
Item No.	Description and Location of the Defect	Agreed Scope of Works	BCA Logic Photograph	Defect Status and Photograph
78.	<p>Security Room</p> <p>The door leading from the security room directly into the fire isolated passageway is provided with a steel ventilation grille.</p> <p>No fire damper is provided within the fire door. A plastic grill system is provided.</p>	<ol style="list-style-type: none"> 1. Subject to the door manufactures tested prototype, some fire doors are designed to incorporate an intumescent damper where ventilation of the room is required. 2. Engage the original fir door manufacturer to supply and install a suitable fire damper within the fire door as per a tested system. 3. Certification to be provided by the manufacturer.

As per BCA Logics scope of works.

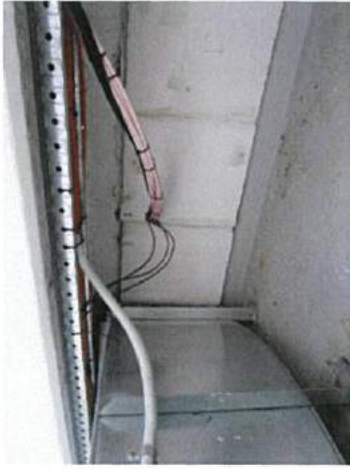
79.	<p>Roof Area</p> <p>Unsealed cable bundle entering into the top floor SOU.</p> <p>There is a large mechanical exhaust duct and fire rated riser shaft located immediately adjacent.</p>	<ol style="list-style-type: none"> 1. Appropriately seal around the electrical cable bundle with an approved fire rated mastic in accordance with the manufacturers recommendations to maintain the fire wall FRL.

<p>Toga to reseal with Promat Promaseal AN Acrylic Sealant</p> <p>Test Report A-13-816</p>

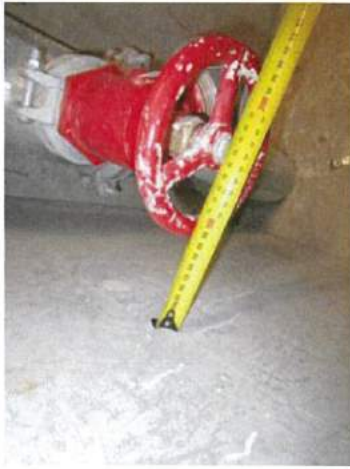
80.	<p>Southern fire stair</p> <p>The Hydrant valve spindle to levels 4, 11 and 12 are located 85mm from the wall.</p>	<ol style="list-style-type: none"> 1. Engage a qualified plumbing contractor to adjust the hydrant valve so that the spindle is located a minimum of 100mm off the wall. 2. Ensure the egress pathway is not obstructed or reduced.

Advised works completed. Awaiting inspection and sign-off from BCA Logic

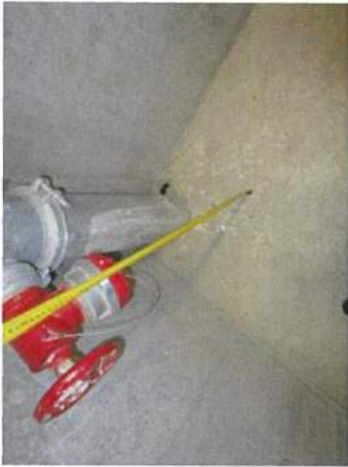
Item No.	Description and Location of the Defect	Agreed Scope of Works	BCA Logic Photograph	Defect Status and Photograph
81.	<p>Southern fire stair</p> <p>The Hydrant valve angle is greater than the maximum permitted angle of 35 degrees below the horizontal.</p> <p>The hydrant valve almost faces the floor. The valve is required to maintain a minimum 1m clearance.</p> <p>We observed this in the following locations:</p> <ul style="list-style-type: none">- Level 2- Level 3- Level 5- Level 6- Level 7- Level 8- Level 9- Level 10- Level 11- Level 12	<p>1. Engage a qualified plumbing contractor to reconfigure the hydrant valves at each level so that they face outwards and maintain a compliant angle.</p>

<p>Advised works completed. Awaiting inspection and sign-off from BCA Logic</p>

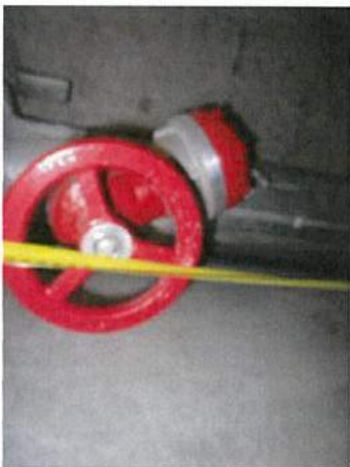
82.	<p>Southern fire stair</p> <p>The Hydrant valve is required to be located between 750mm and 1200mm from the finished floor level.</p> <p>The hydrant valve almost faces the floor. The valve at level 5 was measured at 715mm.</p>	<p>1. Engage a qualified plumbing contractor to reconfigure the hydrant valves to maintain a compliant height.</p>

<p>Advised works completed. Awaiting inspection and sign-off from BCA Logic</p>

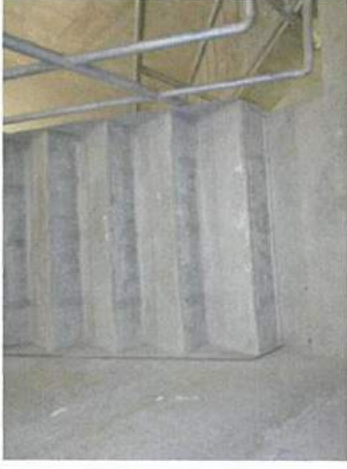
Item No.	Description and Location of the Defect	Agreed Scope of Works	BCA Logic Photograph	Defect Status and Photograph
83.	<p>Southern fire stair</p> <p>The riser heights throughout the stair are generally consistent. The following stair flights had varying riser heights:</p> <ul style="list-style-type: none"> - Intermediate Level 9-170mm to 200mm - Intermediate Level 7 - 175mm to 190mm - Level 6 - 170mm to 180mm - Level 1 - 158mm to 170mm 	<ol style="list-style-type: none"> 1. As appropriate grind or top stair treads to achieve a consistent riser height throughout the stair flight to comply with BCA Clause D2.13. 2. As appropriate adjust stair tread lengths to comply with BCA Clause D2.13. 3. Reinstate floor finish to match existing.

TBC

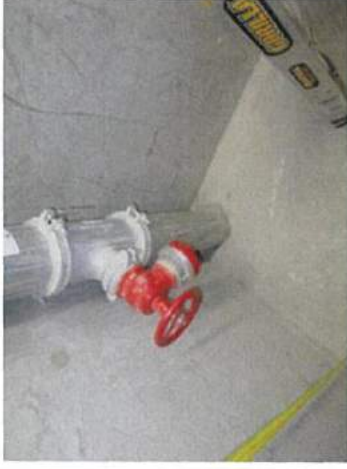
84.	<p>Northern fire stair</p> <p>The Hydrant valve spindle are located less than 100mm from the wall.</p> <p>This was observed in the following locations:</p> <ul style="list-style-type: none"> - Ground Floor - Level 5 - Level 6 - Level 7 - Level 8 - Level 9 - Level 10 	<ol style="list-style-type: none"> 1. Engage a qualified plumbing contractor to adjust the hydrant valve so that the spindle is located a minimum of 100mm off the wall. 2. Ensure the egress pathway is not obstructed or reduced.

Advised works completed. Awaiting inspection and sign-off from BCA Logic

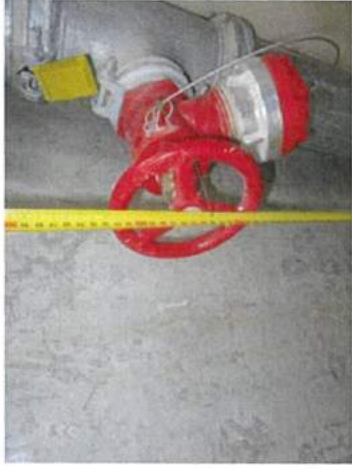
85.	<p>Northern fire stair</p> <p>The Hydrant valve angle is greater than the maximum permitted angle of 35 degrees below the horizontal.</p> <p>The hydrant valve almost faces the floor. The valve is required to maintain a minimum 1m clearance.</p>	<ol style="list-style-type: none"> 1. Engage a qualified plumbing contractor to reconfigure the hydrant valves at each level so that they face outwards and maintain a compliant angle.

Advised works completed. Awaiting inspection and sign-off from BCA Logic

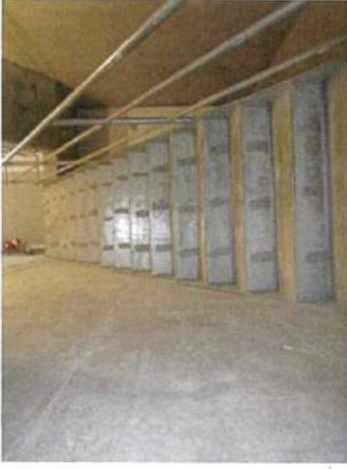
86.	<p>Northern fire stair</p> <p>The riser heights throughout the stair are generally consistent. The following stair flights had varying riser heights:</p> <ul style="list-style-type: none"> - Level 12 – Consistent at 170mm. Bottom riser 185mm - Level 10 – Consistent at 185mm. Bottom riser 175mm - Level 9 – Consistent at 185mm. Bottom riser 160mm - Level 8 – Consistent at 185mm. Bottom riser 195mm - Level 6 – Consistent at 170mm. Bottom riser 185mm - Level 1 – Consistent at 195mm. Bottom riser 175mm - Ground Floor – Consistent at 170-180mm. Bottom riser 200mm 	<ol style="list-style-type: none"> 1. As appropriate grind or top stair treads to achieve a consistent riser height throughout the stair flight to comply with BCA Clause D2.13. 2. As appropriate adjust stair tread lengths to comply with BCA Clause D2.13. 3. Reinstate floor finish to match existing.

TBC

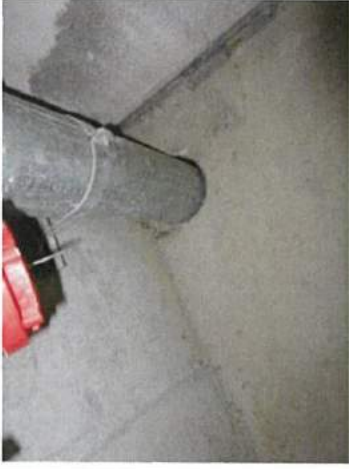
Item No.	Description and Location of the Defect	Agreed Scope of Works	BCA Logic Photograph	Defect Status and Photograph
87.	Northern fire stair Unsealed hydrant pipework through class 2 shaft wall.	1. Appropriately seal the hydrant pipe with an approved fire rated mastic in accordance with the manufacturer's recommendations.

TBC

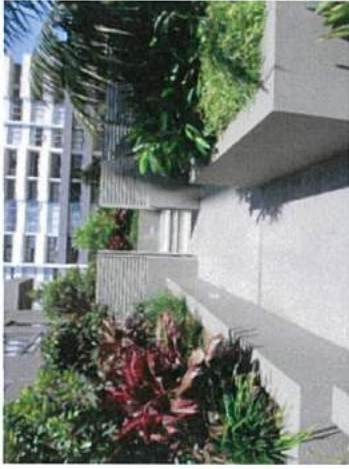
88.	Central courtyard The paths of travels that serve the fire stair discharge points and courtyard exit system that provides egress to a road or open space is along the roof of the area below such as the basement carpark. These paths of travel are classified as roof as open space. We identified a number of penetrations within the floor slab that are not permitted to be located where roof as open space is provided.	<ol style="list-style-type: none"> 1. Provide a retrofit fire collar (such as a Promat Retrofit floor waste Collar), installed in accordance with the manufacturers specifications. 2. Ensure approved fixings are used as per the manufacturer's specifications. 3. The protection method is to ensure that an FRL of 120/120/120 is maintained in accordance with BCA Clause D2.12.

TBC

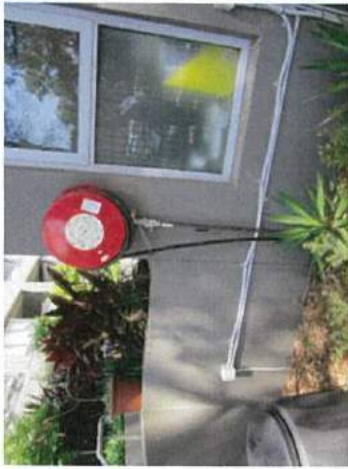
89.	Fire Hose reel The fire hose reel on/off valves is required to be located between 900mm and 1100mm from the finished floor surface. The valve is located at 1400mm. Furthermore, no signage provided to identify the location of the FHR.	<ol style="list-style-type: none"> 1. Engage a qualified plumbing contractor to reduce the height of the fire hose reel valve between 900 and 1100mm. 2. Provide compliant signage on the eastern wall adjacent to the managers office.

Advised works completed. Awaiting inspection and sign-off from BCA Logic

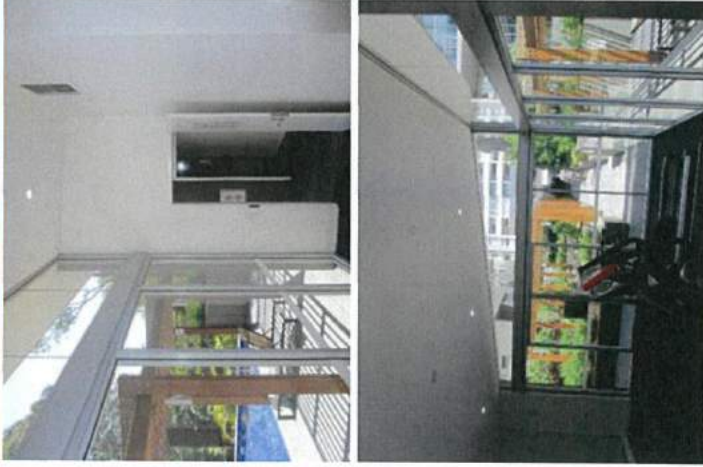
Item No.	Description and Location of the Defect	Agreed Scope of Works	BCA Logic Photograph	Defect Status and Photograph
90.	<p>Gym</p> <p>As the building is over 25m, the gym is required to be provided with 2 exits.</p> <p>There is no directional or exit signage identifying the location of the nearest exit from within the gym area.</p>	<p>1. Supply and install new exit signage to identify the required exits.</p>

As per BCA Logics scope of works.

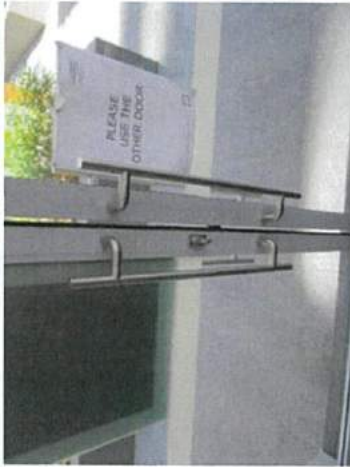
91.	<p>Gym</p> <p>As the building is over 25m, the gym is required to be provided with 2 exits.</p> <p>The southern exit is locked with a non-compliant snib lock and is not readily openable from the direction of egress.</p>	<p>1. Supply and install a new latching mechanism that maintains compliance with BCA Clause D2.21.</p> <p>2. The door latch is to be located between 900mm and 1100mm from finished floor level.</p>

As per BCA Logics scope of works.

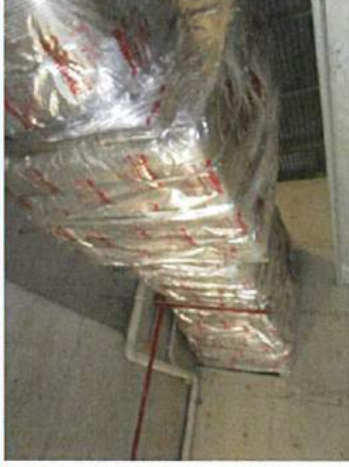
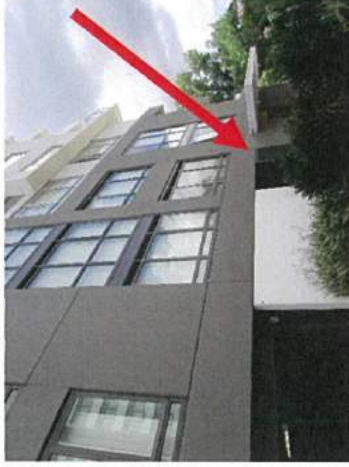
Item No.	Description and Location of the Defect	Agreed Scope of Works	BCA Logic Photograph	Defect Status and Photograph
93.	<p>Driveway Ramp – Entry/Exit</p> <p>The Café exhaust ducting runs from the north eastern corner to the north western corner of the driveway ramp.</p> <p>The exhaust discharges to the western facade within 6m of an openable window.</p>	<ol style="list-style-type: none"> 1. Engage a Mechanical Engineer to assess the current system against the requirements of AS1668.2-1991. 2. Mechanical engineer to provide scope of work to achieve compliance for horizontal discharge or alternative construction methods. 3. We note that there may be requirement to provide commercial carbon filters and other controls by the mechanical engineer.

TBC

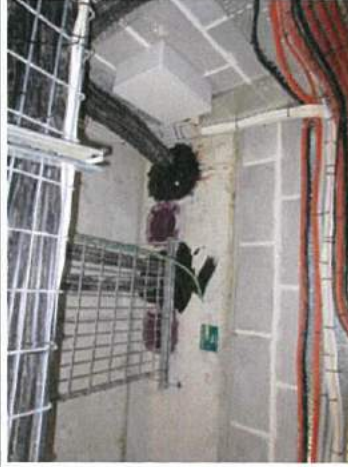
94.	<p>Main switch room</p> <p>There are two redundant penetrations within the fire rated wall that open into the basement carpark.</p>	<ol style="list-style-type: none"> 1. Supply and fix calcium silicate board (such as Trafalgar Maxilite board, or equivalent) over the entire opening with an overlap of not less than 100mm around the outside edge of the penetration. Fix and seal to the wall to maintain a FRL of not less than 120/120/120.

As per BCA Logics scope of works.

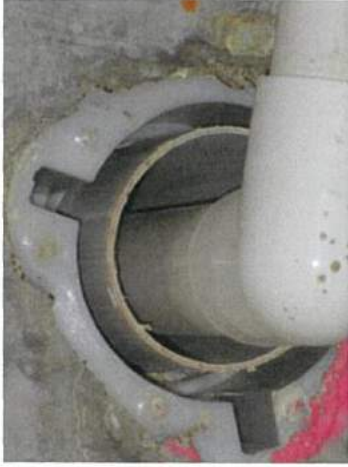
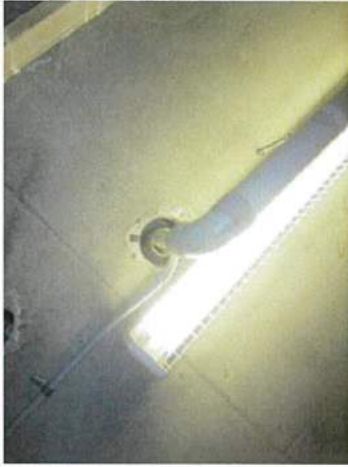
96.	<p>Basement Carpark – Level 1</p> <p>There are various PVC pipes penetrating through the floor slabs with no fire collars.</p> <p>There are a number of 50mm pipes located in 100mm slab block outs with no protection.</p> <p>This was observed in the following locations:</p> <ul style="list-style-type: none"> - C2 1009 – x1 - C2 1202 – x1 - C2 1208 – x1 - C2 1207 – x5 - Visitor (NE corner) – x1 - C2 1106 - x2 - C2 511 – x2 	<p>4. Where the penetration is too large, surround the PVC with a tight fitting calcium silicate board (such as Trafalgar Maxilite board, or equivalent) so that the entire opening in the wall is covered with an overlap of not less than 100mm. Fix and seal to maintain a FRL of not less than 2 hours.</p> <p>5. Seal between the pipe and the board with an acrylic fire rated sealant (such as Trafalgar Fyreflex, or equivalent).</p> <p>6. Provide a retrofit fire collar to each PVC pipe (such as a Promat Retrofit Fire Collar), installed in accordance with the manufacturers specifications.</p>

<p>Toga will surround the oversized penetration with a fire rated board.</p> <p>Toga will supply a retro fit fire collar.</p> <p>Methodology and test system to be advised.</p>

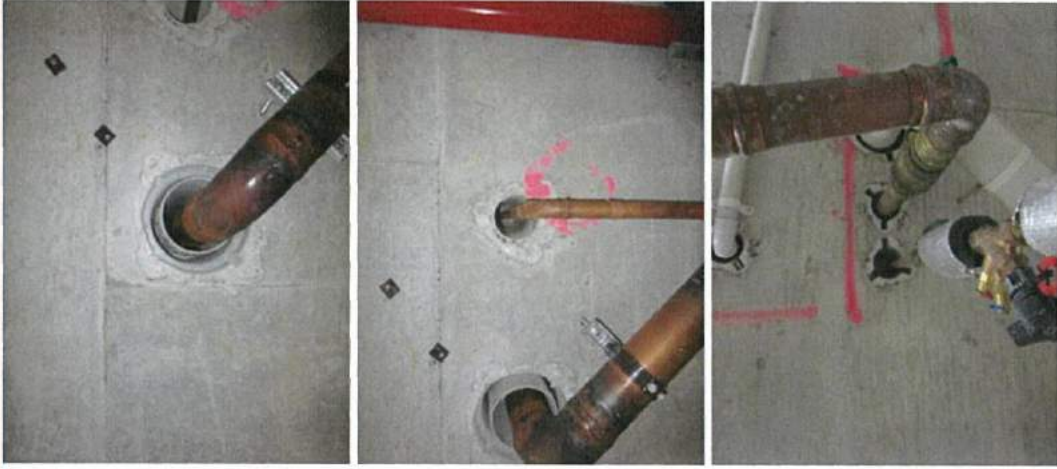
Item No.	Description and Location of the Defect	Agreed Scope of Works	BCA Logic Photograph	Defect Status and Photograph
97.	<p>Basement Carpark – Level 1</p> <p>There are various copper pipes penetrating through the floor slabs with no fire stopping.</p> <p>There are a number of pipes located in 100mm slab block outs with no protection.</p> <p>This was observed in the following locations:</p> <ul style="list-style-type: none"> - C2 1009 – x3 - C2 1102 – x4 - C2 008 – x5 - C2 1208 – x2 - C2 1207 – x5 - C2 1108 – x4 - Visitor (Central-2nd Space) – x1 - C2 006 – x1 - Visitor (south Central) – x1 - North western corner– x2 - C2 1106 – x3 - C2 511 – x2 - Storage 2 511 – x1 	<p>3. Where the penetration is too large, surround the PVC with a tight fitting calcium silicate board (such as Trafalgar Maxilite board, or equivalent) so that the entire opening in the wall is covered with an overlap of not less than 100mm. Fix and seal to maintain a FRL of not less than 2 hours.</p> <p>4. Seal between the pipe and the board with an acrylic fire rated sealant (such as Trafalgar Fyreflex, or equivalent).</p>

<p>Toga will surround the oversized penetration with a fire rated board.</p> <p>Toga to reseal with Promat Promaseal AN Acrylic Sealant</p> <p>Test Report A-13-816</p>

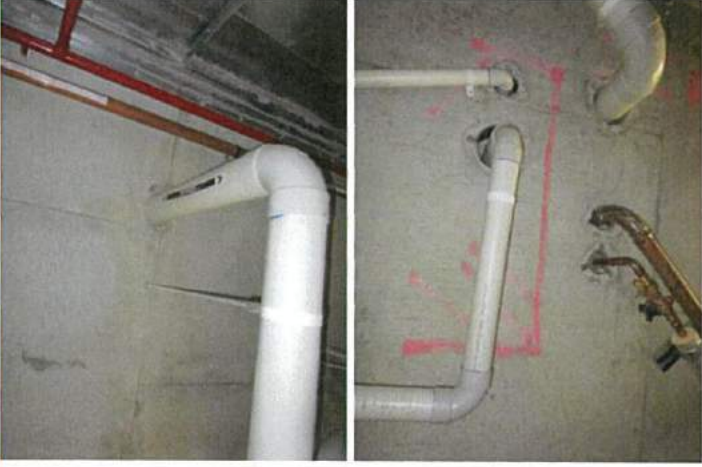
Item No.	Description and Location of the Defect	Agreed Scope of Works	BCA Logic Photograph	Defect Status and Photograph
98.	<p>Basement Carpark – Level 1</p> <p>There are various PVC pipes penetrating through fire rated elements with no fire collars installed.</p> <p>This was observed in the following locations:</p> <ul style="list-style-type: none"> - Basement entering sprinkler valve room – x1 - C2 1202 – x1 - C2-1208 – x1 black PVC pipe - C2 1108 – x1 conduit - North western fire stair – x2 - North western corner – x1 into fire stair - North western corner – x1 conduit - North western visitor carspace – x1 - North western visitor carspace 2 – x1 - C2 511 – x2 - Storage 2 511 – x1 	<p>3. Where the penetration is too large, surround the PVC with a tight fitting calcium silicate board (such as Trafalgar Maxilite board, or equivalent) so that the entire opening in the wall is covered with an overlap of not less than 100mm. Fix and seal to the wall to maintain a FRL of not less than 2 hours.</p> <p>4. Seal between the pipe and the board with an acrylic fire rated sealant (such as Trafalgar Fyreflex, or equivalent).</p> <p>5. Provide a retrofit fire collar to each PVC pipe (such as a Promat Retrofit Fire Collar), installed in accordance with the manufacturers specifications.</p>

<p>Toga will surround the oversized penetration with a fire rated board.</p> <p>Toga will supply a retro fit fire collar.</p> <p>Methodology and test system to be advised.</p>

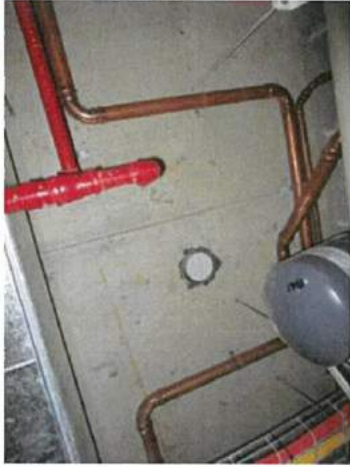
99.	<p>Basement Carpark – Level 1</p> <p>There are a number of redundant PVC pipes located within the slab above.</p> <p>The PVC pipe is protected with a fire collar.</p> <p>The PVC pipe has not been suitably smoke sealed.</p>	<p>3. Gain access to the area above and infill the PVC pipe and provide a high density mortar such as Promat Promastop Cement that maintains the required FRL.</p> <p>4. Alternatively, provide a fire pillow system from within redundant pipe and suitably smoke seal to maintain the required FRL.</p>

TBC

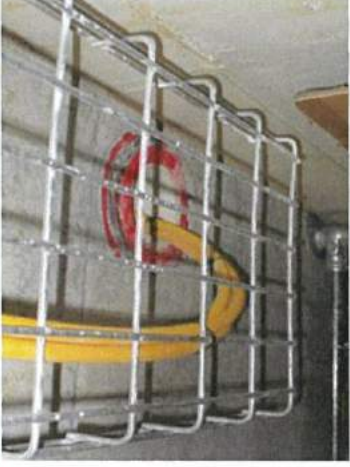
100.	<p>Basement Carpark – Level 1</p> <p>Unsealed electrical penetrations through fire rated elements with no fire stopping.</p> <p>Various electrical cables are located in oversized penetrations.</p> <p>This was observed in the following locations:</p> <ul style="list-style-type: none"> - Storage 2-1206 – x1 in 100mm penetration. - Storage 2-07 – x2 into sprinkler valve room. - North western corner of basement above mechanical ductwork – x2 	<ol style="list-style-type: none"> Where the penetration is too large, surround the penetration with a tight fitting calcium silicate board (such as Trafalgar Maxilite board, or equivalent) so that the entire opening in the wall is covered with an overlap of not less than 100mm. Fix and seal to maintain a FRL of not less than 2 hours. Appropriately seal around the electrical penetrations with an approved fire rated mastic in accordance with the manufacturers recommendations to maintain the FRL.

<p>Toga will surround the oversized penetration with a fire rated board.</p> <p>Toga to reseal with Promat Promaseal AN Acrylic Sealant</p> <p>Test Report A-13-816</p>

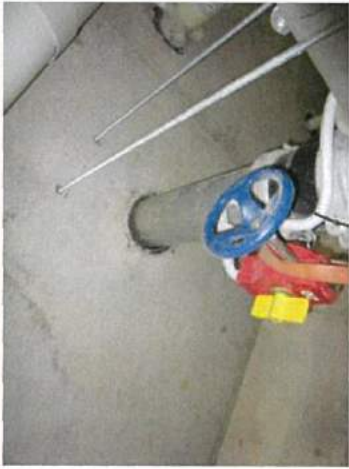
Item No.	Description and Location of the Defect	Agreed Scope of Works	BCA Logic Photograph	Defect Status and Photograph
101.	<p>Basement Carpark – Level 1</p> <p>There are a number of Hydrant pipes penetrating through the floor slabs with no fire stopping.</p> <p>This was observed in the following locations:</p> <ul style="list-style-type: none">- C2 1207 – x1- C2	<p>1. Seal between the pipe and the slab with an approved fire rated sealant in accordance with the manufacturer's recommendations.</p>

<p>Toga to reseal with Promat Promaseal AN Acrylic Sealant</p> <p>Test Report A-13-816</p>

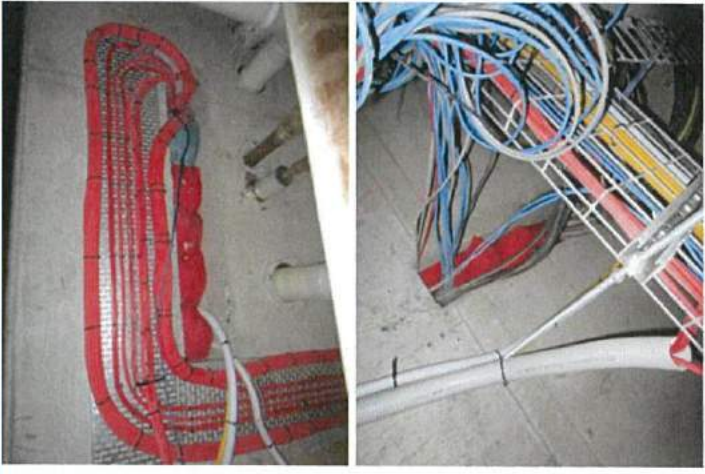
Item No.	Description and Location of the Defect	Agreed Scope of Works	BCA Logic Photograph	Defect Status and Photograph
102.	<p>Basement carpark Level 1 - Driveway opposite Carspace 1208</p> <p>We noted that the floor penetrations where electrical, communications and data cables pass through into the Ground floor Class 2 above are pre-formed voids infilled with fire rated pillows and sealed with fire rated mastic.</p> <p>This was in 2 locations.</p> <p>The cable bundles are poorly sealed. There are large gaps between fire pillows.</p> <p>We note that the fire pillows are located at the top of the penetration and protrude above the finished floor slab. The pillows have been installed horizontally.</p> <p>It is noted that the pillows have been sealed from the top only.</p> <p>Furthermore, we noted a number of electrical conduits passing through the pillows or floor slab with no fire collars or smoke seals to their openings.</p>	<ol style="list-style-type: none"> 1. Remove the existing fire pillows and all mastic. 2. Cut back any electrical conduits passing through the void for the thickness of the pillows or that are located within the slab. 3. Suitably bundle the electrical, communications and data cables into bundles no greater than 50mm. 4. Separate the newly formed bundles in accordance with the fire pillow manufactures recommendations. 5. Reinstall the existing fire rated pillows in a vertically stacked manner within the pre-formed void. The pillow should extend within the penetration so it does not protrude above or below the void. 6. Provide additional pillows as required to fill the void. 7. Seal the perimeter junctions and junctions between pillows with a fire rated mastic in strict accordance with the fire pillow tested details. Confirm with manufacturer if sealing from the top only is compliant with the tested system. 8. Fire pillow system and fire rated mastic in strict accordance with the manufacturer's recommendations. 9. Where conduits are cut back through the slab, appropriately seal around the conduit with a fire rated mastic in strict accordance with the manufacturer's recommendations from below.

As per BCA Logics scope of works.

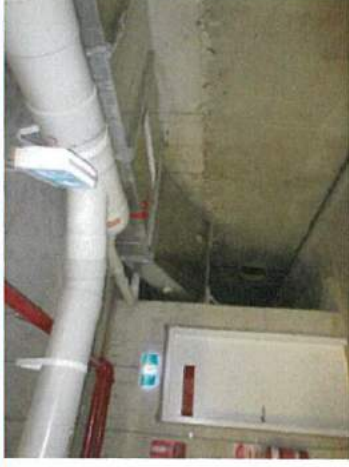
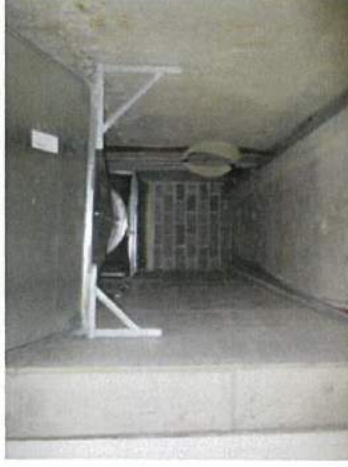
Item No.	Description and Location of the Defect	Agreed Scope of Works	BCA Logic Photograph	Defect Status and Photograph
103.	<p>Basement carpark Level 1 - Northern end adjacent fire stair</p> <p>The mechanical ductwork is measured at 1860mm in the north western corner adjacent to the Fire isolated stair door. The ductwork continues on a downward angle to a low point of 1400mm measured from the finished floor slab to the lowest bracket fixing</p>	<ol style="list-style-type: none"> 1. It is not practical to rectify this defect due to the functional requirements of the exhaust ducting. 2. Engage a qualified fire engineer to provide an Alternative Solution for this defect. 3. The Alternative Solution should include warning signage and highlighting of the hazard.

<p>Toga to install signage and hazard tape/ highlight the danger.</p>

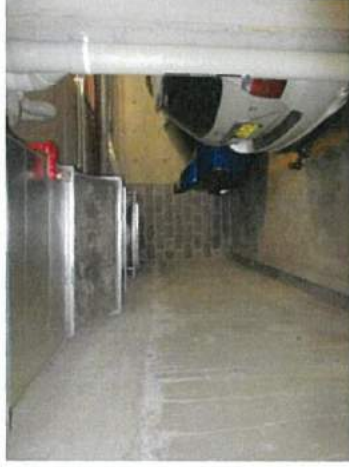
104.	<p>Basement carpark Level 1 - North western visitor carspace</p> <p>The mechanical ductwork is measured at 1890mm at the rear of the carspace with the sprinkler head at 1830mm.</p> <p>The low ductwork continues across to the adjoining carspaces and increases in height to 1950mm.</p>	<ol style="list-style-type: none"> 1. It is not practical to rectify this defect due to the functional requirements of the exhaust ducting. 2. Engage a qualified fire engineer to provide an Alternative Solution for this defect. 3. The Alternative Solution should include warning signage and highlighting of the hazard.

<p>Toga to install signage and hazard tape/ highlight the danger.</p>

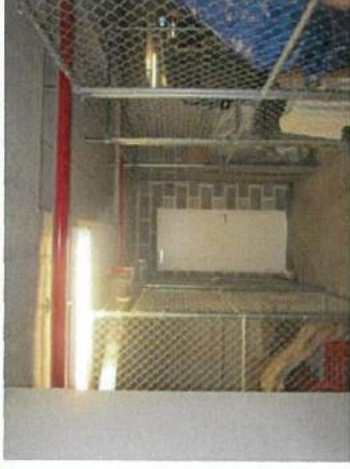
Item No.	Description and Location of the Defect	Agreed Scope of Works	BCA Logic Photograph	Defect Status and Photograph
105.	Basement Carpark Level 2 There is no directional or exit signage identifying the location of the nearest exit.	1. Supply and install new directional exit signs to identify the required exits.

As per BCA Logics Scope of Works.

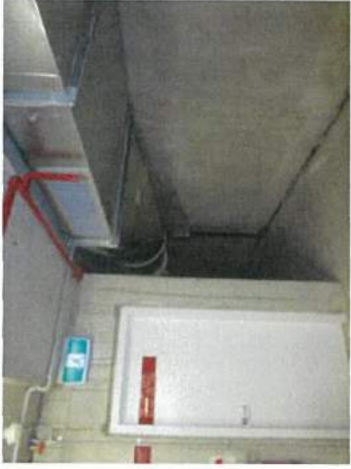
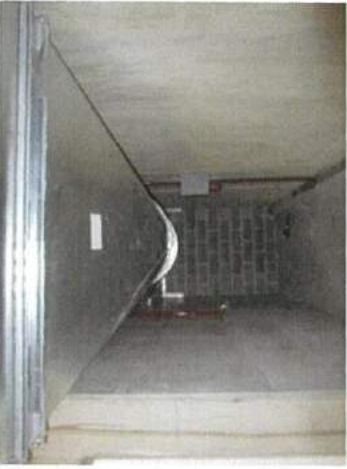
106.	Basement carpark Level 2 - Northern end adjacent fire stair The mechanical ductwork is measured at 1989mm in the north western corner adjacent to the Fire isolated stair door. The ductwork continues on a downward angle to a low point of 1720mm measured from the finished floor slab to the lowest bracket fixing	1. It is not practical to rectify this defect due to the functional requirements of the exhaust ducting. 2. Engage a qualified fire engineer to provide an Alternative Solution for this defect. 3. The Alternative Solution should include warning signage and highlighting of the hazard.

Toga to install signage and hazard tape/ highlight the danger.

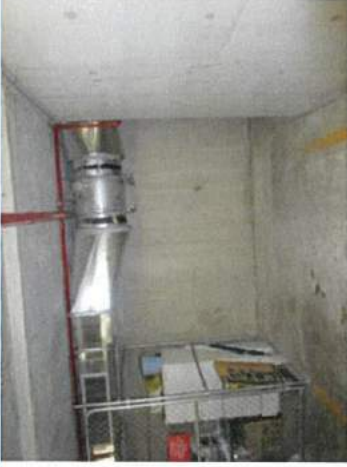
Item No.	Description and Location of the Defect	Agreed Scope of Works	BCA Logic Photograph	Defect Status and Photograph
107.	<p>Basement carpark Level 2 - North western visitor carspace</p> <p>The mechanical ductwork is measured at 1750mm at the rear of the carspace.</p>	<ol style="list-style-type: none"> 1. It is not practical to rectify this defect due to the functional requirements of the exhaust ducting. 2. Engage a qualified fire engineer to provide an Alternative Solution for this defect. 3. The Alternative Solution should include warning signage and highlighting of the hazard.

<p>Toga to install signage and hazard tape/ highlight the danger.</p>

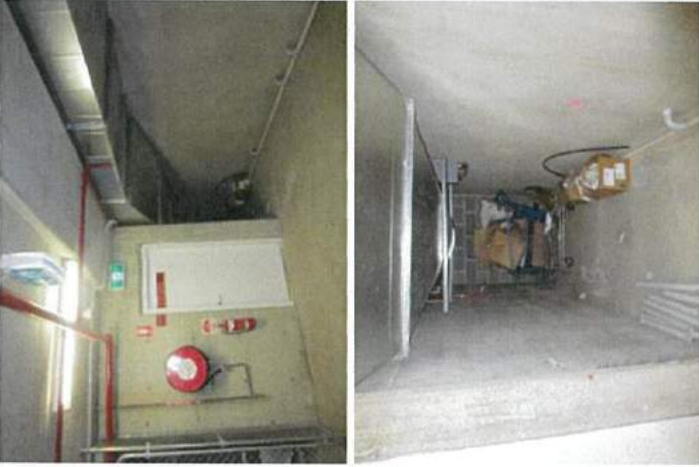
108.	<p>Basement carpark Level 32 - Northern end adjacent fire stair</p> <p>The mechanical ductwork is measured at 1920mm in the north western corner adjacent to the Fire isolated stair door. The ductwork continues on a downward angle to a low point of 1525mm measured from the finished floor slab to the lowest bracket fixing</p>	<ol style="list-style-type: none"> 1. It is not practical to rectify this defect due to the functional requirements of the exhaust ducting. 2. Engage a qualified fire engineer to provide an Alternative Solution for this defect. 3. The Alternative Solution should include warning signage and highlighting of the hazard.

<p>Toga to install signage and hazard tape/ highlight the danger.</p>

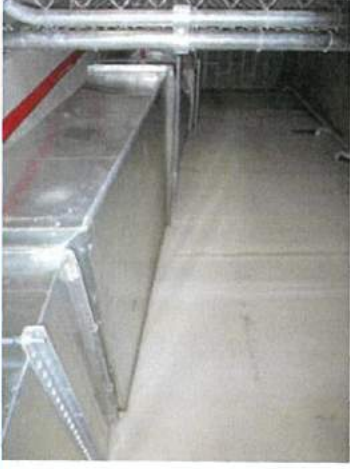
Item No.	Description and Location of the Defect	Agreed Scope of Works	BCA Logic Photograph	Defect Status and Photograph
109.	Basement carpark Level 2 - North western visitor carspace The mechanical ductwork is measured at 1675mm at the rear of the carspace.	<ol style="list-style-type: none"> 1. It is not practical to rectify this defect due to the functional requirements of the exhaust ducting. 2. Engage a qualified fire engineer to provide an Alternative Solution for this defect. 3. The Alternative Solution should include warning signage and highlighting of the hazard.

Toga to install signage and hazard tape/ highlight the danger.

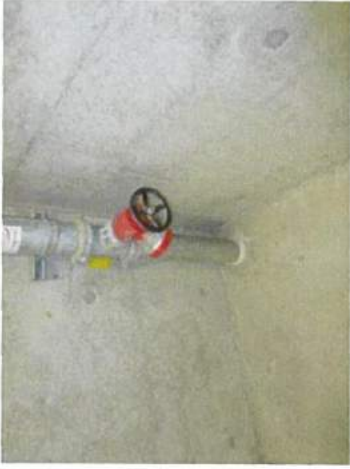
110.	South eastern fire stair The Hydrant valve spindle are located less than 100mm from the wall. This was observed in the following locations: - B3 - B2	<ol style="list-style-type: none"> 1. Engage a qualified plumbing contractor to adjust the hydrant valve so that the spindle is located a minimum of 100mm off the wall. 2. Ensure the egress pathway is not obstructed or reduced.

Advised works completed. Awaiting inspection and sign-off from BCA Logic

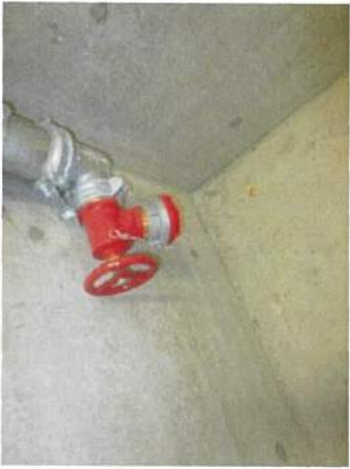
111.	South eastern fire stair The Hydrant valve angle is greater than the maximum permitted angle of 35 degrees below the horizontal. The hydrant valve almost faces the floor. The valve is required to maintain a minimum 1m clearance. We observed this in the following locations: - B3 - B2 - B1	<ol style="list-style-type: none"> 1. Engage a qualified plumbing contractor to reconfigure the hydrant valves at each level so that they face outwards and maintain a compliant angle.

Advised works completed. Awaiting inspection and sign-off from BCA Logic

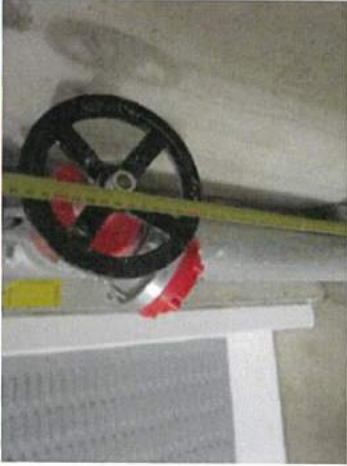
Item No.	Description and Location of the Defect	Agreed Scope of Works	BCA Logic Photograph	Defect Status and Photograph
112.	<p>South eastern fire stair</p> <p>The Hydrant valve is required to be located between 750mm and 1200mm from the finished floor level.</p> <ul style="list-style-type: none"> - B3 – 710mm - B2 – 710mm - B1 – 750mm 	<p>1. Engage a qualified plumbing contractor to reconfigure the hydrant valves to maintain a compliant height.</p>

<p>Advised works completed. Awaiting inspection and sign-off from BCA Logic</p>

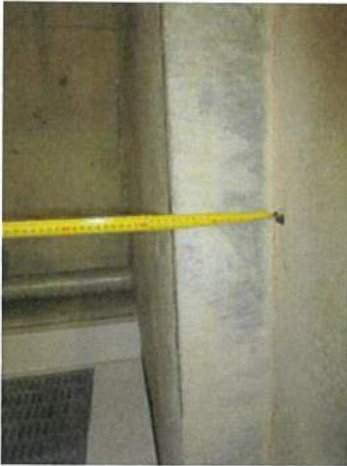
113.	<p>South eastern fire stair</p> <p>The riser heights throughout the stair are generally consistent. The following stair flights had varying riser heights:</p> <ul style="list-style-type: none"> - B2 to Intermediate - Consistent at 175mm. Top riser 160mm - B2 intermediate to B1 - Consistent at 170mm. Top riser 165mm 	<p>1. As appropriate grind or top stair treads to achieve a consistent riser height throughout the stair flight to comply with BCA Clause D2.13.</p> <p>2. As appropriate adjust stair tread lengths to comply with BCA Clause D2.13.</p> <p>3. Reinstate floor finish to match existing.</p>

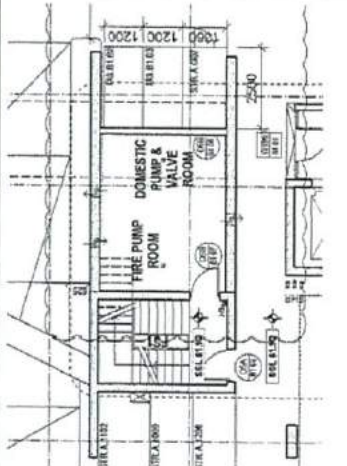
114.	<p>South eastern fire stair Sprinkler Pump room</p> <p>The sprinkler pump room is accessed directly from the fire stair.</p> <p>No airlock is provided to the pump room.</p>	<p>1. Provide a suitable airlock to maintain compliance with this clause and ensure that the pump room does not open directly into the fire isolated passageway.</p> <p>2. Alternatively, engage a qualified fire engineer to prepare an alternative Solution to address this issue.</p>

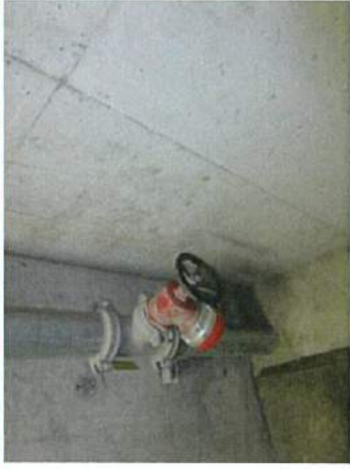
Item No.	Description and Location of the Defect	Agreed Scope of Works	BCA Logic Photograph	Defect Status and Photograph
115.	<p>North western fire stair</p> <p>The Hydrant valve spindle are located less than 100mm from the wall.</p> <p>This was observed in the following locations:</p> <ul style="list-style-type: none"> - B3 - B2 - B1 	<ol style="list-style-type: none"> Engage a qualified plumbing contractor to adjust the hydrant valve so that the spindle is located a minimum of 100mm off the wall. Ensure the egress pathway is not obstructed or reduced.

<p>Advised works completed. Awaiting inspection and sign-off from BCA Logic</p>

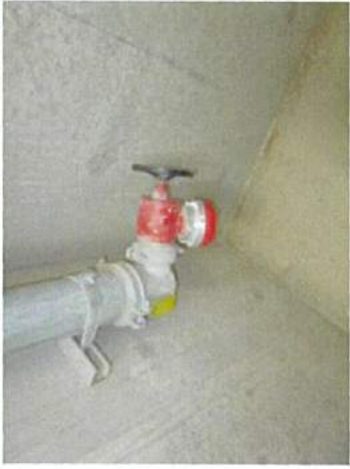
116.	<p>North western fire stair</p> <p>The Hydrant valve angle is greater than the maximum permitted angle of 35 degrees below the horizontal.</p> <p>The hydrant valve almost faces the floor. The valve is required to maintain a minimum 1m clearance.</p> <p>We observed this in the following locations:</p> <ul style="list-style-type: none"> - B3 - B2 - B1 	<ol style="list-style-type: none"> Engage a qualified plumbing contractor to reconfigure the hydrant valves at each level so that they face outwards and maintain a compliant angle.

<p>Advised works completed. Awaiting inspection and sign-off from BCA Logic</p>

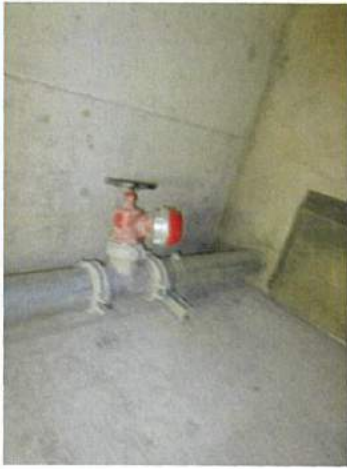
Item No.	Description and Location of the Defect	Agreed Scope of Works	BCA Logic Photograph	Defect Status and Photograph
117.	<p>North western fire stair</p> <p>The Hydrant valve is required to be located between 750mm and 1200mm from the finished floor level.</p> <ul style="list-style-type: none"> - B3 – 735mm - B2 – 725mm - B1 - 720mm 	<p>1. Engage a qualified plumbing contractor to reconfigure the hydrant valves to maintain a compliant height.</p>

<p>Advised works completed. Awaiting inspection and sign-off from BCA Logic</p>

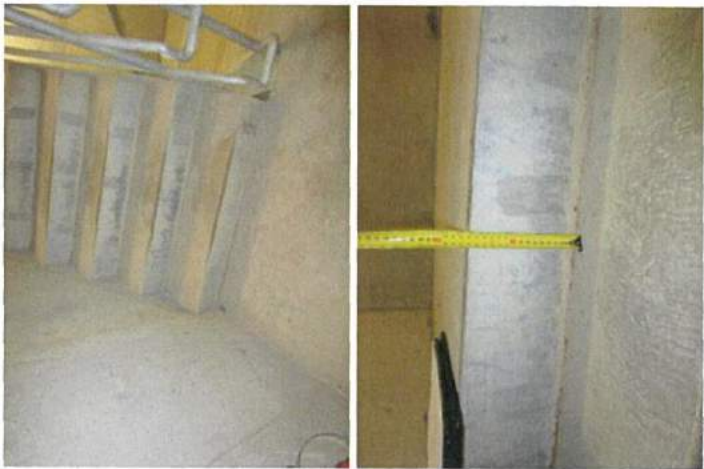
118.	<p>North western fire stair</p> <p>The riser heights throughout the stair are generally consistent. The following stair flights had varying riser heights:</p> <ul style="list-style-type: none"> - B3 to Intermediate riser 160mm - Consistent at 175mm. Top riser 160mm - Intermediate to B2 - Consistent at 175mm. Bottom riser 160mm - B2 to Intermediate - Consistent at 175mm. Bottom riser 160mm - B1 to intermediate - Consistent at 185mm. Bottom riser 165mm 	<p>1. As appropriate grind or top stair treads to achieve a consistent riser height throughout the stair flight to comply with BCA Clause D2.13.</p> <p>2. As appropriate adjust stair tread lengths to comply with BCA Clause D2.13.</p> <p>3. Reinstall floor finish to match existing.</p>

<p>TBC</p>

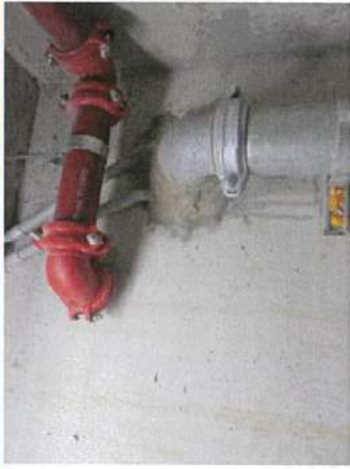
Item No.	Description and Location of the Defect	Agreed Scope of Works	BCA Logic Photograph	Defect Status and Photograph
119.	North western fire stair There are two conduits with no fire collar through fire stair wall into basement at B1.	1. Provide a retrofit fire collar to each conduit (such as a Promat Retrofit conduit Collar), installed in accordance with the manufacturers specifications.

TBC

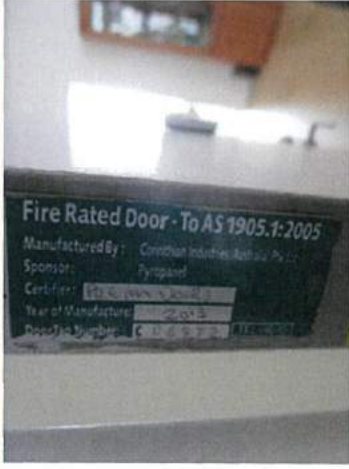
Item No.	Description and Location of the Defect	Agreed Scope of Works	BCA Logic Photograph	Status and Photograph
4.	<p><u>General – Units and common areas</u></p> <p>The fire door tags have not had the required information etched in. The information has been provided by means of a black marking pen.</p> <p>This was observed in all units and common areas inspected</p>	Not a Defect

<p>Refer to details from Premium Doors regarding advice from Corinthian Doors.</p> <p>Agreed site tags are etched if felt.</p> <p>Closed</p>

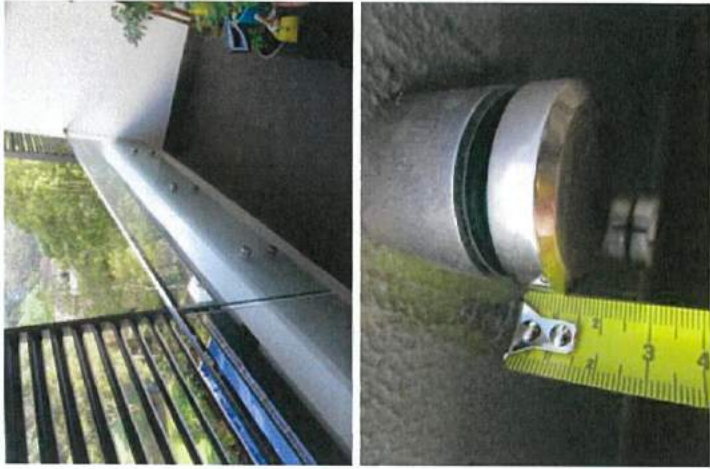
5.	<p><u>General</u></p> <p>The glass balcony balustrades have stainless steel fixings between 300mm and 600mm from finished floor level. Generally, the fixings vary between 9-11mm and consistent at 10mm measured from the glass to the commencement of the splay. The splay appears to be at a 60 degree angle.</p> <p>Balustrades are required to not facilitate climbing between 150mm and 765mm measured from the finished floor level. The BCA does not provide any clear interpretation or specific definition for the climbability requirement of a balustrade. Generally, across the industry, open interpretation of a 10mm toe hold as outlined in the Swimming Pool Act is applied.</p>	No Defect recorded.

Informational – Closed

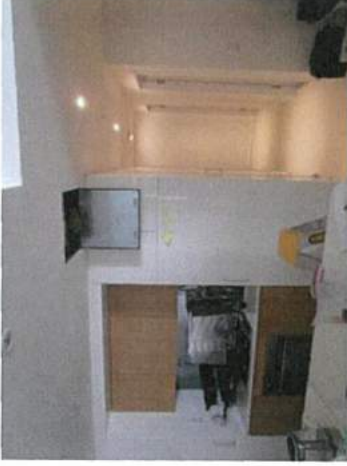
Item No.	Description and Location of the Defect	Agreed Scope of Works	BCA Logic Photograph	Status and Photograph
120.	<p>Unit 703</p> <p>The unit is provided with a smoke detector above bedroom 1.</p> <p>Bedroom 2 is located between the kitchen and bedroom 1.</p> <p>The smoke detector is located approximately 2m past the bedroom.</p>	Not a Defect

<p>Refer to correspondence and advice from Spectrum Engineering Solutions.</p> <p>Closed</p>

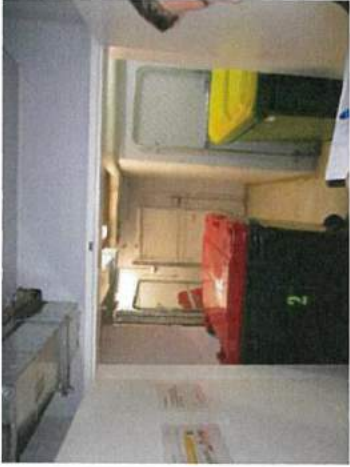
Item No.	Description and Location of the Defect	Agreed Scope of Works	BCA Logic Photograph	Status and Photograph
122.	Ground floor – Garbage room The southern doors leading to the road are not fire rated doors. The room forms part of the garbage shaft and therefore, these doors are openings within a shaft. The room is required to maintain an FRL of -/90/90.	Not a Defect

Shaft opens to open space. Closed.

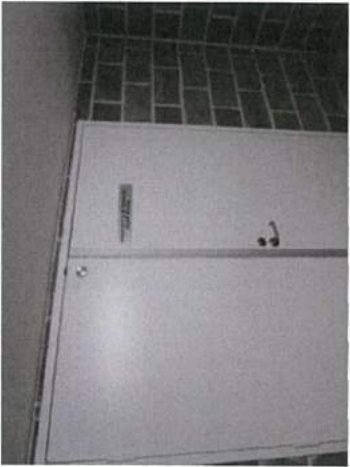
123.	Hydrant and Sprinkler Pump room The hydrant sprinkler and pump room serves Buildings A, B, C and D and is located on the roof over Building A. No airlock is provided to the hydrant pump room. Access is directly via the Fire Isolated passageway that shares an exit door with the roof.	Not a Defect

Anomaly in the BCA and the Australian Standard. The BCA takes precedence, however, the interpretation of the PCA is also valid. BCA Clause E1.3 calls up AS2419.1-2005 and therefore, this permits the pumproom to be directly accessed from a passageway. Closed.

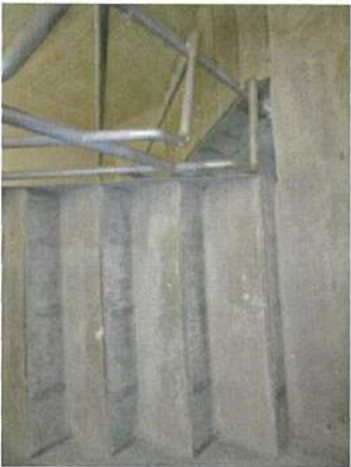
124.	Northern fire stair The balustrade to the intermediate landings and level landings were measured to be less than 1m. Generally, 865mm was observed. This was observed in the following locations: - Level 7 - Level 8 - Level 9 - Level 10 - Level 11 and Level 12.	Not a Defect.

BCA 2011 permits an intermediate handrail to have a minimum height of 865mm through the landing. Closed

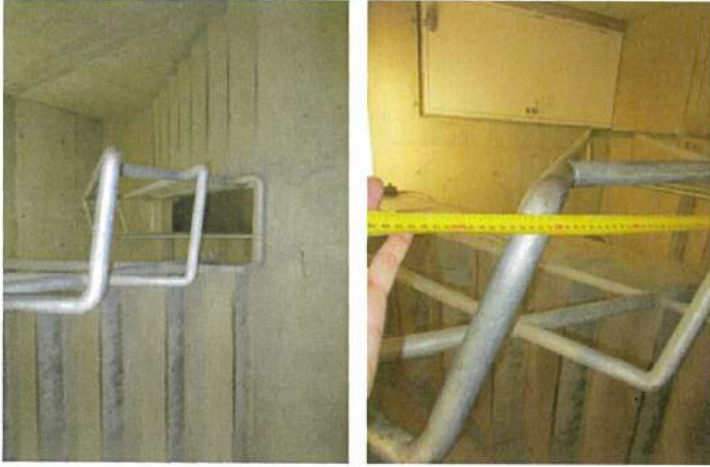
Item No.	Description and Location of the Defect	Agreed Scope of Works	BCA Logic Photograph	Status and Photograph
125.	<p>South eastern fire stair</p> <p>The balustrade to the intermediate landings and level landings were measured to be less than 1m. Generally 950mm was observed.</p> <p>This was observed in the following locations:</p> <ul style="list-style-type: none"> - B1 - B1 Intermediate landing - B2 - B2 Intermediate landing - B3 - B3 Intermediate landing 	Not a Defect.

<p>BCA 2011 permits an intermediate handrail to have a minimum height of 865mm through the landing.</p> <p>Closed</p>

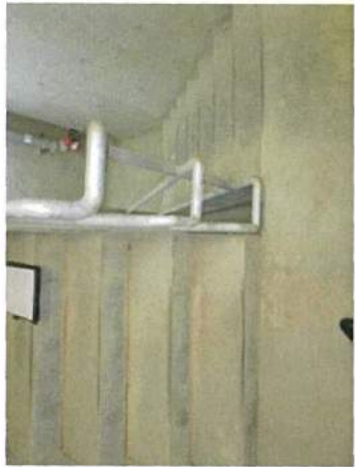
126.	<p>North western fire stair</p> <p>The balustrade to the intermediate landings and level landings were measured to be less than 1m. Generally 950mm was observed.</p> <p>This was observed in the following locations:</p> <ul style="list-style-type: none"> - B1 - B2 - B3 Intermediate landing 	Not a Defect.

<p>BCA 2011 permits an intermediate handrail to have a minimum height of 865mm through the landing.</p> <p>Closed</p>

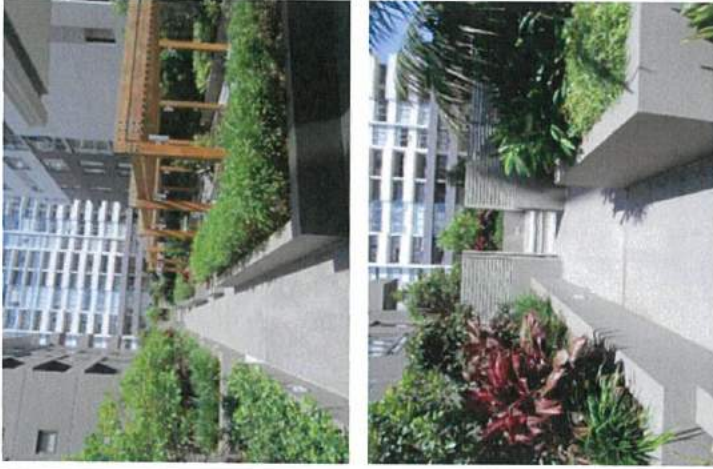
Item No.	Description and Location of the Defect	Agreed Scope of Works	BCA Logic Photograph	Status and Photograph
127.	No Exit signage or directional signage provided to the Podium courtyard to identify the paths of travel to an exit.	Not a Defect.

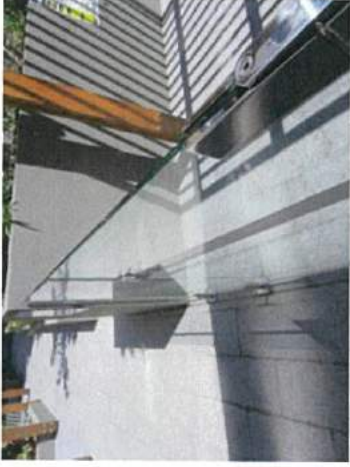
Refer to Vic Lilli letter dated 18/02/16. Closed
128.	<p>Pool Fence</p> <p>The pool fence is constructed purely of Glass supported by spigots at the base.</p> <p>The top edge of the glass has not been provided with a metal rail or a handrail to the balustrade.</p>	No Defect recorded.

<p>We acknowledge the barrier is not a balustrade as there is no fall more than 1m. Therefore, no defect is recorded.</p> <p>Closed.</p>

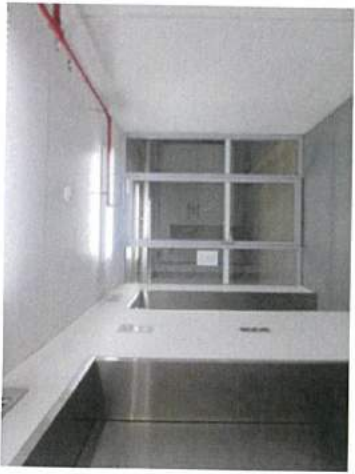
Item No.	Description and Location of the Defect	Agreed Scope of Works	BCA Logic Photograph	Status and Photograph
129.	Basement Levels 1, 2 and 3 – Lobbies There is no directional or exit signage identifying the location of the nearest exit from within the lobby areas.	No defect recorded.

The interpretation of the certifier has been considered and discretion applied. Closed
