SydneyStrataReport

STRATA REPORT

Client	Church Street Parramatta Property Pty Ltd
Address of property	Unit 3303/330 Church Street, Parramatta, NSW.
Lot	359
Strata Plan	SP 94469
Name of Strata Management Co.	NSW Strata
Telephone Number of Strata Agent	8980 1841
Report Date	15 February 2024

BUILDING DEFECTS REPORT Part 1/2

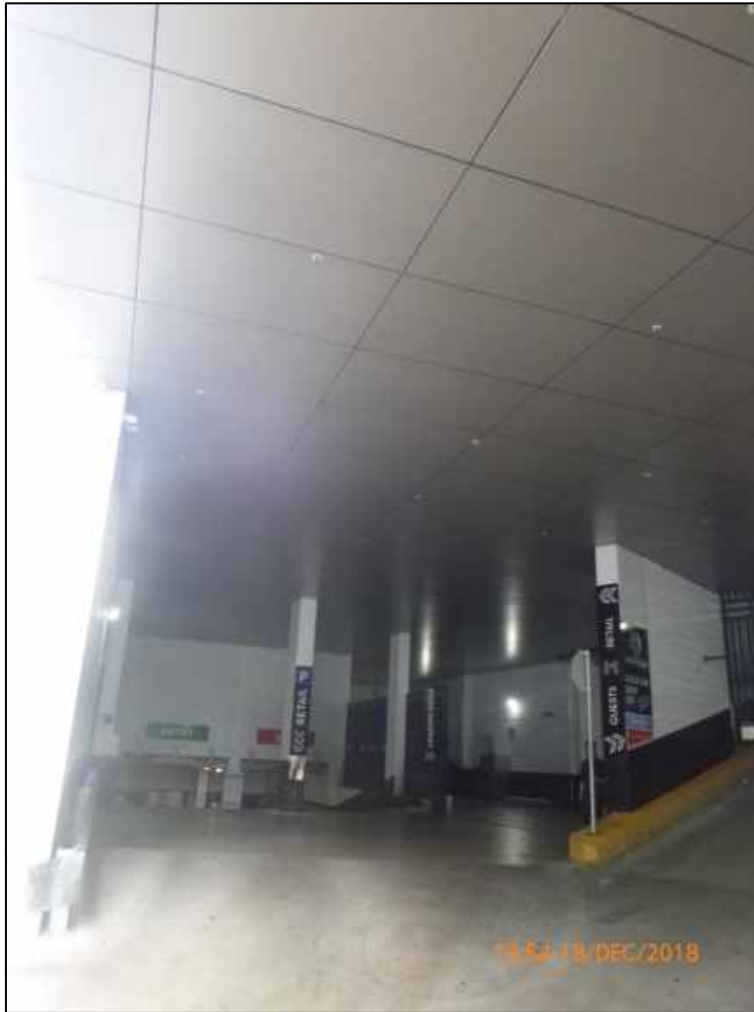
Photograph 2 – Cladding panels identify on the soffit of the carpark entrance on the eastern elevation.

Based on the site review of the installed cladding at the property, it is recommended to undertake a tactile and intrusive investigation of these elements. Intrusive investigations will entail either removal or a sample core hole through the existing panels to confirm whether the panels are solid and do not contain aluminium composite material (ACM). Alternatively, review of the façade drawings may allow for the identification of the installed cladding panels.

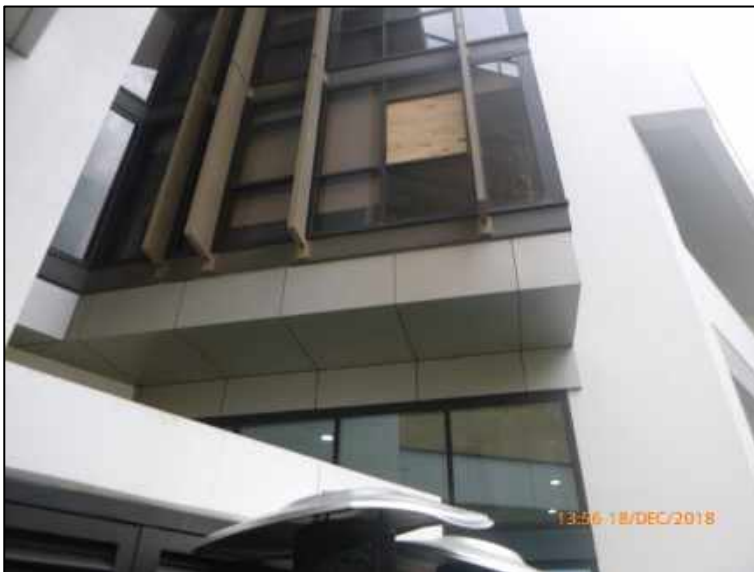
Photograph 3 – Cladding panels identify on the facade on the northern elevation of the building.

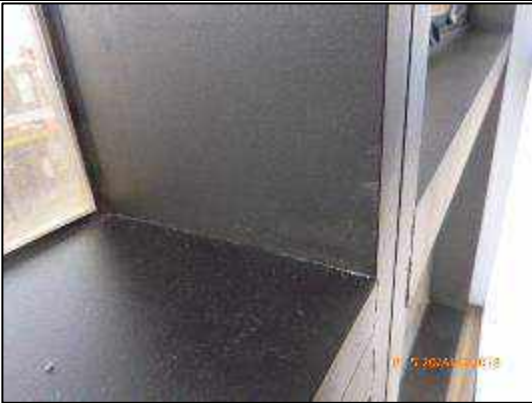
Item	Location	Defect Description and Breach	Rectification	Photograph (if applicable)
Unit 101				
1	<i>Windows frames throughout unit.</i>	See section 5.7.1	See section 5.7.2

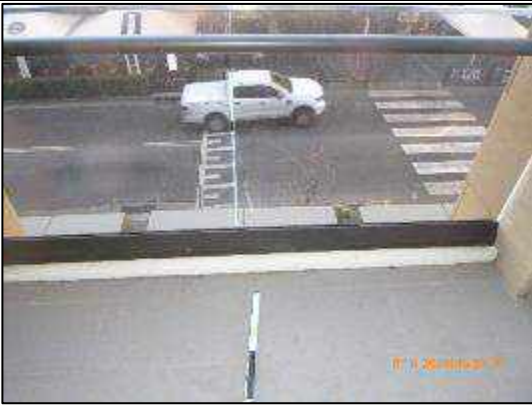
2	<i>Balcony</i>	See section 5.3.1	See section 5.3.2

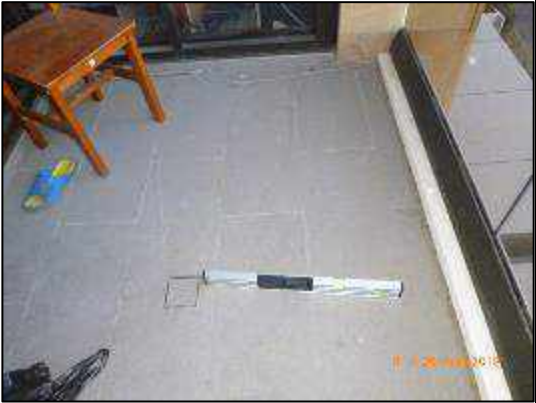
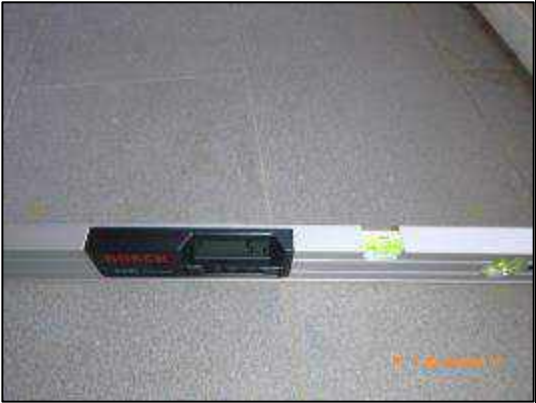
Item	Location	Defect Description and Breach	Rectification	Photograph (if applicable)
3	Balcony	See section 5.2.1 Fall (mm); 5/1000	See section 5.2.2

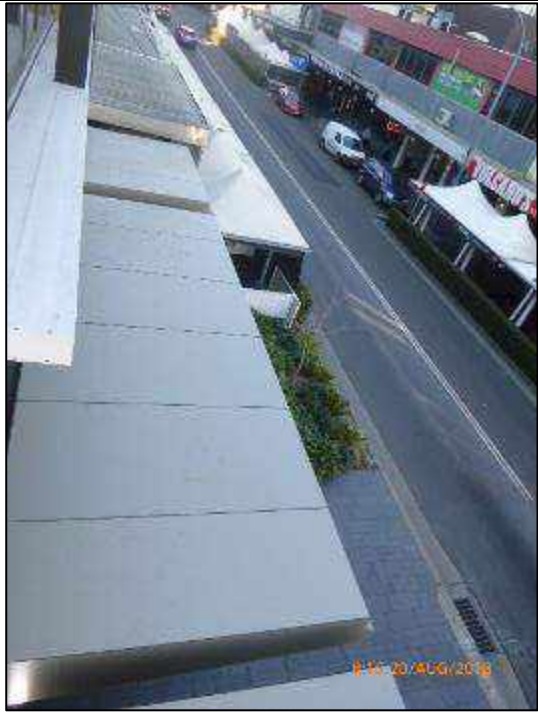
Item	Location	Defect Description and Breach	Rectification	Photograph (if applicable)
4	External façade	<p>Construction debris observed on the external façade.</p> <p>Home Building Act (NSW) 1989</p> <ul style="list-style-type: none"> Part 2C, 18B (a) and (c). <p>This is a breach of part (a) of the act because the surface has not been finished in a proper workmanlike manner that would prevent loss of appearance to the surface.</p> <p>Loss Suffered Loss suffered is cost of rectification.</p>	<p>4. Protect all adjoining surfaces.</p> <p>5. Use a suitable cleaning agent to remove residue and clear debris.</p> <p>6. Clean up the work area.</p>

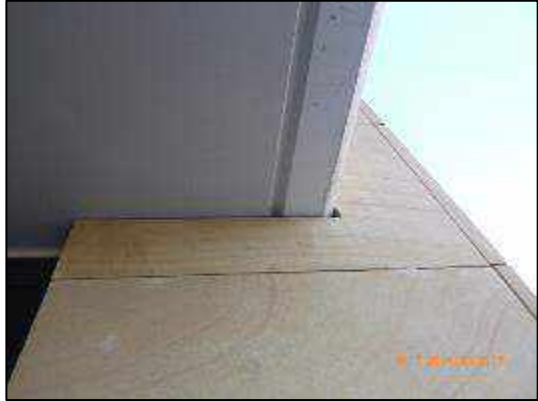
5	Balcony façade wall	<p>Drip groove on façade observed to have no stop end.</p> <p>Home Building Act (NSW) 1989</p> <ul style="list-style-type: none"> Part 2C, 18B (a) and (c). <p>Loss Suffered Loss suffered is cost of rectification.</p>	<p>Engage a licenced tradesman to install stop end to drip groove and redirect water in accordance with manufacturers specifications.</p>

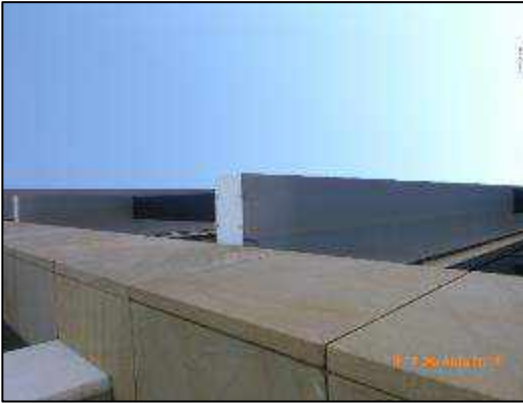
Item	Location	Defect Description and Breach	Rectification	Photograph (if applicable)
6	Balcony façade	<p>Loose gasket observed on awning.</p> <p>Home Building Act (NSW) 1989</p> <ul style="list-style-type: none"> Part 2C, 18B (a) and (c). <p>Loss Suffered Loss suffered is cost of rectification.</p>	Engage a licenced tradesman to correctly fit gasket to awning in accordance with manufacturers specifications.

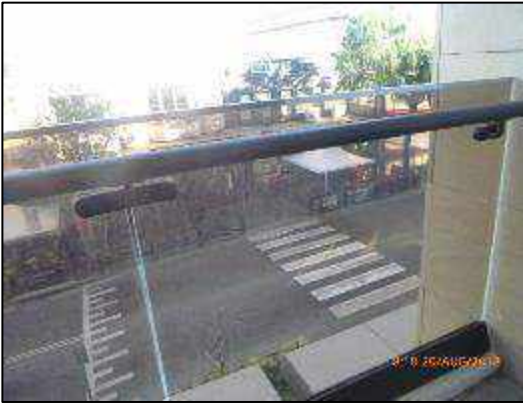
7	Balcony	See section 5.4.1	See section 5.4.2

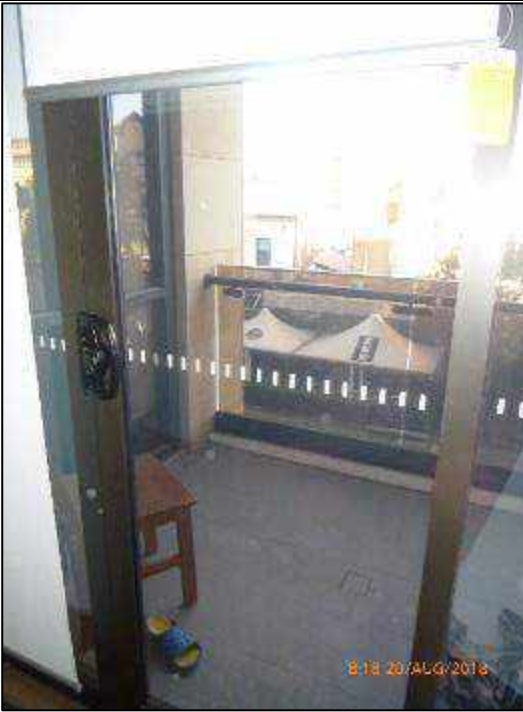
Item	Location	Defect Description and Breach	Rectification	Photograph (if applicable)
8	Balcony sliding door	See section 5.4.1	See section 5.4.2

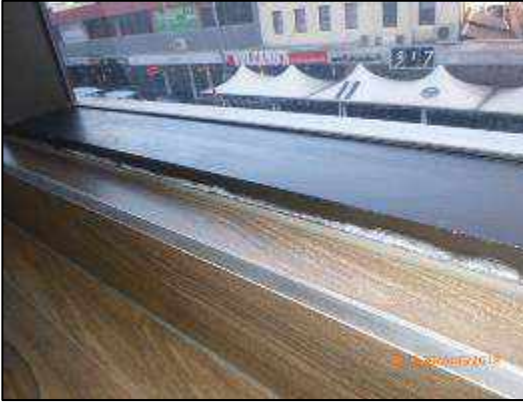
9	Lounge room window frames on southern elevation.	See section 5.8.1	See section 5.8.2

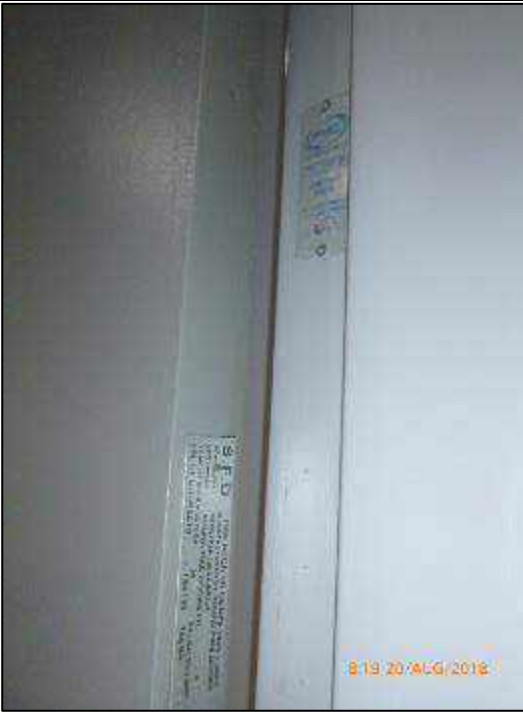
11	Front entry door	<p>Fire door and frame observed to be two different brands.</p> <p>Home Building Act (NSW) 1989</p> <ul style="list-style-type: none"> Part 2C, 18B (a) and (c). <p>Loss Suffered Loss suffered is cost of rectification.</p>	Engage a licenced tradesperson to remove fire door and install a suitable fire door to match existing door frame as advised by fire engineer.

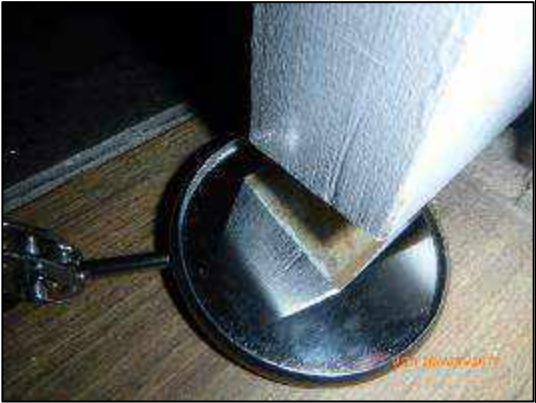
Item	Location	Defect Description and Breach	Rectification	Photograph (if applicable)
12	<i>Doors throughout the unit (x3)</i>	See section 5.5.1	See section 5.5.2

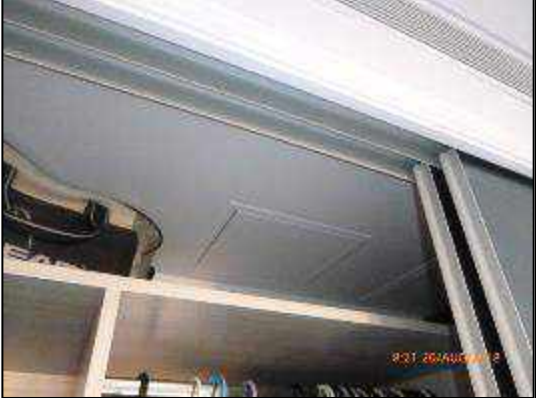
13	<i>Main bedroom built-in</i>	See section 5.6.1	See section 5.6.2

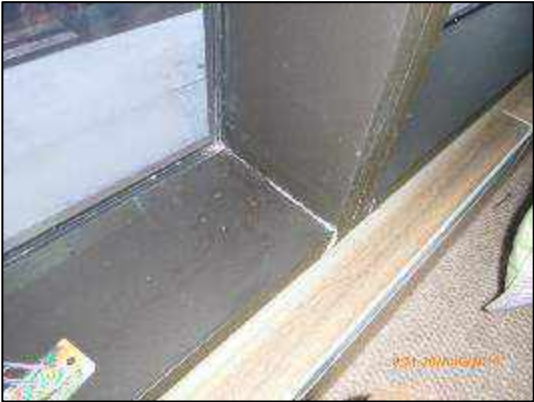
Item	Location	Defect Description and Breach	Rectification	Photograph (if applicable)
14	Main bedroom window frames	See section 5.8.1	See section 5.8.2

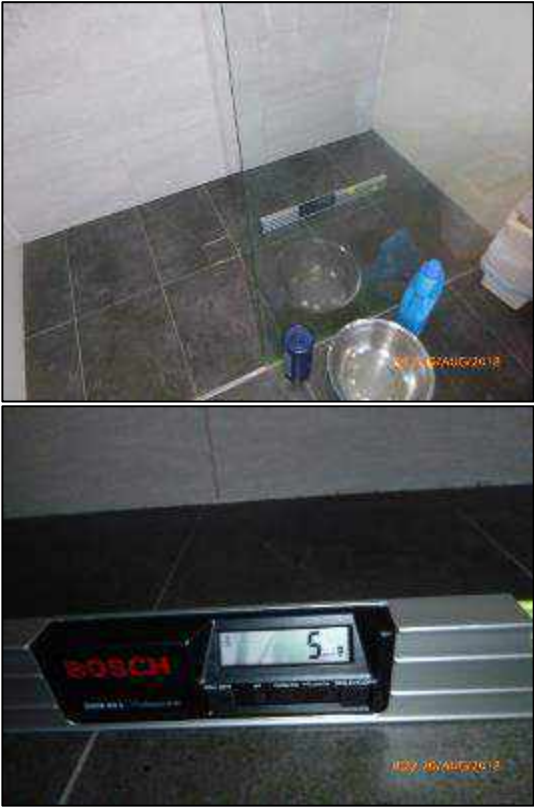
Item	Location	Defect Description and Breach	Rectification	Photograph (if applicable)
15	Main bedroom ensuite	See section 5.1.1 Fall(mm); 5/1000	See section 5.1.2

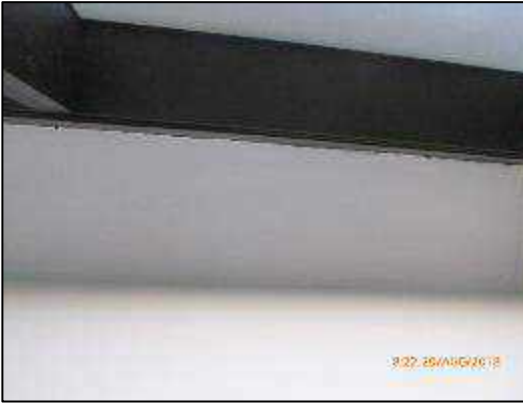
Item	Location	Defect Description and Breach	Rectification	Photograph (if applicable)
16	Main bedroom ensuite window bulkhead	See section 5.10.1	See section 5.10.2

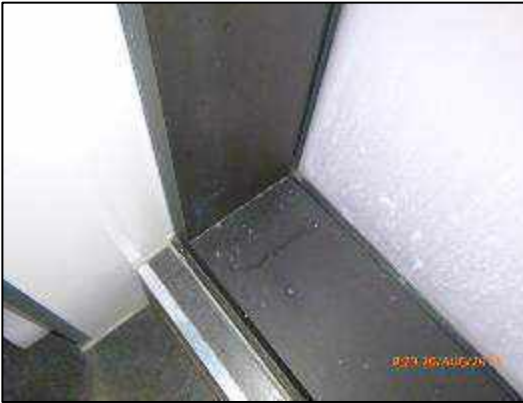
A photograph showing a white bulkhead or window frame area. A timestamp in the bottom right corner reads "2022-08/AUG/20 12".
17	Main bathroom window frames	See section 5.8.1	See section 5.8.2

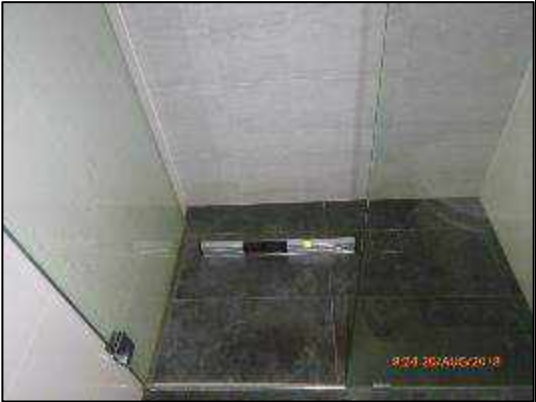
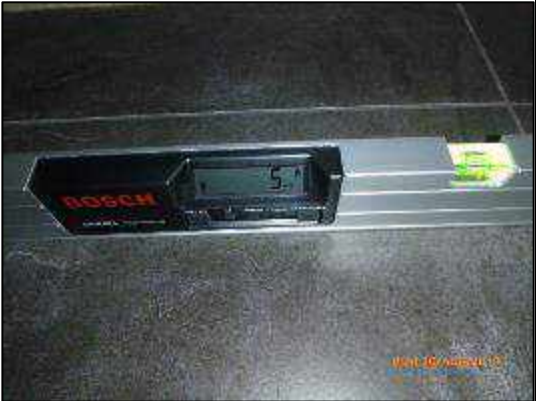
Item	Location	Defect Description and Breach	Rectification	Photograph (if applicable)
18	Main bathroom	See section 5.1.1 Falls(mm); 5/1000	See section 5.1.2

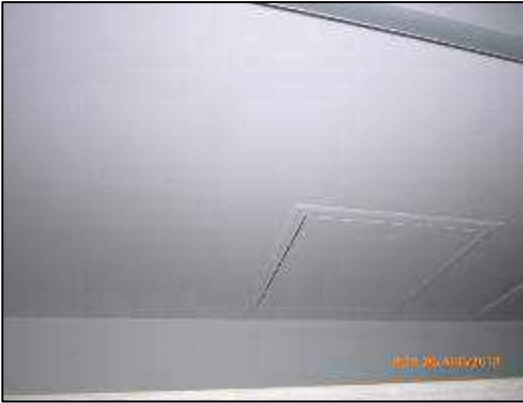
Item	Location	Defect Description and Breach	Rectification	Photograph (if applicable)
19	Second bedroom built-in	See section 5.6.1	See section 5.6.2

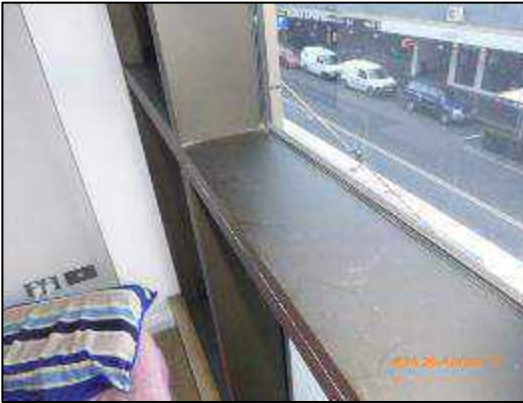
20	Second bedroom window frames	See section 5.8.1	See section 5.8.2

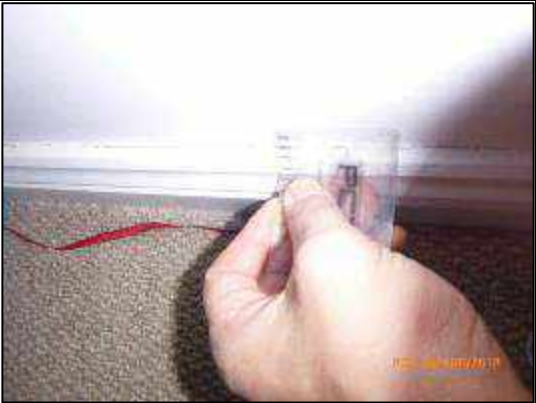
Item	Location	Defect Description and Breach	Rectification	Photograph (if applicable)
21	<i>Second bedroom skirting board.</i>	See section 5.14.1 Separation; 2mm	See section 5.14.2

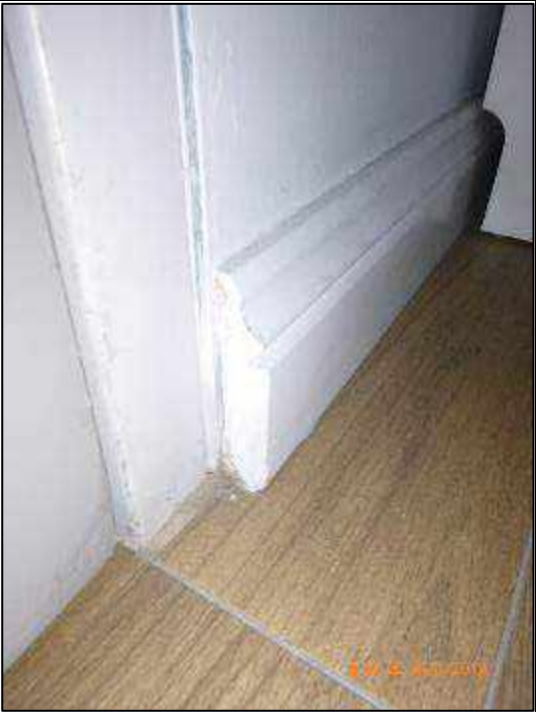
22	<i>Lounge room skirting adjacent to entry door.</i>	See section 5.10.1	See section 5.10.2

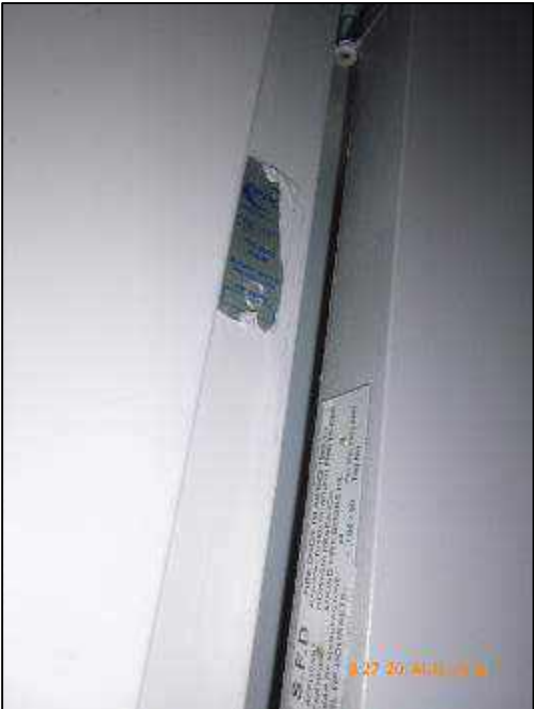
Item	Location	Defect Description and Breach	Rectification	Photograph (if applicable)
Unit 102				
23	Front entry door	<p>Fire door and frame observed to be two different brands.</p> <p>Home Building Act (NSW) 1989</p> <ul style="list-style-type: none"> Part 2C, 18B (a) and (c). <p>Loss Suffered Loss suffered is cost of rectification.</p>	Engage a licenced tradesperson to remove fire door and install a suitable fire door to match existing door frame as advised by fire engineer.

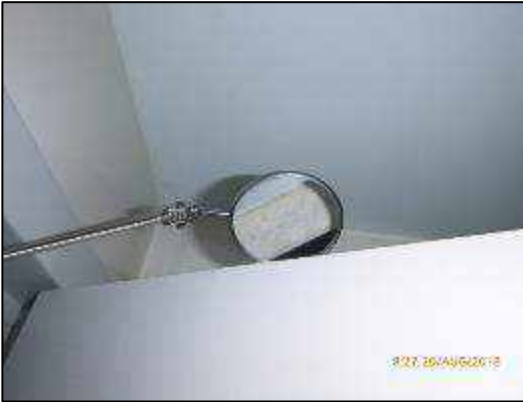
Item	Location	Defect Description and Breach	Rectification	Photograph (if applicable)
24	<i>Doors throughout unit (x3)</i>	See section 5.5.1	See section 5.5.2

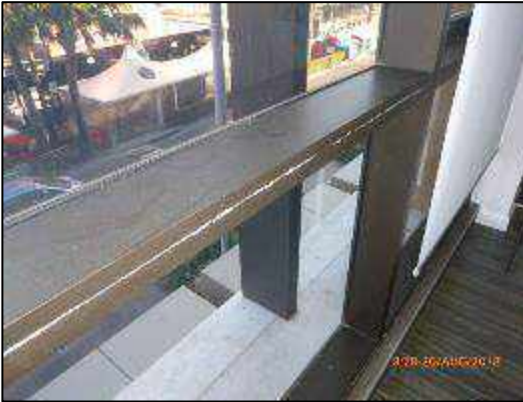
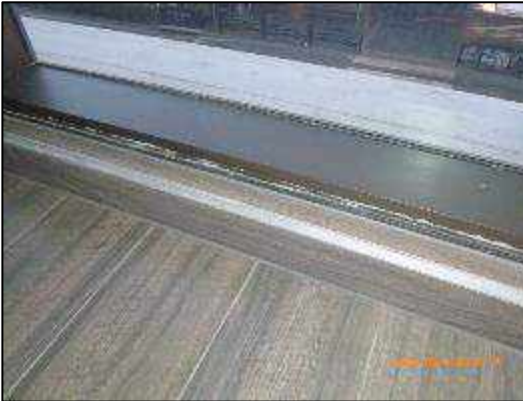
Item	Location	Defect Description and Breach	Rectification	Photograph (if applicable)
25	Lounge room window frames on southern elevation	See section 5.8.1	See section 5.8.2

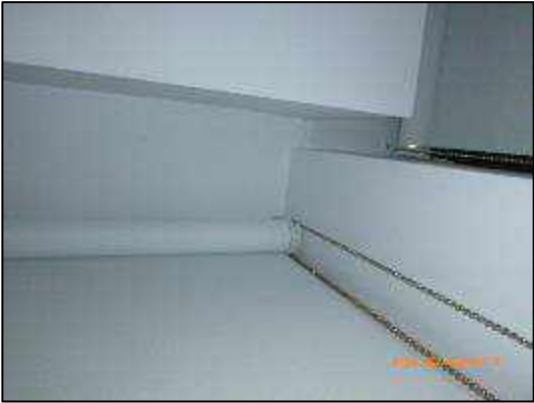
Item	Location	Defect Description and Breach	Rectification	Photograph (if applicable)
26	Lounge room window bulkhead	See section 5.10.1	See section 5.10.2

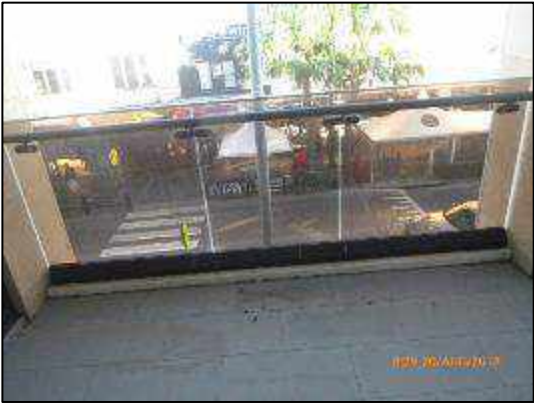
27	Balcony	See section 5.3.1	See section 5.3.2

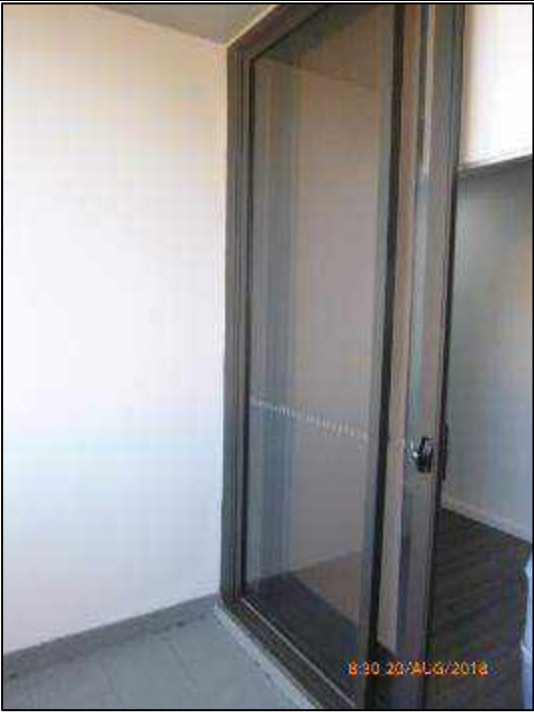
Item	Location	Defect Description and Breach	Rectification	Photograph (if applicable)
28	Balcony sliding door	See section 5.4.1	See section 5.4.2

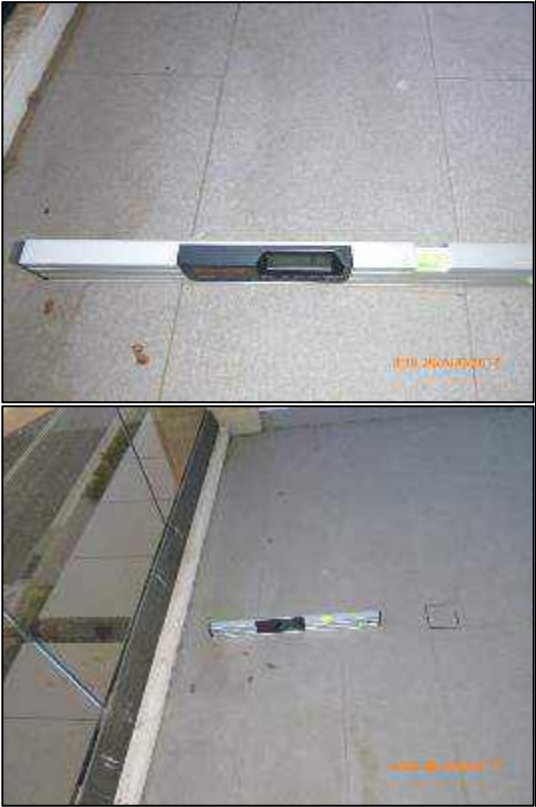
Item	Location	Defect Description and Breach	Rectification	Photograph (if applicable)
29	Balcony	See section 5.2.1	See section 5.2.2

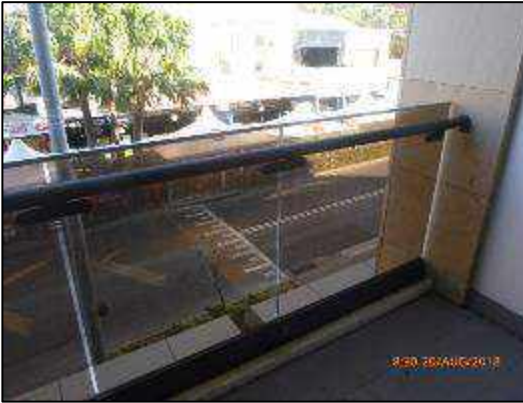
Item	Location	Defect Description and Breach	Rectification	Photograph (if applicable)
30	Balcony	See section 5.3.1	See section 5.3.2

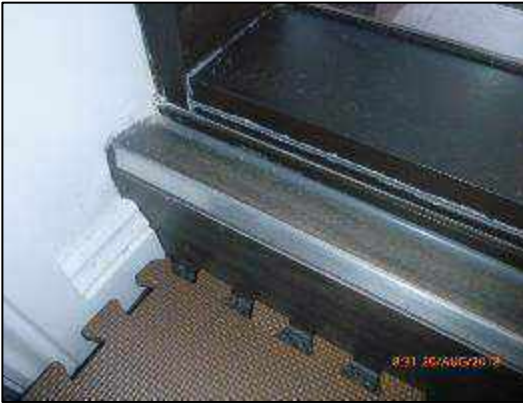
31	Second bedroom window frames	See section 5.8.1	See section 5.8.2

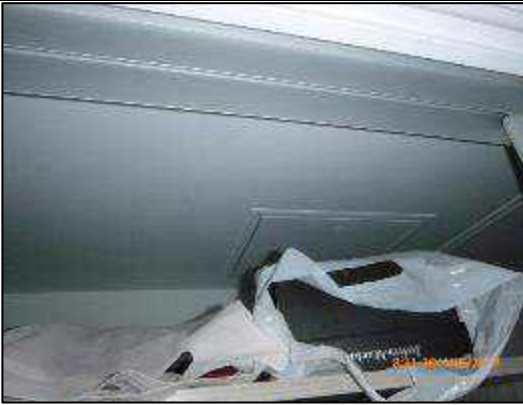
Item	Location	Defect Description and Breach	Rectification	Photograph (if applicable)
32	Second bedroom built-in	See section 5.6.1	See section 5.6.2

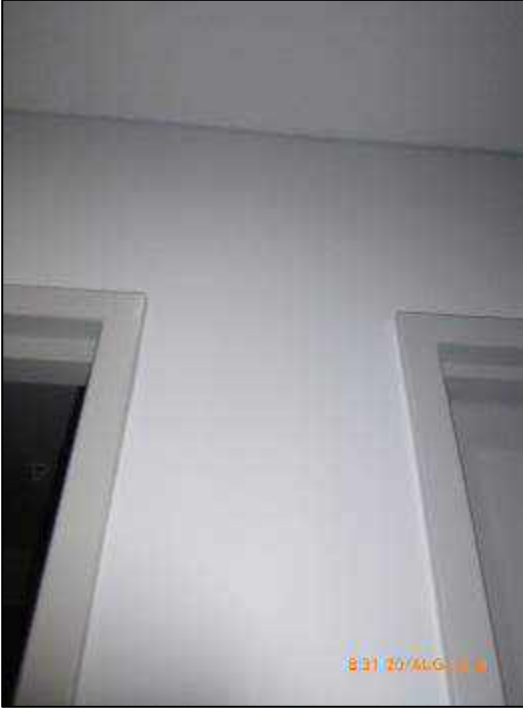
33	Southern wall between study and main bathroom.	See section 5.10.1	See section 5.10.2

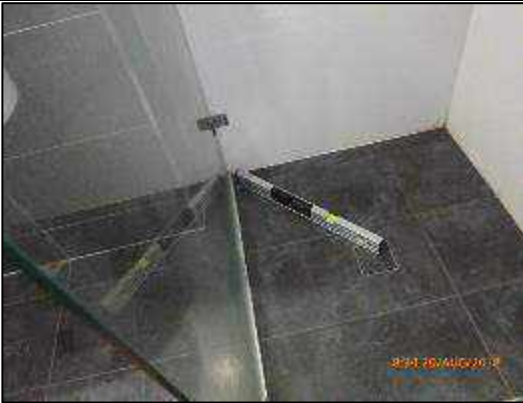
Item	Location	Defect Description and Breach	Rectification	Photograph (if applicable)
35	Main bedroom ensuite	See section 5.1.1 Falls (mm); 6/1000	See section 5.1.2

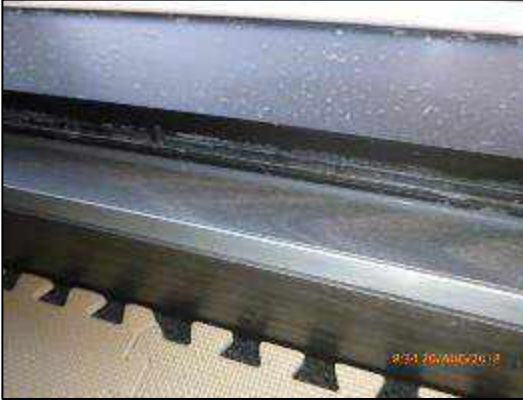
36	Main bedroom window frames	See section 5.8.1	See section 5.8.2

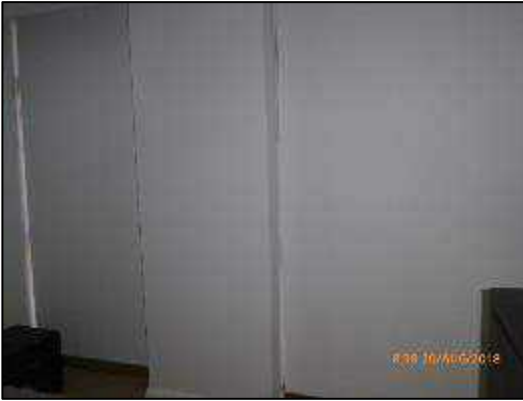
Item	Location	Defect Description and Breach	Rectification	Photograph (if applicable)
		Loss suffered is cost of rectification.		
38	Lounge room wall on northern elevation.	See section 5.10.1	See section 5.10.2

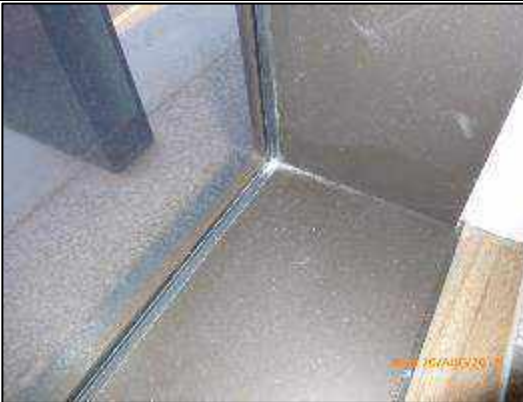
39	Main bedroom window frames	See section 5.8.1	See section 5.8.2

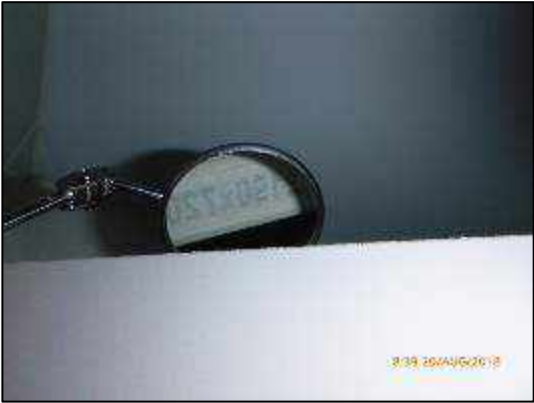
Item	Location	Defect Description and Breach	Rectification	Photograph (if applicable)
40	<i>Doors throughout unit (x3).</i>	See section 5.5.1	See section 5.5.2

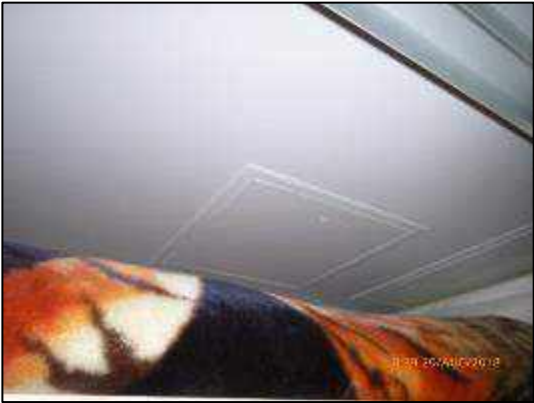
41	<i>Main bedroom built in</i>	See section 5.6.1	See section 5.6.2

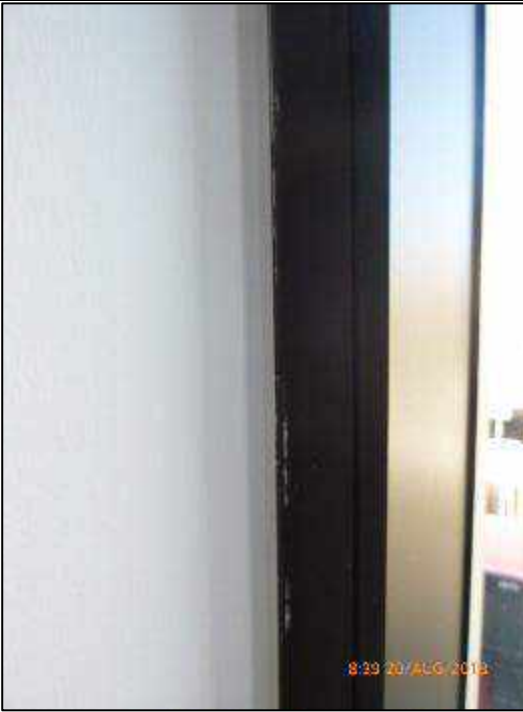
Item	Location	Defect Description and Breach	Rectification	Photograph (if applicable)
42	Lounge room window frames on northern elevation.	See section 5.9.1	See section 5.9.2

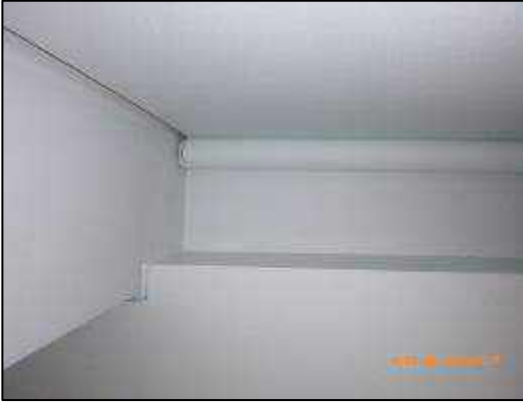
43	Lounge room window bulkhead	See section 5.10.1	See section 5.10.2

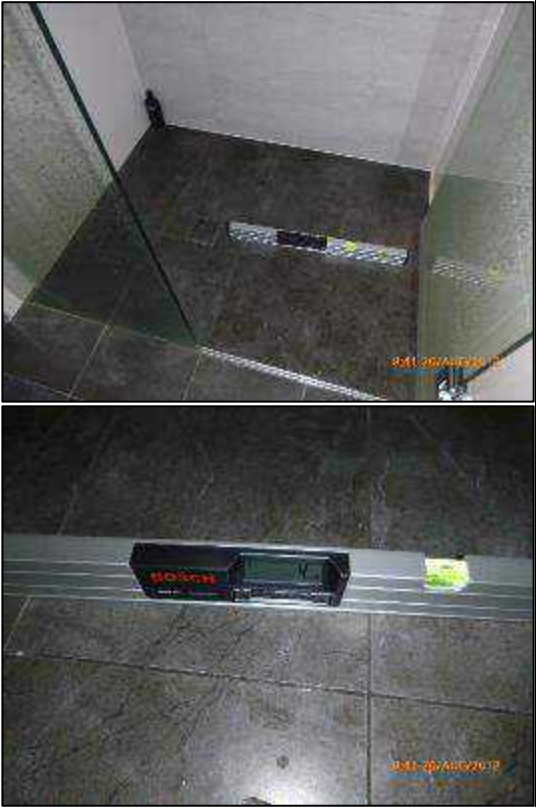
Item	Location	Defect Description and Breach	Rectification	Photograph (if applicable)
45	Main bedroom ensuite	See section 5.1.1 Falls (mm); 4/1000	See section 5.1.2

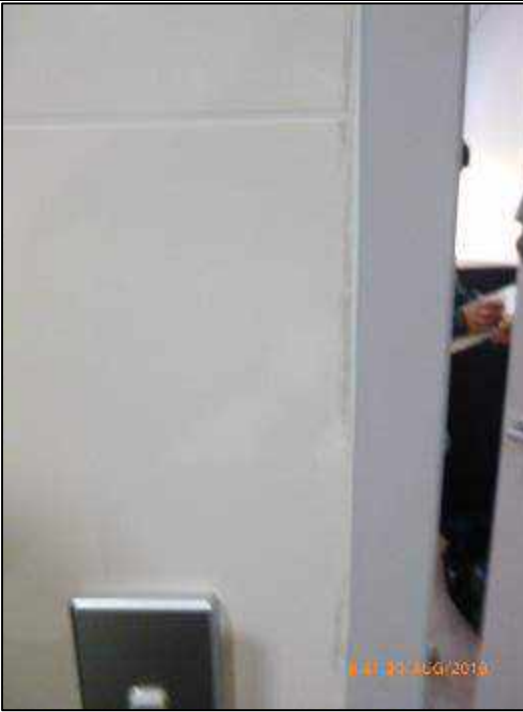
Item	Location	Defect Description and Breach	Rectification	Photograph (if applicable)
46	Wall adjacent to ensuite door	See section 5.9.1	See section 5.9.2

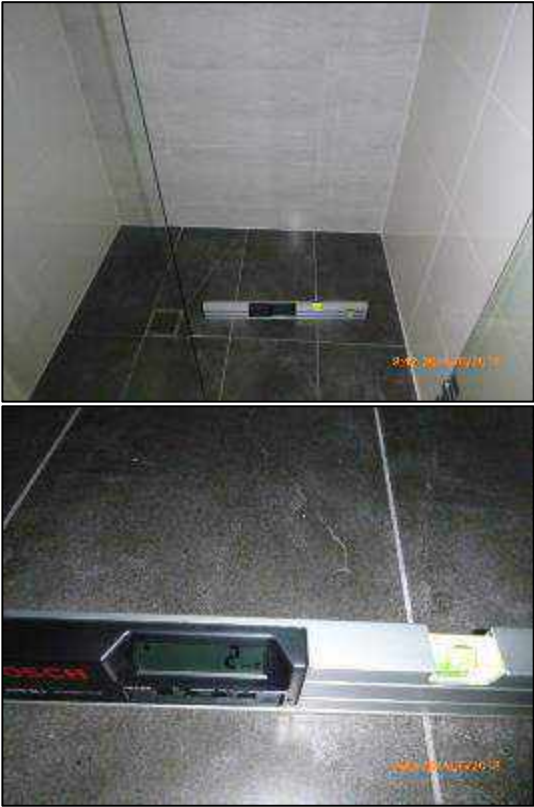
Item	Location	Defect Description and Breach	Rectification	Photograph (if applicable)
47	Main bathroom	See section 5.1.1 Falls (mm); 2/1000	See section 5.1.2

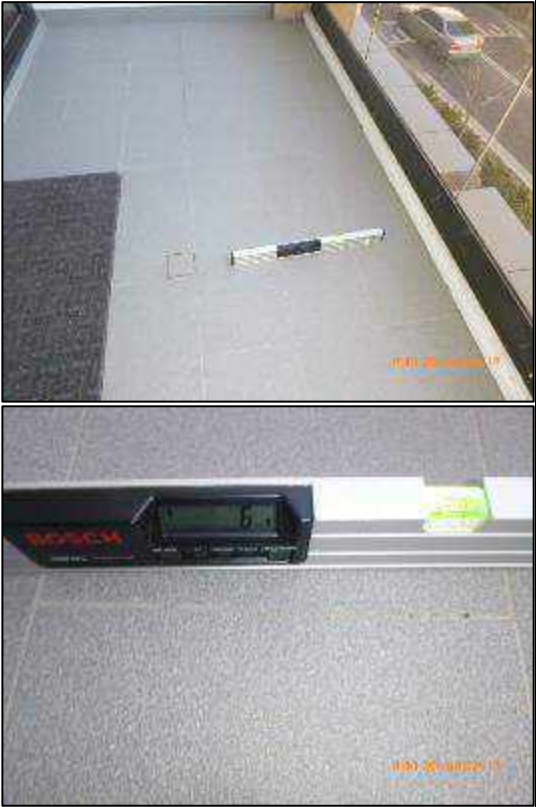
Item	Location	Defect Description and Breach	Rectification	Photograph (if applicable)
49	Balcony	See section 5.2.1 Falls (mm); 6/1000	See section 5.2.2

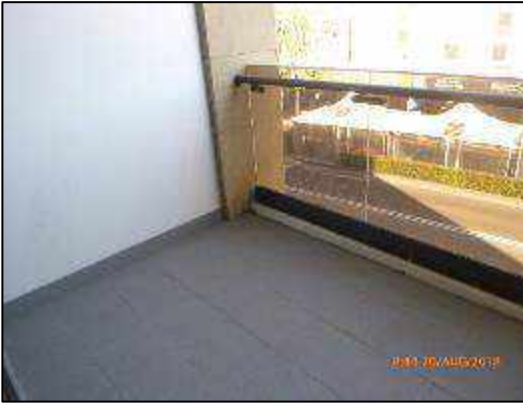
Item	Location	Defect Description and Breach	Rectification	Photograph (if applicable)
50	Balcony	See section 5.3.1	See section 5.3.2

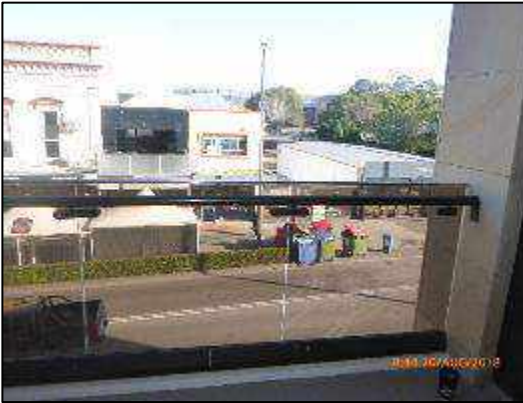
51	Balcony	See section 5.4.1	See section 5.4.2

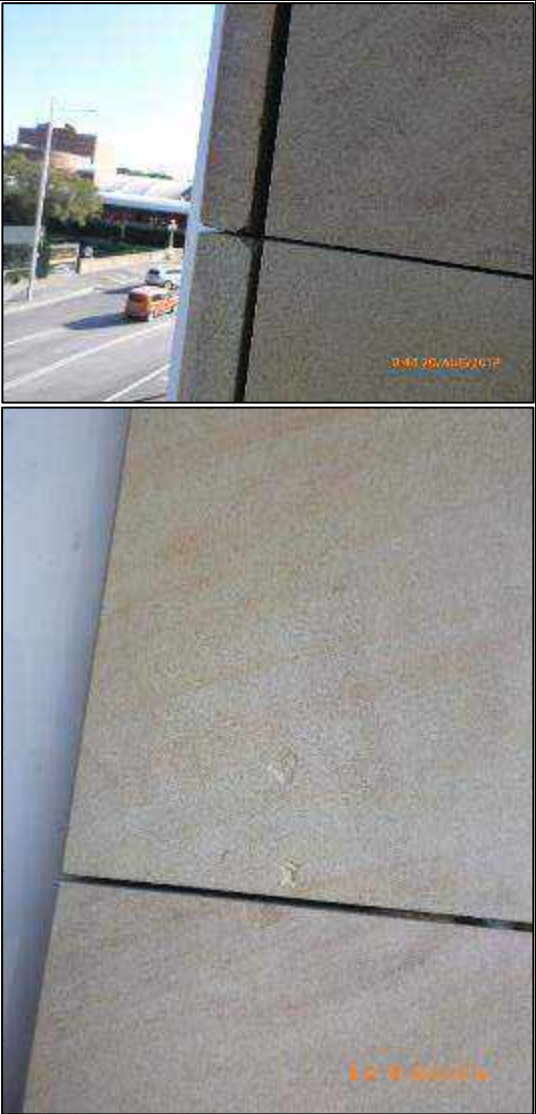
Item	Location	Defect Description and Breach	Rectification	Photograph (if applicable)
52	Northern elevation blade wall of balcony.	<p>Damaged and chipped sandstone throughout façade.</p> <p>Home Building Act (NSW) 1989</p> <ul style="list-style-type: none"> Part 2C, 18B (a) and (c). <p>Loss Suffered Loss suffered is cost of rectification.</p>	<ol style="list-style-type: none"> 1. Protect the surrounding areas. 2. Remove the damaged sandstone tiles. 3. Reinstall new sandstone tiles to match existing. 4. Clean up the work area.

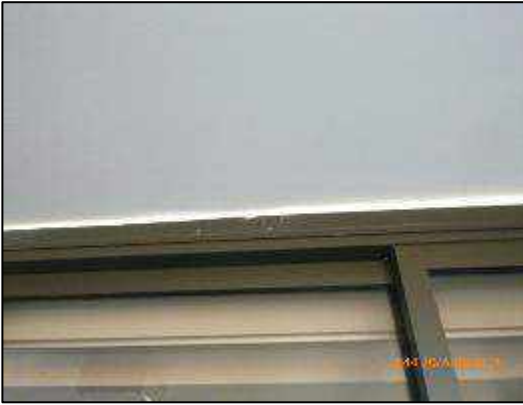
Item	Location	Defect Description and Breach	Rectification	Photograph (if applicable)
53	Balcony sliding door frame.	See section 5.9.1	See section 5.9.2

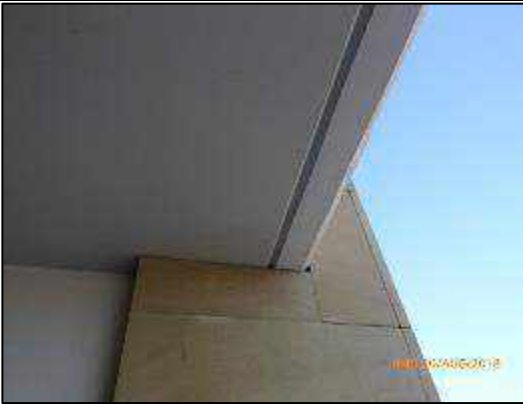
54	Balcony	<p>Drip groove on façade observed to have no stop end.</p> <p>Home Building Act (NSW) 1989</p> <ul style="list-style-type: none"> Part 2C, 18B (a) and (c). <p>Loss Suffered</p> <p>Loss suffered is cost of rectification.</p>	Engage a licenced tradesman to install stop end to drip groove and redirect water in accordance with manufacturers specifications.

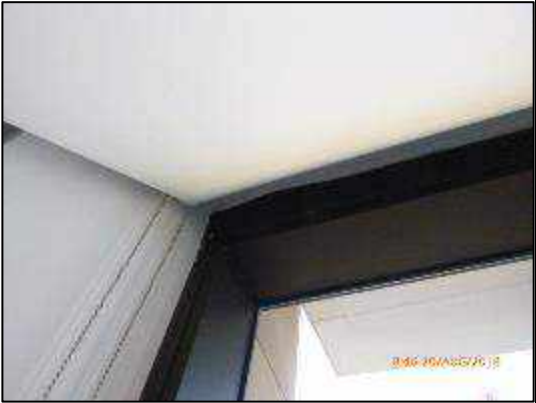
Item	Location	Defect Description and Breach	Rectification	Photograph (if applicable)
55	Second bedroom window bulkhead	See section 5.13.1	See section 5.13.2

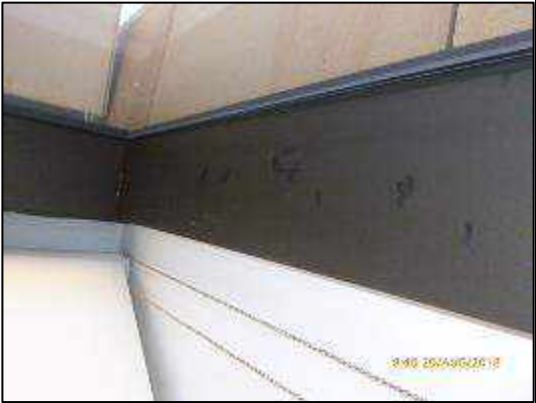
56	Second bedroom window frames	See section 5.7.1	See section 5.7.2

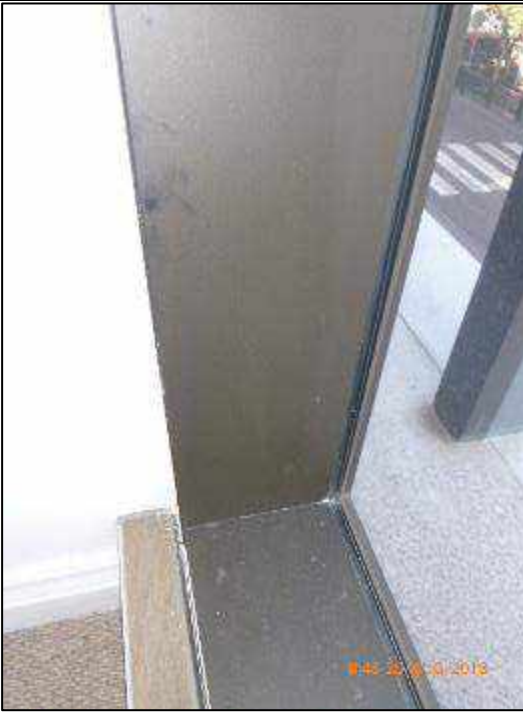
Item	Location	Defect Description and Breach	Rectification	Photograph (if applicable)
57	Second bedroom window frames	See section 5.8.1	See section 5.8.2

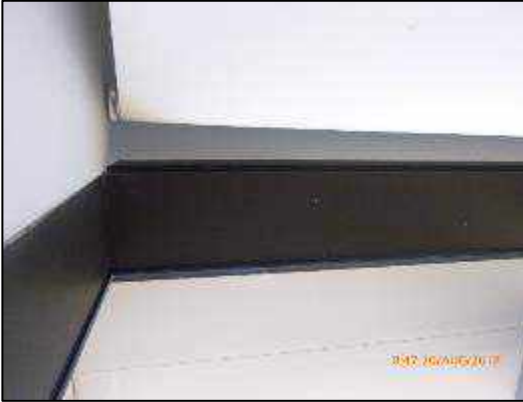
A photograph showing a close-up of a window frame in a second bedroom. The frame is dark-colored and appears to be made of metal or wood. There is a visible gap or defect at the bottom of the frame where it meets the wall. The date stamp '14/08/2012' is visible in the bottom right corner.
58	Kitchen window frames	See section 5.9.1	See section 5.9.2

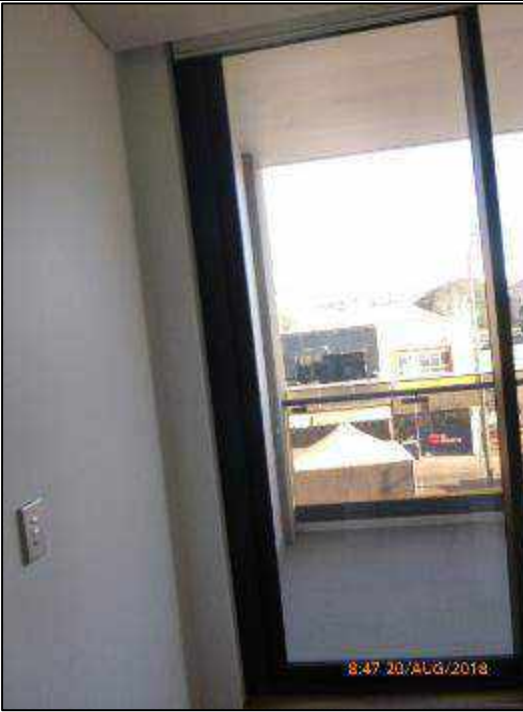
Item	Location	Defect Description and Breach	Rectification	Photograph (if applicable)
59	Lounge room	<p>Sliding door blinds were observed to not be plumb.</p> <p>Home Building Act (NSW) 1989</p> <ul style="list-style-type: none"> Part 2C, 18B (a) and (c). <p>Loss Suffered</p> <p>Loss suffered is cost of rectification.</p>	Engage a licenced tradesman to remove the blinds and re-install to fit the existing sliding door in plumb.

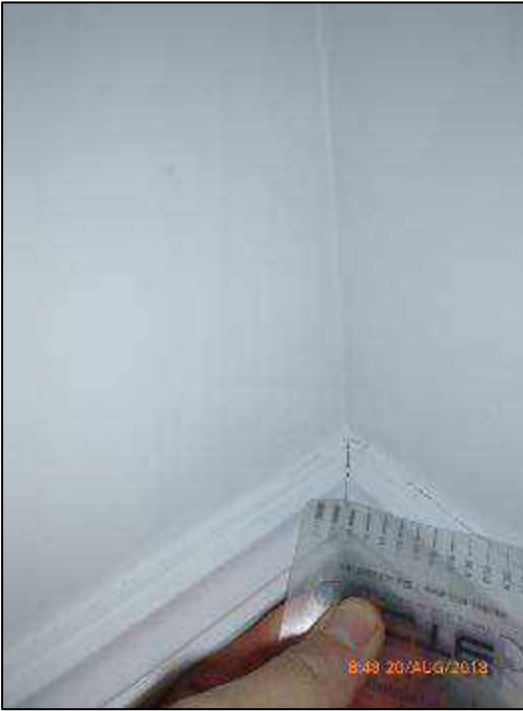
Item	Location	Defect Description and Breach	Rectification	Photograph (if applicable)
60	Hallway skirting board.	See section 5.14.1 Separation; 1.5mm	See section 5.14.2

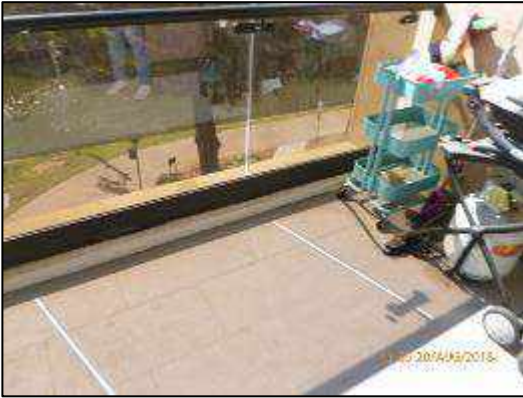
Item	Location	Defect Description and Breach	Rectification	Photograph (if applicable)
63	Balcony	See section 5.3.1	See section 5.3.2

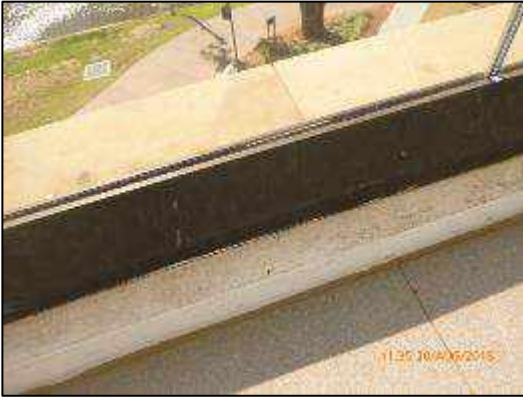
64	Balcony balustrade	See section 5.9.1	See section 5.9.2

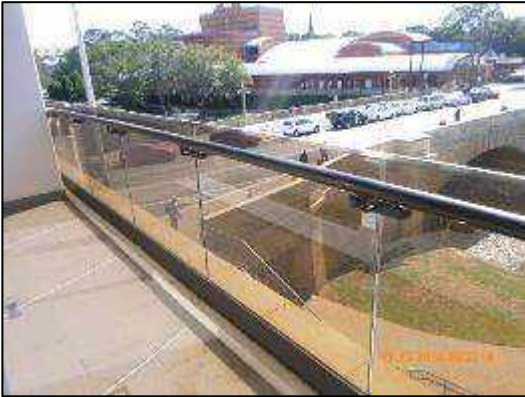
Item	Location	Defect Description and Breach	Rectification	Photograph (if applicable)
65	Balcony	See section 5.4.1	See section 5.4.2

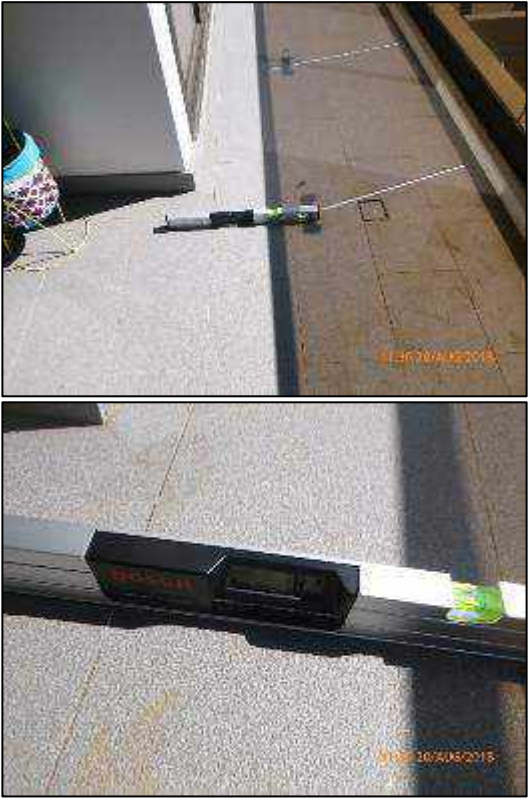
Item	Location	Defect Description and Breach	Rectification	Photograph (if applicable)
66	Balcony	See section 5.2.1 Falls (mm); 8/1000	See section 5.2.2

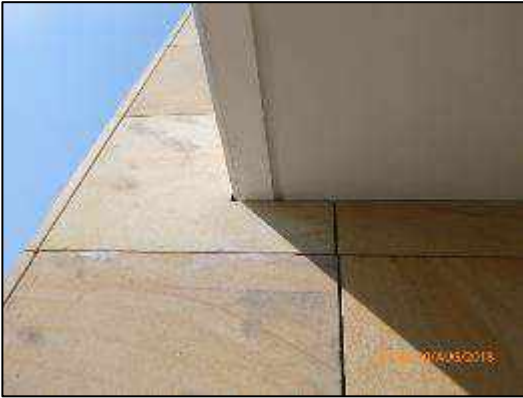
Item	Location	Defect Description and Breach	Rectification	Photograph (if applicable)
67	Balcony blade wall	<p>Drip groove on façade observed to have no stop end.</p> <p>Home Building Act (NSW) 1989</p> <ul style="list-style-type: none"> Part 2C, 18B (a) and (c). <p>Loss Suffered Loss suffered is cost of rectification.</p>	Engage a licenced tradesman to install stop end to drip groove and redirect water in accordance with manufacturers specifications.

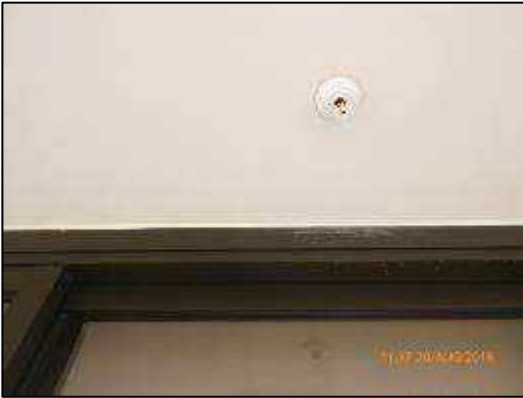
68	Balcony sliding door frame	See section 5.9.1	See section 5.9.2

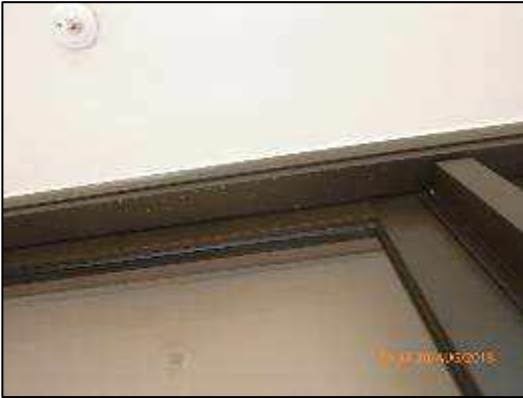
Item	Location	Defect Description and Breach	Rectification	Photograph (if applicable)
69	Balcony sliding door frame	See section 5.7.1	See section 5.7.2

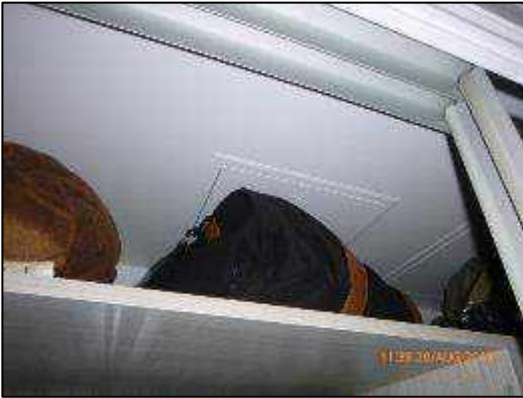
70	Main bedroom built in	See section 5.6.1	See section 5.6.2

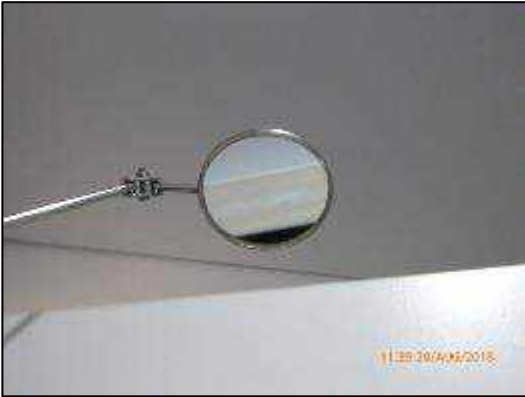
Item	Location	Defect Description and Breach	Rectification	Photograph (if applicable)
71	Doors throughout unit (x4)	See section 5.5.1	See section 5.5.2

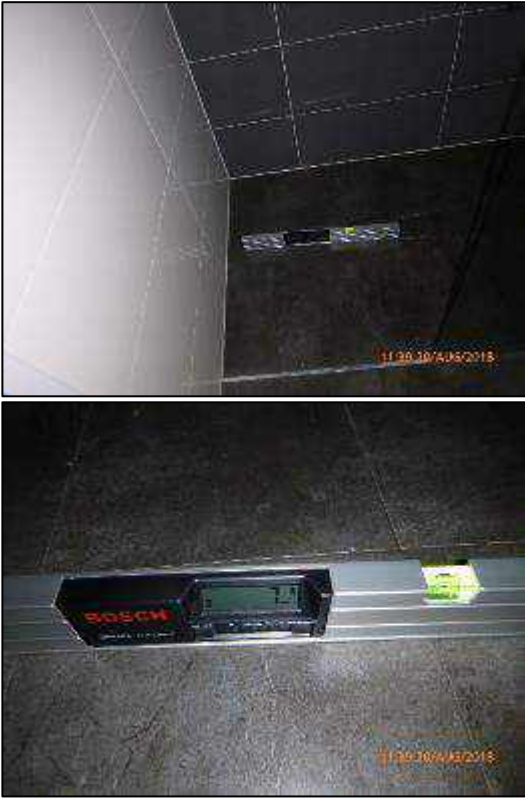
Item	Location	Defect Description and Breach	Rectification	Photograph (if applicable)
72	Main bathroom	See section 5.1.1 Falls (7/1000)	See section 5.1.2
