SydneyStrataReport

STRATA REPORT

Client	Church Street Parramatta Property Pty Ltd
Address of property	Unit 3303/330 Church Street, Parramatta, NSW.
Lot	359
Strata Plan	SP 94469
Name of Strata Management Co.	NSW Strata
Telephone Number of Strata Agent	8980 1841
Report Date	15 February 2024

BUILDING DEFECTS REPORT Part 1/2

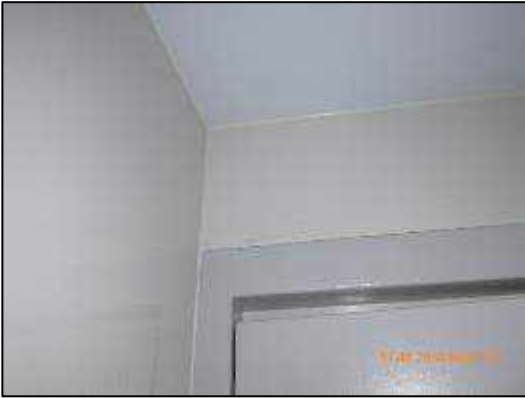
Item	Location	Defect Description and Breach	Rectification	Photograph (if applicable)
73	Main bathroom door frame	See section 5.9.1	See section 5.9.2

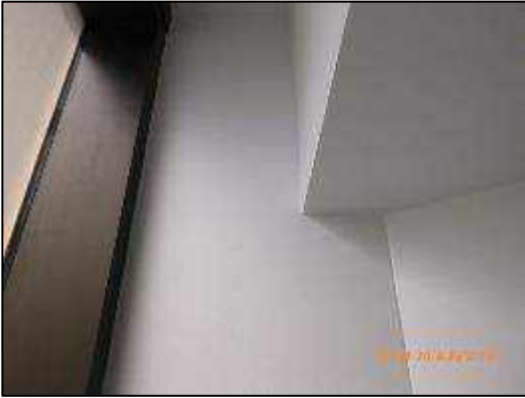
74	Wall adjacent to front entry door	See section 5.13.1	See section 5.13.2

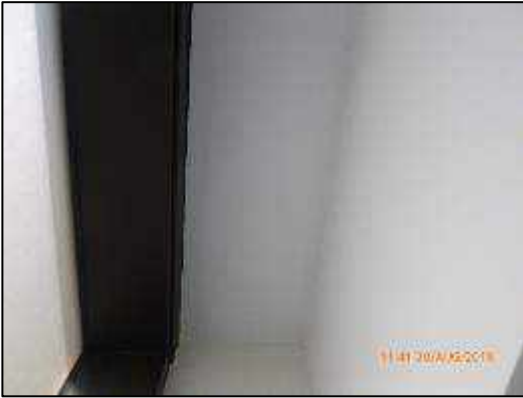
Item	Location	Defect Description and Breach	Rectification	Photograph (if applicable)
75	Window bulkhead adjacent to front entry door	See section 5.13.1	See section 5.13.2

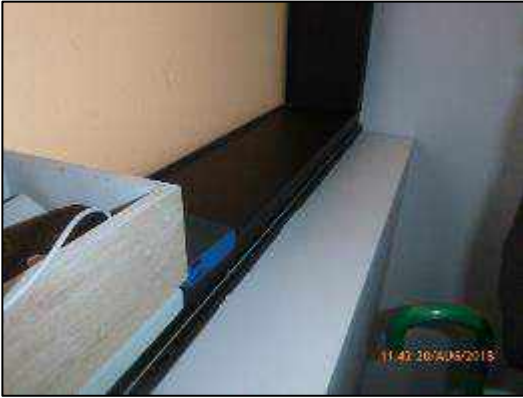
76	Window frames in hallway adjacent to front entrance.	See section 5.9.1	See section 5.9.2

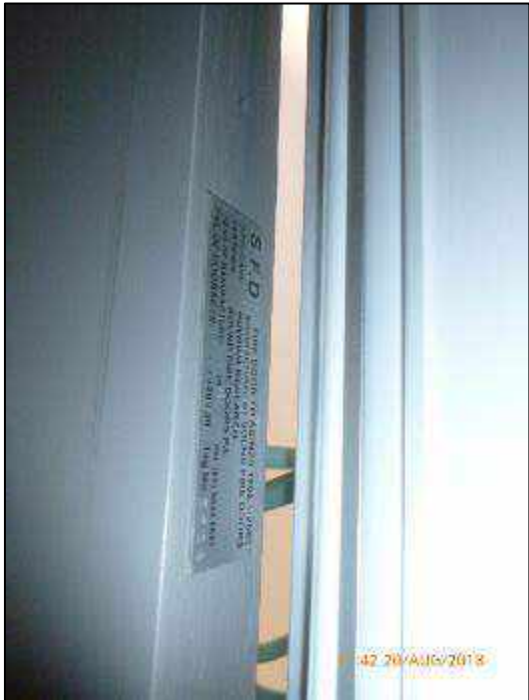
Item	Location	Defect Description and Breach	Rectification	Photograph (if applicable)
77	Front entry door	See section 5.12.1	See section 5.12.2

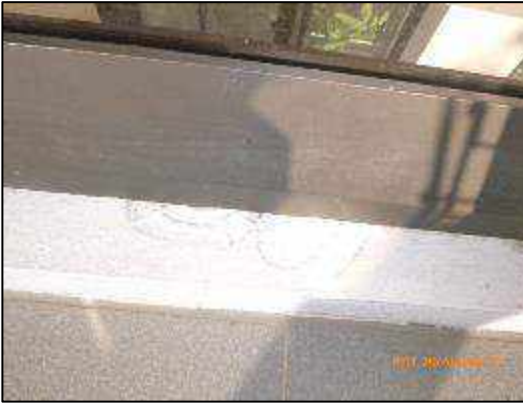
Item	Location	Defect Description and Breach	Rectification	Photograph (if applicable)
78	Balcony hob	<p>Foot print observed in hob of balcony.</p> <p>Home Building Act (NSW) 1989</p> <ul style="list-style-type: none"> Part 2C, 18B (a) and (c). <p>Loss Suffered</p> <p>Loss suffered is cost of rectification.</p>	<ol style="list-style-type: none"> 1. Protect all surrounding areas. 2. Cut out affected area of concrete hob. 3. Fill affected area of concrete hob with suitable concrete and smooth surface of epoxy filler to ensure a proper workmanlike finish. 4. Repaint to the closest architectural line to match existing

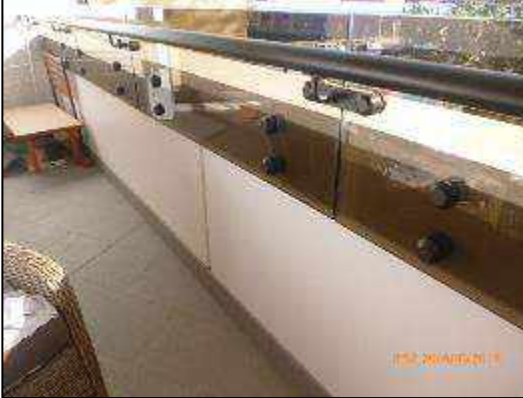
79	Balcony	See section 5.4.1	See section 5.4.2

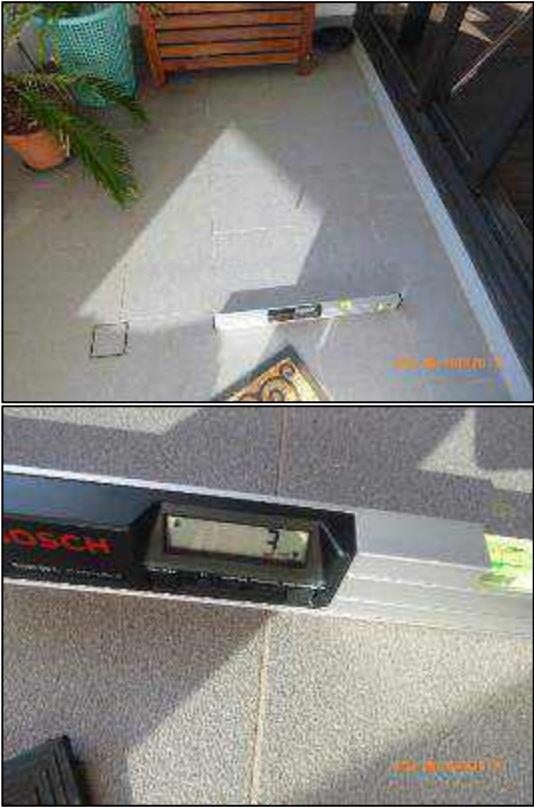
Item	Location	Defect Description and Breach	Rectification	Photograph (if applicable)
80	Balcony	See section 5.2.1 Falls (mm); 3/1000	See section 5.2.2

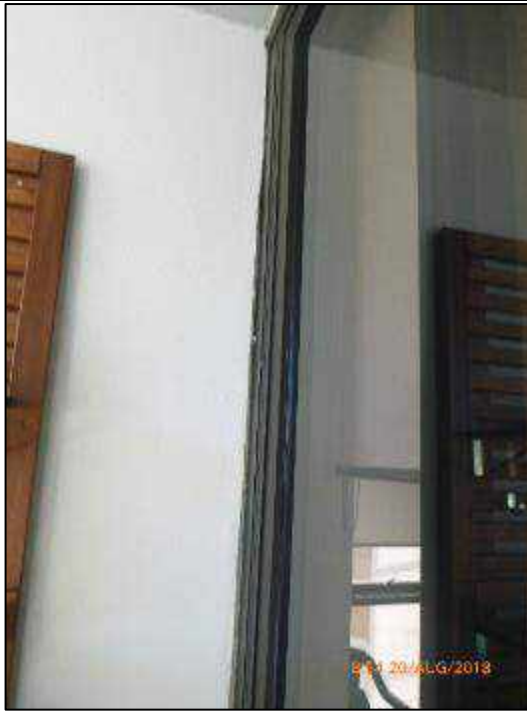
Item	Location	Defect Description and Breach	Rectification	Photograph (if applicable)
83	Balcony	<p>Separation observed between sliding door and northern blade wall.</p> <p>Home Building Act (NSW) 1989</p> <ul style="list-style-type: none"> Part 2C, 18B (a) and (c). <p>Guide to Standards and Tolerances 2017</p> <p>10.16 Cracking at junctions of dissimilar materials-Cracking at junctions between dissimilar materials is a defect if it is greater than 1 mm or is visible from a normal viewing position.</p> <p>Loss Suffered</p> <p>Loss suffered is cost of rectification.</p>	<ol style="list-style-type: none"> 1. Protect all surrounding areas 2. Apply a bead of flexible sealant to the joint between the sliding door frame and wall 3. As required, all affected surfaces are to be painted with an appropriate paint system to match as close as possible to the existing in accordance with the manufacturer's recommendations and AS2311 – Guide to the painting of buildings. 4. Clean up the work area

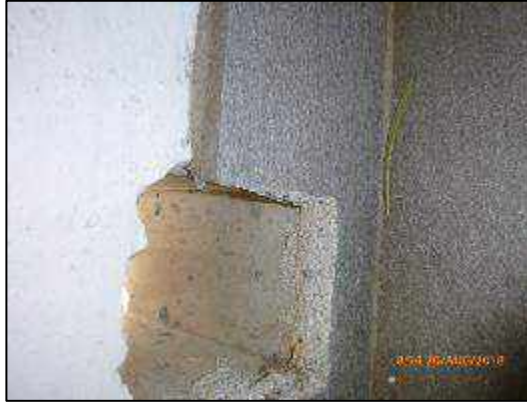
84	Balcony	See section 5.15.1	See section 5.15.2

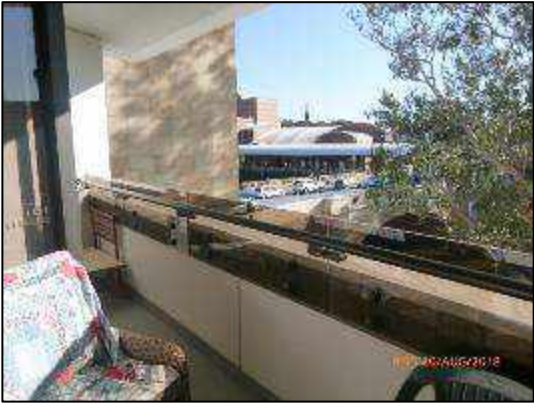
Item	Location	Defect Description and Breach	Rectification	Photograph (if applicable)
85	Balcony	See section 5.4.1	See section 5.4.2

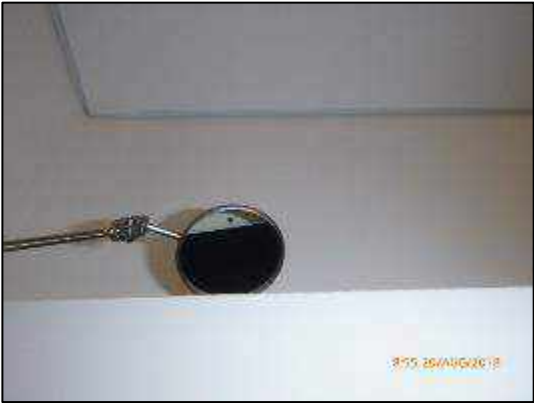
86	Doors throughout the unit (x3)	See section 5.5.1	See section 5.5.2

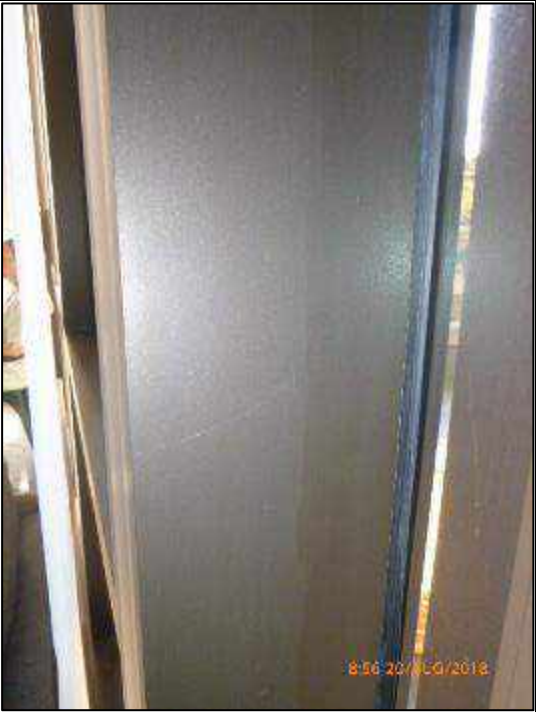
Item	Location	Defect Description and Breach	Rectification	Photograph (if applicable)
87	Lounge room window frames	See section 5.7.1	See section 5.7.2

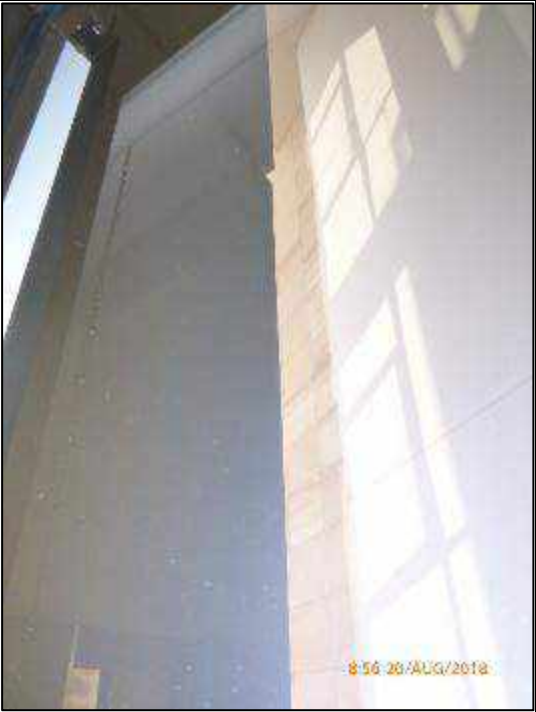
Item	Location	Defect Description and Breach	Rectification	Photograph (if applicable)
88	External façade fins.	See section 5.7.1	See section 5.7.2

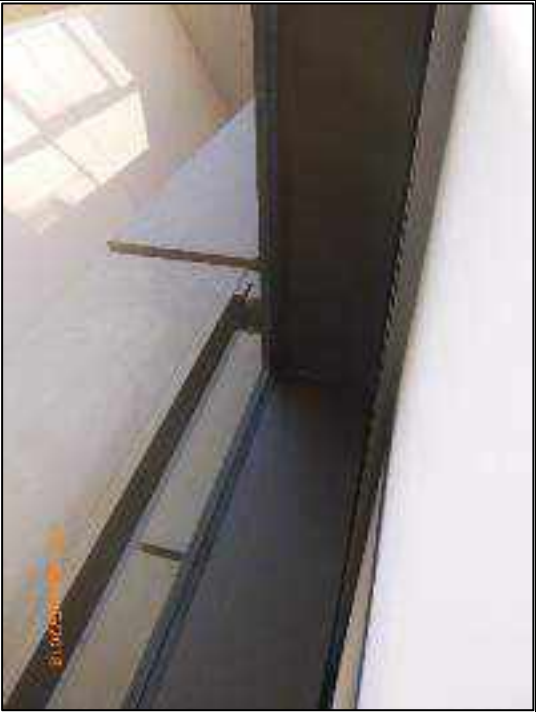
Item	Location	Defect Description and Breach	Rectification	Photograph (if applicable)
89	Balcony slab end adjacent to northern wall.	See section 5.10.1	See section 5.10.2

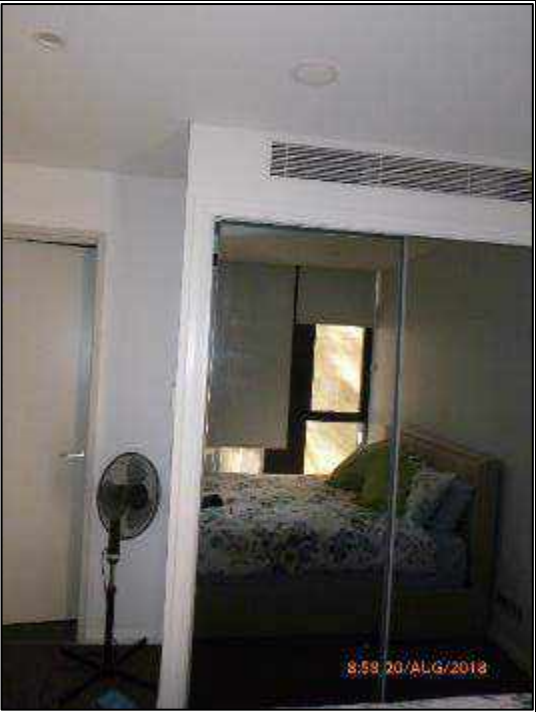
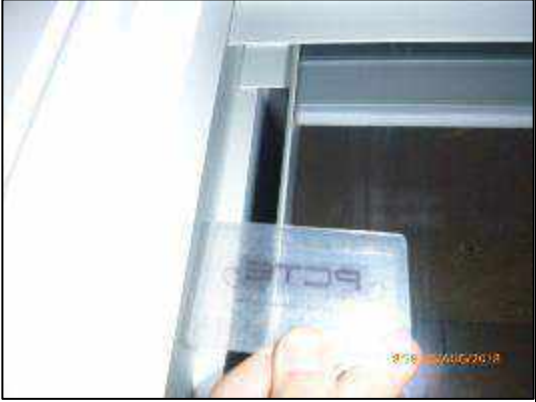
Item	Location	Defect Description and Breach	Rectification	Photograph (if applicable)
90	Main bedroom built in	<p>Sliding door of built in not aligned with a 40mm separation observed.</p> <p>Home Building Act (NSW) 1989</p> <ul style="list-style-type: none"> Part 2C, 18B (a) and (c). <p>Loss Suffered Loss suffered is cost of rectification.</p>	Engage a licenced tradesman to align the built in doors in plumb.

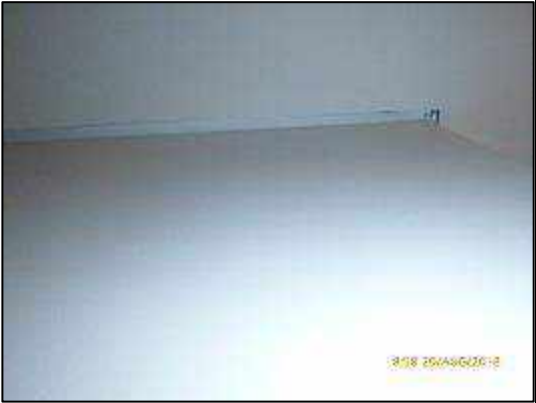
Item	Location	Defect Description and Breach	Rectification	Photograph (if applicable)
91	Main bedroom	See section 5.11.1	See section 5.11.2

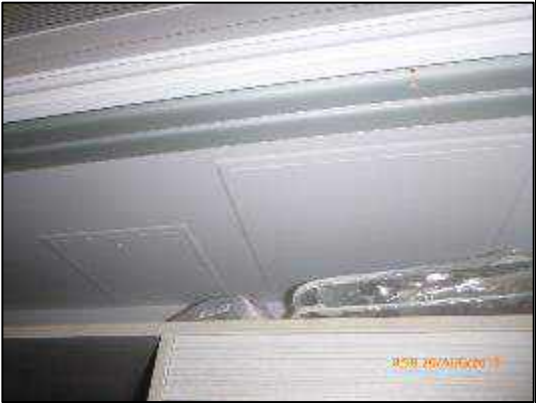
92	Main bedroom built in	See section 5.6.1	See section 5.6.2

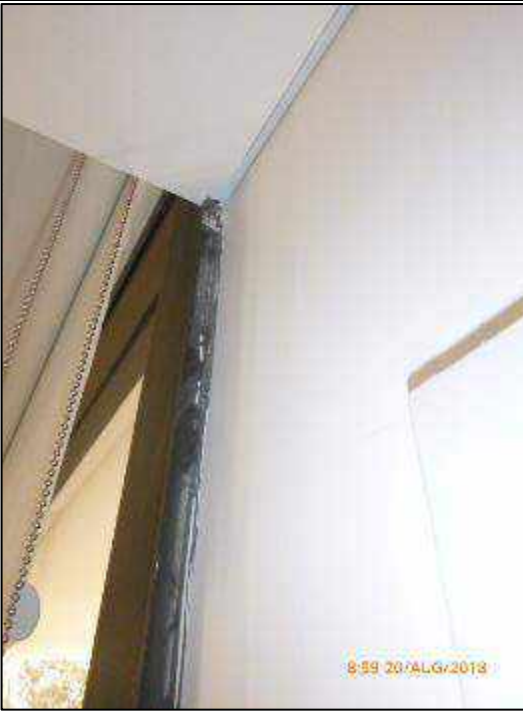
Item	Location	Defect Description and Breach	Rectification	Photograph (if applicable)
93	Main bedroom window frames	See section 5.9.1	See section 5.9.2

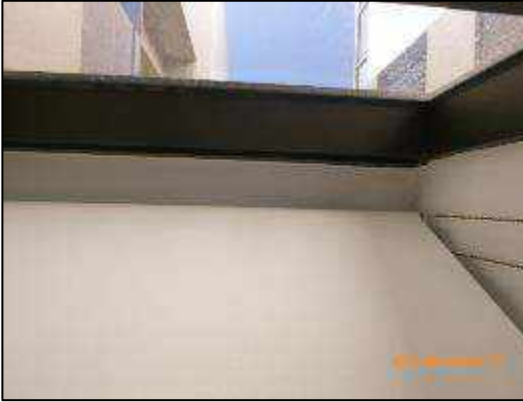
A photograph showing a close-up of a window frame in a room with white walls. The frame appears to be made of dark wood or metal and shows signs of wear or damage. A timestamp '8:59 20/ALG/2018' is visible in the bottom right corner of the image.
94	Main bedroom window bulkhead	See section 5.10.1	See section 5.10.2

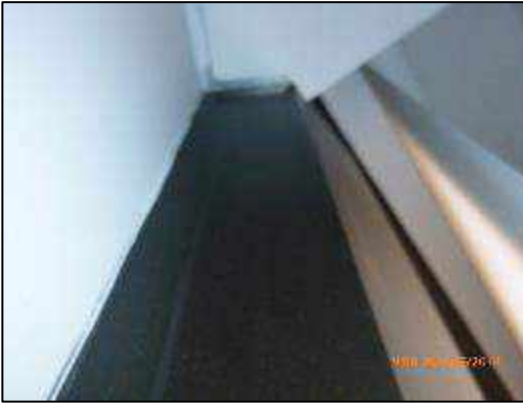
Item	Location	Defect Description and Breach	Rectification	Photograph (if applicable)
95	Second bedroom	See section 5.11.1	See section 5.11.2

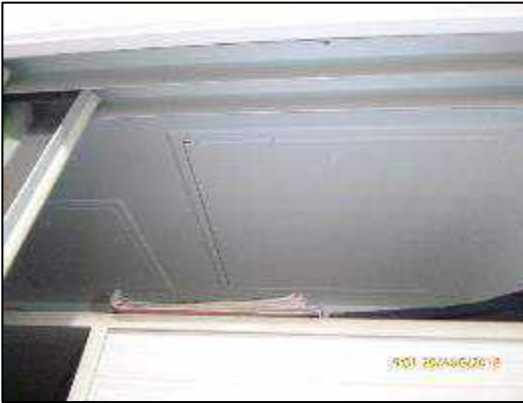
96	Second bedroom built in	See section 5.6.1	See section 5.6.2

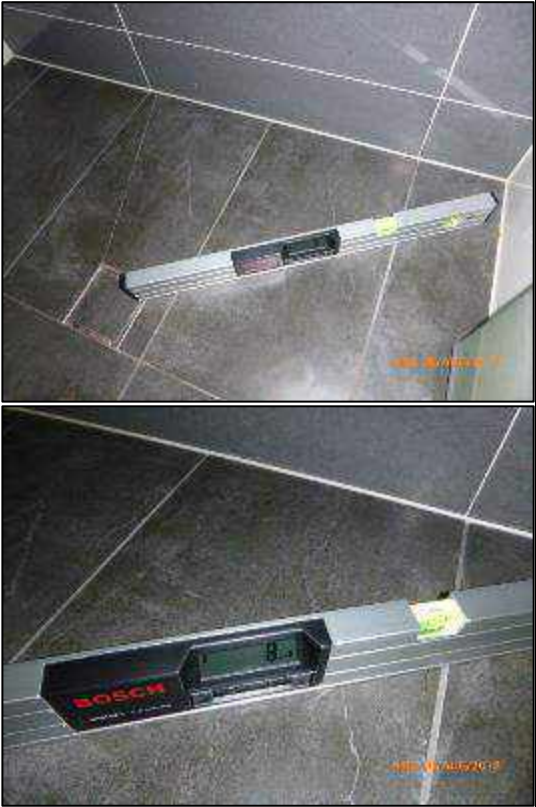
Item	Location	Defect Description and Breach	Rectification	Photograph (if applicable)
97	Main bathroom	See section 5.1.1 Falls (mm); 8/1000	See section 5.1.2

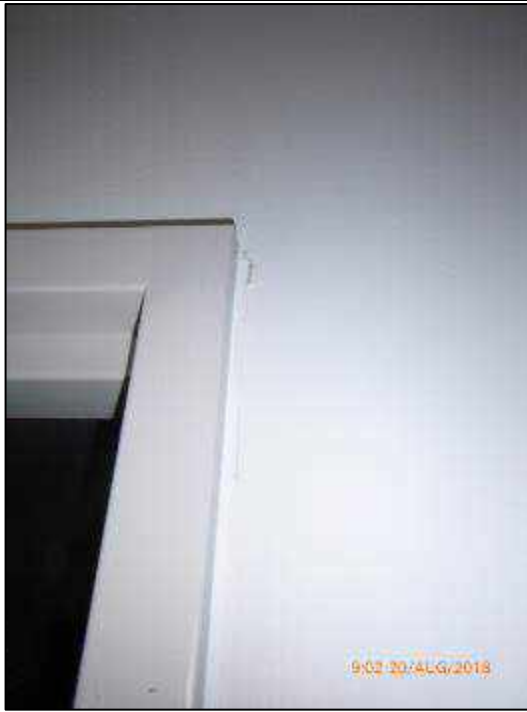
Item	Location	Defect Description and Breach	Rectification	Photograph (if applicable)
98	Wall adjacent to bathroom door.	See section 5.10.1	See section 5.10.2

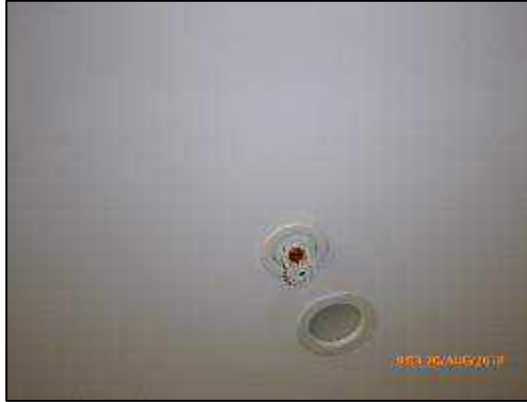
A photograph showing a vertical crack in a white wall corner. The crack runs vertically along the edge of a door frame. A timestamp '9:02:20/4UG/2018' is visible in the bottom right corner.
99	Lounge room ceiling	<p>Cracked plasterboard surrounding fire sprinkler at opening in ceiling.</p> <p>Home Building Act (NSW) 1989</p> <ul style="list-style-type: none"> Part 2C, 18B (a) and (c). <p>Guide to Standards and Tolerances 2017</p> <p>Section 10.14 Cracking in plasterboard, hard plaster and other plaster elements in the Office of fair trading "Guide to standards and tolerances" dated 2017 states that cracking</p>	<ol style="list-style-type: none"> 1. Protect all surrounding surfaces 2. Remove all existing jointing materials. 3. Ensure the plasterboard sheeting is adequately affixed to supporting structure. 4. Re-set the joint between the plasterboard sheets in accordance with the manufacturer's instructions

A photograph of a ceiling with a fire sprinkler. The plasterboard around the sprinkler is cracked and damaged. A timestamp '9:03:20/4UG/2018' is visible in the bottom right corner.

Item	Location	Defect Description and Breach	Rectification	Photograph (if applicable)
		<p>in recessed or butt joints is a defect if visible from a normal viewing position.</p> <p>Loss Suffered Loss suffered is cost of rectification.</p>	<p>5. Repaint the affected ceiling to match existing using suitable interior paint system in accordance with AS2311.</p> <p>6. Clean up work area.</p>	
Unit 107				
100	Second bedroom window frames	See section 5.9.1	See section 5.9.2

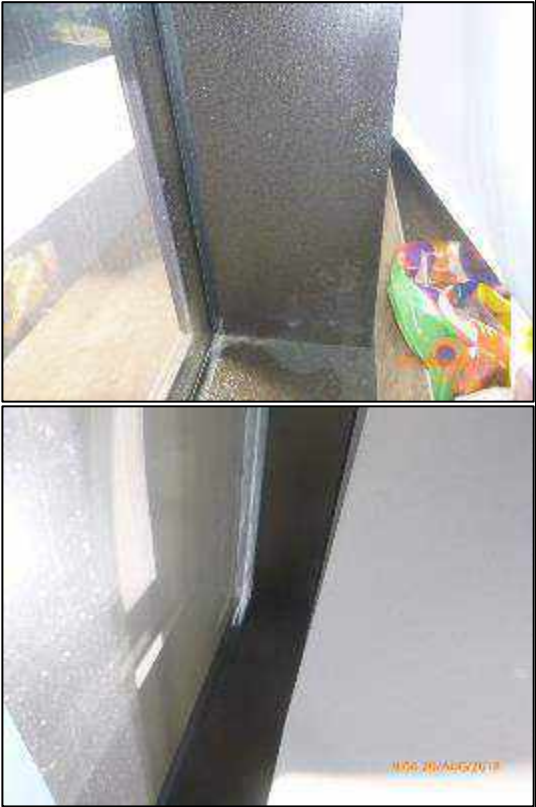
Item	Location	Defect Description and Breach	Rectification	Photograph (if applicable)
101	Second bedroom window frames	See section 5.8.1	See section 5.8.2

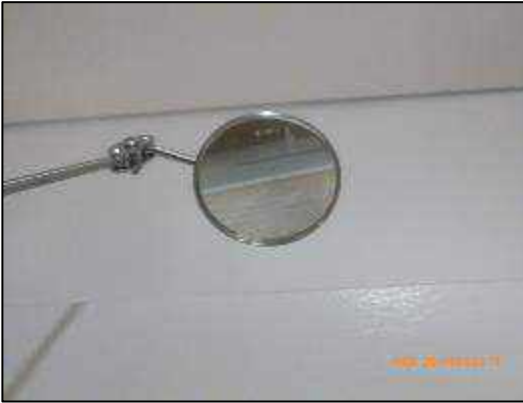
Item	Location	Defect Description and Breach	Rectification	Photograph (if applicable)
102	<i>Doors throughout the unit (x3)</i>	See section 5.5.1	See section 5.5.2

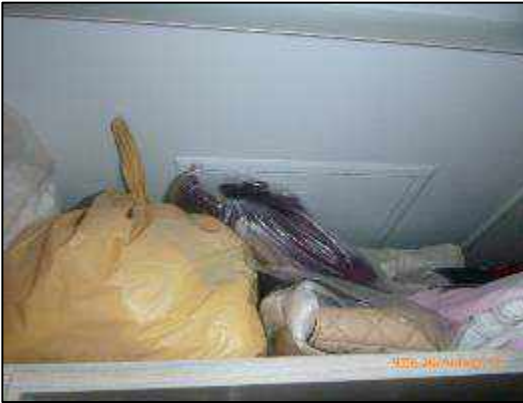
103	<i>Second bedroom built in</i>	See section 5.6.1	See section 5.6.2

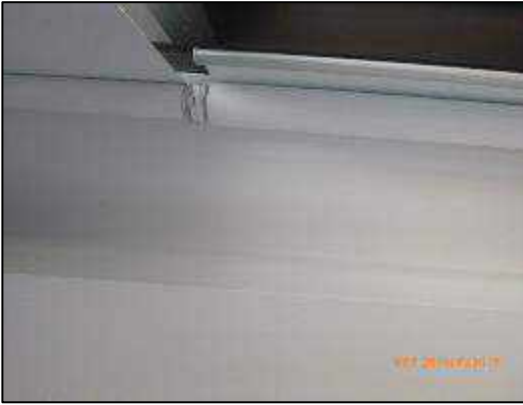
Item	Location	Defect Description and Breach	Rectification	Photograph (if applicable)
104	Lounge room window bulkhead	See section 5.10.1	See section 5.10.2

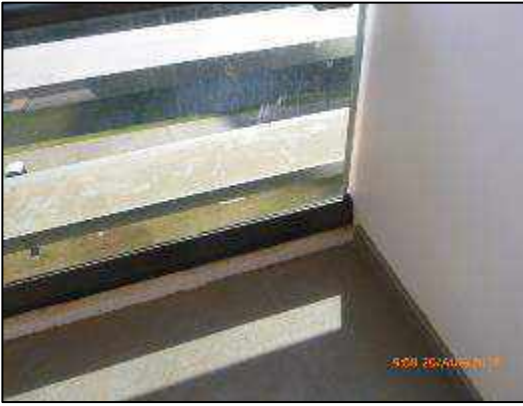
105	Balcony	See section 5.3.1	See section 5.3.2

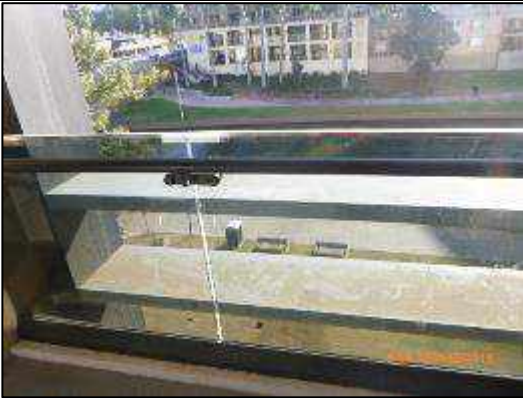
Item	Location	Defect Description and Breach	Rectification	Photograph (if applicable)
106	Balcony	See section 5.4.1	See section 5.4.2

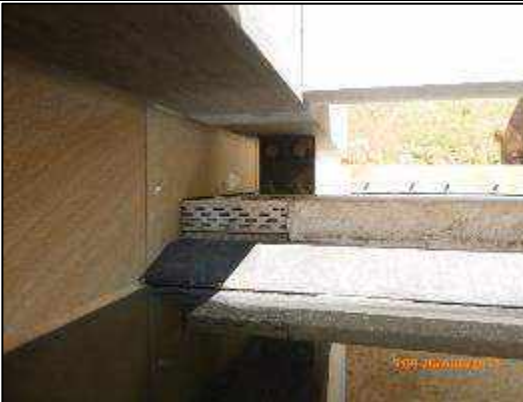
107	Balcony	<p>Unfinished and cracked render section observed around hob of balcony.</p> <p>Home Building Act (NSW) 1989</p> <ul style="list-style-type: none"> Part 2C, 18B (a) and (c). <p>Guide to Standards and Tolerances 2017</p> <ul style="list-style-type: none"> Crack categories are assessed in accordance with Section 3.2. Cracks are classed as exceeding Category 1 but not exceeding Category 2 damage. Category 2 damage cracks are considered a defect and require repair work. <p>AS2870-2011 Residential footings and slabs</p>	<ol style="list-style-type: none"> 1. Protect all surrounding surfaces 2. Remove cracked rendered surfaces to closest architectural line 3. Install new render to blend into the existing surface 4. Repaint to match existing using suitable external paint system in accordance with AS2311.

Item	Location	Defect Description and Breach	Rectification	Photograph (if applicable)
		<ul style="list-style-type: none"> Crack categories are assessed in accordance with Table C1 CLASSIFICATION OF DAMAGE WITH REFERENCE TO WALLS Cracks exceed Category 1 but do not exceed damage Category 2. <p>Loss Suffered Loss suffered is cost of rectification.</p>

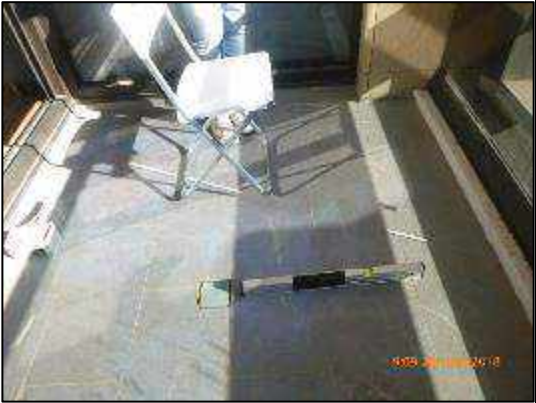
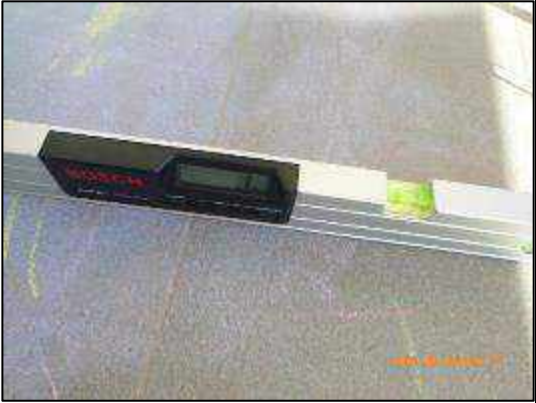
Item	Location	Defect Description and Breach	Rectification	Photograph (if applicable)
108	Balcony	See section 5.2.1 Falls (mm); 1/1000	See section 5.2.2

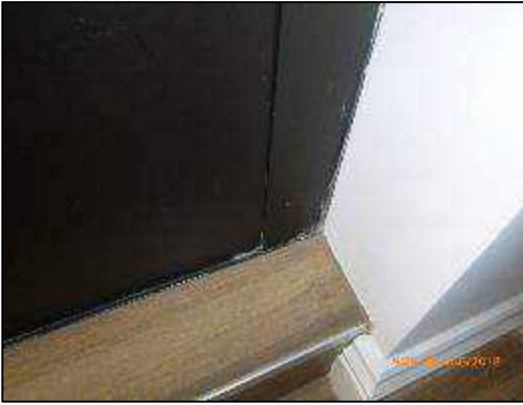
Item	Location	Defect Description and Breach	Rectification	Photograph (if applicable)
109	Main bedroom window frames	See section 5.8.1	See section 5.8.2

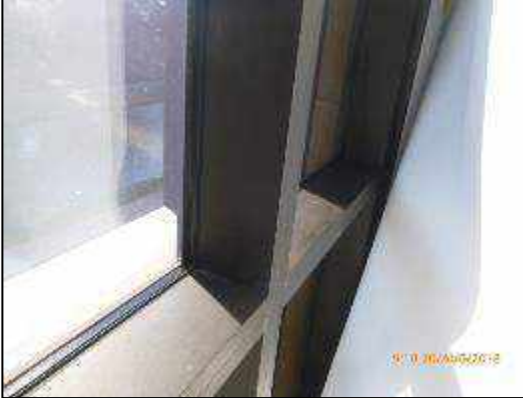
110	Main bedroom window frames	See section 5.7.1	See section 5.7.2

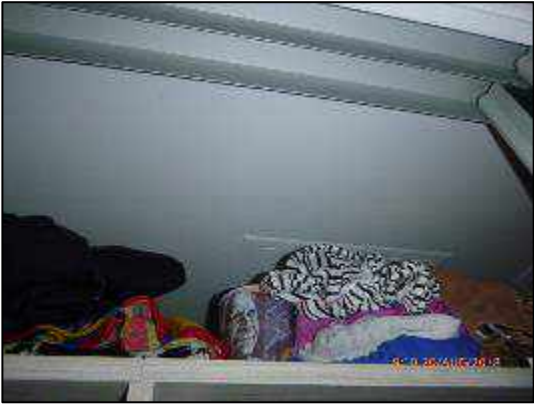
Item	Location	Defect Description and Breach	Rectification	Photograph (if applicable)
111	Main bedroom built in	See section 5.6.1	See section 5.6.2

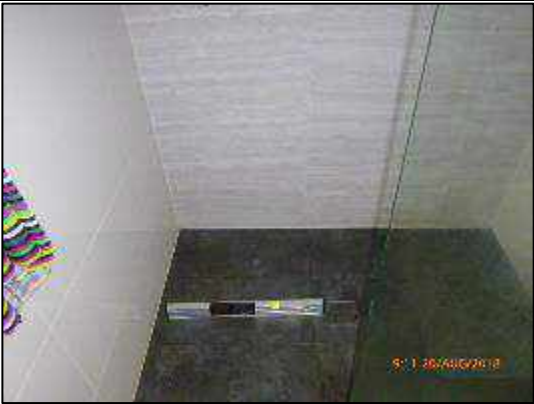
112	Main bedroom ensuite	See section 5.1.1 Falls (mm); 5/1000	See section 5.1.2

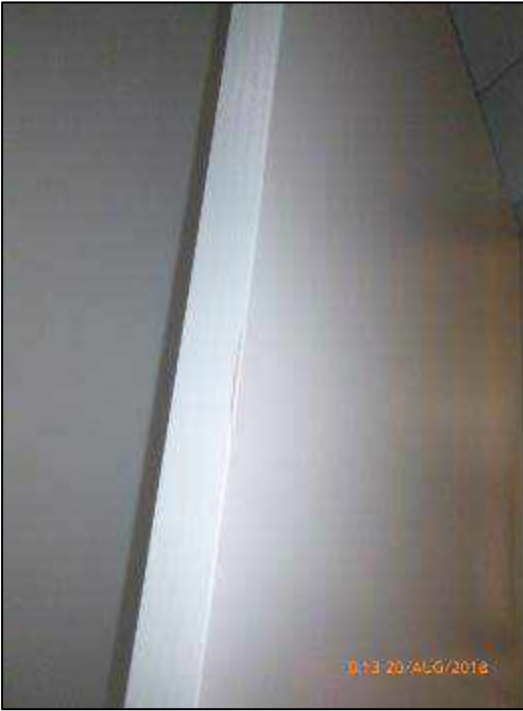
Item	Location	Defect Description and Breach	Rectification	Photograph (if applicable)
113	Main bedroom door	<p>Door observed to be poorly painted and damaged.</p> <p>Home Building Act (NSW) 1989</p> <ul style="list-style-type: none"> Part 2C, 18B (a) and (c). <p>Guide to Standards and Tolerances 2017</p> <p>Paintwork is defective if the application has blemishes such as paint runs, paint sags, wrinkling, dust, bare or starved painted areas, colour variations, surface cracks, irregular and coarse brush marks, sanding marks, blistering, non-uniformity of gloss level and other irregularities in the surface that are visible from a normal viewing position.</p> <p>In failing to adequately paint the doors, an unsatisfactory standard of workmanship has been executed.</p> <p>Loss Suffered</p> <p>Loss suffered is cost of rectification.</p>	<ol style="list-style-type: none"> 1. Protect all adjoining surfaces surrounding the work area. 2. Remove the affected door/s. 3. Repaint the affected door to match existing using suitable interior paint system in accordance with the manufacturers specifications. 4. Reinstate the door/s etc. to match as previous. 5. Clean up work area.

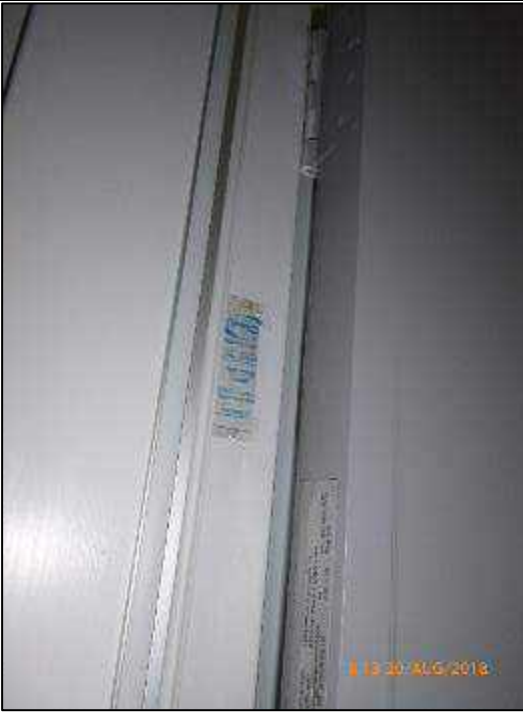
Item	Location	Defect Description and Breach	Rectification	Photograph (if applicable)
114	Front entry door	<p>Fire door and frame observed to be two different brands.</p> <p>Home Building Act (NSW) 1989</p> <ul style="list-style-type: none"> Part 2C, 18B (a) and (c). <p>Loss Suffered</p> <p>Loss suffered is cost of rectification.</p>	Engage a licenced tradesperson to remove fire door and install a suitable fire door to match existing door frame as advised by fire engineer.

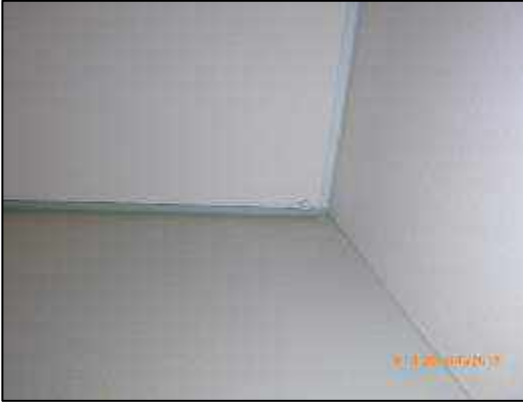
115	Lounge room northern wall	See section 5.10.1	See section 5.10.2

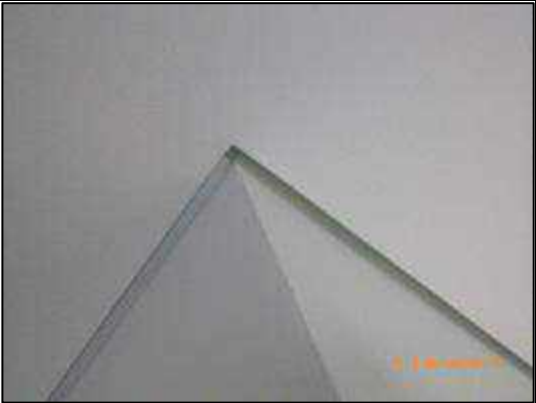
Item	Location	Defect Description and Breach	Rectification	Photograph (if applicable)
116	Lounge room	See section 5.11.1	See section 5.11.2

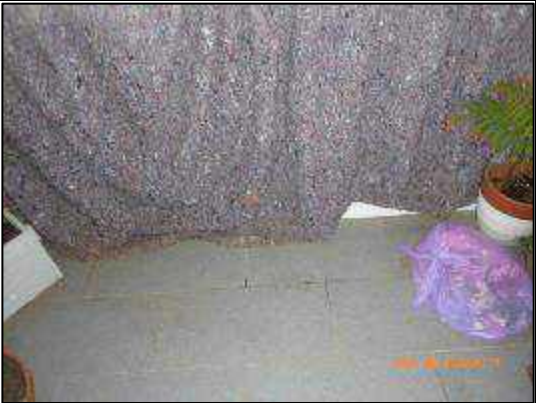
Unit 201				
117	Balcony	See section 5.3.1	See section 5.3.2

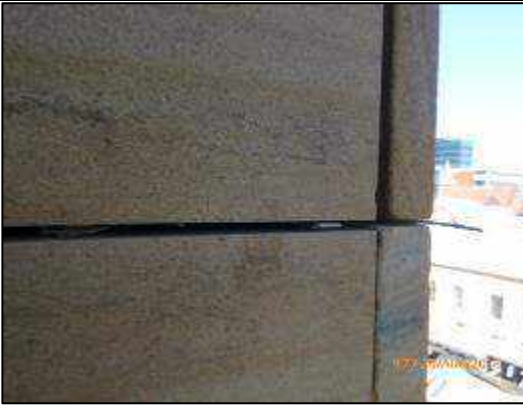
Item	Location	Defect Description and Breach	Rectification	Photograph (if applicable)
119	Balcony	<p>Damaged and chipped sandstone throughout façade.</p> <p>Home Building Act (NSW) 1989</p> <ul style="list-style-type: none"> Part 2C, 18B (a) and (c). <p>Loss Suffered Loss suffered is cost of rectification.</p>	<ol style="list-style-type: none"> 1. Protect the surrounding areas. 2. Remove the damaged sandstone tiles. 3. Reinstall new sandstone tiles to match existing. 4. Clean up the work area.

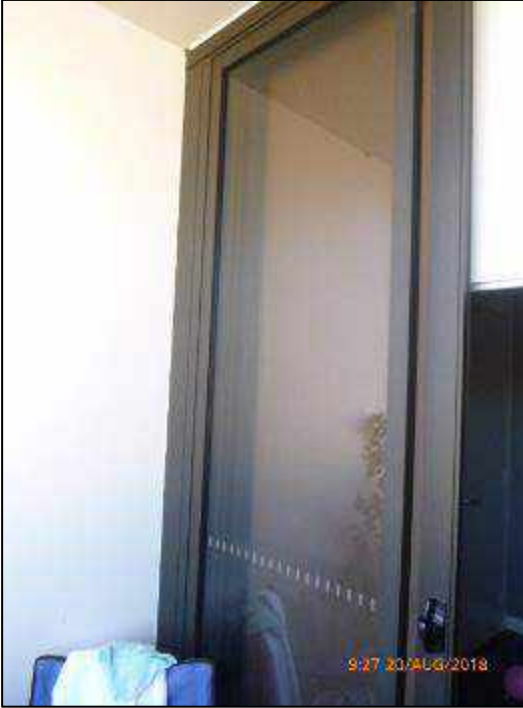
120	Balcony sliding door	See section 5.4.1	See section 5.4.2

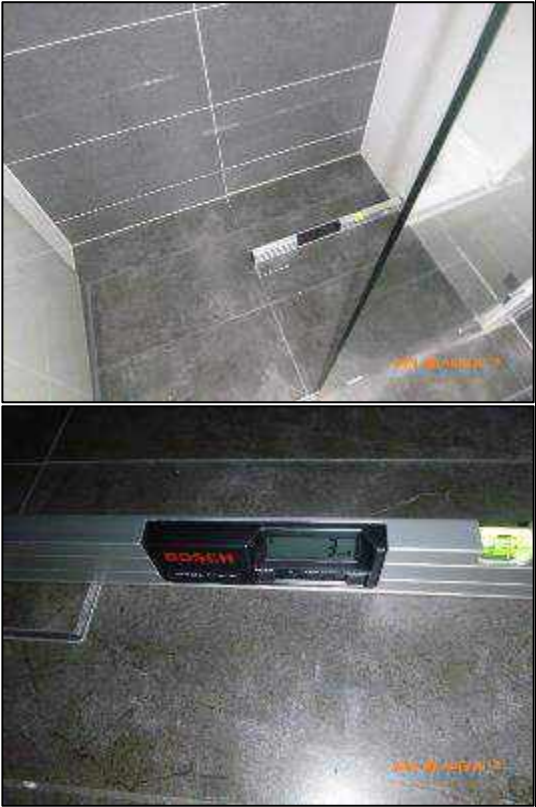
Item	Location	Defect Description and Breach	Rectification	Photograph (if applicable)
121	Main bathroom	See section 5.1.1 Falls (mm); 3/1000	See section 5.1.2

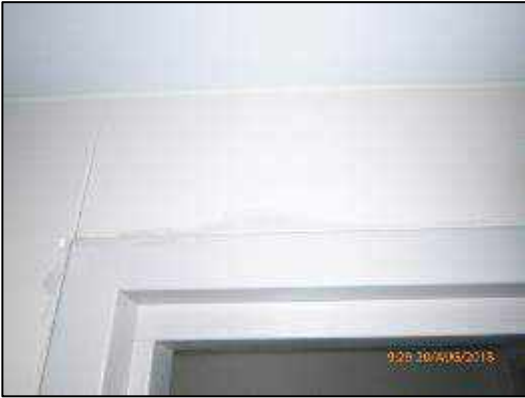
Item	Location	Defect Description and Breach	Rectification	Photograph (if applicable)
122	Wall above bathroom door	See section 5.9.1	See section 5.9.2

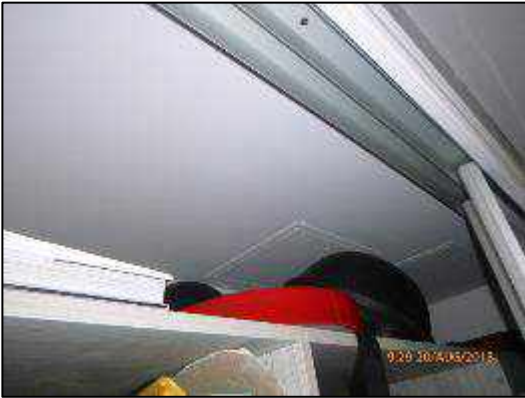
123	Second bedroom built in	See section 5.6.1	See section 5.6.2

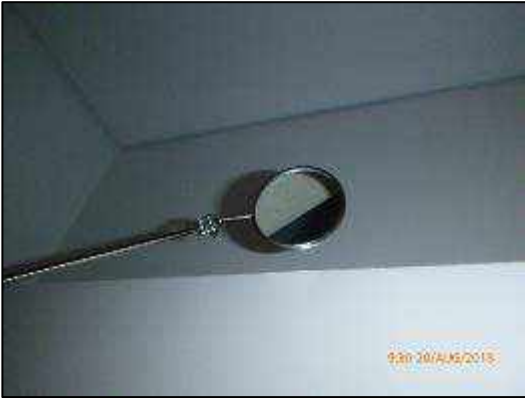
Item	Location	Defect Description and Breach	Rectification	Photograph (if applicable)
124	<i>Doors throughout the unit (x3)</i>	See section 5.5.1	See section 5.5.2

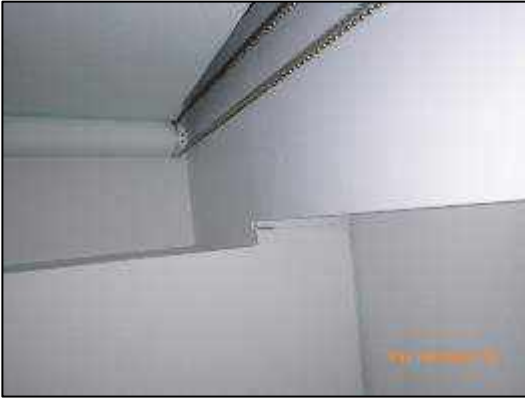
125	<i>Second bedroom</i>	See section 5.11.1	See section 5.11.2

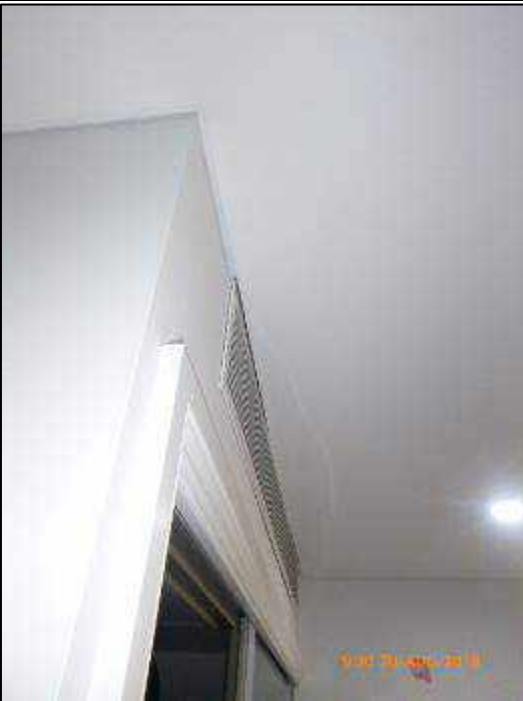
Item	Location	Defect Description and Breach	Rectification	Photograph (if applicable)
126	Second bedroom built in wall	<p>Ceiling adjacent to built-in is out of square by 5mm.</p> <p>Home Building Act (NSW) 1989</p> <ul style="list-style-type: none"> Part 2C, 18B (a) and (c). <p>Loss Suffered</p> <p>Loss suffered is cost of rectification.</p>	<ol style="list-style-type: none"> 1. Protect all surrounding surfaces 2. Remove all existing jointing materials. 3. Ensure the plasterboard sheeting is adequately affixed to supporting structure. 4. Re-set the joint between the plasterboard sheets in accordance with the manufacturer's instructions 5. Repaint the affected bulkhead to match existing using suitable interior paint system in accordance with AS2311. 6. Clean up work area.

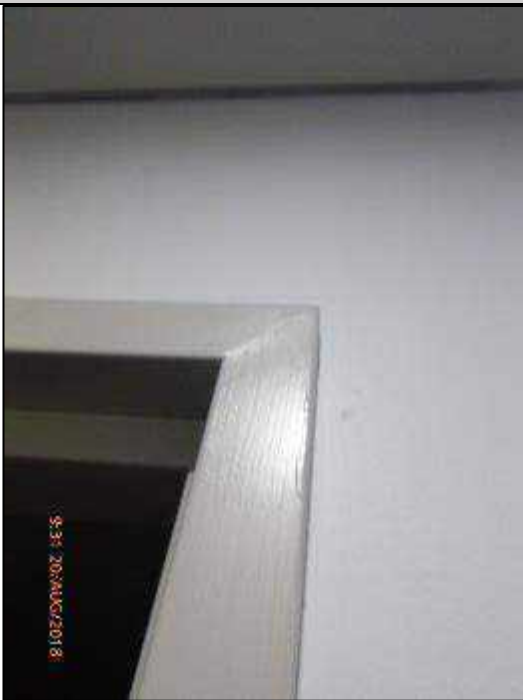
Item	Location	Defect Description and Breach	Rectification	Photograph (if applicable)
127	Wall adjacent to second bedroom door	See section 5.9.1	See section 5.9.2

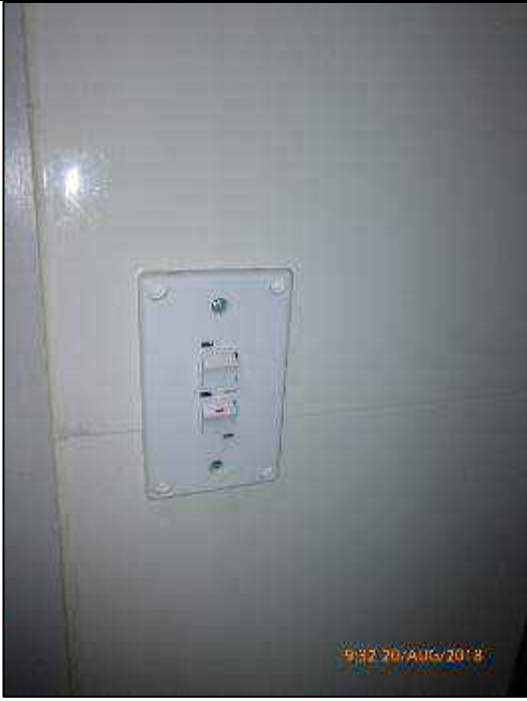
Item	Location	Defect Description and Breach	Rectification	Photograph (if applicable)
129	Laundry	<p>Light switch cover in laundry room is missing.</p> <p>Home Building Act (NSW) 1989</p> <ul style="list-style-type: none"> Part 2C, 18B (a) and (c). <p>Loss Suffered Loss suffered is cost of rectification.</p>	Source a light switch cover to match existing light switches and engage a licenced electrician to install in accordance with manufacturers specifications.

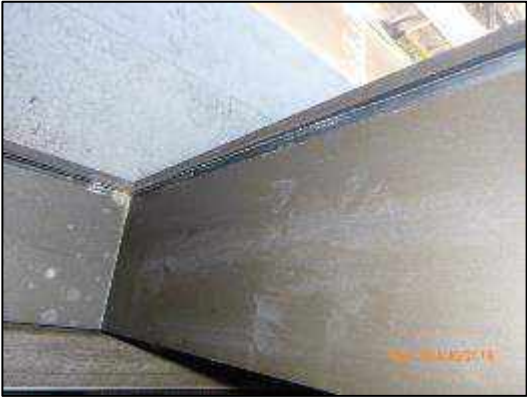
130	Main bedroom window frames	See section 5.7.1	See section 5.7.2

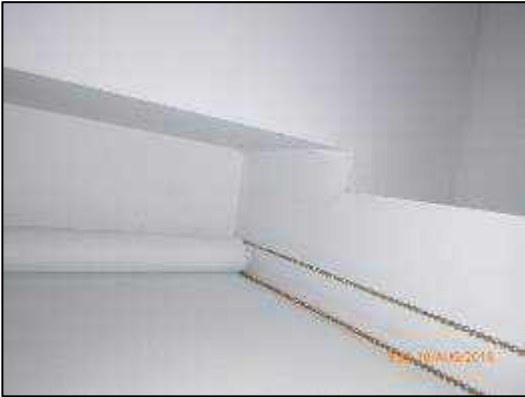
Item	Location	Defect Description and Breach	Rectification	Photograph (if applicable)
131	Main bedroom window bulkhead	See section 5.10.1	See section 5.10.2

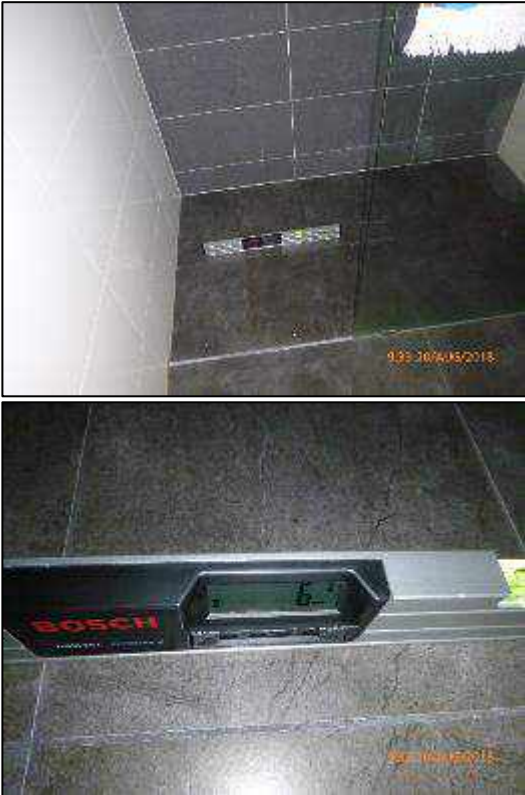
Item	Location	Defect Description and Breach	Rectification	Photograph (if applicable)
132	Main bedroom ensuite	See section 5.1.1 Falls (mm); 6/1000	See section 5.1.2

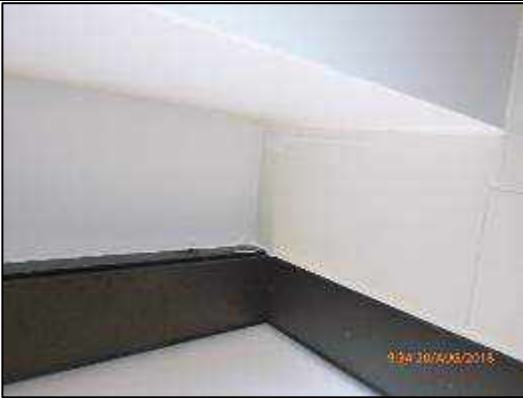
Item	Location	Defect Description and Breach	Rectification	Photograph (if applicable)
133	Main bedroom ensuite window frames	See section 5.9.1	See section 5.9.2

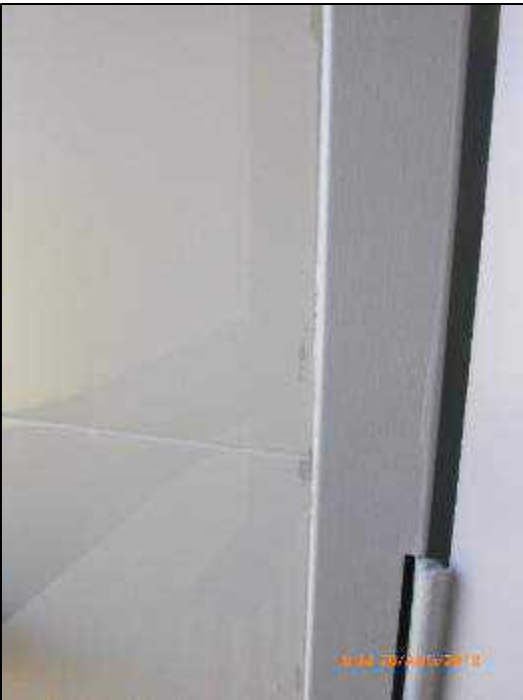
134	Main bedroom ensuite door frame	See section 5.9.1	See section 5.9.2

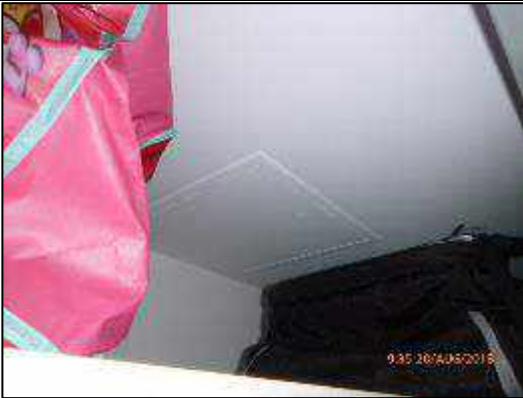
Item	Location	Defect Description and Breach	Rectification	Photograph (if applicable)
135	Main bedroom built in	See section 5.6.1	See section 5.6.2

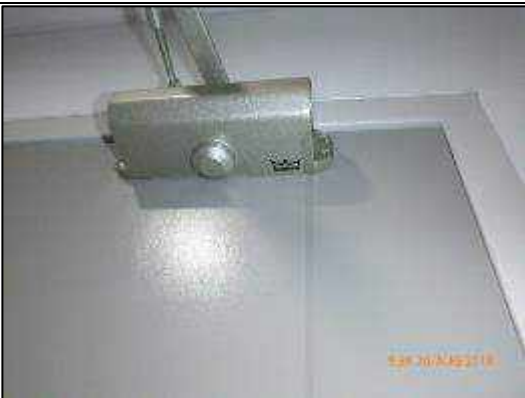
138	<i>Front entry door</i>	<p>Door closer was observed to be leaking oil.</p> <p>Home Building Act (NSW) 1989</p> <ul style="list-style-type: none"> Part 2C, 18B (a) and (c). <p>Loss Suffered Loss suffered is cost of rectification.</p>	<p>Engage a licenced tradesperson to remove door closer and re-install with seals in accordance with manufacturers specifications.</p>

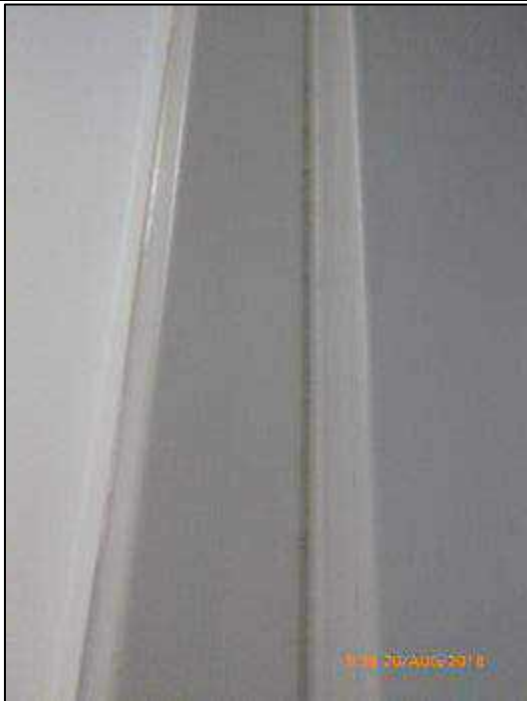
Item	Location	Defect Description and Breach	Rectification	Photograph (if applicable)
139	Front entry door frame	See section 5.10.1	See section 5.10.2

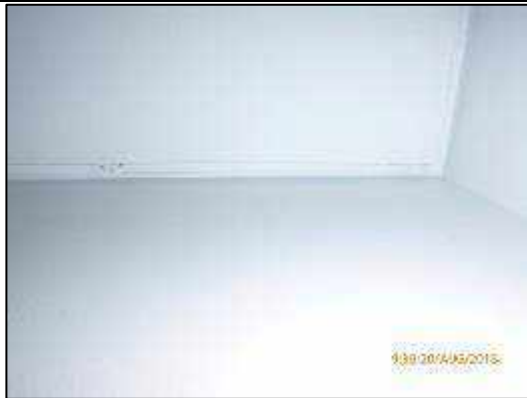
140	Lounge room	See section 5.11.1	See section 5.11.2

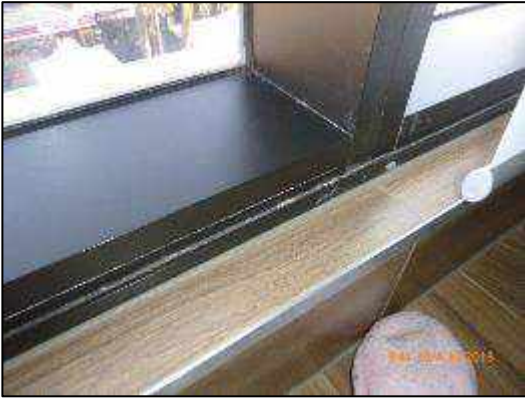
Item	Location	Defect Description and Breach	Rectification	Photograph (if applicable)
141	Lounge room window frames	See section 5.8.1	See section 5.8.2

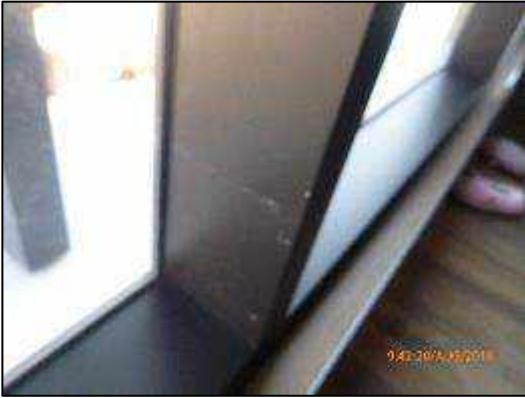
142	Lounge room window frames	See section 5.7.1	See section 5.7.2

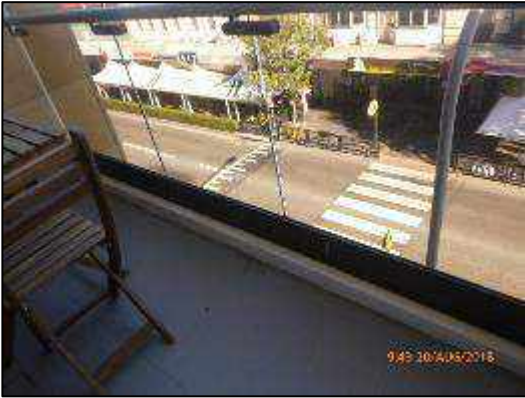
Item	Location	Defect Description and Breach	Rectification	Photograph (if applicable)
143	Balcony	See section 5.3.1	See section 5.3.2

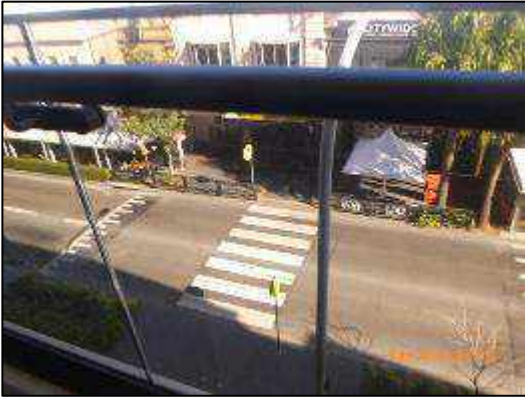
144	Balcony	See section 5.4.1	See section 5.4.2

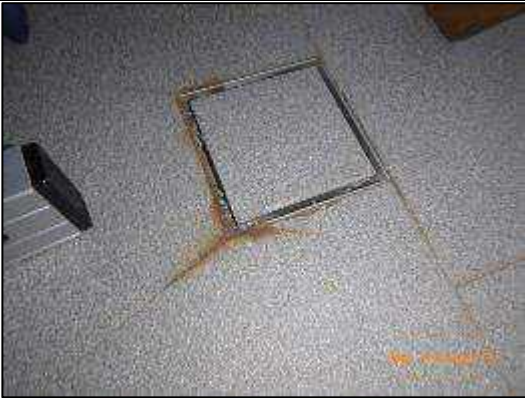
Item	Location	Defect Description and Breach	Rectification	Photograph (if applicable)
145	Balcony	<p>Corrosion observed around drainage outlet on balcony.</p> <p>Home Building Act (NSW) 1989</p> <ul style="list-style-type: none"> Part 2C, 18B (a), (b) and (c). <p>This is a breach of part (a) and (b) of the act because the metal drain is corroded as it has not adequately been prepared to resist the effects of a moisture laden tile screed bed and is not considered fit for purpose.</p> <p>Loss Suffered</p> <p>Loss suffered is cost of rectification.</p>	<ol style="list-style-type: none"> 1. Protect all adjoining surfaces surrounding the work area. 2. Scrape and clean all corroded parts surrounding drain. 3. Apply suitable anticorrosive treatment to metal following adequate surface preparation. 4. Clean up the work area.
