SydneyStrataReport

STRATA REPORT

Client	Church Street Parramatta Property Pty Ltd
Address of property	Unit 3303/330 Church Street, Parramatta, NSW.
Lot	359
Strata Plan	SP 94469
Name of Strata Management Co.	NSW Strata
Telephone Number of Strata Agent	8980 1841
Report Date	15 February 2024

BUILDING DEFECTS REPORT Part 1/2

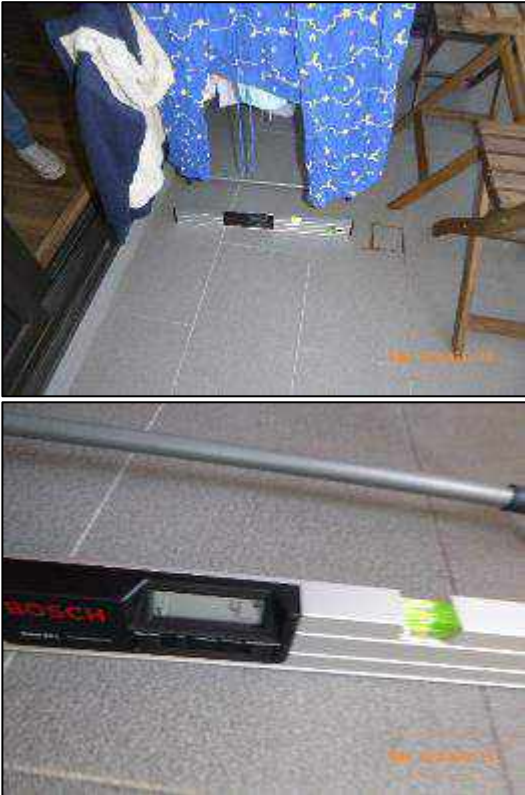
Item	Location	Defect Description and Breach	Rectification	Photograph (if applicable)
146	Balcony	See section 5.2.1 Falls (mm); 4/1000	See section 5.2.2

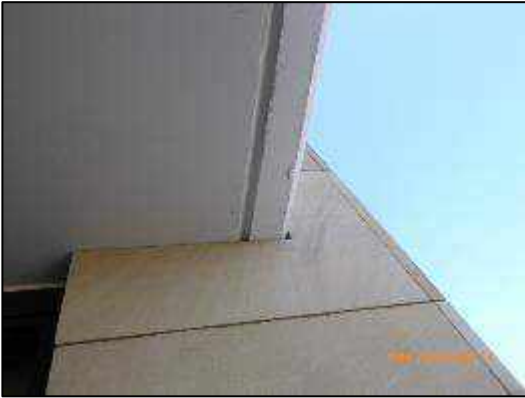
Item	Location	Defect Description and Breach	Rectification	Photograph (if applicable)
147	Balcony	<p>Drip groove on façade observed to have no stop end.</p> <p>Home Building Act (NSW) 1989</p> <ul style="list-style-type: none"> Part 2C, 18B (a) and (c). <p>Loss Suffered Loss suffered is cost of rectification.</p>	Engage a licenced tradesman to install stop end to drip groove and redirect water in accordance with manufacturers specifications.

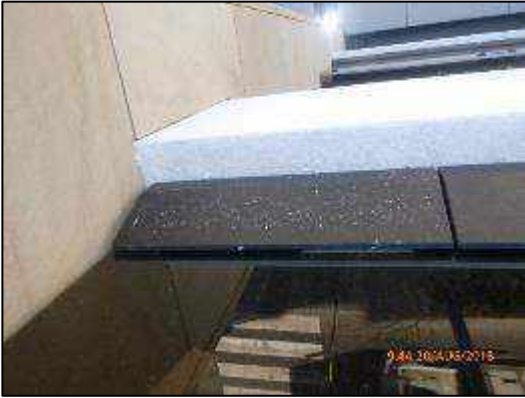
148	Balcony external balustrade	See section 5.9.1	See section 5.9.2

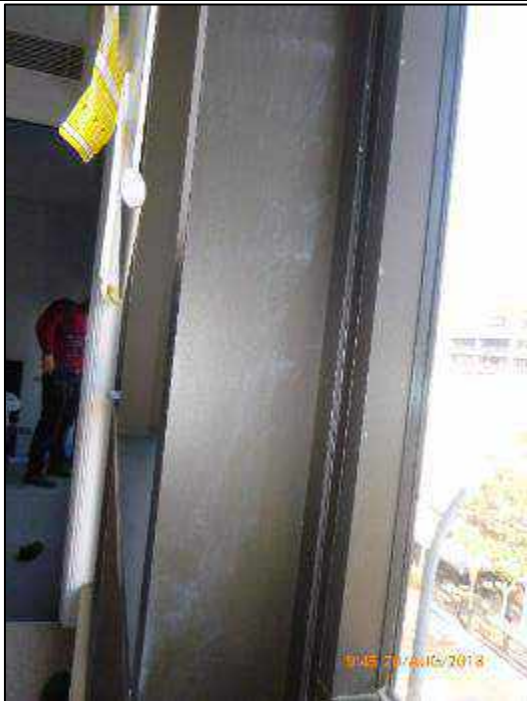
Item	Location	Defect Description and Breach	Rectification	Photograph (if applicable)
149	Second bedroom window frames	See section 5.7.1	See section 5.7.2

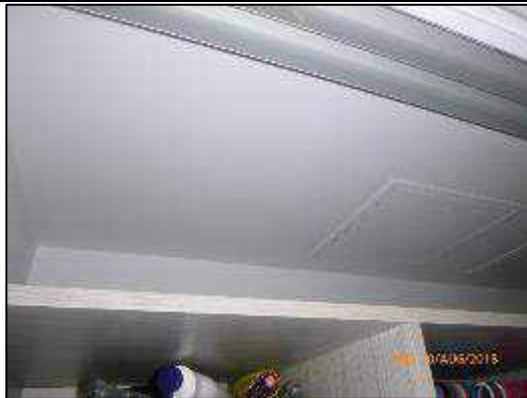
150	Second bedroom built in	See section 5.6.1	See section 5.6.2

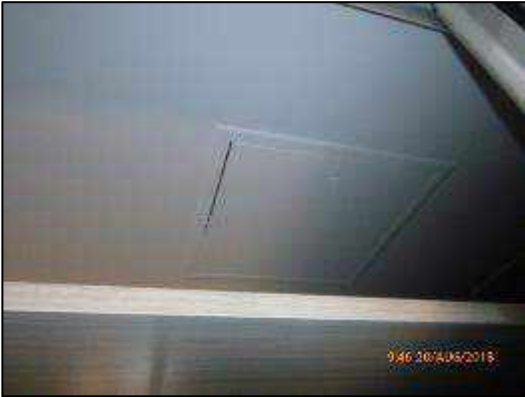
Item	Location	Defect Description and Breach	Rectification	Photograph (if applicable)
151	Main bedroom built in	See section 5.6.1	See section 5.6.2

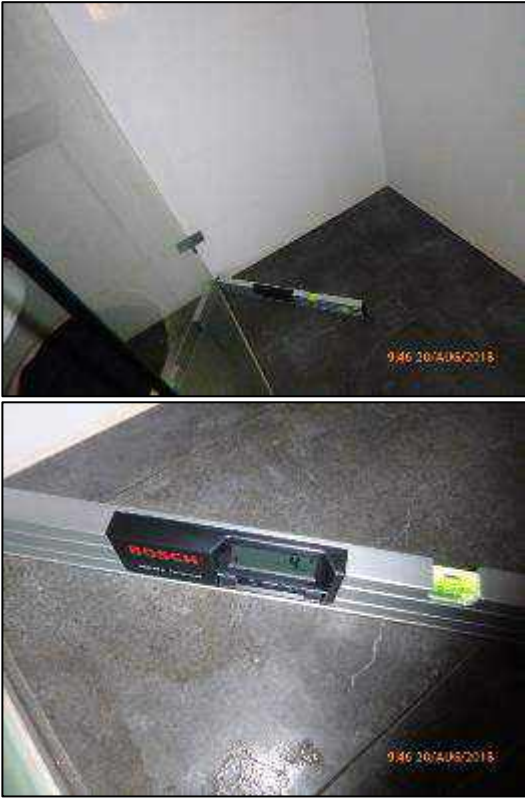
Item	Location	Defect Description and Breach	Rectification	Photograph (if applicable)
152	Main bedroom ensuite	See section 5.1.1 Falls (mm); 4/1000	See section 5.1.2

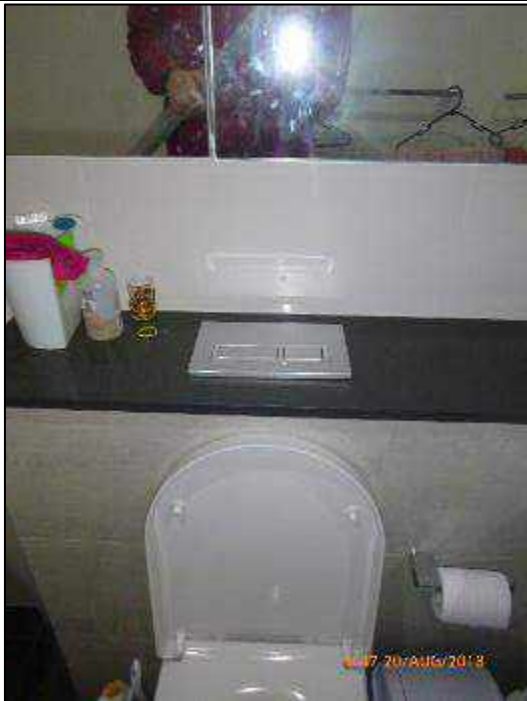
Item	Location	Defect Description and Breach	Rectification	Photograph (if applicable)
153	Main bedroom ensuite	<p>Resident advised that toilet flush was not working.</p> <p>Home Building Act (NSW) 1989</p> <ul style="list-style-type: none"> Part 2C, 18B (a) and (b). <p>This item is a defect as the builder has failed to satisfy implied warranty set out in the Home Building Act 1989 – Section 18B Warranties as to residential building work.</p> <p>(b) a warranty that all materials supplied by the holder or person will be good and suitable for the purpose for which they are used and that, unless otherwise stated in the contract, those materials will be new.</p> <p>Loss Suffered</p> <p>Loss suffered is cost of rectification and loss of amenity.</p>	<ol style="list-style-type: none"> 1. Temporary turn off main water supply to the toilet. 2. Carefully remove the flush from the toilet. 3. Supply and install flush to match existing. 4. Secure the flush to the toilet. 5. Turn on main water supply to toilet.

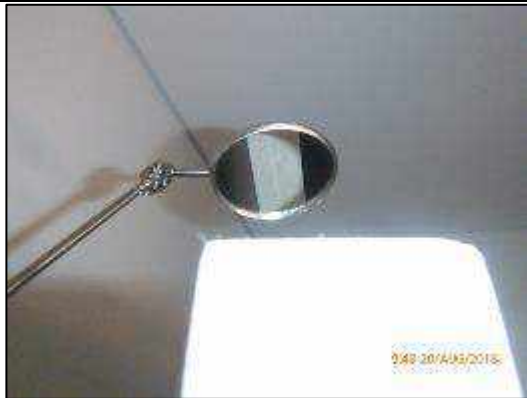
154	Doors throughout the unit (x3)	See section 5.5.1	See section 5.5.2

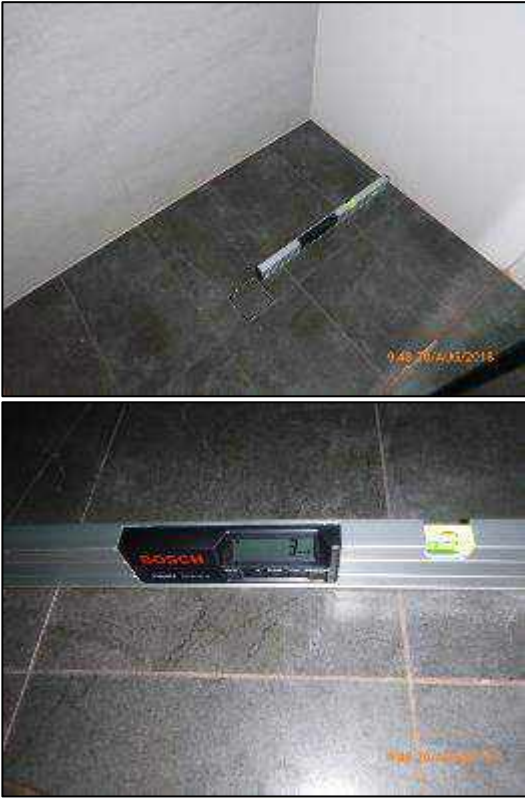
Item	Location	Defect Description and Breach	Rectification	Photograph (if applicable)
155	Main bathroom	See section 5.1.1 Falls (mm); 3/1000	See section 5.1.2

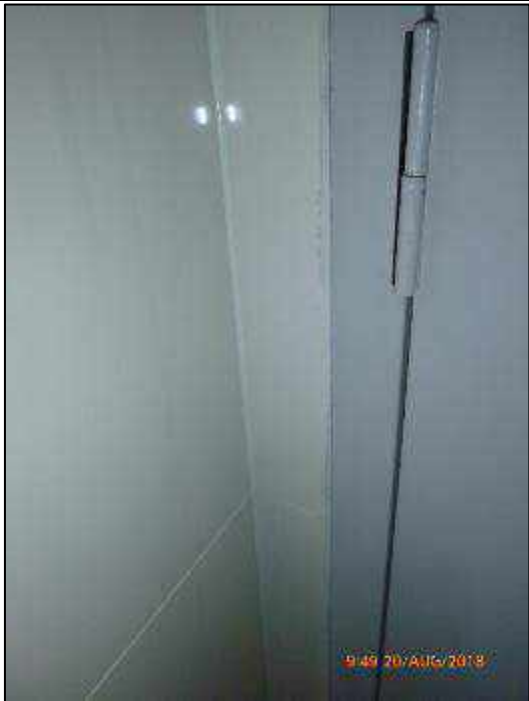
Item	Location	Defect Description and Breach	Rectification	Photograph (if applicable)
156	Main bathroom adjacent to door frame	See section 5.9.1	See section 5.9.2

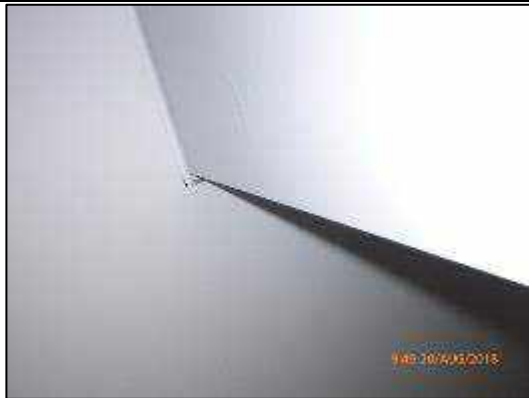
157	Second bedroom	See section 5.11.1	See section 5.11.2

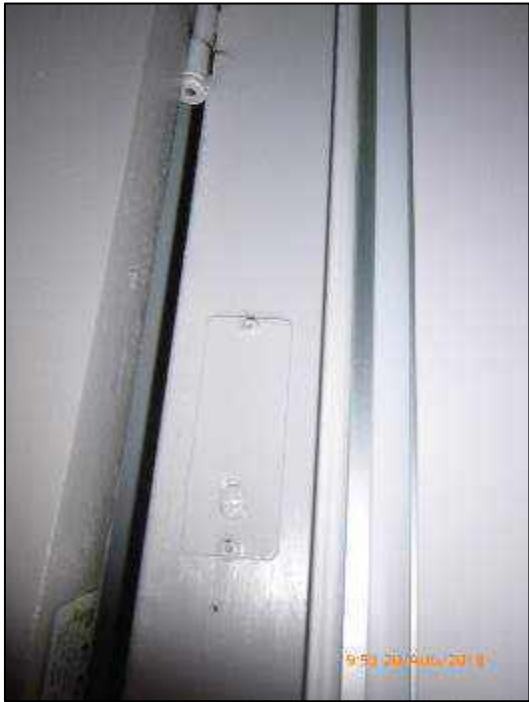
Item	Location	Defect Description and Breach	Rectification	Photograph (if applicable)
Unit 203				
158	Front entry door frame	<p>Door frame label has been painted over.</p> <p>Home Building Act (NSW) 1989</p> <ul style="list-style-type: none"> Part 2C, 18B (a) & (c). <p>Loss Suffered</p> <p>Loss suffered is cost of rectification.</p>	Use a suitable cleaning agent to remove paint from the door frame label.

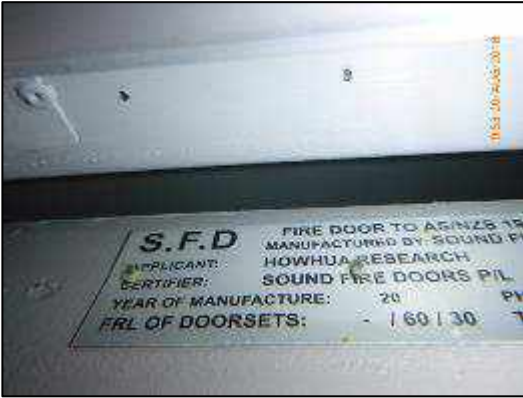
Item	Location	Defect Description and Breach	Rectification	Photograph (if applicable)
159	Front entry door	See section 5.12.1	See section 5.12.2

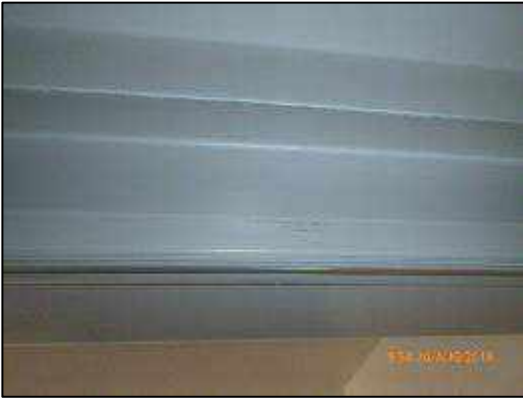
160	Front entry door frame	See section 5.10.1	See section 5.10.2

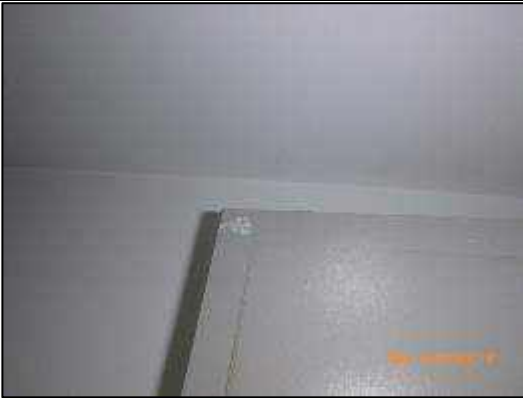
Item	Location	Defect Description and Breach	Rectification	Photograph (if applicable)
161	Front entry door	See section 5.9.1	See section 5.9.2

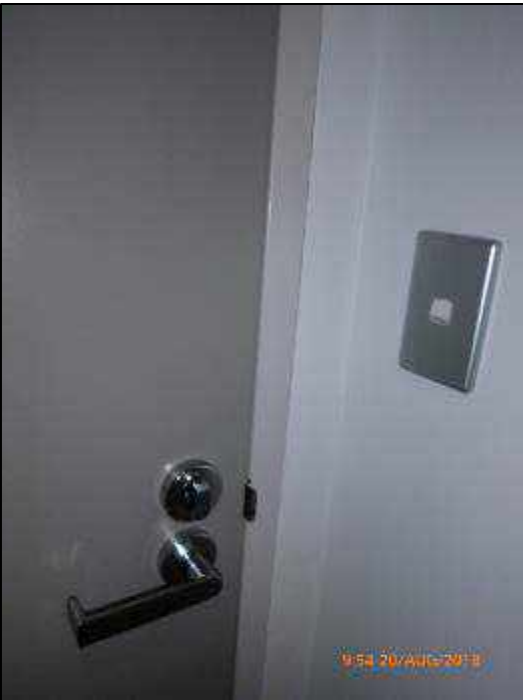
162	Wall adjacent to front entry door frame	See section 5.13.1	See section 5.13.2

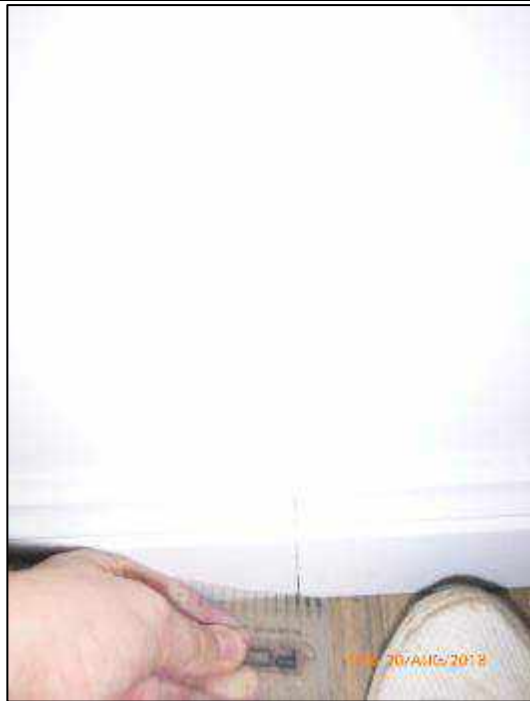
Item	Location	Defect Description and Breach	Rectification	Photograph (if applicable)
163	Northern wall of the front entrance hallway skirting board	See section 5.14.1 Separation; 1.5mm	See section 5.14.2

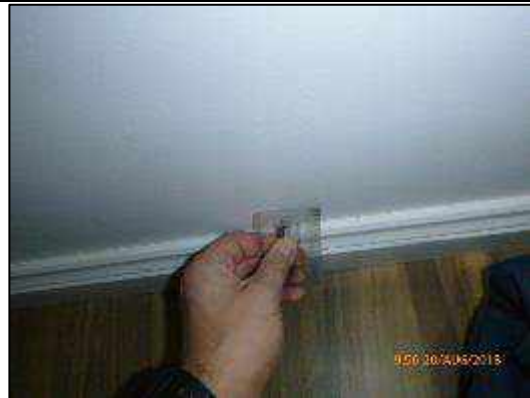
164	Northern wall of the front entrance hallway skirting board	See section 5.14.1 Separation; 1.5mm	See section 5.14.2

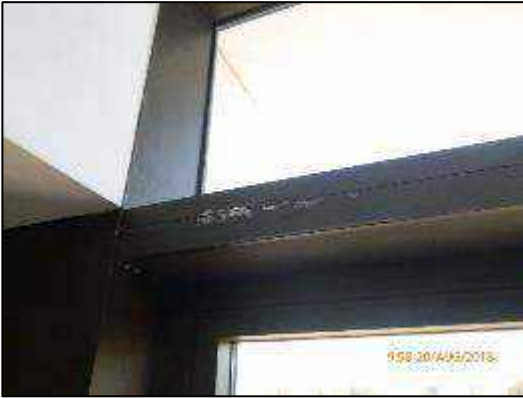
Item	Location	Defect Description and Breach	Rectification	Photograph (if applicable)
165	Kitchen window	See section 5.8.1	See section 5.8.2

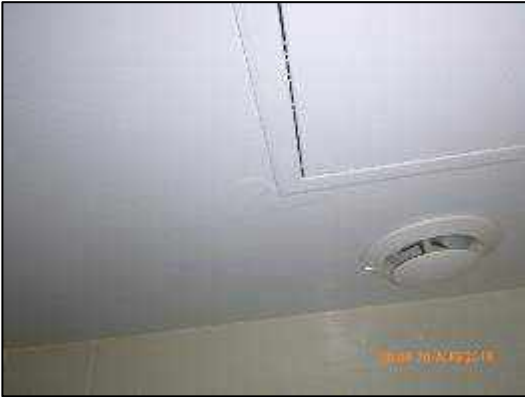
Item	Location	Defect Description and Breach	Rectification	Photograph (if applicable)
167	<i>Ceiling adjacent to inspection hole in laundry room</i>	See section 5.13.1	See section 5.13.2

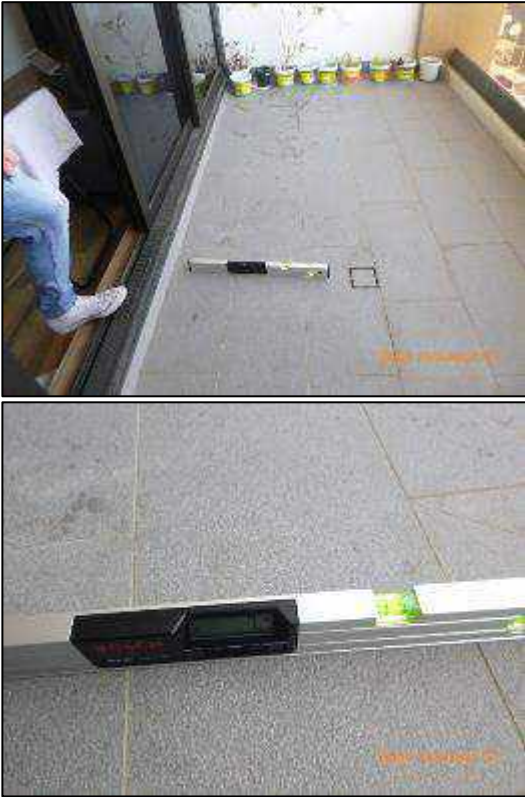
Item	Location	Defect Description and Breach	Rectification	Photograph (if applicable)
168	Balcony	See section 5.2.1 Falls (mm); 7/1000	See section 5.2.2

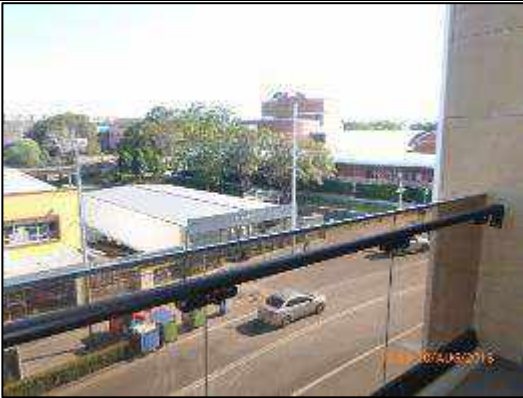
Item	Location	Defect Description and Breach	Rectification	Photograph (if applicable)
169	Balcony	See section 5.4.1	See section 5.4.2

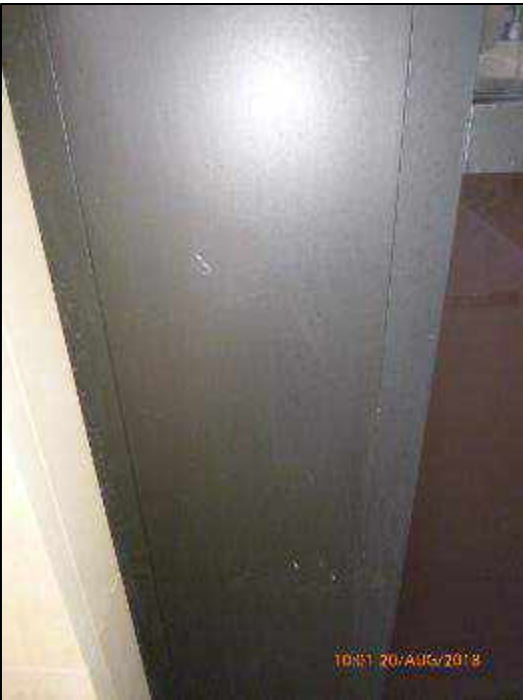
170	Balcony	See section 5.9.1	See section 5.9.2

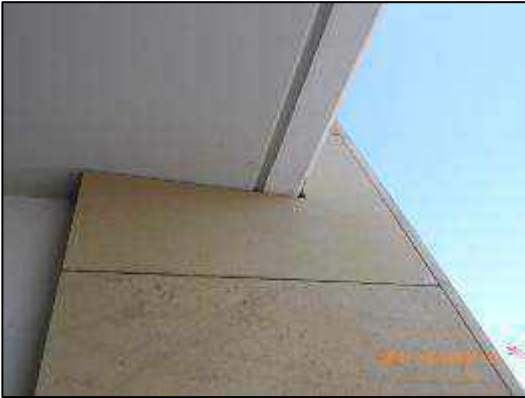
Item	Location	Defect Description and Breach	Rectification	Photograph (if applicable)
171	Balcony	<p>Drip groove on façade observed to have no stop end.</p> <p>Home Building Act (NSW) 1989</p> <ul style="list-style-type: none"> Part 2C, 18B (a) and (c). <p>Loss Suffered Loss suffered is cost of rectification.</p>	Engage a licenced tradesman to install stop end to drip groove and redirect water in accordance with manufacturers specifications.

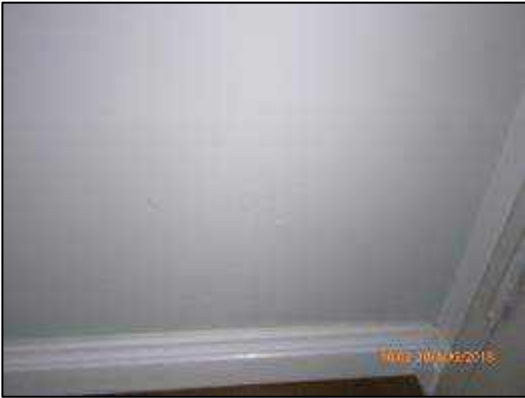
172	Wall adjacent to front entrance	See section 5.10.1	See section 5.10.2

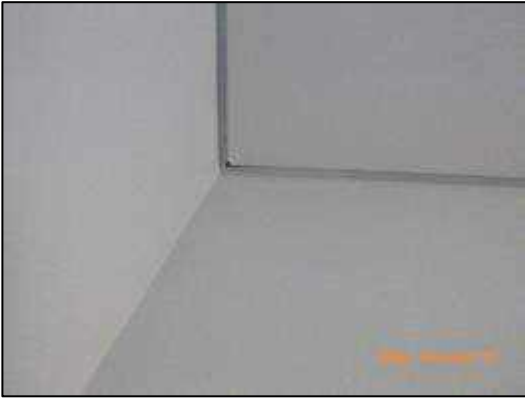
Item	Location	Defect Description and Breach	Rectification	Photograph (if applicable)
173	Second bedroom	See section 5.11.1	See section 5.11.2

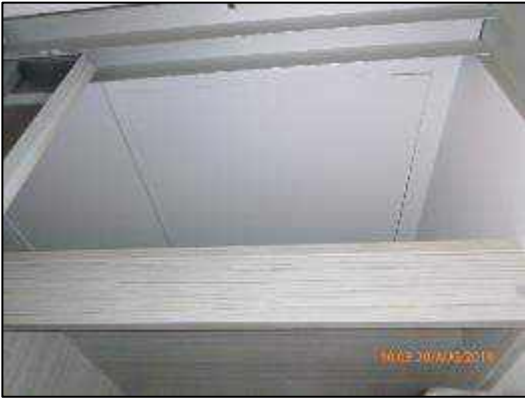
174	Second bedroom built in	See section 5.6.1	See section 5.6.2

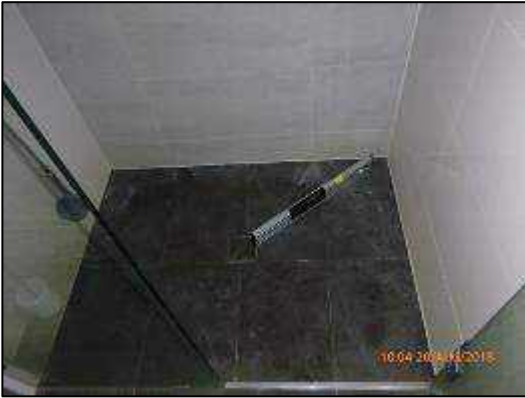
Item	Location	Defect Description and Breach	Rectification	Photograph (if applicable)
175	Main bathroom	See section 5.1.1 Falls (mm); 7/1000	See section 5.1.2

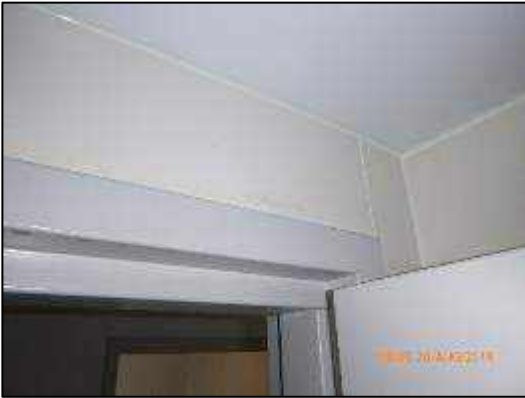
176	Wall above main bathroom door	See section 5.9.1	See section 5.9.2

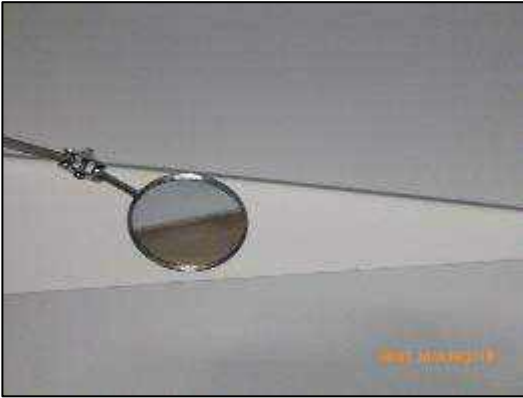
Item	Location	Defect Description and Breach	Rectification	Photograph (if applicable)
177	Doors throughout unit (x3)	See section 5.5.1	See section 5.5.2

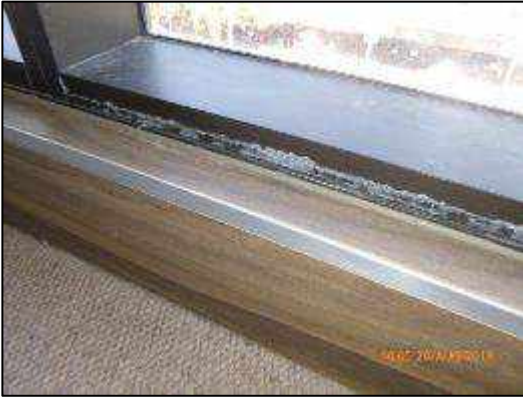
178	Main bedroom window frames	See section 5.8.1	See section 5.8.2

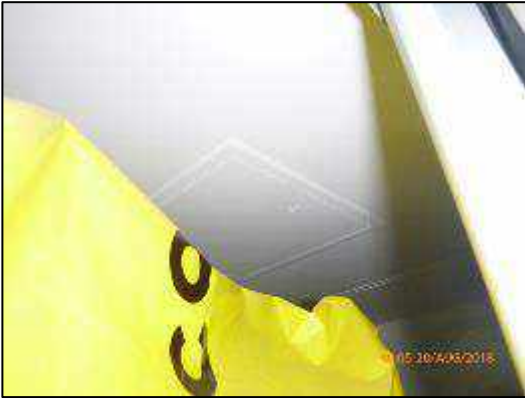
Item	Location	Defect Description and Breach	Rectification	Photograph (if applicable)
179	Main bedroom built in	See section 5.6.1	See section 5.6.2

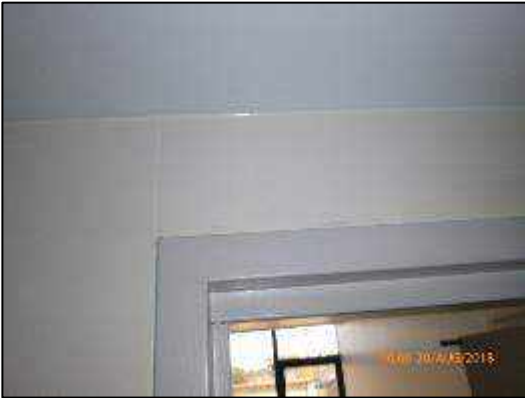
180	Wall above ensuite door	See section 5.9.1	See section 5.9.2

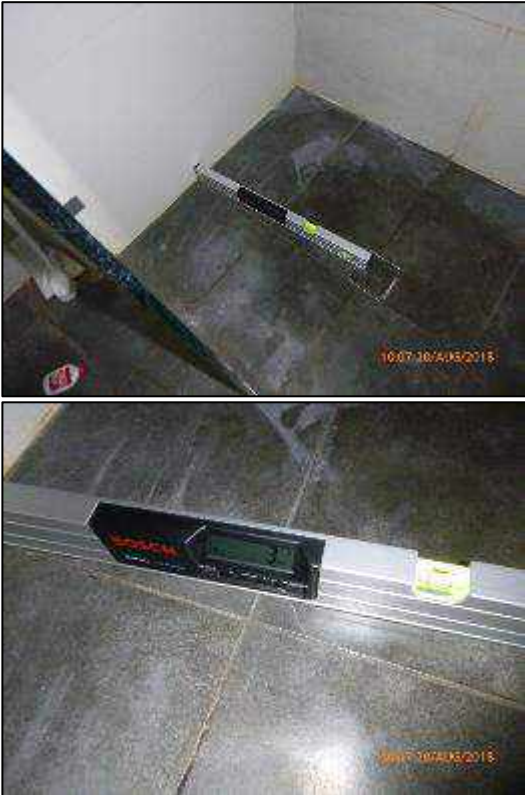
Item	Location	Defect Description and Breach	Rectification	Photograph (if applicable)
181	Main bedroom ensuite	See section 5.1.1 Falls (mm); 3/1000	See section 5.1.2

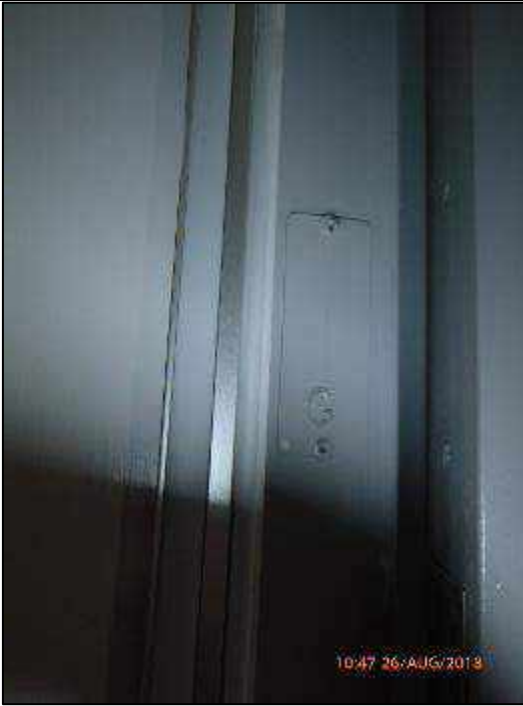
Item	Location	Defect Description and Breach	Rectification	Photograph (if applicable)
182	Front entry door frame	<p>Door frame label has been painted over.</p> <p>Home Building Act (NSW) 1989</p> <ul style="list-style-type: none"> Part 2C, 18B (a) & (c). <p>Loss Suffered Loss suffered is cost of rectification.</p>	Use a suitable cleaning agent to remove paint from the door frame label.

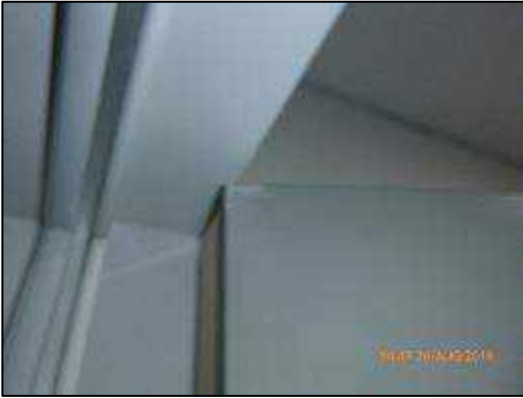
183	Front entry door	See section 5.9.1	See section 5.9.2

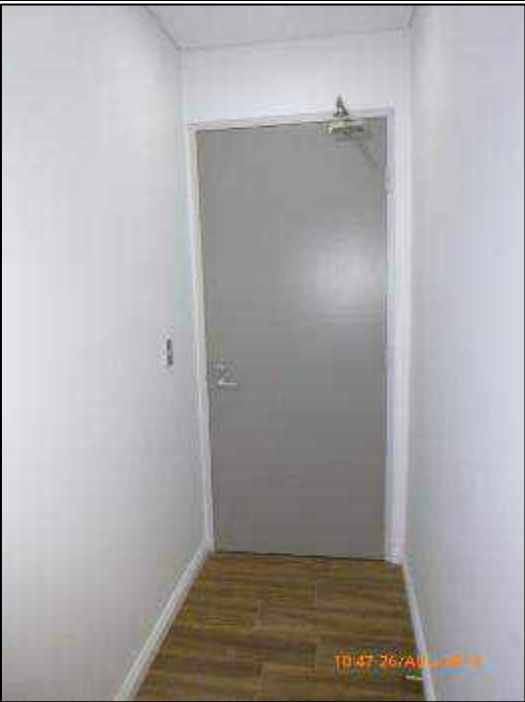
Item	Location	Defect Description and Breach	Rectification	Photograph (if applicable)
184	Front entry door	See section 5.10.1	See section 5.10.2

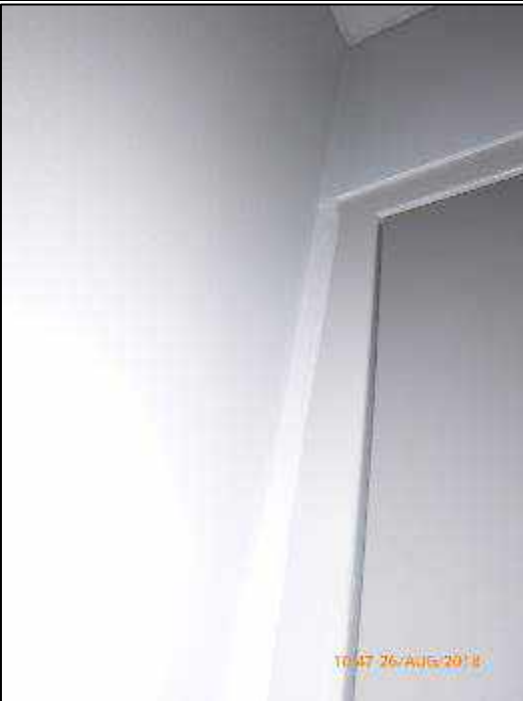
Item	Location	Defect Description and Breach	Rectification	Photograph (if applicable)
185	Wall adjacent to front entry door	See section 5.13.1	See section 5.13.2

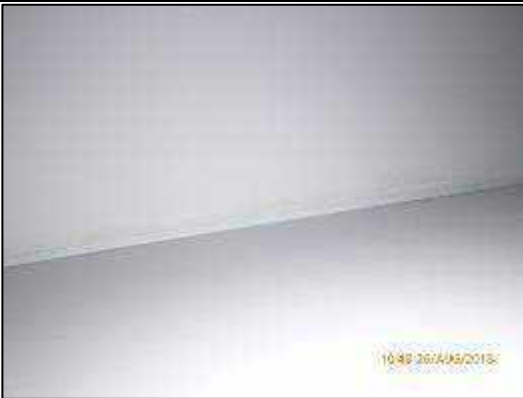
A photograph showing a close-up of a wall corner or door frame area. The wall appears to have some discoloration or a defect. A timestamp '10:47:26/AUG/2018' is visible in the bottom right corner of the image.
186	Lounge room	See section 5.11.1	See section 5.11.2

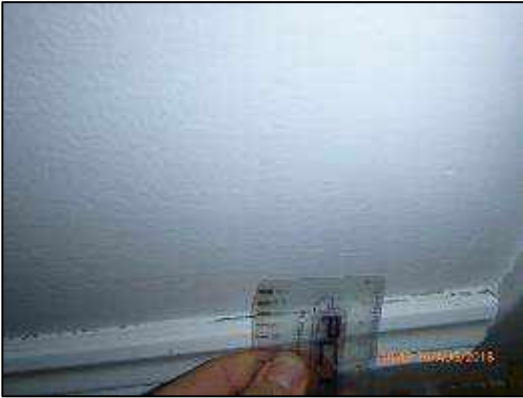
Item	Location	Defect Description and Breach	Rectification	Photograph (if applicable)
187	Hallway western wall skirting board	See section 5.14.1 Separation; 1.5mm	See section 5.14.2

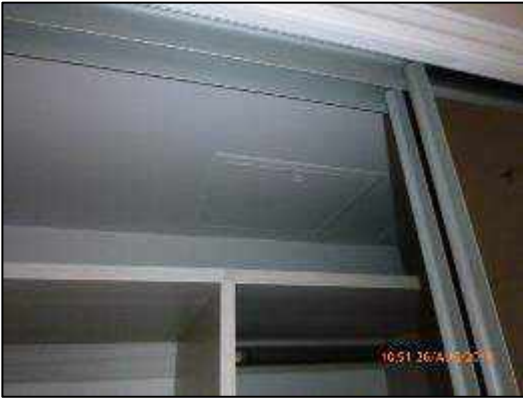
188	Second bedroom built in	See section 5.6.1	See section 5.6.2

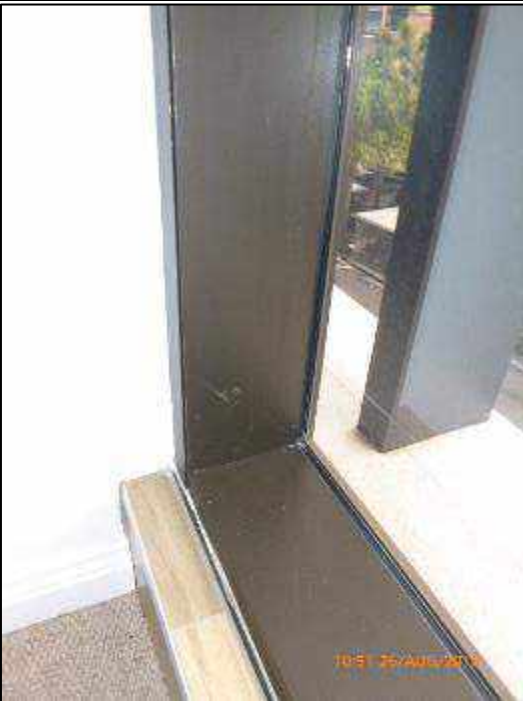
Item	Location	Defect Description and Breach	Rectification	Photograph (if applicable)
189	Second bedroom window frames	See section 5.9.1	See section 5.9.2

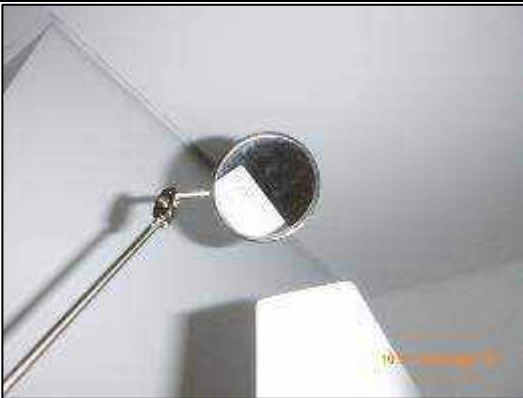
190	Doors throughout the unit (x3)	See section 5.5.1	See section 5.5.2

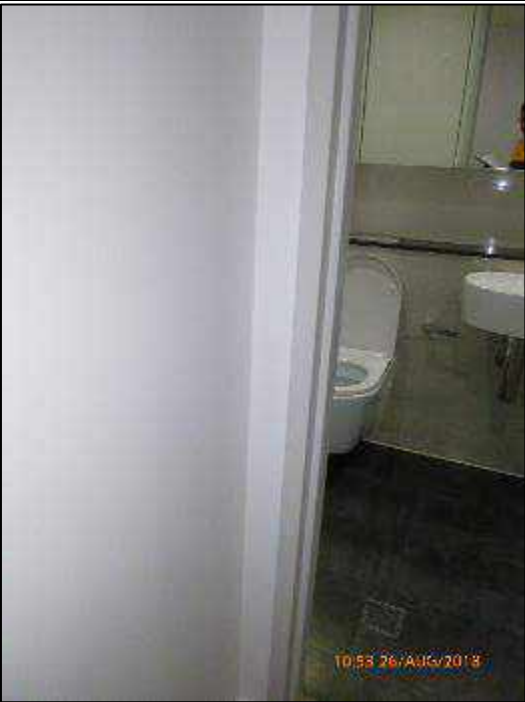
Item	Location	Defect Description and Breach	Rectification	Photograph (if applicable)
191	Wall adjacent to main bathroom door	See section 5.13.1	See section 5.13.2

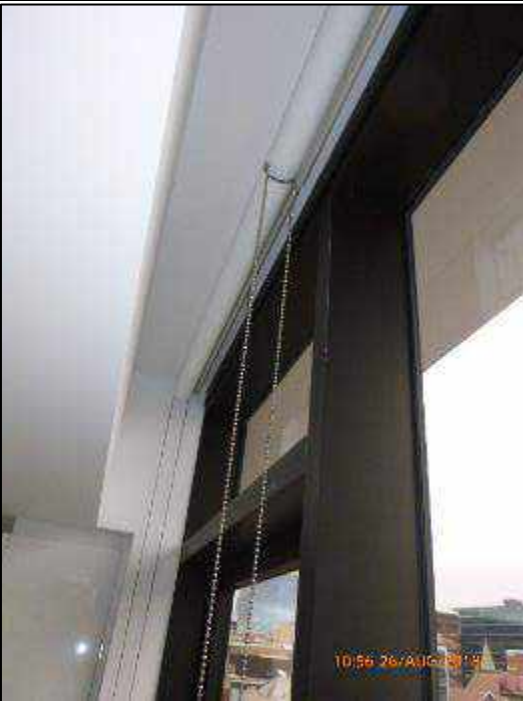
Item	Location	Defect Description and Breach	Rectification	Photograph (if applicable)
192	Main bedroom window bulkhead	See section 5.13.1	See section 5.13.2

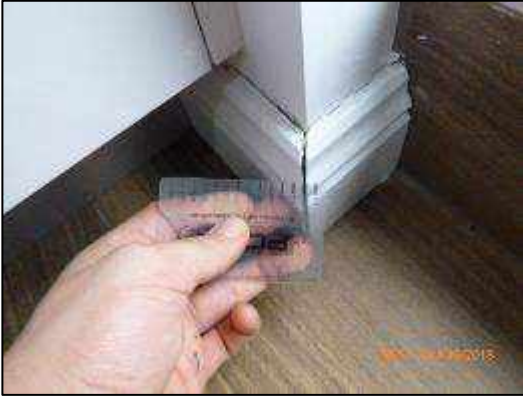
A photograph showing a window bulkhead in a room. A thin, dark line is visible along the top edge of the bulkhead, indicating a defect. The timestamp '10:56 26/AUG/2019' is visible in the bottom right corner.
193	Main bedroom north eastern corner skirting board	See section 5.14.1 Separation; 2mm	See section 5.14.2

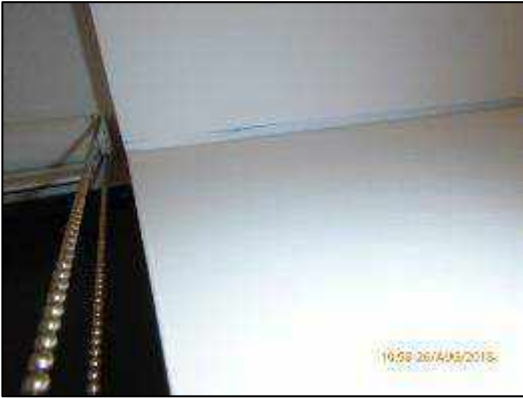
Item	Location	Defect Description and Breach	Rectification	Photograph (if applicable)
194	Main bedroom	See section 5.11.1	See section 5.11.2

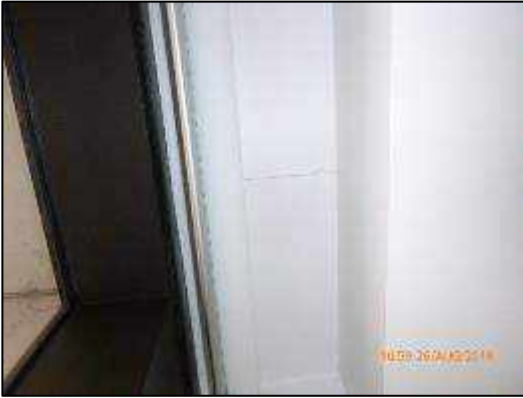
195	Wall adjacent to main bedroom windows	See section 5.14.1 Separation; 1mm	See section 5.14.2

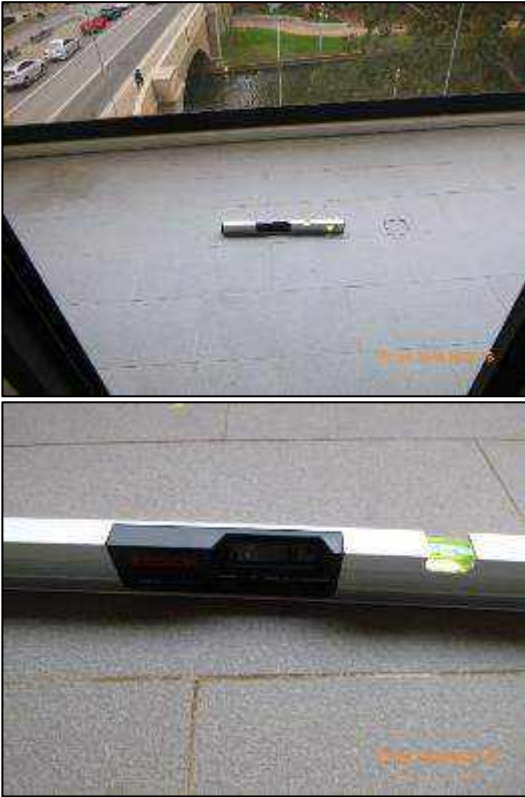
Item	Location	Defect Description and Breach	Rectification	Photograph (if applicable)
196	Balcony	See section 5.2.1 Falls (mm); 8/1000	See section 5.2.2

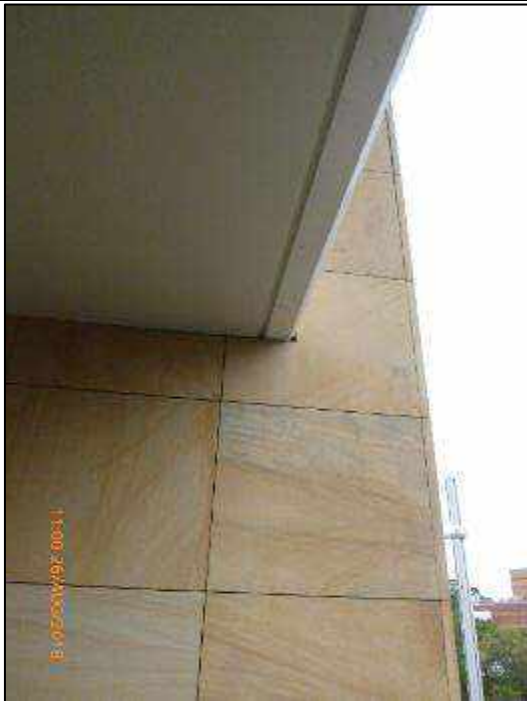
Item	Location	Defect Description and Breach	Rectification	Photograph (if applicable)
197	Balcony eastern blade wal	<p>Drip groove on façade observed to have no stop end.</p> <p>Home Building Act (NSW) 1989</p> <ul style="list-style-type: none"> Part 2C, 18B (a) and (c). <p>Loss Suffered Loss suffered is cost of rectification.</p>	Engage a licenced tradesman to install stop end to drip groove and redirect water in accordance with manufacturers specifications.

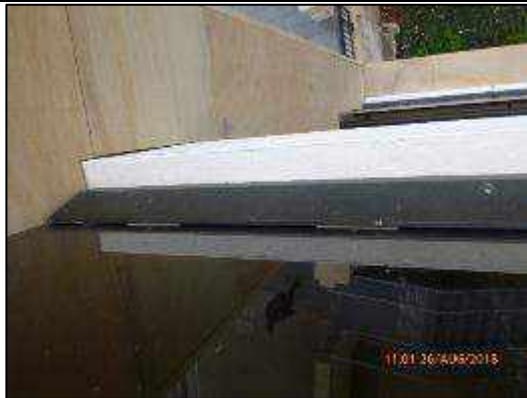
198	Balcony balustrade	See section 5.9.1	See section 5.9.2

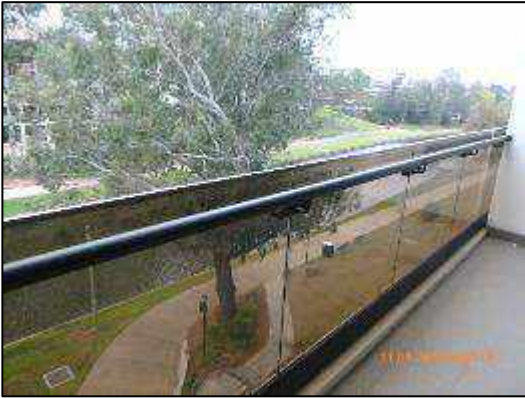
Item	Location	Defect Description and Breach	Rectification	Photograph (if applicable)
199	Balcony	See section 5.4.1	See section 5.4.2

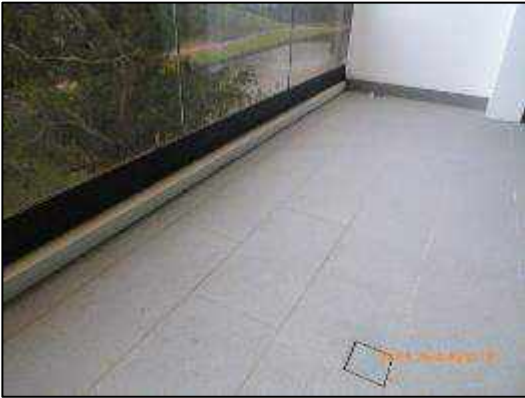
200	Balcony	See section 5.3.1	See section 5.3.2

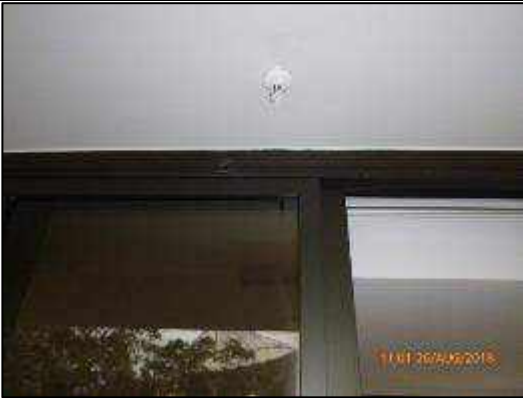
Item	Location	Defect Description and Breach	Rectification	Photograph (if applicable)
201	Balcony sliding door frame	See section 5.9.1	See section 5.9.2

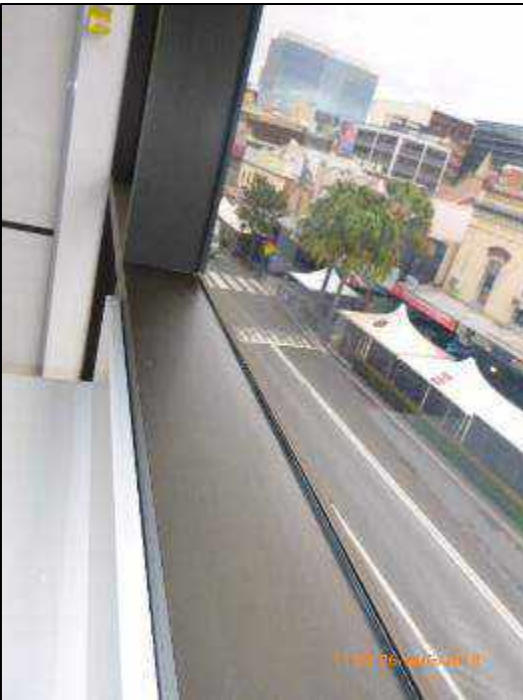
202	Lounge room window frames	See section 5.7.1	See section 5.7.2

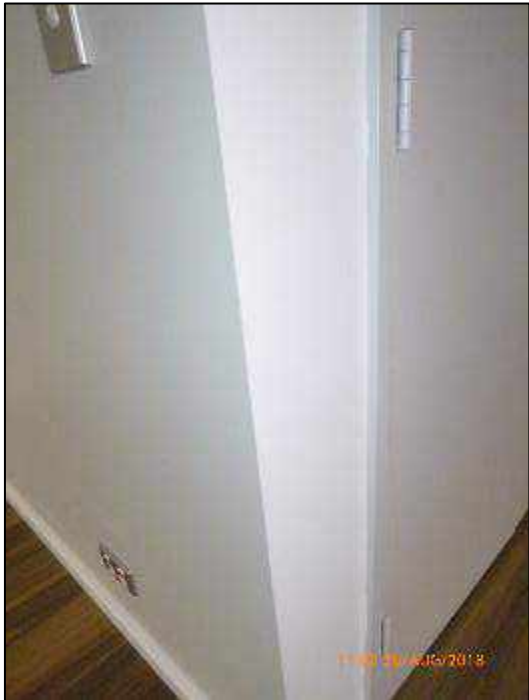
Item	Location	Defect Description and Breach	Rectification	Photograph (if applicable)
203	Walls and ceiling throughout the unit	See section 5.10.1	See section 5.10.2

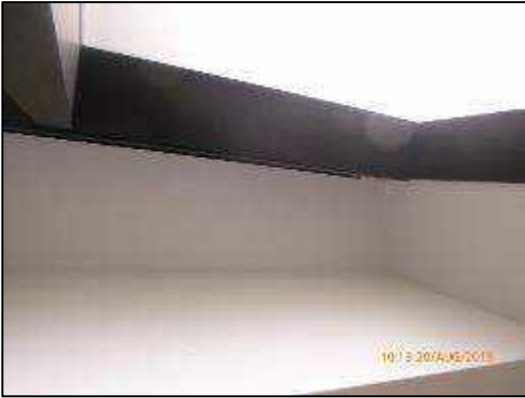
Item	Location	Defect Description and Breach	Rectification	Photograph (if applicable)
205	Bulkhead above lounge room sliding door	<p>Missing sealant between bulkhead and window frame.</p> <p>Home Building Act (NSW) 1989</p> <ul style="list-style-type: none"> Part 2C, 18B (a) and (c). <p>Loss Suffered</p> <p>Loss suffered is cost of rectification.</p>	<ol style="list-style-type: none"> 1. Protect all adjoining surfaces. 2. Apply a bead of flexible sealant to the joint between the window frame and wall 3. As required, all affected surfaces are to be painted with an appropriate paint system to match as close as possible to the existing in accordance with the manufacturer's recommendations and AS2311 – Guide to the painting of buildings. 4. Clean up the work area

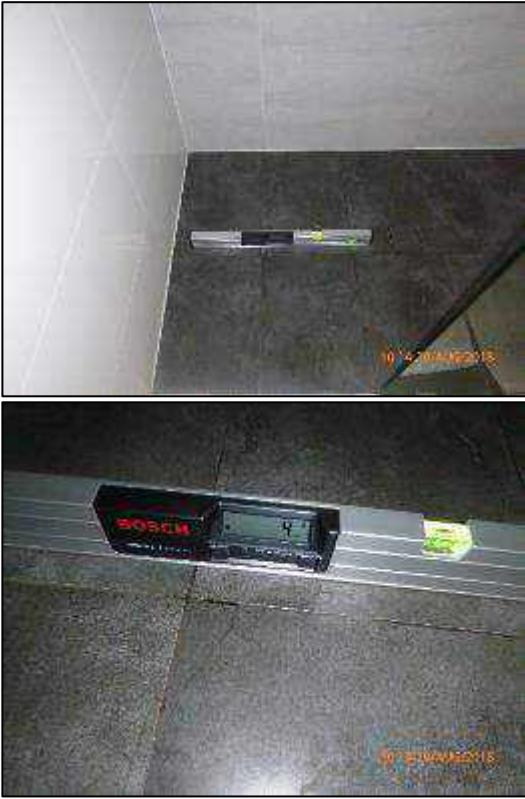
Item	Location	Defect Description and Breach	Rectification	Photograph (if applicable)
206	Main bathroom	See section 5.1.1 Falls (mm); 4/1000	See section 5.1.2

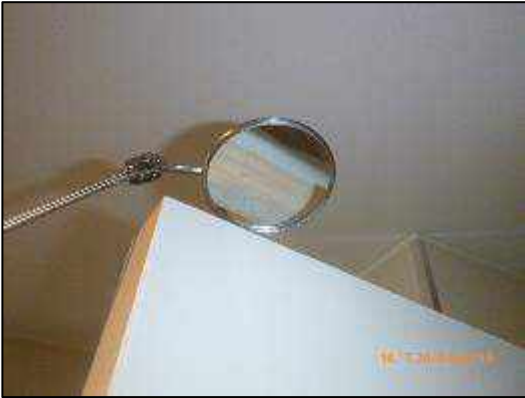
Item	Location	Defect Description and Breach	Rectification	Photograph (if applicable)
207	Doors throughout the unit (x3)	See section 5.5.1	See section 5.5.2

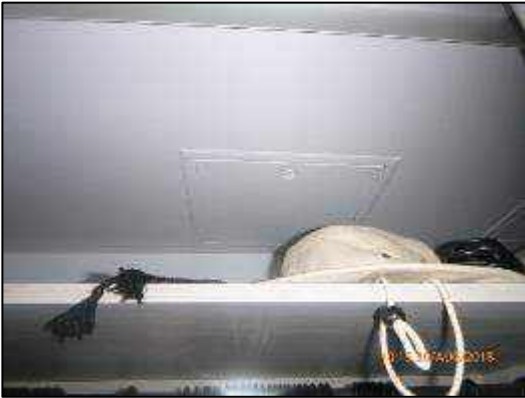
208	Main bedroom built in	See section 5.6.1	See section 5.6.2

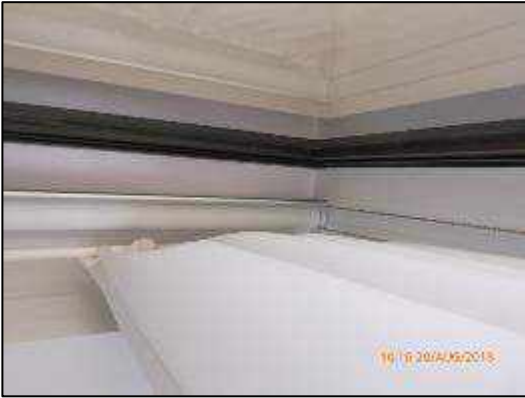
Item	Location	Defect Description and Breach	Rectification	Photograph (if applicable)
209	Lounge room sliding door	See section 5.9.1	See section 5.9.2

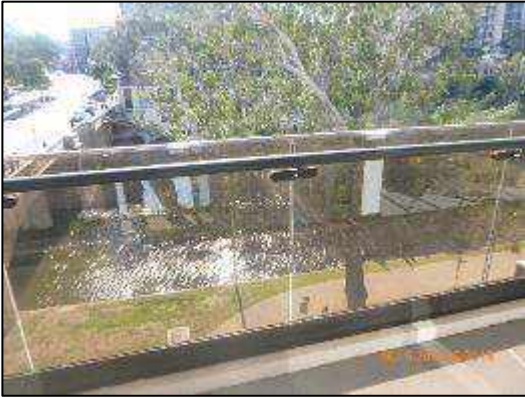
210	Balcony	See section 5.4.1	See section 5.4.2

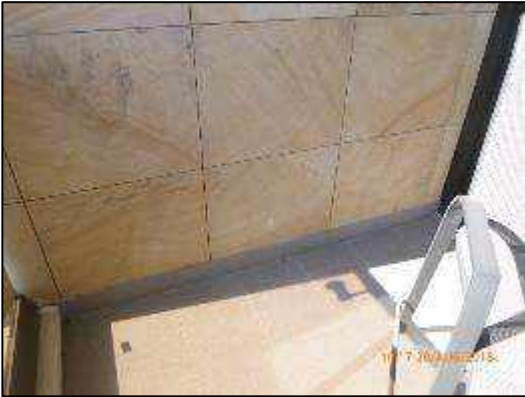
Item	Location	Defect Description and Breach	Rectification	Photograph (if applicable)
211	Balcony	<p>No weep holes or flashing observed on façade in balcony area.</p> <p>Home Building Act (NSW) 1989</p> <ul style="list-style-type: none"> Part 2C, 18B (a) and (c). <p>Loss Suffered Loss suffered is cost of rectification.</p>	<ol style="list-style-type: none"> 1. Remove sandstone tiles on wall in balcony area. 2. Engage a licenced tradesman to install flashing and produce weep holes. 3. Re-instate the sandstone tiles with weep holes. 4. Clean up the work area.

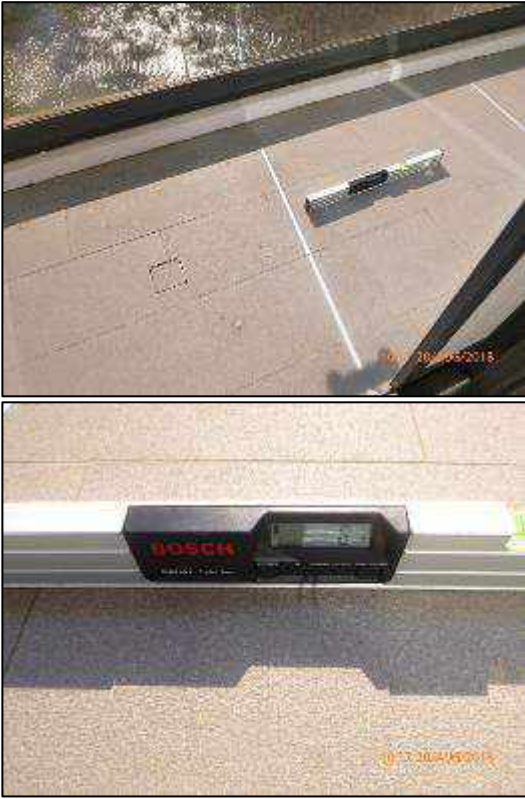
Item	Location	Defect Description and Breach	Rectification	Photograph (if applicable)
212	Balcony	See section 5.2.1 Falls (mm); 6/1000	See section 5.2.2

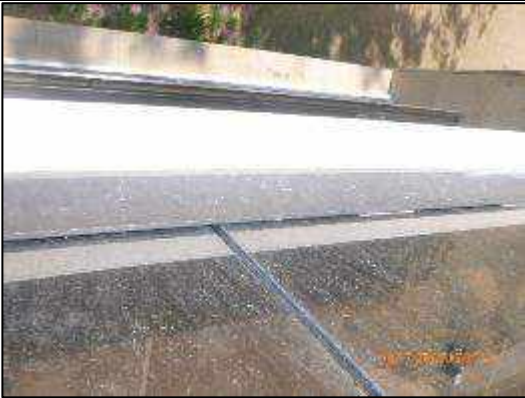
Item	Location	Defect Description and Breach	Rectification	Photograph (if applicable)
213	Balcony	See section 5.9.1	See section 5.9.2

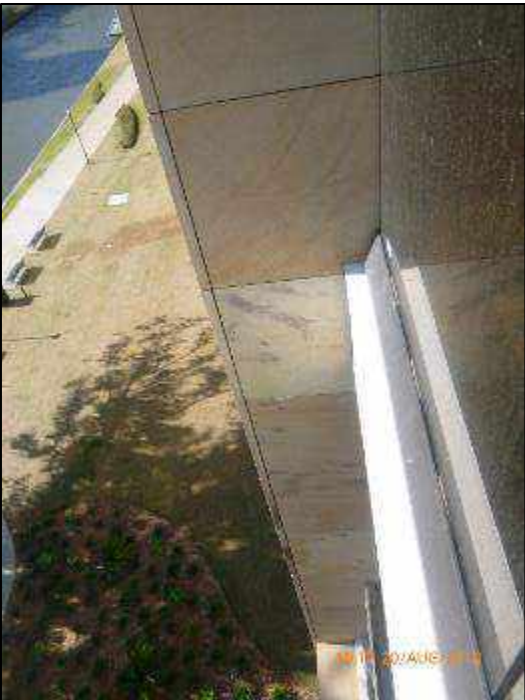
214	Balcony	<p>Damaged and chipped sandstone throughout façade.</p> <p>Home Building Act (NSW) 1989</p> <ul style="list-style-type: none"> Part 2C, 18B (a) and (c). <p>Loss Suffered</p> <p>Loss suffered is cost of rectification.</p>	<p>5. Protect the surrounding areas.</p> <p>6. Remove the damaged sandstone tiles.</p> <p>7. Reinstall new sandstone tiles to match existing.</p> <p>Clean up the work area.</p>

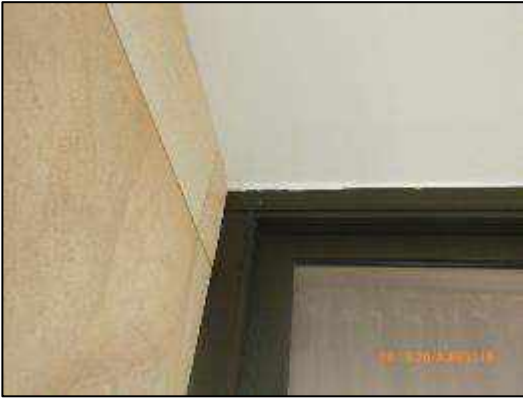
Item	Location	Defect Description and Breach	Rectification	Photograph (if applicable)
215	Balcony	See section 5.9.1	See section 5.9.2

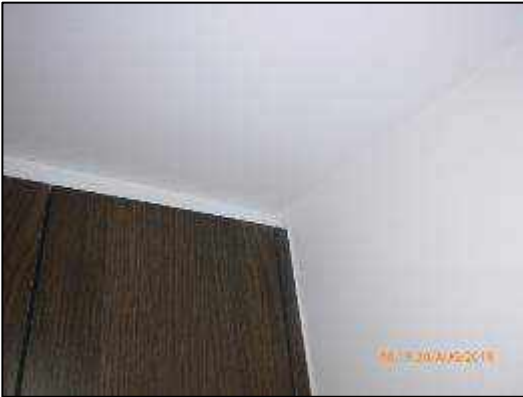
216	Kitchen cupboards	See section 5.9.1	See section 5.9.2

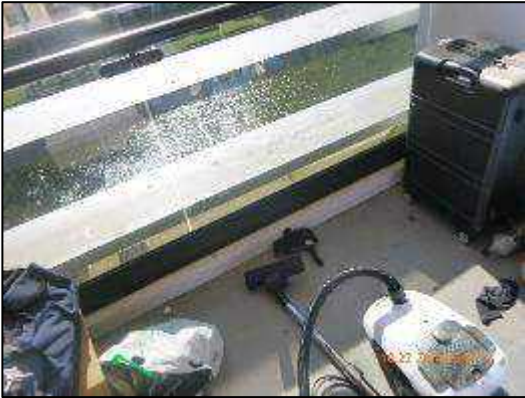
Item	Location	Defect Description and Breach	Rectification	Photograph (if applicable)
218	Balcony	See section 5.3.1	See section 5.3.2

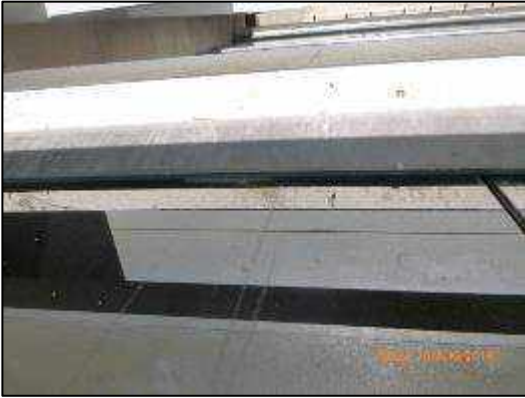
219	Balcony balustrade	See section 5.9.1	See section 5.9.2
