SydneyStrataReport

STRATA REPORT

Client	Church Street Parramatta Property Pty Ltd
Address of property	Unit 3303/330 Church Street, Parramatta, NSW.
Lot	359
Strata Plan	SP 94469
Name of Strata Management Co.	NSW Strata
Telephone Number of Strata Agent	8980 1841
Report Date	15 February 2024

BUILDING DEFECTS REPORT Part 1/2

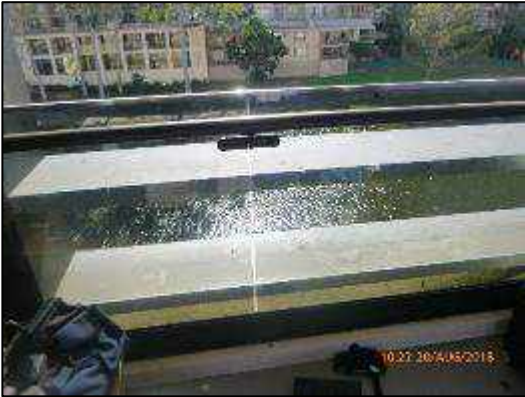
Item	Location	Defect Description and Breach	Rectification	Photograph (if applicable)
220	Balcony	See section 5.4.1	See section 5.4.2

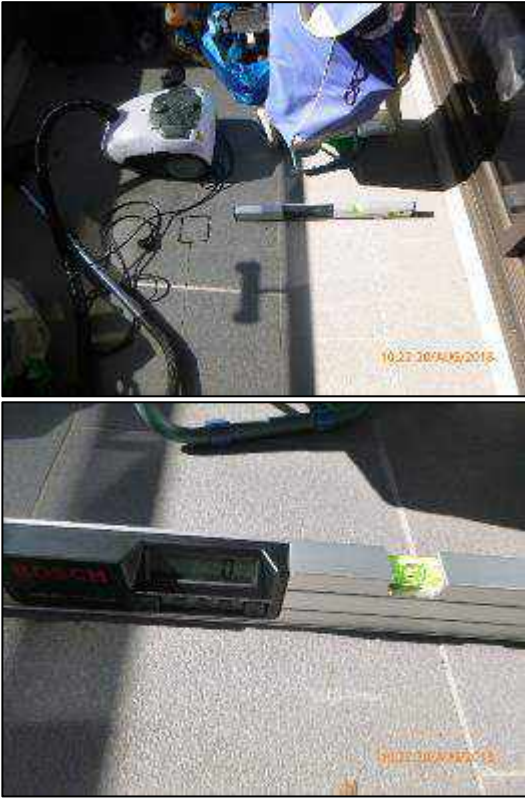
Item	Location	Defect Description and Breach	Rectification	Photograph (if applicable)
221	Balcony	See section 5.2.1 Falls (mm); 0/1000	See section 5.2.2

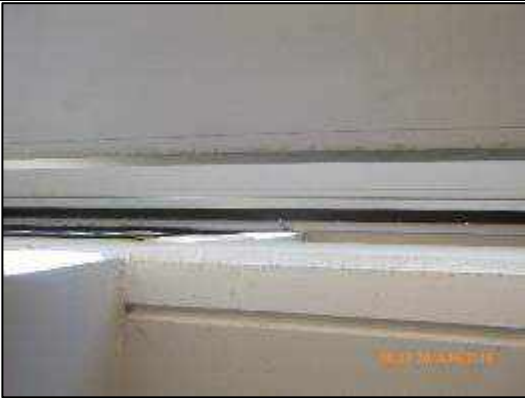
Item	Location	Defect Description and Breach	Rectification	Photograph (if applicable)
222	Balcony soffit of slab above	See section 5.10.1	See section 5.10.2

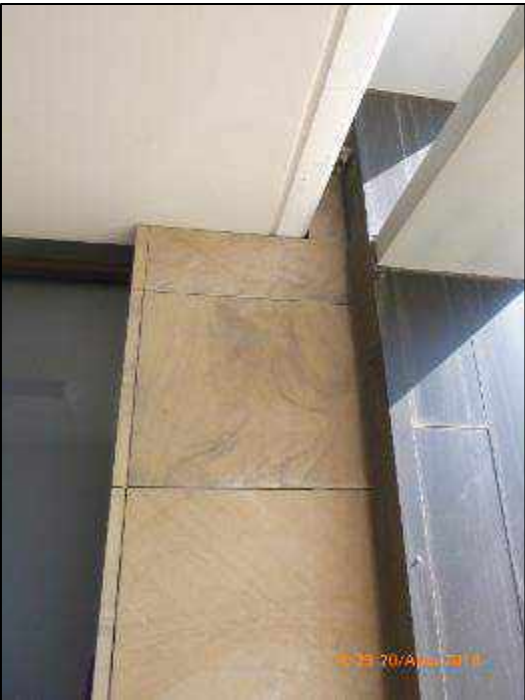
223	Balcony façade	<p>Damaged and chipped sandstone throughout façade.</p> <p>Home Building Act (NSW) 1989</p> <ul style="list-style-type: none"> Part 2C, 18B (a) and (c). <p>Loss Suffered</p> <p>Loss suffered is cost of rectification.</p>	<p>8. Protect the surrounding areas.</p> <p>9. Remove the damaged sandstone tiles.</p> <p>10. Reinstall new sandstone tiles to match existing.</p> <p>Clean up the work area.</p>

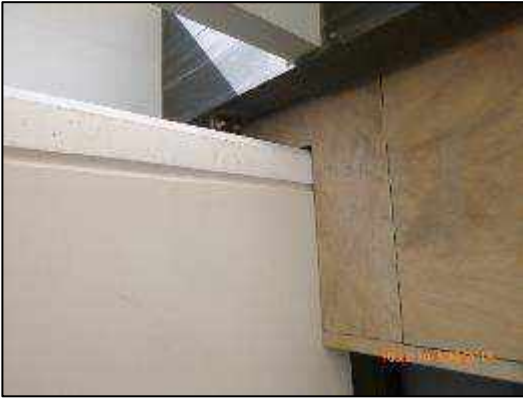
Item	Location	Defect Description and Breach	Rectification	Photograph (if applicable)
224	Balcony	<p>Drip groove on façade observed to have no stop end.</p> <p>Home Building Act (NSW) 1989</p> <ul style="list-style-type: none"> Part 2C, 18B (a) and (c). <p>Loss Suffered Loss suffered is cost of rectification.</p>	Engage a licenced tradesman to install stop end to drip groove and redirect water in accordance with manufacturers specifications.

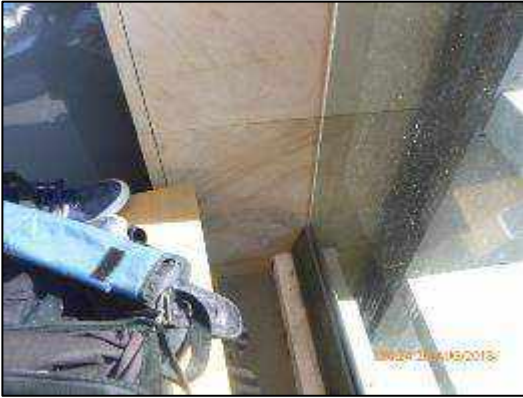
225	Balcony	<p>No weep holes or flashing observed on façade in balcony area.</p> <p>Home Building Act (NSW) 1989</p> <ul style="list-style-type: none"> Part 2C, 18B (a) and (c). <p>Loss Suffered Loss suffered is cost of rectification.</p>	<ol style="list-style-type: none"> 1. Remove sandstone tiles on wall in balcony area. 2. Engage a licenced tradesman to install flashing and produce weep holes. 3. Re-instate the sandstone tiles with weep holes. 4. Clean up the work area.

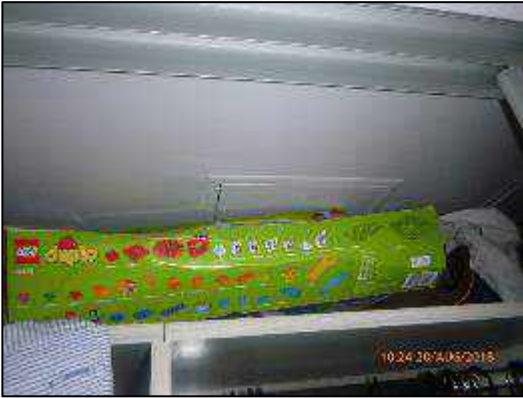
Item	Location	Defect Description and Breach	Rectification	Photograph (if applicable)
226	Main bedroom built in	See section 5.6.1	See section 5.6.2

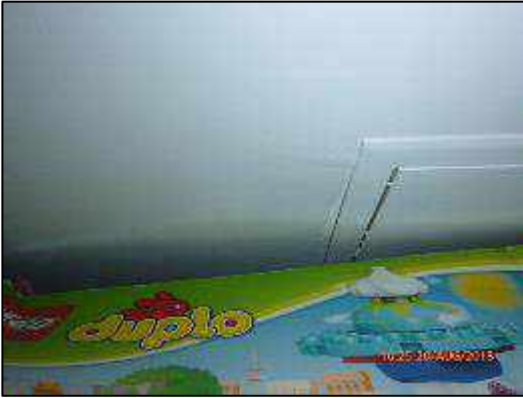
227	Ceiling adjacent to inspection hole in main bedroom	See section 5.10.1	See section 5.10.2

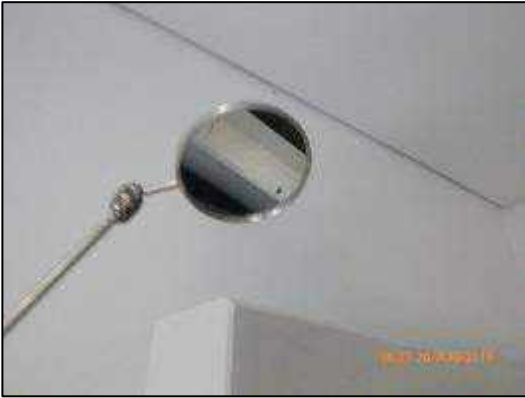
Item	Location	Defect Description and Breach	Rectification	Photograph (if applicable)
228	Doors throughout the unit (x3)	See section 5.5.1	See section 5.5.2

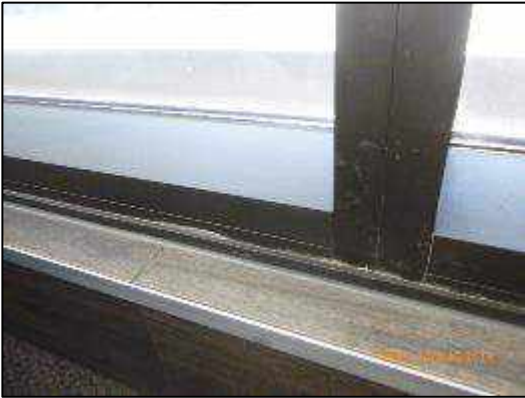
229	Main bedroom window frames	See section 5.8.1	See section 5.8.2

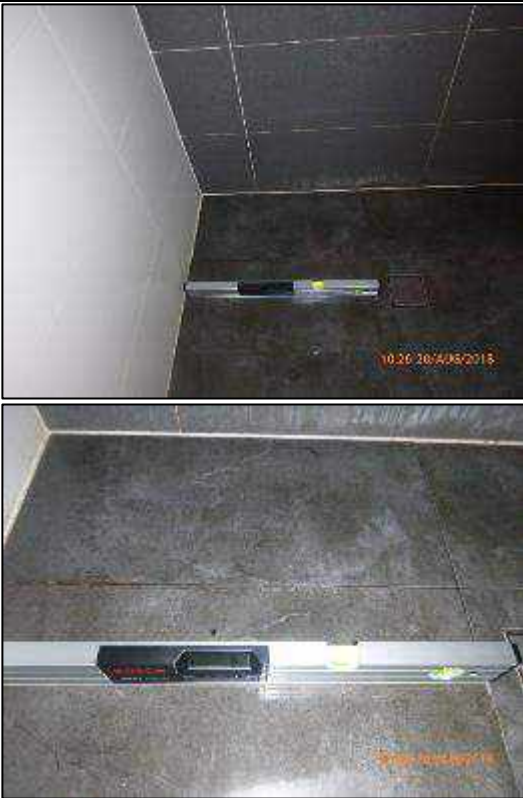
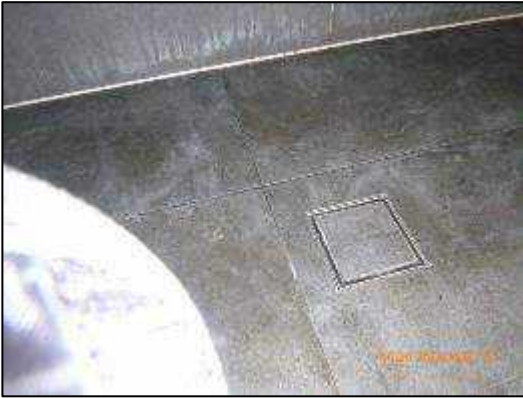
230	<i>Main bedroom ensuite</i>	<p>See section 5.1.1</p> <p>Ponding observed at time of inspection.</p> <p>Falls (mm); 6/1000</p>	See section 5.1.2

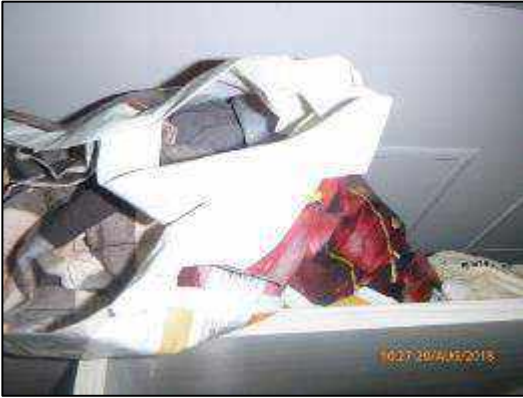
231	<i>Second bedroom built in</i>	See section 5.6.1	See section 5.6.2

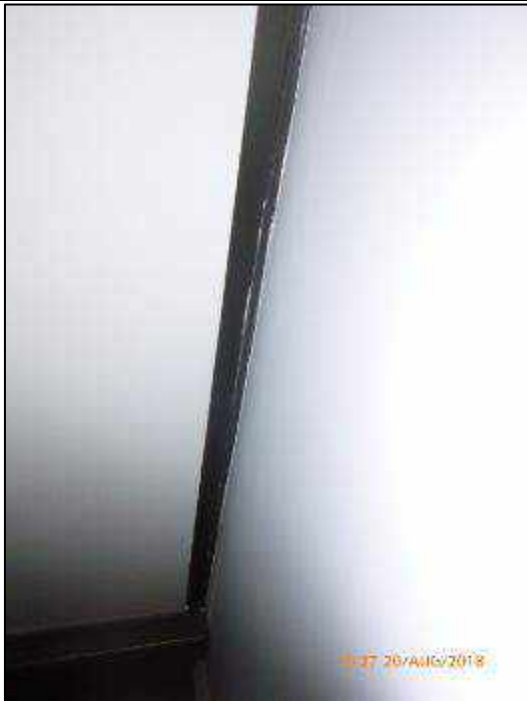
Item	Location	Defect Description and Breach	Rectification	Photograph (if applicable)
232	Second bedroom window frames	See section 5.9.1	See section 5.9.2

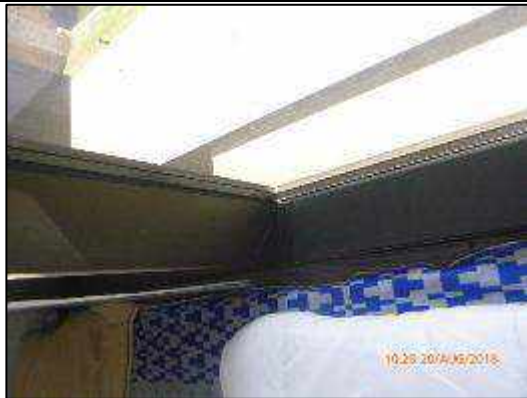
A close-up photograph showing a dark, possibly black, window frame or door frame. The frame is set against a light-colored, slightly textured wall. The lighting is bright, coming from the right, creating a strong highlight on the wall and casting a shadow of the frame. In the bottom right corner, there is a small orange timestamp that reads "10/27 20/AUG/2018".
233	Second bedroom window frames	See section 5.7.1	See section 5.7.2

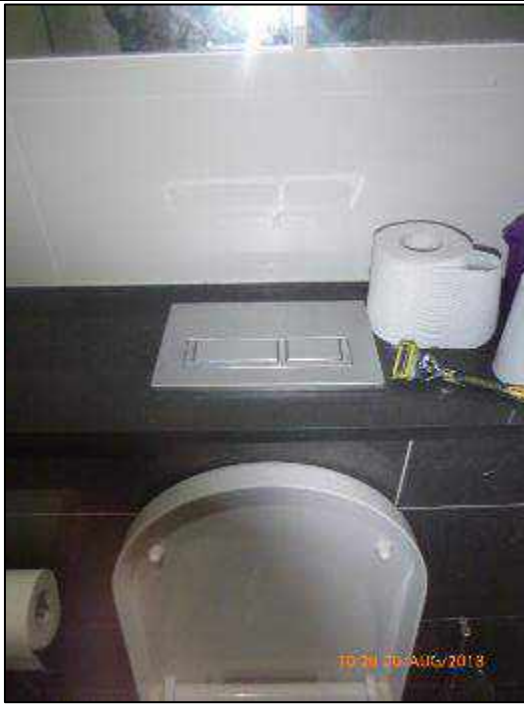
Item	Location	Defect Description and Breach	Rectification	Photograph (if applicable)
234	Main bathroom	<p>Resident advised that toilet flush was not working.</p> <p>Home Building Act (NSW) 1989</p> <ul style="list-style-type: none"> Part 2C, 18B (a) and (b). <p>This item is a defect as the builder has failed to satisfy implied warranty set out in the Home Building Act 1989 – Section 18B Warranties as to residential building work.</p> <p>(b) a warranty that all materials supplied by the holder or person will be good and suitable for the purpose for which they are used and that, unless otherwise stated in the contract, those materials will be new.</p> <p>Loss Suffered</p> <p>Loss suffered is cost of rectification and loss of amenity.</p>	<ol style="list-style-type: none"> 1. Temporary turn off main water supply to the toilet. 2. Carefully remove the flush from the toilet. 3. Supply and install flush to match existing. 4. Secure the flush to the toilet. 5. Turn on main water supply to toilet.

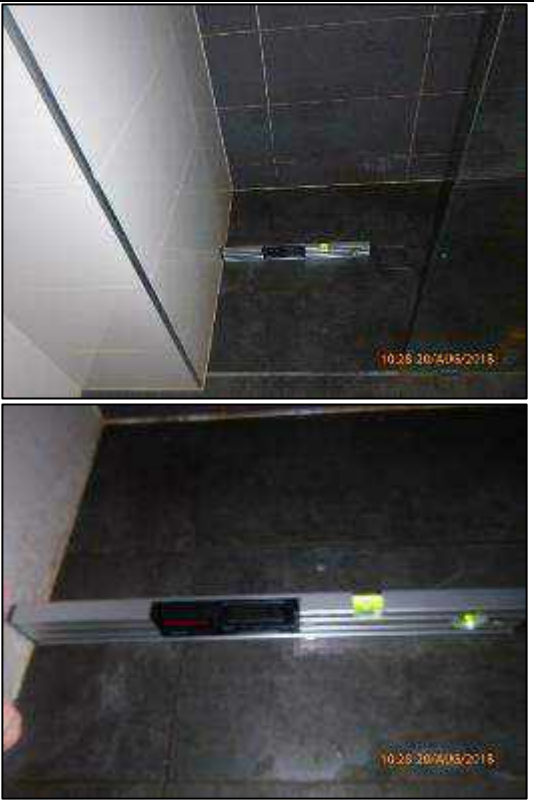
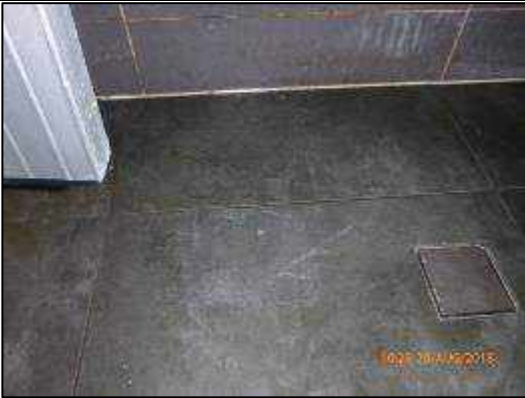
235	Main bathroom	<p>See section 5.1.1 Ponding observed at time of inspection.</p> <p>Falls (mm); 4/1000</p>	See section 5.1.2

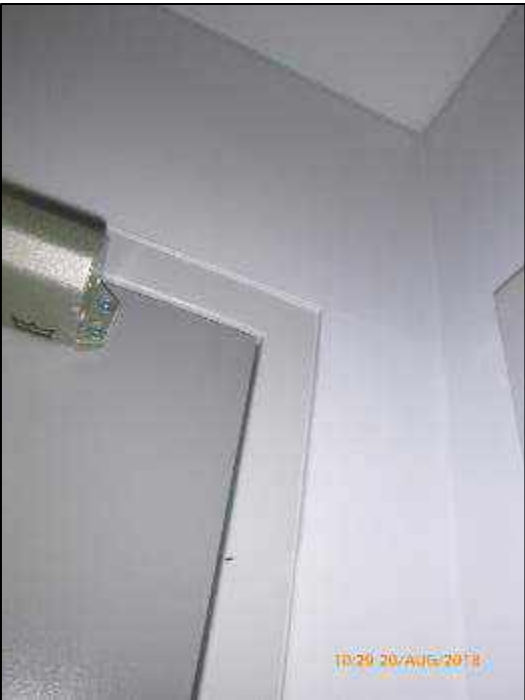
236	Front entry door frame	See section 5.9.1	See section 5.9.2

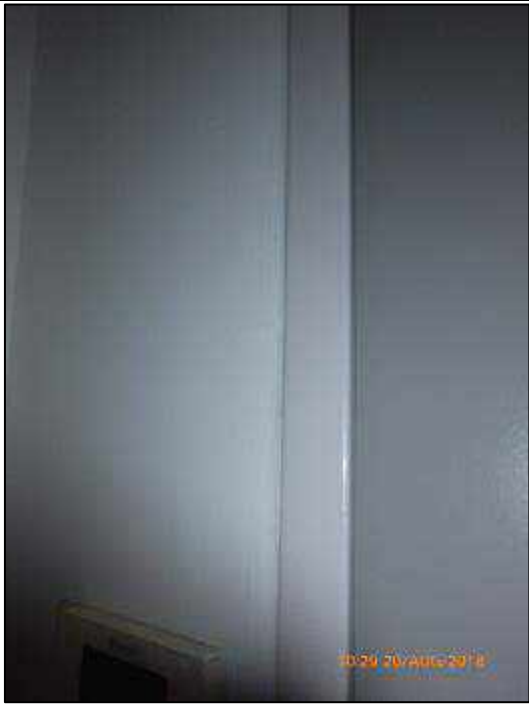
Item	Location	Defect Description and Breach	Rectification	Photograph (if applicable)
237	Wall adjacent to front entry door	See section 5.13.1	See section 5.13.2

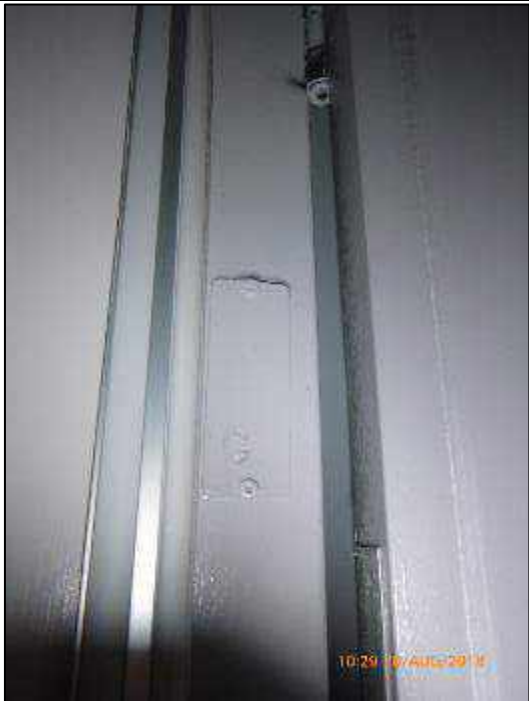
Item	Location	Defect Description and Breach	Rectification	Photograph (if applicable)
238	Front entry door frame	<p>Door frame label has been painted over.</p> <p>Home Building Act (NSW) 1989</p> <ul style="list-style-type: none"> Part 2C, 18B (a) & (c). <p>Loss Suffered Loss suffered is cost of rectification.</p>	Use a suitable cleaning agent to remove paint from the door frame label.

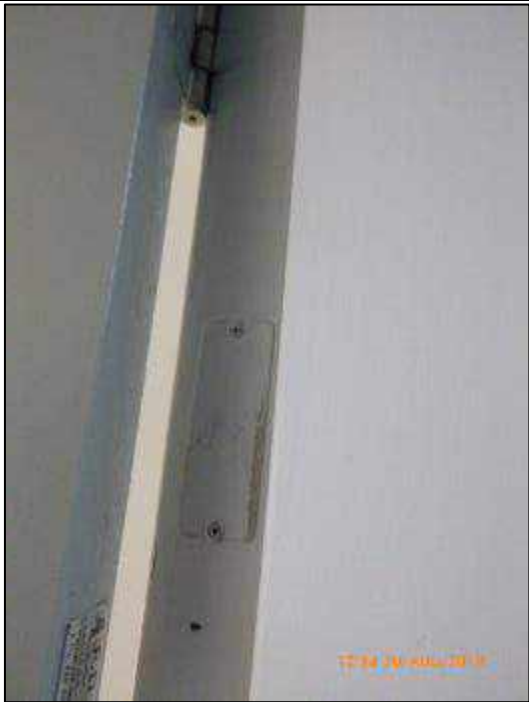
Item	Location	Defect Description and Breach	Rectification	Photograph (if applicable)
240	Front entry door frame	<p>Door frame label has been painted over.</p> <p>Home Building Act (NSW) 1989</p> <ul style="list-style-type: none"> Part 2C, 18B (a) & (c). <p>Loss Suffered</p> <p>Loss suffered is cost of rectification.</p>	Use a suitable cleaning agent to remove paint from the door frame label.

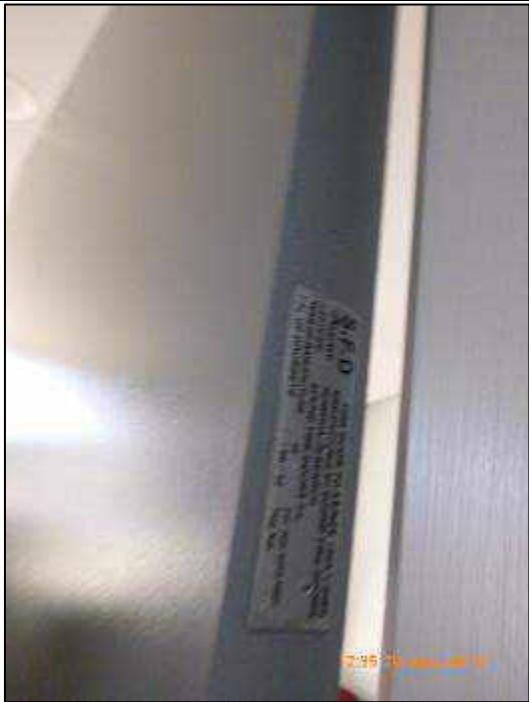
Item	Location	Defect Description and Breach	Rectification	Photograph (if applicable)
241	Front entry door	See section 5.12.1	See section 5.12.2

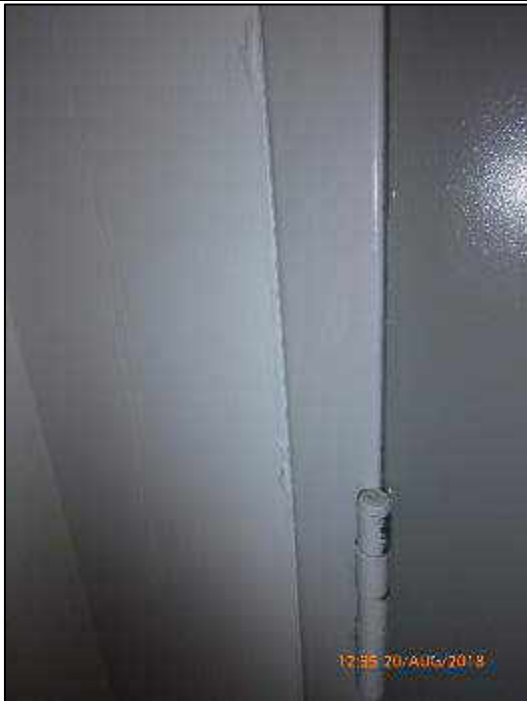
Item	Location	Defect Description and Breach	Rectification	Photograph (if applicable)
242	Wall adjacent to front entry door	See section 5.13.1	See section 5.13.2

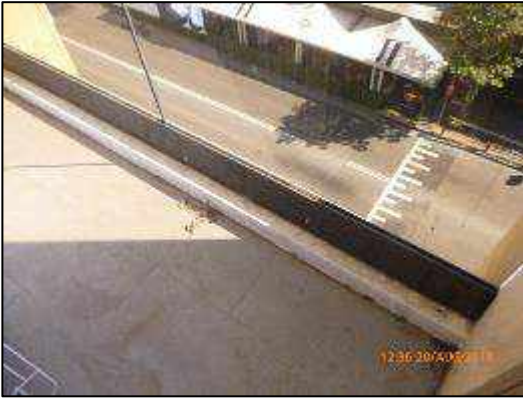
Item	Location	Defect Description and Breach	Rectification	Photograph (if applicable)
244	Balcony	See section 5.3.1	See section 5.3.2

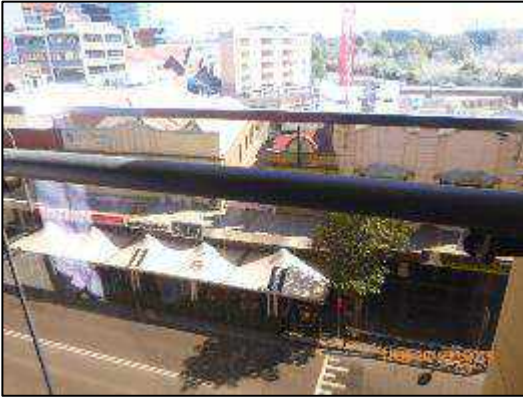
A photograph showing a close-up of a balcony railing. The railing appears to be made of metal or concrete and is situated on a balcony overlooking a street. The railing has a dark, possibly painted, surface. The background shows a paved street and some greenery.
245	Balcony	See section 5.4.1	See section 5.4.2

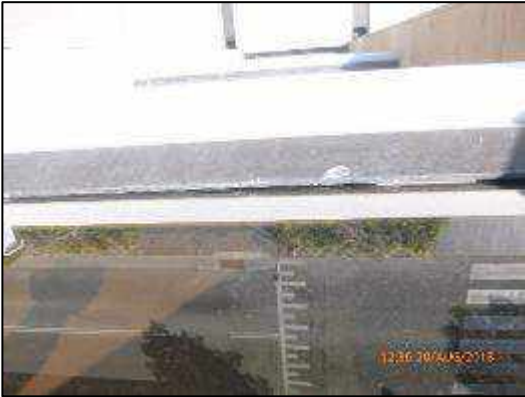
Item	Location	Defect Description and Breach	Rectification	Photograph (if applicable)
246	Balcony balustrade	See section 5.9.1	See section 5.9.2

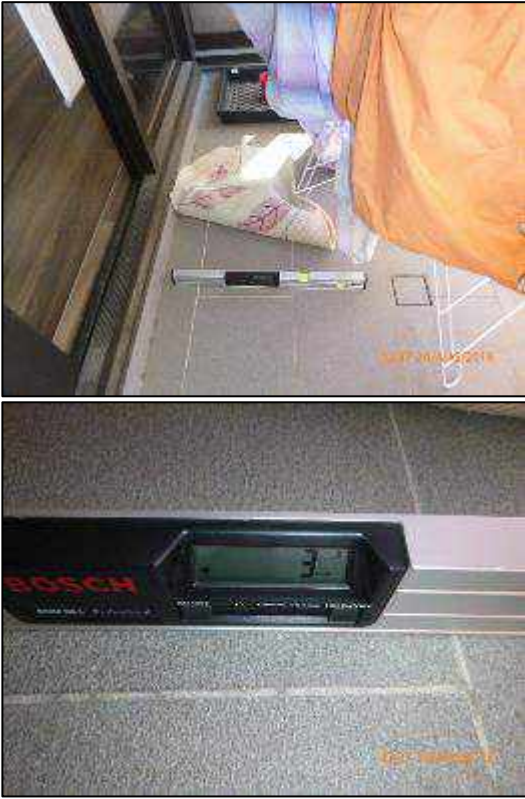
Item	Location	Defect Description and Breach	Rectification	Photograph (if applicable)
247	Balcony	See section 5.2.1 Falls (mm); 3/1000	See section 5.2.2

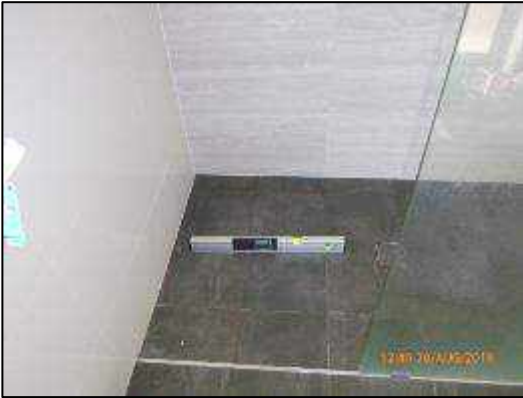
Item	Location	Defect Description and Breach	Rectification	Photograph (if applicable)
248	Main bedroom ensuite	See section 5.1.1 Falls (mm); 1/1000	See section 5.1.2

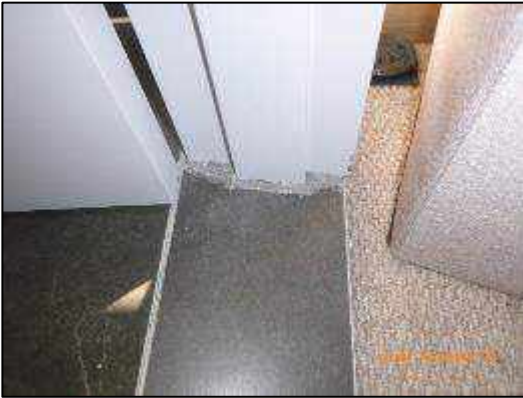
249	Main bedroom ensuite door frame	See section 5.8.1	See section 5.8.2

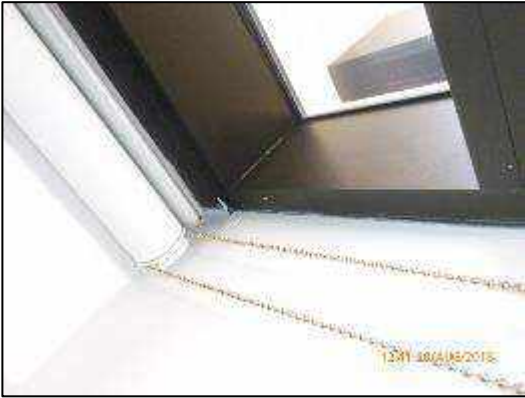
Item	Location	Defect Description and Breach	Rectification	Photograph (if applicable)
250	Main bedroom window frames	See section 5.9.1	See section 5.9.2

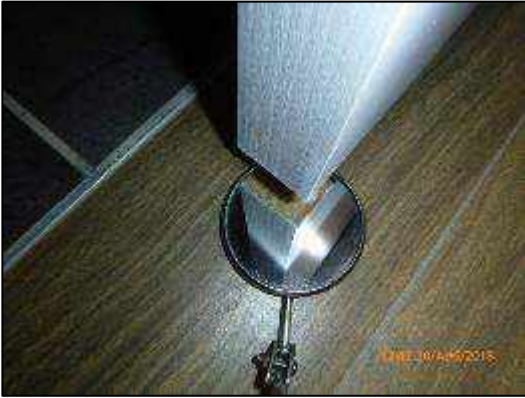
251	Doors throughout the unit (x3)	See section 5.5.1	See section 5.5.2

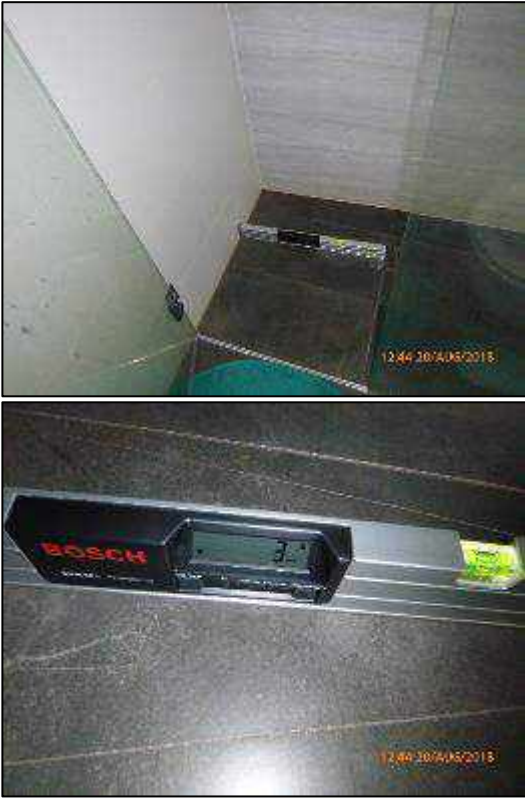
Item	Location	Defect Description and Breach	Rectification	Photograph (if applicable)
252	Main bathroom	See section 5.1.1 Falls (mm); 3/1000	See section 5.1.2

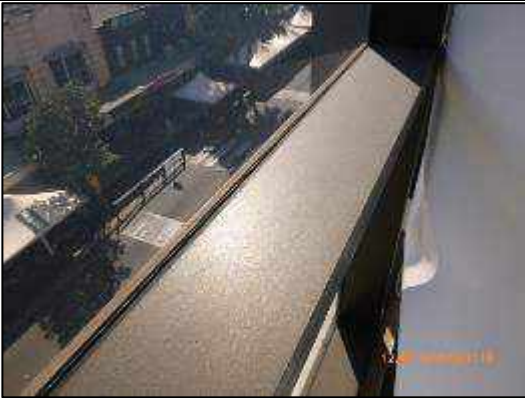
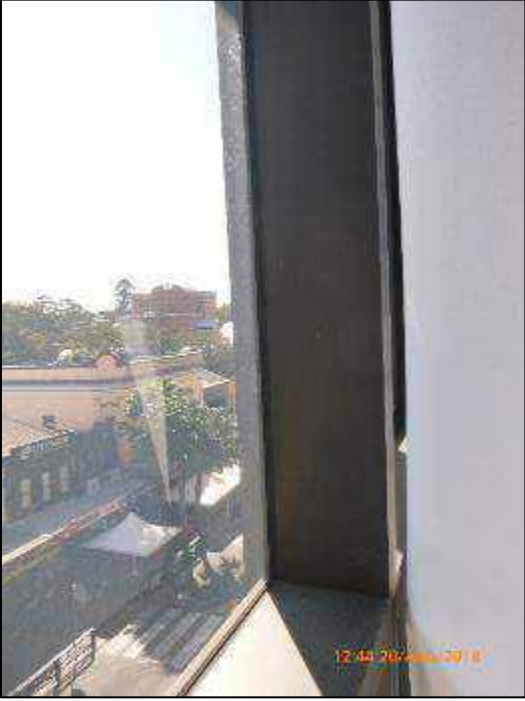
Item	Location	Defect Description and Breach	Rectification	Photograph (if applicable)
253	Second bedroom window frames	See section 5.7.1	See section 5.7.2

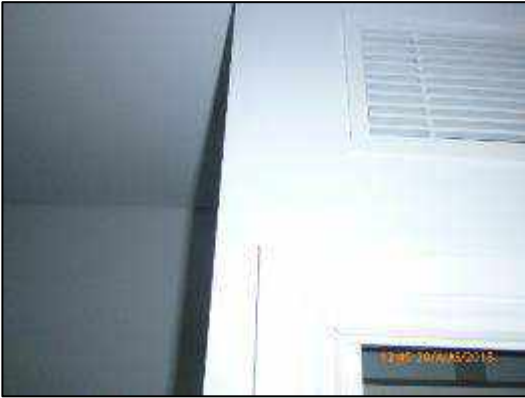
Item	Location	Defect Description and Breach	Rectification	Photograph (if applicable)
254	Second bedroom wall above built in	See section 5.10.1	See section 5.10.2

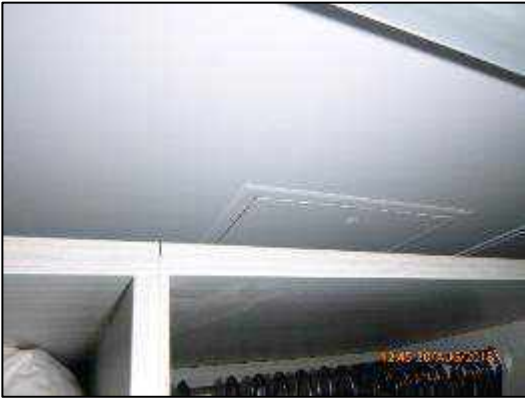
A photograph showing a vertical crack or gap in a white wall, with a window visible above the defect. A timestamp '12:45 10/04/2018' is visible in the bottom right corner.
255	Second bedroom built in	See section 5.6.1	See section 5.6.2

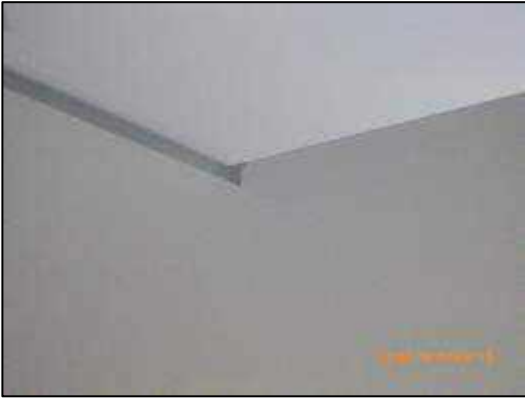
Item	Location	Defect Description and Breach	Rectification	Photograph (if applicable)
256	Lounge room	See section 5.11.1	See section 5.11.2

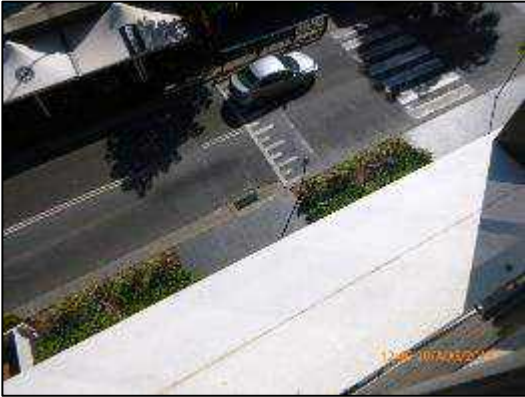
257	Façade outside kitchen area	<p>Construction debris observed on the external façade.</p> <p>Home Building Act (NSW) 1989</p> <ul style="list-style-type: none"> Part 2C, 18B (a) and (c). <p>This is a breach of part (a) of the act because the surface has not been finished in a proper workmanlike manner that would prevent loss of appearance to the surface.</p> <p>Loss Suffered Loss suffered is cost of rectification.</p>	<ol style="list-style-type: none"> 1. Protect all adjoining surfaces. 2. Use a suitable cleaning agent to remove residue and clear debris. 3. Clean up the work area.

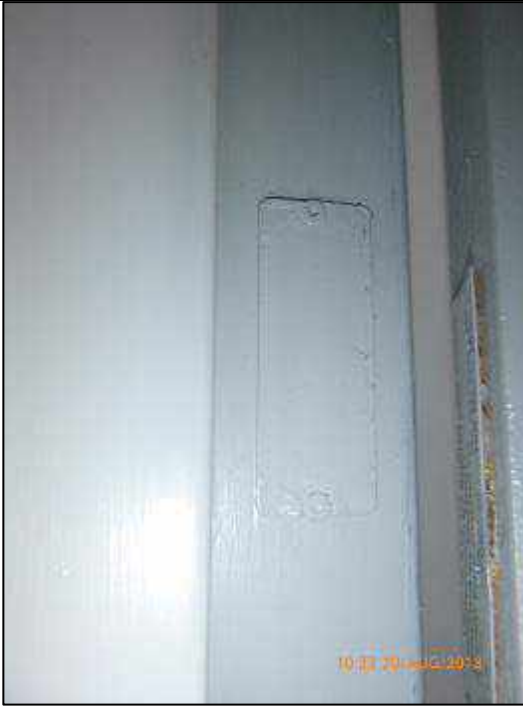
Item	Location	Defect Description and Breach	Rectification	Photograph (if applicable)
258	Front entry door frame	<p>Door frame label has been painted over.</p> <p>Home Building Act (NSW) 1989</p> <ul style="list-style-type: none"> Part 2C, 18B (a) & (c). <p>Loss Suffered Loss suffered is cost of rectification.</p>	Use a suitable cleaning agent to remove paint from the door frame label.

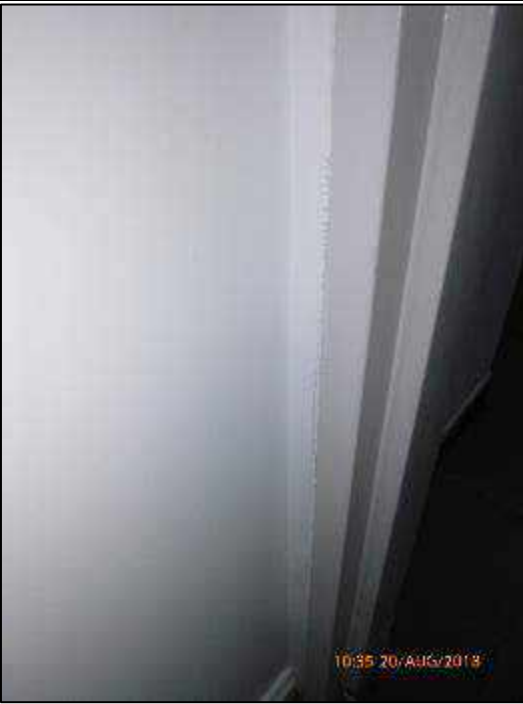
Item	Location	Defect Description and Breach	Rectification	Photograph (if applicable)
261	Wall adjacent to front entry door	See section 5.13.1	See section 5.13.2

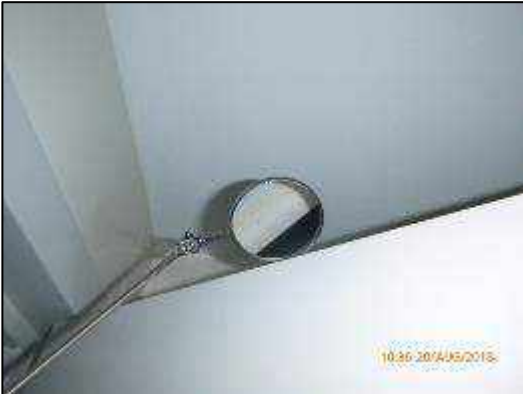
Item	Location	Defect Description and Breach	Rectification	Photograph (if applicable)
263	Doors throughout the unit (x3)	See section 5.5.1	See section 5.5.2

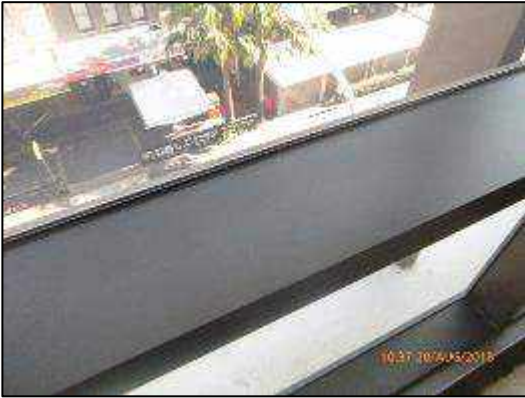
Item	Location	Defect Description and Breach	Rectification	Photograph (if applicable)
265	Lounge room window frames	See section 5.7.1	See section 5.7.2

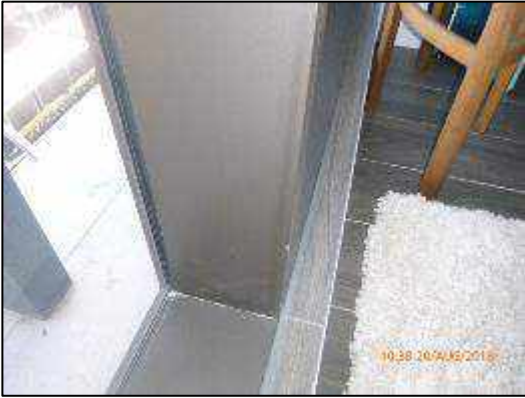
A photograph showing a close-up of a dark-colored window frame. The frame appears to be made of metal or a similar material. There is a visible gap or separation between the frame and the surrounding structure. A timestamp '10/31/10/AUSQ2018' is visible in the bottom right corner of the image.
266	Lounge room window frames	See section 5.8.1	See section 5.8.2

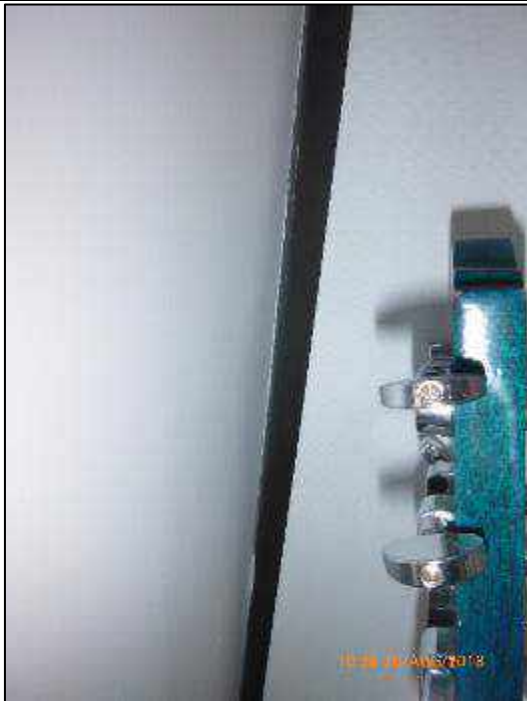
Item	Location	Defect Description and Breach	Rectification	Photograph (if applicable)
267	Lounge room window frames	See section 5.9.1	See section 5.9.2

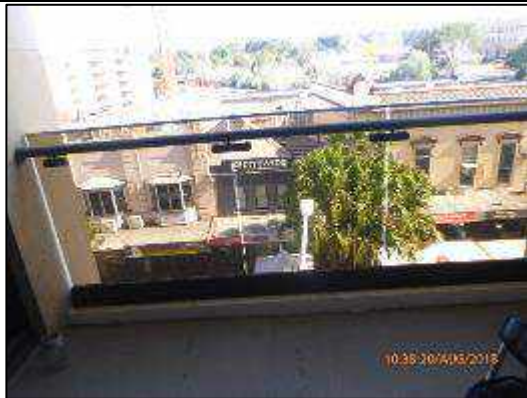
268	Balcony	See section 5.3.1	See section 5.3.2

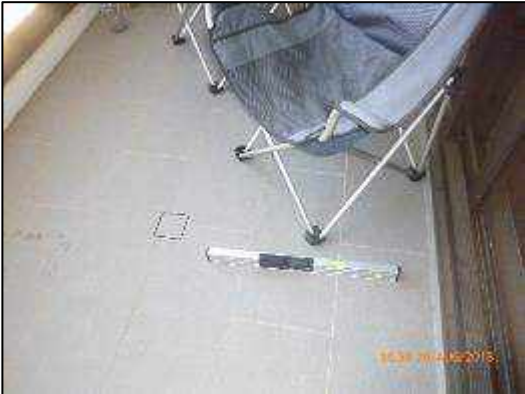
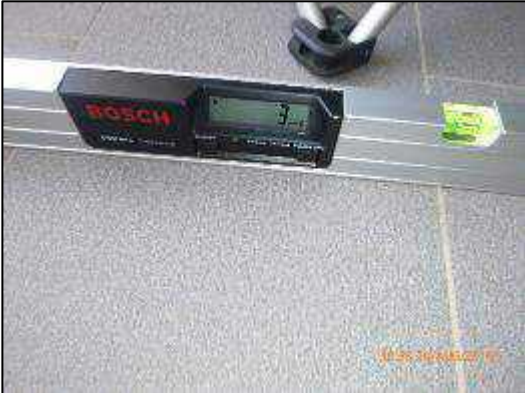
Item	Location	Defect Description and Breach	Rectification	Photograph (if applicable)
269	Balcony	See section 5.2.1 Falls (mm); 3/1000	See section 5.2.2

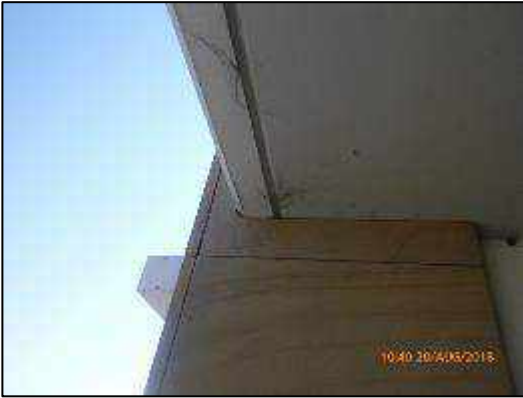
Item	Location	Defect Description and Breach	Rectification	Photograph (if applicable)
270	Balcony blade wall	<p>Drip groove on façade observed to have no stop end.</p> <p>Home Building Act (NSW) 1989</p> <ul style="list-style-type: none"> Part 2C, 18B (a) and (c). <p>Loss Suffered Loss suffered is cost of rectification.</p>	Engage a licenced tradesman to install stop end to drip groove and redirect water in accordance with manufacturers specifications.

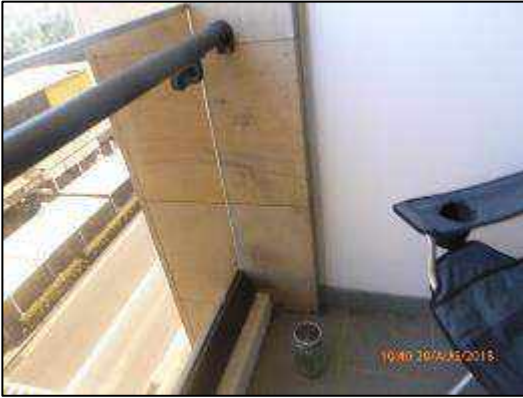
271	Balcony	<p>No weep holes or flashing observed on façade in balcony area.</p> <p>Home Building Act (NSW) 1989</p> <ul style="list-style-type: none"> Part 2C, 18B (a) and (c). <p>Loss Suffered Loss suffered is cost of rectification.</p>	<ol style="list-style-type: none"> 1. Remove sandstone tiles on wall in balcony area. 2. Engage a licenced tradesman to install flashing and produce weep holes. 3. Re-instate the sandstone tiles with weep holes. 4. Clean up the work area.

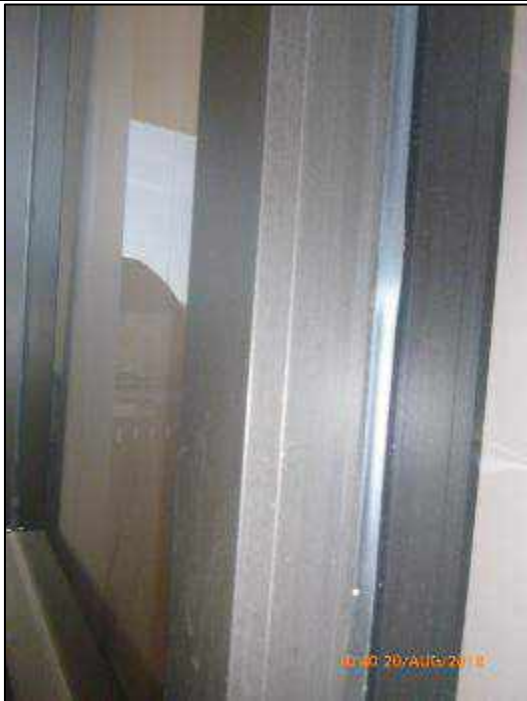
Item	Location	Defect Description and Breach	Rectification	Photograph (if applicable)
272	Balcony sliding door frame	See section 5.7.1	See section 5.7.2

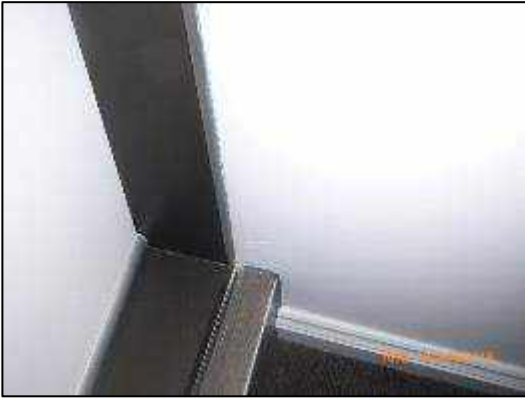
Item	Location	Defect Description and Breach	Rectification	Photograph (if applicable)
274	Wall adjacent to second bedroom window	See section 5.13.1	See section 5.13.2

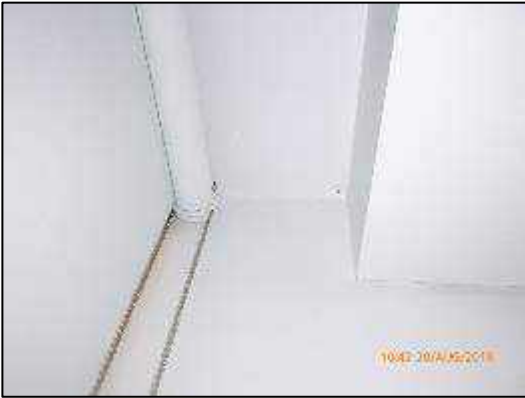
275	Second bedroom window bulkhead	See section 5.13.1	See section 5.13.2

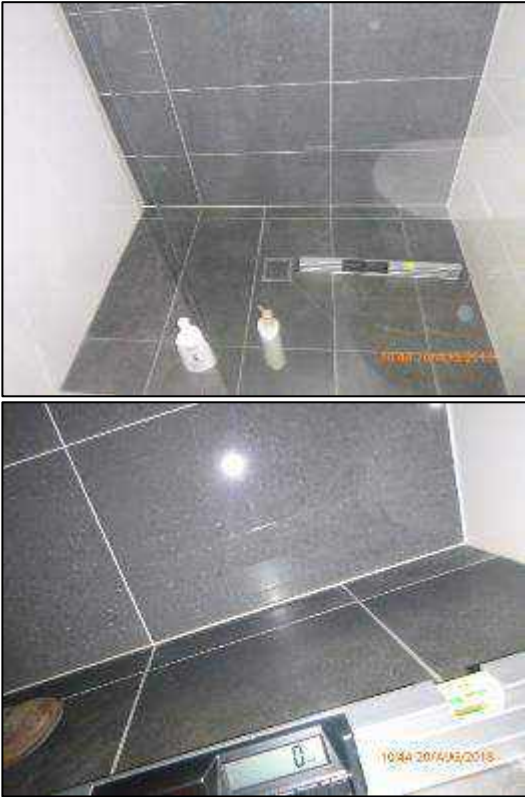
Item	Location	Defect Description and Breach	Rectification	Photograph (if applicable)
276	Main bathroom	See section 5.1.1 Falls (mm); 0/1000	See section 5.1.2

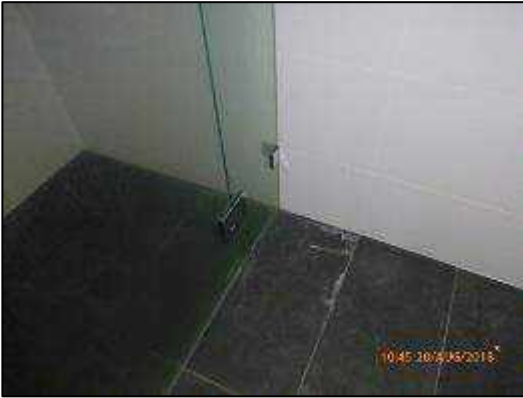
Item	Location	Defect Description and Breach	Rectification	Photograph (if applicable)
277	Main bedroom ensuite	<p>Water egress observed outside of shower recess.</p> <p>Home Building Act (NSW) 1989</p> <ul style="list-style-type: none"> Part 2C, 18B (a), (b) and (c). <p>Building Code of Australia</p> <ul style="list-style-type: none"> Section F Health and Amenity Part F1 Damp and Weatherproofing Sections FO1, FF1.3. <p>This is a breach because the building is not constructed in a manner so as to prevent moisture escaping from the ensuite wet area.</p> <p>Loss Suffered</p> <p>Loss suffered is cost of rectification and loss of amenity to unit occupants.</p>	Remove tiles/fixtures within the shower enclosure to allow provision of suitable new waterproofing membrane system to the wet area. Replace tiles and refit shower fixtures on completion of tiling.

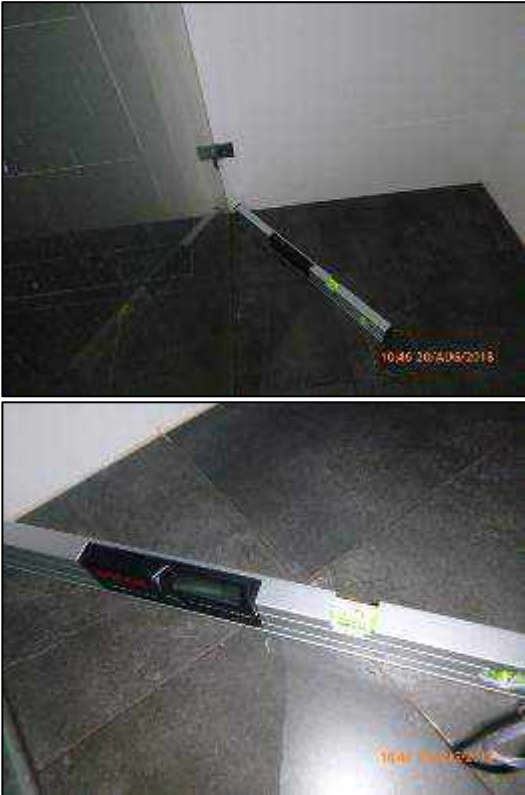
Item	Location	Defect Description and Breach	Rectification	Photograph (if applicable)
278	Main bedroom ensuite	See section 5.1.1 Ponding observed at the time of inspection. Reverse falls (mm); 3/1000	See section 5.1.2

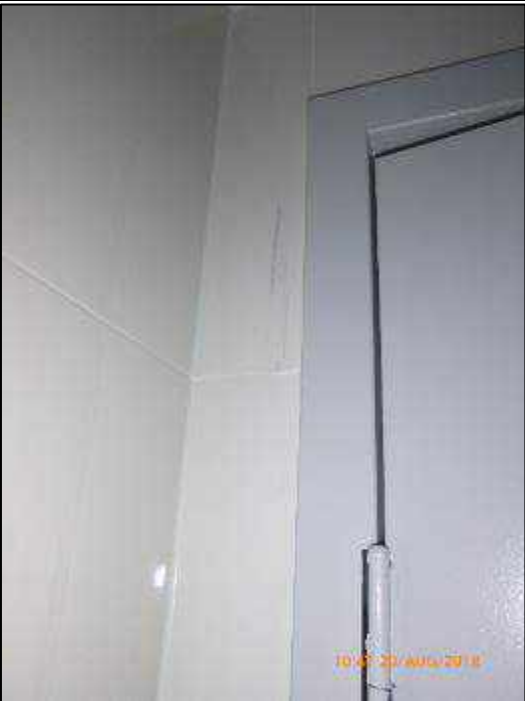
Item	Location	Defect Description and Breach	Rectification	Photograph (if applicable)
279	Main bedroom ensuite	See section 5.9.1	See section 5.9.2

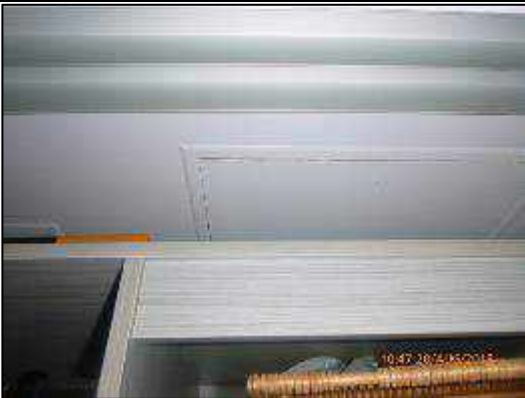
A photograph showing a corner of a room with white walls. There is a visible vertical crack or crease in the wall. A timestamp '10/07/2018' is visible in the bottom right corner of the photo.
280	Main bedroom built in	See section 5.6.1	See section 5.6.2

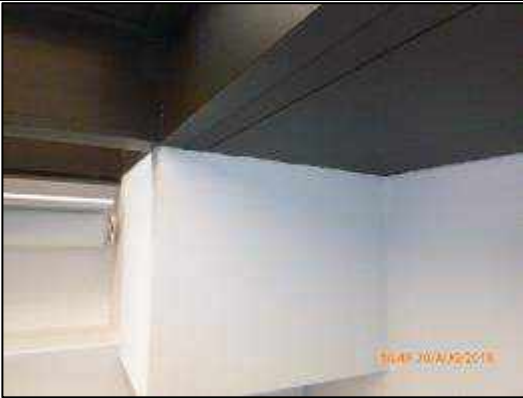
Item	Location	Defect Description and Breach	Rectification	Photograph (if applicable)
281	Main bedroom window bulkhead	See section 5.13.1	See section 5.13.2

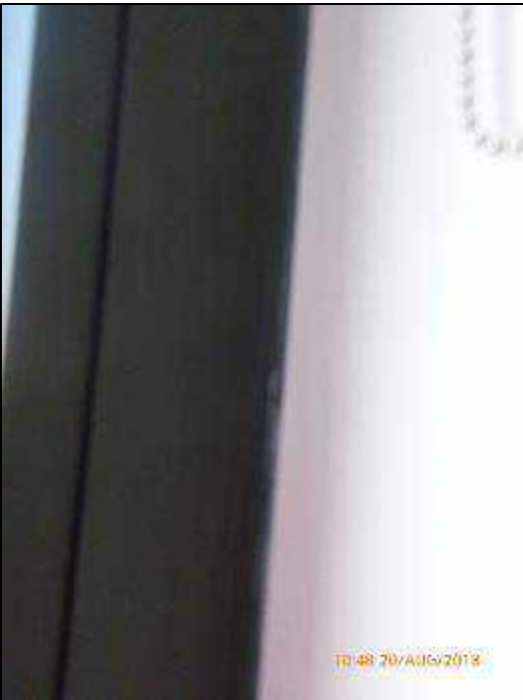
A photograph showing a white, rectangular window bulkhead or partition in a room. The bulkhead is positioned against a wall, and a window is visible in the background. A date stamp '10/48 20/AUG/2018' is visible in the bottom right corner of the image.
282	Main bedroom window frames	See section 5.9.1	See section 5.9.2

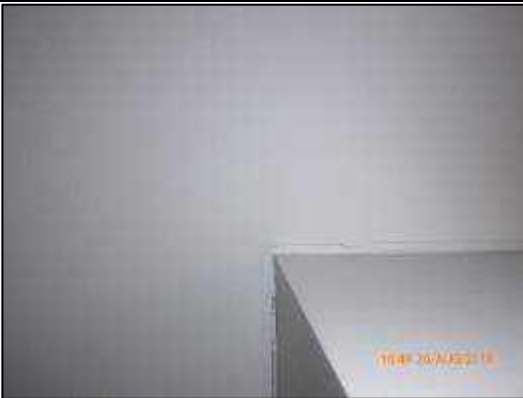
A photograph showing a close-up of a white ceiling. There is a small, dark, circular mark or hole in the center of the frame. A timestamp '10/04/2018' is visible in the bottom right corner of the photo.
284	Main bedroom ceiling	See section 5.13.1	See section 5.13.2	N/A
285	Main bedroom	See section 5.11.1	See section 5.11.2

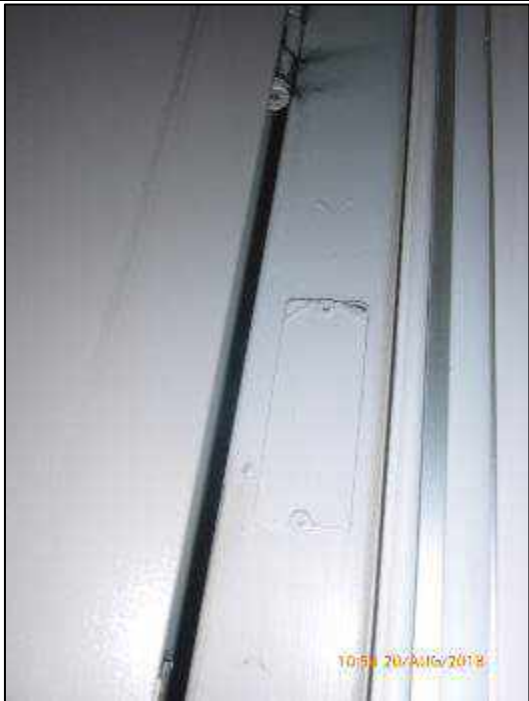
Item	Location	Defect Description and Breach	Rectification	Photograph (if applicable)
286	Front entry door frame	<p>Door frame label has been painted over.</p> <p>Home Building Act (NSW) 1989</p> <ul style="list-style-type: none"> Part 2C, 18B (a) & (c). <p>Loss Suffered Loss suffered is cost of rectification.</p>	Use a suitable cleaning agent to remove paint from the door frame label.

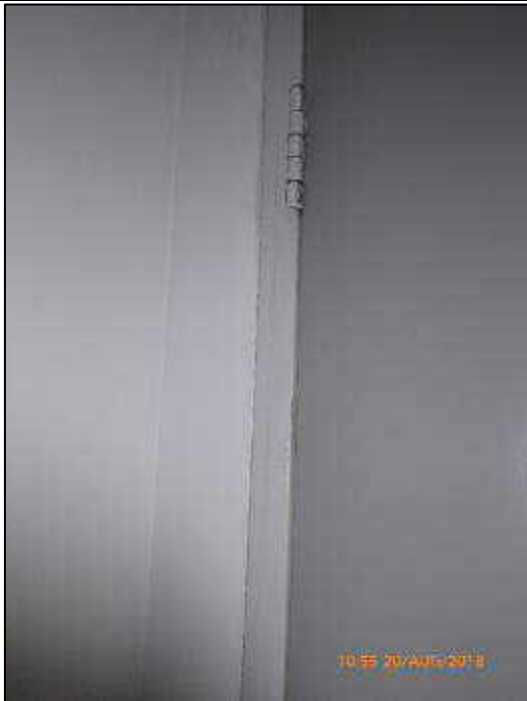
Item	Location	Defect Description and Breach	Rectification	Photograph (if applicable)
288	Wall adjacent to front entry door	See section 5.13.1	See section 5.13.2

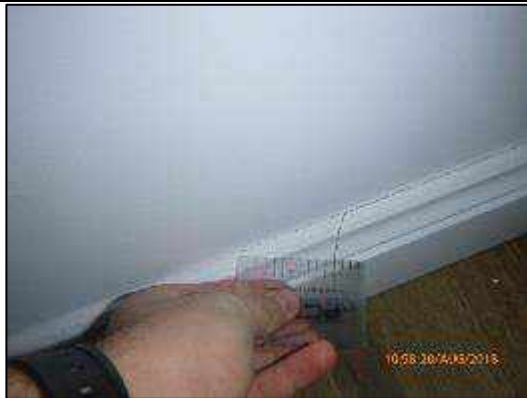
289	Front entrance hallway skirting board	See section 5.14.1 Separation; 1mm	See section 5.14.2

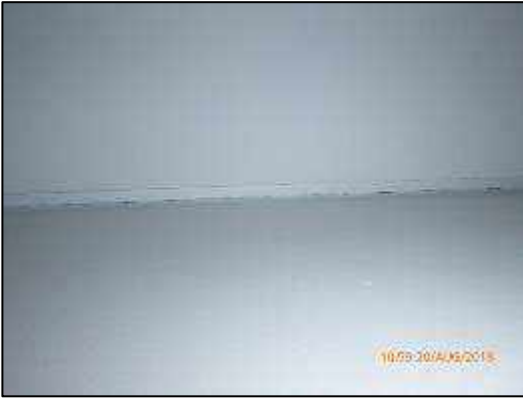
Item	Location	Defect Description and Breach	Rectification	Photograph (if applicable)
290	Lounge room	See section 5.11.1	See section 5.11.2

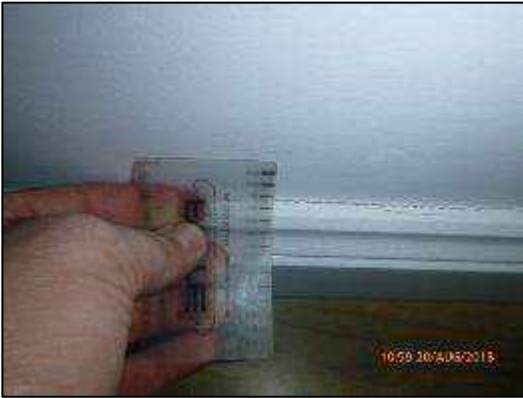
291	Lounge room skirting board	See section 5.14.1 Separation; 1.5mm	See section 5.14.2

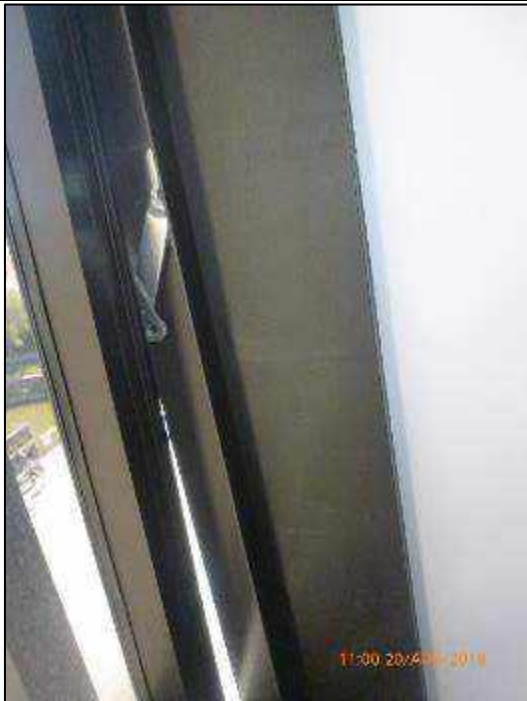
Item	Location	Defect Description and Breach	Rectification	Photograph (if applicable)
292	<i>Kitchen window frame</i>	See section 5.7.1	See section 5.7.2

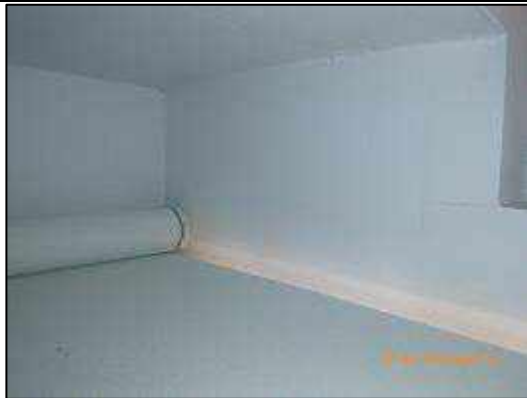
293	<i>Kitchen window bulkhead</i>	See section 5.13.1	See section 5.13.2
