SydneyStrataReport

STRATA REPORT

Client	Church Street Parramatta Property Pty Ltd
Address of property	Unit 3303/330 Church Street, Parramatta, NSW.
Lot	359
Strata Plan	SP 94469
Name of Strata Management Co.	NSW Strata
Telephone Number of Strata Agent	8980 1841
Report Date	15 February 2024

BUILDING DEFECTS REPORT Part 1/2

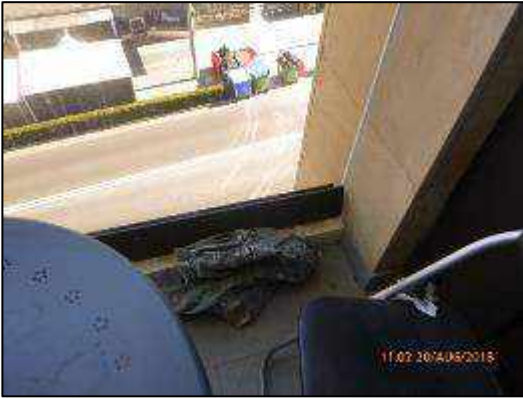
Item	Location	Defect Description and Breach	Rectification	Photograph (if applicable)
294	Balcony	See section 5.3.1	See section 5.3.2

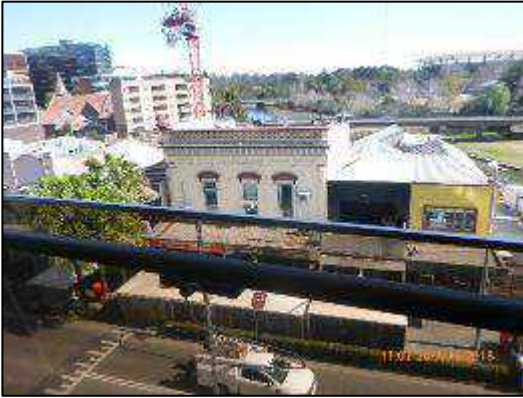
295	Balcony	See section 5.4.1	See section 5.4.2

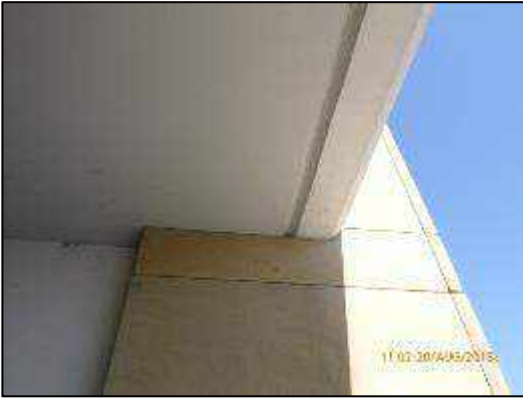
Item	Location	Defect Description and Breach	Rectification	Photograph (if applicable)
296	Balcony	<p>Drip groove on façade observed to have no stop end.</p> <p>Home Building Act (NSW) 1989</p> <ul style="list-style-type: none"> Part 2C, 18B (a) and (c). <p>Loss Suffered Loss suffered is cost of rectification.</p>	Engage a licenced tradesman to install stop end to drip groove and redirect water in accordance with manufacturers specifications.

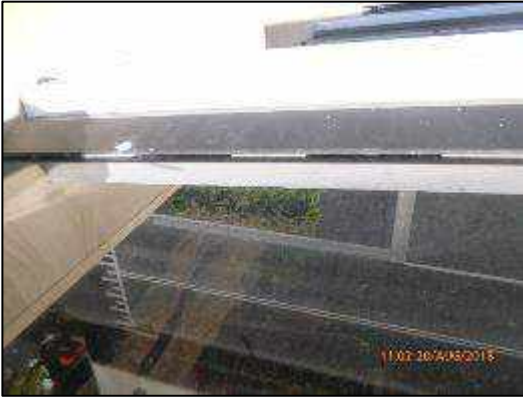
297	Balcony balustrade	See section 5.9.1	See section 5.9.2

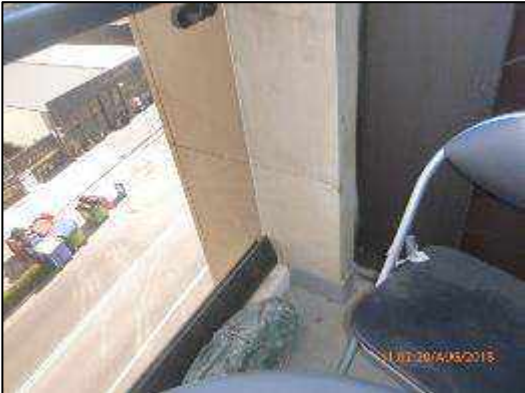
Item	Location	Defect Description and Breach	Rectification	Photograph (if applicable)
298	Balcony	<p>No weep holes or flashing observed on façade in balcony area.</p> <p>Home Building Act (NSW) 1989</p> <ul style="list-style-type: none"> Part 2C, 18B (a) and (c). <p>Loss Suffered Loss suffered is cost of rectification.</p>	<ol style="list-style-type: none"> 1. Remove sandstone tiles on wall in balcony area. 2. Engage a licenced tradesman to install flashing and produce weep holes. 3. Re-instate the sandstone tiles with weep holes. 4. Clean up the work area.

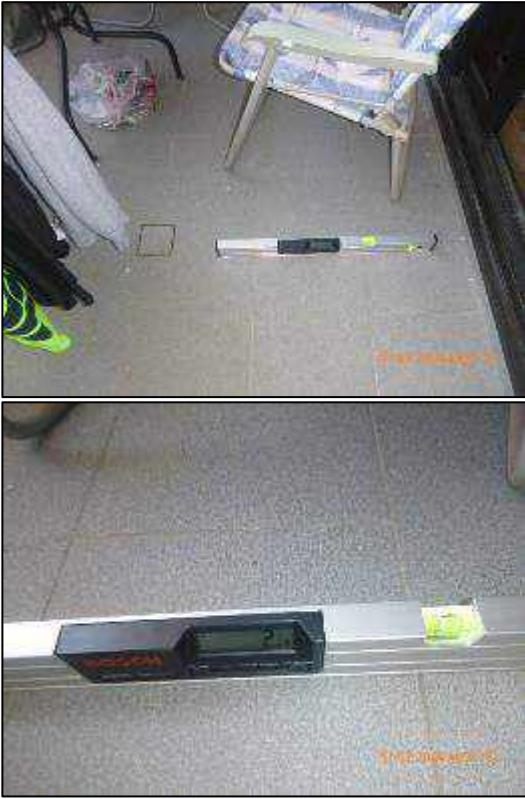
Item	Location	Defect Description and Breach	Rectification	Photograph (if applicable)
299	Balcony	See section 5.2.1 Falls (mm); 2/1000	See section 5.2.2

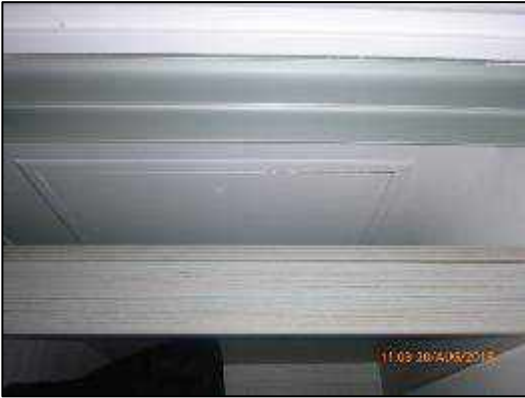
Item	Location	Defect Description and Breach	Rectification	Photograph (if applicable)
300	<i>Second bedroom built in</i>	See section 5.6.1	See section 5.6.2

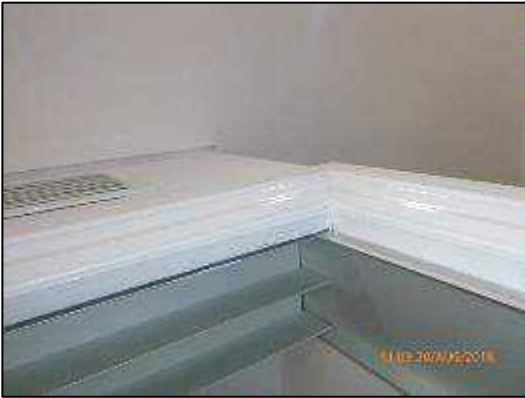
301	<i>Second bedroom built in</i>	See section 5.13.1	See section 5.13.2

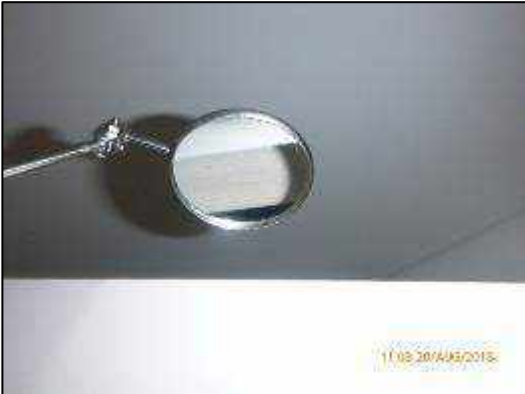
Item	Location	Defect Description and Breach	Rectification	Photograph (if applicable)
302	<i>Doors throughout unit (x4)</i>	See section 5.5.1	See section 5.5.2

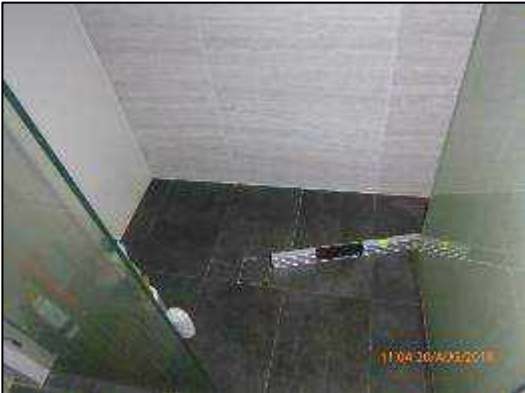
303	<i>Main bathroom</i>	See section 5.1.1 Falls (mm); 3/1000	See section 5.1.2

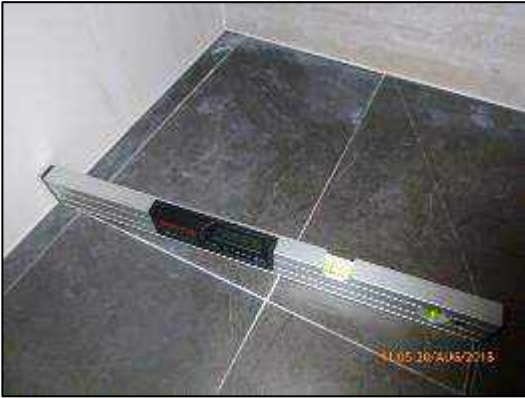
Item	Location	Defect Description and Breach	Rectification	Photograph (if applicable)
304	Main bedroom ensuite	See section 5.1.1 Falls (mm); 7/1000	See section 5.1.2

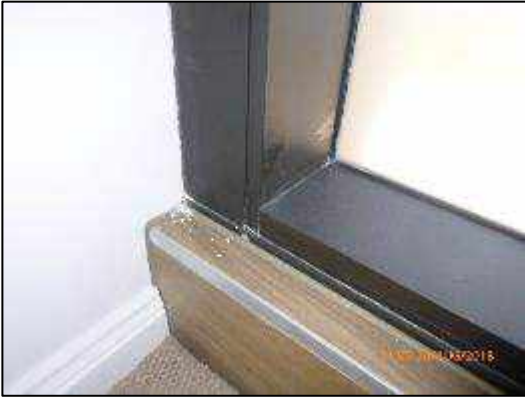
305	Main bedroom window frames	See section 5.8.1	See section 5.8.2

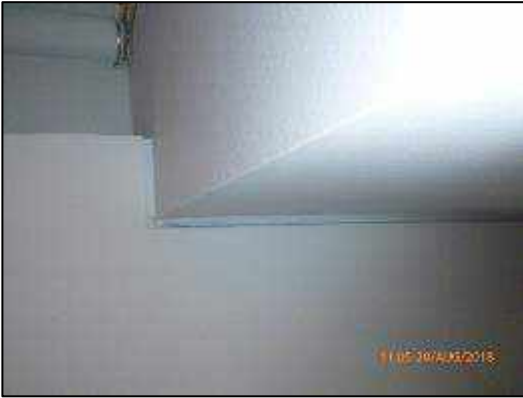
Item	Location	Defect Description and Breach	Rectification	Photograph (if applicable)
306	Main bedroom	See section 5.11.1	See section 5.11.2

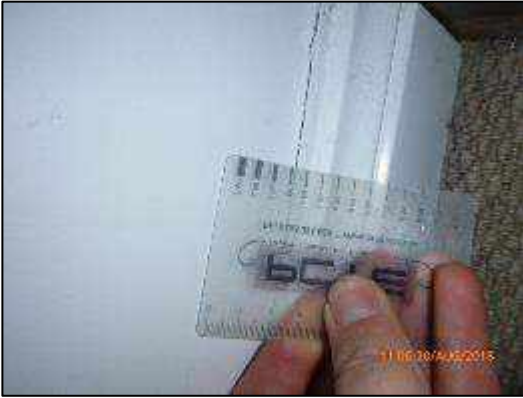
A photograph showing a corner of a room where a wall meets a ceiling. There is a visible gap or defect at the junction. A date stamp '11/05/10/AJG2015' is visible in the bottom right corner.
307	Main bedroom skirting board	See section 5.14.1 Separation; 1mm	See section 5.14.2

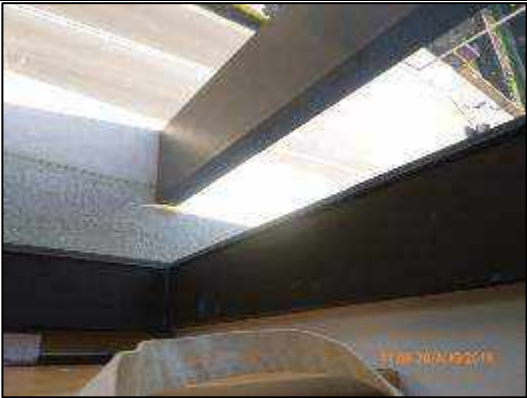
Item	Location	Defect Description and Breach	Rectification	Photograph (if applicable)
308	Main bedroom window frames	See section 5.7.1	See section 5.7.2

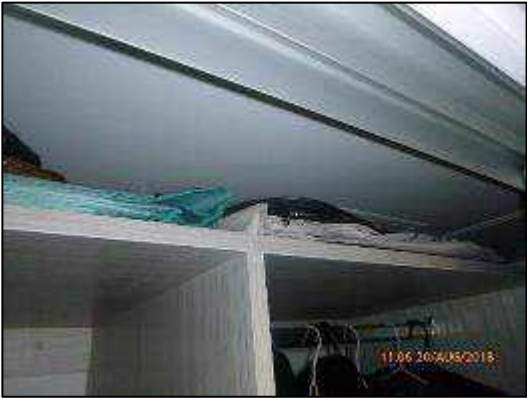
309	Main bedroom built in	See section 5.6.1	See section 5.6.2

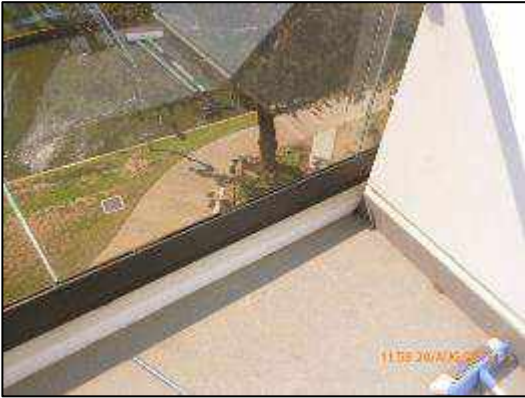
Item	Location	Defect Description and Breach	Rectification	Photograph (if applicable)
310	Balcony	See section 5.3.1	See section 5.3.2

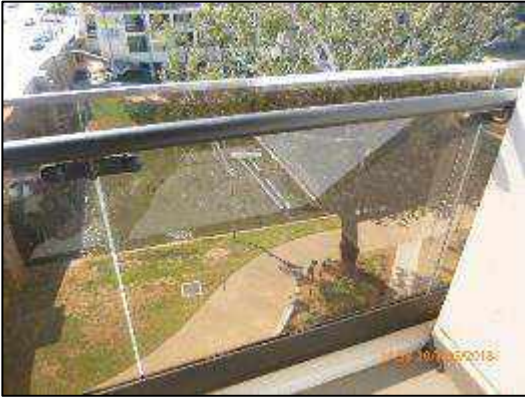
A photograph showing a corner of a balcony with a concrete wall and a metal railing. The view is from the balcony looking out over a grassy area and a road. A date stamp '11/09/2018' is visible in the bottom right corner.
311	Balcony	See section 5.4.1	See section 5.4.2

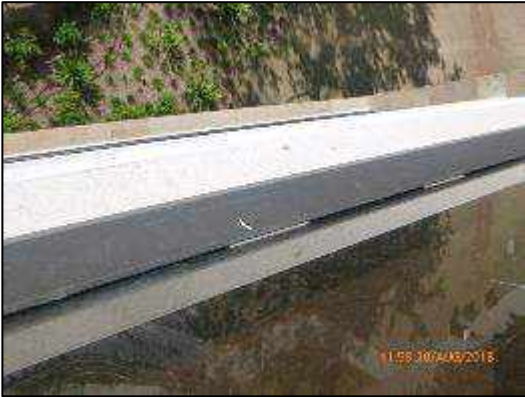
Item	Location	Defect Description and Breach	Rectification	Photograph (if applicable)
312	Balcony balustrade	See section 5.9.1	See section 5.9.2

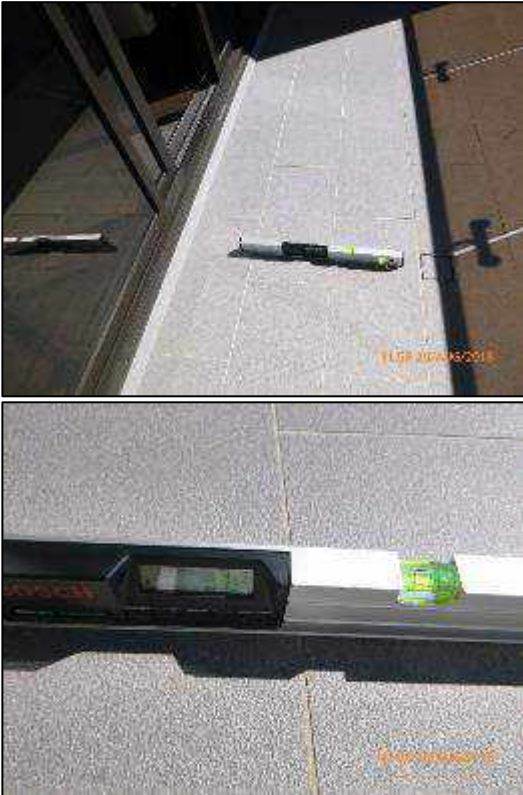
Item	Location	Defect Description and Breach	Rectification	Photograph (if applicable)
313	Balcony	See section 5.2.1 Falls (mm); 7/1000	See section 5.2.2

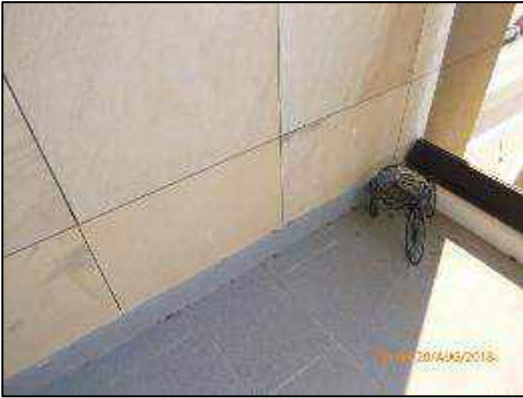
Item	Location	Defect Description and Breach	Rectification	Photograph (if applicable)
314	Balcony	<p>No weep holes or flashing observed on façade in balcony area.</p> <p>Home Building Act (NSW) 1989</p> <ul style="list-style-type: none"> Part 2C, 18B (a) and (c). <p>Loss Suffered Loss suffered is cost of rectification.</p>	<ol style="list-style-type: none"> 1. Remove sandstone tiles on wall in balcony area. 2. Engage a licenced tradesman to install flashing and produce weep holes. 3. Re-instate the sandstone tiles with weep holes. 4. Clean up the work area.

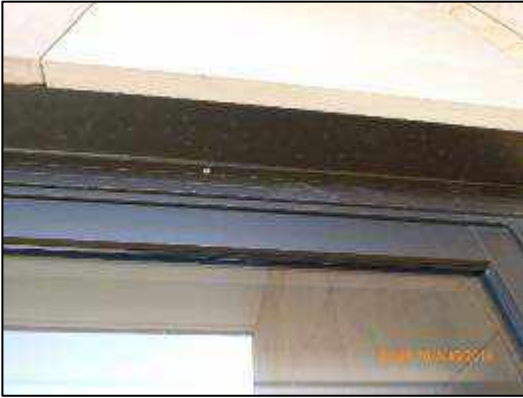
315	Balcony sliding door frame	See section 5.7.1	See section 5.7.2

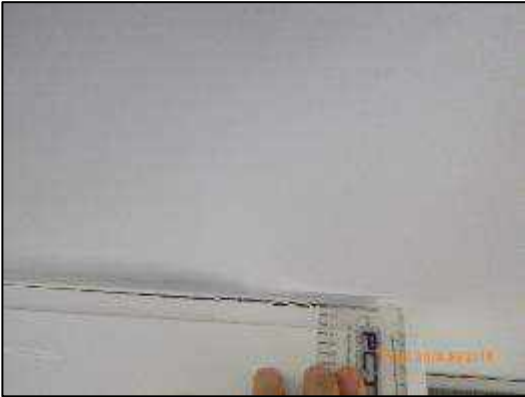
Item	Location	Defect Description and Breach	Rectification	Photograph (if applicable)
318	<i>Ceiling above kitchen cupboards</i>	See section 5.14.1 Separation; 2mm	See section 5.14.2

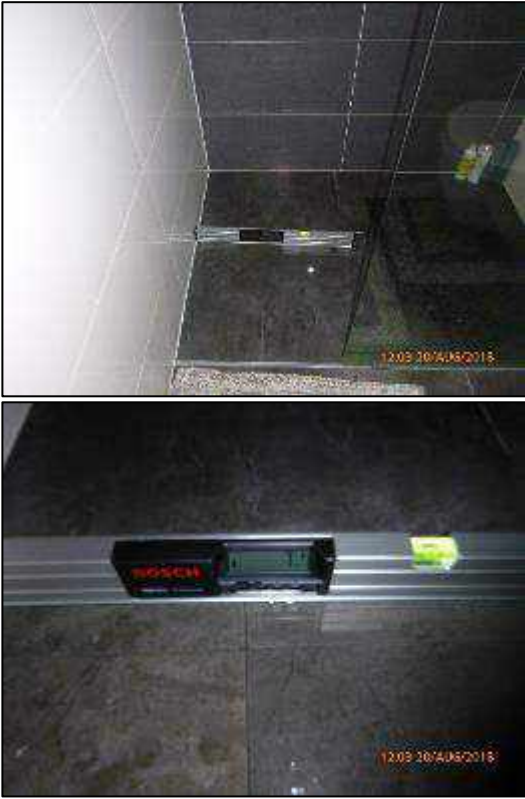
Item	Location	Defect Description and Breach	Rectification	Photograph (if applicable)
319	Main bathroom	See section 5.1.1 Falls (mm); 7/1000	See section 5.1.2

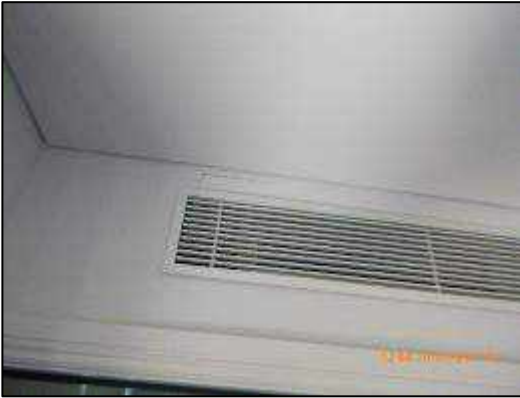
Item	Location	Defect Description and Breach	Rectification	Photograph (if applicable)
320	Main bedroom bulkhead	<p>Damage observed on bulkhead around air conditioner vent</p> <p>Home Building Act (NSW) 1989</p> <ul style="list-style-type: none"> Part 2C, 18B (a) and (c). <p>Guide to Standards and Tolerances 2017 Section 10.14 Cracking in plasterboard, hard plaster and other plaster elements in the Office of fair trading "Guide to standards and tolerances" dated 2017 states that cracking in recessed or butt joints is a defect if visible from a normal viewing position.</p> <p>Loss Suffered Loss suffered is cost of rectification.</p>	<ol style="list-style-type: none"> 1. Protect all surrounding surfaces 2. Remove all existing jointing materials. 3. Ensure the plasterboard sheeting is adequately affixed to supporting structure. 4. Re-set the joint between the plasterboard sheets in accordance with the manufacturer's instructions 5. Repaint the affected ceiling to match existing using suitable interior paint system in accordance with AS2311. 6. Clean up work area.

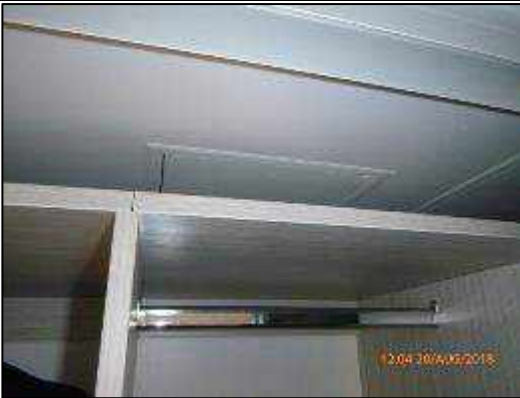
321	Main bedroom built in	See section 5.6.1	See section 5.6.2

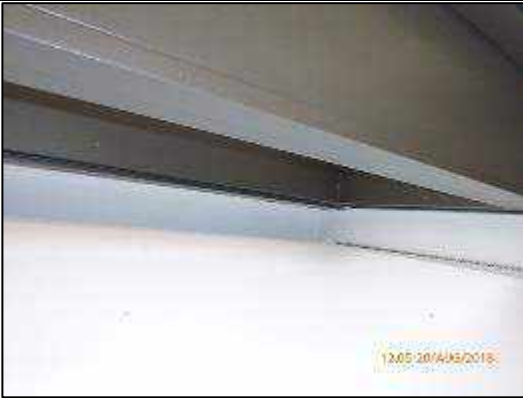
Item	Location	Defect Description and Breach	Rectification	Photograph (if applicable)
322	Main bedroom window bulkhead	See section 5.13.1	See section 5.13.2

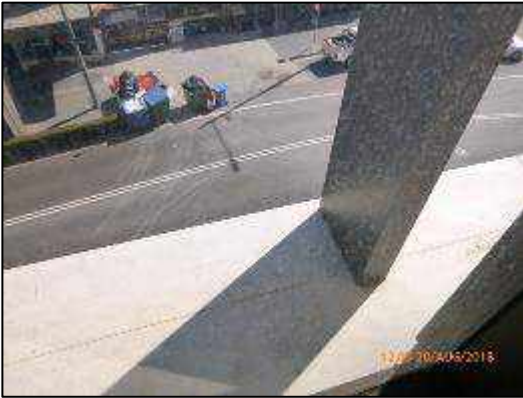
323	Main bedroom external fins	<p>External fins observed to be corroded on the façade of the building.</p> <p>Home Building Act (NSW) 1989 • Part 2C, 18B (a), (b) & (c).</p> <p>This is a breach of part (a) and (b) of the act because the metal fin has corroded as it has not adequately been prepared to resist the effects of a moisture laden environment and is not considered fit for purpose.</p> <p>Loss Suffered Loss suffered is cost of rectification.</p>	<ol style="list-style-type: none"> 1. Protect all adjoining surfaces surrounding the work area. 2. Scrape and clean all corroded metal to external fin. 3. Apply suitable anticorrosive treatment to metal following adequate surface preparation. 4. Fill voids and gaps in door jamb with suitable inert fillers and allow to cure. 5. Smooth down fillers to provide a uniform surface and apply minimum one coat primer and two coats suitable external grade paint.

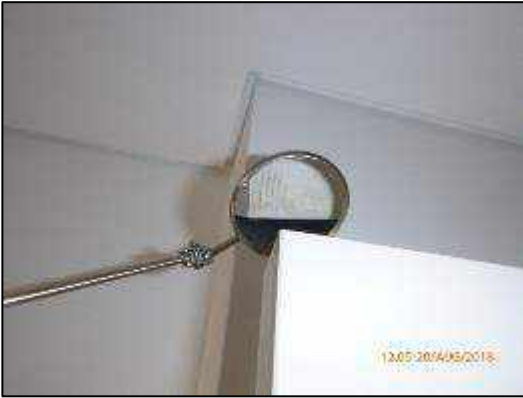
Item	Location	Defect Description and Breach	Rectification	Photograph (if applicable)
324	<i>Doors throughout the unit (x3)</i>	See section 5.5.1	See section 5.5.2

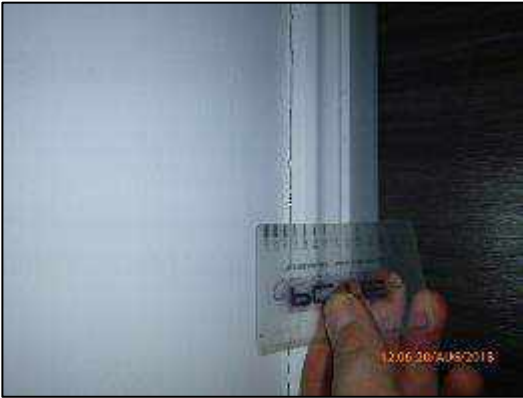
325	<i>Main bedroom door architrave</i>	See section 5.14.1 Separation; 1mm	See section 5.14.2

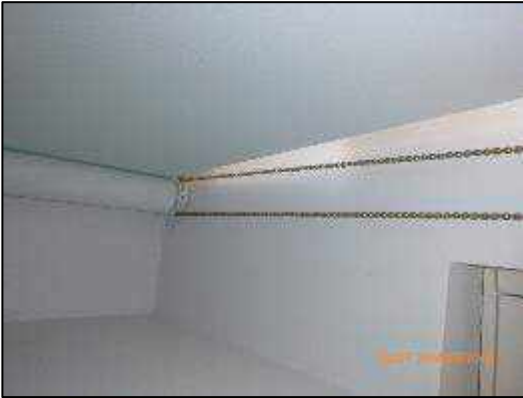
Item	Location	Defect Description and Breach	Rectification	Photograph (if applicable)
326	Main bedroom window bulkhead	See section 5.13.1	See section 5.13.2

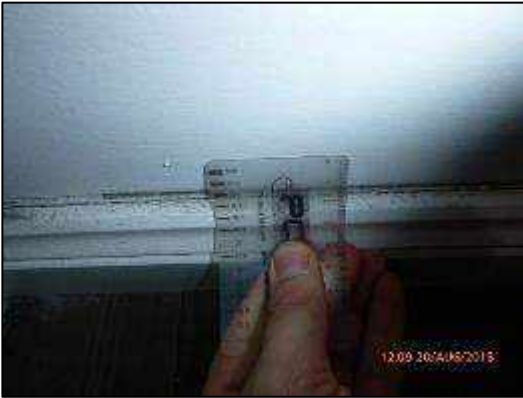
327	Main bedroom skirting board	See section 5.14.1 Separation; 1mm	See section 5.14.2

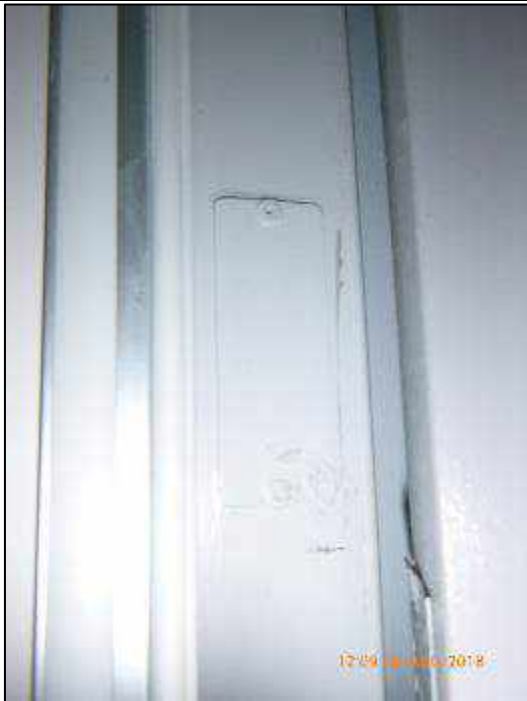
Item	Location	Defect Description and Breach	Rectification	Photograph (if applicable)
328	Front entry door frame	<p>Door frame label has been painted over.</p> <p>Home Building Act (NSW) 1989</p> <ul style="list-style-type: none"> Part 2C, 18B (a) & (c). <p>Loss Suffered</p> <p>Loss suffered is cost of rectification.</p>	Use a suitable cleaning agent to remove paint from the door frame label.

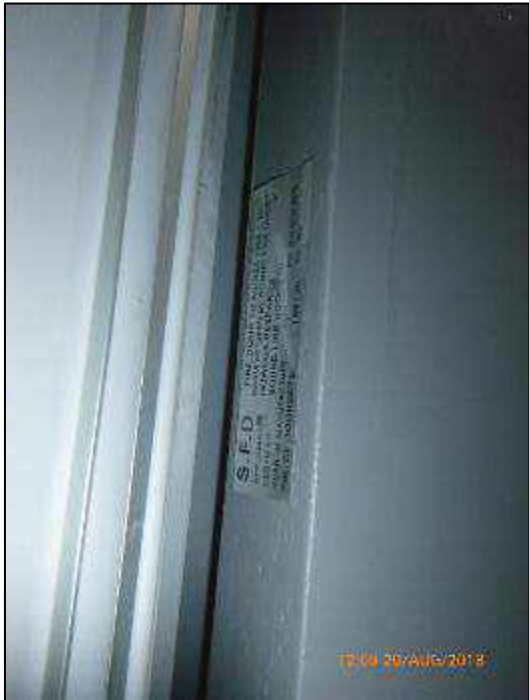
Item	Location	Defect Description and Breach	Rectification	Photograph (if applicable)
329	Front entry door	See section 5.12.1	See section 5.12.2

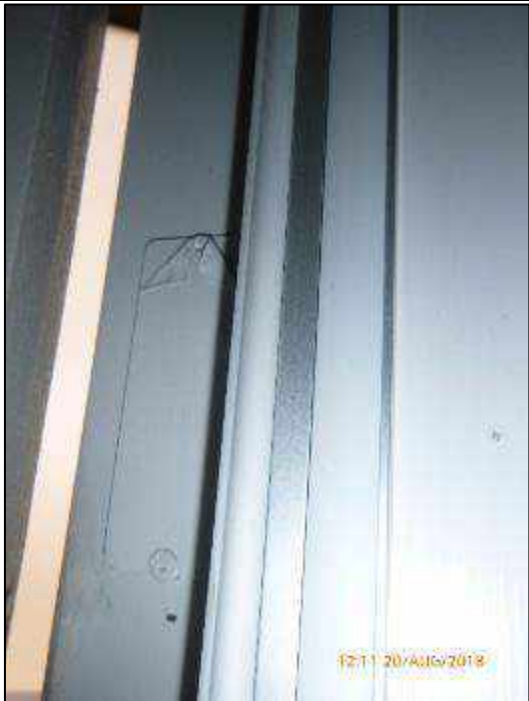
Item	Location	Defect Description and Breach	Rectification	Photograph (if applicable)
330	Front entry door frame	<p>Door frame label has been painted over.</p> <p>Home Building Act (NSW) 1989</p> <ul style="list-style-type: none"> Part 2C, 18B (a) & (c). <p>Loss Suffered Loss suffered is cost of rectification.</p>	Use a suitable cleaning agent to remove paint from the door frame label.

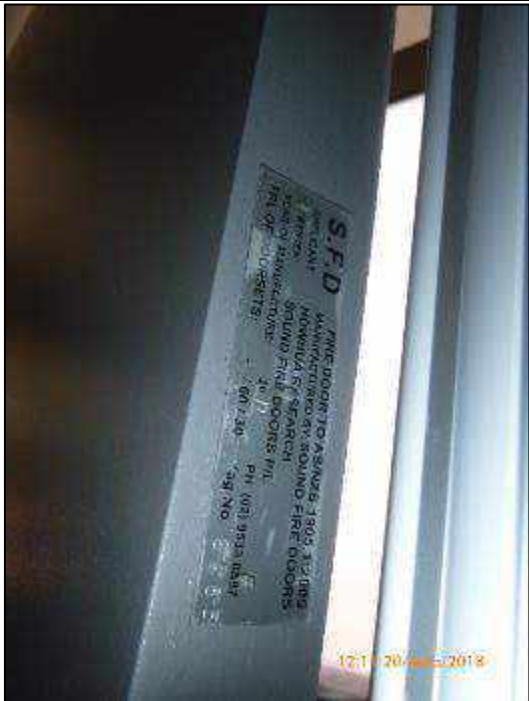
Item	Location	Defect Description and Breach	Rectification	Photograph (if applicable)
331	Front entry door	See section 5.12.1	See section 5.12.2

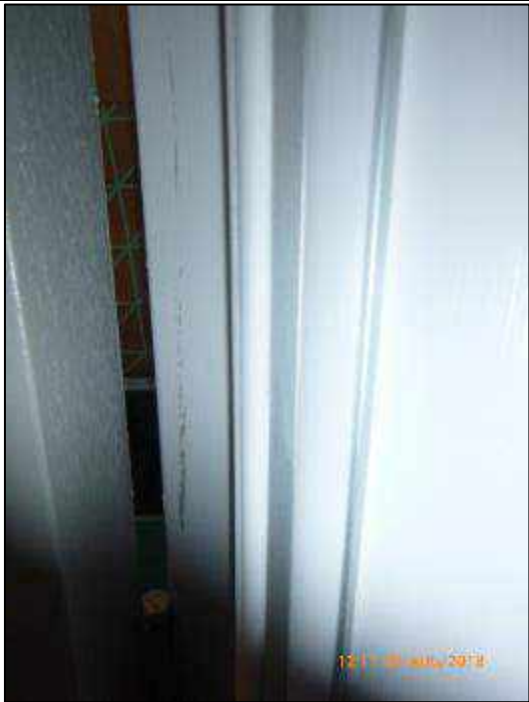
Item	Location	Defect Description and Breach	Rectification	Photograph (if applicable)
332	Front entry door frame	See section 5.10.1	See section 5.10.2

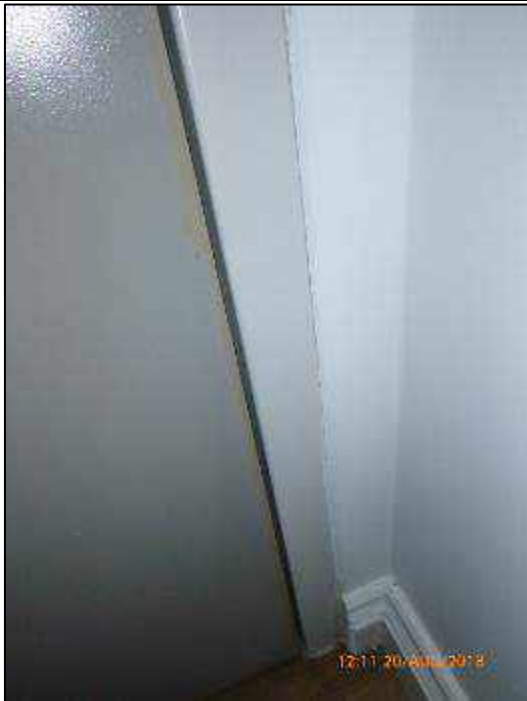
Item	Location	Defect Description and Breach	Rectification	Photograph (if applicable)
333	Wall adjacent to front entry door	See section 5.9.1	See section 5.9.2

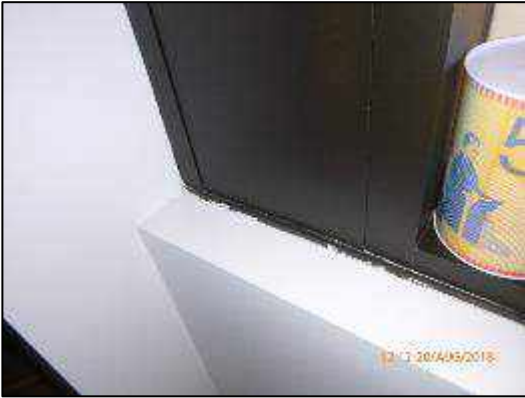
Item	Location	Defect Description and Breach	Rectification	Photograph (if applicable)
335	Window frames adjacent to front entry door	See section 5.10.1	See section 5.10.2

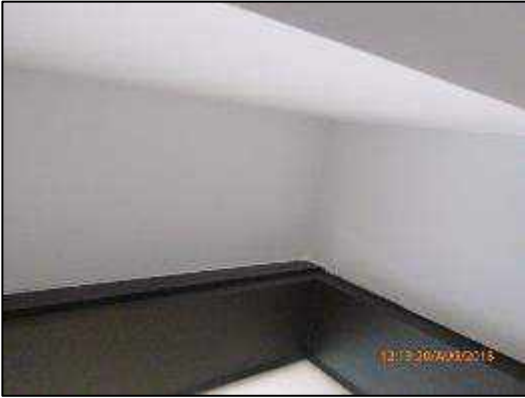
336	Window frame bulkhead adjacent to front entry door	See section 5.13.1	See section 5.13.2

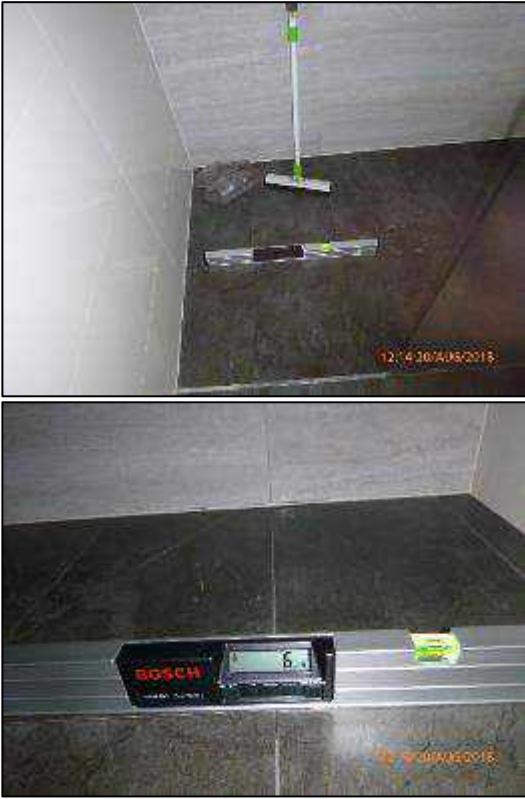
Item	Location	Defect Description and Breach	Rectification	Photograph (if applicable)
337	Main bathroom	See section 5.1.1 Falls (mm); 6/1000	See section 5.1.2

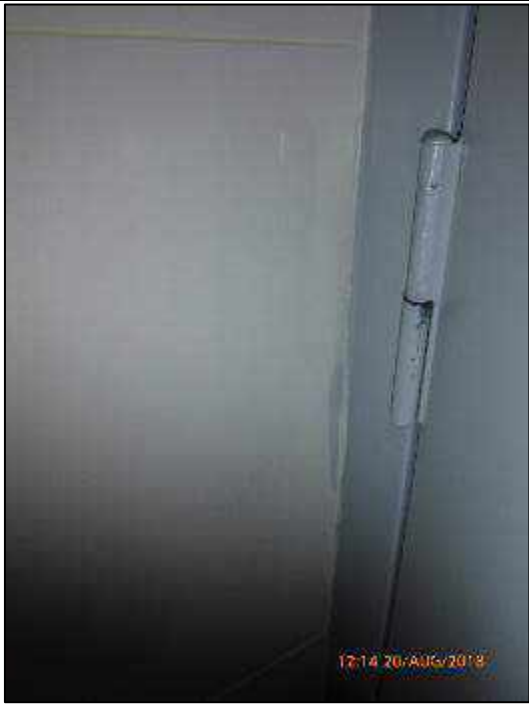
Item	Location	Defect Description and Breach	Rectification	Photograph (if applicable)
338	Wall adjacent to main bathroom door	See section 5.9.1	See section 5.9.2

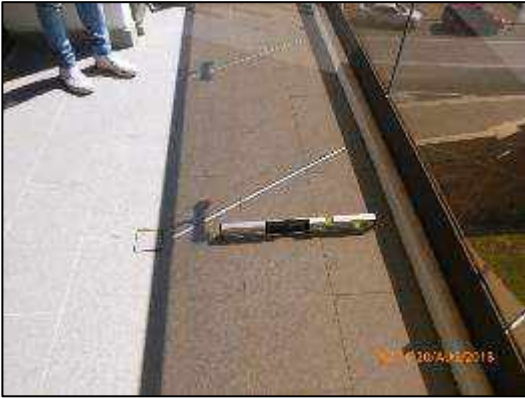
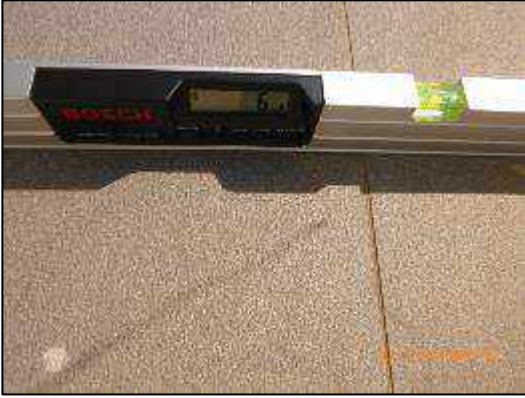
Item	Location	Defect Description and Breach	Rectification	Photograph (if applicable)
339	Balcony	See section 5.2.1 Falls (mm); 6/1000	See section 5.2.2

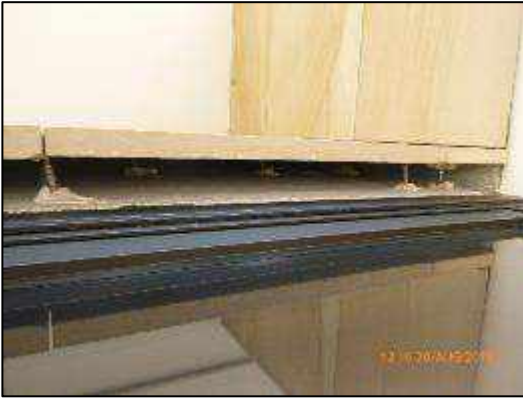
Item	Location	Defect Description and Breach	Rectification	Photograph (if applicable)
340	Balcony	<p>Incomplete sandstone facia above sliding door observed.</p> <p>Home Building Act (NSW) 1989</p> <ul style="list-style-type: none"> Part 2C, 18B (a) and (c). <p>Loss Suffered Loss suffered is cost of rectification.</p>	<ol style="list-style-type: none"> 1. Protect all adjoining surfaces. 2. Source and install sandstone tiles on return of wall to match existing tiles. 3. Clean up the work area.

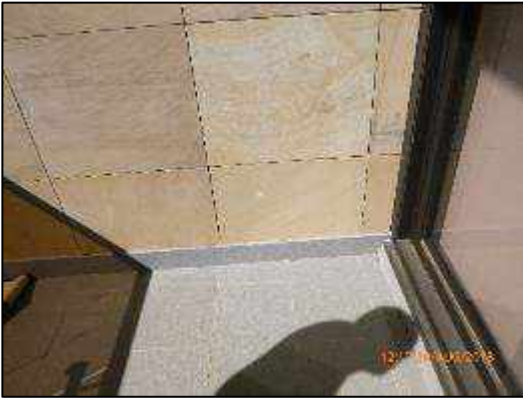
341	Balcony	<p>No weep holes or flashing observed on façade in balcony area.</p> <p>Home Building Act (NSW) 1989</p> <ul style="list-style-type: none"> Part 2C, 18B (a) and (c). <p>Loss Suffered Loss suffered is cost of rectification.</p>	<ol style="list-style-type: none"> 1. Remove sandstone tiles on wall in balcony area. 2. Engage a licenced tradesman to install flashing and produce weep holes. 3. Re-instate the sandstone tiles with weep holes. 4. Clean up the work area.

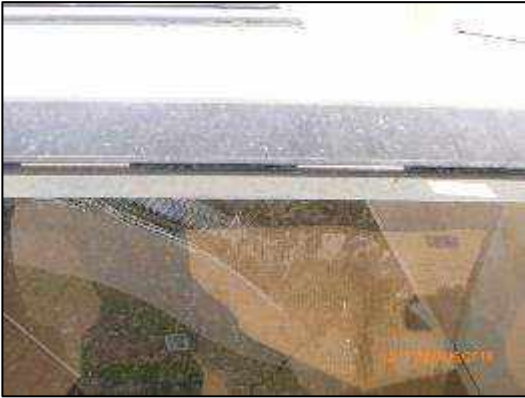
Item	Location	Defect Description and Breach	Rectification	Photograph (if applicable)
342	Balcony balustrade	See section 5.9.1	See section 5.9.2

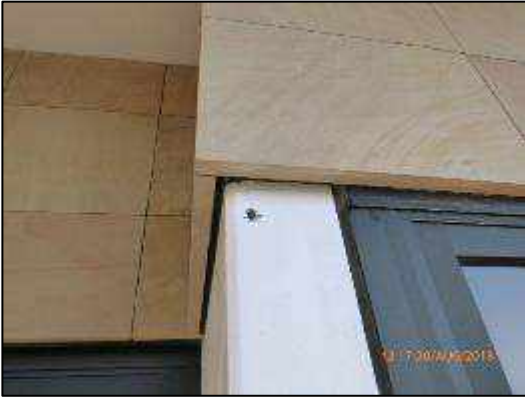
343	Balcony wall adjacent to sliding door	<p>Unsealed holes observed on façade in balcony area.</p> <p>Home Building Act (NSW) 1989</p> <ul style="list-style-type: none"> Part 2C, 18B (a) & (c). <p>Loss Suffered</p> <p>Loss suffered is cost of rectification.</p>	<ol style="list-style-type: none"> 1. Protect all surrounding surfaces 2. Fill cracked concrete column with suitable structural epoxy filler compounds and smooth surface of epoxy filler to ensure a proper workmanlike finish. 3. Repaint to match existing using suitable external paint system in accordance with AS2311.

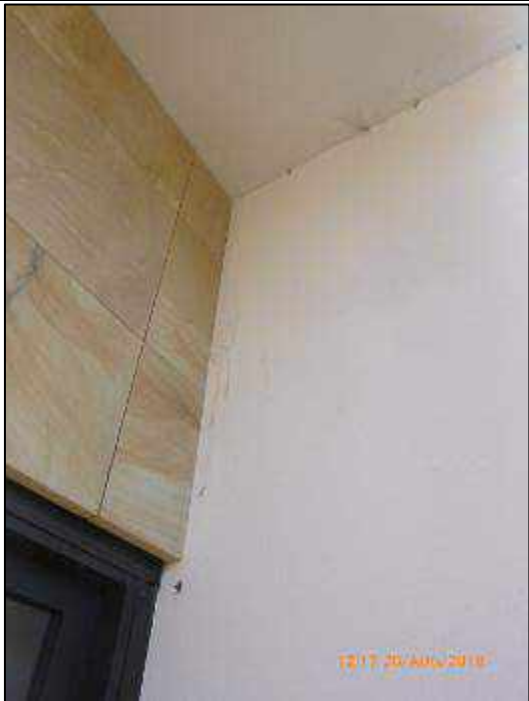
Item	Location	Defect Description and Breach	Rectification	Photograph (if applicable)
344	Balcony western blade wall	See section 5.10.1	See section 5.10.2

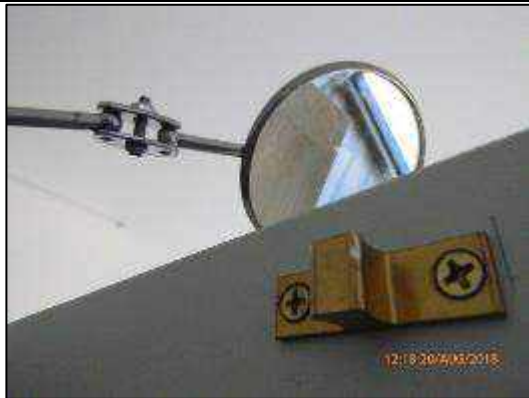
345	Doors throughout unit (x3)	See section 5.5.1	See section 5.5.2

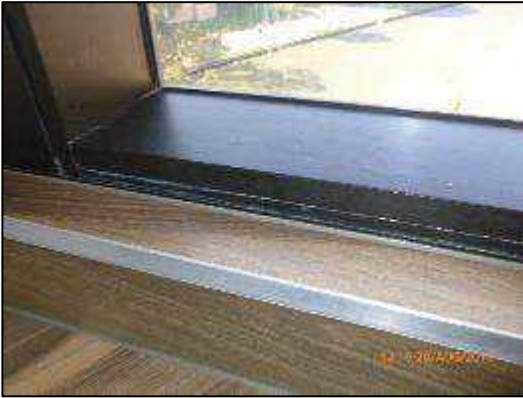
Item	Location	Defect Description and Breach	Rectification	Photograph (if applicable)
346	Main bedroom window frames	See section 5.8.1	See section 5.8.2

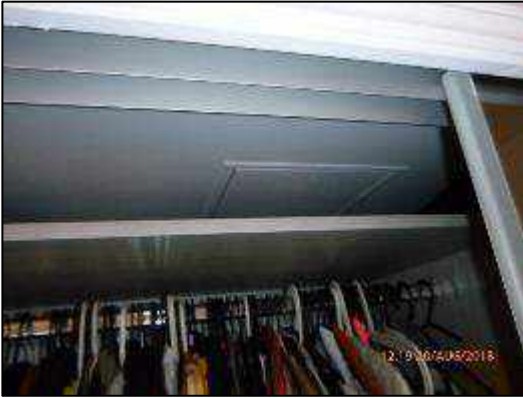
347	Main bedroom built in	See section 5.6.1	See section 5.6.2

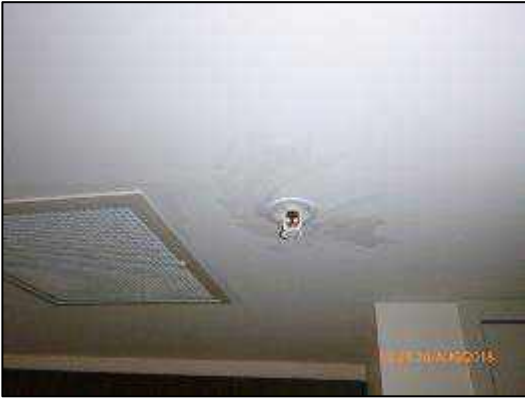
Item	Location	Defect Description and Breach	Rectification	Photograph (if applicable)
348	Lounge room ceiling	<p>Cracked plasterboard surrounding fire sprinkler at opening in ceiling.</p> <p>Home Building Act (NSW) 1989</p> <ul style="list-style-type: none"> Part 2C, 18B (a) and (c). <p>Guide to Standards and Tolerances 2017</p> <p>Section 10.14 Cracking in plasterboard, hard plaster and other plaster elements in the Office of fair trading “Guide to standards and tolerances” dated 2017 states that cracking in recessed or butt joints is a defect if visible from a normal viewing position.</p> <p>Loss Suffered</p> <p>Loss suffered is cost of rectification.</p>	<ol style="list-style-type: none"> 1. Protect all surrounding surfaces 2. Remove all existing jointing materials. 3. Ensure the plasterboard sheeting is adequately affixed to supporting structure. 4. Re-set the joint between the plasterboard sheets in accordance with the manufacturer’s instructions 5. Repaint the affected ceiling to match existing using suitable interior paint system in accordance with AS2311. 6. Clean up work area.

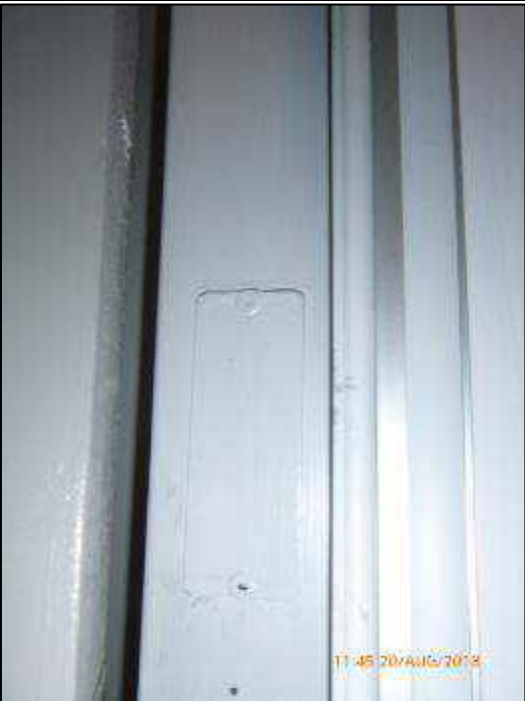
Item	Location	Defect Description and Breach	Rectification	Photograph (if applicable)
349	Front entry door frame	<p>Door frame label has been painted over.</p> <p>Home Building Act (NSW) 1989</p> <ul style="list-style-type: none"> Part 2C, 18B (a) & (c). <p>Loss Suffered</p> <p>Loss suffered is cost of rectification.</p>	Use a suitable cleaning agent to remove paint from the door frame label.

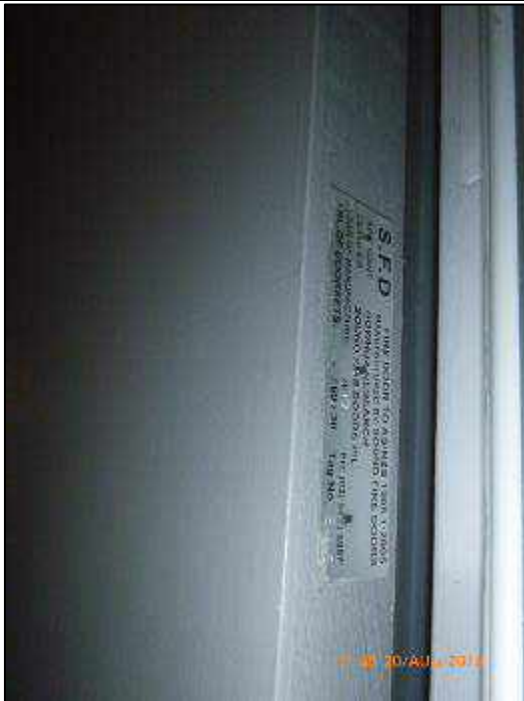
Item	Location	Defect Description and Breach	Rectification	Photograph (if applicable)
350	Front entry door	See section 5.12.1	See section 5.12.2

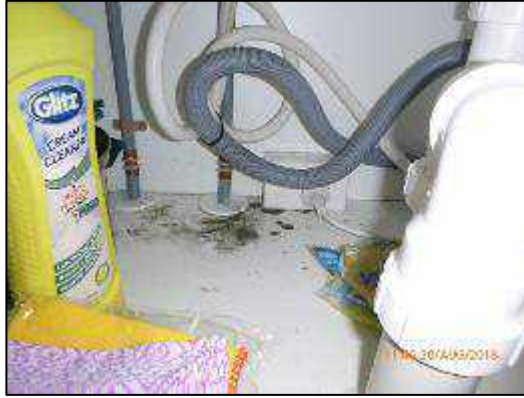
351	Kitchen sink	<p>Kitchen sink was observed to be leaking into cabinetry below.</p> <p>Home Building Act (NSW) 1989</p> <ul style="list-style-type: none"> Part 2C, 18B (a) and (c). <p>This is a breach of part (a) of the act because the basin has not been installed in a proper workmanlike manner that would prevent leaking of the basin, resulting in a loss of amenity.</p>	Engage licensed plumber to complete necessary repairs.

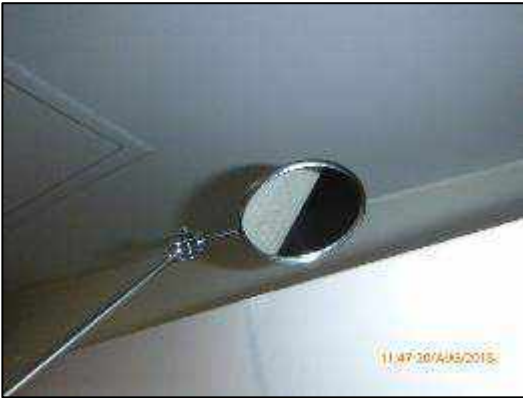
Item	Location	Defect Description and Breach	Rectification	Photograph (if applicable)
		Loss suffered Loss suffered is cost of rectification.		
352	<i>Doors throughout unit (x4)</i>	See section 5.5.1	See section 5.5.2

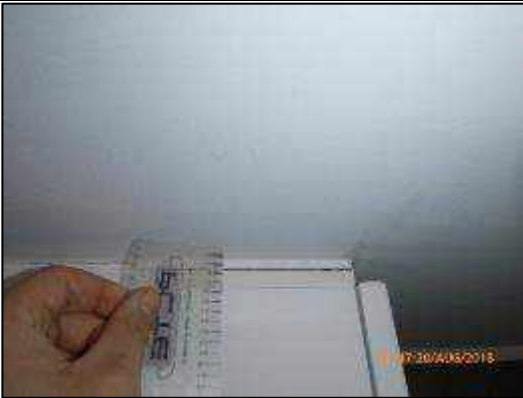
353	<i>Ceiling above kitchen cupboards</i>	See section 5.14.1 Separation; 1.5mm	See section 5.14.2

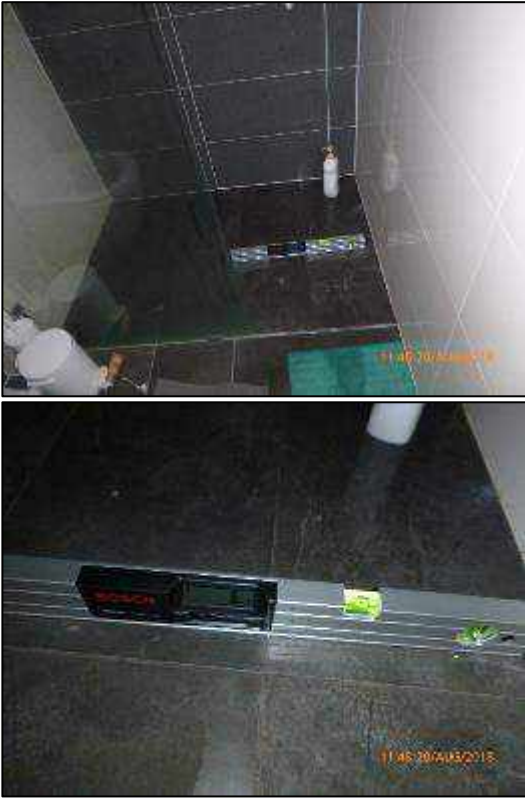
Item	Location	Defect Description and Breach	Rectification	Photograph (if applicable)
354	Main bathroom	See section 5.1.1 Falls (mm); 4/1000	See section 5.1.2

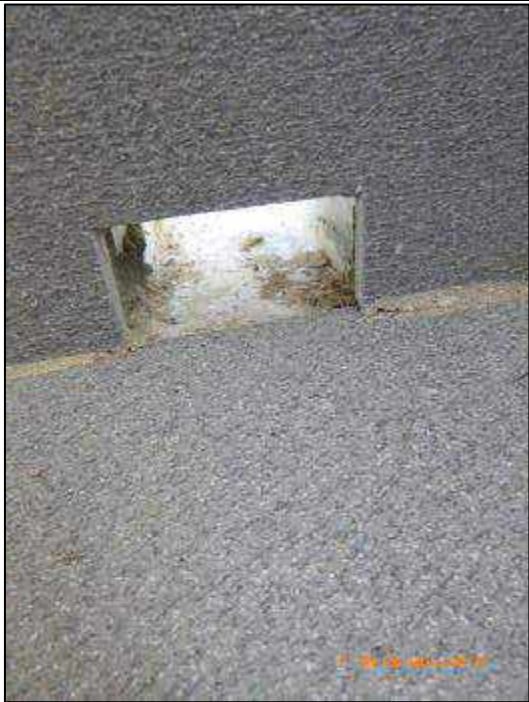
Item	Location	Defect Description and Breach	Rectification	Photograph (if applicable)
355	Balcony	See section 5.15.1	See section 5.15.2

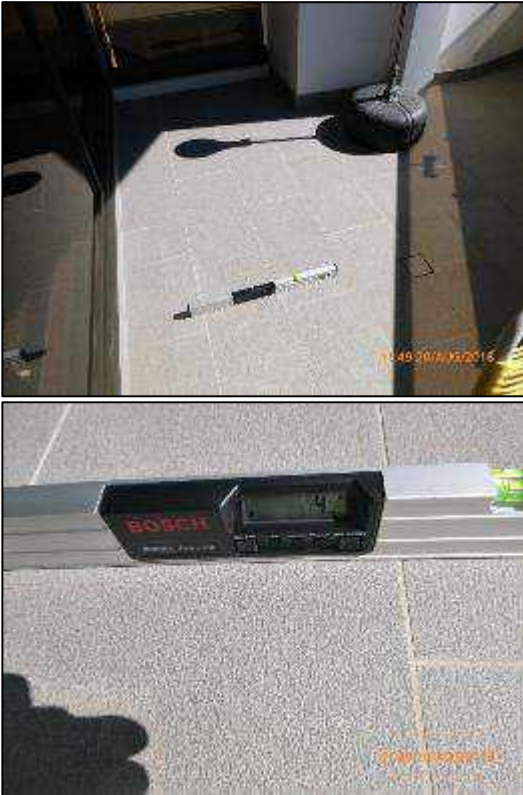
Item	Location	Defect Description and Breach	Rectification	Photograph (if applicable)
356	Balcony	<p>See section 5.2.1 Ponding observed at the time of inspection.</p> <p>Falls (mm); 4/1000</p>	See section 5.2.2

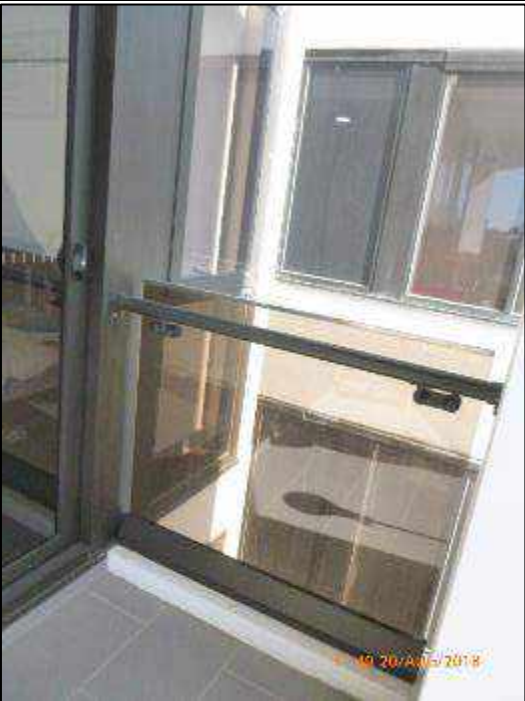
Item	Location	Defect Description and Breach	Rectification	Photograph (if applicable)
357	Balcony	See section 5.4.1	See section 5.4.2

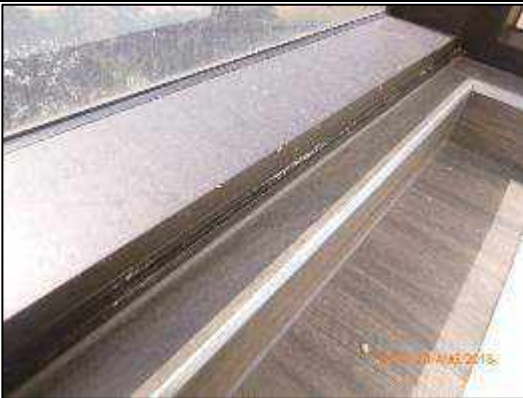
Item	Location	Defect Description and Breach	Rectification	Photograph (if applicable)
358	Balcony sliding door frame	See section 5.7.1	See section 5.7.2	 
359	Lounge room window frames	See section 5.8.1	See section 5.8.2

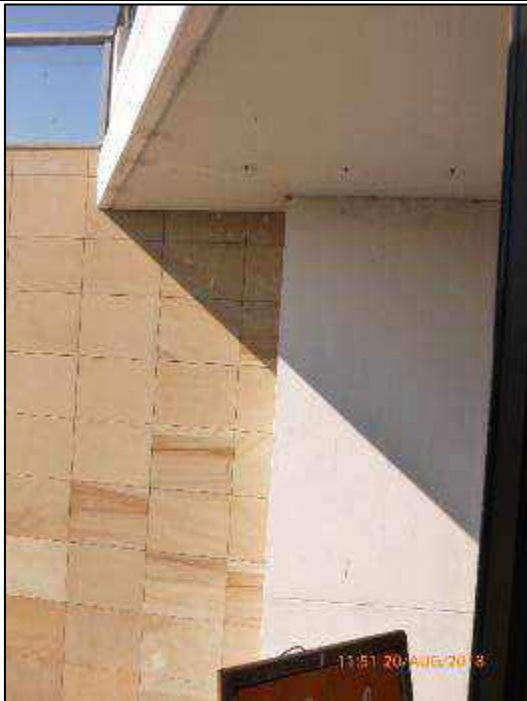
Item	Location	Defect Description and Breach	Rectification	Photograph (if applicable)
360	Balcony	<p>Construction debris observed on the external façade.</p> <p>Home Building Act (NSW) 1989</p> <ul style="list-style-type: none"> Part 2C, 18B (a) and (c). <p>This is a breach of part (a) of the act because the surface has not been finished in a proper workmanlike manner that would prevent loss of appearance to the surface.</p> <p>Loss Suffered Loss suffered is cost of rectification.</p>	<ol style="list-style-type: none"> 1. Protect all adjoining surfaces. 2. Use a suitable cleaning agent to remove residue and clear debris. 3. Clean up the work area.

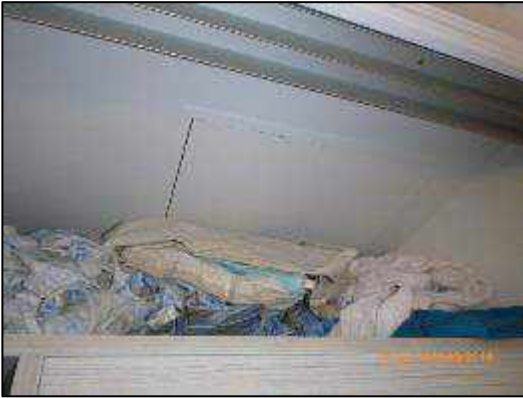
Item	Location	Defect Description and Breach	Rectification	Photograph (if applicable)
362	Main bedroom built in	See section 5.6.1	See section 5.6.2

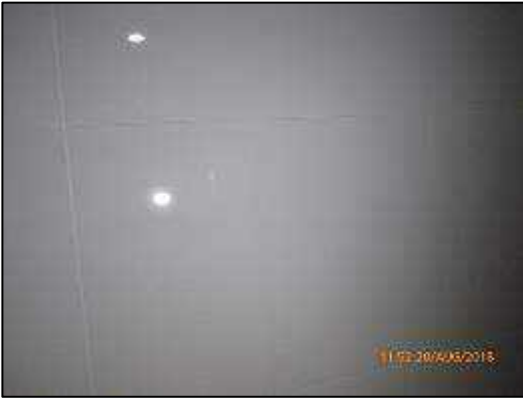
363	Main bedroom ensuite	<p>One cracked tile observed in ensuite western wall.</p> <p>Home Building Act (NSW) 1989</p> <ul style="list-style-type: none"> Part 2C, 18B (a) and (c). <p>Guide to Standards and Tolerances 2017</p> <p>Section 12.5 Cracked, pitted, chipped, scratched, loose or drummy tiles.</p> <p>Loss Suffered</p> <p>Loss suffered is cost of rectification and appearance.</p>	<ol style="list-style-type: none"> 1. Protect all adjoining surfaces surrounding the work area. 2. Remove the affected tile 3. Install new tile to match existing in accordance with manufacturers specifications. 4. Clean up the work area.

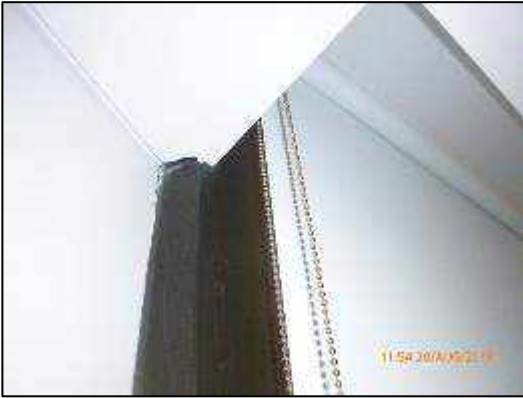
Item	Location	Defect Description and Breach	Rectification	Photograph (if applicable)
364	Second bedroom window frames	See section 5.9.1	See section 5.9.2

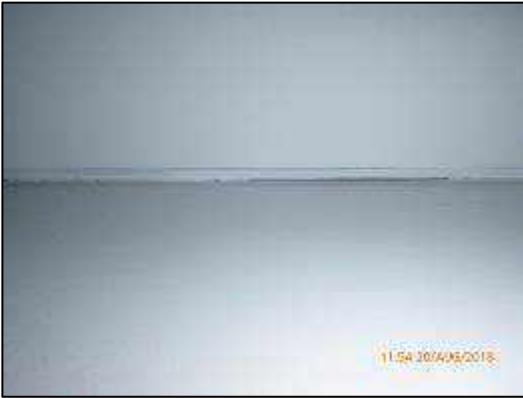
A photograph showing a close-up of a window frame in a second bedroom. The frame appears to be made of metal or a similar material and is set into a wall. The image is taken from a low angle, looking up at the frame. A timestamp '11:54:20/04/02/18' is visible in the bottom right corner.
365	Second bedroom	See section 5.11.1	See section 5.11.2

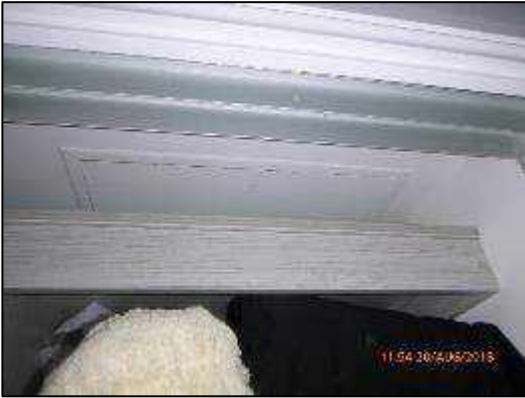
Item	Location	Defect Description and Breach	Rectification	Photograph (if applicable)
366	Second bedroom built in	See section 5.6.1	See section 5.6.2
