SydneyStrataReport

STRATA REPORT

Client	Church Street Parramatta Property Pty Ltd
Address of property	Unit 3303/330 Church Street, Parramatta, NSW.
Lot	359
Strata Plan	SP 94469
Name of Strata Management Co.	NSW Strata
Telephone Number of Strata Agent	8980 1841
Report Date	15 February 2024

BUILDING DEFECTS REPORT Part 1/2

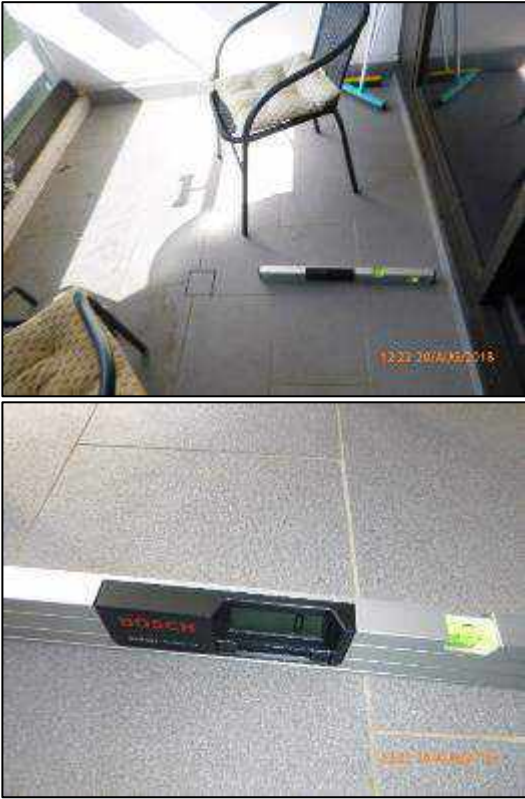
Item	Location	Defect Description and Breach	Rectification	Photograph (if applicable)
367	Balcony	See section 5.2.1 Falls (mm); 0/1000	See section 5.2.2

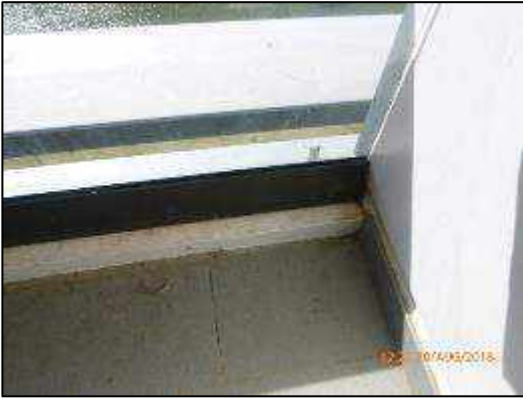
Item	Location	Defect Description and Breach	Rectification	Photograph (if applicable)
368	Balcony	See section 5.3.1	See section 5.3.2

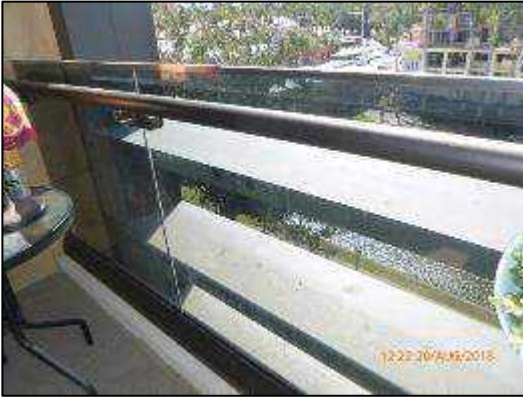
369	Balcony	See section 5.4.1	See section 5.4.2

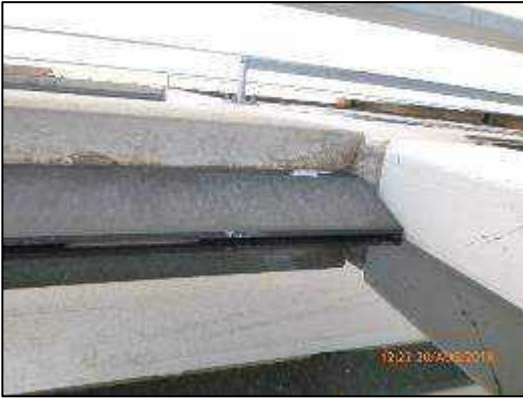
Item	Location	Defect Description and Breach	Rectification	Photograph (if applicable)
370	Balcony balustrade	See section 5.9.1	See section 5.9.2

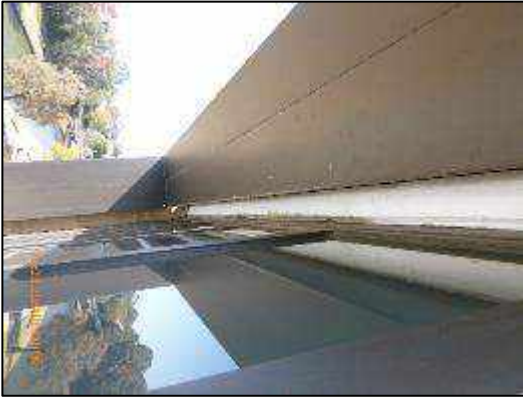
371	Façade of main bedroom window	See section 5.10.1	See section 5.10.2

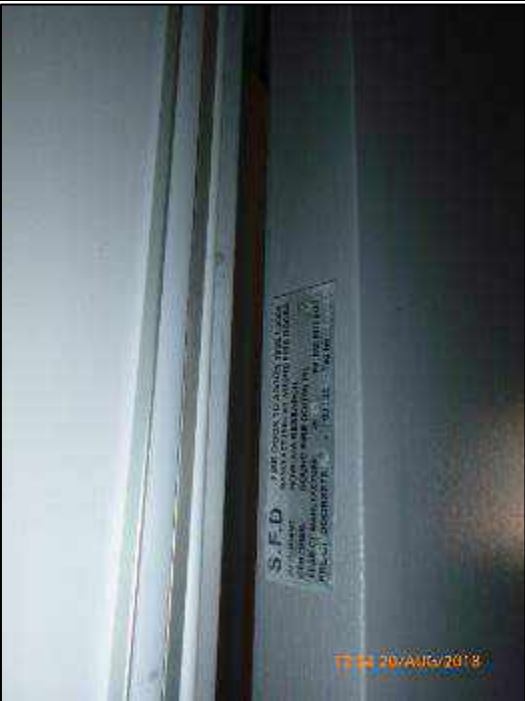
Item	Location	Defect Description and Breach	Rectification	Photograph (if applicable)
373	Front entry door	See section 5.12.1	See section 5.12.2

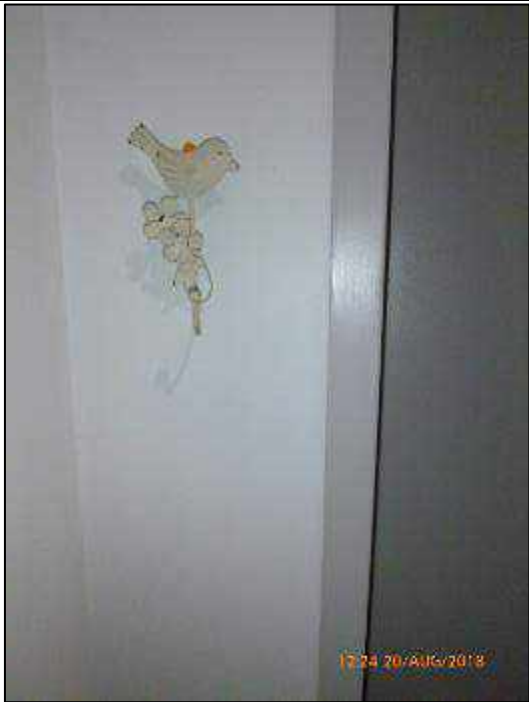
Item	Location	Defect Description and Breach	Rectification	Photograph (if applicable)
374	Wall adjacent to front entry door	See section 5.13.1	See section 5.13.2

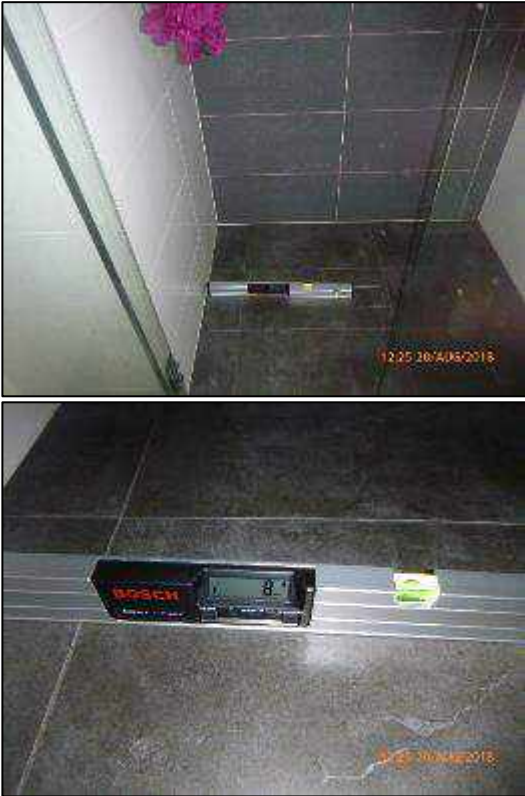
Item	Location	Defect Description and Breach	Rectification	Photograph (if applicable)
375	Main bathroom	See section 5.1.1 Falls (mm); 8/1000	See section 5.1.2

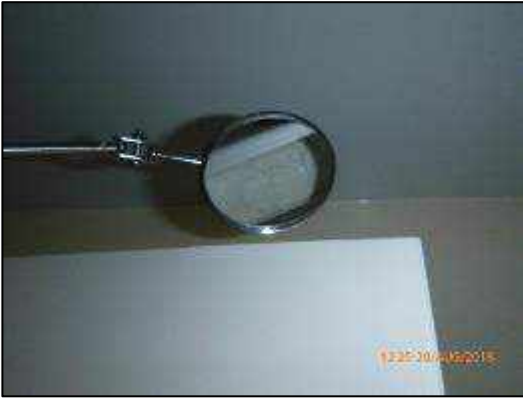
Item	Location	Defect Description and Breach	Rectification	Photograph (if applicable)
376	Doors throughout unit (x5)	See section 5.5.1	See section 5.5.2

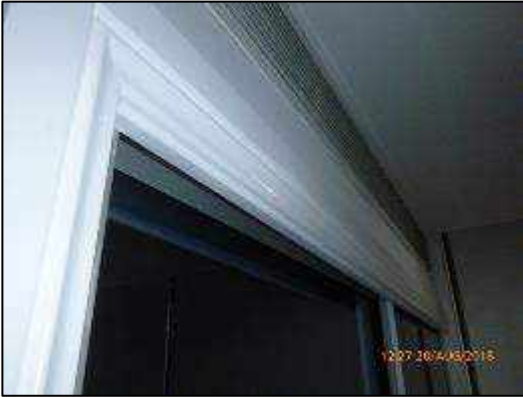
377	Main bedroom built in	<p>Sliding door was observed to be out of plane.</p> <p>Home Building Act (NSW) 1989</p> <ul style="list-style-type: none"> Part 2C, 18B (a) and (c). <p>Guide to Standards and Tolerances 2017</p> <ul style="list-style-type: none"> Section 9.7 Operation of windows and doors. <p>This is a defect because the door does not operate as intended by the manufacturer' as outlined in Section 9.7 of the Guide to Standards and Tolerances 2017.</p> <p>Loss Suffered</p> <p>Loss suffered is cost of rectification.</p>	<ol style="list-style-type: none"> 1. Protect all adjoining surfaces surrounding the work area. 2. Remove the door and appropriately fix and plane as required. 3. Paint door in accordance with AS2311 to match existing 4. Install the door in a workmanship like manner.

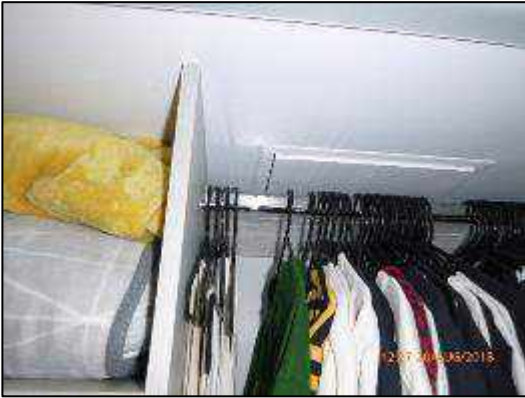
Item	Location	Defect Description and Breach	Rectification	Photograph (if applicable)
378	Main bedroom built in	See section 5.6.1	See section 5.6.2

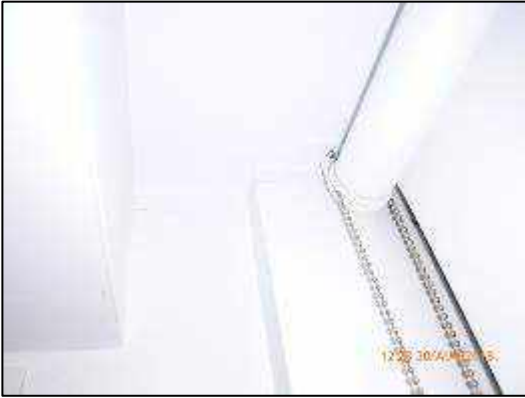
379	Main bedroom window bulkhead	See section 5.13.1	See section 5.13.2

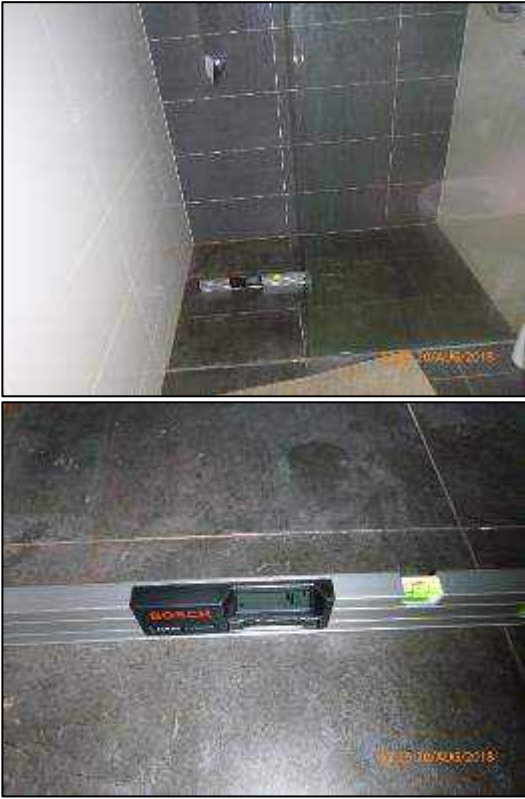
Item	Location	Defect Description and Breach	Rectification	Photograph (if applicable)
380	Main bedroom ensuite	See section 5.1.1 Falls (mm); 4/1000	See section 5.1.2

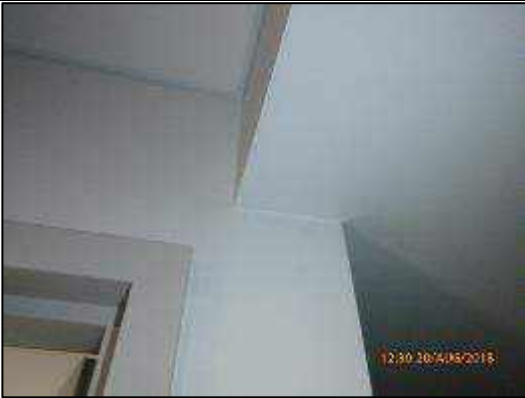
Item	Location	Defect Description and Breach	Rectification	Photograph (if applicable)
381	Wall adjacent to main bedroom door	See section 5.10.1	See section 5.10.2

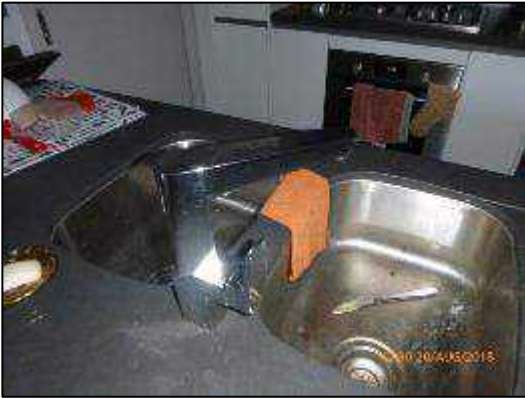
382	Kitchen sink	<p>Resident advised that the kitchen tap was loose.</p> <p>Home Building Act (NSW) 1989</p> <ul style="list-style-type: none"> Part 2C, 18B (a) and (b). <p>This item is a defect as the builder has failed to satisfy implied warranty set out in the Home Building Act 1989 – Section 18B Warranties as to residential building work.</p> <p>(b) a warranty that all materials supplied by the holder or person will be good and suitable for the purpose for which they are used and that, unless otherwise stated in the contract, those materials will be new.</p> <p>Loss Suffered</p> <p>Loss suffered in cost of rectification.</p>	<ol style="list-style-type: none"> 1. Temporary turn off main water supply to sink. 2. Carefully remove the mixer to sink. 3. Supply and install mixer to match existing. 4. Secure the tap flick mixer to the sink. 5. Turn on main water supply to sink.

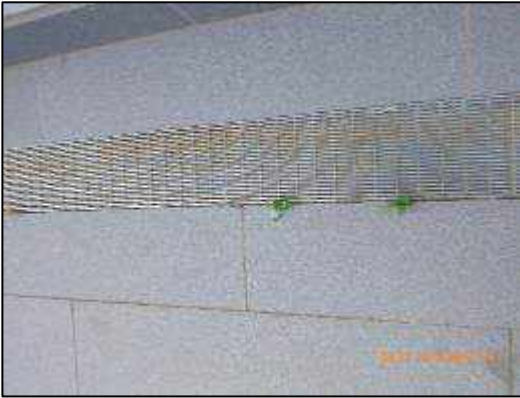
Item	Location	Defect Description and Breach	Rectification	Photograph (if applicable)
383		No access was provided.		
Unit 402				
384		No access was provided.		
Unit 403				
385		No access was provided.		
Unit 404				
386		No access was provided.		
Unit 405				
387	Balcony	<p>Rusting of drainage grate observed on balcony.</p> <p>Home Building Act (NSW) 1989</p> <ul style="list-style-type: none"> Part 2C, 18B (a), (b) & (c). <p>This is a breach of part (a) and (b) of the act because the drainage grate is corroded as it has not adequately been prepared to resist the effects of a moisture laden tile screed bed and is not considered fit for purpose.</p> <p>Loss Suffered</p> <p>Loss suffered is cost of rectification.</p>	<ol style="list-style-type: none"> 1. Protect all adjoining surfaces surrounding the work area. 2. Scrape and clean all corroded metal to grate 3. Apply suitable anticorrosive treatment to metal following adequate surface preparation. 4. Fill voids and gaps in door jamb with suitable inert fillers and allow to cure. 5. Smooth down fillers to provide a uniform surface and apply minimum one coat primer and two coats suitable internal grade paint.

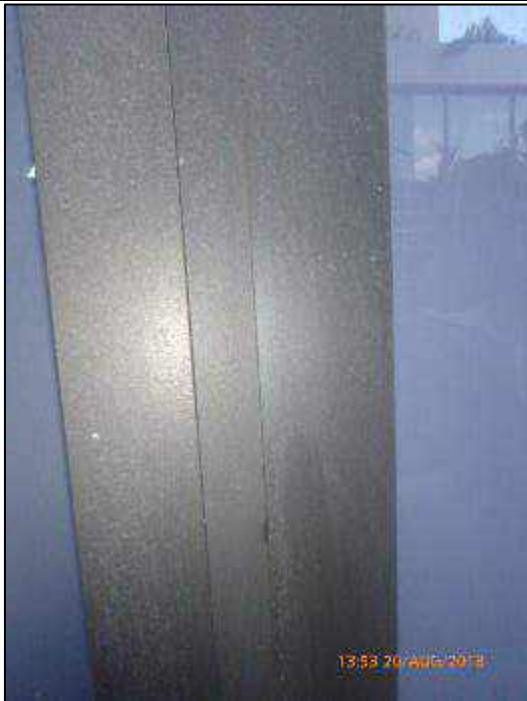
Item	Location	Defect Description and Breach	Rectification	Photograph (if applicable)
388	Balcony	See section 5.7.1	See section 5.7.2

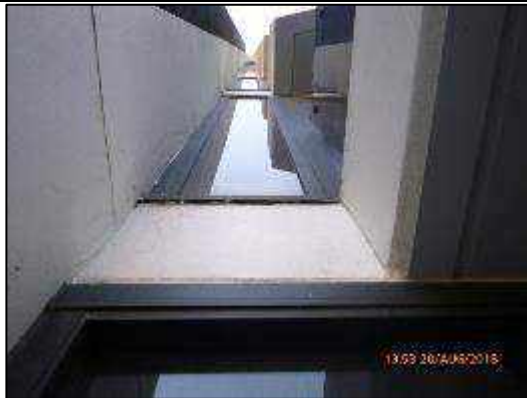
389	Balcony	<p>Cracking in render observed on facade of building in balcony area.</p> <p>Home Building Act (NSW) 1989</p> <ul style="list-style-type: none"> Part 2C, 18B (a) and (c). <p>Guide to Standards and Tolerances 2017</p> <ul style="list-style-type: none"> Crack categories are assessed in accordance with Section 3.2. 	<ol style="list-style-type: none"> 1. Protect all surrounding surfaces 2. Remove cracked rendered surfaces to closest architectural line 3. Install suitable flexible sealant 4. Install new render to blend into the existing surface 5. Repaint to match existing using suitable external paint system in accordance with AS2311.

Item	Location	Defect Description and Breach	Rectification	Photograph (if applicable)
		<ul style="list-style-type: none"> Cracks are classed as exceeding Category 1 but not exceeding Category 2 damage. Category 2 damage cracks are considered a defect and require repair work. <p>AS2870-2011 Residential footings and slabs</p> <ul style="list-style-type: none"> Crack categories are assessed in accordance with Table C1 CLASSIFICATION OF DAMAGE WITH REFERENCE TO WALLS Cracks exceed Category 1 but do not exceed damage Category 2. <p>Loss Suffered Loss suffered is cost of rectification.</p>

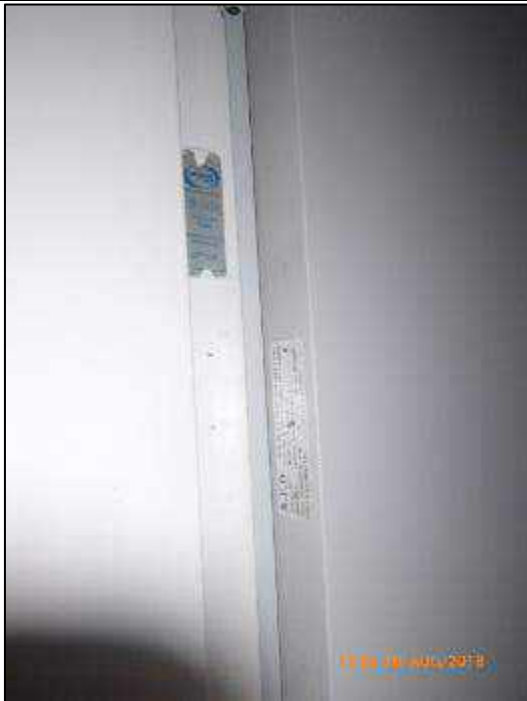
Item	Location	Defect Description and Breach	Rectification	Photograph (if applicable)
390	Front entry door	<p>Fire door and frame observed to be two different brands.</p> <p>Home Building Act (NSW) 1989</p> <ul style="list-style-type: none"> Part 2C, 18B (a) and (c). <p>Loss Suffered Loss suffered is cost of rectification.</p>	Engage a licenced tradesperson to remove fire door and install a suitable fire door to match existing door frame as advised by fire engineer.

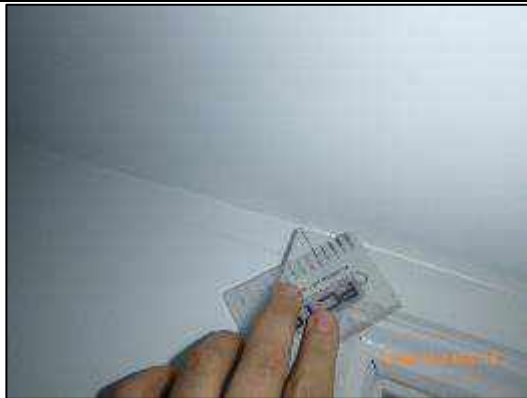
391	Front entry door frame	<p>See section 5.14.1</p> <p>Separation; 1mm</p>	See section 5.14.2

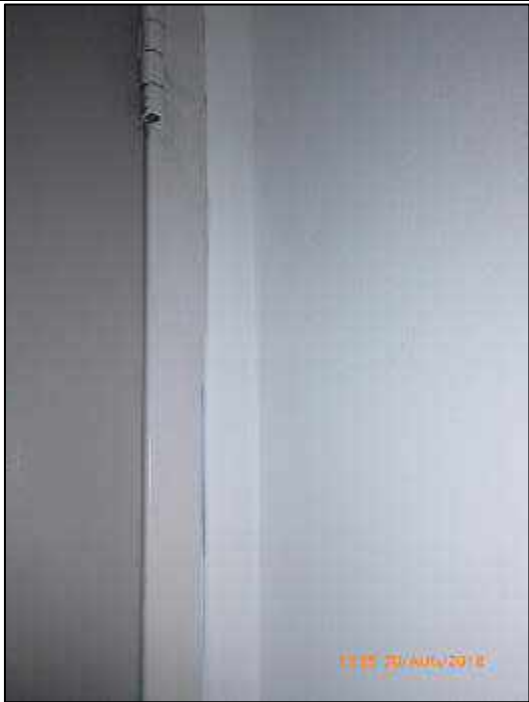
Item	Location	Defect Description and Breach	Rectification	Photograph (if applicable)
392	Wall adjacent to front entry door	See section 5.13.1	See section 5.13.2

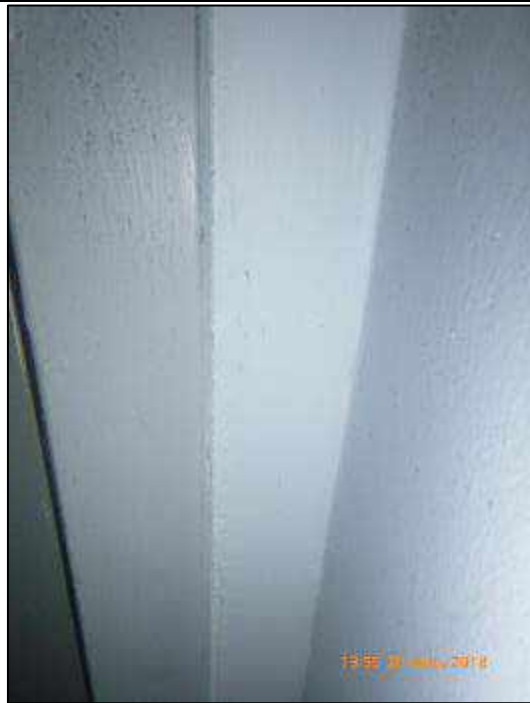
Item	Location	Defect Description and Breach	Rectification	Photograph (if applicable)
393	Front entry door jamb	See section 5.14.1 Separation; 1mm	See section 5.14.2

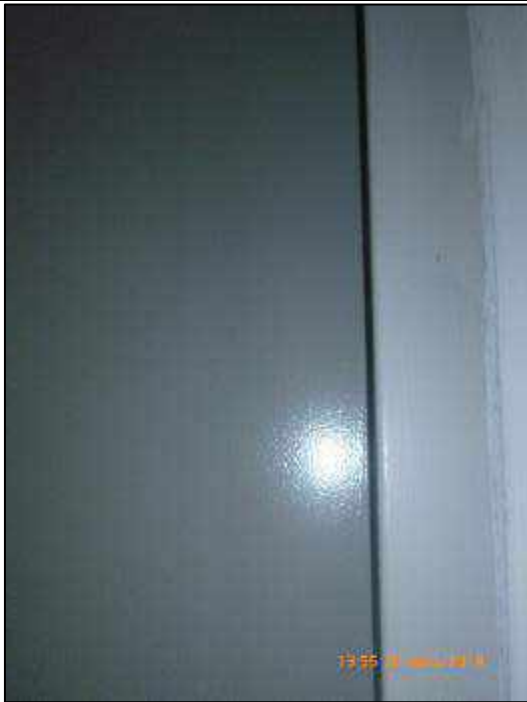
Item	Location	Defect Description and Breach	Rectification	Photograph (if applicable)
394	Front entry door	See section 5.10.1	See section 5.10.2

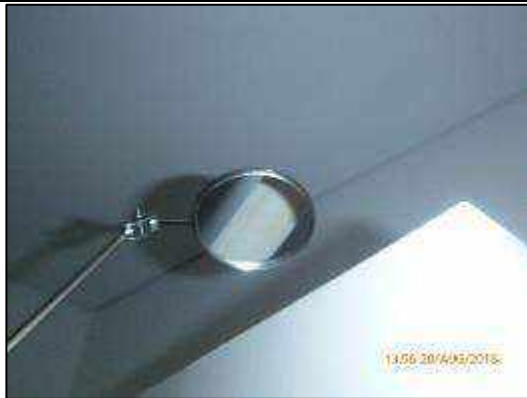
395	Doors throughout unit (x4)	See section 5.5.1	See section 5.5.2

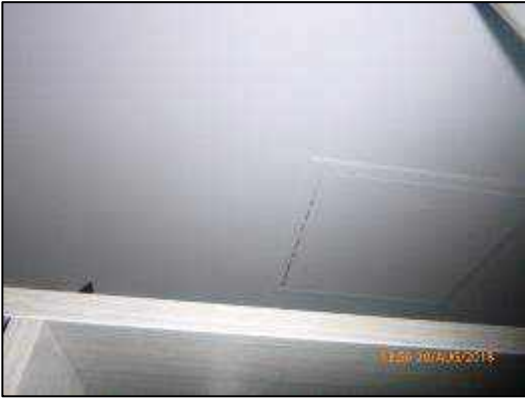
Item	Location	Defect Description and Breach	Rectification	Photograph (if applicable)
396	<i>Second bedroom built in</i>	See section 5.6.1	See section 5.6.2

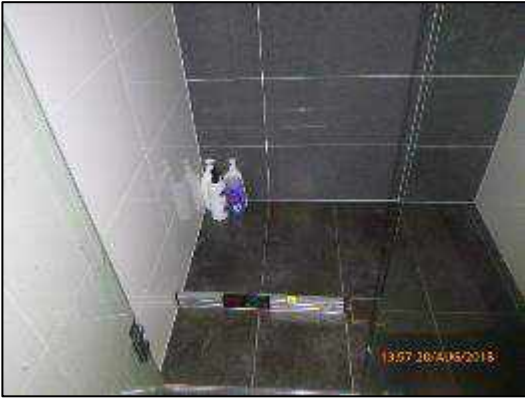
Item	Location	Defect Description and Breach	Rectification	Photograph (if applicable)
398	Main bathroom	See section 5.1.1 Falls (mm); 8/1000	See section 5.1.2

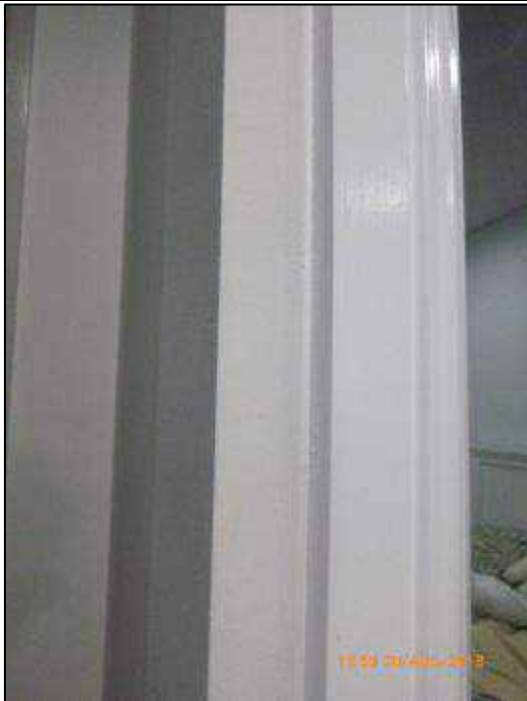
Item	Location	Defect Description and Breach	Rectification	Photograph (if applicable)
400	Main bedroom door frame	See section 5.10.1	See section 5.10.2

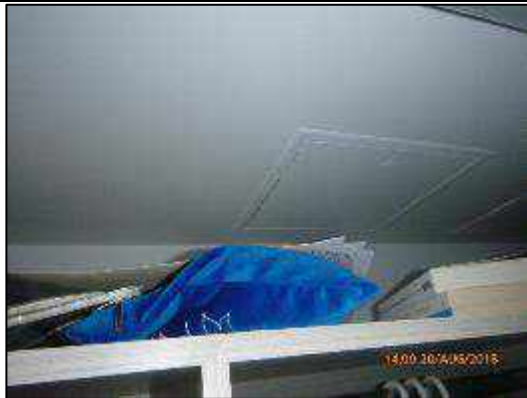
401	Main bedroom built in	See section 5.6.1	See section 5.6.2

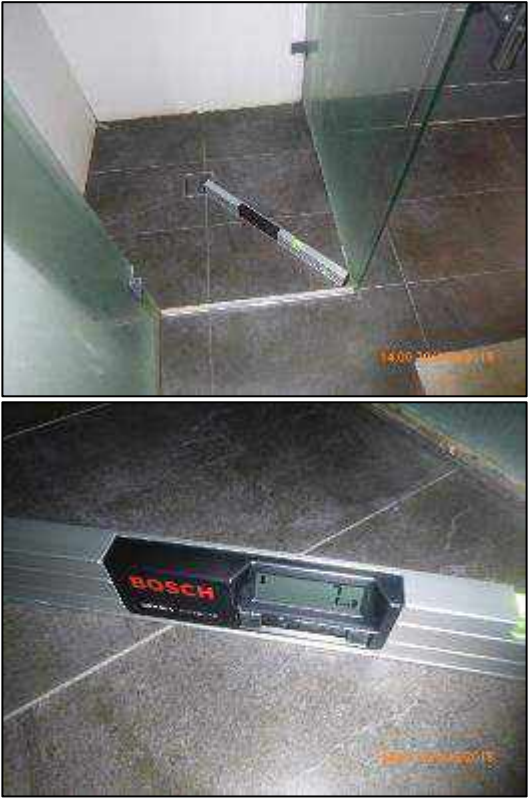
Item	Location	Defect Description and Breach	Rectification	Photograph (if applicable)
402	Main bedroom ensuite	See section 5.1.1 Falls (mm); 7/1000	See section 5.1.2

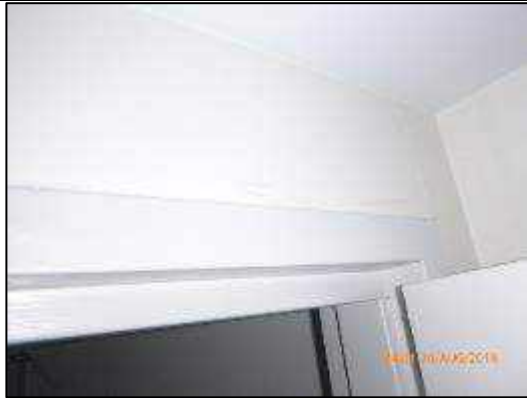
Item	Location	Defect Description and Breach	Rectification	Photograph (if applicable)
403	Main bedroom ensuite door frame	See section 5.9.1	See section 5.9.2

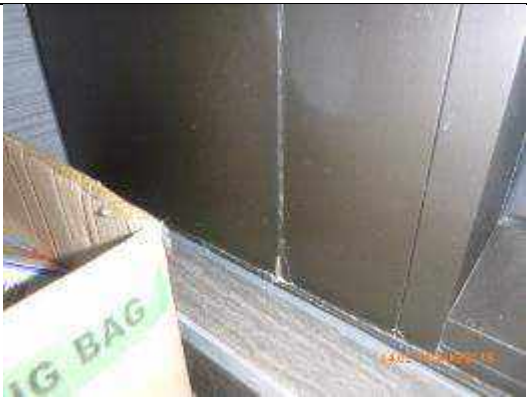
404	Lounge windows room	See section 5.8.1	See section 5.8.2

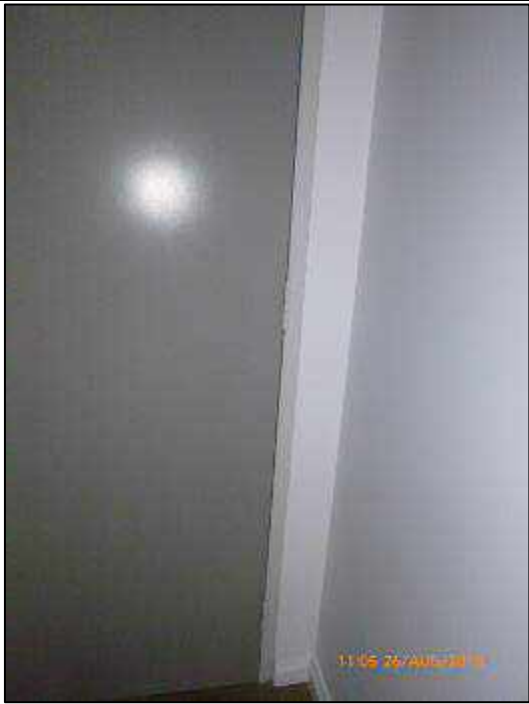
Item	Location	Defect Description and Breach	Rectification	Photograph (if applicable)
405	Wall adjacent to front entry door	See section 5.13.1	See section 5.13.2

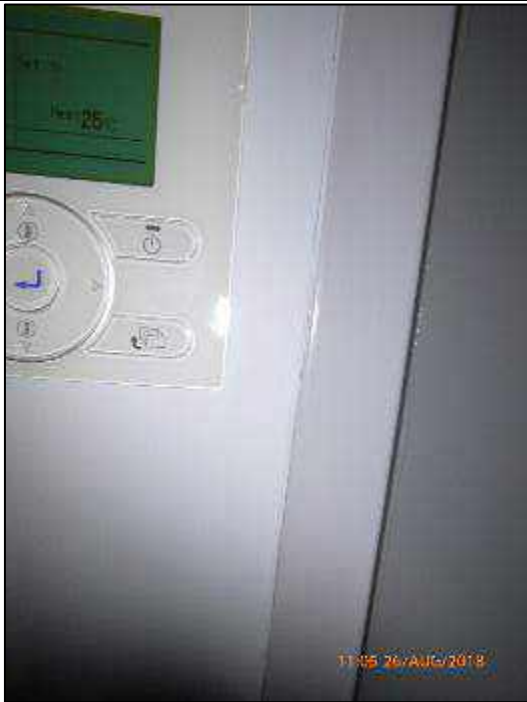
Item	Location	Defect Description and Breach	Rectification	Photograph (if applicable)
406	Wall adjacent to main bedroom door	See section 5.9.1	See section 5.9.2

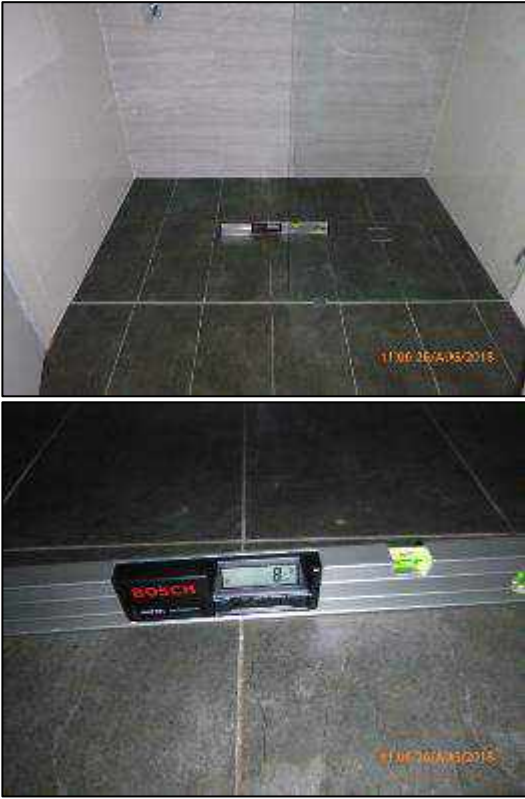
Item	Location	Defect Description and Breach	Rectification	Photograph (if applicable)
409	Main bedroom ensuite	See section 5.1.1 Falls (mm); 8/1000	See section 5.1.2

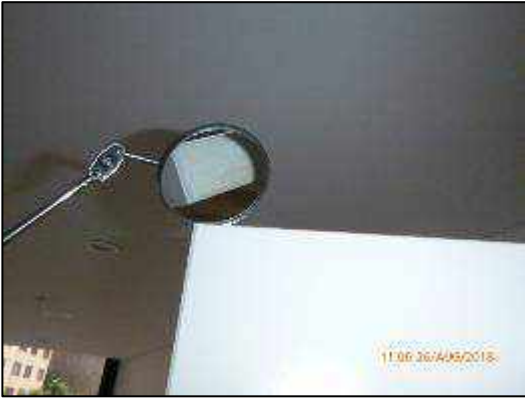
Item	Location	Defect Description and Breach	Rectification	Photograph (if applicable)
410	<i>Doors throughout the unit (x3)</i>	See section 5.5.1	See section 5.5.2

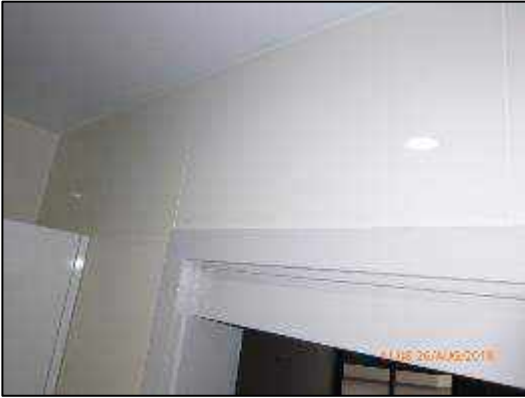
A photograph showing a close-up of a door handle and lock mechanism. The handle is metallic and the lock is visible. A timestamp '11:00 26/04/2018' is visible in the bottom right corner.
411	<i>Wall above main bathroom door</i>	See section 5.9.1	See section 5.9.2

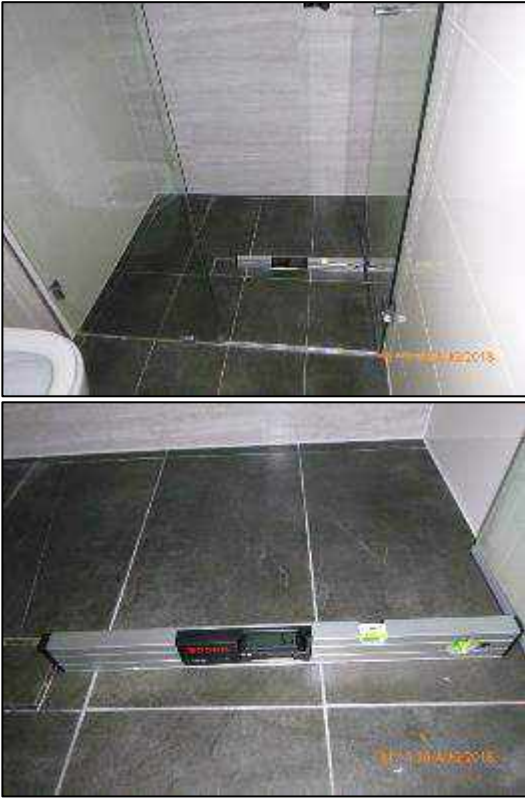
Item	Location	Defect Description and Breach	Rectification	Photograph (if applicable)
412	Main bathroom	See section 5.1.1 Falls (mm); 5/1000	See section 5.1.2

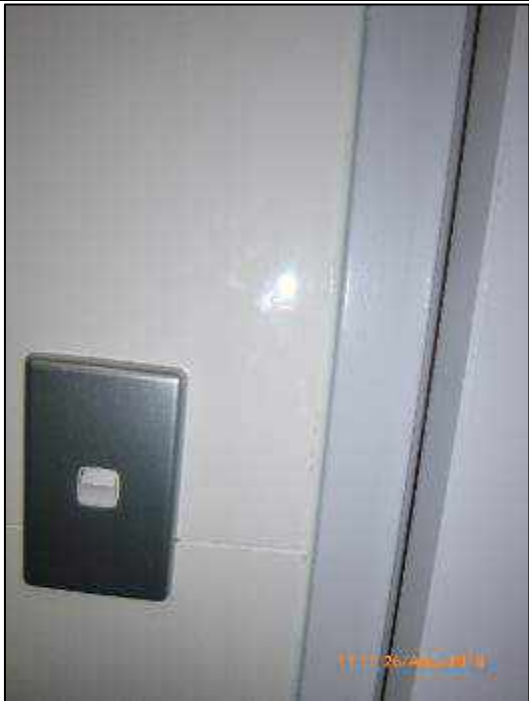
Item	Location	Defect Description and Breach	Rectification	Photograph (if applicable)
413	Wall adjacent to main bathroom door	See section 5.9.1	See section 5.9.2

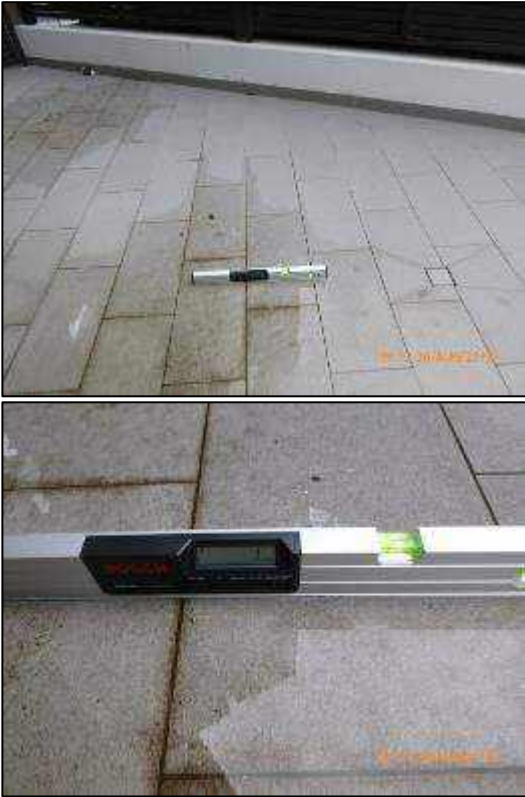
Item	Location	Defect Description and Breach	Rectification	Photograph (if applicable)
414	Balcony	<p>See section 5.2.1 Ponding observed at the time of inspection.</p> <p>Falls (mm); 1/1000</p>	See section 5.2.2

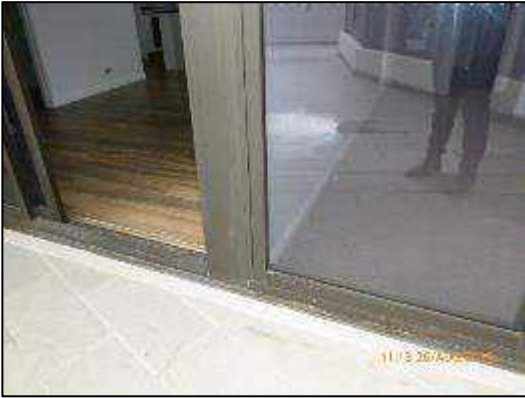
Item	Location	Defect Description and Breach	Rectification	Photograph (if applicable)
415	Balcony sliding door frame	See section 5.8.1	See section 5.8.2

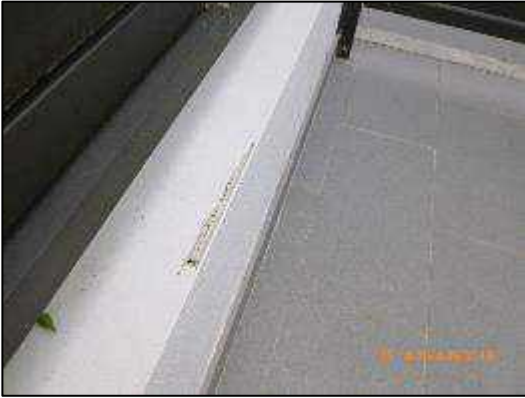
416	Balcony sliding door hob	See section 5.10.1	See section 5.10.2

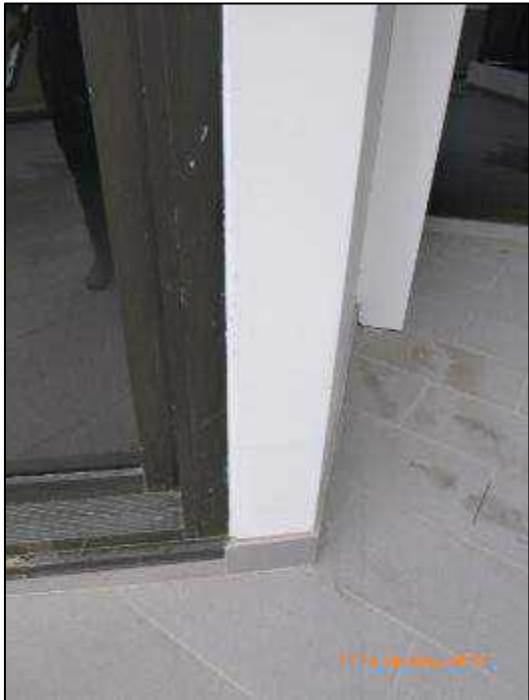
Item	Location	Defect Description and Breach	Rectification	Photograph (if applicable)
417	Balcony sliding door frame	See section 5.9.1	See section 5.9.2

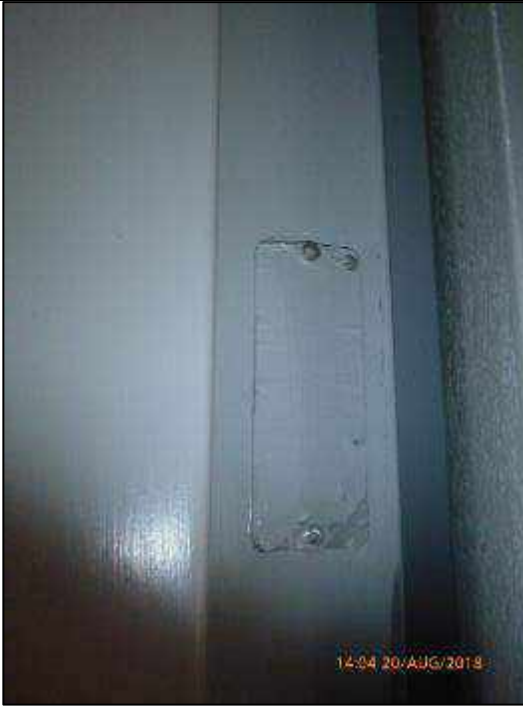
Item	Location	Defect Description and Breach	Rectification	Photograph (if applicable)
418	Front entry door frame	<p>Door frame label has been painted over.</p> <p>Home Building Act (NSW) 1989</p> <ul style="list-style-type: none"> Part 2C, 18B (a) & (c). <p>Loss Suffered</p> <p>Loss suffered is cost of rectification.</p>	Use a suitable cleaning agent to remove paint from the door frame label.

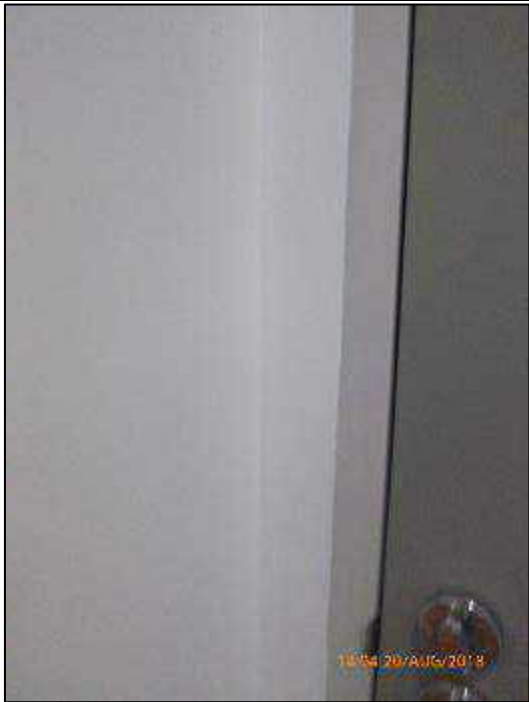
Item	Location	Defect Description and Breach	Rectification	Photograph (if applicable)
421	Wall adjacent to front entry door frame	See section 5.13.1	See section 5.13.2

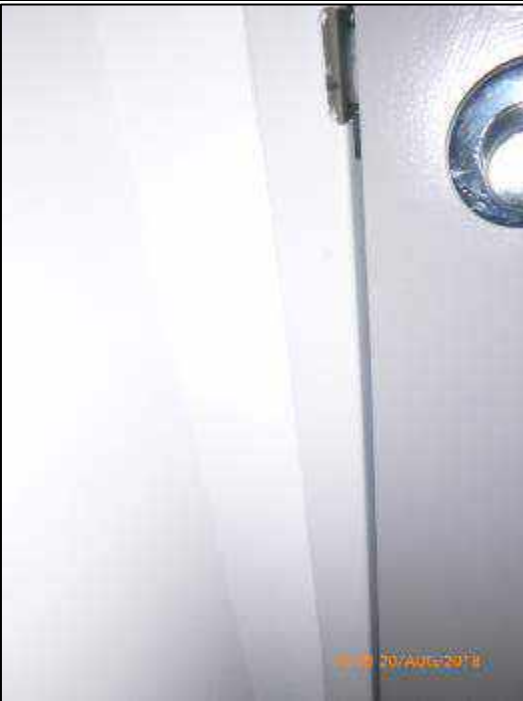
Item	Location	Defect Description and Breach	Rectification	Photograph (if applicable)
422	Front entry door frame	See section 5.10.1	See section 5.10.2

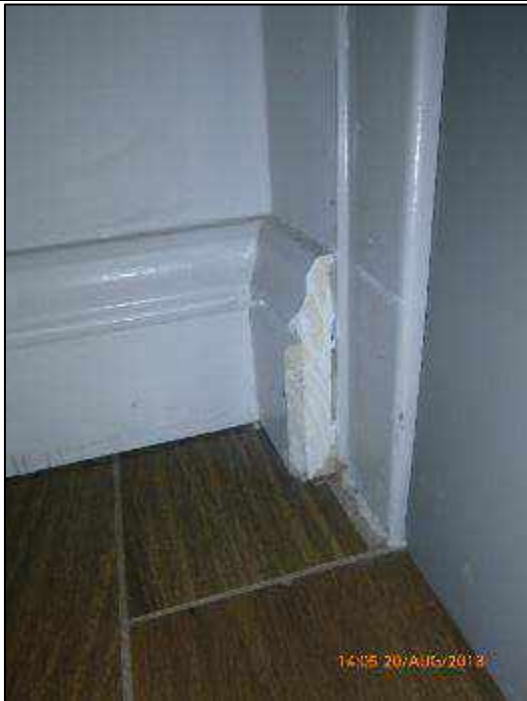
Item	Location	Defect Description and Breach	Rectification	Photograph (if applicable)
423	Skirting adjacent to board front entrance	See section 5.10.1	See section 5.10.2

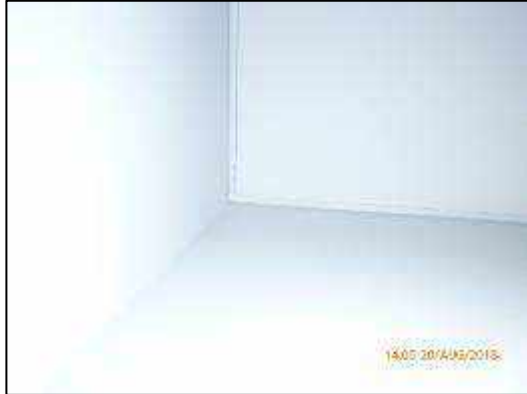
424	Lounge room	See section 5.11.1	See section 5.11.2

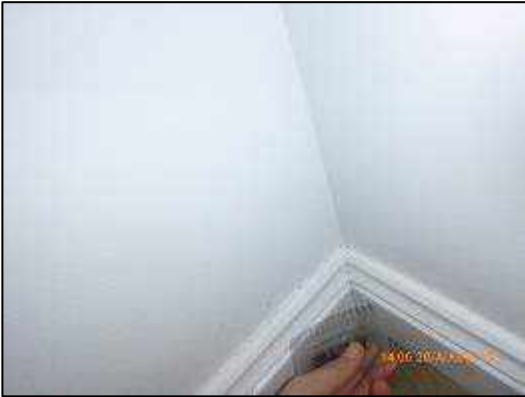
Item	Location	Defect Description and Breach	Rectification	Photograph (if applicable)
425	Southwestern corner of hallway adjacent to entrance skirting board	See section 5.14.1 Separation; 1mm	See section 5.14.2

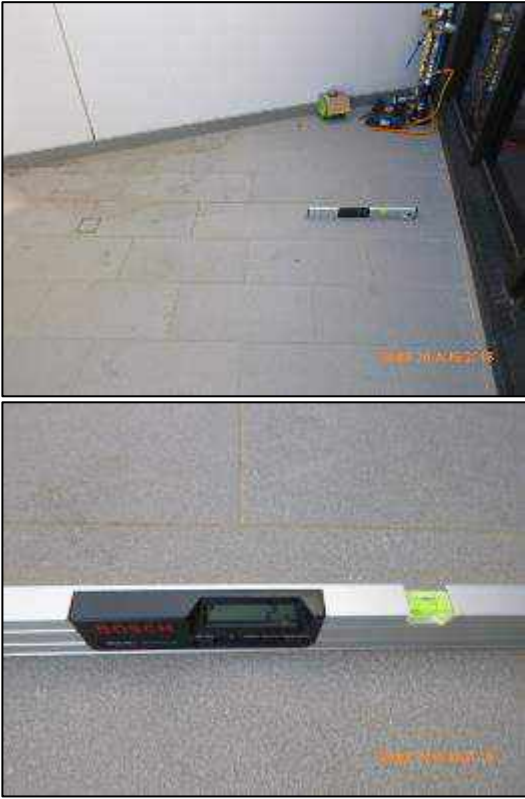
Item	Location	Defect Description and Breach	Rectification	Photograph (if applicable)
426	Balcony	See section 5.2.1 Falls (mm); 2/1000	See section 5.2.2

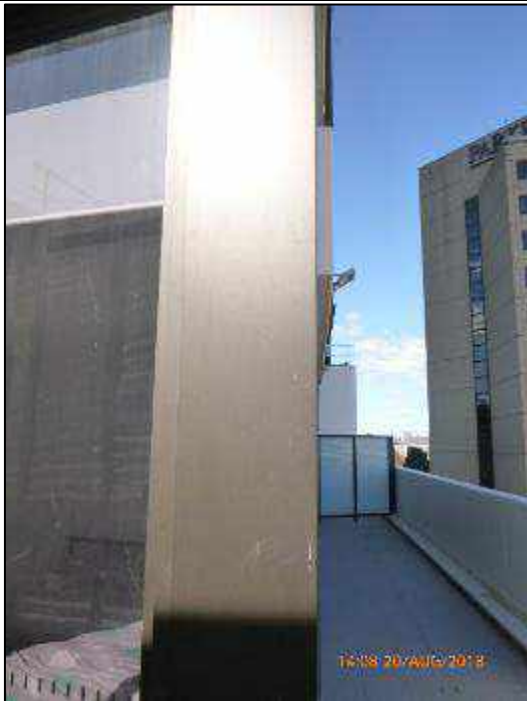
Item	Location	Defect Description and Breach	Rectification	Photograph (if applicable)
427	Balcony panels façade	<p>Construction debris observed on the external façade.</p> <p>Home Building Act (NSW) 1989</p> <ul style="list-style-type: none"> Part 2C, 18B (a) and (c). <p>This is a breach of part (a) of the act because the surface has not been finished in a proper workmanlike manner that would prevent loss of appearance to the surface.</p> <p>Loss Suffered Loss suffered is cost of rectification.</p>	<ol style="list-style-type: none"> 1. Protect all adjoining surfaces. 2. Use a suitable cleaning agent to remove residue and clear debris. 3. Clean up the work area.

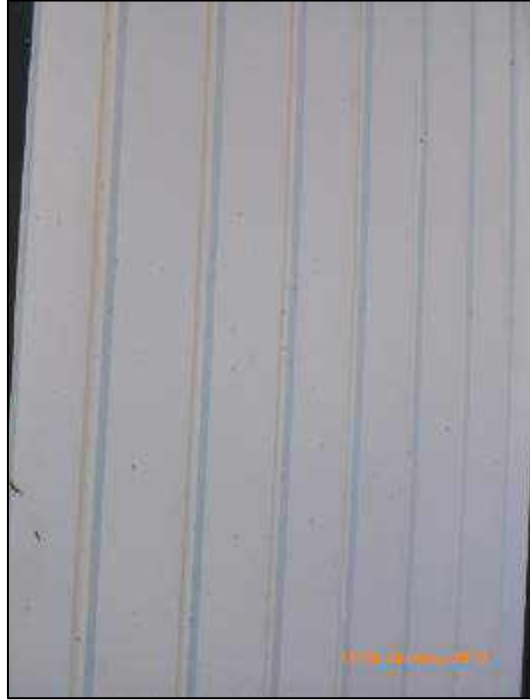
Item	Location	Defect Description and Breach	Rectification	Photograph (if applicable)
428	Balcony façade	<p>Construction debris observed on the external façade.</p> <p>Home Building Act (NSW) 1989</p> <ul style="list-style-type: none"> Part 2C, 18B (a) and (c). <p>This is a breach of part (a) of the act because the surface has not been finished in a proper workmanlike manner that would prevent loss of appearance to the surface.</p> <p>Loss Suffered</p> <p>Loss suffered is cost of rectification.</p>	<ol style="list-style-type: none"> 1. Protect all adjoining surfaces. 2. Use a suitable cleaning agent to remove residue and clear debris. 3. Clean up the work area.

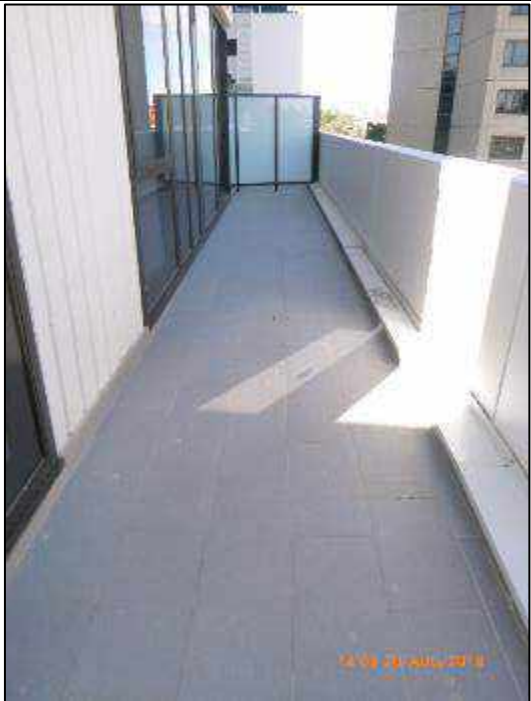
Item	Location	Defect Description and Breach	Rectification	Photograph (if applicable)
429	Balcony façade	<p>Construction debris observed on the external façade.</p> <p>Home Building Act (NSW) 1989</p> <ul style="list-style-type: none"> Part 2C, 18B (a) and (c). <p>This is a breach of part (a) of the act because the surface has not been finished in a proper workmanlike manner that would prevent loss of appearance to the surface.</p> <p>Loss Suffered Loss suffered is cost of rectification.</p>	<ol style="list-style-type: none"> 1. Protect all adjoining surfaces. 2. Use a suitable cleaning agent to remove residue and clear debris. 3. Clean up the work area.

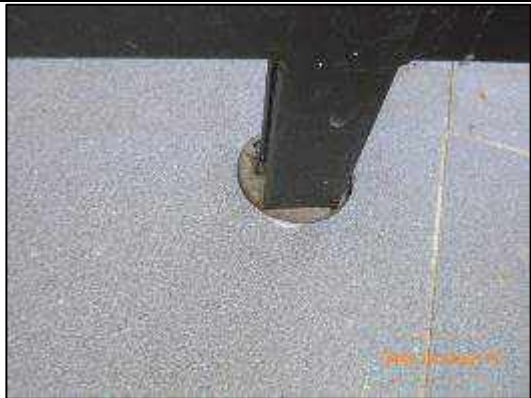
430	Balcony	<p>Balustrade cover plates have not been installed.</p> <p>Home Building Act (NSW) 1989</p> <ul style="list-style-type: none"> Part 2C, 18B (a) and (c). <p>This is a breach of part (a) of the act because the spigot has been installed without a cover and therefore not been installed in a proper workmanlike manner that would prevent moisture ingress.</p> <p>Loss Suffered</p>	<ol style="list-style-type: none"> 1. Protect all adjoining surfaces surrounding the work area. 2. Remove the top-rail and glass balustrade 3. Install spigot cover 4. Reinstall fixtures to match existing

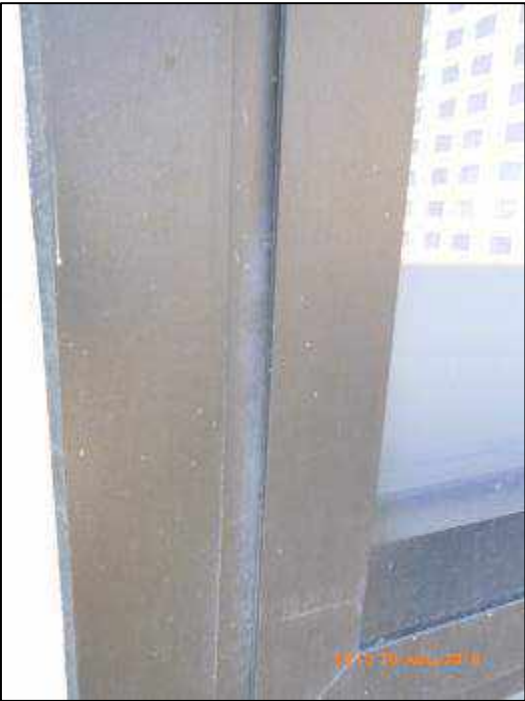
Item	Location	Defect Description and Breach	Rectification	Photograph (if applicable)
		Loss suffered is cost of rectification.		
431	Balcony window frames	See section 5.7.1	See section 5.7.2

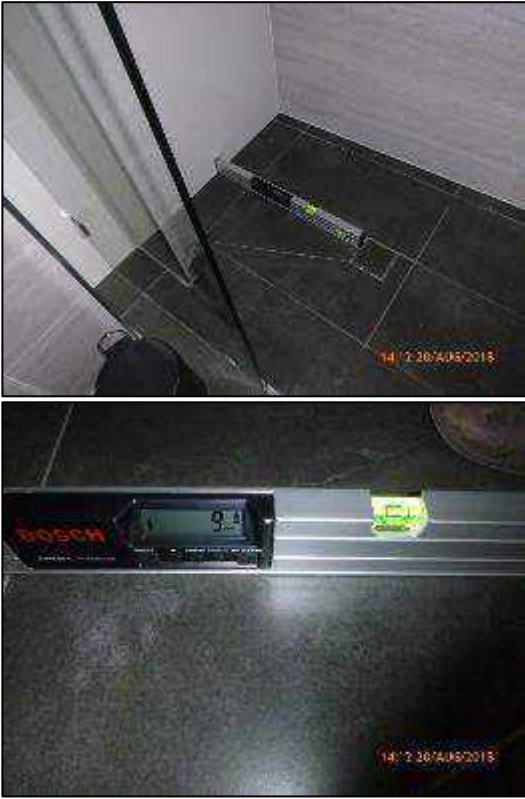
Item	Location	Defect Description and Breach	Rectification	Photograph (if applicable)
432	Main bathroom	See section 5.1.1 Falls (mm); 9/1000	See section 5.1.2

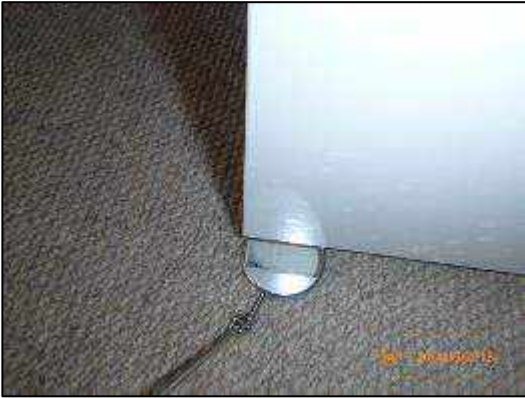
Item	Location	Defect Description and Breach	Rectification	Photograph (if applicable)
433	<i>Doors throughout the unit (x5)</i>	See section 5.5.1	See section 5.5.2

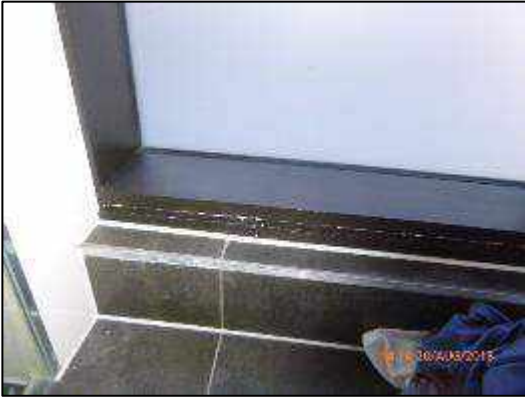
434	<i>Main bedroom ensuite windows</i>	See section 5.8.1	See section 5.8.2

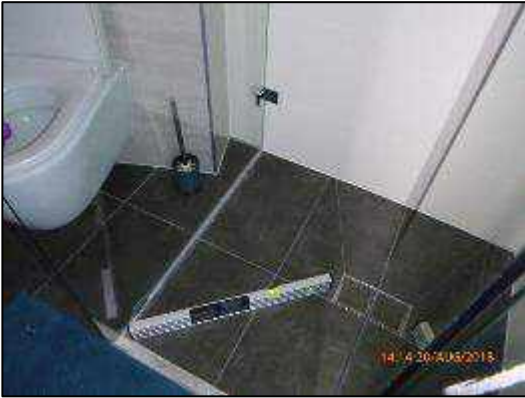
Item	Location	Defect Description and Breach	Rectification	Photograph (if applicable)
435	Main bedroom ensuite	See section 5.1.1 Falls (mm); 7/1000	See section 5.1.2

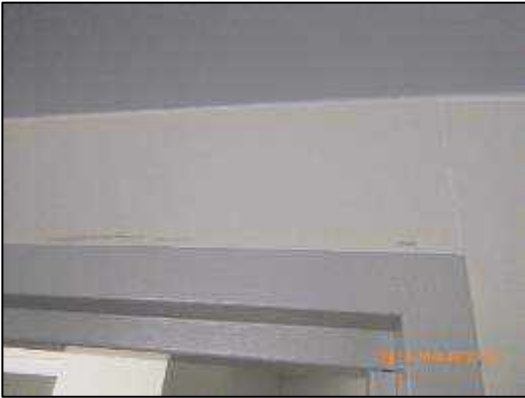
436	Main bedroom ensuite above door frame	See section 5.9.1	See section 5.9.2

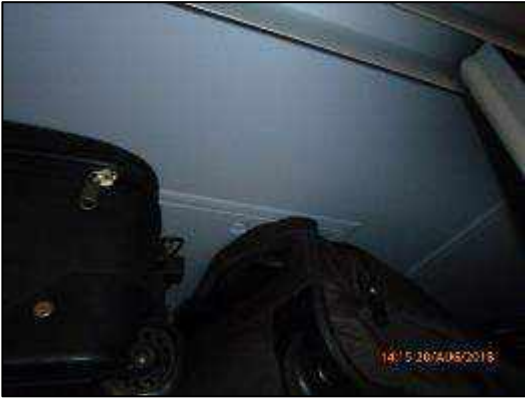
Item	Location	Defect Description and Breach	Rectification	Photograph (if applicable)
437	Main bedroom built in	See section 5.6.1	See section 5.6.2

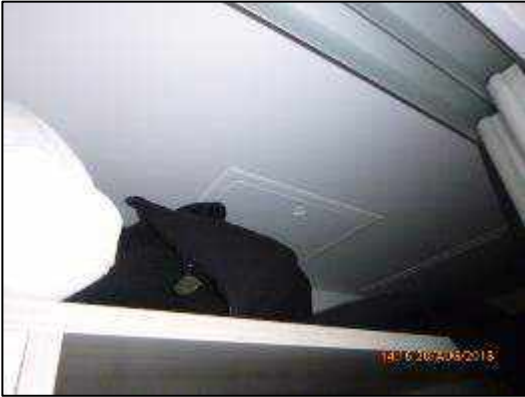
438	Second bedroom built in	See section 5.6.1	See section 5.6.2

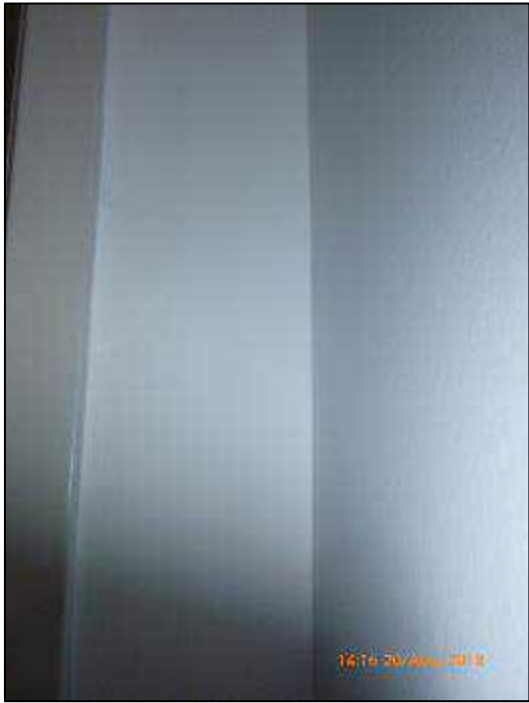
Item	Location	Defect Description and Breach	Rectification	Photograph (if applicable)
439	Second bedroom wall adjacent to built in	See section 5.13.1	See section 5.13.2
