SydneyStrataReport

STRATA REPORT

Client	Church Street Parramatta Property Pty Ltd
Address of property	Unit 3303/330 Church Street, Parramatta, NSW.
Lot	359
Strata Plan	SP 94469
Name of Strata Management Co.	NSW Strata
Telephone Number of Strata Agent	8980 1841
Report Date	15 February 2024

BUILDING DEFECTS REPORT Part 1/2

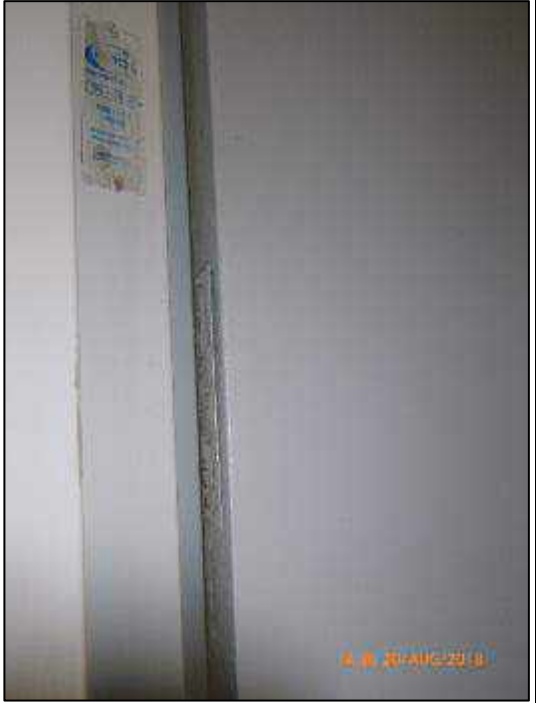
Item	Location	Defect description and Breach	Rectification	Photograph (if applicable)
Unit 501				
441	Front entry door	<p>Fire door and frame observed to be two different brands.</p> <p>Home Building Act (NSW) 1989</p> <ul style="list-style-type: none"> Part 2C, 18B (a) and (c). <p>Loss Suffered</p> <p>Loss suffered is cost of rectification.</p>	Engage a licenced tradesperson to remove fire door and install a suitable fire door to match existing door frame as advised by fire engineer.

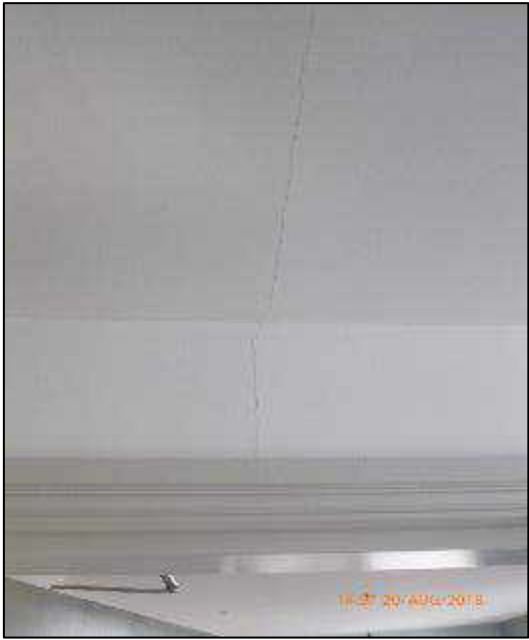
Item	Location	Defect description and Breach	Rectification	Photograph (if applicable)
442	Wall above front entry door	See section 5.14.1 Separation; 1.5mm	See section 5.14.2

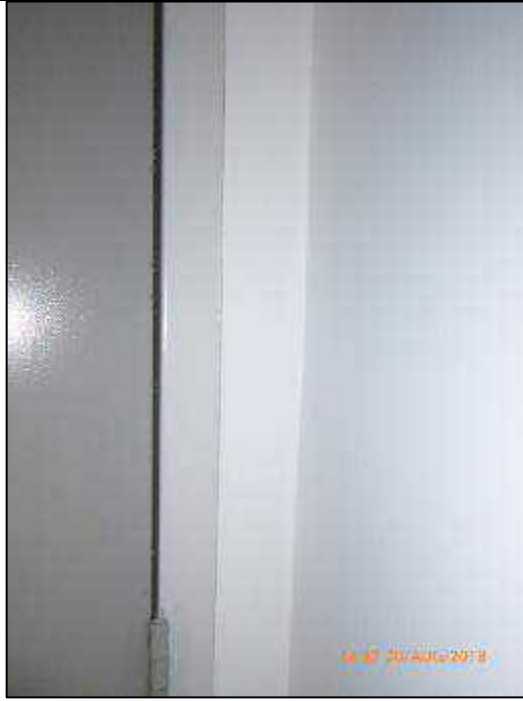
Item	Location	Defect description and Breach	Rectification	Photograph (if applicable)
443	Wall adjacent to front entry door	See section 5.13.1	See section 5.13.2

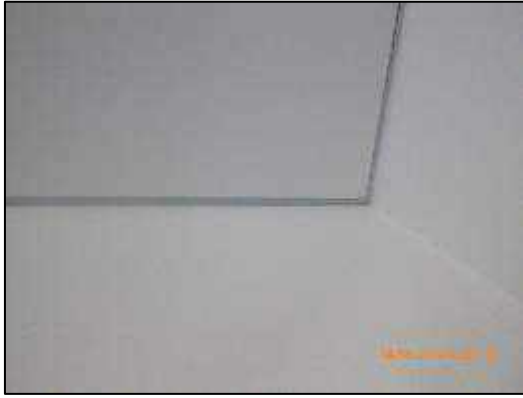
A photograph showing a vertical crack or gap in a light-colored wall. The crack runs from the top to the bottom of the frame. A date stamp in orange text at the bottom right reads "14:27 20-AUG-2018".
444	Lounge room	See section 5.11.1	See section 5.11.2

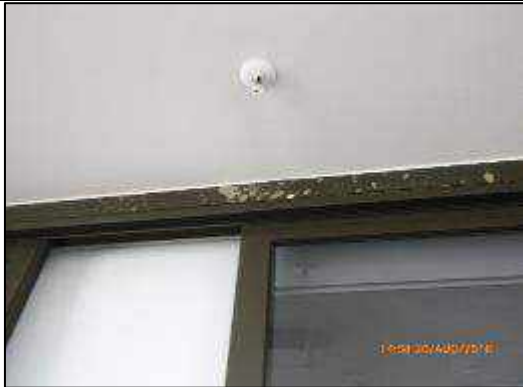
Item	Location	Defect description and Breach	Rectification	Photograph (if applicable)
445	Balcony sliding door frame	<p>Construction debris observed on sliding door frame.</p> <p>Home Building Act (NSW) 1989</p> <ul style="list-style-type: none"> Part 2C, 18B (a) and (c). <p>This is a breach of part (a) of the act because the surface has not been finished in a proper workmanlike manner that would prevent loss of appearance to the surface.</p> <p>Loss Suffered</p> <p>Loss suffered is cost of rectification.</p>	<ol style="list-style-type: none"> 1. Protect all adjoining surfaces. 2. Use a suitable cleaning agent to remove residue and clear debris. 3. Clean up the work area.

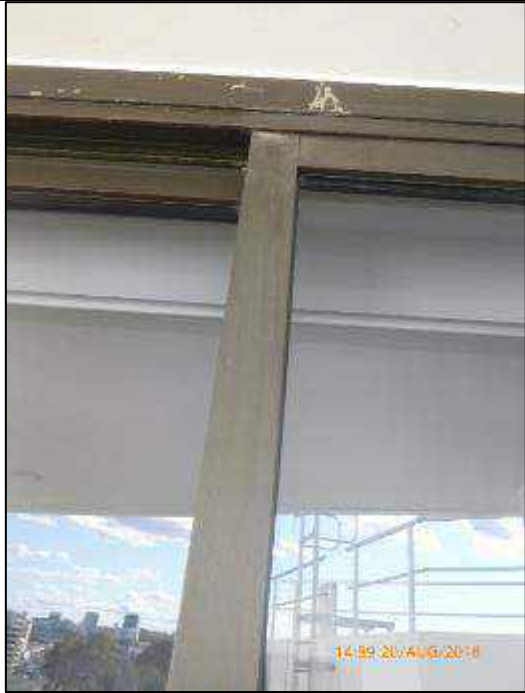
Item	Location	Defect description and Breach	Rectification	Photograph (if applicable)
446	Balcony sliding door frame	See section 5.7.1	See section 5.7.2

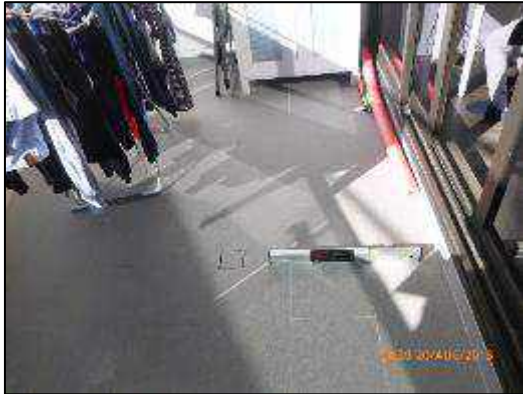
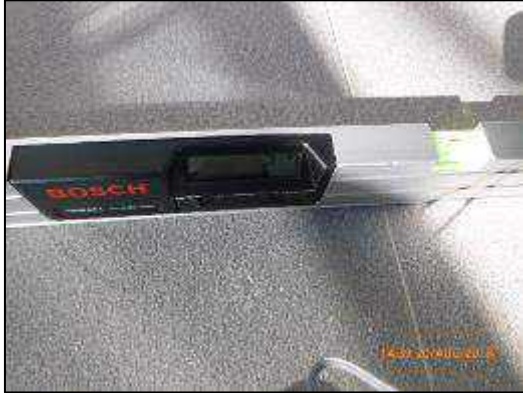
Item	Location	Defect description and Breach	Rectification	Photograph (if applicable)
447	Balcony	See section 5.2.1 Falls (mm); 2/1000	See section 5.2.2

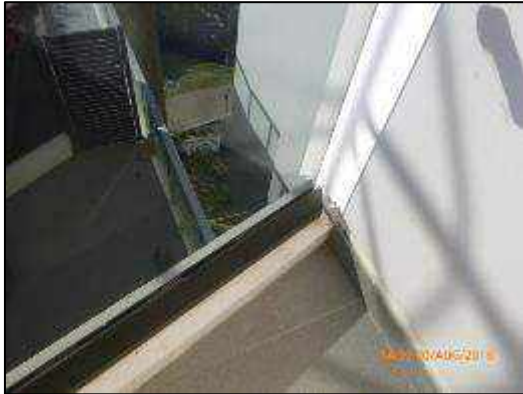
Item	Location	Defect description and Breach	Rectification	Photograph (if applicable)
448	Balcony	See section 5.3.1	See section 5.3.2

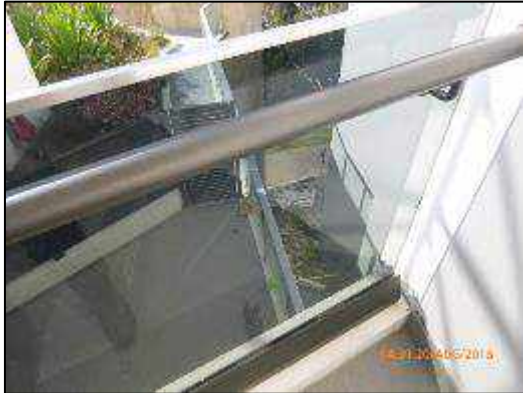
A photograph showing a close-up of a balcony railing. The railing consists of a metal handrail and a glass panel. There is a visible gap or defect in the railing assembly. A date stamp '12/12/2018' is visible in the bottom right corner of the photo.
449	Balcony	See section 5.4.1	See section 5.4.2

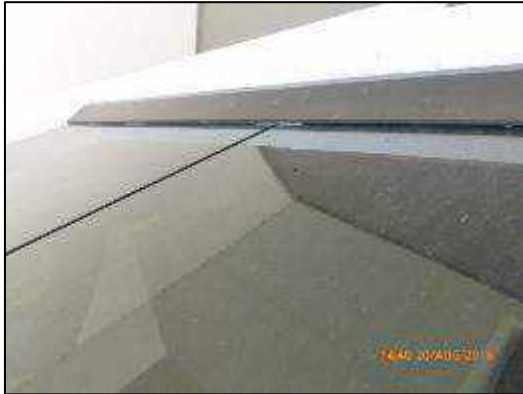
Item	Location	Defect description and Breach	Rectification	Photograph (if applicable)
450	Balcony balustrade	See section 5.9.1	See section 5.9.2

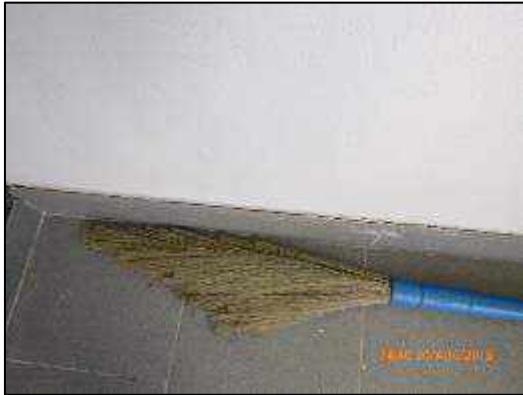
451	Balcony	<p>No weep holes or flashing observed on façade in balcony area.</p> <p>Home Building Act (NSW) 1989</p> <ul style="list-style-type: none"> Part 2C, 18B (a) and (c). <p>Loss Suffered</p> <p>Loss suffered is cost of rectification.</p>	<ol style="list-style-type: none"> 1. Remove sandstone tiles on wall in balcony area. 2. Engage a licenced tradesman to install flashing and produce weep holes. 3. Re-instate the sandstone tiles with weep holes. 4. Clean up the work area.

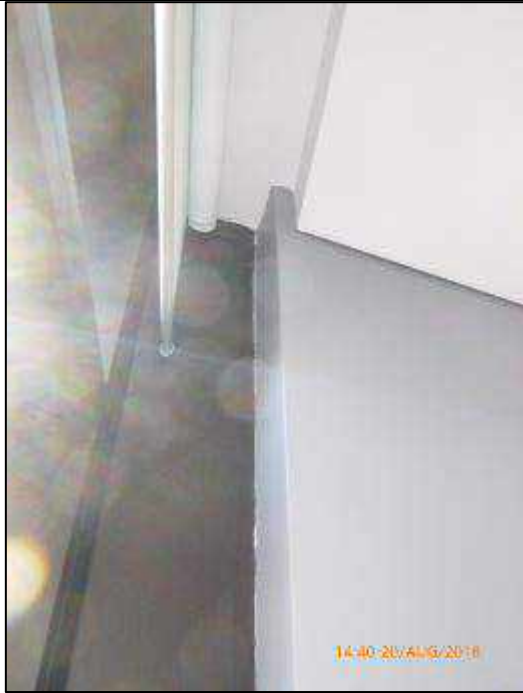
Item	Location	Defect description and Breach	Rectification	Photograph (if applicable)
452	Balcony flooring	<p>Drummy and loose skirting tiles observed on balcony.</p> <p>Home Building Act (NSW) 1989</p> <ul style="list-style-type: none"> Part 2C, 18B (a) and (c). <p>Guide to Standards and Tolerances 2017</p> <p>Section 12.5 Cracked, pitted, chipped, scratched, loose or drummy tiles.</p> <p>Loss Suffered</p> <p>Loss suffered is cost of rectification and appearance.</p>	<ol style="list-style-type: none"> 1. Protect all adjoining surfaces surrounding the work area. 2. Remove the tiles 3. Install new tile to match existing

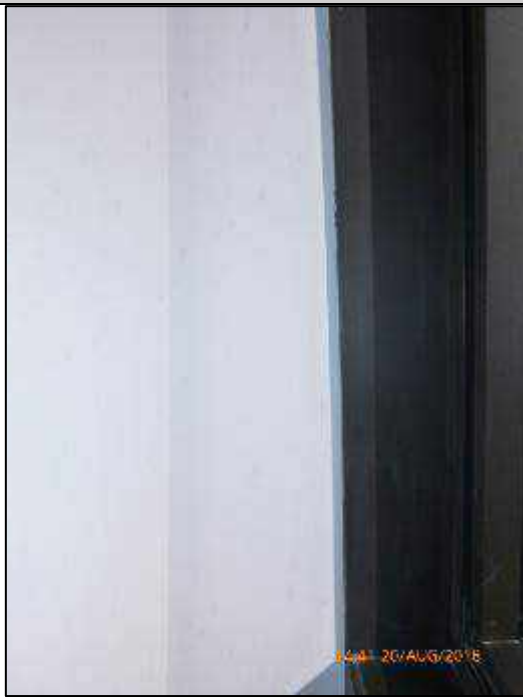
Item	Location	Defect description and Breach	Rectification	Photograph (if applicable)
453	Lounge room window frame on south western corner	See section 5.13.1	See section 5.13.2

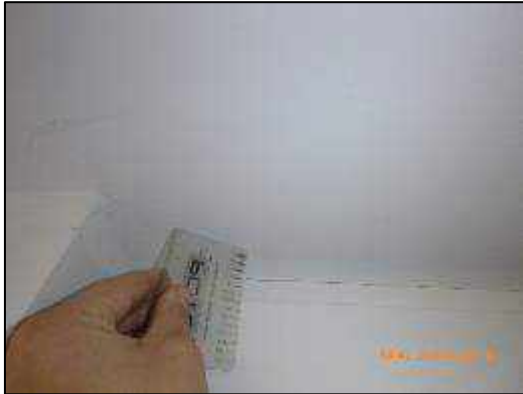
Item	Location	Defect description and Breach	Rectification	Photograph (if applicable)
455	<i>Ceiling above kitchen cupboards</i>	See section 5.14.1 Separation; 1.5mm	See section 5.14.2

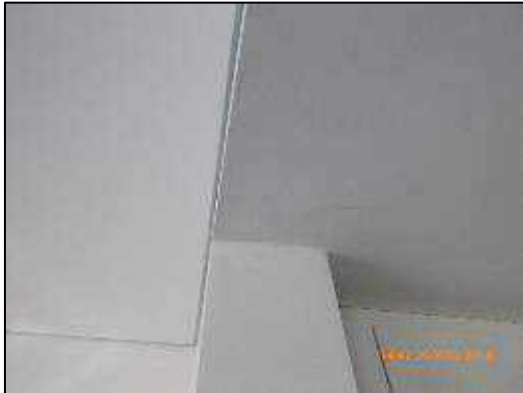
456	<i>Fridge return wall in kitchen area</i>	See section 5.13.1	See section 5.13.2

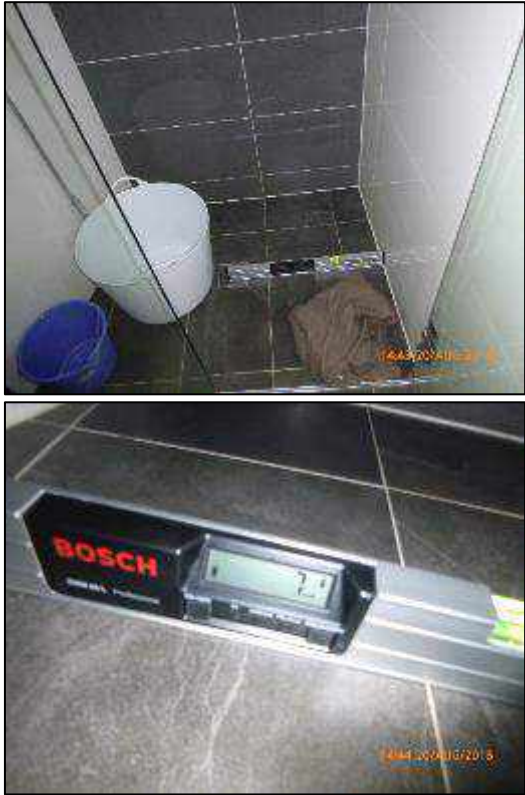
Item	Location	Defect description and Breach	Rectification	Photograph (if applicable)
457	Main bathroom	See section 5.1.1 Falls (mm); 7/1000	See section 5.1.2

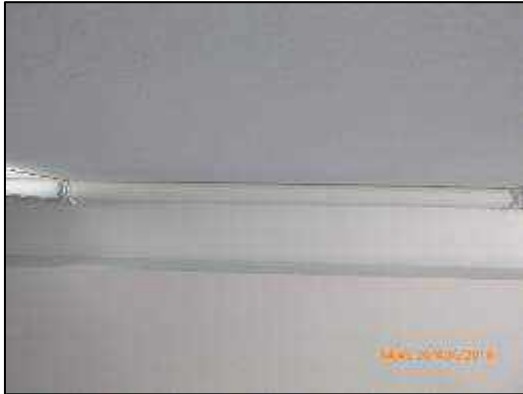
Item	Location	Defect description and Breach	Rectification	Photograph (if applicable)
458	Second bedroom window bulkhead	See section 5.10.1	See section 5.10.2

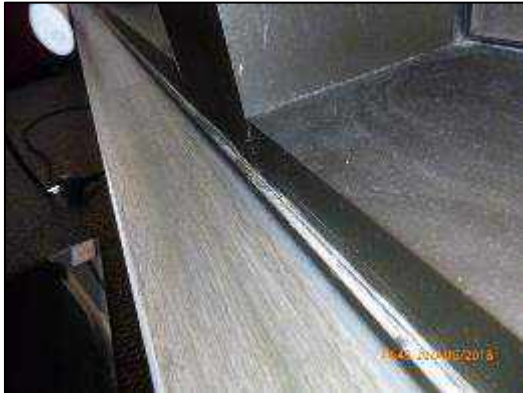
A photograph showing a horizontal window bulkhead with a visible gap or defect. An orange timestamp '14/05/2018 15:20:18' is visible in the bottom right corner.
459	Second bedroom window frames	See section 5.8.1	See section 5.8.2

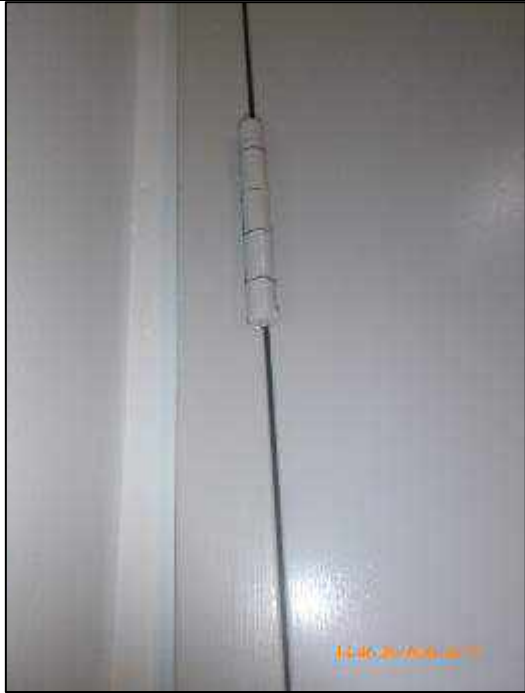
Item	Location	Defect description and Breach	Rectification	Photograph (if applicable)
460	Wall adjacent to second bedroom door	See section 5.13.1	See section 5.13.2

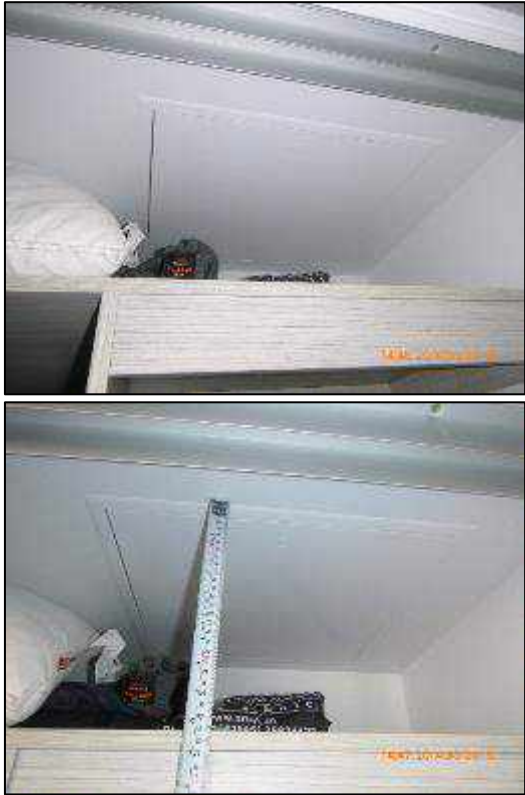
Item	Location	Defect description and Breach	Rectification	Photograph (if applicable)
461	Second bedroom built in	See section 5.6.1	See section 5.6.2

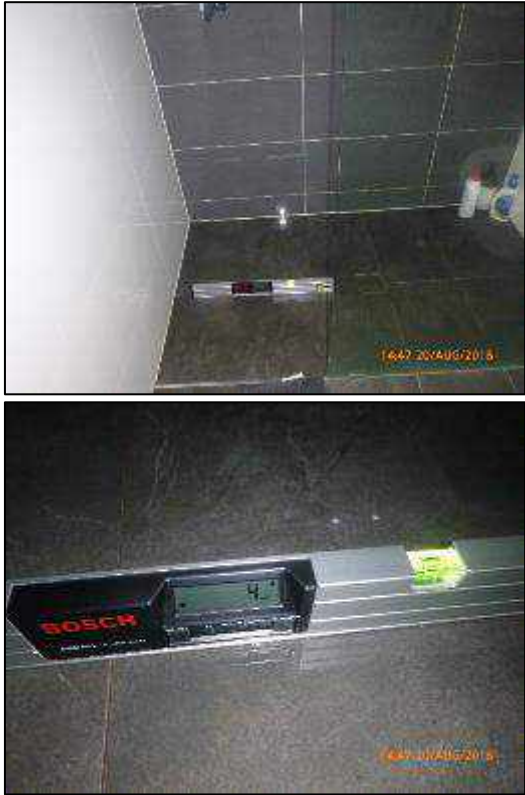
Item	Location	Defect description and Breach	Rectification	Photograph (if applicable)
462	Main bedroom ensuite	<p>See section 5.1.1 Ponding observed at time of inspection.</p> <p>Falls (mm); 4/1000</p>	See section 5.1.2

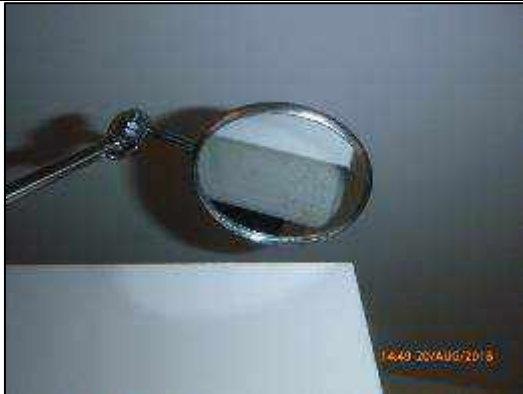
Item	Location	Defect description and Breach	Rectification	Photograph (if applicable)
463	<i>Doors throughout unit (x5)</i>	See section 5.5.1	See section 5.5.2

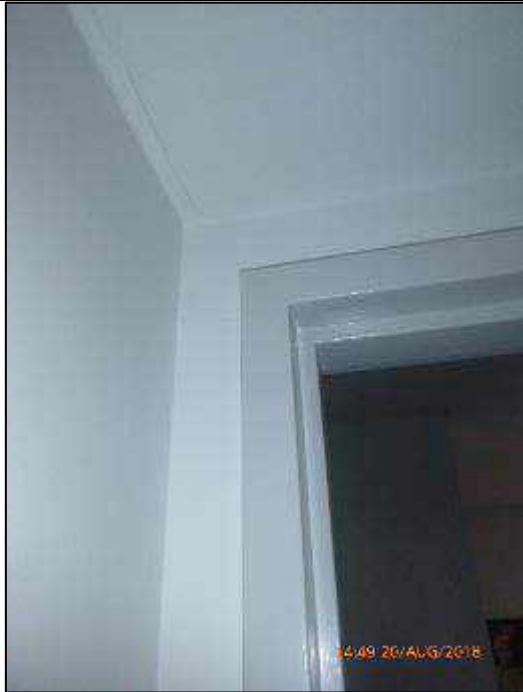
464	<i>Ceiling above main bedroom door</i>	See section 5.14.1 Separation; 1.5mm	See section 5.14.2

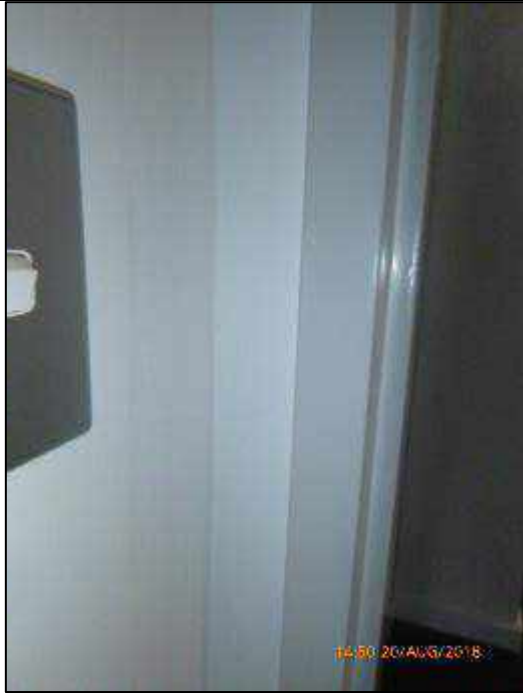
Item	Location	Defect description and Breach	Rectification	Photograph (if applicable)
465	Wall adjacent to main bedroom door	See section 5.13.1	See section 5.13.2

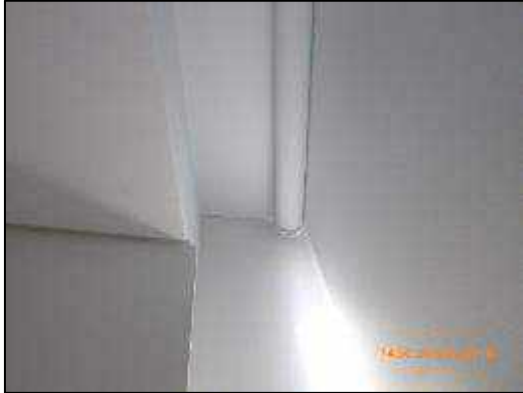
466	Main bedroom above windows between ceiling and bulkhead	See section 5.14.1 Separation; 1mm	See section 5.14.2

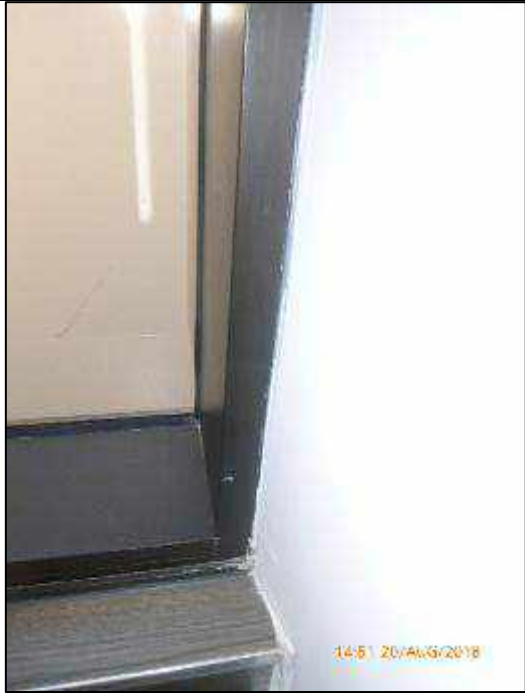
Item	Location	Defect description and Breach	Rectification	Photograph (if applicable)
467	Main bedroom window frames	See section 5.9.1	See section 5.9.2

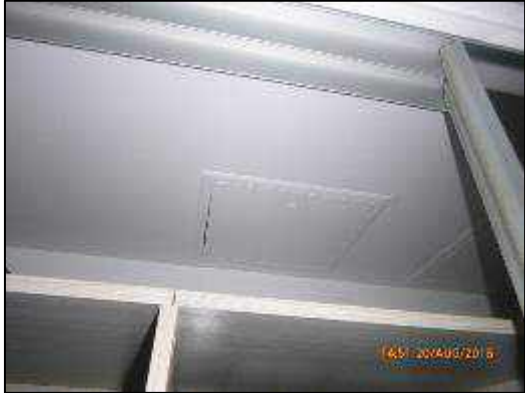
468	Main bedroom built in	See section 5.6.1	See section 5.6.2

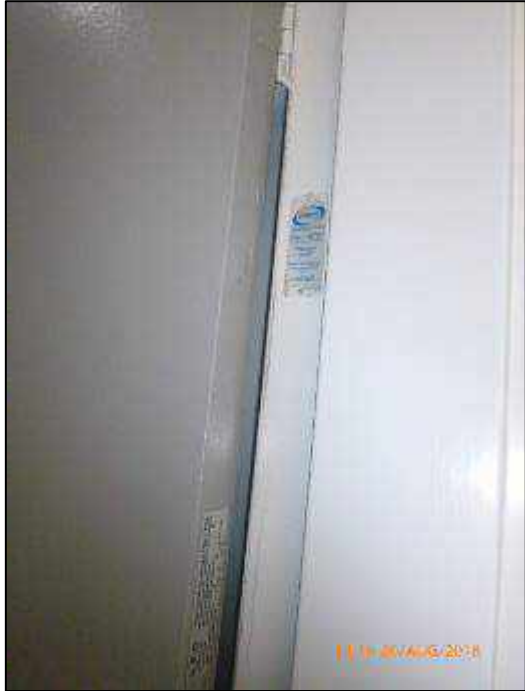
Item	Location	Defect description and Breach	Rectification	Photograph (if applicable)
Unit 502				
469	Front entry door	<p>Fire door and frame observed to be two different brands.</p> <p>Home Building Act (NSW) 1989</p> <ul style="list-style-type: none"> Part 2C, 18B (a) and (c). <p>Loss Suffered Loss suffered is cost of rectification.</p>	Engage a licenced tradesperson to remove fire door and install a suitable fire door to match existing door frame as advised by fire engineer.

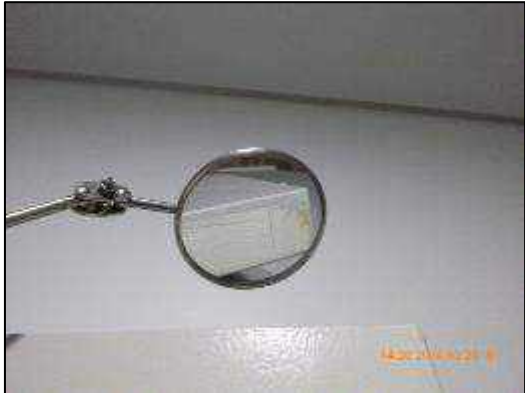
Item	Location	Defect description and Breach	Rectification	Photograph (if applicable)
470	Doors throughout unit (x4)	See section 5.5.1	See section 5.5.2

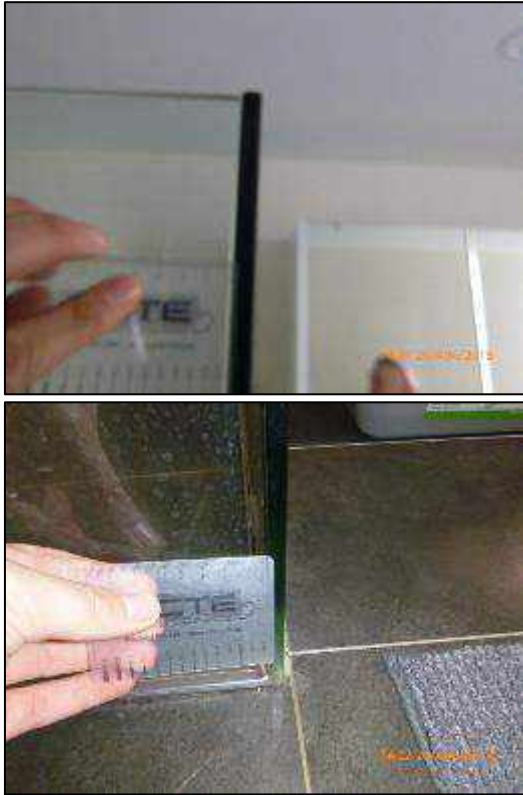
Item	Location	Defect description and Breach	Rectification	Photograph (if applicable)
471	Main bedroom ensuite	<p>Shower screen in ensuite was observed to be out of plane.</p> <p>Home Building Act (NSW) 1989</p> <ul style="list-style-type: none"> Part 2C, 18B (a) & (c). <p>Guide to Standards and Tolerances 2017</p> <ul style="list-style-type: none"> Section 9.7 Operation of windows and doors. <p>This is a defect because the door does not operate as intended by the manufacturer' as outlined in Section 9.7 of the Guide to Standards and Tolerances 2017.</p> <p>Loss Suffered Loss suffered is cost of rectification.</p>	<ol style="list-style-type: none"> 1. Protect all surrounding surfaces 2. Remove door and plane as required. 3. Re-instate the door 4. Clean up work area.

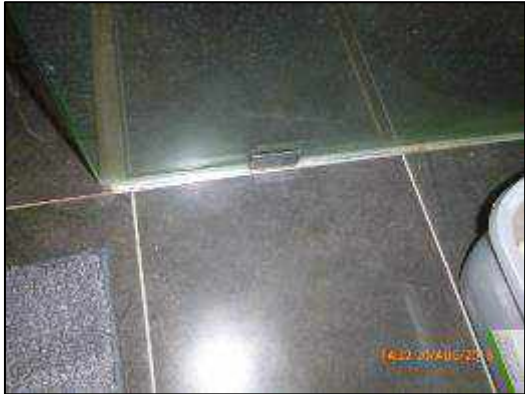
Item	Location	Defect description and Breach	Rectification	Photograph (if applicable)
472	Main bedroom ensuite	<p>Water egress observed outside of shower recess.</p> <p>Home Building Act (NSW) 1989</p> <ul style="list-style-type: none"> Part 2C, 18B (a), (b) and (c). <p>Building Code of Australia</p> <ul style="list-style-type: none"> Section F Health and Amenity Part F1 Damp and Weatherproofing Sections FO1, FF1.3. <p>This is a breach because the building is not constructed in a manner so as to prevent moisture escaping from the ensuite wet area.</p> <p>Loss Suffered</p> <p>Loss suffered is cost of rectification and loss of amenity to unit occupants.</p>	Remove tiles/fixtures within the shower enclosure to allow provision of suitable new waterproofing membrane system to the wet area. Replace tiles and refit shower fixtures on completion of tiling.

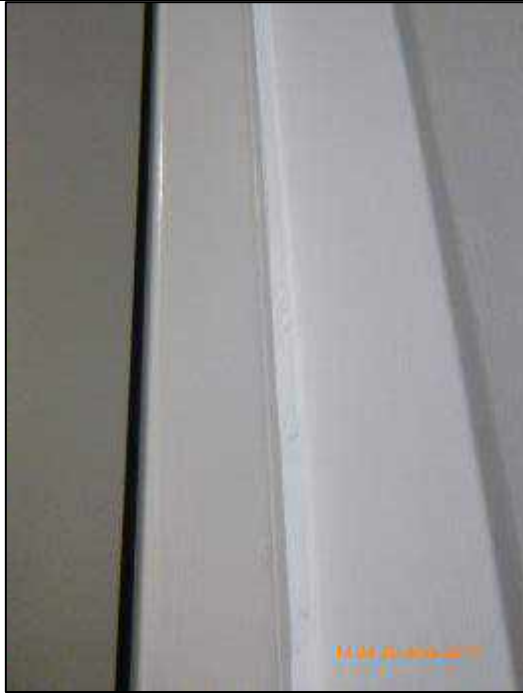
Item	Location	Defect description and Breach	Rectification	Photograph (if applicable)
473	Wall adjacent to main bedroom ensuite door	See section 5.13.1	See section 5.13.2

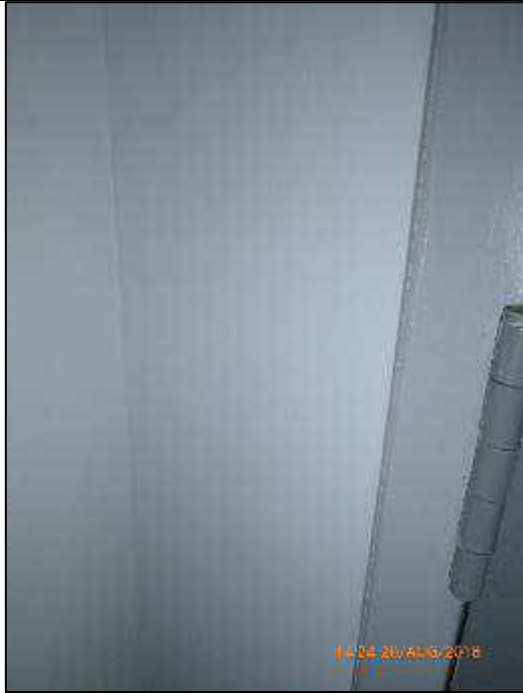
Item	Location	Defect description and Breach	Rectification	Photograph (if applicable)
474	Wall adjacent to front entry door	See section 5.13.1	See section 5.13.2

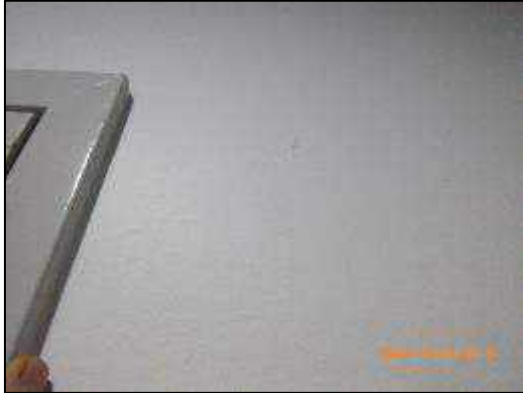
A photograph showing a close-up of a light-colored wall. A vertical line, possibly a crack or a joint, runs down the wall. A portion of a grey, textured object, likely a door handle or part of a door frame, is visible on the right side. In the bottom right corner, there is an orange timestamp that reads "14/04/2019 15:20:18".
475	Wall adjacent to front entry door	See section 5.13.1	See section 5.13.2

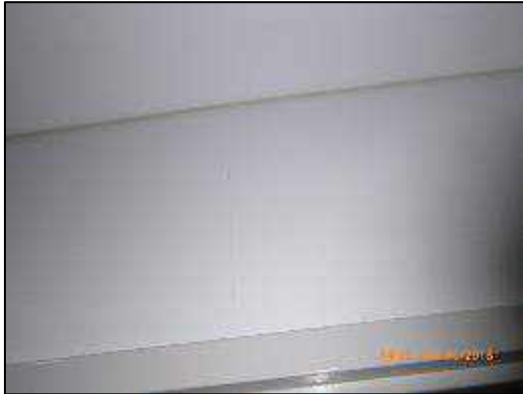
Item	Location	Defect description and Breach	Rectification	Photograph (if applicable)
476	Wall above front entry door	See section 5.13.1	See section 5.13.2

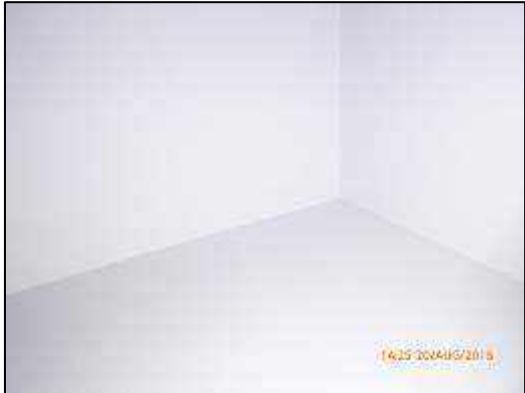
Item	Location	Defect description and Breach	Rectification	Photograph (if applicable)
478	<i>Kitchen western wall</i>	See section 5.10.1	See section 5.10.2

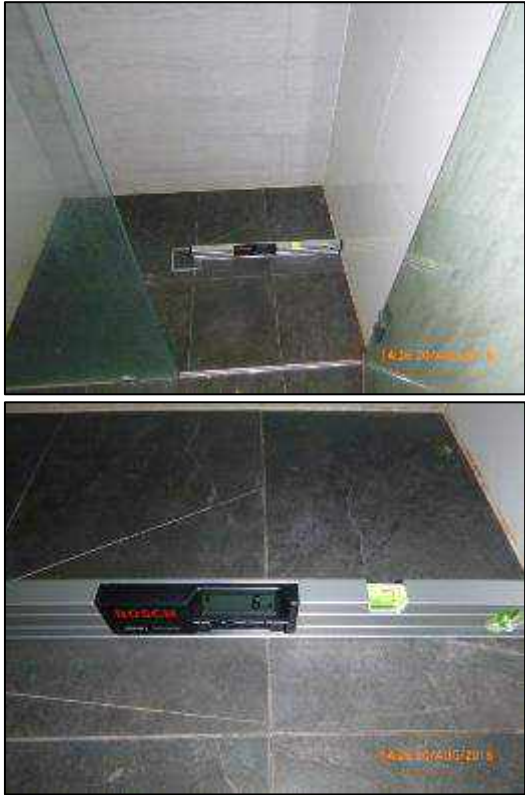
Item	Location	Defect description and Breach	Rectification	Photograph (if applicable)
479	Main bathroom	See section 5.1.1 Falls (mm); 6/1000	See section 5.1.2

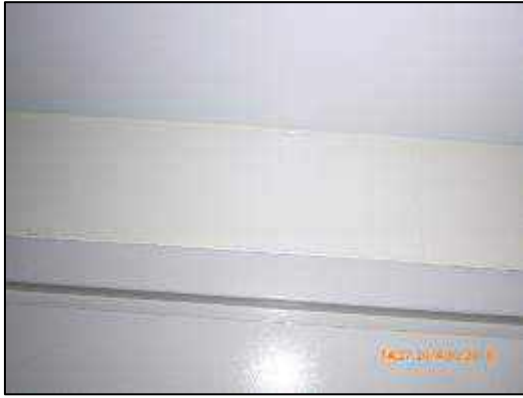
Item	Location	Defect description and Breach	Rectification	Photograph (if applicable)
480	Main bathroom door frame	See section 5.9.1	See section 5.9.2

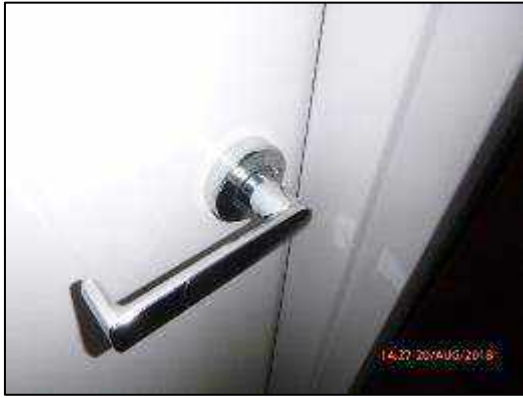
481	Second bedroom door	<p>Door was observed to be loose and not functional.</p> <p>Home Building Act (NSW) 1989</p> <ul style="list-style-type: none"> Part 2C, 18B (a) & (c). <p>Guide to Standards and Tolerances 2017</p> <ul style="list-style-type: none"> Section 9.7 Operation of windows and doors. <p>This is a defect because the door does not operate as intended by the manufacturer' as outlined in Section 9.7 of the Guide to Standards and Tolerances 2017.</p> <p>Loss Suffered Loss suffered is cost of rectification.</p>	Repair/adjust lock as required to reinstate satisfactory operation of the door.

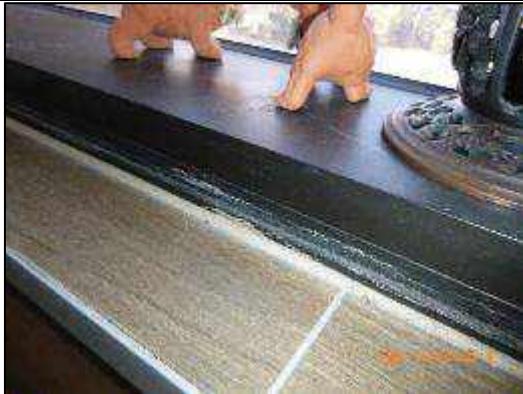
Item	Location	Defect description and Breach	Rectification	Photograph (if applicable)
482	Second bedroom window frame	See section 5.9.1	See section 5.9.2

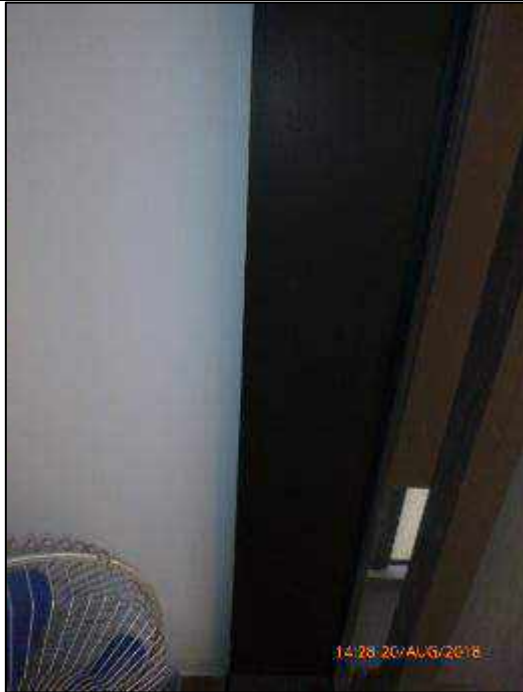
483	Second bedroom window frame	See section 5.7.1	See section 5.7.2

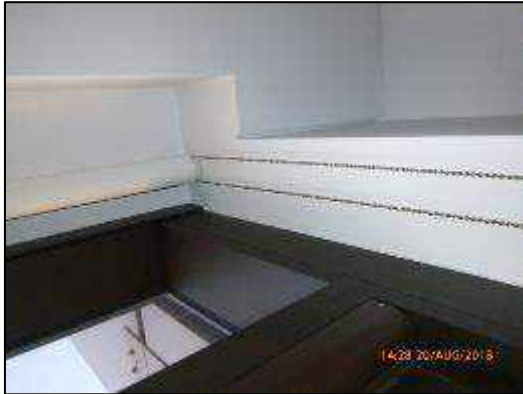
Item	Location	Defect description and Breach	Rectification	Photograph (if applicable)
484	Second bedroom window bulkhead	See section 5.13.1	See section 5.13.2

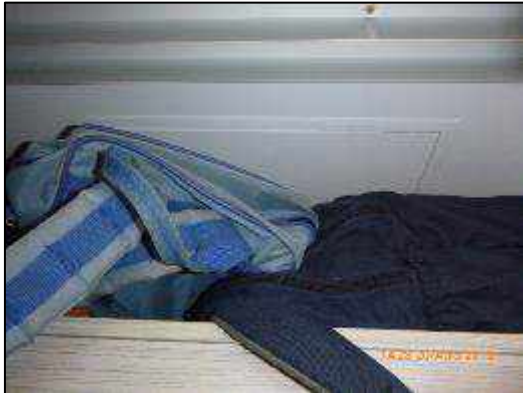
485	Second bedroom built in	See section 5.6.1	See section 5.6.2

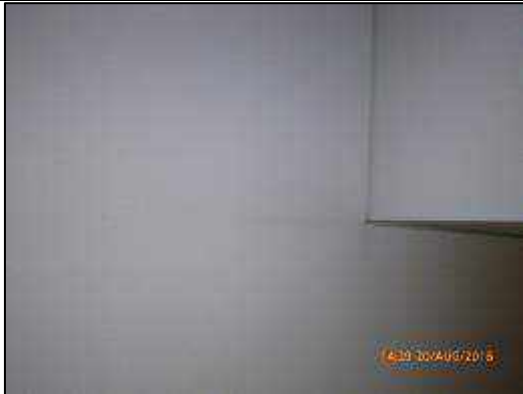
Item	Location	Defect description and Breach	Rectification	Photograph (if applicable)
486	Lounge room	See section 5.14.1	See section 5.14.2

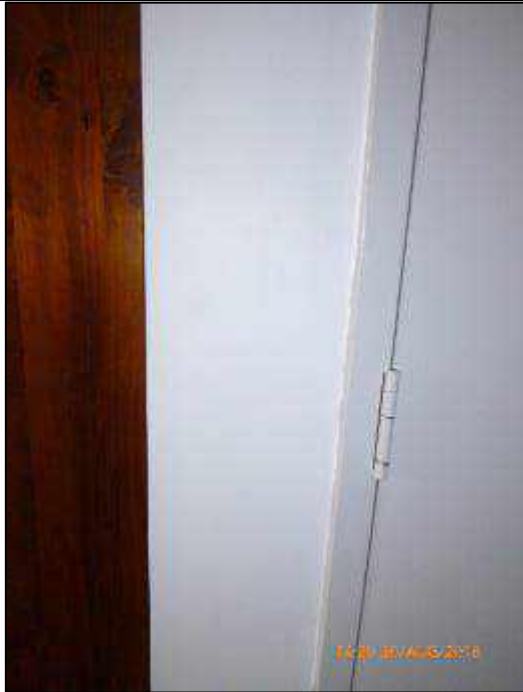
A photograph showing a plain white wall in a lounge room. A small portion of a dark object, possibly a shelf or picture frame, is visible on the right side. A timestamp in the bottom right corner reads "14:39 10/AUG/2018".
487	Wall adjacent to study room	See section 5.13.1	See section 5.13.2

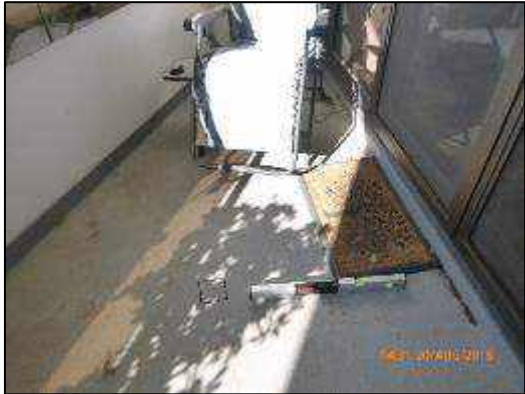
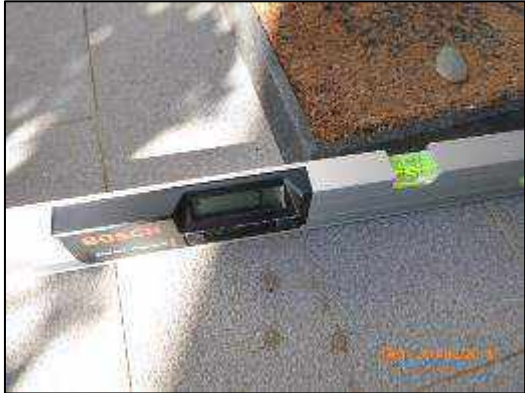
Item	Location	Defect description and Breach	Rectification	Photograph (if applicable)
490	Balcony	See section 5.2.1 Falls (mm); 3/1000	See section 5.2.2

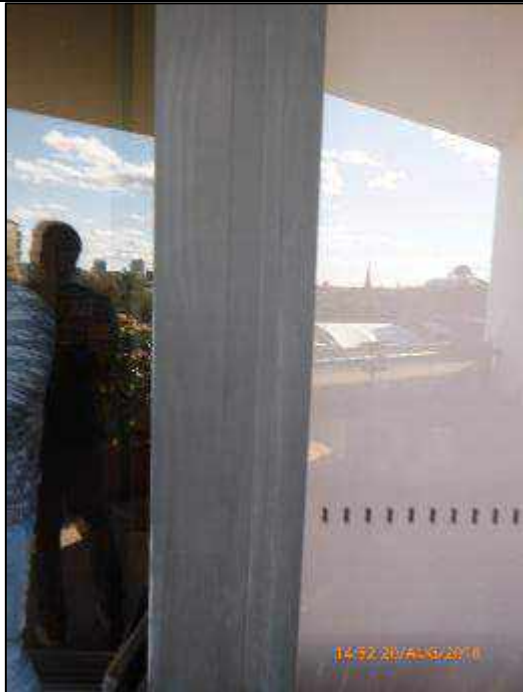
493	Balcony sliding door frames	See section 5.7.1	See section 5.7.2

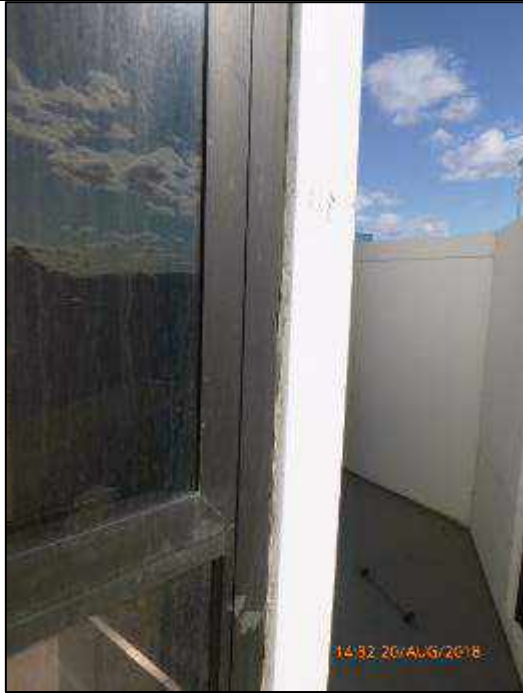
Item	Location	Defect description and Breach	Rectification	Photograph (if applicable)
494	Balcony	<p>Construction debris left on balcony windows.</p> <p>Home Building Act (NSW) 1989</p> <ul style="list-style-type: none"> Part 2C, 18B (a) and (c). <p>This is a breach of part (a) of the act because the surface has not been finished in a proper workmanlike manner that would prevent loss of appearance to the surface.</p> <p>Loss Suffered Loss suffered is cost of rectification.</p>	<ol style="list-style-type: none"> 1. Protect all adjoining surfaces. 2. Use a suitable cleaning agent to remove residue and clear debris. 3. Clean up the work area.

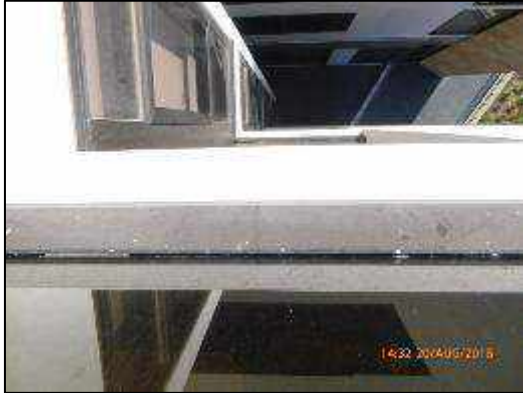
<p>A photograph showing a balcony window frame with construction debris and residue. The date stamp in the bottom right corner reads '14/32 20/AUG/2018'.</p>
495	Balcony balustrade	See section 5.9.1	See section 5.9.2

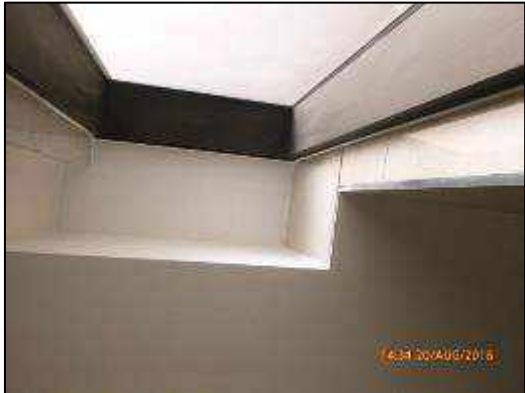
497	<i>Main bedroom ensuite ceiling</i>	See section 5.10.1	See section 5.10.2

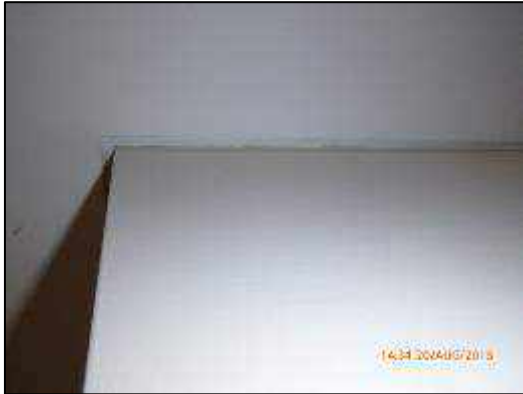
Item	Location	Defect description and Breach	Rectification	Photograph (if applicable)
498	Main bedroom	See section 5.11.1	See section 5.11.2

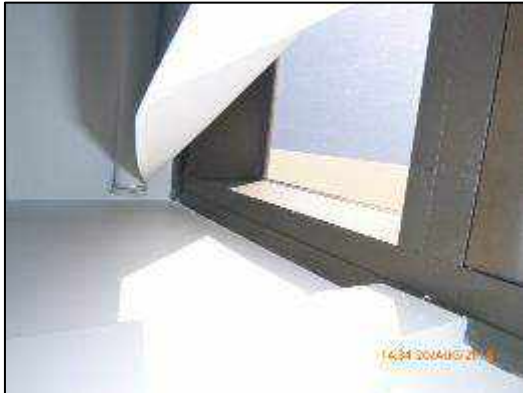
A photograph showing a corner of a white wall. A dark, possibly wooden or metal, trim piece is visible along the top edge of the wall. The lighting is somewhat dim, and there's a slight shadow in the corner.
499	Main bedroom window frames	See section 5.9.1	See section 5.9.2

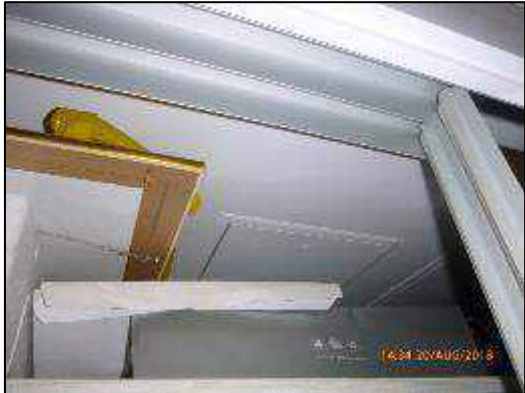
Item	Location	Defect description and Breach	Rectification	Photograph (if applicable)
500	Main bedroom built in	See section 5.6.1	See section 5.6.2

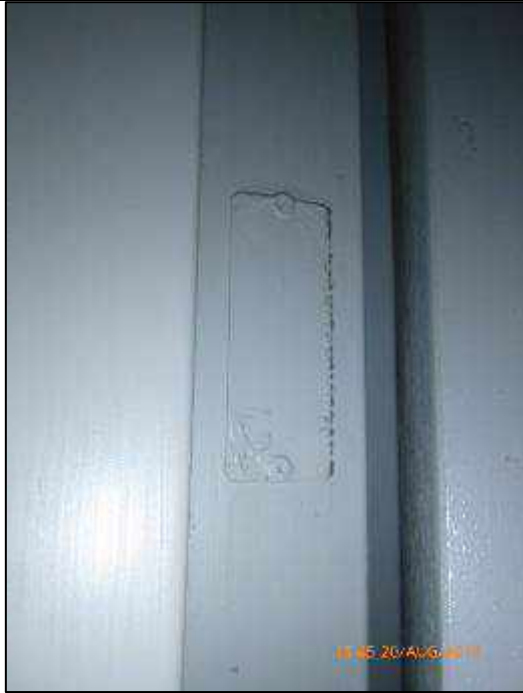
Item	Location	Defect description and Breach	Rectification	Photograph (if applicable)
Unit 503				
501	Front entry door	<p>Door frame label has been painted over.</p> <p>Home Building Act (NSW) 1989</p> <ul style="list-style-type: none"> Part 2C, 18B (a) & (c). <p>Loss Suffered</p> <p>Loss suffered is cost of rectification.</p>	Use a suitable cleaning agent to remove paint from the door frame label.

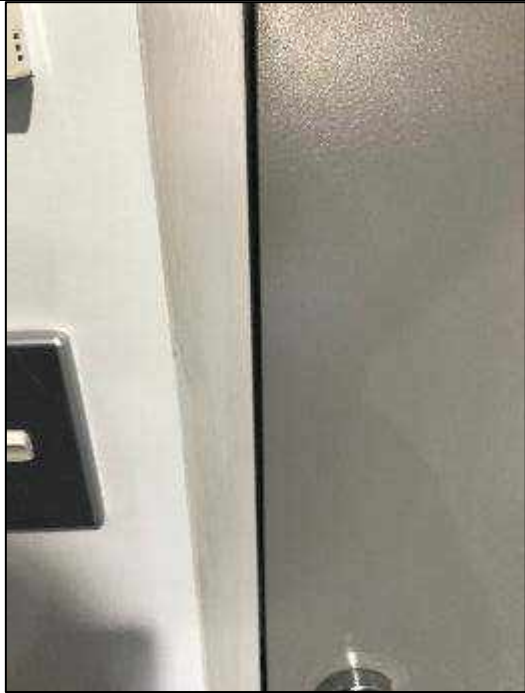
Item	Location	Defect description and Breach	Rectification	Photograph (if applicable)
504	Wall adjacent to front entry door	See section 5.13.1	See section 5.13.2

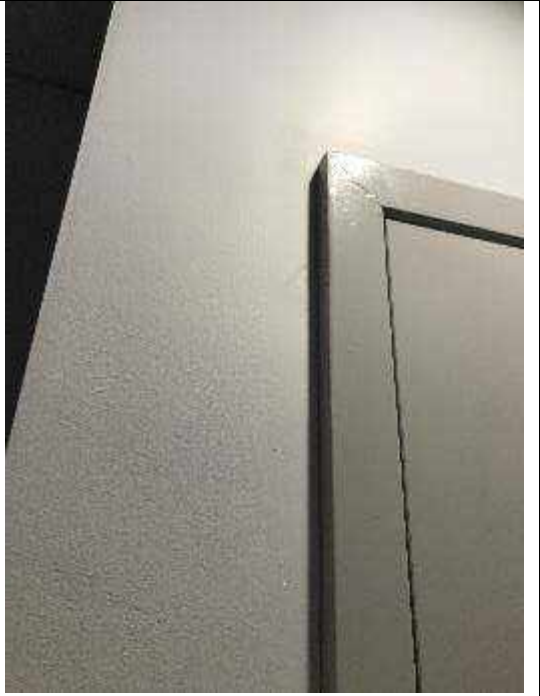
Item	Location	Defect description and Breach	Rectification	Photograph (if applicable)
505	Wall adjacent to linen cupboard door	See section 5.13.1	See section 5.13.2

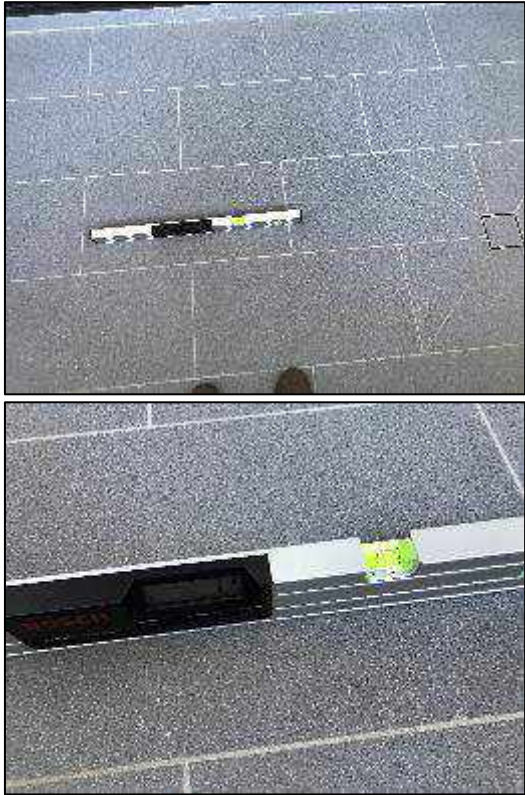
Item	Location	Defect description and Breach	Rectification	Photograph (if applicable)
506	Balcony	See section 5.2.1 Falls (mm); 7/1000	See section 5.2.2

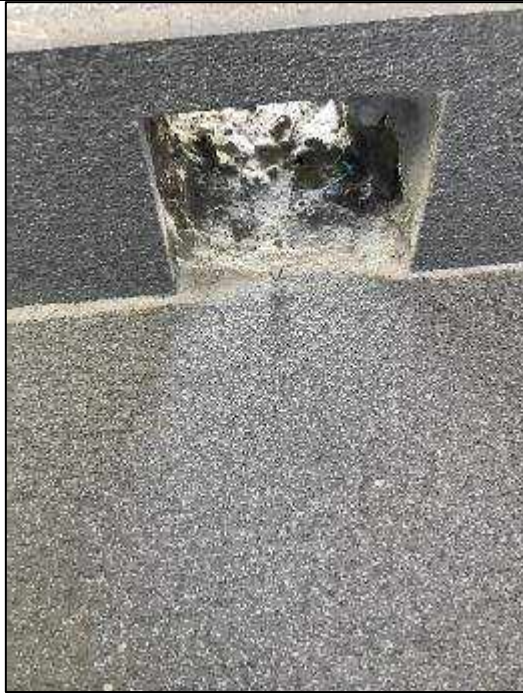
Item	Location	Defect description and Breach	Rectification	Photograph (if applicable)
507	Balcony	See section 5.15.1	See section 5.15.2

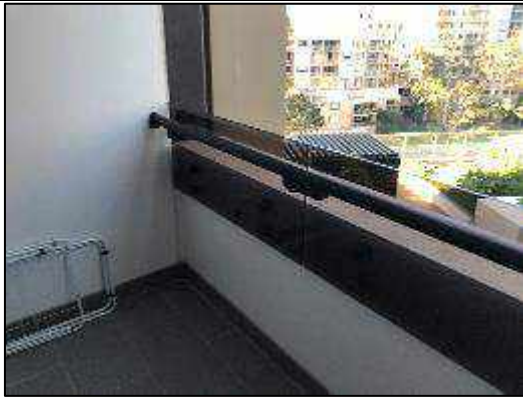
508	Balcony	See section 5.4.1	See section 5.4.2

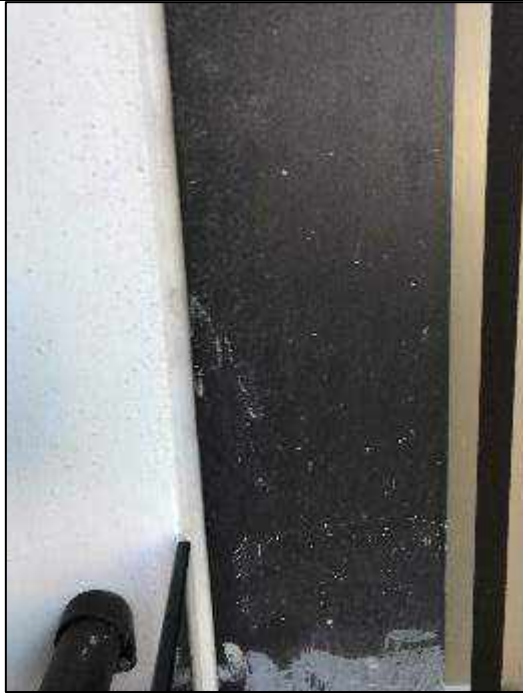
Item	Location	Defect description and Breach	Rectification	Photograph (if applicable)
509	Balcony sliding door frame	<p>Construction debris observed on sliding door frame.</p> <p>Home Building Act (NSW) 1989</p> <ul style="list-style-type: none"> Part 2C, 18B (a) and (c). <p>This is a breach of part (a) of the act because the surface has not been finished in a proper workmanlike manner that would prevent loss of appearance to the surface.</p> <p>Loss Suffered Loss suffered is cost of rectification.</p>	<ol style="list-style-type: none"> 1. Protect all adjoining surfaces. 2. Use a suitable cleaning agent to remove residue and clear debris. 3. Clean up the work area.

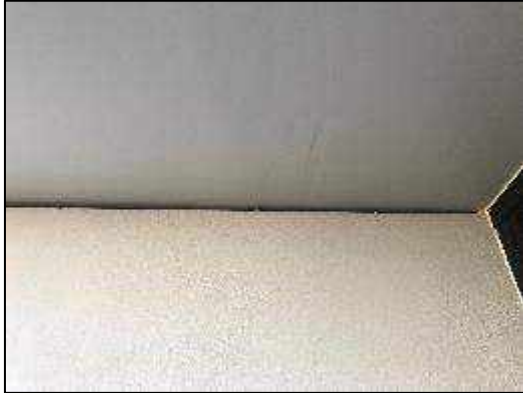
510	Balcony eastern blade wall	<p>Unsealed joint between eastern wall of balcony and ceiling.</p> <p>Home Building Act (NSW) 1989</p> <ul style="list-style-type: none"> Part 2C, 18B (a) and (c). <p>Loss Suffered Loss suffered is cost of rectification.</p>	<ol style="list-style-type: none"> 1. Apply a bead of flexible sealant to the joint between the ceiling and wall 2. As required, all affected surfaces are to be painted with an appropriate paint system to match as close as possible to the existing in accordance with the manufacturer's recommendations and AS2311 – Guide to the painting of buildings. 3. Clean up the work area

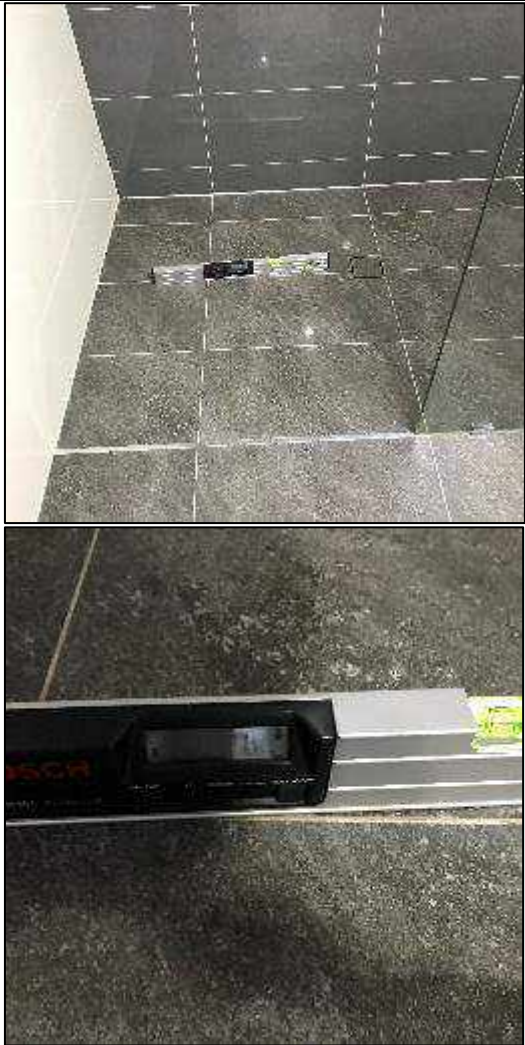
Item	Location	Defect description and Breach	Rectification	Photograph (if applicable)
511	Main bathroom	See section 5.1.1 Falls (mm); 1/1000	See section 5.1.2
