SydneyStrataReport

STRATA REPORT

Client	Church Street Parramatta Property Pty Ltd
Address of property	Unit 3303/330 Church Street, Parramatta, NSW.
Lot	359
Strata Plan	SP 94469
Name of Strata Management Co.	NSW Strata
Telephone Number of Strata Agent	8980 1841
Report Date	15 February 2024

BUILDING DEFECTS REPORT Part 1/2

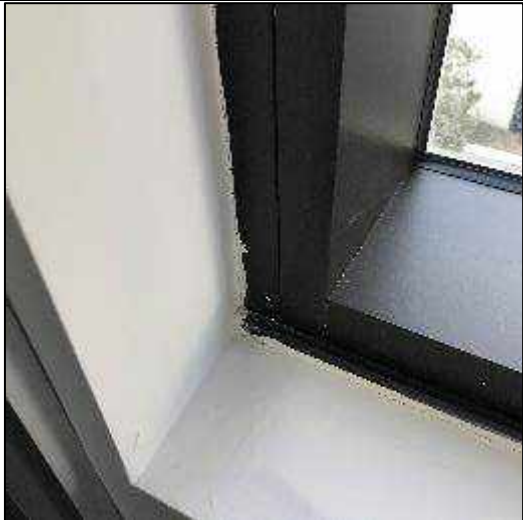
Item	Location	Defect description and Breach	Rectification	Photograph (if applicable)
512	Main bedroom window frames	See section 5.9.1	See section 5.9.2

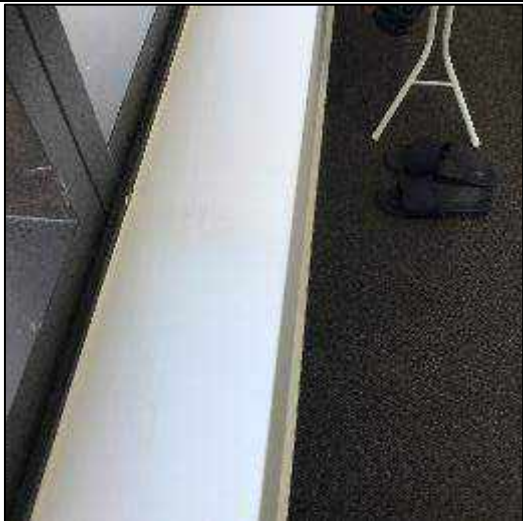
513	Main bedroom window sill	See section 5.13.1	See section 5.13.2

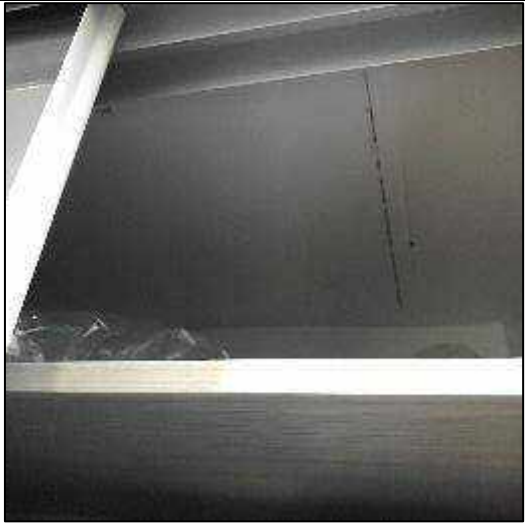
Item	Location	Defect description and Breach	Rectification	Photograph (if applicable)
514	Main bedroom built in	See section 5.6.1	See section 5.6.2

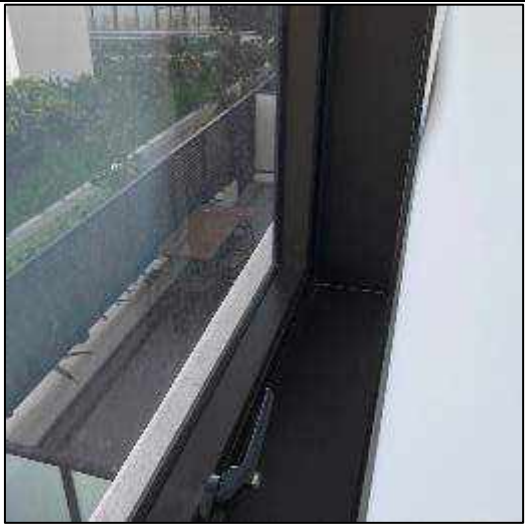
515	Main bedroom window frame	See section 5.7.1	See section 5.7.2

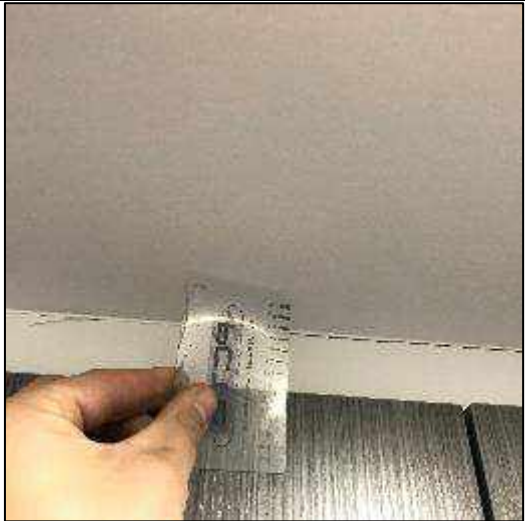
Item	Location	Defect description and Breach	Rectification	Photograph (if applicable)
516	<i>Ceiling above kitchen cupboards</i>	See section 5.14.1 Separation; 2mm	See section 5.14.2

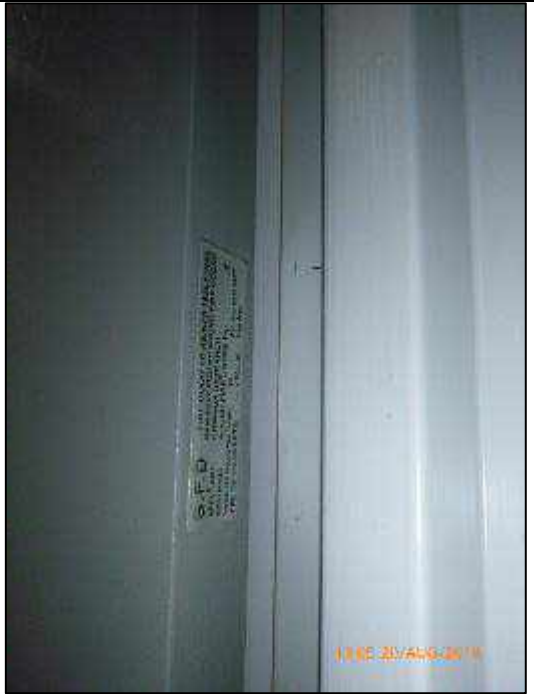
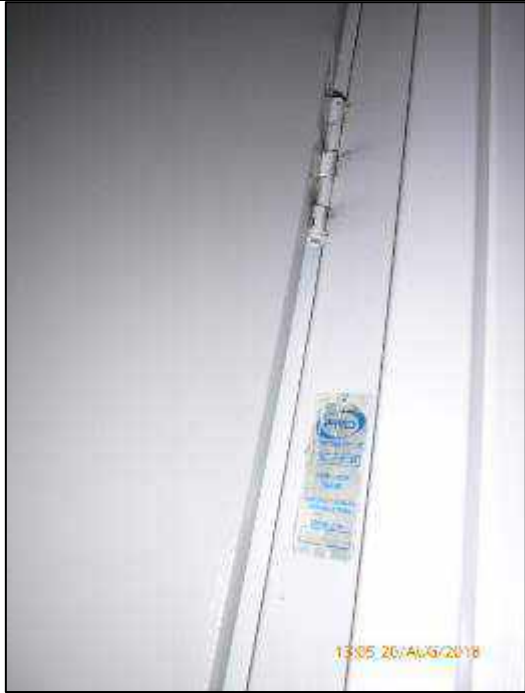
517	Front entry door	<p>Fire door and frame observed to be two different brands.</p> <p>Home Building Act (NSW) 1989</p> <ul style="list-style-type: none"> Part 2C, 18B (a) and (c). <p>Loss Suffered Loss suffered is cost of rectification.</p>	<p>Engage a licenced tradesperson to remove fire door and install a suitable fire door to match existing door frame as advised by fire engineer.</p>

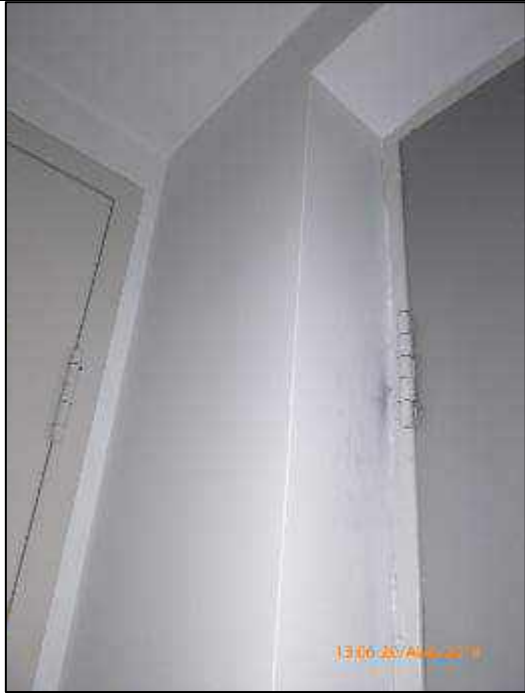
Item	Location	Defect description and Breach	Rectification	Photograph (if applicable)
519	Door jamb at front entry door	See section 5.13.1	See section 5.13.2

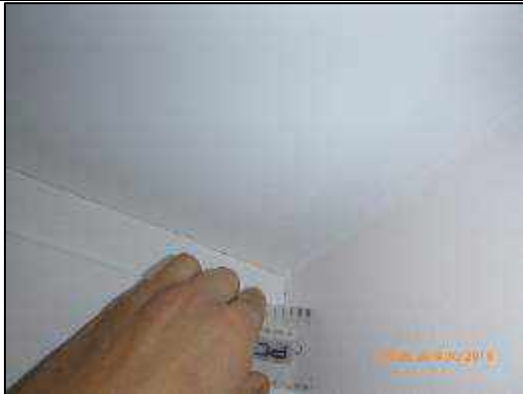
Item	Location	Defect description and Breach	Rectification	Photograph (if applicable)
522	<i>Ceiling above kitchen cupboards</i>	See section 5.14.1 Separation; 1mm	See section 5.14.2

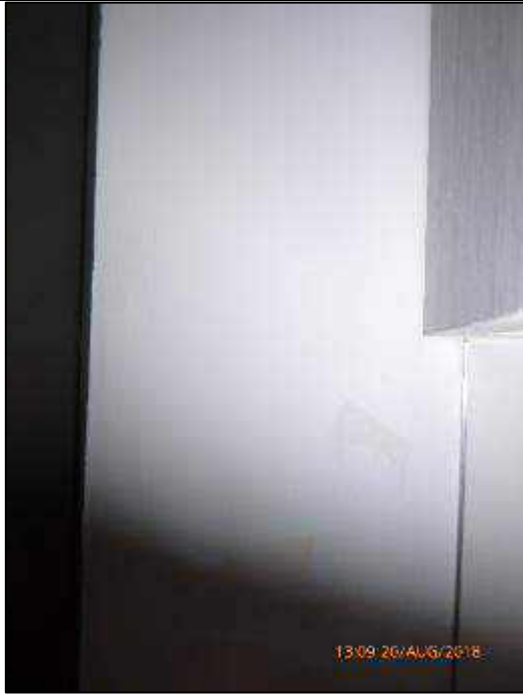
523	<i>Eastern wall adjacent to sliding door.</i>	See section 5.13.1	See section 5.13.2

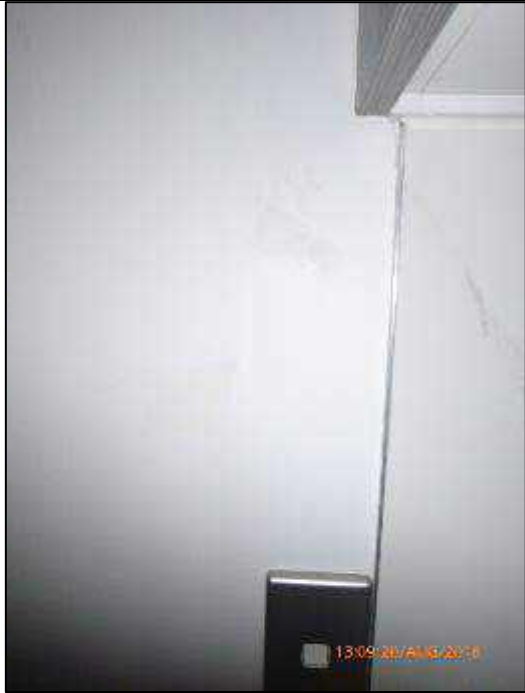
Item	Location	Defect description and Breach	Rectification	Photograph (if applicable)
524	<i>Eastern wall adjacent to sliding door.</i>	See section 5.10.1	See section 5.10.2

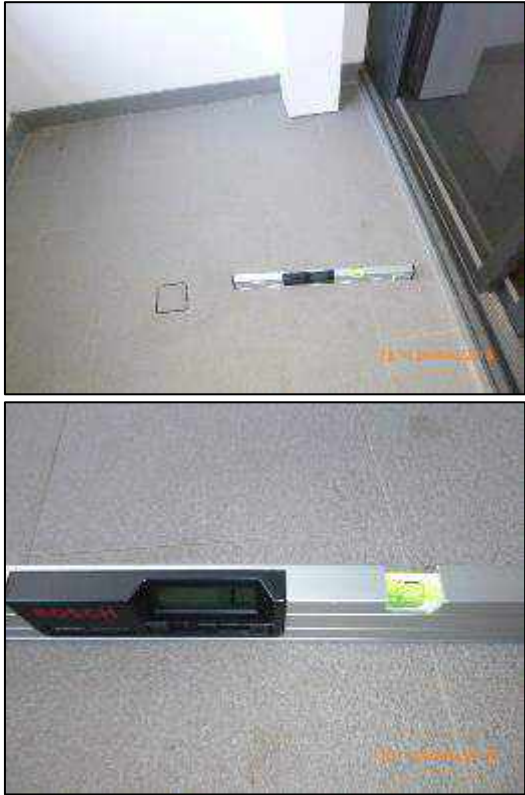
Item	Location	Defect description and Breach	Rectification	Photograph (if applicable)
525	Balcony	See section 5.2.1 Falls (mm); 1/1000	See section 5.2.2

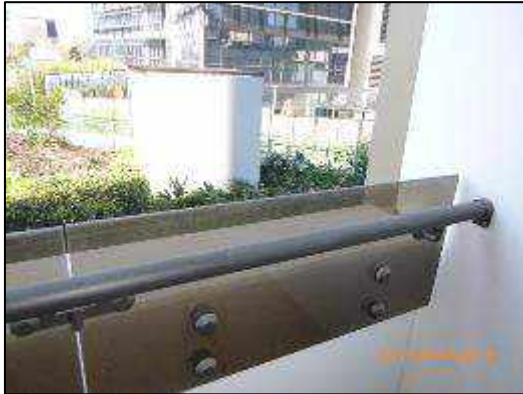
Item	Location	Defect description and Breach	Rectification	Photograph (if applicable)
526	Balcony	See section 5.4.1	See section 5.4.2

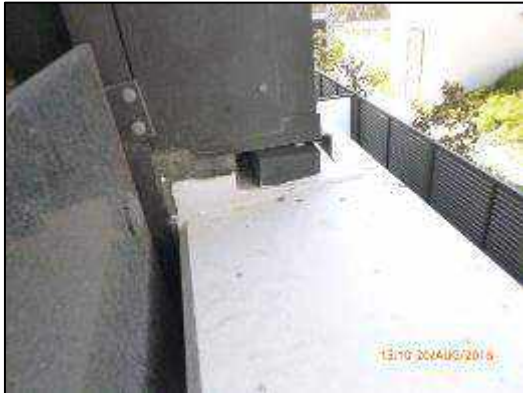
527	Façade balustrade in balcony area.	See section 5.10.1	See section 5.10.2

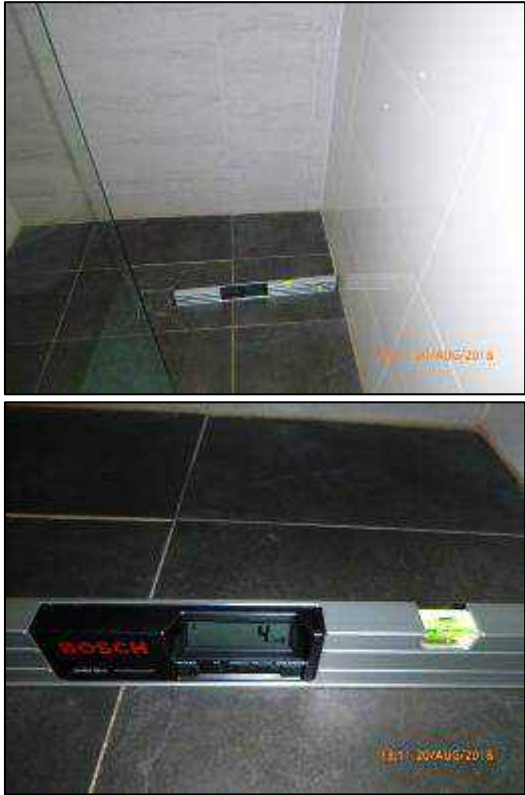
Item	Location	Defect description and Breach	Rectification	Photograph (if applicable)
529	Main bathroom	See section 5.1.1 Falls (mm); 4/1000	See section 5.1.2

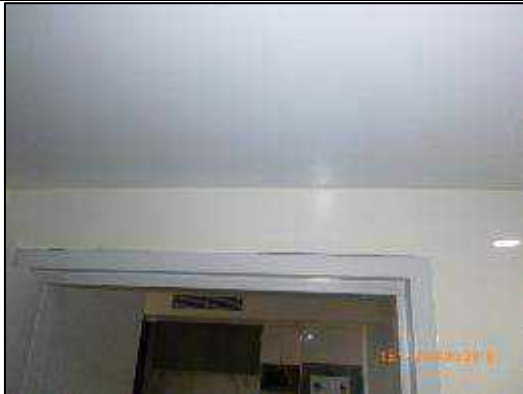
Item	Location	Defect description and Breach	Rectification	Photograph (if applicable)
530	Main bathroom door frame	<p>Unsealed joint between door frame and tiles.</p> <p>Home Building Act (NSW) 1989</p> <ul style="list-style-type: none"> Part 2C, 18B (a) and (c). <p>Loss Suffered Loss suffered is cost of rectification.</p>	<ol style="list-style-type: none"> 1. Apply a bead of flexible sealant to the joint between the ceiling and wall 2. As required, all affected surfaces are to be painted with an appropriate paint system to match as close as possible to the existing in accordance with the manufacturer's recommendations and AS2311 – Guide to the painting of buildings. 3. Clean up the work area

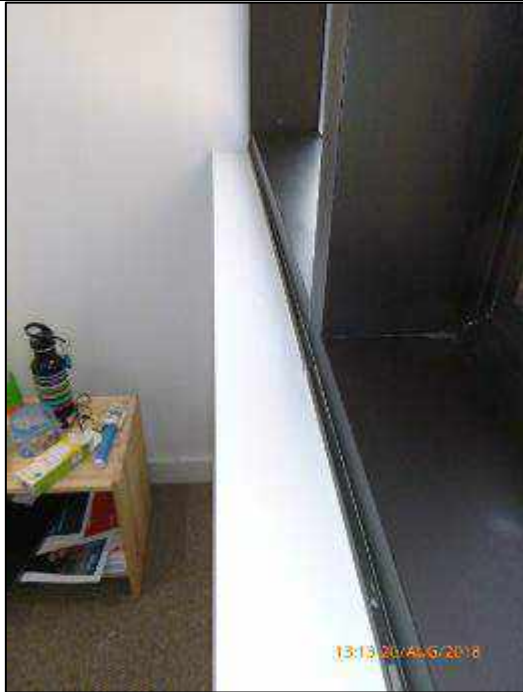
531	Main bedroom window sill	See section 5.10.1	See section 5.10.2

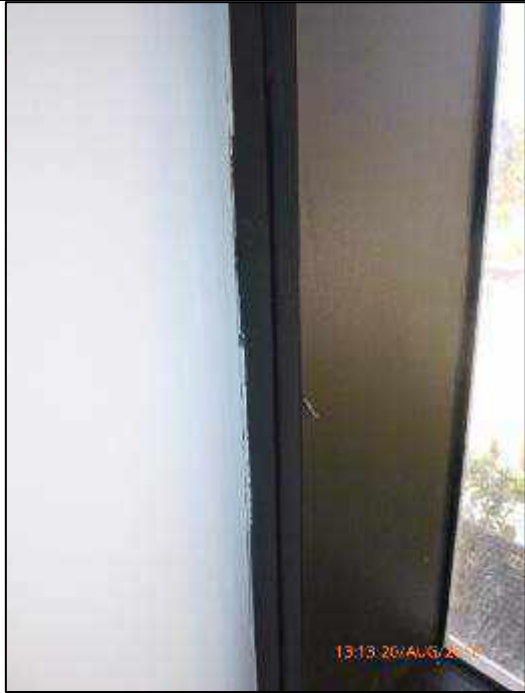
Item	Location	Defect description and Breach	Rectification	Photograph (if applicable)
532	Main bedroom window frames	See section 5.9.1	See section 5.9.2

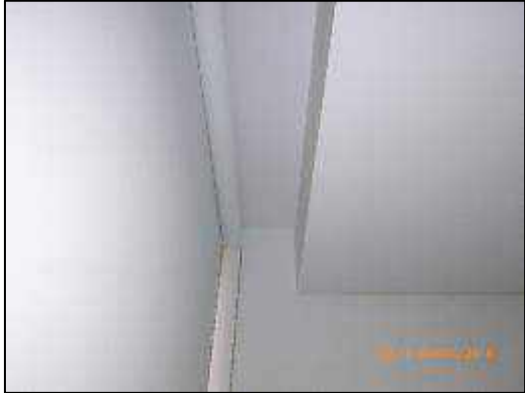
533	Main bedroom window bulkhead	See section 5.13.1	See section 5.13.2

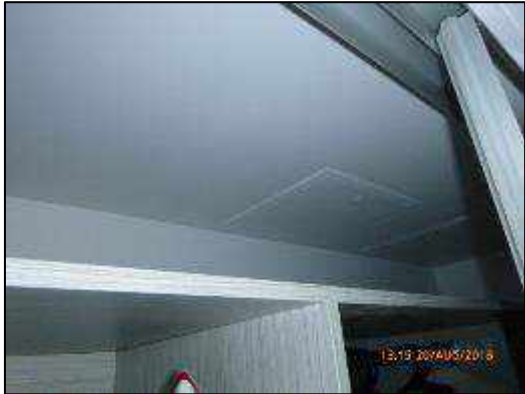
Item	Location	Defect description and Breach	Rectification	Photograph (if applicable)
534	Main bedroom built in	See section 5.6.1	See section 5.6.2

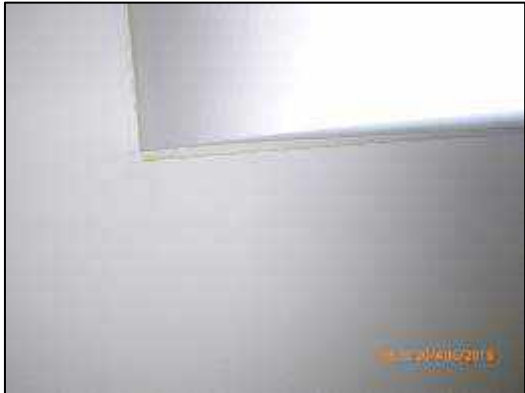
535	Main bedroom	See section 5.11.1	See section 5.11.2

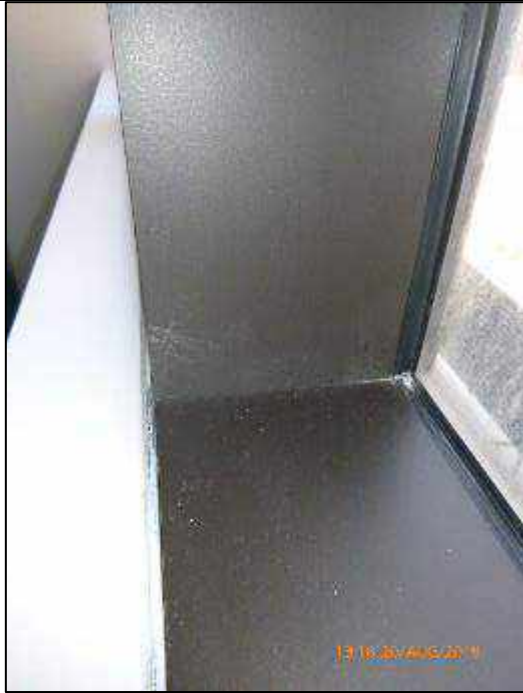
Item	Location	Defect description and Breach	Rectification	Photograph (if applicable)
536	Lounge room window frames	See section 5.7.1	See section 5.7.2

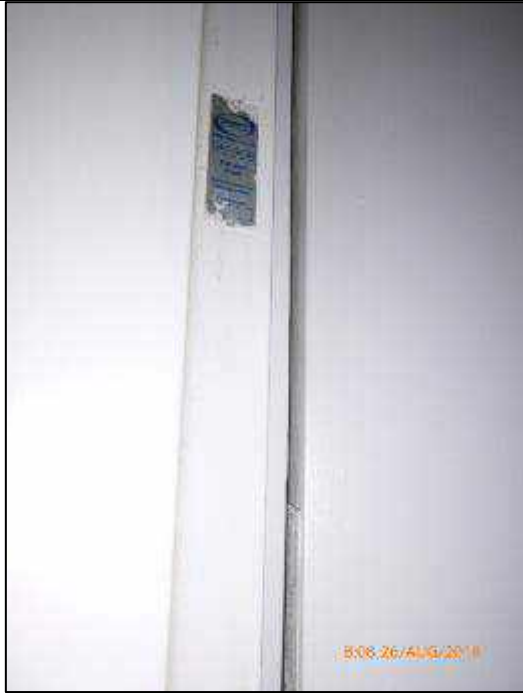
Item	Location	Defect description and Breach	Rectification	Photograph (if applicable)
Unit 505				
537	Front entry door frame	<p>Fire door and frame observed to be two different brands.</p> <p>Home Building Act (NSW) 1989</p> <ul style="list-style-type: none"> Part 2C, 18B (a) and (c). <p>Loss Suffered</p> <p>Loss suffered is cost of rectification.</p>	Engage a licenced tradesperson to remove fire door and install a suitable fire door to match existing door frame as advised by fire engineer.

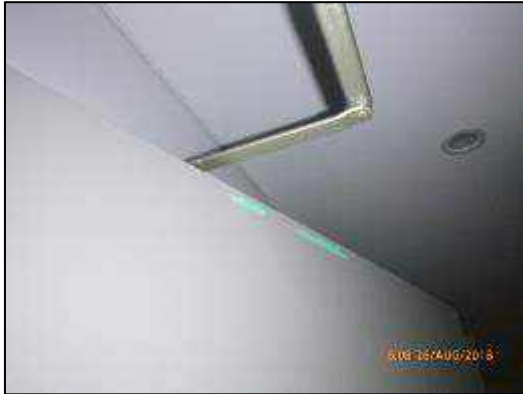
Item	Location	Defect description and Breach	Rectification	Photograph (if applicable)
538	Front entry door	See section 5.9.1	See section 5.9.2

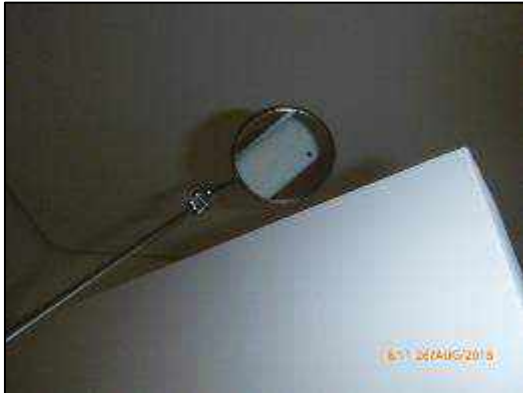
A photograph showing the top corner of a white door frame against a dark ceiling. A small, dark, circular object is visible on the ceiling near the frame. A date stamp in the bottom right corner reads "6/18/2018 16:48:20".
539	Doors throughout unit (x2)	See section 5.5.1	See section 5.5.2

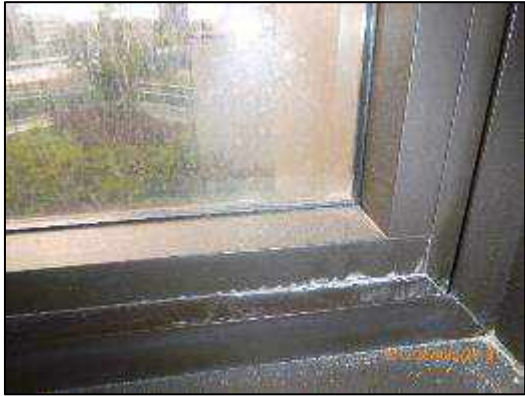
Item	Location	Defect description and Breach	Rectification	Photograph (if applicable)
540	Main bedroom window frames	See section 5.8.1	See section 5.8.2

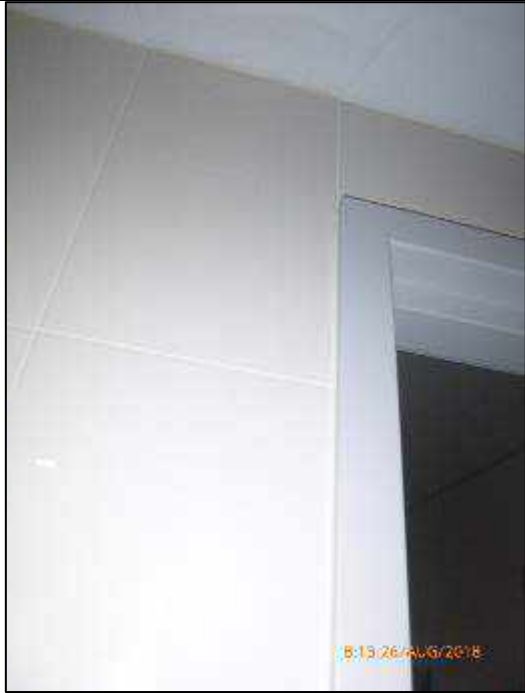
Item	Location	Defect description and Breach	Rectification	Photograph (if applicable)
542	Main bedroom ensuite door frame	See section 5.9.1	See section 5.9.2

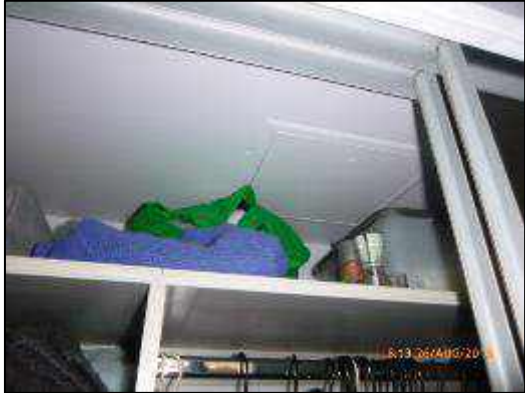
543	Main bedroom built in	See section 5.6.1	See section 5.6.2

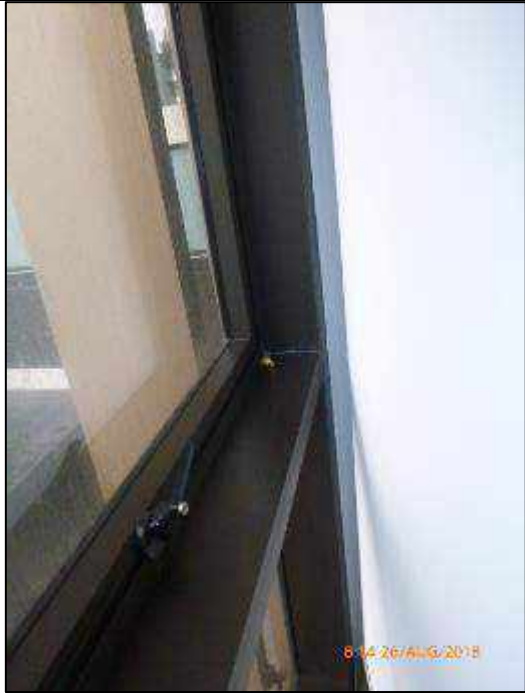
Item	Location	Defect description and Breach	Rectification	Photograph (if applicable)
544	Lounge room window frames	See section 5.8.1	See section 5.8.2

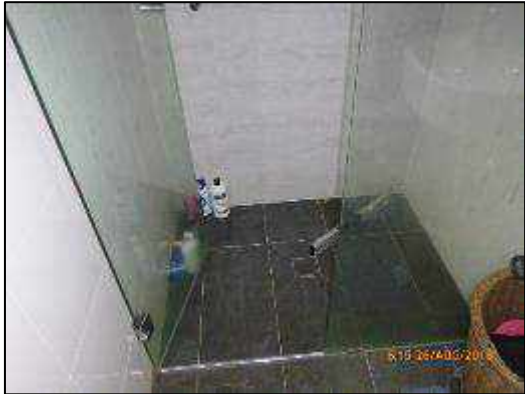
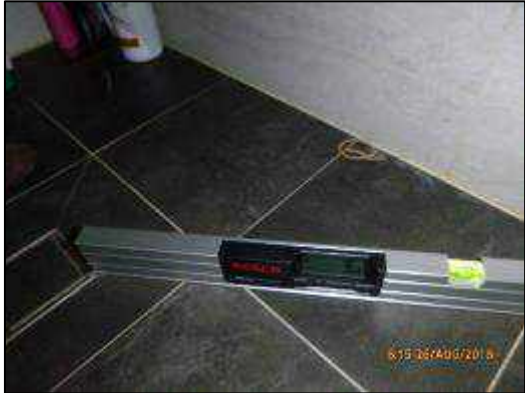
Item	Location	Defect description and Breach	Rectification	Photograph (if applicable)
545	Main bathroom	See section 5.1.1 Falls (mm); 9/1000	See section 5.1.2

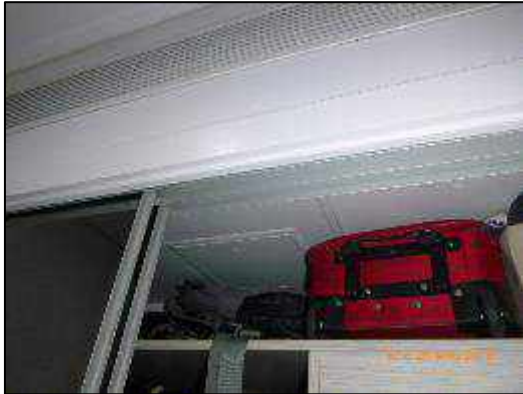
Item	Location	Defect description and Breach	Rectification	Photograph (if applicable)
546	<i>Second bedroom built in</i>	See section 5.6.1	See section 5.6.2

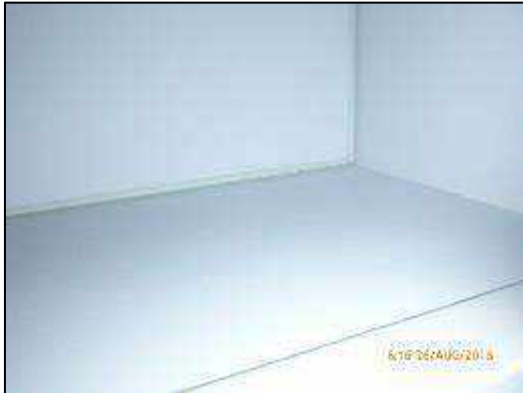
547	<i>Second bedroom</i>	See section 5.11.1	See section 5.11.2

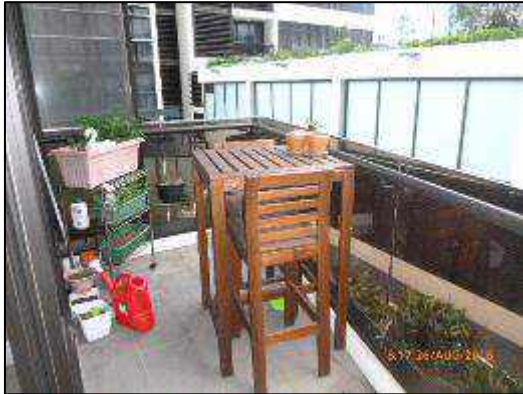
Item	Location	Defect description and Breach	Rectification	Photograph (if applicable)
548	Balcony	See section 5.3.1	See section 5.3.2

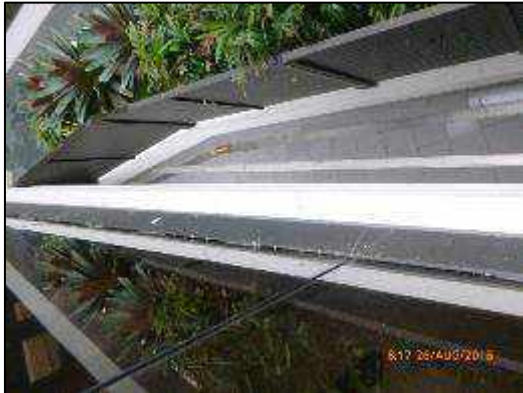
549	Balcony balustrade	See section 5.9.1	See section 5.9.2

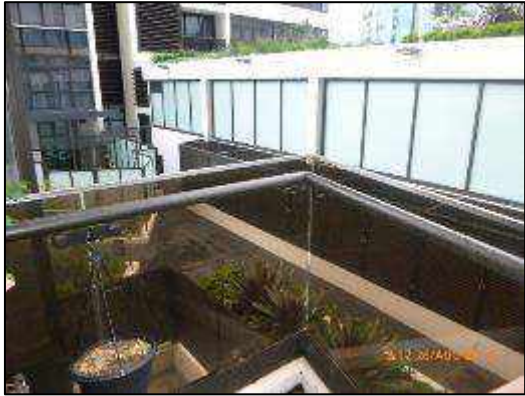
Item	Location	Defect description and Breach	Rectification	Photograph (if applicable)
550	Balcony	See section 5.4.1	See section 5.4.2

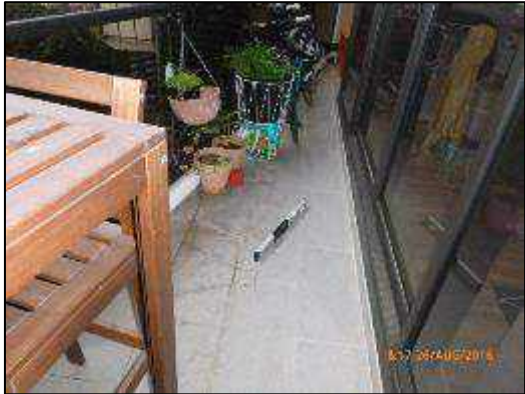
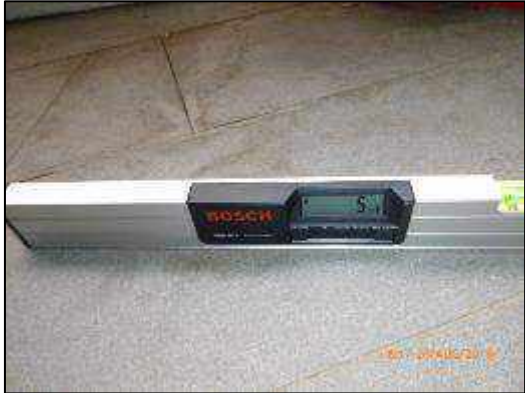
Item	Location	Defect description and Breach	Rectification	Photograph (if applicable)
551	Balcony	See section 5.2.1 Falls (mm); 5/1000	See section 5.2.2

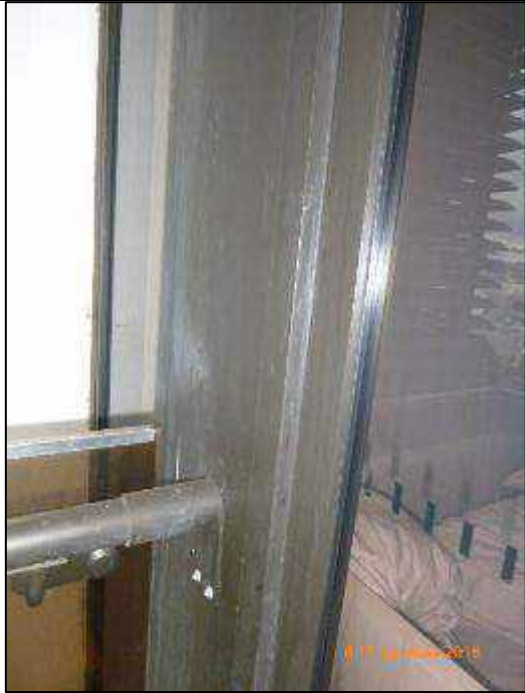
Item	Location	Defect description and Breach	Rectification	Photograph (if applicable)
552	Balcony sliding door frame	See section 5.8.1	See section 5.8.2

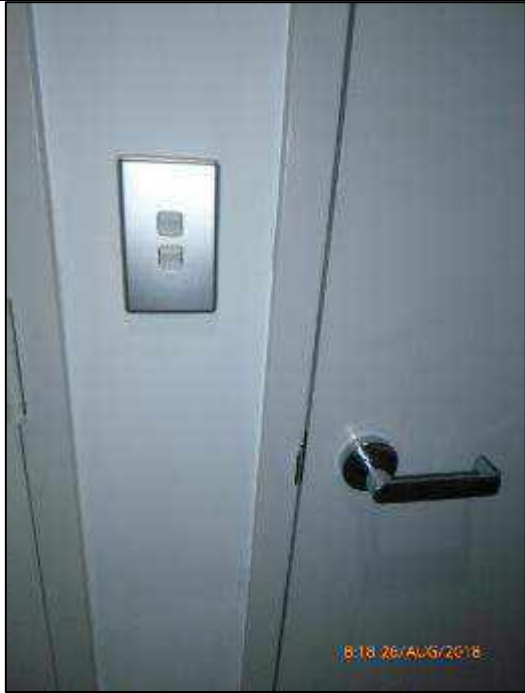
Item	Location	Defect description and Breach	Rectification	Photograph (if applicable)
553	Wall adjacent to front entry door	See section 5.13.1	See section 5.13.2

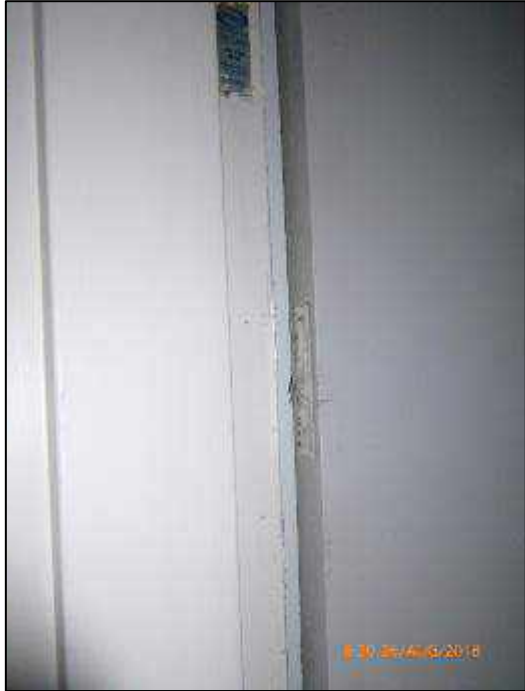
Item	Location	Defect description and Breach	Rectification	Photograph (if applicable)
Unit 506				
554	Front entry door	<p>Fire door and frame observed to be two different brands.</p> <p>Home Building Act (NSW) 1989</p> <ul style="list-style-type: none"> Part 2C, 18B (a) and (c). <p>Loss Suffered Loss suffered is cost of rectification.</p>	Engage a licenced tradesperson to remove fire door and install a suitable fire door to match existing door frame as advised by fire engineer.

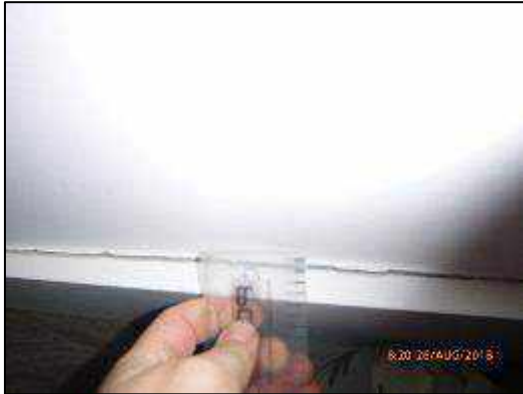
Item	Location	Defect description and Breach	Rectification	Photograph (if applicable)
555	Lounge room skirting board at western wall	See section 5.14.1 Separation; 2mm	See section 5.14.2

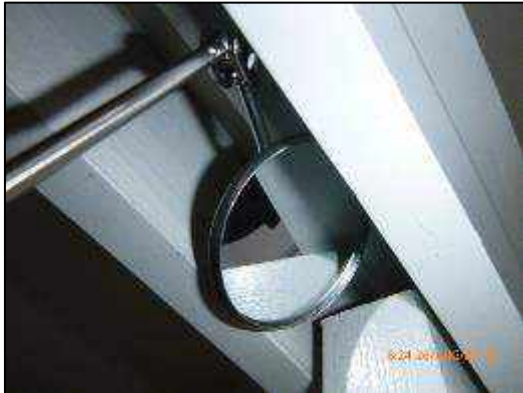
556	Doors through the unit (x2)	See section 5.5.1	See section 5.5.2

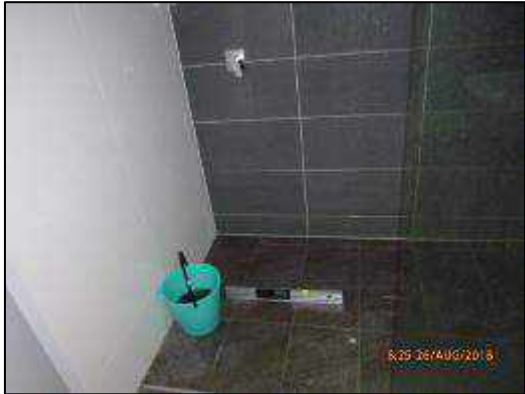
Item	Location	Defect description and Breach	Rectification	Photograph (if applicable)
557	Main bedroom ensuite	See section 5.1.1 Falls (mm); 5/1000	See section 5.1.2

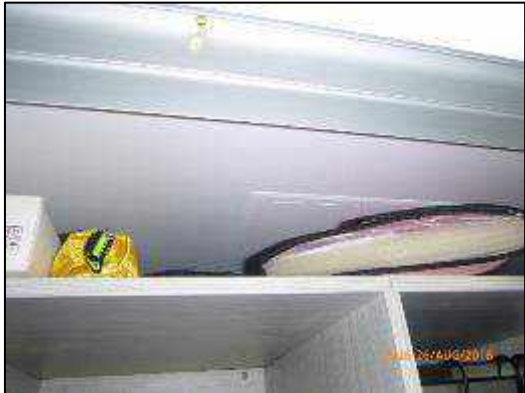
558	Main bedroom built in	See section 5.6.1	See section 5.6.2

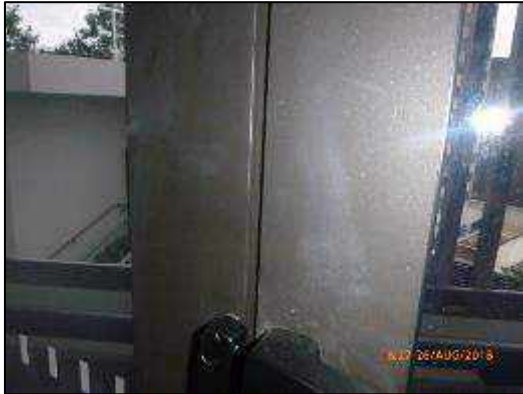
Item	Location	Defect description and Breach	Rectification	Photograph (if applicable)
559	Balcony sliding door frame	See section 5.7.1	See section 5.7.2

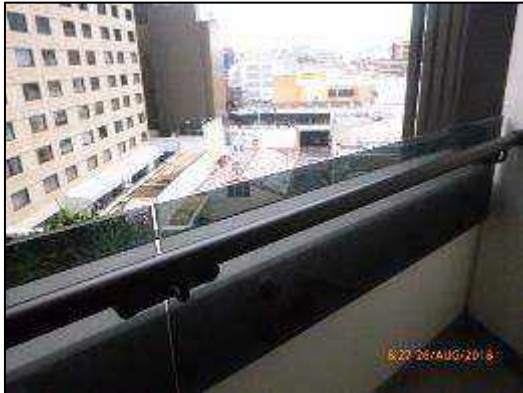
560	Balcony	See section 5.4.1	See section 5.4.2

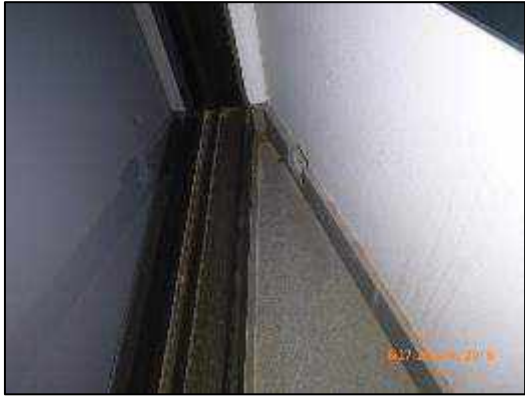
Item	Location	Defect description and Breach	Rectification	Photograph (if applicable)
561	Balcony	See section 5.15.1	See section 5.15.2

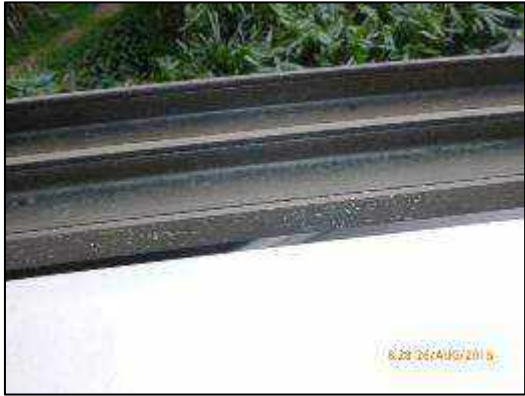
Item	Location	Defect description and Breach	Rectification	Photograph (if applicable)
562	Balcony façade fins external	See section 5.7.1	See section 5.7.2

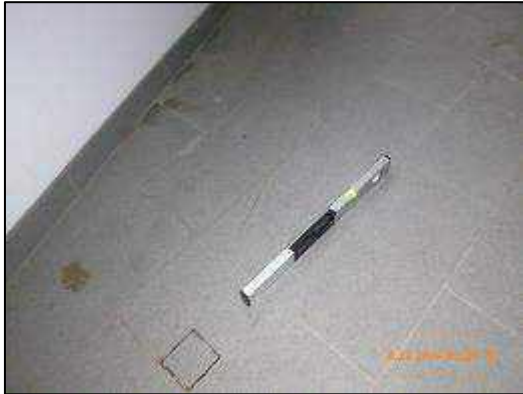
Item	Location	Defect description and Breach	Rectification	Photograph (if applicable)
563	Balcony	See section 5.2.1 Falls (mm); 5/1000	See section 5.2.2

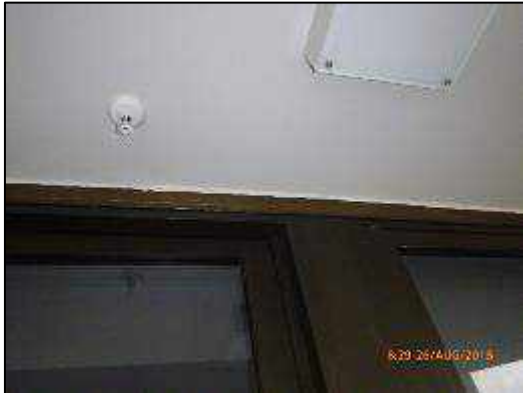
564	Balcony sliding door frames	See section 5.9.1	See section 5.9.2

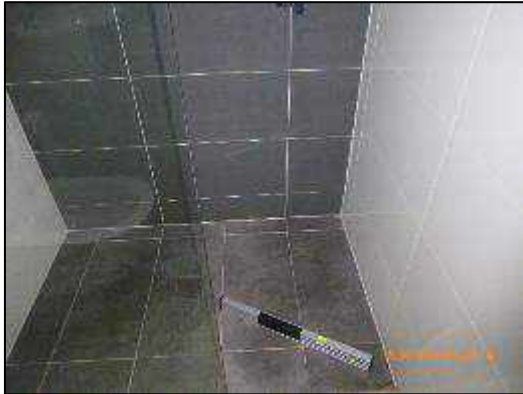
Item	Location	Defect description and Breach	Rectification	Photograph (if applicable)
565	Main bathroom	See section 5.1.1 Falls (mm); 3/1000	See section 5.1.2

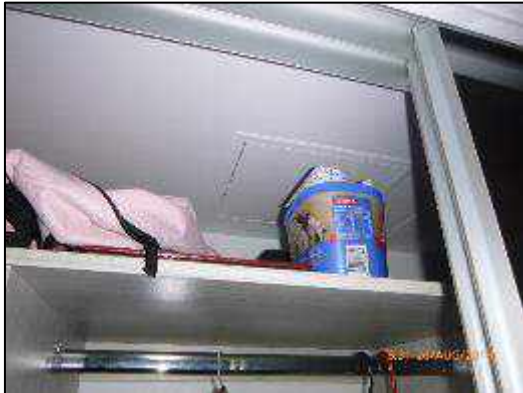
566	Second bedroom built in	See section 5.6.1	See section 5.6.2

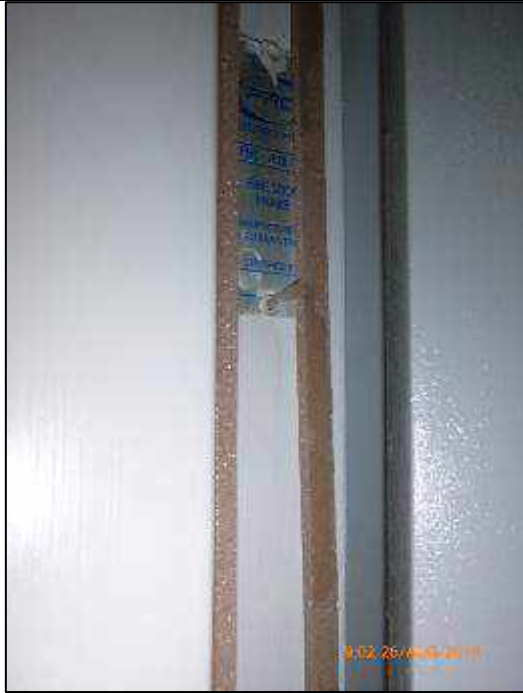
Item	Location	Defect description and Breach	Rectification	Photograph (if applicable)
Unit 601				
569	Front entry door	<p>Fire door and frame observed to be two different brands.</p> <p>Home Building Act (NSW) 1989</p> <ul style="list-style-type: none"> Part 2C, 18B (a) and (c). <p>Loss Suffered Loss suffered is cost of rectification.</p>	Engage a licenced tradesperson to remove fire door and install a suitable fire door to match existing door frame as advised by fire engineer.

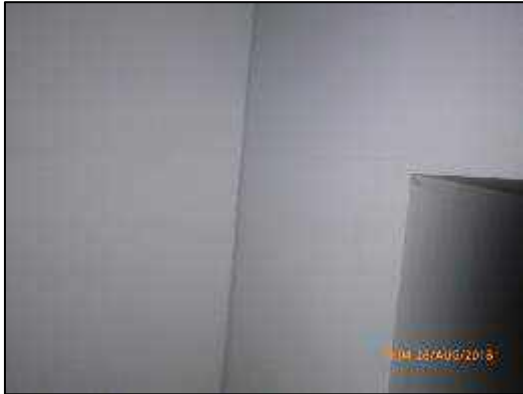
Item	Location	Defect description and Breach	Rectification	Photograph (if applicable)
570	<i>Living room western wall bulkhead</i>	See section 5.14.1	See section 5.14.2

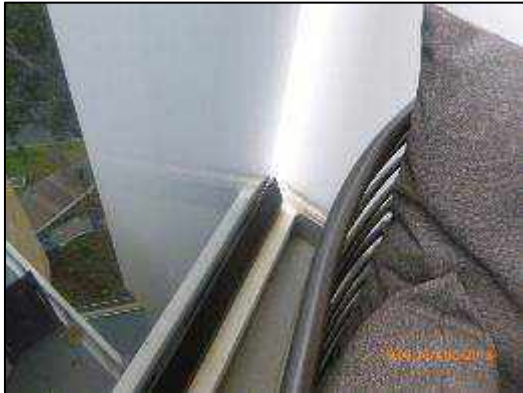
A photograph showing a close-up of a grey, textured wall bulkhead. The wall is slightly uneven and has a vertical seam or joint visible. A date stamp in the bottom right corner reads "14/08/2018".
571	<i>Balcony balustrade</i>	See section 5.3.1	See section 5.3.2

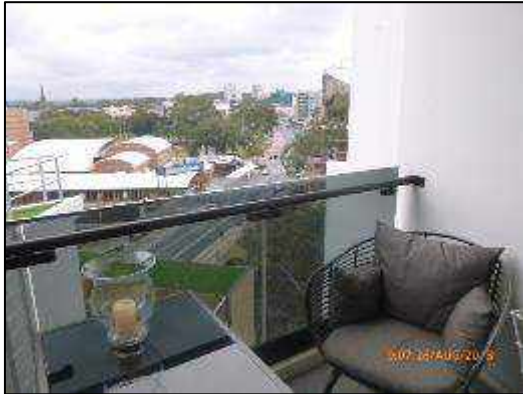
Item	Location	Defect description and Breach	Rectification	Photograph (if applicable)
572	Balcony	See section 5.4.1	See section 5.4.2

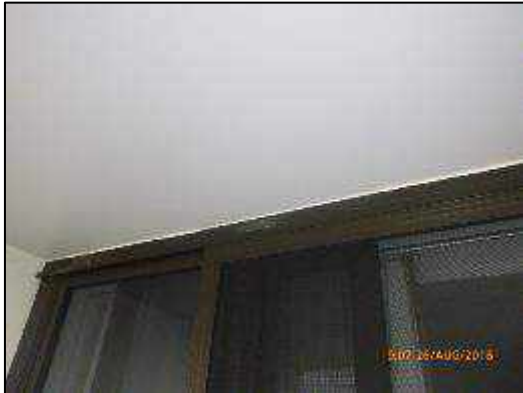
573	Balcony sliding door frame	See section 5.9.1	See section 5.9.2

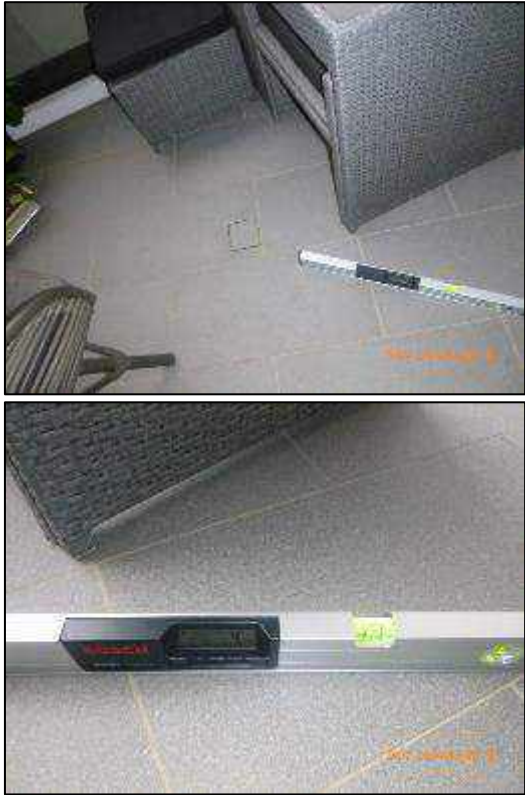
Item	Location	Defect description and Breach	Rectification	Photograph (if applicable)
574	Balcony	See section 5.2.1 Falls (mm); 4/1000	See section 5.2.2

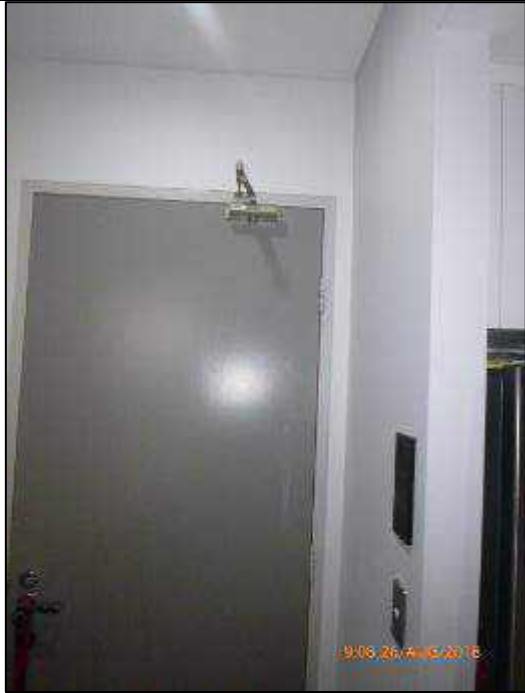
Item	Location	Defect description and Breach	Rectification	Photograph (if applicable)
575	Front entry door	See section 5.10.1	See section 5.10.2

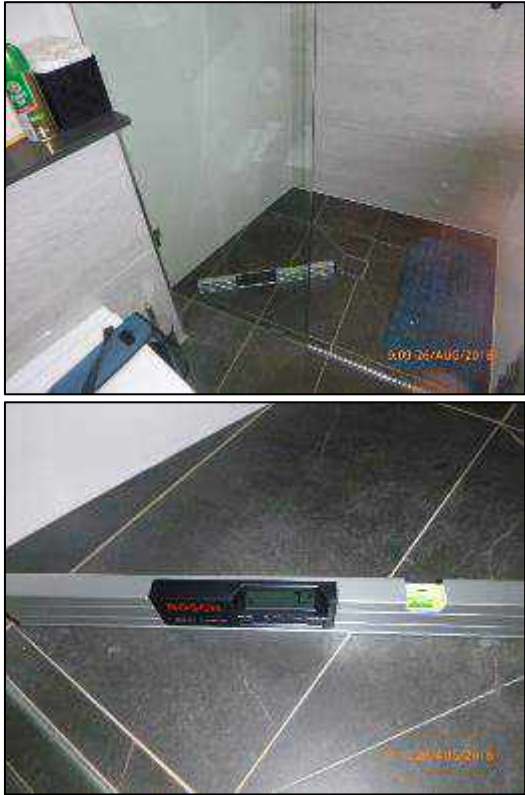
Item	Location	Defect description and Breach	Rectification	Photograph (if applicable)
576	Main bathroom	See section 5.1.1 Falls (mm); 7/1000	See section 5.1.2

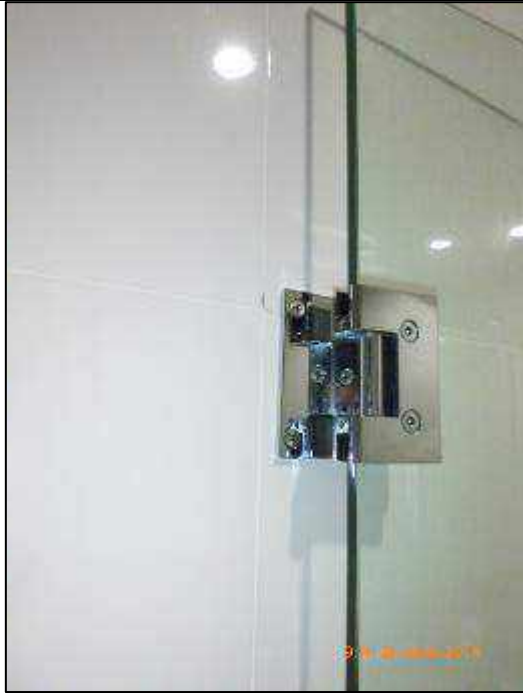
Item	Location	Defect description and Breach	Rectification	Photograph (if applicable)
577	Main bathroom	<p>Shower screen door panel observed to be loose and not closing orderly.</p> <p>Home Building Act (NSW) 1989</p> <ul style="list-style-type: none"> Part 2C, 18B (a) and (b). <p>This item is a defect as the builder has failed to satisfy implied warranty set out in the Home Building Act 1989 – Section 18B Warranties as to residential building work.</p> <p>(b) a warranty that all materials supplied by the holder or person will be good and suitable for the purpose for which they are used and that, unless otherwise stated in the contract, those materials will be new.</p> <p>Loss Suffered</p> <p>This defect results in loss of rectification and loss of amenity to unit occupants.</p>	<ol style="list-style-type: none"> 1. Protect all surrounding surfaces 2. Remove existing shower screen and fix appropriately

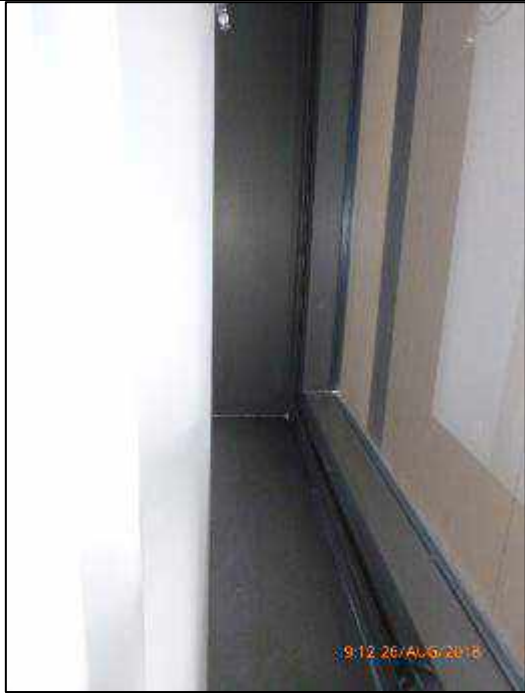
Item	Location	Defect description and Breach	Rectification	Photograph (if applicable)
578	Second bedroom window frames	See section 5.9.1	See section 5.9.2

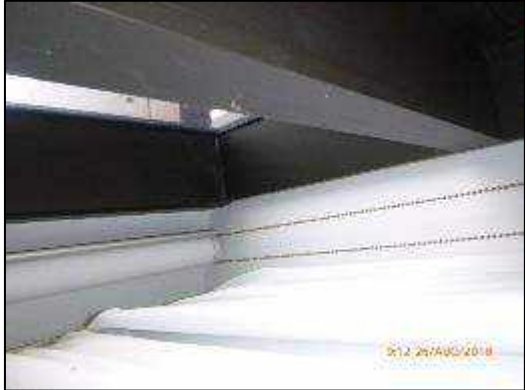
579	Second bedroom window frames	See section 5.7.1	See section 5.7.2

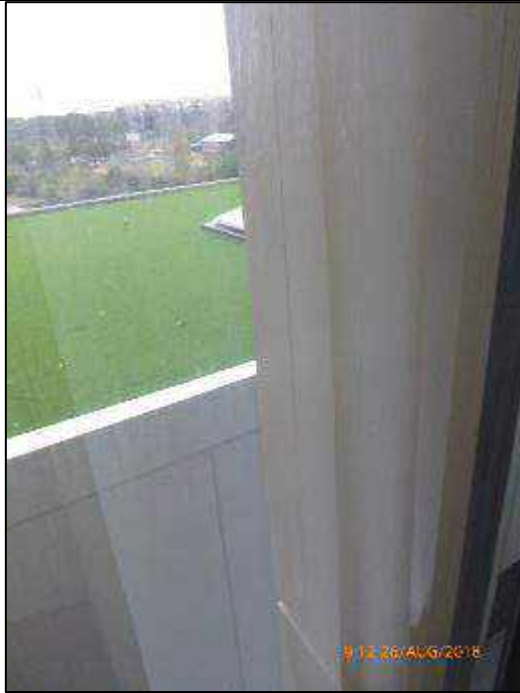
Item	Location	Defect description and Breach	Rectification	Photograph (if applicable)
580	Second bedroom external fins	<p>Construction debris observed on external fins outside the main bedroom.</p> <p>Home Building Act (NSW) 1989</p> <ul style="list-style-type: none"> Part 2C, 18B (a) and (c). <p>This is a breach of part (a) of the act because the surface has not been finished in a proper workmanlike manner that would prevent loss of appearance to the surface.</p> <p>Loss Suffered Loss suffered is cost of rectification.</p>	<ol style="list-style-type: none"> 1. Protect all adjoining surfaces. 2. Use a suitable cleaning agent to remove residue and clear debris. 3. Clean up the work area.

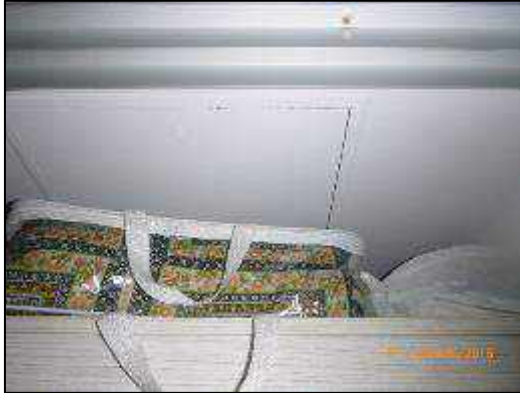
581	Second bedroom built in	See section 5.6.1	See section 5.6.2

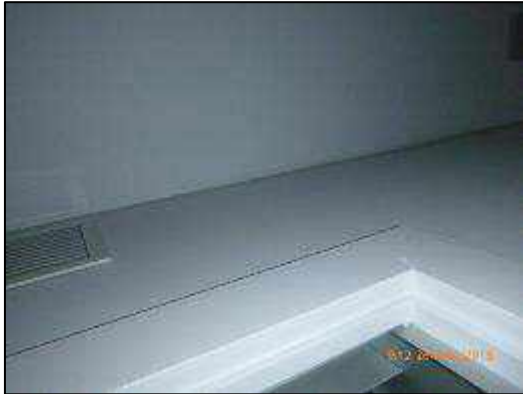
Item	Location	Defect description and Breach	Rectification	Photograph (if applicable)
582	Wall above built in in second bedroom	See section 5.13.1	See section 5.13.2

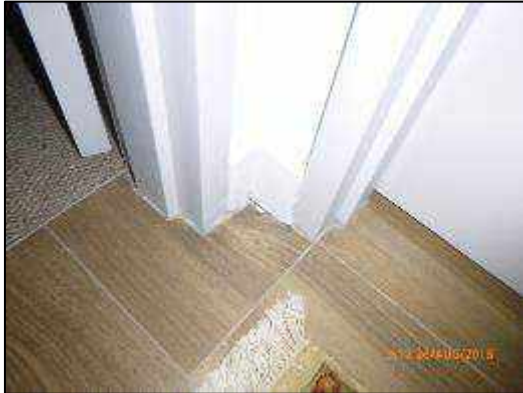
583	Skirting boards between bedrooms.	See section 5.10.1	See section 5.10.2

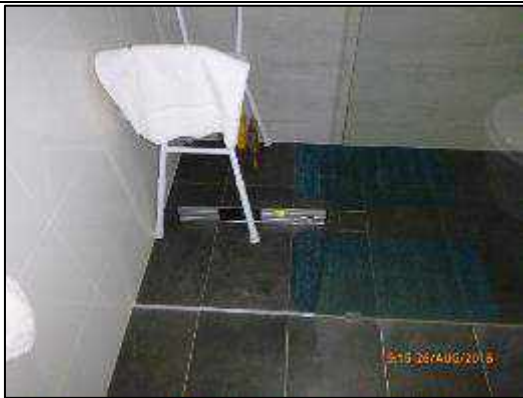
Item	Location	Defect description and Breach	Rectification	Photograph (if applicable)
584	Wall adjacent to main bedroom	See section 5.13.1	See section 5.13.2	 
585	Main bedroom ensuite	See section 5.1.1 Falls (mm); 8/1000	See section 5.1.2

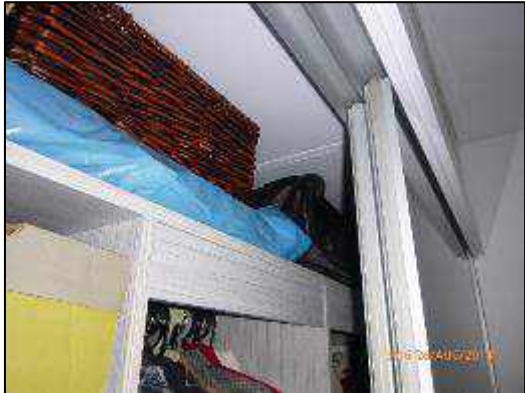
Item	Location	Defect description and Breach	Rectification	Photograph (if applicable)
586	Main bedroom built in	See section 5.6.1	See section 5.6.2

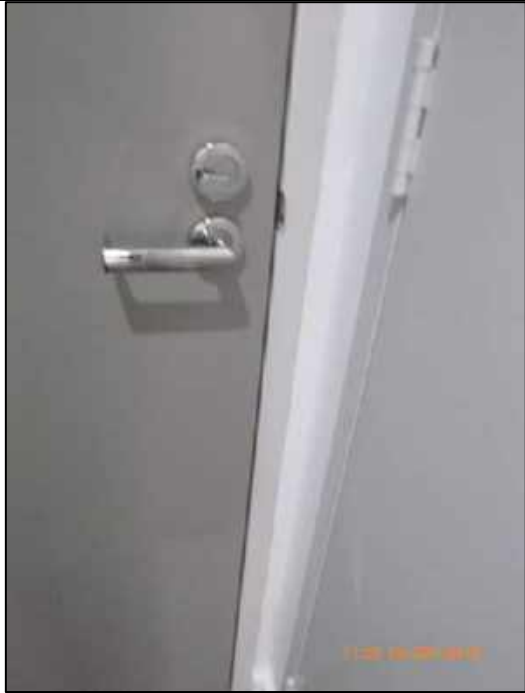
Item	Location	Defect description and Breach	Rectification	Photograph (if applicable)
588	Wall adjacent to front entry door	See section 5.13.1	See section 5.13.2

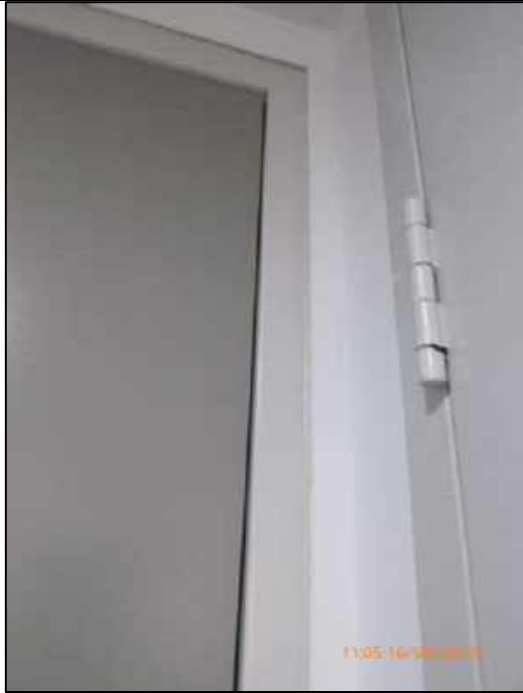
Item	Location	Defect description and Breach	Rectification	Photograph (if applicable)
589	Wall adjacent to front entry door	See section 5.9.1	See section 5.9.2
