SydneyStrataReport

STRATA REPORT

Client	Church Street Parramatta Property Pty Ltd
Address of property	Unit 3303/330 Church Street, Parramatta, NSW.
Lot	359
Strata Plan	SP 94469
Name of Strata Management Co.	NSW Strata
Telephone Number of Strata Agent	8980 1841
Report Date	15 February 2024

BUILDING DEFECTS REPORT Part 1/2

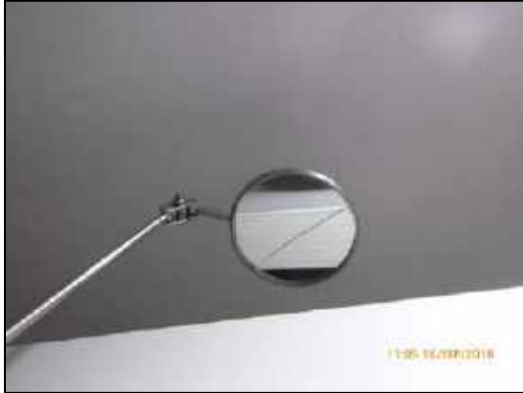
A photograph showing a close-up of a metal door hinge mounted on a light-colored wall. The hinge is slightly loose and the wall around it appears to be peeling or damaged. An orange timestamp '11:05:16/2018' is visible in the bottom right corner.
590	Doors throughout the unit (x4)	See section 5.5.1	See section 5.5.2

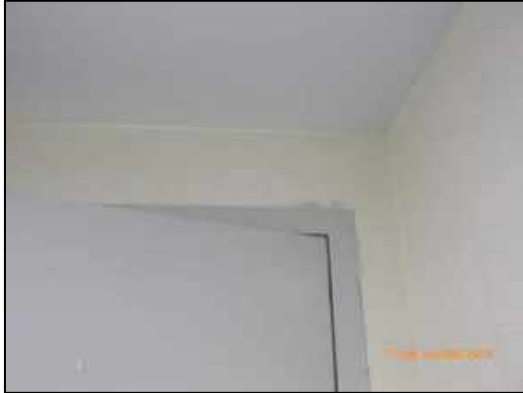
Item	Location	Defect description and Breach	Rectification	Photograph (if applicable)
591	<i>Walls and ceiling throughout the unit</i>	See section 5.10.1	See section 5.10.2	 
592	<i>Wall above main bathroom door</i>	See section 5.9.1	See section 5.9.2

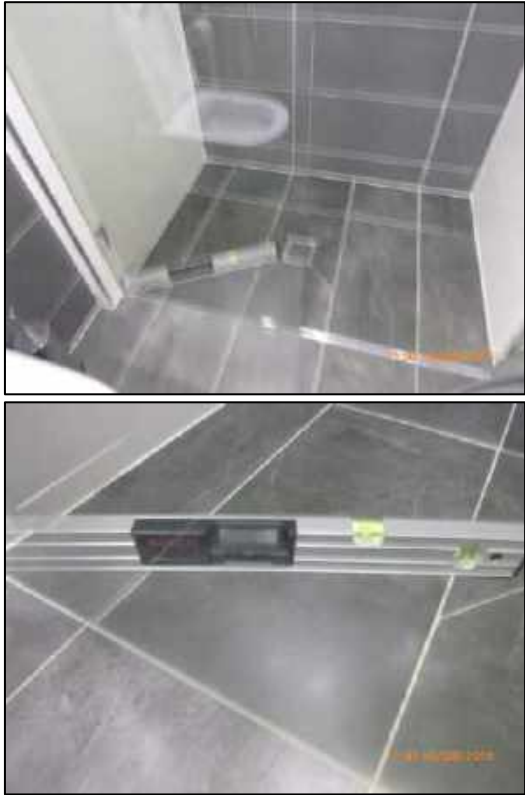
Item	Location	Defect description and Breach	Rectification	Photograph (if applicable)
593	Main bathroom	See section 5.1.1 Falls (mm); 8/1000	See section 5.1.2

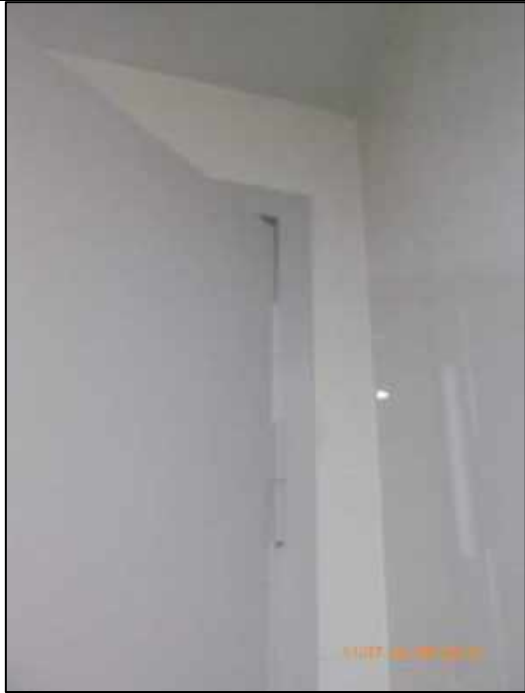
Item	Location	Defect description and Breach	Rectification	Photograph (if applicable)
594	Wall adjacent to main bathroom door	See section 5.9.1	See section 5.9.2

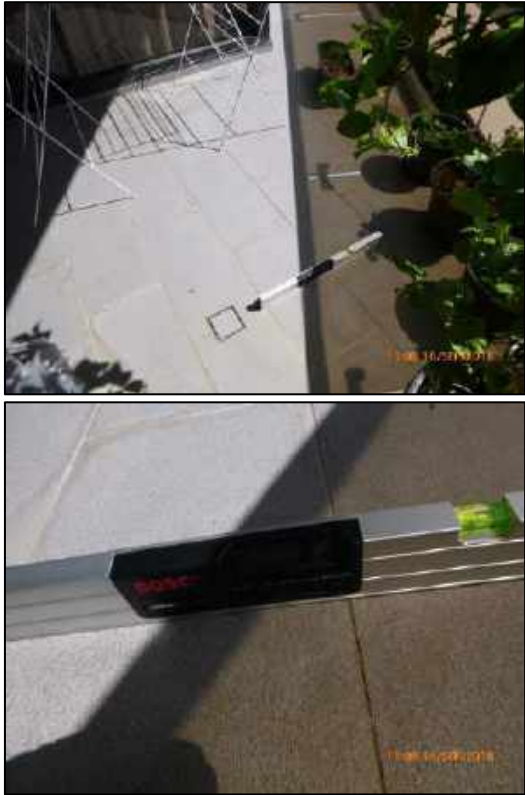
Item	Location	Defect description and Breach	Rectification	Photograph (if applicable)
595	Balcony	See section 5.2.1 Falls (mm); 8/1000	See section 5.2.2

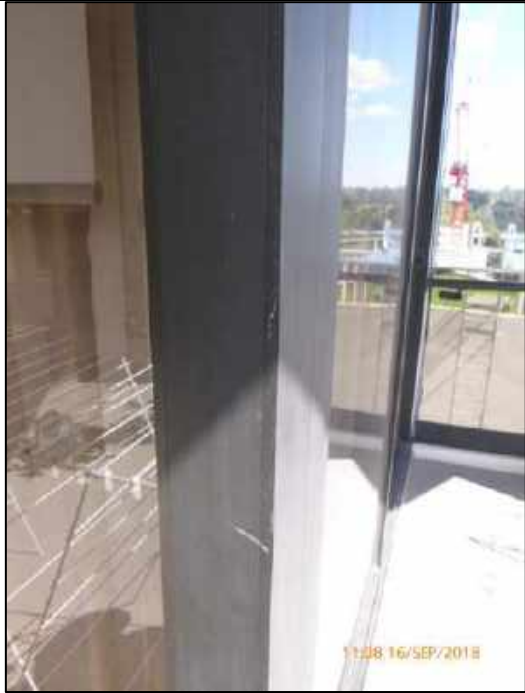
Item	Location	Defect description and Breach	Rectification	Photograph (if applicable)
596	Balcony sliding door frame	See section 5.9.1	See section 5.9.2

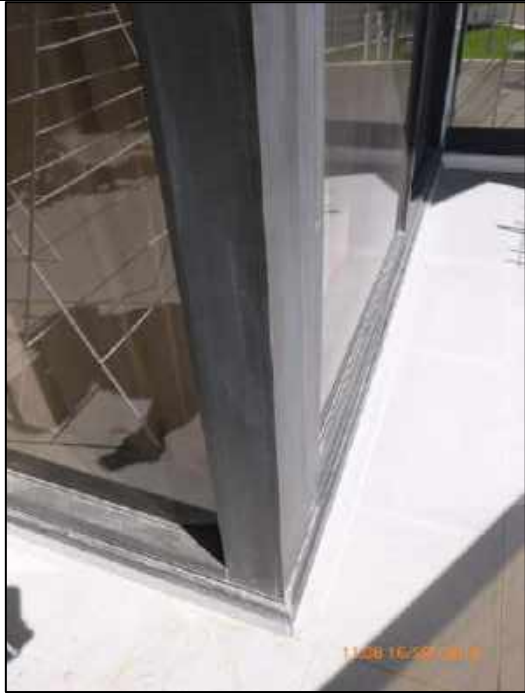
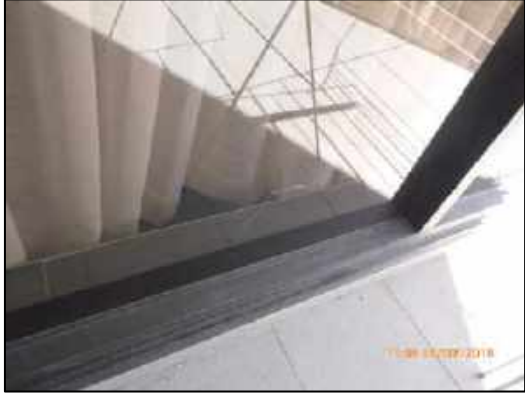
Item	Location	Defect description and Breach	Rectification	Photograph (if applicable)
597	Balcony sliding door frame	See section 5.7.1	See section 5.7.2

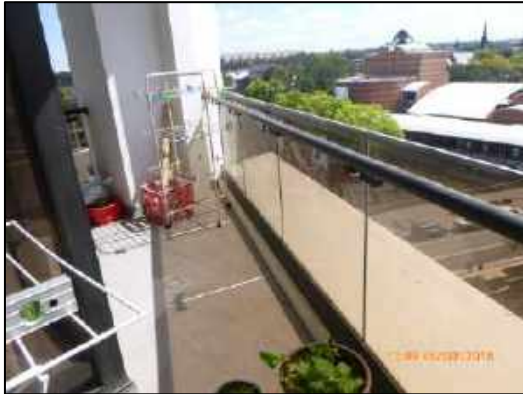
Item	Location	Defect description and Breach	Rectification	Photograph (if applicable)
598	Balcony balustrade	See section 5.4.1	See section 5.4.2

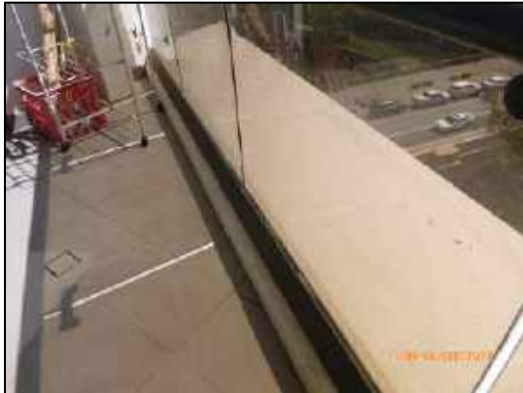
599	Balcony	See section 5.3.1	See section 5.3.2

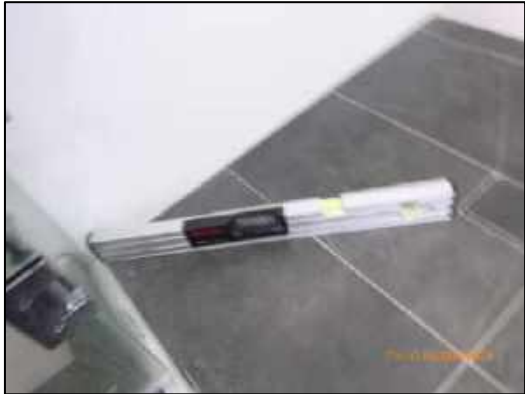
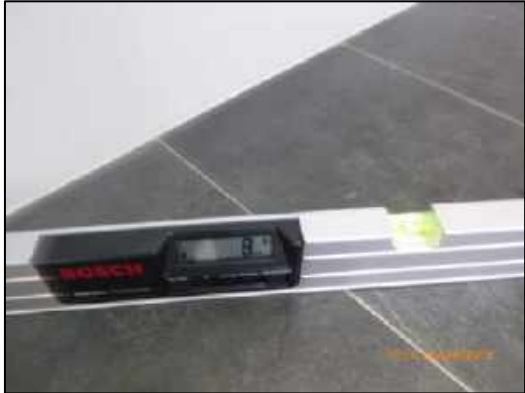
Item	Location	Defect description and Breach	Rectification	Photograph (if applicable)
600	Main bedroom ensuite	See section 5.1.1 Falls (mm); 8/1000	See section 5.1.2

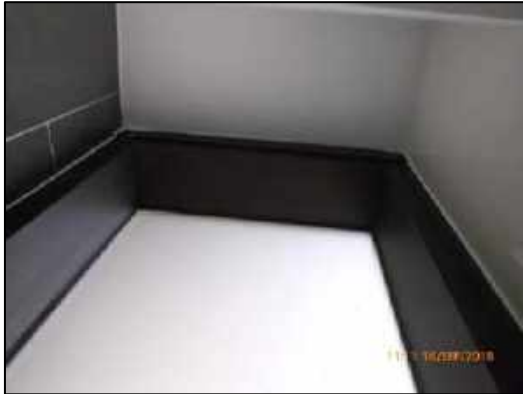
Item	Location	Defect description and Breach	Rectification	Photograph (if applicable)
603	<i>Ceiling adjacent to ensuite window</i>	See section 5.10.1	See section 5.10.2

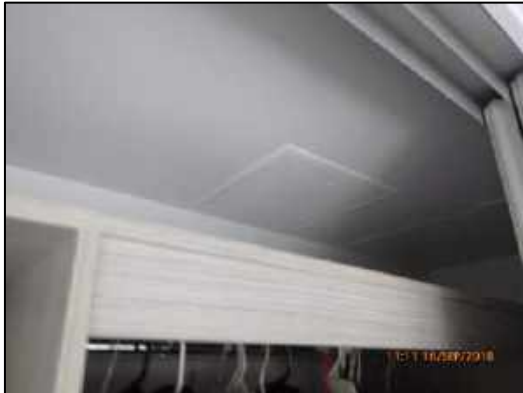
604	<i>Main bedroom built in</i>	See section 5.6.1	See section 5.6.2

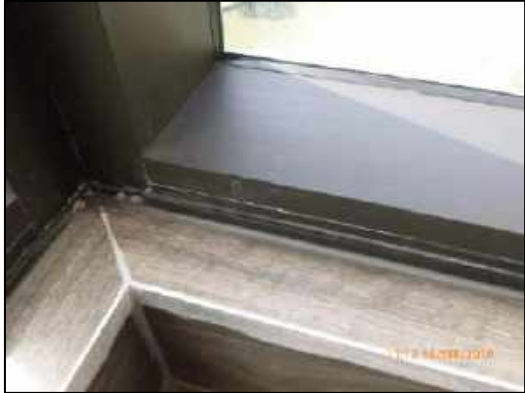
Item	Location	Defect description and Breach	Rectification	Photograph (if applicable)
605	Main bedroom window frames	See section 5.9.1	See section 5.9.2	 
606	Main bedroom window frames	See section 5.8.1	See section 5.8.2

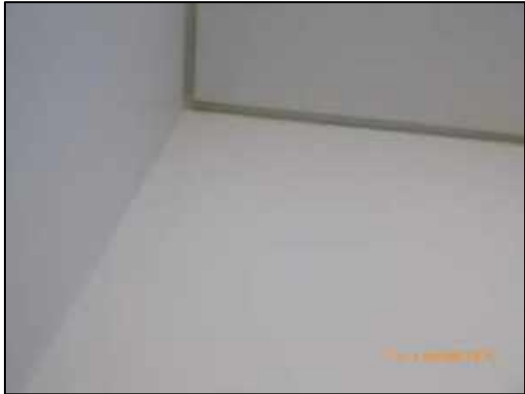
Item	Location	Defect description and Breach	Rectification	Photograph (if applicable)
607	<i>Throughout the unit</i>	See section 5.11.1	See section 5.11.2

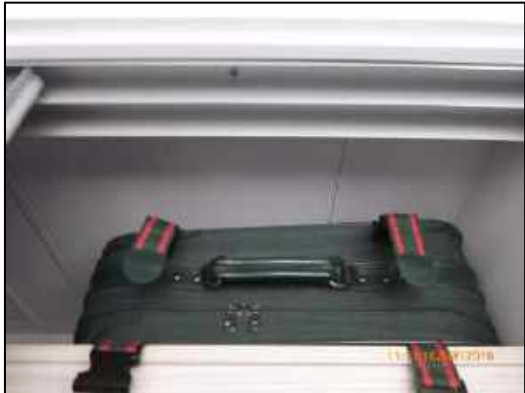
608	<i>Second bedroom built in</i>	See section 5.6.1	See section 5.6.2

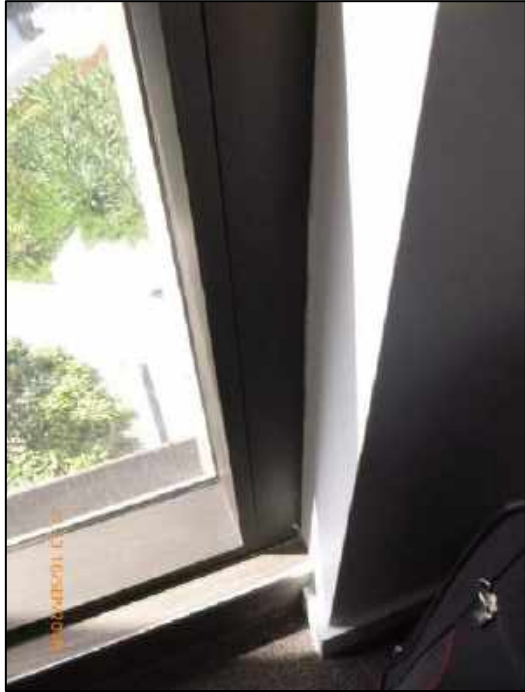
Item	Location	Defect description and Breach	Rectification	Photograph (if applicable)
609	Second bedroom window frames

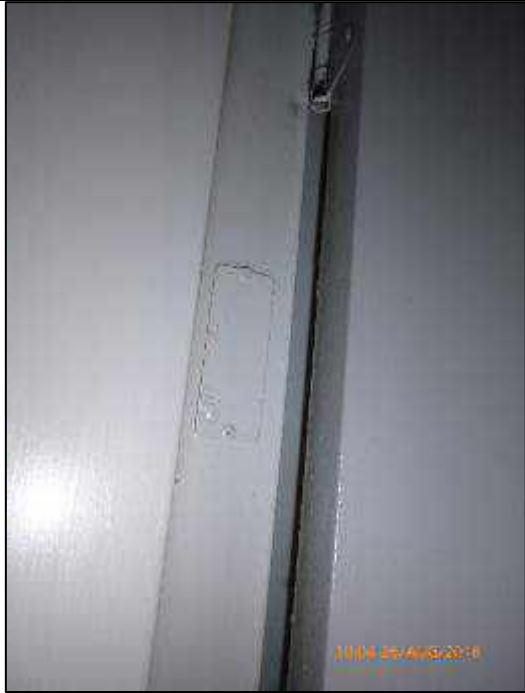
Item	Location	Defect description and Breach	Rectification	Photograph (if applicable)
610	Front entry door	<p>Door frame label has been painted over.</p> <p>Home Building Act (NSW) 1989</p> <ul style="list-style-type: none"> Part 2C, 18B (a) & (c). <p>Loss Suffered Loss suffered is cost of rectification.</p>	Use a suitable cleaning agent to remove paint from the door frame label.

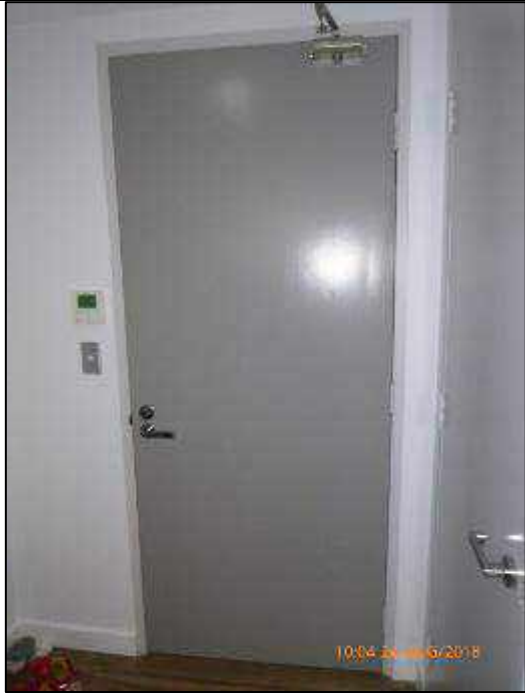
Item	Location	Defect description and Breach	Rectification	Photograph (if applicable)
611	Front entry door	See section 5.10.1	See section 5.10.2

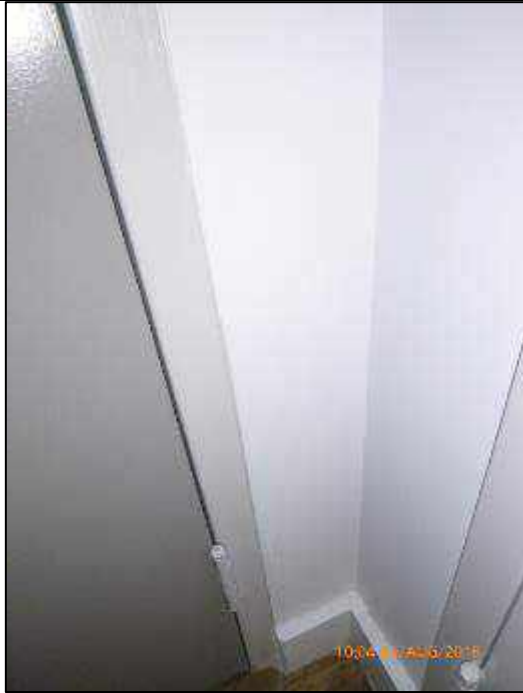
Item	Location	Defect description and Breach	Rectification	Photograph (if applicable)
612	Wall adjacent to front entry door	See section 5.13.1	See section 5.13.2

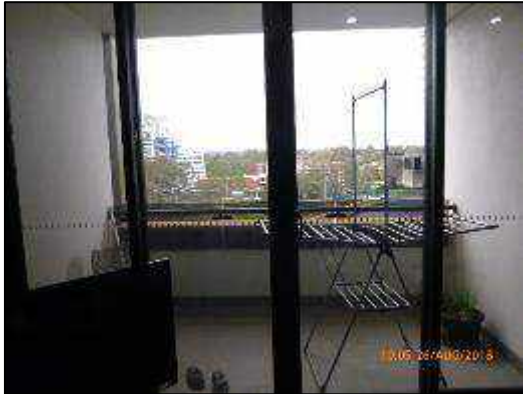
Item	Location	Defect description and Breach	Rectification	Photograph (if applicable)
614	Balcony	See section 5.3.1	See section 5.3.2

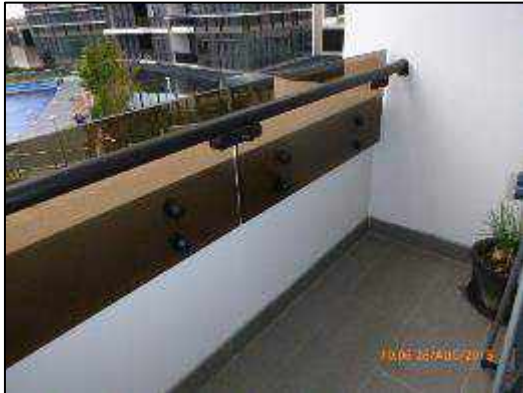
615	Balcony	See section 5.4.1	See section 5.4.2

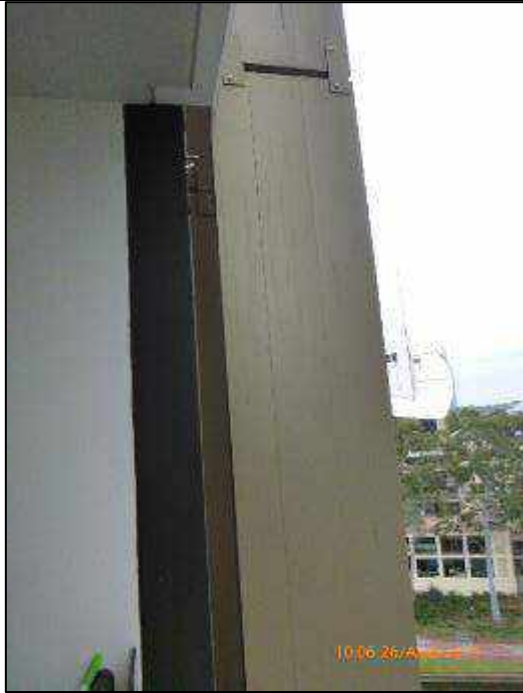
Item	Location	Defect description and Breach	Rectification	Photograph (if applicable)
616	Balcony	<p>Construction debris observed on façade of the building.</p> <p>Home Building Act (NSW) 1989</p> <ul style="list-style-type: none"> Part 2C, 18B (a) and (c). <p>This is a breach of part (a) of the act because the surface has not been finished in a proper workmanlike manner that would prevent loss of appearance to the surface.</p> <p>Loss Suffered Loss suffered is cost of rectification.</p>	<ol style="list-style-type: none"> 1. Protect all adjoining surfaces. 2. Use a suitable cleaning agent to remove residue and clear debris. 3. Clean up the work area.

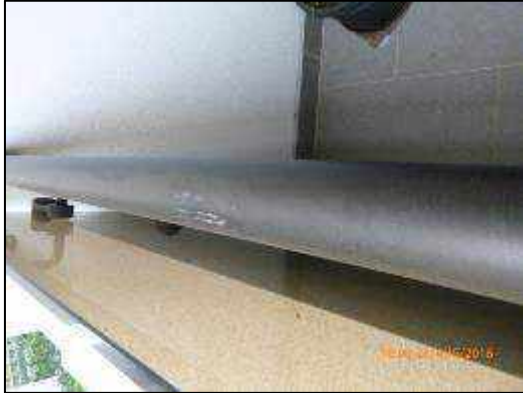
617	Balcony balustrade hand rail	See section 5.7.1	See section 5.7.2

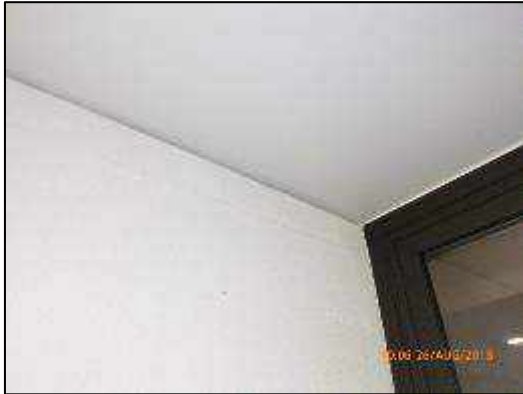
Item	Location	Defect description and Breach	Rectification	Photograph (if applicable)
618	Balcony	<p>Unsealed joint between eastern wall of balcony and ceiling.</p> <p>Home Building Act (NSW) 1989</p> <ul style="list-style-type: none"> Part 2C, 18B (a) and (c). <p>Loss Suffered Loss suffered is cost of rectification.</p>	<ol style="list-style-type: none"> 1. Apply a bead of flexible sealant to the joint between the ceiling and wall 2. As required, all affected surfaces are to be painted with an appropriate paint system to match as close as possible to the existing in accordance with the manufacturer's recommendations and AS2311 – Guide to the painting of buildings. 3. Clean up the work area

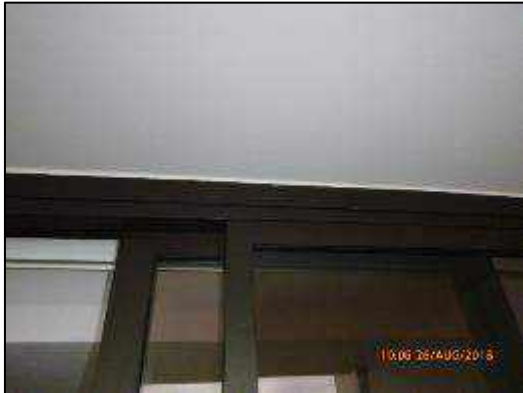
619	Balcony sliding door frame	See section 5.9.1	See section 5.9.2

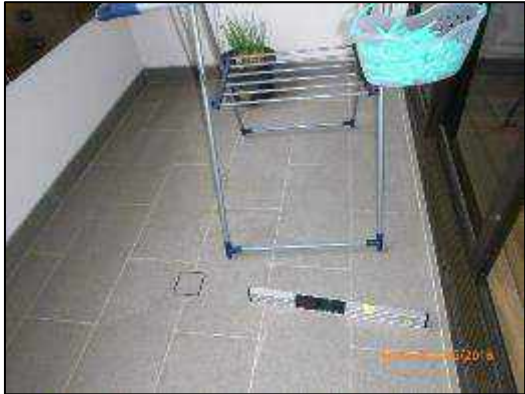
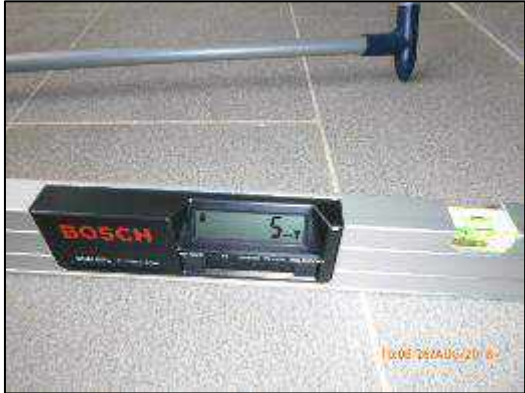
Item	Location	Defect description and Breach	Rectification	Photograph (if applicable)
620	Balcony	See section 5.2.1 Falls (mm); 5/1000	See section 5.2.2

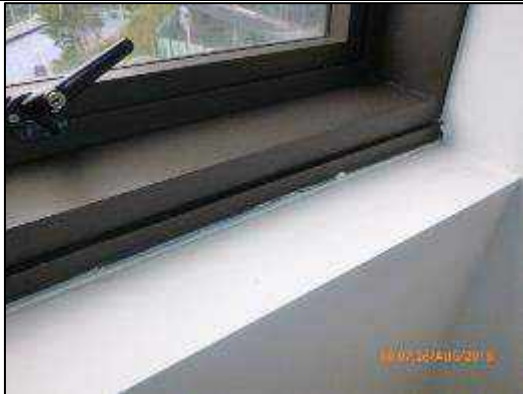
Item	Location	Defect description and Breach	Rectification	Photograph (if applicable)
621	Main bedroom window frames	See section 5.9.1	See section 5.9.2

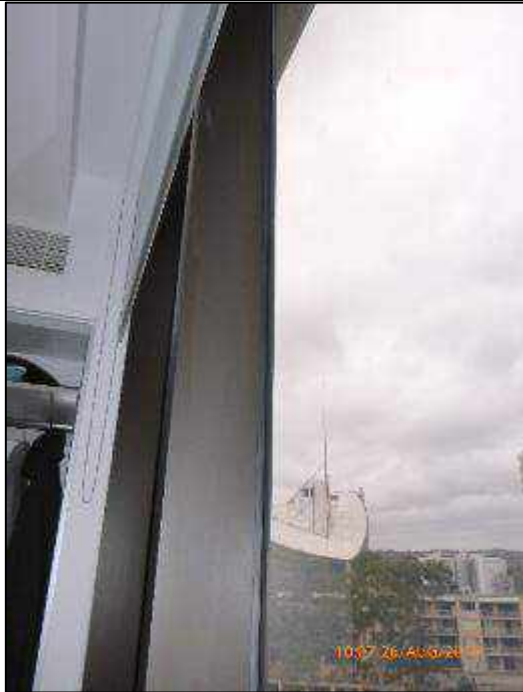
622	Main bedroom window frames	See section 5.7.1	See section 5.7.2

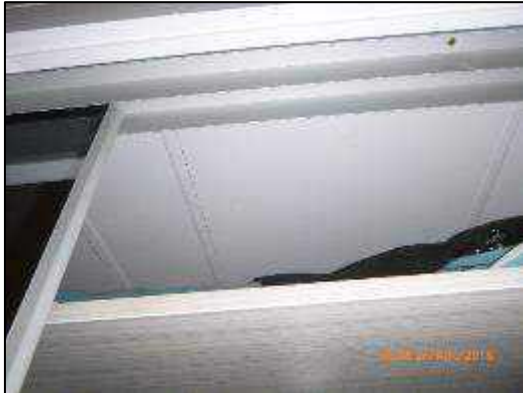
Item	Location	Defect description and Breach	Rectification	Photograph (if applicable)
623	Main bedroom built in	See section 5.6.1	See section 5.6.2

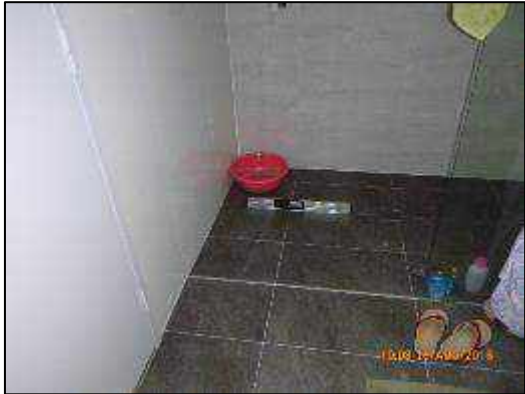
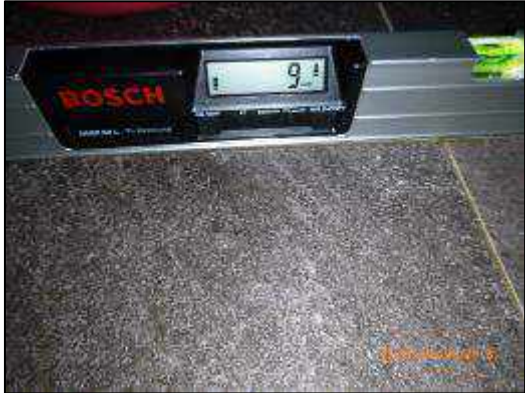
Item	Location	Defect description and Breach	Rectification	Photograph (if applicable)
624	Main bedroom ensuite	See section 5.1.1 Falls (mm); 9/1000	See section 5.1.2

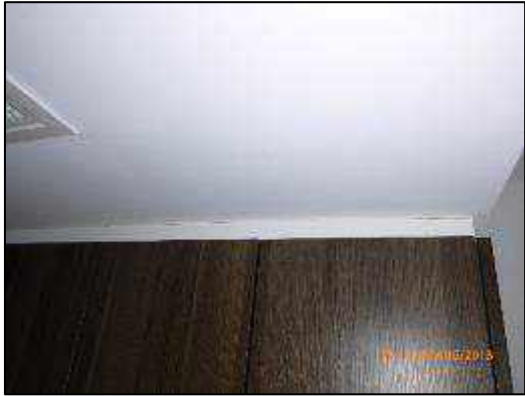
Item	Location	Defect description and Breach	Rectification	Photograph (if applicable)
625	<i>Ceiling above kitchen cupboards</i>	See section 5.14.1 Separation; 1mm	See section 5.14.2

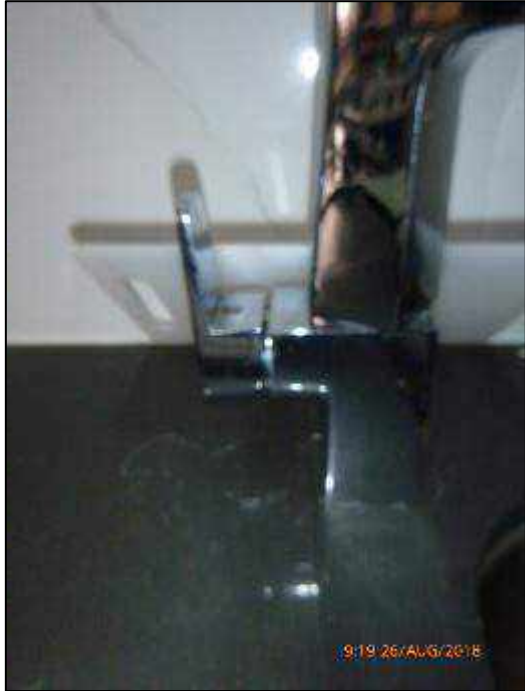
Item	Location	Defect description and Breach	Rectification	Photograph (if applicable)
Unit 604				
626	Kitchen sink	<p>Resident advised that the kitchen tap was loose.</p> <p>Home Building Act (NSW) 1989</p> <ul style="list-style-type: none"> Part 2C, 18B (a) and (b). <p>This item is a defect as the builder has failed to satisfy implied warranty set out in the Home Building Act 1989 – Section 18B Warranties as to residential building work.</p> <p>(b) a warranty that all materials supplied by the holder or person will be good and suitable for the purpose for which they are used and that, unless otherwise stated in the contract, those materials will be new.</p> <p>Loss Suffered Loss suffered in cost of rectification.</p>	<ol style="list-style-type: none"> 1. Temporary turn off main water supply to sink. 2. Carefully remove the mixer to sink. 3. Supply and install mixer to match existing. 4. Secure the tap flick mixer to the sink. 5. Turn on main water supply to sink.

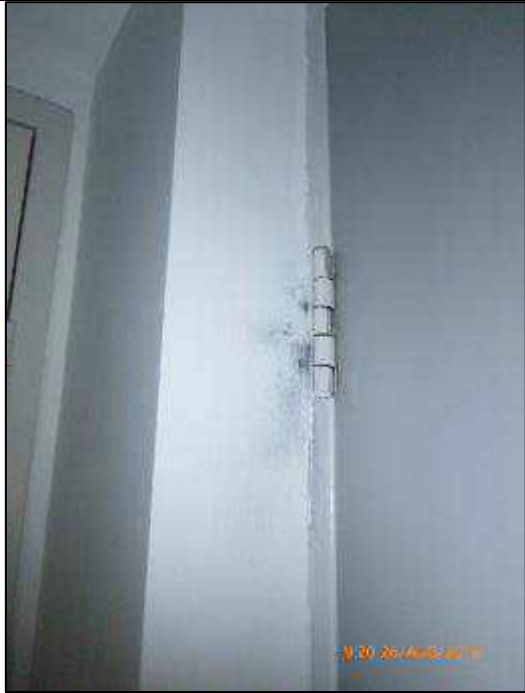
Item	Location	Defect description and Breach	Rectification	Photograph (if applicable)
627	Front entry door	<p>The hinges of the front entry door are leaking.</p> <p>Home Building Act (NSW) 1989</p> <ul style="list-style-type: none"> Part 2C, 18B (a) and (b). <p>This item is a defect as the builder has failed to satisfy implied warranty set out in the Home Building Act 1989 – Section 18B Warranties as to residential building work.</p> <p>(b) a warranty that all materials supplied by the holder or person will be good and suitable for the purpose for which they are used and that, unless otherwise stated in the contract, those materials will be new.</p> <p>Loss Suffered Loss suffered in cost of rectification.</p>	Engage a licenced carpenter to remove faulty door hinges and reinstate with new hinges matching existing in accordance with manufacturers specifications.

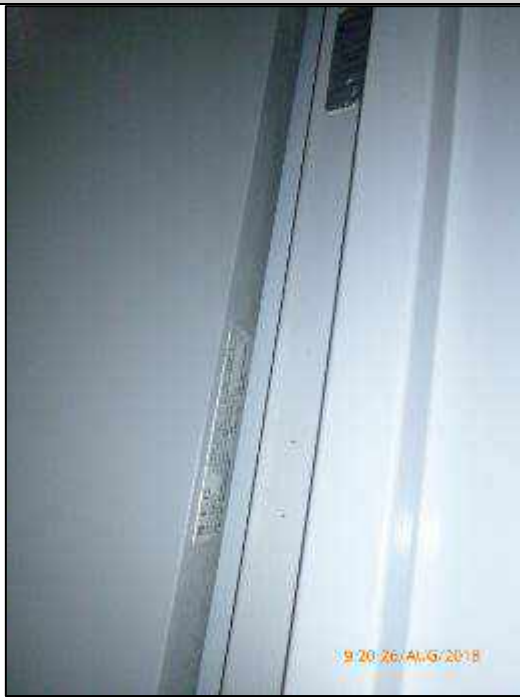
Item	Location	Defect description and Breach	Rectification	Photograph (if applicable)
628	Front entry door	<p>Fire door and frame observed to be two different brands.</p> <p>Home Building Act (NSW) 1989</p> <ul style="list-style-type: none"> Part 2C, 18B (a) and (c). <p>Loss Suffered</p> <p>Loss suffered is cost of rectification.</p>	Engage a licenced tradesperson to remove fire door and install a suitable fire door to match existing door frame as advised by fire engineer.

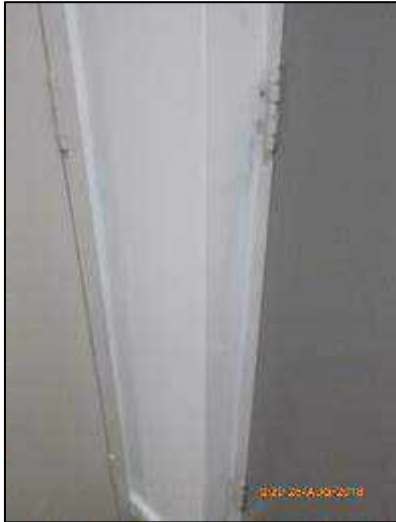
Item	Location	Defect description and Breach	Rectification	Photograph (if applicable)
629	Wall adjacent to front entry door	See section 5.13.1	See section 5.13.2

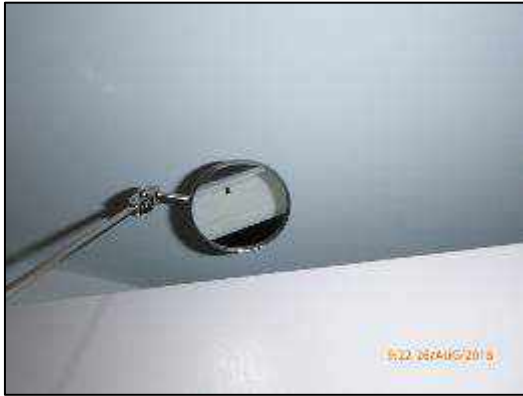
630	Doors throughout the unit (x1)	See section 5.5.1	See section 5.5.2

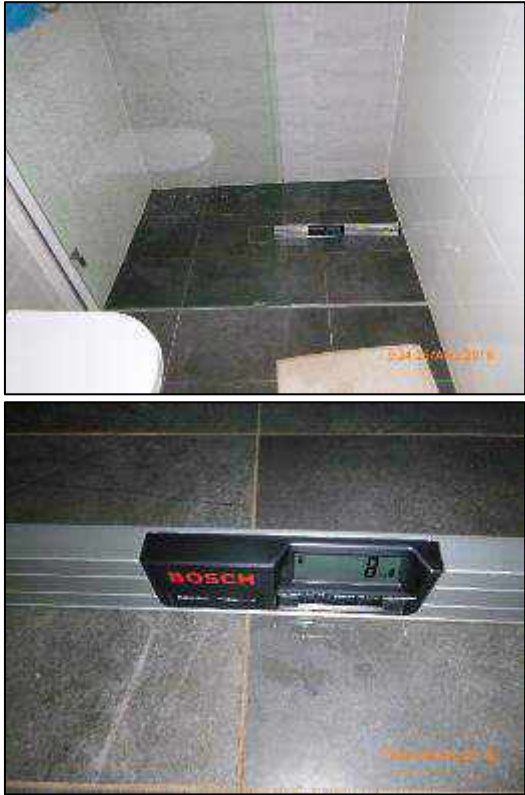
Item	Location	Defect description and Breach	Rectification	Photograph (if applicable)
631	Main bedroom ensuite	See section 5.1.1 Falls (mm); 8/1000	See section 5.1.2

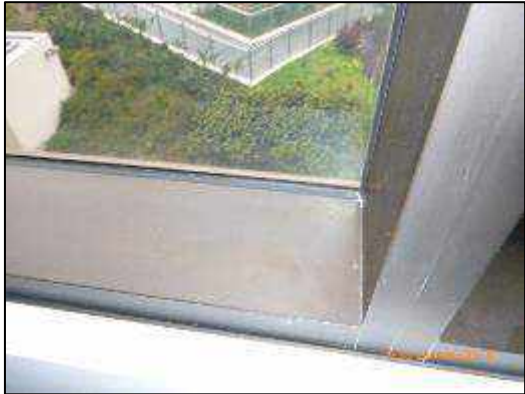
Item	Location	Defect description and Breach	Rectification	Photograph (if applicable)
632	<i>Living room window frames</i>	See section 5.8.1	See section 5.8.2

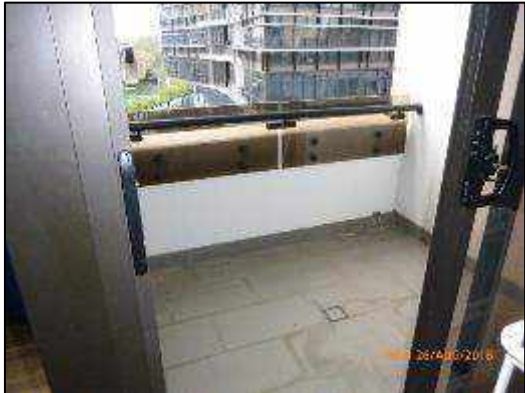
633	<i>Balcony</i>	See section 5.4.1	See section 5.4.2

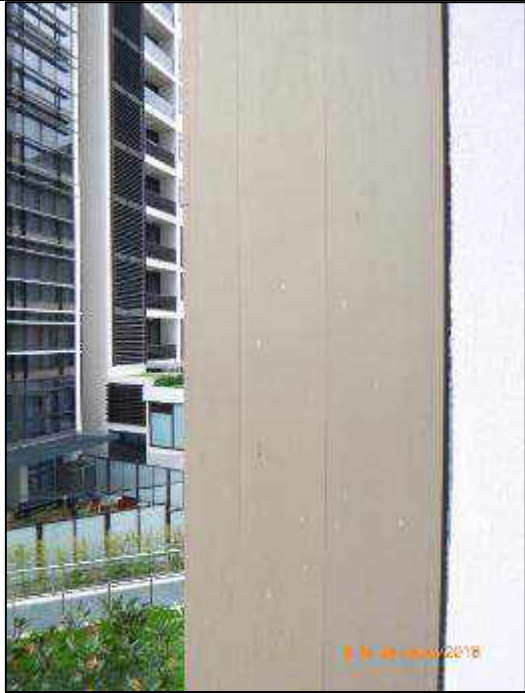
Item	Location	Defect description and Breach	Rectification	Photograph (if applicable)
636	Balcony	<p>Construction debris observed on façade of the building.</p> <p>Home Building Act (NSW) 1989</p> <ul style="list-style-type: none"> Part 2C, 18B (a) and (c). <p>This is a breach of part (a) of the act because the surface has not been finished in a proper workmanlike manner that would prevent loss of appearance to the surface.</p> <p>Loss Suffered Loss suffered is cost of rectification.</p>	<ol style="list-style-type: none"> 1. Protect all adjoining surfaces. 2. Use a suitable cleaning agent to remove residue and clear debris. 3. Clean up the work area.

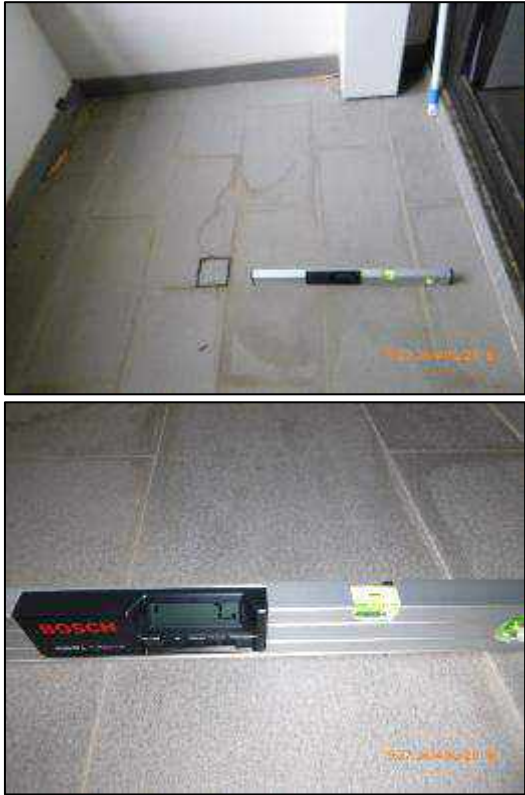
Item	Location	Defect description and Breach	Rectification	Photograph (if applicable)
637	Balcony	See section 5.2.1 Falls (mm); 7/1000	See section 5.2.2

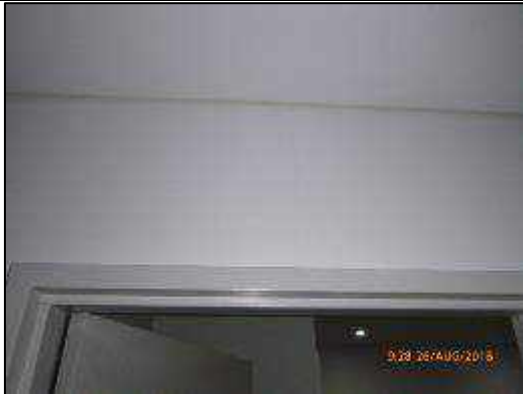
Item	Location	Defect description and Breach	Rectification	Photograph (if applicable)
638	Main bedroom	See section 5.11.1	See section 5.11.2

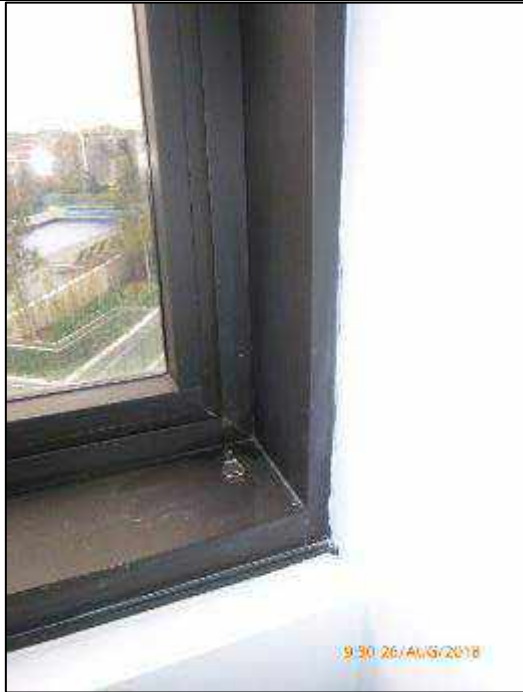
A photograph showing a close-up of a ceiling corner in a bedroom. There is a faint, horizontal, yellowish-green line or stain on the white ceiling. A timestamp '9:28 26/AUG/2018' is visible in the bottom right corner of the photo.
639	Main bedroom window frames	See section 5.9.1	See section 5.9.2

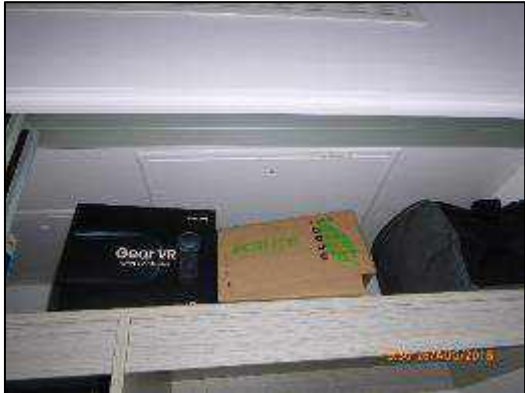
Item	Location	Defect description and Breach	Rectification	Photograph (if applicable)
640	Main bedroom built in	See section 5.6.1	See section 5.6.2

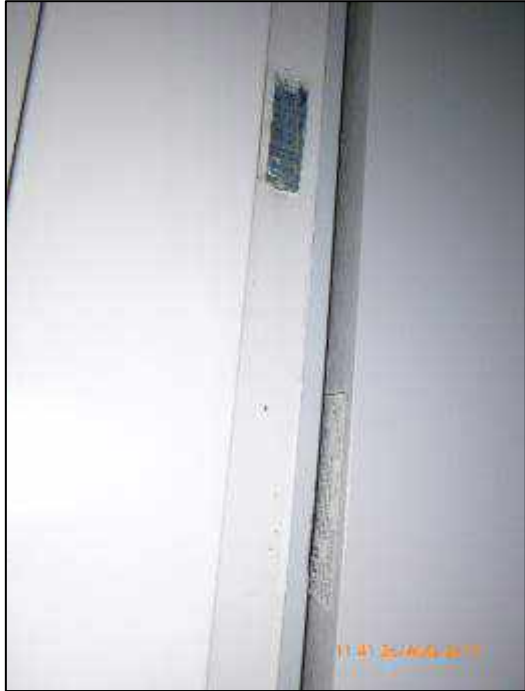
Item	Location	Defect description and Breach	Rectification	Photograph (if applicable)
Unit 605				
641	Front entry door	<p>Fire door and frame observed to be two different brands.</p> <p>Home Building Act (NSW) 1989</p> <ul style="list-style-type: none"> Part 2C, 18B (a) and (c). <p>Loss Suffered Loss suffered is cost of rectification.</p>	Engage a licenced tradesperson to remove fire door and install a suitable fire door to match existing door frame as advised by fire engineer.

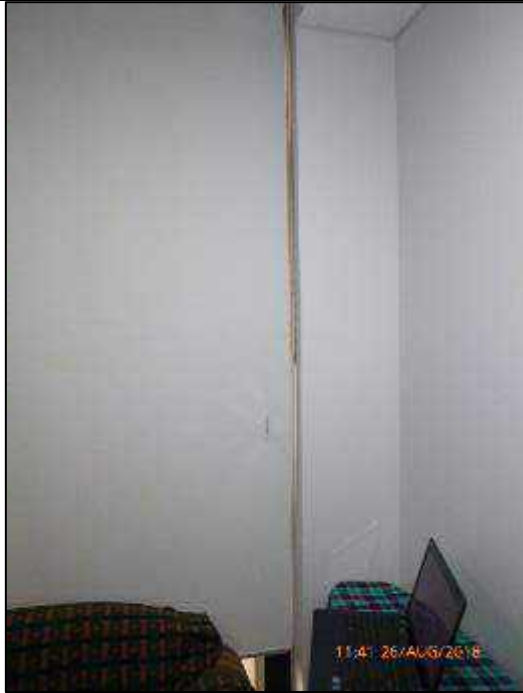
Item	Location	Defect description and Breach	Rectification	Photograph (if applicable)
642	Lounge room windows	<p>Blinds in the lounge room are out of plumb with the window frame.</p> <p>Home Building Act (NSW) 1989</p> <ul style="list-style-type: none"> Part 2C, 18B (a) and (c). <p>Loss Suffered Loss suffered is cost of rectification.</p>	Engage a licenced tradesman to remove the blinds and re-install to fit the existing window in plumb.

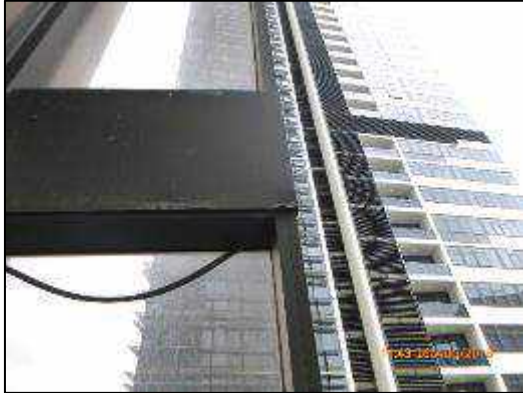
643	Balcony	<p>Construction debris observed on façade of the building.</p> <p>Home Building Act (NSW) 1989</p> <ul style="list-style-type: none"> Part 2C, 18B (a) and (c). <p>This is a breach of part (a) of the act because the surface has not been finished in a proper workmanlike manner that would prevent loss of appearance to the surface.</p> <p>Loss Suffered</p>	<ol style="list-style-type: none"> 1. Protect all adjoining surfaces. 2. Use a suitable cleaning agent to remove residue and clear debris. 3. Clean up the work area.

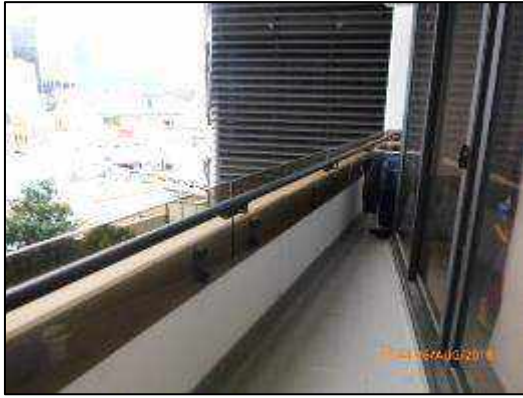
Item	Location	Defect description and Breach	Rectification	Photograph (if applicable)
		Loss suffered is cost of rectification.		
644	Balcony	See section 5.4.1	See section 5.4.2

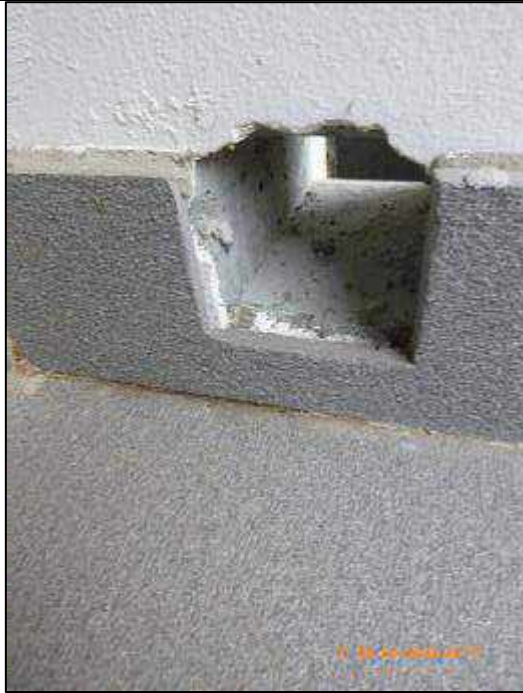
Item	Location	Defect description and Breach	Rectification	Photograph (if applicable)
645	Balcony	See section 5.15.1	See section 5.15.2

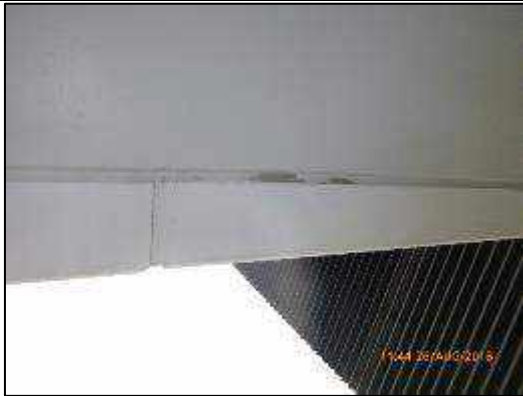
646	Balcony soffit of slab above	See section 5.10.1	See section 5.10.2

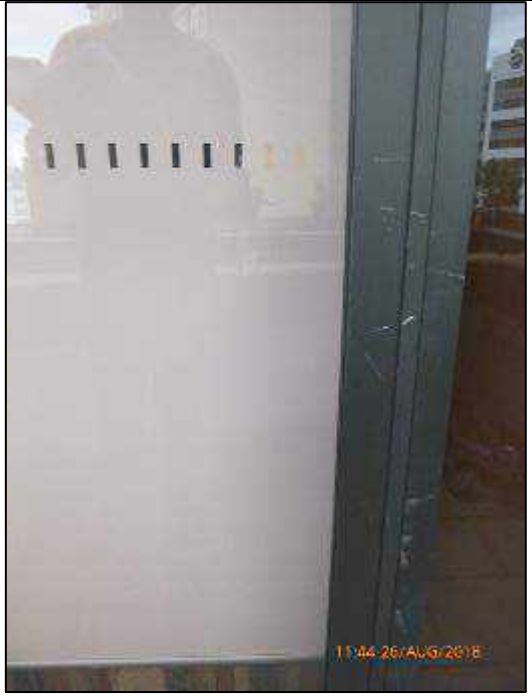
Item	Location	Defect description and Breach	Rectification	Photograph (if applicable)
647	Balcony sliding door frames	See section 5.7.1	See section 5.7.2

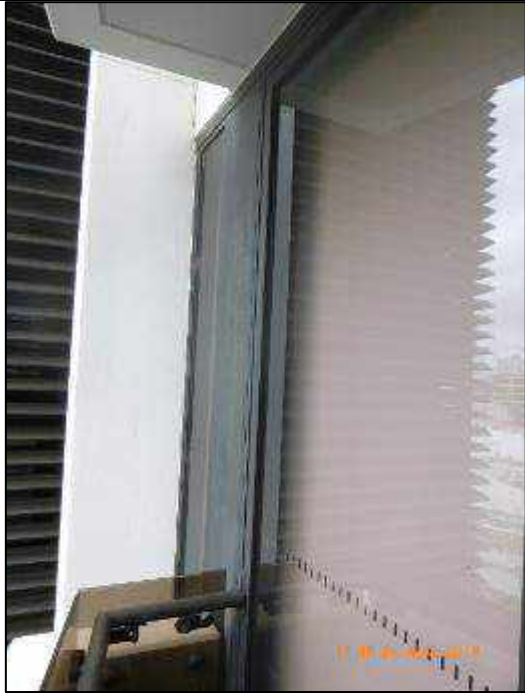
Item	Location	Defect description and Breach	Rectification	Photograph (if applicable)
648	Balcony sliding door frames	See section 5.9.1	See section 5.9.2

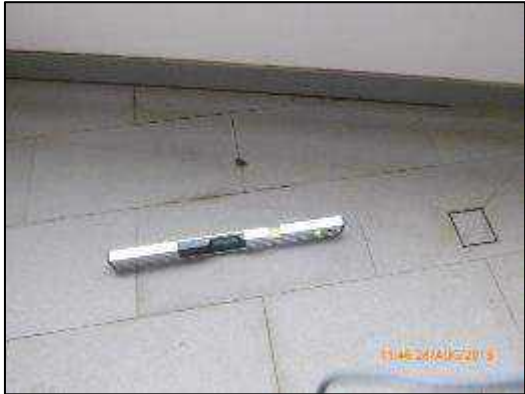
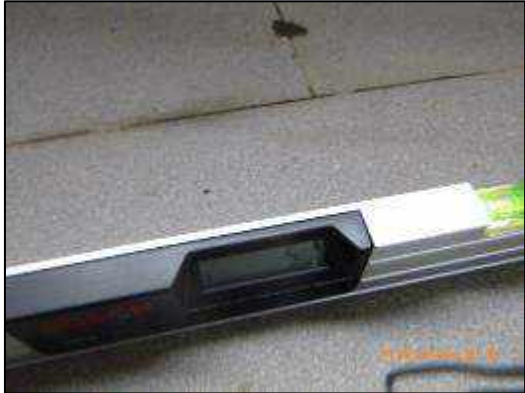
Item	Location	Defect description and Breach	Rectification	Photograph (if applicable)
649	Balcony	See section 5.2.1 Falls (mm); 5/1000	See section 5.2.2

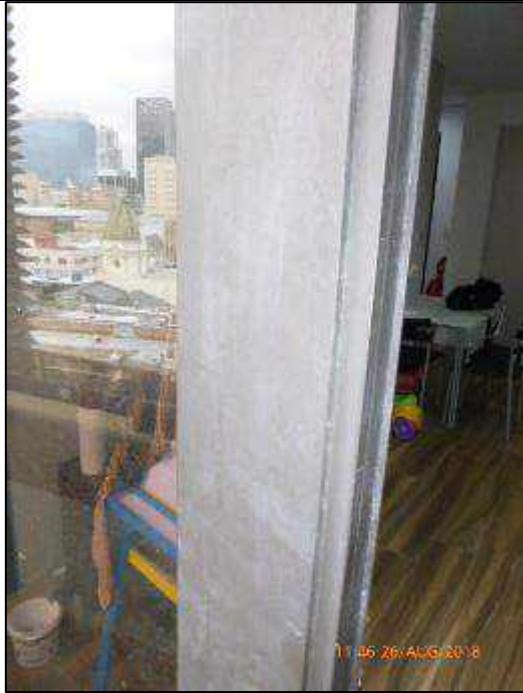
Item	Location	Defect description and Breach	Rectification	Photograph (if applicable)
650	Balcony sliding door frame	See section 5.7.1	See section 5.7.2

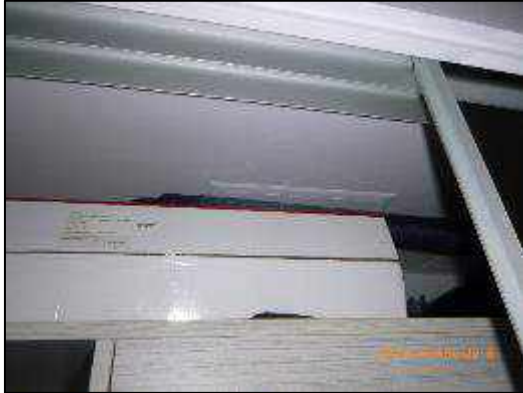
651	Second bedroom built in	See section 5.6.1	See section 5.6.2

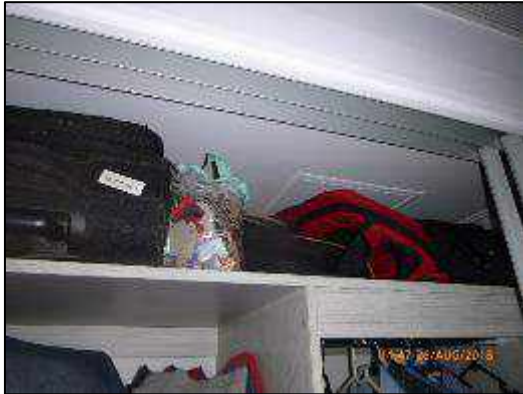
Item	Location	Defect description and Breach	Rectification	Photograph (if applicable)
652	Main bedroom built in	See section 5.6.1	See section 5.6.2

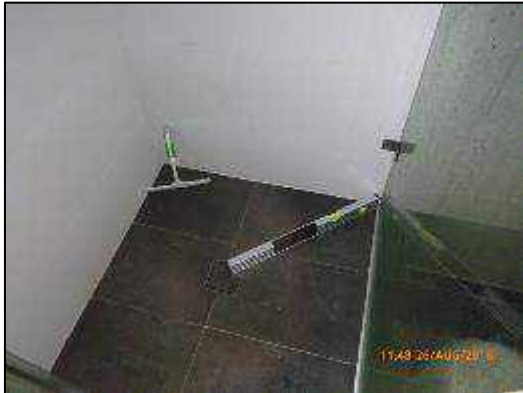
653	Main bedroom ensuite	See section 5.1.1 Falls (mm); 9/1000	See section 5.1.2

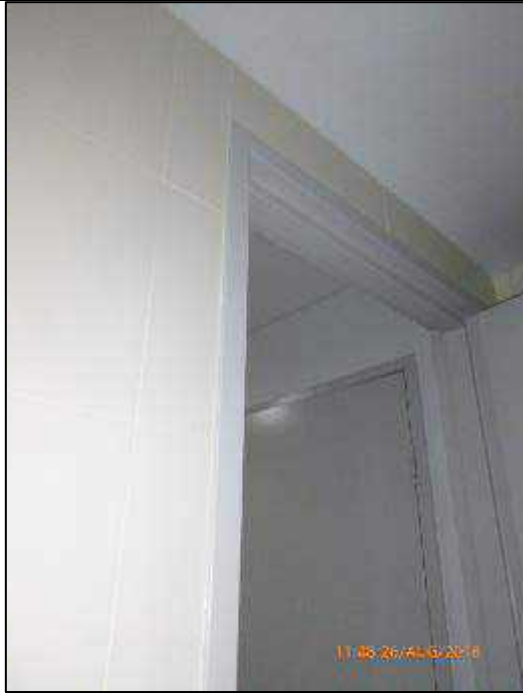
Item	Location	Defect description and Breach	Rectification	Photograph (if applicable)
654	Main bedroom ensuite door frame	See section 5.9.1	See section 5.9.2

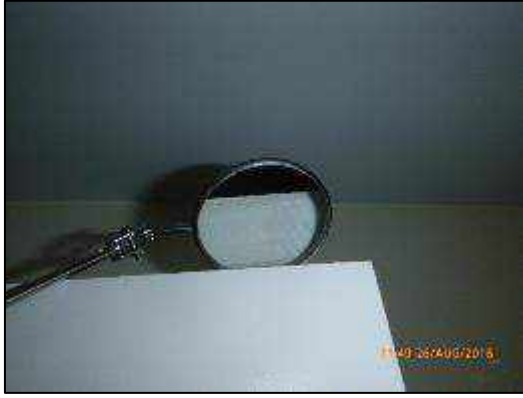
655	Doors throughout the unit (x3)	See section 5.5.1	See section 5.5.2

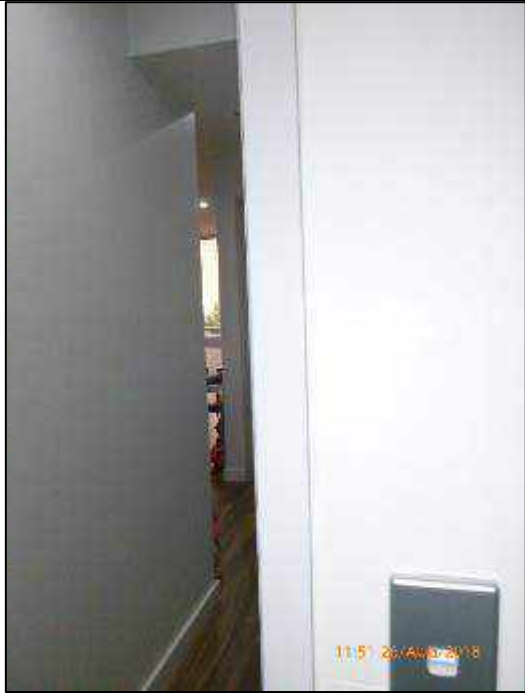
Item	Location	Defect description and Breach	Rectification	Photograph (if applicable)
656	Main bathroom door frame	See section 5.9.1	See section 5.9.2

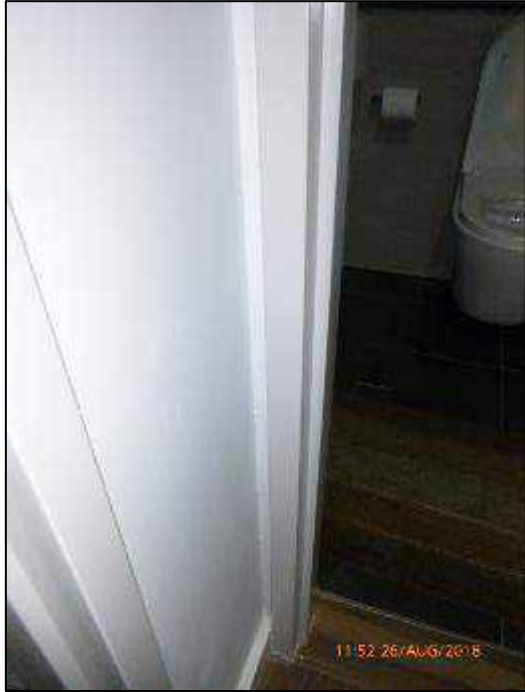
Item	Location	Defect description and Breach	Rectification	Photograph (if applicable)
657	Wall adjacent to main bathroom	See section 5.13.1	See section 5.13.2

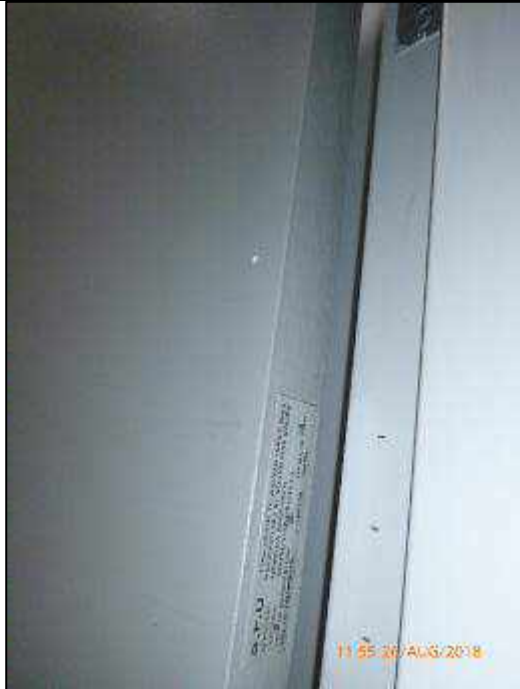
Item	Location	Defect description and Breach	Rectification	Photograph (if applicable)
Unit 607				
659	Front entry door	<p>Fire door and frame observed to be two different brands.</p> <p>Home Building Act (NSW) 1989</p> <ul style="list-style-type: none"> Part 2C, 18B (a) and (c). <p>Loss Suffered</p> <p>Loss suffered is cost of rectification.</p>	Engage a licenced tradesperson to remove fire door and install a suitable fire door to match existing door frame as advised by fire engineer.

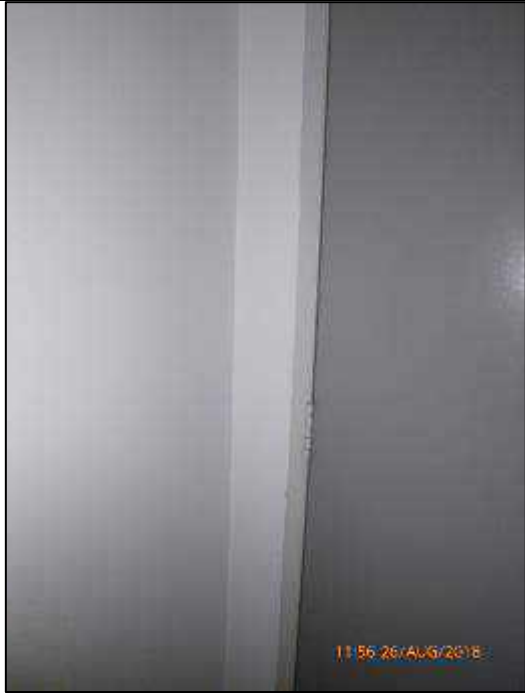
Item	Location	Defect description and Breach	Rectification	Photograph (if applicable)
660	Wall adjacent to front entry door	See section 5.13.1	See section 5.13.2
