SydneyStrataReport

STRATA REPORT

Client	Church Street Parramatta Property Pty Ltd
Address of property	Unit 3303/330 Church Street, Parramatta, NSW.
Lot	359
Strata Plan	SP 94469
Name of Strata Management Co.	NSW Strata
Telephone Number of Strata Agent	8980 1841
Report Date	15 February 2024

BUILDING DEFECTS REPORT Part 1/2

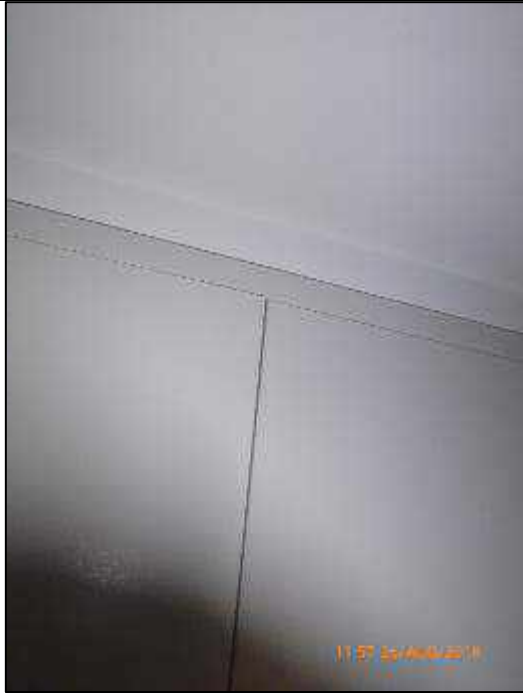
Item	Location	Defect description and Breach	Rectification	Photograph (if applicable)
661	Study room doors	<p>Study room doors were observed to be misaligned and do not effectively close.</p> <p>Home Building Act (NSW) 1989</p> <ul style="list-style-type: none"> Part 2C, 18B (a) & (c). <p>Guide to Standards and Tolerances 2017</p> <ul style="list-style-type: none"> Section 9.7 Operation of windows and doors. <p>This is a defect because the door does not operate as intended by the manufacturer' as outlined in Section 9.7 of the Guide to Standards and Tolerances 2017.</p> <p>Loss Suffered Loss suffered is cost of rectification.</p>

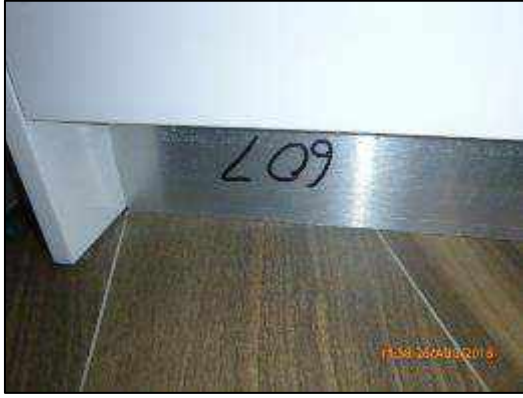
662	Kitchen	<p>Marking observed on the kickboard of the kitchen cupboards</p> <p>Home Building Act (NSW) 1989</p> <ul style="list-style-type: none"> Part 2C, 18B (a) and (c). <p>This is a breach of part (a) of the act because the surface has not been finished in a proper workmanlike manner that would prevent loss of appearance to the surface.</p> <p>Loss Suffered</p>	<ol style="list-style-type: none"> 1. Protect all adjoining surfaces. 2. Use a suitable cleaning agent to remove marking and clear debris. 3. Clean up the work area.

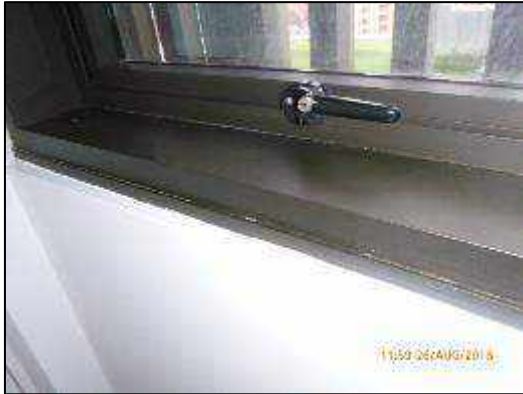
Item	Location	Defect description and Breach	Rectification	Photograph (if applicable)
		Loss suffered is cost of rectification.		
663	<i>Kitchen window frame</i>	See section 5.9.1	See section 5.9.2

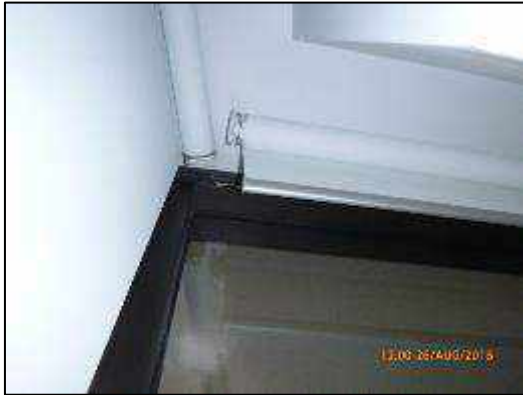
664	<i>Lounge room window frames</i>	See section 5.9.1	See section 5.9.2

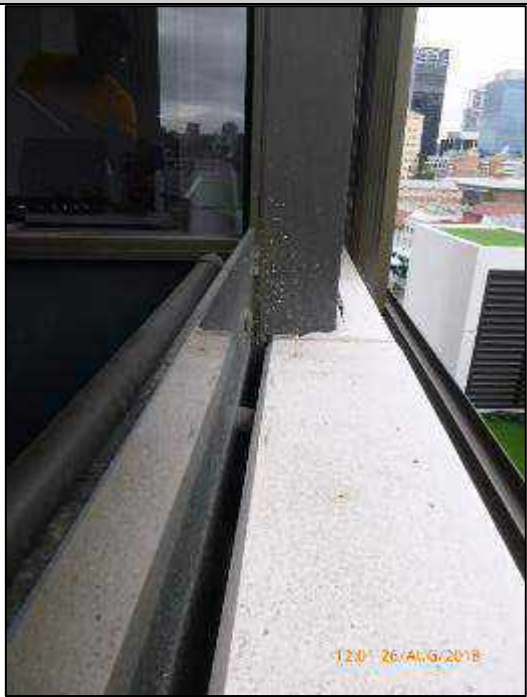
Item	Location	Defect description and Breach	Rectification	Photograph (if applicable)
665	Balcony	<p>Construction debris observed on façade of the building.</p> <p>Home Building Act (NSW) 1989</p> <ul style="list-style-type: none"> Part 2C, 18B (a) and (c). <p>This is a breach of part (a) of the act because the surface has not been finished in a proper workmanlike manner that would prevent loss of appearance to the surface.</p> <p>Loss Suffered Loss suffered is cost of rectification.</p>	<ol style="list-style-type: none"> 1. Protect all adjoining surfaces. 2. Use a suitable cleaning agent to remove residue and clear debris. 3. Clean up the work area.

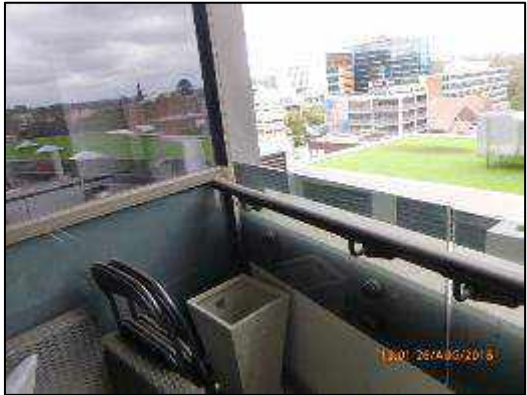
666	Balcony	See section 5.4.1	See section 5.4.2

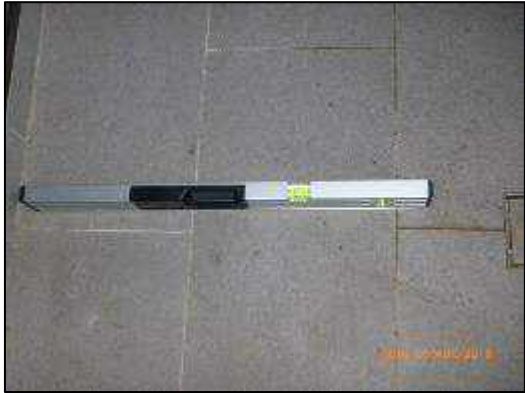
Item	Location	Defect description and Breach	Rectification	Photograph (if applicable)
669	Baclony	See section 5.2.1 Falls (mm); 1/1000	See section 5.2.2

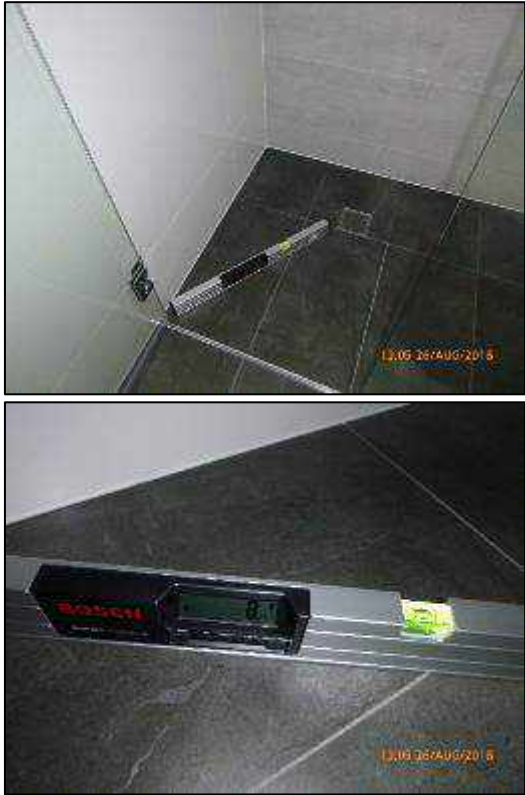
Item	Location	Defect description and Breach	Rectification	Photograph (if applicable)
670	Main bathroom	See section 5.1.1 Falls (mm); 8/1000	See section 5.1.2

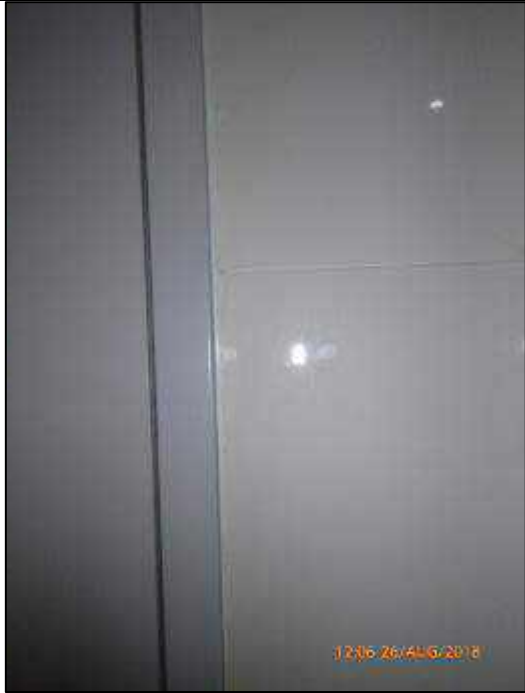
Item	Location	Defect description and Breach	Rectification	Photograph (if applicable)
671	Main bathroom door frame	See section 5.9.1	See section 5.9.2

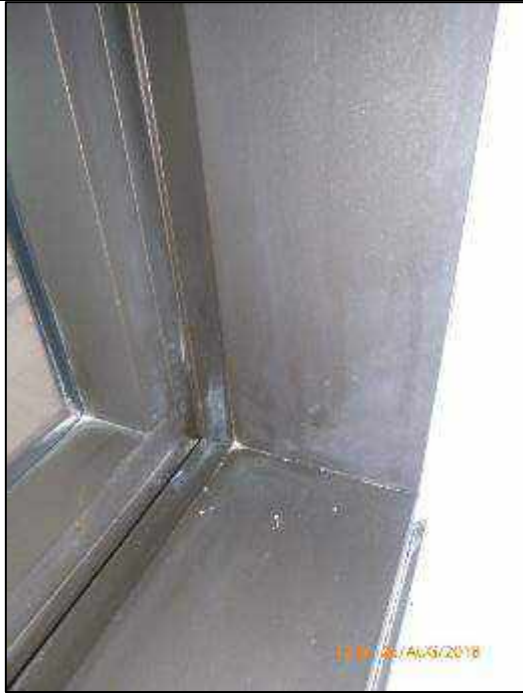
Item	Location	Defect description and Breach	Rectification	Photograph (if applicable)
672	Main bedroom window frames	See section 5.7.1	See section 5.7.2

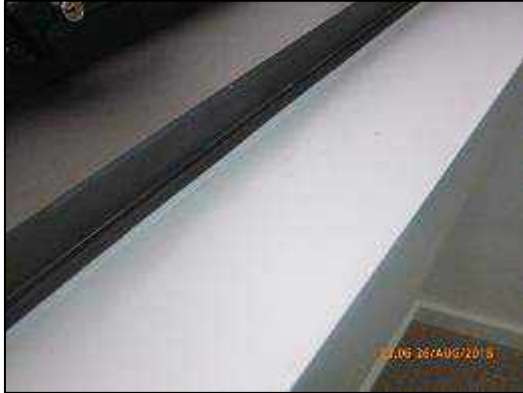
673	Main bedroom window frames	See section 5.9.1	See section 5.9.2

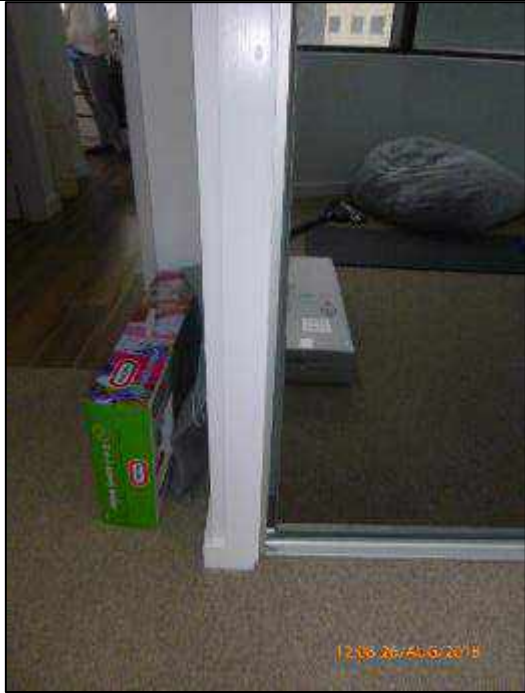
Item	Location	Defect description and Breach	Rectification	Photograph (if applicable)
674	Main bedroom wall adjacent to built in	See section 5.13.1	See section 5.13.2

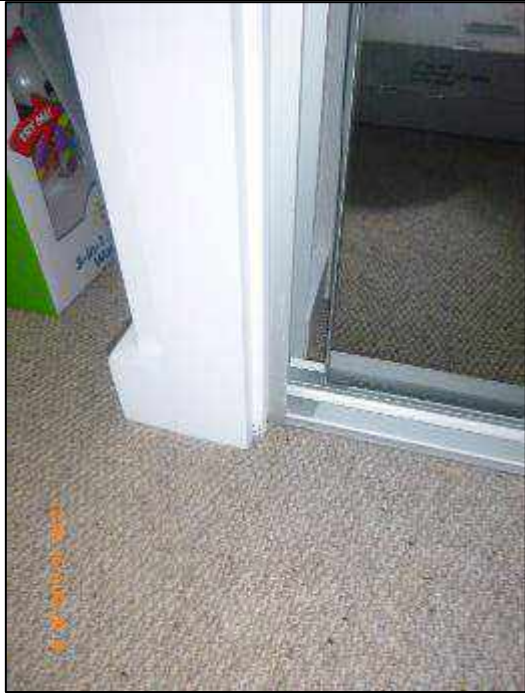
Item	Location	Defect description and Breach	Rectification	Photograph (if applicable)
675	Main bedroom skirting board adjacent to built in	See section 5.10.1	See section 5.10.2

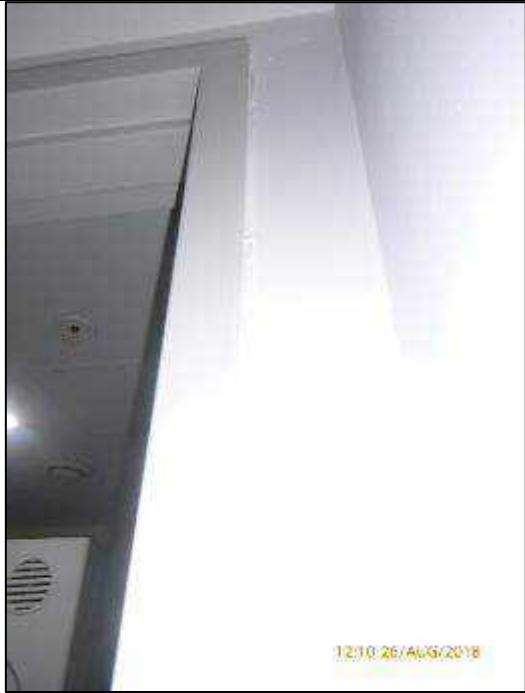
Item	Location	Defect description and Breach	Rectification	Photograph (if applicable)
676	Wall adjacent to laundry door frame	See section 5.13.1	See section 5.13.2

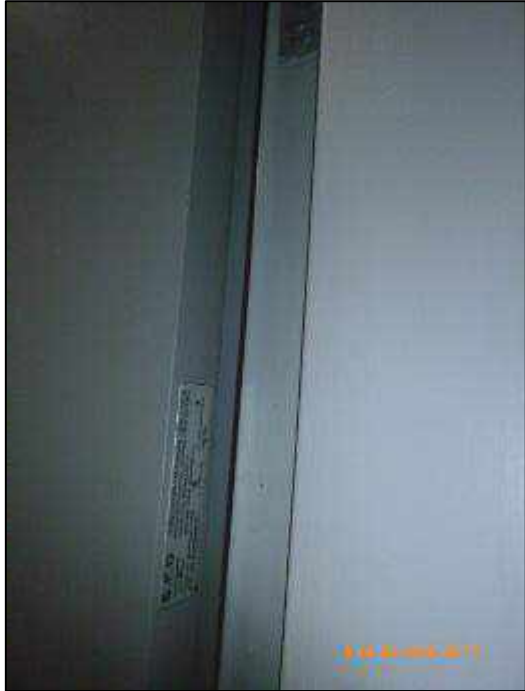
Item	Location	Defect description and Breach	Rectification	Photograph (if applicable)
Unit 608				
677	Front entry door	See section 5.12.1	See section 5.12.2

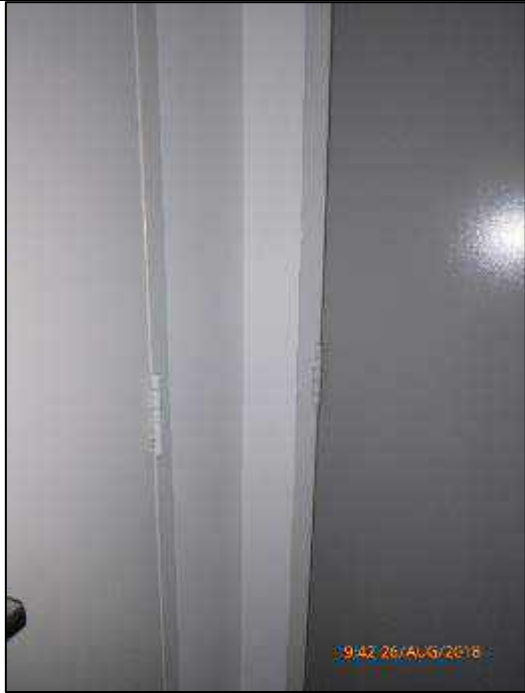
Item	Location	Defect description and Breach	Rectification	Photograph (if applicable)
678	Wall adjacent to front entry door	See section 5.13.1	See section 5.13.2

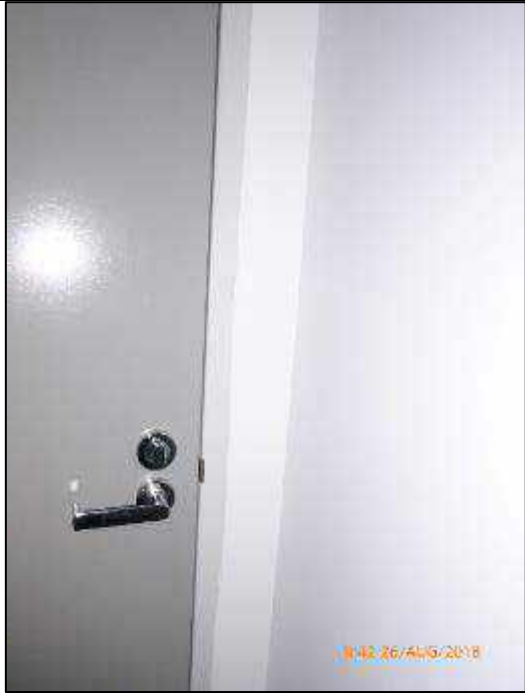
Item	Location	Defect description and Breach	Rectification	Photograph (if applicable)
679	Wall adjacent to front entry door	See section 5.13.1	See section 5.13.2

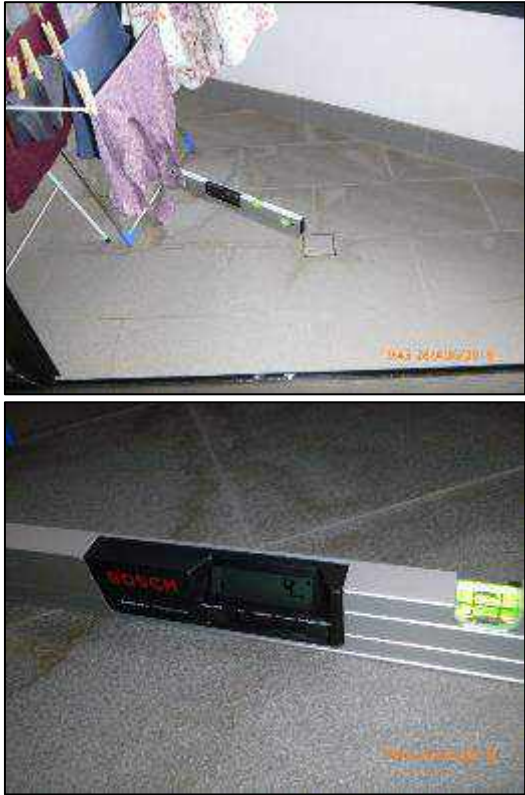
Item	Location	Defect description and Breach	Rectification	Photograph (if applicable)
680	Balcony	See section 5.2.1 Falls (mm); 4/1000	See section 5.2.2

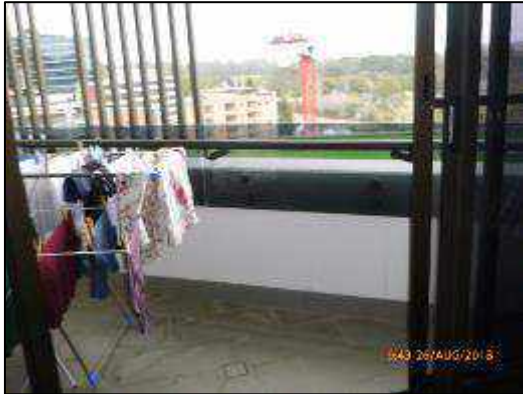
Item	Location	Defect description and Breach	Rectification	Photograph (if applicable)
681	Balcony	See section 5.3.1	See section 5.3.2

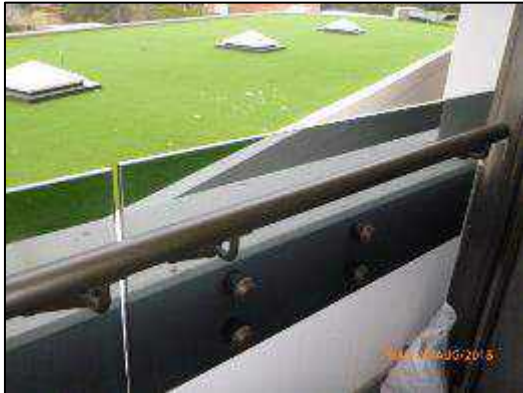
682	Balcony	See section 5.4.1	See section 5.4.2

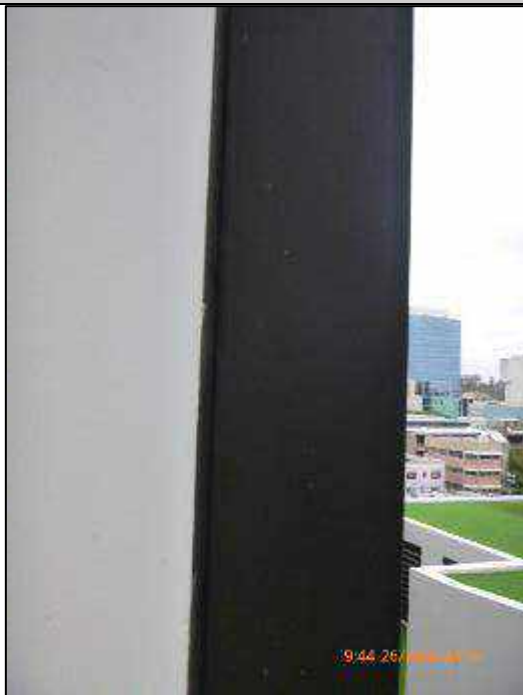
Item	Location	Defect description and Breach	Rectification	Photograph (if applicable)
683	Balcony	<p>Construction debris observed on façade of the building.</p> <p>Home Building Act (NSW) 1989</p> <ul style="list-style-type: none"> Part 2C, 18B (a) and (c). <p>This is a breach of part (a) of the act because the surface has not been finished in a proper workmanlike manner that would prevent loss of appearance to the surface.</p> <p>Loss Suffered Loss suffered is cost of rectification.</p>	<ol style="list-style-type: none"> 1. Protect all adjoining surfaces. 2. Use a suitable cleaning agent to remove residue and clear debris. 3. Clean up the work area.

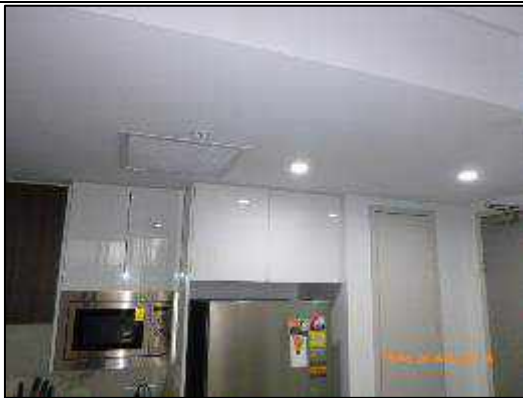
684	Kitchen ceiling	See section 5.10.1	See section 5.10.2

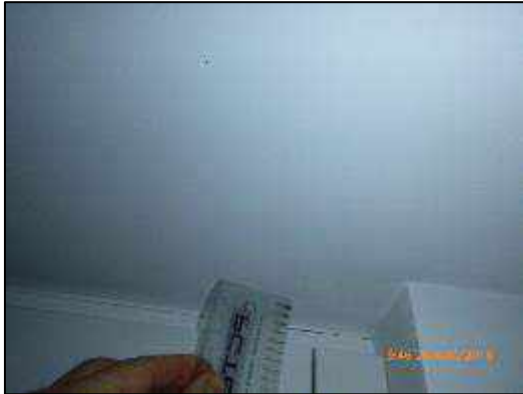
Item	Location	Defect description and Breach	Rectification	Photograph (if applicable)
685	<i>Ceiling above kitchen cupboards</i>	See section 5.14.1 Separation; 1mm	See section 5.14.2

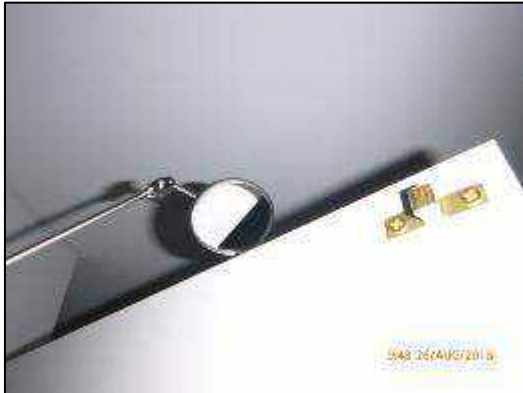
686	<i>Doors throughout the unit (x3)</i>	See section 5.5.1	See section 5.5.2

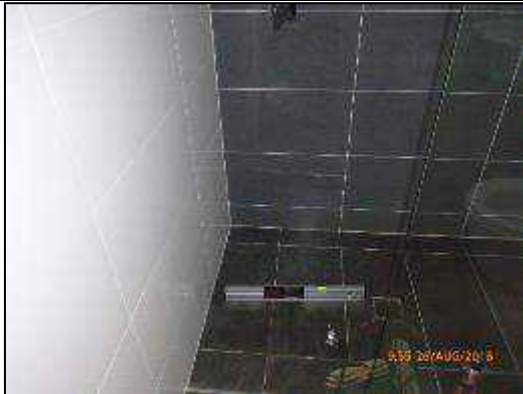
Item	Location	Defect description and Breach	Rectification	Photograph (if applicable)
687	Main bathroom	See section 5.1.1 Falls (mm); 8/1000	See section 5.1.2

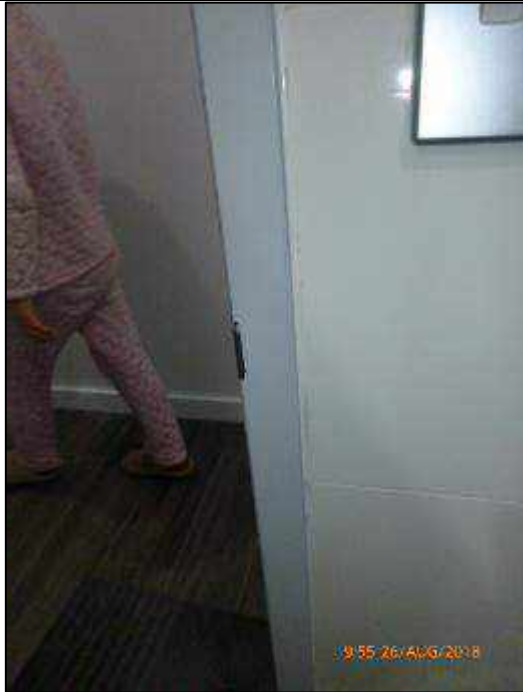
A photograph of a bathroom floor with a dark grid pattern. A small, light-colored object is visible on the floor. The date '03/28/AUG/2018' is printed in the bottom right corner.
688	Main bathroom door frame	See section 5.9.1	See section 5.9.2

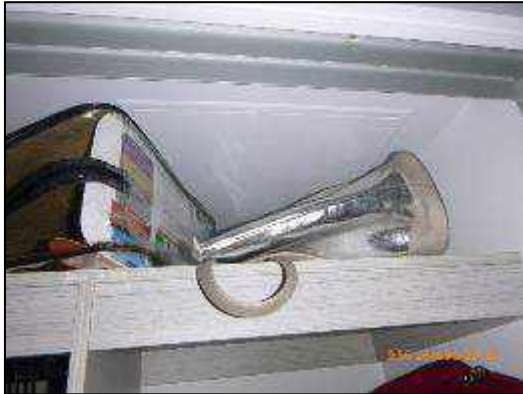
Item	Location	Defect description and Breach	Rectification	Photograph (if applicable)
689	Main bedroom built in	See section 5.6.1	See section 5.6.2

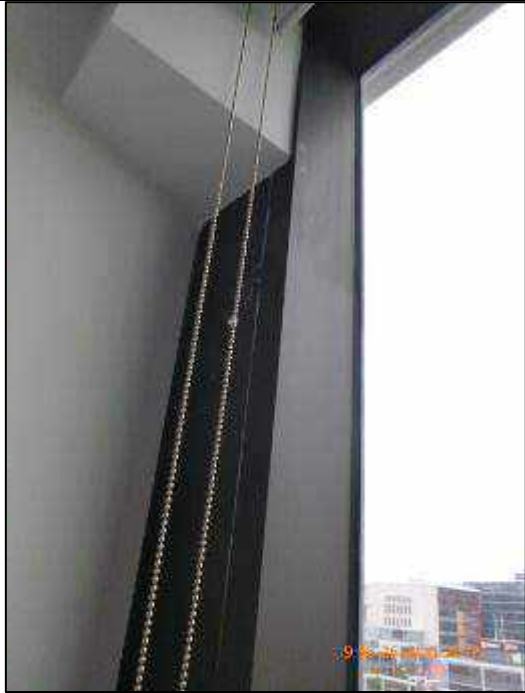
Item	Location	Defect description and Breach	Rectification	Photograph (if applicable)
691	Main bedroom ensuite window frames	See section 5.8.1	See section 5.8.2

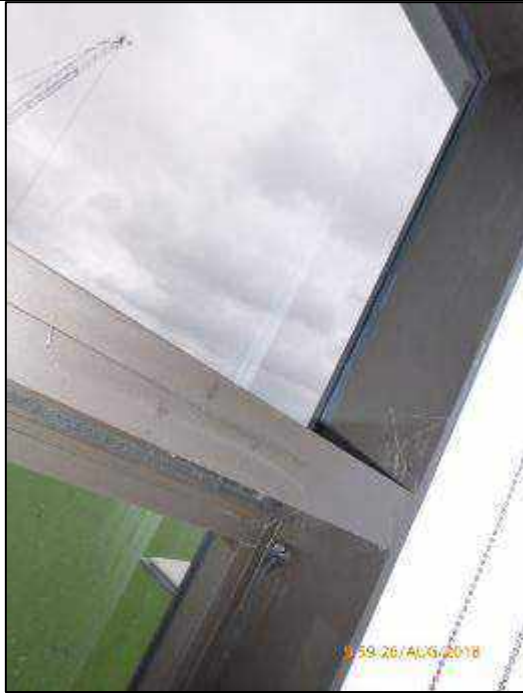
Item	Location	Defect description and Breach	Rectification	Photograph (if applicable)
692	Main bedroom window frames	See section 5.7.1	See section 5.7.2

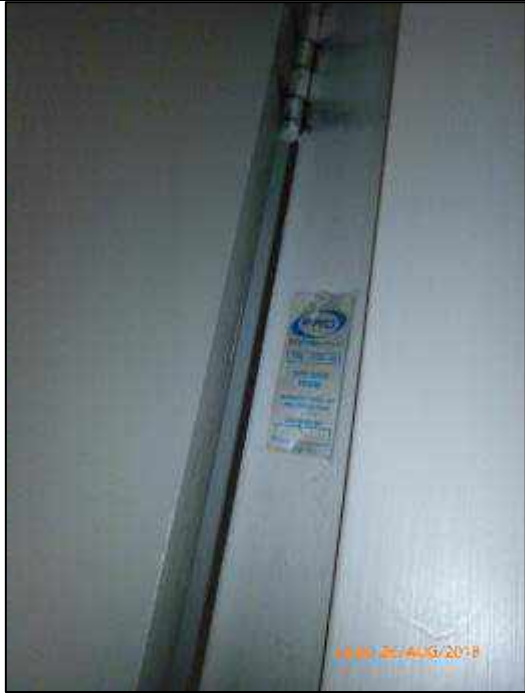
Item	Location	Defect description and Breach	Rectification	Photograph (if applicable)
693	Front entry door	<p>Fire door and frame observed to be two different brands.</p> <p>Home Building Act (NSW) 1989</p> <ul style="list-style-type: none"> Part 2C, 18B (a) and (c). <p>Loss Suffered</p> <p>Loss suffered is cost of rectification.</p>	Engage a licenced tradesperson to remove fire door and install a suitable fire door to match existing door frame as advised by fire engineer.

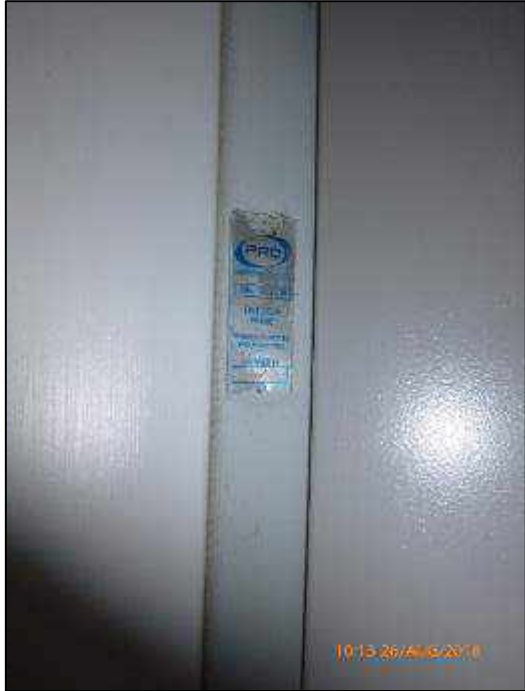
Item	Location	Defect description and Breach	Rectification	Photograph (if applicable)
Unit 701				
694	Front entry door	<p>Fire door and frame observed to be two different brands.</p> <p>Home Building Act (NSW) 1989</p> <ul style="list-style-type: none"> Part 2C, 18B (a) and (c). <p>Loss Suffered</p> <p>Loss suffered is cost of rectification.</p>	Engage a licenced tradesperson to remove fire door and install a suitable fire door to match existing door frame as advised by fire engineer.

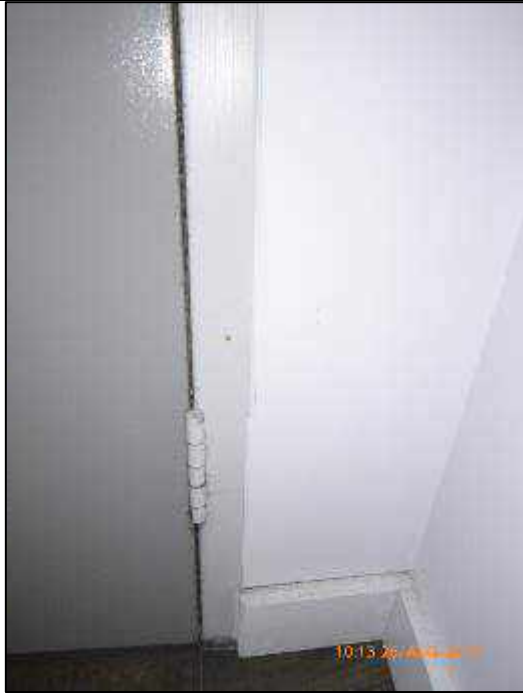
Item	Location	Defect description and Breach	Rectification	Photograph (if applicable)
695	Wall adjacent to front entry door	See section 5.13.1	See section 5.13.2

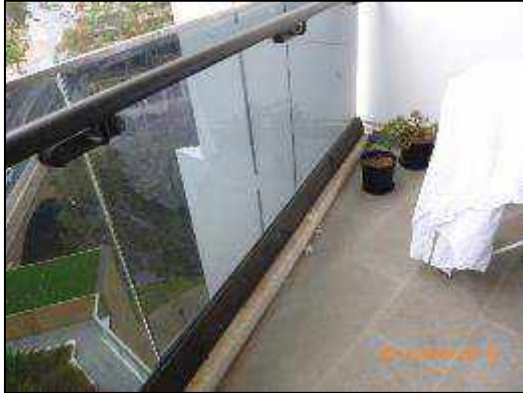
696	Balcony	See section 5.3.1	See section 5.3.2

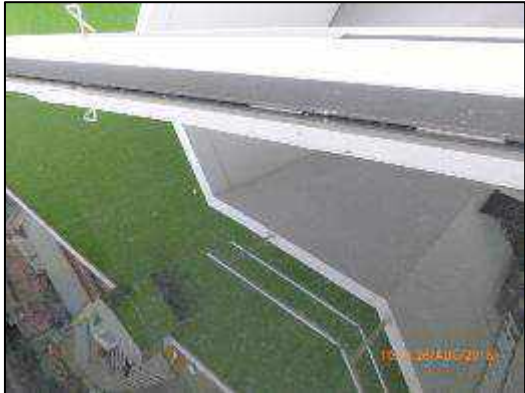
Item	Location	Defect description and Breach	Rectification	Photograph (if applicable)
697	Balcony balustrade	See section 5.9.1	See section 5.9.2

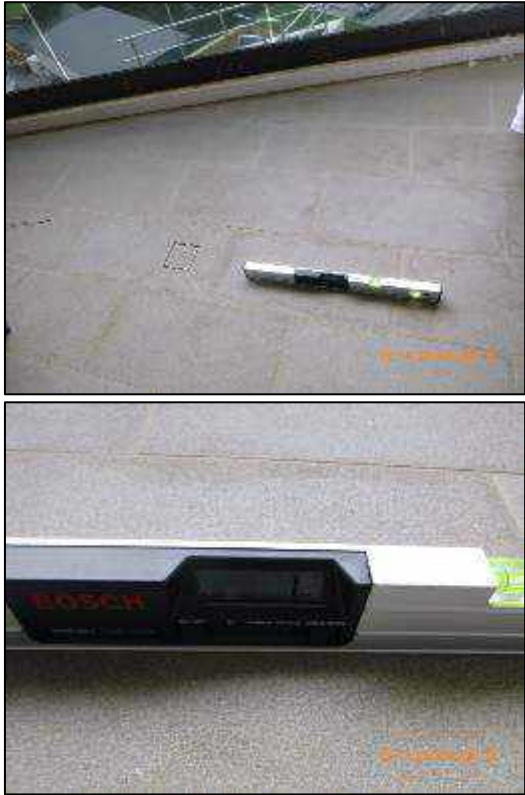
Item	Location	Defect description and Breach	Rectification	Photograph (if applicable)
698	Balcony	See section 5.2.1 Falls (mm); 1/1000	See section 5.2.2

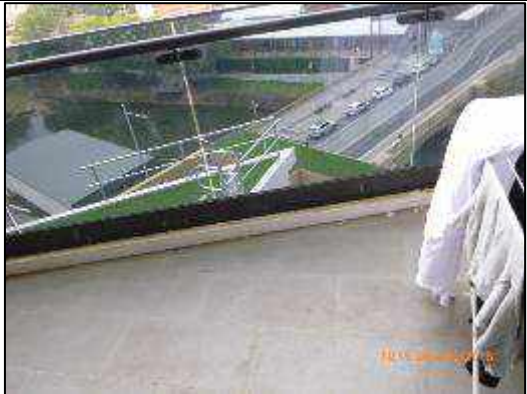
Item	Location	Defect description and Breach	Rectification	Photograph (if applicable)
699	Balcony	See section 5.4.1	See section 5.4.2

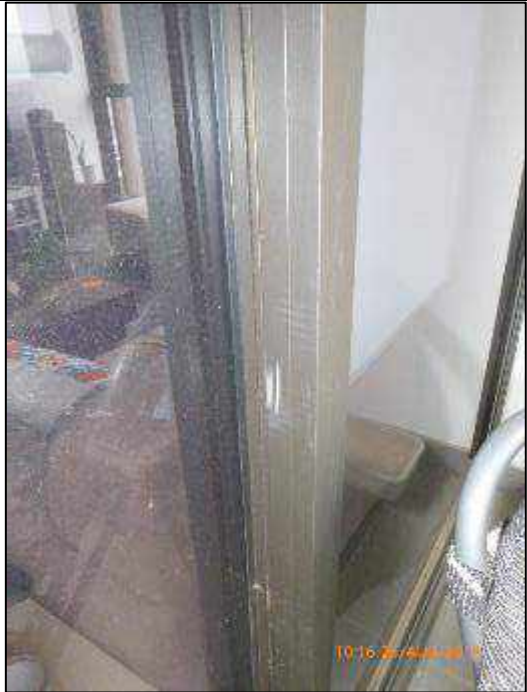
700	Balcony sliding door frame	See section 5.7.1	See section 5.7.2

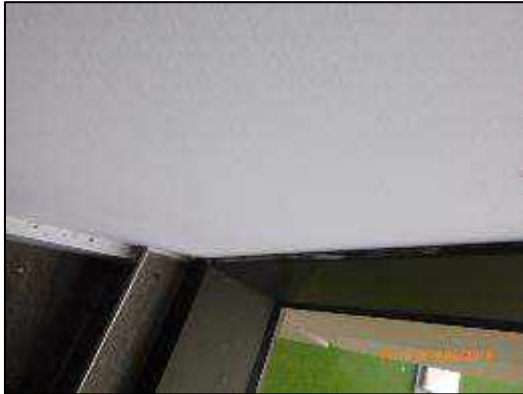
Item	Location	Defect description and Breach	Rectification	Photograph (if applicable)
701	Lounge room window frames	See section 5.9.1	See section 5.9.2

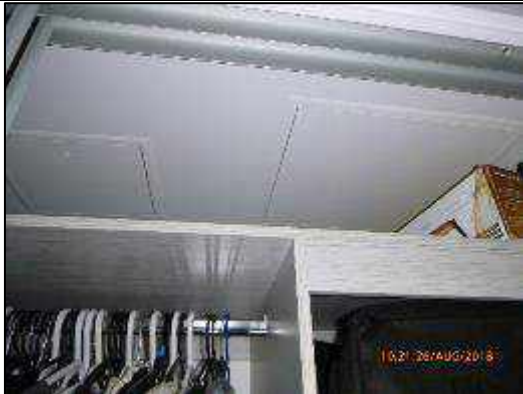
Item	Location	Defect description and Breach	Rectification	Photograph (if applicable)
705	Main bedroom built in	See section 5.6.1	See section 5.6.2

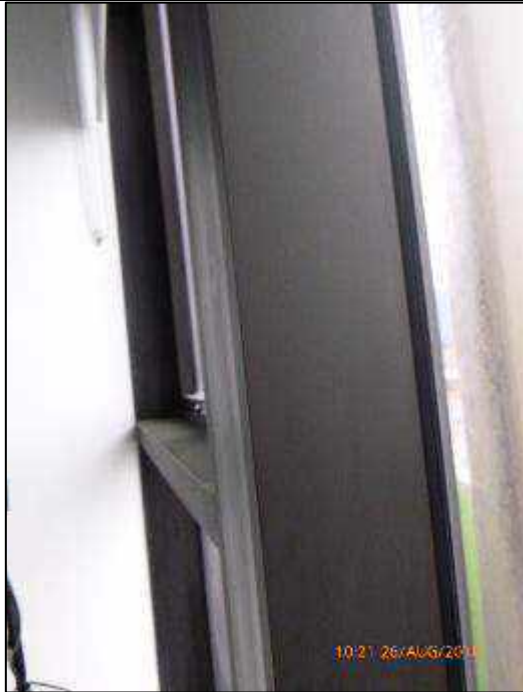
706	Main bedroom window frames	See section 5.7.1	See section 5.7.2

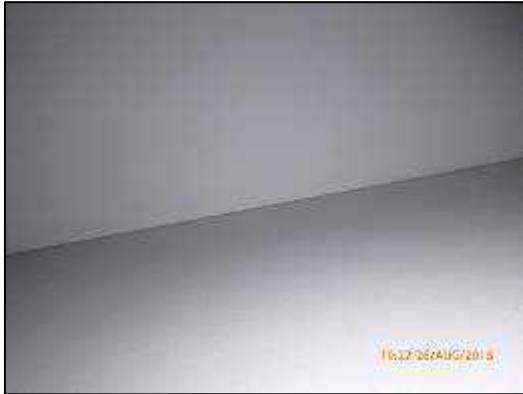
Item	Location	Defect description and Breach	Rectification	Photograph (if applicable)
707	Main bedroom	See section 5.11.1	See section 5.11.2

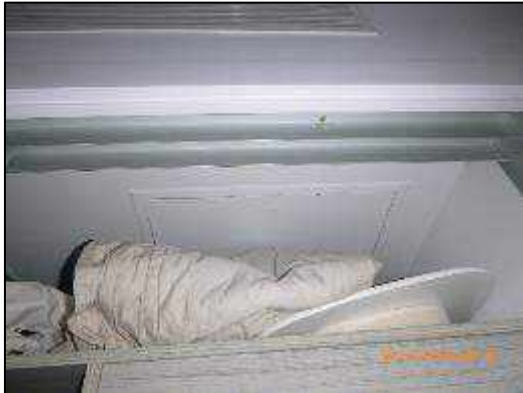
708	Second bedroom built in	See section 5.6.1	See section 5.6.2

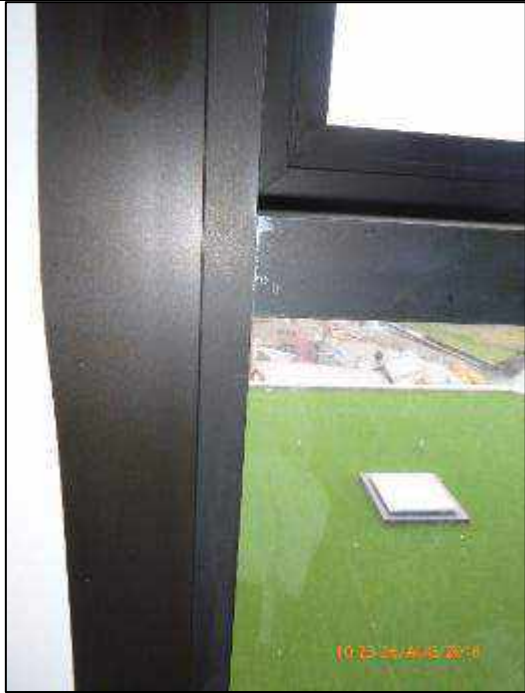
Item	Location	Defect description and Breach	Rectification	Photograph (if applicable)
709	Second bedroom window frames	See section 5.8.1	See section 5.8.2

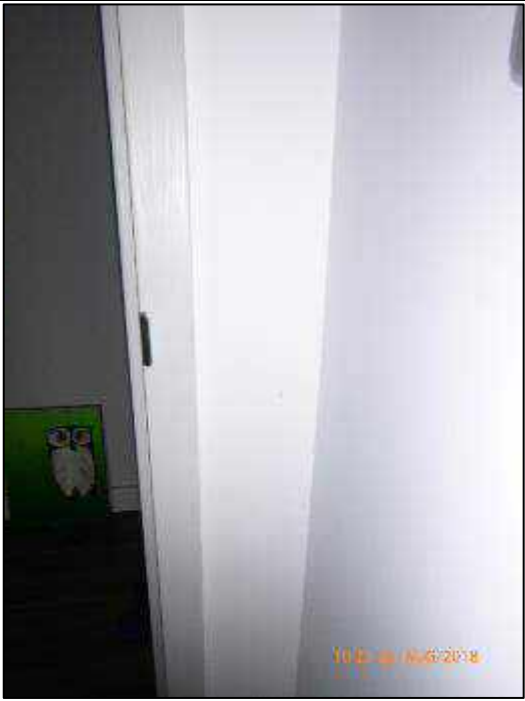
Item	Location	Defect description and Breach	Rectification	Photograph (if applicable)
710	Wall adjacent to second bedroom door frame	See section 5.13.1	See section 5.13.2

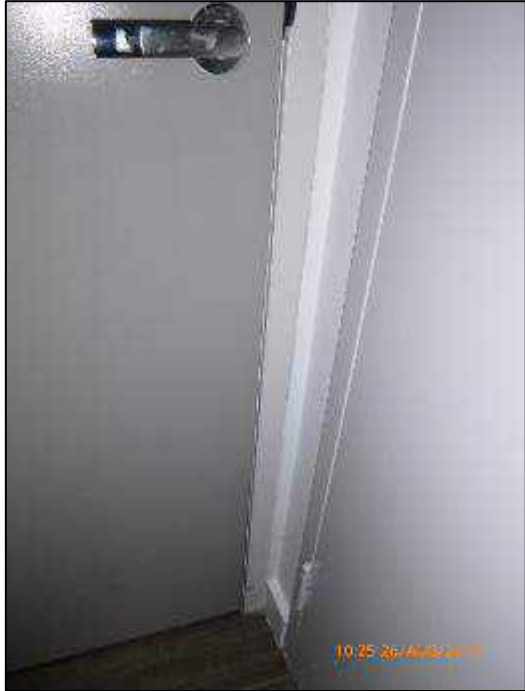
Item	Location	Defect description and Breach	Rectification	Photograph (if applicable)
Unit 702				
711	Wall adjacent to front entry door	See section 5.13.1	See section 5.13.2

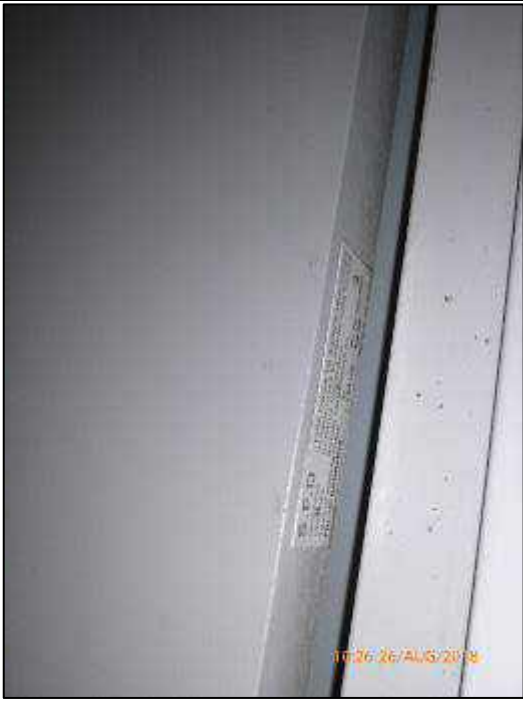
Item	Location	Defect description and Breach	Rectification	Photograph (if applicable)
712	Front entry door	See section 5.12.1	See section 5.12.2

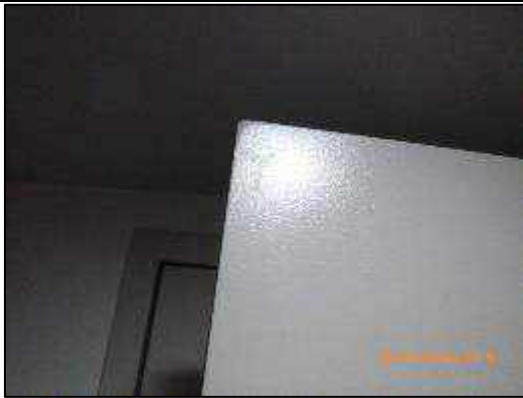
A photograph showing a close-up of a door frame. A small, rectangular label is affixed to the frame. The label contains text that is partially legible, including '10/26/26/AL/S/2018'. The background is a plain, light-colored wall.
713	Front entry door	See section 5.10.1	See section 5.10.2

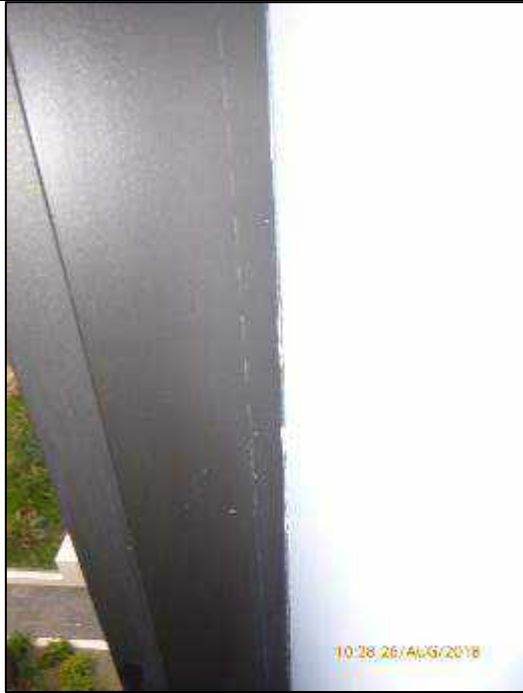
Item	Location	Defect description and Breach	Rectification	Photograph (if applicable)
716	Second bedroom window frames	See section 5.9.1	See section 5.9.2

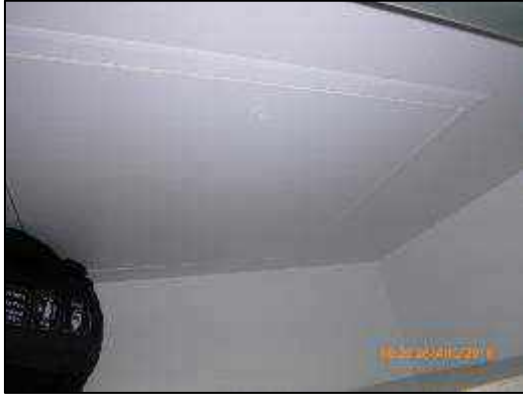
717	Second bedroom built in	See section 5.6.1	See section 5.6.2

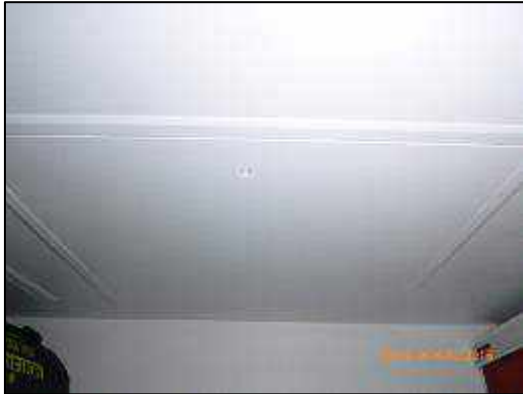
Item	Location	Defect description and Breach	Rectification	Photograph (if applicable)
718	Main bedroom built in	See section 5.6.1	See section 5.6.2

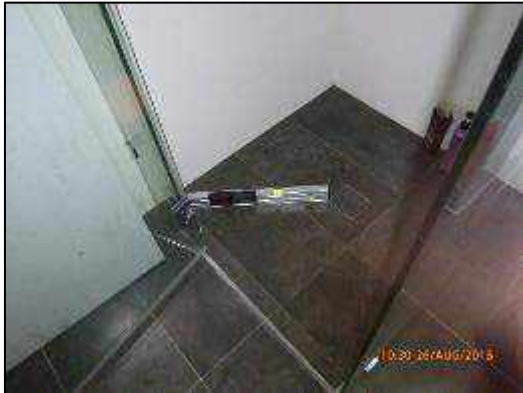
719	Main bedroom ensuite	See section 5.1.1 Falls (mm); 5/1000	See section 5.1.2

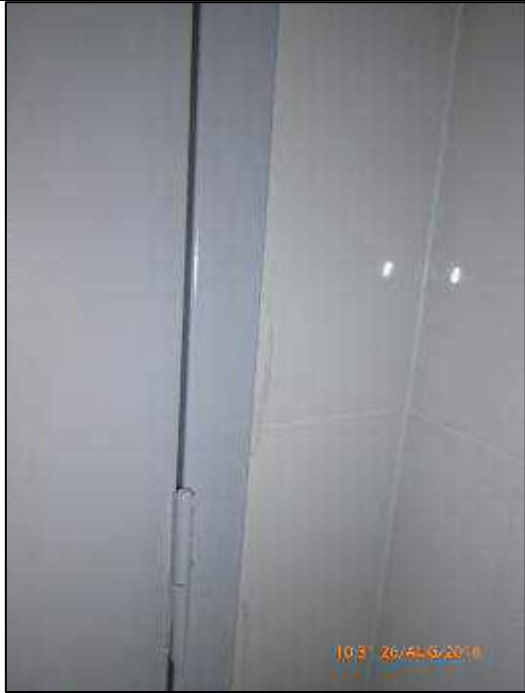
Item	Location	Defect description and Breach	Rectification	Photograph (if applicable)
720	Main bedroom ensuite door frame	See section 5.9.1	See section 5.9.2

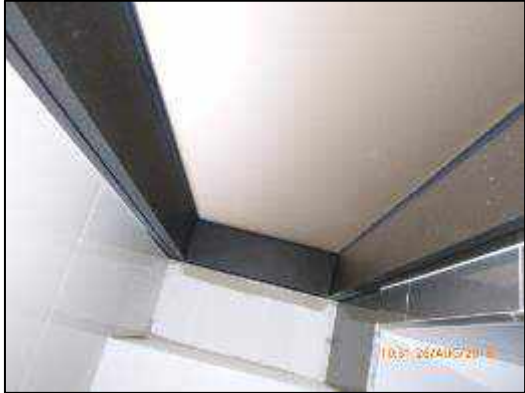
<p>A photograph showing a close-up of a dark-colored door frame. The frame appears to be made of wood or a similar material. There is a visible gap or defect in the frame, possibly related to the hinge area. The background is a light-colored wall. A timestamp '10:31 26/AUG/2018' is visible in the bottom right corner of the photo.</p>
721	Main bedroom ensuite window frames	See section 5.8.1	See section 5.8.2

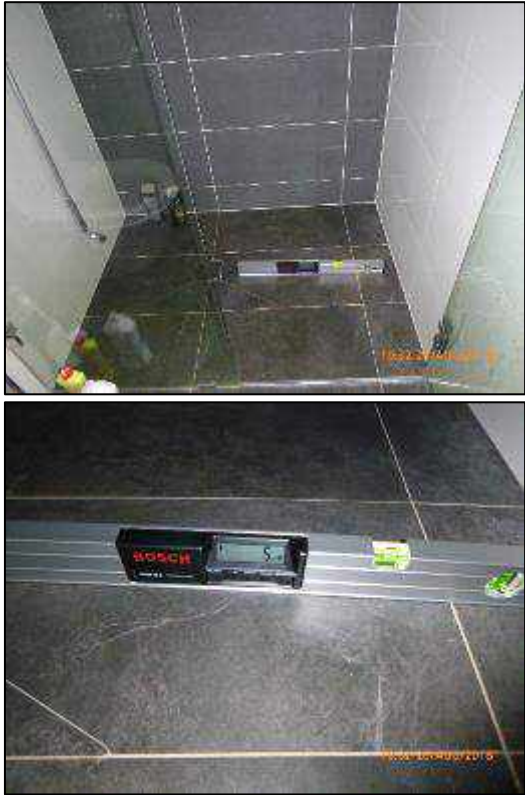
Item	Location	Defect description and Breach	Rectification	Photograph (if applicable)
722	Main bathroom	See section 5.1.1 Falls (mm); 5/1000	See section 5.1.2

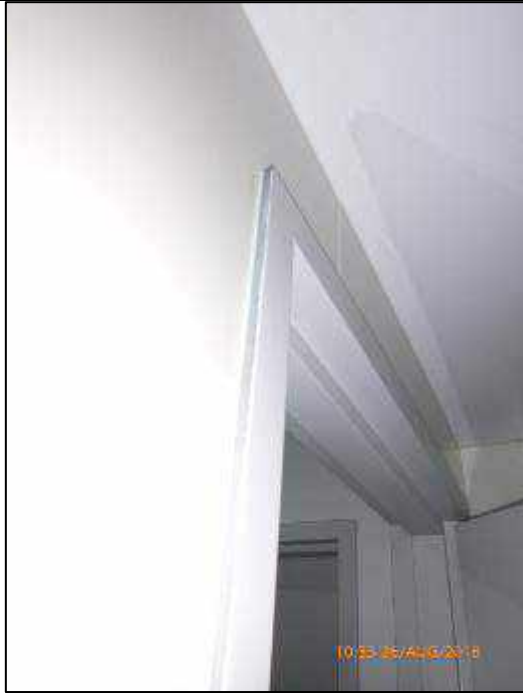
Item	Location	Defect description and Breach	Rectification	Photograph (if applicable)
723	Main bathroom door frame	See section 5.10.1	See section 5.10.2

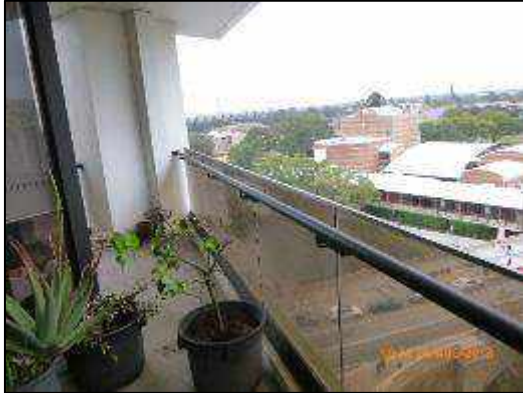
724	Balcony	See section 5.3.1	See section 5.3.2

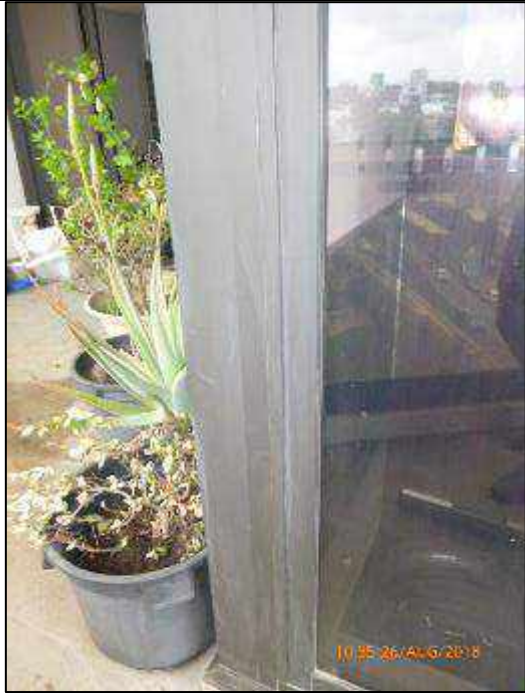
Item	Location	Defect description and Breach	Rectification	Photograph (if applicable)
725	Balcony window frames	See section 5.7.1	See section 5.7.2

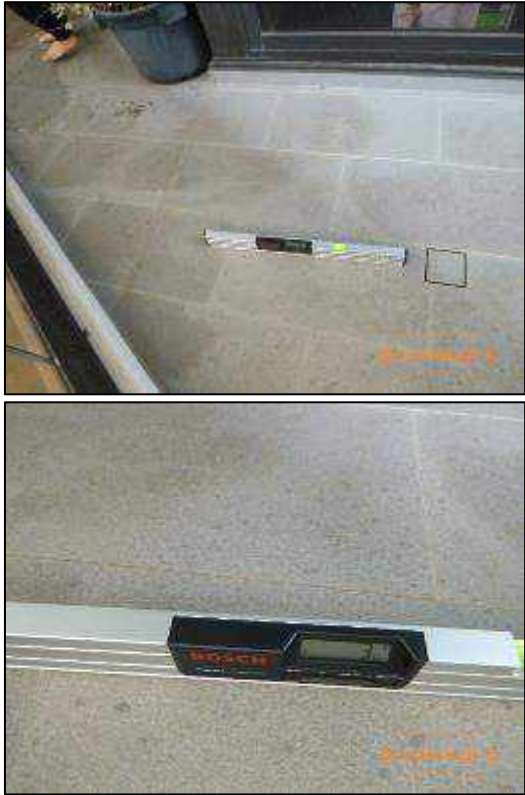
Item	Location	Defect description and Breach	Rectification	Photograph (if applicable)
728	Balcony	See section 5.2.1 Falls (mm); 3/1000	See section 5.2.2

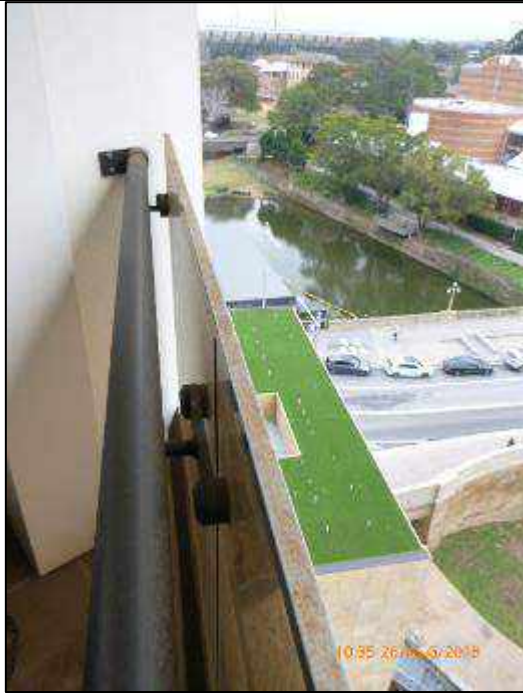
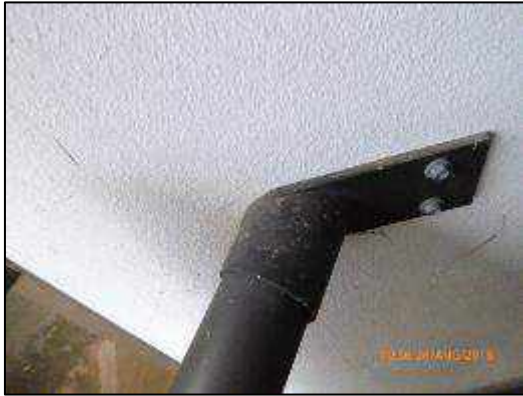
Item	Location	Defect description and Breach	Rectification	Photograph (if applicable)
729	Balcony balustrade	<p>Excessive movement observed in balustrade.</p> <p>Home Building Act (NSW) 1989</p> <ul style="list-style-type: none"> Part 2C, 18B (a) and (c). <p>AS/NZS 1170.1 – Structural Design Actions- The current arrangement of the balustrade does not comply with AS1107.1</p> <p>Loss Suffered Loss suffered is cost of rectification.</p>	Appropriately fix the balustrade in accordance with AS1107.1

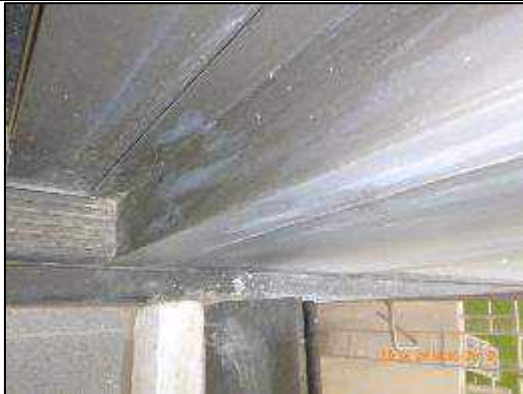
Item	Location	Defect description and Breach	Rectification	Photograph (if applicable)
730	Balcony window frames	See section 5.8.1	See section 5.8.2

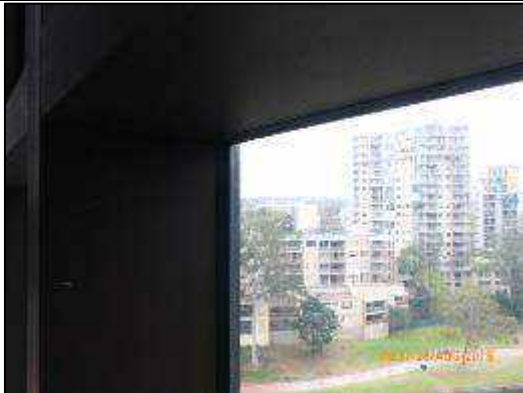
731	Lounge room window frames	<p>Lounge room windows observed to lack adequate sealant.</p> <p>Home Building Act (NSW) 1989</p> <ul style="list-style-type: none"> Part 2C, 18B (a) & (c). <p>Guide to Standards and Tolerances 2017</p> <ul style="list-style-type: none"> Section 9.2 Weather-tightness of windows <p>This is a defect because the window has not been sealed in accordance with the BCA as outlined in Section 9.2 of the Guide to Standards and Tolerances 2017.</p> <p>Loss Suffered Loss suffered is cost of rectification.</p>	<ol style="list-style-type: none"> 1. Protect all adjoining surfaces surrounding the work area. 2. Remove glass panel from window frame and re-install using a suitable sealant application. 3. Clean up the work area.

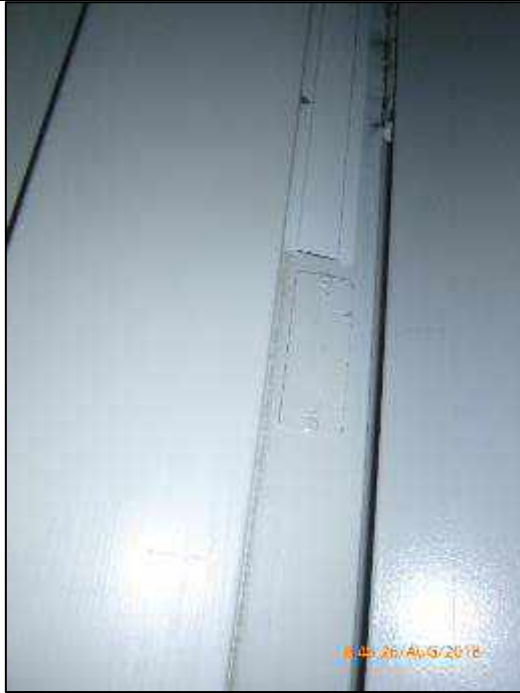
Item	Location	Defect description and Breach	Rectification	Photograph (if applicable)
Unit 703				
732	Front entry door frame	<p>Door frame label has been painted over.</p> <p>Home Building Act (NSW) 1989</p> <ul style="list-style-type: none"> Part 2C, 18B (a) & (c). <p>Loss Suffered</p> <p>Loss suffered is cost of rectification.</p>	Use a suitable cleaning agent to remove paint from the door frame label.

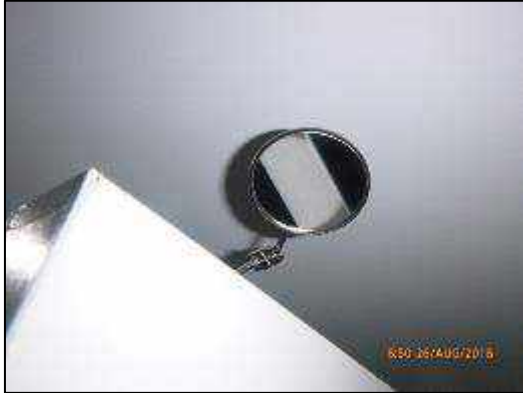
Item	Location	Defect description and Breach	Rectification	Photograph (if applicable)
733	Wall adjacent to front entry door	See section 5.13.1	See section 5.13.2	 
734	Doors throughout the unit (x2)	See section 5.5.1	See section 5.5.2

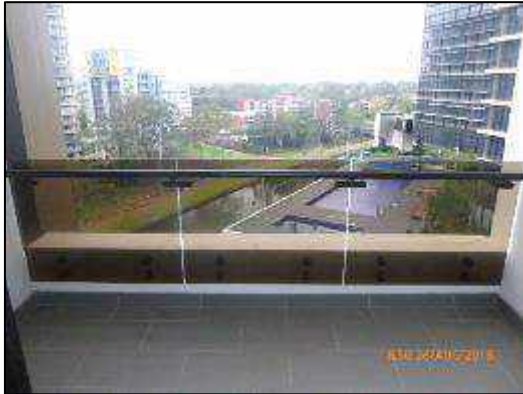
Item	Location	Defect description and Breach	Rectification	Photograph (if applicable)
735	Balcony	See section 5.3.1	See section 5.3.2

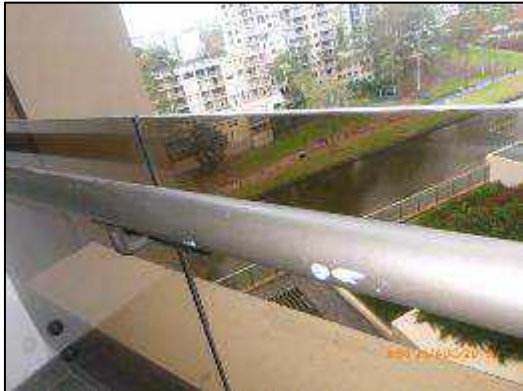
736	Balcony	See section 5.4.1	See section 5.4.2
