SydneyStrataReport

STRATA REPORT

Client	Church Street Parramatta Property Pty Ltd
Address of property	Unit 3303/330 Church Street, Parramatta, NSW.
Lot	359
Strata Plan	SP 94469
Name of Strata Management Co.	NSW Strata
Telephone Number of Strata Agent	8980 1841
Report Date	15 February 2024

BUILDING DEFECTS REPORT Part 1/2

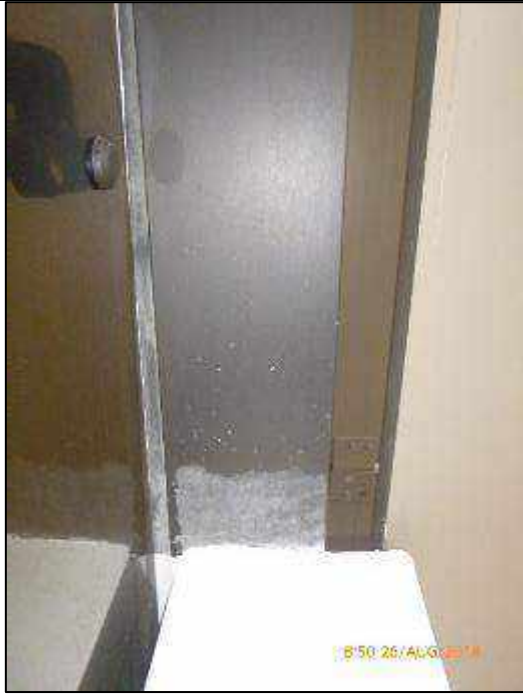
Item	Location	Defect description and Breach	Rectification	Photograph (if applicable)
737	Balcony external fins	See section 5.7.1	See section 5.7.2

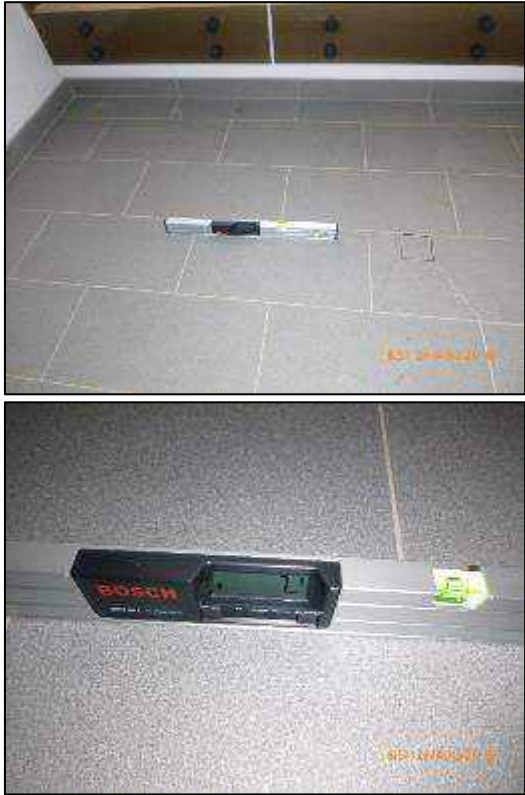
Item	Location	Defect description and Breach	Rectification	Photograph (if applicable)
738	Balcony	See section 5.2.1 Falls (mm); 7/1000	See section 5.2.2

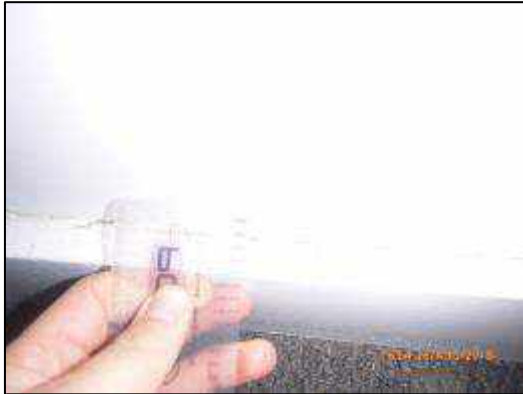
Item	Location	Defect description and Breach	Rectification	Photograph (if applicable)
741	Main bedroom skirting board	See section 5.14.1 Separation; 2mm	See section 5.14.2

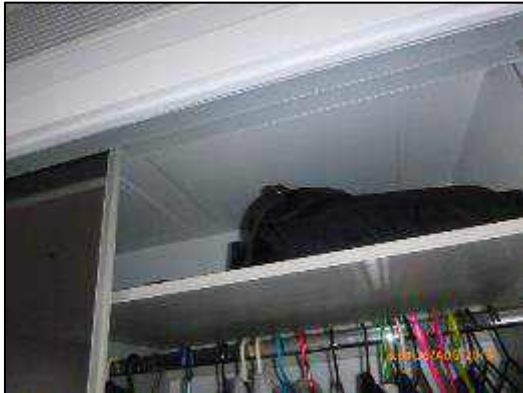
742	Main bedroom built in	See section 5.6.1	See section 5.6.1

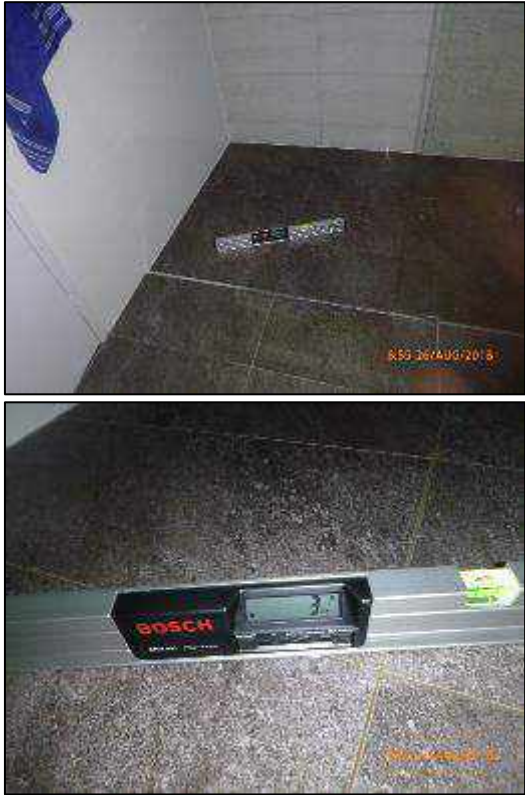
Item	Location	Defect description and Breach	Rectification	Photograph (if applicable)
743	Main bedroom ensuite	See section 5.1.1 Falls (mm); 3/1000	See section 5.1.1

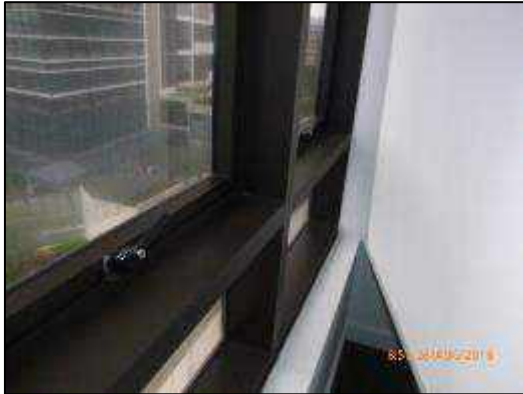
Item	Location	Defect description and Breach	Rectification	Photograph (if applicable)
744	Main bedroom window frames	See section 5.7.1	See section 5.7.1

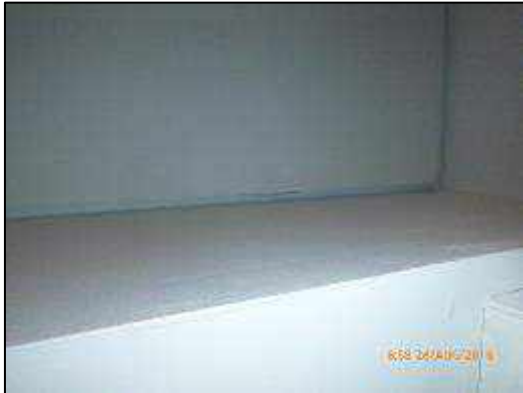
745	Main bedroom	See section 5.11.1	See section 5.11.1

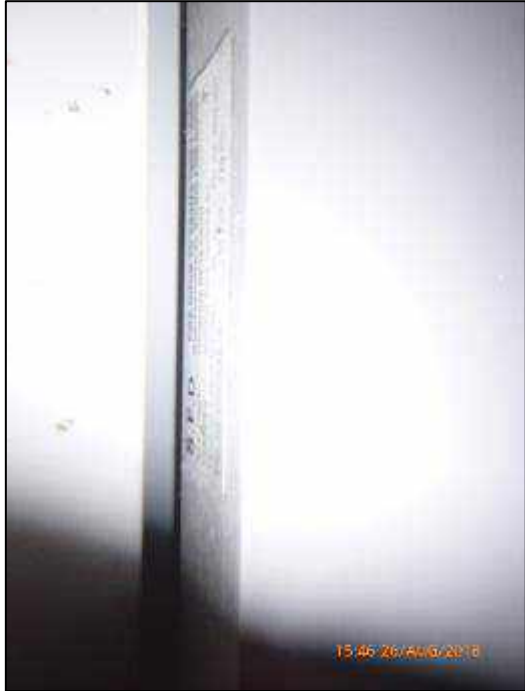
Item	Location	Defect description and Breach	Rectification	Photograph (if applicable)
Unit 705				
748	Front entry door	See section 5.12.1	See section 5.12.2

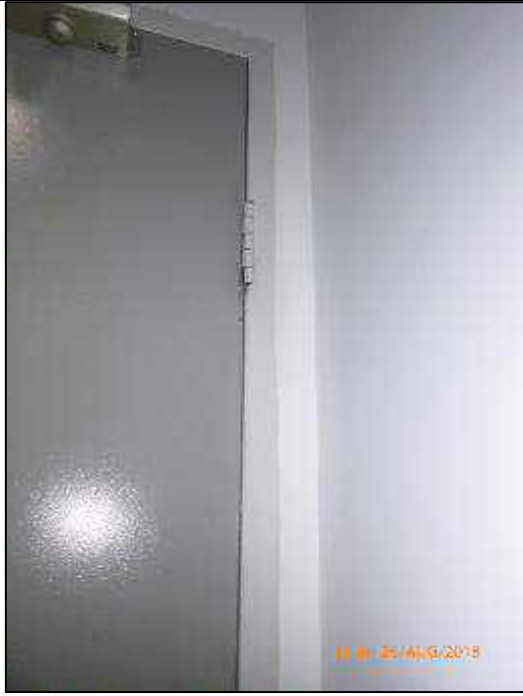
Item	Location	Defect description and Breach	Rectification	Photograph (if applicable)
749	Wall adjacent to front entry door	See section 5.13.1	See section 5.13.2

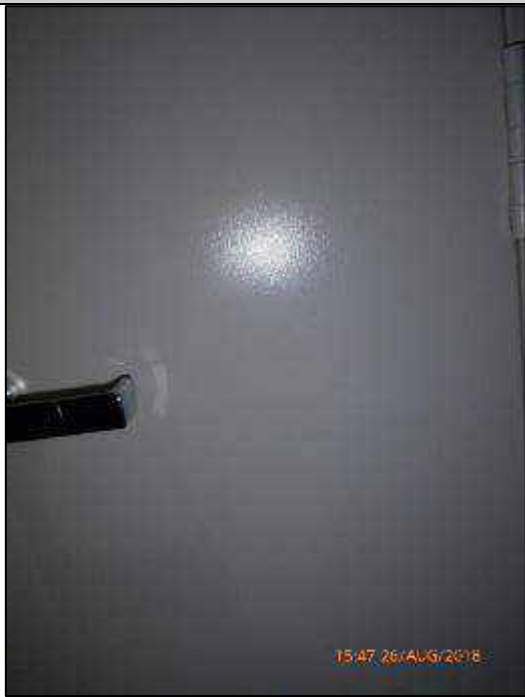
Item	Location	Defect description and Breach	Rectification	Photograph (if applicable)
750	Front entry door	See section 5.10.1	See section 5.10.2

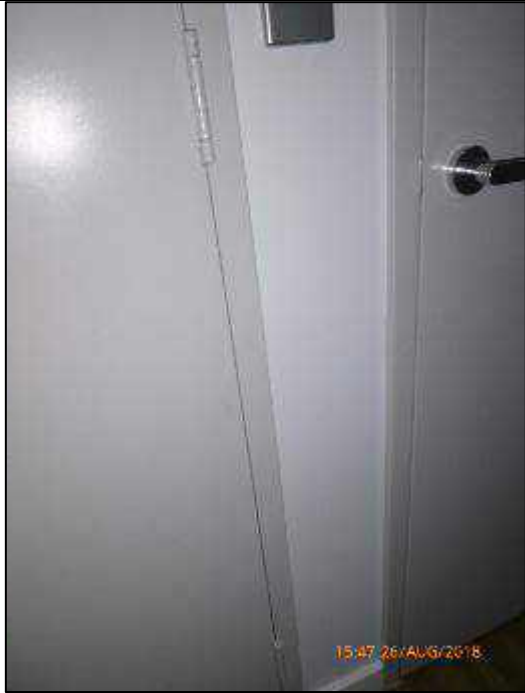
Item	Location	Defect description and Breach	Rectification	Photograph (if applicable)
751	Wall adjacent to front entry door	See section 5.13.1	See section 5.13.2

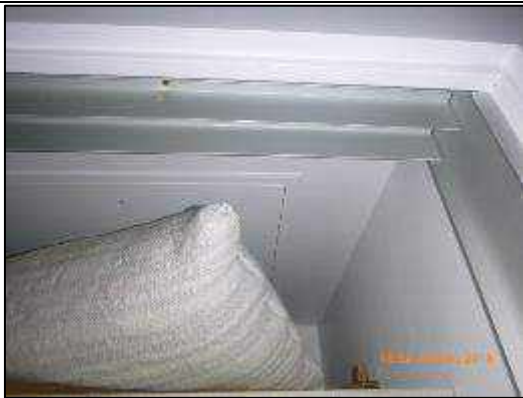
Item	Location	Defect description and Breach	Rectification	Photograph (if applicable)
752	Front entry door frame	See section 5.9.1	See section 5.9.2	 
753	Second bedroom built in	See section 5.6.1	See section 5.6.2

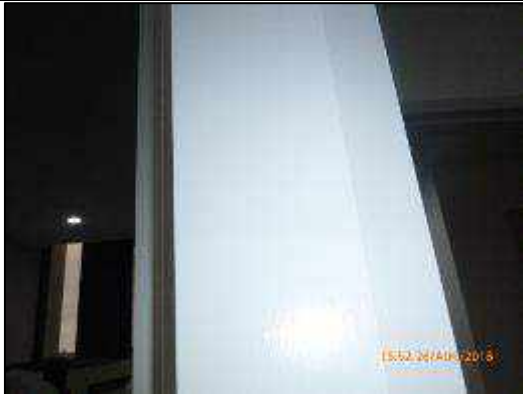
Item	Location	Defect description and Breach	Rectification	Photograph (if applicable)
754	Wall adjacent to linen cupboard.	See section 5.10.1	See section 5.10.2

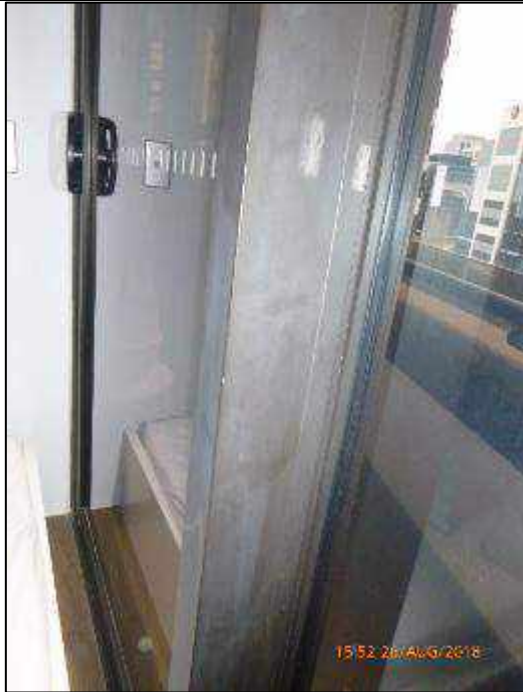
A photograph showing a close-up of a light-colored wall. There is a dark, irregular mark or stain on the wall, which is the defect being documented. A timestamp '15/02/20/AUG/2018' is visible in the bottom right corner of the photo.
755	Balcony sliding door frame	See section 5.7.1	See section 5.7.2

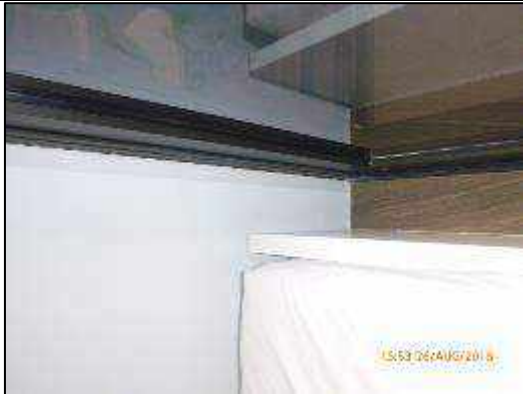
Item	Location	Defect description and Breach	Rectification	Photograph (if applicable)
756	Lounge room sliding door frame	See section 5.8.1	See section 5.8.2

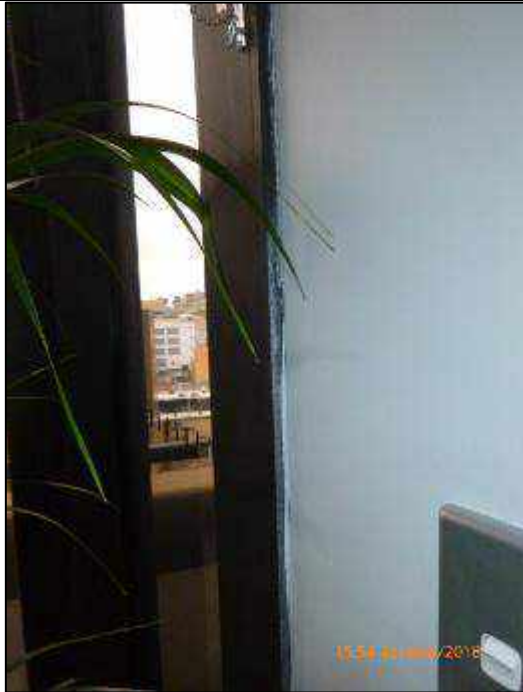
757	Lounge room window frames	See section 5.9.1	See section 5.9.2

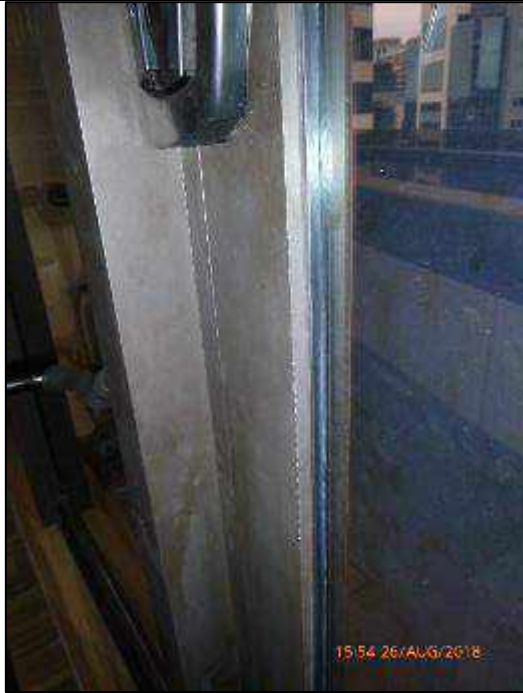
Item	Location	Defect description and Breach	Rectification	Photograph (if applicable)
758	Lounge room sliding door frame	See section 5.7.1	See section 5.7.2

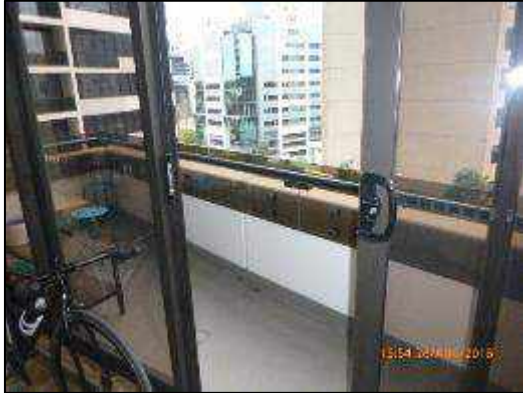
759	Balcony	See section 5.3.1	See section 5.3.2

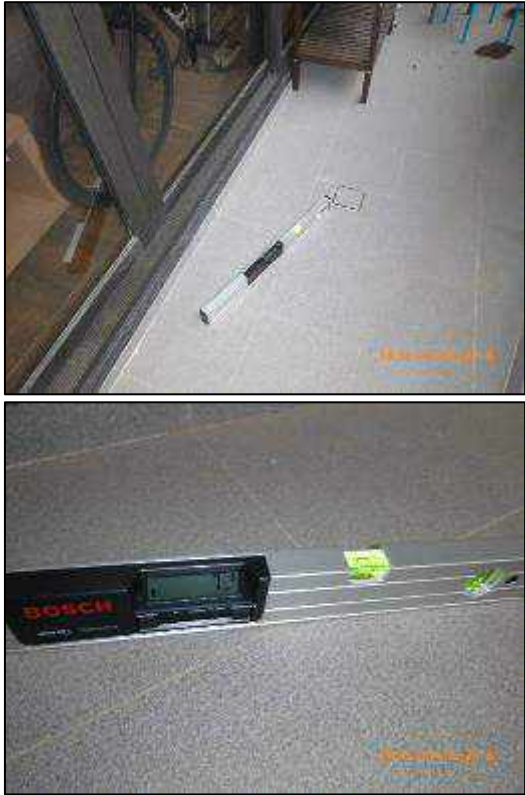
Item	Location	Defect description and Breach	Rectification	Photograph (if applicable)
760	Balcony	See section 5.2.1 Falls (mm); 7/1000	See section 5.2.2

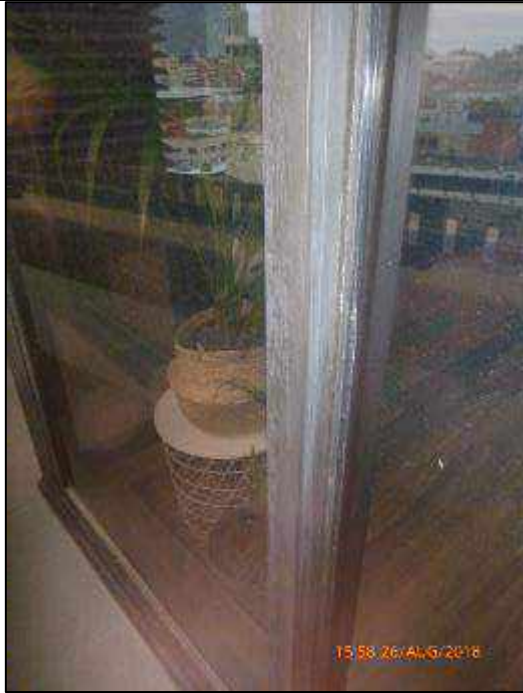
Item	Location	Defect description and Breach	Rectification	Photograph (if applicable)
761	Balcony sliding door frame	See section 5.7.1	See section 5.7.2

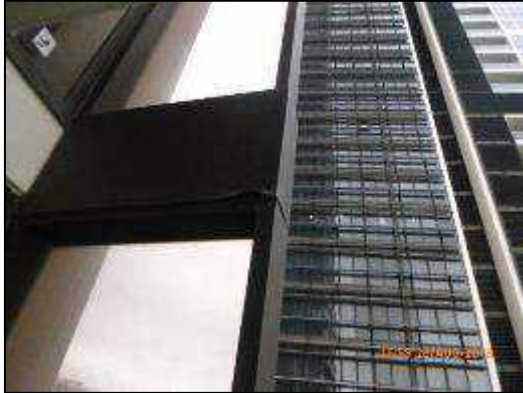
762	Western elevation façade of building from balcony	See section 5.8.1	See section 5.8.2

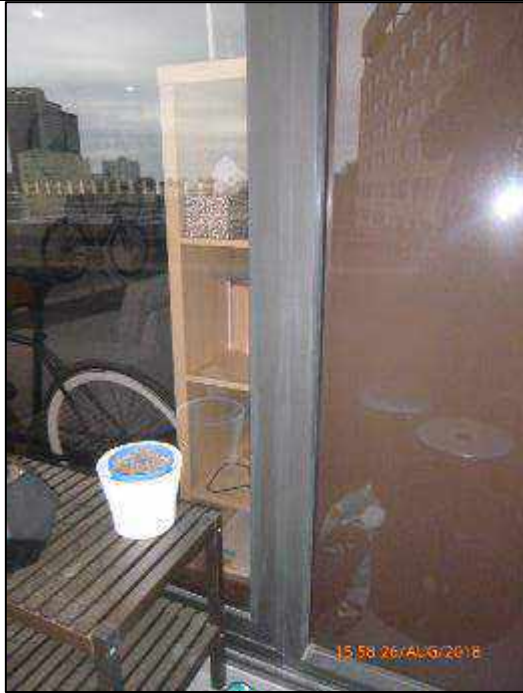
Item	Location	Defect description and Breach	Rectification	Photograph (if applicable)
763	Balcony sliding door frames	See section 5.7.1	See section 5.7.2

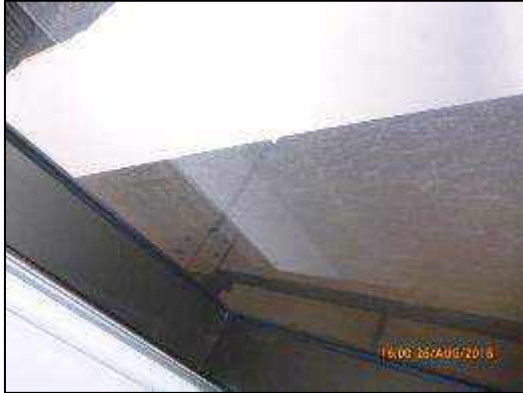
<p>15:58:26/AUG/2018</p>
764	Lounge room window frames	See section 5.8.1	See section 5.8.2

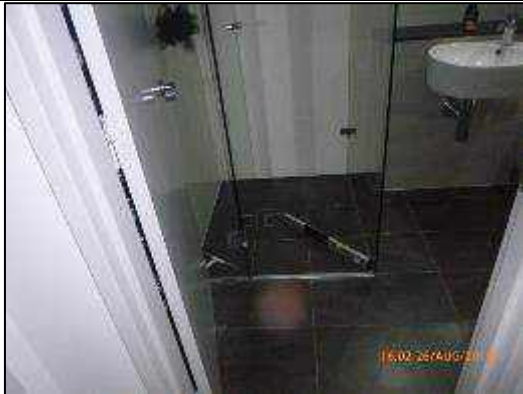
Item	Location	Defect description and Breach	Rectification	Photograph (if applicable)
765	Main bedroom ensuite	See section 5.1.1 Falls (mm); 5/1000	See section 5.1.2

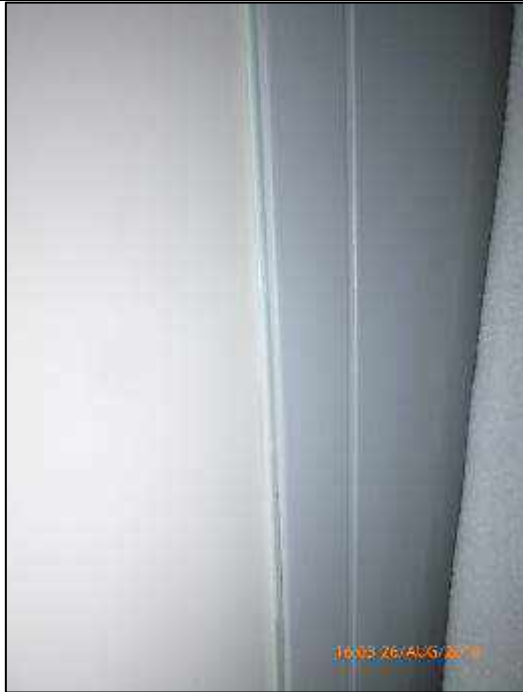
766	Main bedroom ensuite door frame	See section 5.10.1	See section 5.10.2

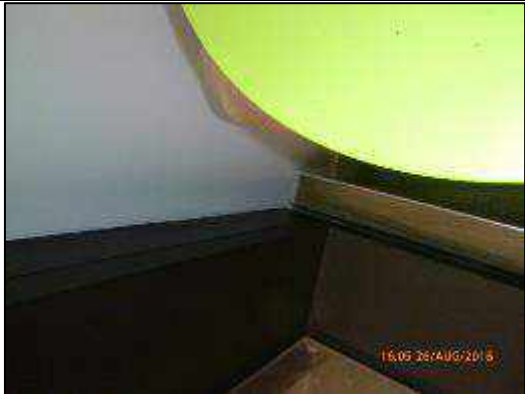
Item	Location	Defect description and Breach	Rectification	Photograph (if applicable)
767	Main bedroom window frames	See section 5.8.1	See section 5.8.2

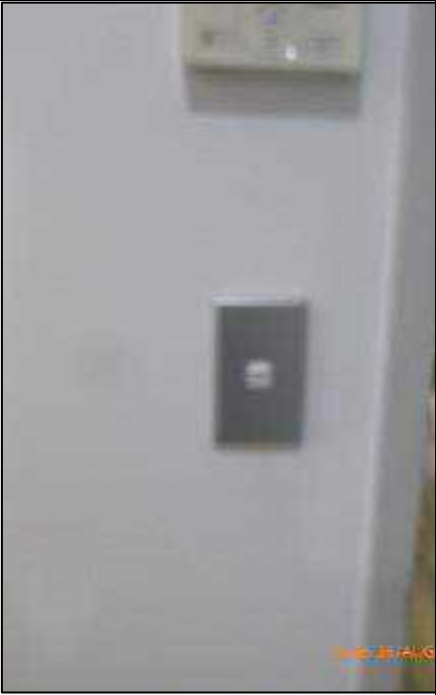
A photograph showing a close-up of a window frame in a room. The frame is dark, and the glass is partially visible. A date stamp '15.05.26/AUG/2018' is visible in the bottom right corner of the image.
768	Main bedroom wall adjacent to door	See section 5.10.1	See section 5.10.2

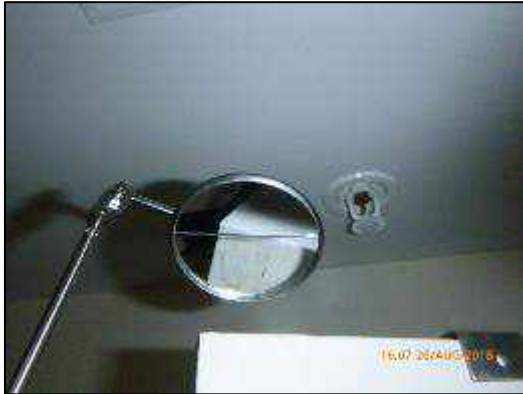
Item	Location	Defect description and Breach	Rectification	Photograph (if applicable)
769	Doors throughout the unit (x3)	See section 5.5.1	See section 5.5.2

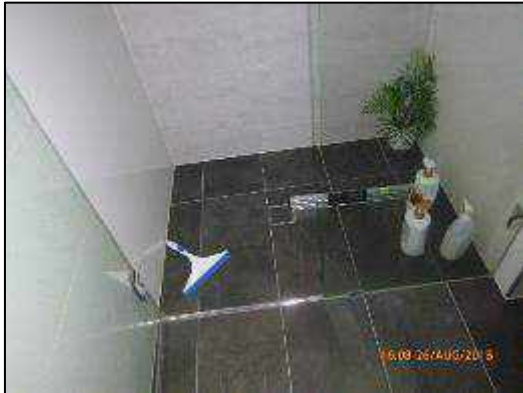
770	Main bathroom	See section 5.1.1 Falls (mm); 6/1000	See section 5.1.2

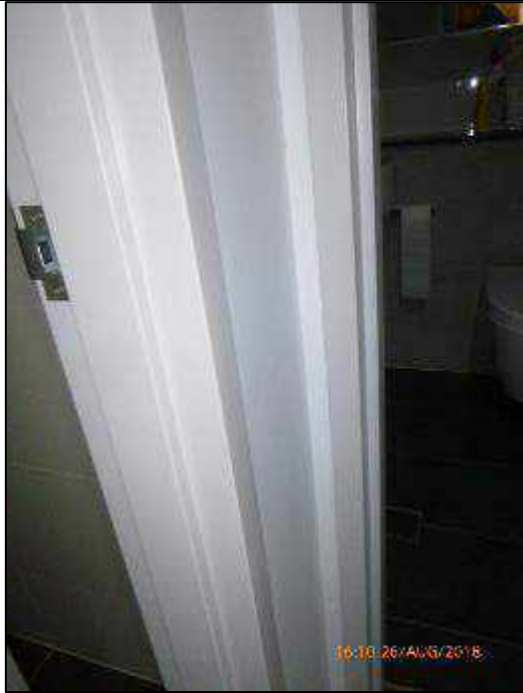
Item	Location	Defect description and Breach	Rectification	Photograph (if applicable)
771	Main bathroom door frame	See section 5.10.1	See section 5.10.2

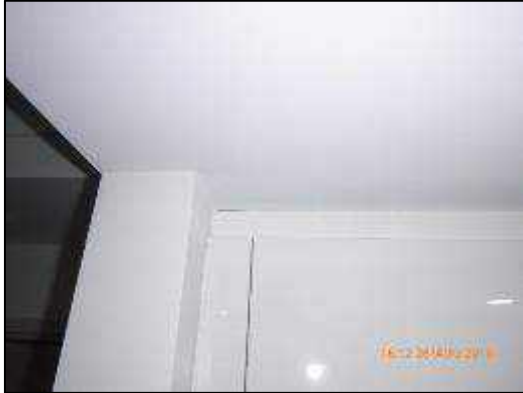
772	Main bathroom above storage cupboard.	See section 5.14.1 Separation; 1mm	See section 5.14.2

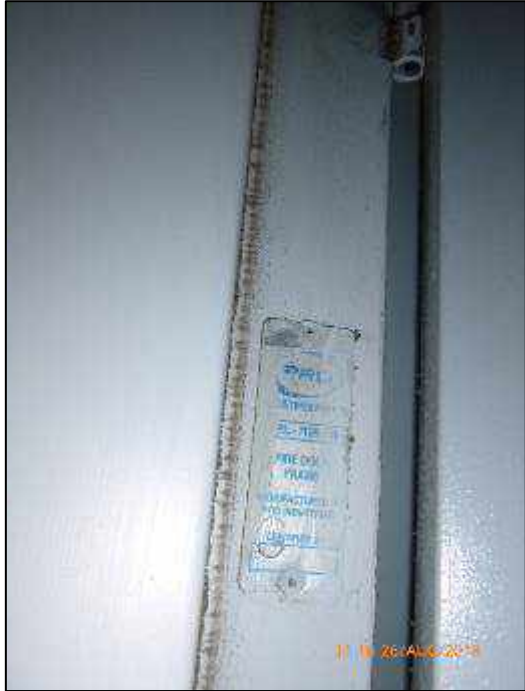
Item	Location	Defect description and Breach	Rectification	Photograph (if applicable)
Unit 706				
773	Front entry door	<p>Fire door and frame observed to be two different brands.</p> <p>Home Building Act (NSW) 1989</p> <ul style="list-style-type: none"> Part 2C, 18B (a) and (c). <p>Loss Suffered</p> <p>Loss suffered is cost of rectification.</p>	Engage a licenced tradesperson to remove fire door and install a suitable fire door to match existing door frame as advised by fire engineer.

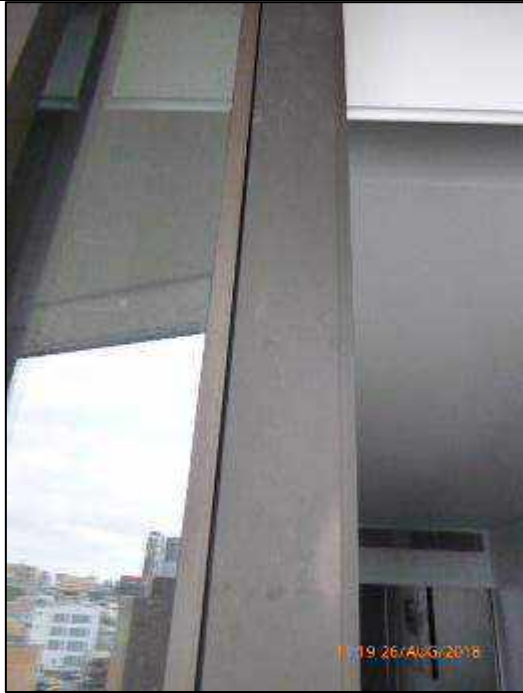
Item	Location	Defect description and Breach	Rectification	Photograph (if applicable)
774	Balcony	See section 5.7.1	See section 5.7.2

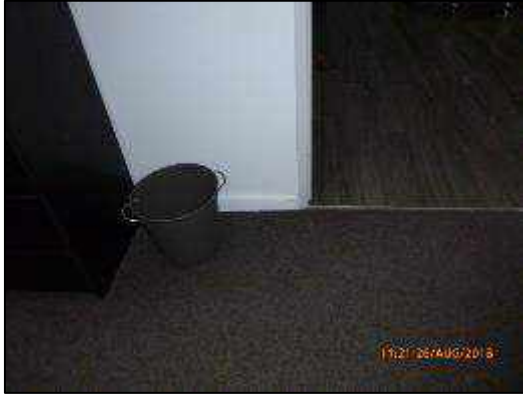
775	Lounge room skirting board on western wall	See section 5.10.1	See section 5.10.2

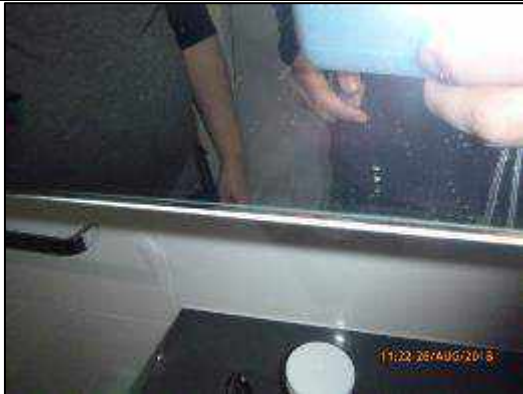
Item	Location	Defect description and Breach	Rectification	Photograph (if applicable)
776	Main bedroom ensuite	<p>Chip observed in the internal glass cabinet of the ensuite.</p> <p>Home Building Act (NSW) 1989</p> <ul style="list-style-type: none"> Part 2C, 18B (a) and (c). <p>Guide to Standards and Tolerances 2017</p> <p>Section 12.5 Cracked, pitted, chipped, scratched, loose or drummy tiles.</p> <p>Loss Suffered</p> <p>Loss suffered is cost of rectification and appearance.</p>	<ol style="list-style-type: none"> 1. Remove existing glass cabinet and source a new glass panel to match existing. 2. Install new glass panel to fit in accordance with manufacturers specifications. 3. Clean up the work area.

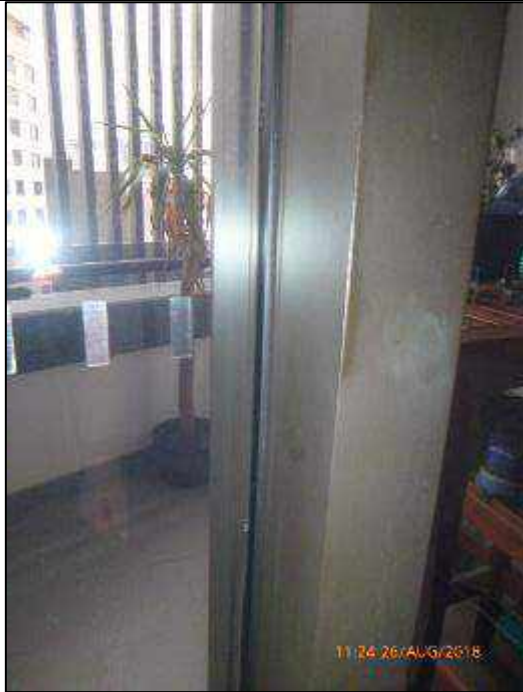
777	Lounge room sliding door	See section 5.7.1	See section 5.7.2

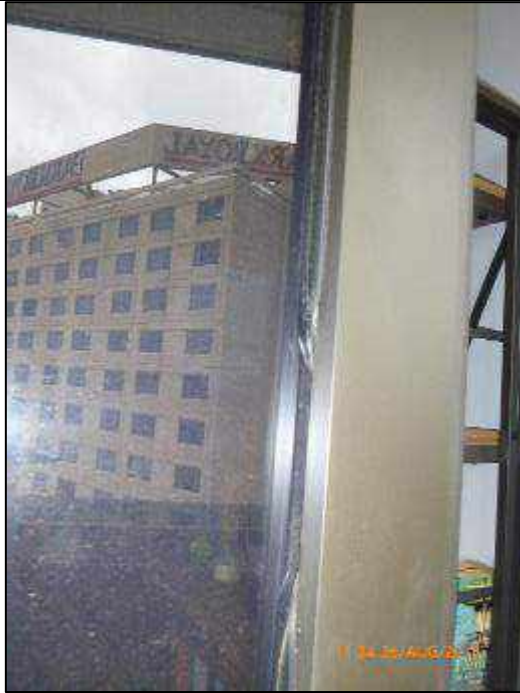
Item	Location	Defect description and Breach	Rectification	Photograph (if applicable)
778	Lounge room sliding door	<p>Rubber seal around the glass of sliding door observed to be incorrectly installed.</p> <p>Home Building Act (NSW) 1989</p> <ul style="list-style-type: none"> Part 2C, 18B (a) & (c). <p>Guide to Standards and Tolerances 2017</p> <ul style="list-style-type: none"> Section 9.2 Weather-tightness of windows <p>This is a defect because the window has not been sealed in accordance with the BCA as outlined in Section 9.2 of the Guide to Standards and Tolerances 2017.</p> <p>Loss Suffered Loss suffered is cost of rectification.</p>	<ol style="list-style-type: none"> 1. Protect all adjoining surfaces surrounding the work area. 2. Remove glass panel from window frame and re-install using a suitable sealant application. 3. Clean up the work area.

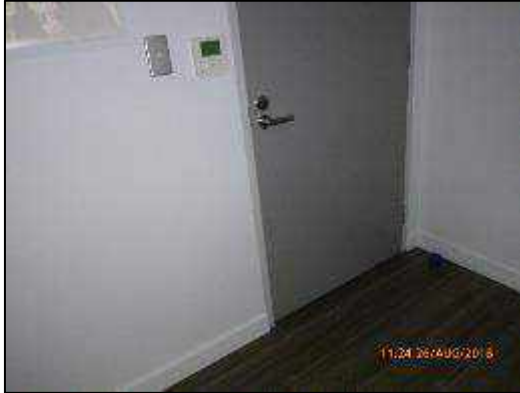
779	Front entry door	<p>Excessive wind noise observed through front door.</p> <p>Home Building Act (NSW) 1989</p> <ul style="list-style-type: none"> Part 2C, 18B (a) & (c). <p>Loss Suffered Loss suffered is cost of rectification.</p>	Engage a licenced tradesman to reseal door to prevent excessive noise to the unit in accordance with manufacturers specifications.

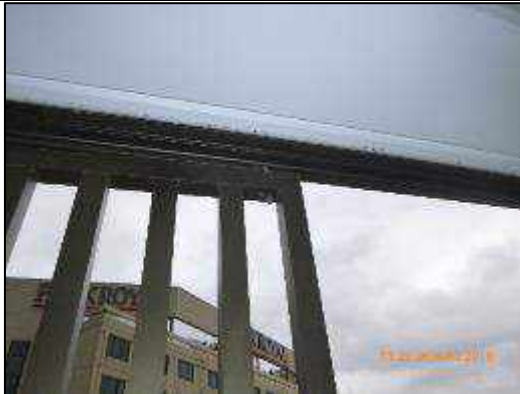
Item	Location	Defect description and Breach	Rectification	Photograph (if applicable)
780	Balcony ceiling	See section 5.8.1	See section 5.8.2

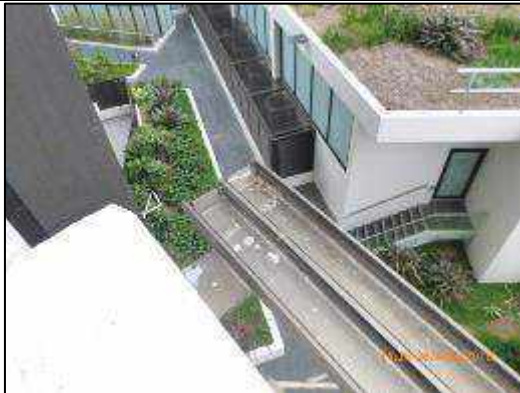
781	Façade adjacent to balcony area.	<p>Construction debris observed on façade of the building.</p> <p>Home Building Act (NSW) 1989</p> <ul style="list-style-type: none"> Part 2C, 18B (a) and (c). <p>This is a breach of part (a) of the act because the surface has not been finished in a proper workmanlike manner that would prevent loss of appearance to the surface.</p> <p>Loss Suffered</p> <p>Loss suffered is cost of rectification.</p>	<ol style="list-style-type: none"> 1. Protect all adjoining surfaces. 2. Use a suitable cleaning agent to remove residue and clear debris. 3. Clean up the work area.

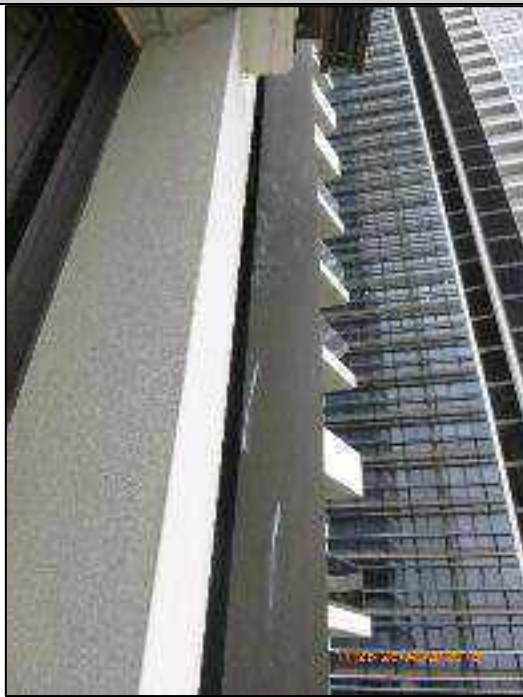
Item	Location	Defect description and Breach	Rectification	Photograph (if applicable)
782	<i>Façade adjacent to balcony area.</i>	See section 5.8.1	See section 5.8.2

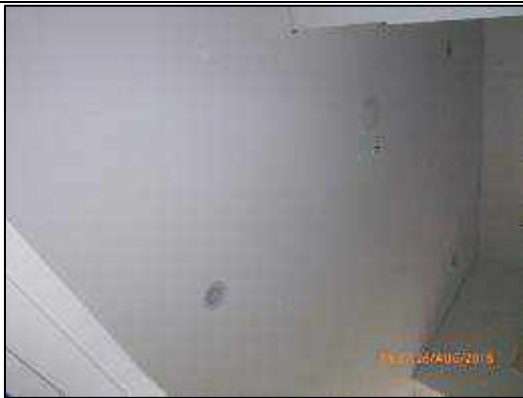
783	<i>Main bedroom</i>	<p>Drainage pipework through ceiling observed to be uninsulated causing excessive noise through bedroom.</p> <p>Home Building Act (NSW) 1989</p> <ul style="list-style-type: none"> Part 2C, 18B (a) and (c). <p>Loss Suffered Loss suffered is cost of rectification.</p>	Engage a licenced tradesman to insulate the pipework in the ceiling space in accordance with manufacturers specifications.

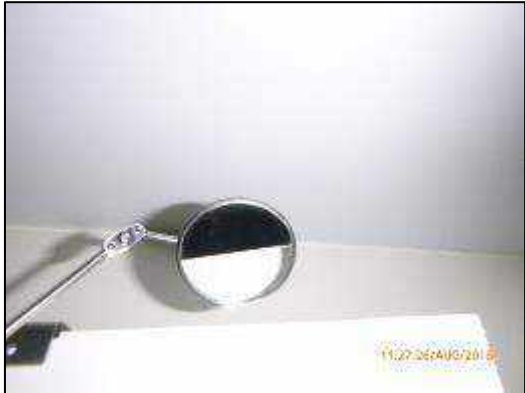
Item	Location	Defect description and Breach	Rectification	Photograph (if applicable)
784	Doors throughout unit (x3)	See section 5.5.1	See section 5.5.2

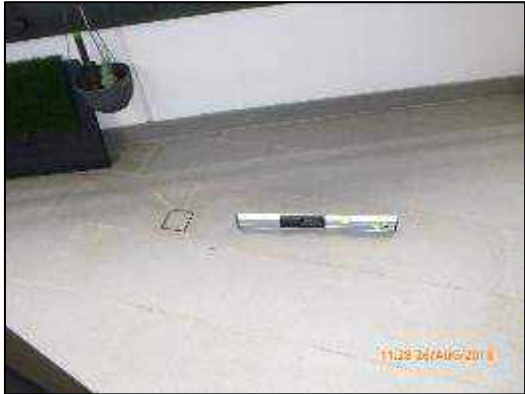
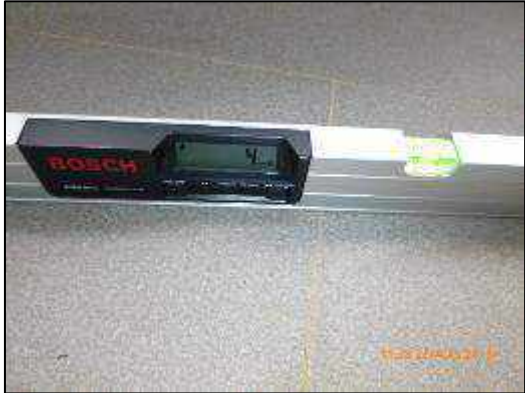
Item	Location	Defect description and Breach	Rectification	Photograph (if applicable)
785	Balcony	See section 5.2.1 Falls (mm); 4/1000	See section 5.2.2

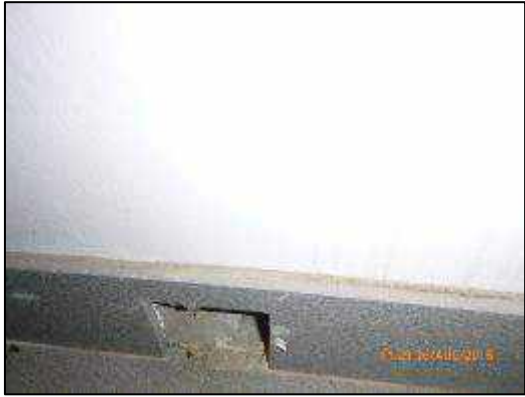
Item	Location	Defect description and Breach	Rectification	Photograph (if applicable)
786	Balcony	See section 5.15.1	See section 5.15.2

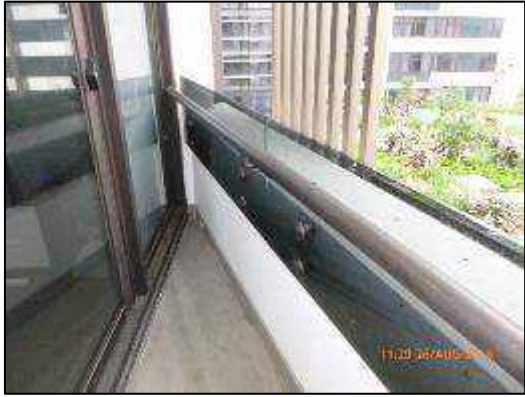
787	Balcony	See section 5.4.1	See section 5.4.2

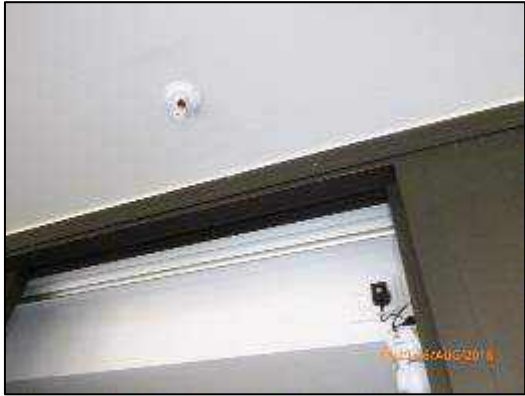
Item	Location	Defect description and Breach	Rectification	Photograph (if applicable)
788	Lounge room eastern wall	See section 5.9.1	See section 5.9.2

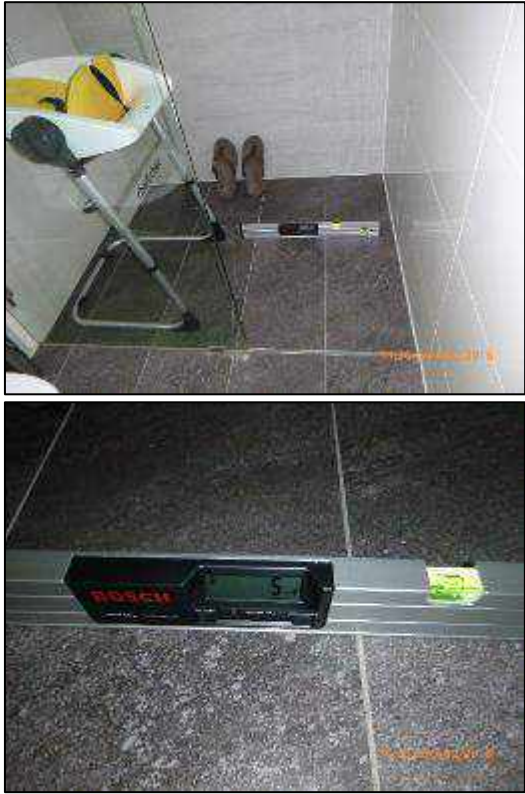
Item	Location	Defect description and Breach	Rectification	Photograph (if applicable)
789	Main bathroom	See section 5.1.1 Falls (mm); 5/1000	See section 5.1.2

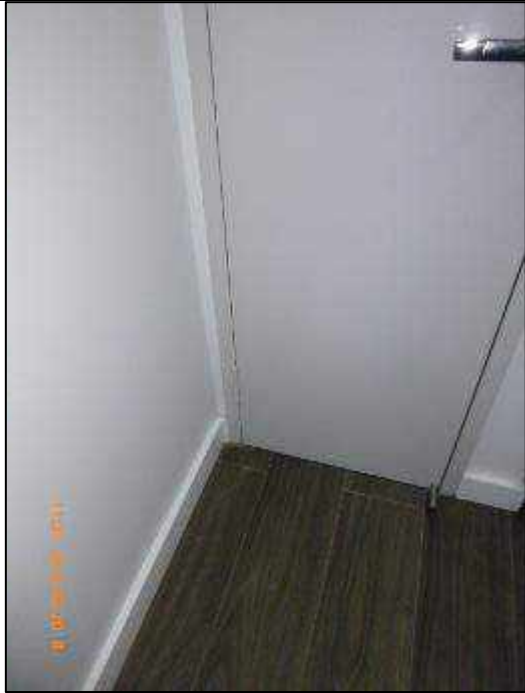
Item	Location	Defect description and Breach	Rectification	Photograph (if applicable)
790	Wall adjacent to pantry door	See section 5.13.1	See section 5.13.2

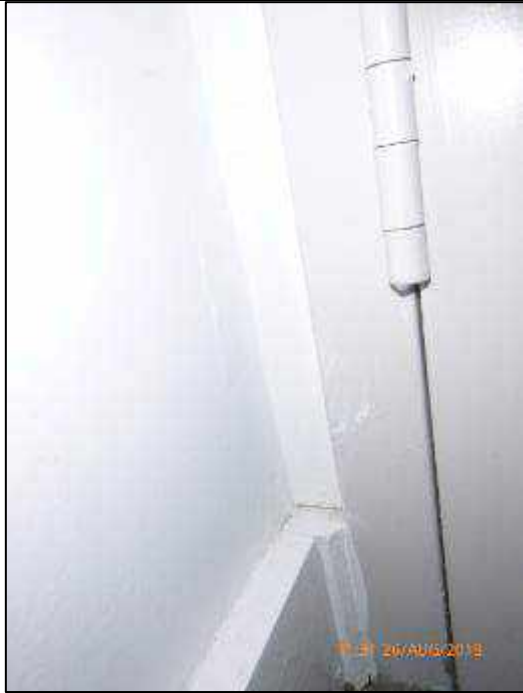
Item	Location	Defect description and Breach	Rectification	Photograph (if applicable)
791	Pantry door frame	See section 5.9.1	See section 5.9.2

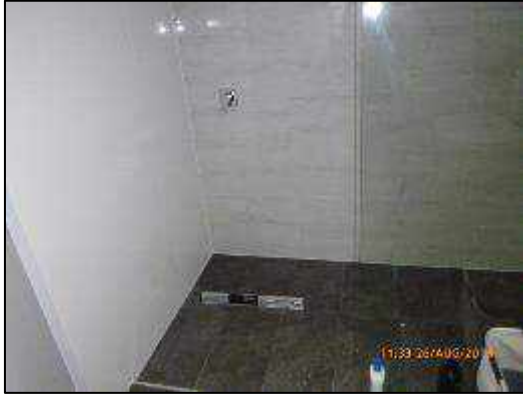
792	Main bedroom ensuite	See section 5.1.1 Falls (mm); 6/1000	See section 5.1.2

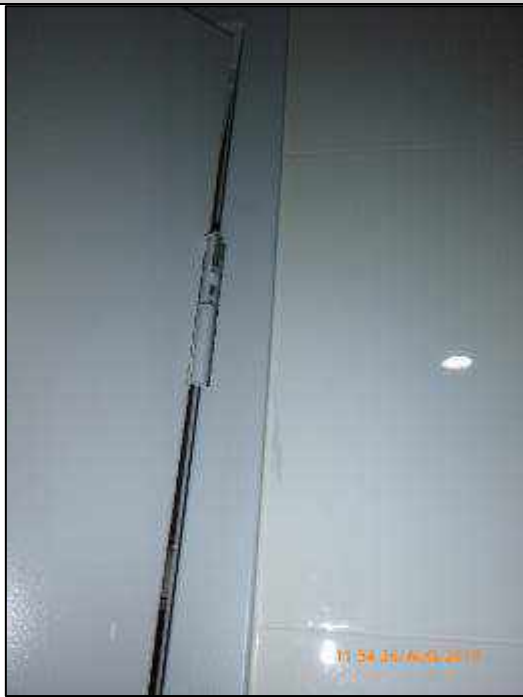
Item	Location	Defect description and Breach	Rectification	Photograph (if applicable)
793	Wall adjacent to ensuite door frame	See section 5.9.1	See section 5.9.2

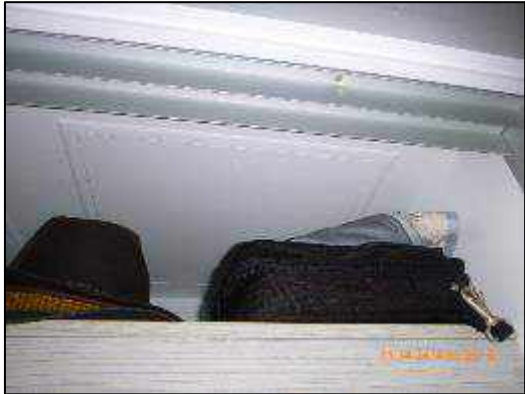
Item	Location	Defect description and Breach	Rectification	Photograph (if applicable)
795	Main bedroom built in	See section 5.6.1	See section 5.6.2

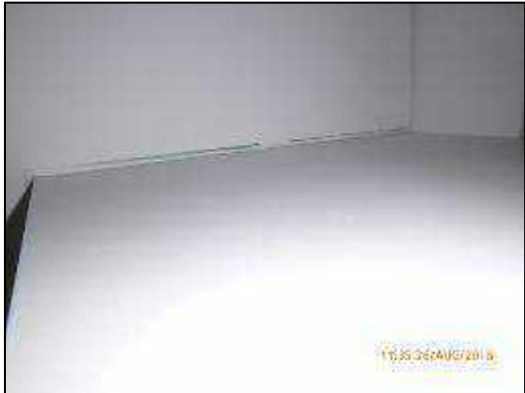
796	Main bedroom	See section 5.11.1	See section 5.11.2

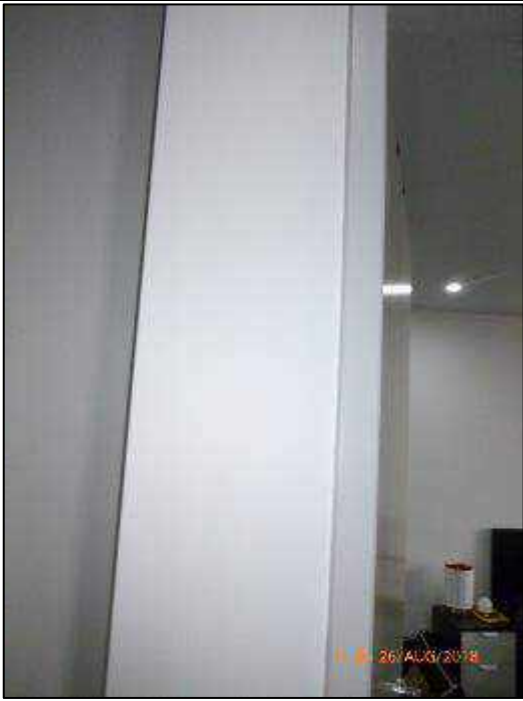
Item	Location	Defect description and Breach	Rectification	Photograph (if applicable)
797	Wall adjacent to main bedroom door	See section 5.13.1	See section 5.13.2

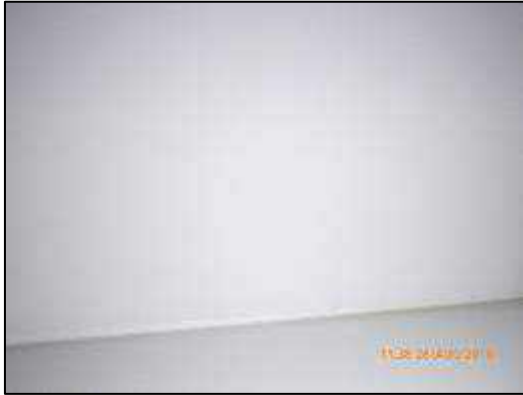
798	Main bedroom ceiling	See section 5.10.1	See section 5.10.2

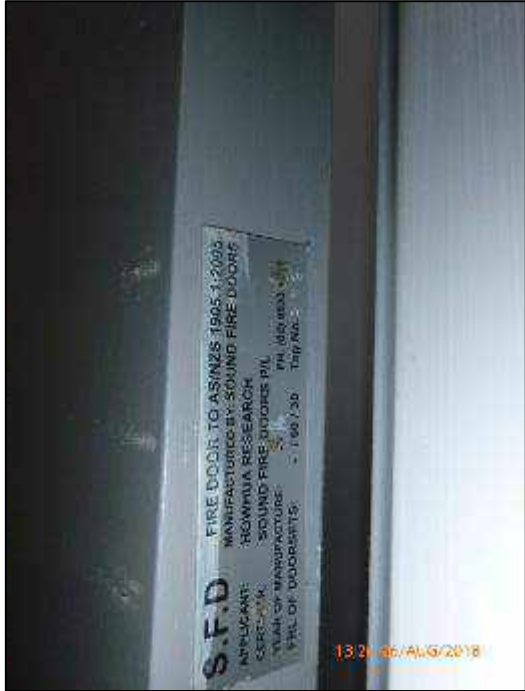
Item	Location	Defect description and Breach	Rectification	Photograph (if applicable)
Unit 707				
799	Front entry door	See section 5.12.1	See section 5.12.2

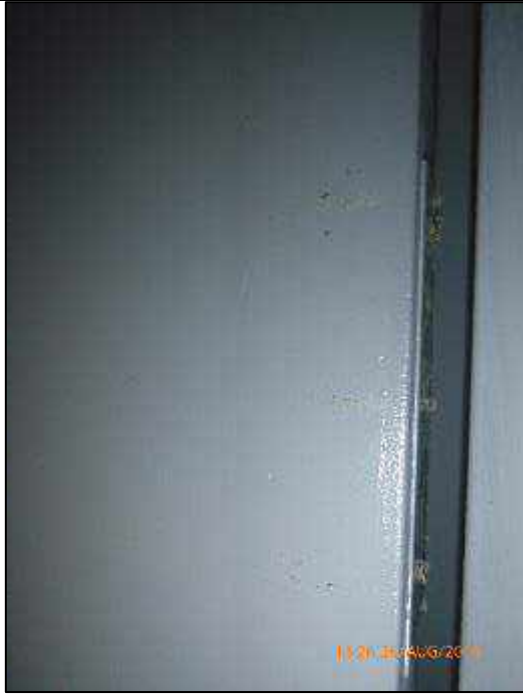
Item	Location	Defect description and Breach	Rectification	Photograph (if applicable)
800	Front entry door	See section 5.10.1	See section 5.10.2

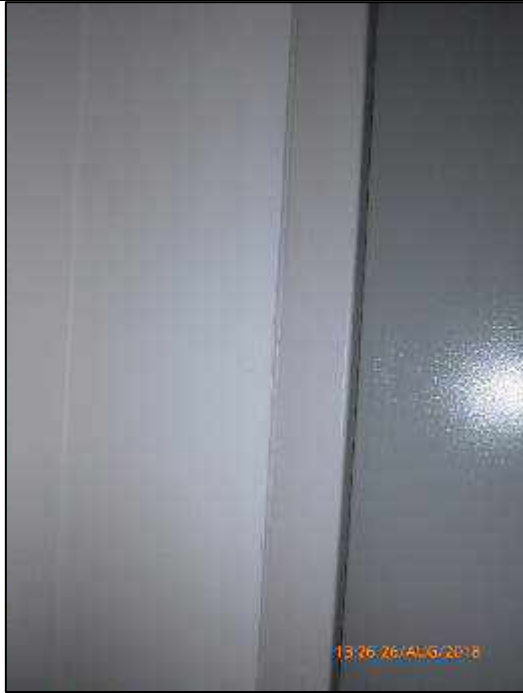
Item	Location	Defect description and Breach	Rectification	Photograph (if applicable)
801	Wall adjacent to front entry door	See section 5.13.1	See section 5.13.2

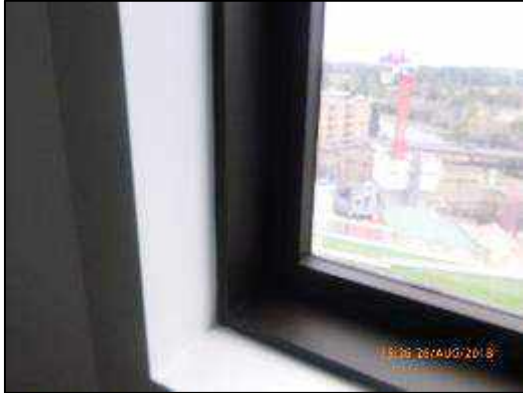
802	Lounge windows room	See section 5.9.1	See section 5.9.2

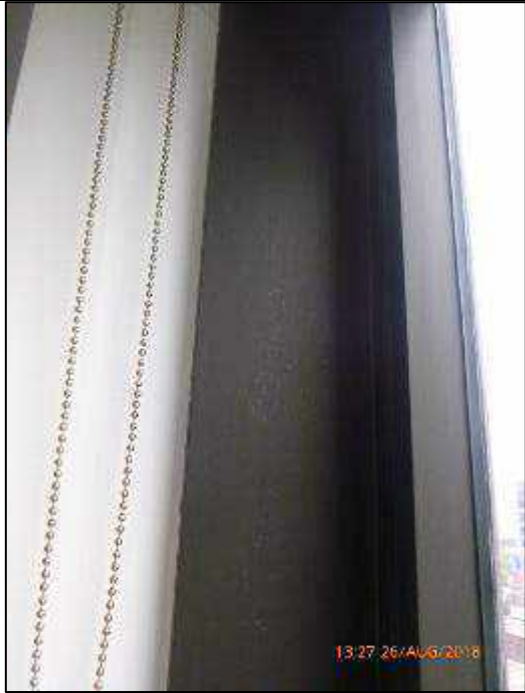
Item	Location	Defect description and Breach	Rectification	Photograph (if applicable)
803	Lounge room windows	See section 5.7.1	See section 5.7.2

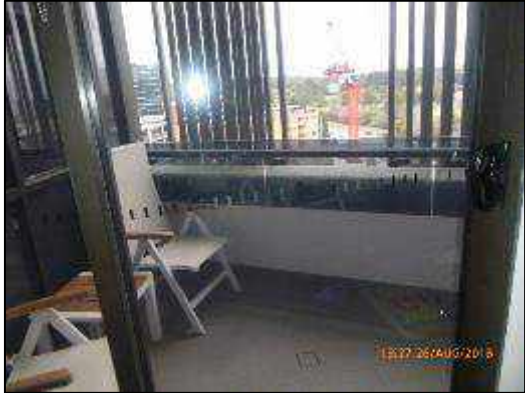
804	Balcony	See section 5.3.1	See section 5.3.2

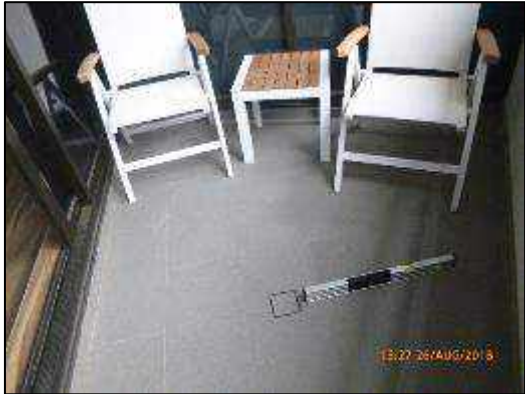
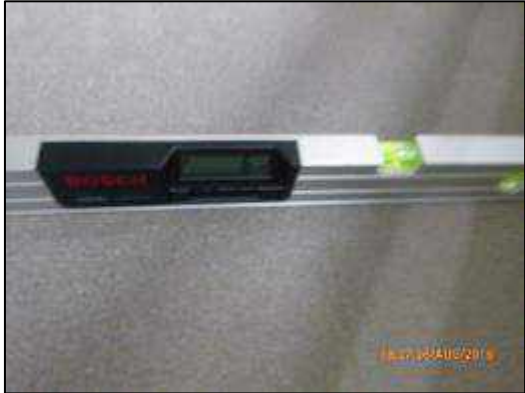
Item	Location	Defect description and Breach	Rectification	Photograph (if applicable)
805	Balcony	See section 5.2.1 Falls (mm); 6/1000	See section 5.2.2

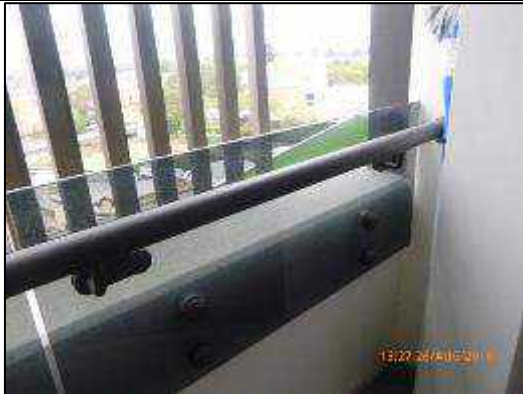
Item	Location	Defect description and Breach	Rectification	Photograph (if applicable)
806	Balcony	See section 5.4.1	See section 5.4.2

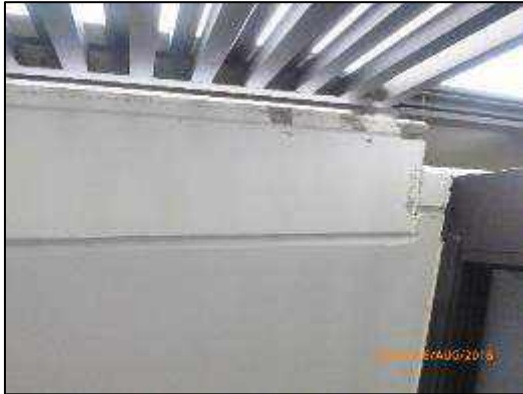
Item	Location	Defect description and Breach	Rectification	Photograph (if applicable)
808	Balcony ceiling	See section 5.10.1	See section 5.10.2

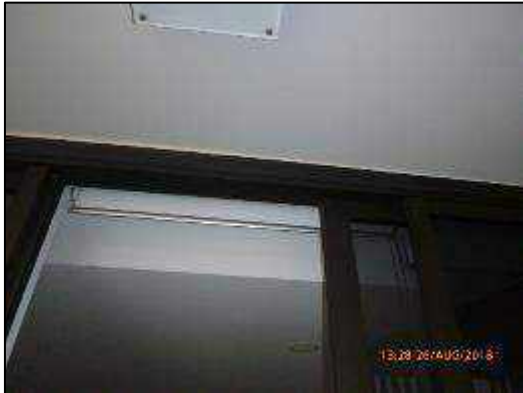
809	Balcony sliding door	See section 5.9.1	See section 5.9.2

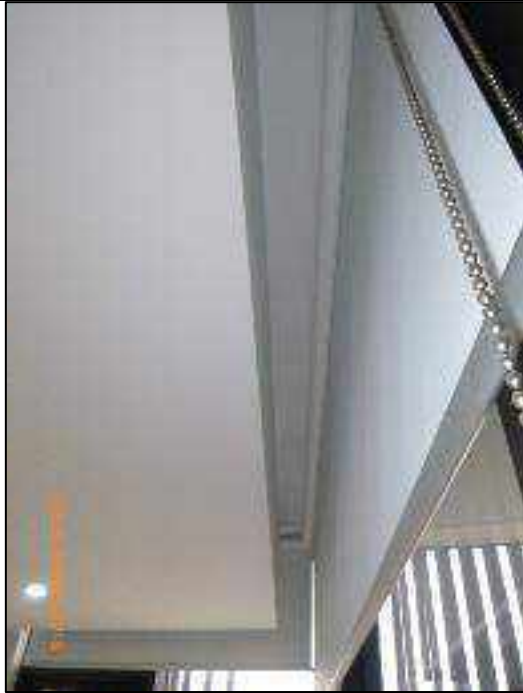
Item	Location	Defect description and Breach	Rectification	Photograph (if applicable)
810	Kitchen window bulkhead	See section 5.13.1	See section 5.13.2

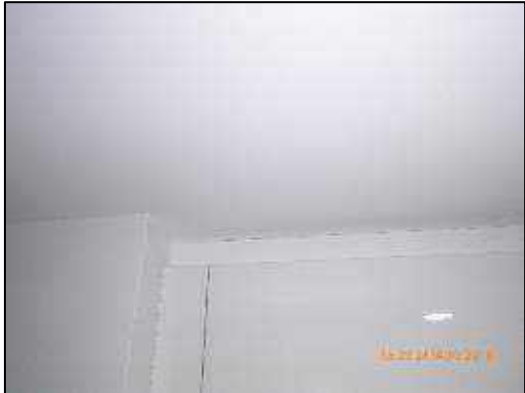
Item	Location	Defect description and Breach	Rectification	Photograph (if applicable)
812	<i>Ceiling above kitchen cupboards.</i>	See section 5.14.1 Separation; 1mm	See section 5.14.2
