SydneyStrataReport

STRATA REPORT

Client	Church Street Parramatta Property Pty Ltd
Address of property	Unit 3303/330 Church Street, Parramatta, NSW.
Lot	359
Strata Plan	SP 94469
Name of Strata Management Co.	NSW Strata
Telephone Number of Strata Agent	8980 1841
Report Date	15 February 2024

BUILDING DEFECTS REPORT Part 1/2

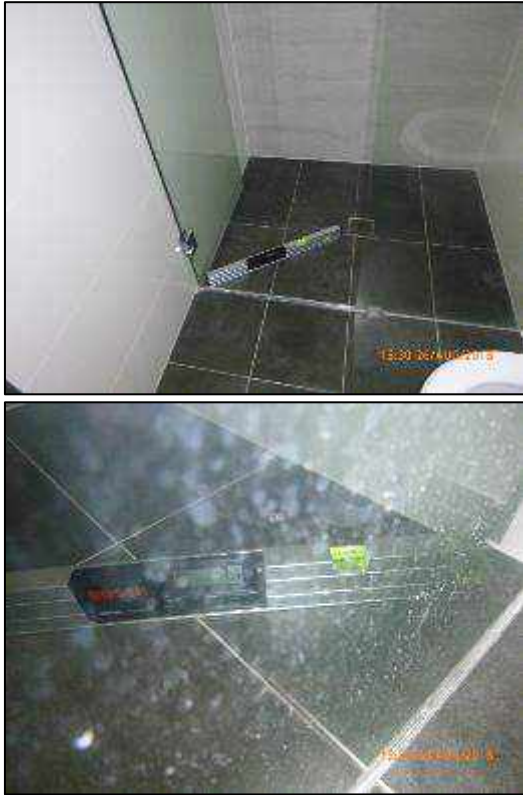
Item	Location	Defect description and Breach	Rectification	Photograph (if applicable)
813	Main bathroom	See section 5.1.1 Falls (mm); 7/1000	See section 5.1.2

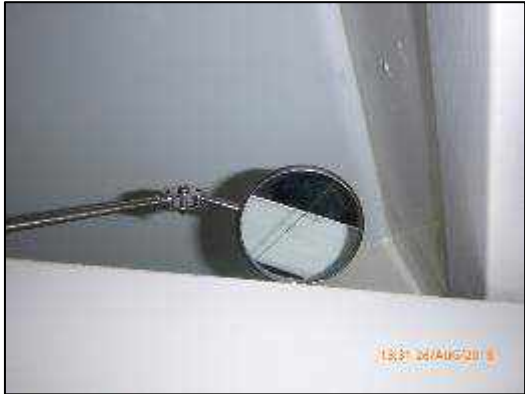
Item	Location	Defect description and Breach	Rectification	Photograph (if applicable)
816	Doors throughout unit (x3)	See section 5.5.1	See section 5.5.2

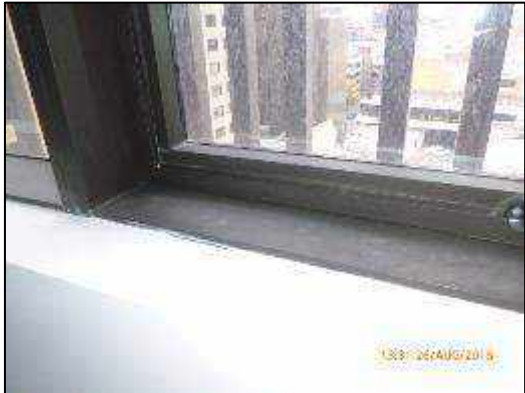
817	Second bedroom windows	See section 5.7.1	See section 5.7.2

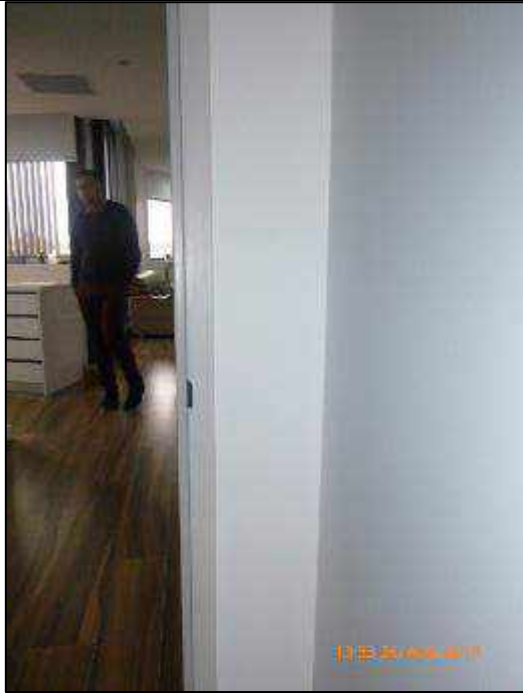
Item	Location	Defect description and Breach	Rectification	Photograph (if applicable)
818	Wall adjacent to second bedroom door frame	See section 5.13.1	See section 5.13.2

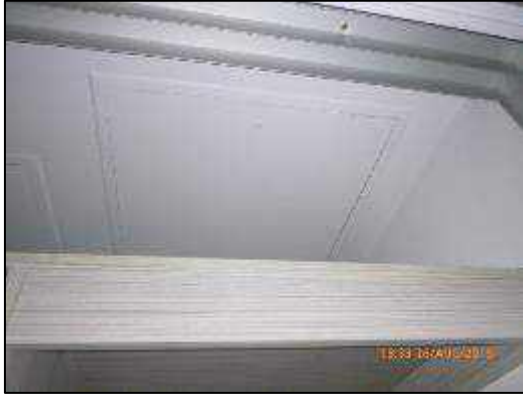
819	Main bedroom built in	See section 5.6.1	See section 5.6.2

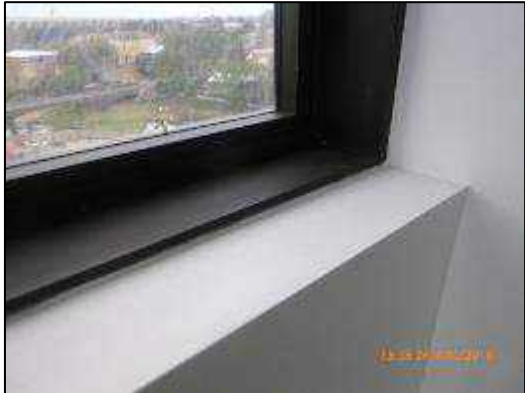
Item	Location	Defect description and Breach	Rectification	Photograph (if applicable)
820	Main bedroom window frames	See section 5.9.1	See section 5.9.2

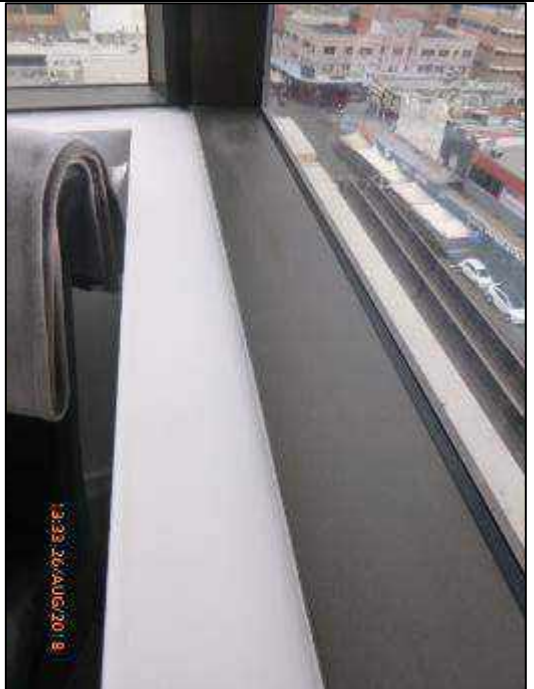
821	Main bedroom window frames	See section 5.7.1	See section 5.7.2

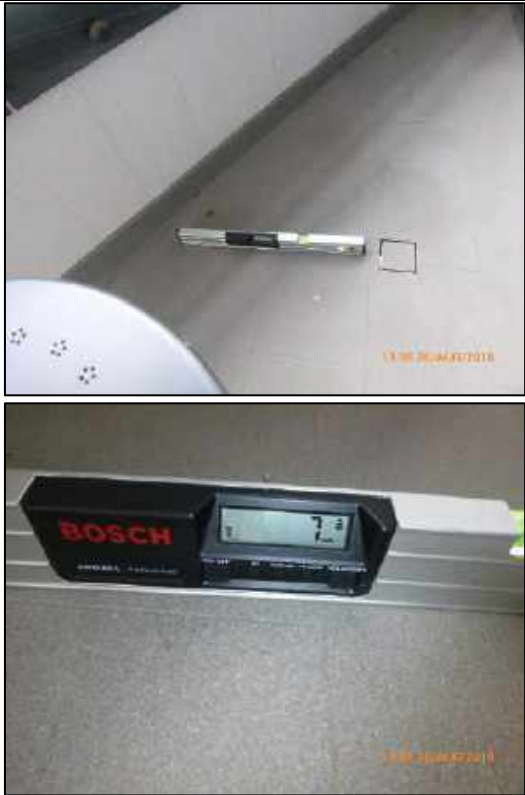
Item	Location	Defect description and Breach	Rectification	Photograph (if applicable)
Unit 708				
826	Balcony	See section 5.2.1 Falls (mm); 7/1000	See section 5.2.2

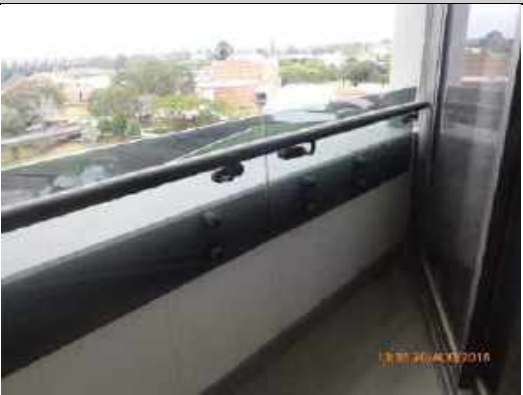
Item	Location	Defect description and Breach	Rectification	Photograph (if applicable)
827	Balcony	See section 5.4.1	See section 5.4.2

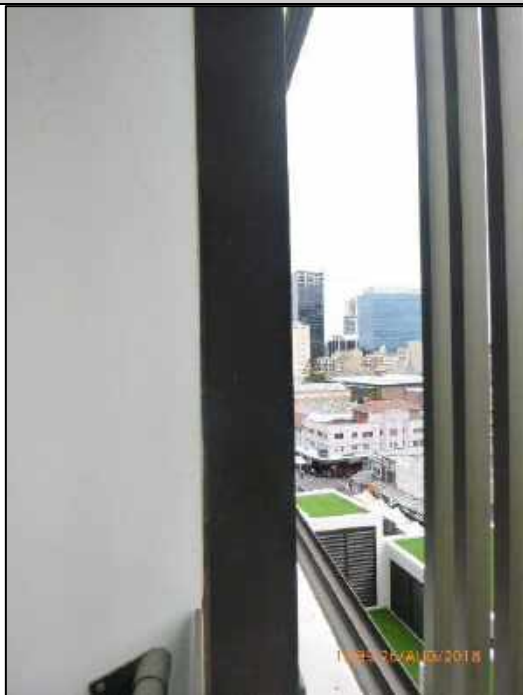
Item	Location	Defect description and Breach	Rectification	Photograph (if applicable)
831	Facade of balcony area	<p>Construction debris observed on façade of the building.</p> <p>Home Building Act (NSW) 1989</p> <ul style="list-style-type: none"> Part 2C, 18B (a) and (c). <p>This is a breach of part (a) of the act because the surface has not been finished in a proper workmanlike manner that would prevent loss of appearance to the surface.</p> <p>Loss Suffered Loss suffered is cost of rectification.</p>	<ol style="list-style-type: none"> 1. Protect all adjoining surfaces. 2. Use a suitable cleaning agent to remove residue and clear debris. 3. Clean up the work area.

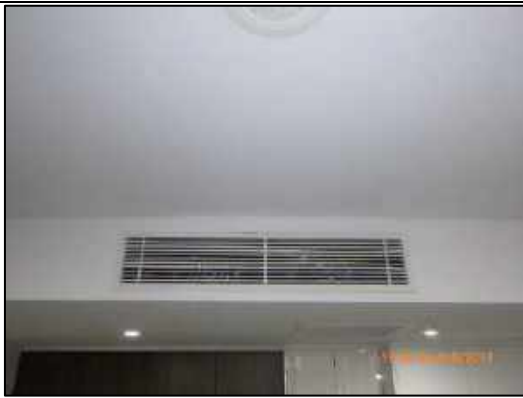
832	Wall adjacent to air conditioner vent in lounge room	See section 5.13.1	See section 5.13.2

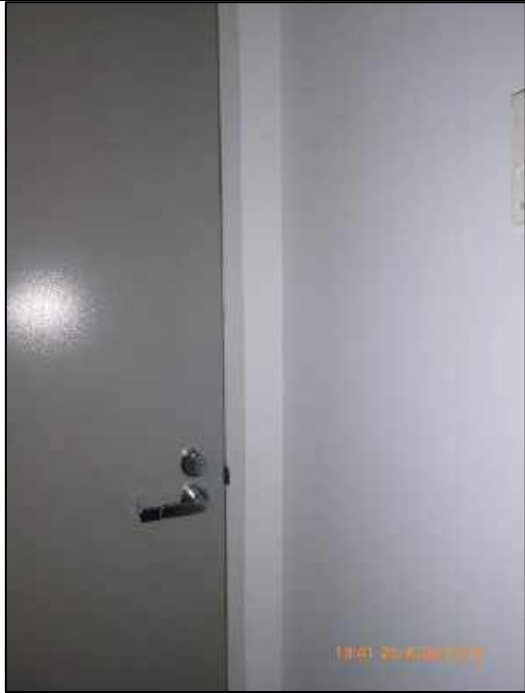
Item	Location	Defect description and Breach	Rectification	Photograph (if applicable)
833	Wall adjacent to front entrance	See section 5.13.1	See section 5.13.2

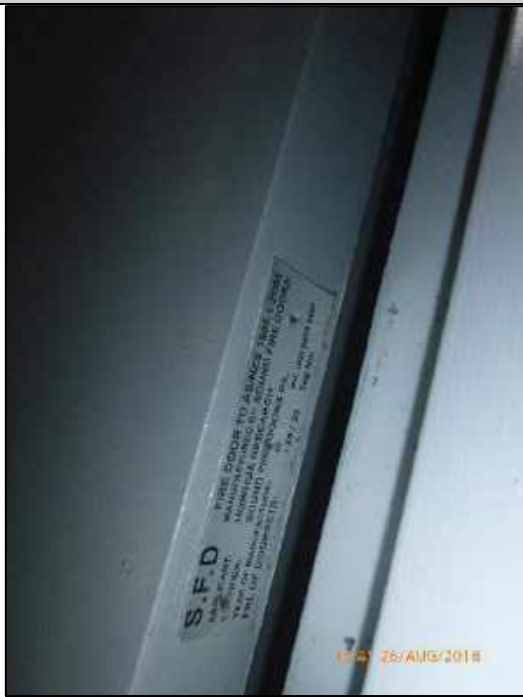
Item	Location	Defect description and Breach	Rectification	Photograph (if applicable)
834	Front entry door	See section 5.12.1	See section 5.12.2

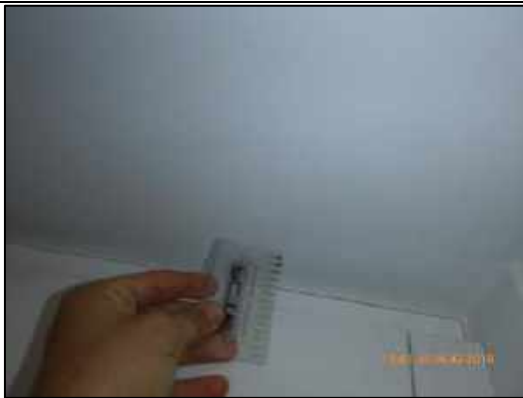
A photograph showing a close-up of a fire door. A label is visible on the door, which includes the text 'S.F.D. FIRE DOOR TO ADJACENT FIRE ZONE' and 'MOUNTED TO THE STRUCTURE'. The date '19/01/25/AMG/2018' is printed in orange at the bottom right of the image.
835	Ceiling above kitchen cupboards.	See section 5.14.1 Separation; 2mm	See section 5.14.2

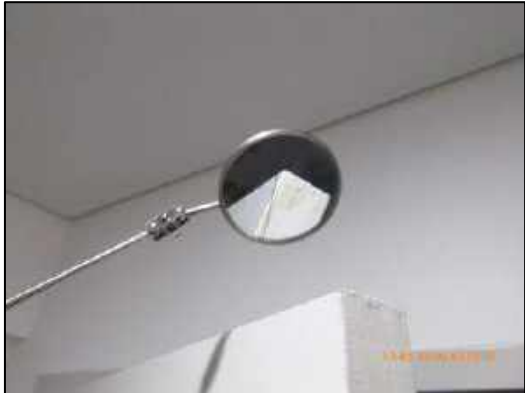
Item	Location	Defect description and Breach	Rectification	Photograph (if applicable)
836	<i>Doors throughout unit (x3)</i>	See section 5.5.1	See section 5.5.2

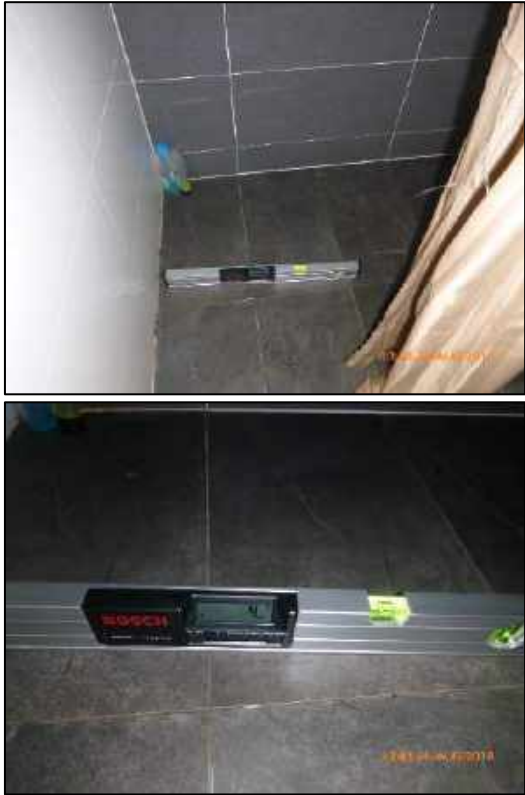
Item	Location	Defect description and Breach	Rectification	Photograph (if applicable)
837	Main bathroom	See section 5.1.1 Falls; 4/1000	See section 5.1.2

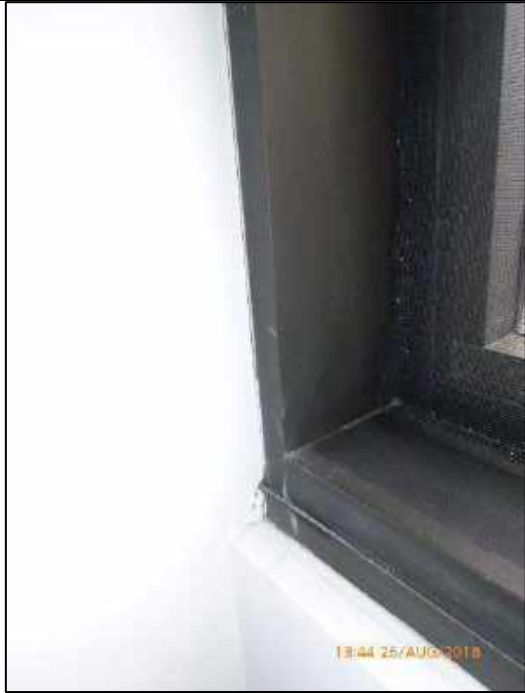
Item	Location	Defect description and Breach	Rectification	Photograph (if applicable)
838	Second bedroom window frames	See section 5.9.1	See section 5.9.2

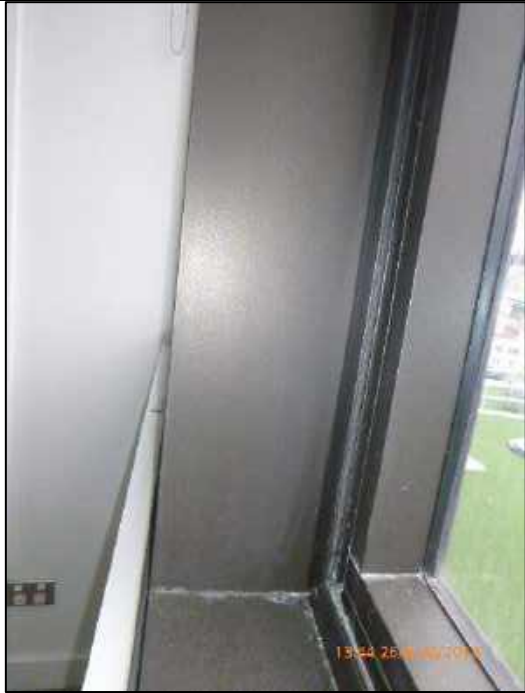
Item	Location	Defect description and Breach	Rectification	Photograph (if applicable)
839	Second bedroom window frames	See section 5.8.1	See section 5.8.2

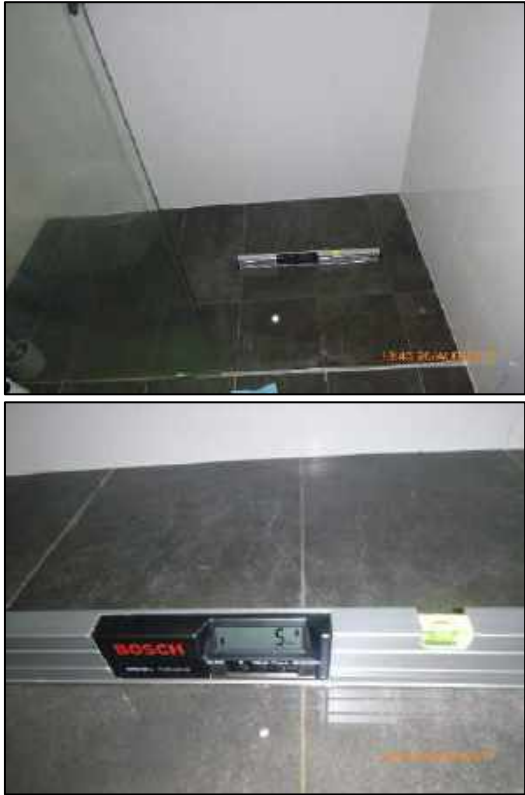
Item	Location	Defect description and Breach	Rectification	Photograph (if applicable)
840	Main bedroom ensuite	See section 5.1.1 Falls (mm); 5/1000	See section 5.1.2

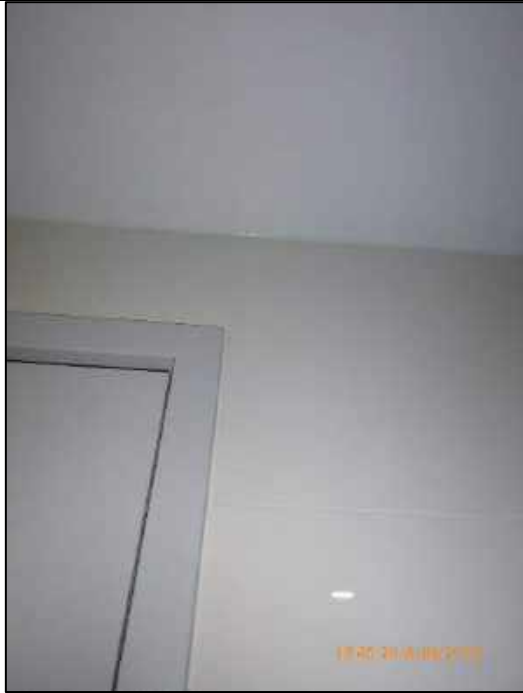
Item	Location	Defect description and Breach	Rectification	Photograph (if applicable)
841	Wall adjacent to main bedroom ensuite	See section 5.9.1	See section 5.9.2

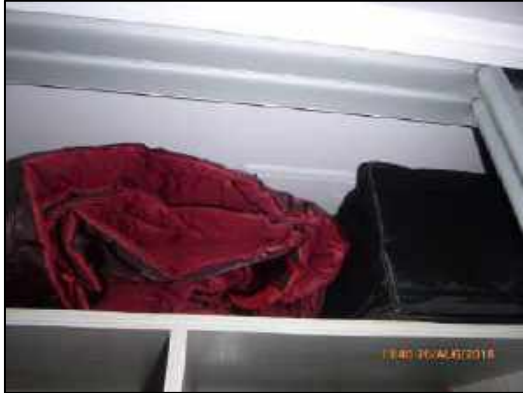
842	Main bedroom built in	See section 5.6.1	See section 5.6.2

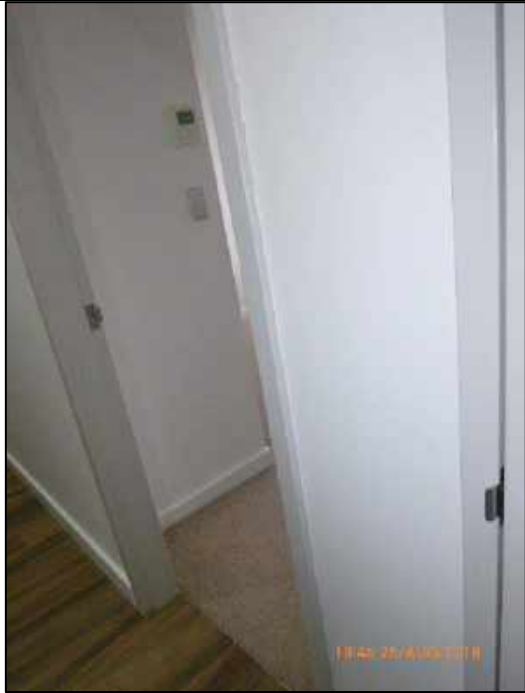
Item	Location	Defect description and Breach	Rectification	Photograph (if applicable)
843	Wall adjacent to second bedroom	See section 5.10.1	See section 5.10.2

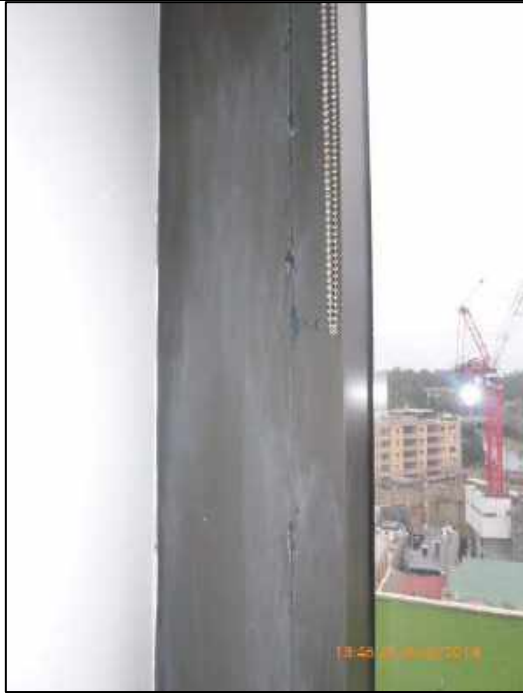
Item	Location	Defect description and Breach	Rectification	Photograph (if applicable)
844	Second bedroom windows	See section 5.8.1	See section 5.8.2

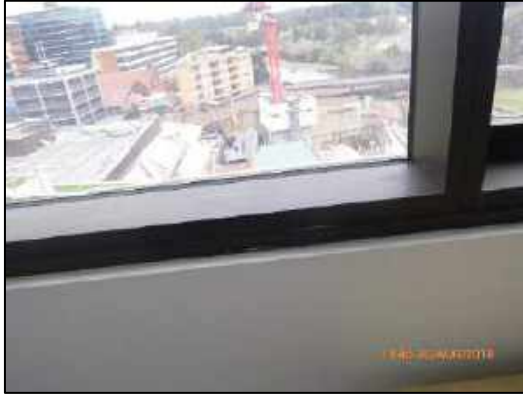
845	Second bedroom windows	See section 5.9.1	See section 5.9.2

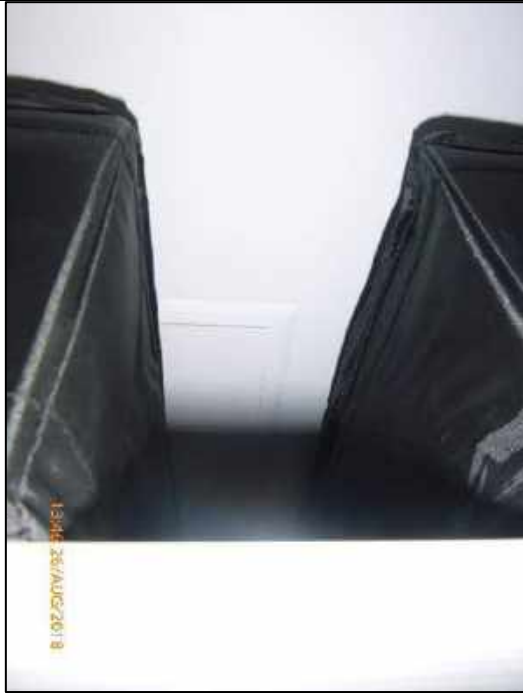
Item	Location	Defect description and Breach	Rectification	Photograph (if applicable)
846	Second bedroom built in	See section 5.6.1	See section 5.6.2

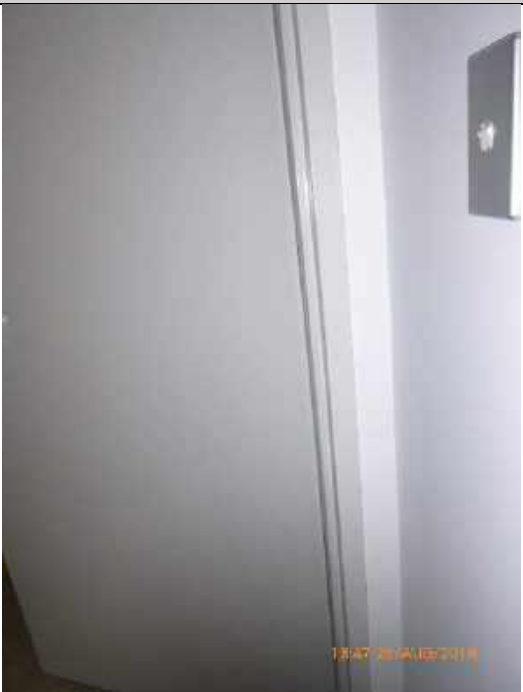
Item	Location	Defect description and Breach	Rectification	Photograph (if applicable)
847	Wall adjacent to second bedroom door	See section 5.13.1	See section 5.13.2

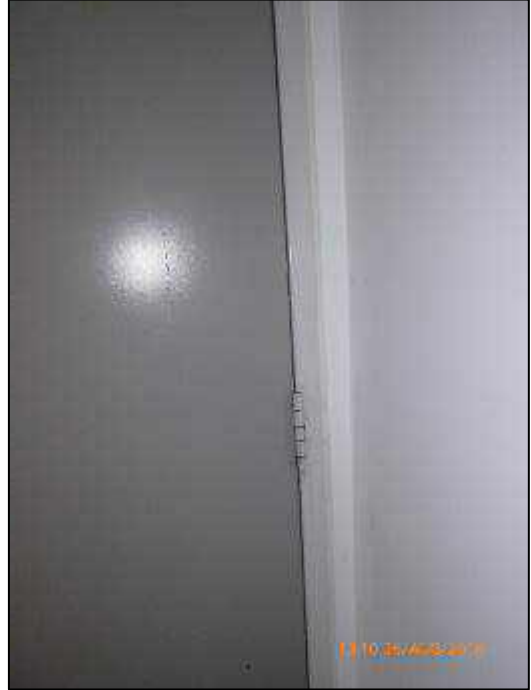
Item	Location	Defect description and Breach	Rectification	Photograph (if applicable)
Unit 801				
848	Wall adjacent to front entry door	See section 5.13.1	See section 5.13.2

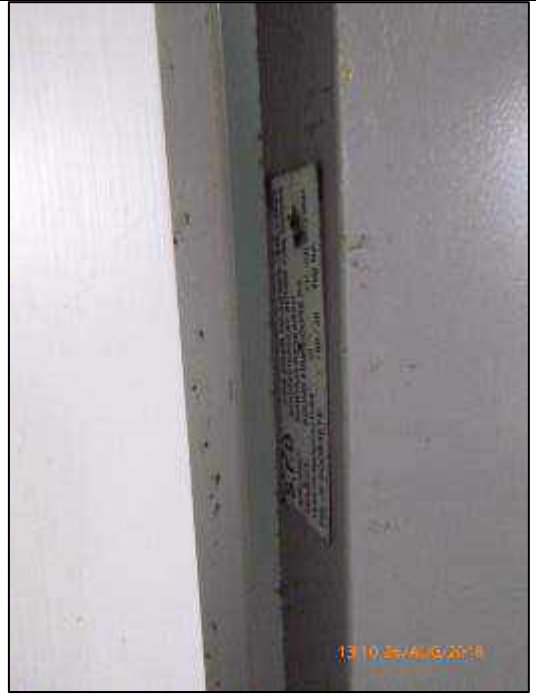
Item	Location	Defect description and Breach	Rectification	Photograph (if applicable)
849	Front entry door	See section 5.12.1	See section 5.12.2

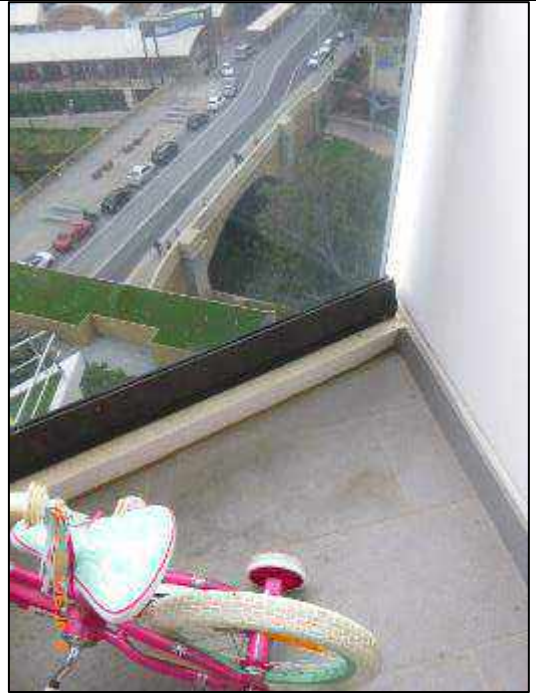
Item	Location	Defect description and Breach	Rectification	Photograph (if applicable)
850	Balcony	See section 5.3.1	See section 5.3.2

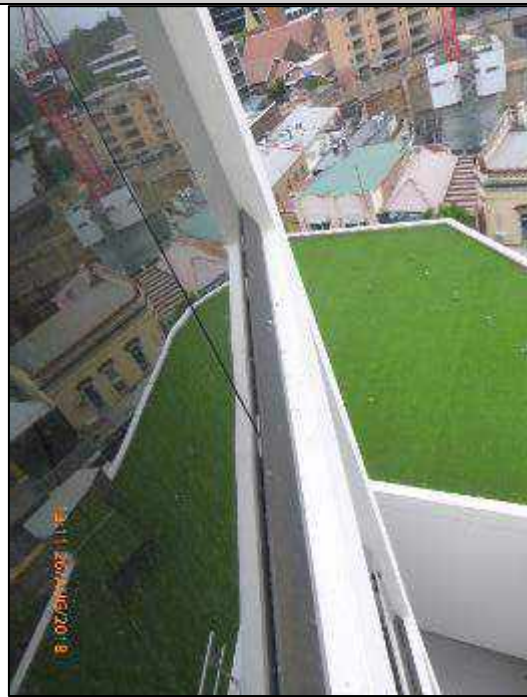
Item	Location	Defect description and Breach	Rectification	Photograph (if applicable)
851	Balcony balustrade	See section 5.9.1	See section 5.9.2

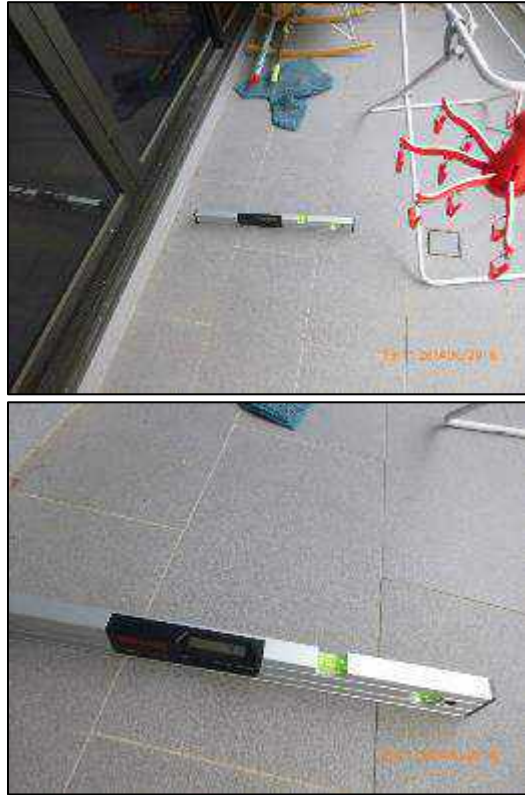
Item	Location	Defect description and Breach	Rectification	Photograph (if applicable)
852	Balcony	See section 5.2.1 Falls (mm); 4/1000	See section 5.2.2

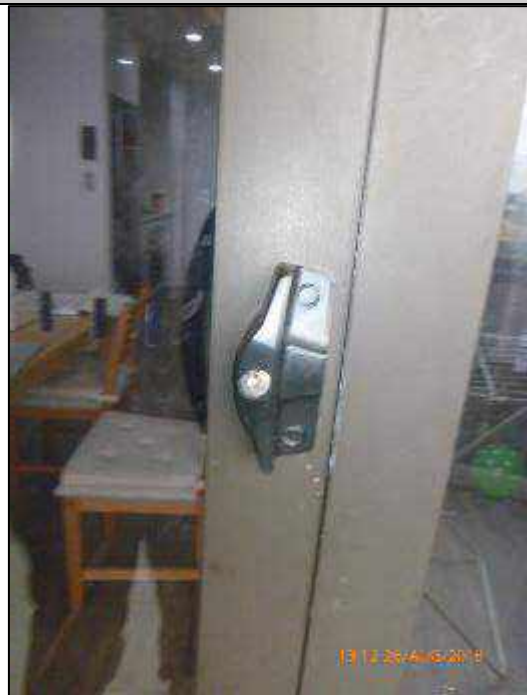
Item	Location	Defect description and Breach	Rectification	Photograph (if applicable)
853	Balcony sliding door	See section 5.7.1	See section 5.7.2

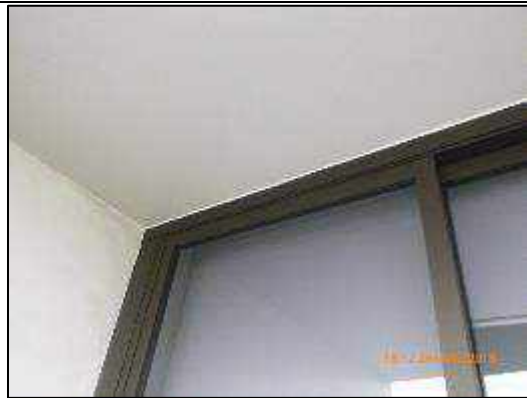
854	Balcony sliding door	See section 5.9.1	See section 5.9.2

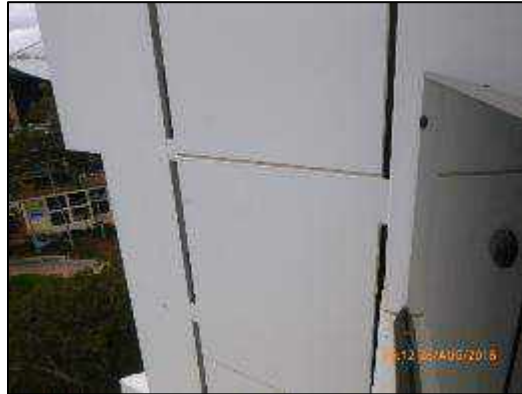
Item	Location	Defect description and Breach	Rectification	Photograph (if applicable)
855	<i>Façade of balcony area</i>	<p>Construction debris observed on façade of building</p> <p>Home Building Act (NSW) 1989</p> <ul style="list-style-type: none"> Part 2C, 18B (a) and (c). <p>This is a breach of part (a) of the act because the surface has not been finished in a proper workmanlike manner that would prevent loss of appearance to the surface.</p> <p>Loss Suffered Loss suffered is cost of rectification.</p>	<ol style="list-style-type: none"> 1. Protect all adjoining surfaces. 2. Use a suitable cleaning agent to remove residue and clear debris. 3. Clean up the work area.

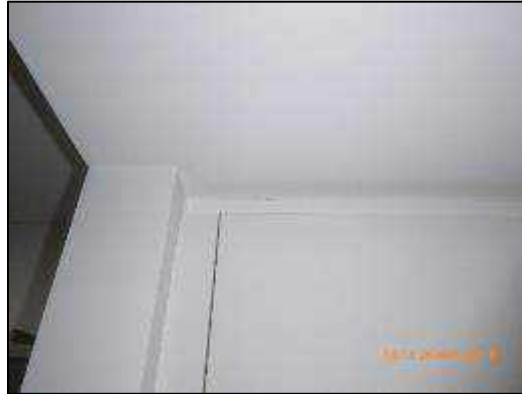
856	<i>Ceiling above kitchen cupboards</i>	<p>See section 5.14.1</p> <p>Separation; 1mm</p>	See section 5.14.2

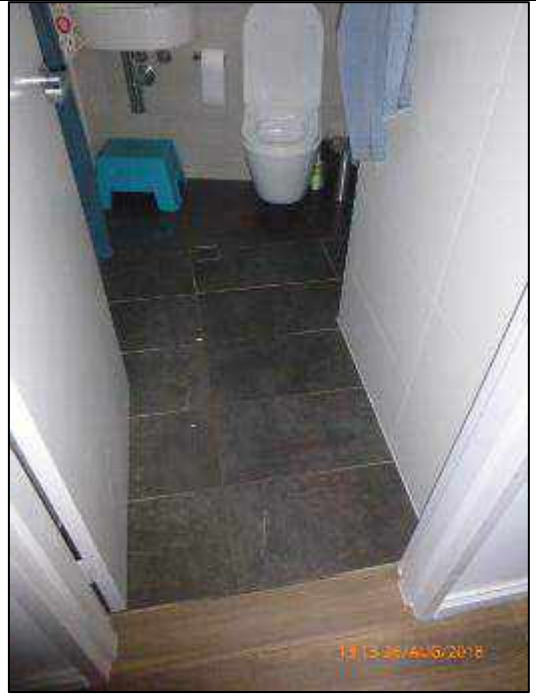
Item	Location	Defect description and Breach	Rectification	Photograph (if applicable)
857	Main bathroom floor tiles	See section 5.8.1	See section 5.8.2

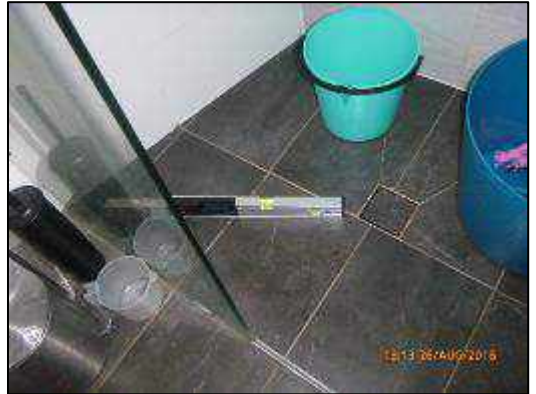
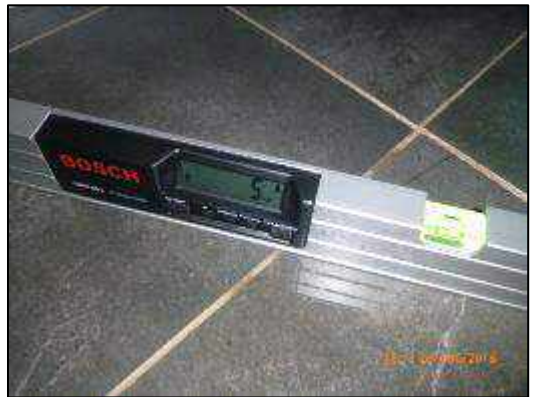
Item	Location	Defect description and Breach	Rectification	Photograph (if applicable)
858	Main bathroom	See section 5.2.1 Falls (mm); 5/1000	See section 5.2.2

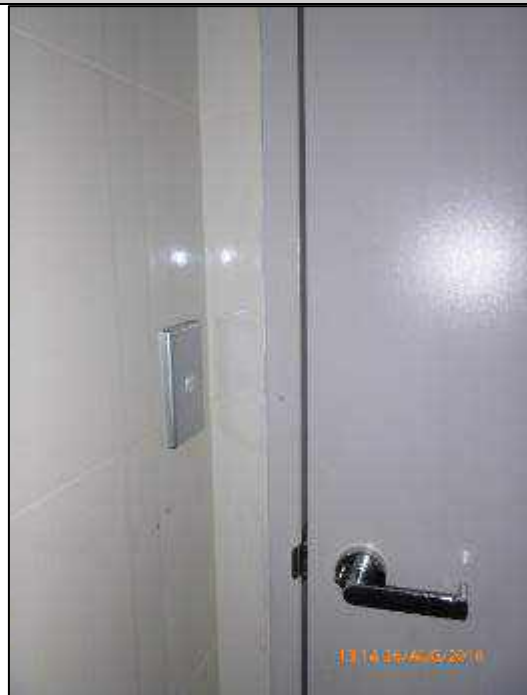
Item	Location	Defect description and Breach	Rectification	Photograph (if applicable)
859	Wall adjacent to main bathroom door	See section 5.9.1	See section 5.9.2

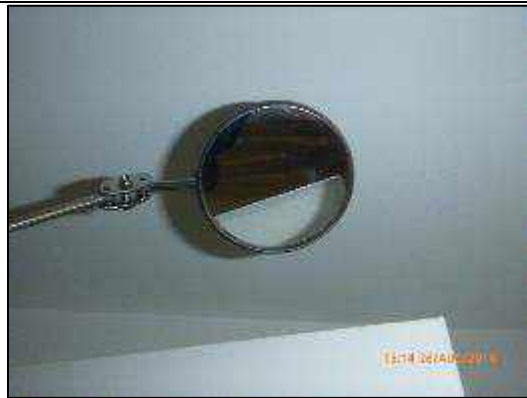
860	Doors throughout the unit (x3)	See section 5.5.1	See section 5.5.2

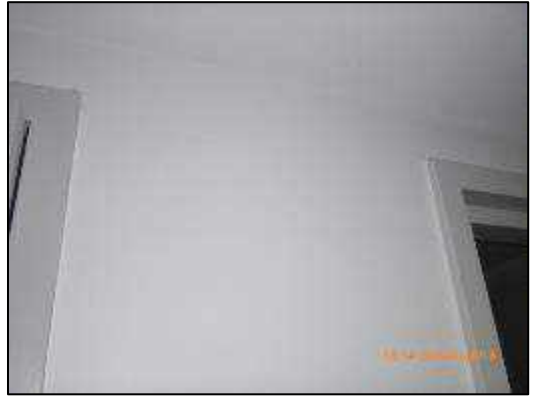
Item	Location	Defect description and Breach	Rectification	Photograph (if applicable)
861	Wall adjacent to main bathroom door	See section 5.13.1	See section 5.13.2

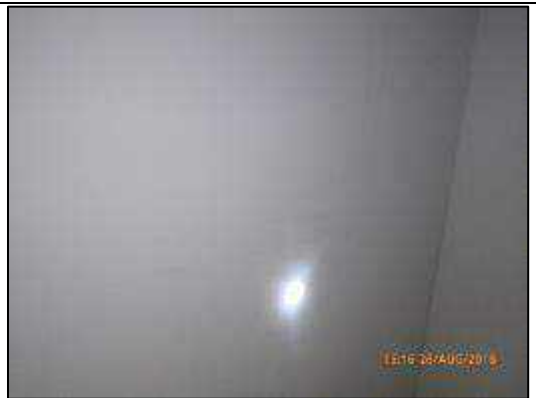
A photograph showing a close-up of a white wall. There is a faint, irregular mark or stain on the wall, possibly a water mark or a defect in the paint. The lighting is somewhat dim, and the image is slightly blurry.
862	Ceiling in main bedroom	See section 5.10.1	See section 5.10.2

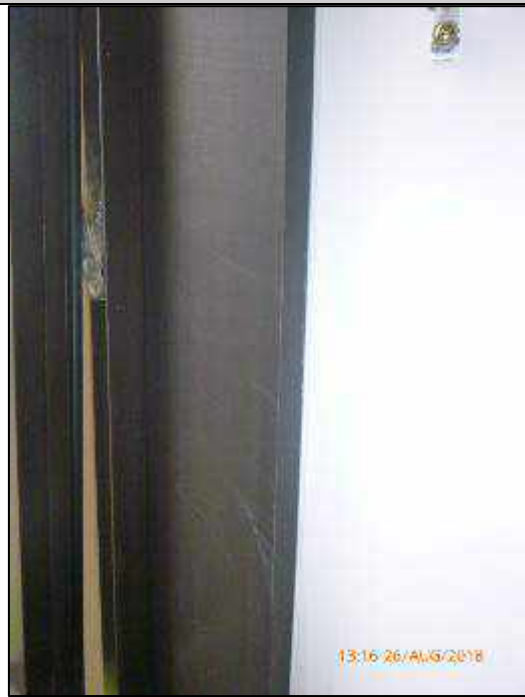
Item	Location	Defect description and Breach	Rectification	Photograph (if applicable)
863	Main bedroom windows	See section 5.7.1	See section 5.7.2

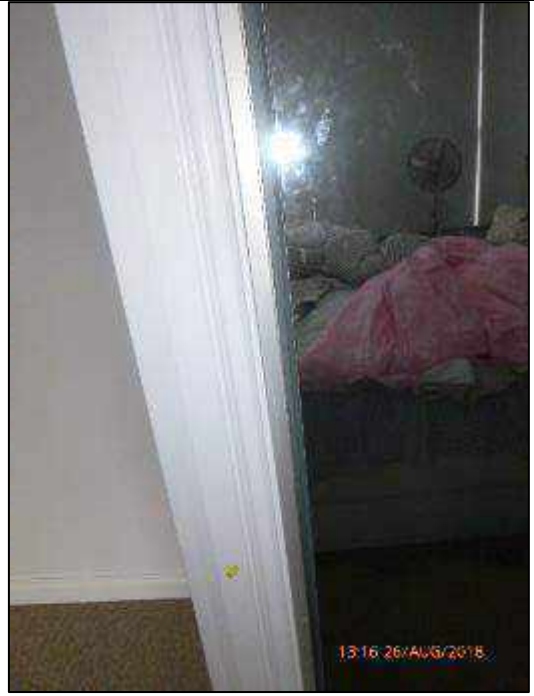
Item	Location	Defect description and Breach	Rectification	Photograph (if applicable)
864	Architrave around built in in main bedroom	See section 5.10.1	See section 5.10.2

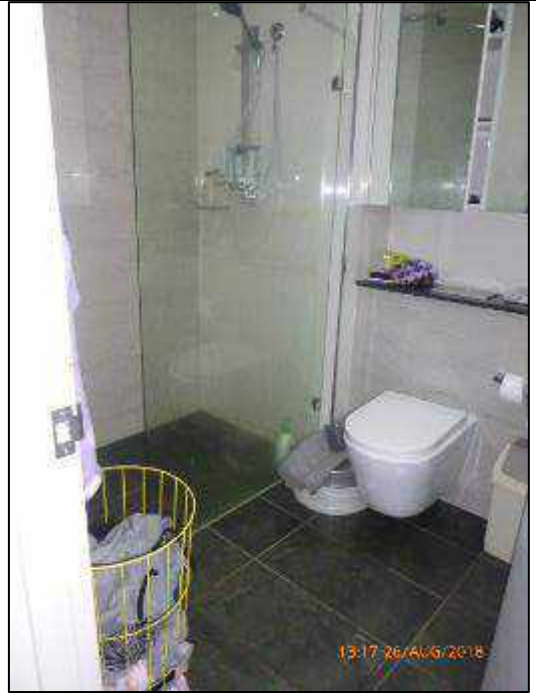
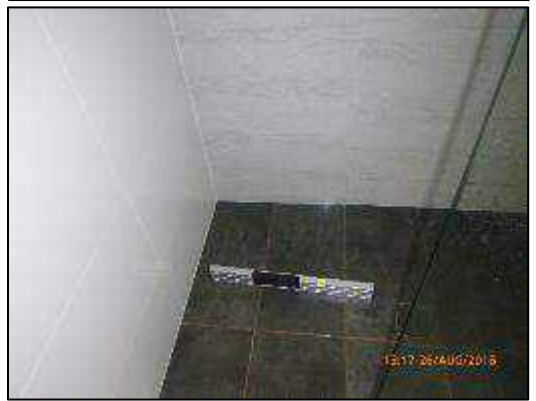
Item	Location	Defect description and Breach	Rectification	Photograph (if applicable)
865	Main bedroom ensuite	See section 5.1.1 Falls (mm); 7/1000	See section 5.1.2

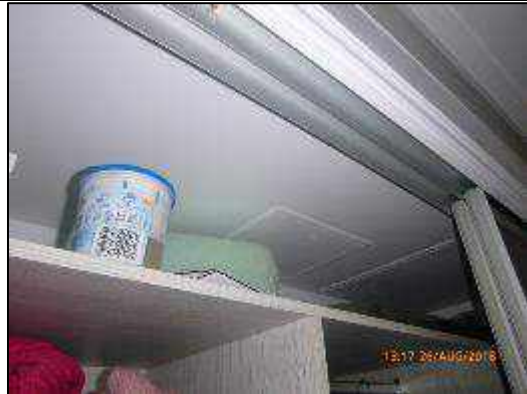
Item	Location	Defect description and Breach	Rectification	Photograph (if applicable)
866	Main bedroom built in	See section 5.6.1	See section 5.6.2

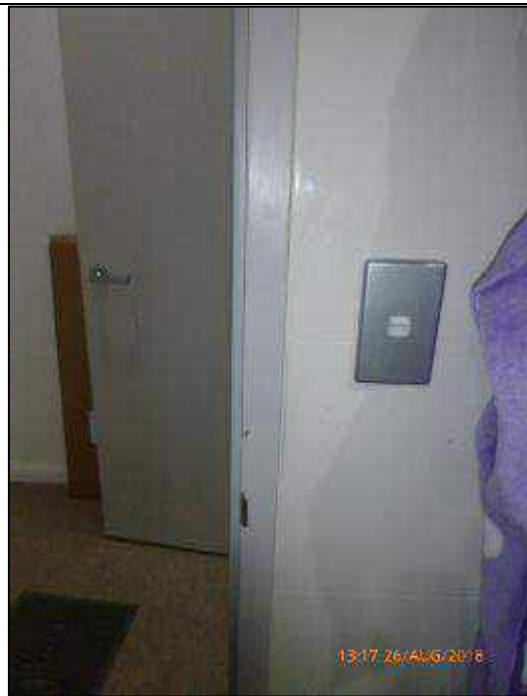
867	Wall adjacent to main bedroom door	See section 5.13.1	See section 5.13.2

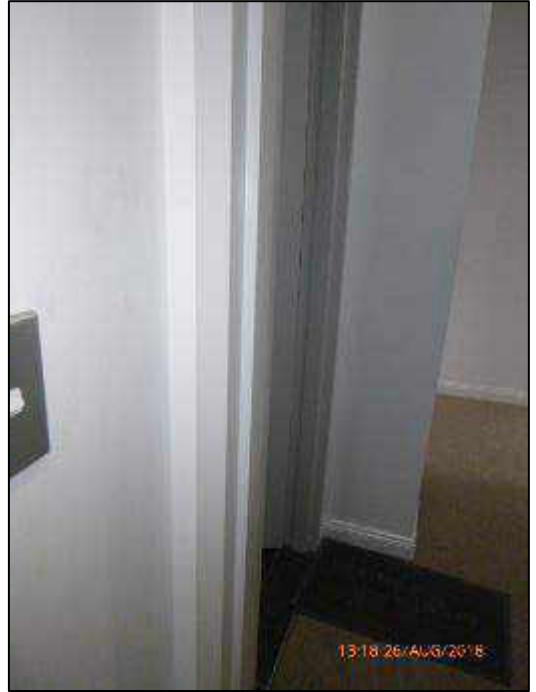
Item	Location	Defect description and Breach	Rectification	Photograph (if applicable)
868	Wall adjacent to main bedroom door	See section 5.13.1	See section 5.13.2

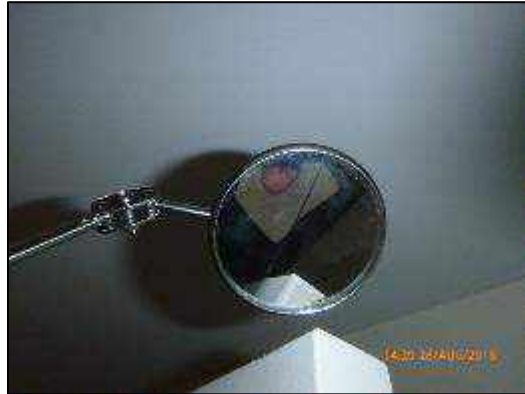
Item	Location	Defect description and Breach	Rectification	Photograph (if applicable)
Unit 803				
870	<i>Doors throughout unit (x3)</i>	See section 5.5.1	See section 5.5.2

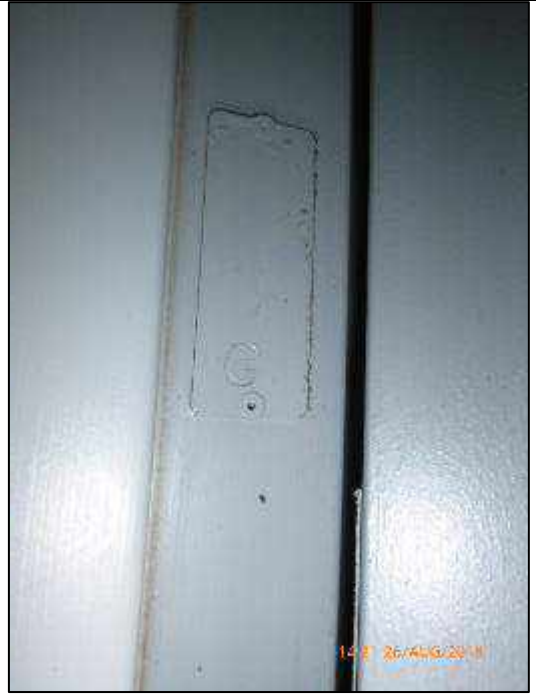
Item	Location	Defect description and Breach	Rectification	Photograph (if applicable)
871	Front entry door frame	<p>Door frame label has been painted over.</p> <p>Home Building Act (NSW) 1989</p> <ul style="list-style-type: none"> Part 2C, 18B (a) & (c). <p>Loss Suffered</p> <p>Loss suffered is cost of rectification.</p>	Use a suitable cleaning agent to remove paint from the door frame label.

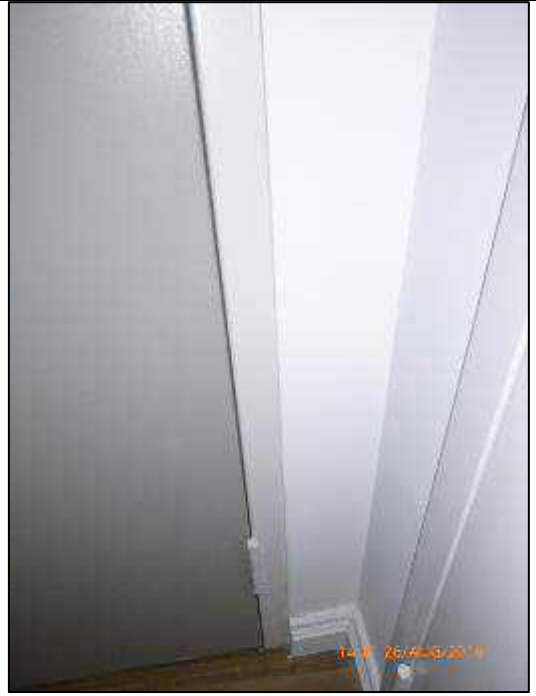
Item	Location	Defect description and Breach	Rectification	Photograph (if applicable)
872	Wall adjacent to front entry door	See section 5.13.1	See section 5.13.2

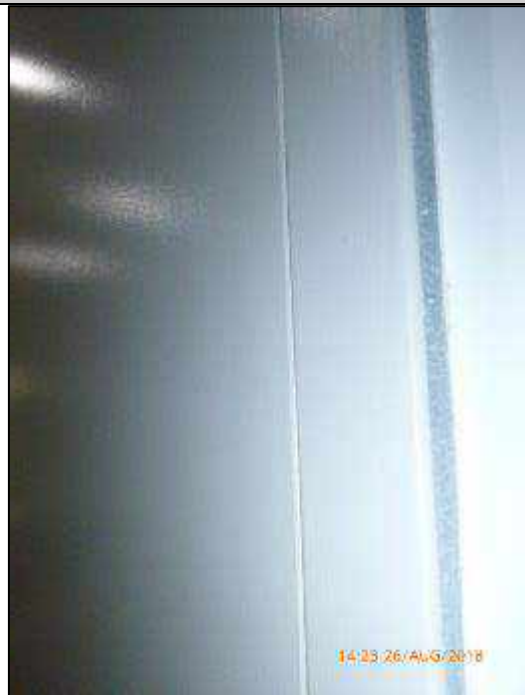
Item	Location	Defect description and Breach	Rectification	Photograph (if applicable)
873	Laundry door frame	See section 5.10.1	See section 5.10.2

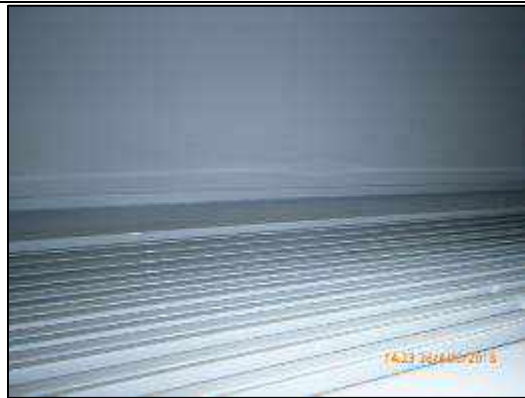
A close-up photograph of a dark, possibly metallic or plastic, door frame or panel. The surface appears slightly worn or discolored. A timestamp '14:23:26/AUG/2018' is visible in the bottom right corner.
874	Kitchen area	See section 5.11.1	See section 5.11.2

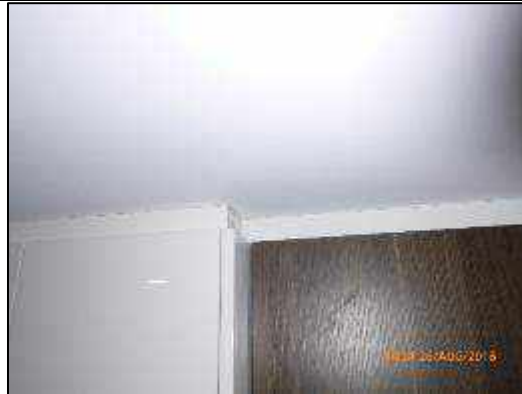
Item	Location	Defect description and Breach	Rectification	Photograph (if applicable)
875	Ceiling above kitchen cupboards	See section 5.14.1 Separation; 1.5mm	See section 5.14.2

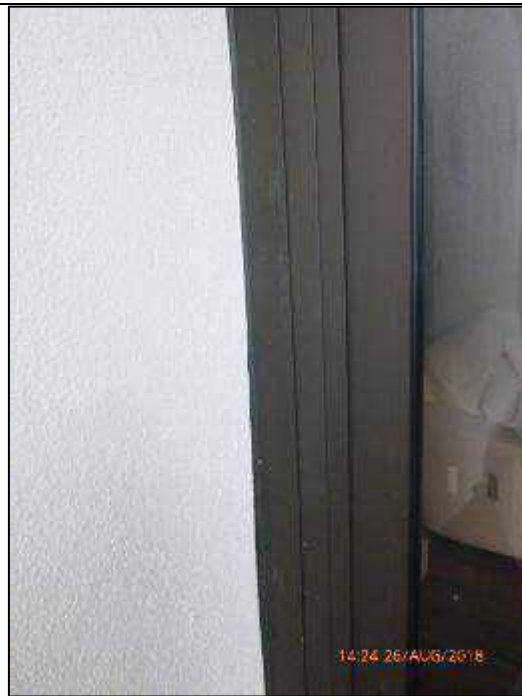
A photograph showing a white ceiling above dark kitchen cupboards. There is a visible gap or separation between the ceiling and the cupboards. A date stamp '14/24 26/AUG/2018' is visible in the bottom right corner.
876	Lounge room window frames	See section 5.7.1	See section 5.7.2

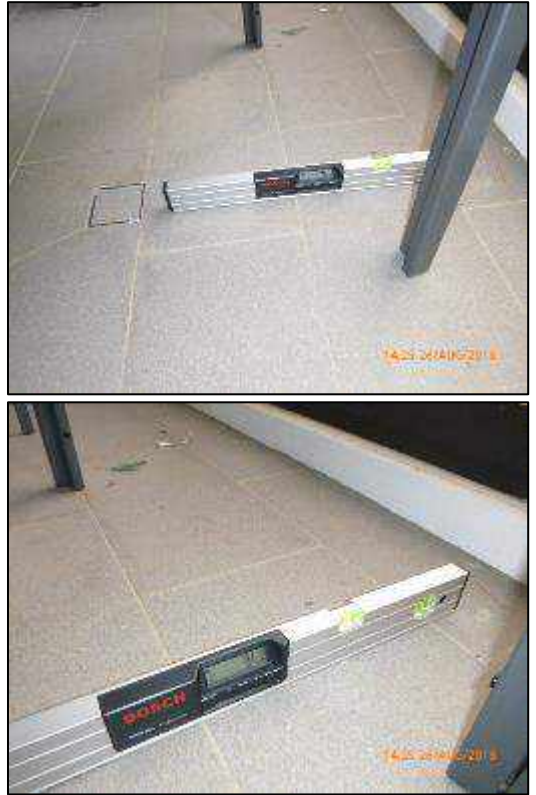
Item	Location	Defect description and Breach	Rectification	Photograph (if applicable)
877	Balcony	See section 5.2.1 Falls (mm); 4/1000	See section 5.2.2

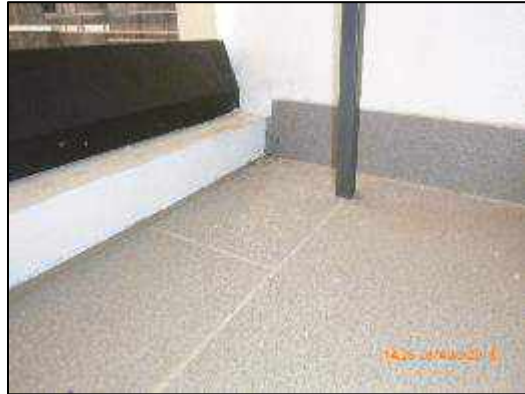
Item	Location	Defect description and Breach	Rectification	Photograph (if applicable)
878	Balcony	See section 5.3.1	See section 5.3.2

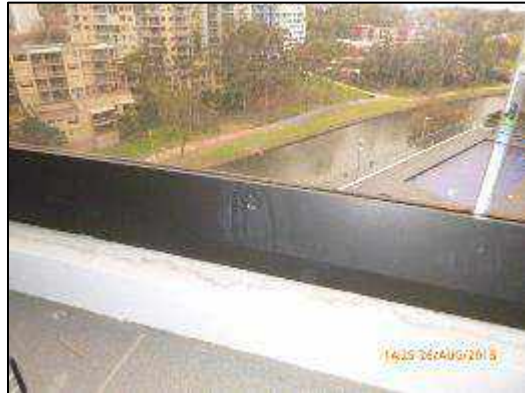
879	Balcony balustrade	See section 5.8.1	See section 5.8.2

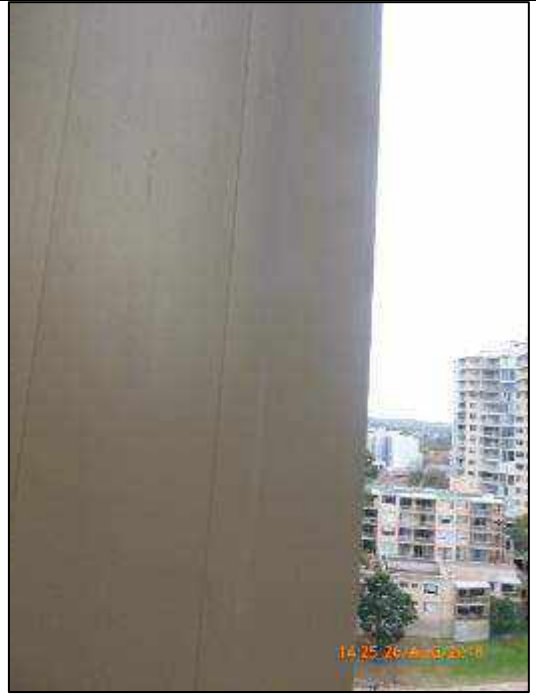
Item	Location	Defect description and Breach	Rectification	Photograph (if applicable)
880	Balcony façade fins	See section 5.7.1	See section 5.7.2

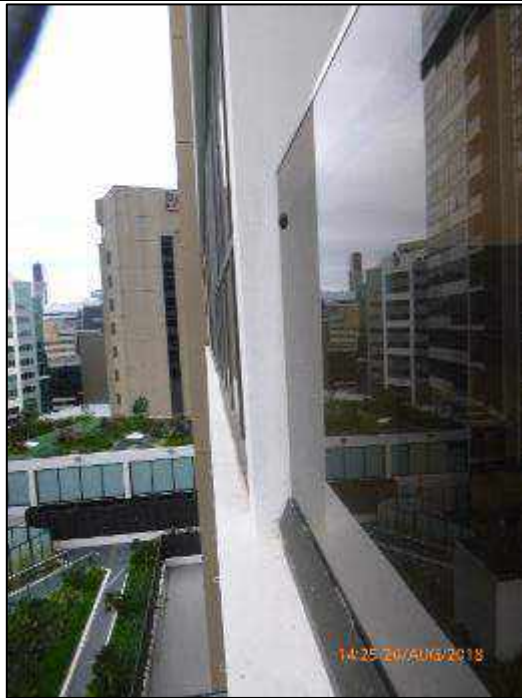
Item	Location	Defect description and Breach	Rectification	Photograph (if applicable)
881	Balcony balustrade	See section 5.9.1	See section 5.9.2

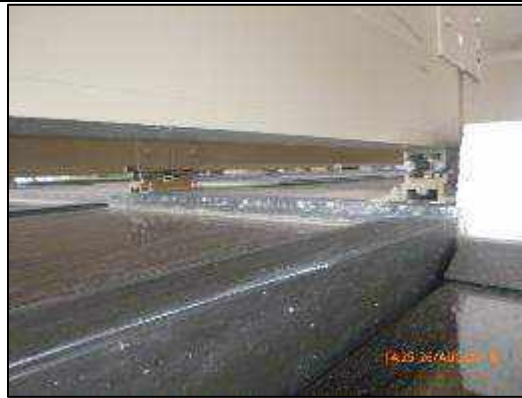
882	Façade in balcony area.	<p>Construction debris observed on façade of building</p> <p>Home Building Act (NSW) 1989</p> <ul style="list-style-type: none"> Part 2C, 18B (a) and (c). <p>This is a breach of part (a) of the act because the surface has not been finished in a proper workmanlike manner that would prevent loss of appearance to the surface.</p>	<ol style="list-style-type: none"> 1. Protect all adjoining surfaces. 2. Use a suitable cleaning agent to remove residue and clear debris. 3. Clean up the work area.

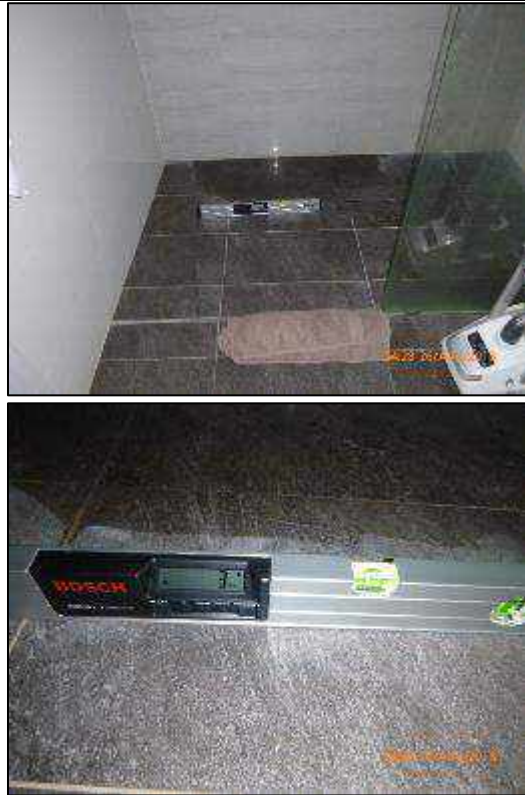
Item	Location	Defect description and Breach	Rectification	Photograph (if applicable)
		Loss Suffered Loss suffered is cost of rectification.		
883	Main bathroom	See section 5.1.1 Falls (mm); 3/1000	See section 5.1.2

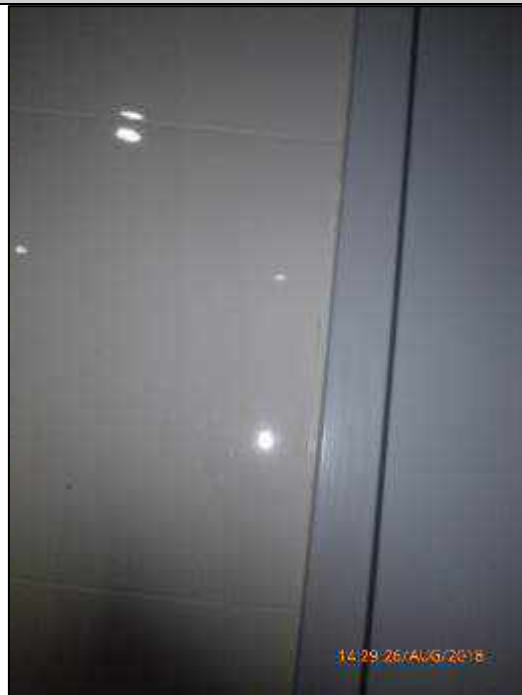
Item	Location	Defect description and Breach	Rectification	Photograph (if applicable)
884	Wall adjacent to main bathroom door	See section 5.9.1	See section 5.9.2
