SydneyStrataReport

STRATA REPORT

Client	Church Street Parramatta Property Pty Ltd
Address of property	Unit 3303/330 Church Street, Parramatta, NSW.
Lot	359
Strata Plan	SP 94469
Name of Strata Management Co.	NSW Strata
Telephone Number of Strata Agent	8980 1841
Report Date	15 February 2024

BUILDING DEFECTS REPORT Part 1/2

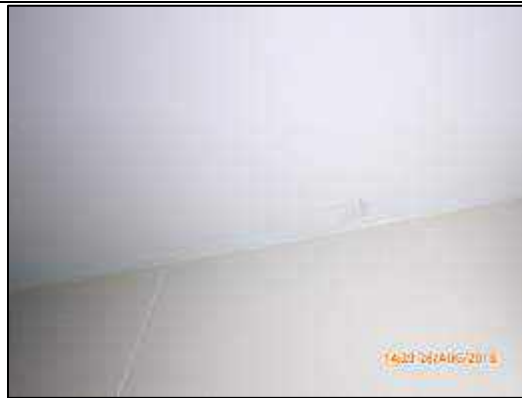
A photograph showing a dark, possibly wet or stained, area on a wall. The lighting is dim, and there are some bright spots that could be reflections or light sources. The date '14/29/26/AUG/2018' is visible in the bottom right corner.
885	Ceiling in main bathroom	See section 5.10.1	See section 5.10.2

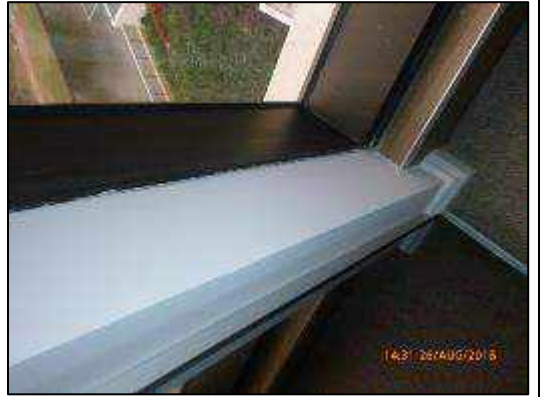
Item	Location	Defect description and Breach	Rectification	Photograph (if applicable)
886	Main bedroom window frames	See section 5.9.1	See section 5.9.2

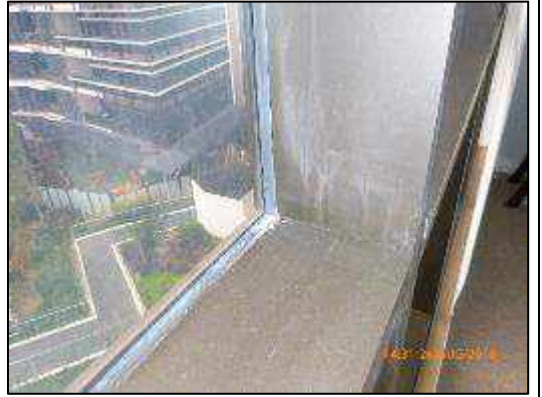
887	Main bedroom window frames	See section 5.8.1	See section 5.8.2

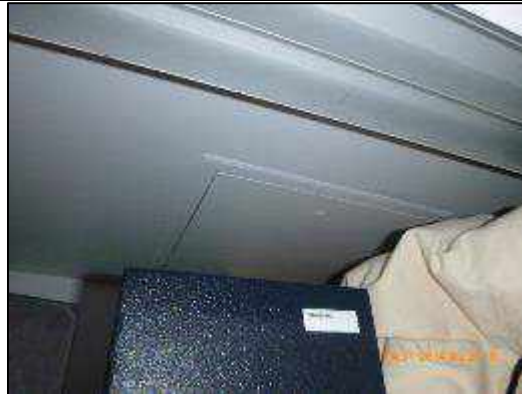
Item	Location	Defect description and Breach	Rectification	Photograph (if applicable)
888	Main bedroom built in	See section 5.6.1	See section 5.6.2

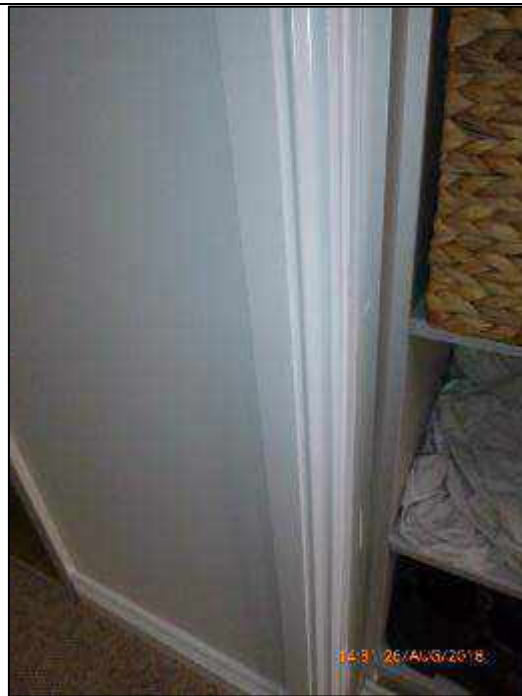
889	Wall adjacent to main bedroom built in	See section 5.13.1	See section 5.13.2

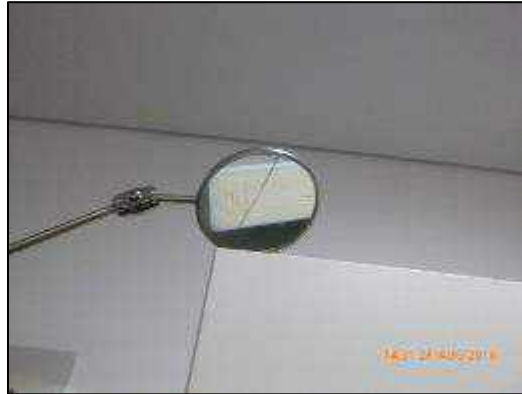
Item	Location	Defect description and Breach	Rectification	Photograph (if applicable)
890	<i>Doors throughout the unit (x2)</i>	See section 5.5.1	See section 5.5.2

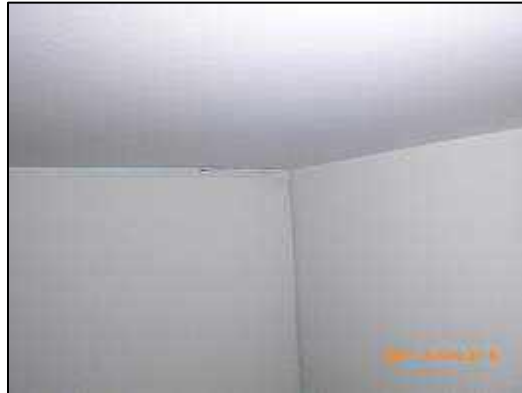
891	<i>Lounge room</i>	See section 5.11.1	See section 5.11.2

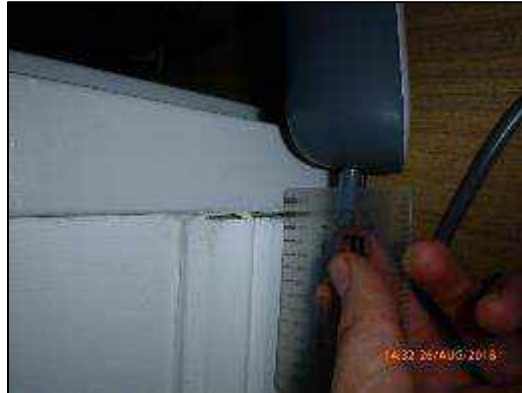
Item	Location	Defect description and Breach	Rectification	Photograph (if applicable)
892	Lounge room skirting board adjacent to linen cupboard.	See section 5.14.1 Separation; 2mm	See section 5.14.2

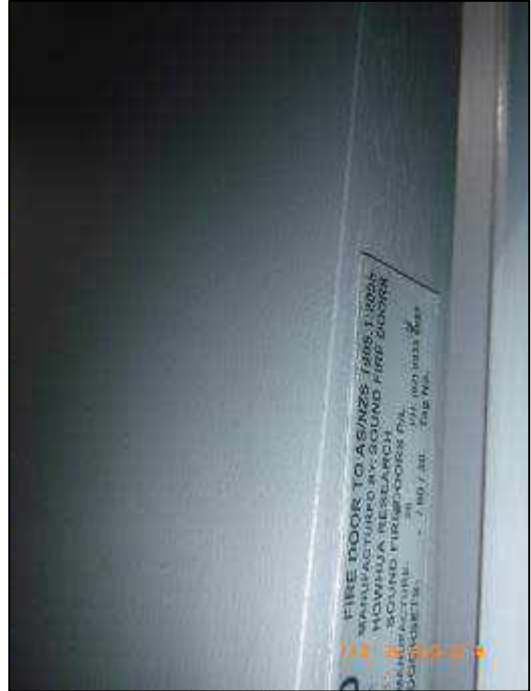
Item	Location	Defect description and Breach	Rectification	Photograph (if applicable)
Unit 804				
893	Front entry door	See section 5.12.1	See section 5.12.2

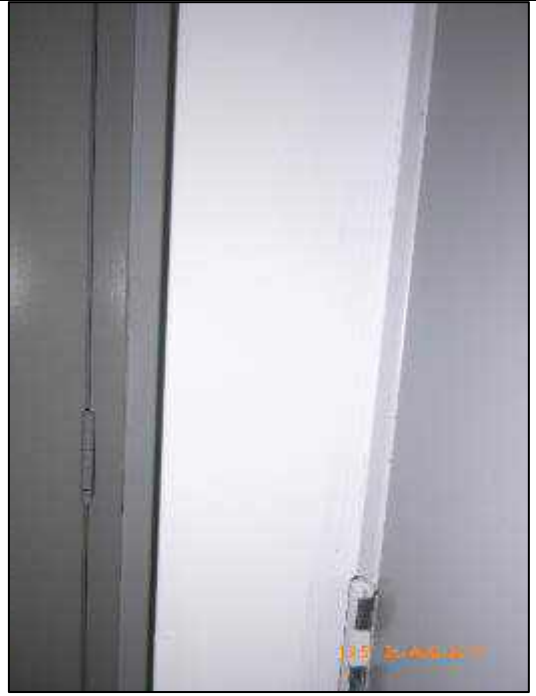
Item	Location	Defect description and Breach	Rectification	Photograph (if applicable)
894	Wall adjacent to front entry door	See section 5.13.1	See section 5.13.2

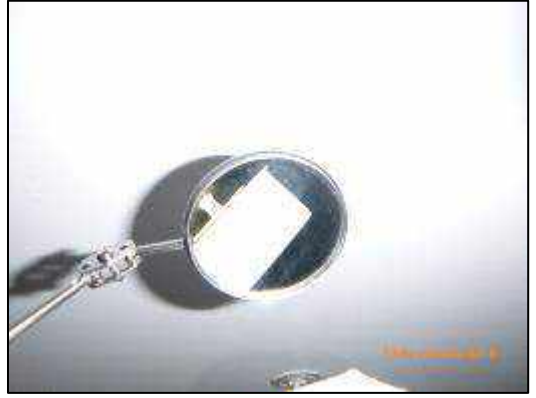
895	Doors throughout the unit (x3)	See section 5.5.1	See section 5.5.2

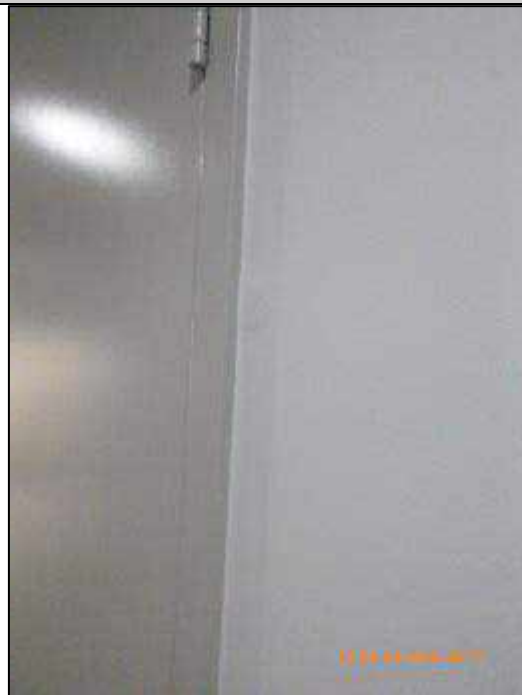
Item	Location	Defect description and Breach	Rectification	Photograph (if applicable)
896	Wall adjacent to front entry door	See section 5.10.1	See section 5.10.2

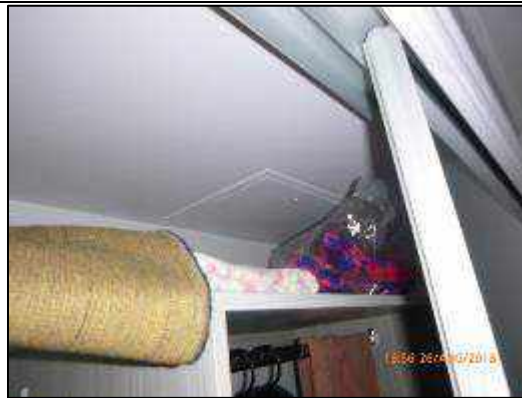
897	Main bedroom built in	See section 5.6.1	See section 5.6.2

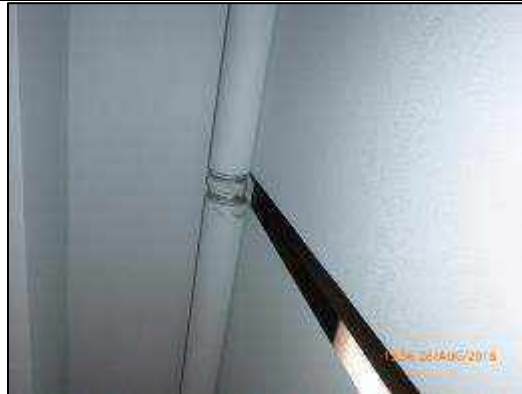
Item	Location	Defect description and Breach	Rectification	Photograph (if applicable)
898	Main bedroom window bulkhead	See section 5.13.1	See section 5.13.2

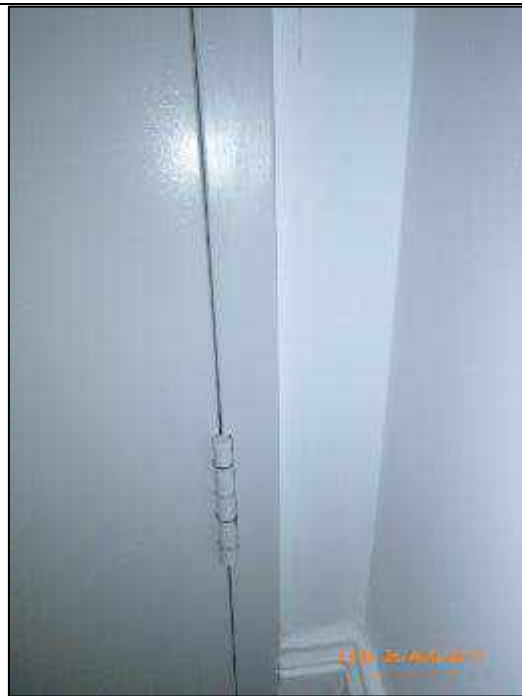
899	Wall adjacent to main bedroom door	See section 5.10.1	See section 5.10.2

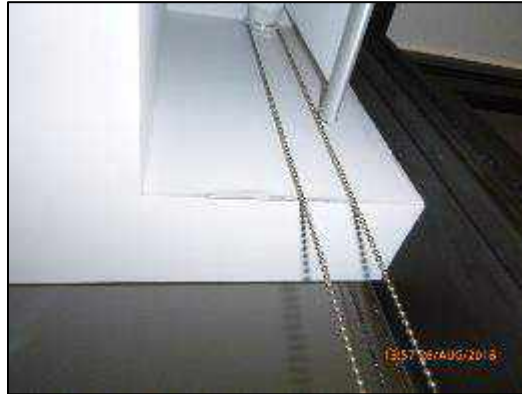
Item	Location	Defect description and Breach	Rectification	Photograph (if applicable)
900	Lounge room sliding door bulkhead	See section 5.10.1	See section 5.10.2

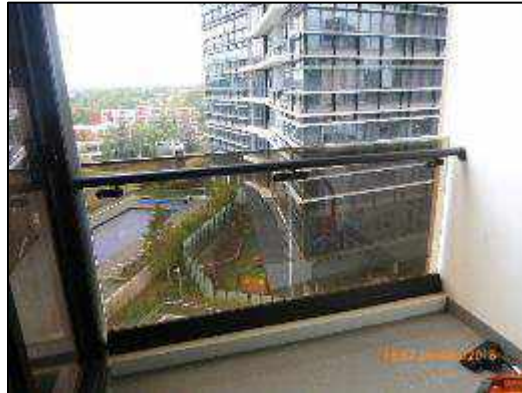
901	Balcony	See section 5.4.1	See section 5.4.2

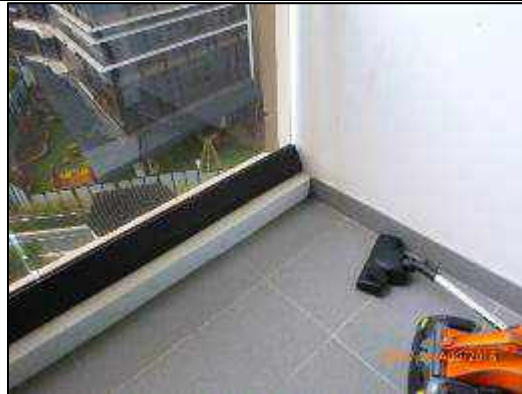
Item	Location	Defect description and Breach	Rectification	Photograph (if applicable)
902	Balcony	See section 5.3.1	See section 5.3.2

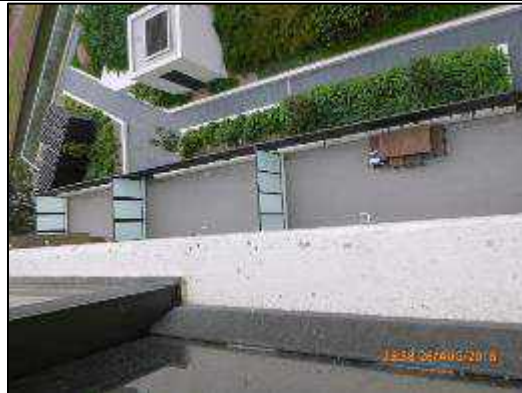
903	Balcony balustrade	<p>Construction debris observed on façade of building</p> <p>Home Building Act (NSW) 1989</p> <ul style="list-style-type: none"> Part 2C, 18B (a) and (c). <p>This is a breach of part (a) of the act because the surface has not been finished in a proper workmanlike manner that would prevent loss of appearance to the surface.</p> <p>Loss Suffered Loss suffered is cost of rectification.</p>	<ol style="list-style-type: none"> 1. Protect all adjoining surfaces. 2. Use a suitable cleaning agent to remove residue and clear debris. 3. Clean up the work area.

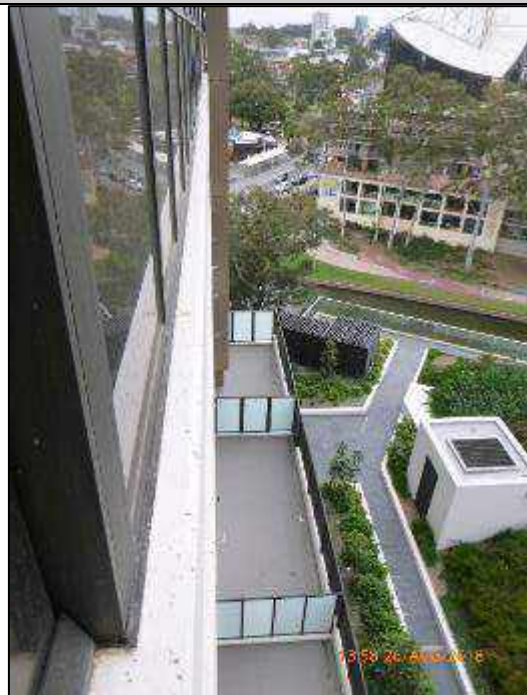
Item	Location	Defect description and Breach	Rectification	Photograph (if applicable)
904	<i>Façade of balcony area</i>	<p>Construction debris observed on façade of building</p> <p>Home Building Act (NSW) 1989</p> <ul style="list-style-type: none"> Part 2C, 18B (a) and (c). <p>This is a breach of part (a) of the act because the surface has not been finished in a proper workmanlike manner that would prevent loss of appearance to the surface.</p> <p>Loss Suffered Loss suffered is cost of rectification.</p>	<ol style="list-style-type: none"> 1. Protect all adjoining surfaces. 2. Use a suitable cleaning agent to remove residue and clear debris. 3. Clean up the work area.

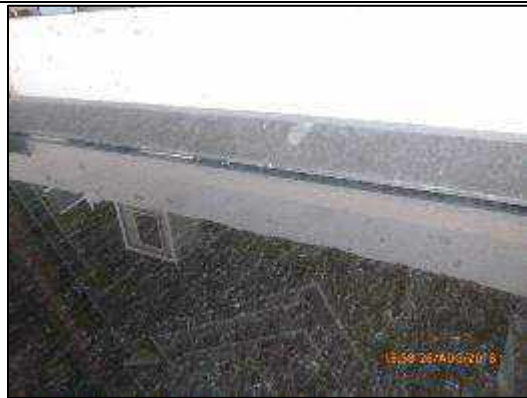
905	<i>Balcony balustrade</i>	See section 5.8.1	See section 5.8.2

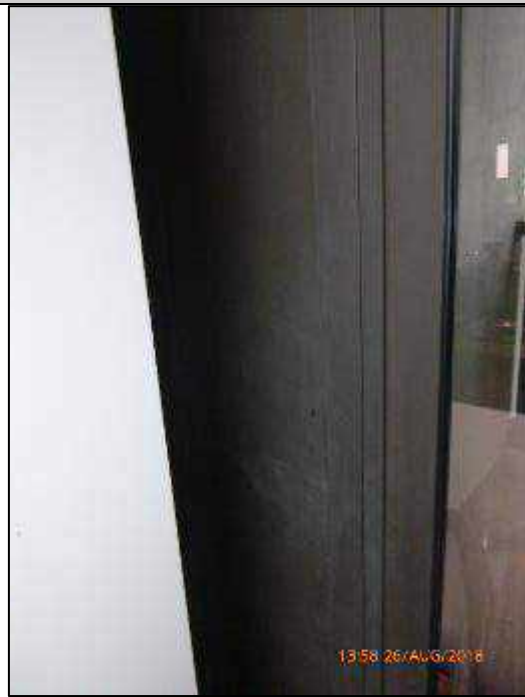
Item	Location	Defect description and Breach	Rectification	Photograph (if applicable)
906	Balcony sliding door	See section 5.7.1	See section 5.7.2

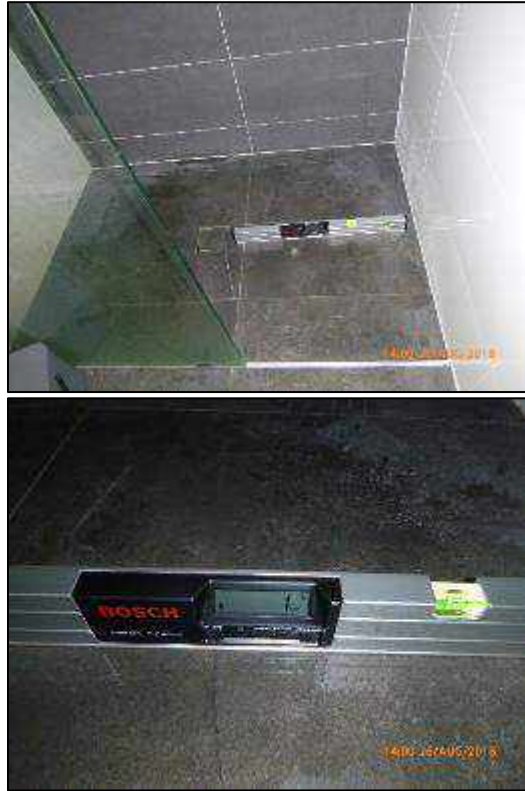
Item	Location	Defect description and Breach	Rectification	Photograph (if applicable)
907	Main bathroom	See section 5.2.1 Falls (mm); 1/1000	See section 5.2.2

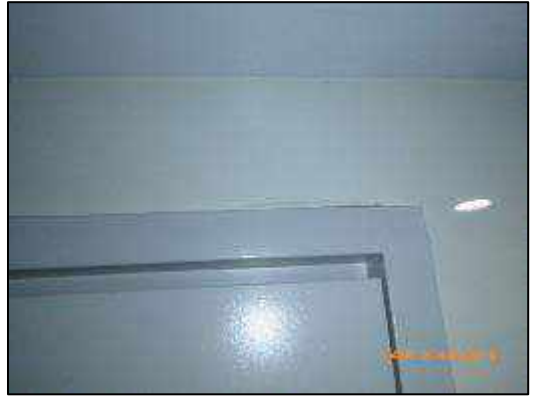
Item	Location	Defect description and Breach	Rectification	Photograph (if applicable)
908	Wall above main bathroom door	See section 5.9.1	See section 5.9.2

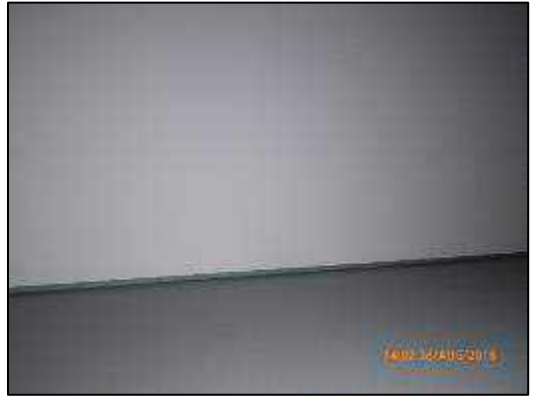
909	Lounge room	See section 5.11.1	See section 5.11.2

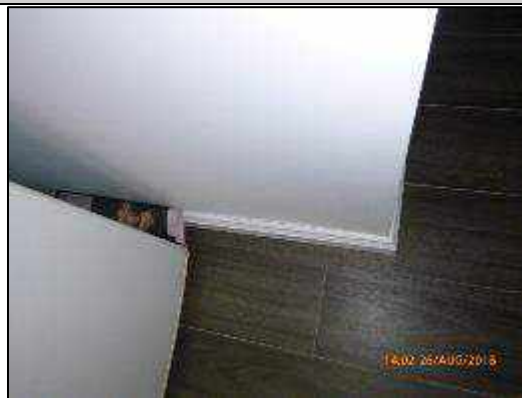
Item	Location	Defect description and Breach	Rectification	Photograph (if applicable)
910	Lounge room skirting board	See section 5.10.1	See section 5.10.2

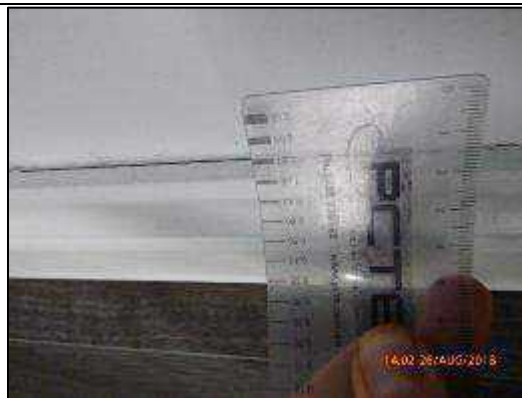
A photograph showing a close-up of a white skirting board meeting a dark wall. There is a visible gap or separation between the board and the wall. A timestamp '14/02/2018 10:15' is visible in the bottom right corner.
911	Lounge room skirting board	See section 5.14.1 Separation; 1.5mm	See section 5.14.2

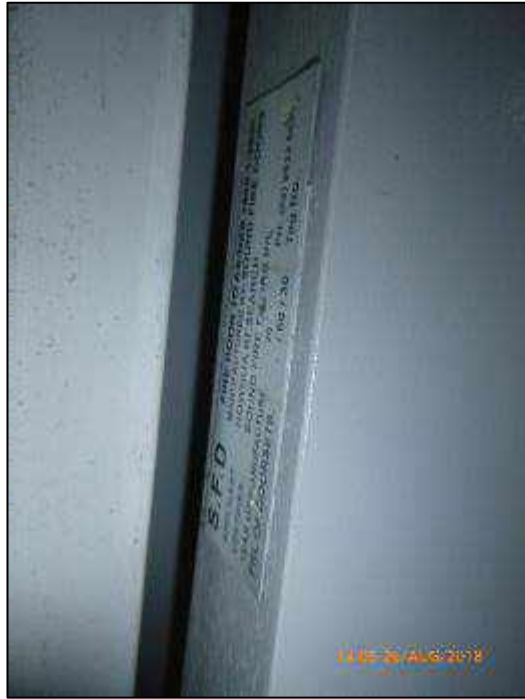
Item	Location	Defect description and Breach	Rectification	Photograph (if applicable)
Unit 806				
913	Front entry door	See section 5.12.1	See section 5.12.2

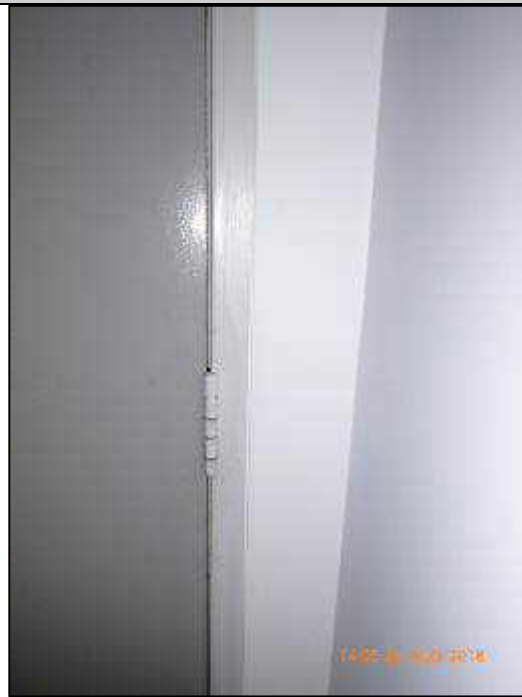
Item	Location	Defect description and Breach	Rectification	Photograph (if applicable)
914	Wall adjacent to front entry door	See section 5.13.1	See section 5.13.2

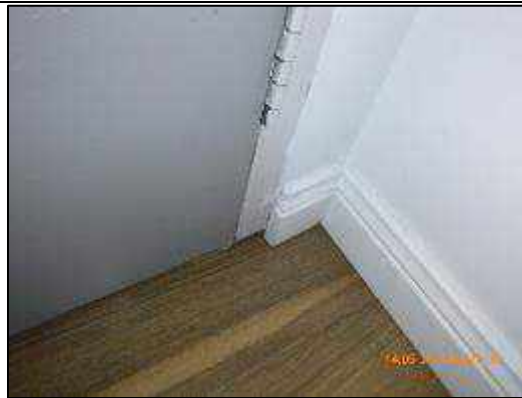
915	Wall adjacent to front entry door	See section 5.9.1	See section 5.9.2

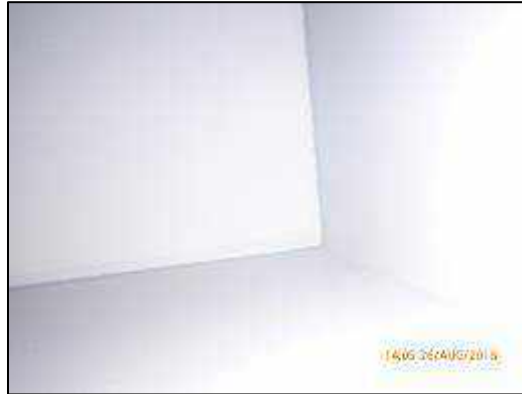
Item	Location	Defect description and Breach	Rectification	Photograph (if applicable)
916	Front entrance ceiling	See section 5.10.1	See section 5.10.2

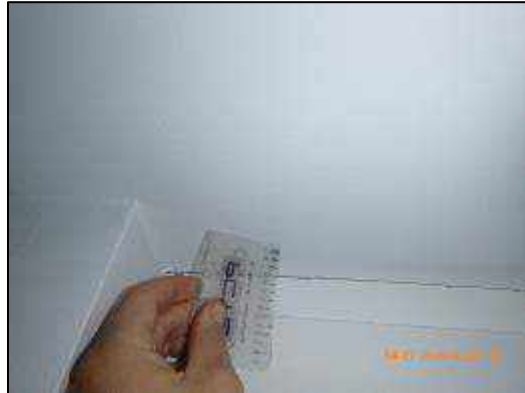
Item	Location	Defect description and Breach	Rectification	Photograph (if applicable)
918	<i>Ceiling above kitchen cupboards</i>	See section 5.14.1 Separation; 2mm	See section 5.14.2

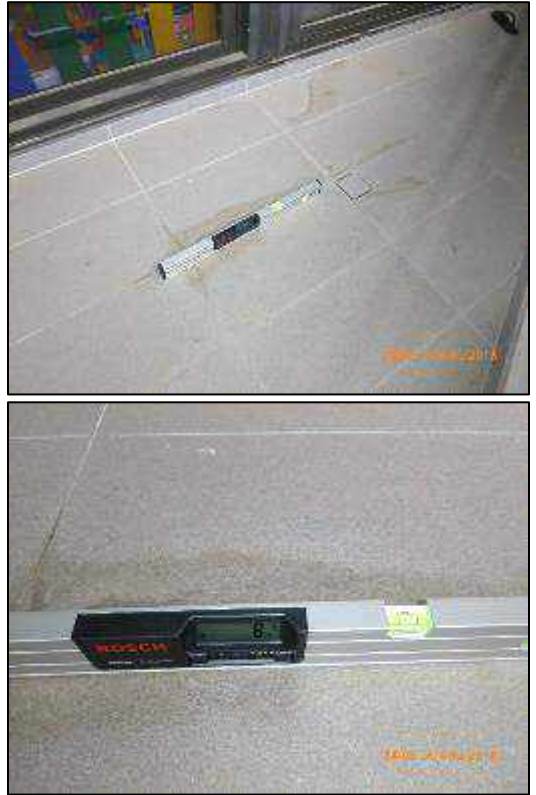
Item	Location	Defect description and Breach	Rectification	Photograph (if applicable)
919	Balcony	See section 5.2.1 Falls (mm); 8/1000	See section 5.2.2

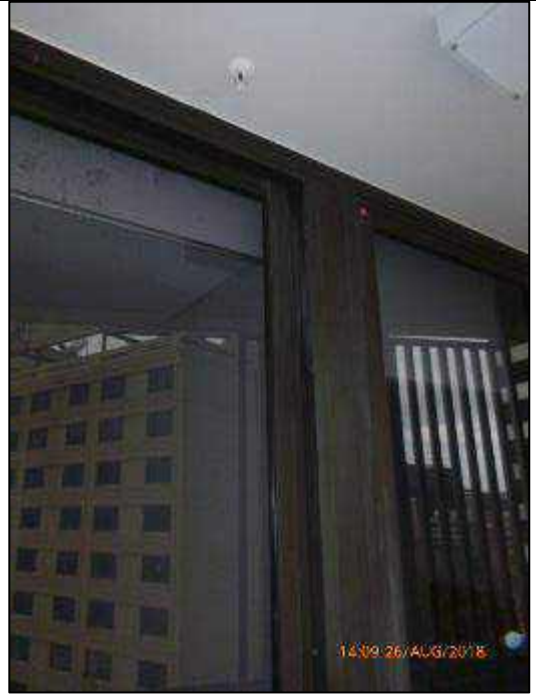
Item	Location	Defect description and Breach	Rectification	Photograph (if applicable)
920	Balcony sliding door	See section 5.9.1	See section 5.9.2

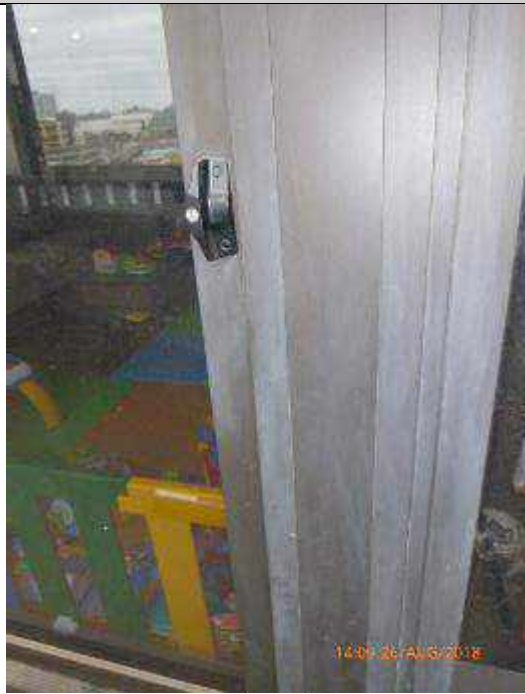
Item	Location	Defect description and Breach	Rectification	Photograph (if applicable)
921	Balcony sliding door	See section 5.7.1	See section 5.7.2

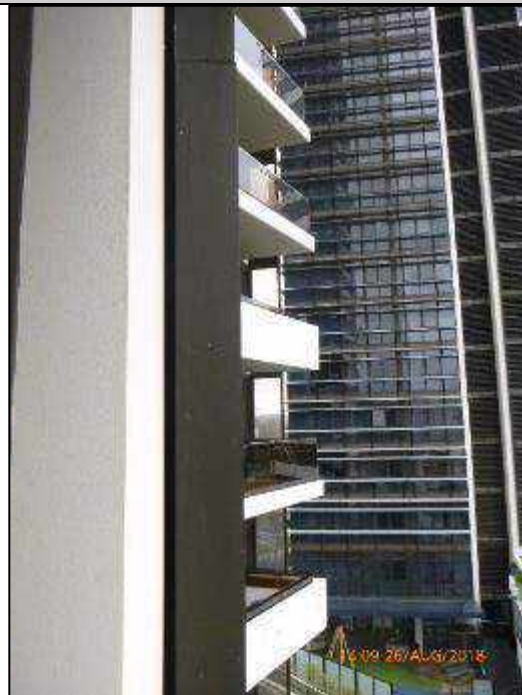
Item	Location	Defect description and Breach	Rectification	Photograph (if applicable)
922	<i>Façade of balcony area</i>	<p>Construction debris observed on façade of building</p> <p>Home Building Act (NSW) 1989</p> <ul style="list-style-type: none"> Part 2C, 18B (a) and (c). <p>This is a breach of part (a) of the act because the surface has not been finished in a proper workmanlike manner that would prevent loss of appearance to the surface.</p> <p>Loss Suffered Loss suffered is cost of rectification.</p>	<ol style="list-style-type: none"> 1. Protect all adjoining surfaces. 2. Use a suitable cleaning agent to remove residue and clear debris. 3. Clean up the work area.

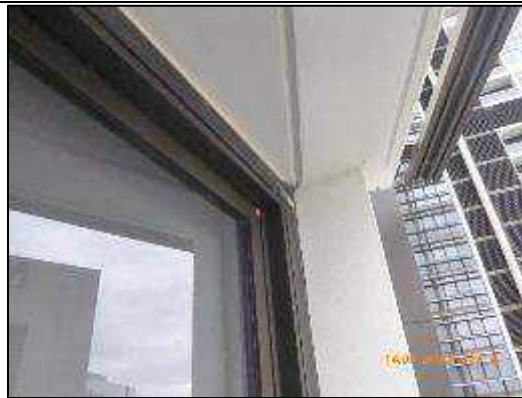
923	<i>Balcony ceiling</i>	See section 5.10.1	See section 5.10.2

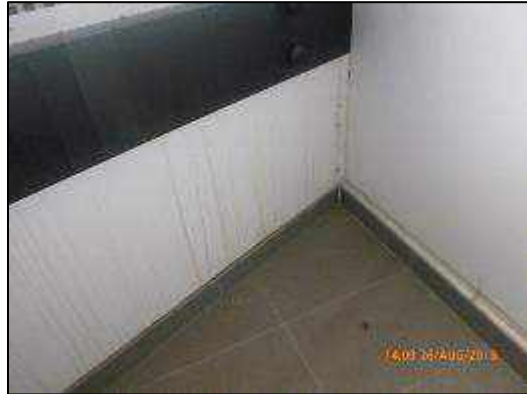
Item	Location	Defect description and Breach	Rectification	Photograph (if applicable)
924	Balcony	See section 5.3.1	See section 5.3.2

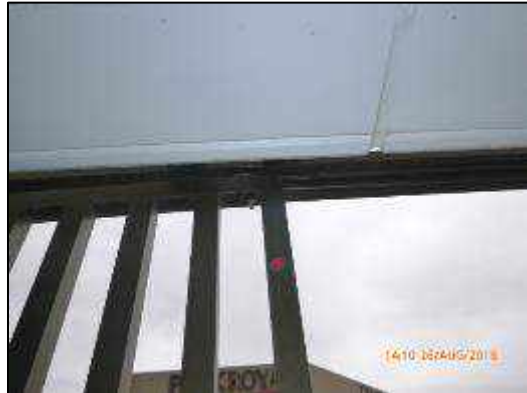
925	Balcony ceiling above balustrade	See section 5.9.1	See section 5.9.2

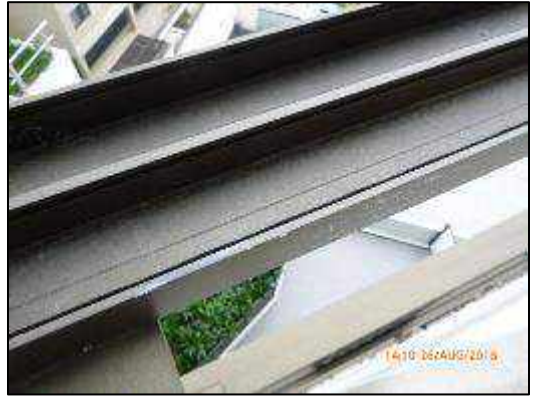
Item	Location	Defect description and Breach	Rectification	Photograph (if applicable)
926	Main bedroom window frames	See section 5.7.1	See section 5.7.2

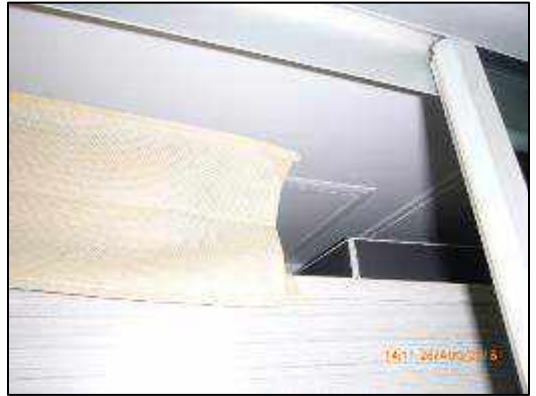
927	Main bedroom built in	See section 5.6.1	See section 5.6.2

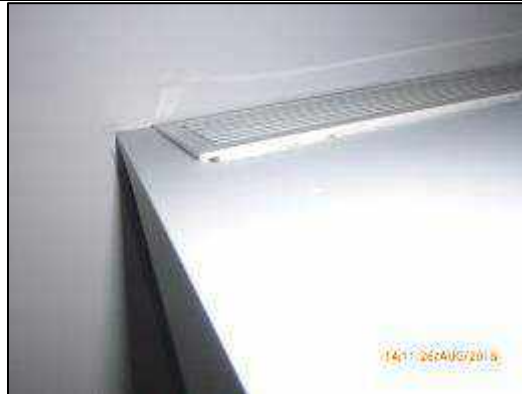
Item	Location	Defect description and Breach	Rectification	Photograph (if applicable)
928	Main bedroom air conditioner vent	<p>Air conditioner vent above built in in main bedroom observed to be incorrectly installed.</p> <p>Home Building Act (NSW) 1989</p> <ul style="list-style-type: none"> Part 2C, 18B (a) and (c). <p>This is a breach of part (a) of the act because the air conditioner vent has not been finished in a proper workmanlike manner that would prevent loss of appearance to the unit.</p> <p>Loss Suffered Loss suffered is cost of rectification</p>	Engage a licenced tradesman to remove and correctly re-install the air conditioner vent to fit flush with the wall.

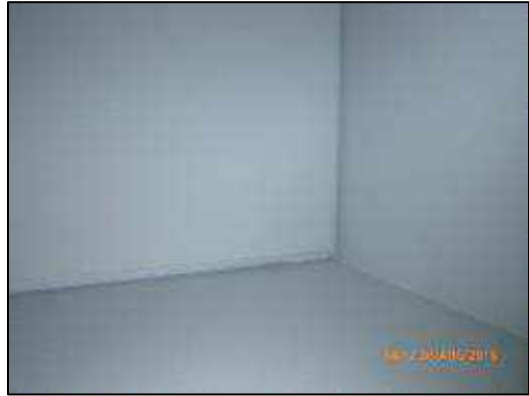
Item	Location	Defect description and Breach	Rectification	Photograph (if applicable)
930	Main bedroom	See section 5.11.1	See section 5.11.2

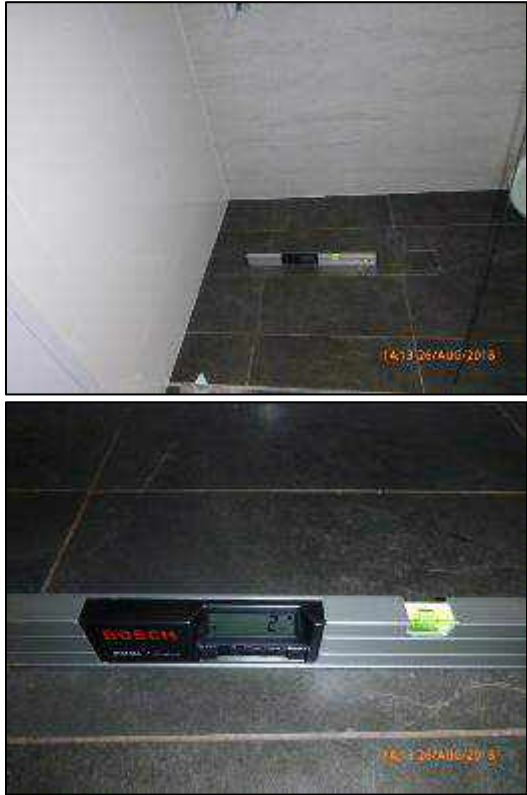
Item	Location	Defect description and Breach	Rectification	Photograph (if applicable)
931	Main bedroom ensuite	See section 5.1.1 Falls (mm); 2/1000	See section 5.1.2

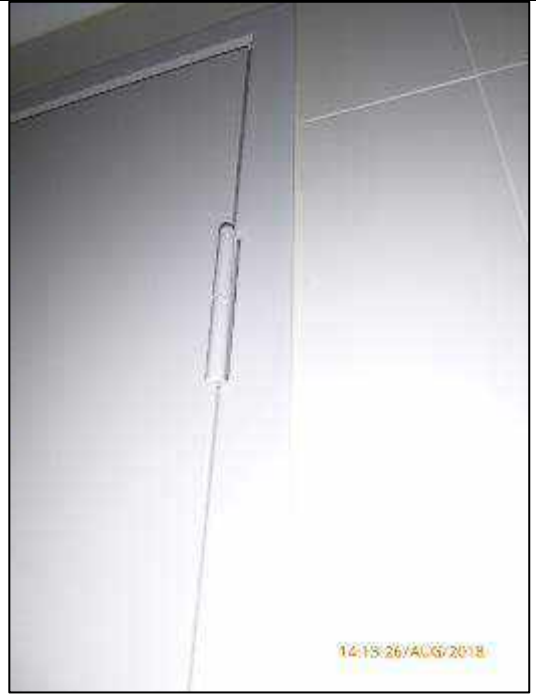
Item	Location	Defect description and Breach	Rectification	Photograph (if applicable)
932	Wall adjacent to main bedroom ensuite door	See section 5.9.1	See section 5.9.2

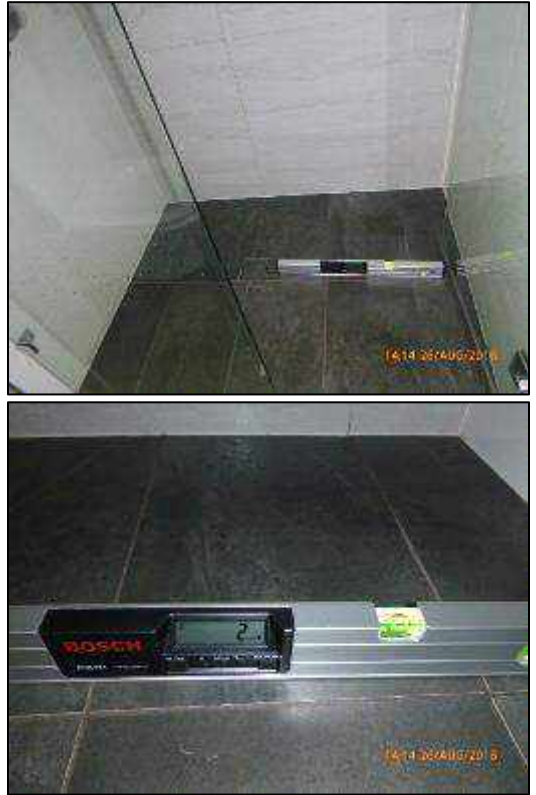
Item	Location	Defect description and Breach	Rectification	Photograph (if applicable)
933	Main bathroom	See section 5.1.1 Falls (mm); 2/1000	See section 5.1.2

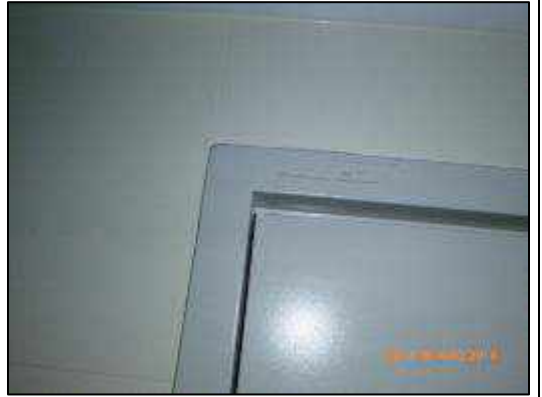
Item	Location	Defect description and Breach	Rectification	Photograph (if applicable)
934	Main bathroom door frame	See section 5.10.1	See section 5.10.2

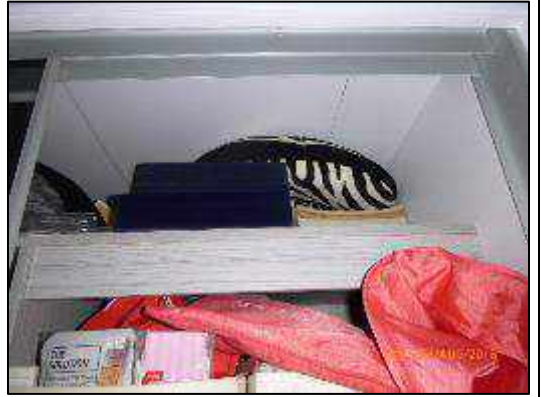
935	Second bedroom built in	See section 5.6.1	See section 5.6.2

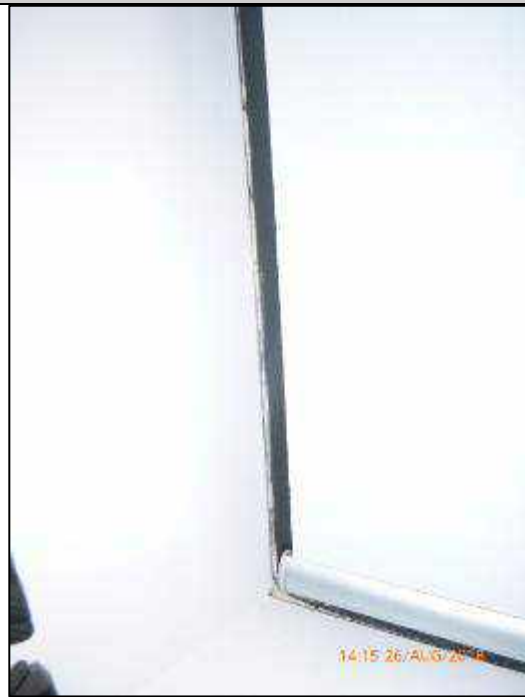
Item	Location	Defect description and Breach	Rectification	Photograph (if applicable)
936	Second bedroom window frames	See section 5.9.1	See section 5.9.2

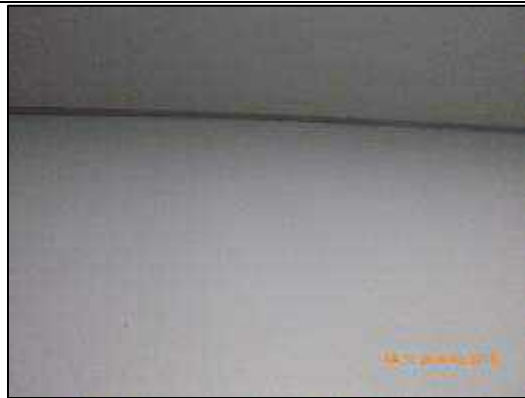
937	Second bedroom	See section 5.11.1	See section 5.11.2

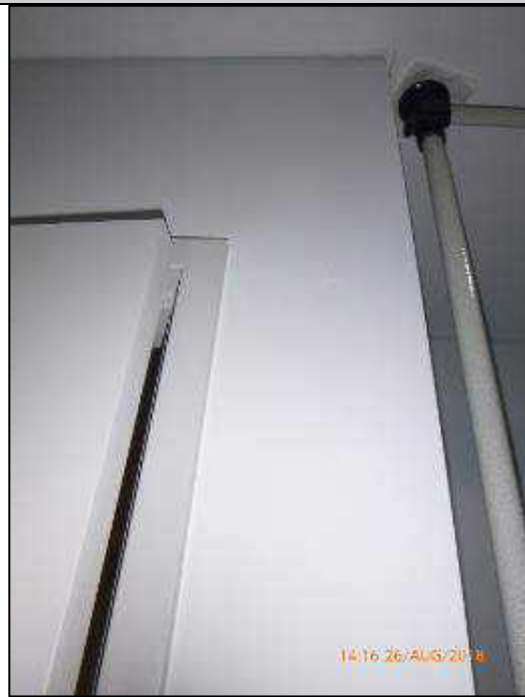
Item	Location	Defect description and Breach	Rectification	Photograph (if applicable)
938	Wall adjacent to study room	See section 5.13.1	See section 5.13.2

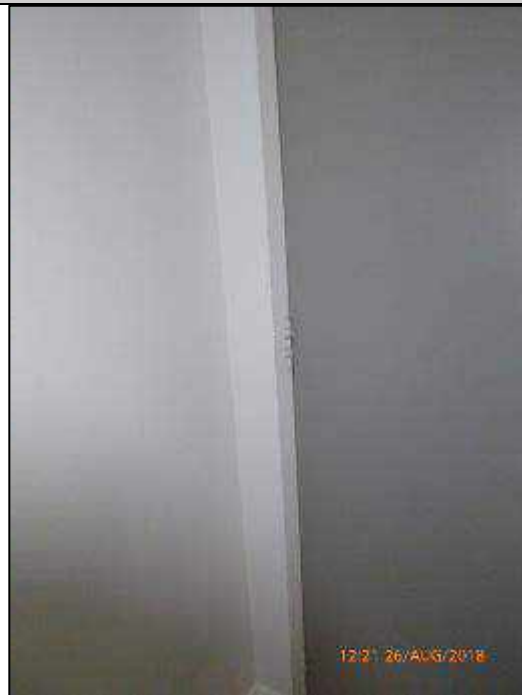
Item	Location	Defect description and Breach	Rectification	Photograph (if applicable)
940	Wall adjacent to front entry door	See section 5.13.1	See section 5.13.2

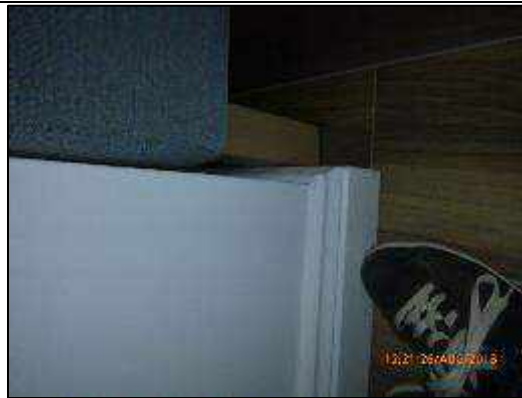
A photograph showing a vertical crack or gap in a light-colored wall. The crack runs vertically down the center of the frame. A timestamp '12/21/26/AUG/2018' is visible in the bottom right corner.
941	Lounge room wall adjacent to front entrance	See section 5.13.1	See section 5.13.2

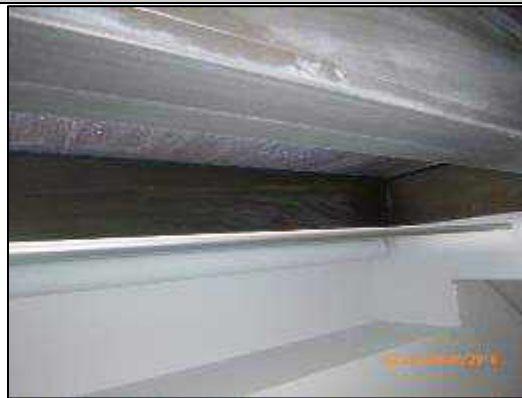
Item	Location	Defect description and Breach	Rectification	Photograph (if applicable)
942	Kitchen window bulkhead	See section 5.13.1	See section 5.13.2

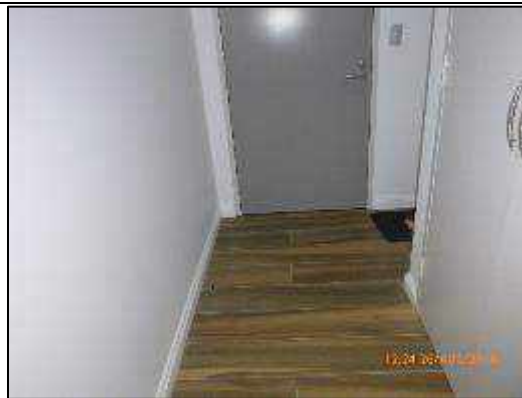
943	Front entry door	<p>Resident advised of excessive wind noise coming through front door.</p> <p>Home Building Act (NSW) 1989</p> <ul style="list-style-type: none"> Part 2C, 18B (a) & (c). <p>Loss Suffered</p> <p>Loss suffered is cost of rectification.</p>	Engage a licenced tradesman to reseal door to prevent excessive noise to the unit in accordance with manufacturers specifications.

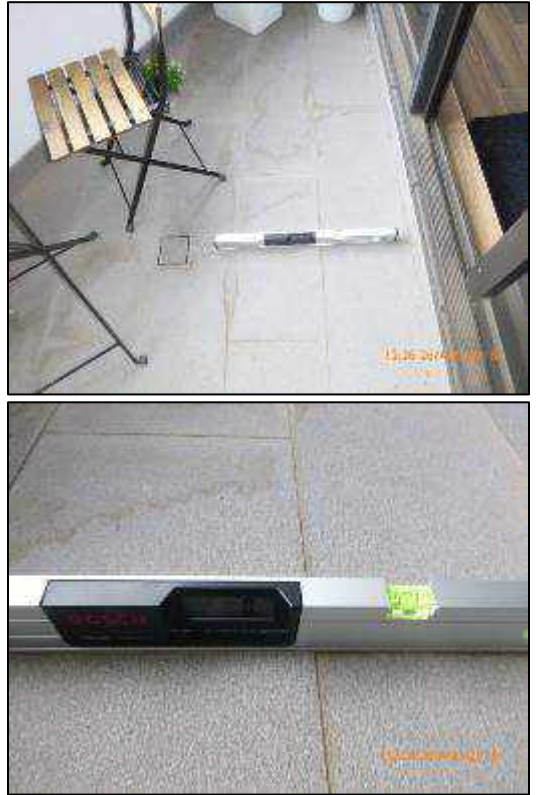
Item	Location	Defect description and Breach	Rectification	Photograph (if applicable)
946	Balcony	See section 5.2.1 Falls (mm); 0/1000	See section 5.2.2

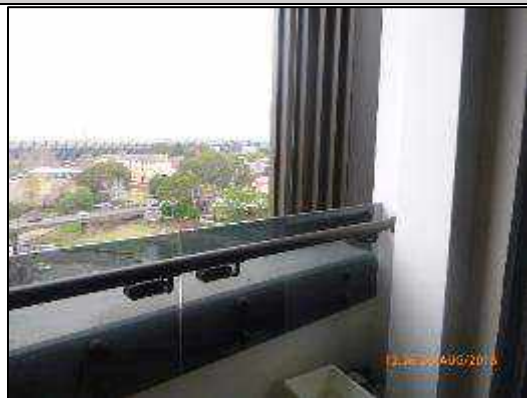
Item	Location	Defect description and Breach	Rectification	Photograph (if applicable)
947	Balcony	See section 5.4.1	See section 5.4.2

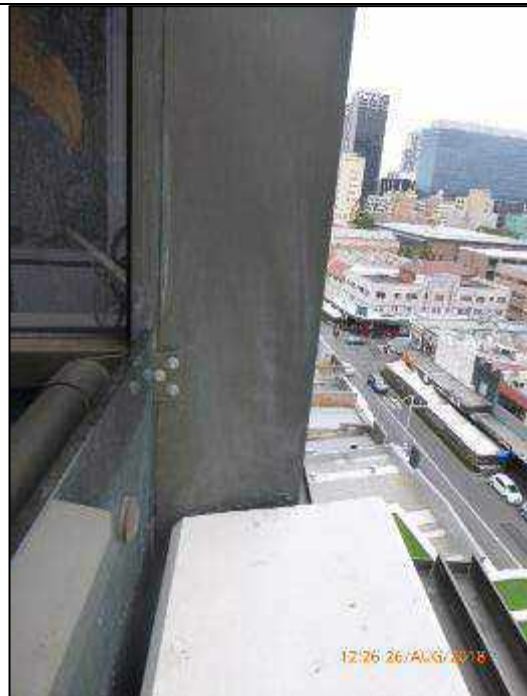
A photograph showing a balcony railing and a view of a cityscape through a window. The railing is dark and appears to be made of metal. The view outside shows a city with buildings and greenery. A timestamp '12/26/2018' is visible in the bottom right corner of the photo.
948	Façade panel in balcony area	See section 5.8.1	See section 5.8.2

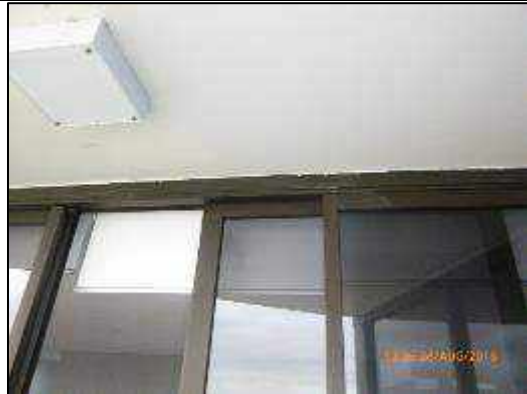
Item	Location	Defect description and Breach	Rectification	Photograph (if applicable)
949	Balcony sliding door	See section 5.9.1	See section 5.9.2

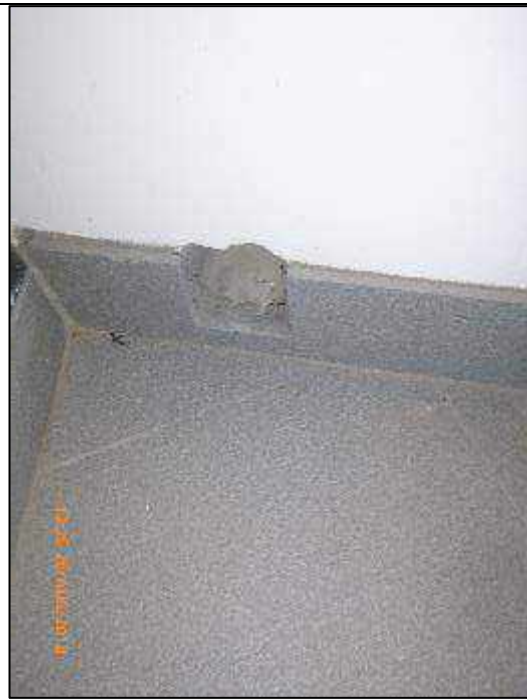
950	Balcony	See section 5.15.1	See section 5.15.2

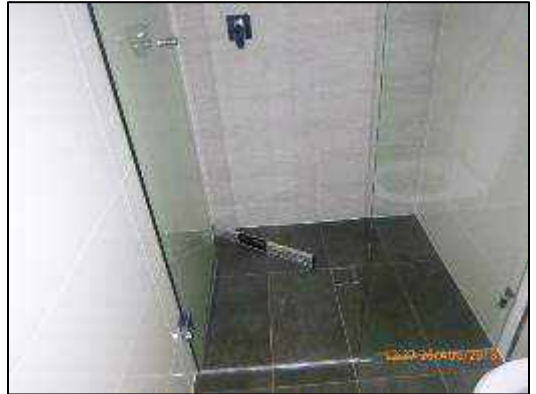
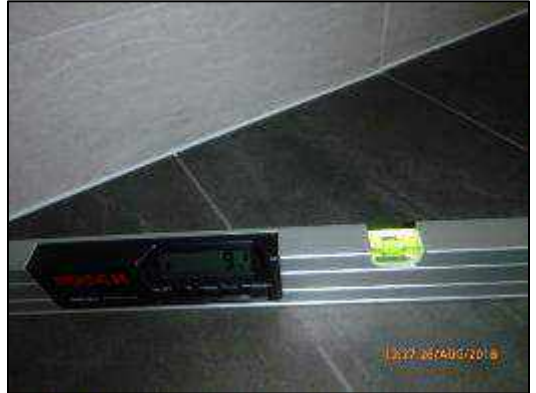
Item	Location	Defect description and Breach	Rectification	Photograph (if applicable)
951	Main bathroom	See section 5.1.1 Falls (mm); 9/1000	See section 5.1.2

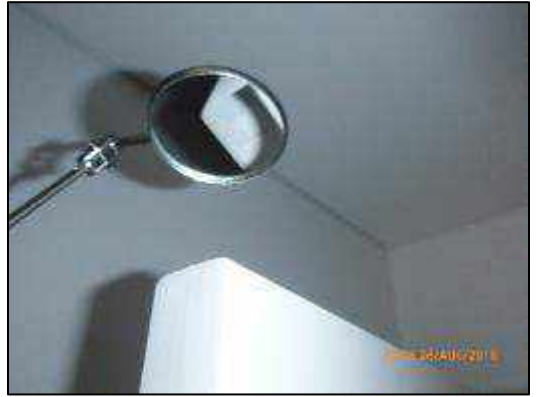
Item	Location	Defect description and Breach	Rectification	Photograph (if applicable)
952	<i>Doors throughout the unit (x3)</i>	See section 5.5.1	See section 5.5.2

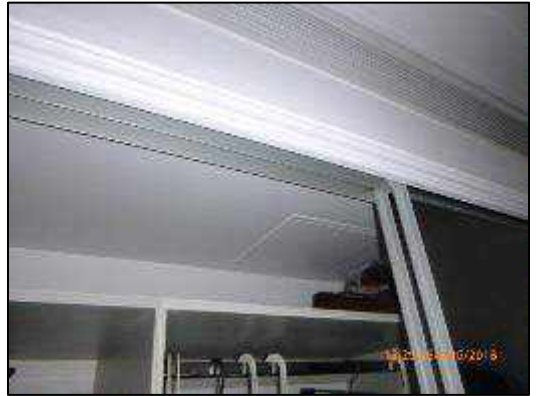
953	<i>Second bedroom built in</i>	See section 5.6.1	See section 5.6.2

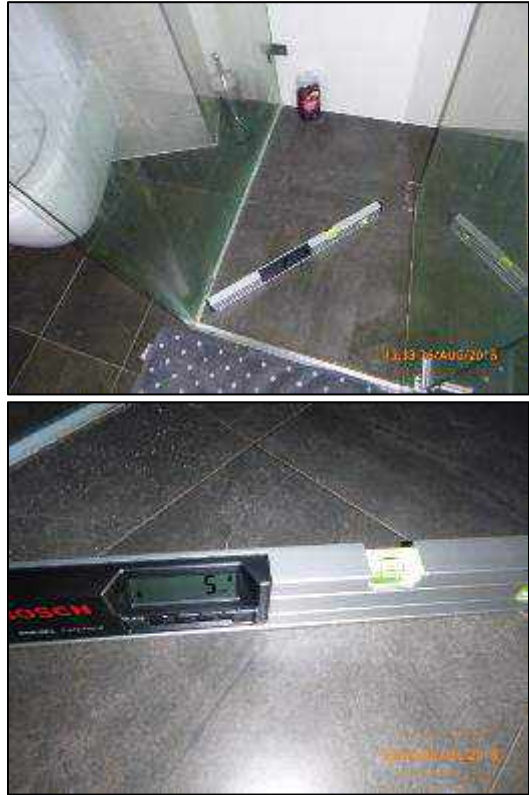
Item	Location	Defect description and Breach	Rectification	Photograph (if applicable)
956	Main bedroom ensuite	See section 5.1.1 Falls (mm); 5/1000	See section 5.1.2

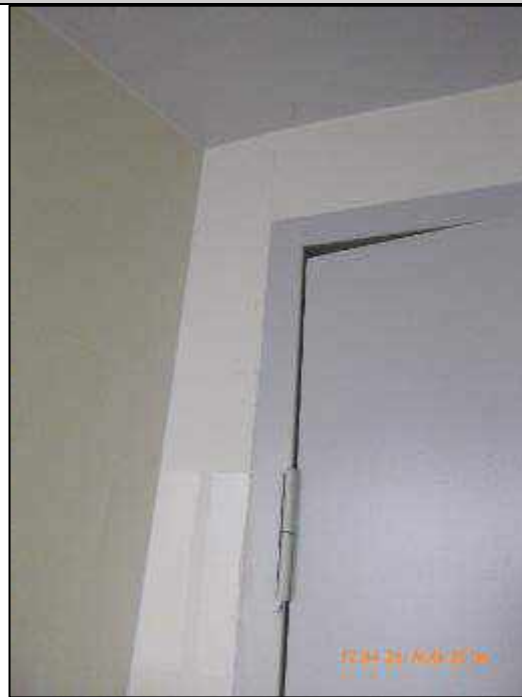
Item	Location	Defect description and Breach	Rectification	Photograph (if applicable)
957	Wall adjacent to main bedroom door	See section 5.10.1	See section 5.10.2

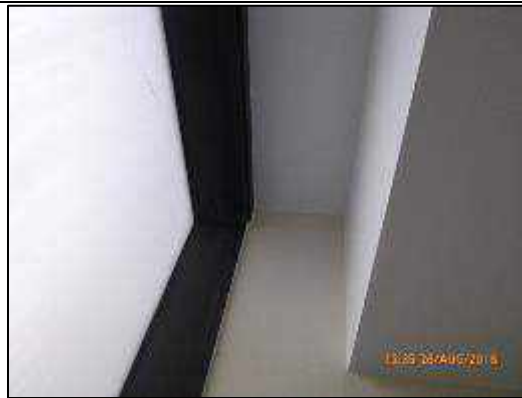
958	Main bedroom window bulkhead	See section 5.13.1	See section 5.13.2

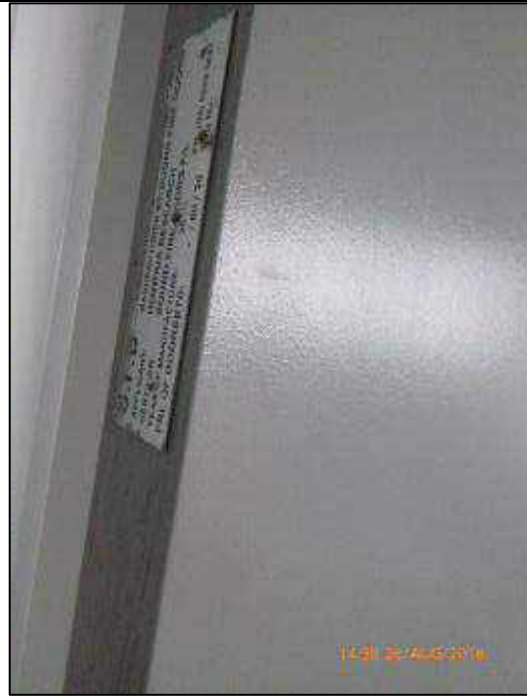
Item	Location	Defect description and Breach	Rectification	Photograph (if applicable)
Unit 808				
959		No access was provided.		
Unit 901				
960	Front entry door	See section 5.12.1	See section 5.12.2

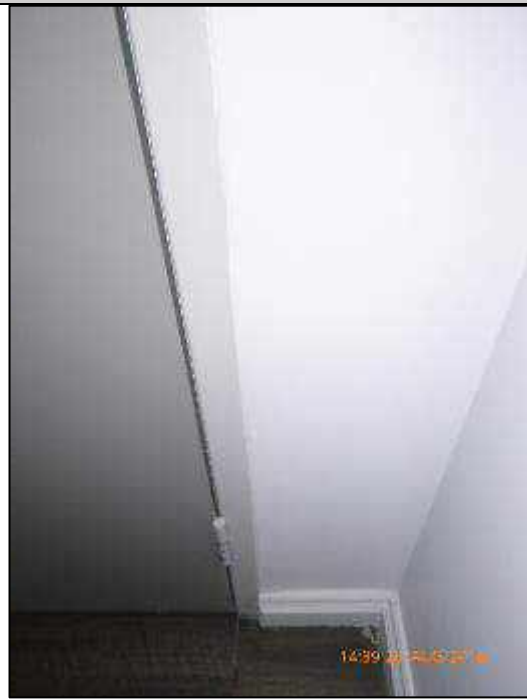
Item	Location	Defect description and Breach	Rectification	Photograph (if applicable)
961	Wall adjacent to front entry door	See section 5.13.1	See section 5.13.2

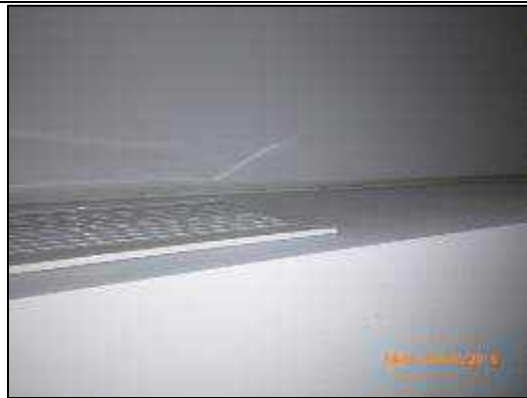
962	Kitchen area	See section 5.11.1	See section 5.11.2
