SydneyStrataReport

STRATA REPORT

Client	Church Street Parramatta Property Pty Ltd
Address of property	Unit 3303/330 Church Street, Parramatta, NSW.
Lot	359
Strata Plan	SP 94469
Name of Strata Management Co.	NSW Strata
Telephone Number of Strata Agent	8980 1841
Report Date	15 February 2024

BUILDING DEFECTS REPORT Part 1/2

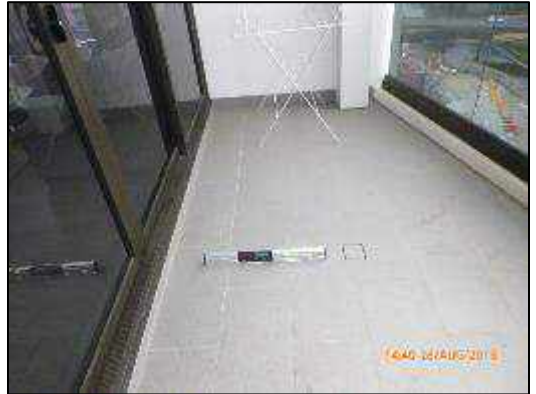
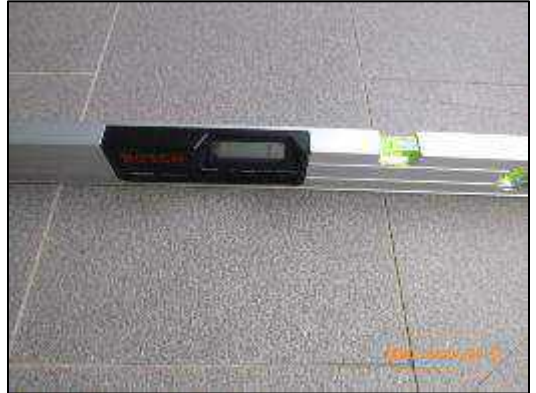
Item	Location	Defect description and Breach	Rectification	Photograph (if applicable)
963	Balcony	See section 5.2.1 Falls (mm); 1/1000	See section 5.2.2

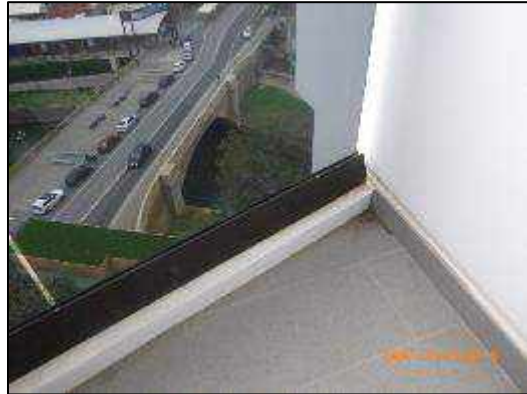
Item	Location	Defect description and Breach	Rectification	Photograph (if applicable)
964	Balcony	See section 5.3.1	See section 5.3.2

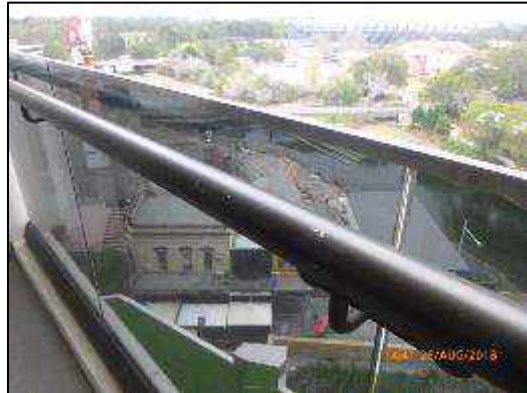
965	Balcony	See section 5.4.1	See section 5.4.2

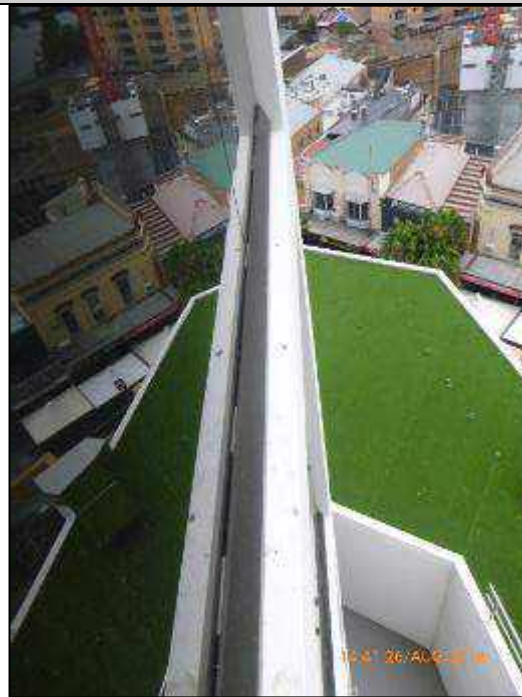
Item	Location	Defect description and Breach	Rectification	Photograph (if applicable)
966	Balcony façade balustrade	<p>Construction debris observed on façade of building</p> <p>Home Building Act (NSW) 1989</p> <ul style="list-style-type: none"> Part 2C, 18B (a) and (c). <p>This is a breach of part (a) of the act because the surface has not been finished in a proper workmanlike manner that would prevent loss of appearance to the surface.</p> <p>Loss Suffered Loss suffered is cost of rectification.</p>	<ol style="list-style-type: none"> 1. Protect all adjoining surfaces. 2. Use a suitable cleaning agent to remove residue and clear debris. 3. Clean up the work area.

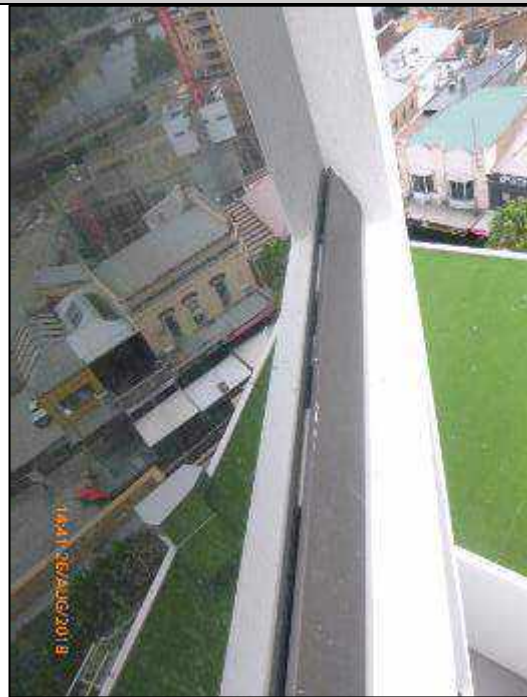
Item	Location	Defect description and Breach	Rectification	Photograph (if applicable)
967	Balcony balustrade	See section 5.9.1	See section 5.9.2

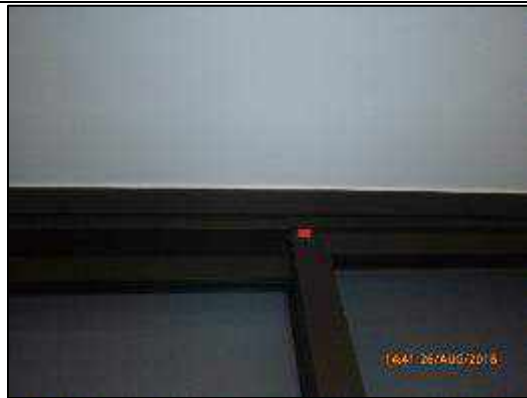
968	Balcony sliding door	See section 5.9.1	See section 5.9.2

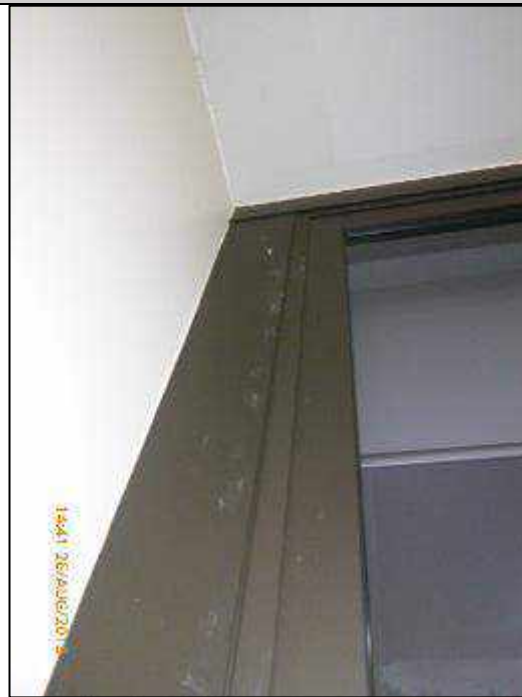
Item	Location	Defect description and Breach	Rectification	Photograph (if applicable)
969	Balcony sliding door	See section 5.8.1	See section 5.8.2

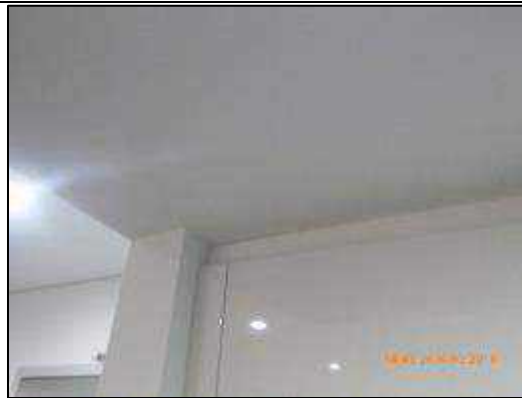
970	Ceiling above kitchen cupboards	See section 5.14.1 Separation; 1mm	See section 5.14.2

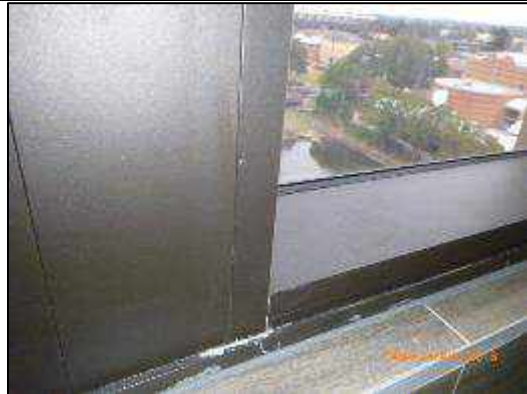
Item	Location	Defect description and Breach	Rectification	Photograph (if applicable)
971	Living room window frames	See section 5.8.1	See section 5.8.2

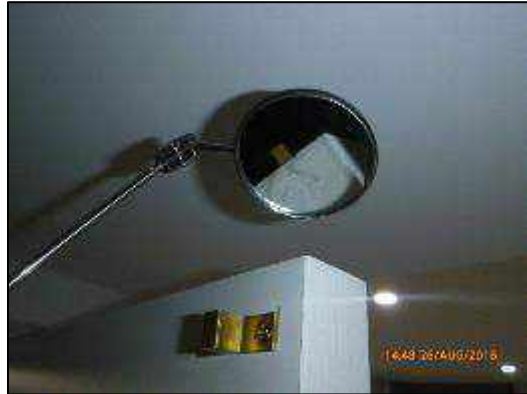
Item	Location	Defect description and Breach	Rectification	Photograph (if applicable)
973	<i>Doors throughout the unit (x3)</i>	See section 5.5.1	See section 5.5.2

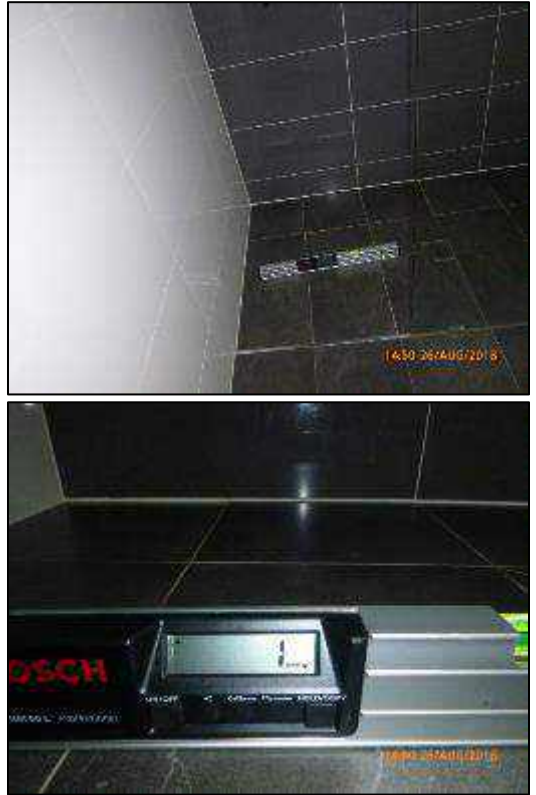
Item	Location	Defect description and Breach	Rectification	Photograph (if applicable)
976	Main bedroom ensuite	See section 5.1.1 Falls (mm); 1/1000	See section 5.1.2

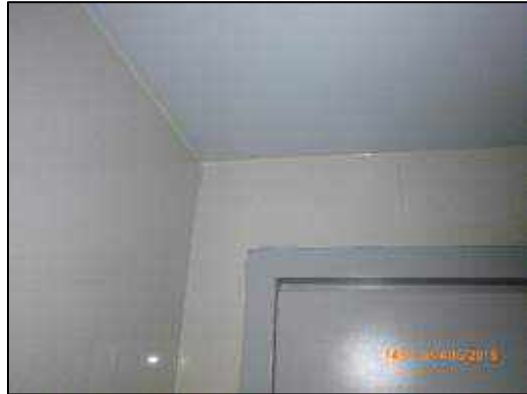
Item	Location	Defect description and Breach	Rectification	Photograph (if applicable)
977	Main bedroom ensuite door frame	See section 5.10.1	See section 5.10.2

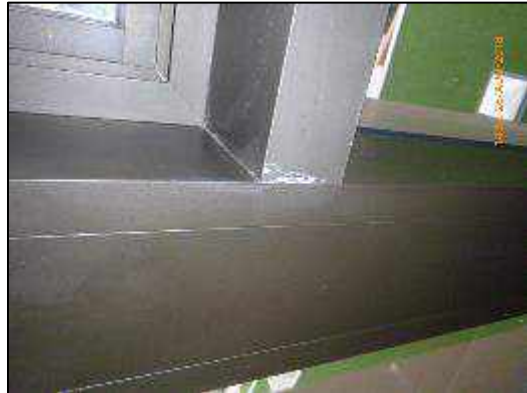
978	Main bedroom window frames	See section 5.8.1	See section 5.8.2

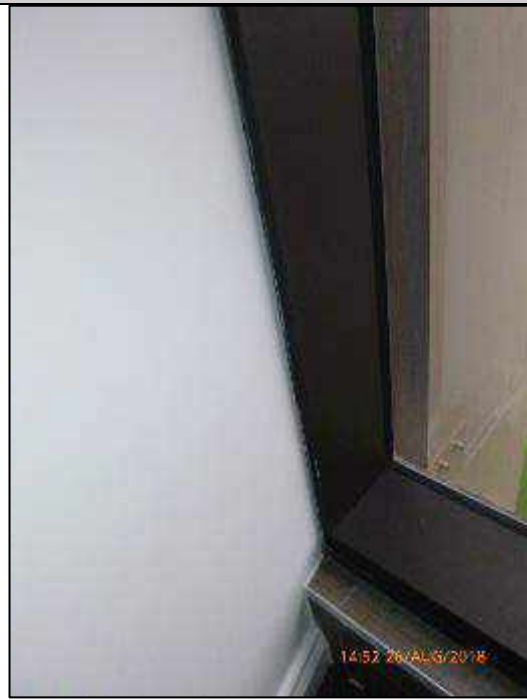
Item	Location	Defect description and Breach	Rectification	Photograph (if applicable)
979	Main bedroom window frames	See section 5.9.1	See section 5.9.2

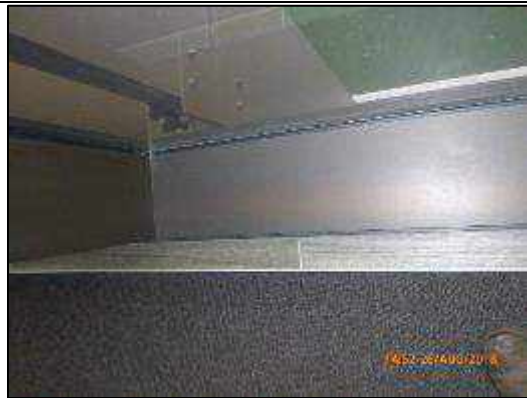
980	Main bedroom window frames	See section 5.7.1	See section 5.7.2

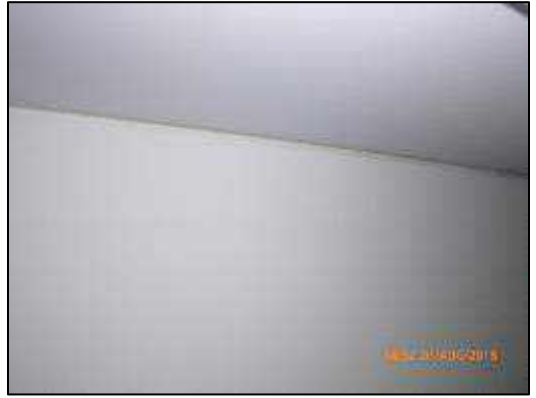
Item	Location	Defect description and Breach	Rectification	Photograph (if applicable)
981	<i>Walls and ceiling throughout the unit</i>	See section 5.10.1	See section 5.10.2

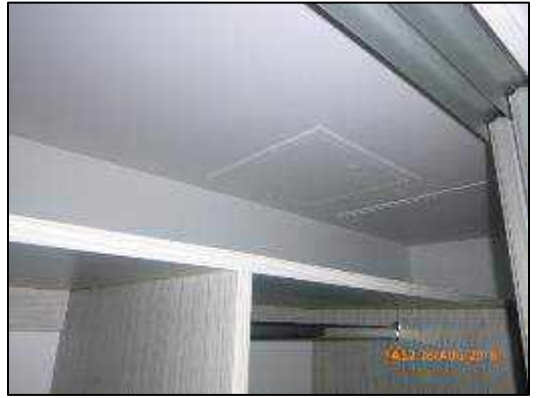
982	<i>Main bedroom built in</i>	See section 5.6.1	See section 5.6.2

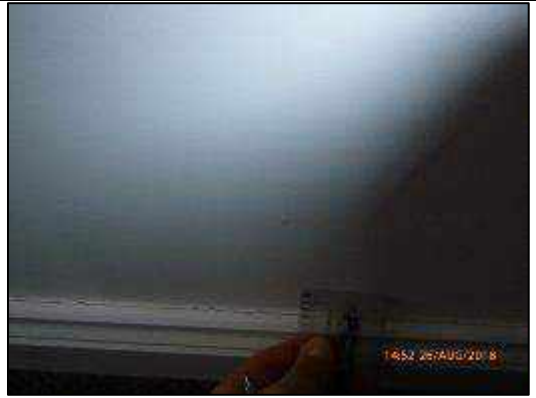
Item	Location	Defect description and Breach	Rectification	Photograph (if applicable)
983	Main bedroom skirting board	See section 5.14.1 Separation; 1.5mm	See section 5.14.2

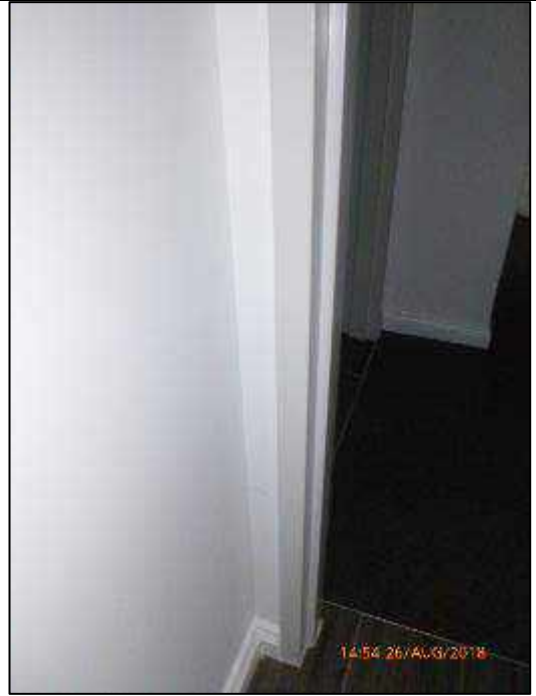
A photograph showing a close-up of a dark, textured surface, likely a skirting board. The image is dark and grainy, with a timestamp '14:52 26/AUG/2018' visible in the bottom right corner.
984	Wall adjacent to second bedroom door	See section 5.13.1	See section 5.13.2

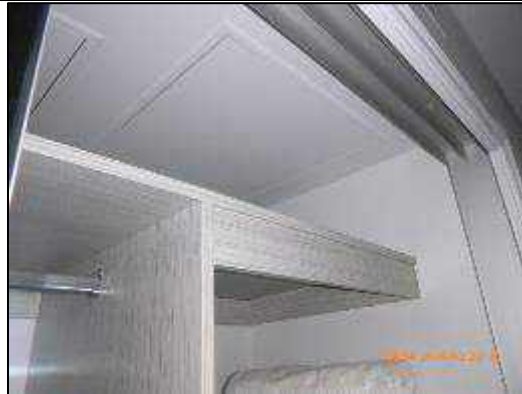
Item	Location	Defect description and Breach	Rectification	Photograph (if applicable)
985	Second bedroom built in	See section 5.6.1	See section 5.6.2

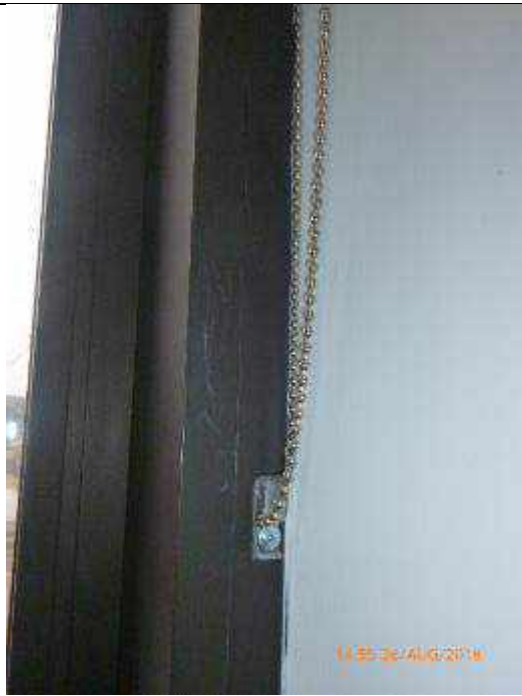
986	Second bedroom window frames	See section 5.7.1	See section 5.7.2

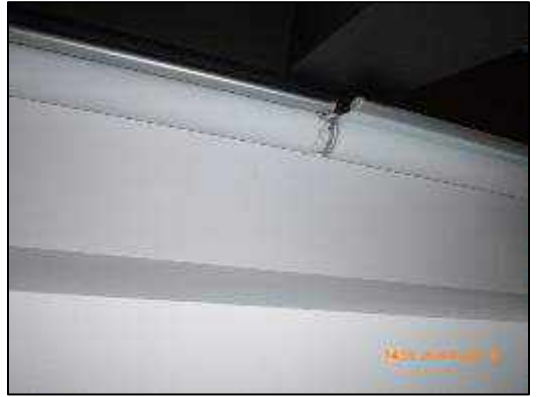
Item	Location	Defect description and Breach	Rectification	Photograph (if applicable)
987	Second bedroom window bulkhead	See section 5.13.1	See section 5.13.2

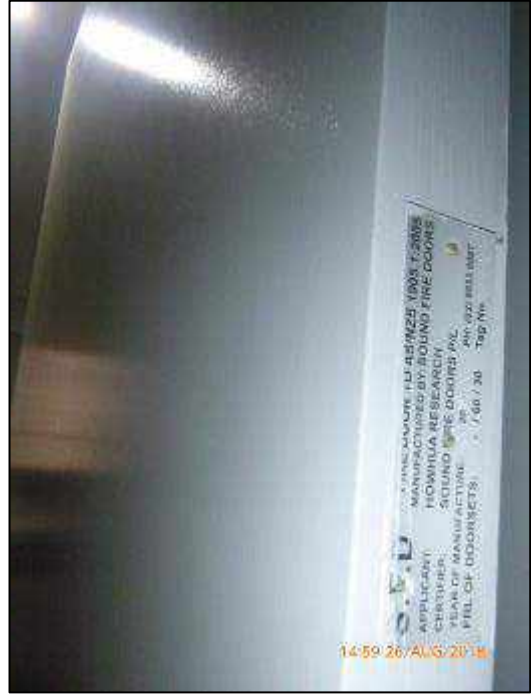
Item	Location	Defect description and Breach	Rectification	Photograph (if applicable)
Unit 902				
988	Front entry door	See section 5.12.1	See section 5.12.2

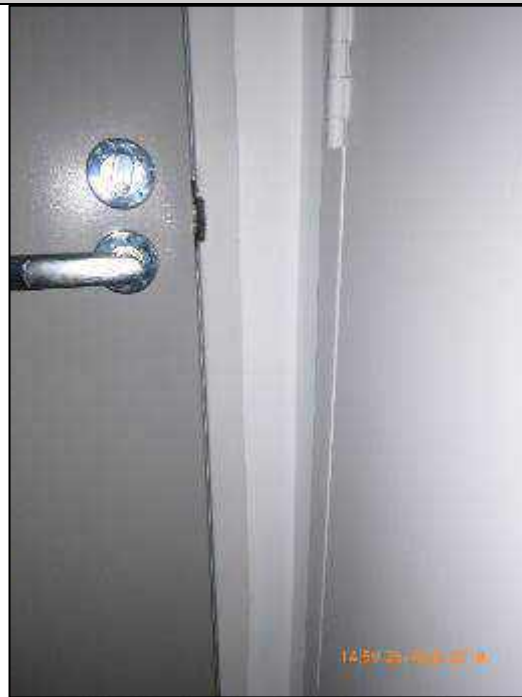
Item	Location	Defect description and Breach	Rectification	Photograph (if applicable)
989	Wall adjacent to front entry door	See section 5.13.1	See section 5.13.2

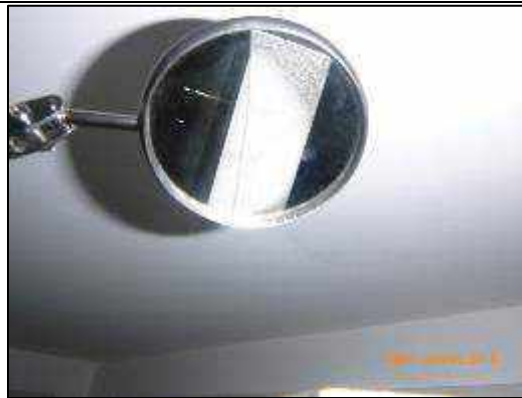
990	Doors throughout the unit (x3)	See section 5.5.1	See section 5.5.2

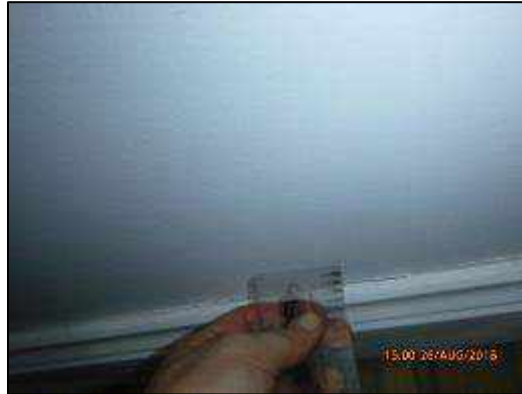
Item	Location	Defect description and Breach	Rectification	Photograph (if applicable)
991	Hallway eastern wall skirting board	See section 5.14.1 Separation; 2mm	See section 5.14.2

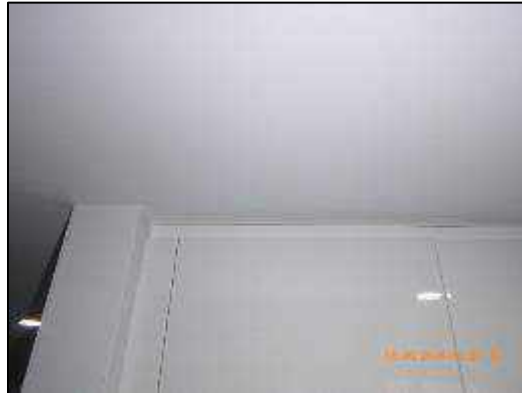
992	Ceiling above kitchen cupboards	See section 5.14.1 Separation; 1mm	See section 5.14.2

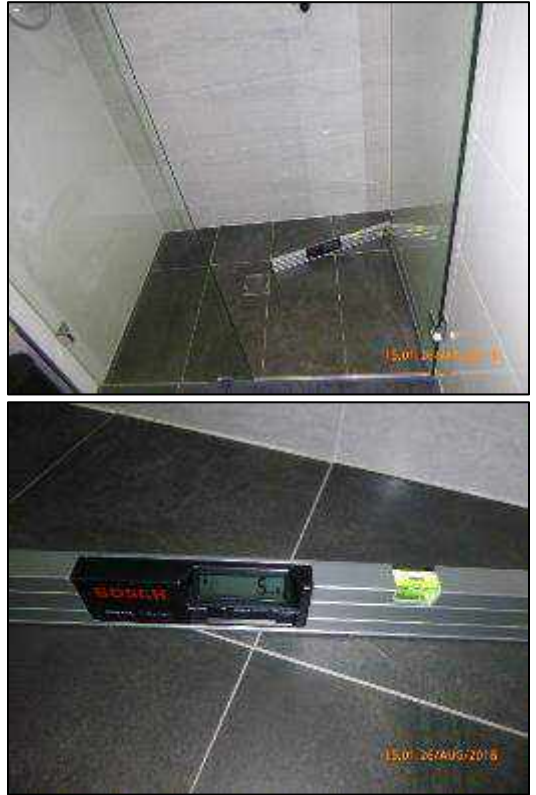
Item	Location	Defect description and Breach	Rectification	Photograph (if applicable)
993	Main bathroom	See section 5.1.1 Falls (mm); 5/1000	See section 5.1.2

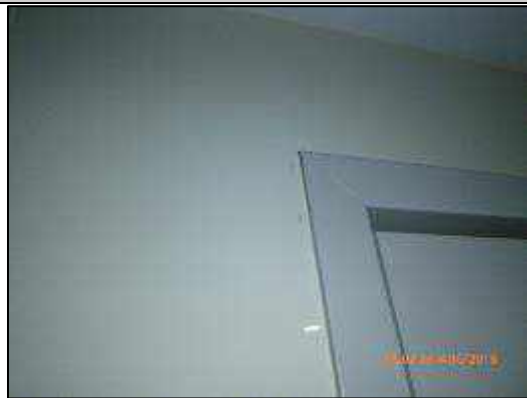
Item	Location	Defect description and Breach	Rectification	Photograph (if applicable)
994	Wall adjacent to main bathroom door	See section 5.9.1	See section 5.9.2

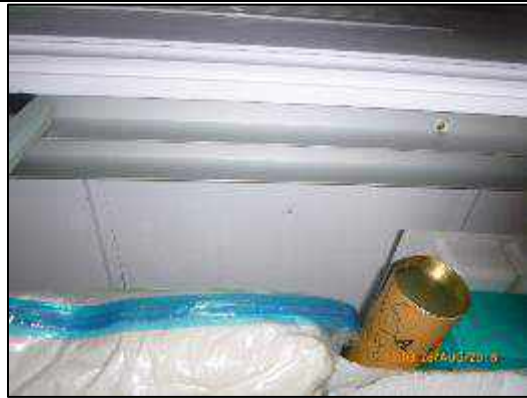
995	Second bedroom built in	See section 5.6.1	See section 5.6.2

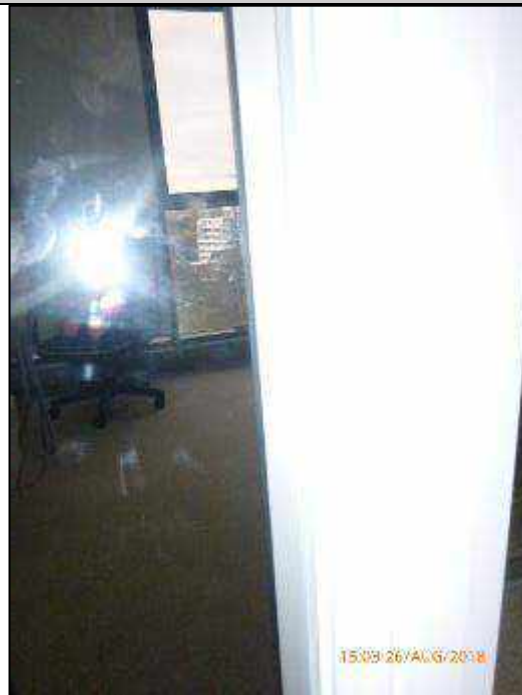
Item	Location	Defect description and Breach	Rectification	Photograph (if applicable)
996	Wall adjacent to second bedroom built in	See section 5.13.1	See section 5.13.2

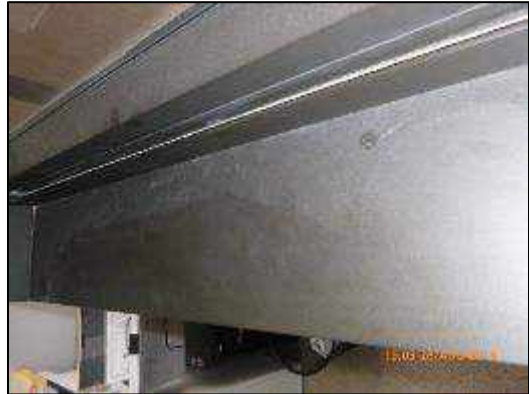
Item	Location	Defect description and Breach	Rectification	Photograph (if applicable)
998	Second bedroom window frames	See section 5.7.1	See section 5.7.2

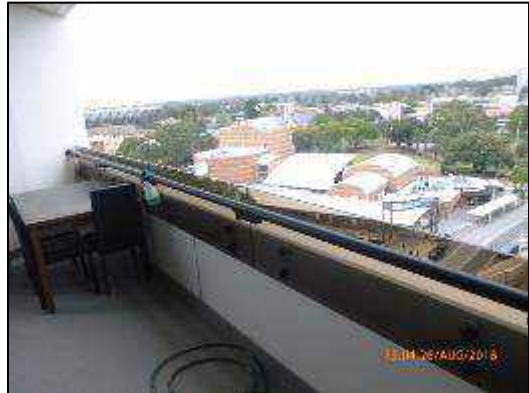
999	Balcony	See section 5.4.1	See section 5.4.2

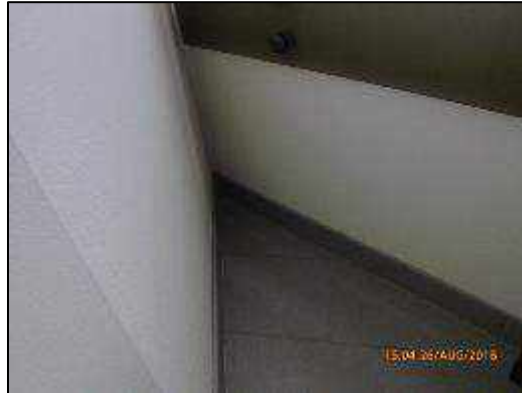
Item	Location	Defect description and Breach	Rectification	Photograph (if applicable)
1000	Balcony	See section 5.3.1	See section 5.3.2

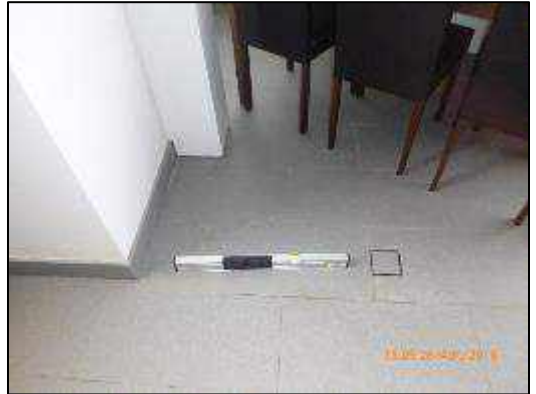
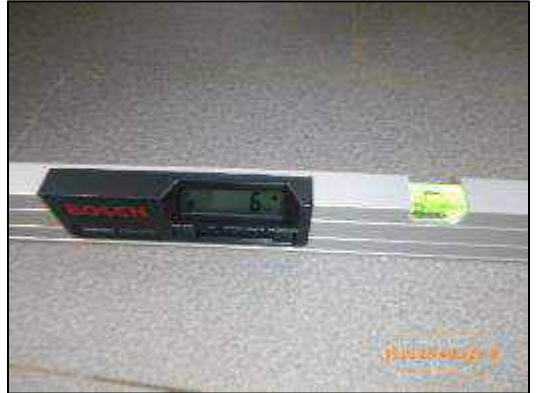
Item	Location	Defect description and Breach	Rectification	Photograph (if applicable)
1001	Balcony	See section 5.2.1 Falls (mm); 6/1000	See section 5.2.2

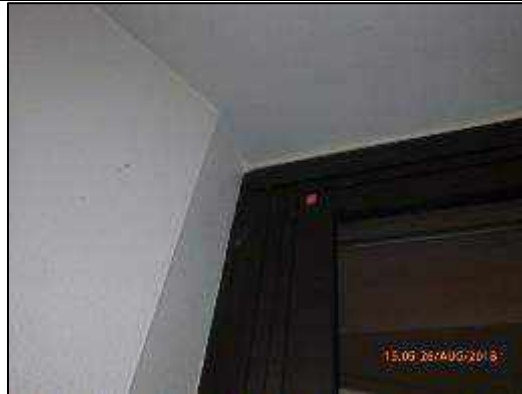
Item	Location	Defect description and Breach	Rectification	Photograph (if applicable)
1002	Balcony sliding door	See section 5.8.1	See section 5.8.2

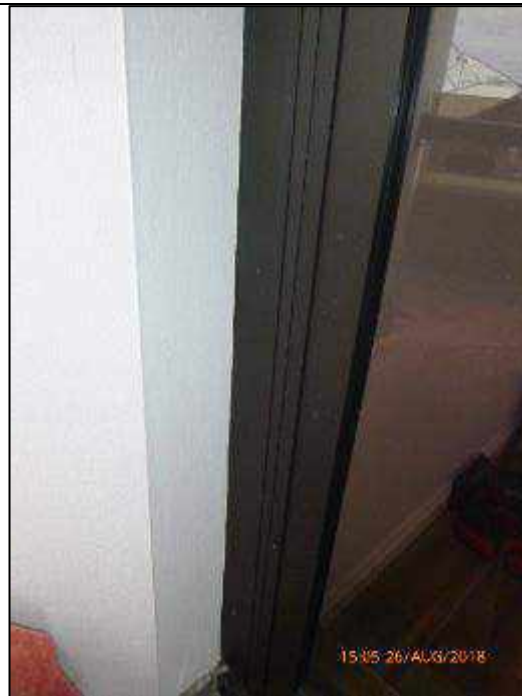
1003	Balcony sliding door	See section 5.7.1	See section 5.7.2

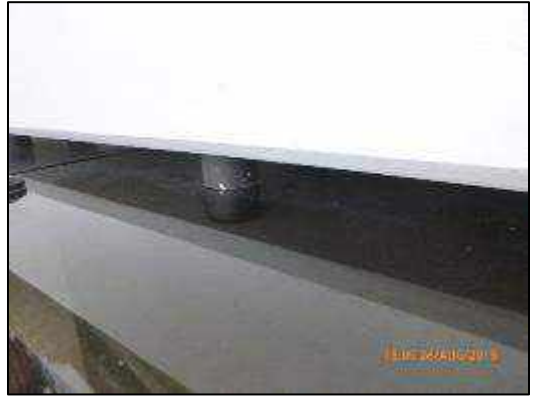
Item	Location	Defect description and Breach	Rectification	Photograph (if applicable)
1004	Balcony balustrade	See section 5.9.1	See section 5.9.2

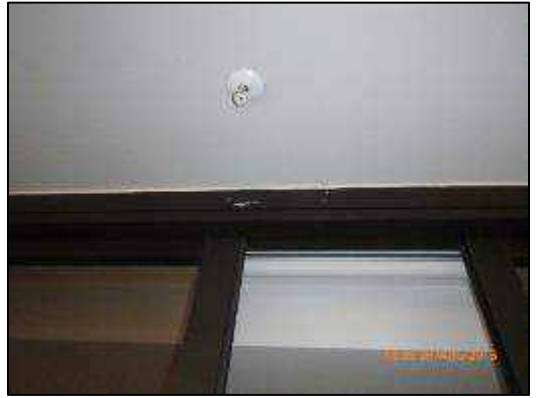
1005	Balcony sliding door	See section 5.9.1	See section 5.9.2

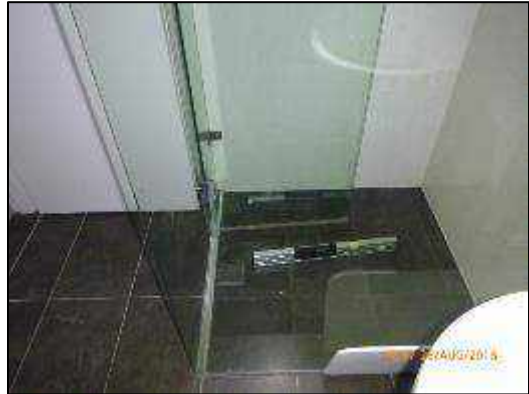
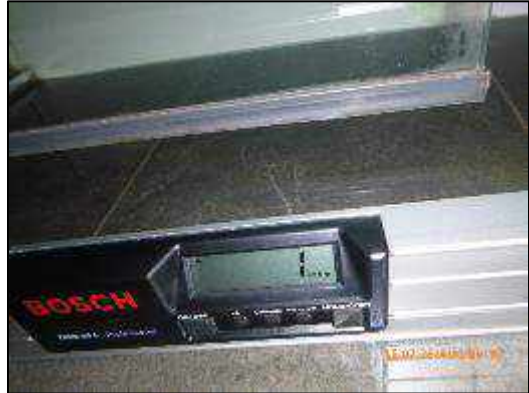
Item	Location	Defect description and Breach	Rectification	Photograph (if applicable)
1006	Main bedroom ensuite	See section 5.1.1 Falls (mm); 1/1000	See section 5.1.2

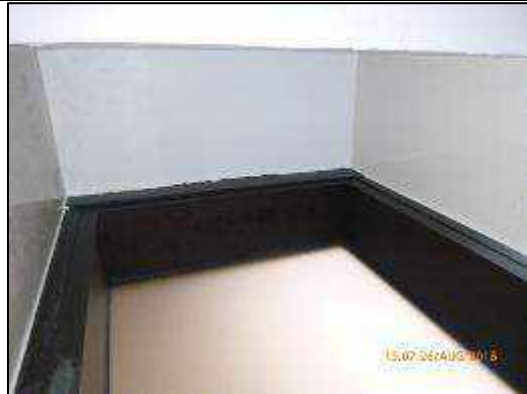
Item	Location	Defect description and Breach	Rectification	Photograph (if applicable)
1007	Main bedroom ensuite window frame	See section 5.9.1	See section 5.9.2

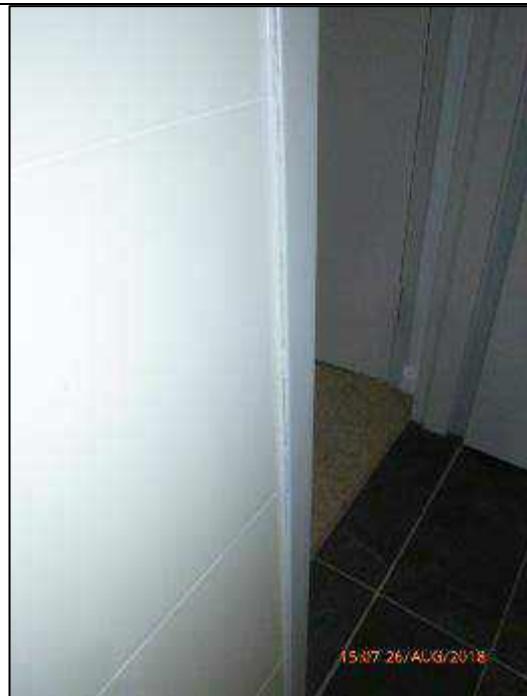
1008	Wall adjacent to ensuite door frame	See section 5.9.1	See section 5.9.2

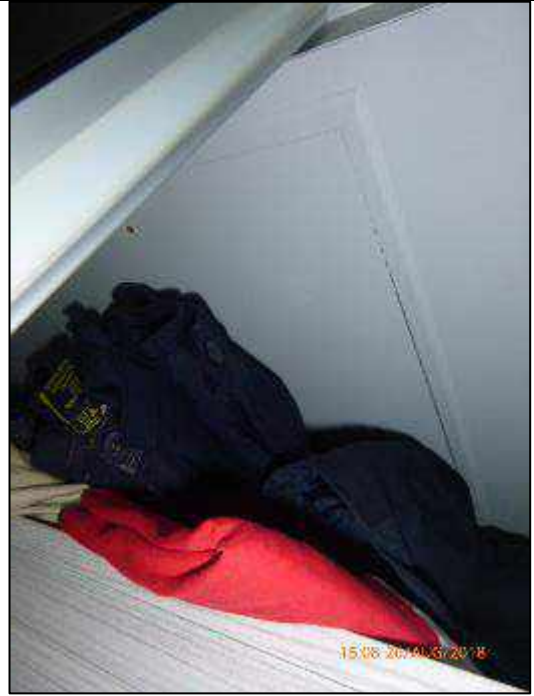
Item	Location	Defect description and Breach	Rectification	Photograph (if applicable)
1009	Main bedroom built in	See section 5.6.1	See section 5.6.2

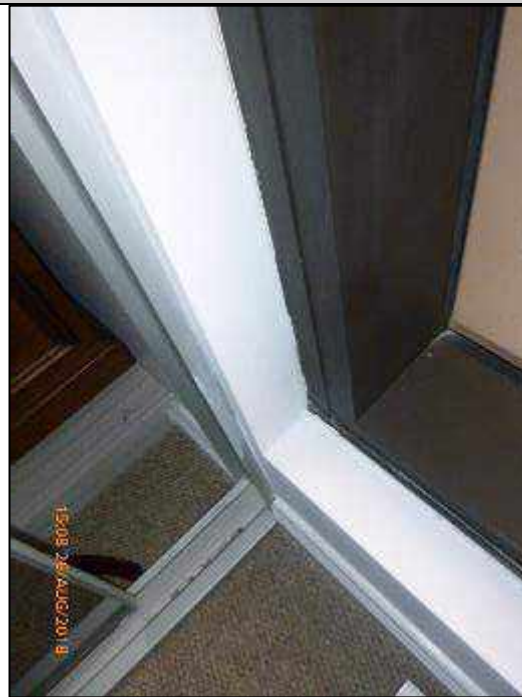
Item	Location	Defect description and Breach	Rectification	Photograph (if applicable)
1010	Main bedroom built in	See section 5.9.1	See section 5.9.2

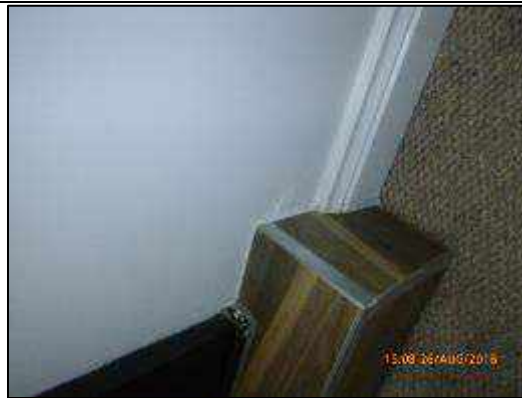
A photograph showing the corner of a window frame where it meets the wall and the floor. The frame is white, and the wall is a light color. The floor is covered with a brown carpet. A date stamp '15/08/2018' is visible in the bottom left corner of the photo.
1011	Main bedroom wall adjacent to windows	See section 5.13.1	See section 5.13.2

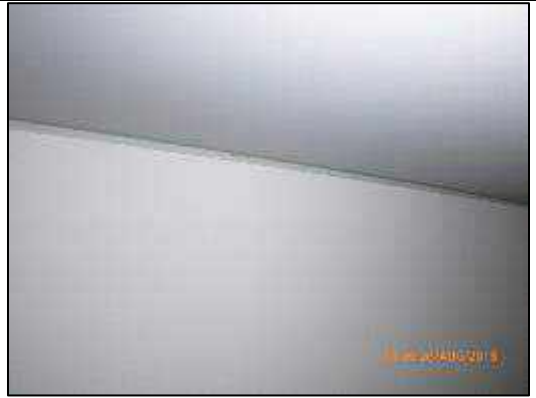
Item	Location	Defect description and Breach	Rectification	Photograph (if applicable)
1012	Lounge room ceiling	See section 5.10.1	See section 5.10.2

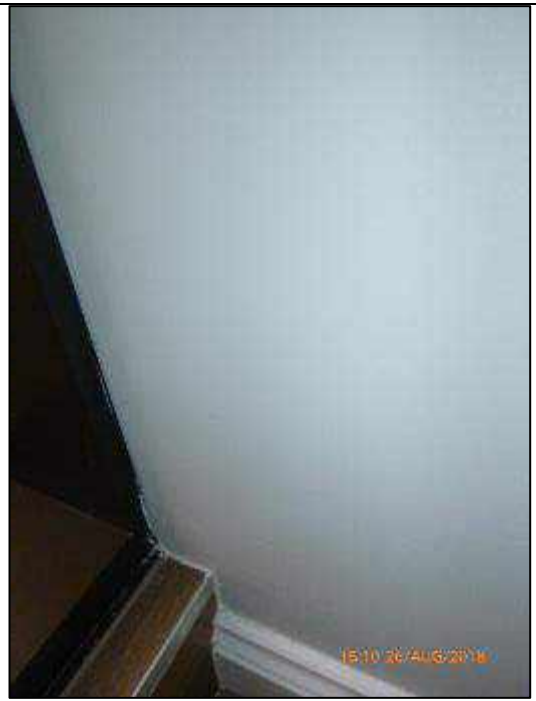
1013	Lounge room wall adjacent to windows	See section 5.13.1	See section 5.13.2

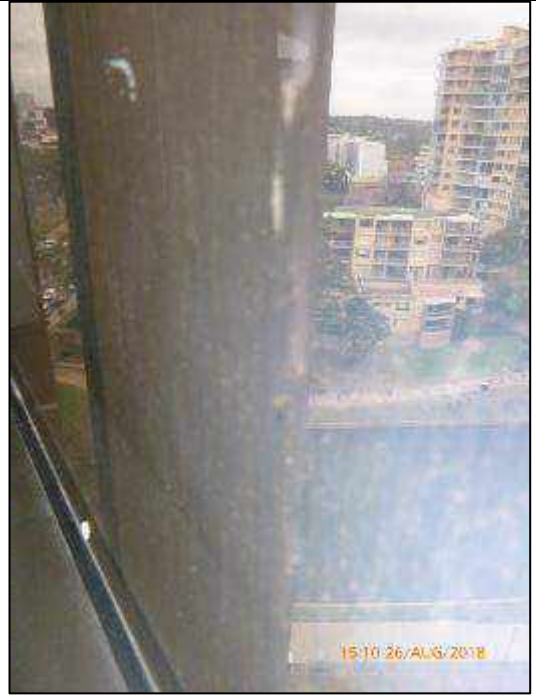
Item	Location	Defect description and Breach	Rectification	Photograph (if applicable)
1014	Lounge room window frames	See section 5.8.1	See section 5.8.2

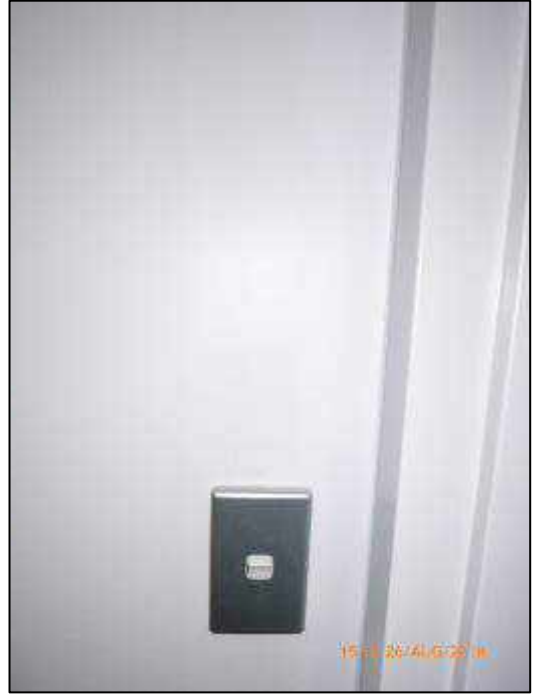
Item	Location	Defect description and Breach	Rectification	Photograph (if applicable)
1015	Wall adjacent to study room door	See section 5.13.1	See section 5.13.2

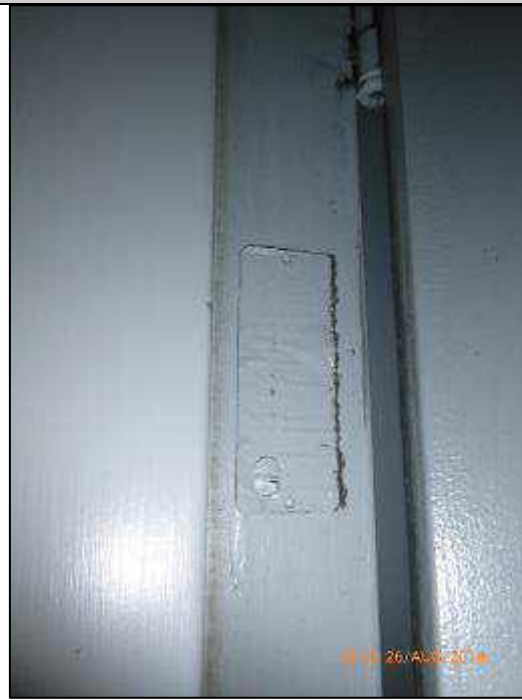
Item	Location	Defect description and Breach	Rectification	Photograph (if applicable)
1016	Front entry door frame	<p>Door frame label has been painted over.</p> <p>Home Building Act (NSW) 1989</p> <ul style="list-style-type: none"> Part 2C, 18B (a) & (c). <p>Loss Suffered</p> <p>Loss suffered is cost of rectification.</p>	Use a suitable cleaning agent to remove paint from the door frame label.

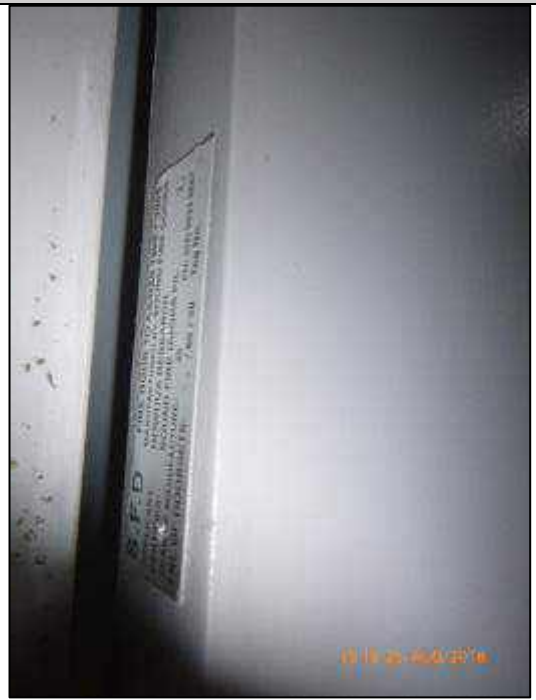
Item	Location	Defect description and Breach	Rectification	Photograph (if applicable)
1017	Front entry door	See section 5.12.1	See section 5.12.2

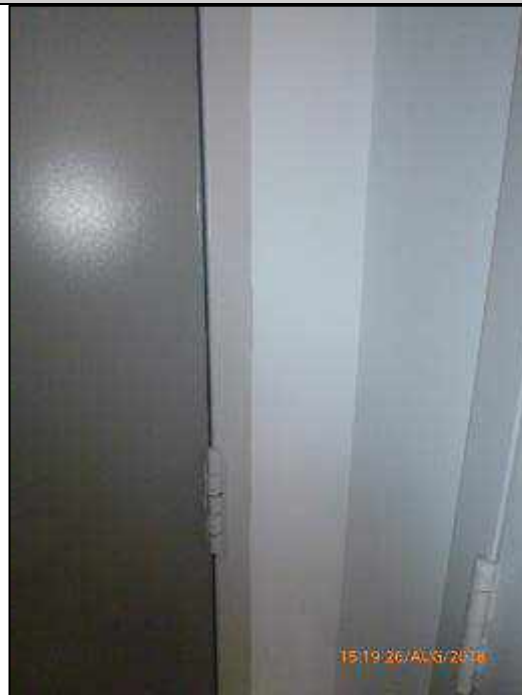
Item	Location	Defect description and Breach	Rectification	Photograph (if applicable)
1018	Wall adjacent to front entry door	See section 5.13.1	See section 5.13.2

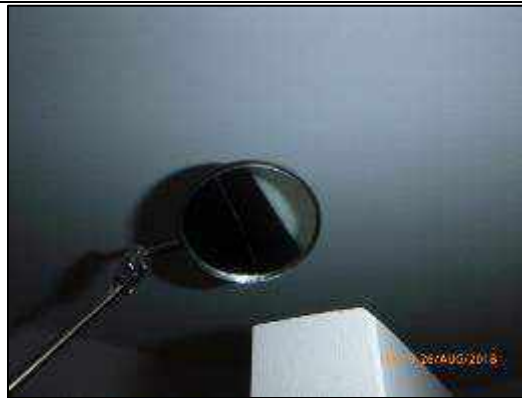
1019	Doors throughout the unit (x3)	See section 5.5.1	See section 5.5.2

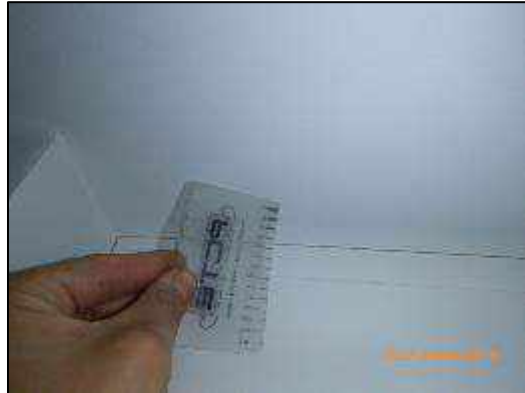
Item	Location	Defect description and Breach	Rectification	Photograph (if applicable)
1020	<i>Ceiling above kitchen cupboards</i>	See section 5.14.1 Separation; 1.5mm	See section 5.14.2

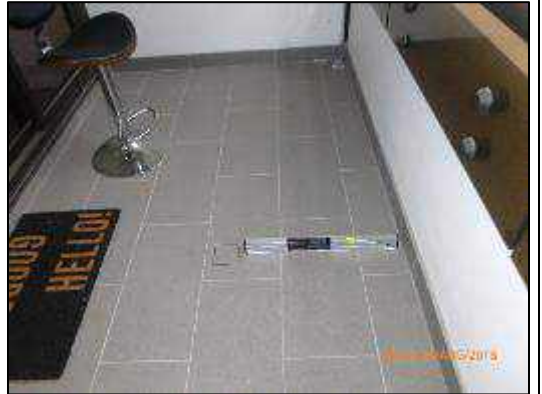
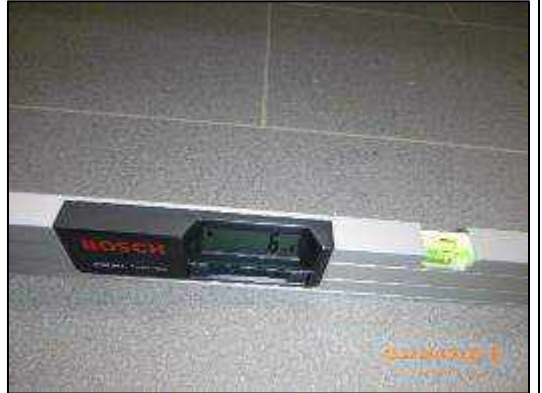
Item	Location	Defect description and Breach	Rectification	Photograph (if applicable)
1021	Balcony	See section 5.2.1 Falls (mm); 6/1000	See section 5.2.2

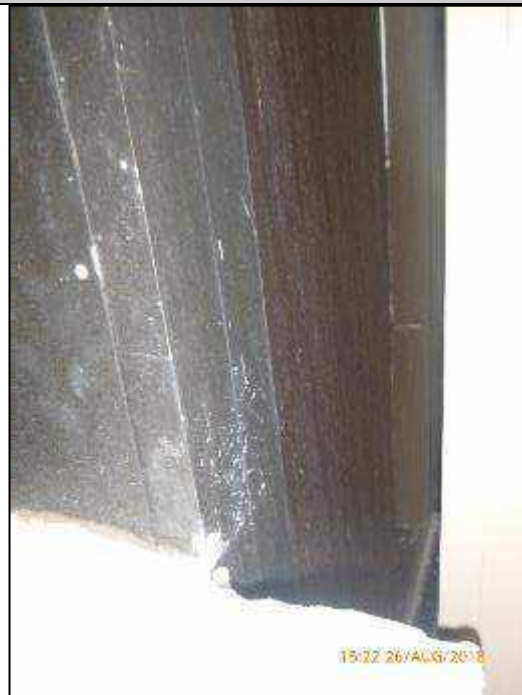
Item	Location	Defect description and Breach	Rectification	Photograph (if applicable)
1022	External fins on façade.	<p>Construction debris observed on façade of building</p> <p>Home Building Act (NSW) 1989</p> <ul style="list-style-type: none"> Part 2C, 18B (a) and (c). <p>This is a breach of part (a) of the act because the surface has not been finished in a proper workmanlike manner that would prevent loss of appearance to the surface.</p> <p>Loss Suffered Loss suffered is cost of rectification.</p>	<ol style="list-style-type: none"> 1. Protect all adjoining surfaces. 2. Use a suitable cleaning agent to remove residue and clear debris. 3. Clean up the work area.

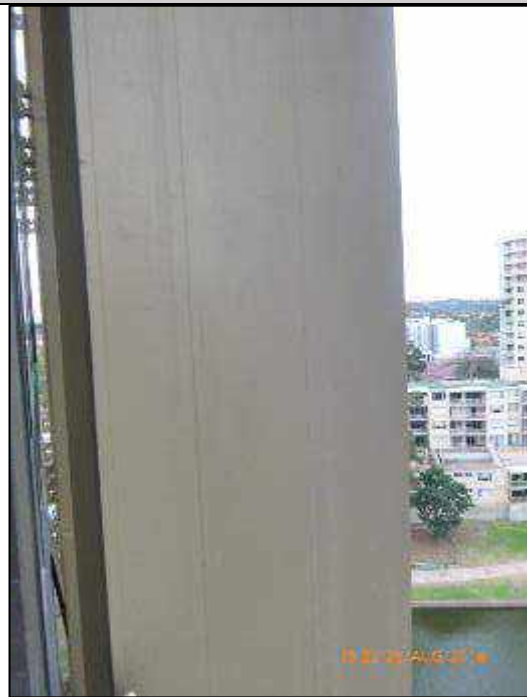
Item	Location	Defect description and Breach	Rectification	Photograph (if applicable)
1023	<i>Façade panel in balcony area</i>	See section 5.7.1	See section 5.7.2

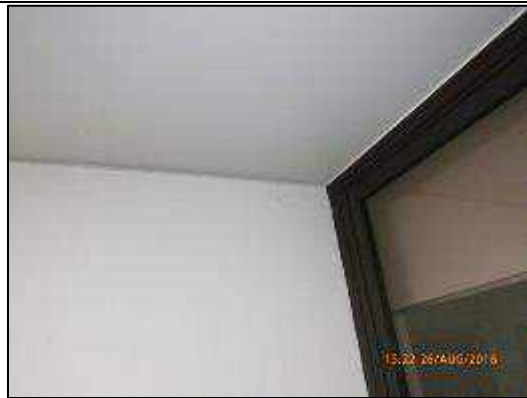
A photograph showing a balcony area with a facade panel. The panel is light-colored and appears to be made of concrete or a similar material. The balcony railing is visible on the left side. In the background, there are other buildings and a body of water. A timestamp '13.22.25/AUG/2018' is visible in the bottom right corner of the photo.
1024	<i>Balcony sliding door</i>	See section 5.9.1	See section 5.9.2

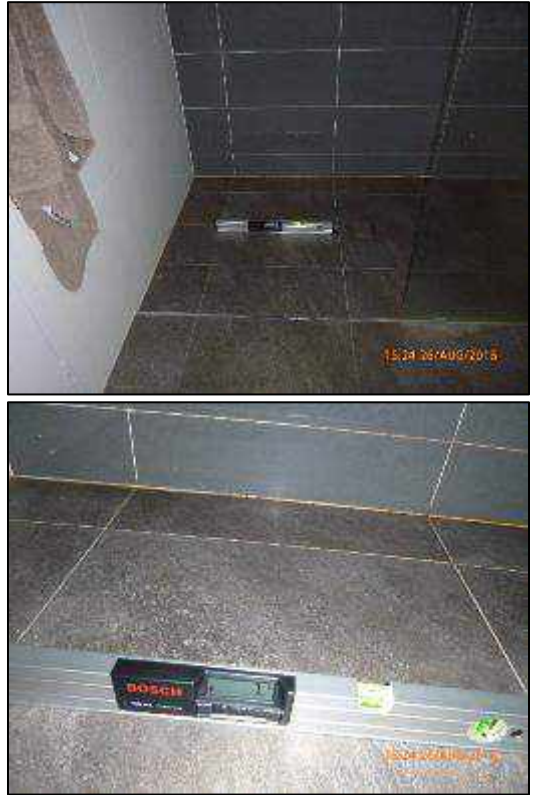
Item	Location	Defect description and Breach	Rectification	Photograph (if applicable)
1025	Main bathroom	See section 5.1.1 Falls (mm); 7/1000	See section 5.1.2

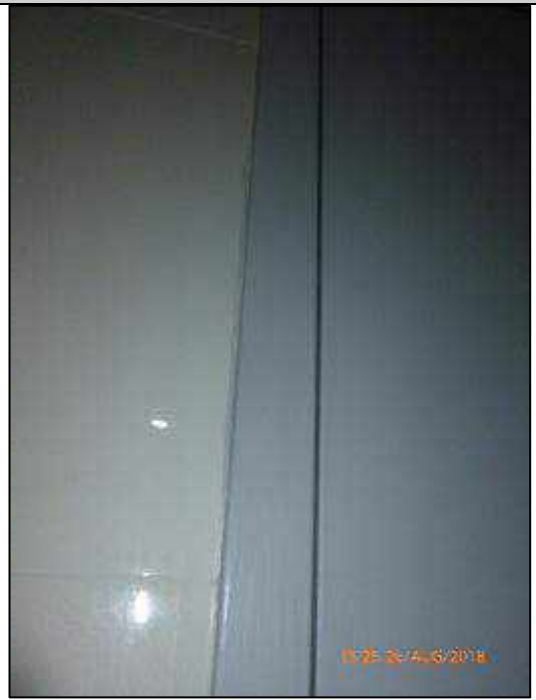
Item	Location	Defect description and Breach	Rectification	Photograph (if applicable)
1026	Main bathroom door frame	See section 5.10.1	See section 5.10.2

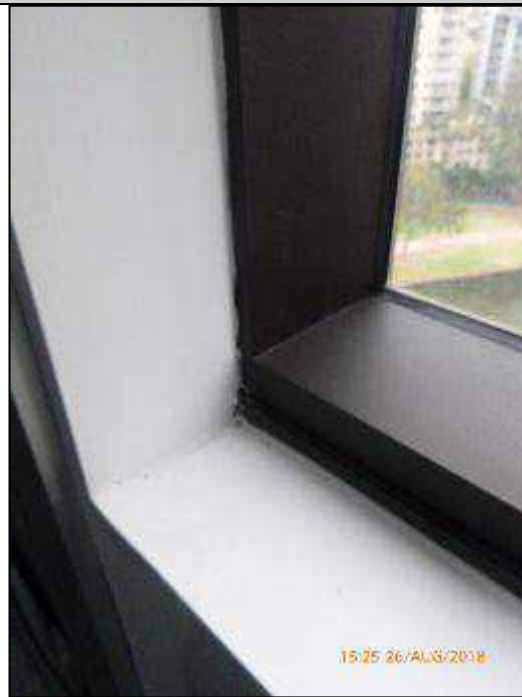
Item	Location	Defect description and Breach	Rectification	Photograph (if applicable)
1027	Main bathroom window frames	See section 5.9.1	See section 5.9.2

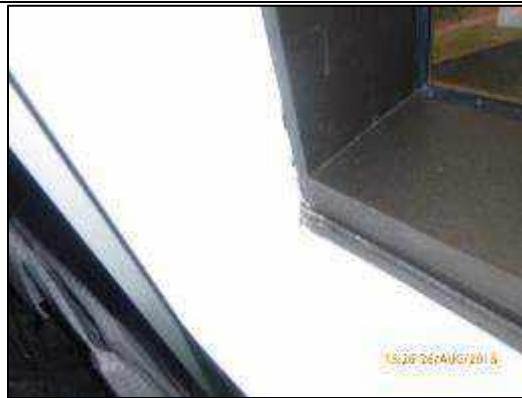
1028	Main bedroom window frames	See section 5.9.1	See section 5.9.2

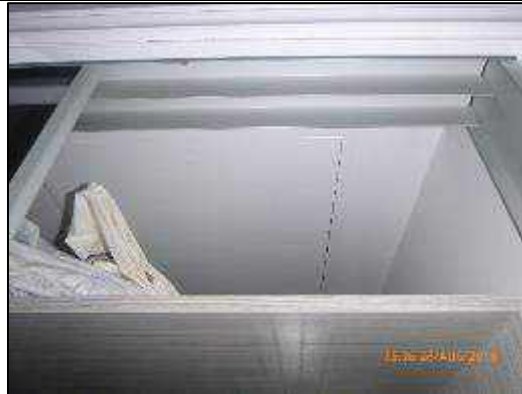
Item	Location	Defect description and Breach	Rectification	Photograph (if applicable)
1029	Main bedroom built in	See section 5.6.1	See section 5.6.2

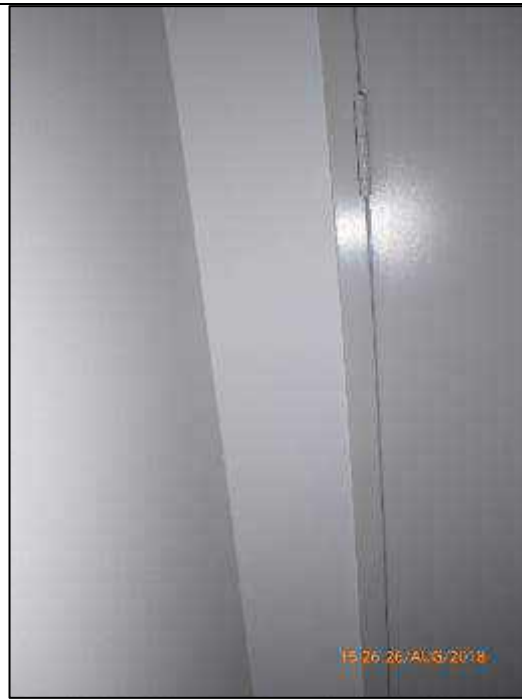
1030	Wall adjacent to main bedroom door	See section 5.10.1	See section 5.10.2

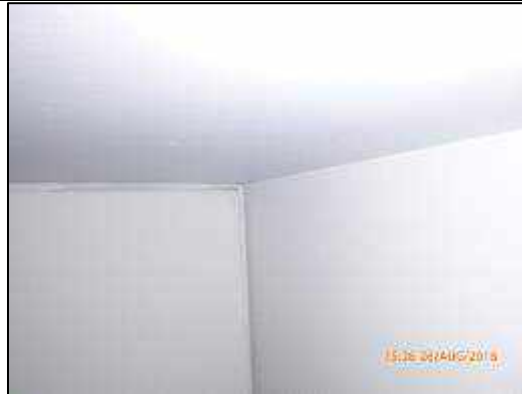
Item	Location	Defect description and Breach	Rectification	Photograph (if applicable)
1031	Main bedroom	See section 5.11.1	See section 5.11.2

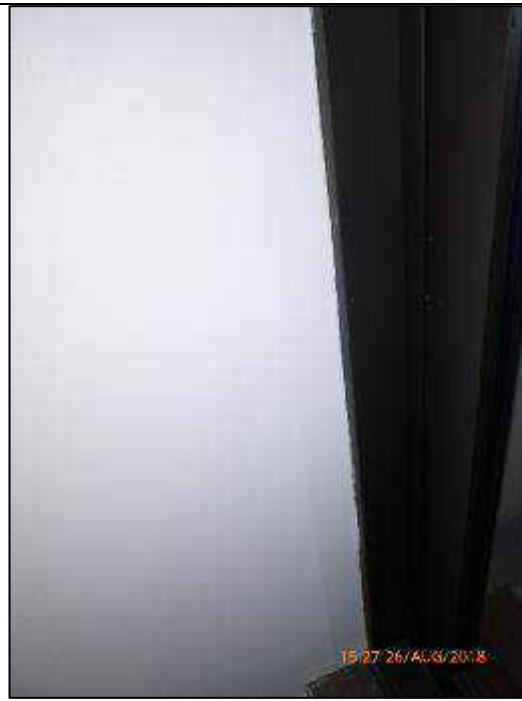
A photograph showing the corner of a room where a white wall meets a white ceiling. The lighting is bright, and there is a small orange timestamp in the bottom right corner that reads "15/26/2018".
1032	Lounge room window frames	See section 5.9.1	See section 5.9.2

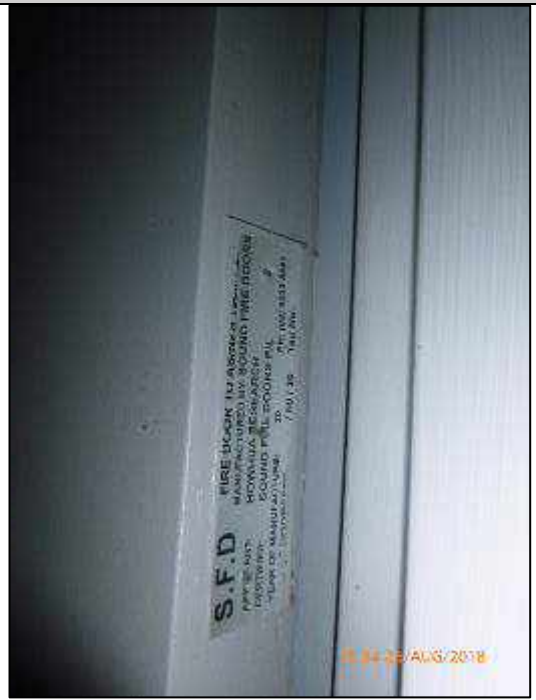
Item	Location	Defect description and Breach	Rectification	Photograph (if applicable)
1034	Front entry door	See section 5.12.1	See section 5.12.2
