SydneyStrataReport

STRATA REPORT

Client	Church Street Parramatta Property Pty Ltd
Address of property	Unit 3303/330 Church Street, Parramatta, NSW.
Lot	359
Strata Plan	SP 94469
Name of Strata Management Co.	NSW Strata
Telephone Number of Strata Agent	8980 1841
Report Date	15 February 2024

BUILDING DEFECTS REPORT Part 1/2

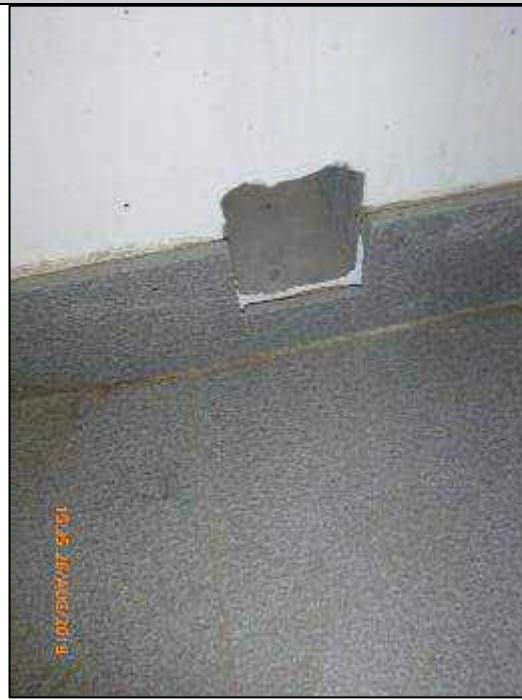
Item	Location	Defect description and Breach	Rectification	Photograph (if applicable)
1035	Balcony	See section 5.15.1	See section 5.15.2

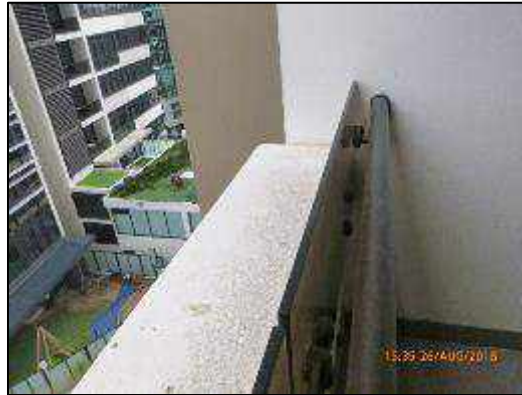
1036	Balcony facade balustrade	<p>Construction debris observed on façade of building</p> <p>Home Building Act (NSW) 1989</p> <ul style="list-style-type: none"> Part 2C, 18B (a) and (c). <p>This is a breach of part (a) of the act because the surface has not been finished in a proper workmanlike manner that would prevent loss of appearance to the surface.</p>	<ol style="list-style-type: none"> 1. Protect all adjoining surfaces. 2. Use a suitable cleaning agent to remove residue and clear debris. 3. Clean up the work area.

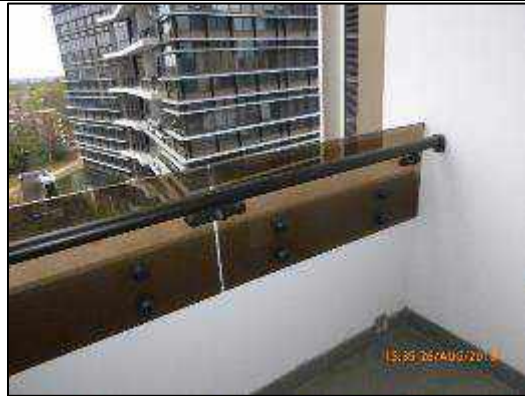
Item	Location	Defect description and Breach	Rectification	Photograph (if applicable)
		Loss Suffered Loss suffered is cost of rectification.		
1037	Balcony	See section 5.4.1	See section 5.4.2

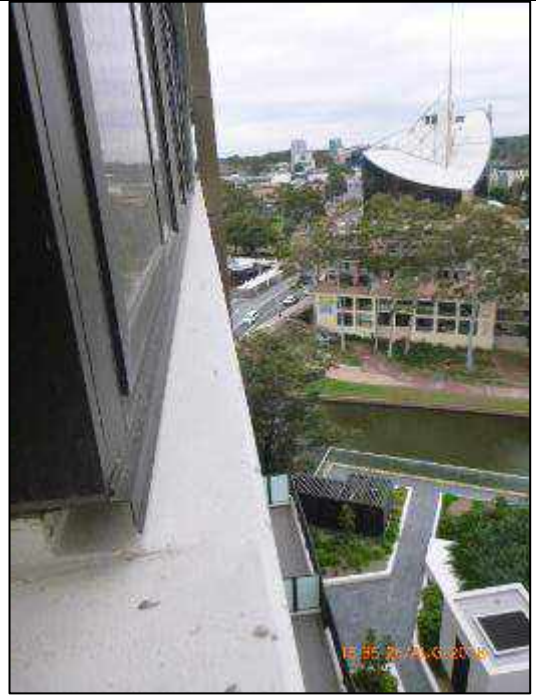
Item	Location	Defect description and Breach	Rectification	Photograph (if applicable)
1039	<i>Façade adjacent to balcony area</i>	<p>Construction debris observed on façade of building</p> <p>Home Building Act (NSW) 1989</p> <ul style="list-style-type: none"> Part 2C, 18B (a) and (c). <p>This is a breach of part (a) of the act because the surface has not been finished in a proper workmanlike manner that would prevent loss of appearance to the surface.</p> <p>Loss Suffered</p> <p>Loss suffered is cost of rectification.</p>	<ol style="list-style-type: none"> 1. Protect all adjoining surfaces. 2. Use a suitable cleaning agent to remove residue and clear debris. 3. Clean up the work area.

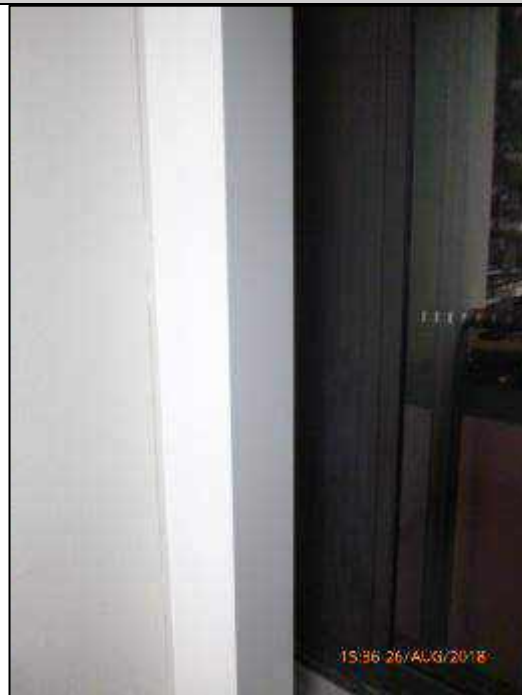
Item	Location	Defect description and Breach	Rectification	Photograph (if applicable)
1040	Balcony sliding door	See section 5.7.1	See section 5.7.2

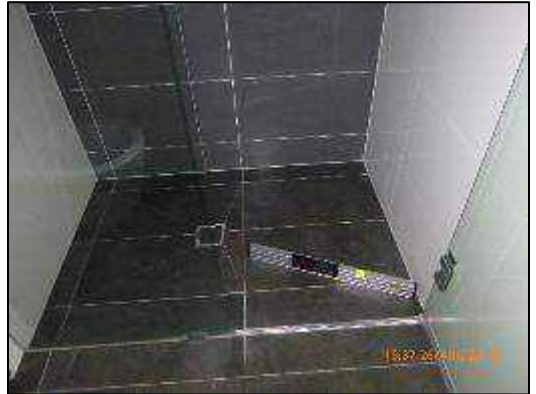
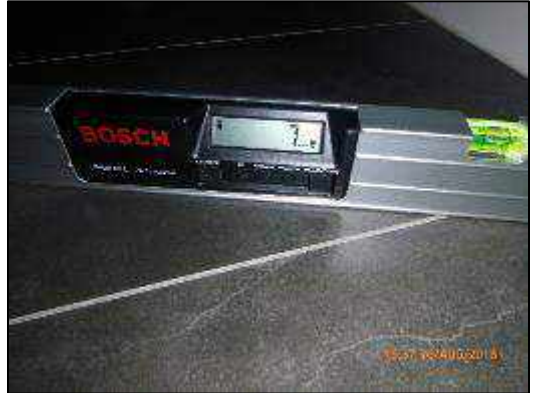
Item	Location	Defect description and Breach	Rectification	Photograph (if applicable)
1041	Main bathroom	See section 5.1.1 Falls (mm); 7/1000	See section 5.1.2

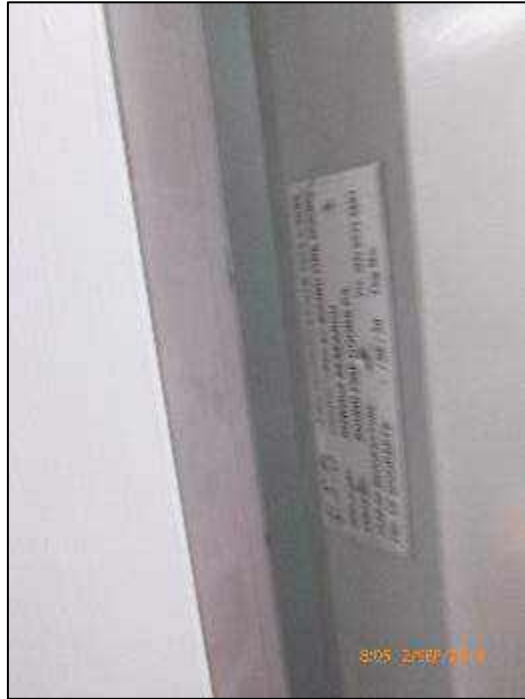
Item	Location	Defect description and Breach	Rectification	Photograph (if applicable)
Unit 905				
1042	Front entry door	See section 5.12.1	See section 5.12.2

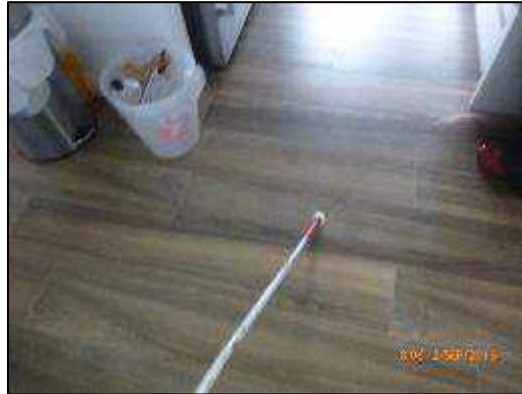
Item	Location	Defect description and Breach	Rectification	Photograph (if applicable)
1043	Front entrance	<p>Drummy tiles observed at front entrance adjacent to kitchen area.</p> <p>Home Building Act (NSW) 1989</p> <ul style="list-style-type: none"> Part 2C, 18B (a) and (c). <p>Guide to Standards and Tolerances 2017</p> <p>Section 12.5 Cracked, pitted, chipped, scratched, loose or drummy tiles.</p> <p>Loss Suffered</p> <p>Loss suffered is cost of rectification and appearance.</p>	<ol style="list-style-type: none"> 1. Protect all adjoining surfaces surrounding the work area. 2. Remove the affected tiles 3. Install new tiles to match existing 4. Clean up the work area.

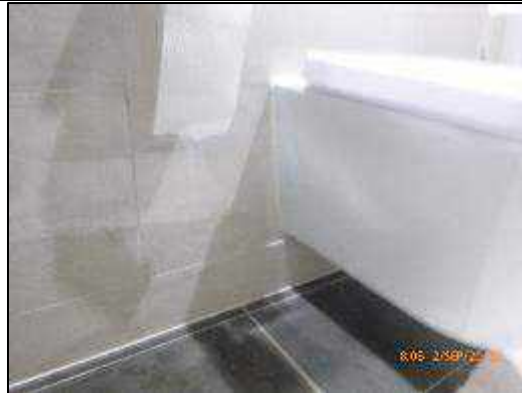
1044	Main bedroom ensuite	<p>Wall tiles observed to be poorly installed following the repair of the toilet.</p> <p>Home Building Act (NSW) 1989</p> <ul style="list-style-type: none"> Part 2C, 18B (a) and (c). <p>Guide to Standards and Tolerances 2017</p> <p>Section 12.8 Uneven tiling</p> <p>Loss Suffered</p> <p>Loss suffered is cost of rectification and appearance.</p>	<ol style="list-style-type: none"> 1. Protect all adjoining surfaces surrounding the work area. 2. Remove the affected tiles 3. Install new tiles to match existing 4. Clean up the work area.

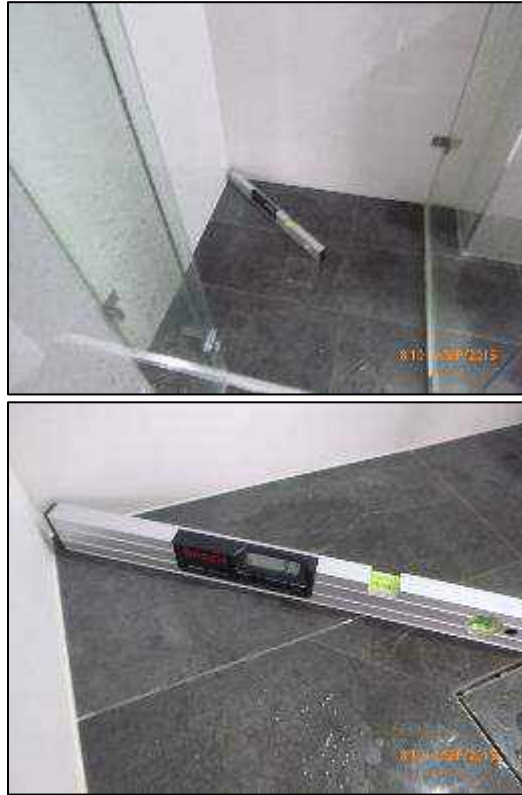
Item	Location	Defect description and Breach	Rectification	Photograph (if applicable)
1045	Main bedroom ensuite	See section 5.1.1 Falls (mm); 9/1000	See section 5.1.2

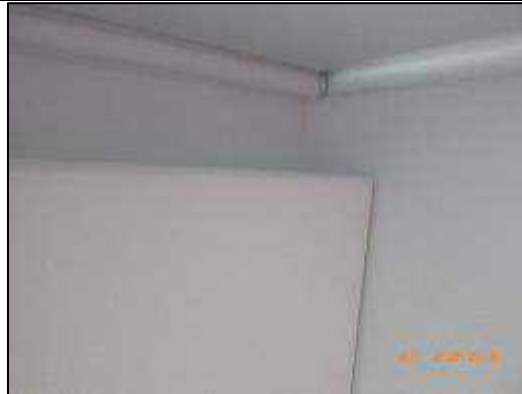
Item	Location	Defect description and Breach	Rectification	Photograph (if applicable)
1046	Main bedroom window bulkhead	See section 5.13.1	See section 5.13.2

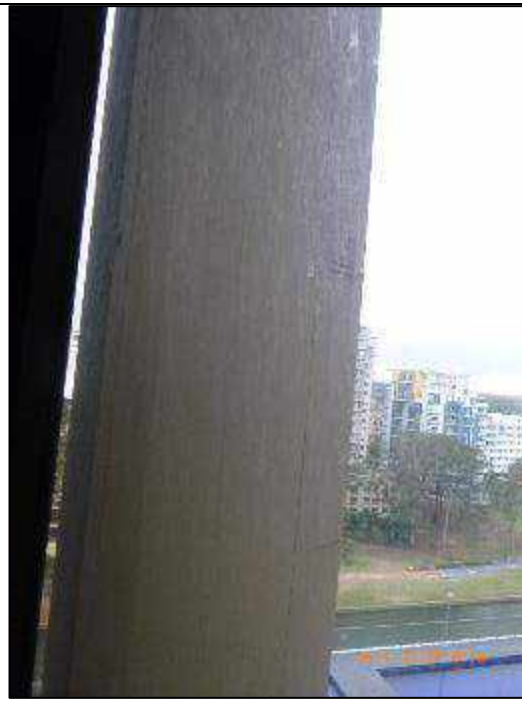
1047	Façade fins outside main bedroom	<p>Construction debris observed on façade of building</p> <p>Home Building Act (NSW) 1989</p> <ul style="list-style-type: none"> Part 2C, 18B (a) and (c). <p>This is a breach of part (a) of the act because the surface has not been finished in a proper workmanlike manner that would prevent loss of appearance to the surface.</p> <p>Loss Suffered</p> <p>Loss suffered is cost of rectification.</p>	<ol style="list-style-type: none"> 1. Protect all adjoining surfaces. 2. Use a suitable cleaning agent to remove residue and clear debris. 3. Clean up the work area.

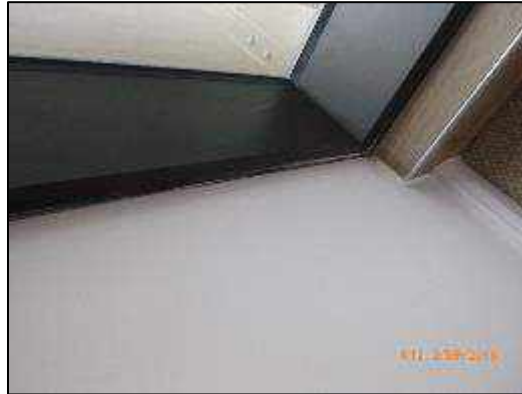
Item	Location	Defect description and Breach	Rectification	Photograph (if applicable)
1048	Main bedroom window frames	See section 5.9.1	See section 5.9.2

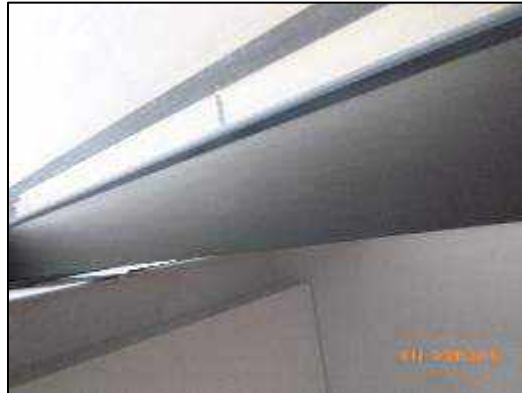
1049	Main bedroom windows	See section 5.7.1	See section 5.7.2

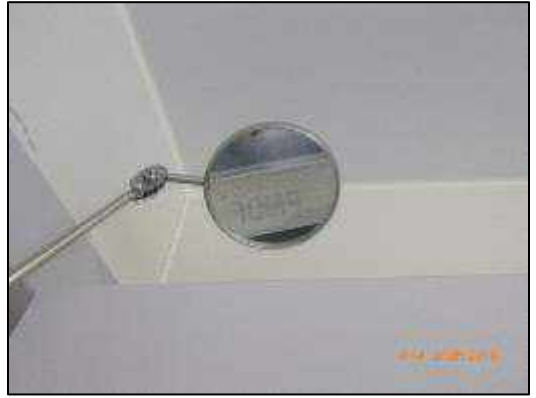
Item	Location	Defect description and Breach	Rectification	Photograph (if applicable)
1050	<i>Doors throughout the unit (x3)</i>	See section 5.5.1	See section 5.5.2

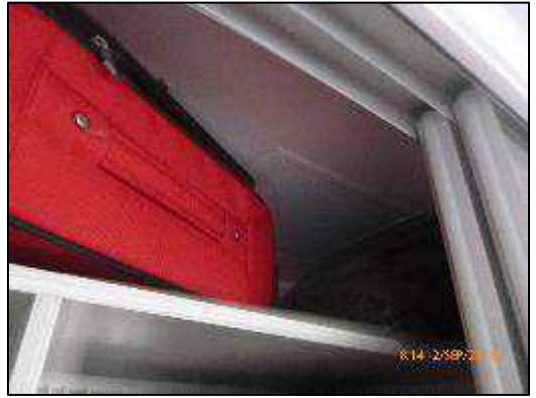
1051	<i>Main bedroom built in</i>	See section 5.6.1	See section 5.6.2

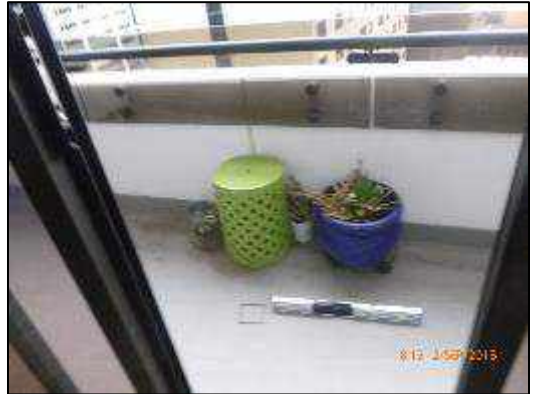
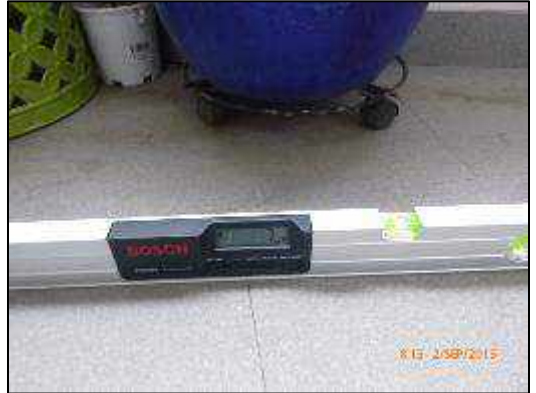
Item	Location	Defect description and Breach	Rectification	Photograph (if applicable)
1052	Balcony	See section 5.2.1 Falls (mm); 7/1000	See section 5.2.2

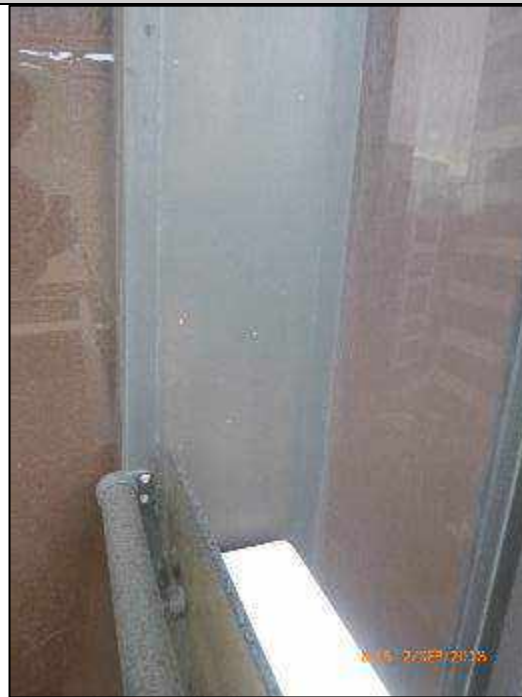
Item	Location	Defect description and Breach	Rectification	Photograph (if applicable)
1053	<i>Façade adjacent to balcony area</i>	See section 5.7.1	See section 5.7.2

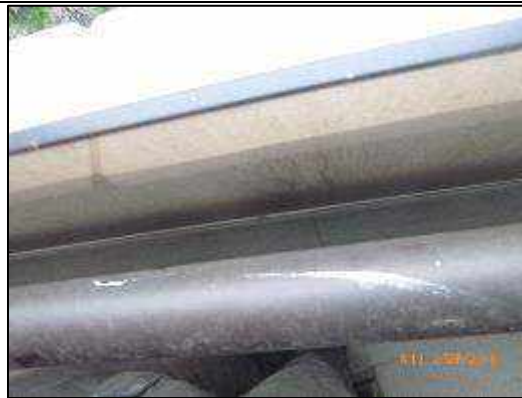
A photograph showing a close-up of a balcony railing. The railing is made of metal and has a white, possibly painted or plastic, section at the bottom. The background shows a building facade with a reddish-brown brick pattern. A date stamp '2018-02-22 10:18' is visible in the bottom right corner.
1054	<i>Balcony balustrade railing</i>	See section 5.9.1	See section 5.9.2

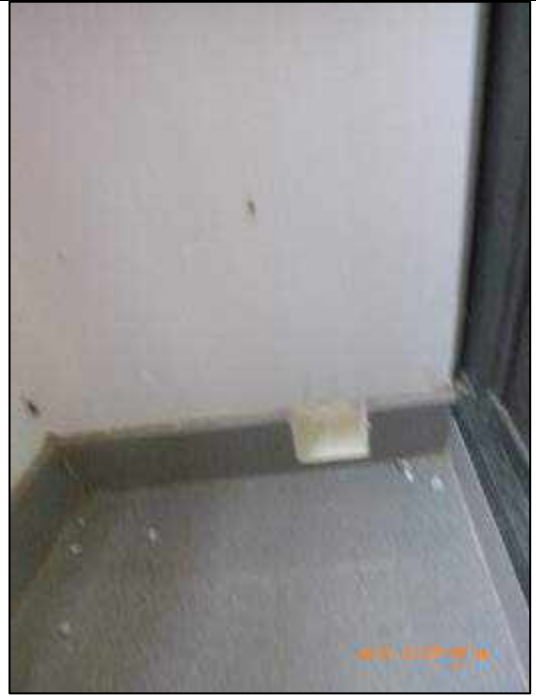
Item	Location	Defect description and Breach	Rectification	Photograph (if applicable)
1055	Balcony	See section 5.15.1	See section 5.15.2

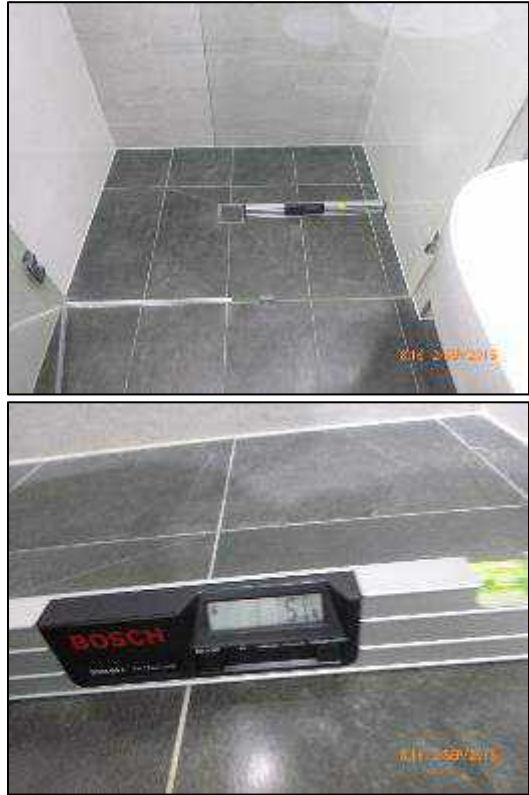
Item	Location	Defect description and Breach	Rectification	Photograph (if applicable)
1056	Main bathroom	See section 5.1.1 Falls (mm); 5/1000	See section 5.1.2

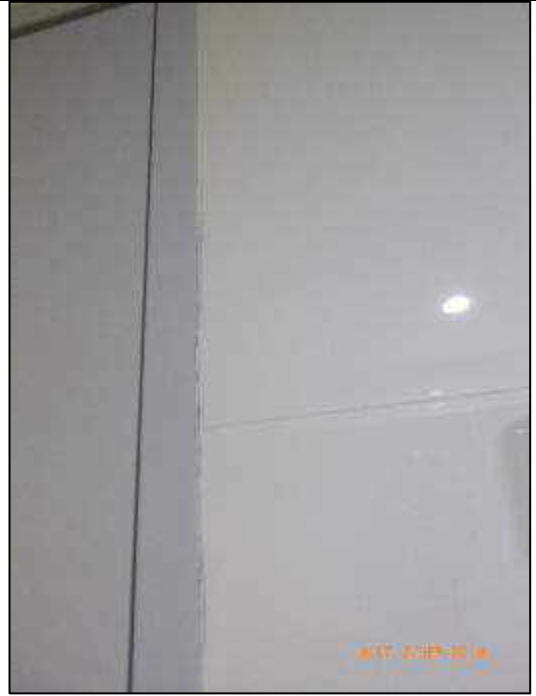
Item	Location	Defect description and Breach	Rectification	Photograph (if applicable)
1057	Main bathroom door frame	See section 5.9.1	See section 5.9.2

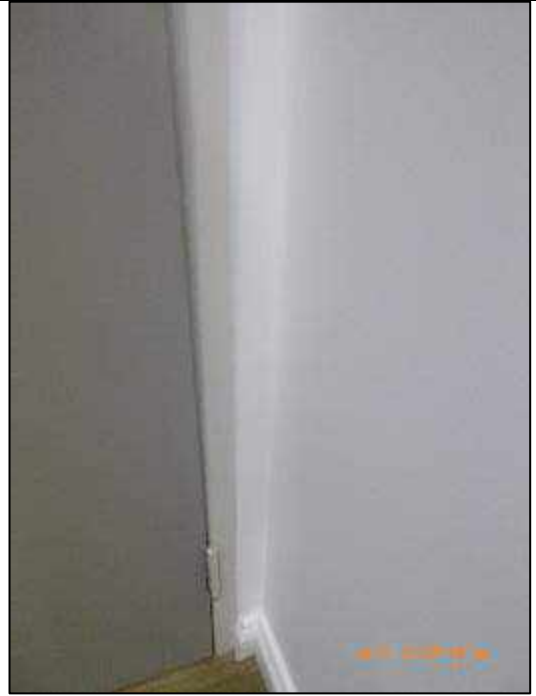
Item	Location	Defect description and Breach	Rectification	Photograph (if applicable)
1058	Wall adjacent to front entry door	See section 5.13.1	See section 5.13.2

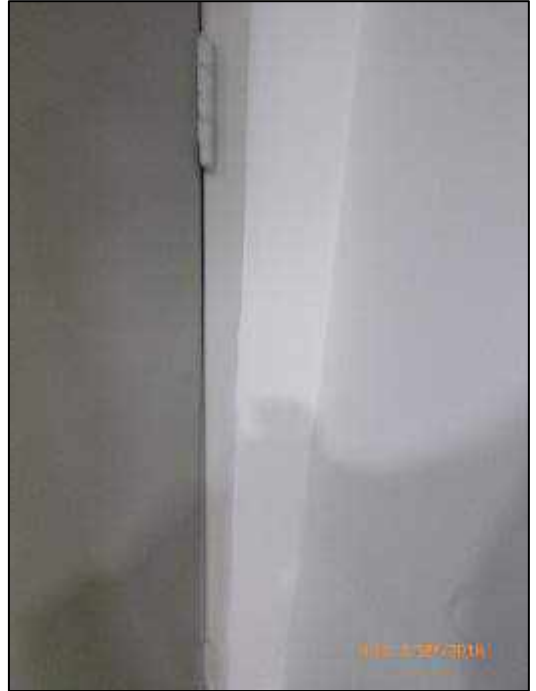
Item	Location	Defect description and Breach	Rectification	Photograph (if applicable)
Unit 906				
1059	Wall adjacent to front entry door	See section 5.13.1	See section 5.13.2

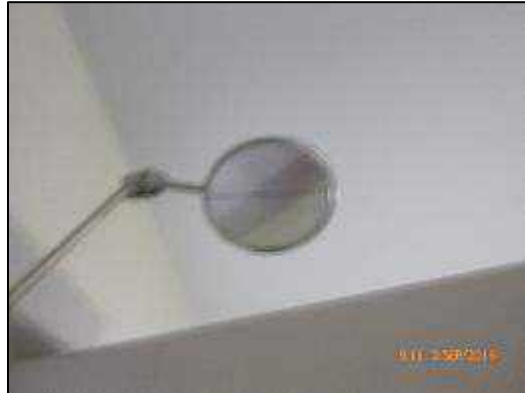
Item	Location	Defect description and Breach	Rectification	Photograph (if applicable)
1060	<i>Doors throughout the unit (x2)</i>	See section 5.5.1	See section 5.5.2

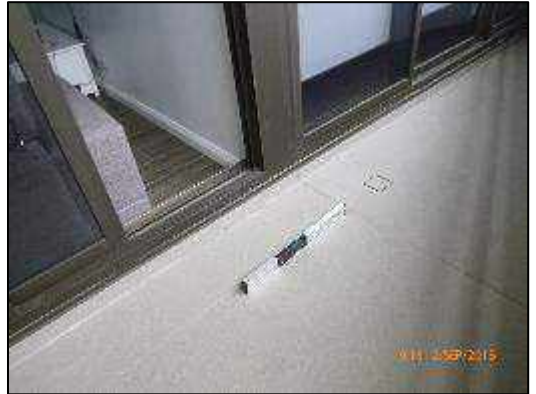
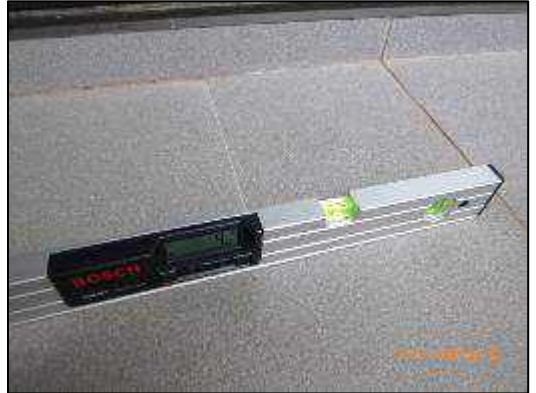
Item	Location	Defect description and Breach	Rectification	Photograph (if applicable)
1062	Balcony	See section 5.2.1 Falls (mm); 4/1000	See section 5.2.2

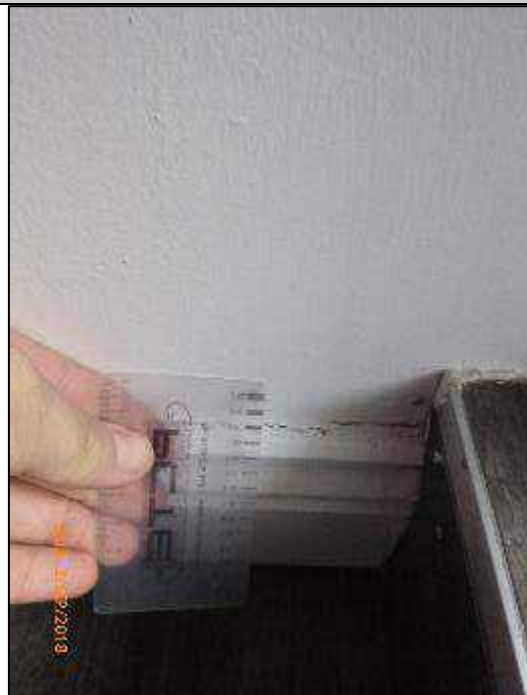
Item	Location	Defect description and Breach	Rectification	Photograph (if applicable)
1067	Main bedroom skirting board	See section 5.14.1 Separation; 1.5mm	See section 5.14.2

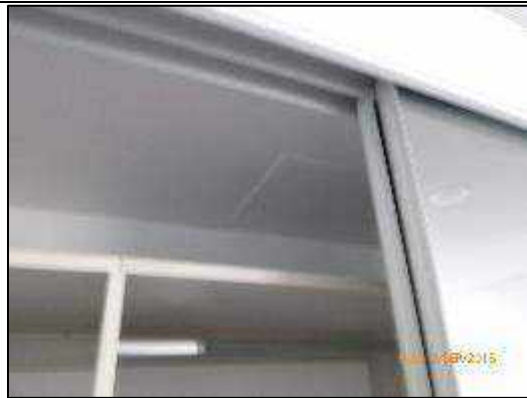
1068	Main bedroom built in	See section 5.6.1	See section 5.6.2

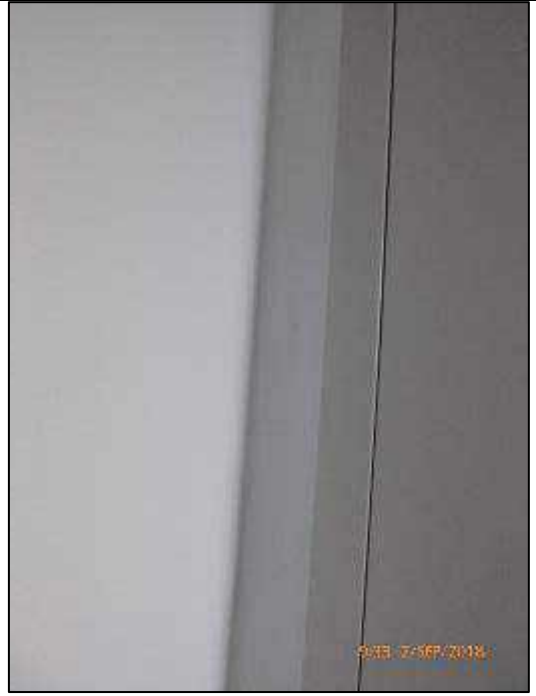
Item	Location	Defect description and Breach	Rectification	Photograph (if applicable)
1069	Wall adjacent to main bedroom door	See section 5.13.1	See section 5.13.2

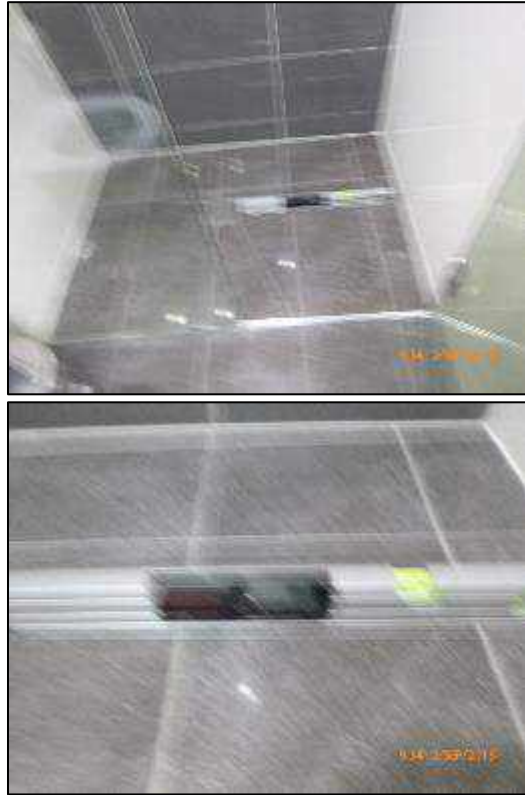
Item	Location	Defect description and Breach	Rectification	Photograph (if applicable)
1070	Main bedroom ensuite	See section 5.1.1 Falls (mm); 4/1000	See section 5.1.2

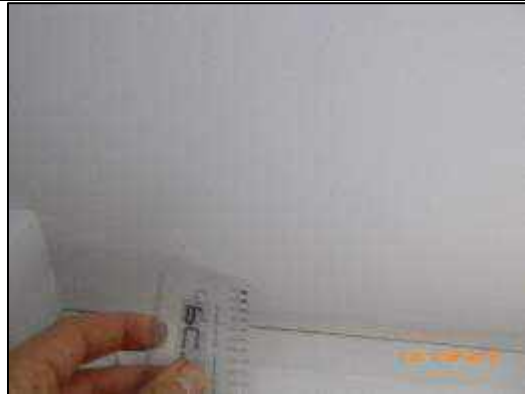
Item	Location	Defect description and Breach	Rectification	Photograph (if applicable)
1071	<i>Ceiling above kitchen cupboards</i>	See section 5.14.1 Separation; 2mm	See section 5.14.2

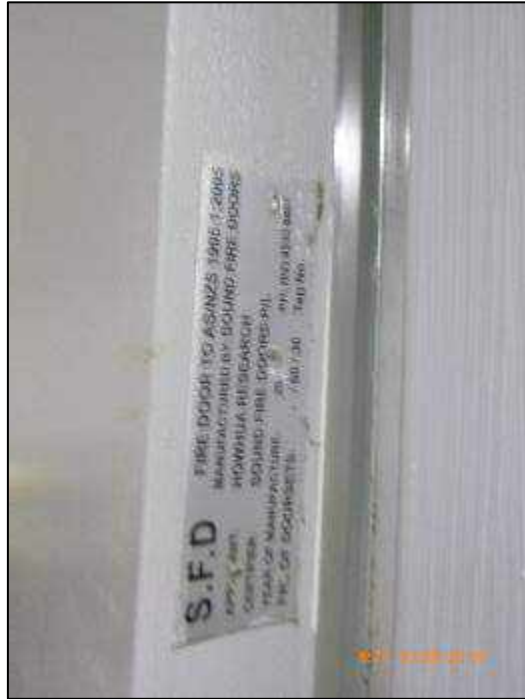
Item	Location	Defect description and Breach	Rectification	Photograph (if applicable)
Unit 908				
1073	Front entry door	See section 5.12.1	See section 5.12.2

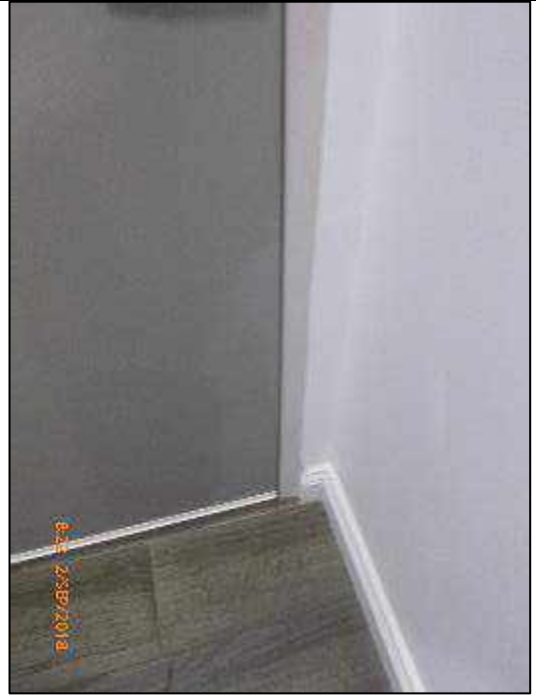
Item	Location	Defect description and Breach	Rectification	Photograph (if applicable)
1074	Wall adjacent to front entry door	See section 5.10.1	See section 5.10.2

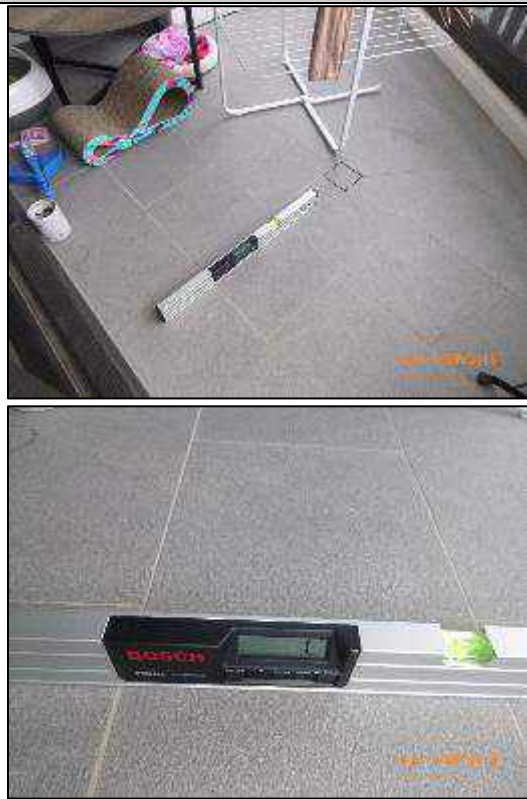
Item	Location	Defect description and Breach	Rectification	Photograph (if applicable)
1075	Balcony	See section 5.2.1 Falls (mm); 1/1000	See section 5.2.2

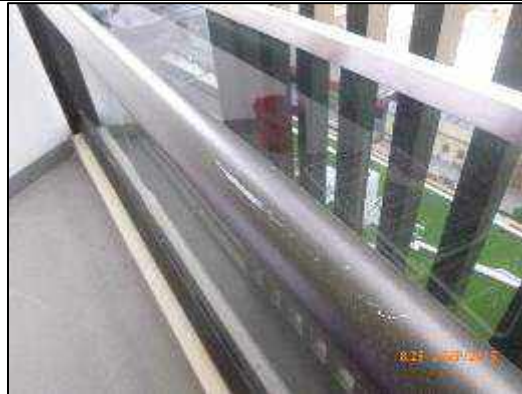
Item	Location	Defect description and Breach	Rectification	Photograph (if applicable)
1076	Balcony railing <i>balustrade</i>	See section 5.9.1	See section 5.9.2

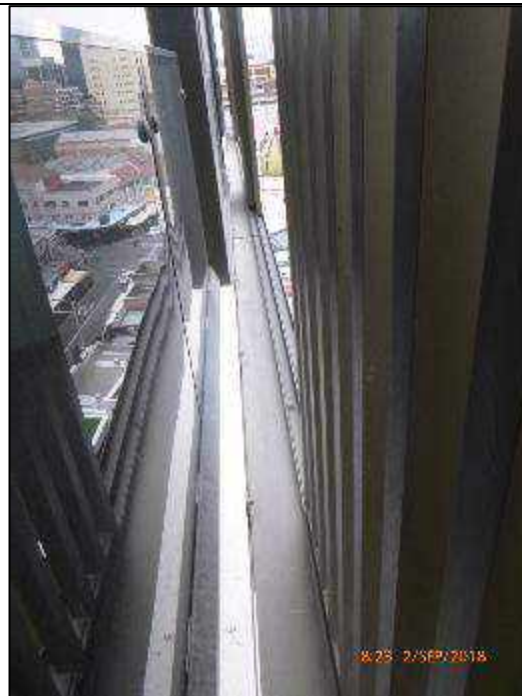
1077	Balcony facade <i>balustrade</i>	<p>Construction debris observed on façade of building</p> <p>Home Building Act (NSW) 1989</p> <ul style="list-style-type: none"> Part 2C, 18B (a) and (c). <p>This is a breach of part (a) of the act because the surface has not been finished in a proper workmanlike manner that would prevent loss of appearance to the surface.</p> <p>Loss Suffered Loss suffered is cost of rectification.</p>	<ol style="list-style-type: none"> 1. Protect all adjoining surfaces. 2. Use a suitable cleaning agent to remove residue and clear debris. 3. Clean up the work area.

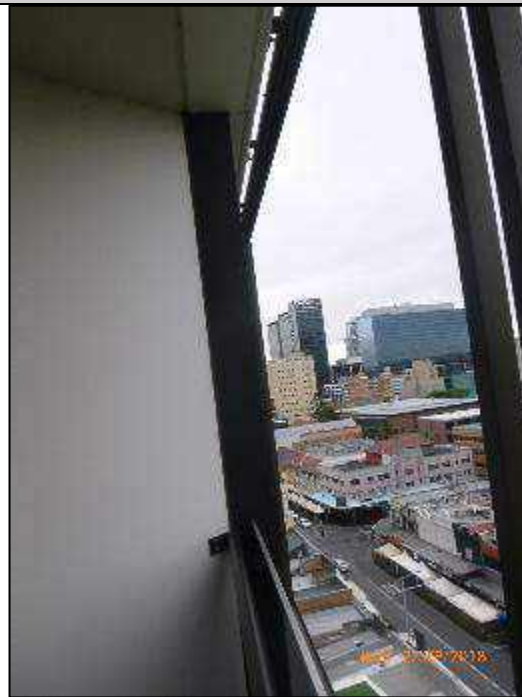
Item	Location	Defect description and Breach	Rectification	Photograph (if applicable)
1078	<i>Façade panels in balcony area</i>	<p>Construction debris observed on façade of building</p> <p>Home Building Act (NSW) 1989</p> <ul style="list-style-type: none"> Part 2C, 18B (a) and (c). <p>This is a breach of part (a) of the act because the surface has not been finished in a proper workmanlike manner that would prevent loss of appearance to the surface.</p> <p>Loss Suffered Loss suffered is cost of rectification.</p>	<ol style="list-style-type: none"> 1. Protect all adjoining surfaces. 2. Use a suitable cleaning agent to remove residue and clear debris. 3. Clean up the work area.

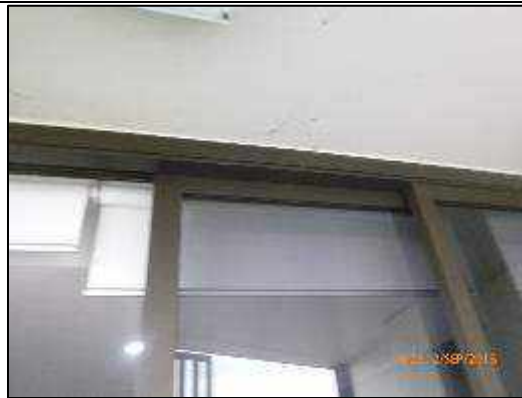
1079	<i>Balcony sliding door</i>	See section 5.9.1	See section 5.9.2

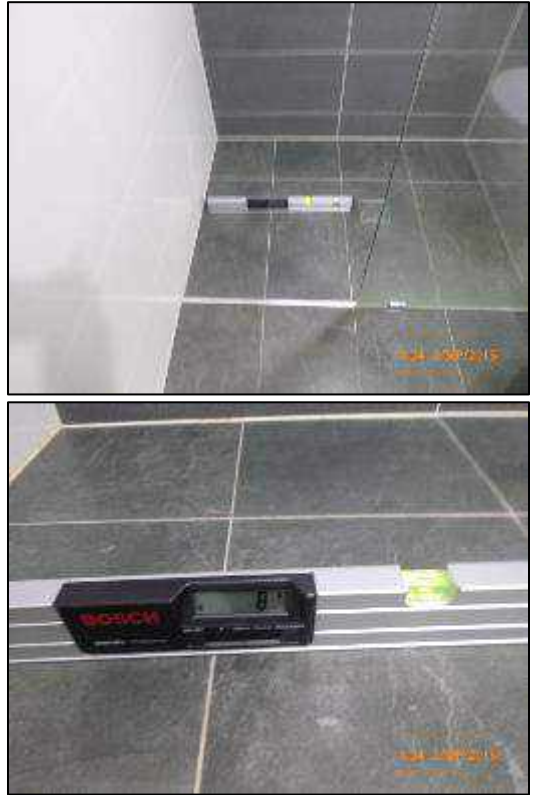
Item	Location	Defect description and Breach	Rectification	Photograph (if applicable)
1080	Main bathroom	See section 5.1.1 Falls (mm); 8/1000	See section 5.1.2

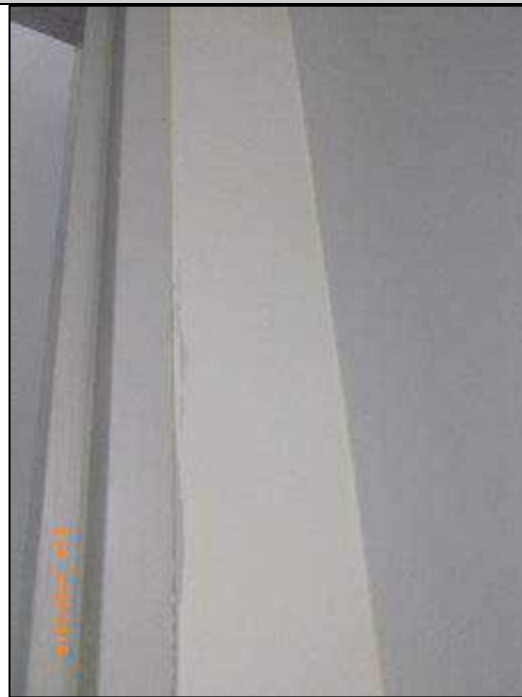
Item	Location	Defect description and Breach	Rectification	Photograph (if applicable)
1081	Wall adjacent to main bathroom door.	See section 5.9.1	See section 5.9.2

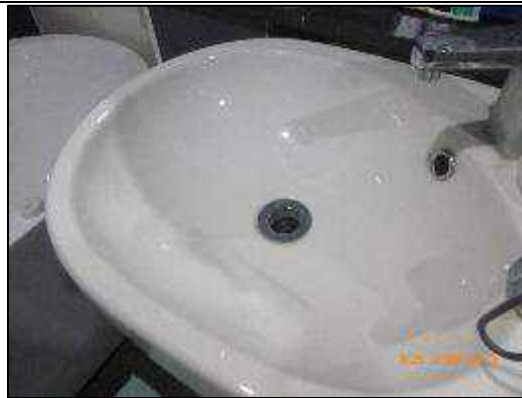
A photograph showing a vertical crack or gap in a white wall, likely adjacent to a door frame.
1082	Main bedroom ensuite	<p>Sink drainage plug observed to be non-functional.</p> <p>Home Building Act (NSW) 1989</p> <ul style="list-style-type: none"> Part 2C, 18B (a) and (c). <p>This is a breach of part (a) of the act because the basin has not been installed in a proper workmanlike manner that would prevent leaking of the basin, resulting in a loss of amenity.</p> <p>Loss suffered</p>	Engage licensed plumber to complete necessary repairs.

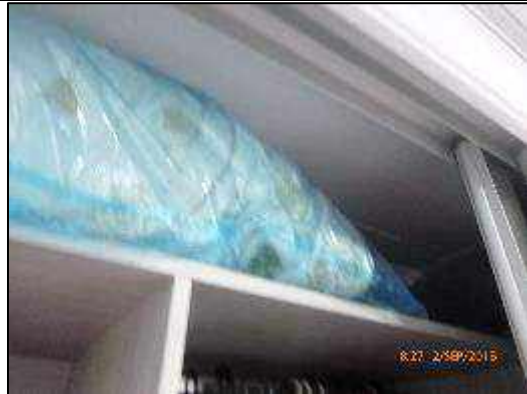
Item	Location	Defect description and Breach	Rectification	Photograph (if applicable)
		Loss suffered is cost of rectification.		
1083	Main bedroom	See section 5.6.1	See section 5.6.2

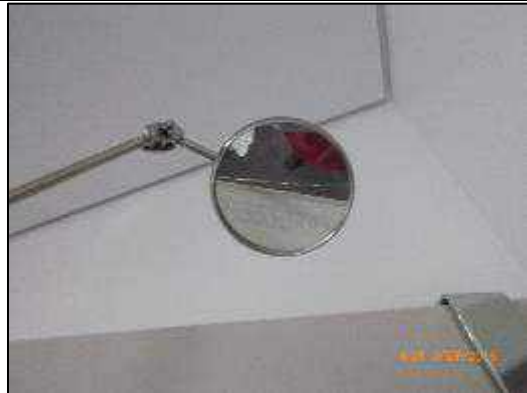
1084	Doors throughout the unit (x3)	See section 5.5.1	See section 5.5.2

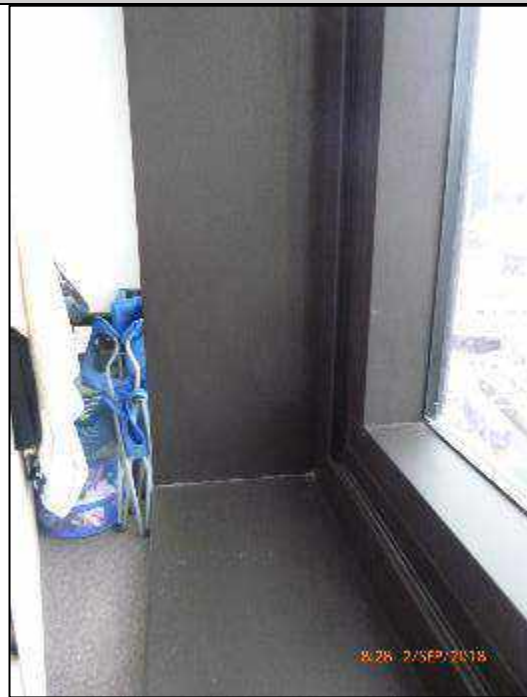
Item	Location	Defect description and Breach	Rectification	Photograph (if applicable)
1085	Lounge room window frames	See section 5.8.1	See section 5.8.2

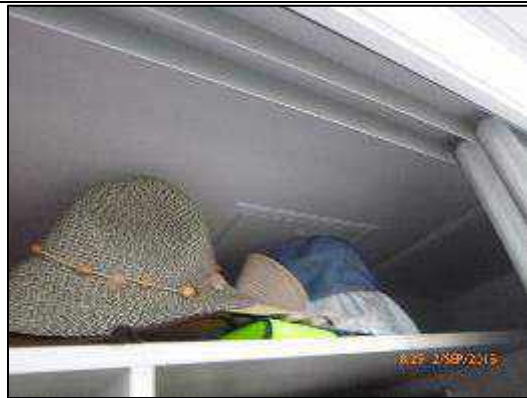
A photograph showing a close-up of a dark-colored window frame. There is a visible gap between the frame and the wall, and some debris is visible on the floor next to the frame. A timestamp in the bottom right corner reads '8/28/2018 2:58:18'.
1086	Second bedroom built in	See section 5.6.1	See section 5.6.2

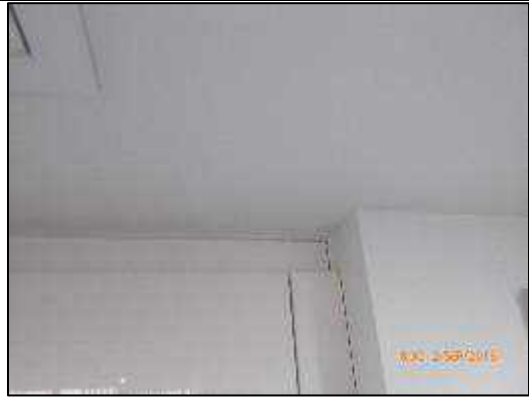
Item	Location	Defect description and Breach	Rectification	Photograph (if applicable)
1087	<i>Ceiling above kitchen cupboards</i>	See section 5.14.1 Separation; 2mm	See section 5.14.2

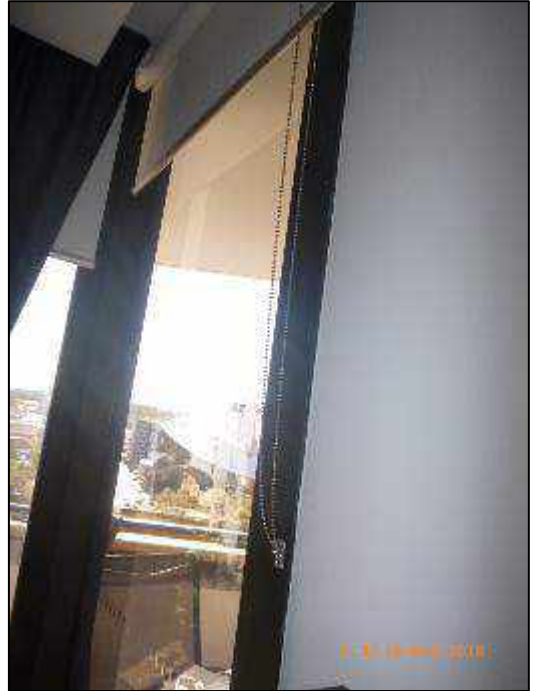
Item	Location	Defect description and Breach	Rectification	Photograph (if applicable)
Unit 1002				
1089	Lounge room window frames	See section 5.9.1	See section 5.9.2

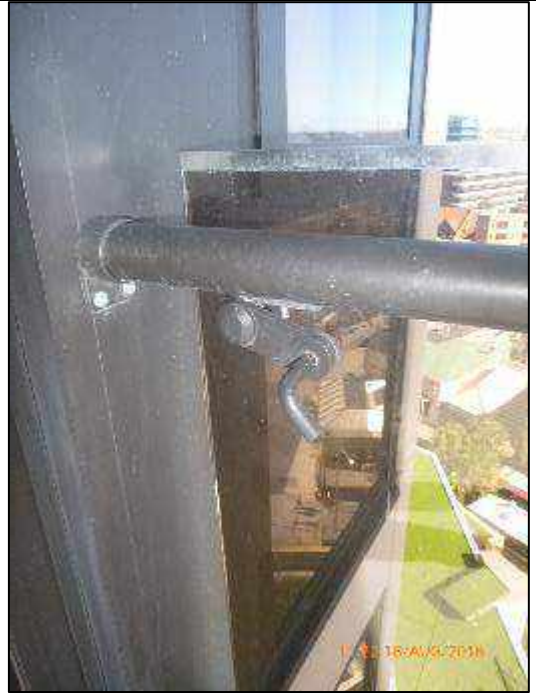
Item	Location	Defect description and Breach	Rectification	Photograph (if applicable)
1090	Balcony balustrade rail	See section 5.9.1	See section 5.9.2

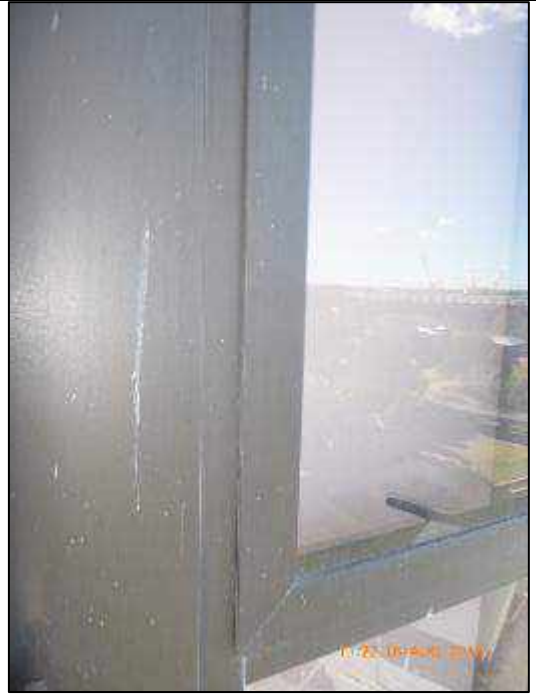
Item	Location	Defect description and Breach	Rectification	Photograph (if applicable)
1091	Balcony sliding door frame	See section 5.9.1	See section 5.9.2

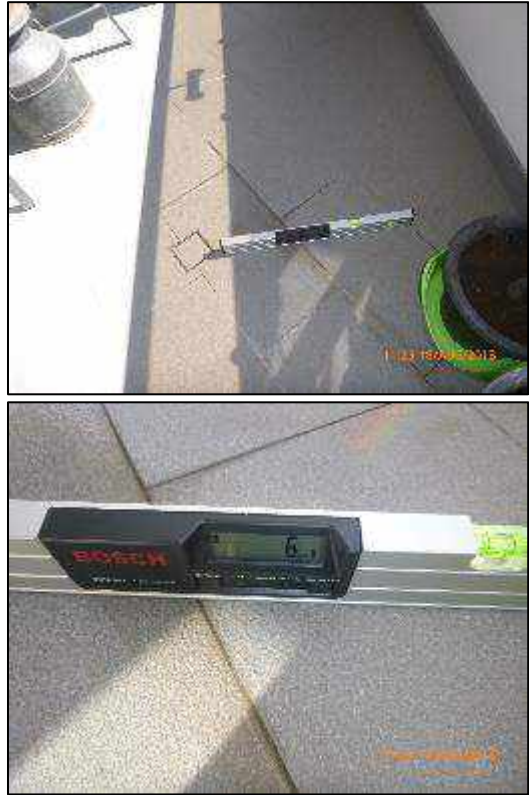
Item	Location	Defect description and Breach	Rectification	Photograph (if applicable)
1092	Balcony	See section 5.2.1 Falls (mm); 6/1000	See section 5.2.2

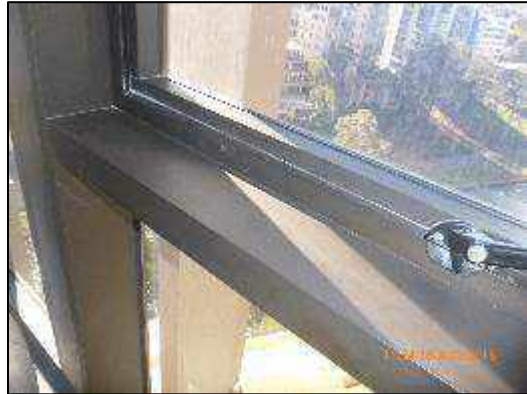
Item	Location	Defect description and Breach	Rectification	Photograph (if applicable)
1094	Main bedroom window frames	See section 5.7.1	See section 5.7.2

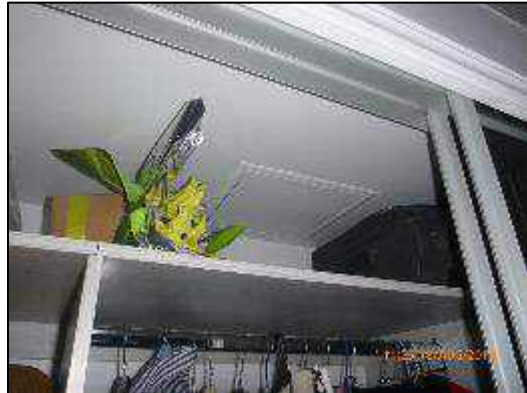
1095	Main bedroom built in	See section 5.6.1	See section 5.6.2

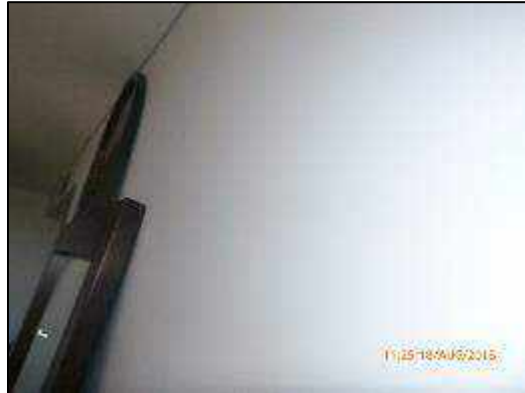
Item	Location	Defect description and Breach	Rectification	Photograph (if applicable)
1096	Main bedroom	See section 5.11.1	See section 5.11.2

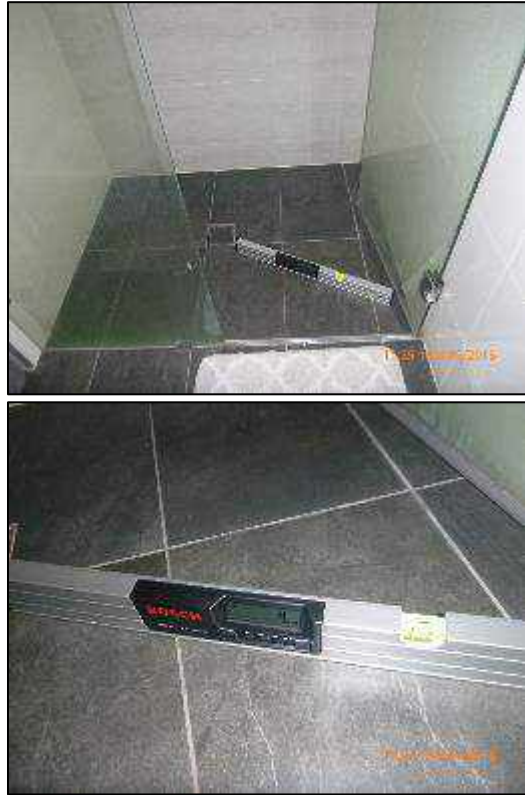
Item	Location	Defect description and Breach	Rectification	Photograph (if applicable)
1097	Main bedroom ensuite	See section 5.1.1 Falls (mm); 4/1000	See section 5.1.2

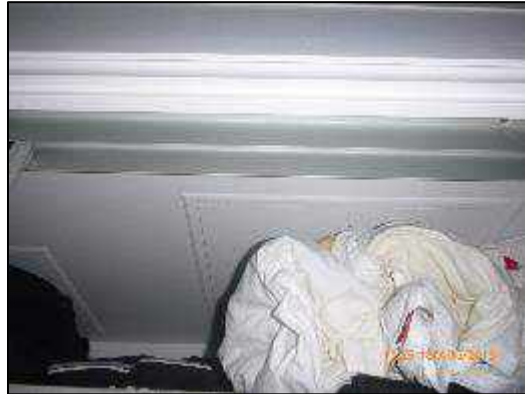
Item	Location	Defect description and Breach	Rectification	Photograph (if applicable)
1098	Second bedroom built in	See section 5.6.1	See section 5.6.2

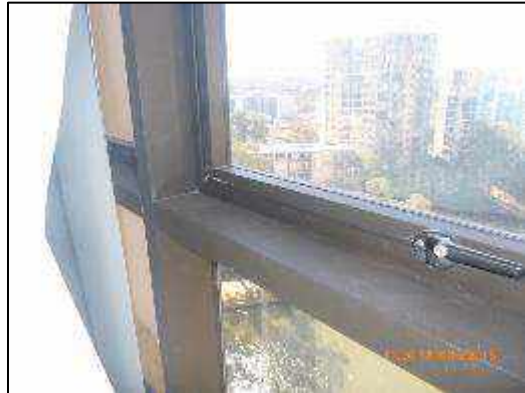
1099	Second bedroom window frames	See section 5.7.1	See section 5.7.2

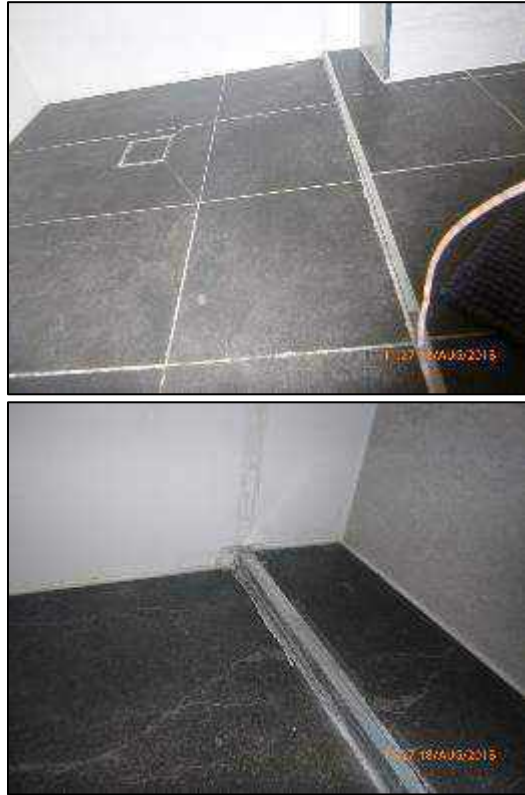
Item	Location	Defect description and Breach	Rectification	Photograph (if applicable)
1100	Main bathroom shower recess	See section 5.8.1	See section 5.8.2

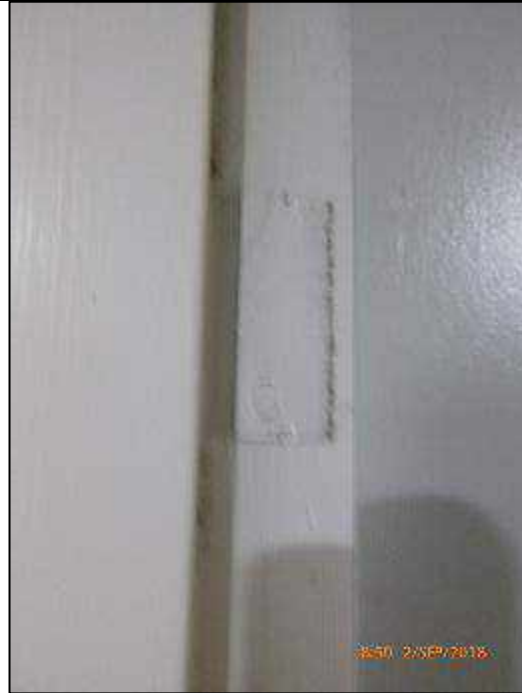
Item	Location	Defect description and Breach	Rectification	Photograph (if applicable)
Unit 1003				
1101	Front entry door	<p>Door frame label has been painted over.</p> <p>Home Building Act (NSW) 1989</p> <ul style="list-style-type: none"> Part 2C, 18B (a) & (c). <p>Loss Suffered</p> <p>Loss suffered is cost of rectification.</p>	Use a suitable cleaning agent to remove paint from the door frame label.

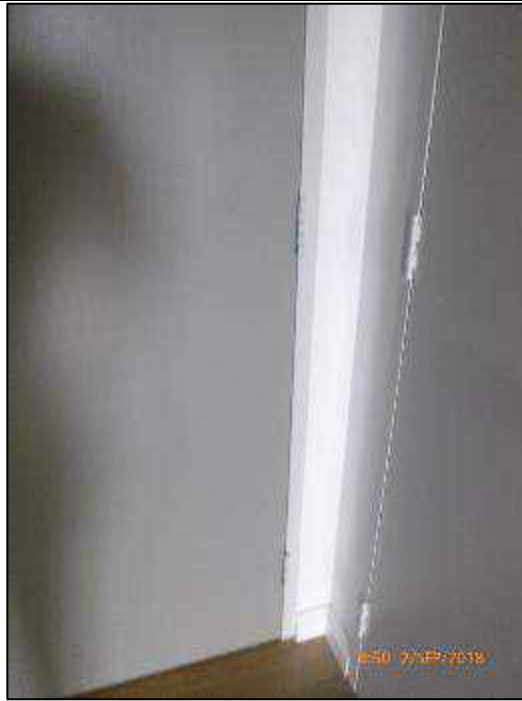
Item	Location	Defect description and Breach	Rectification	Photograph (if applicable)
1102	Wall adjacent to entry door	See section 5.13.1	See section 5.13.2

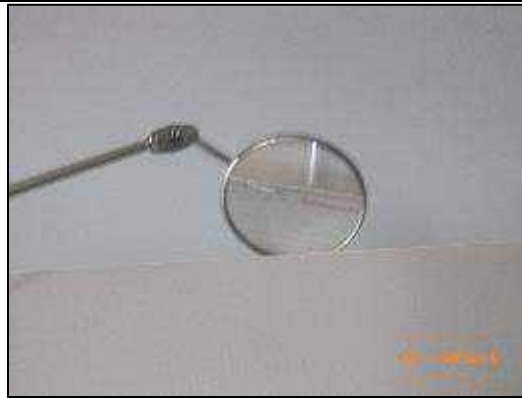
1103	Doors throughout the unit (x3)	See section 5.5.1	See section 5.5.2

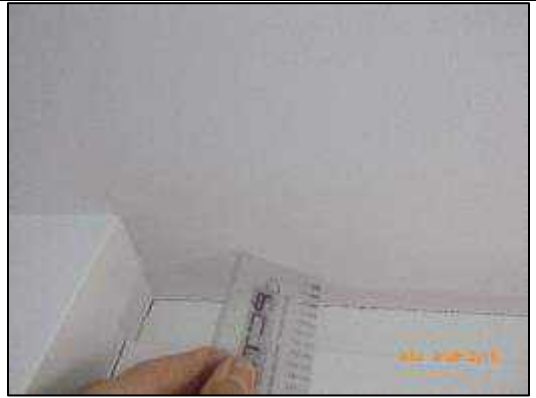
Item	Location	Defect description and Breach	Rectification	Photograph (if applicable)
1104	<i>Ceiling above kitchen cupboards</i>	See section 5.14.1 Separation; 1.5mm	See section 5.14.2

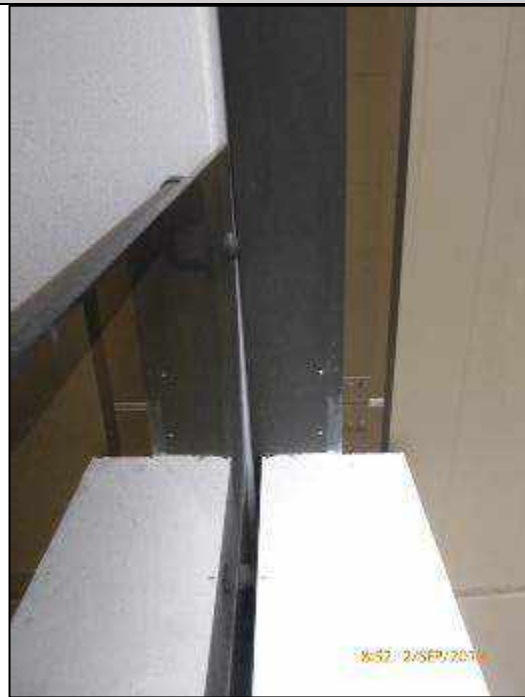
Item	Location	Defect description and Breach	Rectification	Photograph (if applicable)
1106	Façade in balcony area	See section 5.9.1	See section 5.9.2
