SydneyStrataReport

STRATA REPORT

Client	Church Street Parramatta Property Pty Ltd
Address of property	Unit 3303/330 Church Street, Parramatta, NSW.
Lot	359
Strata Plan	SP 94469
Name of Strata Management Co.	NSW Strata
Telephone Number of Strata Agent	8980 1841
Report Date	15 February 2024

BUILDING DEFECTS REPORT Part 1/2

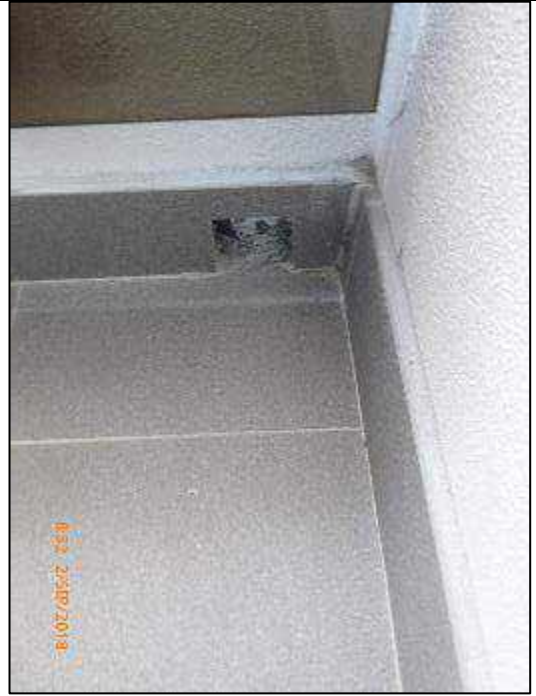
Item	Location	Defect description and Breach	Rectification	Photograph (if applicable)
1107	Balcony	See section 5.15.1	See section 5.15.2

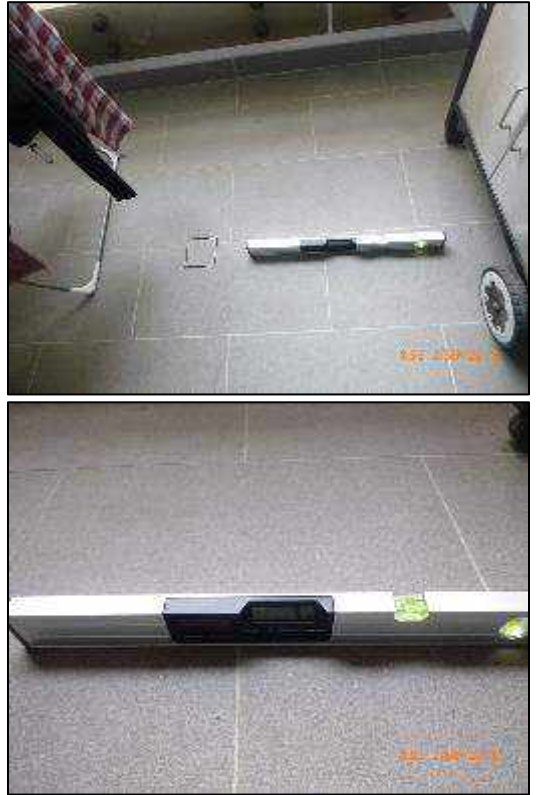
Item	Location	Defect description and Breach	Rectification	Photograph (if applicable)
1108	Balcony	See section 5.2.1 Falls (mm); 5/1000	See section 5.2.2

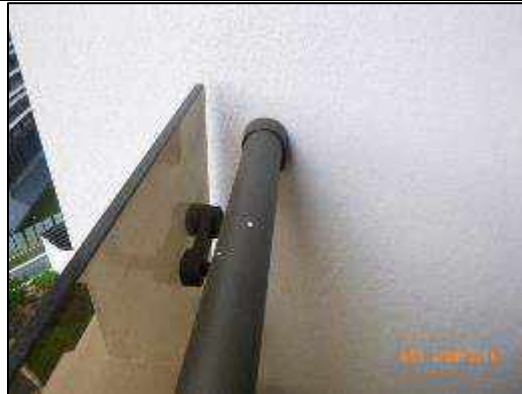
Item	Location	Defect description and Breach	Rectification	Photograph (if applicable)
1109	Balcony balustrade rail	See section 5.9.1	See section 5.9.2

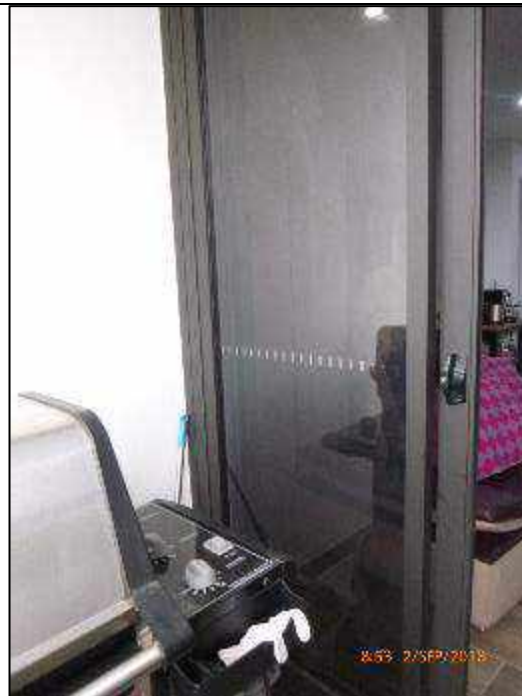
1110	Balcony	See section 5.4.1	See section 5.4.2

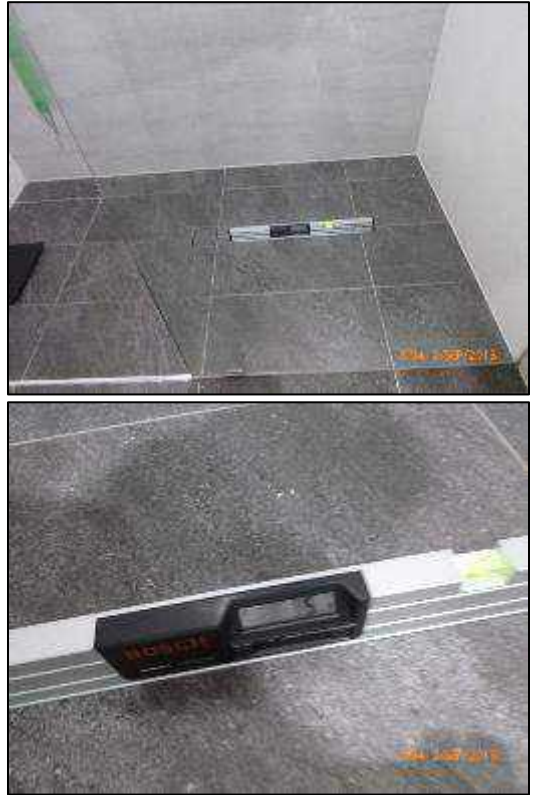
Item	Location	Defect description and Breach	Rectification	Photograph (if applicable)
1111	Main bathroom	See section 5.1.1 Falls (mm); 5/1000	See section 5.1.2

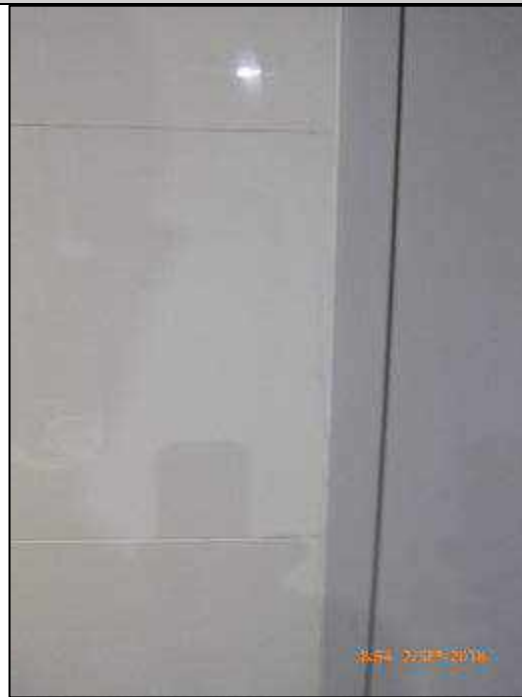
Item	Location	Defect description and Breach	Rectification	Photograph (if applicable)
1112	Main bathroom door frame	See section 5.9.1	See section 5.9.2

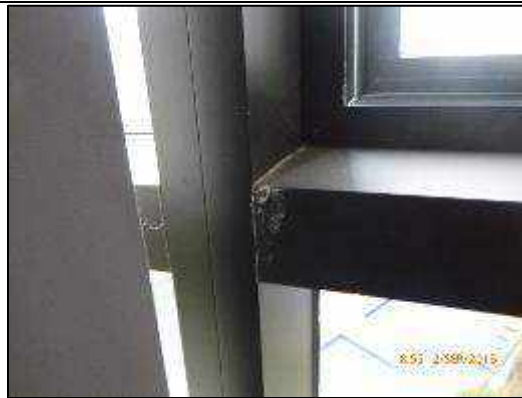
1113	Main bedroom windows	<p>Excess sealant observed on main bedroom window joints.</p> <p>Home Building Act (NSW) 1989</p> <ul style="list-style-type: none"> Part 2C, 18B (a) and (c). <p>This is a breach of part (a) of the act because the surface has not been finished in a proper workmanlike manner that would prevent loss of appearance to the surface.</p>	<ol style="list-style-type: none"> 1. Protect all adjoining surfaces. 2. Use a suitable cleaning agent to remove residue and clear debris. 3. Clean up the work area.

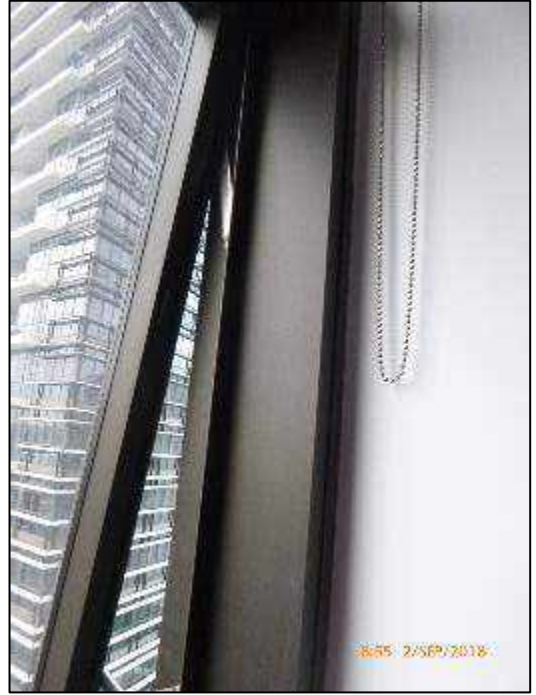
Item	Location	Defect description and Breach	Rectification	Photograph (if applicable)
		Loss Suffered Loss suffered is cost of rectification.		
1114	Main bedroom window frames	See section 5.7.1	See section 5.7.2

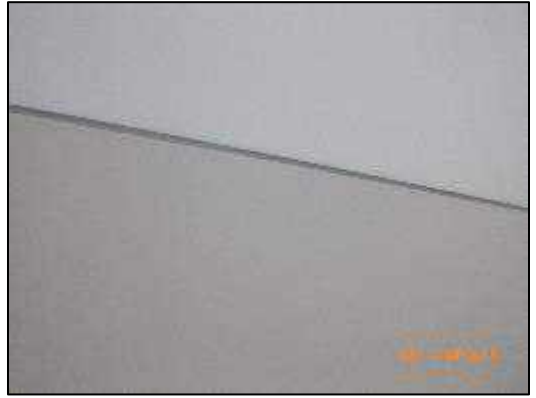
Item	Location	Defect description and Breach	Rectification	Photograph (if applicable)
1115	Main bedroom	See section 5.11.1	See section 5.11.2

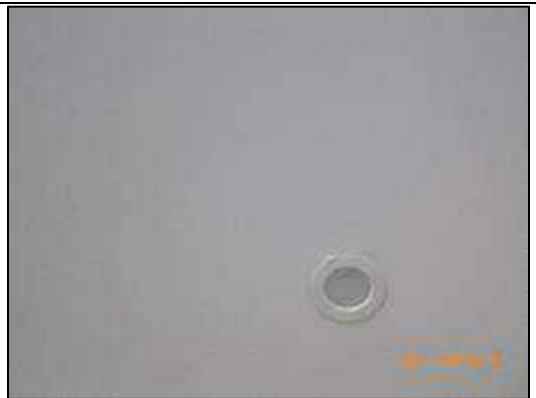
1116	Downlight in main bedroom	See section 5.13.1	See section 5.13.2

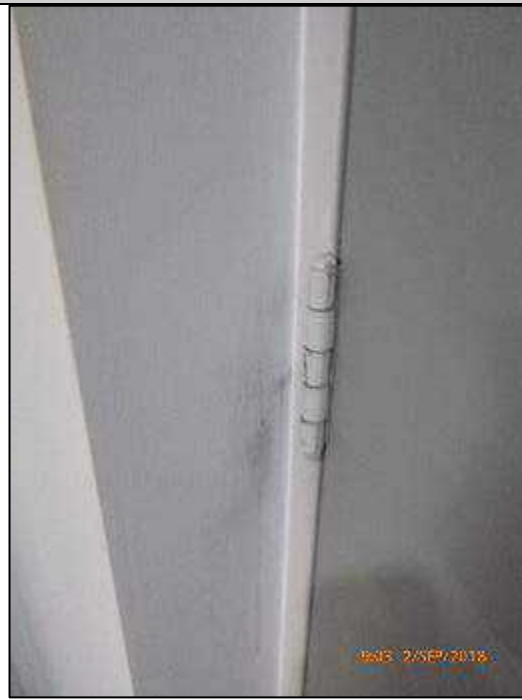
Item	Location	Defect description and Breach	Rectification	Photograph (if applicable)
1118	Front entry door	<p>The hinges of the front entry door are leaking.</p> <p>Home Building Act (NSW) 1989</p> <ul style="list-style-type: none"> Part 2C, 18B (a) and (b). <p>This item is a defect as the builder has failed to satisfy implied warranty set out in the Home Building Act 1989 – Section 18B Warranties as to residential building work.</p> <p>(b) a warranty that all materials supplied by the holder or person will be good and suitable for the purpose for which they are used and that, unless otherwise stated in the contract, those materials will be new.</p> <p>Loss Suffered Loss suffered in cost of rectification.</p>	Engage a licenced carpenter to remove faulty door hinges and reinstate with new hinges matching existing in accordance with manufacturers specifications.

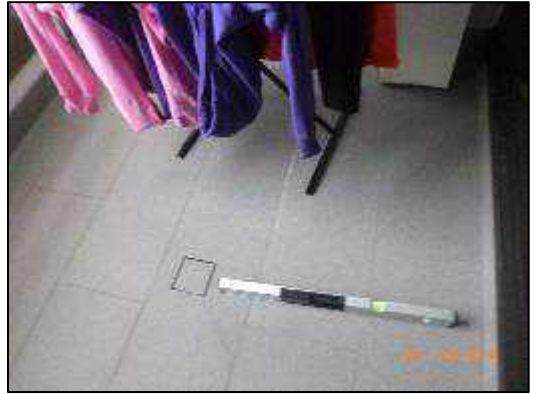
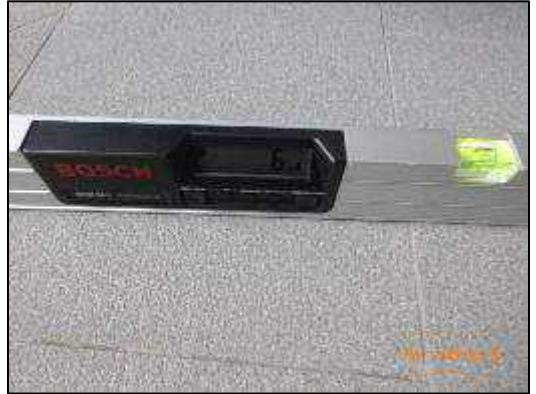
Item	Location	Defect description and Breach	Rectification	Photograph (if applicable)
1121	Balcony	See section 5.2.1 Falls (mm); 6/1000	See section 5.2.2

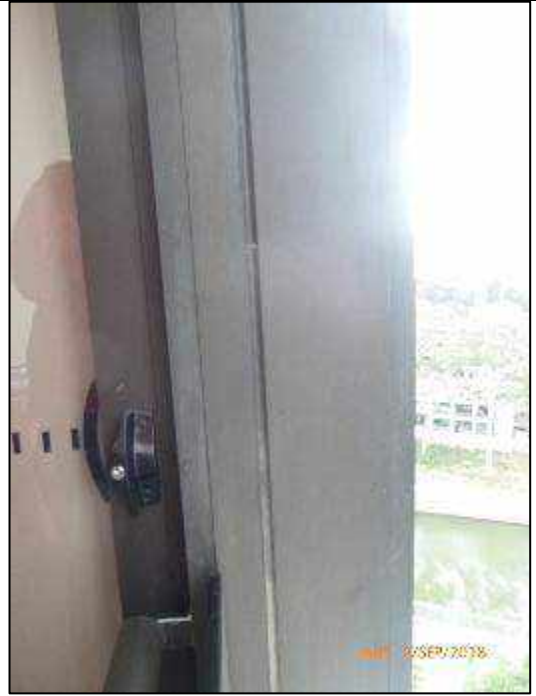
Item	Location	Defect description and Breach	Rectification	Photograph (if applicable)
1122	<i>Façade of balcony area</i>	See section 5.9.1	See section 5.9.2

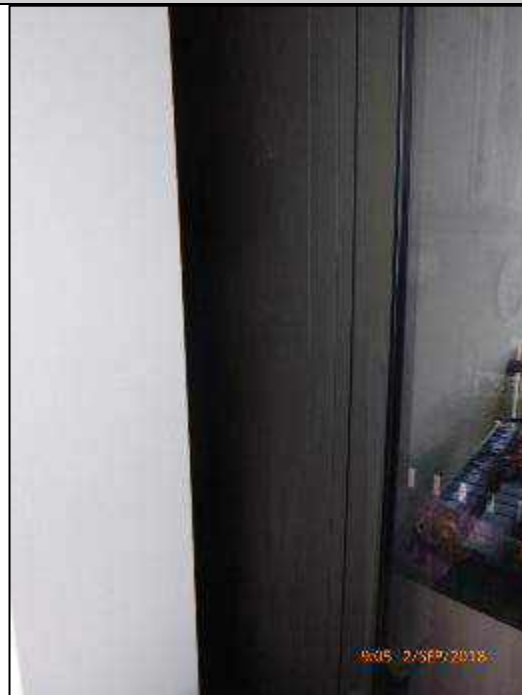
Item	Location	Defect description and Breach	Rectification	Photograph (if applicable)
1123	Balcony sliding door frame	See section 5.7.1	See section 5.7.2

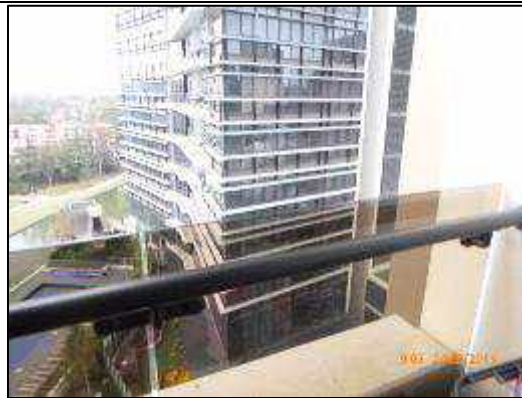
A close-up photograph of a dark-colored sliding door frame on a balcony. The frame appears to be made of metal or plastic and shows some wear or a defect. A timestamp in the bottom right corner reads "05/09/2018".
1124	Balcony	See section 5.4.1	See section 5.4.2

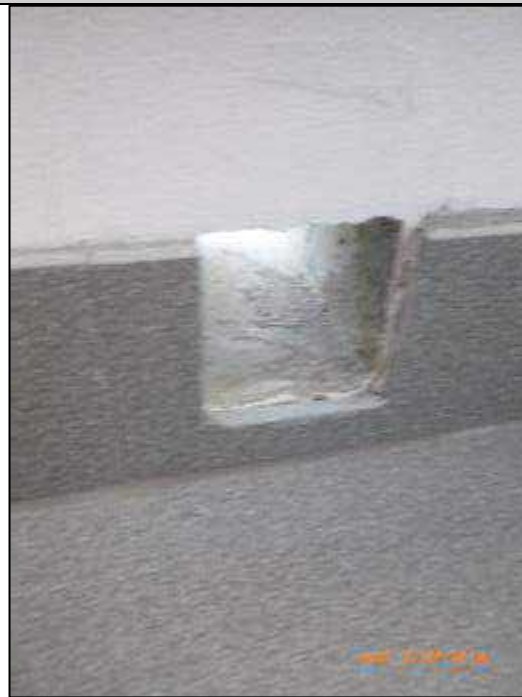
Item	Location	Defect description and Breach	Rectification	Photograph (if applicable)
1125	Balcony	See section 5.15.1	See section 5.15.2

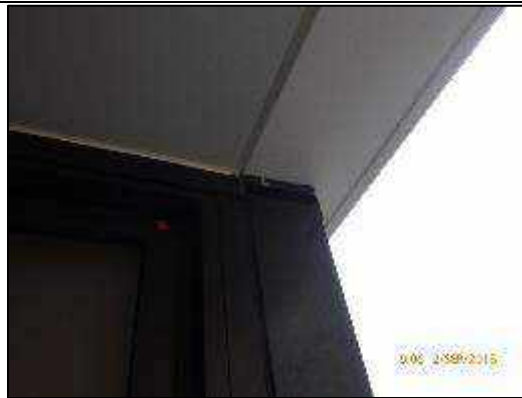
A photograph showing a close-up of a balcony railing. The railing appears to be made of metal or concrete and is showing signs of wear or damage, possibly a missing or loose section.
1126	Façade of balcony area	See section 5.9.1	See section 5.9.2

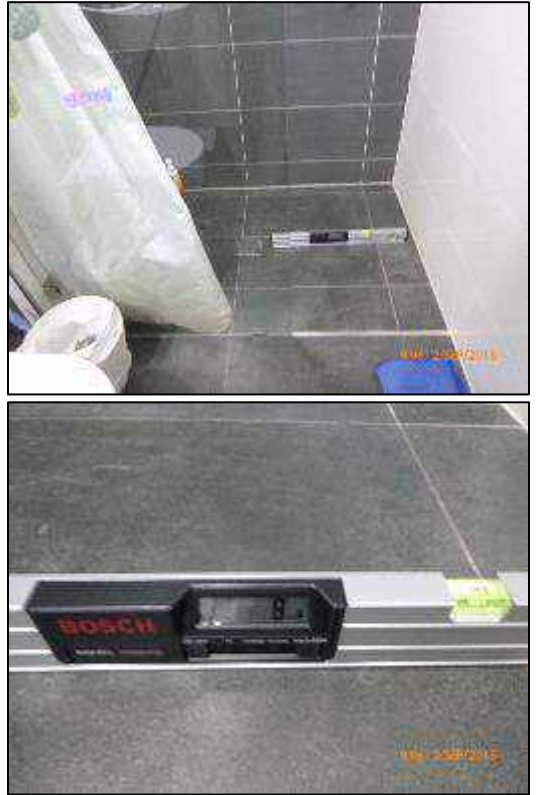
Item	Location	Defect description and Breach	Rectification	Photograph (if applicable)
1127	Main bathroom	See section 5.1.1 Falls (mm); 8/1000	See section 5.1.2

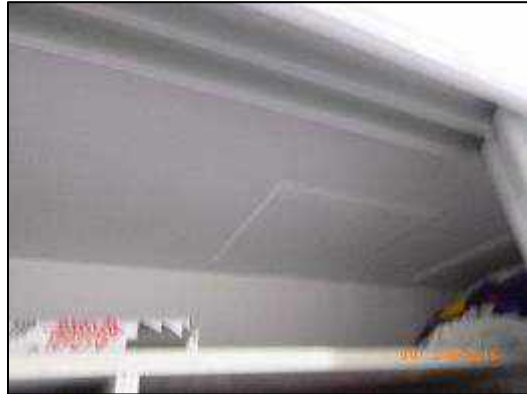
Item	Location	Defect description and Breach	Rectification	Photograph (if applicable)
1128	Main bedroom built in	See section 5.6.1	See section 5.6.2

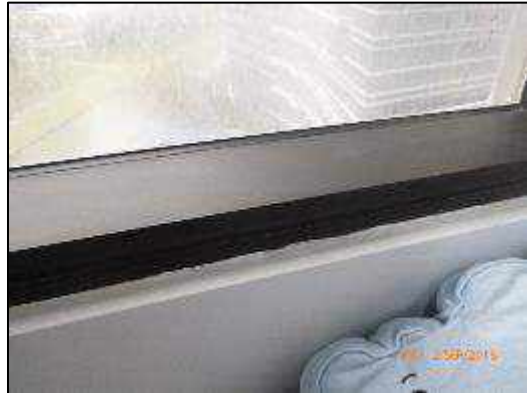
1129	Main bedroom window frames	See section 5.9.1	See section 5.9.2

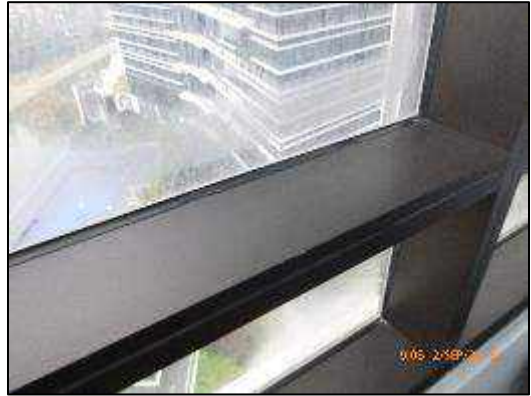
Item	Location	Defect description and Breach	Rectification	Photograph (if applicable)
1130	Main bedroom window frames	See section 5.7.1	See section 5.7.2

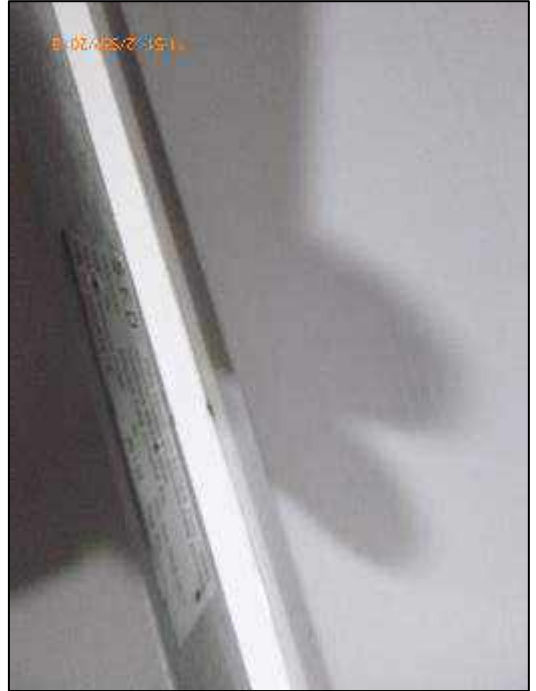
Item	Location	Defect description and Breach	Rectification	Photograph (if applicable)
Unit 1005				
1131	Front entry door	See section 5.12.1	See section 5.12.2

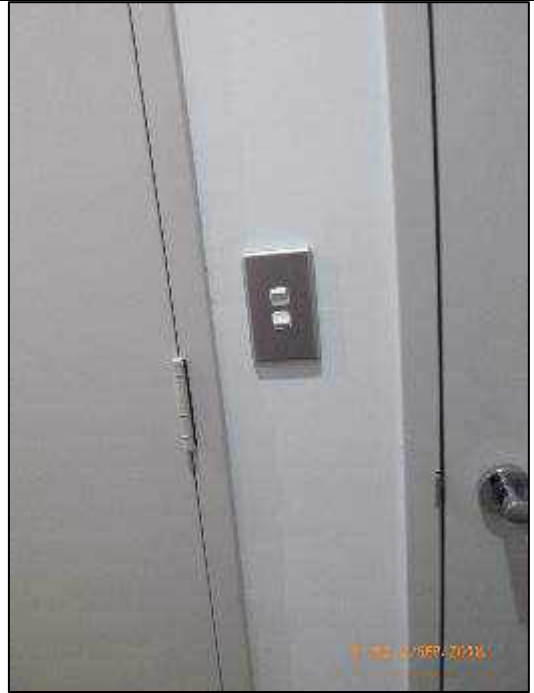
Item	Location	Defect description and Breach	Rectification	Photograph (if applicable)
1132	Wall adjacent to front entry door	See section 5.13.1	See section 5.13.2

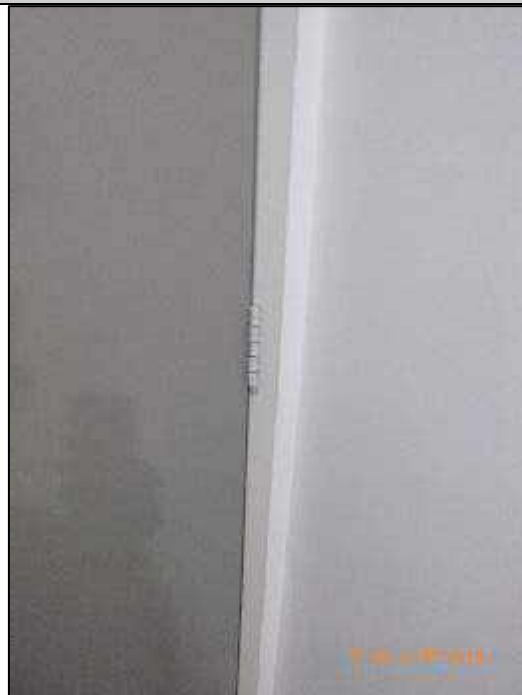
Item	Location	Defect description and Breach	Rectification	Photograph (if applicable)
1133	Wall adjacent to front entry door	See section 5.9.1	See section 5.9.2

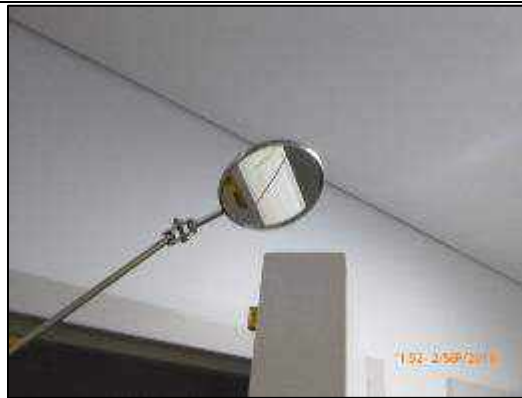
1134	Doors throughout the unit (x3)	See section 5.5.1	See section 5.5.2

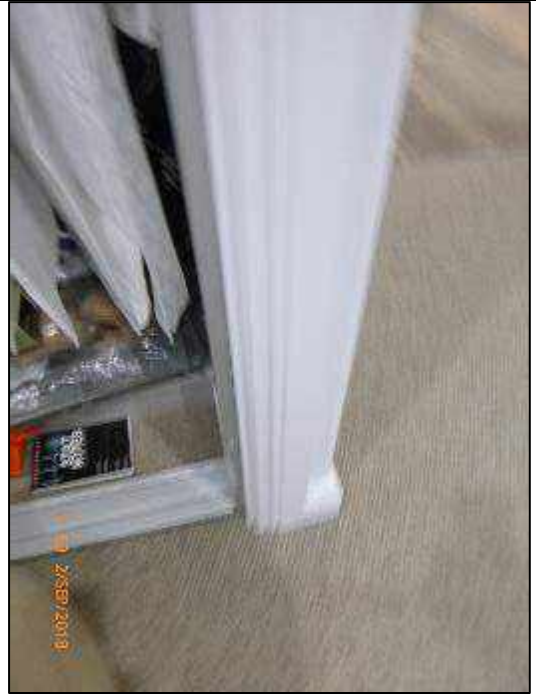
Item	Location	Defect description and Breach	Rectification	Photograph (if applicable)
1135	Main bedroom built in architrave	See section 5.10.1	See section 5.10.2

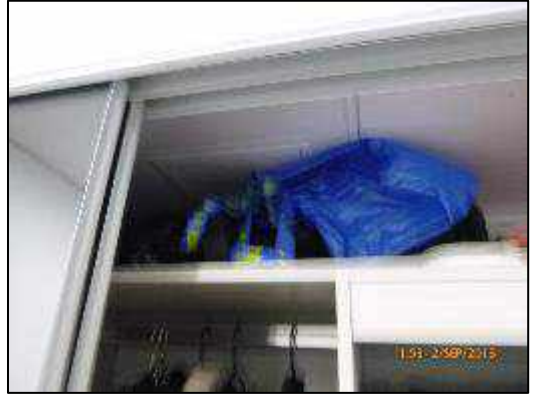
1136	Main bedroom built in	See section 5.6.1	See section 5.6.2

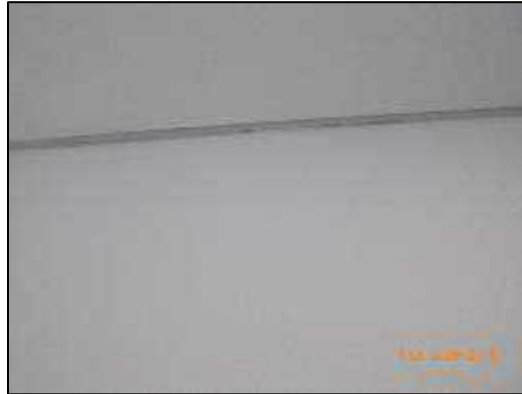
Item	Location	Defect description and Breach	Rectification	Photograph (if applicable)
1137	Main bedroom	See section 5.11.1	See section 5.11.2

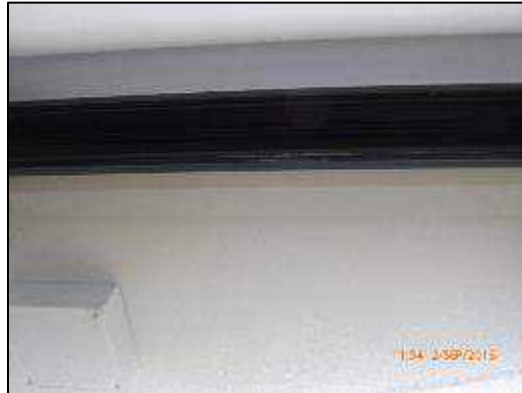
1138	Main bedroom window frame	See section 5.9.1	See section 5.9.2

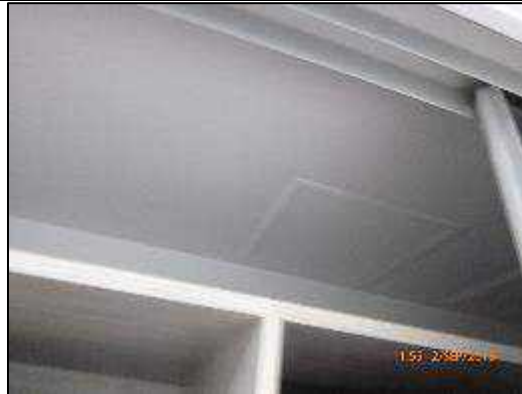
Item	Location	Defect description and Breach	Rectification	Photograph (if applicable)
1139	Second bedroom built in	See section 5.6.1	See section 5.6.2

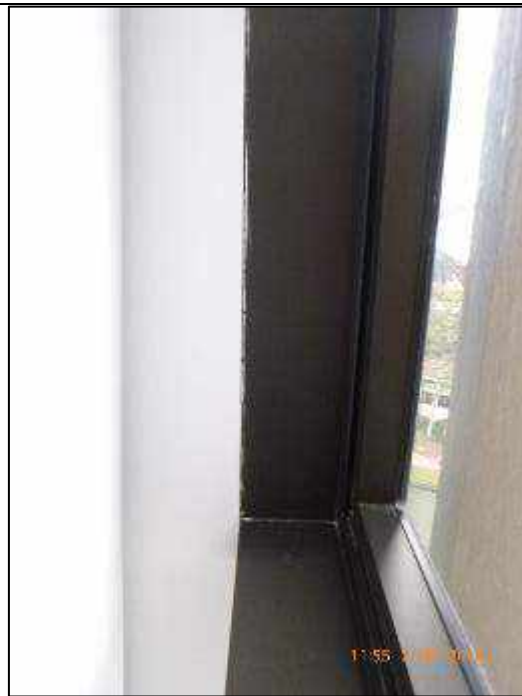
1140	Second bedroom window frames	See section 5.9.1	See section 5.9.2

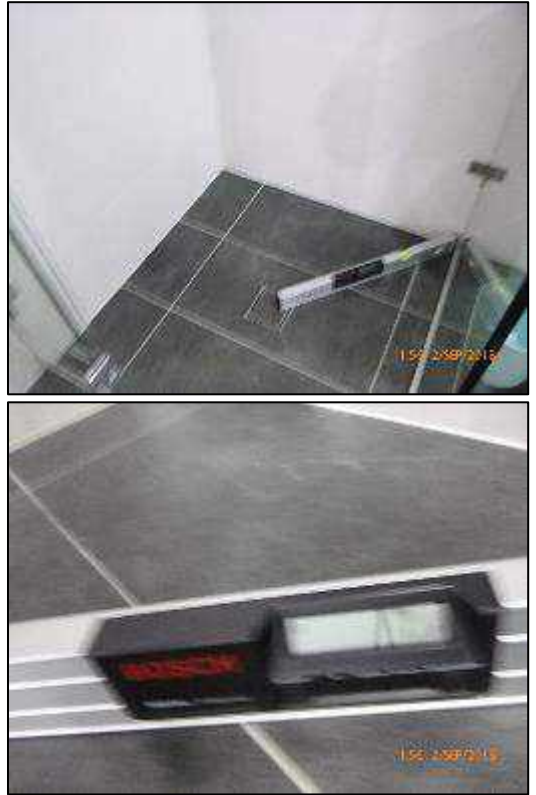
Item	Location	Defect description and Breach	Rectification	Photograph (if applicable)
1141	Main bedroom ensuite	See section 5.1.1 Falls (mm); 4/1000	See section 5.1.2

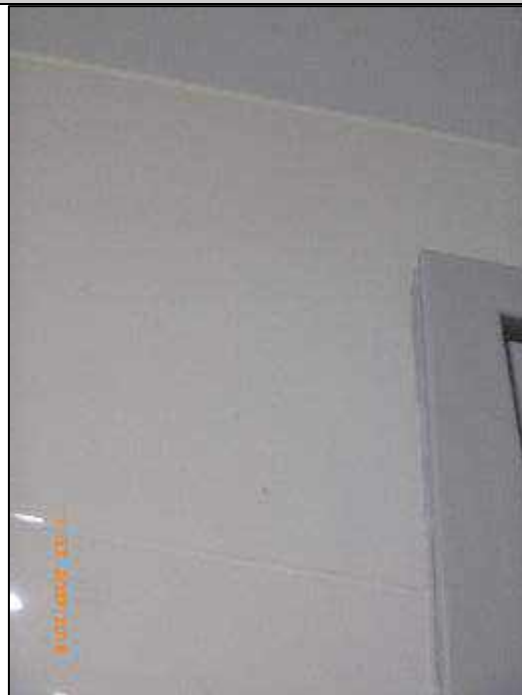
Item	Location	Defect description and Breach	Rectification	Photograph (if applicable)
1142	Wall adjacent to ensuite door	See section 5.9.1	See section 5.9.2

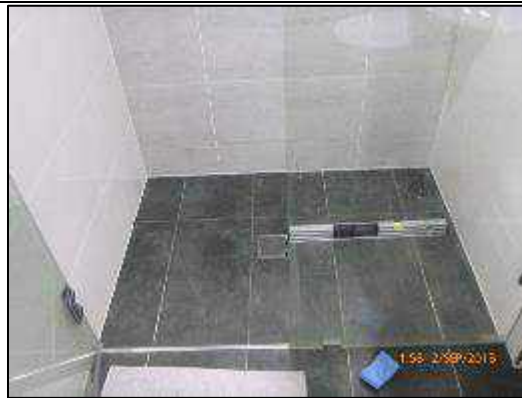
1143	Main bathroom	See section 5.1.1 Falls (mm); 6/1000	See section 5.1.2

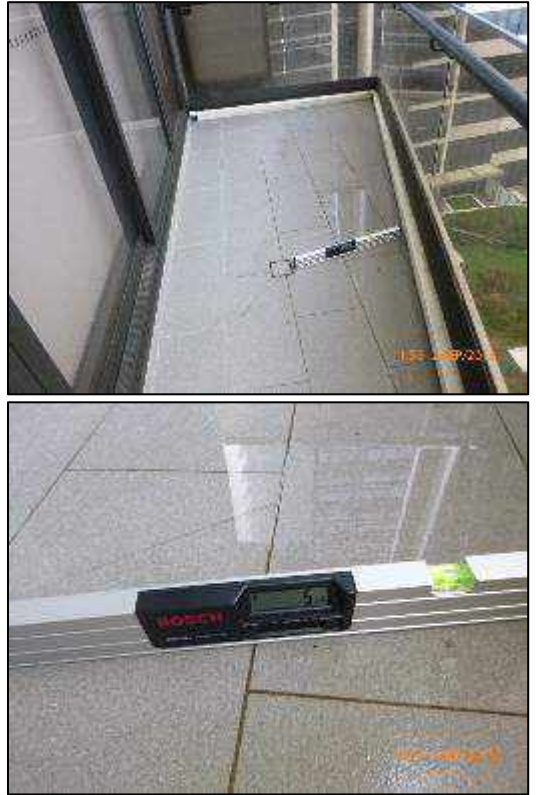
Item	Location	Defect description and Breach	Rectification	Photograph (if applicable)
1144	Balcony	See section 5.2.1 Falls (mm); 5/1000	See section 5.2.2

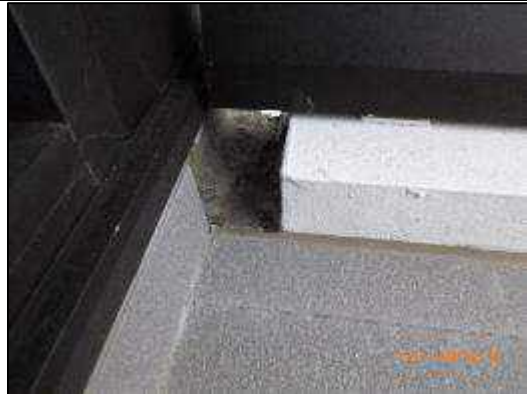
Item	Location	Defect description and Breach	Rectification	Photograph (if applicable)
1145	Balcony	See section 5.15.1	See section 5.15.2

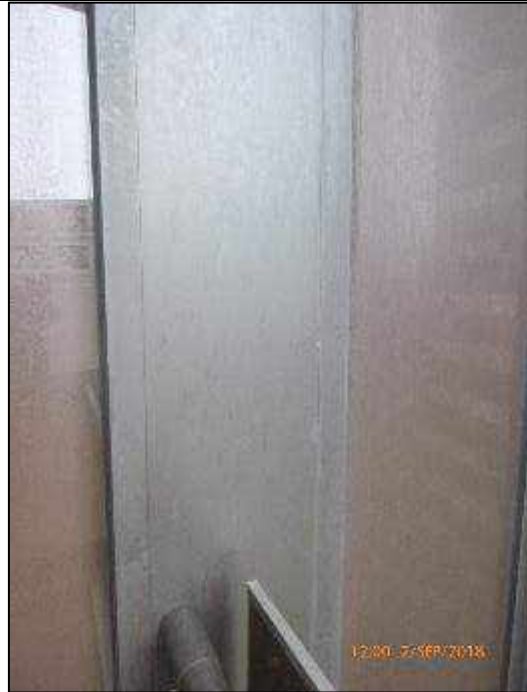
1146	Balcony sliding door frame	See section 5.7.1	See section 5.7.2

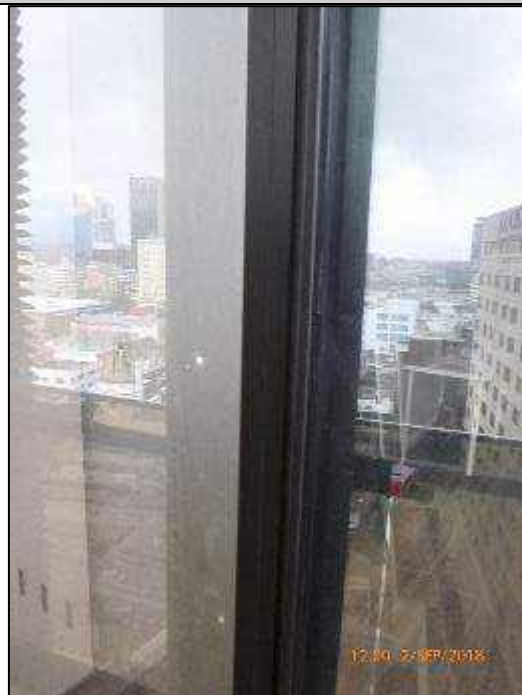
Item	Location	Defect description and Breach	Rectification	Photograph (if applicable)
1147	Balcony sliding door frame	See section 5.9.1	See section 5.9.2

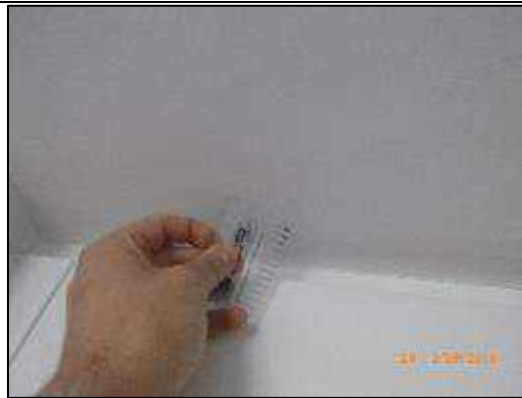
A photograph showing a balcony sliding door frame. The frame appears to be made of dark metal or wood. The glass pane is visible, showing a view of a city street with buildings and a road. There is a timestamp in the bottom right corner of the photo: 12:00 22 SEP 2018.
1148	Ceiling above kitchen cupboards	See section 5.14.1 Separation; 2mm	See section 5.14.2

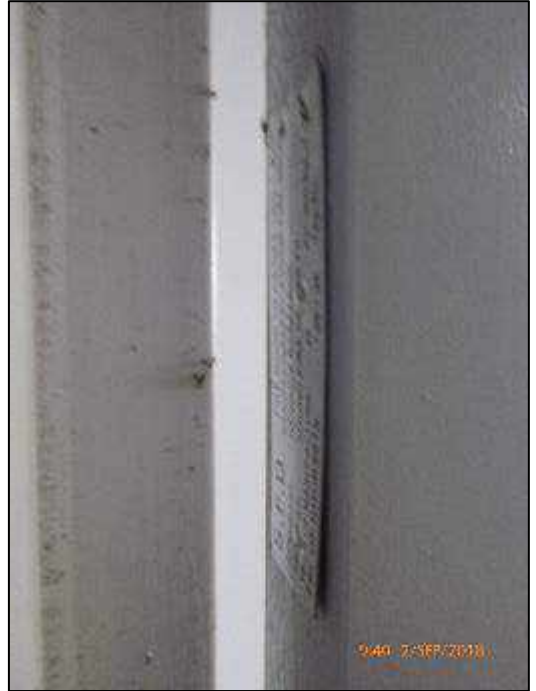
Item	Location	Defect description and Breach	Rectification	Photograph (if applicable)
Unit 1006				
1149	Front entry door	See section 5.12.1	See section 5.12.2

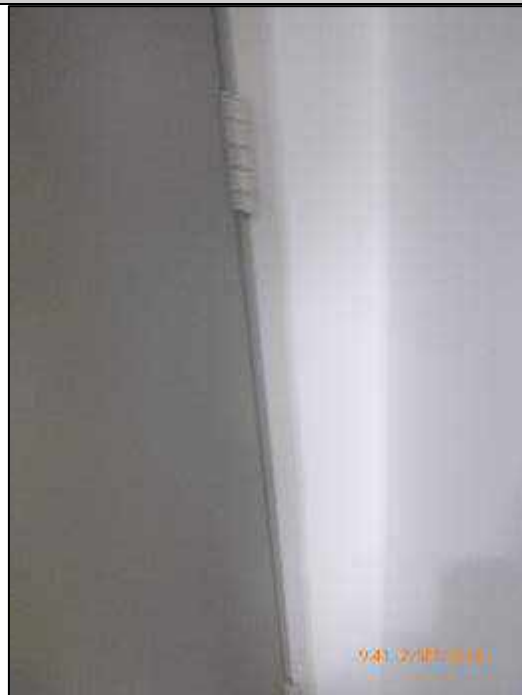
Item	Location	Defect description and Breach	Rectification	Photograph (if applicable)
1150	Wall adjacent to front entry door	See section 5.13.1	See section 5.13.2

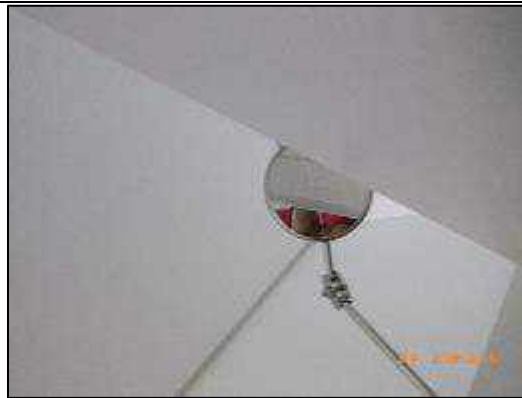
A photograph showing a close-up of a wall surface. A vertical line, possibly a crack or a joint, is visible. The wall appears to be made of a light-colored material, possibly plaster or concrete. There is some discoloration or staining near the bottom right corner of the image.
1151	Doors throughout the unit (x3)	See section 5.1.1	See section 5.12.2

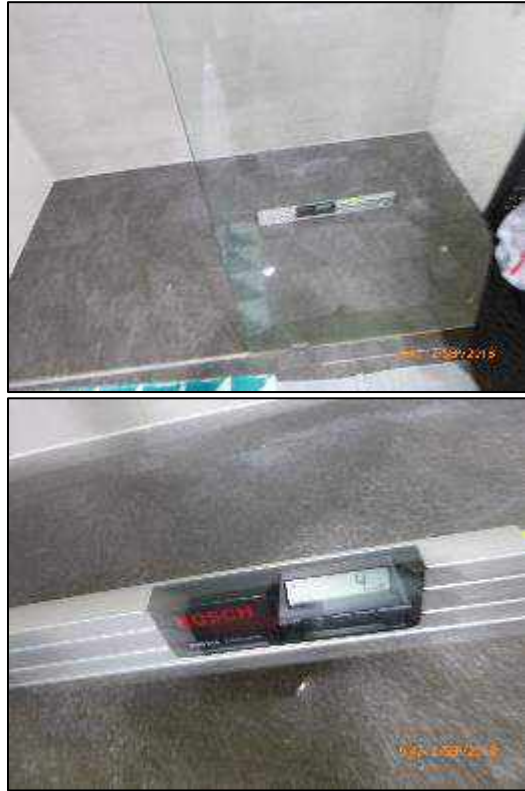
Item	Location	Defect description and Breach	Rectification	Photograph (if applicable)
1152	Main bedroom ensuite	See section 5.1.1 Falls (mm); 4/1000	See section 5.1.2

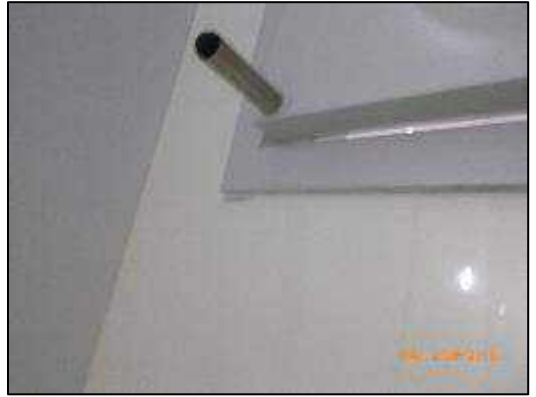
Item	Location	Defect description and Breach	Rectification	Photograph (if applicable)
1153	Wall adjacent to ensuite door	See section 5.9.1	See section 5.9.2

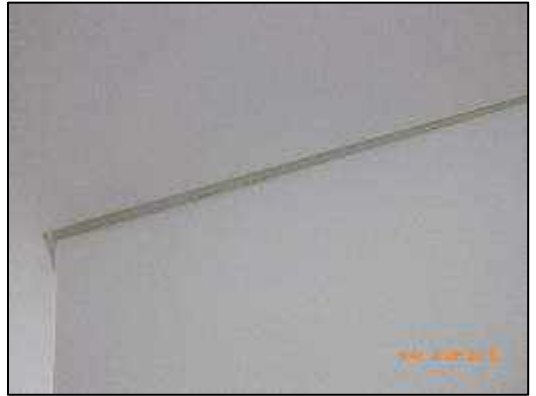
A photograph showing a close-up of a white wall. A small, dark, cylindrical object, possibly a nail or a small hole, is visible on the wall. A white door frame is partially visible on the right side of the image.
1154	Lounge room	See section 5.11.1	See section 5.11.2

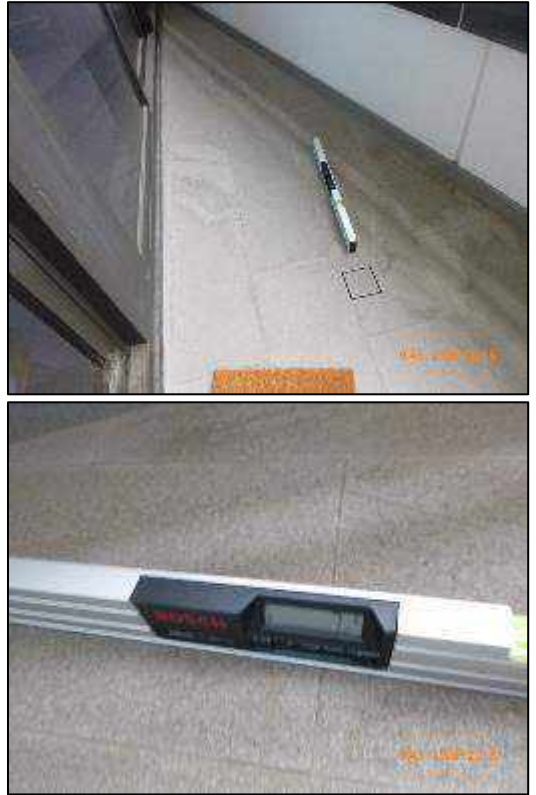
Item	Location	Defect description and Breach	Rectification	Photograph (if applicable)
1155	Balcony	See section 5.2.1 Falls (mm); 7/1000	See section 5.2.2

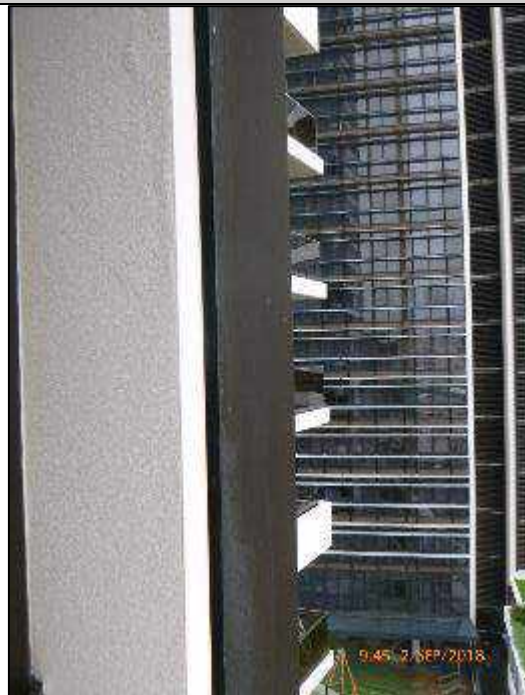
Item	Location	Defect description and Breach	Rectification	Photograph (if applicable)
1156	External façade panels in balcony area	See section 5.9.1	See section 5.9.2

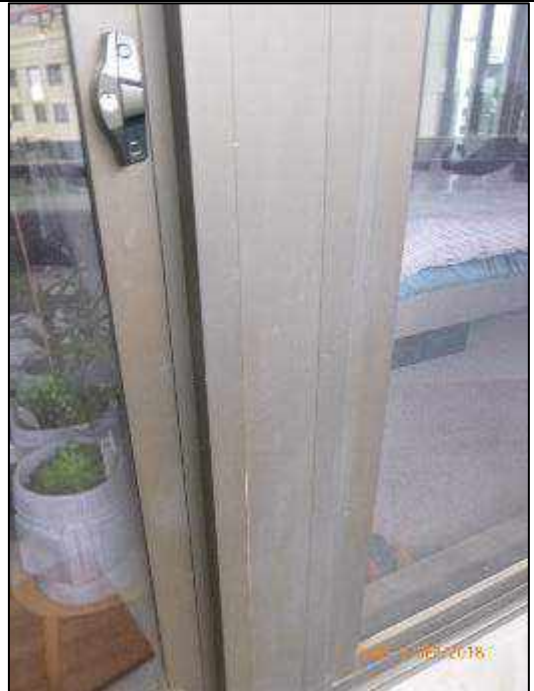
1157	Balcony sliding door frame	See section 5.7.1	See section 5.7.2

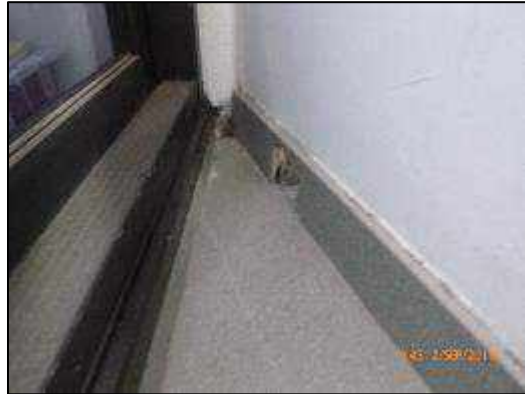
Item	Location	Defect description and Breach	Rectification	Photograph (if applicable)
1159	Balcony	See section 5.15.1	See section 5.15.2

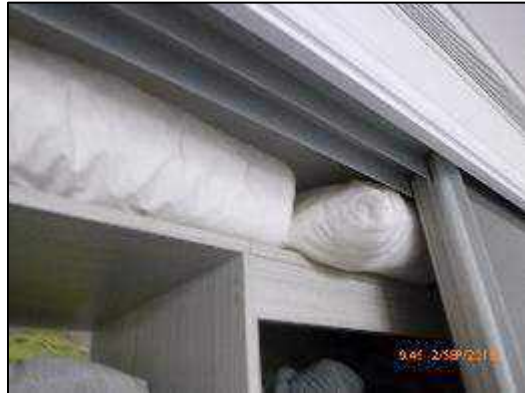
1160	Main bedroom built in	See section 5.6.1	See section 5.6.2

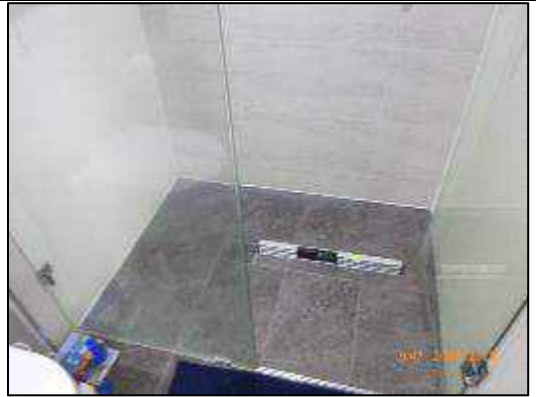
Item	Location	Defect description and Breach	Rectification	Photograph (if applicable)
1161	Main bathroom	See section 5.1.1 Falls (mm); 7/1000	See section 5.1.2

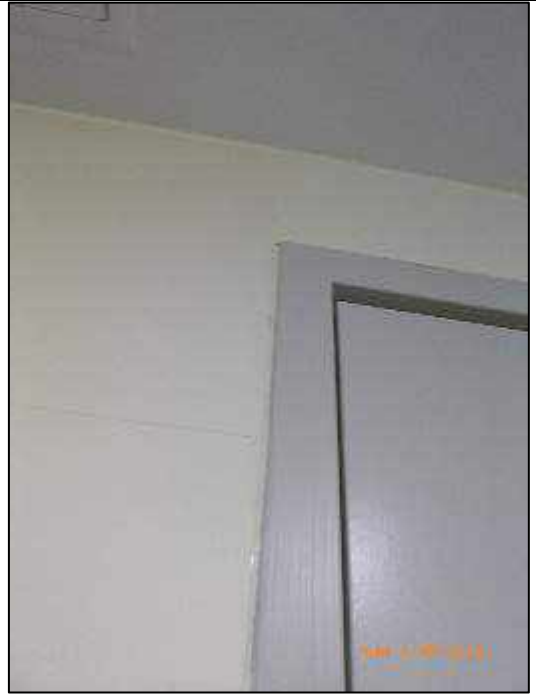
1162	Wall adjacent to main bathroom door	See section 5.9.1	See section 5.9.2

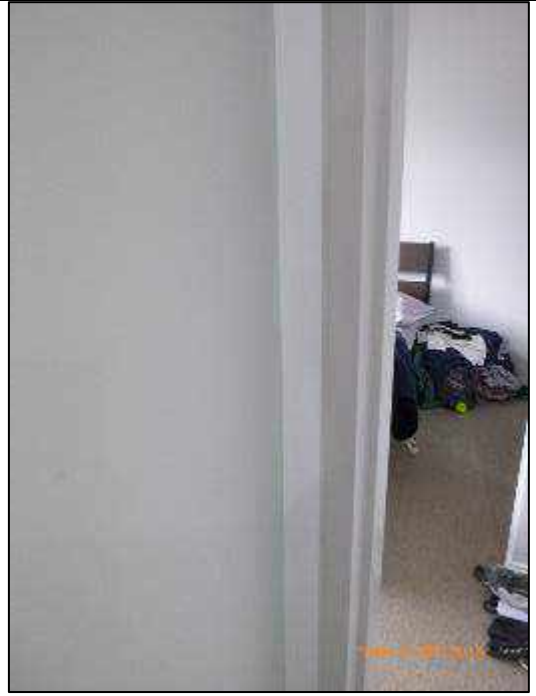
Item	Location	Defect description and Breach	Rectification	Photograph (if applicable)
1163	Wall adjacent to second bedroom door	See section 5.13.1	See section 5.13.2

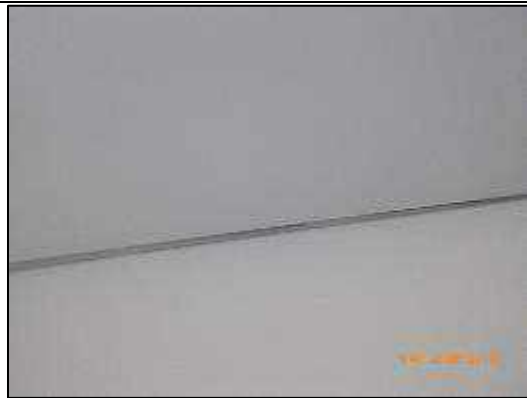
Item	Location	Defect description and Breach	Rectification	Photograph (if applicable)
1164	Wall adjacent to second bedroom	See section 5.13.1	See section 5.13.2	  A photograph showing a white wall with a light switch. To the right, a television is on a dark stand. A date stamp '9:48 2/SEP/2018' is visible in the bottom right corner of the photo.
1165	Lounge room	See section 5.11.1	See section 5.11.2

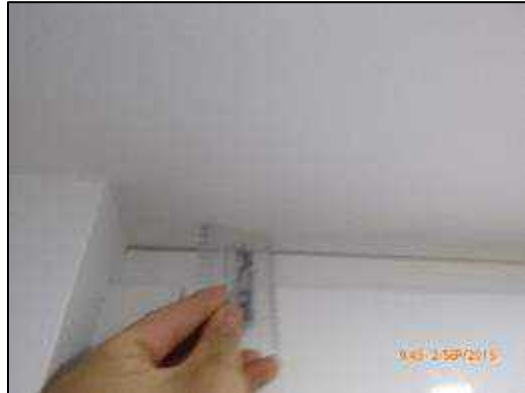
Item	Location	Defect description and Breach	Rectification	Photograph (if applicable)
1166	<i>Ceiling above kitchen cupboards</i>	See section 5.14.1 Separation; 2mm	See section 5.14.2

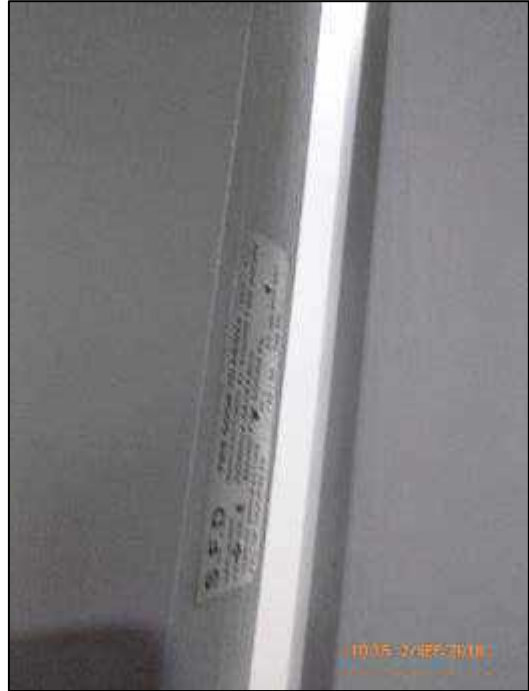
Item	Location	Defect description and Breach	Rectification	Photograph (if applicable)
Unit 1007				
1167	Front entry door	See section 5.12.1	See section 5.12.2

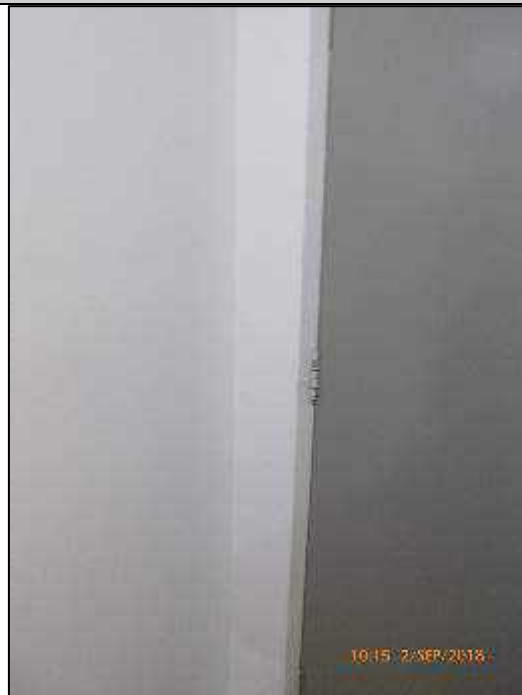
Item	Location	Defect description and Breach	Rectification	Photograph (if applicable)
1168	Wall adjacent to front entry door	See section 5.1 .1	See section 5.11.2

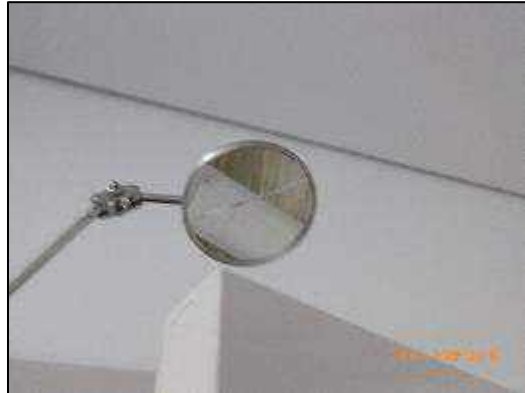
Item	Location	Defect description and Breach	Rectification	Photograph (if applicable)
1170	Doors throughout the unit (x3)	See section 5.5.1	See section 5.5.2

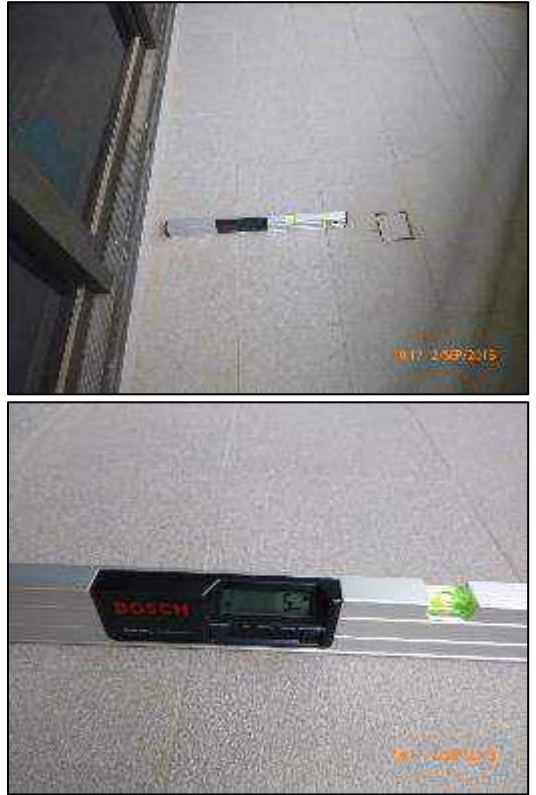
Item	Location	Defect description and Breach	Rectification	Photograph (if applicable)
1171	Balcony	See section 5.2.1 Falls (mm); 5/1000	See section 5.2.2

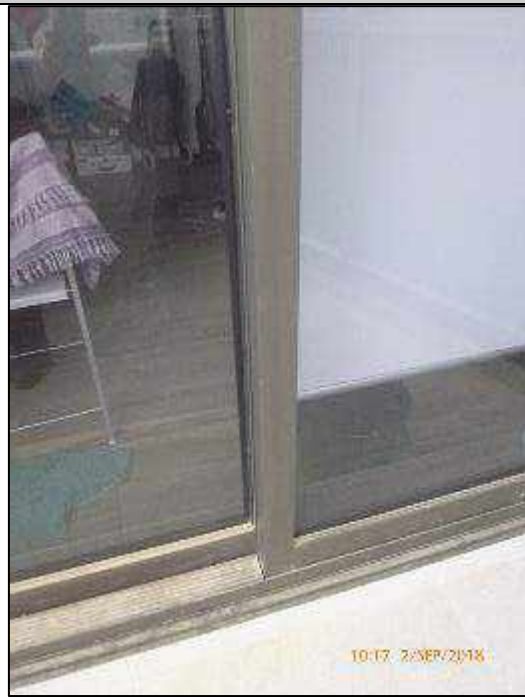
Item	Location	Defect description and Breach	Rectification	Photograph (if applicable)
1172	Balcony sliding door	See section 5.8.1	See section 5.8.2

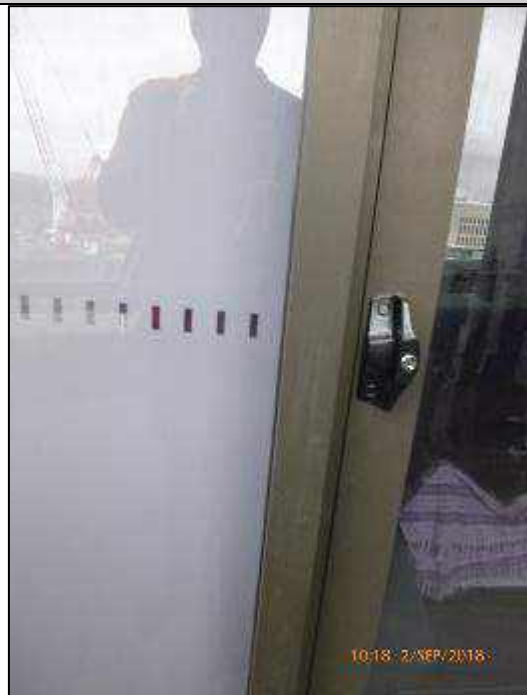
Item	Location	Defect description and Breach	Rectification	Photograph (if applicable)
1173	Balcony sliding door	See section 5.7.1	See section 5.7.2

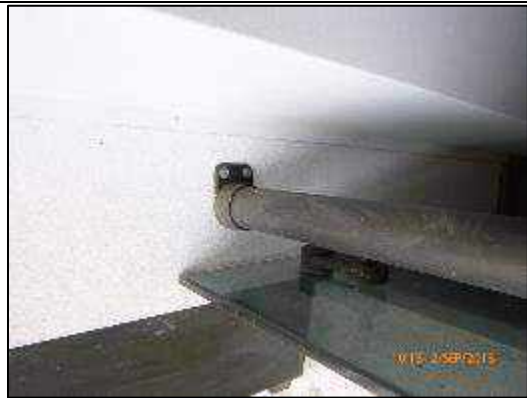
A photograph showing a close-up of a balcony sliding door. The door is white with a silver handle and lock mechanism. The reflection of a person is visible on the glass. A timestamp '10:18 2/SEP/2018' is visible in the bottom right corner.
1174	Balcony balustrade rail	See section 5.7.1	See section 5.7.2

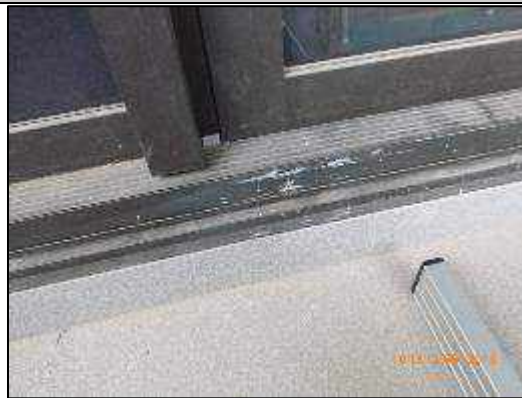
Item	Location	Defect description and Breach	Rectification	Photograph (if applicable)
1175	Balcony sliding door frame	See section 5.7.1	See section 5.7.2

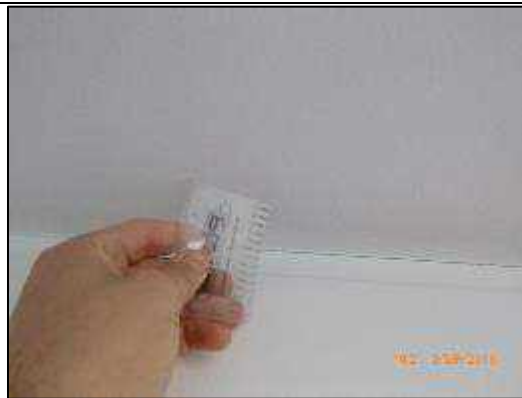
1176	Ceiling above kitchen cupboards	See section 5.14.1 Separation; 1.5mm	See section 5.14.2

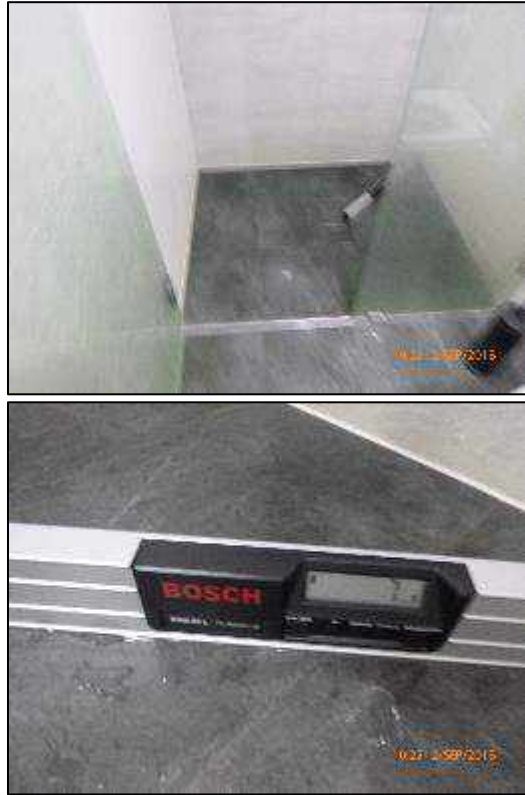
Item	Location	Defect description and Breach	Rectification	Photograph (if applicable)
1177	Main bathroom	See section 5.1.1 Falls (mm); 7/1000	See section 5.1.2
