SydneyStrataReport

STRATA REPORT

Client	Church Street Parramatta Property Pty Ltd
Address of property	Unit 3303/330 Church Street, Parramatta, NSW.
Lot	359
Strata Plan	SP 94469
Name of Strata Management Co.	NSW Strata
Telephone Number of Strata Agent	8980 1841
Report Date	15 February 2024

BUILDING DEFECTS REPORT Part 1/2

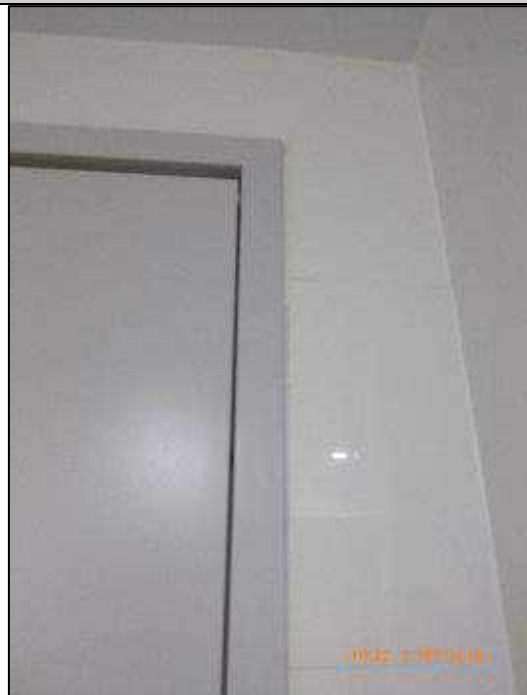
Item	Location	Defect description and Breach	Rectification	Photograph (if applicable)
1178	Wall adjacent to main bathroom door	See section 5.9.1	See section 5.9.2

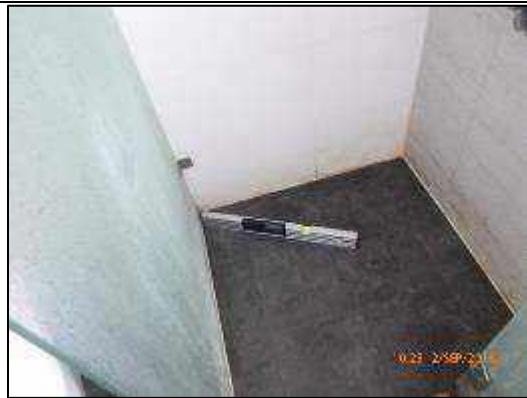
1179	Main bedroom ensuite	See section 5.1.1 Falls (mm); 7/1000	See section 5.1.2

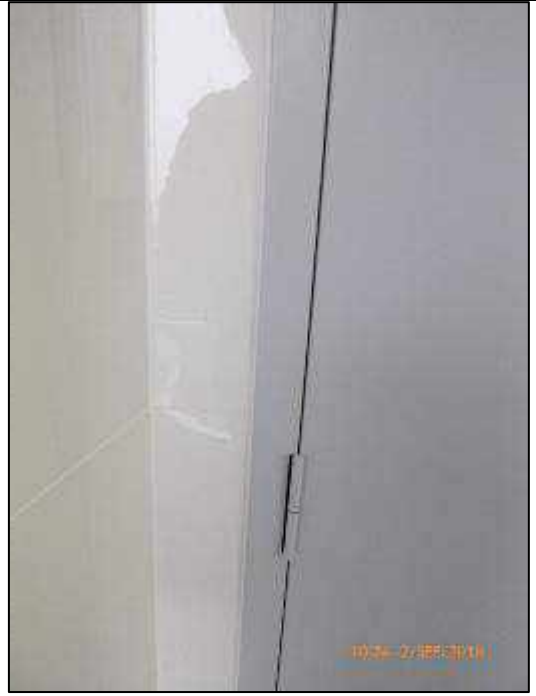
Item	Location	Defect description and Breach	Rectification	Photograph (if applicable)
1180	Wall adjacent to ensuite door	See section 5.9.1	See section 5.9.2

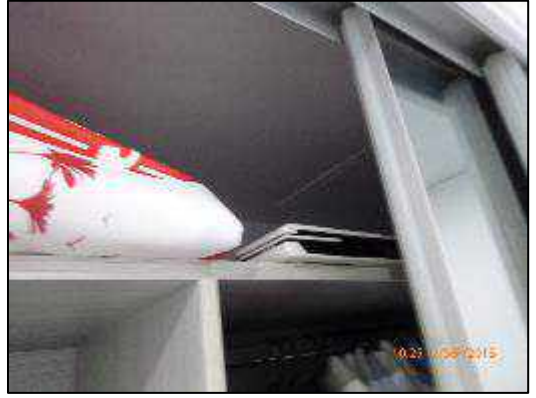
A photograph showing a close-up of a light-colored wall. There is a significant area of peeling or missing paint, revealing a darker surface underneath. The defect is located near a dark door frame. A timestamp '10/26/2018' is visible in the bottom right corner of the photo.
1181	Main bedroom built in	See section 5.6.1	See section 5.6.2

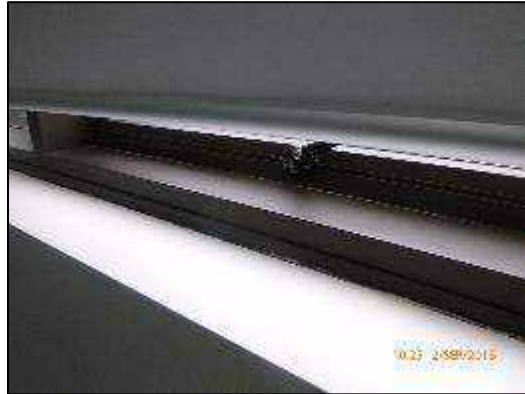
Item	Location	Defect description and Breach	Rectification	Photograph (if applicable)
1182	Main bedroom window frames on northern wall	See section 5.9.1	See section 5.9.2

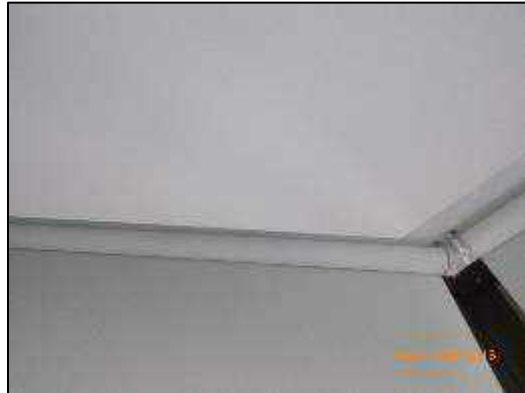
1183	Main bedroom window bulkhead	See section 5.13.1	See section 5.13.2

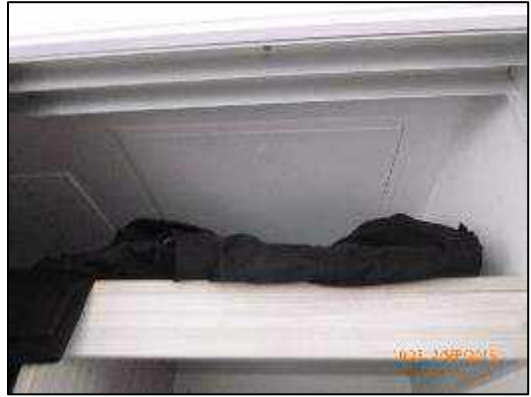
Item	Location	Defect description and Breach	Rectification	Photograph (if applicable)
1184	Second bedroom built in	See section 5.6.1	See section 5.6.2

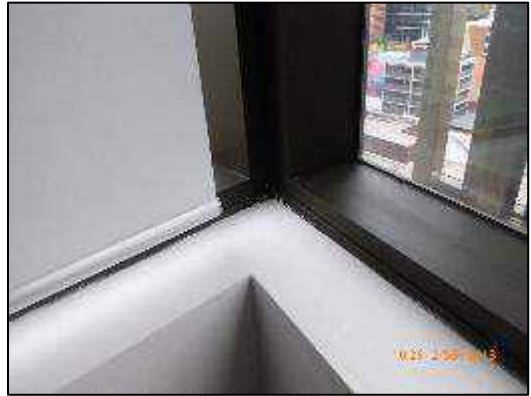
1185	Second bedroom window frames	See section 5.9.1	See section 5.9.2

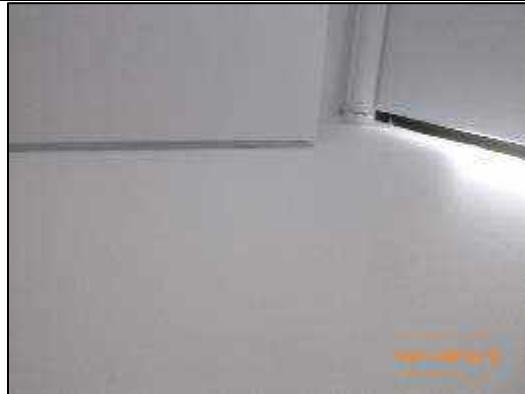
Item	Location	Defect description and Breach	Rectification	Photograph (if applicable)
1186	Second bedroom window bulkhead	See section 5.13.1	See section 5.13.2

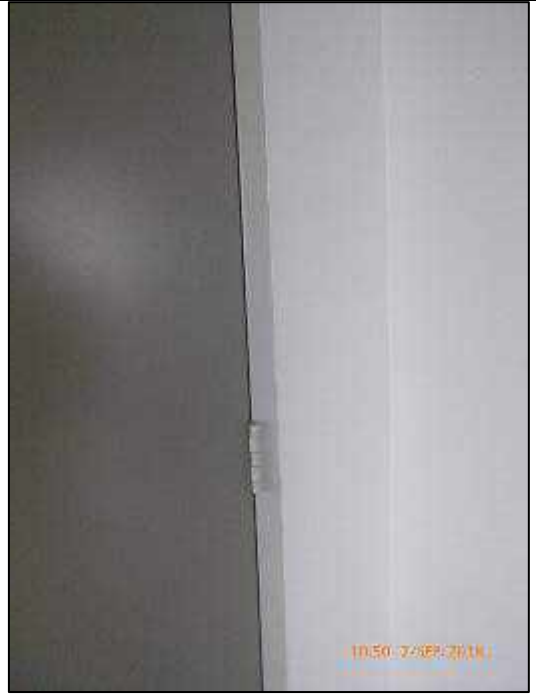
Item	Location	Defect description and Breach	Rectification	Photograph (if applicable)
1189	Wall adjacent to front entry door	See section 5.13.1	See section 5.13.2

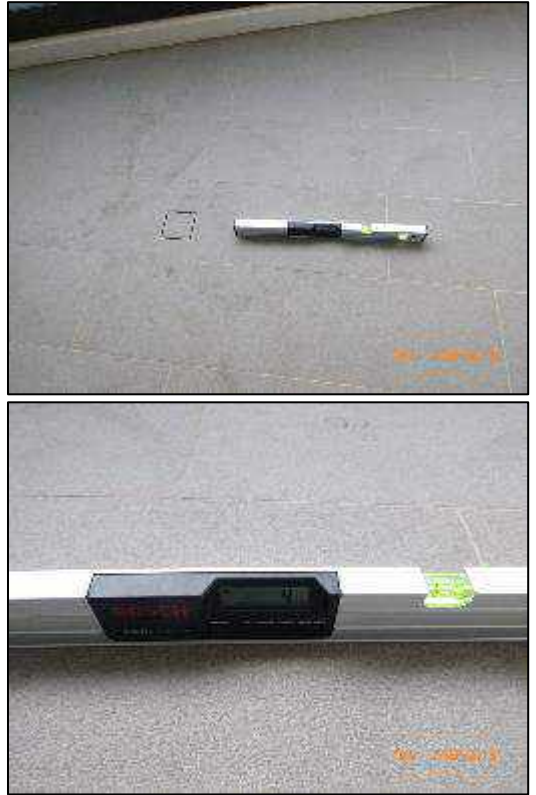
Item	Location	Defect description and Breach	Rectification	Photograph (if applicable)
1190	Balcony	See section 5.1.1 Falls (mm); 4/1000	See section 5.1.2

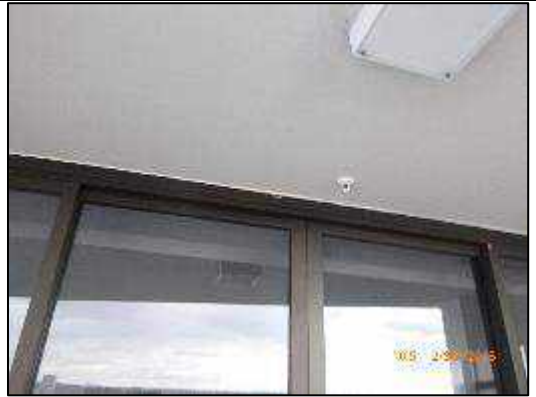
Item	Location	Defect description and Breach	Rectification	Photograph (if applicable)
1191	Balcony sliding door frame	See section 5.9.1	See section 5.9.2

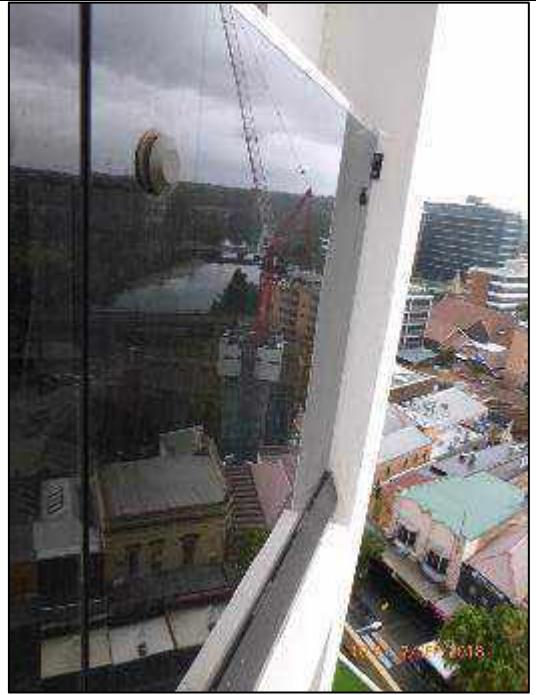
A photograph showing a close-up of a balcony sliding door frame. The frame is dark-colored and appears to be made of metal or wood. There is a visible gap or defect in the frame. A timestamp '10/5/2018' is visible in the bottom right corner of the photo.
1192	Balcony balustrade	See section 5.9.1	See section 5.9.2

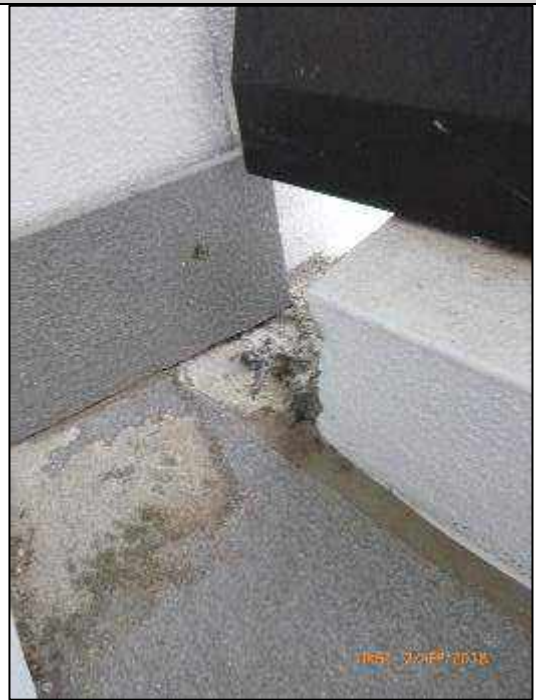
Item	Location	Defect description and Breach	Rectification	Photograph (if applicable)
1193	Balcony	See section 5.15.1	See section 5.15.2

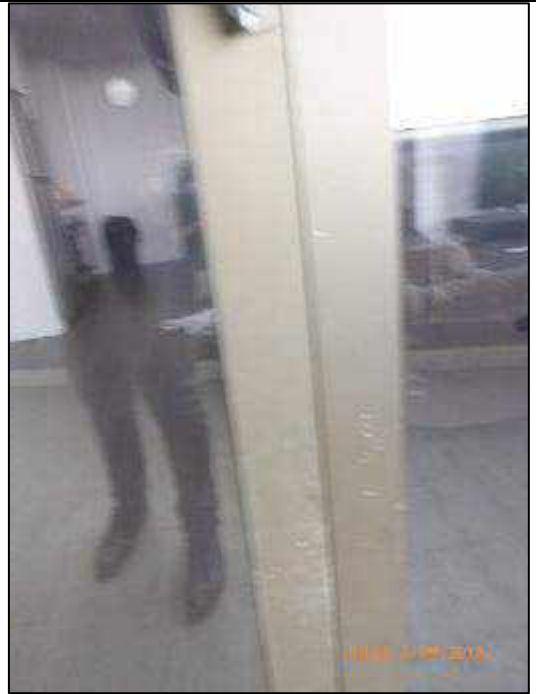
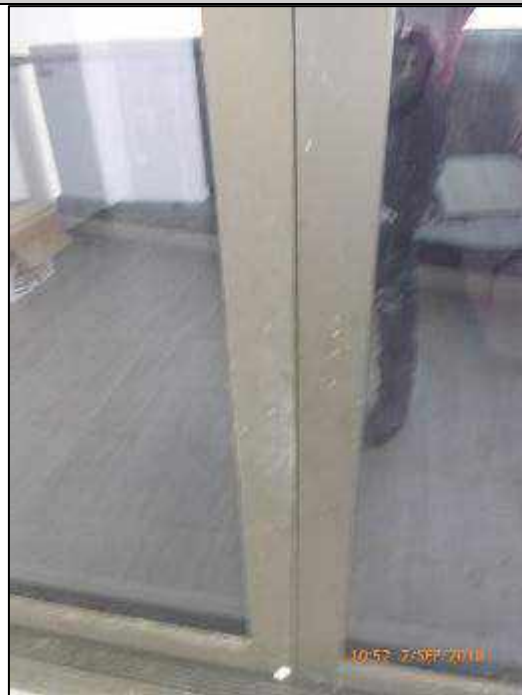
1194	Balcony sliding door	See section 5.7.1	See section 5.7.2

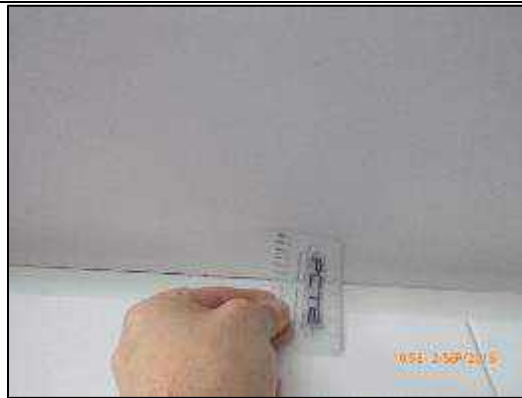
1195	<i>Ceiling above kitchen cupboards</i>	See section 5.14.1 Separation; 1.5mm	See section 5.14.2

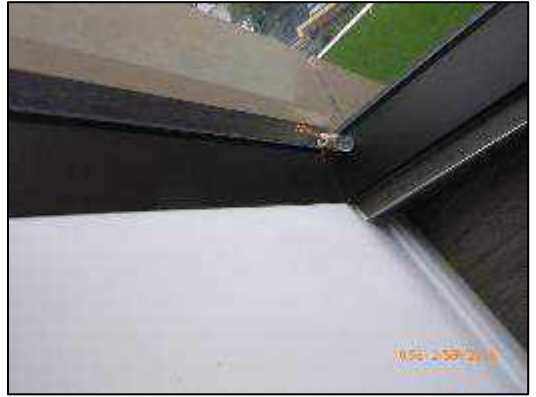
Item	Location	Defect description and Breach	Rectification	Photograph (if applicable)
1196	Lounge room window frames	See section 5.9.1	See section 5.9.2

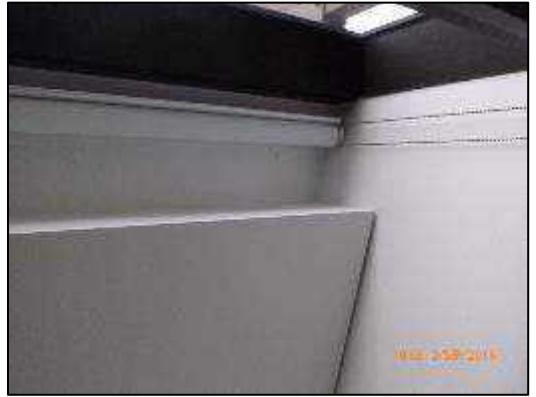
A close-up photograph of a window frame showing a significant gap or separation between the frame and the surrounding structure. The frame is dark, and the gap is filled with a light-colored material. A date stamp '10/05/2016' is visible in the bottom right corner.
1197	Lounge room window bulkhead	See section 5.13.1	See section 5.13.2

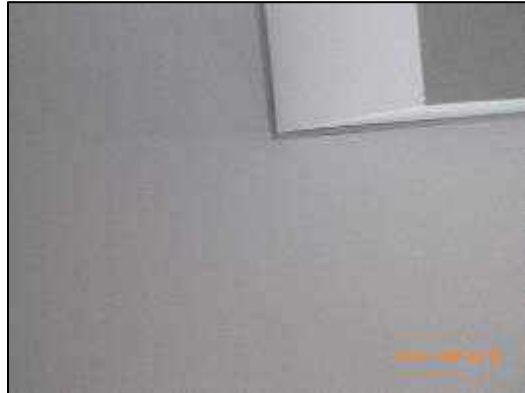
Item	Location	Defect description and Breach	Rectification	Photograph (if applicable)
1198	Lounge room	See section 5.11.1	See section 5.11.2

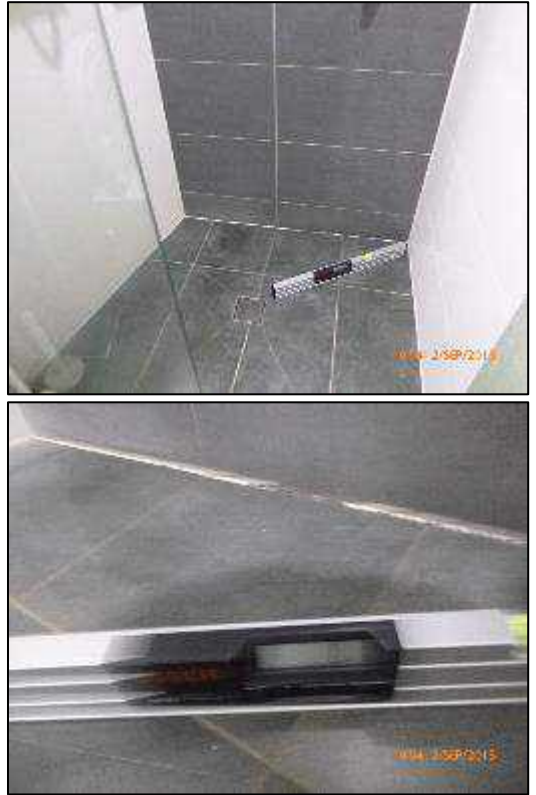
Item	Location	Defect description and Breach	Rectification	Photograph (if applicable)
1199	Main bathroom	See section 5.1.1 Falls (mm); 0/1000	See section 5.1.2

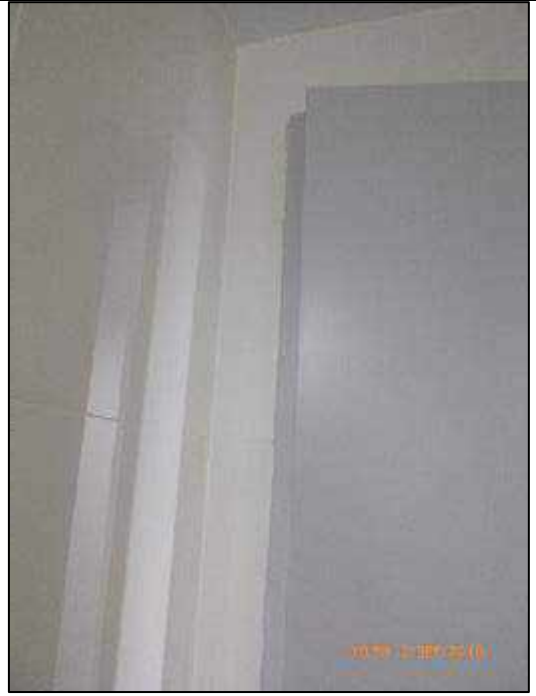
Item	Location	Defect description and Breach	Rectification	Photograph (if applicable)
1200	Main bathroom door frame	See section 5.10.1	See section 5.10.2

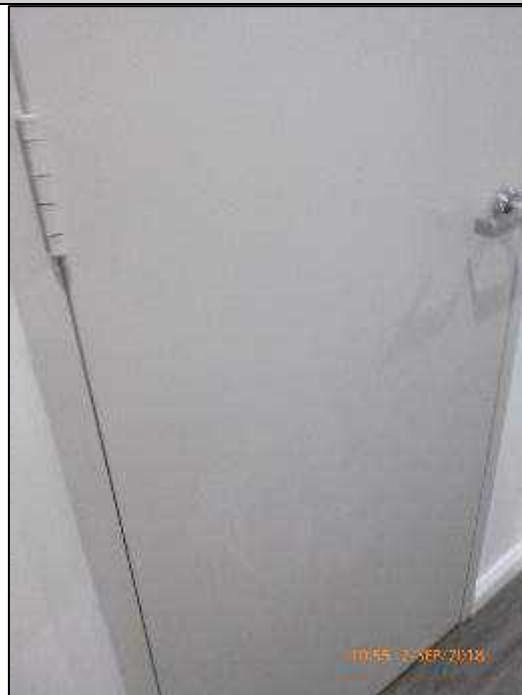
Item	Location	Defect description and Breach	Rectification	Photograph (if applicable)
1201	<i>Linen cupboard door</i>	See section 5.10.1	See section 5.10.2

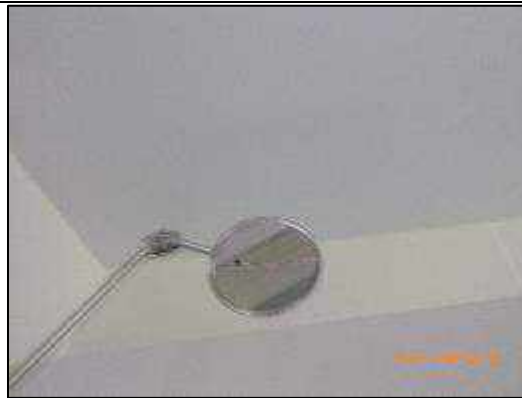
1202	<i>Doors throughout the unit (x4)</i>	See section 5.5.1	See section 5.5.2

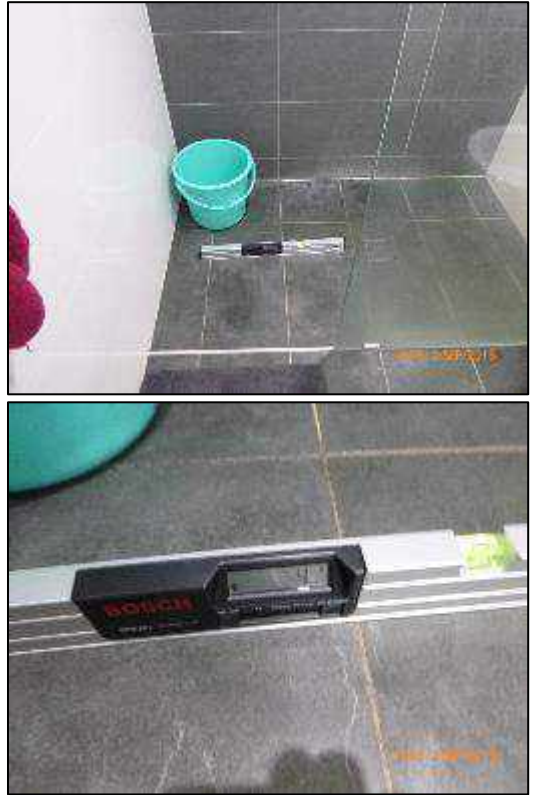
Item	Location	Defect description and Breach	Rectification	Photograph (if applicable)
1203	Main bedroom ensuite	See section 5.1.1 Falls (mm); 4/1000	See section 5.1.2

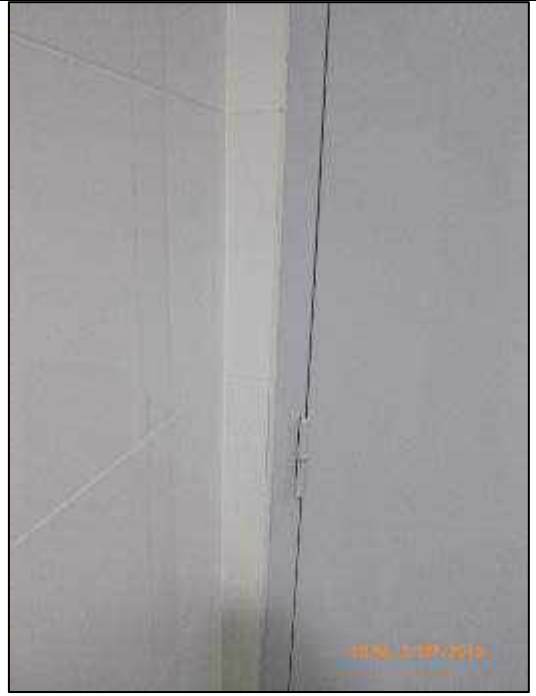
Item	Location	Defect description and Breach	Rectification	Photograph (if applicable)
1204	Wall adjacent to ensuite door	See section 5.9.1	See section 5.9.2

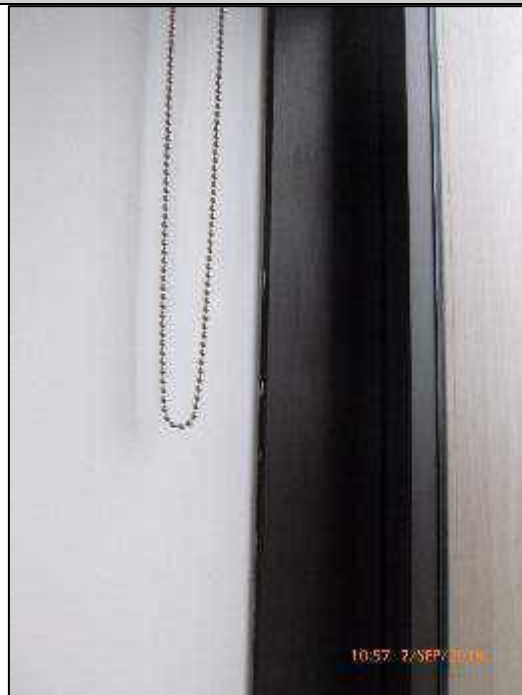
Item	Location	Defect description and Breach	Rectification	Photograph (if applicable)
1207	Main bedroom window frames	See section 5.9.1	See section 5.9.2

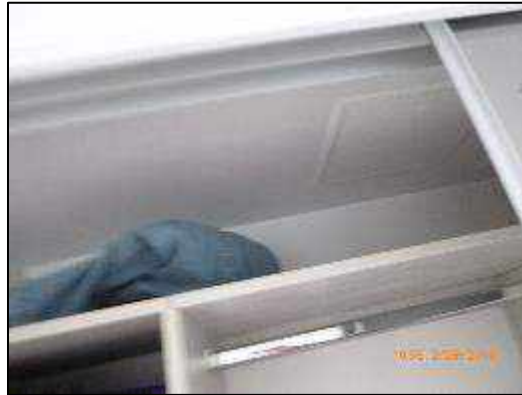
A photograph showing a close-up of a window frame. A metal chain is hanging from the top of the frame. The frame appears to be made of wood or a similar material. The background is a plain wall.
1208	Second bedroom built in	See section 5.6.1	See section 5.6.2

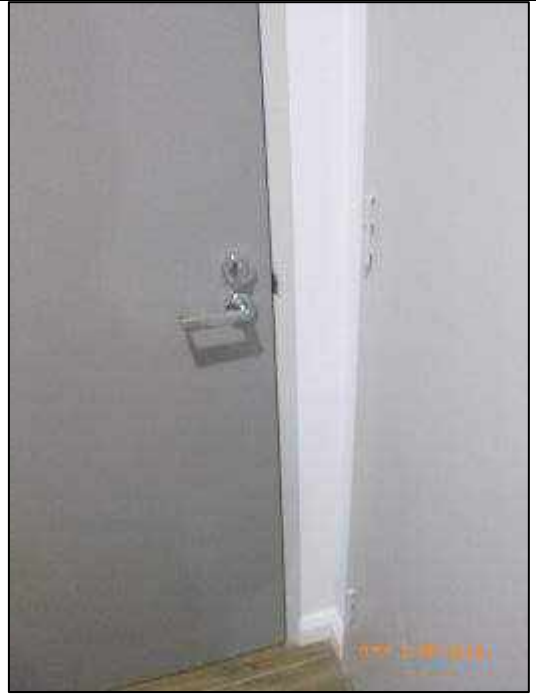
Item	Location	Defect description and Breach	Rectification	Photograph (if applicable)
1210	Wall adjacent to front entry door	See section 5.13.1	See section 5.13.2

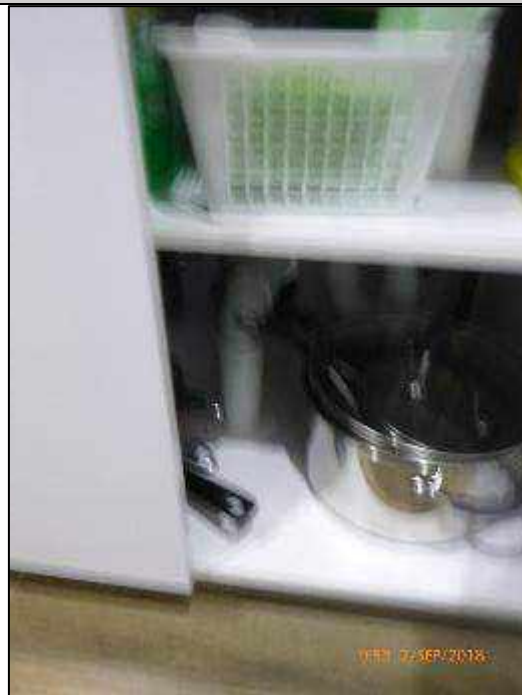
Item	Location	Defect description and Breach	Rectification	Photograph (if applicable)
1211	Kitchen sink	<p>Kitchen sink was observed to be leaking into cabinetry below.</p> <p>Home Building Act (NSW) 1989</p> <ul style="list-style-type: none"> Part 2C, 18B (a) and (c). <p>This is a breach of part (a) of the act because the basin has not been installed in a proper workmanlike manner that would prevent leaking of the basin, resulting in a loss of amenity.</p> <p>Loss suffered Loss suffered is cost of rectification.</p>	Engage licensed plumber to complete necessary repairs.

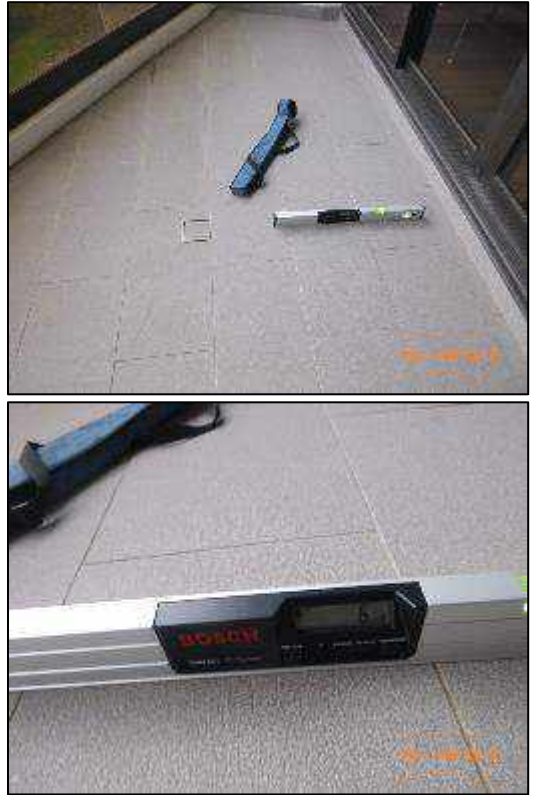
Item	Location	Defect description and Breach	Rectification	Photograph (if applicable)
1212	Balcony	See section 5.2.1 Falls (mm); 6/1000	See section 5.2.2

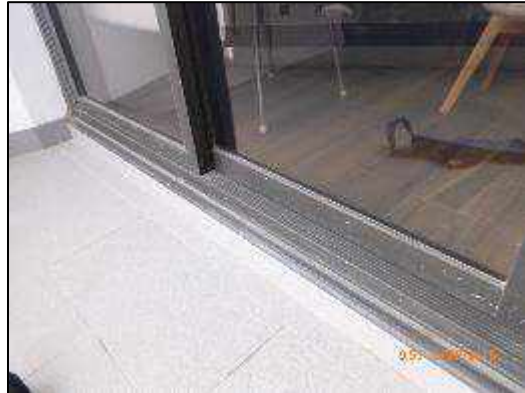
Item	Location	Defect description and Breach	Rectification	Photograph (if applicable)
1213	Balcony sliding door frame	See section 5.9.1	See section 5.9.2

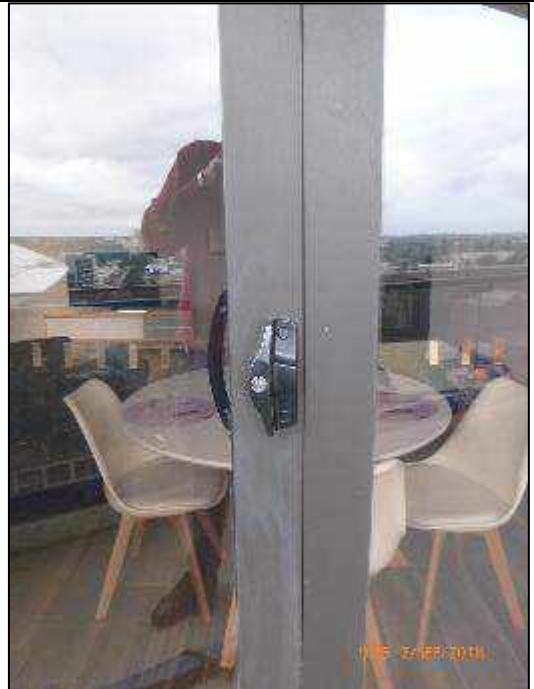
1214	Balcony sliding door frame	See section 5.7.1	See section 5.7.2

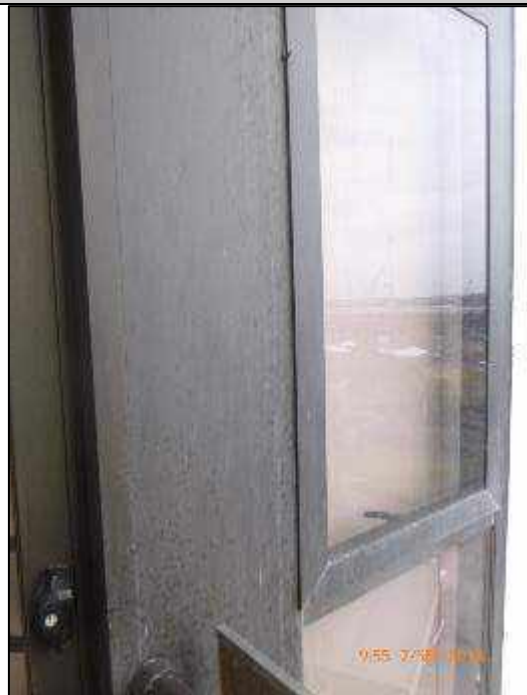
1215	Balcony balustrade	See section 5.9.1	See section 5.9.2

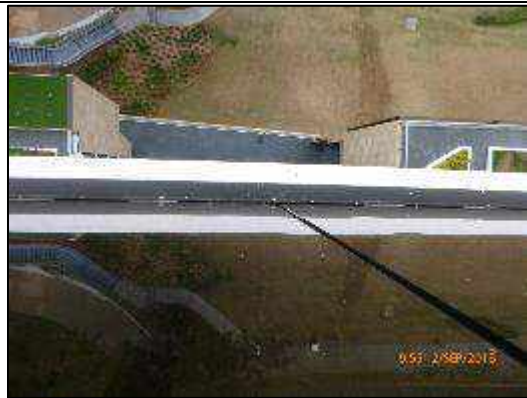
Item	Location	Defect description and Breach	Rectification	Photograph (if applicable)
1216	Balcony	See section 5.15.1	See section 5.15.2

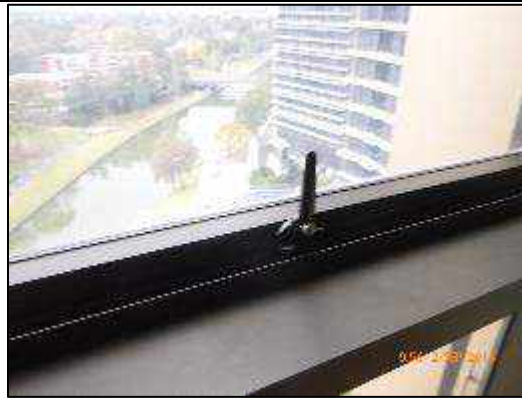
Item	Location	Defect description and Breach	Rectification	Photograph (if applicable)
		<p>(b) a warranty that all materials supplied by the holder or person will be good and suitable for the purpose for which they are used and that, unless otherwise stated in the contract, those materials will be new.</p> <p>Loss Suffered Loss suffered is cost of rectification.</p>		
1218	Lounge room	See section 5.11.1	See section 5.11.2

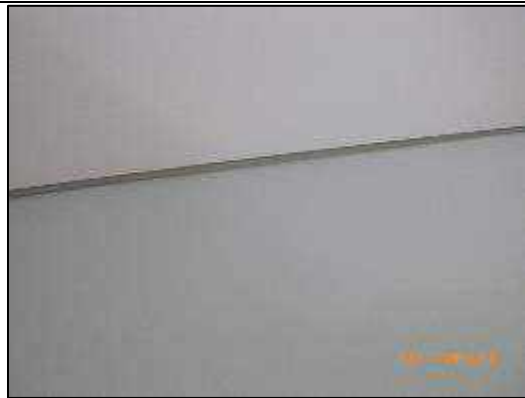
Item	Location	Defect description and Breach	Rectification	Photograph (if applicable)
1219	Main bathroom	See section 5.1.1 Falls (mm); 7/1000	See section 5.1.2

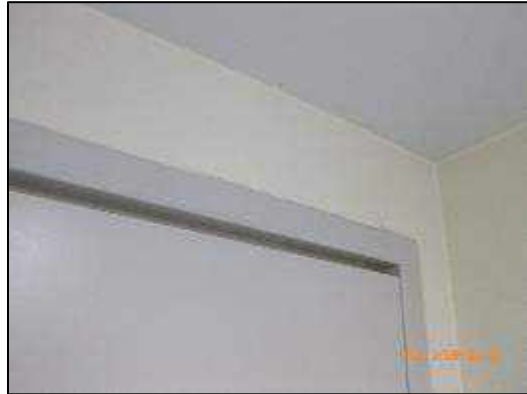
1221	Doors throughout the unit (x3)	See section 5.5.1	See section 5.5.2

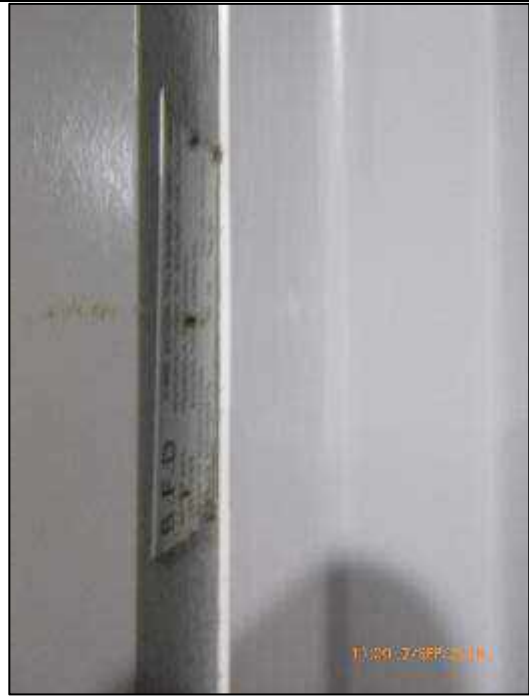
Item	Location	Defect description and Breach	Rectification	Photograph (if applicable)
1230	Front entry door	<p>The hinges of the front entry door are leaking.</p> <p>Home Building Act (NSW) 1989</p> <ul style="list-style-type: none"> Part 2C, 18B (a) and (b). <p>This item is a defect as the builder has failed to satisfy implied warranty set out in the Home Building Act 1989 – Section 18B Warranties as to residential building work.</p> <p>(b) a warranty that all materials supplied by the holder or person will be good and suitable for the purpose for which they are used and that, unless otherwise stated in the contract, those materials will be new.</p> <p>Loss Suffered Loss suffered in cost of rectification.</p>	Engage a licenced carpenter to remove faulty door hinges and reinstate with new hinges matching existing in accordance with manufacturers specifications.

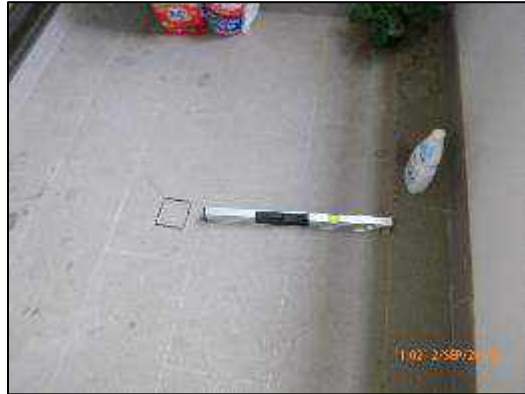
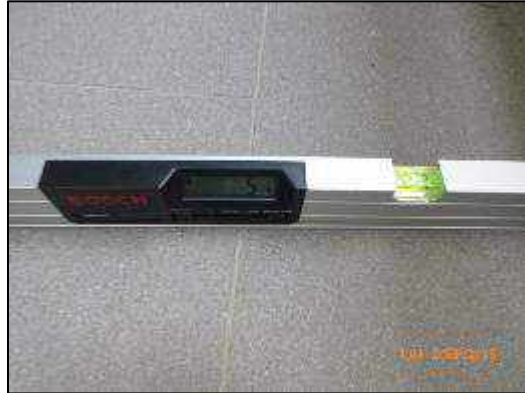
Item	Location	Defect description and Breach	Rectification	Photograph (if applicable)
1233	Balcony	See section 5.2.1 Falls (mm); 5/1000	See section 5.2.2

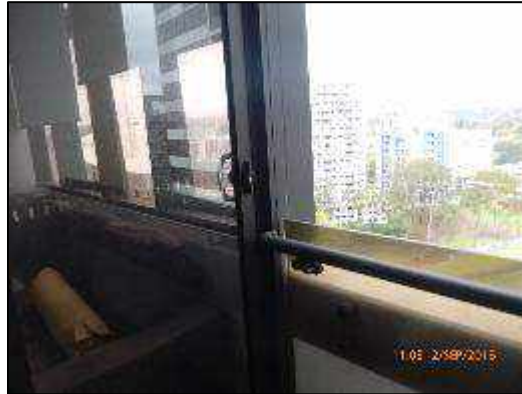
1235	Balcony sliding door frame	<p>Separation observed between sliding door and ceiling in balcony.</p> <p>Home Building Act (NSW) 1989</p> <ul style="list-style-type: none"> Part 2C, 18B (a) and (c). <p>Guide to Standards and Tolerances 2017</p> <p>10.16 Cracking at junctions of dissimilar materials-Cracking at junctions between dissimilar materials is a defect if it is greater than 1 mm or is visible from a normal viewing position.</p> <p>Loss Suffered</p> <p>Loss suffered is cost of rectification.</p>	<ol style="list-style-type: none"> 1. Protect all surrounding areas 2. Apply a bead of flexible sealant to the joint between the sliding door frame and wall 3. As required, all affected surfaces are to be painted with an appropriate paint system to match as close as possible to the existing in accordance with the manufacturer's recommendations and AS2311 – Guide to the painting of buildings. 4. Clean up the work area

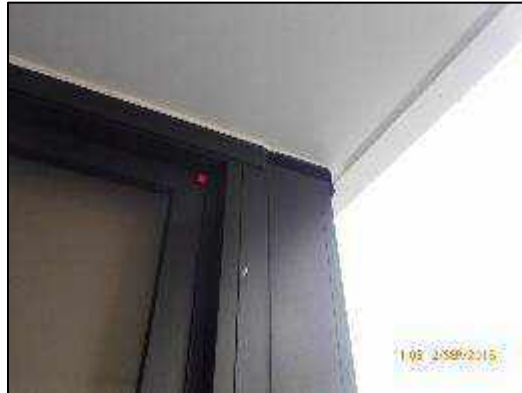
Item	Location	Defect description and Breach	Rectification	Photograph (if applicable)
1236	Balcony ceiling	See section 5.14.1 Separation; 1mm	See section 5.14.2

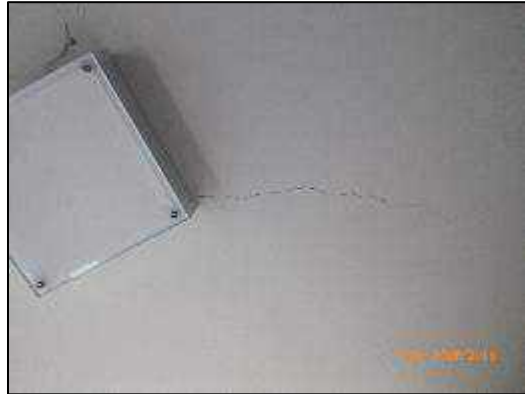
1237	Balcony	See section 5.15.1	See section 5.15.2

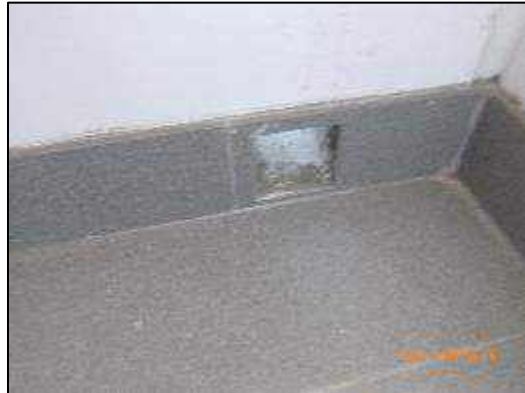
Item	Location	Defect description and Breach	Rectification	Photograph (if applicable)
1238	Exterior façade panels in balcony area	See section 5.9.1	See section 5.9.2

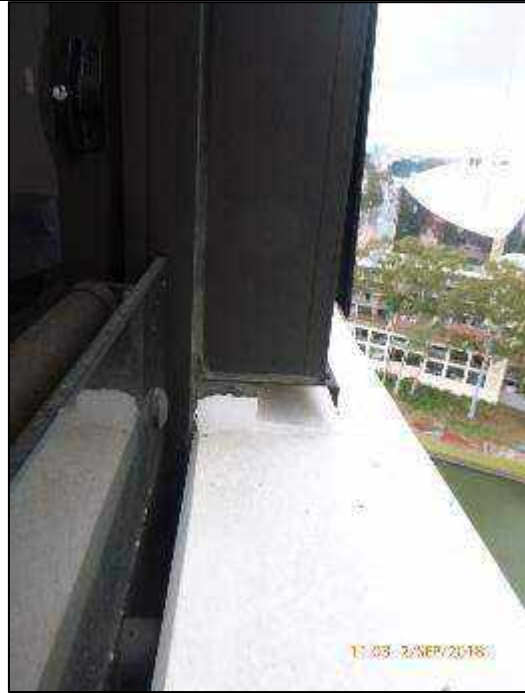
Item	Location	Defect description and Breach	Rectification	Photograph (if applicable)
1239	Balcony sliding door frame	See section 5.7.1	See section 5.7.2

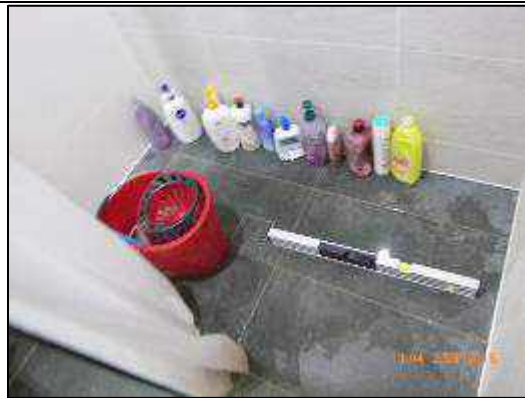
A photograph showing a close-up of a dark-colored sliding door frame on a balcony. The frame appears to be made of metal or heavy plastic. To the right, a portion of a multi-story building is visible through the glass. A timestamp in the bottom right corner reads '17:04 - 2 SEP 2018'.
1240	Main bathroom	See section 5.1.1 Falls (mm); 5/1000	See section 5.1.2

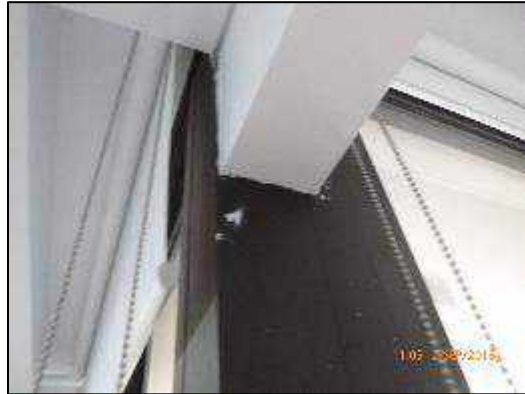
1242	Lounge room window frames	See section 5.9.1	See section 5.9.2

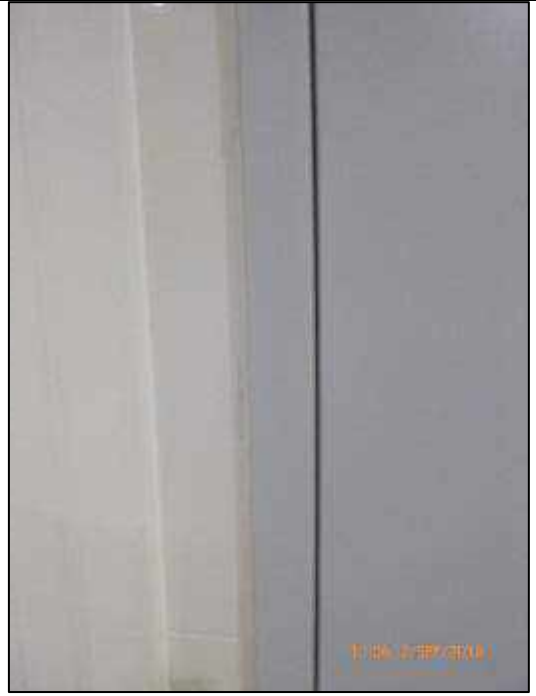
1245	Main bedroom built in	See section 5.6.1	See section 5.6.2

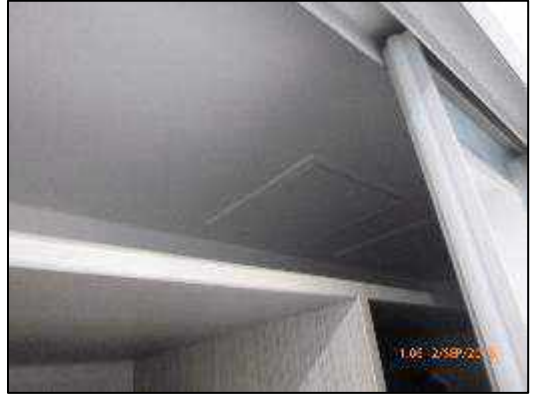
Item	Location	Defect description and Breach	Rectification	Photograph (if applicable)
1246	Main bedroom	See section 5.11.1	See section 5.11.2

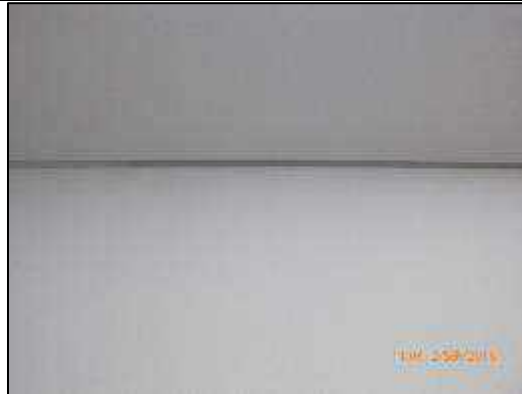
1247	Wall adjacent to main bedroom door	See section 5.13.1	See section 5.13.2

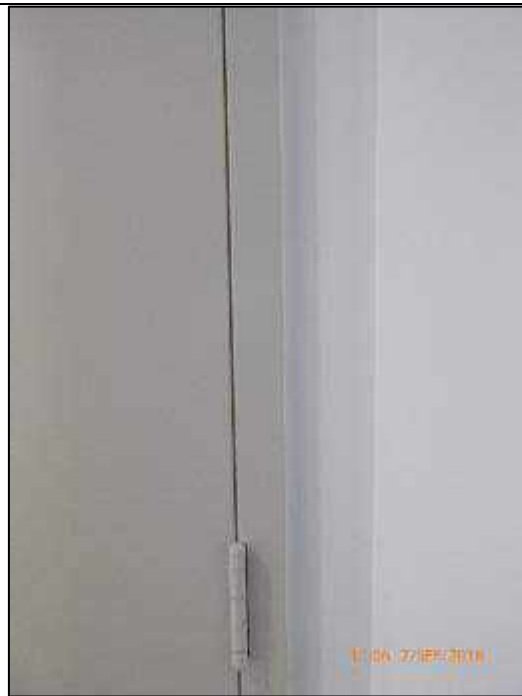
Item	Location	Defect description and Breach	Rectification	Photograph (if applicable)
Unit 1105				
1248	Front entry door	See section 5.12.1	See section 5.12.2

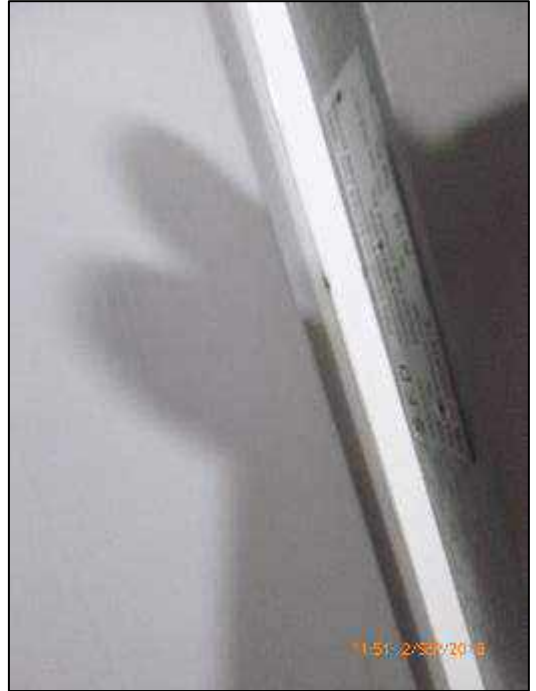
Item	Location	Defect description and Breach	Rectification	Photograph (if applicable)
1249	Wall adjacent to study room	See section 5.13.1	See section 5.13.2

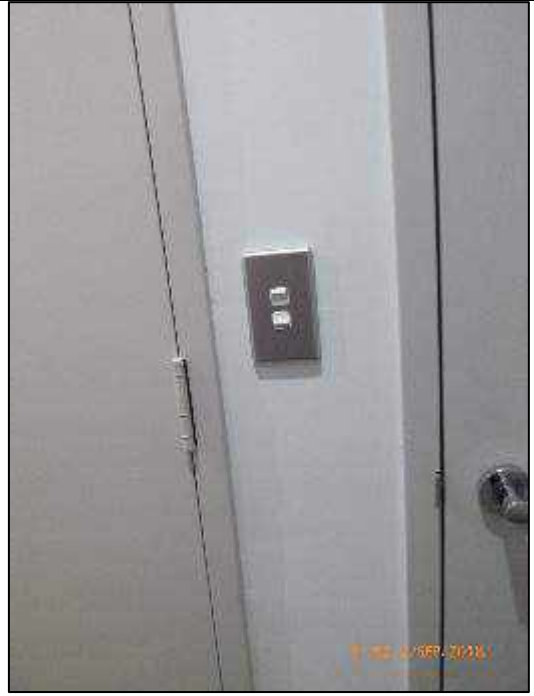
Item	Location	Defect description and Breach	Rectification	Photograph (if applicable)
1250	Wall adjacent to front entry door	See section 5.13.1	See section 5.13.2

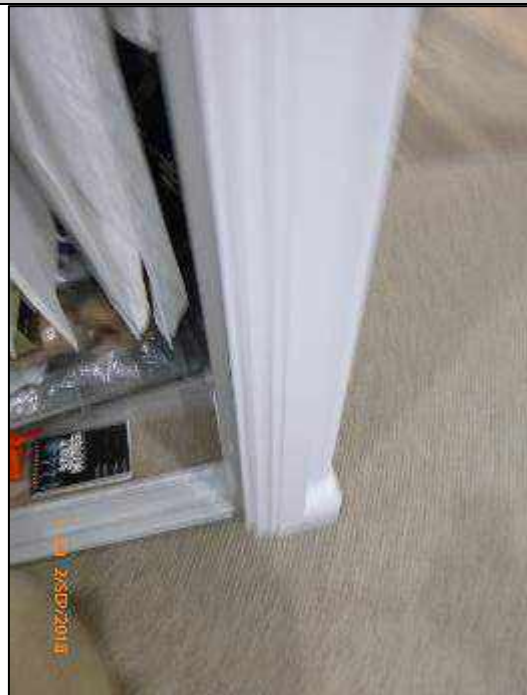
1253	Second bedroom built in	See section 5.6.1	See section 5.6.2

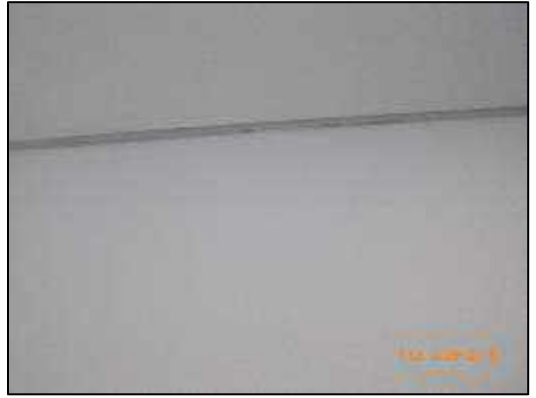
1255	Second bedroom sliding door frame	See section 5.8.1	See section 5.8.2

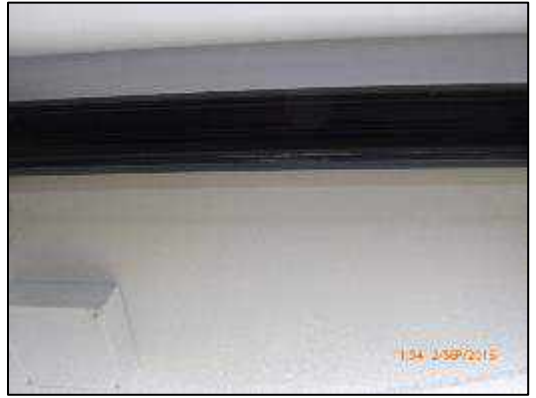
Item	Location	Defect description and Breach	Rectification	Photograph (if applicable)
1256	Main bedroom built in	See section 5.6.1	See section 5.6.2

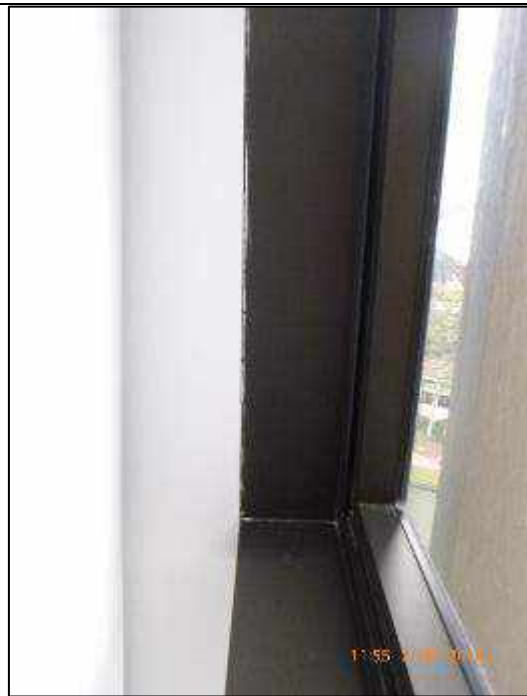
1257	Main bedroom window frames	See section 5.9.1	See section 5.9.2

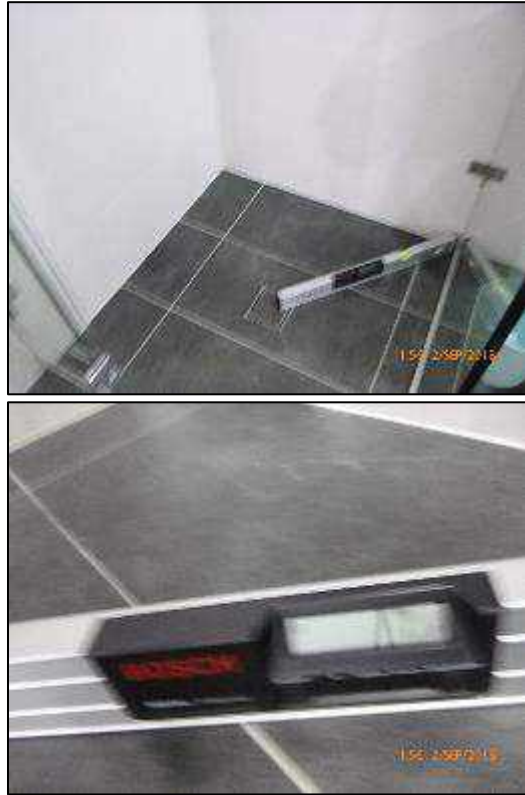
Item	Location	Defect description and Breach	Rectification	Photograph (if applicable)
1258	Main bedroom ensuite	See section 5.1.1 Falls (mm); 2/1000	See section 5.1.2

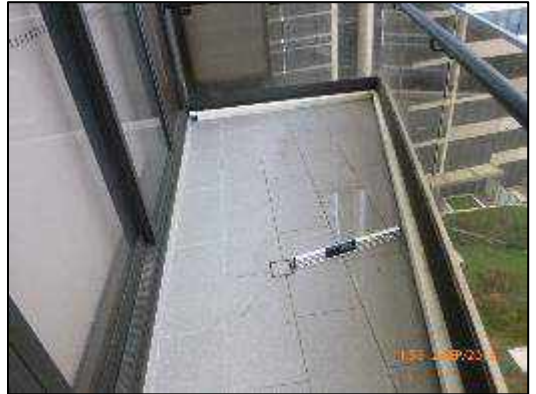
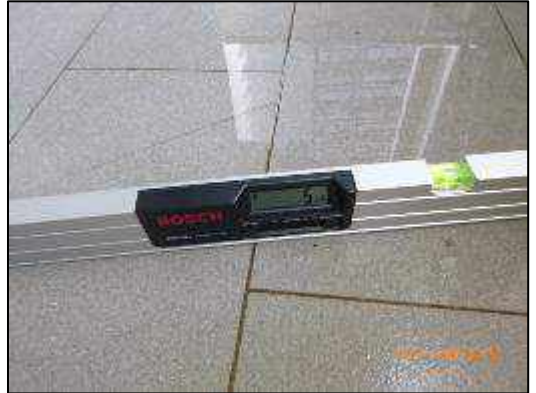
Item	Location	Defect description and Breach	Rectification	Photograph (if applicable)
1261	Balcony	See section 5.2.1 Falls (mm); 5/1000	See section 5.2.2

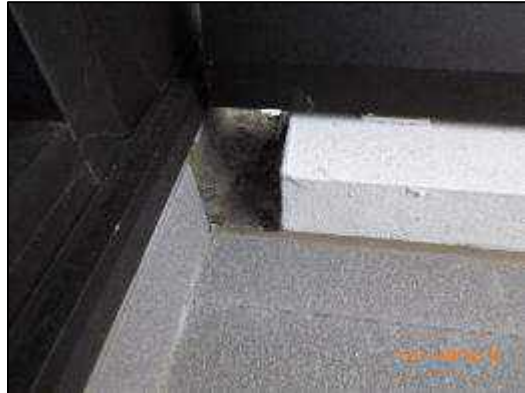
Item	Location	Defect description and Breach	Rectification	Photograph (if applicable)
1262	Balcony	See section 5.15.1	See section 5.15.2

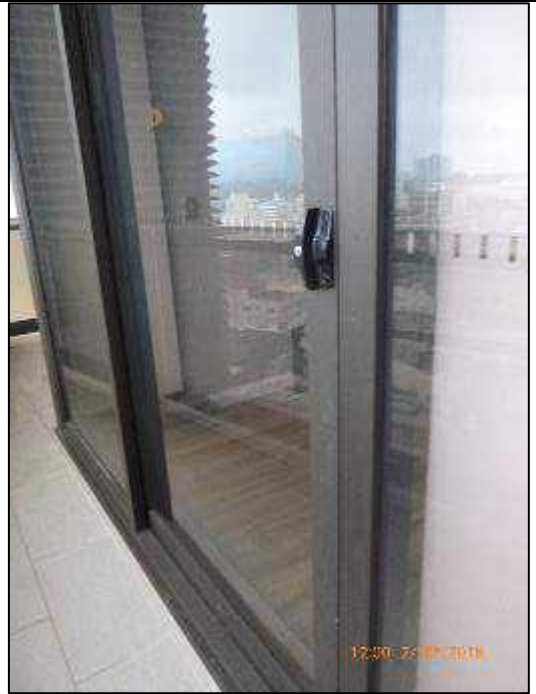
1263	Balcony sliding door frame	See section 5.7.1	See section 5.7.2

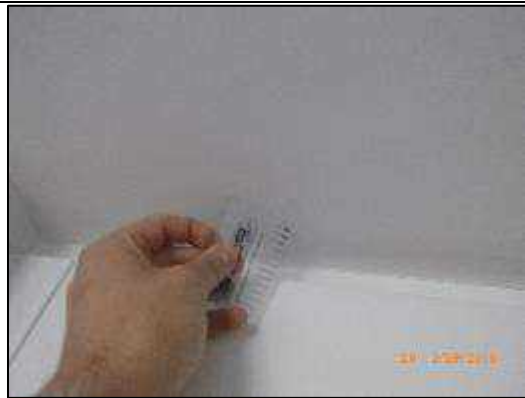
Item	Location	Defect description and Breach	Rectification	Photograph (if applicable)
				  A photograph showing a vertical crack or separation in a light-colored wall or ceiling. A dark vertical line runs down the center of the frame. In the bottom right corner, there is an orange timestamp that reads "12:00: 27-SEP-2018".
1264	<i>Ceiling above kitchen cupboards</i>	See section 5.14.1 Separation; 1mm	See section 5.14.2

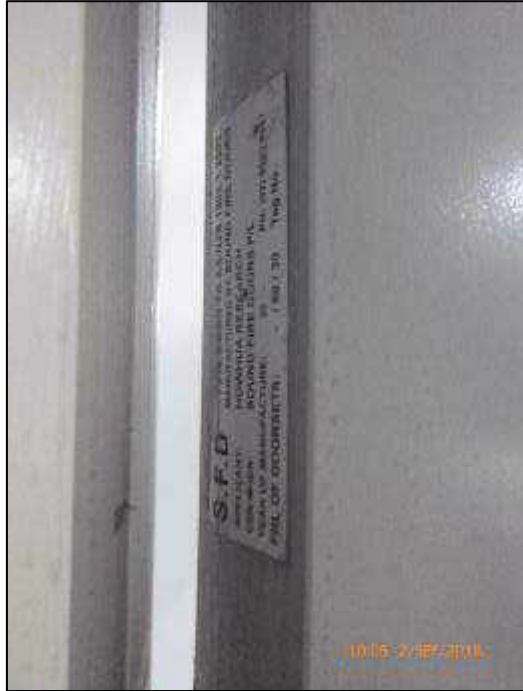
Item	Location	Defect description and Breach	Rectification	Photograph (if applicable)
Unit 1106				
1265	Front entry door	See section 5.12.1	See section 5.12.2

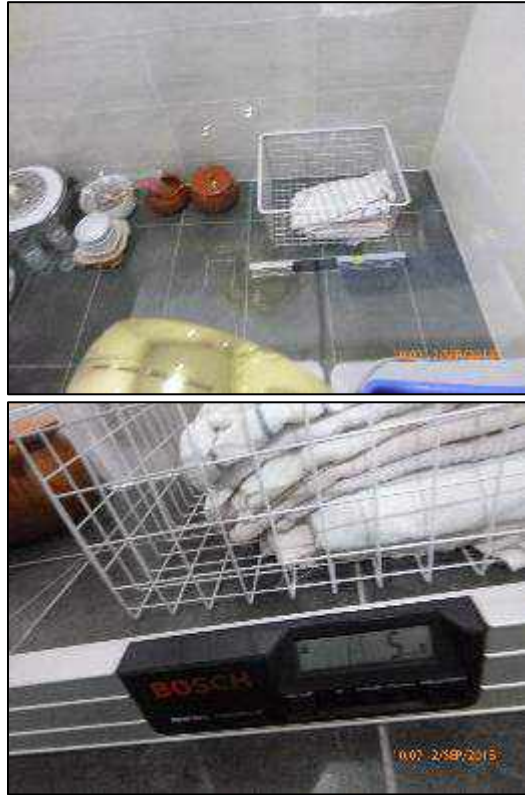
Item	Location	Defect description and Breach	Rectification	Photograph (if applicable)
1268	Main bedroom ensuite	See section 5.1.1 Falls (mm); 5/1000	See section 5.1.2

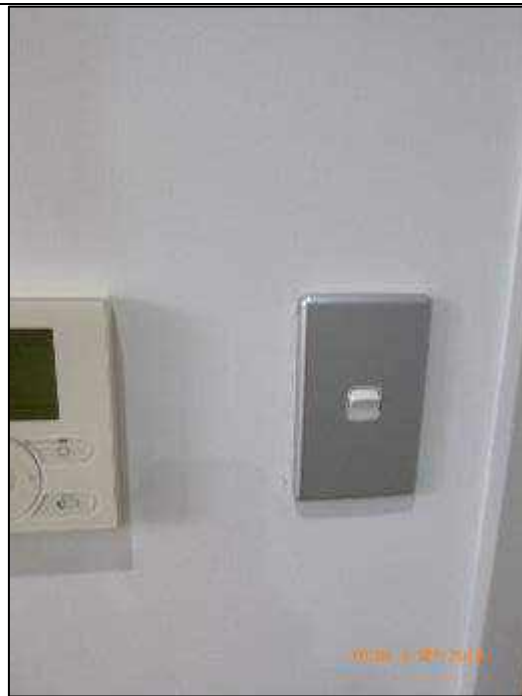
Item	Location	Defect description and Breach	Rectification	Photograph (if applicable)
1269	Main bedroom built in	See section 5.6.1	See section 5.6.2	 
1270	Wall adjacent to main bedroom door	See section 5.10.1	See section 5.10.2
