SydneyStrataReport

STRATA REPORT

Client	Church Street Parramatta Property Pty Ltd
Address of property	Unit 3303/330 Church Street, Parramatta, NSW.
Lot	359
Strata Plan	SP 94469
Name of Strata Management Co.	NSW Strata
Telephone Number of Strata Agent	8980 1841
Report Date	15 February 2024

BUILDING DEFECTS REPORT Part 1/2

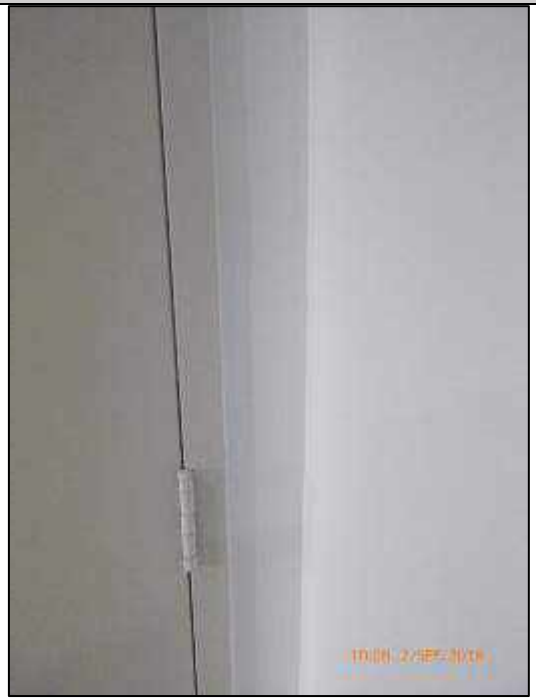
Item	Location	Defect description and Breach	Rectification	Photograph (if applicable)
1271	Wall adjacent to main bedroom door frame	See section 5.13.1	See section 5.13.2

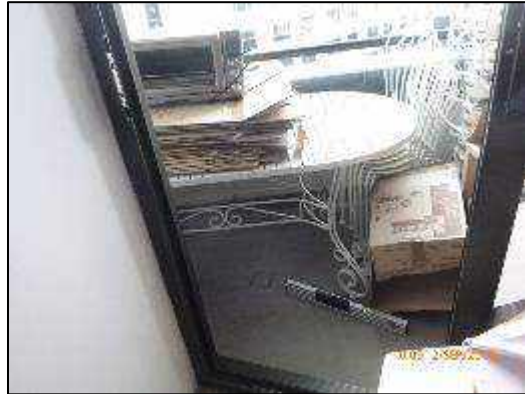
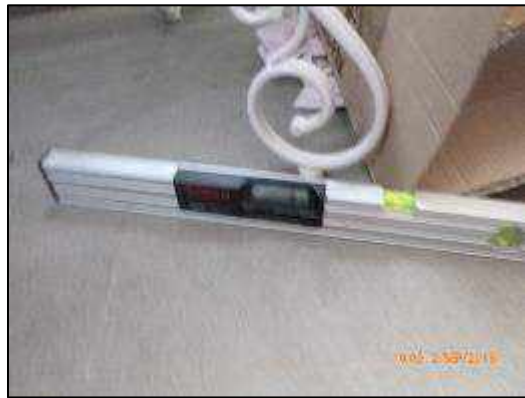
Item	Location	Defect description and Breach	Rectification	Photograph (if applicable)
1272	Balcony	See section 5.2.1 Falls (mm); 6/1000	See section 5.2.2

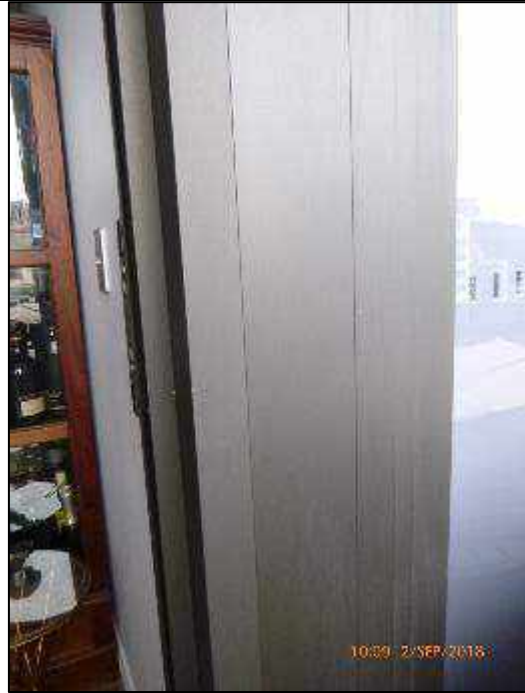
Item	Location	Defect description and Breach	Rectification	Photograph (if applicable)
1273	Balcony sliding door frame	See section 5.7.1	See section 5.7.2

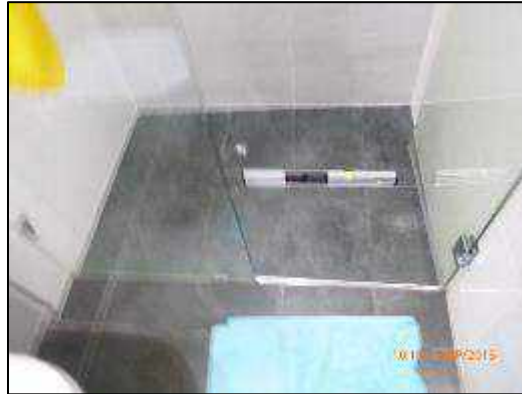
Item	Location	Defect description and Breach	Rectification	Photograph (if applicable)
1275	Main bathroom	See section 5.1.1 Falls (mm); 6/1000	See section 5.1.2

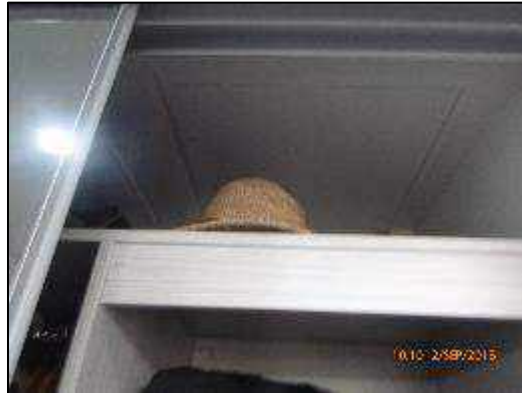
1276	Second bedroom built in	See section 5.6.1	See section 5.6.2

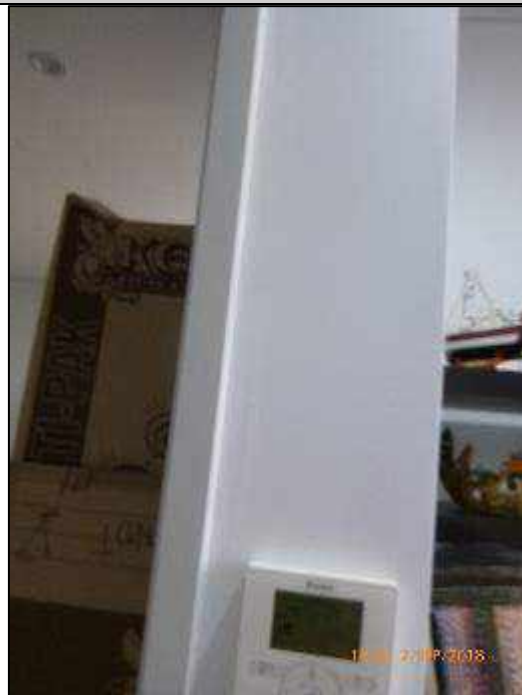
Item	Location	Defect description and Breach	Rectification	Photograph (if applicable)
1277	Wall adjacent to second bedroom door	See section 5.13.1	See section 5.13.2

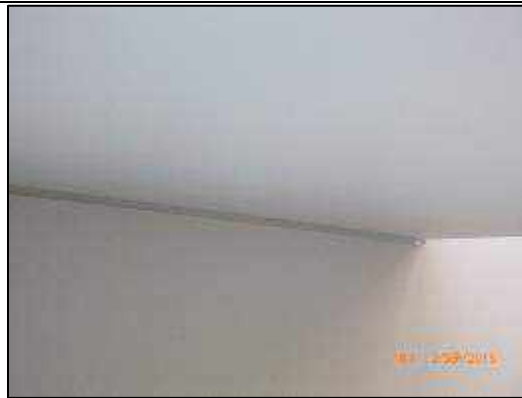
1278	Lounge room	See section 5.11.1	See section 5.11.2

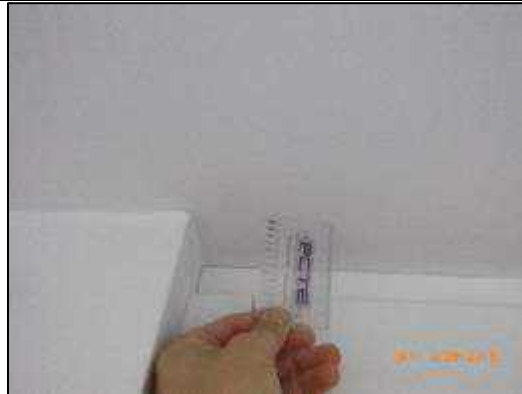
Item	Location	Defect description and Breach	Rectification	Photograph (if applicable)
1279	<i>Ceiling above kitchen cupboards</i>	See section 5.14.1 Separation; 2mm	See section 5.14.2

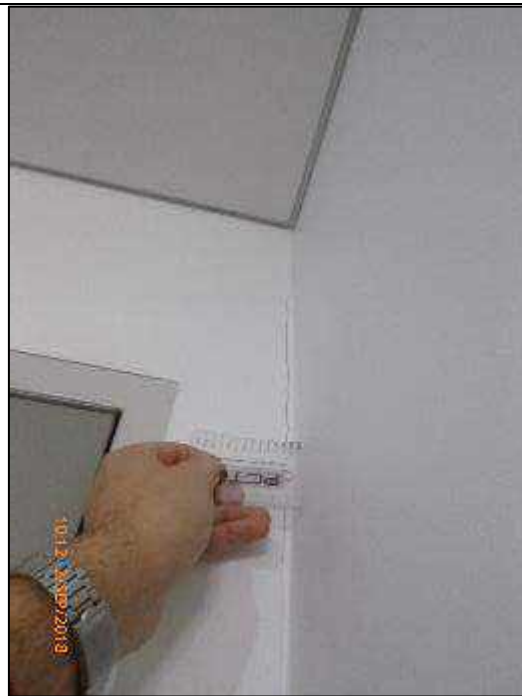
1280	<i>Wall adjacent to front entry door</i>	See section 5.14.1 Separation; 1mm	See section 5.14.2

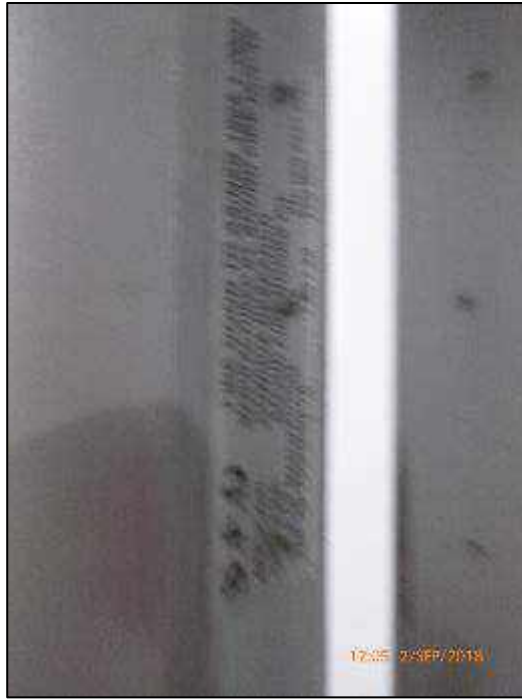
Item	Location	Defect description and Breach	Rectification	Photograph (if applicable)
Unit 1107				
1281	Front entry door	See section 5.12.1	See section 5.12.2

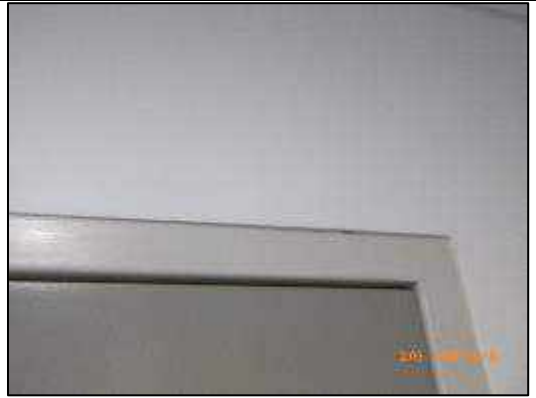
Item	Location	Defect description and Breach	Rectification	Photograph (if applicable)
1282	Wall above front entry door	See section 5.10.1	See section 5.10.2

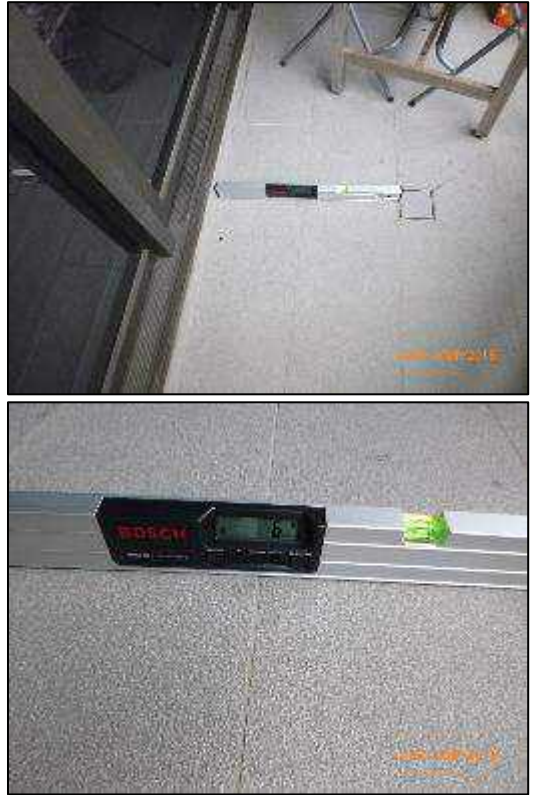
Item	Location	Defect description and Breach	Rectification	Photograph (if applicable)
1285	Balcony	See section 5.2.1 Falls (mm); 6/1000	See section 5.2.2

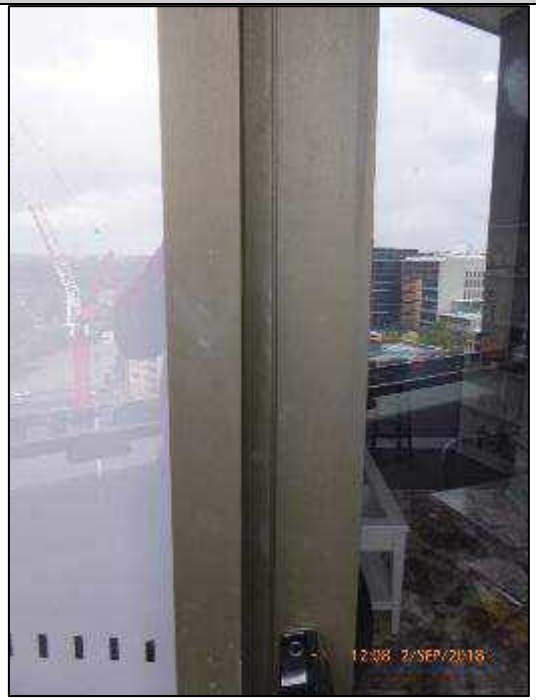
Item	Location	Defect description and Breach	Rectification	Photograph (if applicable)
1286	Balcony sliding door frame	See section 5.7.1	See section 5.7.2

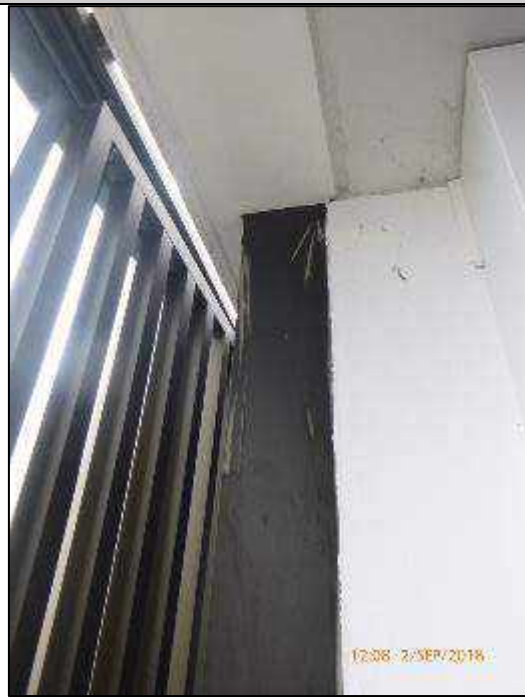
Item	Location	Defect description and Breach	Rectification	Photograph (if applicable)
1287	External façade panels in balcony area	<p>Construction debris observed on façade of building</p> <p>Home Building Act (NSW) 1989</p> <ul style="list-style-type: none"> Part 2C, 18B (a) and (c). <p>This is a breach of part (a) of the act because the surface has not been finished in a proper workmanlike manner that would prevent loss of appearance to the surface.</p> <p>Loss Suffered</p> <p>Loss suffered is cost of rectification.</p>	<ol style="list-style-type: none"> 1. Protect all adjoining surfaces. 2. Use a suitable cleaning agent to remove residue and clear debris. 3. Clean up the work area.

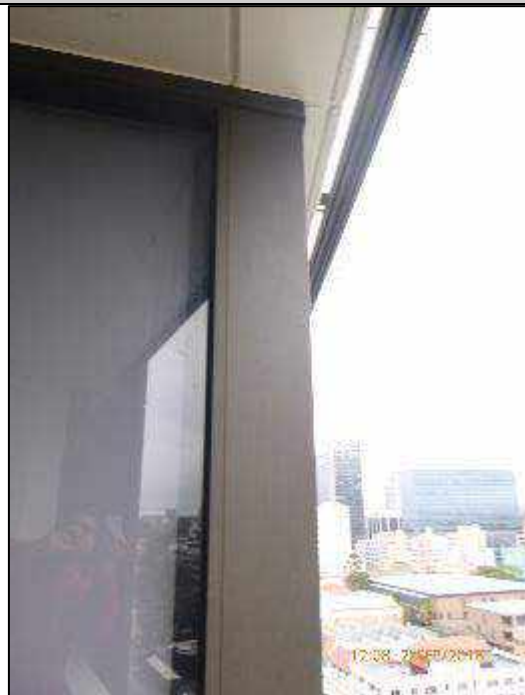
Item	Location	Defect description and Breach	Rectification	Photograph (if applicable)
1288	External façade panels in balcony area	See section 5.9.1	See section 5.9.2

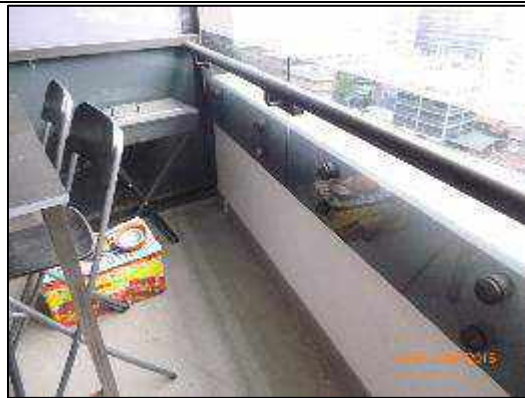
A photograph showing a view from a balcony looking out at a city skyline. The image is taken from a high vantage point, showing several buildings in the distance. The balcony's edge and part of the building's exterior are visible in the foreground.
1289	Balcony	See section 5.4.1	See section 5.4.2

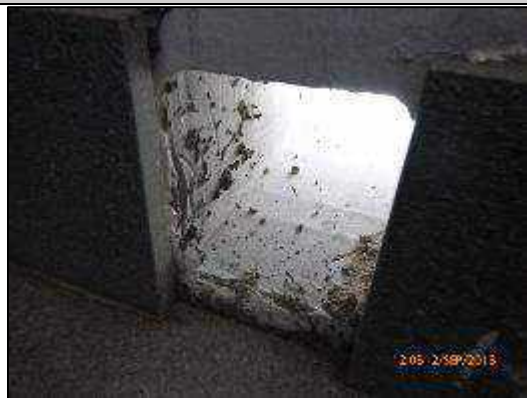
Item	Location	Defect description and Breach	Rectification	Photograph (if applicable)
1290	Balcony	See section 5.15.1	See section 5.15.2

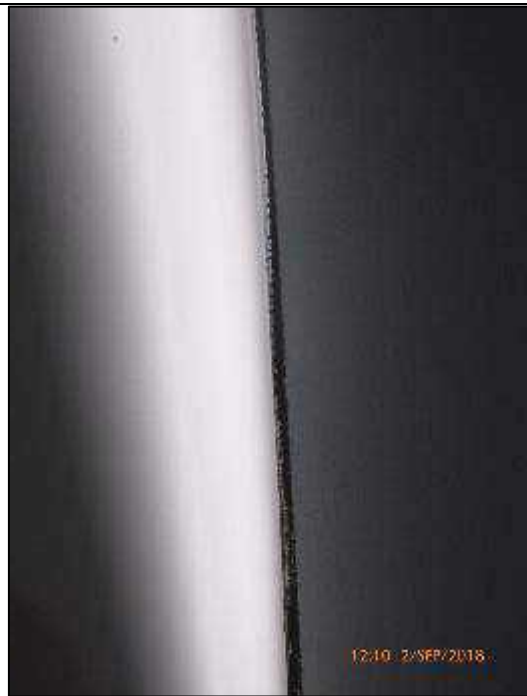
1291	Lounge room window frames	See section 5.9.1	See section 5.9.2

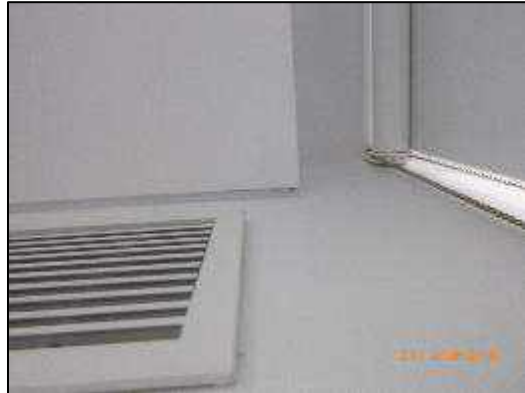
Item	Location	Defect description and Breach	Rectification	Photograph (if applicable)
1292	Main bedroom	See section 5.11.1	See section 5.11.2

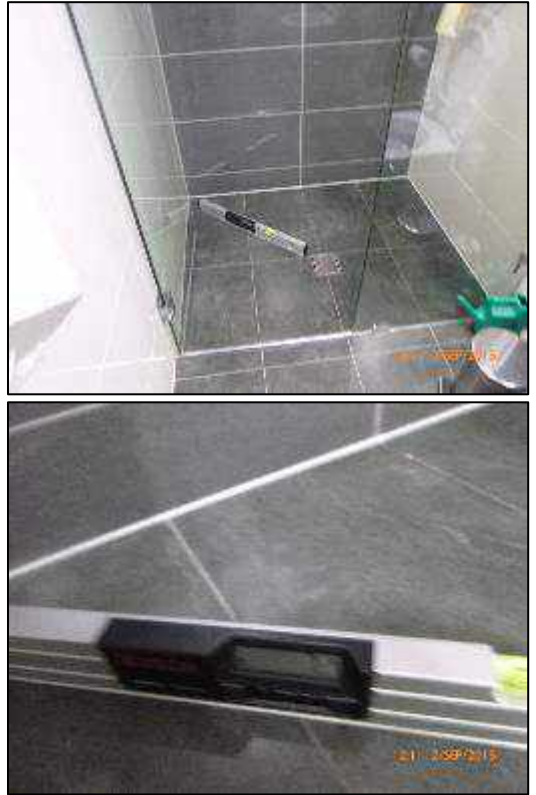
Item	Location	Defect description and Breach	Rectification	Photograph (if applicable)
1293	Main bathroom	See section 5.1.1 Falls (mm); 7/1000	See section 5.1.2

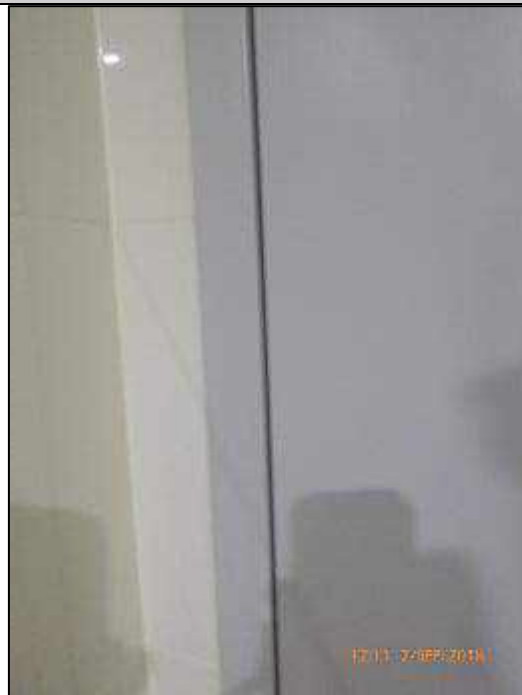
Item	Location	Defect description and Breach	Rectification	Photograph (if applicable)
1294	Main bathroom door frame	See section 5.10.1	See section 5.10.2

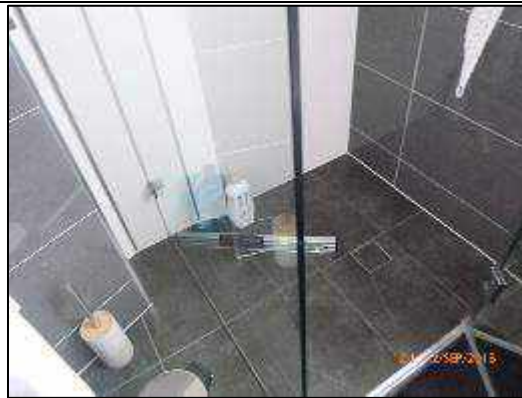
1295	Main bedroom ensuite	See section 5.1.1 Falls (mm); 6/1000	See section 5.1.2

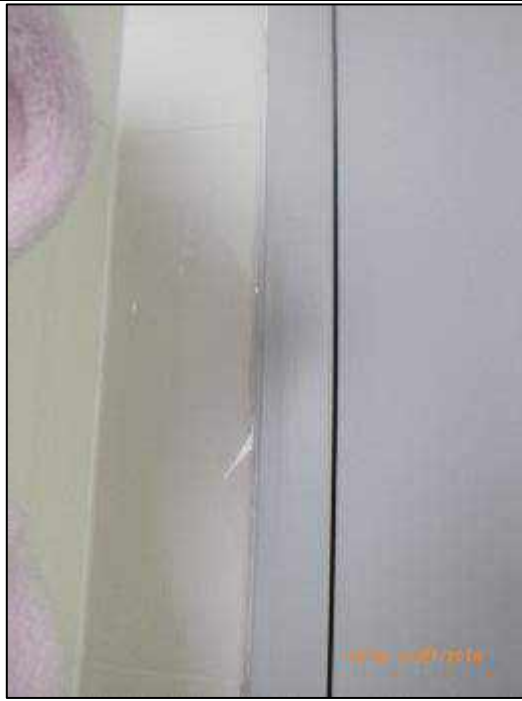
Item	Location	Defect description and Breach	Rectification	Photograph (if applicable)
1296	Wall adjacent to ensuite door	See section 5.9.1	See section 5.9.2

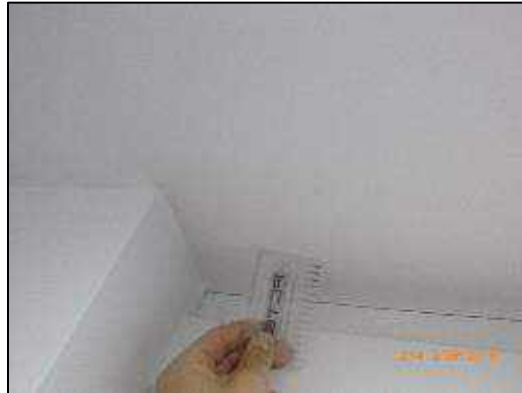
1299	Ceiling above kitchen cupboards	See section 5.14.1 Separation; 1.5mm	See section 5.14.2

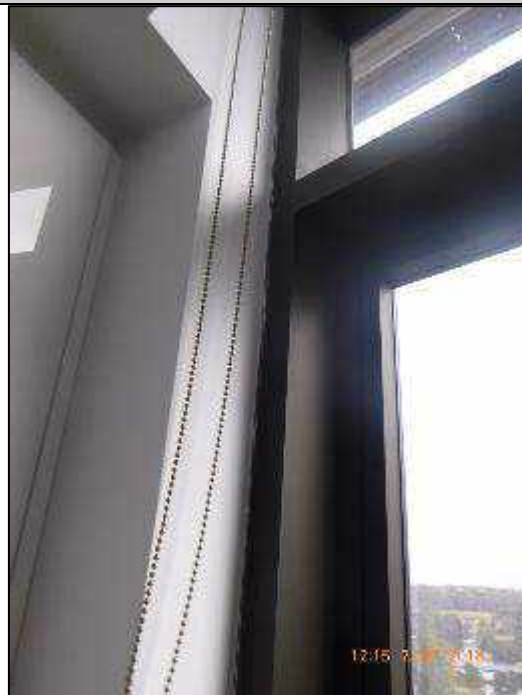
Item	Location	Defect description and Breach	Rectification	Photograph (if applicable)
1300	Kitchen window frames	See section 5.9.1	See section 5.9.2

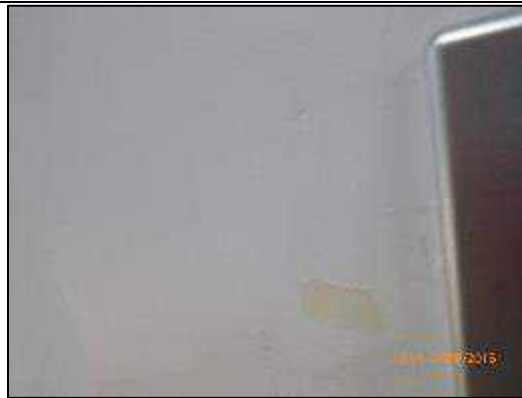
A photograph showing a close-up of a white window frame. The frame appears to be made of a material with a textured, possibly metallic or plastic, surface. There is a visible gap or defect in the frame where it meets the wall. The background shows a bright outdoor scene with some greenery.
1301	Lounge room southern wall	See section 5.10.1	See section 5.10.2

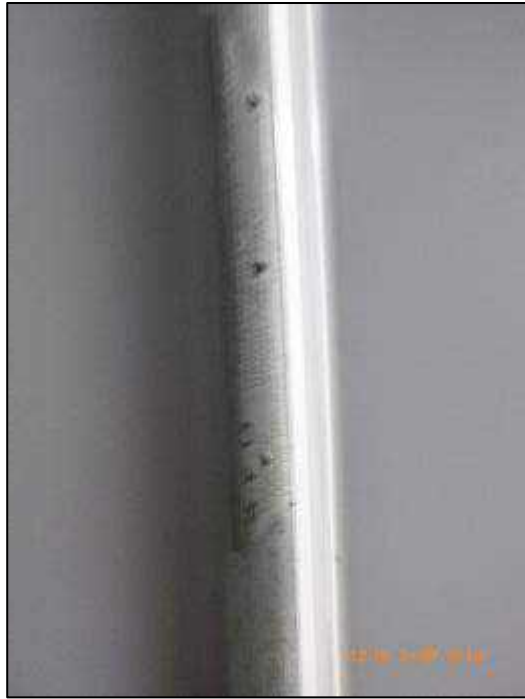
Item	Location	Defect description and Breach	Rectification	Photograph (if applicable)
Unit 1108				
1302	Front entry door	See section 5.12.1	See section 5.12.2

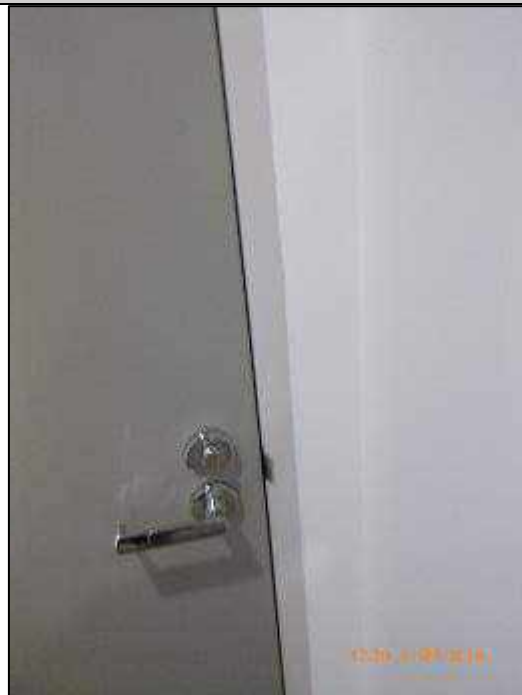
Item	Location	Defect description and Breach	Rectification	Photograph (if applicable)
1303	Wall adjacent to front entry door	See section 5.13.1	See section 5.13.2

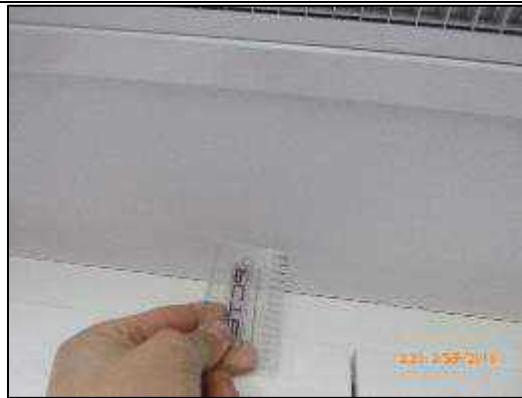
1304	Ceiling above kitchen cupboards	See section 5.14.1 Separation; 1.5mm	See section 5.14.2

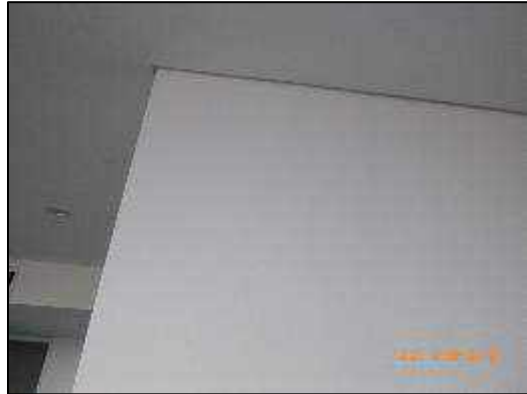
Item	Location	Defect description and Breach	Rectification	Photograph (if applicable)
1305	Lounge room northern wall	See section 5.10.1	See section 5.10.2

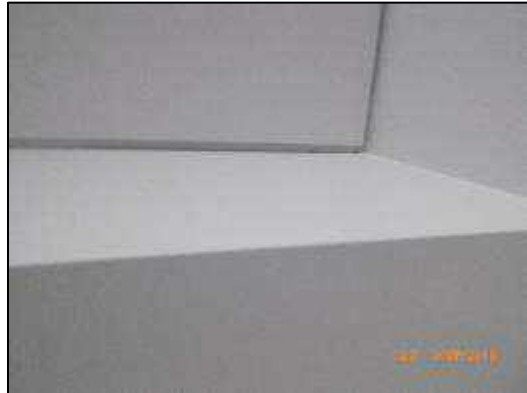
1306	Lounge room	See section 5.11.1	See section 5.11.2

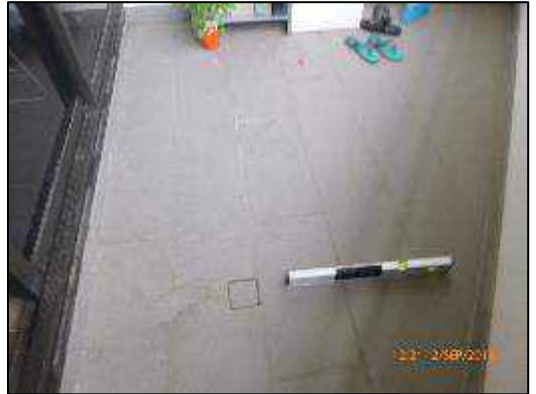
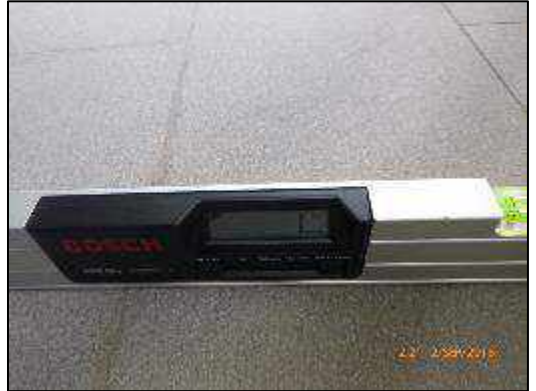
Item	Location	Defect description and Breach	Rectification	Photograph (if applicable)
1307	Balcony	See section 5.2.1 Falls (mm); 1/1000	See section 5.2.2

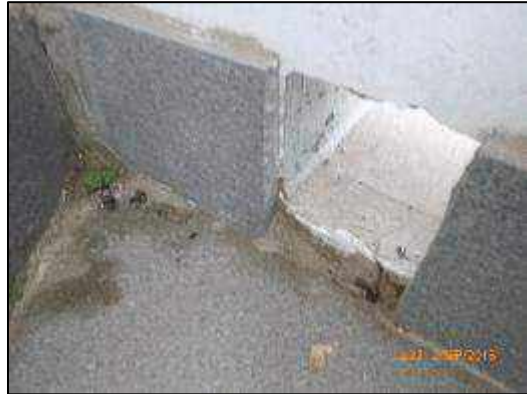
Item	Location	Defect description and Breach	Rectification	Photograph (if applicable)
1308	Balcony	See section 5.15.1	See section 5.15.2

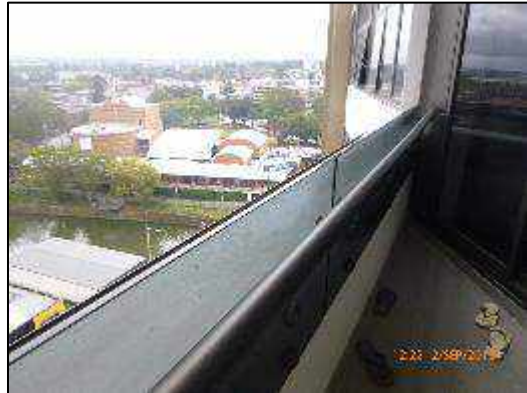
1309	Balcony	See section 5.4.1	See section 5.4.2

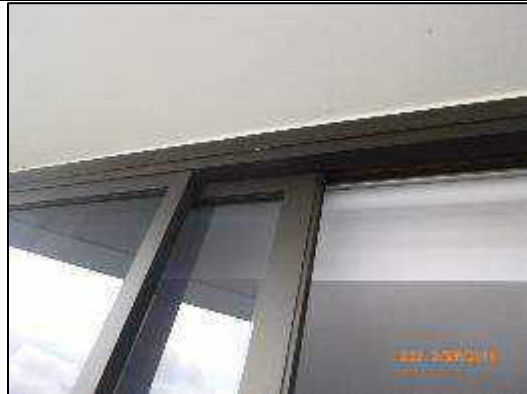
Item	Location	Defect description and Breach	Rectification	Photograph (if applicable)
1310	Balcony sliding door frame	See section 5.9.1	See section 5.9.2

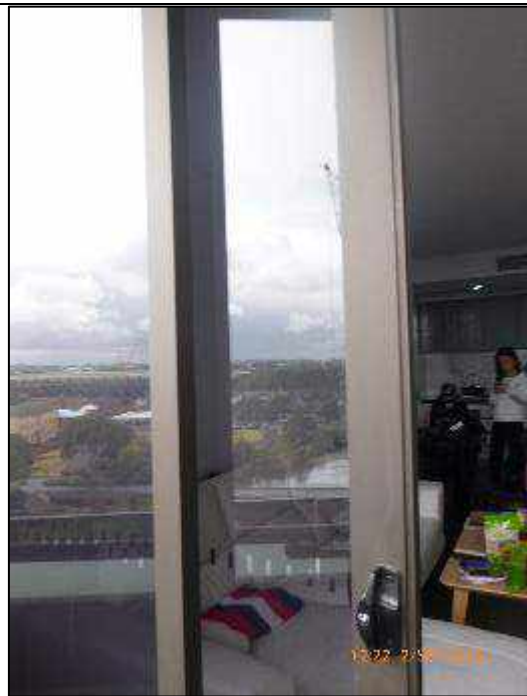
1311	Balcony sliding door frame	See section 5.7.1	See section 5.7.2

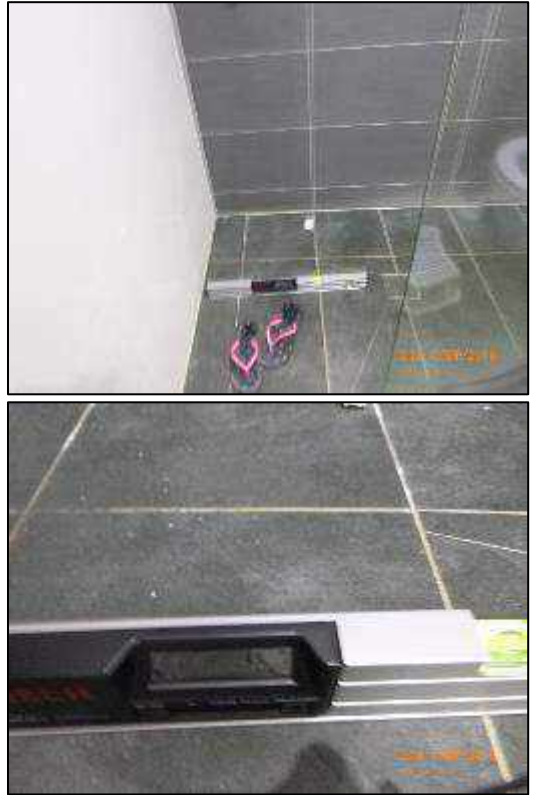
Item	Location	Defect description and Breach	Rectification	Photograph (if applicable)
1312	Main bathroom	See section 5.1.1 Falls (mm); 4/1000	See section 5.1.2

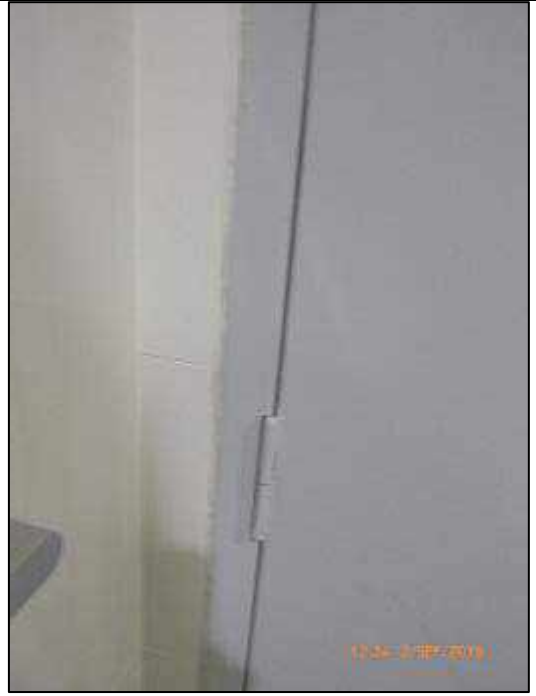
Item	Location	Defect description and Breach	Rectification	Photograph (if applicable)
1313	Wall adjacent to main bathroom door	See section 5.9.1	See section 5.9.2

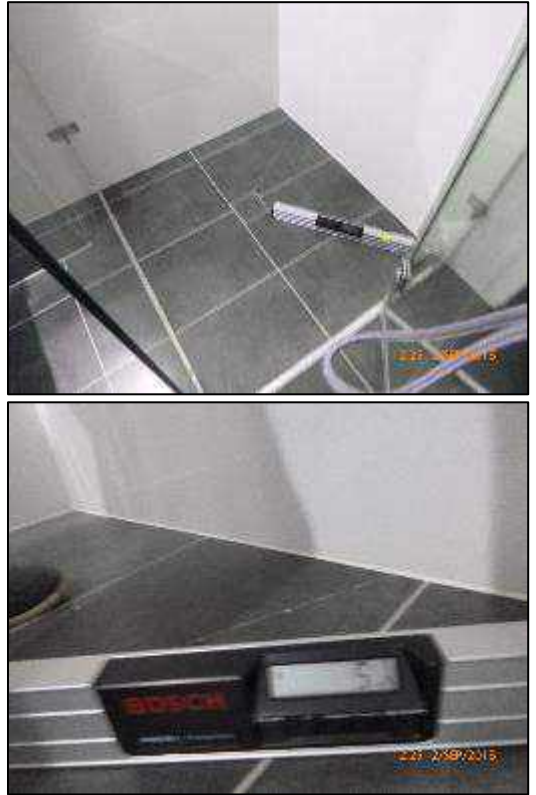
Item	Location	Defect description and Breach	Rectification	Photograph (if applicable)
1314	Main bedroom ensuite	See section 5.1.1 Falls (mm); 5/1000	See section 5.1.2

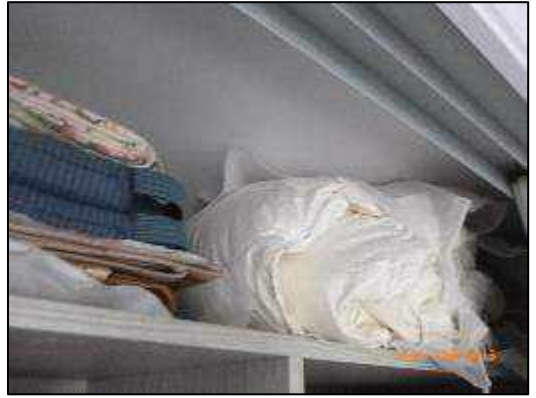
Item	Location	Defect description and Breach	Rectification	Photograph (if applicable)
1315	Second bedroom built in	See section 5.6.1	See section 5.6.2

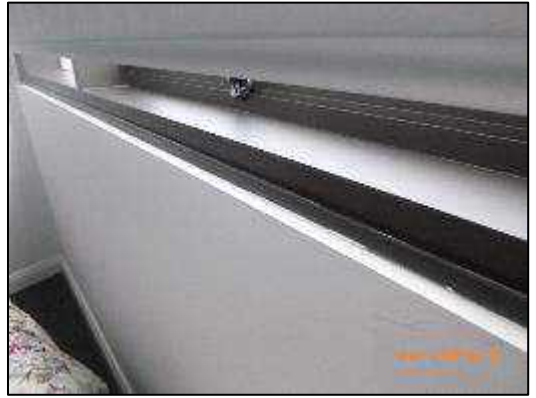
1316	Second bedroom window frames	See section 5.9.1	See section 5.9.2

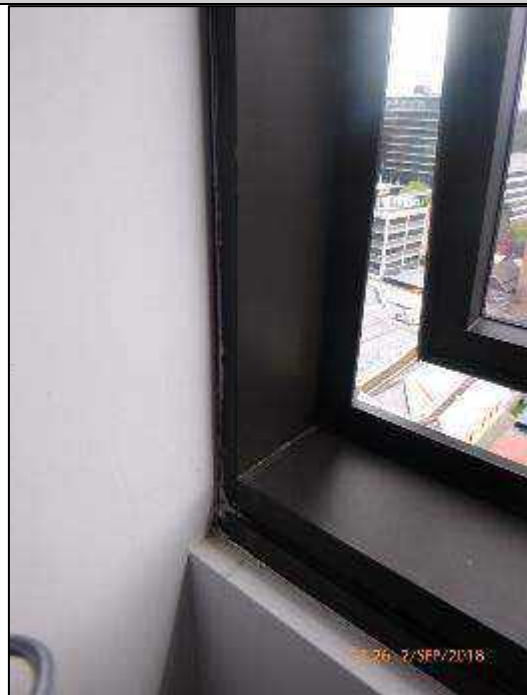
Item	Location	Defect description and Breach	Rectification	Photograph (if applicable)
1317	Main bedroom window frames	See section 5.8.1	See section 5.8.2

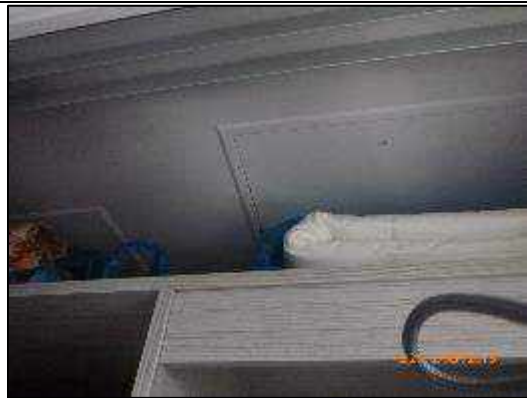
1318	Main bedroom built in	See section 5.6.1	See section 5.5.2

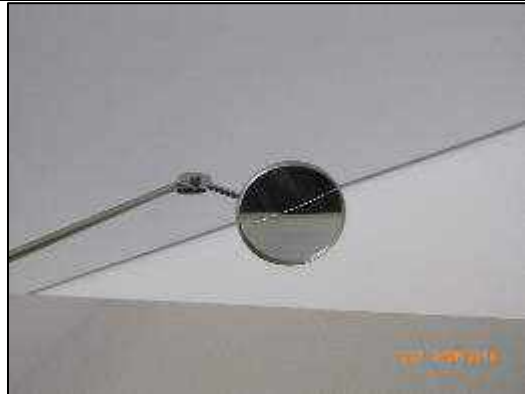
Item	Location	Defect description and Breach	Rectification	Photograph (if applicable)
1319	<i>Doors throughout the unit (x3)</i>	See section 5.5.1	See section 5.5.2

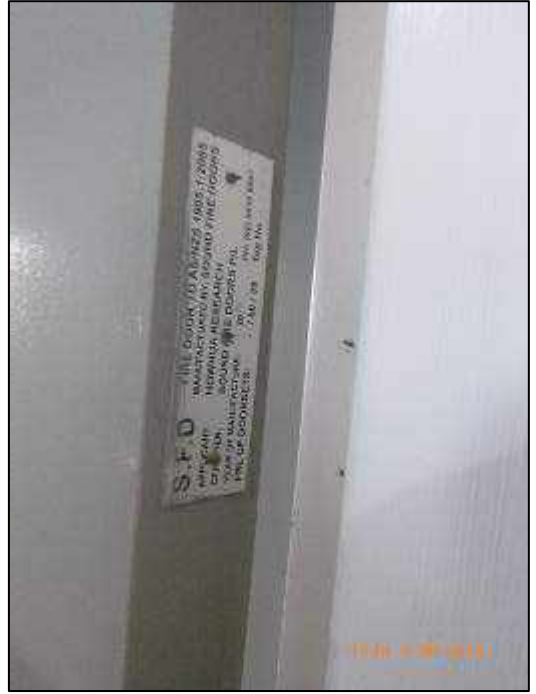
Item	Location	Defect description and Breach	Rectification	Photograph (if applicable)
Unit 1202				
1321	Front entry door	See section 5.12.1	See section 5.12.2

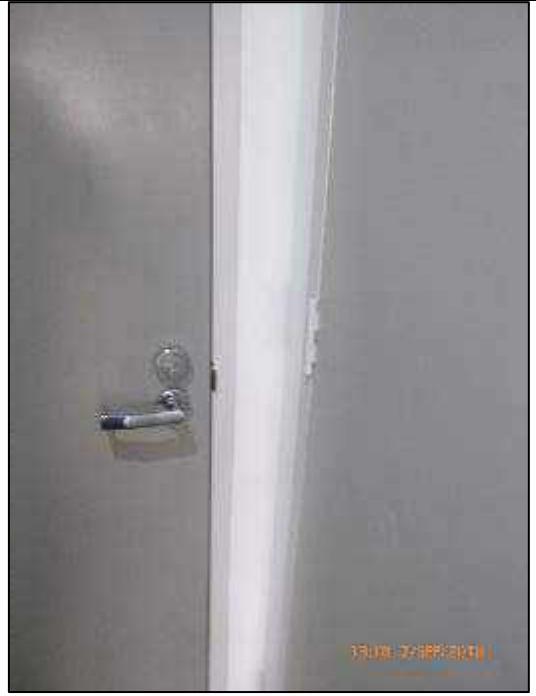
Item	Location	Defect description and Breach	Rectification	Photograph (if applicable)
1322	Wall adjacent to front entry door	See section 5.13.1	See section 5.13.2

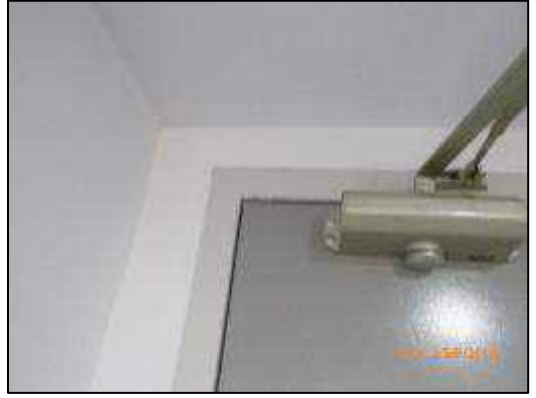
1323	Wall adjacent to front entry door	See section 5.10.1	See section 5.10.2

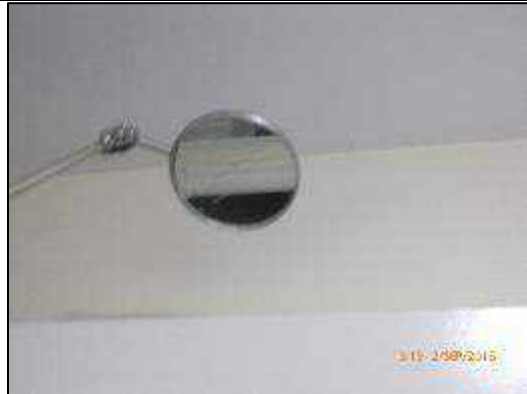
Item	Location	Defect description and Breach	Rectification	Photograph (if applicable)
1324	<i>Doors throughout the unit (x4)</i>	See section 5.5.1	See section 5.5.2

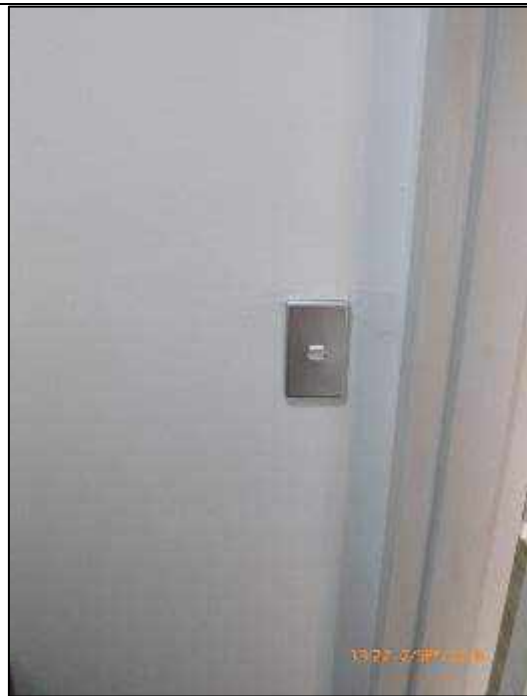
A photograph showing a circular metal fastener or bolt on a light-colored wall. The fastener is slightly protruding. A date stamp '13/10/2015' is visible in the bottom right corner of the image.
1325	<i>Wall adjacent to study room</i>	See section 5.13.1	See section 5.13.2

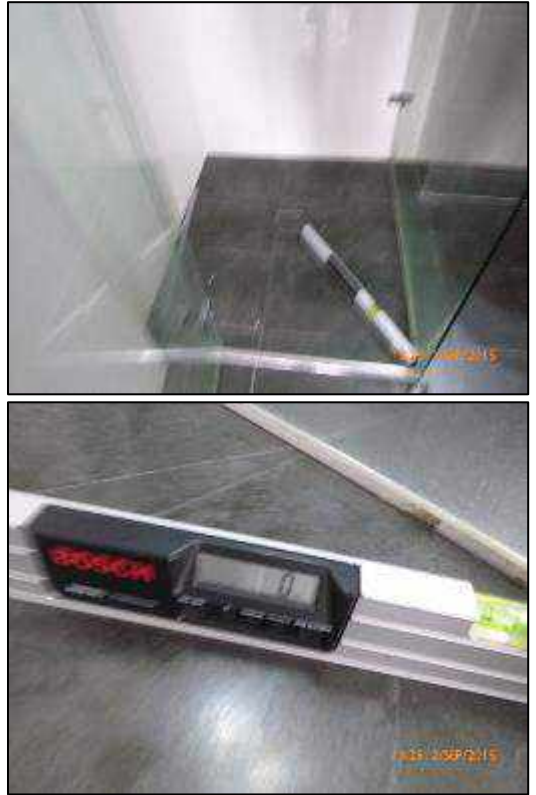
Item	Location	Defect description and Breach	Rectification	Photograph (if applicable)
1327	Main bedroom ensuite	See section 5.1.1 Falls (mm); 0/1000	See section 5.1.2

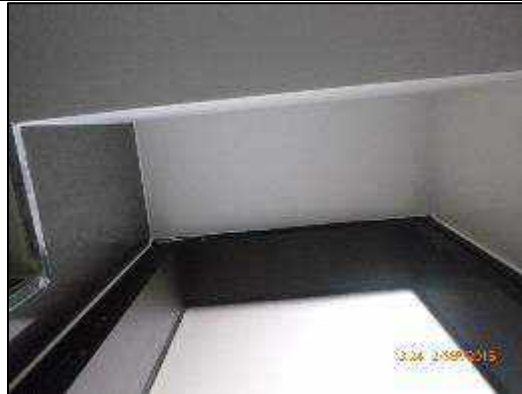
Item	Location	Defect description and Breach	Rectification	Photograph (if applicable)
1328	Main bedroom ensuite window frames	See section 5.9.1	See section 5.9.2

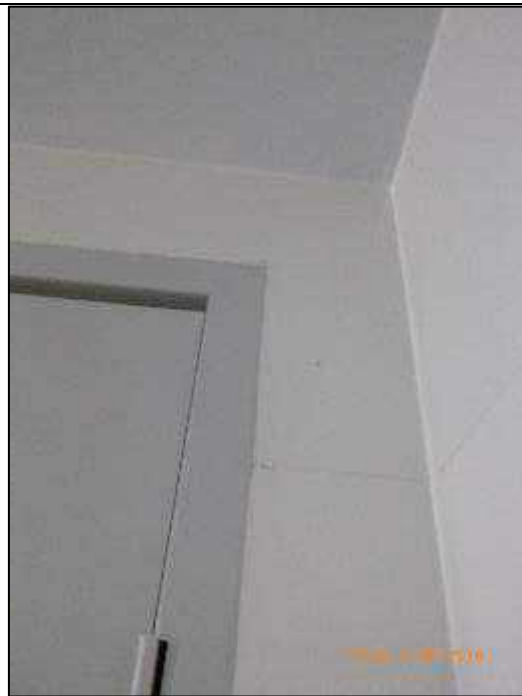
1329	Wall adjacent to ensuite door	See section 5.9.1	See section 5.9.2

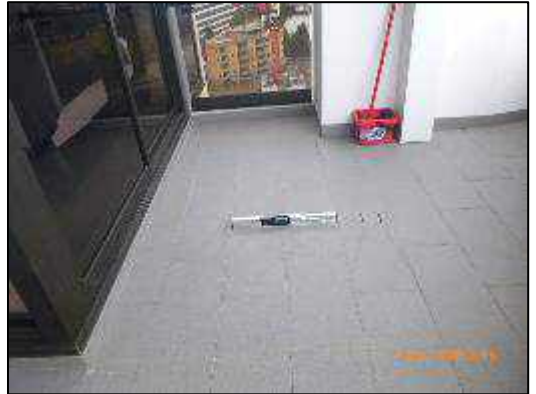
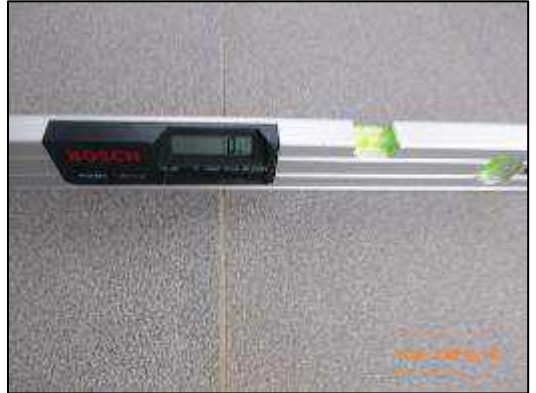
Item	Location	Defect description and Breach	Rectification	Photograph (if applicable)
1330	Balcony	See section 5.2.1 Falls (mm); 0/1000	See section 5.2.2

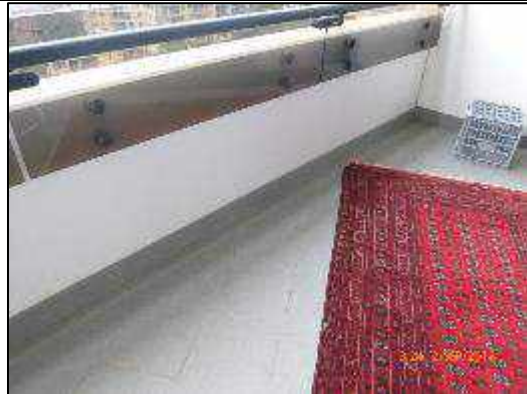
Item	Location	Defect description and Breach	Rectification	Photograph (if applicable)
1331	Balcony	See section 5.3.1	See section 5.3.2

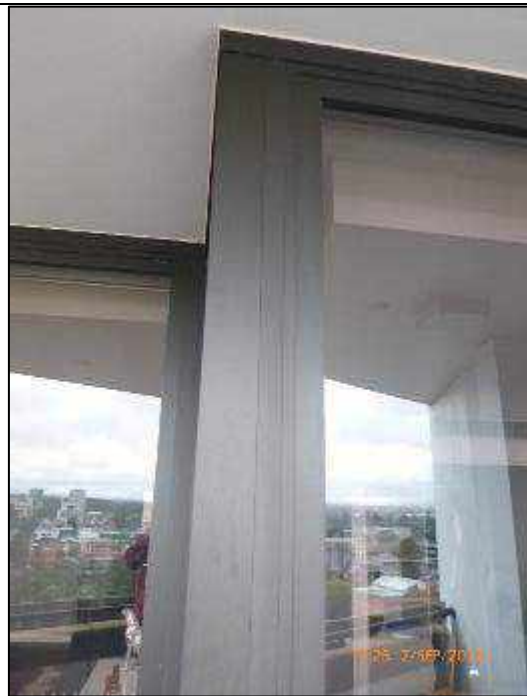
1332	Balcony sliding door frames	See section 5.7.1	See section 5.7.2

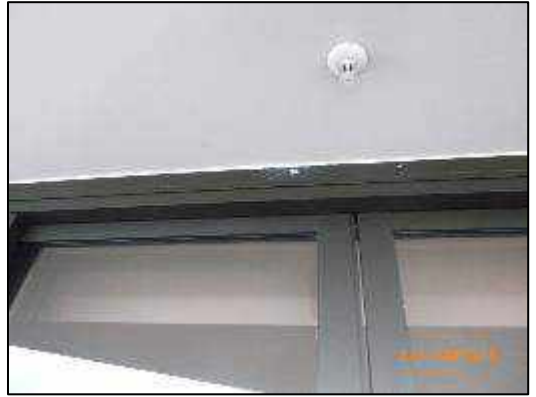
Item	Location	Defect description and Breach	Rectification	Photograph (if applicable)
1333	Balcony sliding door frames	See section 5.9.1	See section 5.9.2

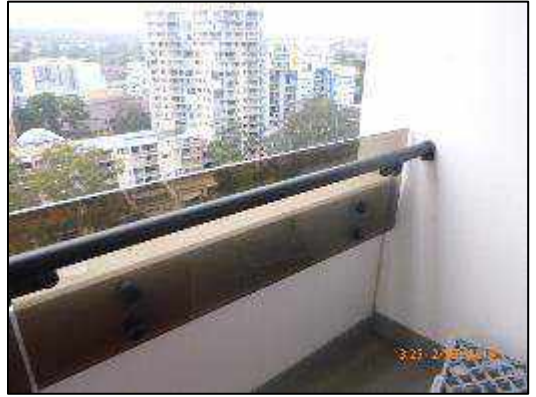
1334	Balcony	See section 5.4.1	See section 5.4.2

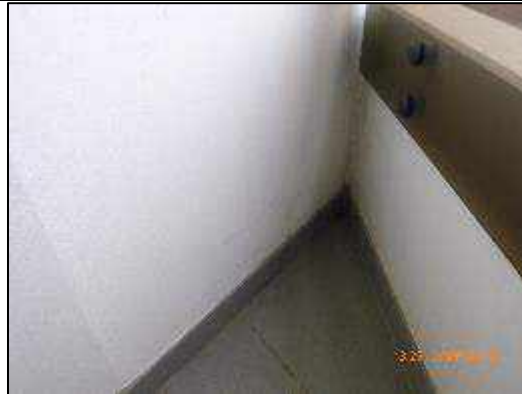
Item	Location	Defect description and Breach	Rectification	Photograph (if applicable)
1335	Balcony southern wall	<p>Cracking in render observed on facade of building in balcony area.</p> <p>Home Building Act (NSW) 1989</p> <ul style="list-style-type: none"> Part 2C, 18B (a) and (c). <p>Guide to Standards and Tolerances 2017</p> <ul style="list-style-type: none"> Crack categories are assessed in accordance with Section 3.2. Cracks are classed as exceeding Category 1 but not exceeding Category 2 damage. Category 2 damage cracks are considered a defect and require repair work. <p>AS2870-2011 Residential footings and slabs</p> <ul style="list-style-type: none"> Crack categories are assessed in accordance with Table C1 <p>CLASSIFICATION OF DAMAGE WITH REFERENCE TO WALLS</p> <ul style="list-style-type: none"> Cracks exceed Category 1 but do not exceed damage Category 2. <p>Loss Suffered Loss suffered is cost of rectification.</p>	<ol style="list-style-type: none"> 1. Protect all surrounding surfaces 2. Remove cracked rendered surfaces to closest architectural line 3. Install suitable flexible sealant 4. Install new render to blend into the existing surface 5. Repaint to match existing using suitable external paint system in accordance with AS2311.

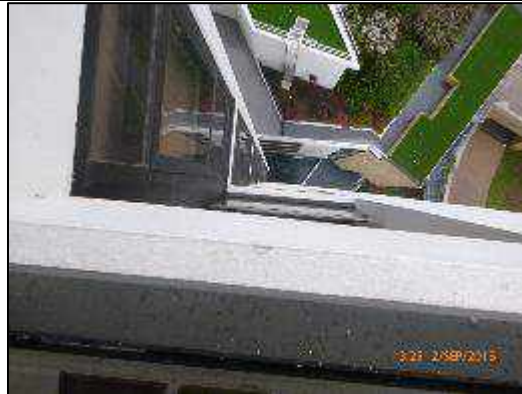
Item	Location	Defect description and Breach	Rectification	Photograph (if applicable)
1336	Balcony	<p>Cracked render section observed around hob of balcony.</p> <p>Home Building Act (NSW) 1989</p> <ul style="list-style-type: none"> Part 2C, 18B (a) and (c). <p>Guide to Standards and Tolerances 2017</p> <ul style="list-style-type: none"> Crack categories are assessed in accordance with Section 3.2. Cracks are classed as exceeding Category 1 but not exceeding Category 2 damage. Category 2 damage cracks are considered a defect and require repair work. <p>AS2870-2011 Residential footings and slabs</p> <ul style="list-style-type: none"> Crack categories are assessed in accordance with Table C1 CLASSIFICATION OF DAMAGE WITH REFERENCE TO WALLS Cracks exceed Category 1 but do not exceed damage Category 2. <p>Loss Suffered Loss suffered is cost of rectification.</p>	<ol style="list-style-type: none"> 1. Protect all surrounding surfaces 2. Remove cracked rendered surfaces to closest architectural line 3. Install new render to blend into the existing surface 4. Repaint to match existing using suitable external paint system in accordance with AS2311.

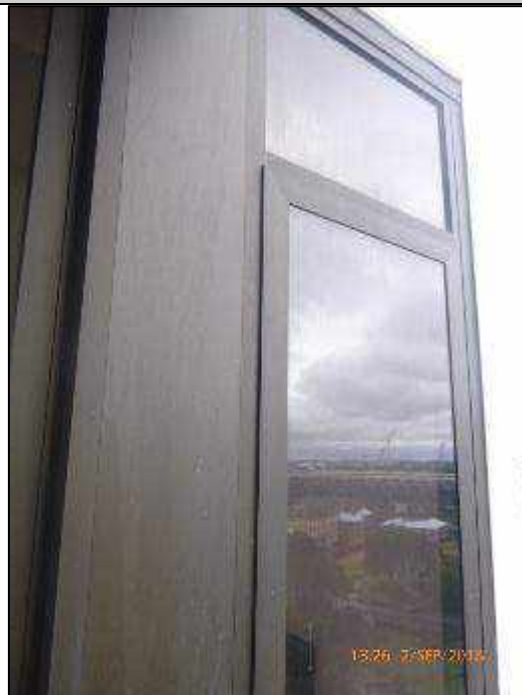
Item	Location	Defect description and Breach	Rectification	Photograph (if applicable)
1337	External façade panels in balcony.	<p>Construction debris observed on façade of building</p> <p>Home Building Act (NSW) 1989</p> <ul style="list-style-type: none"> Part 2C, 18B (a) and (c). <p>This is a breach of part (a) of the act because the surface has not been finished in a proper workmanlike manner that would prevent loss of appearance to the surface.</p> <p>Loss Suffered Loss suffered is cost of rectification.</p>	<ol style="list-style-type: none"> 1. Protect all adjoining surfaces. 2. Use a suitable cleaning agent to remove residue and clear debris. 3. Clean up the work area.

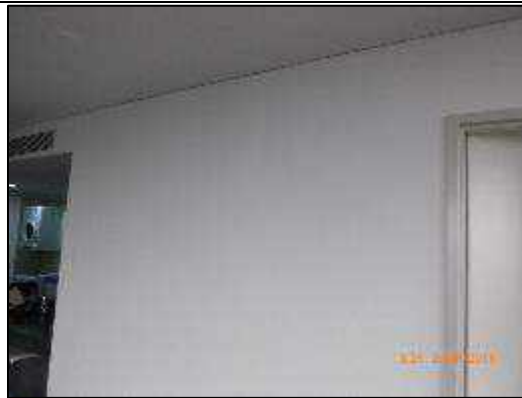
1338	Lounge room northern wall	See section 5.10.1	See section 5.10.2

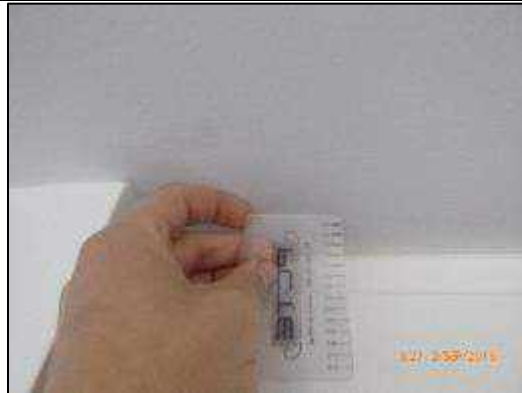
1340	Ceiling above kitchen cupboards	See section 5.14.1 Separation; 1mm	See section 5.14.2

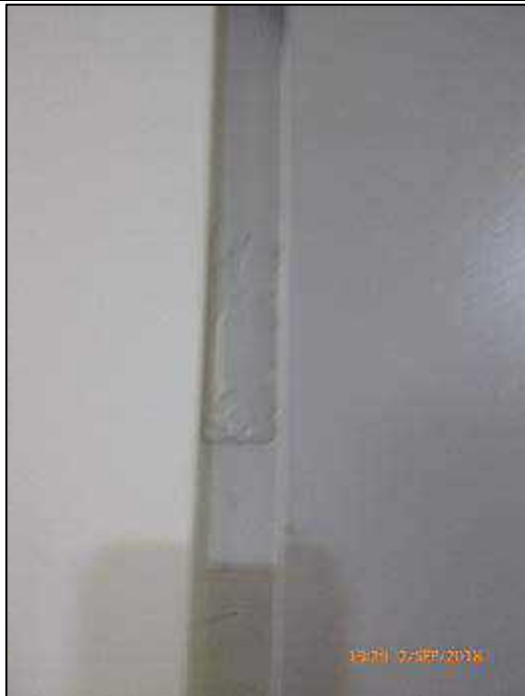
Item	Location	Defect description and Breach	Rectification	Photograph (if applicable)
1341	Front entry door	<p>Door frame label has been painted over.</p> <p>Home Building Act (NSW) 1989</p> <ul style="list-style-type: none"> Part 2C, 18B (a) & (c). <p>Loss Suffered</p> <p>Loss suffered is cost of rectification.</p>	Use a suitable cleaning agent to remove paint from the door frame label.

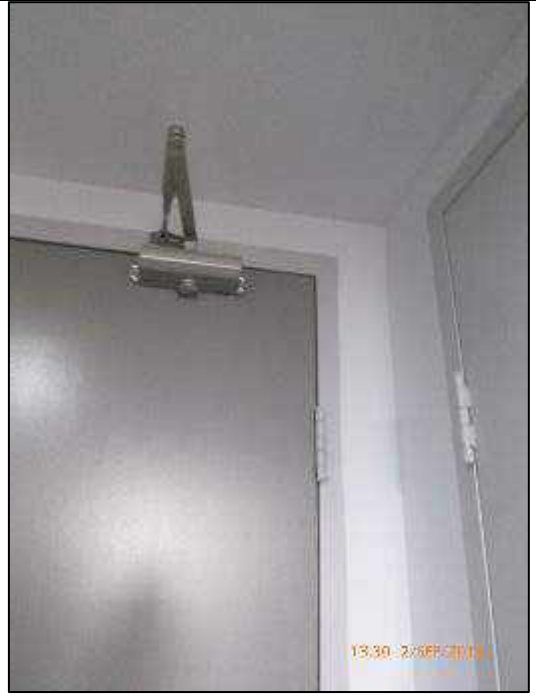
Item	Location	Defect description and Breach	Rectification	Photograph (if applicable)
1342	Wall adjacent to front entry door	See section 5.13.1	See section 5.13.2

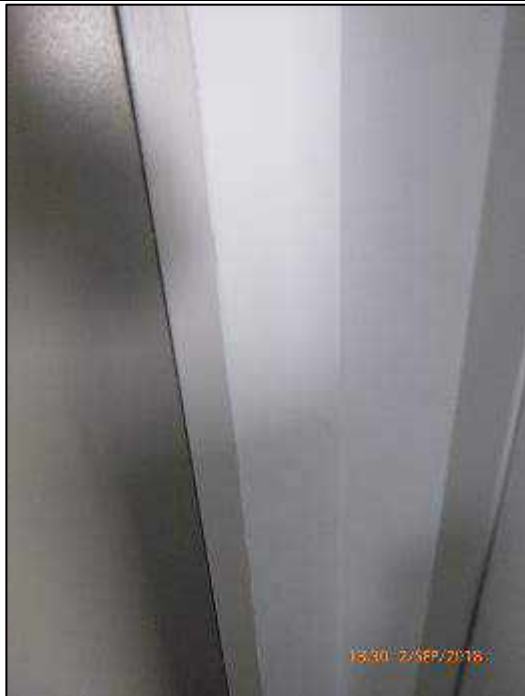
Item	Location	Defect description and Breach	Rectification	Photograph (if applicable)
1343	Wall adjacent to front entry door	See section 5.13.1	See section 5.13.2
