SydneyStrataReport

STRATA REPORT

Client	Church Street Parramatta Property Pty Ltd
Address of property	Unit 3303/330 Church Street, Parramatta, NSW.
Lot	359
Strata Plan	SP 94469
Name of Strata Management Co.	NSW Strata
Telephone Number of Strata Agent	8980 1841
Report Date	15 February 2024

BUILDING DEFECTS REPORT Part 1/2

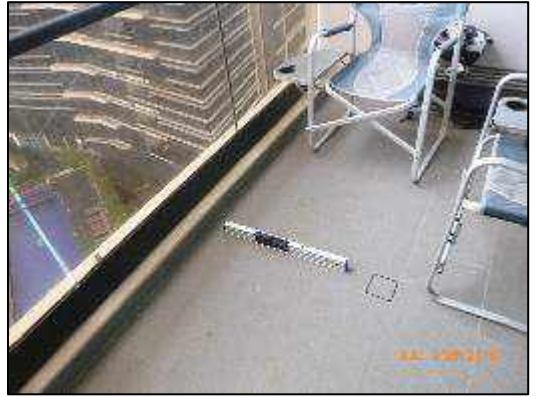
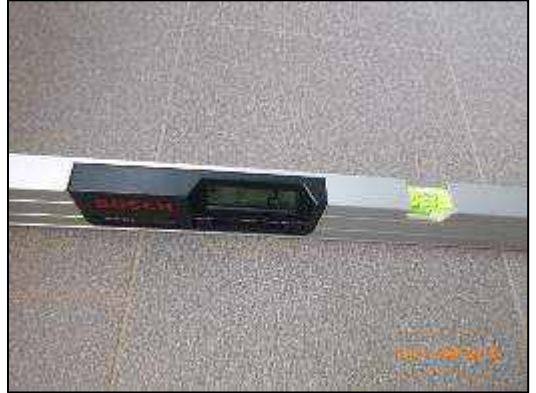
Item	Location	Defect description and Breach	Rectification	Photograph (if applicable)
1344	Balcony	See section 5.2.1 Falls (mm); 2/1000	See section 5.2.2

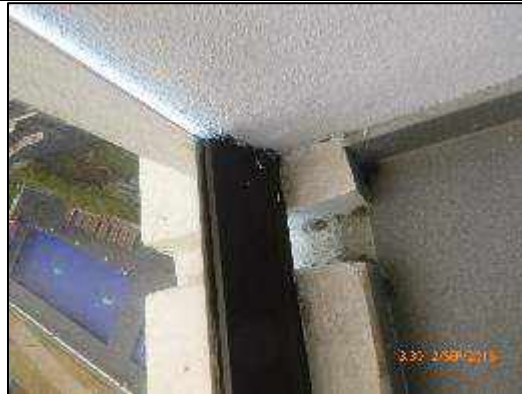
Item	Location	Defect description and Breach	Rectification	Photograph (if applicable)
1345	Balcony	See section 5.15.1	See section 5.15.2

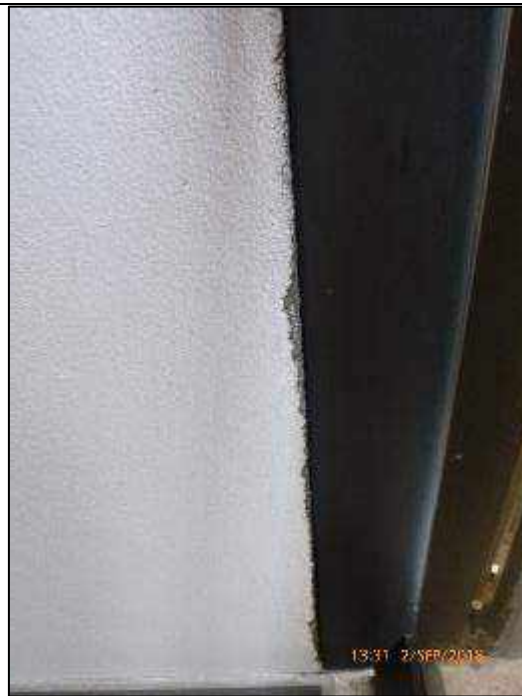
1346	Balcony	<p>Un-workmanship like finish to western blade wall adjacent to balustrade.</p> <p>Home Building Act (NSW) 1989</p> <ul style="list-style-type: none"> Part 2C, 18B (a) and (c). <p>Guide to Standards and Tolerances 2017</p> <p>10.16 Cracking at junctions of dissimilar materials-Cracking at junctions between dissimilar materials is a defect if it is greater than 1 mm or is visible from a normal viewing position.</p> <p>Loss Suffered</p> <p>Loss suffered is cost of rectification.</p>	<ol style="list-style-type: none"> 1. Protect all surrounding areas 2. Apply a bead of flexible sealant to the joint between the sliding door frame and wall 3. As required, all affected surfaces are to be painted with an appropriate paint system to match as close as possible to the existing in accordance with the manufacturer's recommendations and AS2311 – Guide to the painting of buildings. 4. Clean up the work area

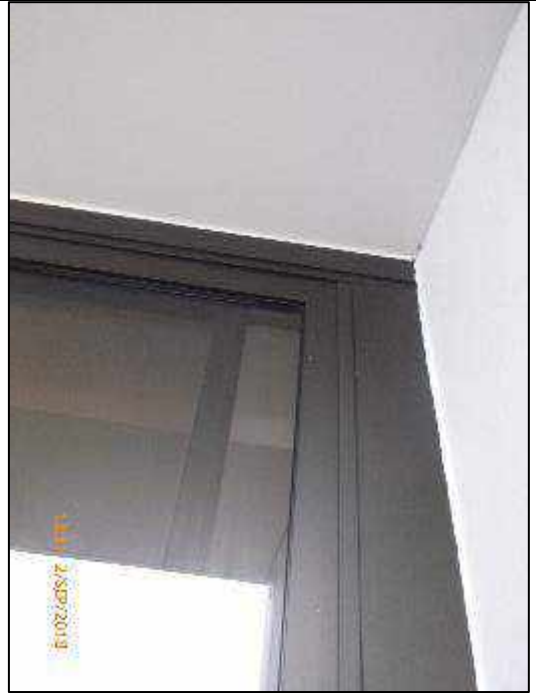
Item	Location	Defect description and Breach	Rectification	Photograph (if applicable)
1347	Balcony sliding door frame	See section 5.9.1	See section 5.9.2

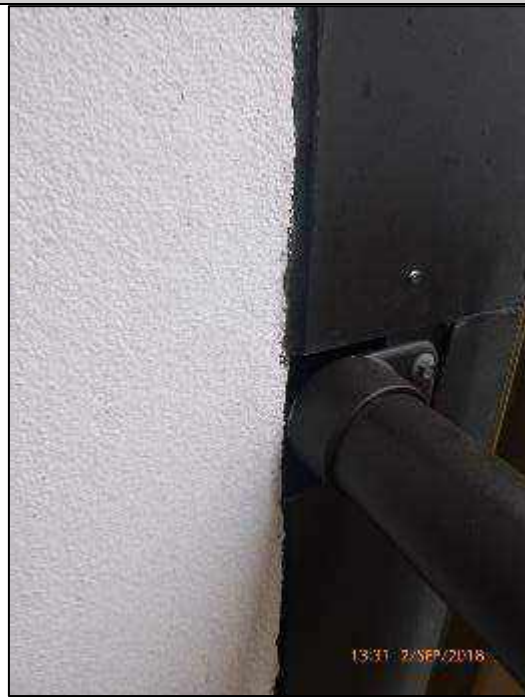
Item	Location	Defect description and Breach	Rectification	Photograph (if applicable)
1348	Balcony blade wall adjacent to balustrade	See section 5.9.1	See section 5.9.2

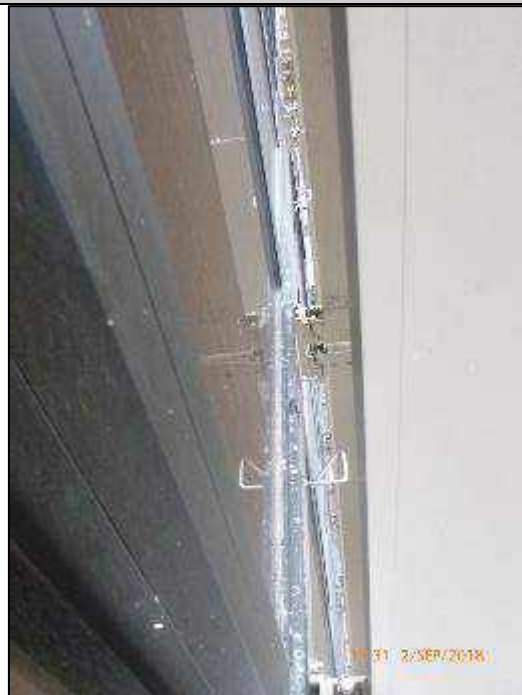
Item	Location	Defect description and Breach	Rectification	Photograph (if applicable)
1349	External façade adjacent to balcony area	<p>Construction debris observed on façade of building</p> <p>Home Building Act (NSW) 1989</p> <ul style="list-style-type: none"> Part 2C, 18B (a) and (c). <p>This is a breach of part (a) of the act because the surface has not been finished in a proper workmanlike manner that would prevent loss of appearance to the surface.</p> <p>Loss Suffered Loss suffered is cost of rectification.</p>	<ol style="list-style-type: none"> 1. Protect all adjoining surfaces. 2. Use a suitable cleaning agent to remove residue and clear debris. 3. Clean up the work area.

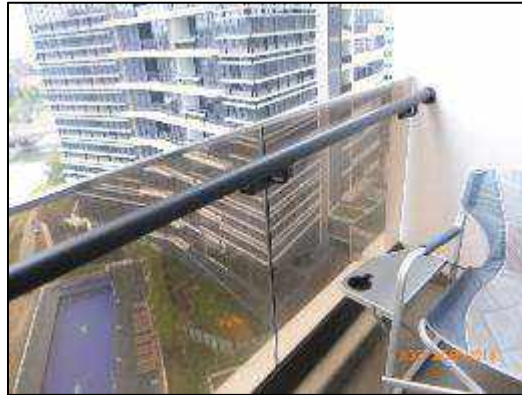
1350	Balcony	See section 5.4.1	See section 5.4.2

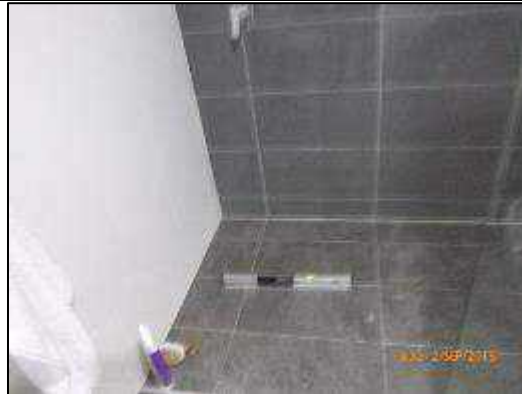
Item	Location	Defect description and Breach	Rectification	Photograph (if applicable)
1351	Main bathroom	See section 5.1.1 Falls (mm); 6/1000	See section 5.1.2

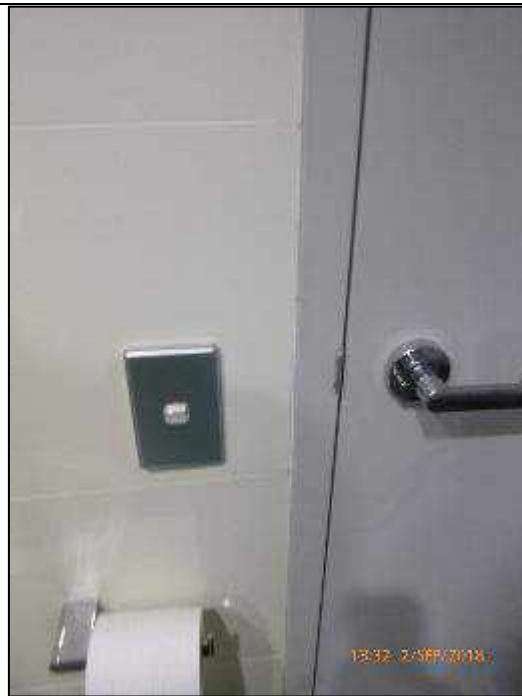
1352	Wall adjacent to main bathroom door	See section 5.9.1	See section 5.9.2

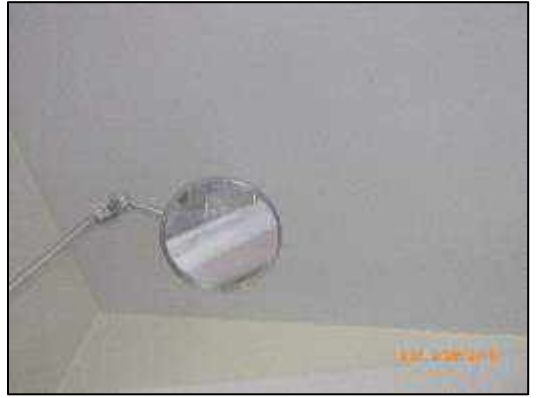
Item	Location	Defect description and Breach	Rectification	Photograph (if applicable)
1353	Doors throughout the unit (x3)	See section 5.5.1	See section 5.5.2

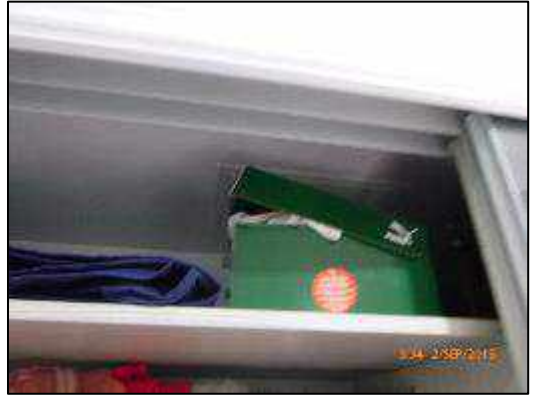
1354	Main bedroom built in	See section 5.6.1	See section 5.6.2

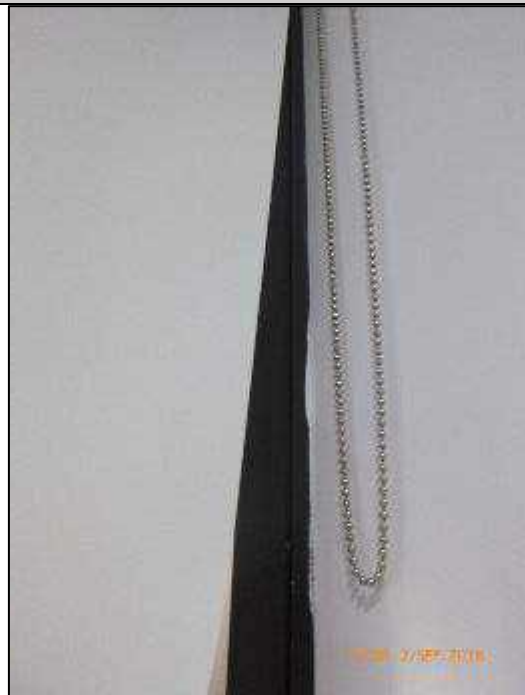
Item	Location	Defect description and Breach	Rectification	Photograph (if applicable)
1355	Main bedroom window frames	See section 5.9.1	See section 5.9.2

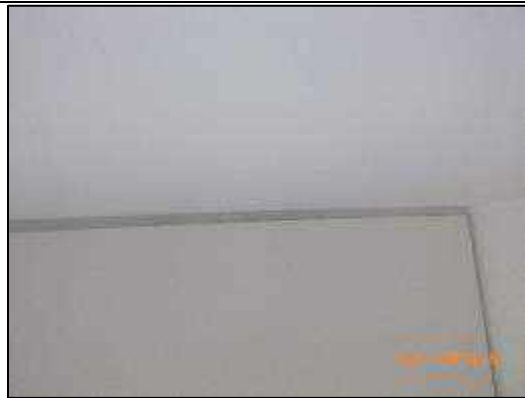
1356	Lounge room	See section 5.4.1	See section 5.4.2

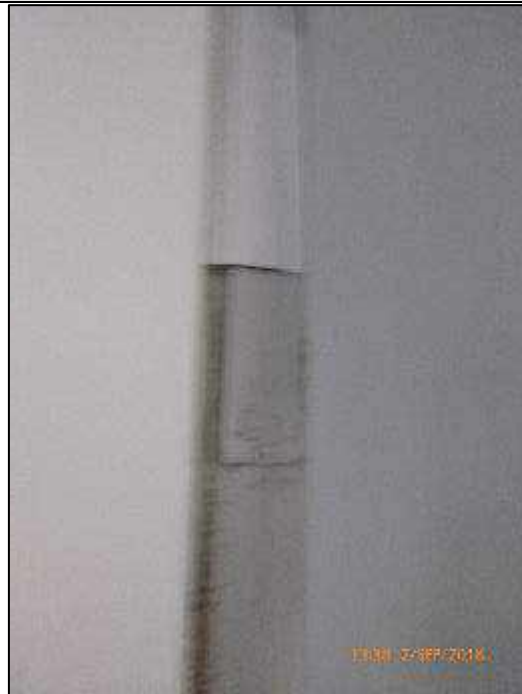
Item	Location	Defect description and Breach	Rectification	Photograph (if applicable)
Unit 1204				
1357		No access was provided.		
Unit 1205				
1358		No access was provided.		
Unit 1206				
1359	Front entry door	<p>Door frame label has been painted over.</p> <p>Home Building Act (NSW) 1989</p> <ul style="list-style-type: none"> Part 2C, 18B (a) & (c). <p>Loss Suffered</p> <p>Loss suffered is cost of rectification.</p>	Use a suitable cleaning agent to remove paint from the door frame label.

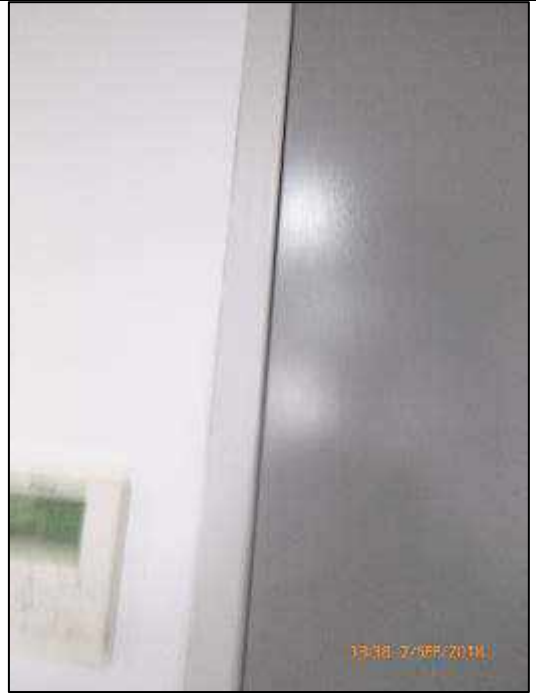
Item	Location	Defect description and Breach	Rectification	Photograph (if applicable)
1360	Wall adjacent to front entry door	See section 5.13.1	See section 5.13.2

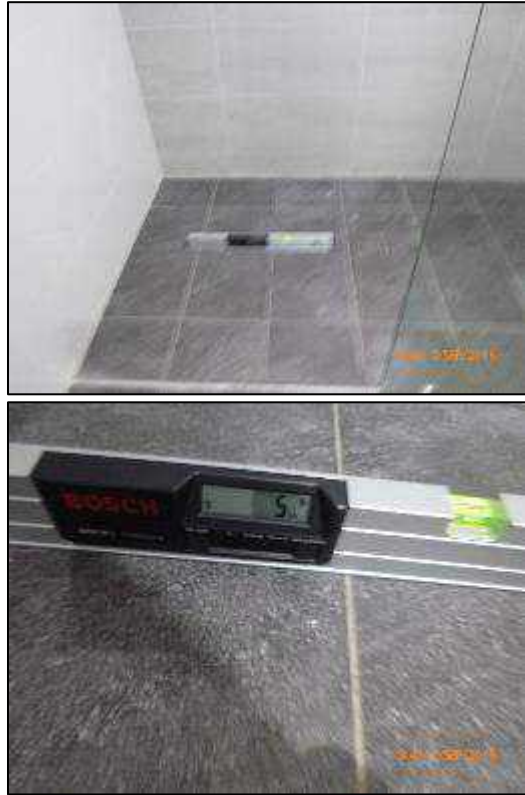
Item	Location	Defect description and Breach	Rectification	Photograph (if applicable)
1363	Main bedroom ensuite	See section 5.1.1 Falls (mm); 5/1000	See section 5.1.2

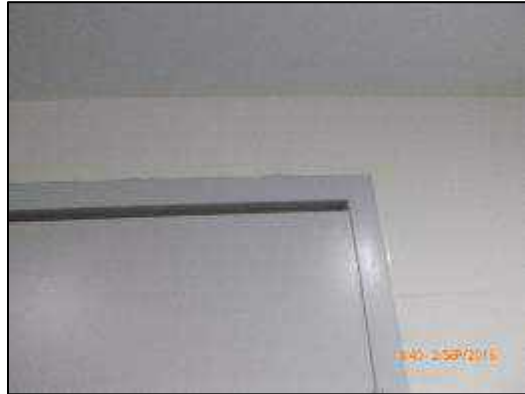
Item	Location	Defect description and Breach	Rectification	Photograph (if applicable)
1364	Wall adjacent to ensuite door	See section 5.9.1	See section 5.9.2

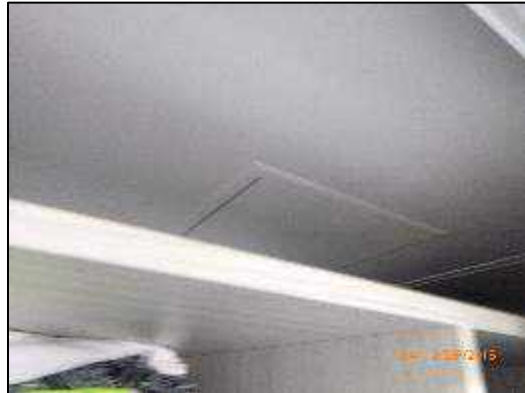
A photograph showing a close-up of a wall corner or door frame area. There is a visible gap or defect in the wall material. A date stamp '13/01/2015' is visible in the bottom right corner of the photo.
1365	Main bedroom built in	See section 5.6.1	See section 5.6.2

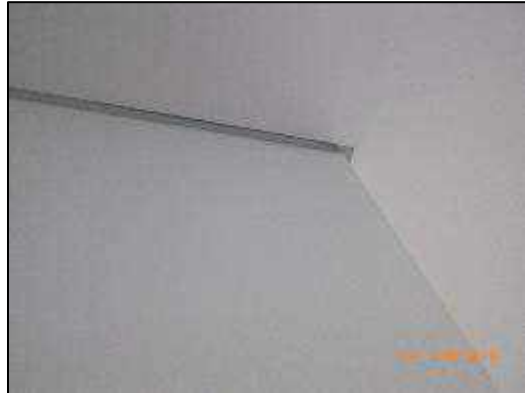
Item	Location	Defect description and Breach	Rectification	Photograph (if applicable)
1366	Main bedroom	See section 5.11.1	See section 5.11.2

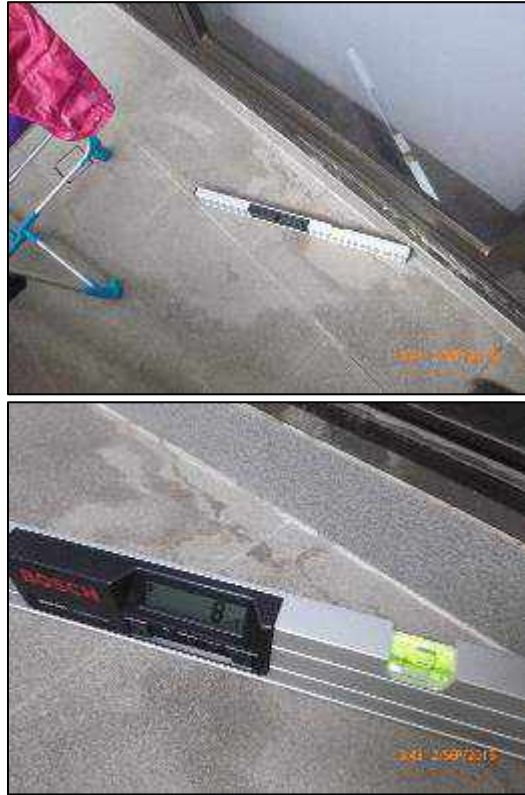
Item	Location	Defect description and Breach	Rectification	Photograph (if applicable)
1367	Balcony	See section 5.2.1 Falls (mm); 8/1000	See section 5.2.2

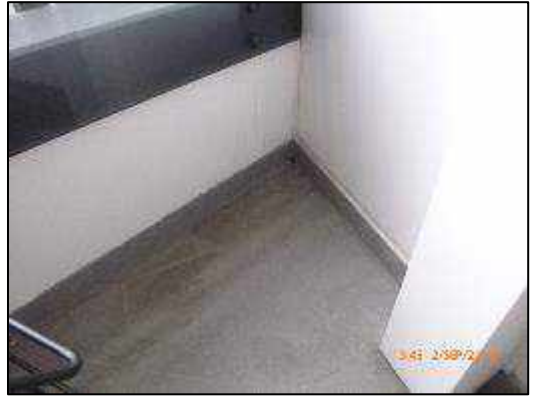
Item	Location	Defect description and Breach	Rectification	Photograph (if applicable)
1368	Balcony	See section 5.3.1	See section 5.3.2

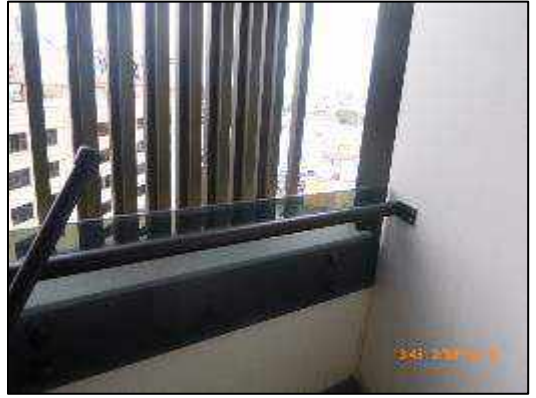
1369	Balcony	See section 5.4.1	See section 5.4.2

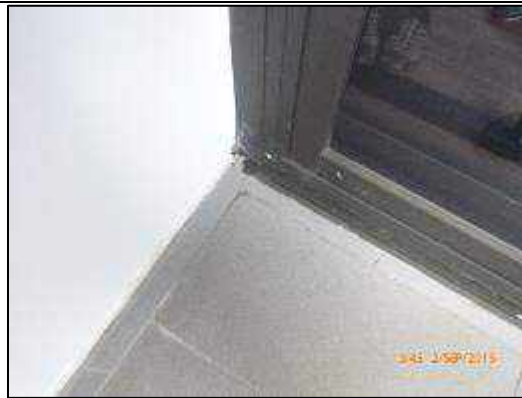
Item	Location	Defect description and Breach	Rectification	Photograph (if applicable)
1370	Balcony sliding door frame	See section 5.7.1	See section 5.7.2	  A photograph showing a close-up of a balcony sliding door frame. The frame is made of a light-colored material, possibly wood or composite. The glass pane is visible, showing a view of a city street with buildings and a cloudy sky. There is a small orange timestamp in the bottom right corner of the photo.
1371	Balcony sliding door frame	See section 5.9.1	See section 5.9.2

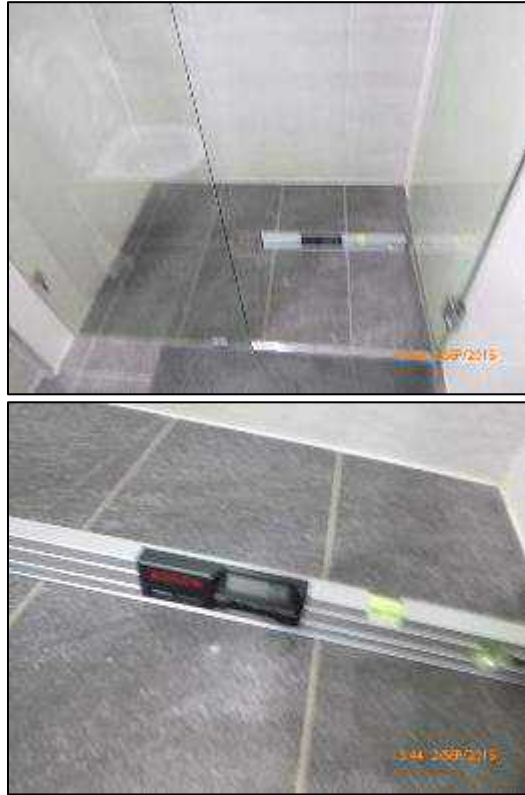
Item	Location	Defect description and Breach	Rectification	Photograph (if applicable)
1372	Main bathroom	See section 5.1.1 Falls (mm); 0/1000	See section 5.1.2

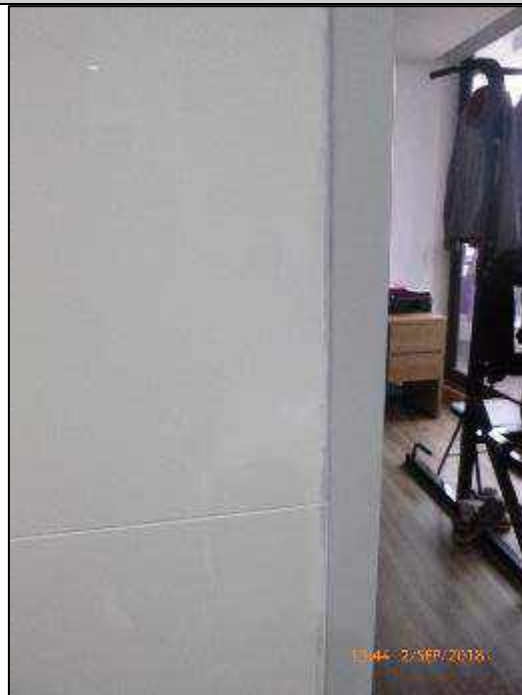
Item	Location	Defect description and Breach	Rectification	Photograph (if applicable)
1373	Wall adjacent to main bathroom door	See section 5.9.1	See section 5.9.2

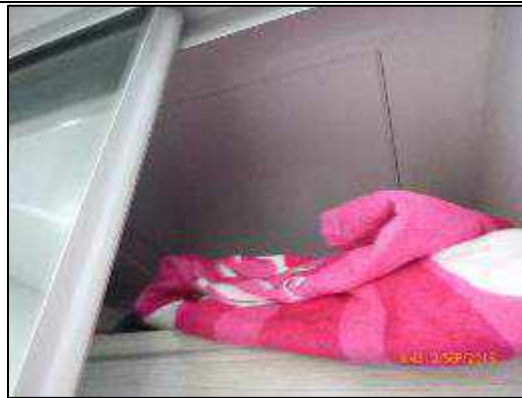
1374	Main bedroom built in	See section 5.6.1	See section 5.6.2

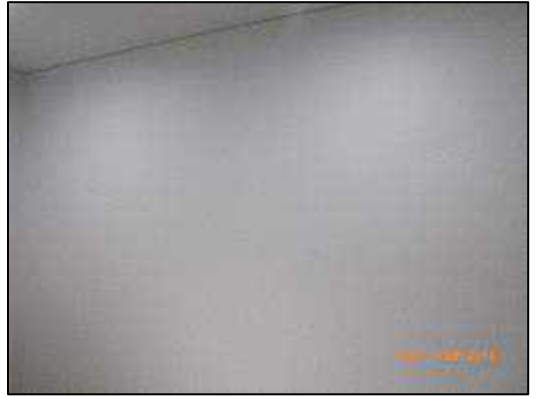
Item	Location	Defect description and Breach	Rectification	Photograph (if applicable)
1375	Lounge room northern wall	See section 5.10.1	See section 5.10.2

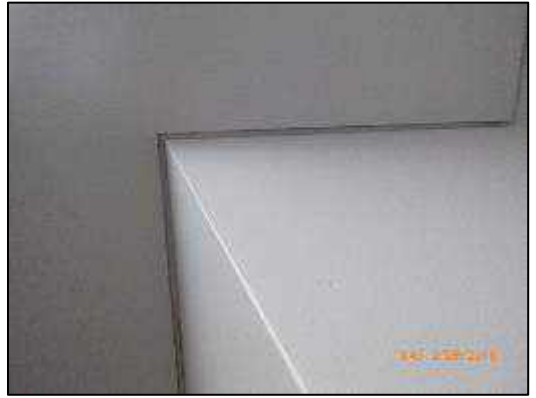
1376	Lounge room	See section 5.11.1	See section 5.11.2

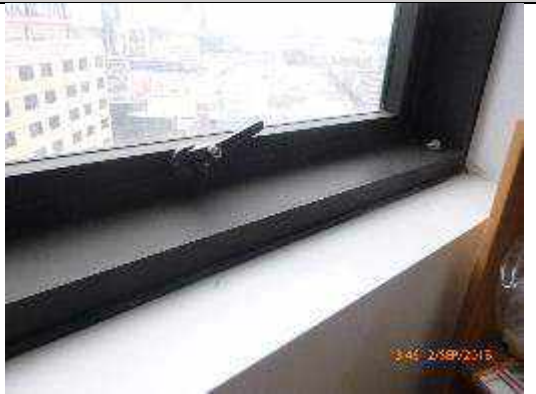
Item	Location	Defect description and Breach	Rectification	Photograph (if applicable)
1377	Second bedroom window frames	See section 5.9.1	See section 5.9.2

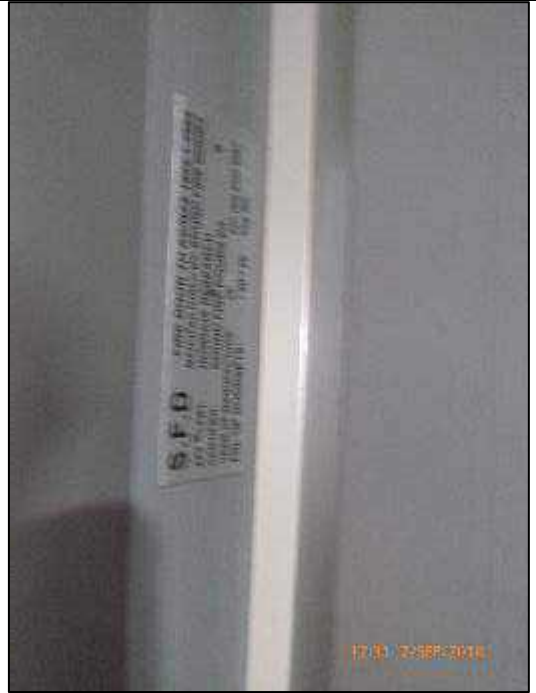
Item	Location	Defect description and Breach	Rectification	Photograph (if applicable)
Unit 1207				
1378	Front entry door	See section 5.12.1	See section 5.12.2

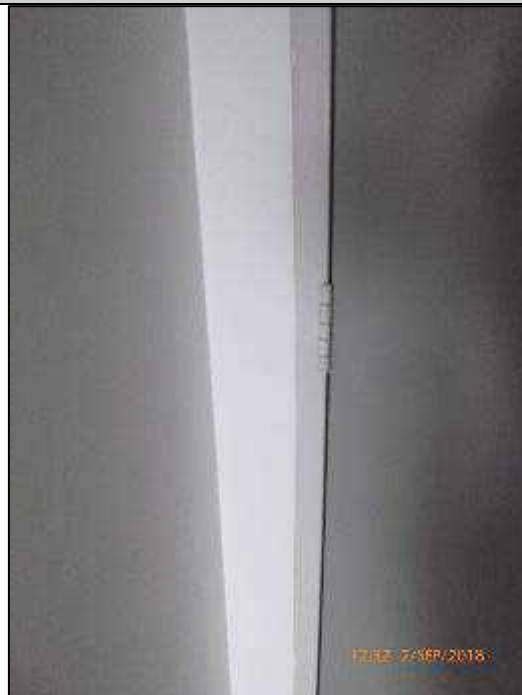
Item	Location	Defect description and Breach	Rectification	Photograph (if applicable)
1379	Wall adjacent to front entry door	See section 5.13.1	See section 5.13.2

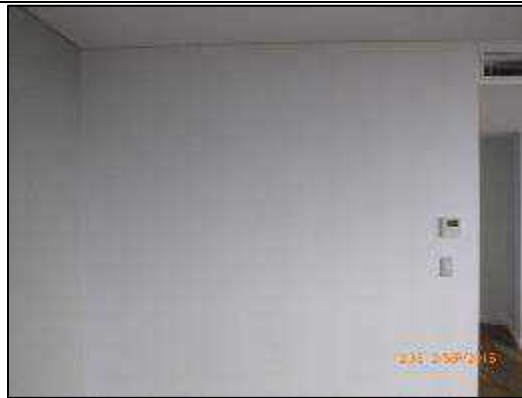
A close-up photograph of a vertical crack in a light-colored wall. The crack is dark and runs vertically. A timestamp '12/02/2018 11:18' is visible in the bottom right corner.
1380	Lounge room northern wall	See section 5.10.1	See section 5.10.2

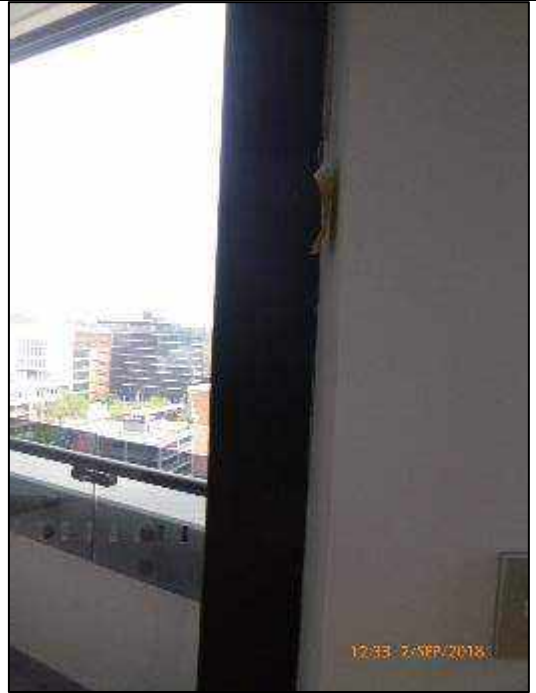
Item	Location	Defect description and Breach	Rectification	Photograph (if applicable)
1381	Lounge room sliding door frame	See section 5.9.1	See section 5.9.2

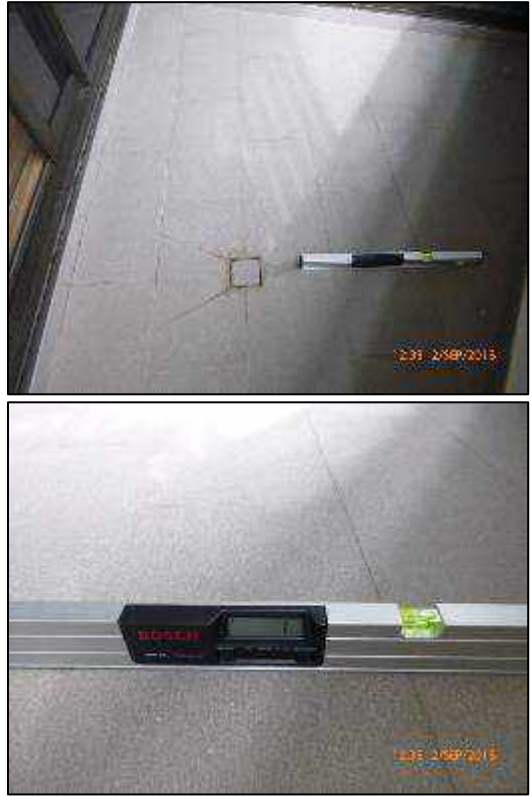
Item	Location	Defect description and Breach	Rectification	Photograph (if applicable)
1382	Balcony	See section 5.2.1 Falls (mm); 1/1000	See section 5.2.2

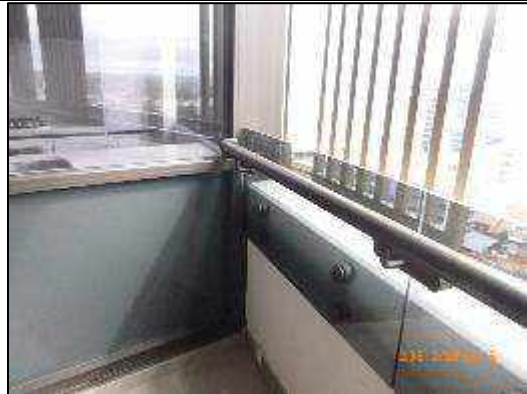
Item	Location	Defect description and Breach	Rectification	Photograph (if applicable)
1383	Balcony	See section 5.4.1	See section 5.4.2

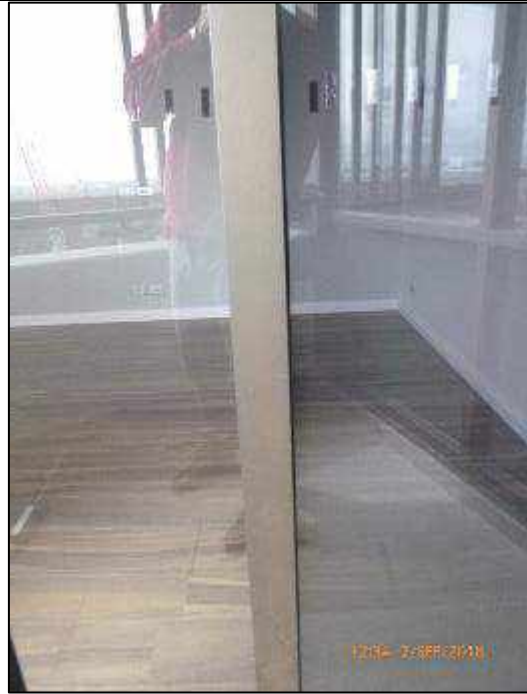
1384	Balcony sliding door frame	See section 5.7.1	See section 5.7.2

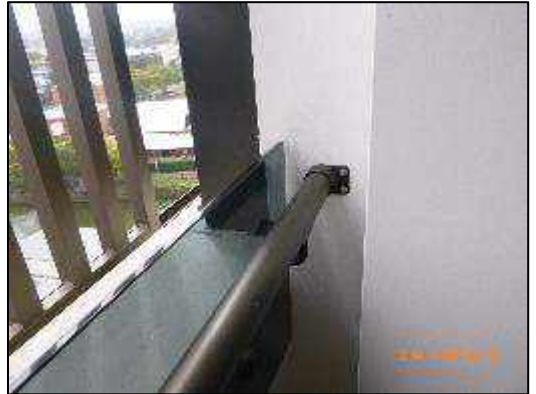
Item	Location	Defect description and Breach	Rectification	Photograph (if applicable)
1385	Balcony balustrade rail	See section 5.9.1	See section 5.9.2

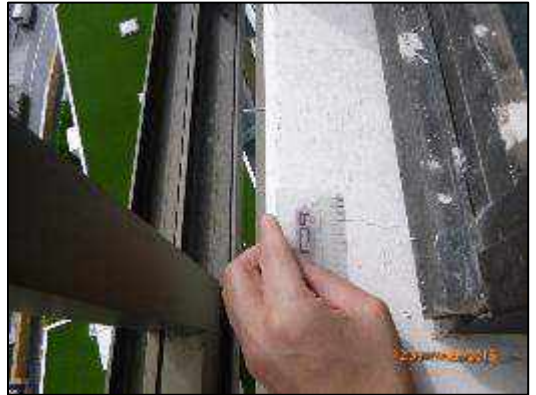
1386	Façade adjacent to balustrade on south western corner	See section 5.14.1 Separation; 1mm	See section 5.14.2

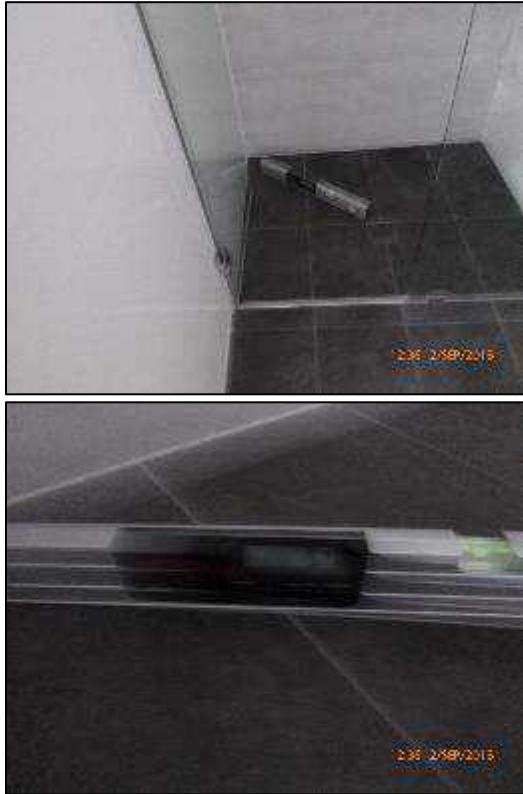
Item	Location	Defect description and Breach	Rectification	Photograph (if applicable)
1387	Main bathroom	See section 5.1.1 Falls (mm); 9/1000	See section 5.1.2

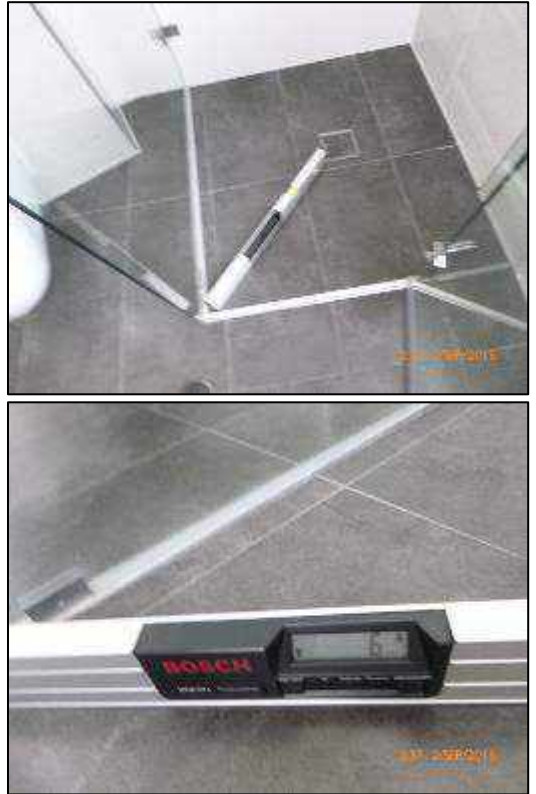
Item	Location	Defect description and Breach	Rectification	Photograph (if applicable)
1388	Main bedroom ensuite	See section 5.1.1 Falls (mm); 6/1000	See section 5.1.2

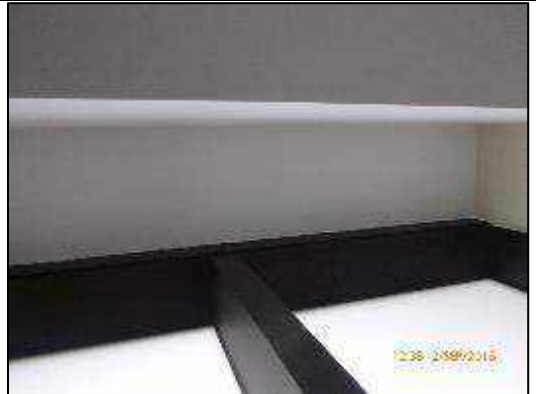
Item	Location	Defect description and Breach	Rectification	Photograph (if applicable)
1389	Main bedroom ensuite ceiling adjacent to window	See section 5.13.1	See section 5.13.2

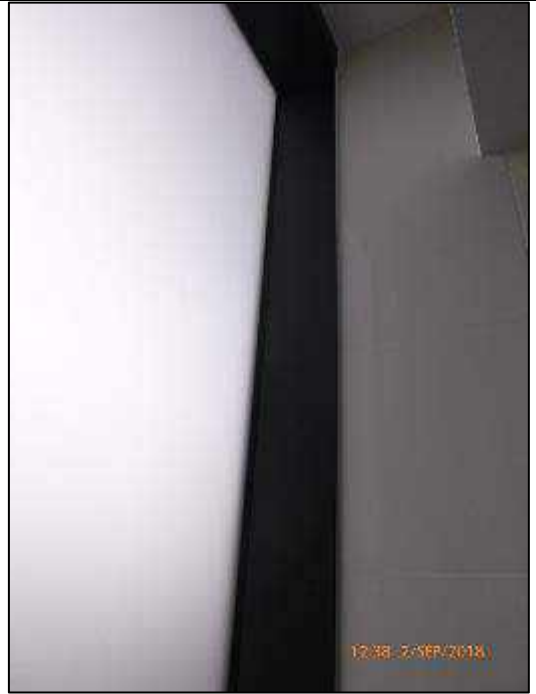
1390	Main bedroom ensuite window frame	See section 5.9.1	See section 5.9.2

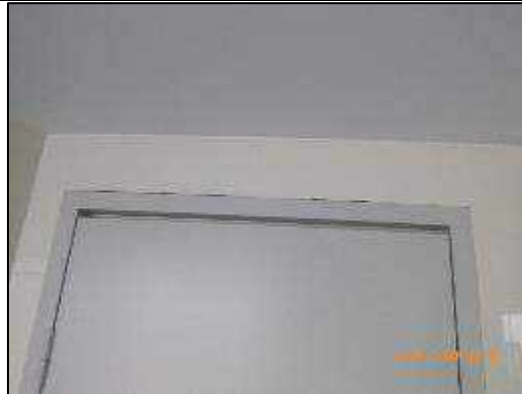
Item	Location	Defect description and Breach	Rectification	Photograph (if applicable)
1391	Main bedroom ensuite	<p>Missing sealant observed around main bedroom ensuite door frame.</p> <p>Home Building Act (NSW) 1989</p> <ul style="list-style-type: none"> Part 2C, 18B (a) and (c). <p>Loss Suffered</p> <p>Loss suffered is cost of rectification.</p>	<ol style="list-style-type: none"> 1. Protect all adjoining surfaces. 2. Apply a bead of flexible sealant to the joint between the door frame and wall 3. As required, all affected surfaces are to be painted with an appropriate paint system to match as close as possible to the existing in accordance with the manufacturer's recommendations and AS2311 – Guide to the painting of buildings. 4. Clean up the work area

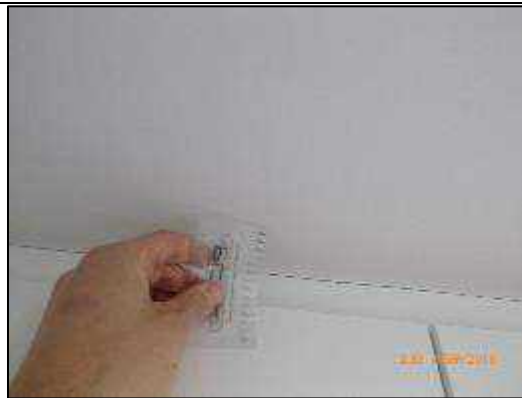
1392	Ceiling above kitchen cupboards	<p>See section 5.14.1</p> <p>Separation; 1.5mm</p>	See section 5.14.2

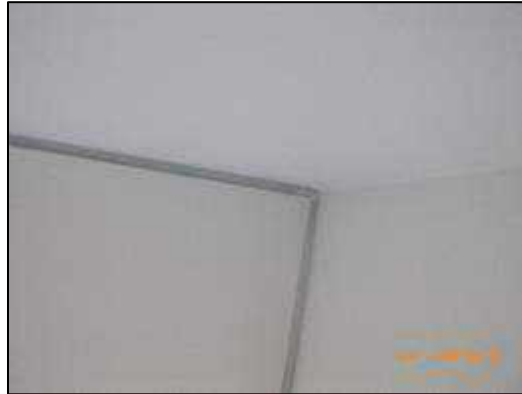
Item	Location	Defect description and Breach	Rectification	Photograph (if applicable)
1395	Main bedroom	See section 5.11.1	See section 5.11.2

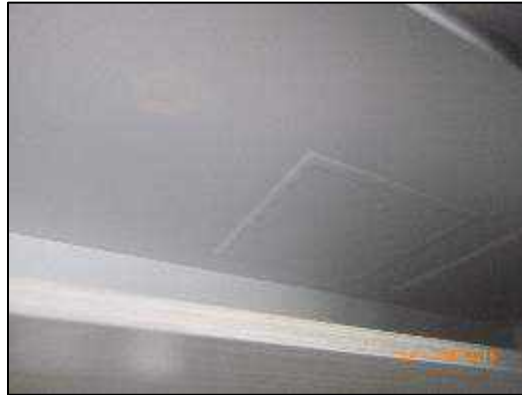
1396	Second bedroom built in	See section 5.6.1	See section 5.6.2

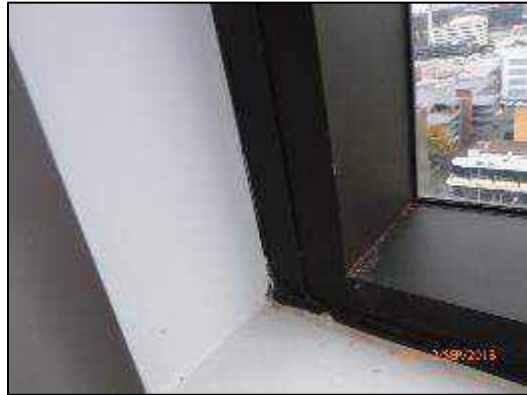
1398	Second bedroom window frames	See section 5.9.1	See section 5.9.2

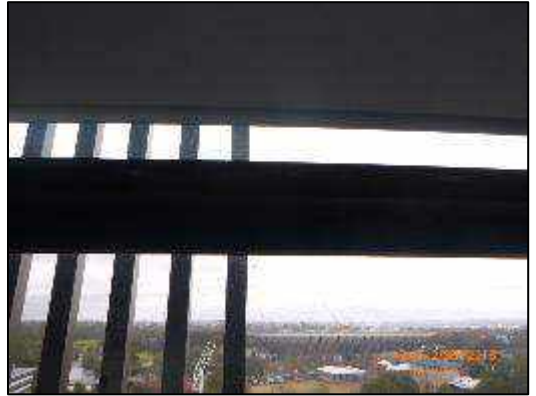
Item	Location	Defect description and Breach	Rectification	Photograph (if applicable)
1399	Second bedroom window frames	See section 5.8.1	See section 5.8.2

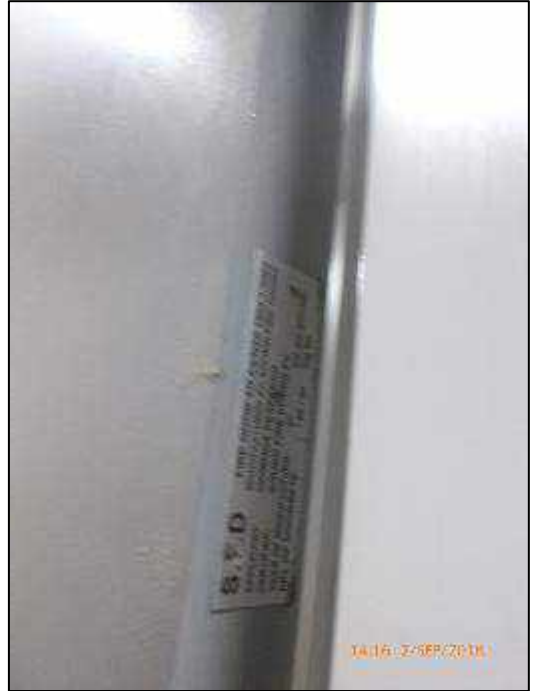
Item	Location	Defect description and Breach	Rectification	Photograph (if applicable)
Unit 1208				
1400	Front entry door	See section 5.12.1	See section 5.12.2

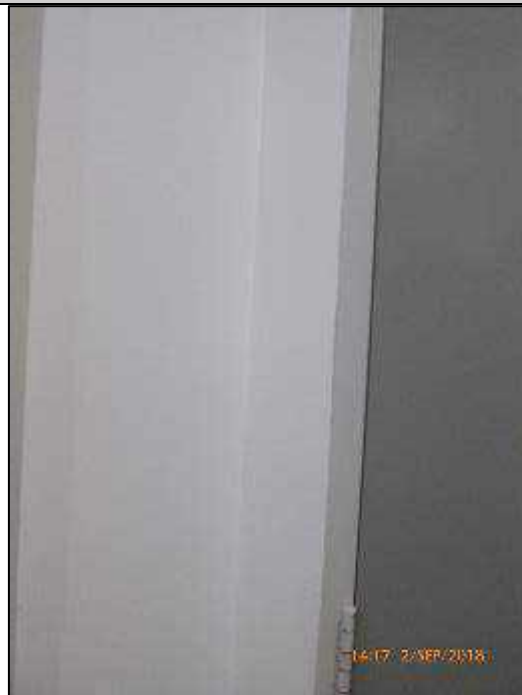
Item	Location	Defect description and Breach	Rectification	Photograph (if applicable)
1401	Wall adjacent to front entry door	See section 5.10.1	See section 5.10.2

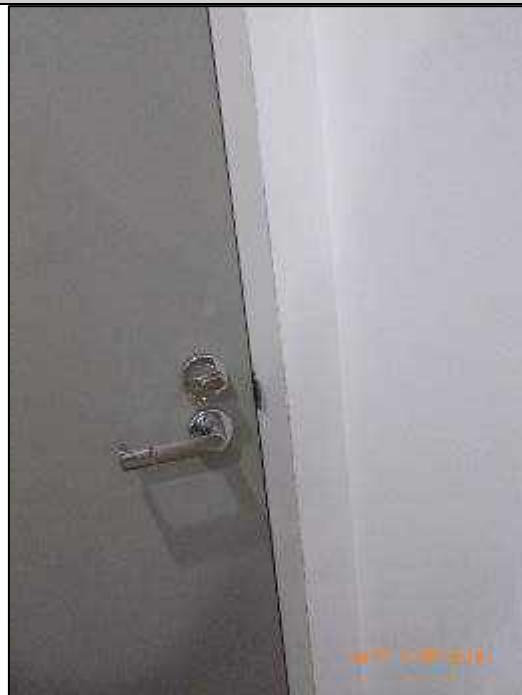
Item	Location	Defect description and Breach	Rectification	Photograph (if applicable)
1402	Wall adjacent to front entry door	See section 5.13.1	See section 5.13.2

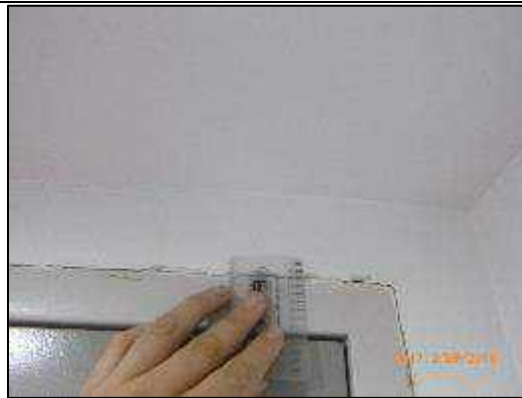
1403	Wall above front entry door frame	See section 5.14.1 Separation; 2mm	See section 5.14.2

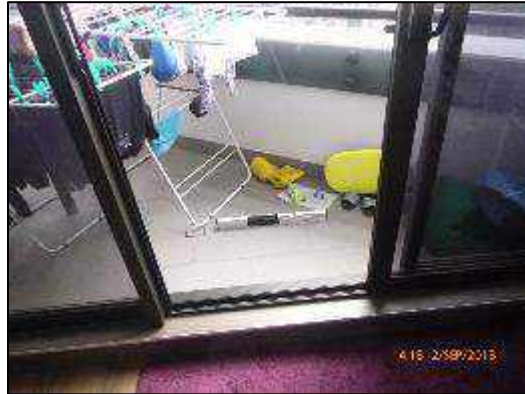
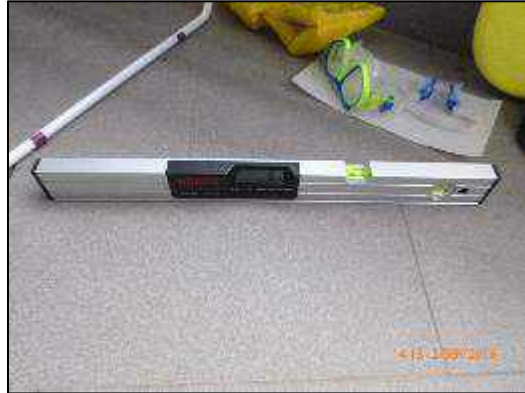
Item	Location	Defect description and Breach	Rectification	Photograph (if applicable)
1404	Balcony	See section 5.1.1 Falls (mm); 6/1000	See section 5.1.2

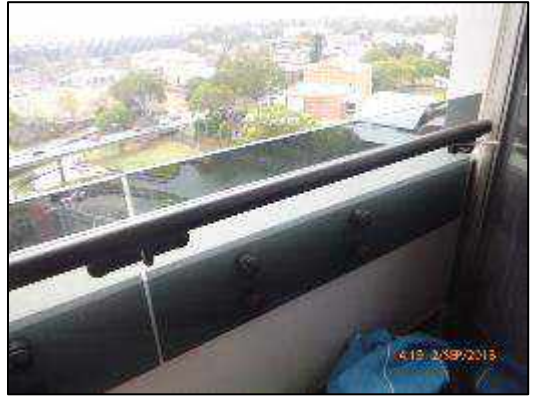
Item	Location	Defect description and Breach	Rectification	Photograph (if applicable)
1405	Balcony	See section 5.4.1	See section 5.4.2

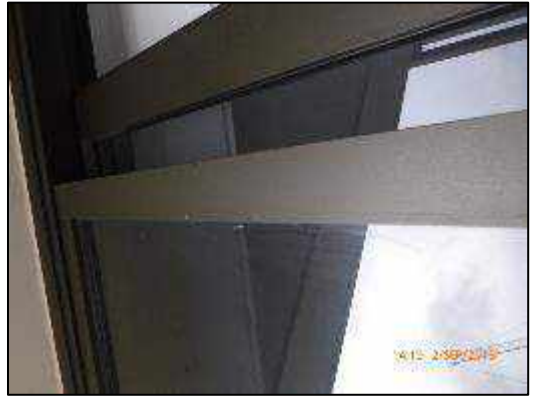
A photograph showing a balcony railing and a view of a residential area with houses and trees. A date stamp '4/15/2015' is visible in the bottom right corner.
1406	Balcony sliding door frame	See section 5.9.1	See section 5.9.2

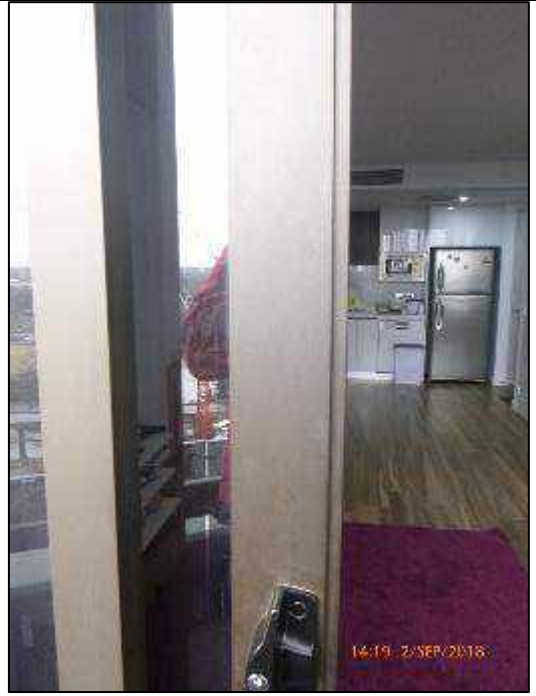
Item	Location	Defect description and Breach	Rectification	Photograph (if applicable)
1407	Balcony sliding door frame	See section 5.7.1	See section 5.7.2

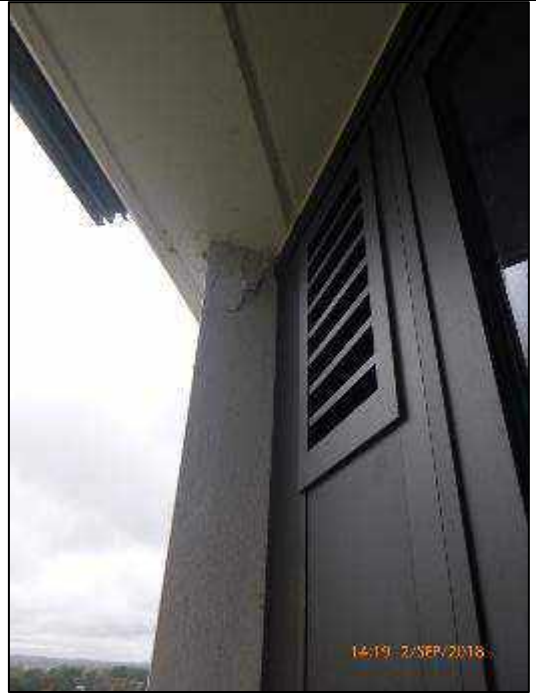
Item	Location	Defect description and Breach	Rectification	Photograph (if applicable)
1408	Western column of balcony	See section 5.15.1 Separation; 2mm	See section 5.15.2

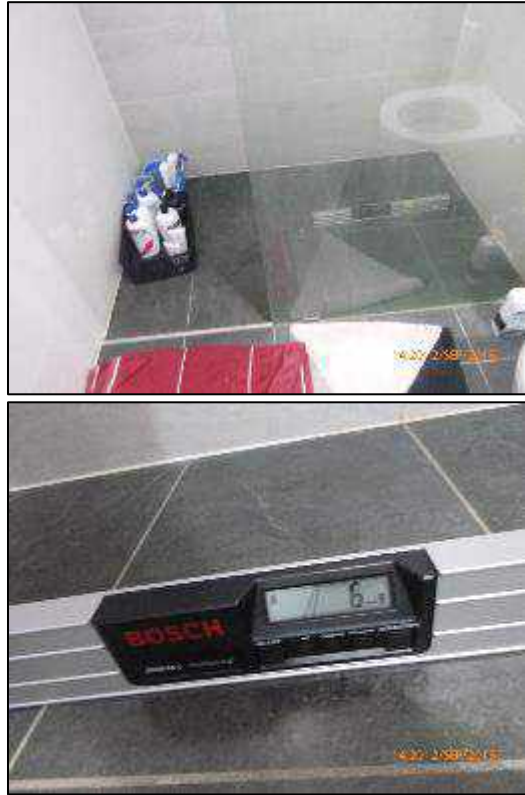
Item	Location	Defect description and Breach	Rectification	Photograph (if applicable)
1409	Main bathroom	See section 5.1.1 Falls (mm); 6/1000	See section 5.1.2

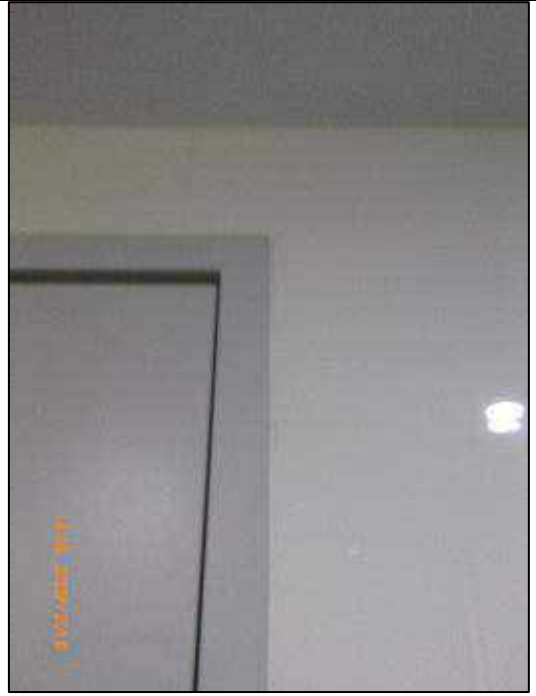
Item	Location	Defect description and Breach	Rectification	Photograph (if applicable)
1410	Wall adjacent to main bathroom door	See section 5.9.1	See section 5.9.2

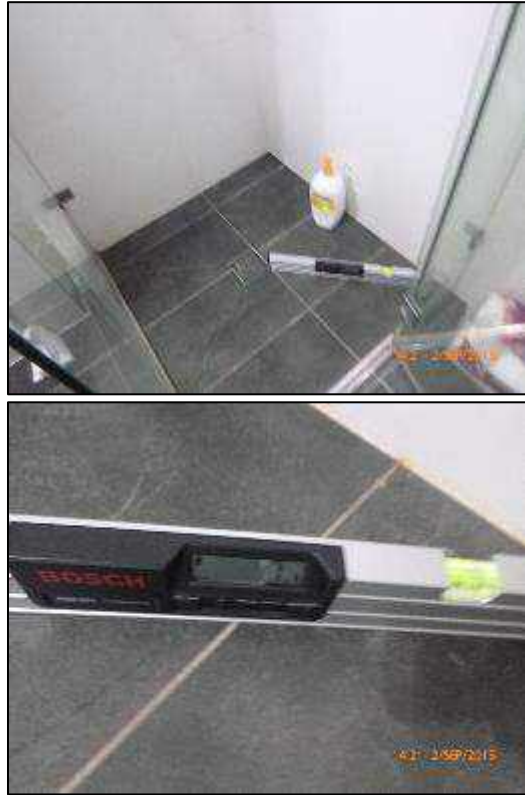
Item	Location	Defect description and Breach	Rectification	Photograph (if applicable)
1411	Main bedroom ensuite	See section 5.1.1 Falls (mm); 7/1000	See section 5.1.2

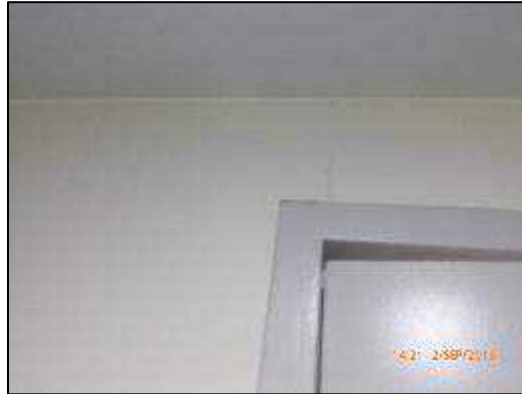
Item	Location	Defect description and Breach	Rectification	Photograph (if applicable)
1412	Wall adjacent to ensuite door	See section 5.9.1	See section 5.9.2

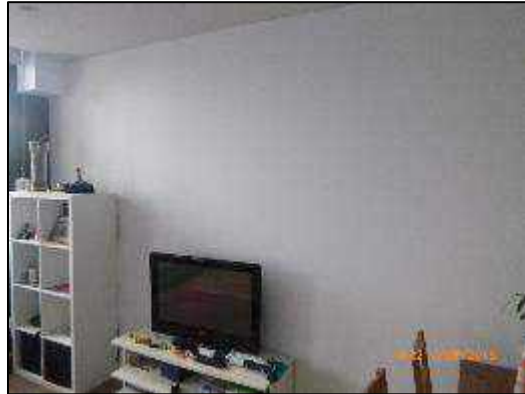
Item	Location	Defect description and Breach	Rectification	Photograph (if applicable)
1414	Lounge room eastern wall	See section 5.10.1	See section 5.10.2

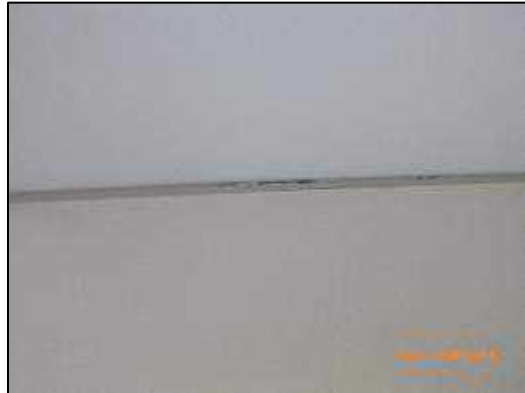
1415	Lounge room	See section 5.11.1	See section 5.11.2

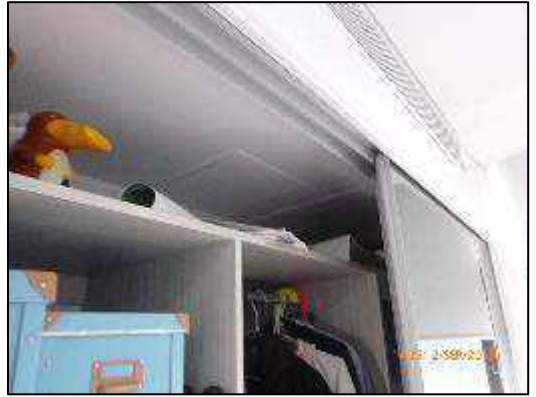
Item	Location	Defect description and Breach	Rectification	Photograph (if applicable)
1416	Main bedroom built in	See section 5.6.1	See section 5.6.2

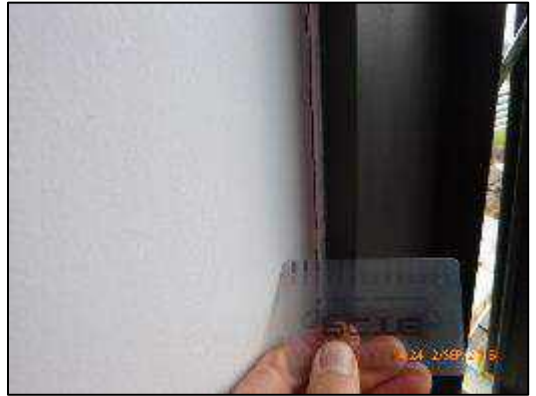
1417	Main bedroom window frame	See section 5.14.1 Separation; 1.5mm	See section 5.14.2

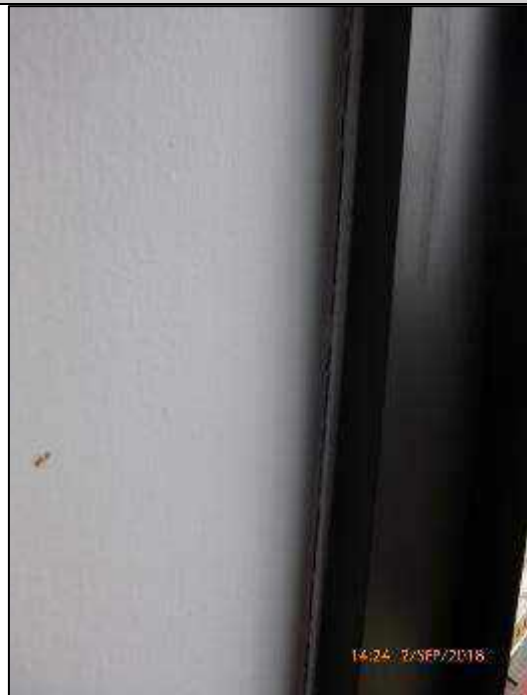
Item	Location	Defect description and Breach	Rectification	Photograph (if applicable)
1418	Main bedroom window frames	See section 5.9.1	See section 5.9.2

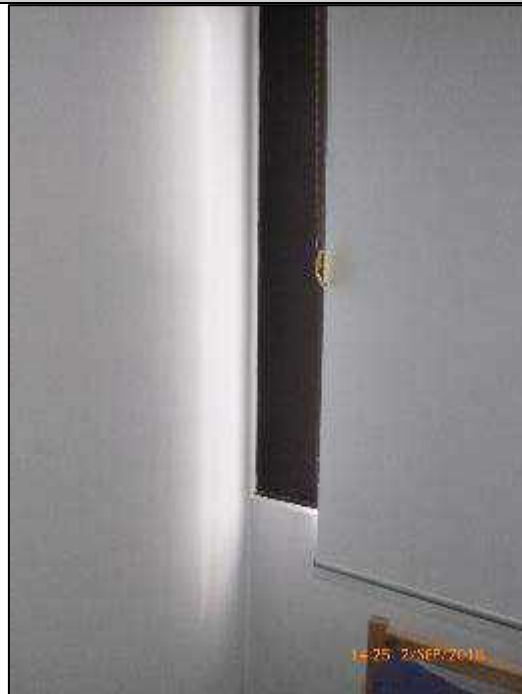
Item	Location	Defect description and Breach	Rectification	Photograph (if applicable)
1420	Second bedroom window frames	See section 5.9.1	See section 5.9.2
