SydneyStrataReport

STRATA REPORT

Client	Church Street Parramatta Property Pty Ltd
Address of property	Unit 3303/330 Church Street, Parramatta, NSW.
Lot	359
Strata Plan	SP 94469
Name of Strata Management Co.	NSW Strata
Telephone Number of Strata Agent	8980 1841
Report Date	15 February 2024

BUILDING DEFECTS REPORT Part 1/2

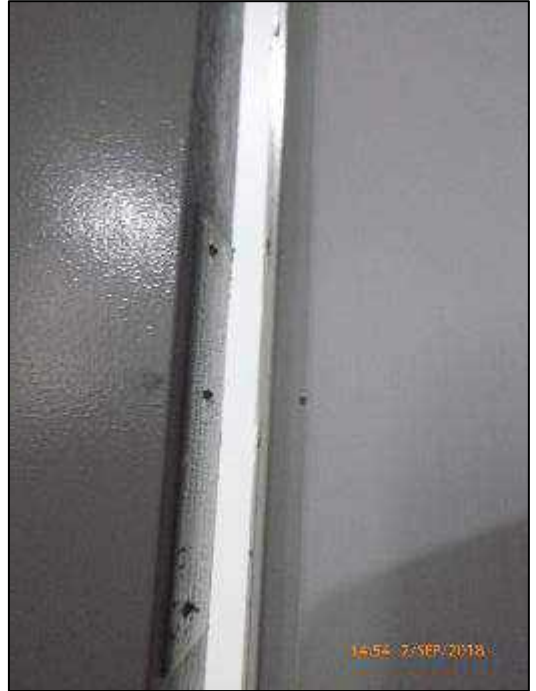
Item	Location	Defect description and Breach	Rectification	Photograph (if applicable)
Unit 1302				
1422	Front entry door	See section 5.12.1	See section 5.12.2

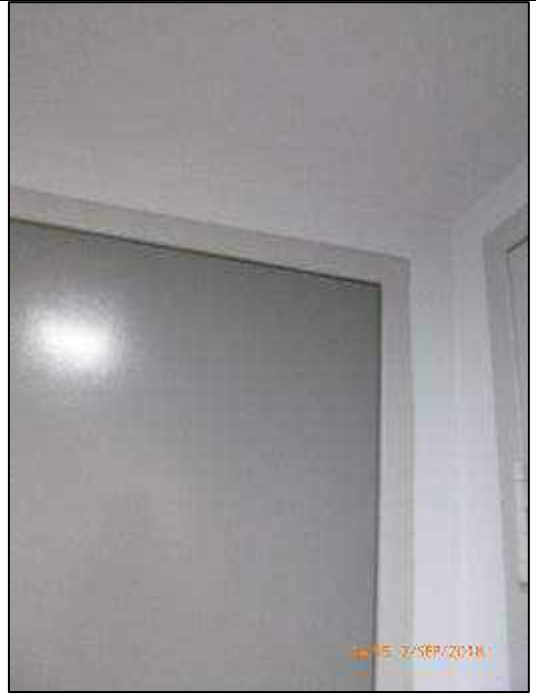
Item	Location	Defect description and Breach	Rectification	Photograph (if applicable)
1423	Wall adjacent to front entry door	See section 5.10.1	See section 5.10.2

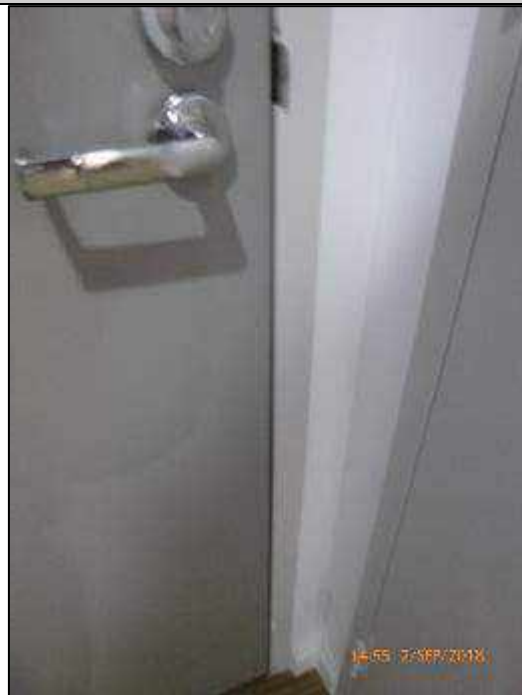
Item	Location	Defect description and Breach	Rectification	Photograph (if applicable)
1424	Wall adjacent to front entry door	See section 5.13.1	See section 5.13.2

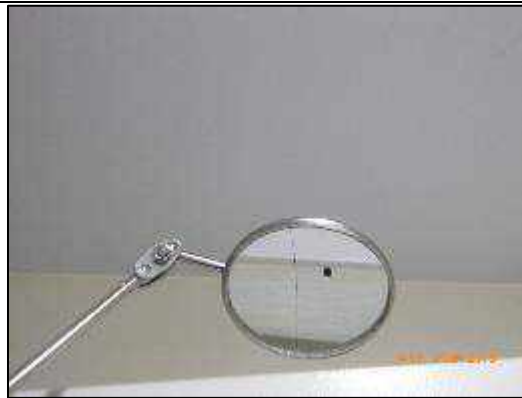
1425	Doors throughout the unit (x3)	See section 5.5.1	See section 5.5.2

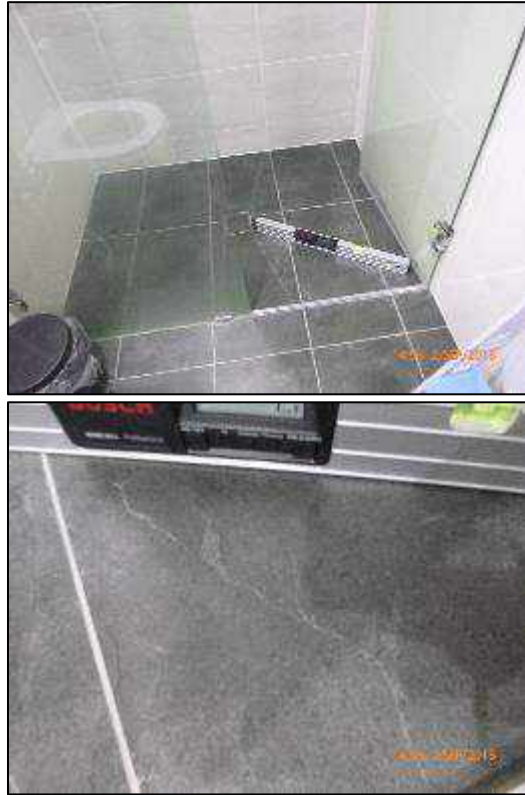
Item	Location	Defect description and Breach	Rectification	Photograph (if applicable)
1426	Main bathroom	See section 5.1.1 Falls (mm); 1/1000	See section 5.1.2

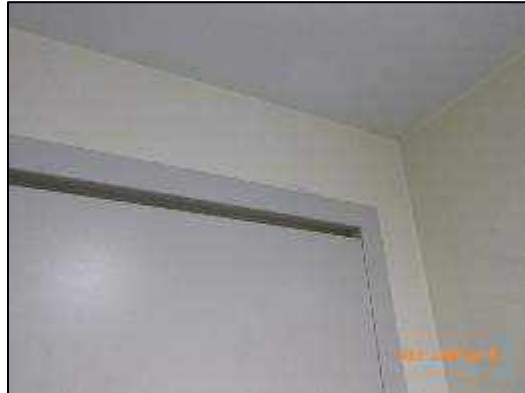
Item	Location	Defect description and Breach	Rectification	Photograph (if applicable)
1427	Wall adjacent to bathroom door	See section 5.9.1	See section 5.9.2

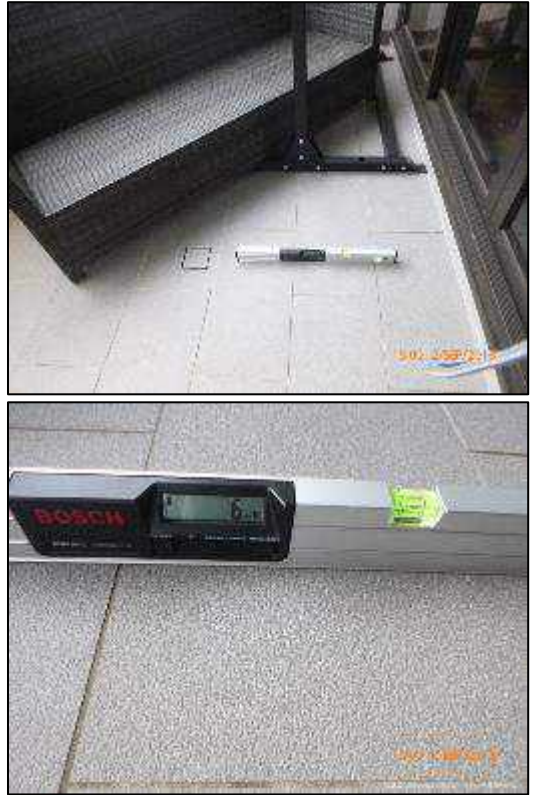
Item	Location	Defect description and Breach	Rectification	Photograph (if applicable)
1428	Balcony	See section 5.2.1 Falls (mm); 6/1000	See section 5.2.2

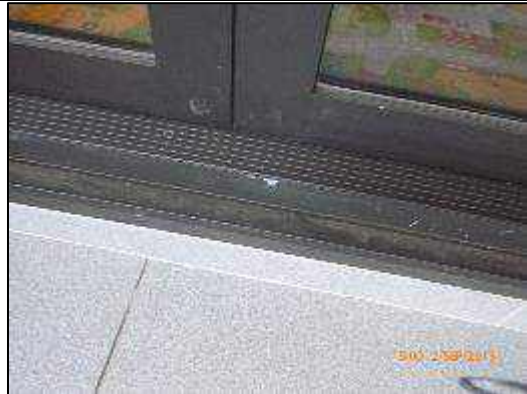
Item	Location	Defect description and Breach	Rectification	Photograph (if applicable)
1429	Balcony sliding door frame	See section 5.9.1	See section 5.9.2

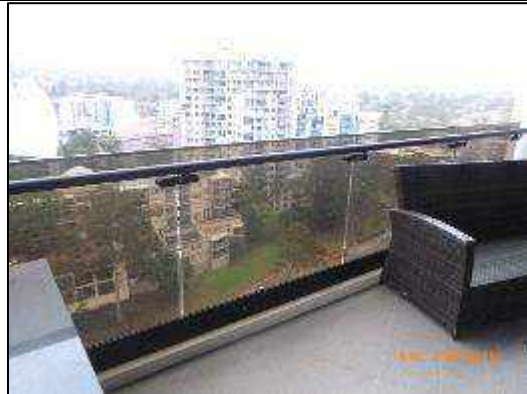
Item	Location	Defect description and Breach	Rectification	Photograph (if applicable)
1431	Balcony	See section 5.4.1	See section 5.4.2

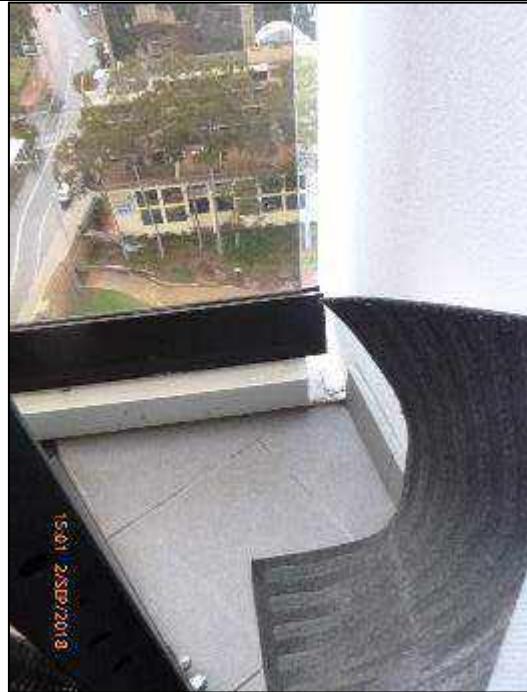
1432	Balcony	See section 5.15.1	See section 5.15.2

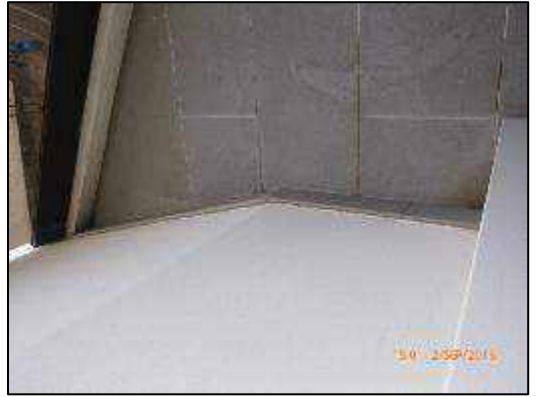
Item	Location	Defect description and Breach	Rectification	Photograph (if applicable)
1433	Balcony tile skirting	See section 5.14.1 Separation; 2mm	See section 5.14.2

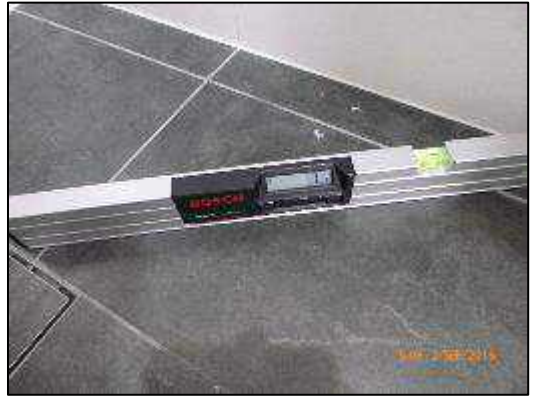
1434	Main bedroom ensuite	See section 5.1.1 Falls (mm); 7/1000	See section 5.1.2

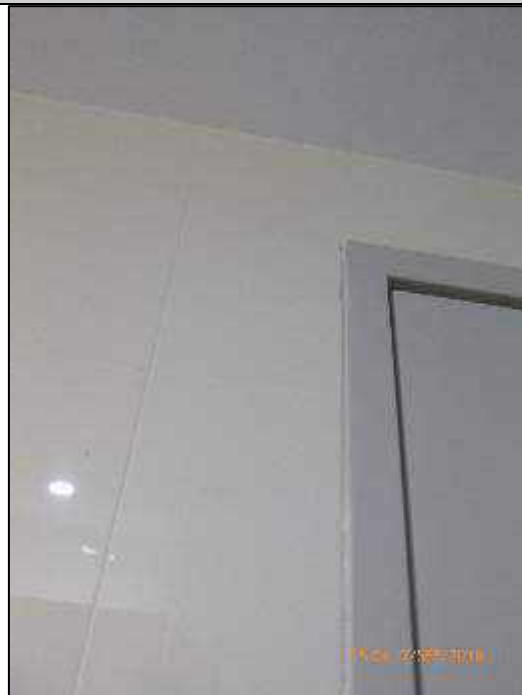
Item	Location	Defect description and Breach	Rectification	Photograph (if applicable)
1435	Wall adjacent to ensuite door	See section 5.9.1	See section 5.9.2

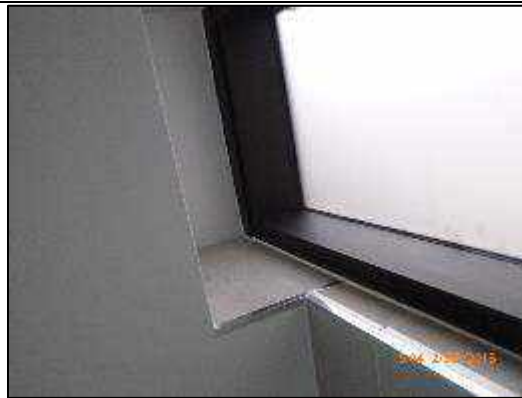
1436	Main bedroom ensuite window frames	See section 5.9.1	See section 5.9.2

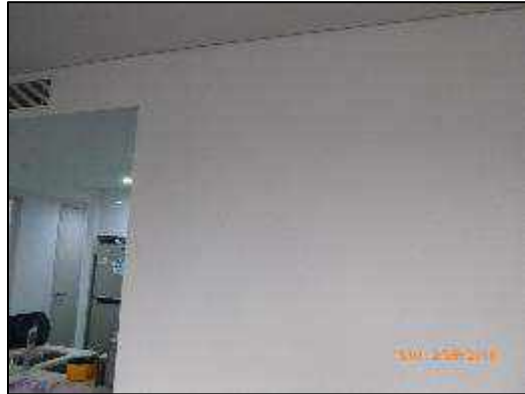
Item	Location	Defect description and Breach	Rectification	Photograph (if applicable)
1437	Lounge room northern wall	See section 5.10.1	See section 5.10.2

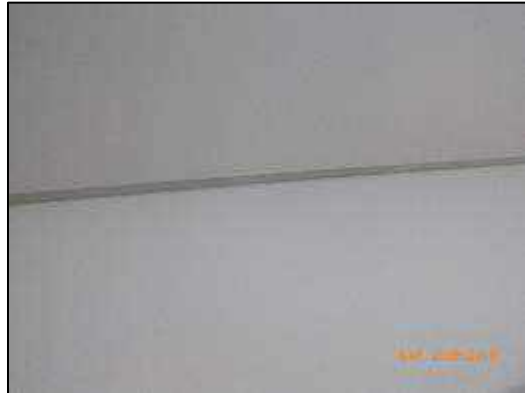
1438	Lounge room	See section 5.11.1	See section 5.11.2

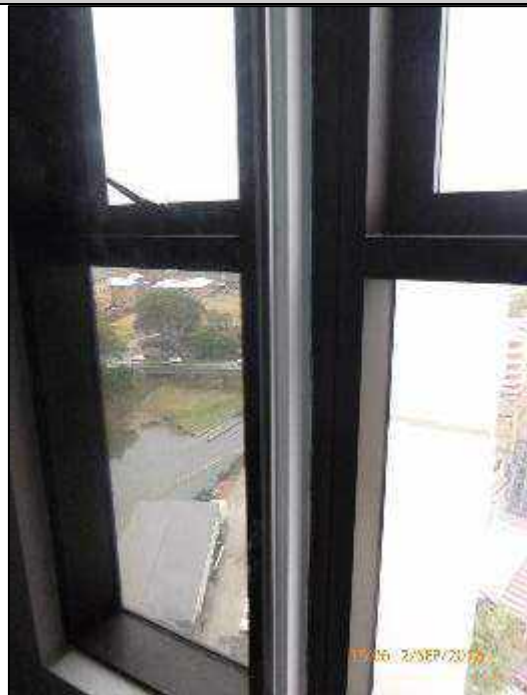
Item	Location	Defect description and Breach	Rectification	Photograph (if applicable)
1439	Main bedroom window frames	See section 5.9.1	See section 5.9.2

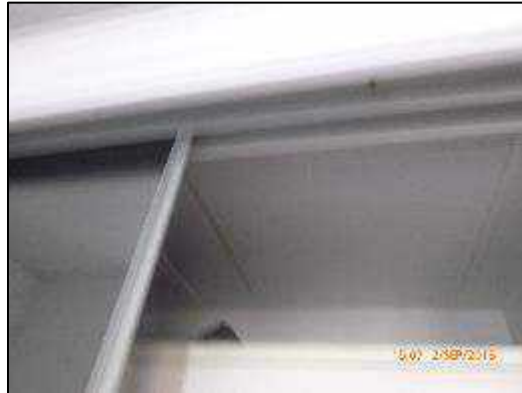
1442	Second bedroom built in	See section 5.6.1	See section 5.6.2

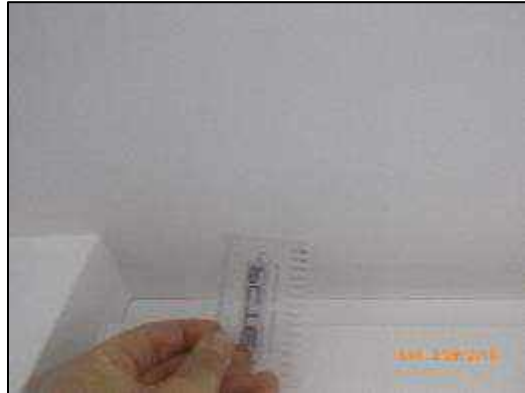
Item	Location	Defect description and Breach	Rectification	Photograph (if applicable)
1443	<i>Ceiling above kitchen cupboards</i>	See section 5.14.1 Separation; 1mm	See section 5.14.2

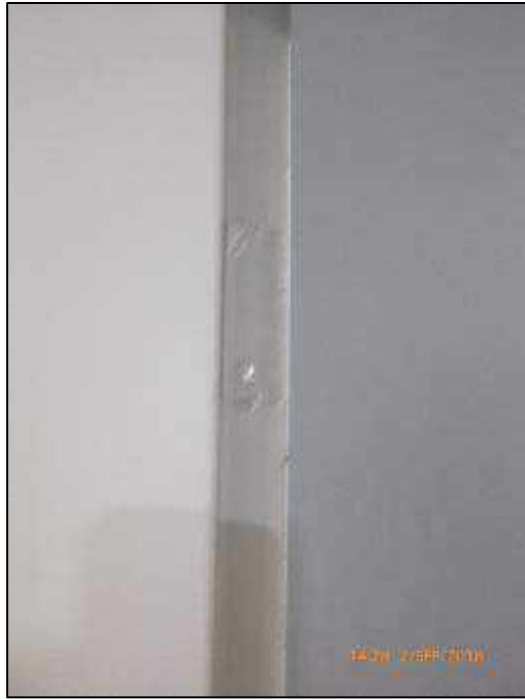
Item	Location	Defect description and Breach	Rectification	Photograph (if applicable)
Unit 1303				
1444	Front entry door frame	<p>Door frame label has been painted over.</p> <p>Home Building Act (NSW) 1989</p> <ul style="list-style-type: none"> Part 2C, 18B (a) & (c). <p>Loss Suffered</p> <p>Loss suffered is cost of rectification.</p>	Use a suitable cleaning agent to remove paint from the door frame label.

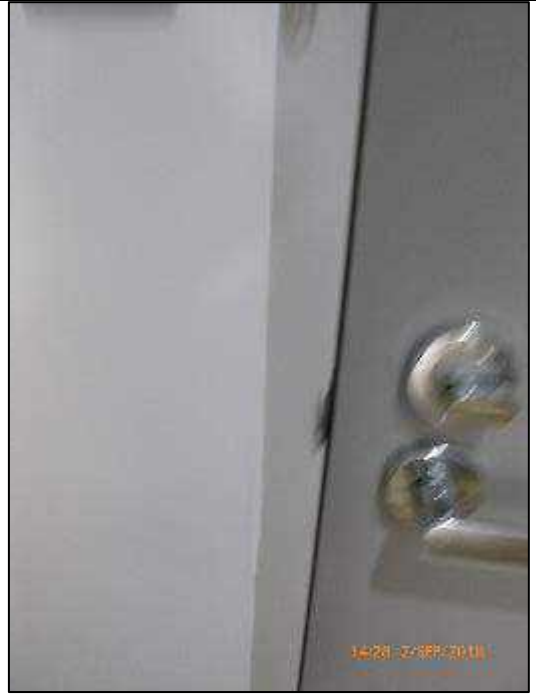
Item	Location	Defect description and Breach	Rectification	Photograph (if applicable)
1445	Wall adjacent to front entry door	See section 5.9.1	See section 5.9.2

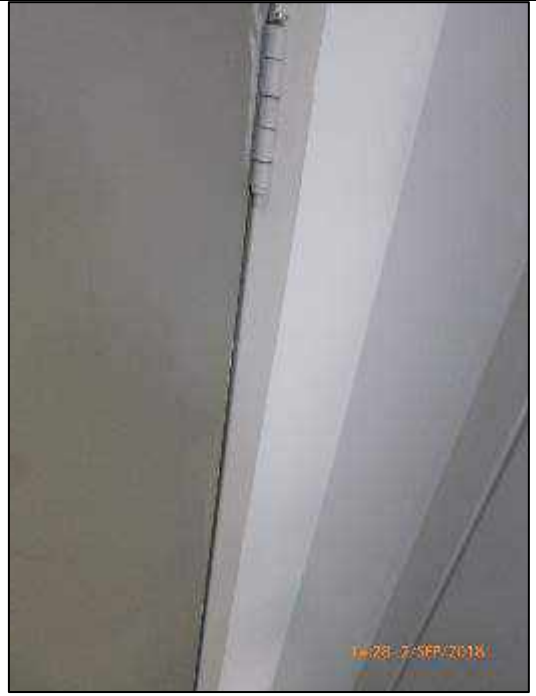
Item	Location	Defect description and Breach	Rectification	Photograph (if applicable)
1446	Wall adjacent to front entry door	See section 5.13.1	See section 5.13.2

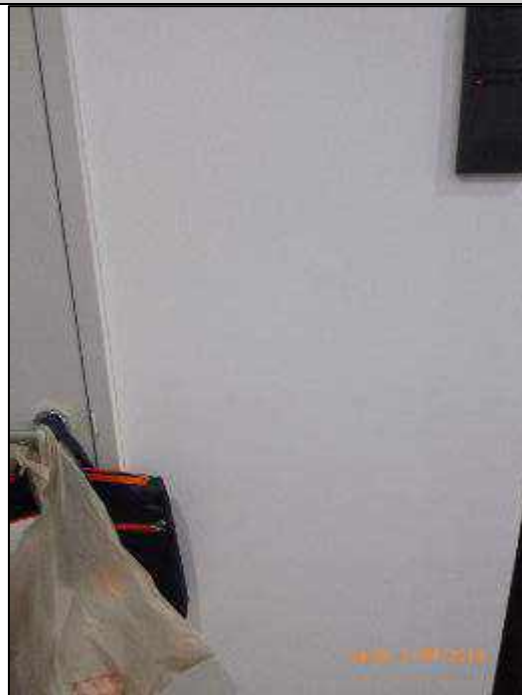
Item	Location	Defect description and Breach	Rectification	Photograph (if applicable)
1447	Lounge room wall adjacent to linen cupboard	See section 5.10.1	See section 5.10.2

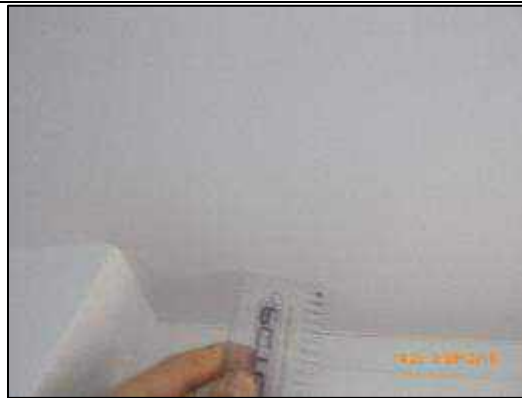
1448	Ceiling above kitchen cupboards	See section 5.14.1 Separation; 1.5mm	See section 5.14.2

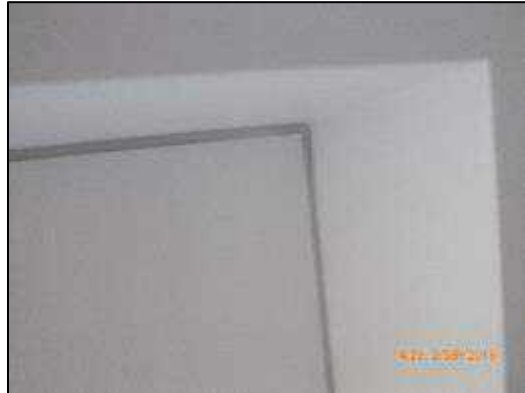
Item	Location	Defect description and Breach	Rectification	Photograph (if applicable)
1449	Lounge room	See section 5.11.1	See section 5.11.2

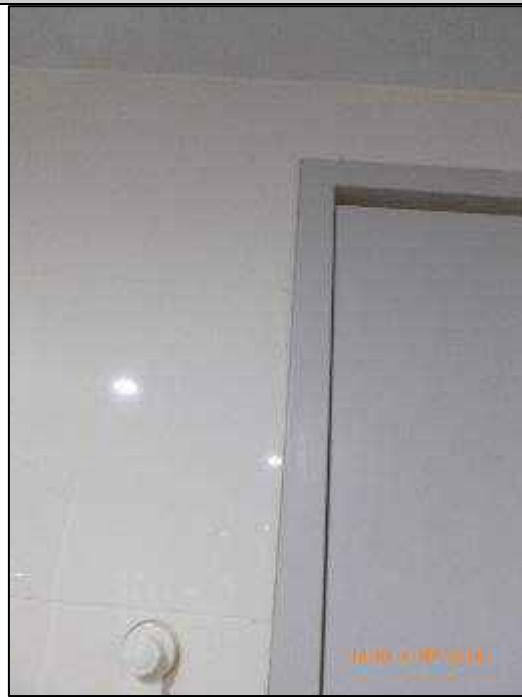
Item	Location	Defect description and Breach	Rectification	Photograph (if applicable)
1451	Wall adjacent to main bathroom door	See section 5.9.1	See section 5.9.2

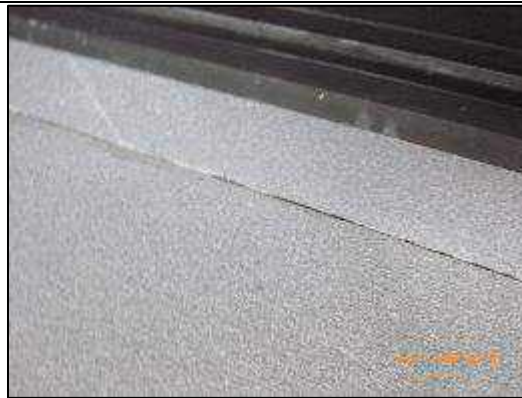
1452	Balcony	<p>Missing sealant observed at floor to skirting tile junction in balcony area.</p> <p>Home Building Act (NSW) 1989</p> <ul style="list-style-type: none"> Part 2C, 18B (a) and (c). <p>Loss Suffered</p> <p>Loss suffered is cost of rectification.</p>	<ol style="list-style-type: none"> 1. Protect all adjoining surfaces. 2. Apply a bead of flexible sealant to the joint between the door frame and wall 3. As required, all affected surfaces are to be painted with an appropriate paint system to match as close as possible to the existing in accordance with the manufacturer's recommendations and AS2311 – Guide to the painting of buildings. 4. Clean up the work area

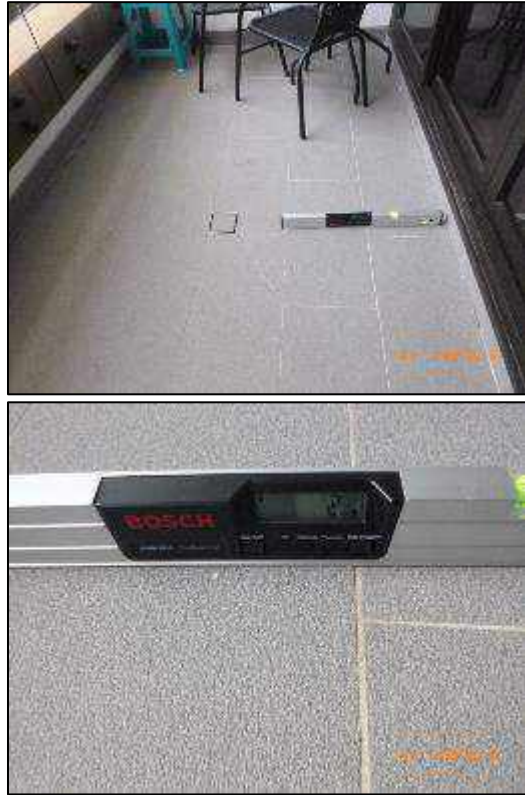
Item	Location	Defect description and Breach	Rectification	Photograph (if applicable)
1453	Balcony	See section 5.2.1 Falls (mm); 2/1000	See section 5.2.2

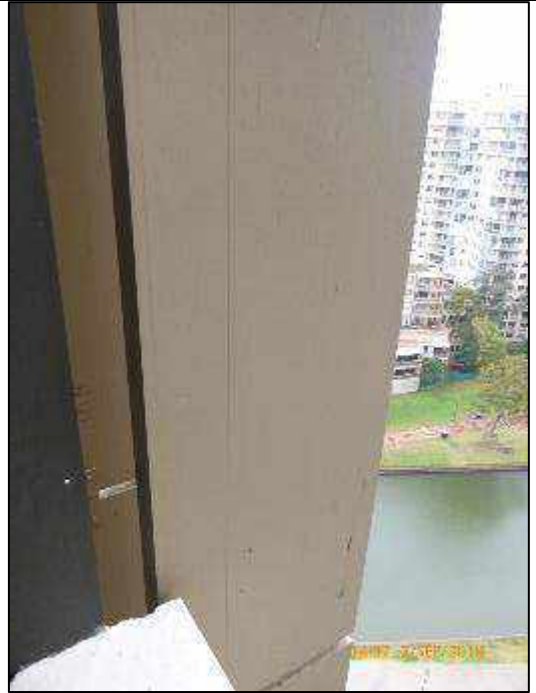
Item	Location	Defect description and Breach	Rectification	Photograph (if applicable)
1456	External façade panels in balcony.	See section 5.7.1	See section 5.7.2

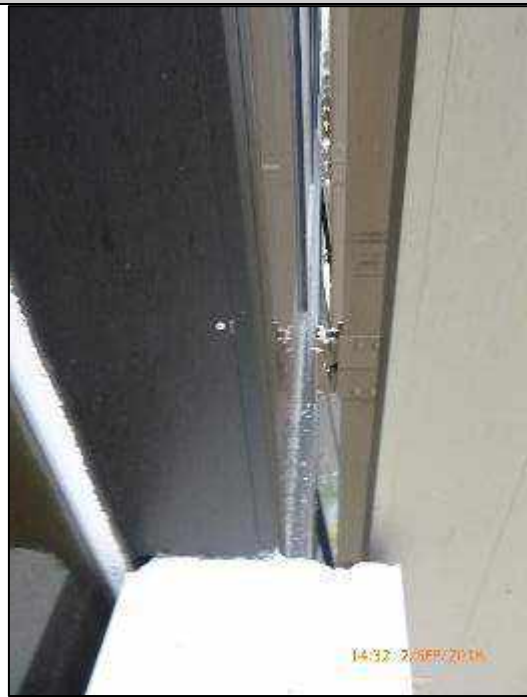
Item	Location	Defect description and Breach	Rectification	Photograph (if applicable)
1457	External façade panels adjacent to balustrade.	See section 5.9.1	See section 5.9.2

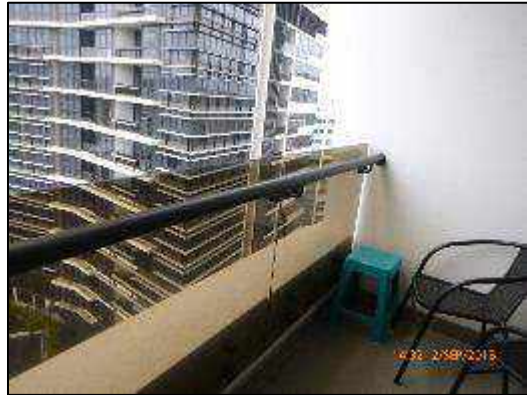
1458	Balcony	See section 5.4.1	See section 5.4.2

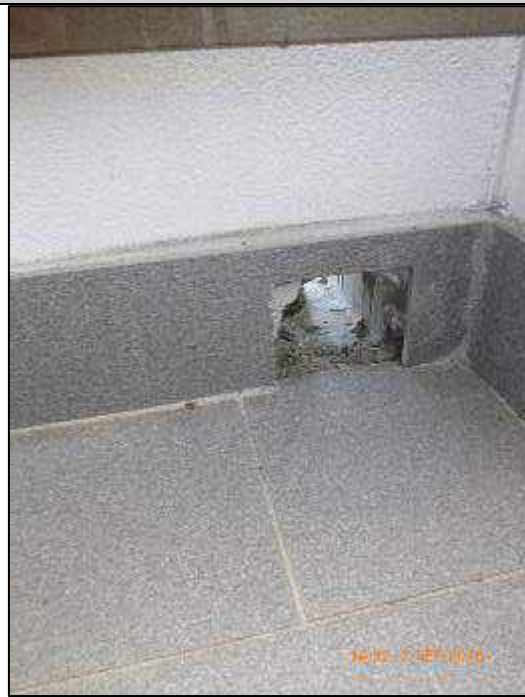
Item	Location	Defect description and Breach	Rectification	Photograph (if applicable)
1459	Balcony	See section 5.15.1	See section 5.15.2

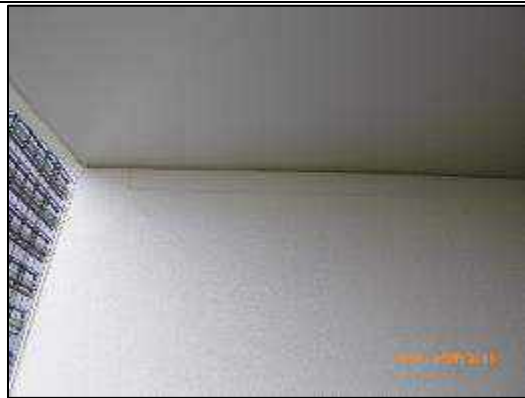
1460	Balcony blade wall eastern	See section 5.14.1 Separation; 2mm	See section 5.14.2

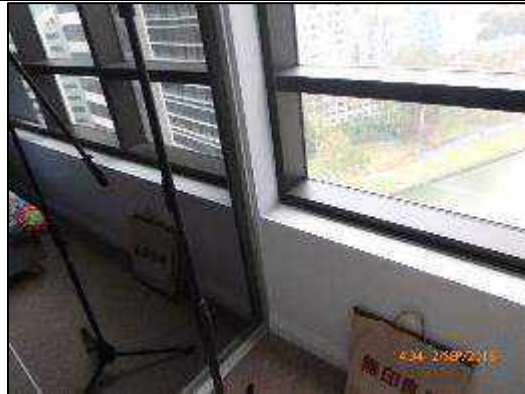
Item	Location	Defect description and Breach	Rectification	Photograph (if applicable)
1461	Main bedroom window frames	See section 5.9.1	See section 5.9.2

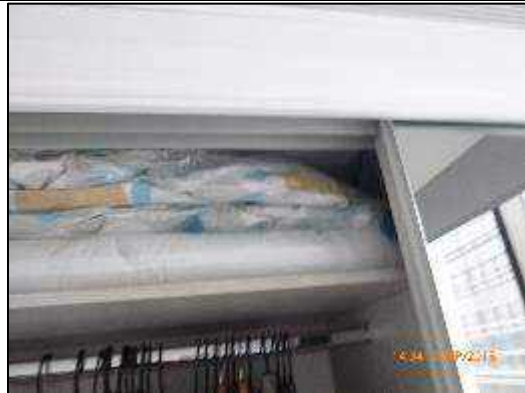
1462	Main bedroom built in	See section 5.6.1	See section 5.6.2

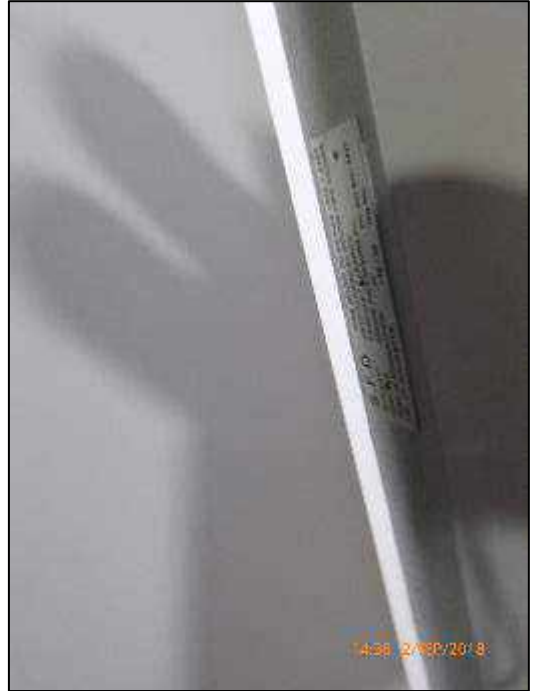
Item	Location	Defect description and Breach	Rectification	Photograph (if applicable)
Unit 1305				
1464	Front entry door	See section 5.12.1	See section 5.12.2

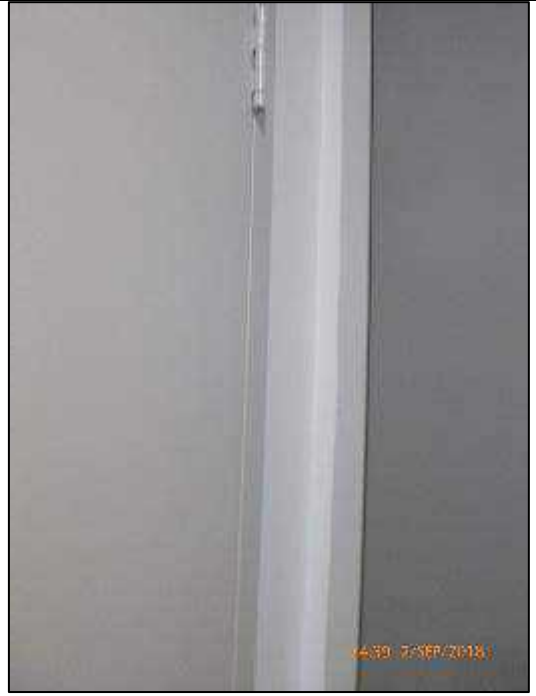
Item	Location	Defect description and Breach	Rectification	Photograph (if applicable)
1465	Wall adjacent to study room door	See section 5.13.1	See section 5.13.2

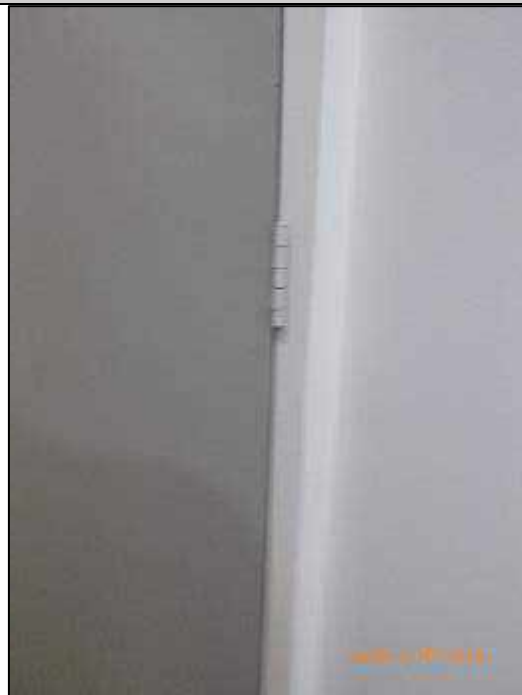
Item	Location	Defect description and Breach	Rectification	Photograph (if applicable)
1466	Wall adjacent to front entry door	See section 5.9.1	See section 5.9.2

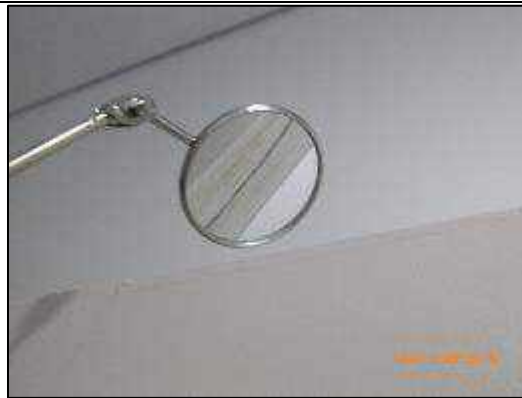
1467	Doors throughout the unit (x4)	See section 5.5.1	See section 5.5.2

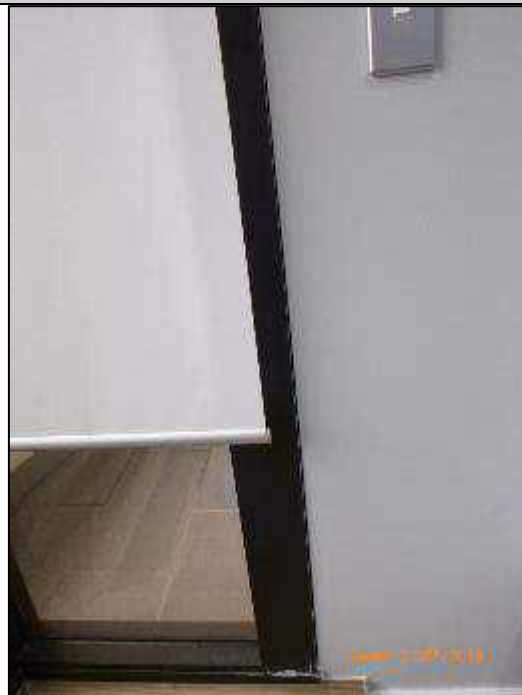
Item	Location	Defect description and Breach	Rectification	Photograph (if applicable)
1468	Main bedroom window frame on eastern wall	See section 5.14.1 Separation; 1mm	See section 5.14.2

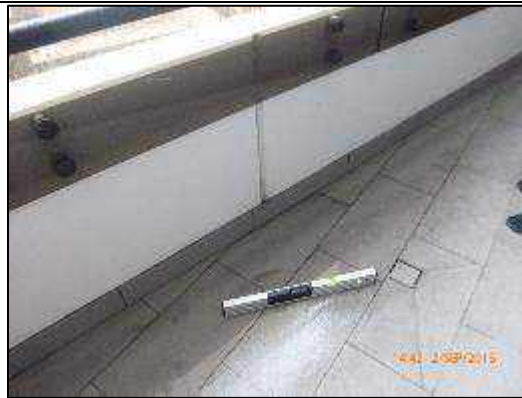
1469	Balcony	See section 5.2.1 Falls (mm); 7/1000	See section 5.2.2

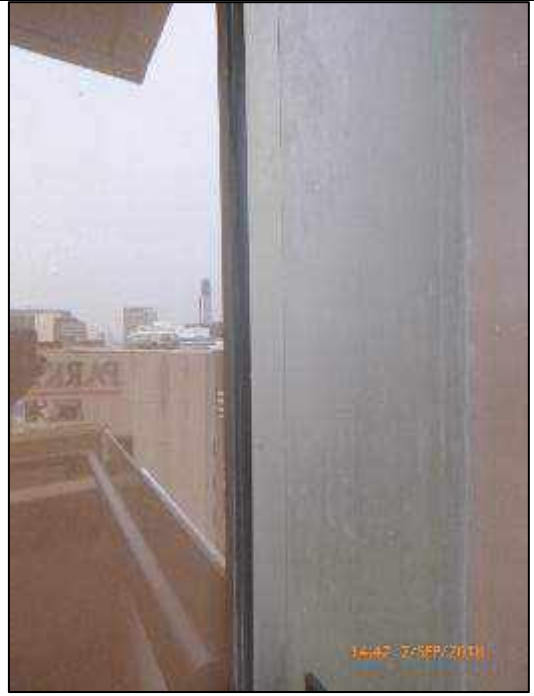
Item	Location	Defect description and Breach	Rectification	Photograph (if applicable)
1470	Balcony sliding door frame	See section 5.7.1	See section 5.7.2

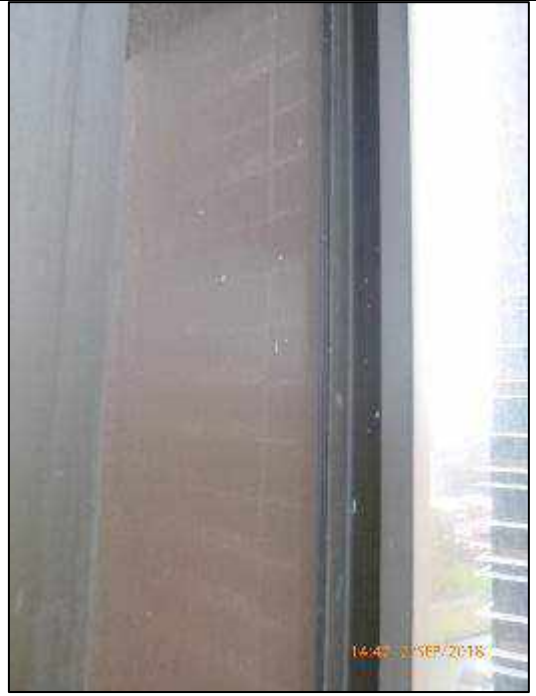
Item	Location	Defect description and Breach	Rectification	Photograph (if applicable)
1471	Balcony sliding door frame	See section 5.9.1	See section 5.9.2

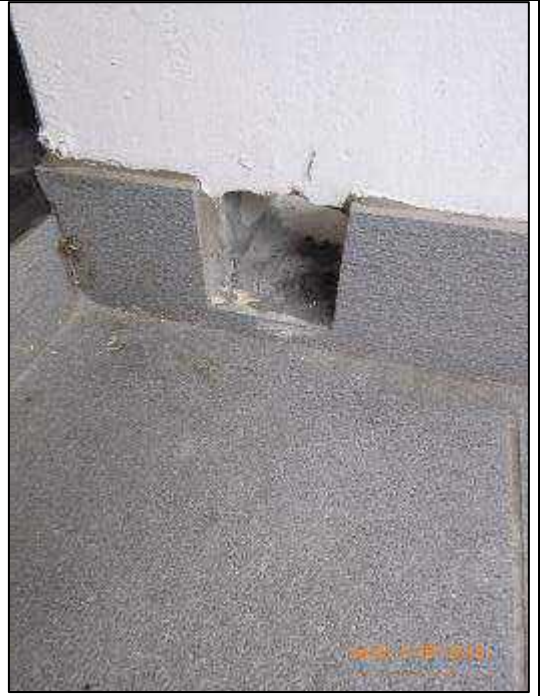
Item	Location	Defect description and Breach	Rectification	Photograph (if applicable)
1473	Balcony	See section 5.15.1	See section 5.15.2

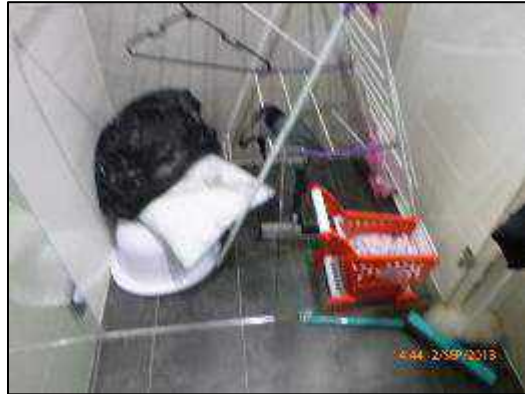
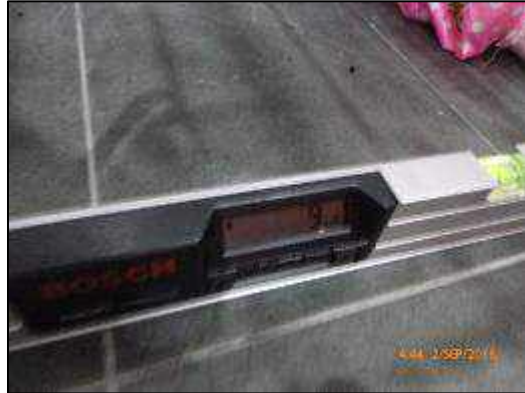
Item	Location	Defect description and Breach	Rectification	Photograph (if applicable)
1474	Main bathroom	See section 5.1.1 Falls (mm); 9/1000	See section 5.1.2

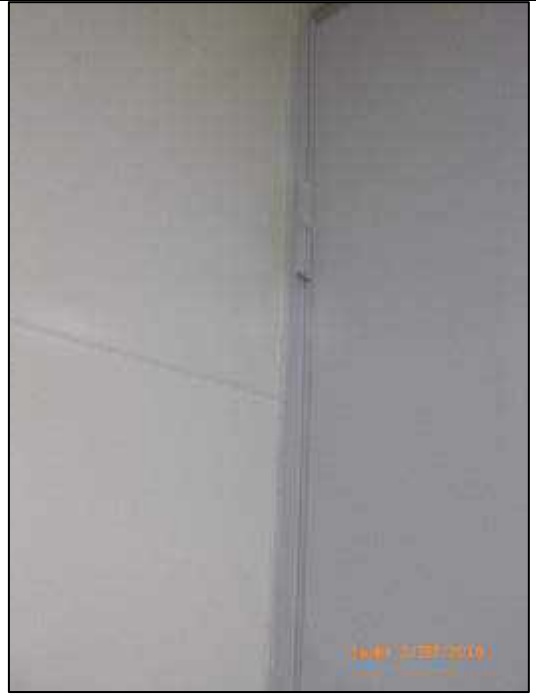
Item	Location	Defect description and Breach	Rectification	Photograph (if applicable)
1475	Wall adjacent to main bathroom door	See section 5.9.1	See section 5.9.2

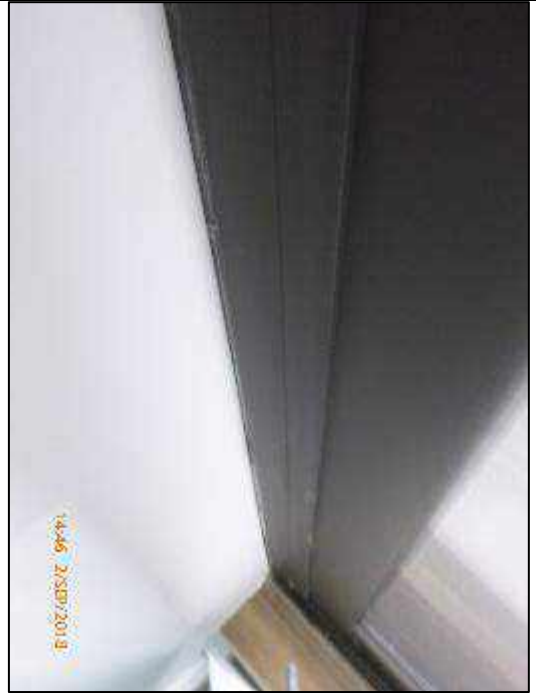
Item	Location	Defect description and Breach	Rectification	Photograph (if applicable)
1477	Second bedroom window frames	See section 5.9.1	See section 5.9.2

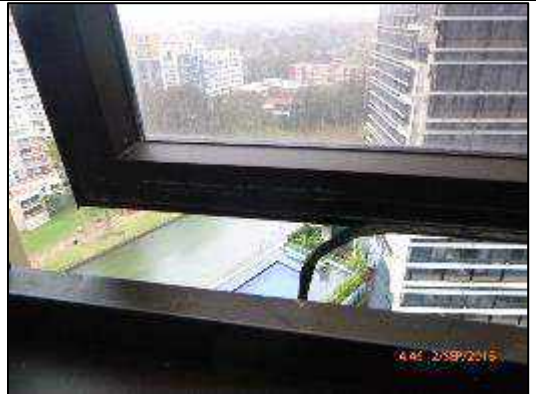
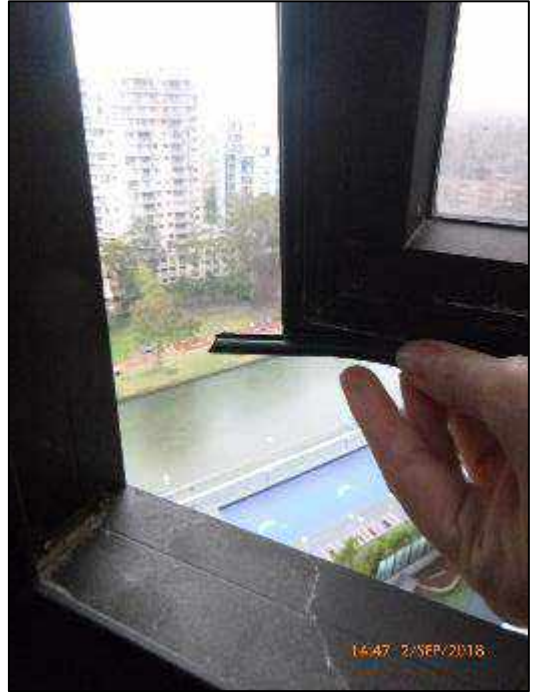
Item	Location	Defect description and Breach	Rectification	Photograph (if applicable)
1478	Main bedroom windows	<p>Rubber gasket of window was found to be missing.</p> <p>Home Building Act (NSW) 1989</p> <ul style="list-style-type: none"> Part 2C, 18B (a) & (c). <p>Loss Suffered</p> <p>Loss suffered is cost of rectification.</p>	Engage a licenced tradesman to reseal window to prevent excessive noise to the unit in accordance with manufacturers specifications.

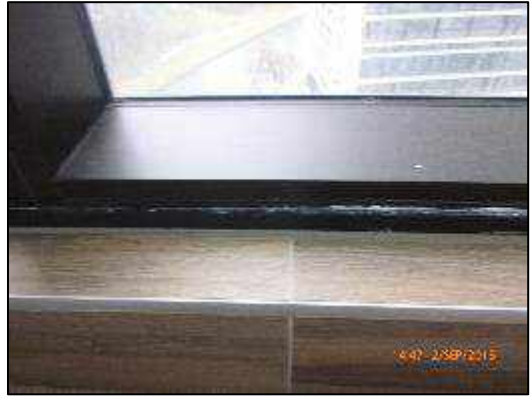
Item	Location	Defect description and Breach	Rectification	Photograph (if applicable)
1479	Main bedroom window frames	See section 5.8.1	See section 5.8.2

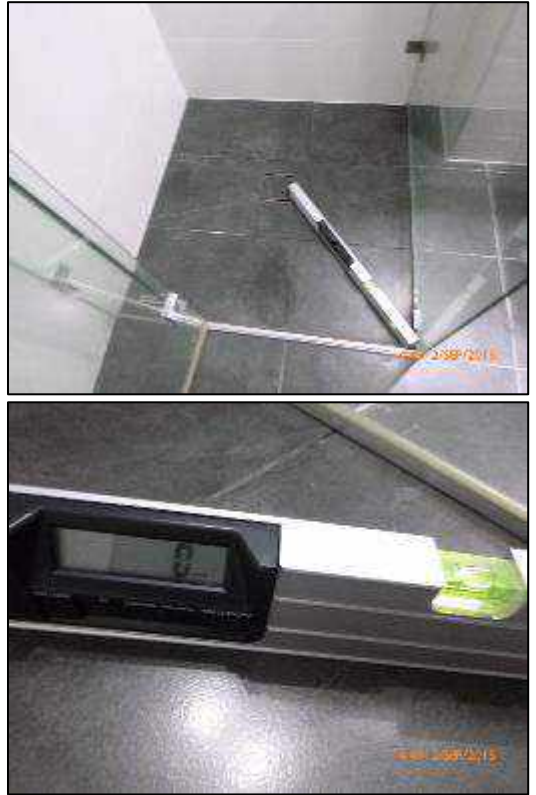
Item	Location	Defect description and Breach	Rectification	Photograph (if applicable)
1480	Main bedroom ensuite	See section 5.1.1 Falls (mm); 0/1000	See section 5.1.2

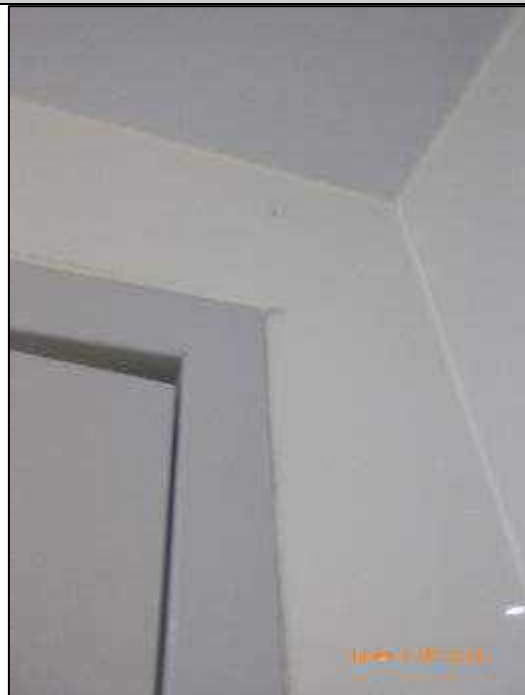
Item	Location	Defect description and Breach	Rectification	Photograph (if applicable)
1481	Wall adjacent to ensuite door	See section 5.9.1	See section 5.9.2

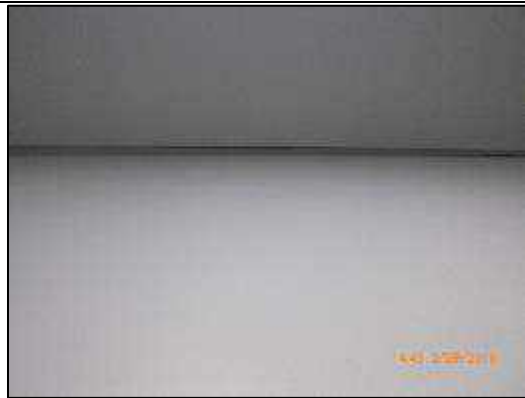
1482	Lounge room	See section 5.11.1	See section 5.11.2

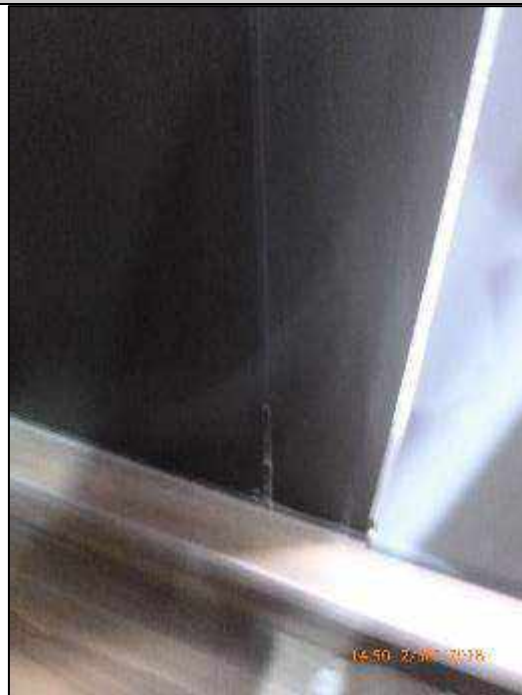
Item	Location	Defect description and Breach	Rectification	Photograph (if applicable)
1483	Lounge room window frames	See section 5.8.1	See section 5.8.2

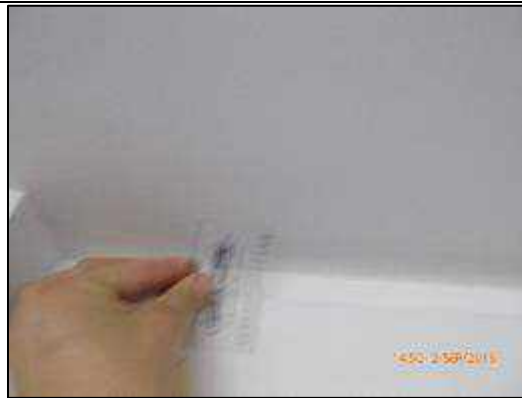
1484	Ceiling above kitchen cupboards	See section 5.14.1 Separation; 1.5mm	See section 5.14.2

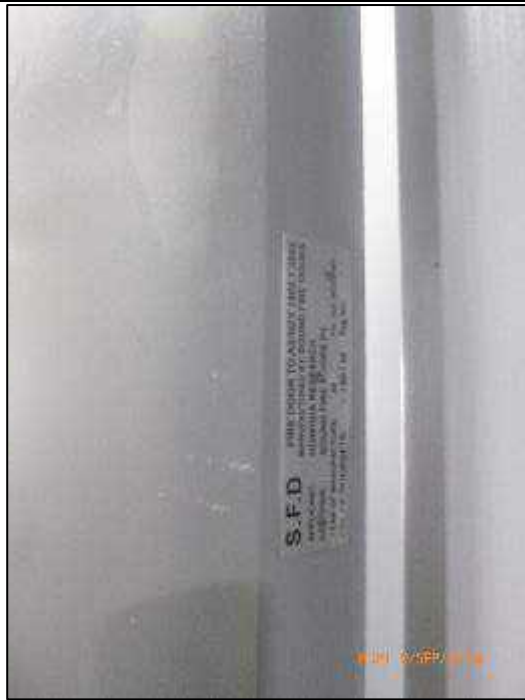
Item	Location	Defect description and Breach	Rectification	Photograph (if applicable)
Unit 1306				
1485		No access was provided.		
Unit 1307				
1486	Front entry door	See section 5.12.1	See section 5.12.2

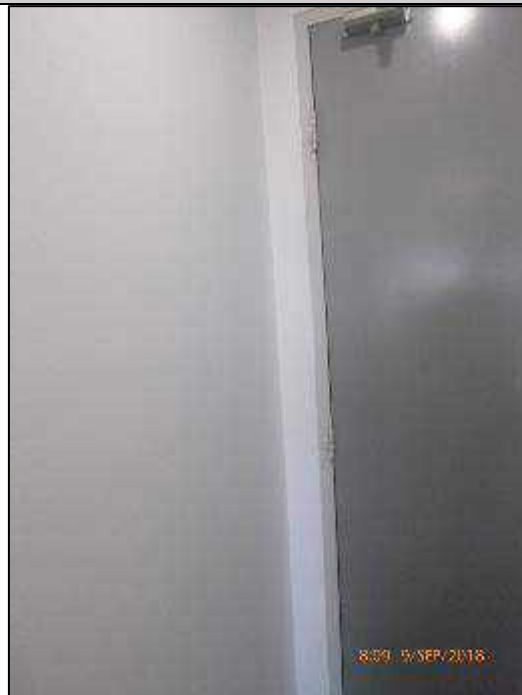
Item	Location	Defect description and Breach	Rectification	Photograph (if applicable)
1487	Wall adjacent to front entry door	See section 5.13.1	See section 5.13.2

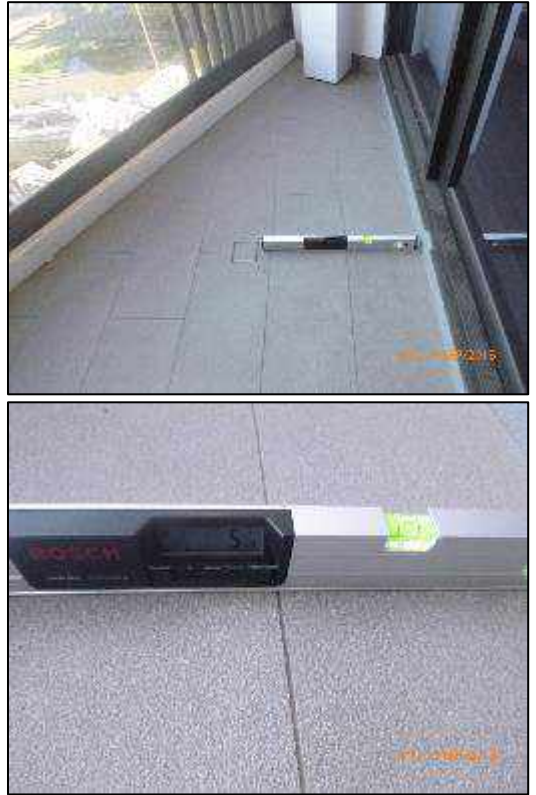
Item	Location	Defect description and Breach	Rectification	Photograph (if applicable)
1490	Balcony	See section 5.2.1 Falls(mm); 5/1000	See section 5.2.2

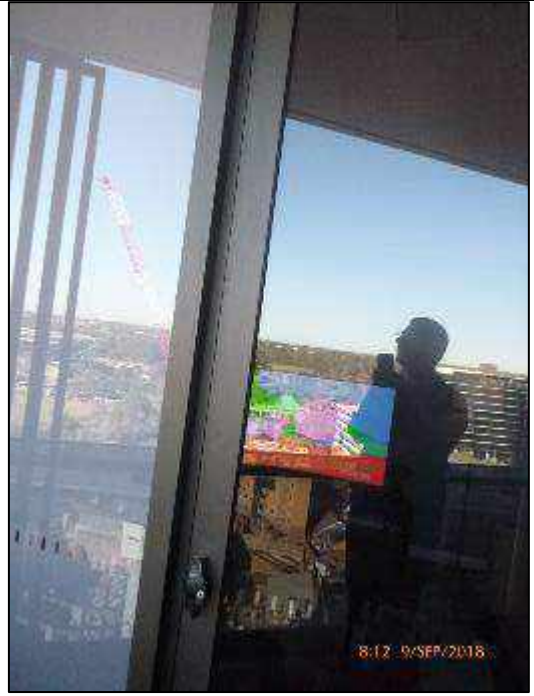
Item	Location	Defect description and Breach	Rectification	Photograph (if applicable)
1491	Balcony sliding door frame	See section 5.7.1	See section 5.7.2

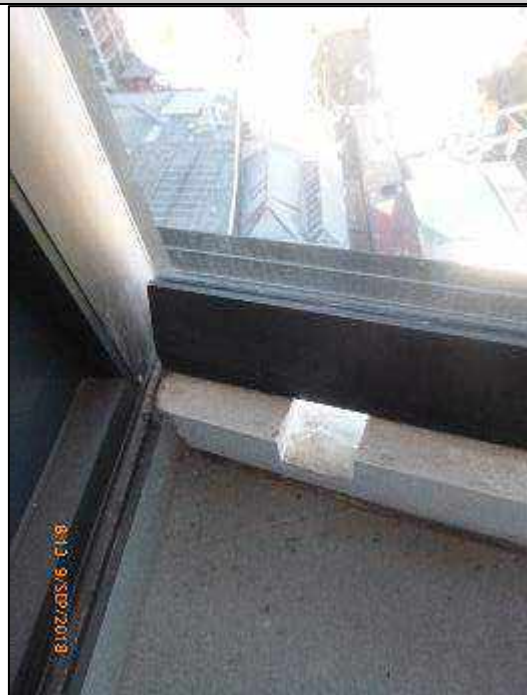
Item	Location	Defect description and Breach	Rectification	Photograph (if applicable)
1492	Balcony	See section 5.15.1	See section 5.15.2

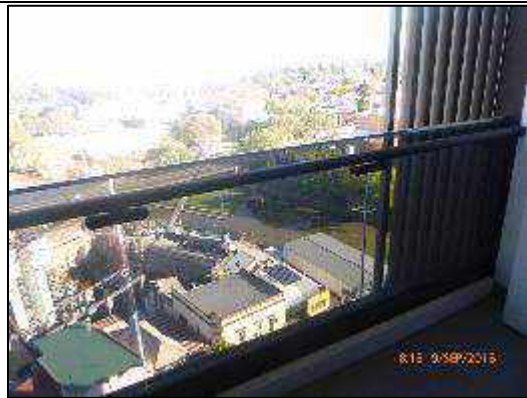
1493	Balcony	See section 5.4.1	See section 5.4.2

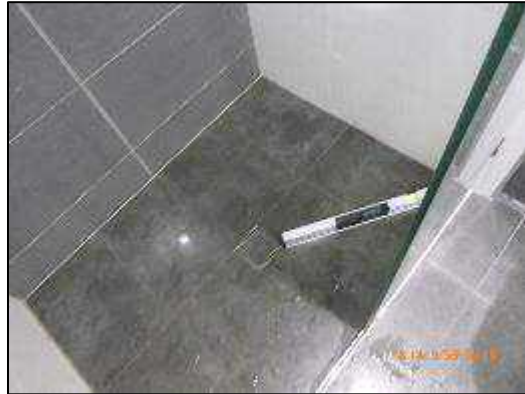
Item	Location	Defect description and Breach	Rectification	Photograph (if applicable)
1494	Main bathroom	See section 5.1.1 Falls (mm); 6/1000	See section 5.1.2

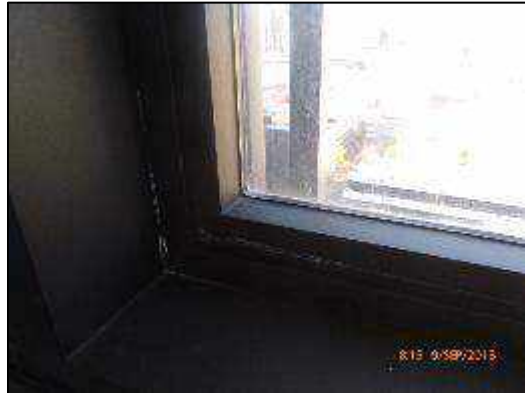
1495	Second bedroom window frames	See section 5.8.1	See section 5.8.2

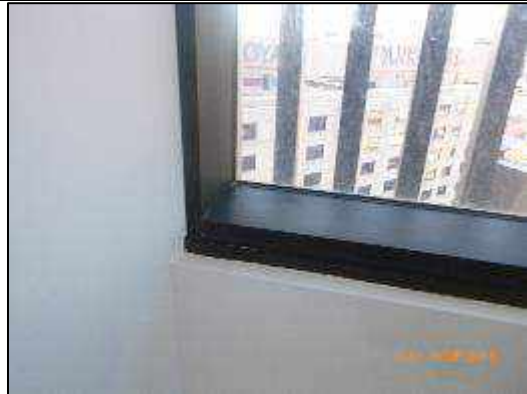
Item	Location	Defect description and Breach	Rectification	Photograph (if applicable)
1496	Second bedroom window frames	See section 5.9.1	See section 5.9.2

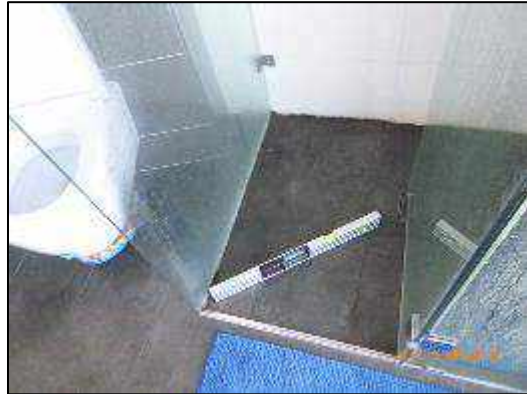
Item	Location	Defect description and Breach	Rectification	Photograph (if applicable)
1498	Main bedroom ensuite	See section 5.1.1 Falls (mm); 8/1000	See section 5.1.2

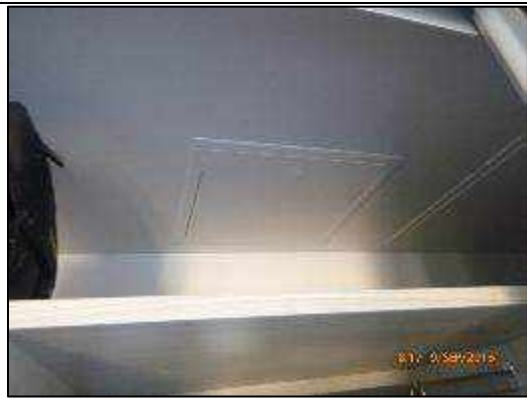
1499	Main bedroom built in	See section 5.6.1	See section 5.6.2

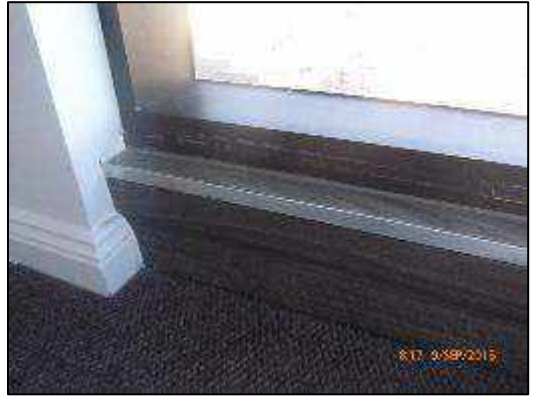
Item	Location	Defect description and Breach	Rectification	Photograph (if applicable)
1500	Main bedroom window frames	See section 5.8.1	See section 5.8.2
