SydneyStrataReport

STRATA REPORT

Client	Church Street Parramatta Property Pty Ltd
Address of property	Unit 3303/330 Church Street, Parramatta, NSW.
Lot	359
Strata Plan	SP 94469
Name of Strata Management Co.	NSW Strata
Telephone Number of Strata Agent	8980 1841
Report Date	15 February 2024

BUILDING DEFECTS REPORT Part 1/2

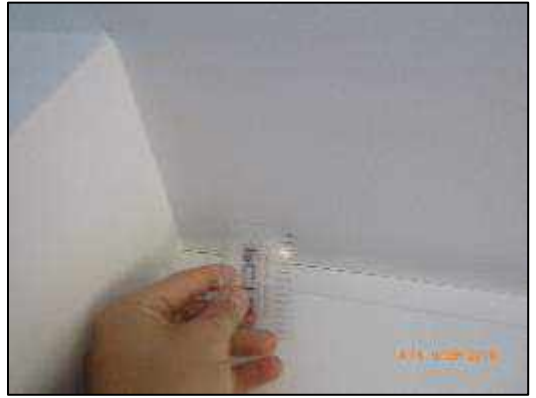
1501	Ceiling above kitchen cupboards	See section 5.14.1 Separation; 1.5mm	See section 5.14.2

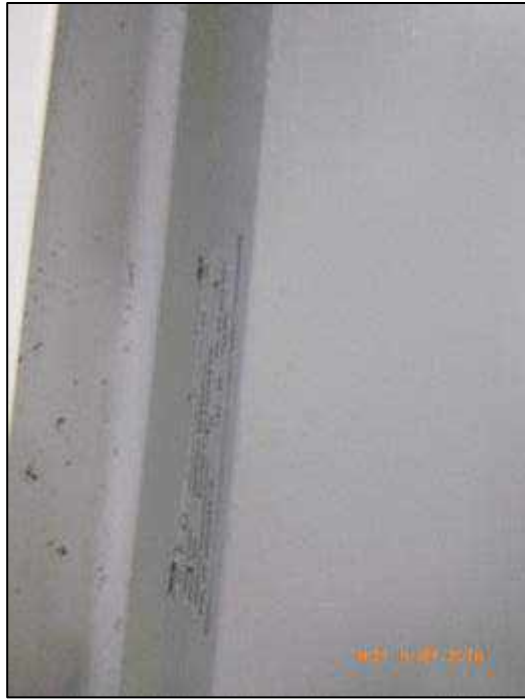
Item	Location	Defect description and Breach	Rectification	Photograph (if applicable)
Unit 1308				
1502	Front entry door	See section 5.12.1	See section 5.12.2

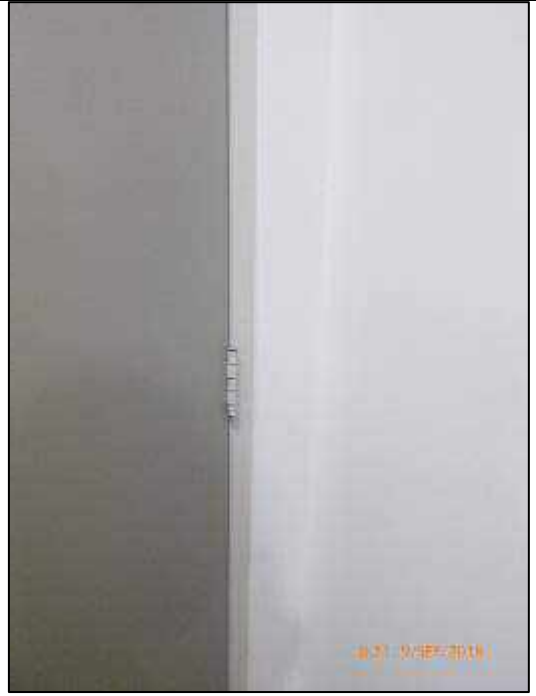
Item	Location	Defect description and Breach	Rectification	Photograph (if applicable)
1503	Wall adjacent to front entry door	See section 5.13.1	See section 5.13.2

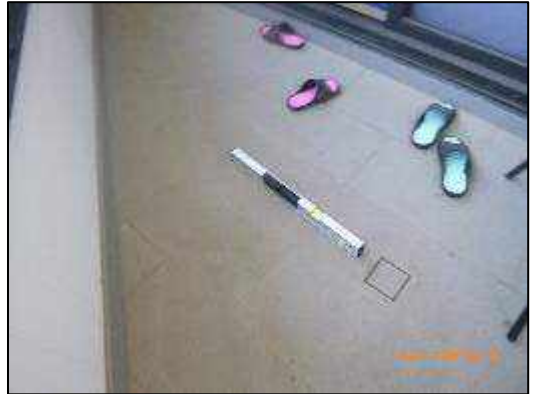
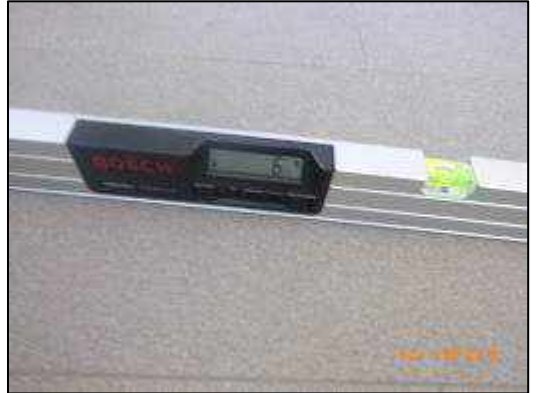
Item	Location	Defect description and Breach	Rectification	Photograph (if applicable)
1506	Balcony	See section 5.2.1 Falls (mm); 6/1000	See section 5.2.2

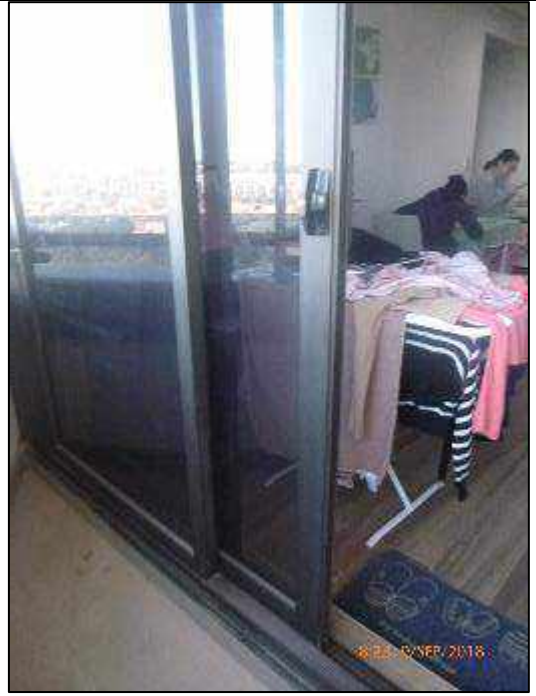
Item	Location	Defect description and Breach	Rectification	Photograph (if applicable)
1507	Balcony sliding door frame	See section 5.7.1	See section 5.7.2

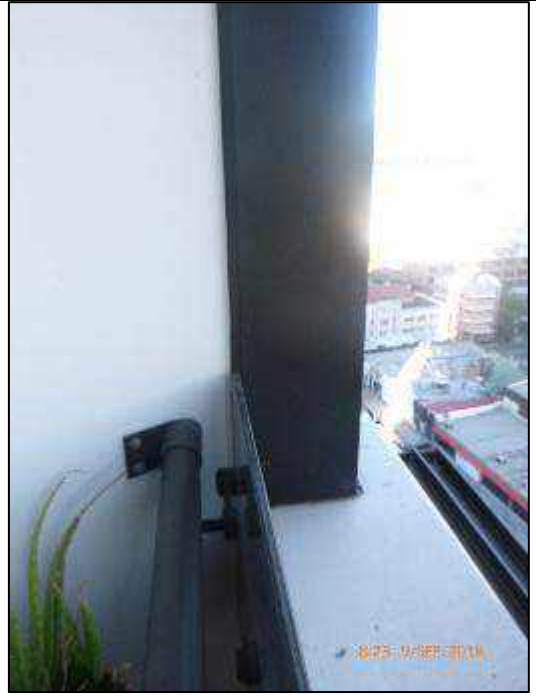
Item	Location	Defect description and Breach	Rectification	Photograph (if applicable)
1508	<i>External façade panels adjacent to balustrade</i>	See section 5.9.1	See section 5.9.2

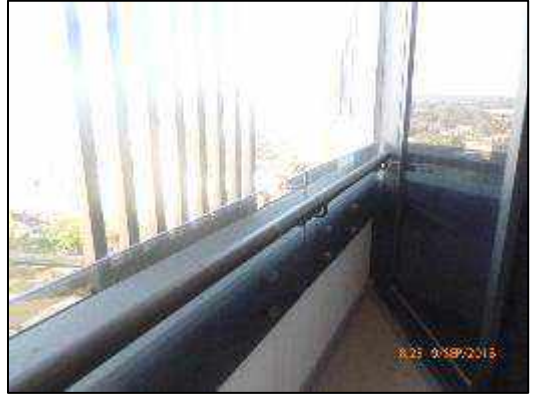
1509	<i>Balcony</i>	See section 5.4.1	See section 5.4.2

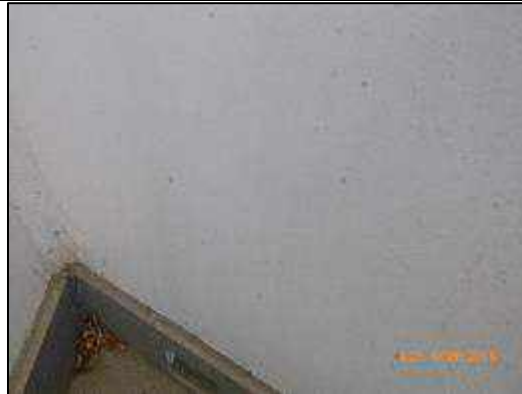
Item	Location	Defect description and Breach	Rectification	Photograph (if applicable)
1510	Balcony	See section 5.15.1	See section 5.15.2

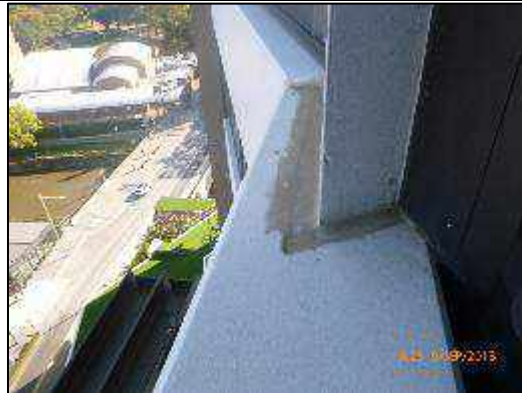
1511	Balcony	<p>Poorly applied sealant observed between balustrade wall and façade.</p> <p>Home Building Act (NSW) 1989</p> <ul style="list-style-type: none"> Part 2C, 18B (a) and (c). <p>This is a breach of part (a) of the act because the surface has not been finished in a proper workmanlike manner that would prevent loss of appearance to the surface.</p> <p>Loss Suffered Loss suffered is cost of rectification.</p>	<ol style="list-style-type: none"> 1. Protect all adjoining surfaces. 2. Use a suitable cleaning agent to remove residue and clear debris. 3. Clean up the work area.

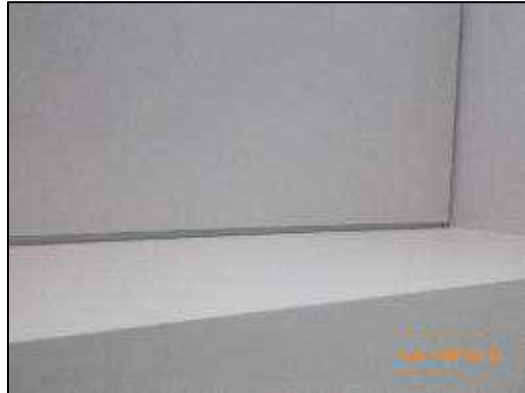
Item	Location	Defect description and Breach	Rectification	Photograph (if applicable)
1512	Lounge room	See section 5.11.1	See section 5.11.2

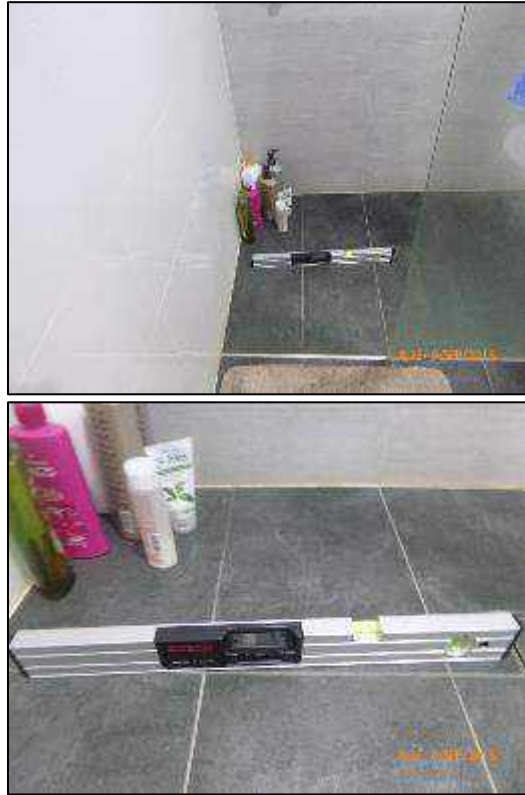
Item	Location	Defect description and Breach	Rectification	Photograph (if applicable)
1513	Main bathroom	See section 5.1.1 Falls (mm); 7/1000	See section 5.1.2

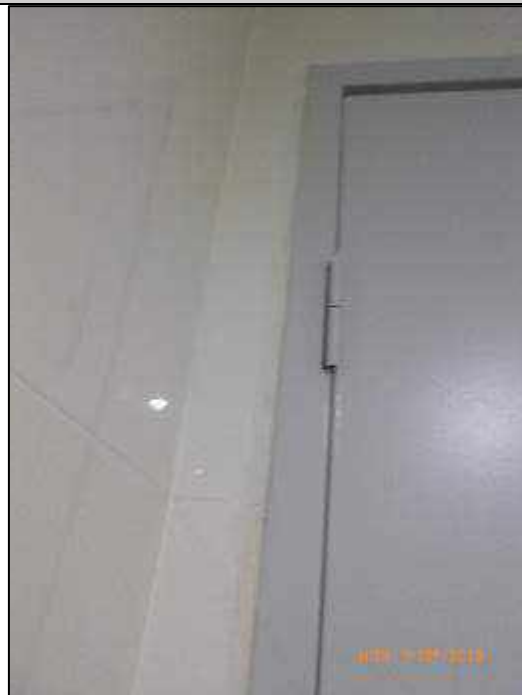
Item	Location	Defect description and Breach	Rectification	Photograph (if applicable)
1514	Wall adjacent to bathroom door	See section 5.9.1	See section 5.9.2

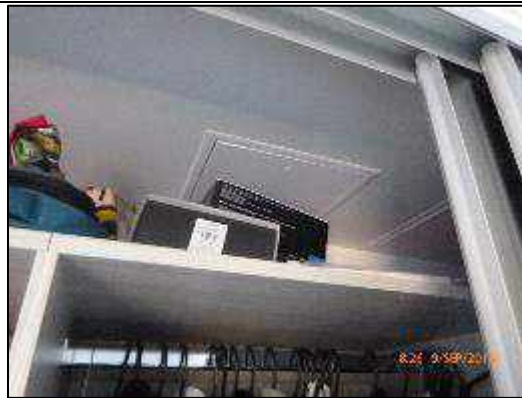
1515	Second bedroom built in	See section 5.6.1	See section 5.6.2

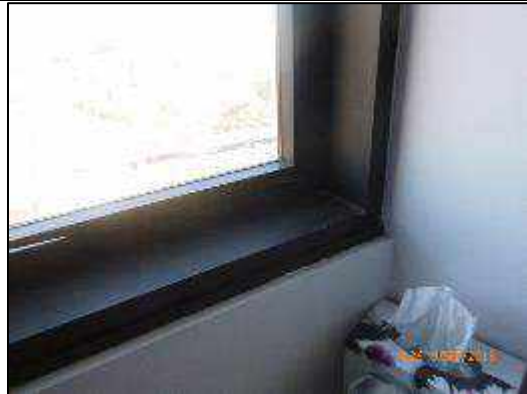
Item	Location	Defect description and Breach	Rectification	Photograph (if applicable)
1516	Second bedroom window frame	See section 5.9.1	See section 5.9.2

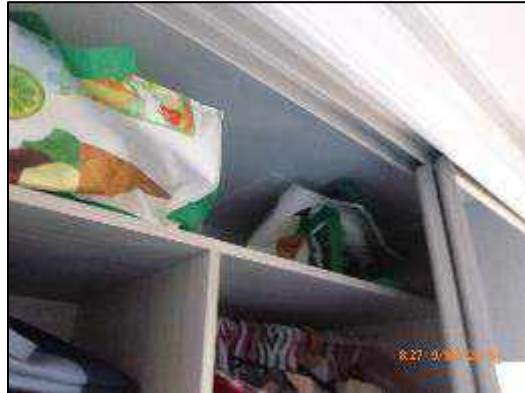
Item	Location	Defect description and Breach	Rectification	Photograph (if applicable)
1518	Main bedroom built in	See section 5.6.1	See section 5.6.2

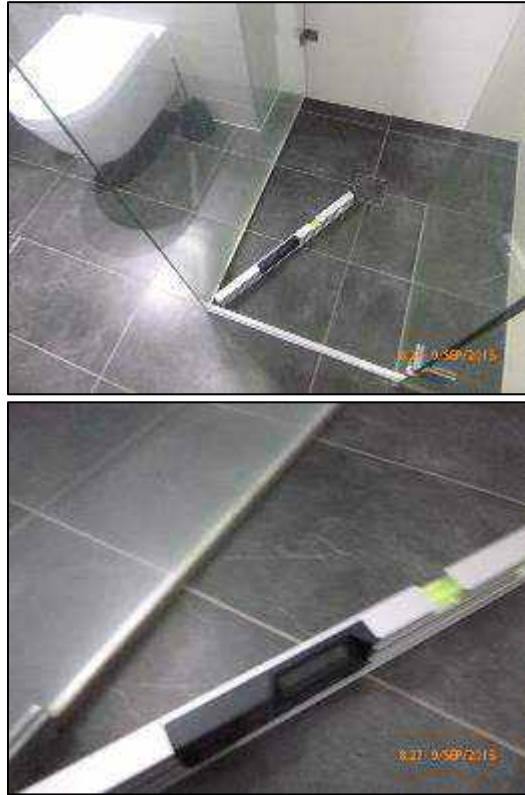
Item	Location	Defect description and Breach	Rectification	Photograph (if applicable)
1519	Main bedroom ensuite	See section 5.1.1 Falls; 0/1000	See section 5.1.2

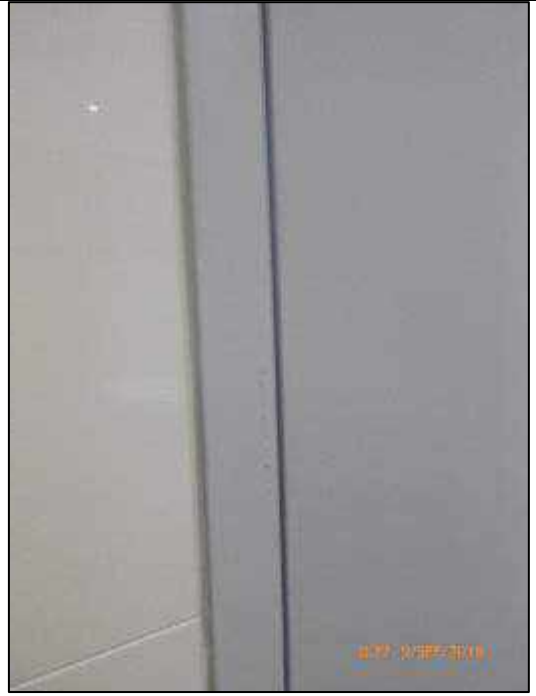
Item	Location	Defect description and Breach	Rectification	Photograph (if applicable)
1520	Wall adjacent to ensuite door	See section 5.9.1	See section 5.9.2

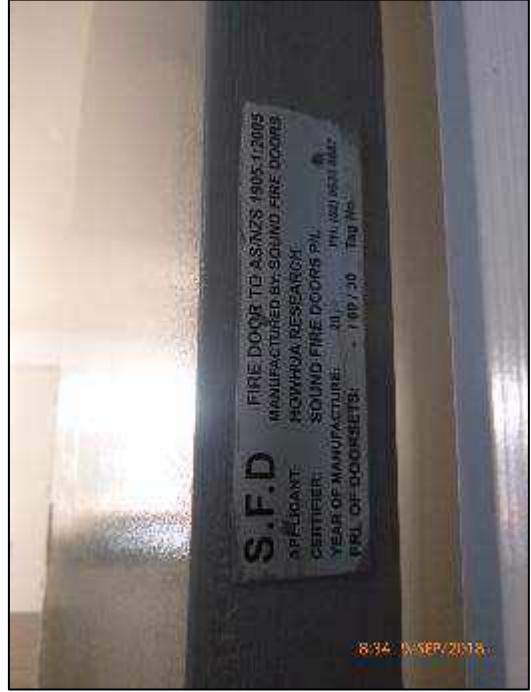
Item	Location	Defect description and Breach	Rectification	Photograph (if applicable)
Unit 1401				
1521		No access was provided.		
Unit 1402				
1522	Front entry door	See section 5.12.1	See section 5.12.2

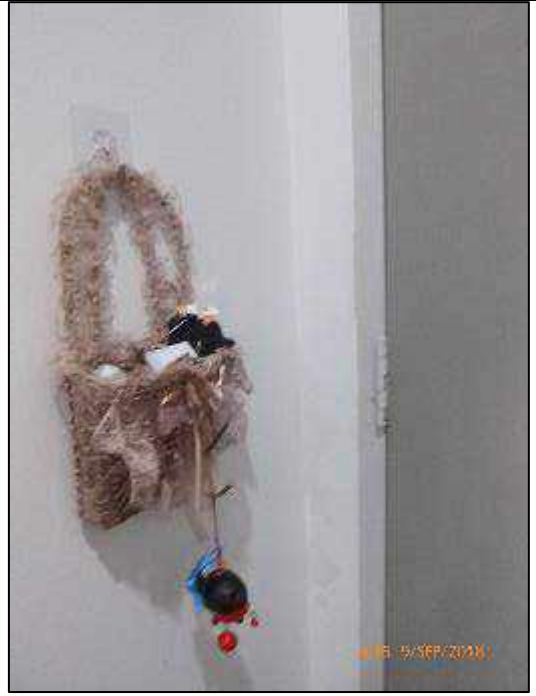
Item	Location	Defect description and Breach	Rectification	Photograph (if applicable)
1523	Wall adjacent to front entry door	See section 5.13.1	See section 5.13.2

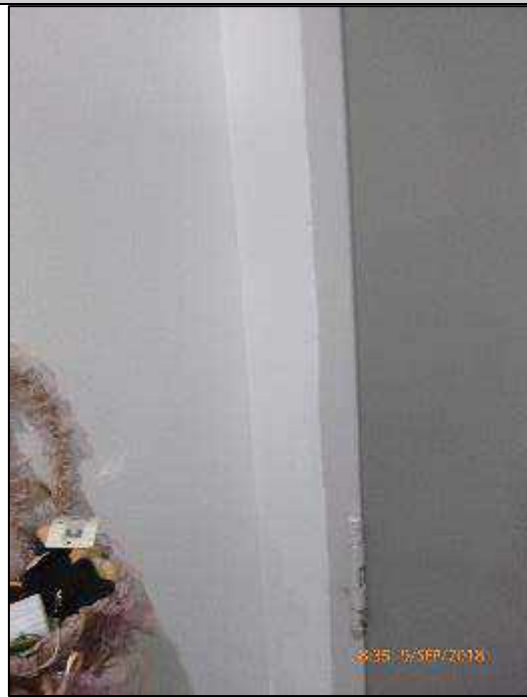
Item	Location	Defect description and Breach	Rectification	Photograph (if applicable)
1524	Wall adjacent to front entry door	See section 5.9.1	See section 5.9.2

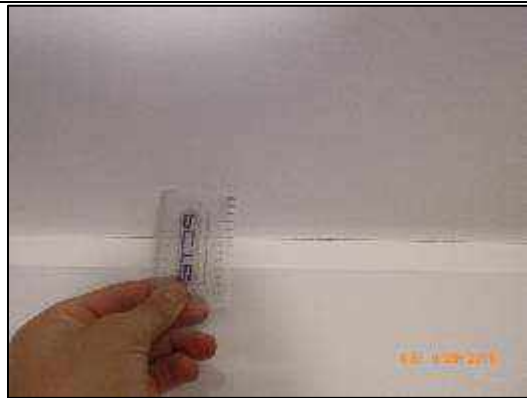
A photograph showing a vertical crack or gap in a light-colored wall. A small white tag is visible on the left side of the crack. The date '15/SEP/2018' is printed in orange in the bottom right corner.
1525	Ceiling above kitchen cupboards	See section 5.14.1 Separation; 1.5mm	See section 5.14.2

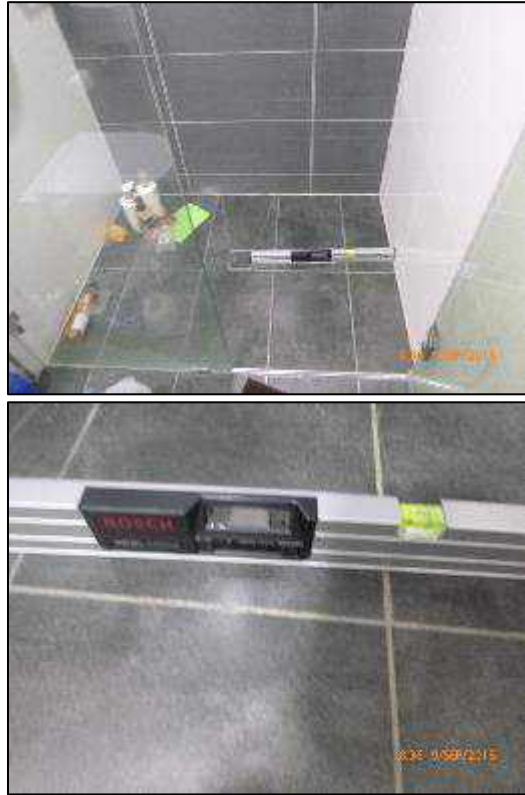
Item	Location	Defect description and Breach	Rectification	Photograph (if applicable)
1526	Main bathroom	See section 5.1.1 Falls (mm); 7/1000	See section 5.1.2

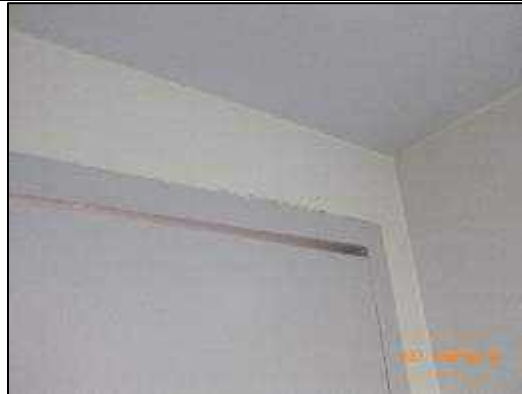
Item	Location	Defect description and Breach	Rectification	Photograph (if applicable)
1527	Wall adjacent to main bathroom door	See section 5.9.1	See section 5.9.2

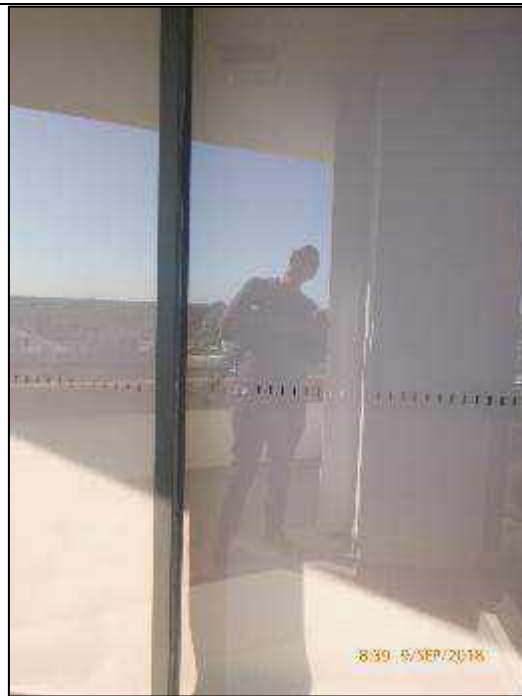
1528	Balcony sliding door	<p>Resident advised of excessive noise and vibration in sliding door during windy days.</p> <p>Home Building Act (NSW) 1989</p> <ul style="list-style-type: none"> Part 2C, 18B (a) & (c). <p>Loss Suffered Loss suffered is cost of rectification.</p>	Engage a licenced tradesman to reseal door to prevent excessive noise to the unit in accordance with manufacturers specifications.

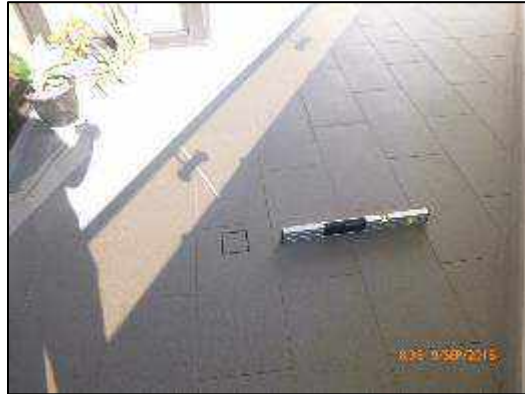
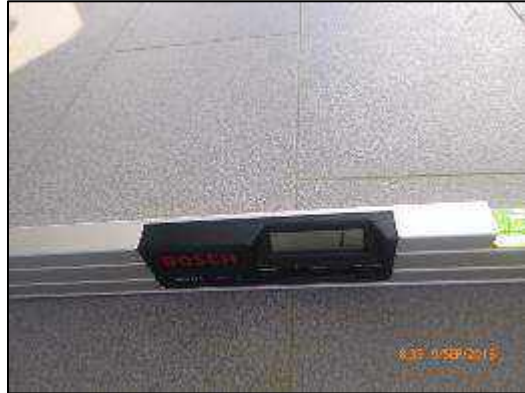
Item	Location	Defect description and Breach	Rectification	Photograph (if applicable)
1529	Balcony	See section 5.2.1 Falls (mm); 1/1000	See section 5.2.2

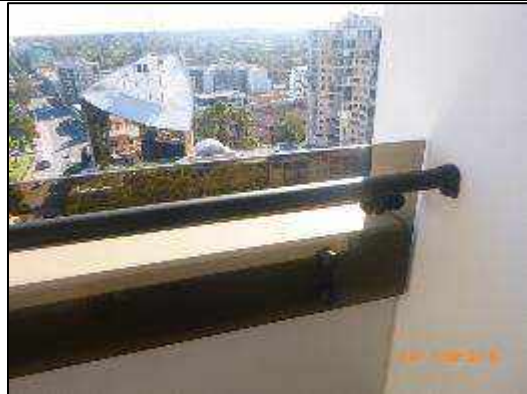
Item	Location	Defect description and Breach	Rectification	Photograph (if applicable)
1530	Balcony	See section 5.4.1	See section 5.4.2

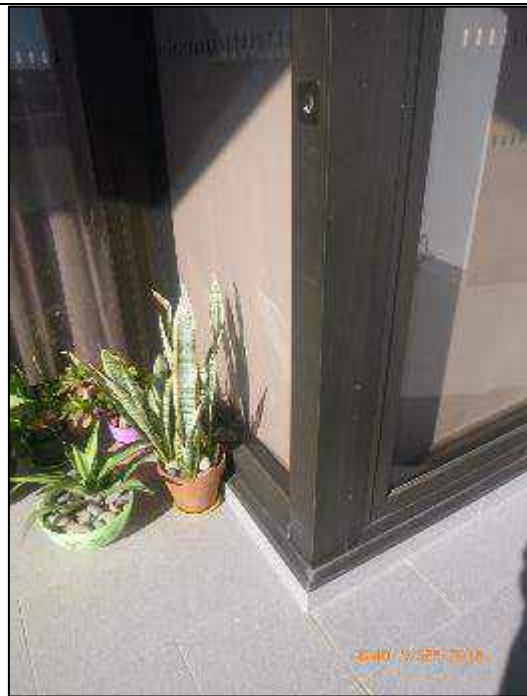
1531	Balcony sliding door frame	See section 5.7.1	See section 5.7.2

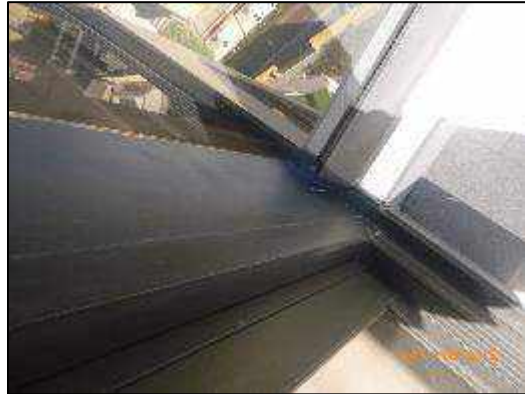
Item	Location	Defect description and Breach	Rectification	Photograph (if applicable)
1532	Balcony sliding door frame	See section 5.9.1	See section 5.9.2

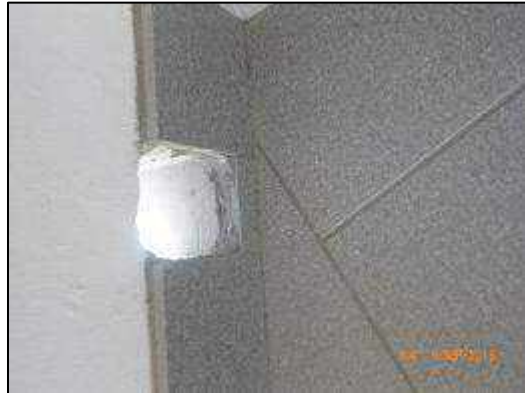
1533	Balcony	See section 5.15.1	See section 5.15.2

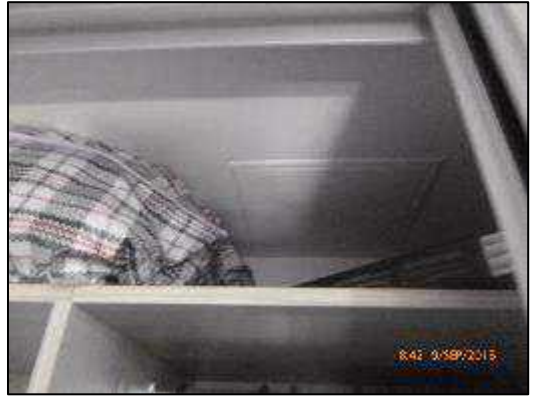
Item	Location	Defect description and Breach	Rectification	Photograph (if applicable)
1534	<i>Second bedroom built in</i>	See section 5.6.1	See section 5.6.2

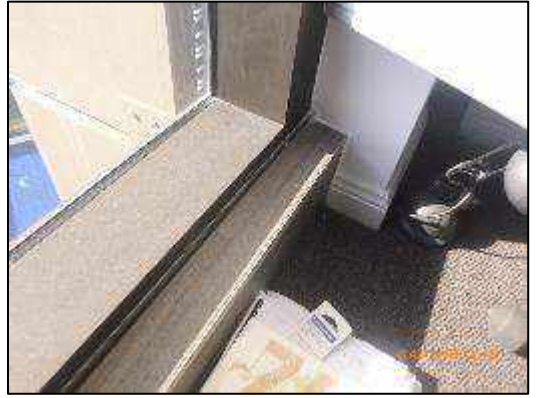
1535	<i>Second bedroom window frames</i>	See section 5.8.1	See section 5.8.2

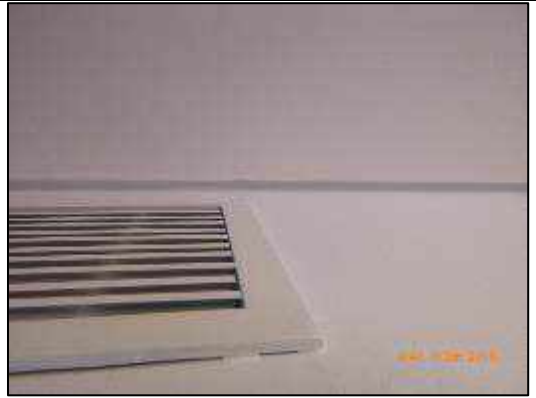
Item	Location	Defect description and Breach	Rectification	Photograph (if applicable)
1536	Lounge room	See section 5.11.1	See section 5.11.2

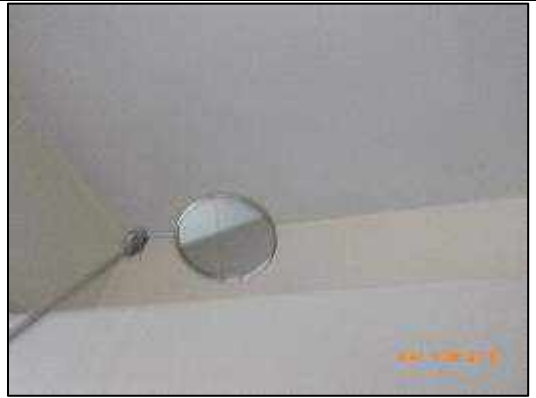
1537	Doors throughout the unit (x3)	See section 5.5.1	See section 5.5.2

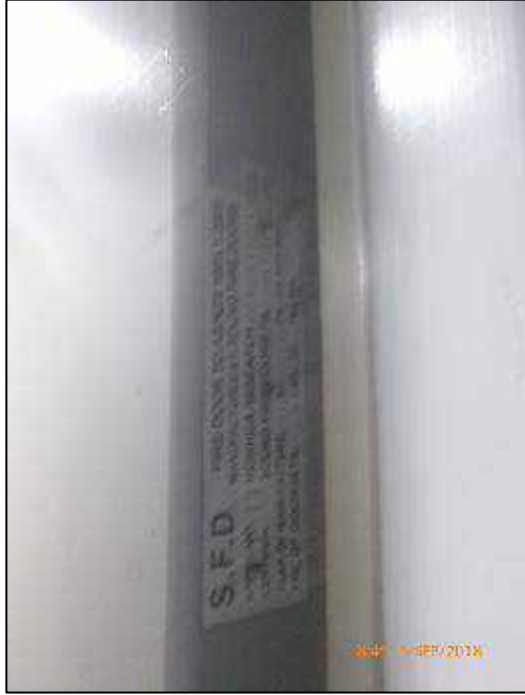
Item	Location	Defect description and Breach	Rectification	Photograph (if applicable)
Unit 1404				
1539	Front entry door	See section 5.12.1	See section 5.12.2

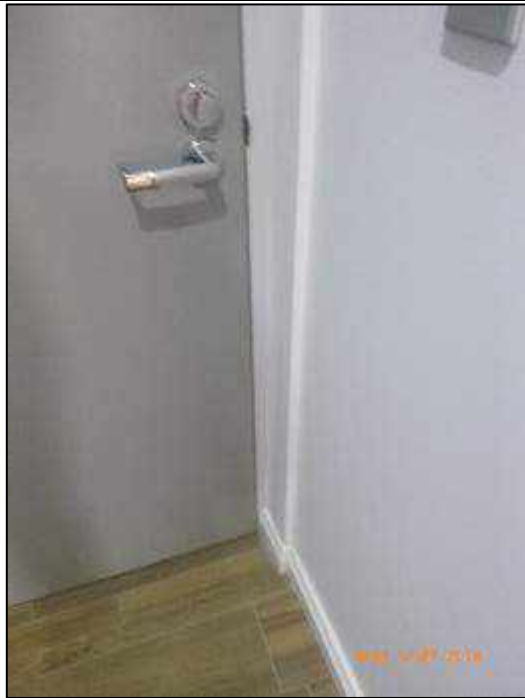
Item	Location	Defect description and Breach	Rectification	Photograph (if applicable)
1540	Wall adjacent to front entry door	See section 5.13.1	See section 5.13.2

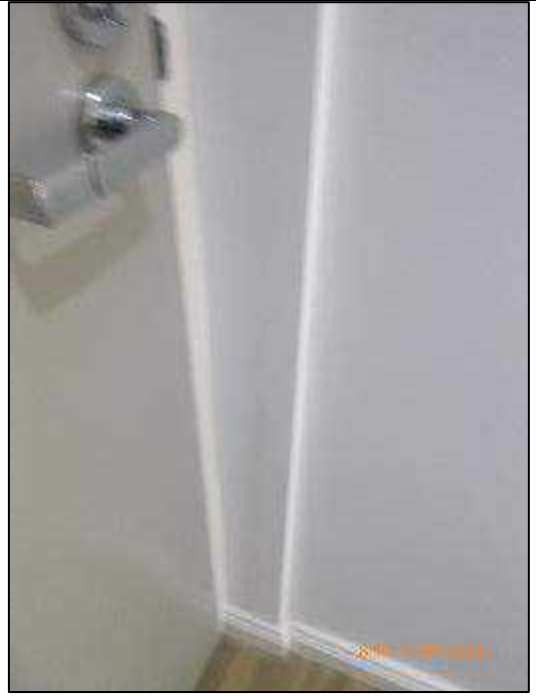
Item	Location	Defect description and Breach	Rectification	Photograph (if applicable)
1541	Wall adjacent to front entry door	See section 5.9.1	See section 5.9.2

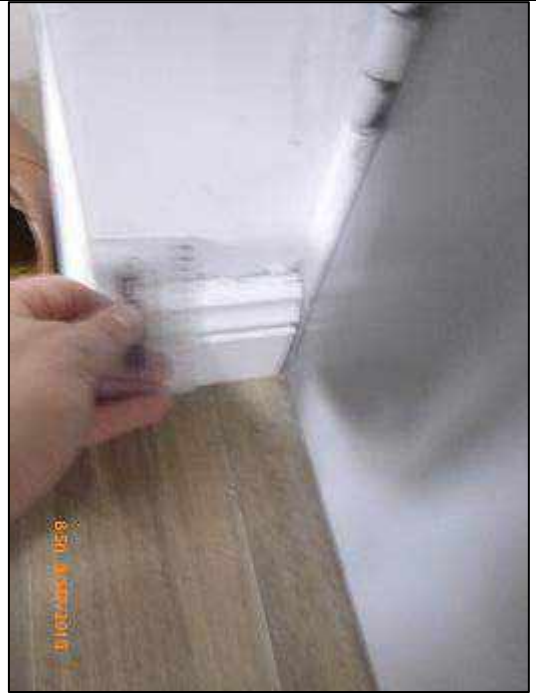
Item	Location	Defect description and Breach	Rectification	Photograph (if applicable)
1542	Wall adjacent to front entry door skirting board	See section 5.14.1 Separation; 1.5mm	See section 5.14.2

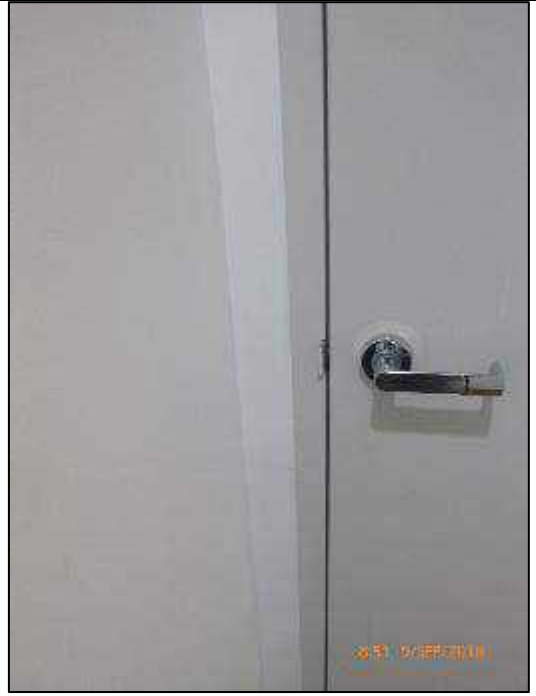
Item	Location	Defect description and Breach	Rectification	Photograph (if applicable)
1543	Wall adjacent to front entry wardrobe	See section 5.13.1	See section 5.13.2

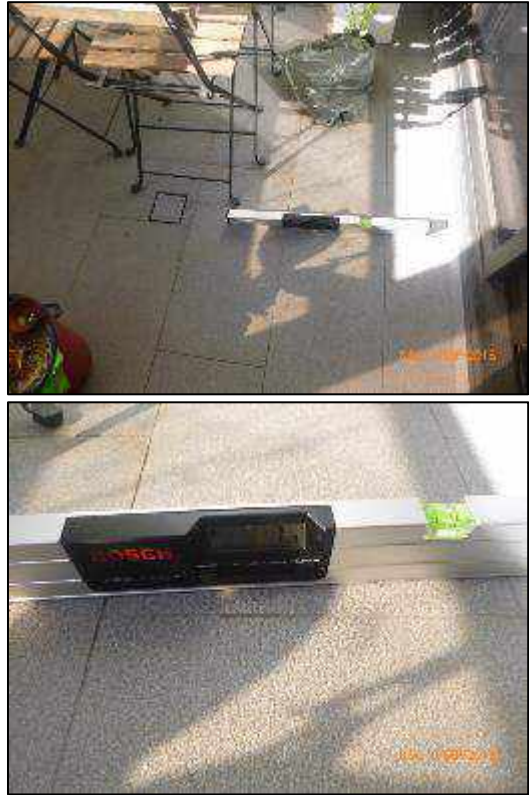
Item	Location	Defect description and Breach	Rectification	Photograph (if applicable)
1544	Balcony	See section 5.2.1 Falls (mm); 7/1000	See section 5.2.2

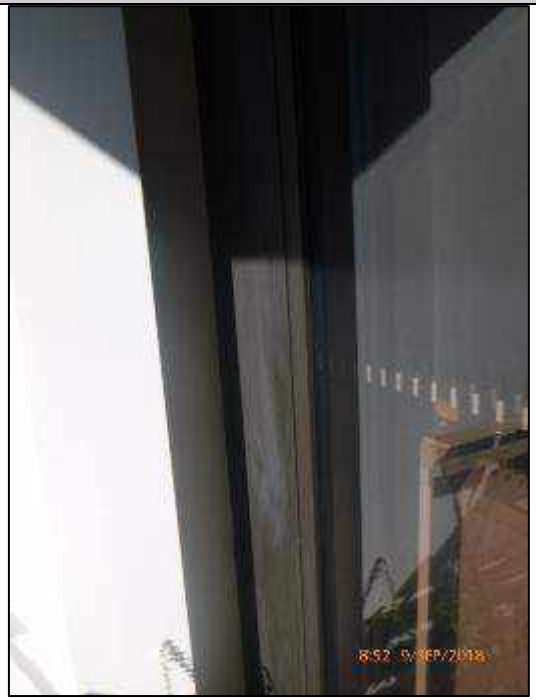
Item	Location	Defect description and Breach	Rectification	Photograph (if applicable)
1545	Balcony sliding door frame	See section 5.7.1	See section 5.7.2

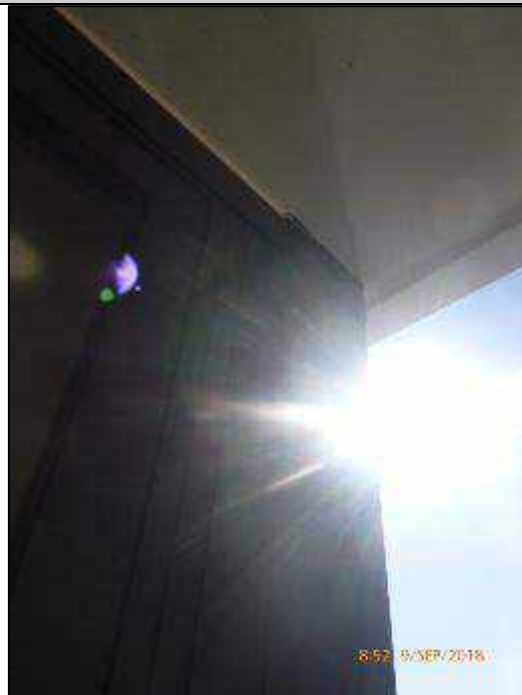
Item	Location	Defect description and Breach	Rectification	Photograph (if applicable)
1546	Balcony	<p>Separation observed between sliding door and ceiling.</p> <p>Home Building Act (NSW) 1989</p> <ul style="list-style-type: none"> Part 2C, 18B (a) and (c). <p>Guide to Standards and Tolerances 2017</p> <p>10.16 Cracking at junctions of dissimilar materials-Cracking at junctions between dissimilar materials is a defect if it is greater than 1 mm or is visible from a normal viewing position.</p> <p>Loss Suffered</p> <p>Loss suffered is cost of rectification.</p>	<ol style="list-style-type: none"> 1. Protect all surrounding areas 2. Apply a bead of flexible sealant to the joint between the sliding door frame and wall 3. As required, all affected surfaces are to be painted with an appropriate paint system to match as close as possible to the existing in accordance with the manufacturer's recommendations and AS2311 – Guide to the painting of buildings. 4. Clean up the work area

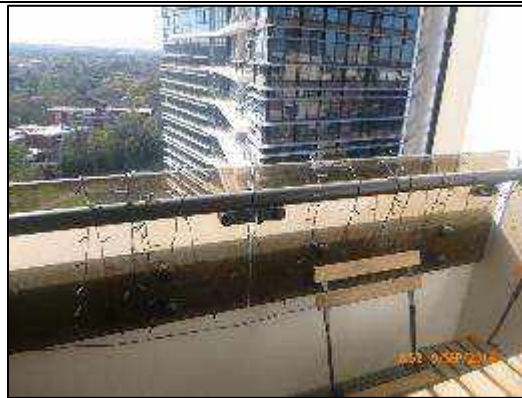
1547	Balcony	See section 5.4.1	See section 5.4.2

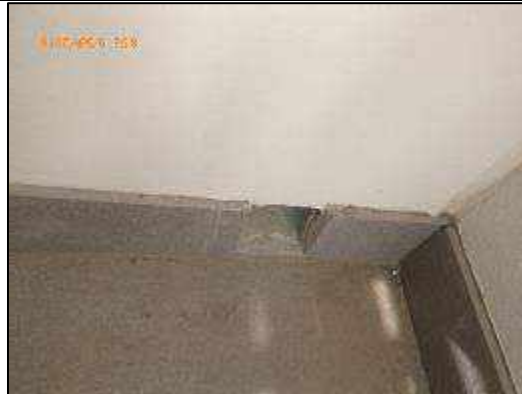
Item	Location	Defect description and Breach	Rectification	Photograph (if applicable)
1548	Balcony	See section 5.15.1	See section 5.15.2

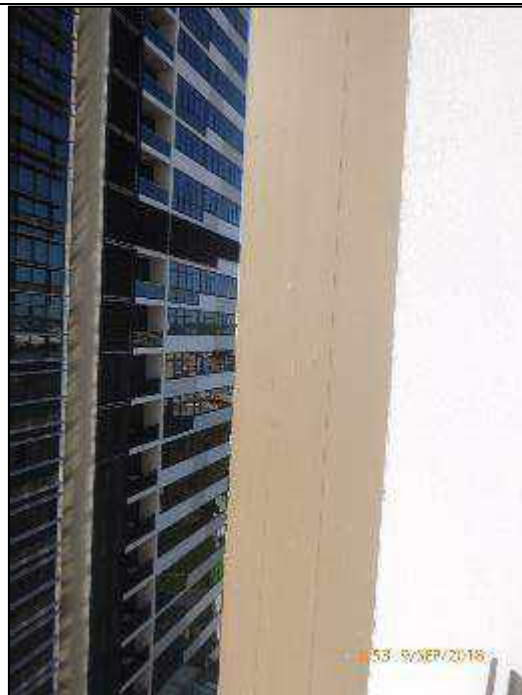
1549	External façade panels in balcony area	See section 5.9.1	See section 5.9.2

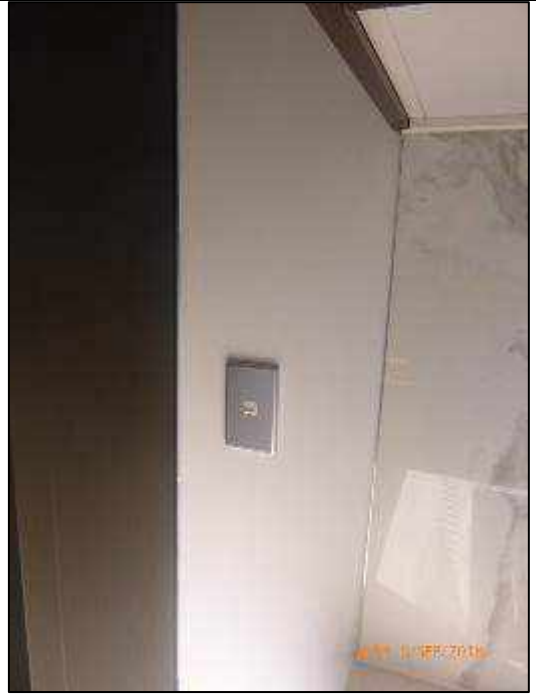
Item	Location	Defect description and Breach	Rectification	Photograph (if applicable)
1550	Wall adjacent to kitchen cupboards	See section 5.13.1	See section 5.13.2

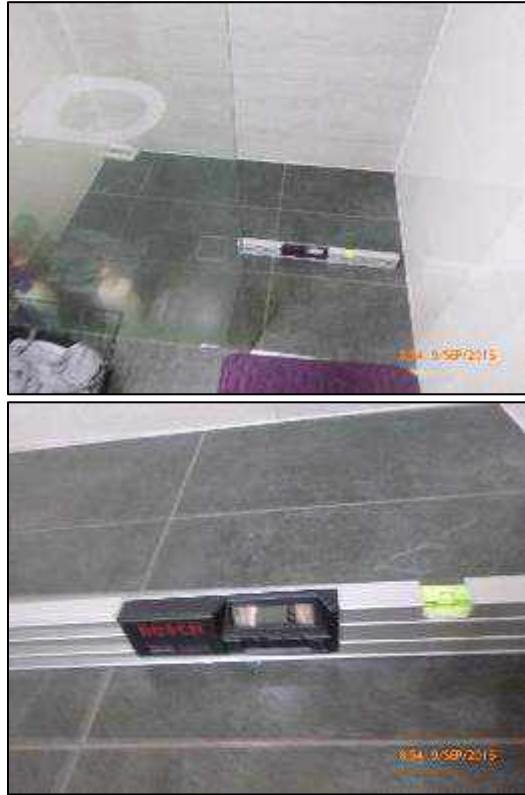
Item	Location	Defect description and Breach	Rectification	Photograph (if applicable)
1551	Main bathroom	See section 5.1.1 Falls (mm); 8/1000	See section 5.1.2

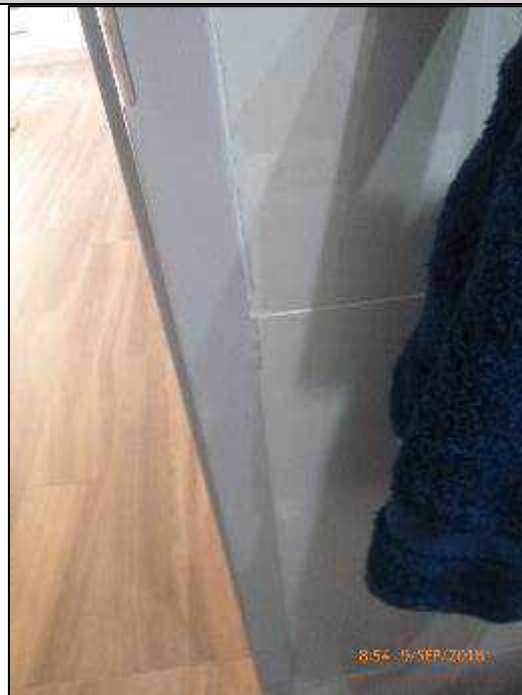
Item	Location	Defect description and Breach	Rectification	Photograph (if applicable)
1552	Wall adjacent to main bathroom door	See section 5.9.1	See section 5.9.2

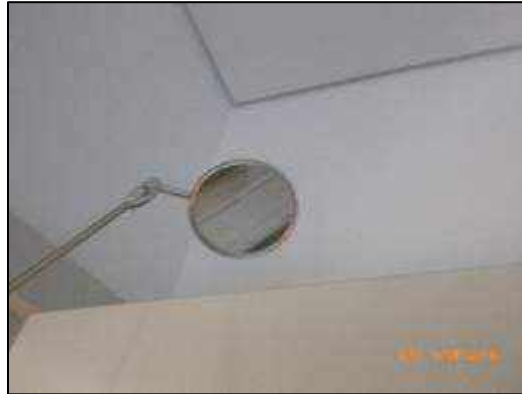
Item	Location	Defect description and Breach	Rectification	Photograph (if applicable)
1554	Doors throughout the unit (x2)	See section 5.5.1	See section 5.5.2

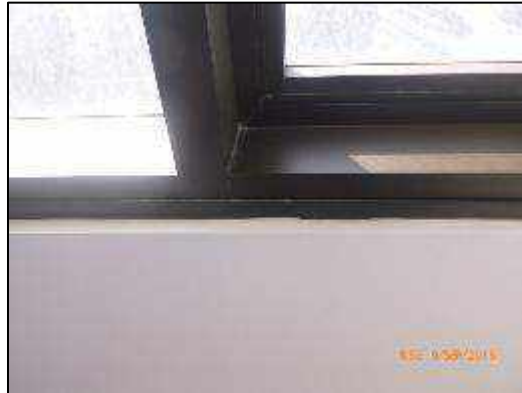
1555	Main bedroom window frames	See section 5.9.1	See section 5.9.2

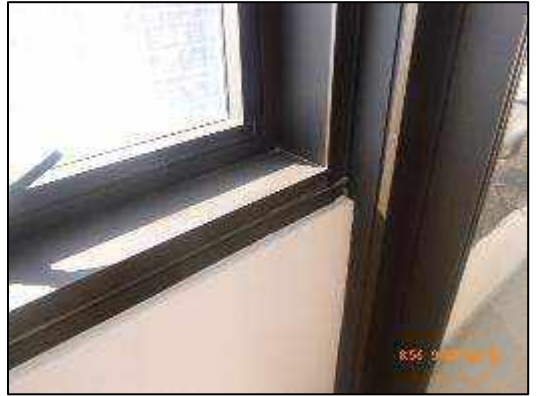
Item	Location	Defect description and Breach	Rectification	Photograph (if applicable)
1556	Lounge room window frames	See section 5.9.1	See section 5.9.2

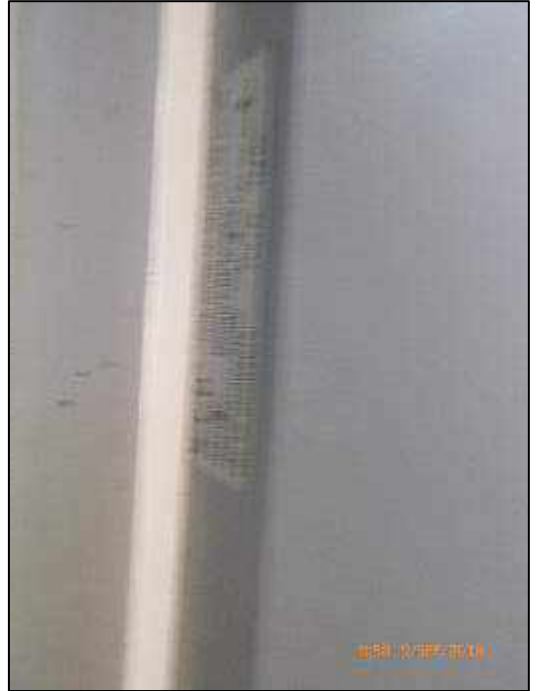
Item	Location	Defect description and Breach	Rectification	Photograph (if applicable)
Unit 1405				
1557	Front entry door	See section 5.12.1	See section 5.12.2

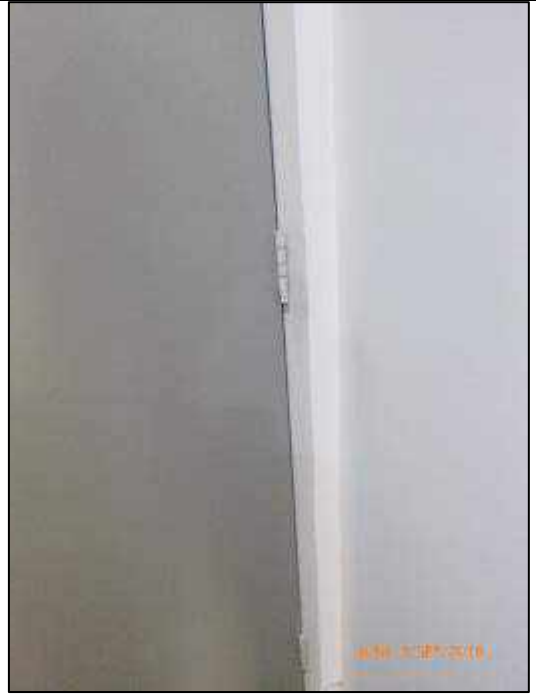
Item	Location	Defect description and Breach	Rectification	Photograph (if applicable)
1558	Wall adjacent to front entry door	See section 5.13.1	See section 5.13.2

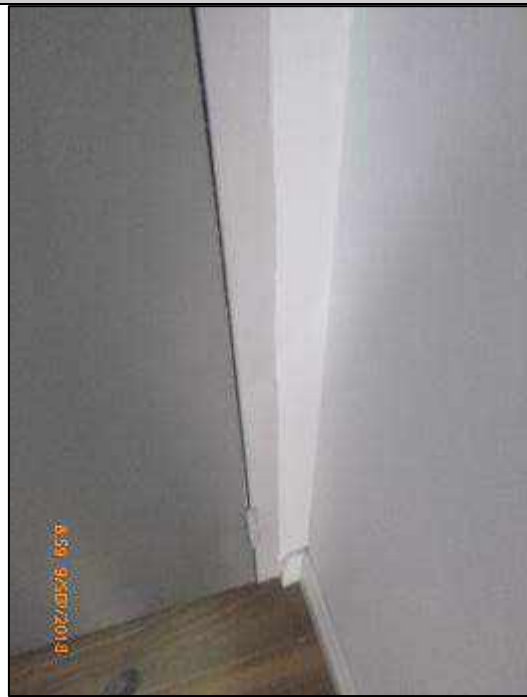
Item	Location	Defect description and Breach	Rectification	Photograph (if applicable)
1559	Wall adjacent to front entry door	See section 5.9.1	See section 5.9.2

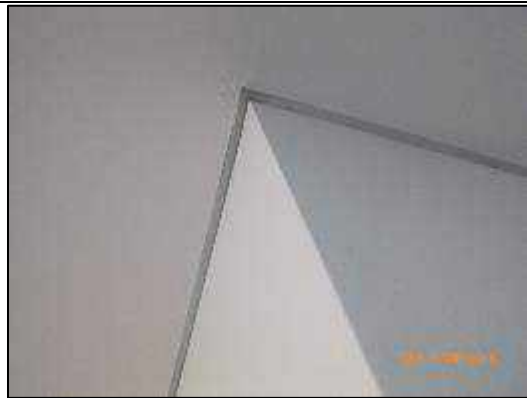
A photograph showing a vertical crack or gap in a light-colored wall. The crack runs from the top of the frame down to a dark, possibly wooden, base or door frame. The lighting is somewhat dim, and the wall appears slightly textured.
1560	Lounge room	See section 5.11.1	See section 5.11.2

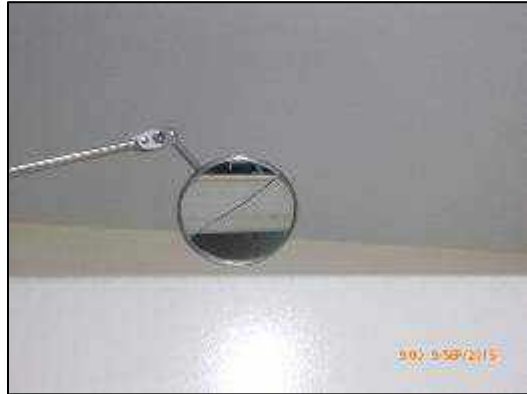
Item	Location	Defect description and Breach	Rectification	Photograph (if applicable)
1561	<i>Doors throughout the unit (x3)</i>	See section 5.5.1	See section 5.5.2

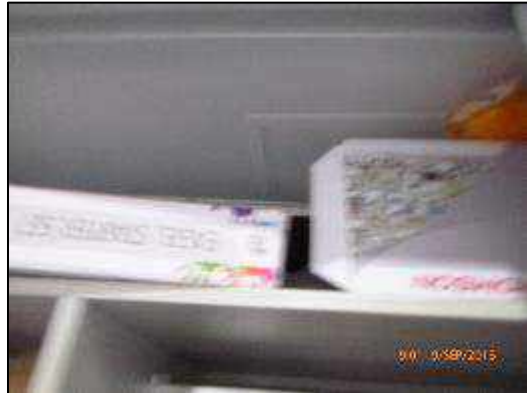
1562	<i>Second bedroom built in</i>	See section 5.6.1	See section 5.6.2

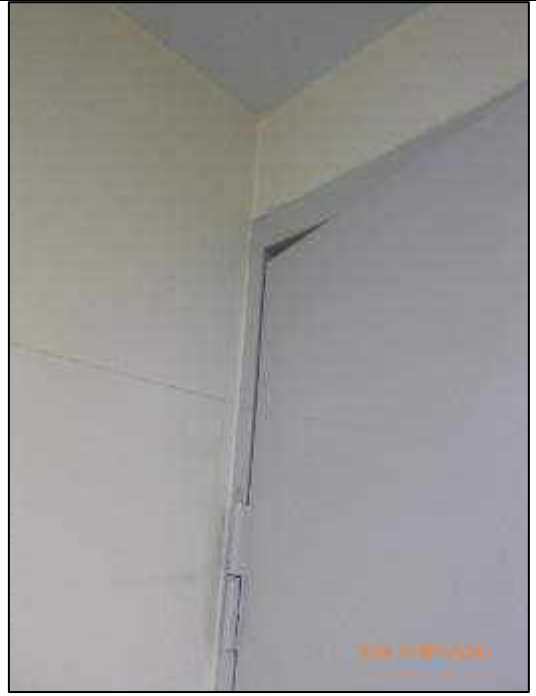
Item	Location	Defect description and Breach	Rectification	Photograph (if applicable)
1563	Wall adjacent to main bathroom door	See section 5.9.1	See section 5.9.2

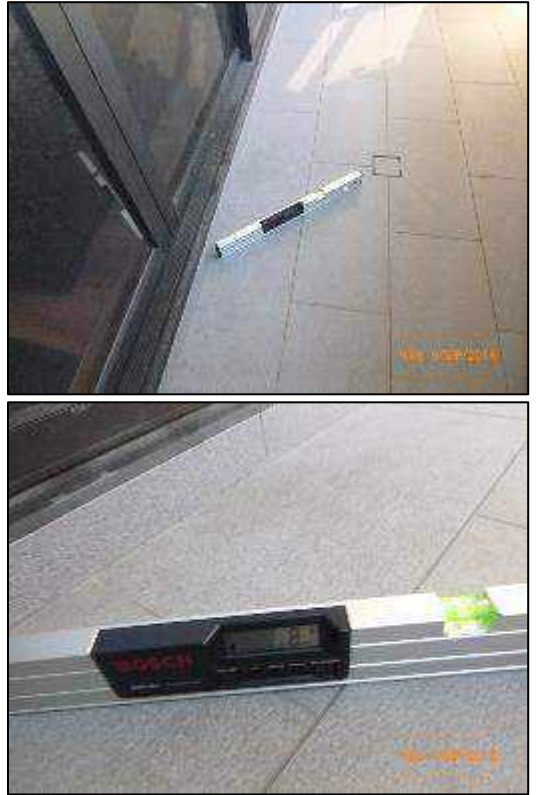
Item	Location	Defect description and Breach	Rectification	Photograph (if applicable)
1564	Balcony	See section 5.2.1 Falls (mm); 8/1000	See section 5.2.2

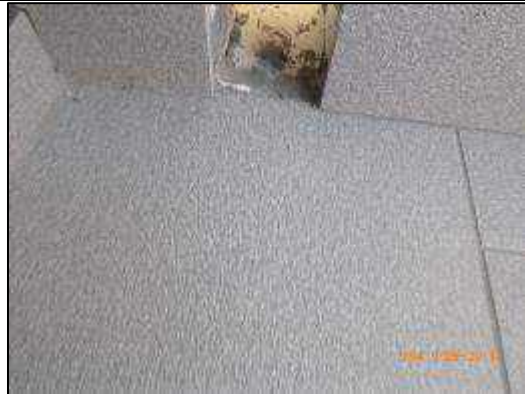
Item	Location	Defect description and Breach	Rectification	Photograph (if applicable)
1565	Balcony	See section 5.15.1	See section 5.15.2

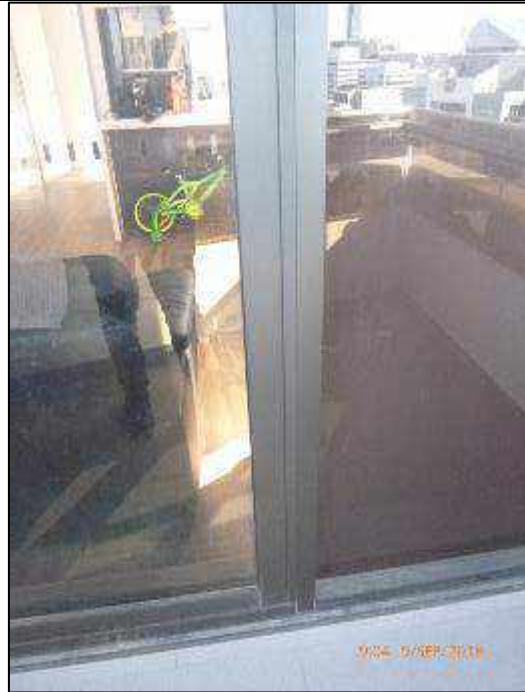
1566	Balcony sliding door frame	See section 5.7.1	See section 5.7.2

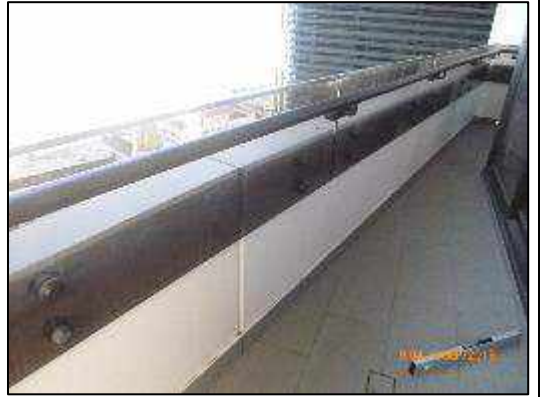
Item	Location	Defect description and Breach	Rectification	Photograph (if applicable)
1567	Balcony	See section 5.4.1	See section 5.4.2

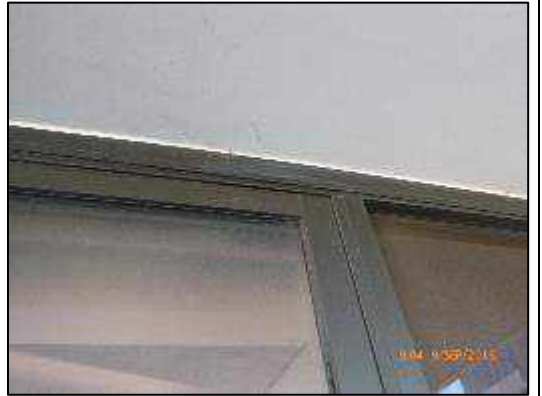
1568	Balcony sliding door frame	See section 5.9.1	See section 5.9.2

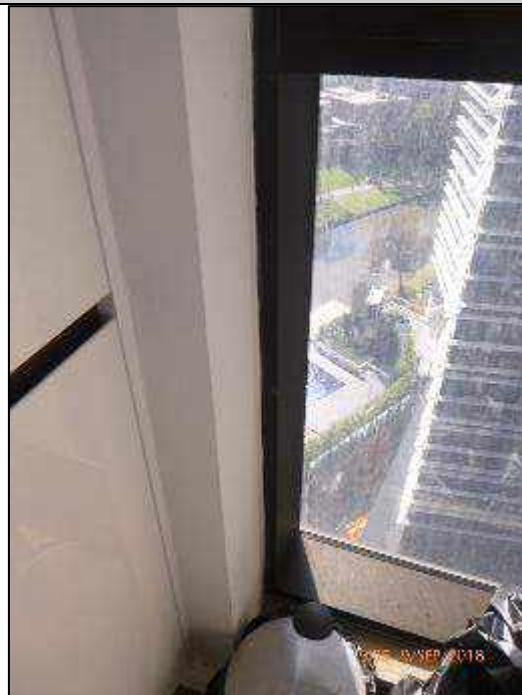
Item	Location	Defect description and Breach	Rectification	Photograph (if applicable)
1569	Kitchen window frames	See section 5.9.1	See section 5.9.2

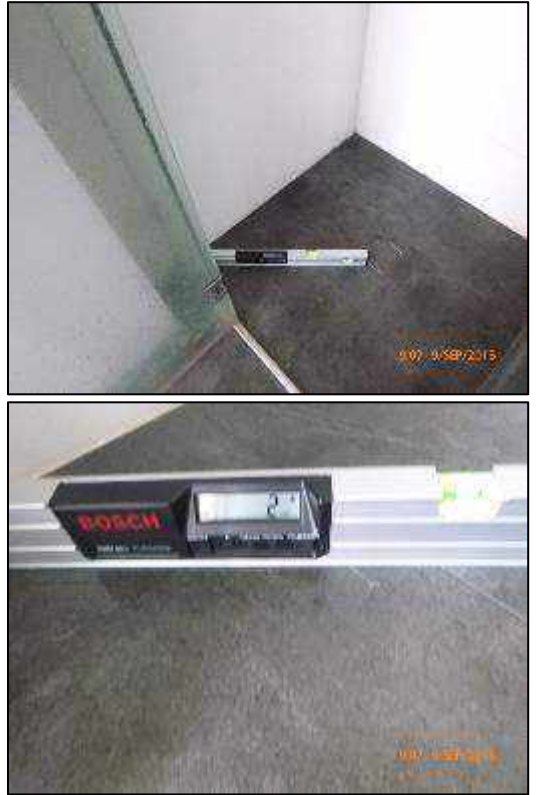
Item	Location	Defect description and Breach	Rectification	Photograph (if applicable)
1571	Main bedroom ensuite	See section 5.1.1 Falls (mm); 2/1000	See section 5.1.2

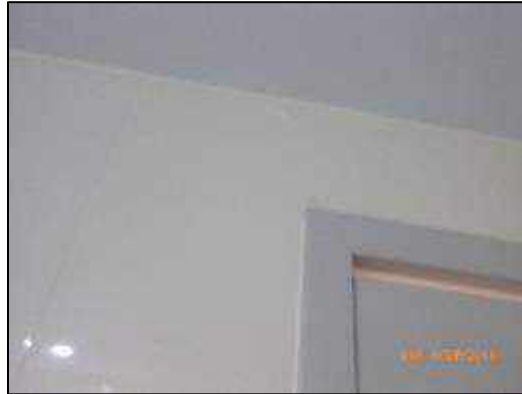
Item	Location	Defect description and Breach	Rectification	Photograph (if applicable)
1572	Wall adjacent to ensuite door	See section 5.9.1	See section 5.9.2
