SydneyStrataReport

STRATA REPORT

Client	Church Street Parramatta Property Pty Ltd
Address of property	Unit 3303/330 Church Street, Parramatta, NSW.
Lot	359
Strata Plan	SP 94469
Name of Strata Management Co.	NSW Strata
Telephone Number of Strata Agent	8980 1841
Report Date	15 February 2024

BUILDING DEFECTS REPORT Part 1/2

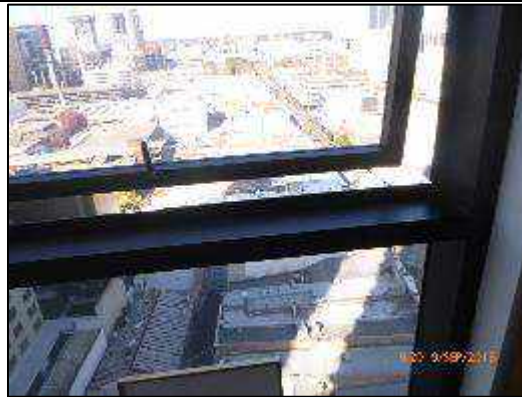
Unit 1406				
1573		No access was provided.		
Unit 1407				
1574	Main bedroom	<p>Resident advised of window whistling in southern windows.</p> <p>Home Building Act (NSW) 1989</p> <ul style="list-style-type: none"> Part 2C, 18B (a) & (c). <p>Loss Suffered</p> <p>Loss suffered is cost of rectification.</p>	Engage a licenced tradesman to reseal windows to prevent excessive noise to the unit in accordance with manufacturers specifications.

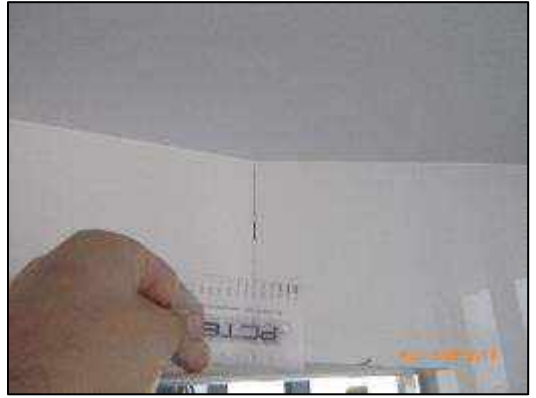
Item	Location	Defect description and Breach	Rectification	Photograph (if applicable)
1575	Main bedroom ensuite northern wall joint	See section 5.14.1 Separation; 2mm	See section 5.14.2

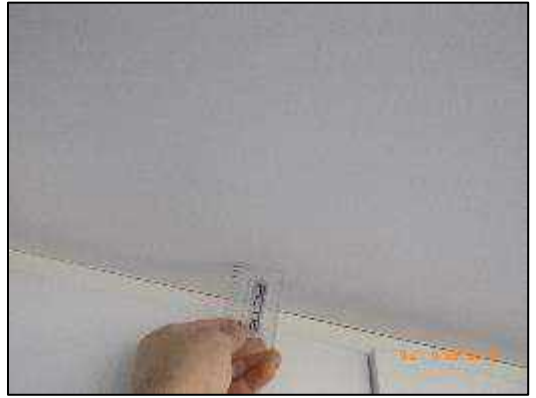
1576	Ceiling above kitchen cupboards	See section 5.14.1 Separation; 1.5mm	See section 5.14.2

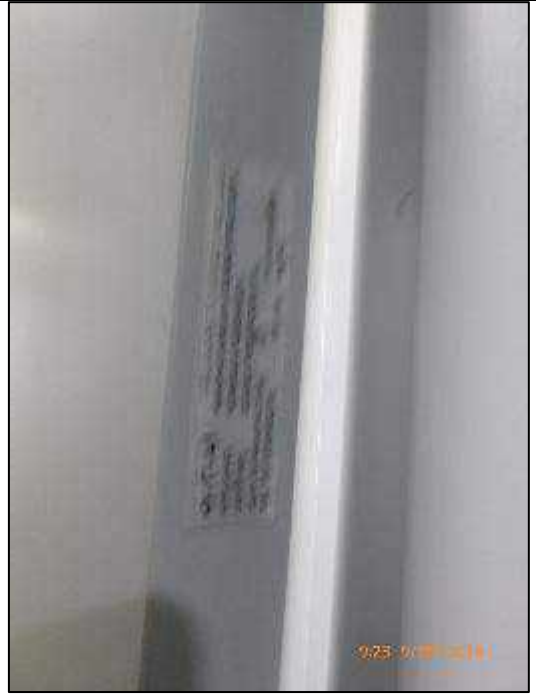
Item	Location	Defect description and Breach	Rectification	Photograph (if applicable)
1577	Front entry door	See section 5.12.1	See section 5.12.2

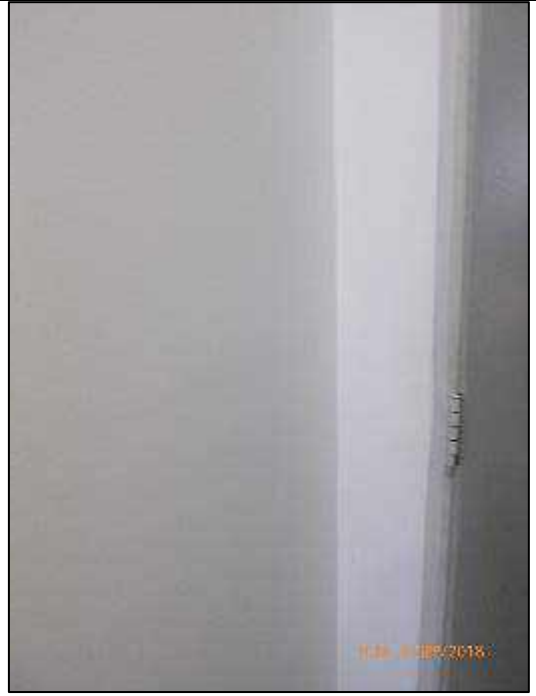
Item	Location	Defect description and Breach	Rectification	Photograph (if applicable)
1578	Wall adjacent to front entry door	See section 5.13.1	See section 5.13.2

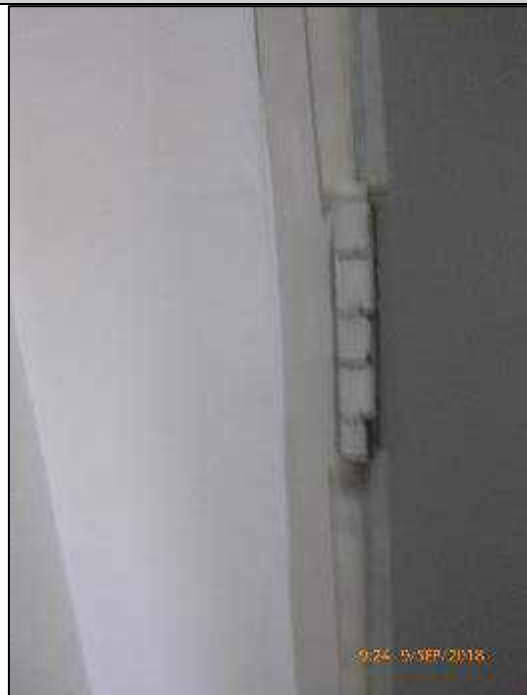
Item	Location	Defect description and Breach	Rectification	Photograph (if applicable)
1579	Wall adjacent to front entry door	See section 5.9.1	See section 5.9.2

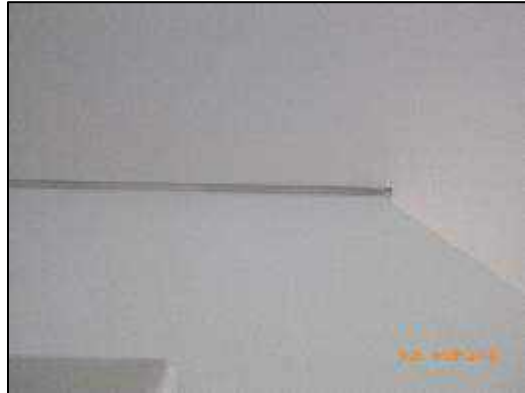
Item	Location	Defect description and Breach	Rectification	Photograph (if applicable)
1581	Lounge room	See section 5.11.1	See section 5.11.2

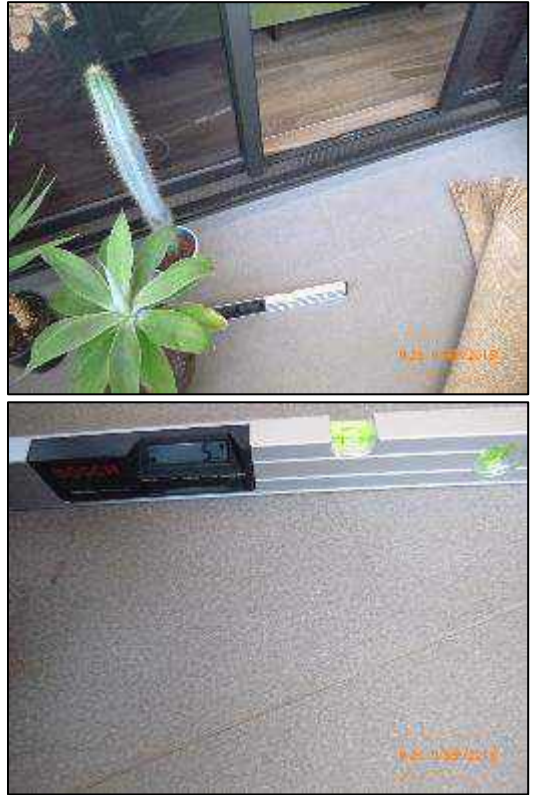
Item	Location	Defect description and Breach	Rectification	Photograph (if applicable)
1582	Balcony	See section 5.2.1 Falls (mm); 5/1000	See section 5.2.2

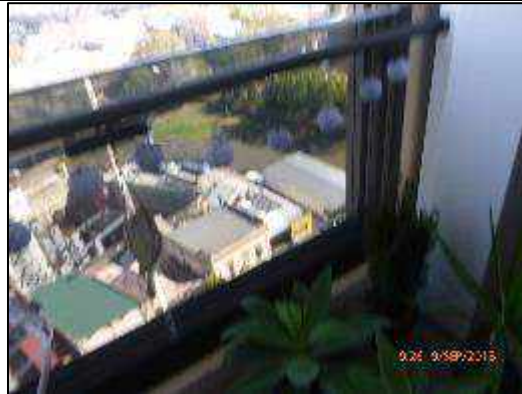
Item	Location	Defect description and Breach	Rectification	Photograph (if applicable)
1583	Balcony	See section 5.4.1	See section 5.4.2

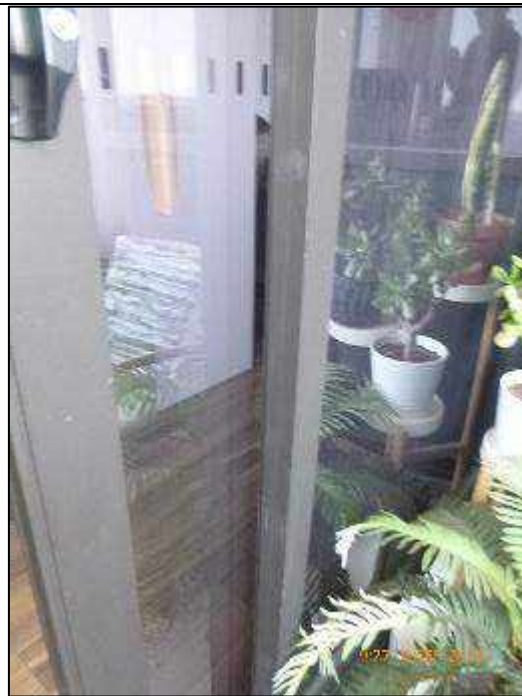
1584	Balcony sliding door frame	See section 5.7.1	See section 5.7.2

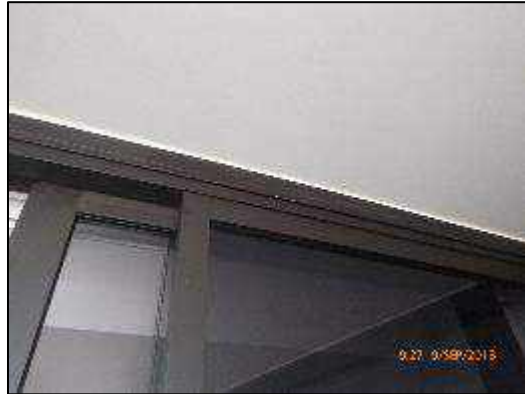
Item	Location	Defect description and Breach	Rectification	Photograph (if applicable)
1585	Balcony sliding door frame	See section 5.9.1	See section 5.9.2

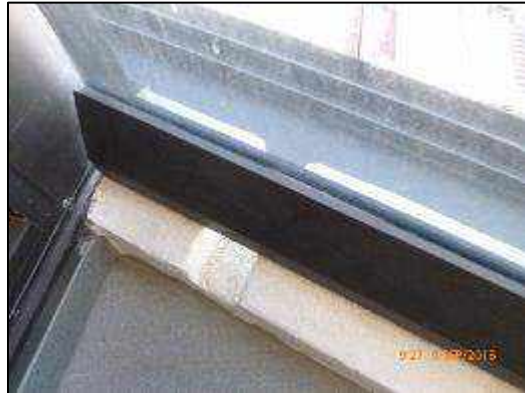
1586	Balcony	See section 5.15.1	See section 5.15.2

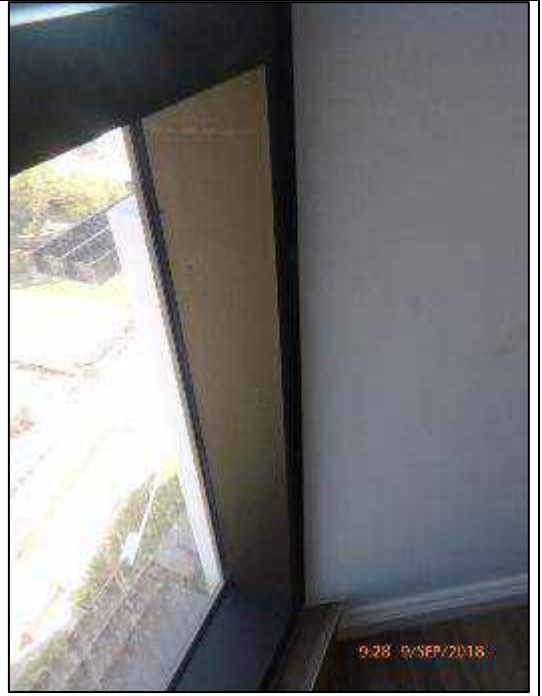
Item	Location	Defect description and Breach	Rectification	Photograph (if applicable)
1588	Dining room window frame	See section 5.7.1	See section 5.7.2

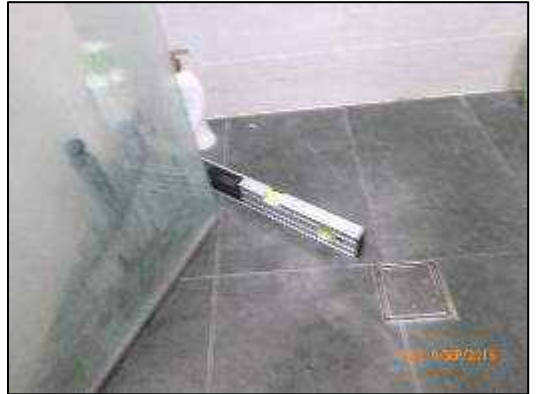
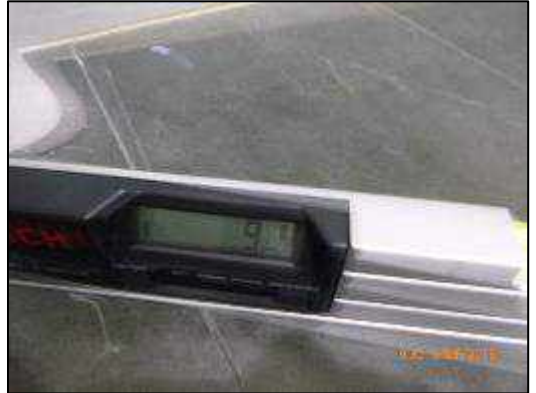
Item	Location	Defect description and Breach	Rectification	Photograph (if applicable)
1589	Main bathroom	See section 5.1.1 Falls (mm); 9/1000	See section 5.1.2

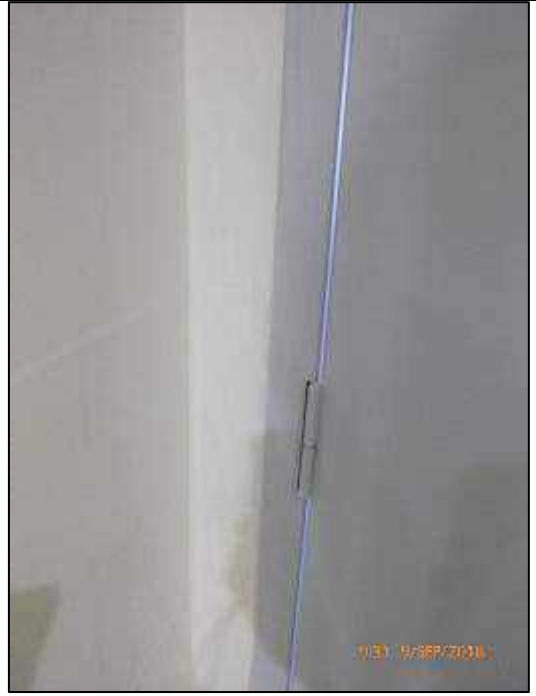
Item	Location	Defect description and Breach	Rectification	Photograph (if applicable)
1590	Wall adjacent to main bathroom door	See section 5.9.1	See section 5.9.2

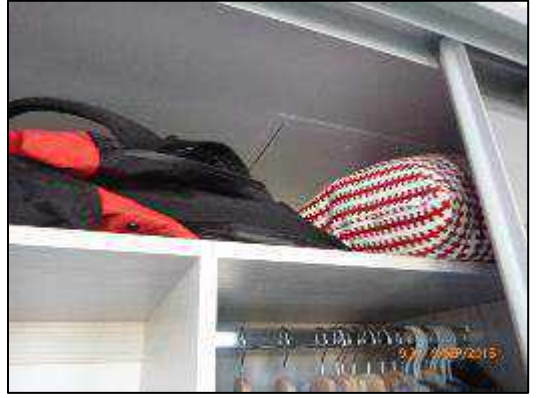
1591	Main bedroom built in	See section 5.6.1	See section 5.6.2

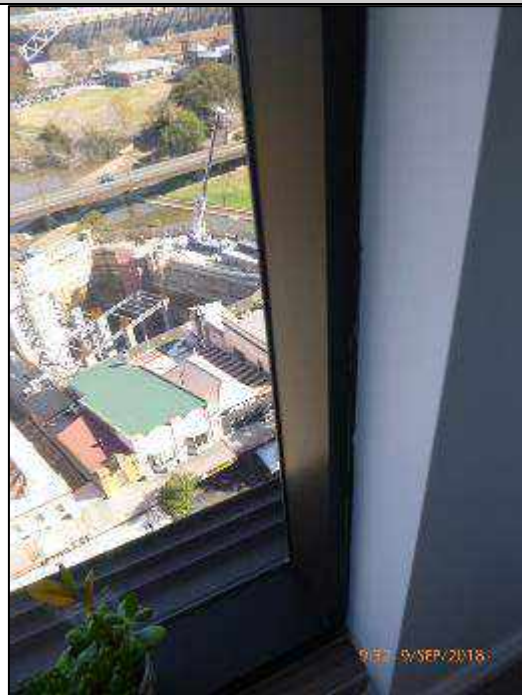
Item	Location	Defect description and Breach	Rectification	Photograph (if applicable)
1592	Main bedroom window frames	See section 5.9.1	See section 5.9.2

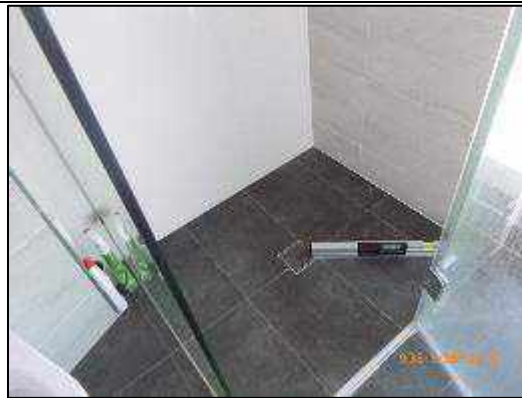
1593	Main bedroom ensuite	See section 5.1.1 Falls (mm); 8/1000	See section 5.1.2

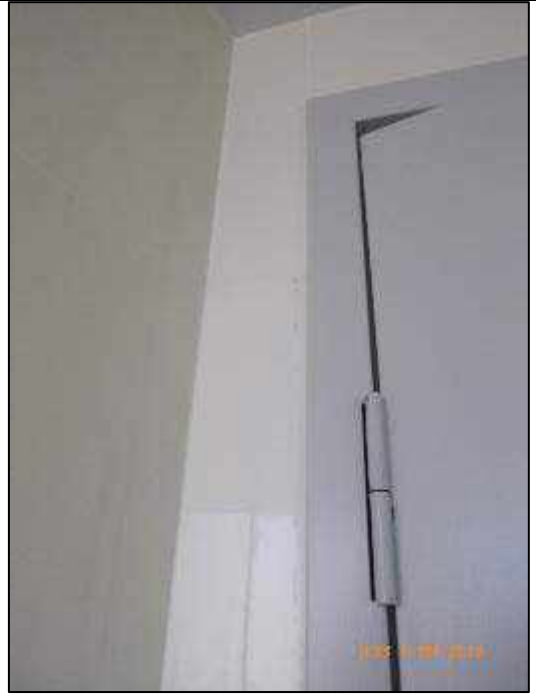
Item	Location	Defect description and Breach	Rectification	Photograph (if applicable)
1594	Wall adjacent to ensuite door	See section 5.9.1	See section 5.9.2

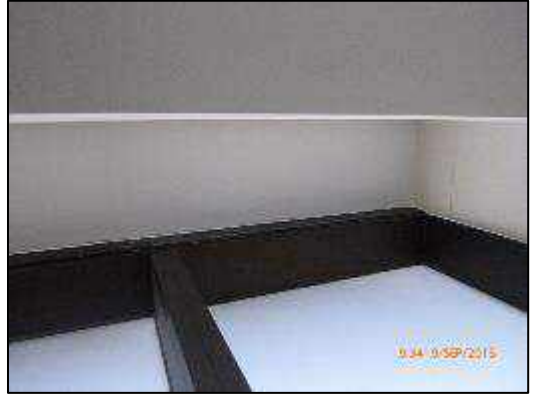
1595	Main bedroom ensuite ceiling	See section 5.10.1	See section 5.10.2

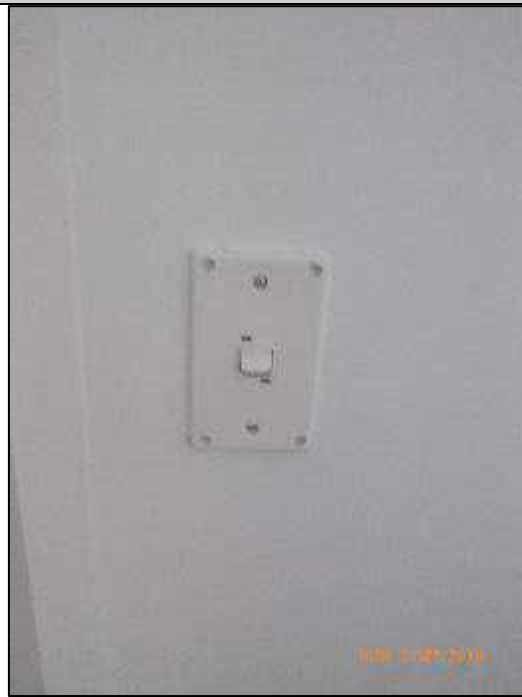
Item	Location	Defect description and Breach	Rectification	Photograph (if applicable)
1596	Study room	<p>Light switch cover in study room is missing.</p> <p>Home Building Act (NSW) 1989</p> <ul style="list-style-type: none"> Part 2C, 18B (a) and (c). <p>Loss Suffered</p> <p>Loss suffered is cost of rectification.</p>	Source a light switch cover to match existing light switches and engage a licenced electrician to install in accordance with manufacturers specifications.

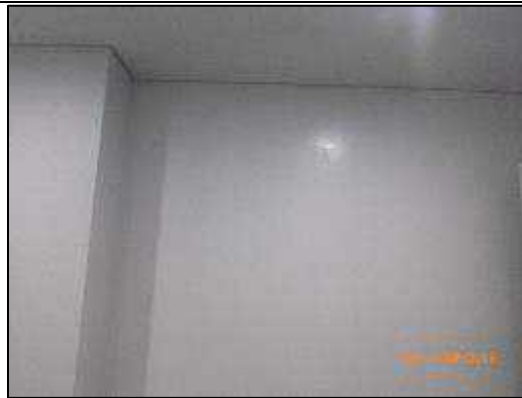
1597	Second bedroom southern wall	See section 5.13.1	See section 5.13.2

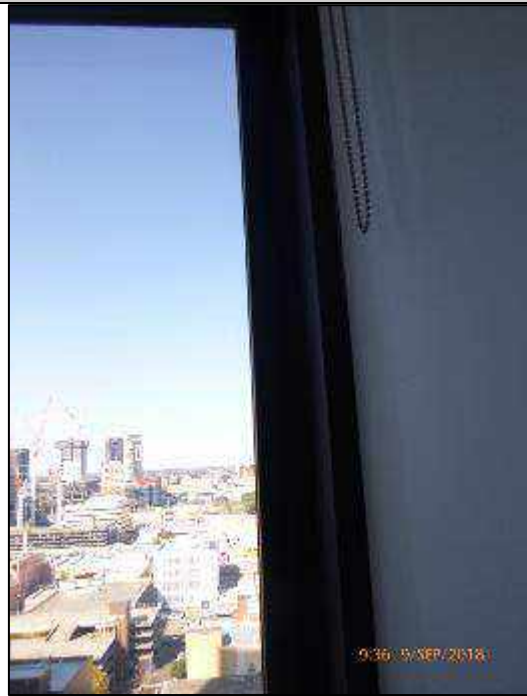
Item	Location	Defect description and Breach	Rectification	Photograph (if applicable)
1598	Second bedroom window frames	See section 5.9.1	See section 5.9.2

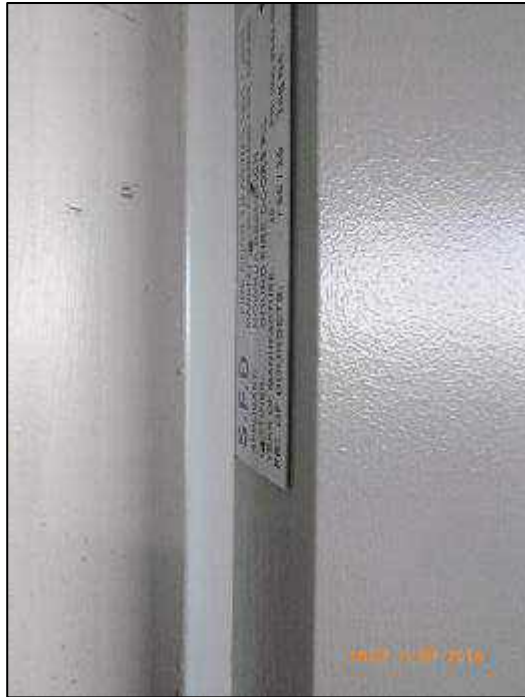
Item	Location	Defect description and Breach	Rectification	Photograph (if applicable)
Unit 1501				
1600	Front entry door	See section 5.12.1	See section 5.12.2

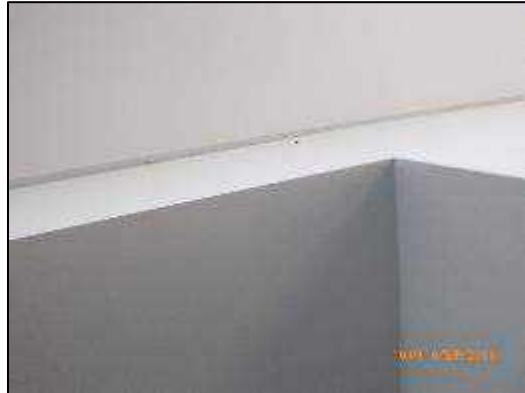
Item	Location	Defect description and Breach	Rectification	Photograph (if applicable)
1601	Lounge room	See section 5.11.1	See section 5.11.2

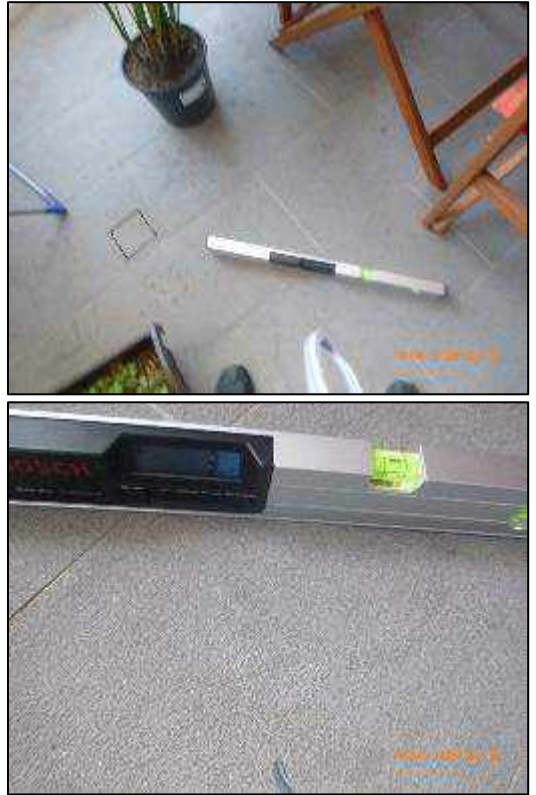
Item	Location	Defect description and Breach	Rectification	Photograph (if applicable)
1602	Balcony	See section 5.2.1 Falls (mm); 3/1000	See section 5.2.2

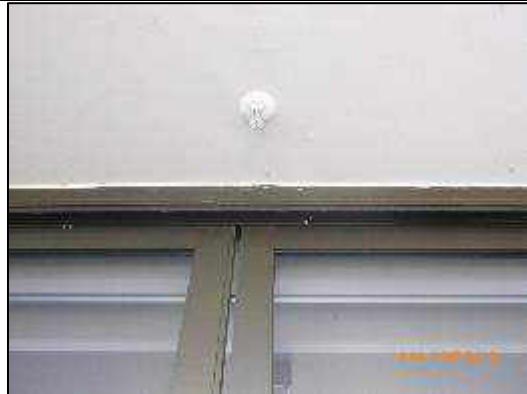
Item	Location	Defect description and Breach	Rectification	Photograph (if applicable)
1603	Balcony sliding door frame	See section 5.9.1	See section 5.9.2

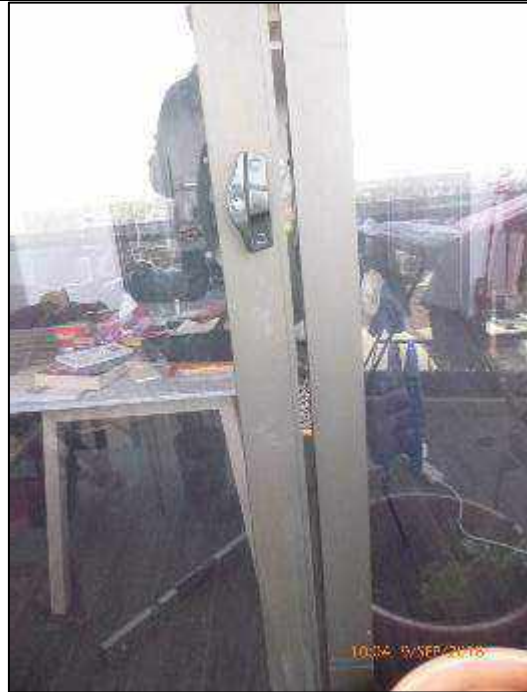
1604	Balcony sliding door frame	See section 5.7.1	See section 5.7.2

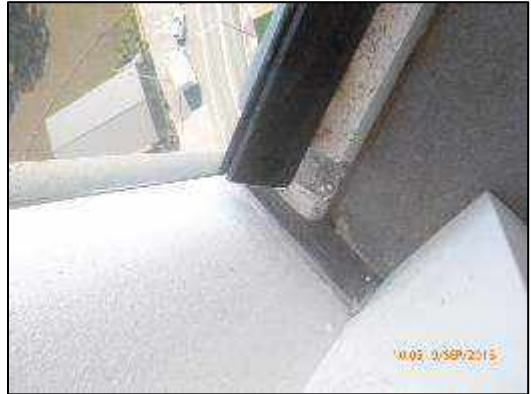
Item	Location	Defect description and Breach	Rectification	Photograph (if applicable)
1605	Balcony	See section 5.15.1	See section 5.15.2

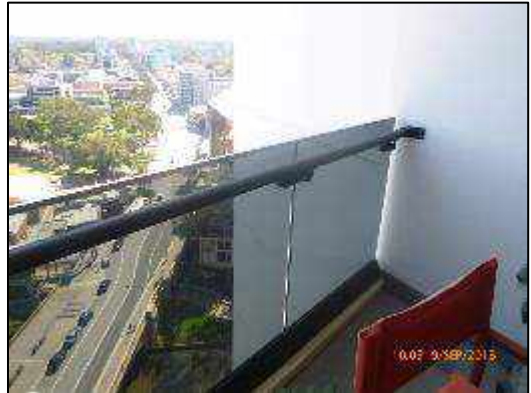
1606	Balcony	See section 5.4.1	See section 5.4.2

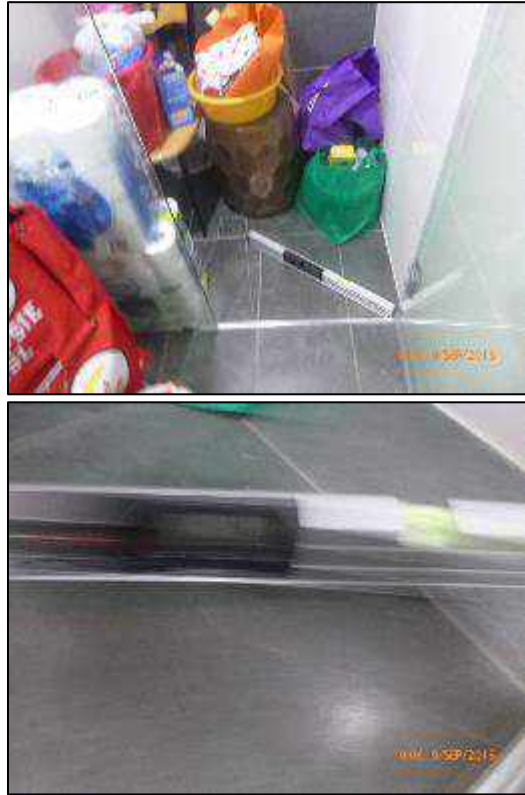
Item	Location	Defect description and Breach	Rectification	Photograph (if applicable)
1607	Main bathroom	See section 5.1.1 Falls (mm); 4/1000	See section 5.1.2

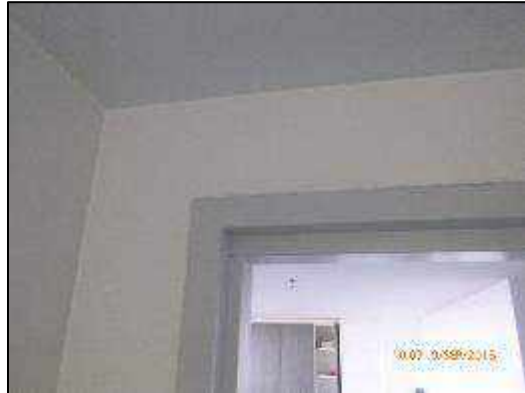
Item	Location	Defect description and Breach	Rectification	Photograph (if applicable)
1608	Wall adjacent to main bathroom door	See section 5.9.1	See section 5.9.2

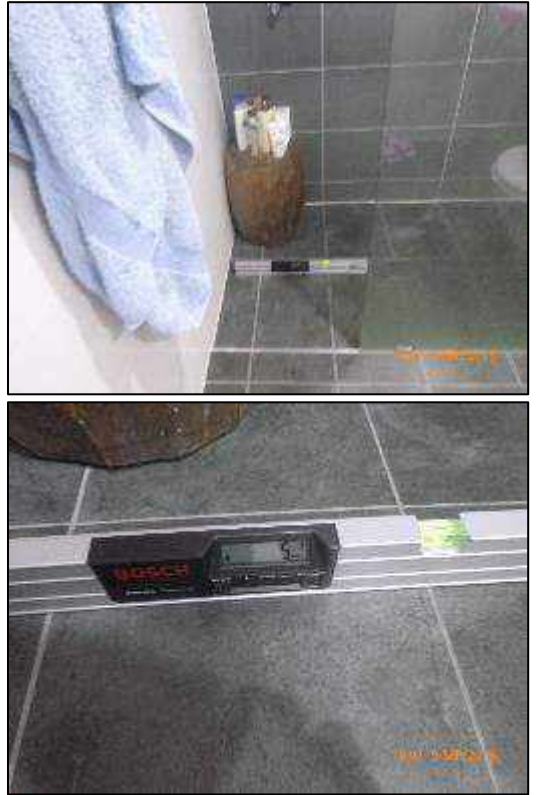
Item	Location	Defect description and Breach	Rectification	Photograph (if applicable)
1609	Main bedroom ensuite	See section 5.1.1 Falls (mm); 5/1000	See section 5.1.2

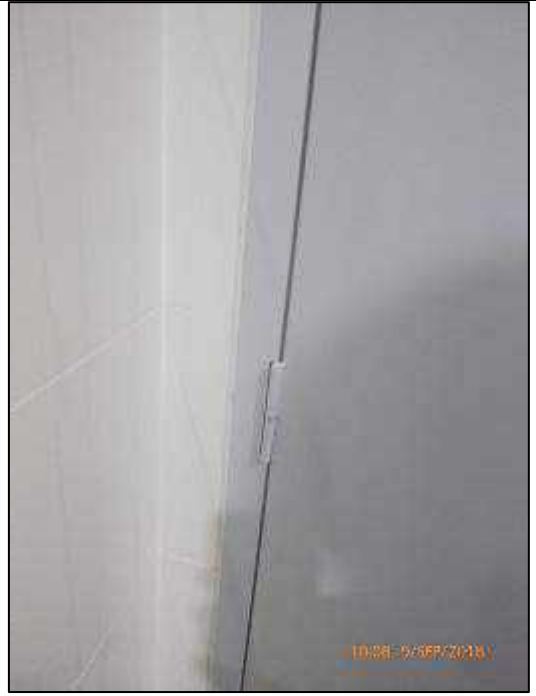
Item	Location	Defect description and Breach	Rectification	Photograph (if applicable)
1610	Wall adjacent to ensuite door	See section 5.9.1	See section 5.9.2

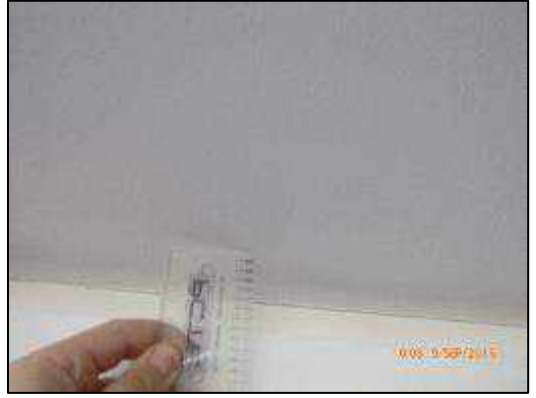
1611	Ceiling above kitchen cupboards	See section 5.14.1 Separation; 2mm	See section 5.14.2

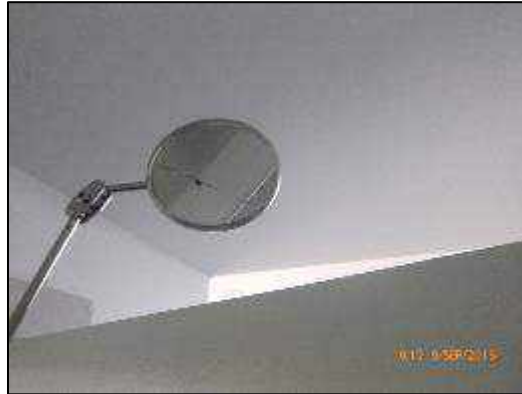
Item	Location	Defect description and Breach	Rectification	Photograph (if applicable)
1612	<i>Doors throughout the unit (x3)</i>	See section 5.5.1	See section 5.5.2

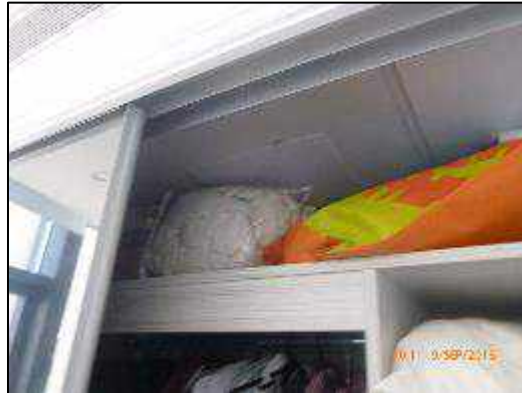
1613	<i>Second bedroom built in</i>	See section 5.6.1	See section 5.6.2

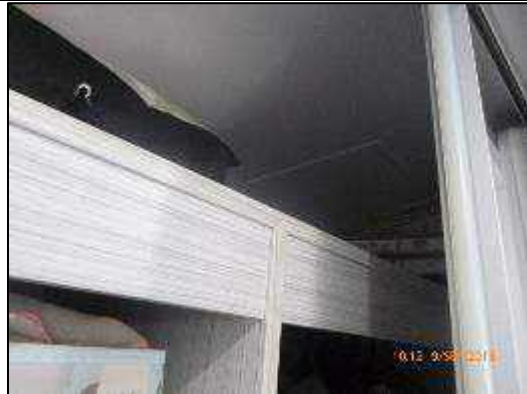
Item	Location	Defect description and Breach	Rectification	Photograph (if applicable)
1616	Main bedroom built in	See section 5.6.1	See section 5.6.2

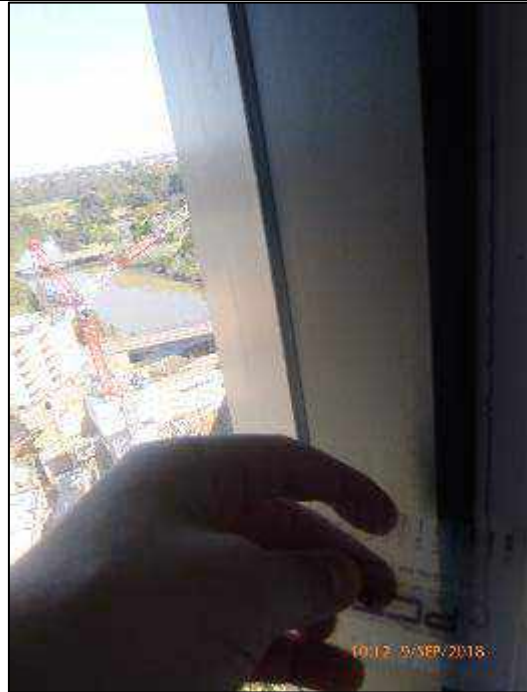
1617	Main bedroom window frames	See section 5.14.1 Separation; 1.5mm	See section 5.14.2

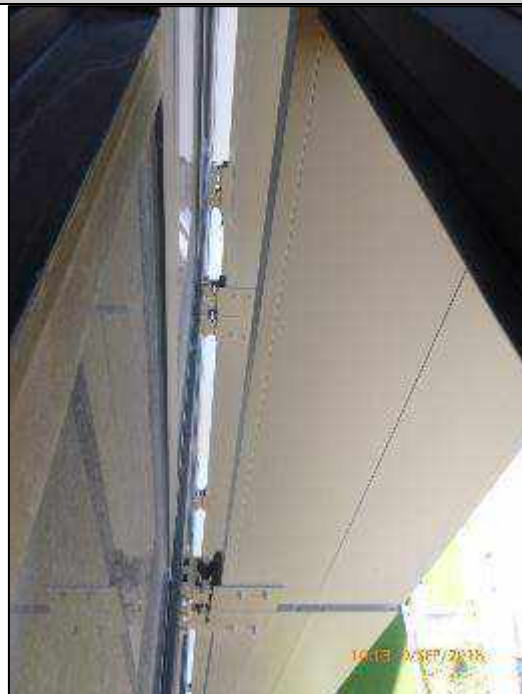
Item	Location	Defect description and Breach	Rectification	Photograph (if applicable)
1618	External façade panels outside main bedroom	<p>Construction debris observed on the external façade.</p> <p>Home Building Act (NSW) 1989</p> <ul style="list-style-type: none"> Part 2C, 18B (a) and (c). <p>This is a breach of part (a) of the act because the surface has not been finished in a proper workmanlike manner that would prevent loss of appearance to the surface.</p> <p>Loss Suffered Loss suffered is cost of rectification.</p>	<ol style="list-style-type: none"> 1. Protect all adjoining surfaces. 2. Use a suitable cleaning agent to remove residue and clear debris. 3. Clean up the work area.

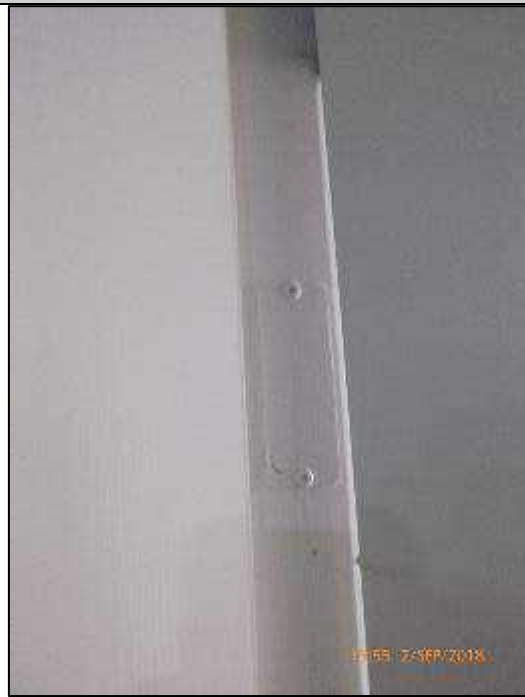
Item	Location	Defect description and Breach	Rectification	Photograph (if applicable)
1620	Front entry door frame	<p>Door frame label has been painted over.</p> <p>Home Building Act (NSW) 1989</p> <ul style="list-style-type: none"> Part 2C, 18B (a) & (c). <p>Loss Suffered</p> <p>Loss suffered is cost of rectification.</p>	Use a suitable cleaning agent to remove paint from the door frame label.

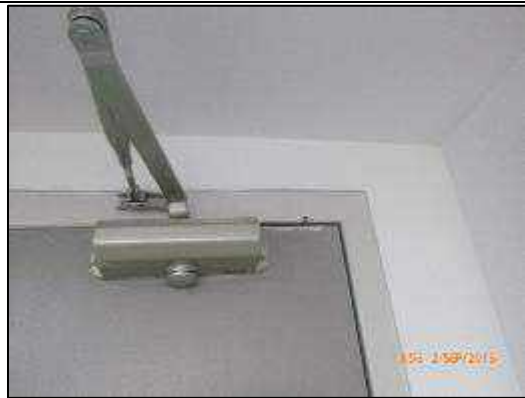
1621	Wall above front entry door	See section 5.13.1	See section 5.13.2

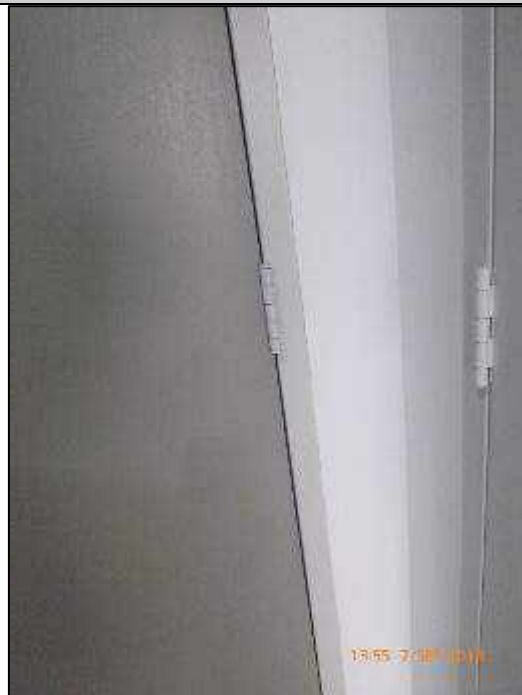
Item	Location	Defect description and Breach	Rectification	Photograph (if applicable)
1622	Wall adjacent to front entry door	See section 5.9.1	See section 5.9.2

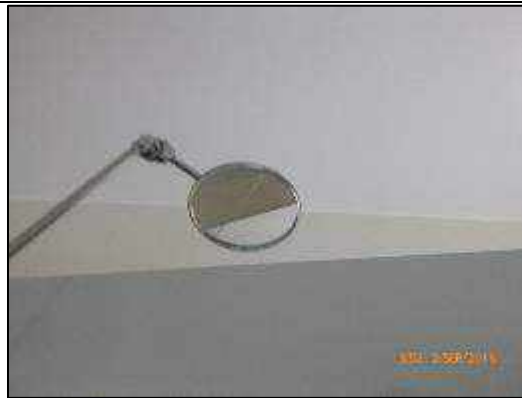
1623	Doors throughout the unit (x3)	See section 5.5.1	See section 5.5.2

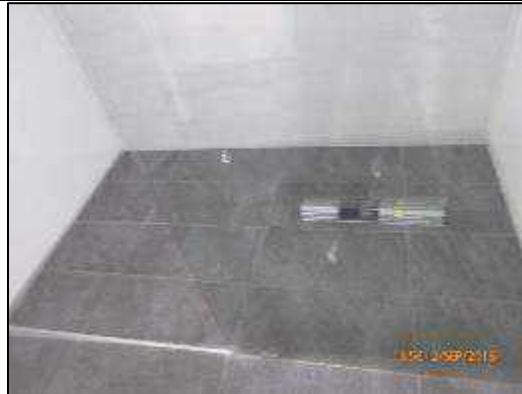
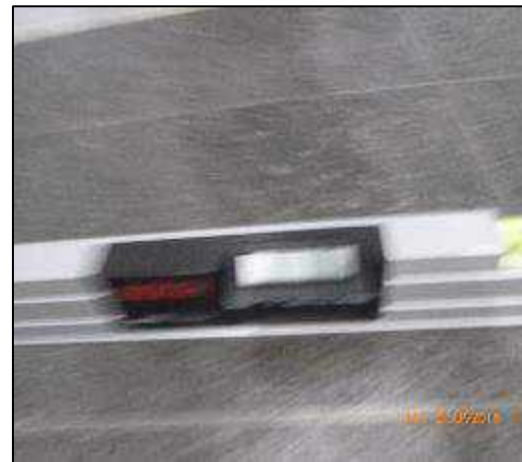
Item	Location	Defect description and Breach	Rectification	Photograph (if applicable)
1624	Main bathroom	See section 5.1.1 Falls (mm); 7/1000	See section 5.1.2

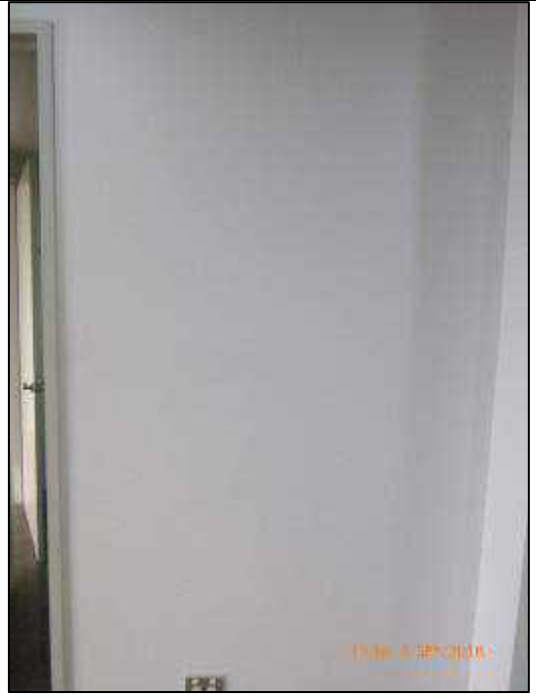
Item	Location	Defect description and Breach	Rectification	Photograph (if applicable)
1625	<i>Walls and ceiling throughout the unit</i>	See section 5.10.1	See section 5.10.2

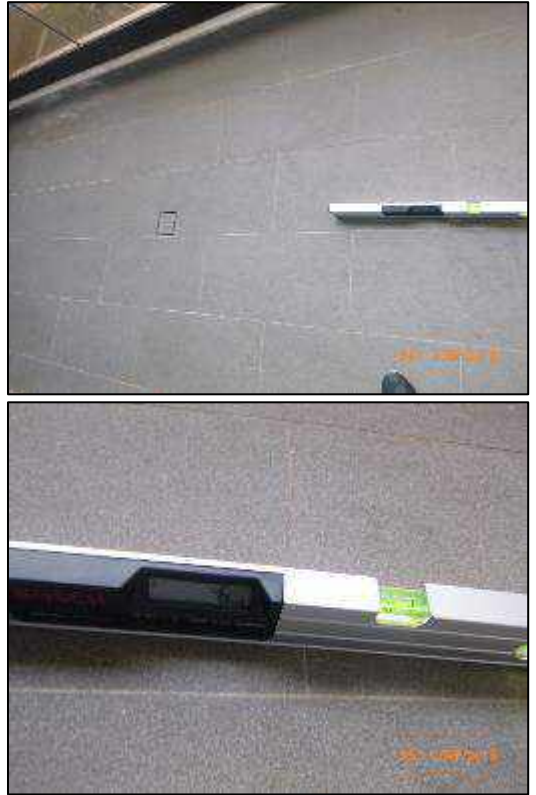
Item	Location	Defect description and Breach	Rectification	Photograph (if applicable)
1626	Balcony	See section 5.2.1 Falls (mm); 6/1000	See section 5.2.2

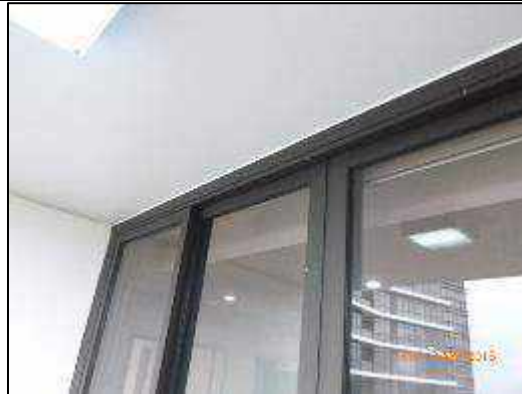
Item	Location	Defect description and Breach	Rectification	Photograph (if applicable)
1627	Balcony sliding door frame	See section 5.9.1	See section 5.9.2

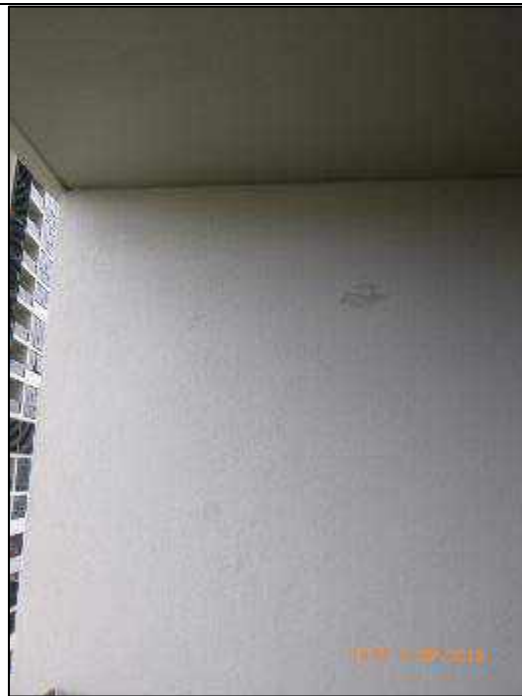
1628	Balcony eastern blade wall	See section 5.10.1	See section 5.10.2

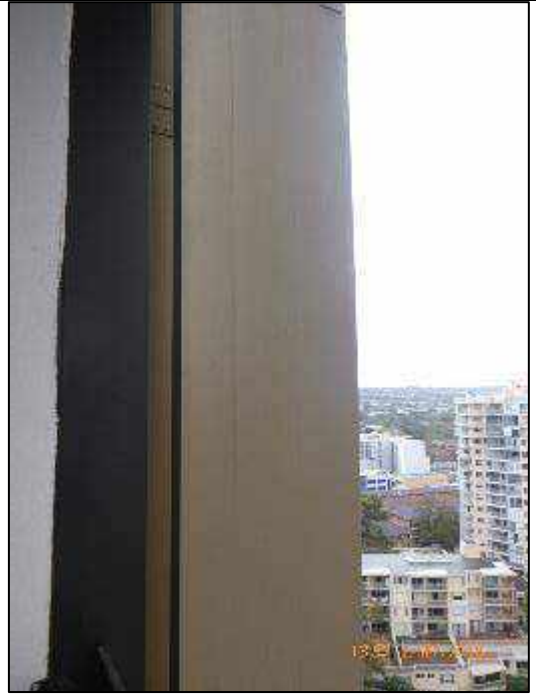
Item	Location	Defect description and Breach	Rectification	Photograph (if applicable)
1629	External façade panel of balcony	See section 5.7.1	See section 5.7.2

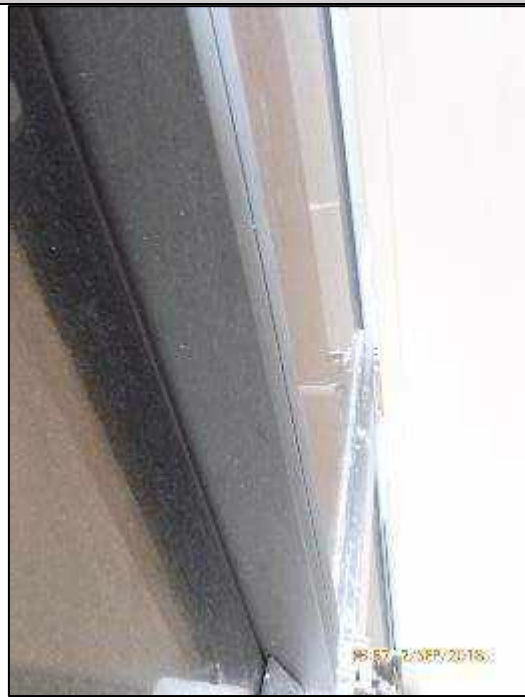
Item	Location	Defect description and Breach	Rectification	Photograph (if applicable)
1630	<i>Façade of the building adjacent to balcony area.</i>	<p>Construction debris observed on the external façade.</p> <p>Home Building Act (NSW) 1989</p> <ul style="list-style-type: none"> Part 2C, 18B (a) and (c). <p>This is a breach of part (a) of the act because the surface has not been finished in a proper workmanlike manner that would prevent loss of appearance to the surface.</p> <p>Loss Suffered Loss suffered is cost of rectification.</p>	<ol style="list-style-type: none"> 1. Protect all adjoining surfaces. 2. Use a suitable cleaning agent to remove residue and clear debris. 3. Clean up the work area.

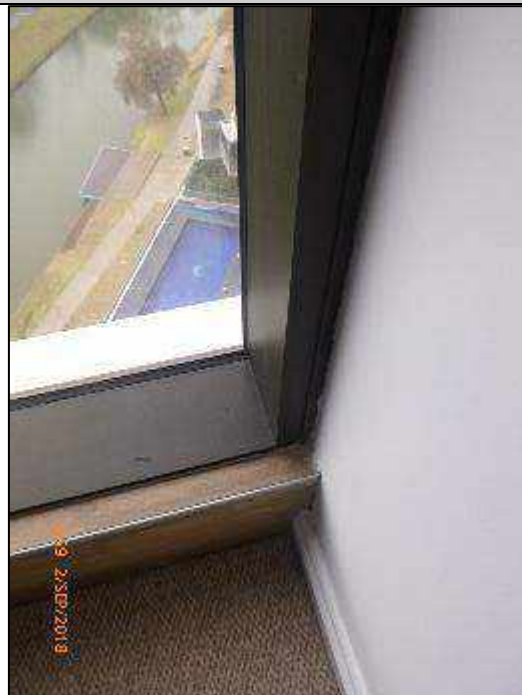
Item	Location	Defect description and Breach	Rectification	Photograph (if applicable)
1633	Main bedroom window frames	See section 5.9.1	See section 5.9.2

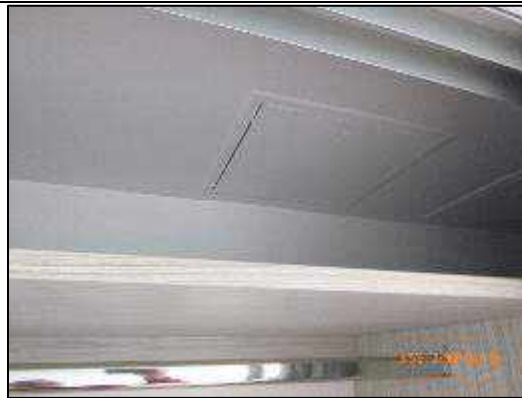
1634	Main bedroom built in	See section 5.6.1	See section 5.6.2

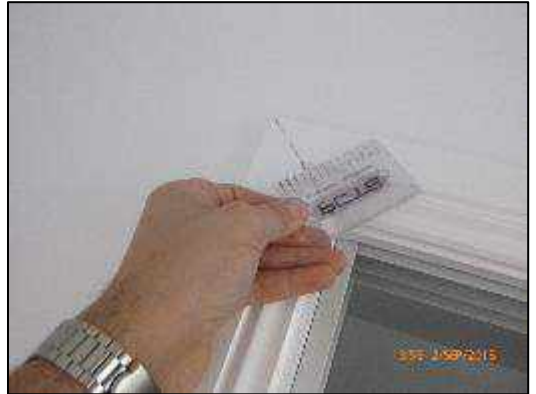
Item	Location	Defect description and Breach	Rectification	Photograph (if applicable)
1635	Main bedroom door architrave	See section 5.14.1 Separation; 1.5mm	See section 5.14.2

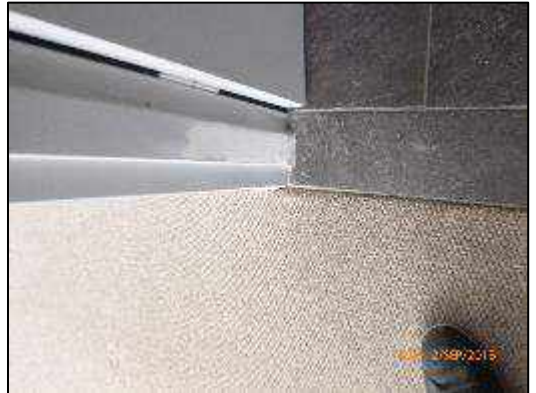
1636	Laundry door frame	See section 5.10.1	See section 5.10.2

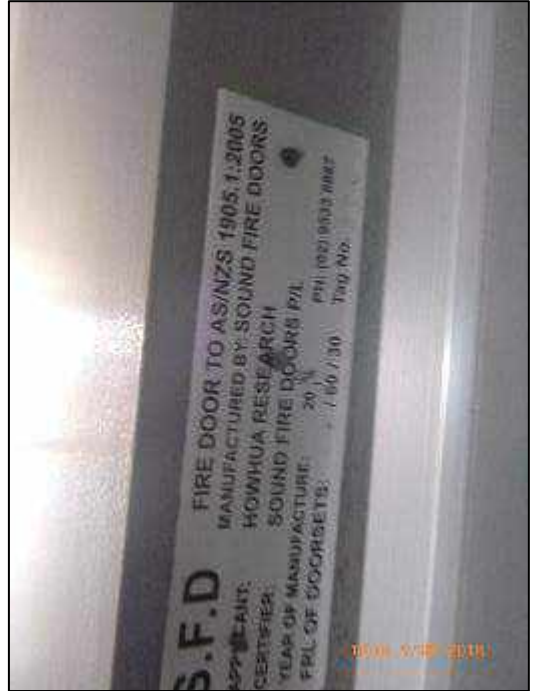
Item	Location	Defect description and Breach	Rectification	Photograph (if applicable)
Unit 1504				
1637	Front entry door	See section 5.12.1	See section 5.12.2

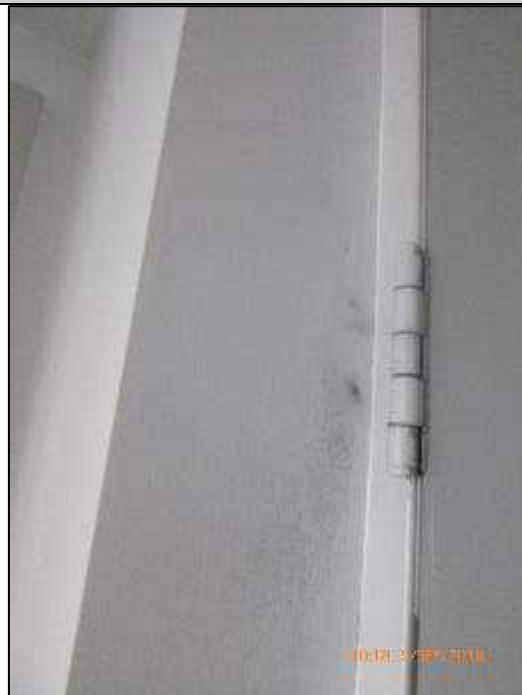
Item	Location	Defect description and Breach	Rectification	Photograph (if applicable)
1638	Front entry door	<p>The hinges of the front entry door are leaking.</p> <p>Home Building Act (NSW) 1989</p> <ul style="list-style-type: none"> Part 2C, 18B (a) and (b). <p>This item is a defect as the builder has failed to satisfy implied warranty set out in the Home Building Act 1989 – Section 18B Warranties as to residential building work.</p> <p>(b) a warranty that all materials supplied by the holder or person will be good and suitable for the purpose for which they are used and that, unless otherwise stated in the contract, those materials will be new.</p> <p>Loss Suffered Loss suffered in cost of rectification.</p>	Engage a licenced carpenter to remove faulty door hinges and reinstate with new hinges matching existing in accordance with manufacturers specifications.

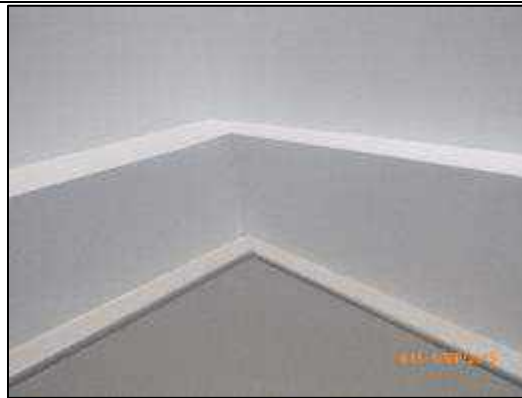
1639	Wall adjacent to front entry door	See section 5.13.1	See section 5.13.2

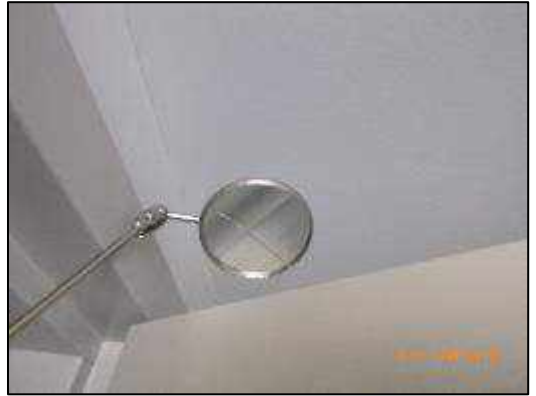
Item	Location	Defect description and Breach	Rectification	Photograph (if applicable)
1640	<i>Doors throughout the unit (x2)</i>	See section 5.5.1	See section 5.5.2

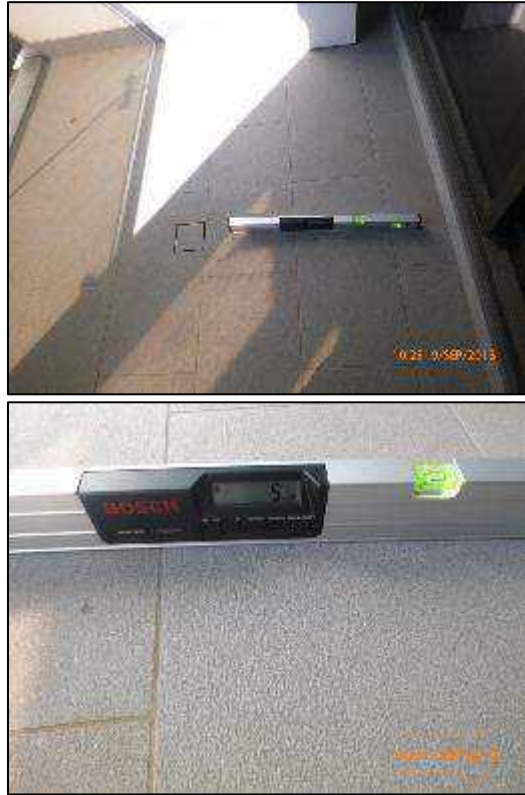
Item	Location	Defect description and Breach	Rectification	Photograph (if applicable)
1641	Balcony	See section 5.2.1 Falls (mm); 5/1000	See section 5.2.2

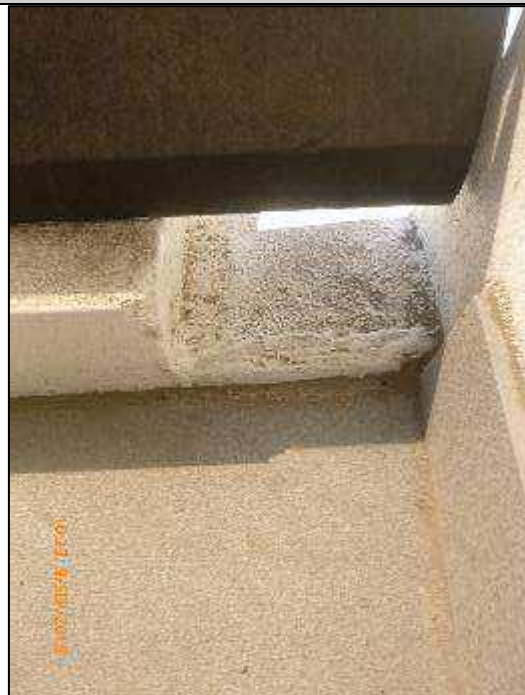
Item	Location	Defect description and Breach	Rectification	Photograph (if applicable)
1642	Balcony	See section 5.15.1	See section 5.15.2

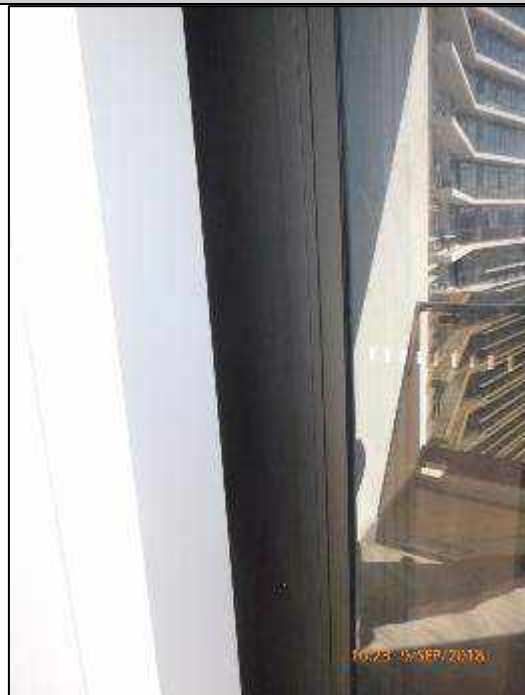
Item	Location	Defect description and Breach	Rectification	Photograph (if applicable)
1643	Balcony	See section 5.7.1	See section 5.7.2

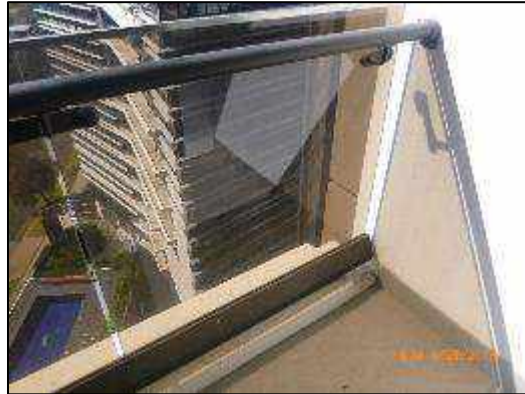
Item	Location	Defect description and Breach	Rectification	Photograph (if applicable)
1645	Balcony	See section 5.4.1	See section 5.4.2

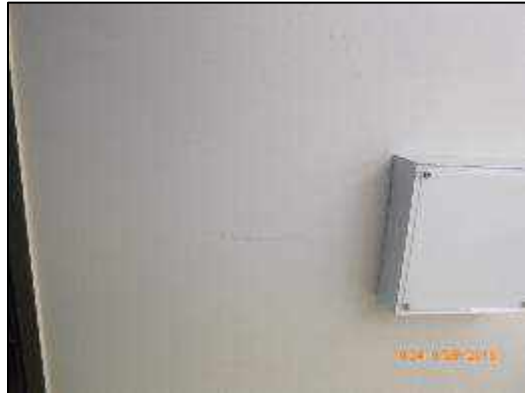
1646	Balcony ceiling	See section 5.14.1 Separation; 1mm	See section 5.14.2

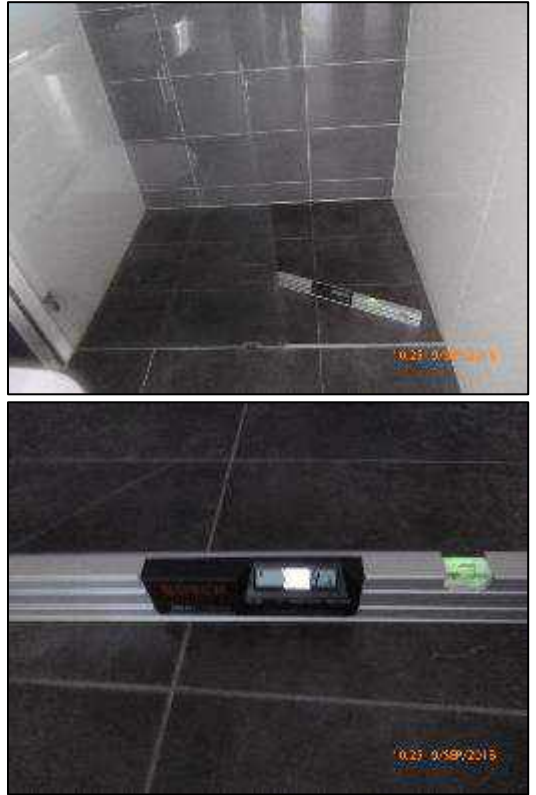
Item	Location	Defect description and Breach	Rectification	Photograph (if applicable)
1647	Main bathroom	See section 5.1.1 Falls (mm); 8/1000	See section 5.1.2
