SydneyStrataReport

STRATA REPORT

Client	Church Street Parramatta Property Pty Ltd
Address of property	Unit 3303/330 Church Street, Parramatta, NSW.
Lot	359
Strata Plan	SP 94469
Name of Strata Management Co.	NSW Strata
Telephone Number of Strata Agent	8980 1841
Report Date	15 February 2024

BUILDING DEFECTS REPORT Part 1/2

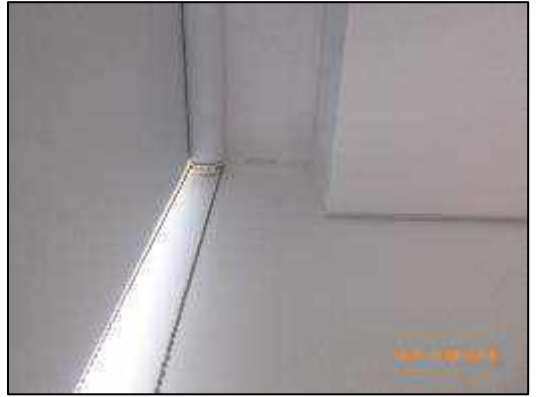
Item	Location	Defect description and Breach	Rectification	Photograph (if applicable)
1648	Main bedroom window bulkhead	See section 5.13.1	See section 5.13.2

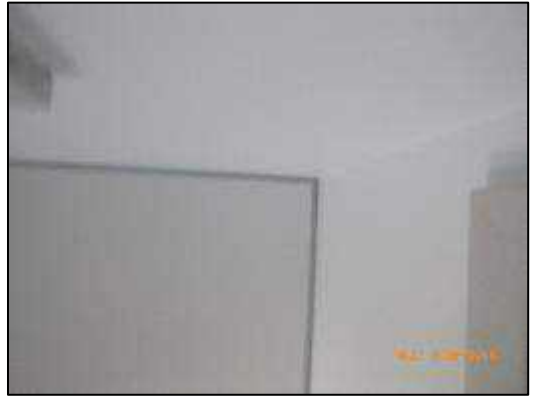
1649	Main bedroom	See section 5.11.1	See section 5.11.2

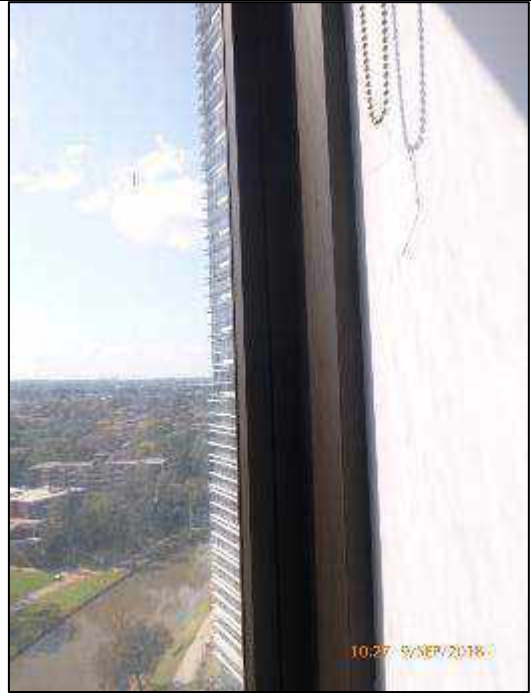
Item	Location	Defect description and Breach	Rectification	Photograph (if applicable)
1650	Main bedroom window frames	See section 5.9.1	See section 5.9.2

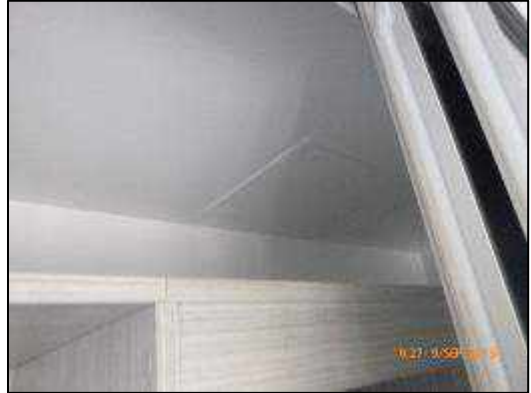
1651	Main bedroom built in	See section 5.6.1	See section 5.6.2

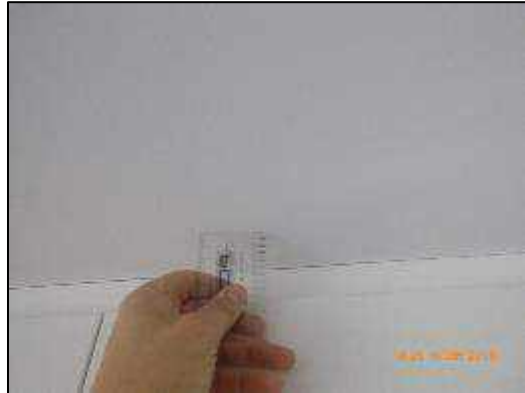
Item	Location	Defect description and Breach	Rectification	Photograph (if applicable)
1652	<i>Ceiling above kitchen cupboards</i>	See section 5.14.1 Separation; 1.5mm	See section 5.14.2

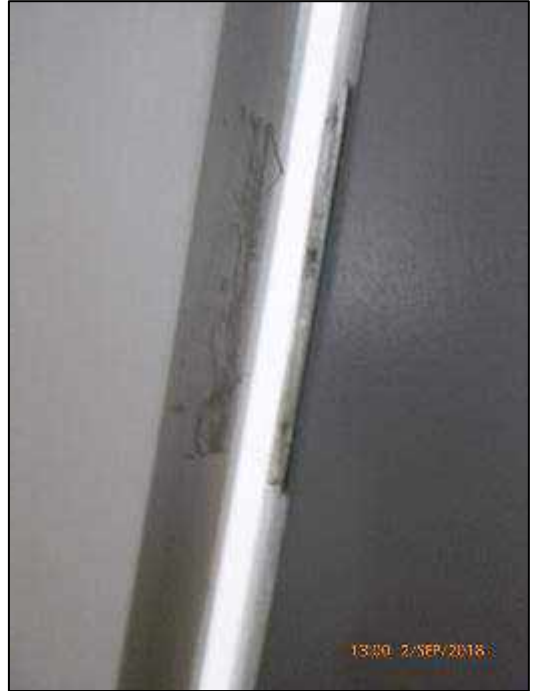
Item	Location	Defect description and Breach	Rectification	Photograph (if applicable)
Unit 1505				
1653	Front entry door	See section 5.12.1	See section 5.12.2

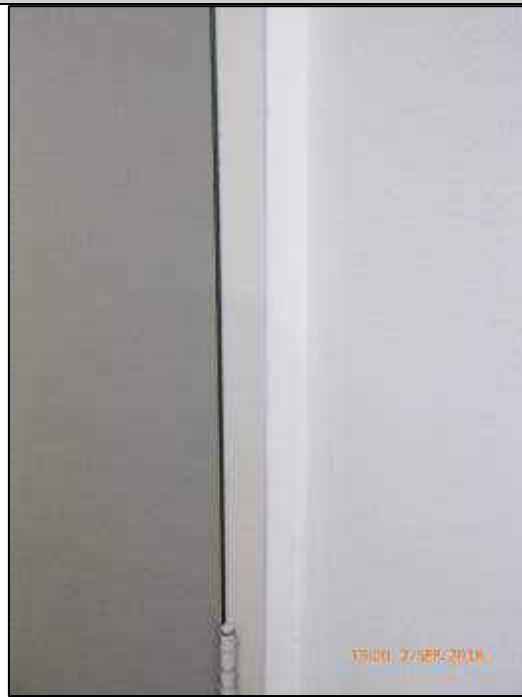
Item	Location	Defect description and Breach	Rectification	Photograph (if applicable)
1654	Wall adjacent to front entry door	See section 5.13.1	See section 5.13.2

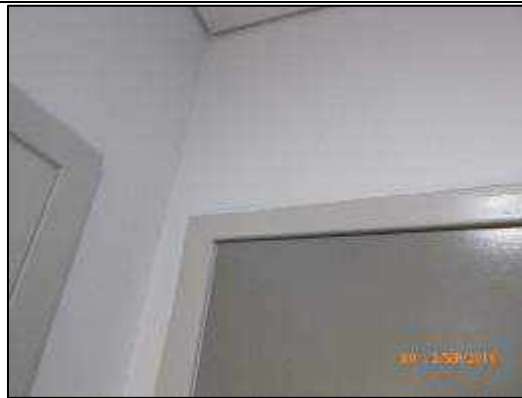
1655	Wall adjacent to front entry door	See section 5.9.1	See section 5.9.2

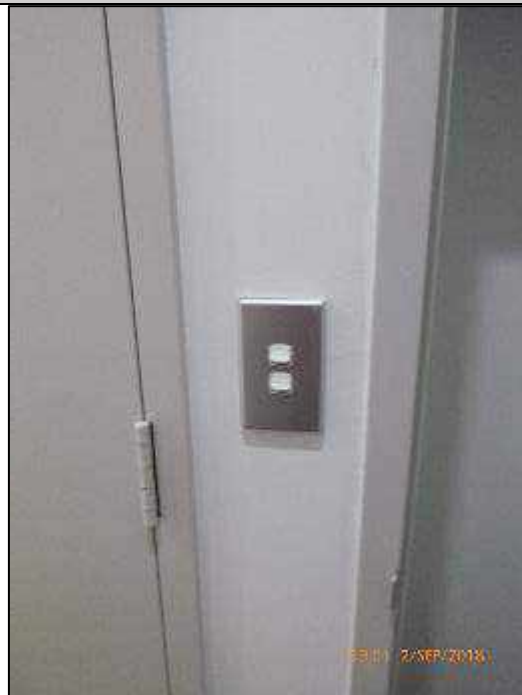
Item	Location	Defect description and Breach	Rectification	Photograph (if applicable)
1656	Wall between study room and linen cupboard.	See section 5.10.1	See section 5.10.2

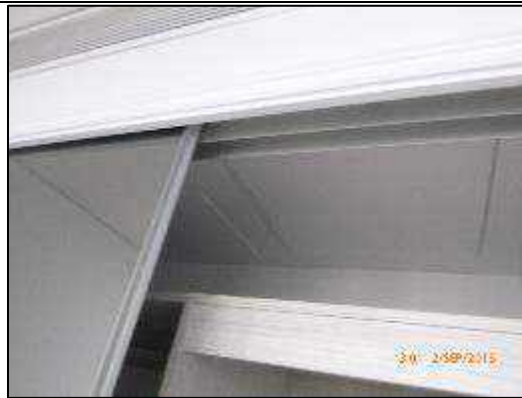
A photograph showing a white wall with a light switch and a hinge. The date stamp '2/SEP/2015' is visible in the bottom right corner.
1657	Main bedroom built in	See section 5.6.1	See section 5.6.2

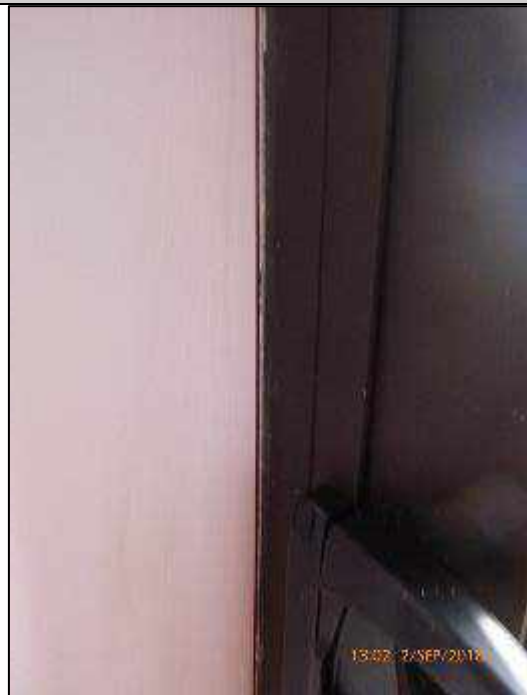
Item	Location	Defect description and Breach	Rectification	Photograph (if applicable)
1658	Balcony sliding door frame	See section 5.9.1	See section 5.9.2

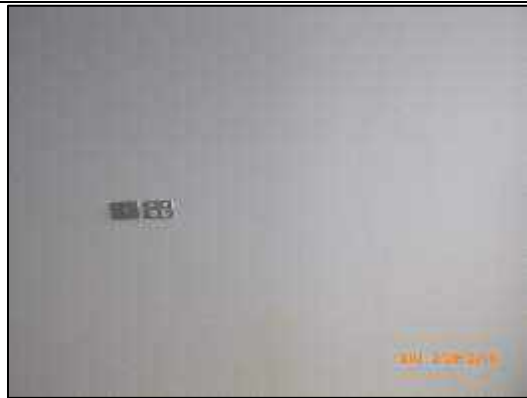
A photograph showing a close-up of a balcony sliding door frame. The frame is dark, and the glass panel is visible. There is a date stamp in the bottom right corner that reads "13.02.2012 14:58:29".
1659	Walls and ceiling throughout the unit	See section 5.10.1	See section 5.10.2

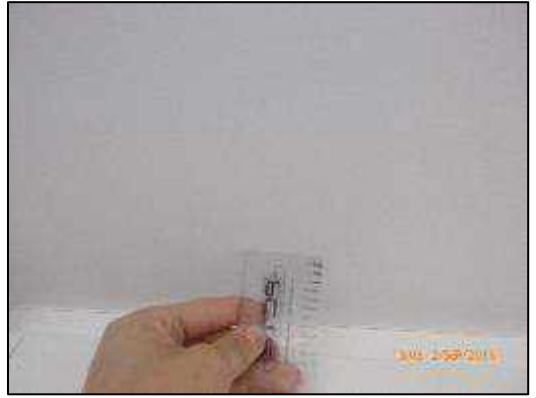
Item	Location	Defect description and Breach	Rectification	Photograph (if applicable)
1660	<i>Ceiling above kitchen cupboards</i>	See section 5.14.1 Separation; 1mm	See section 5.14.2

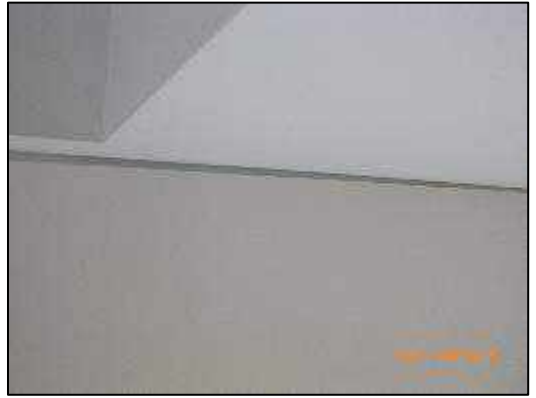
1661	<i>Lounge room</i>	See section 5.11.1	See section 5.11.2

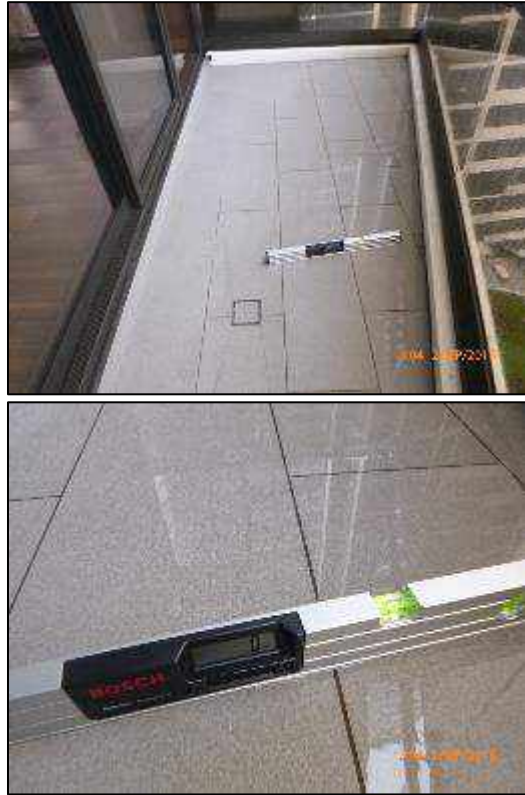
Item	Location	Defect description and Breach	Rectification	Photograph (if applicable)
1662	Balcony	See section 5.2.1 Falls (mm); 0/1000	See section 5.2.2

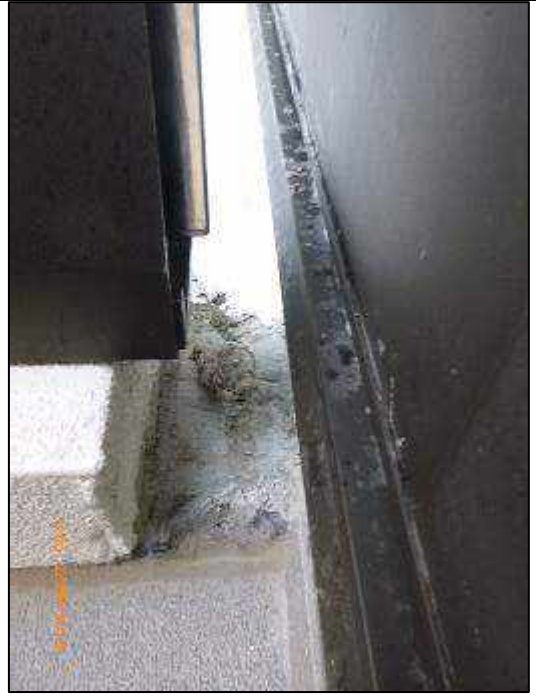
Item	Location	Defect description and Breach	Rectification	Photograph (if applicable)
1663	Balcony	See section 5.15.1	See section 5.15.2

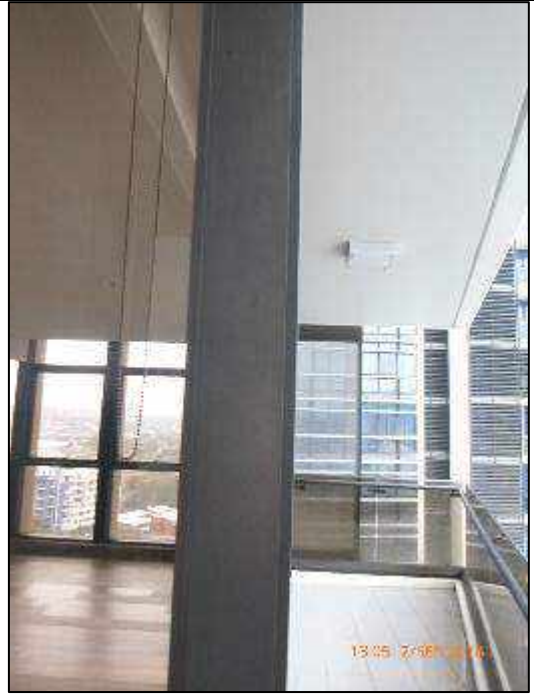
Item	Location	Defect description and Breach	Rectification	Photograph (if applicable)
1664	Balcony sliding door frame	See section 5.7.1	See section 5.7.2

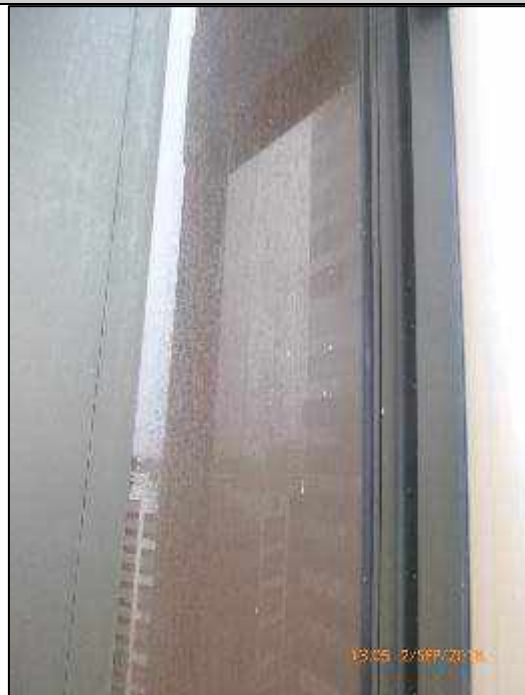
Item	Location	Defect description and Breach	Rectification	Photograph (if applicable)
1665	Balcony sliding door frame	See section 5.9.1	See section 5.9.2

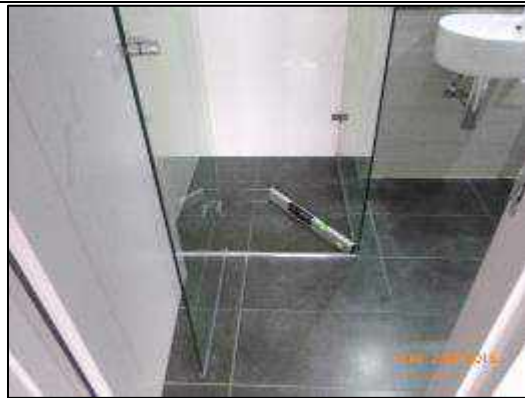
A photograph showing a close-up of a balcony sliding door frame. The frame appears to be made of metal or wood and is set into a wall. There is a visible gap or defect in the frame. A date stamp '13/05/2019' is visible in the bottom right corner of the photo.
1666	Main bathroom	See section 5.1.1 Falls (mm); 6/1000	See section 5.1.2

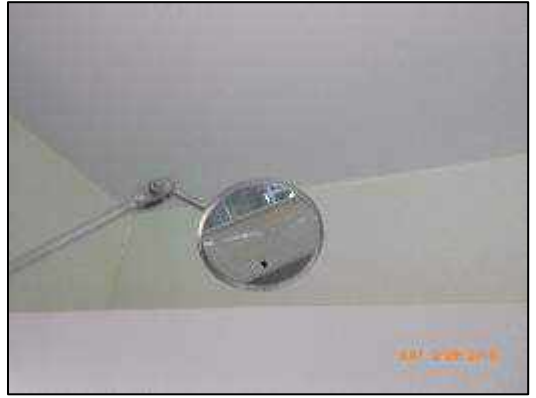
Item	Location	Defect description and Breach	Rectification	Photograph (if applicable)
1667	<i>Doors throughout the unit (x3)</i>	See section 5.5.1	See section 5.5.2

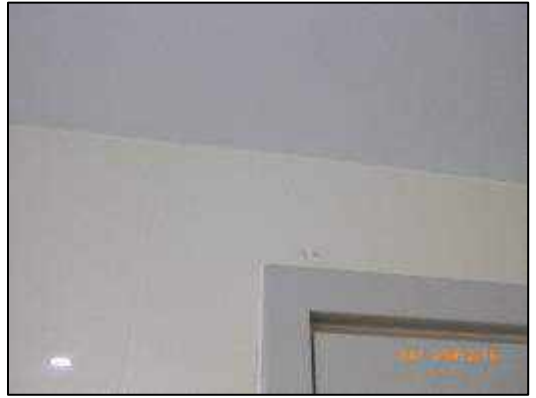
1668	<i>Wall adjacent to bathroom door</i>	See section 5.9.1	See section 5.9.2

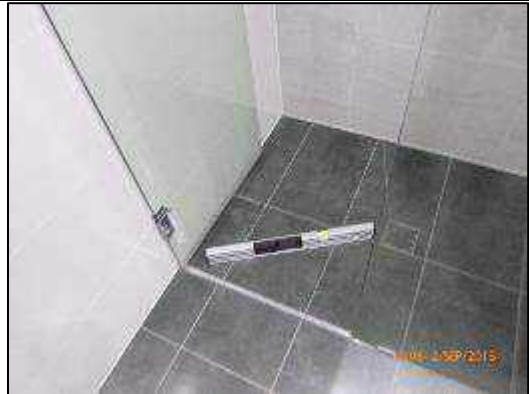
Item	Location	Defect description and Breach	Rectification	Photograph (if applicable)
1669	Main bedroom ensuite	See section 5.1.1 Falls (mm); 5/1000	See section 5.1.2

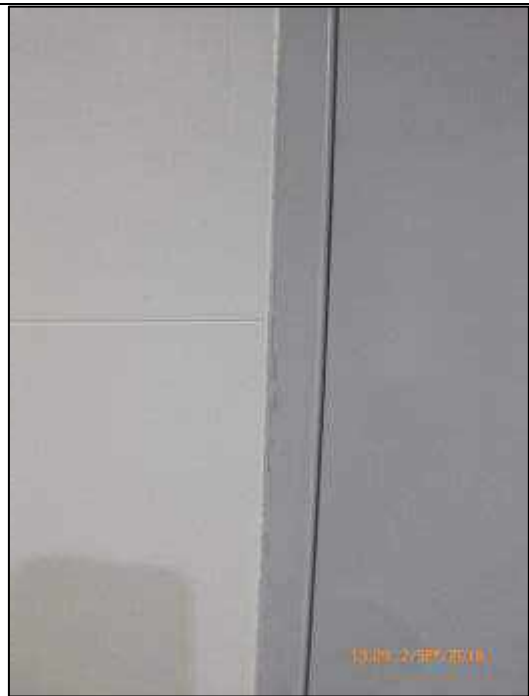
1670	Wall adjacent to ensuite door	See section 5.9.1	See section 5.9.2

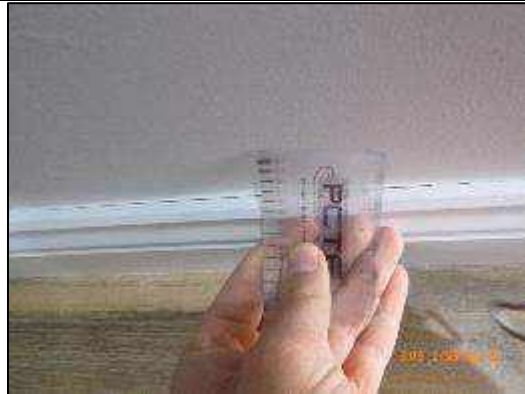
Item	Location	Defect description and Breach	Rectification	Photograph (if applicable)
1671	Western hallway wall skirting board	See section 5.14.1 Separation; 1mm	See section 5.14.2

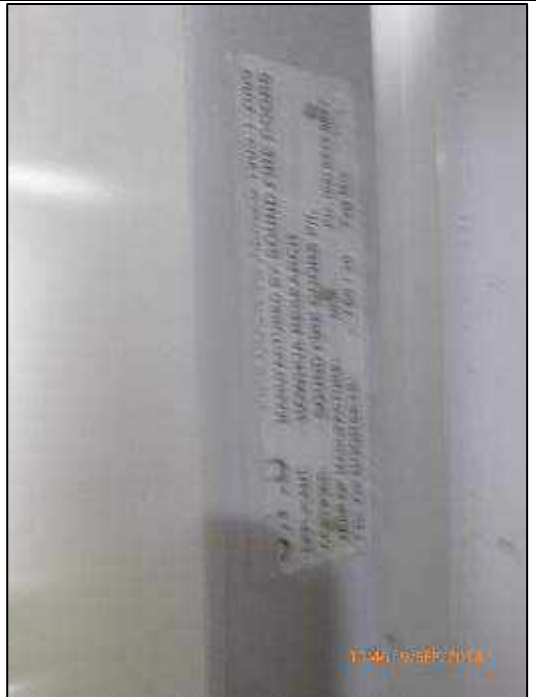
Item	Location	Defect description and Breach	Rectification	Photograph (if applicable)
Unit 1507				
1673	Front entry door	See section 5.12.1	See section 5.12.2

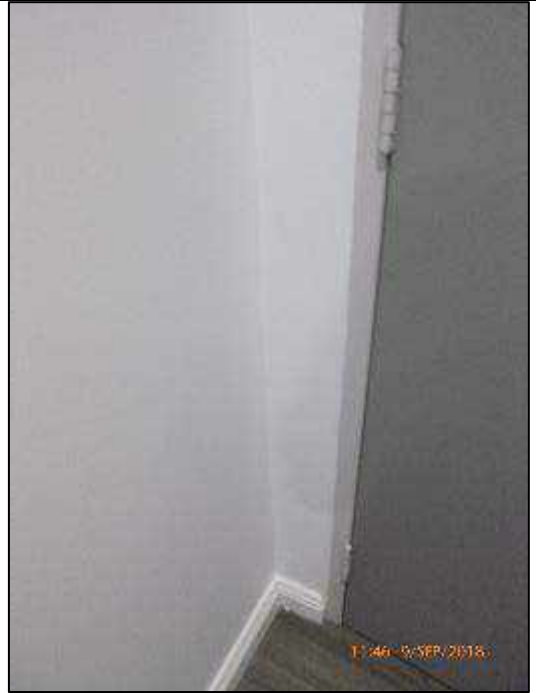
Item	Location	Defect description and Breach	Rectification	Photograph (if applicable)
1674	Wall adjacent to front entry door	See section 5.9.1	See section 5.9.2

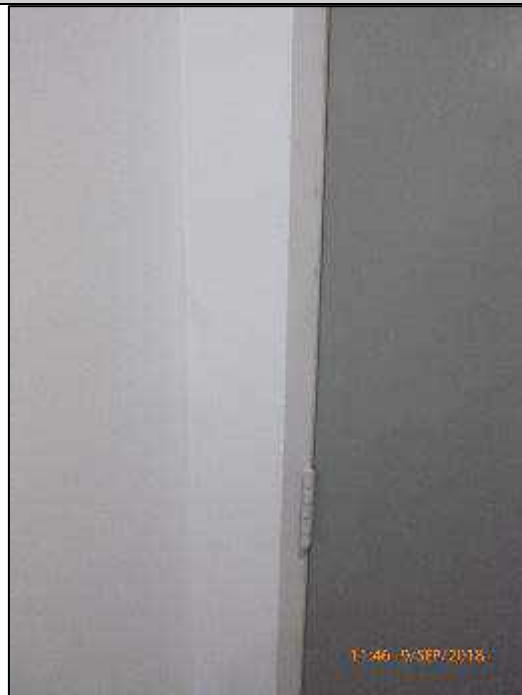
Item	Location	Defect description and Breach	Rectification	Photograph (if applicable)
1675	Wall adjacent to front entry door	See section 5.13.1	See section 5.13.2

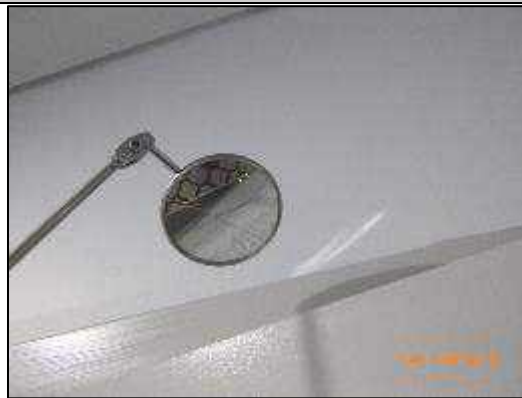
Item	Location	Defect description and Breach	Rectification	Photograph (if applicable)
1677	<i>Doors throughout the unit (x3)</i>	See section 5.5.1	See section 5.5.2

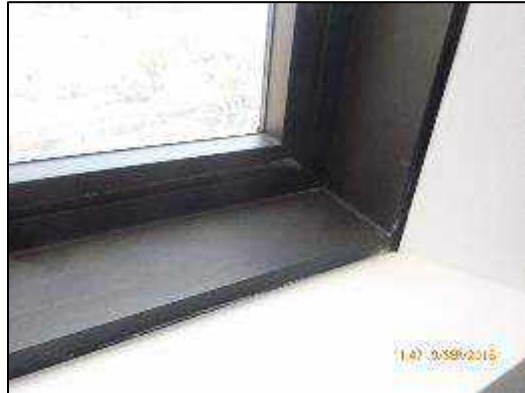
Item	Location	Defect description and Breach	Rectification	Photograph (if applicable)
1679	Lounge room window frames	See section 5.9.1	See section 5.9.2

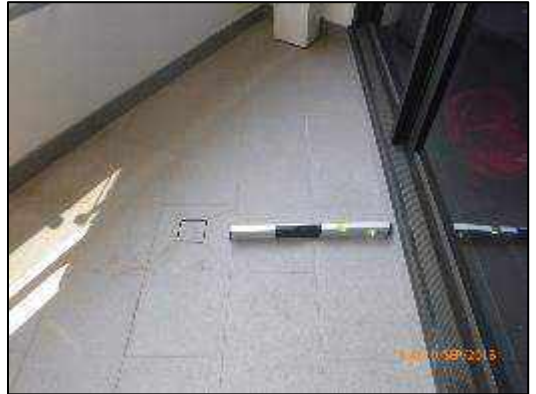
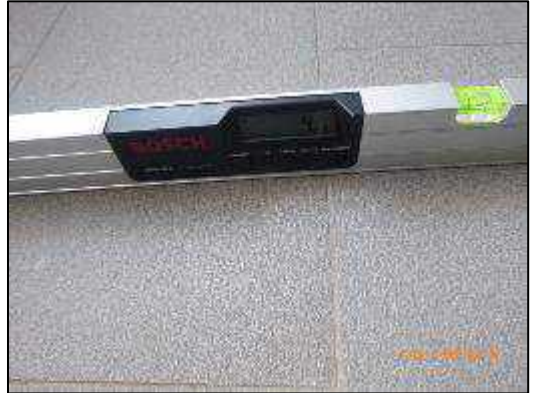
Item	Location	Defect description and Breach	Rectification	Photograph (if applicable)
1680	Balcony	See section 5.2.1 Falls (mm); 4/1000	See section 5.2.2

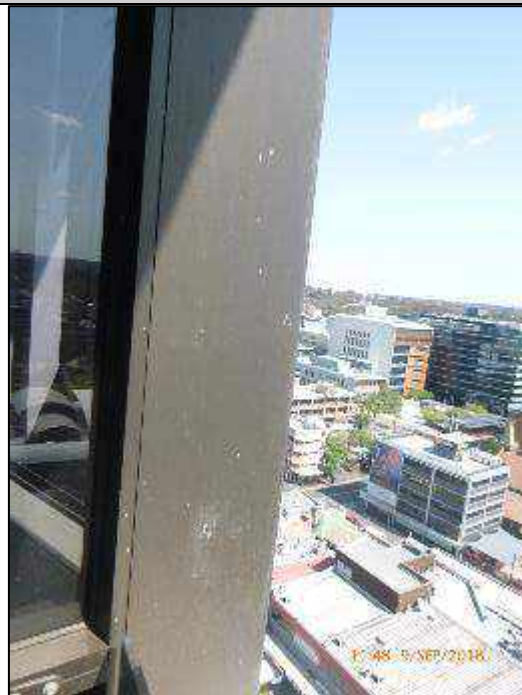
Item	Location	Defect description and Breach	Rectification	Photograph (if applicable)
1681	Balcony sliding door frame	<p>Construction debris observed on the external façade.</p> <p>Home Building Act (NSW) 1989</p> <ul style="list-style-type: none"> Part 2C, 18B (a) and (c). <p>This is a breach of part (a) of the act because the surface has not been finished in a proper workmanlike manner that would prevent loss of appearance to the surface.</p> <p>Loss Suffered Loss suffered is cost of rectification.</p>	<ol style="list-style-type: none"> 1. Protect all adjoining surfaces. 2. Use a suitable cleaning agent to remove residue and clear debris. 3. Clean up the work area.

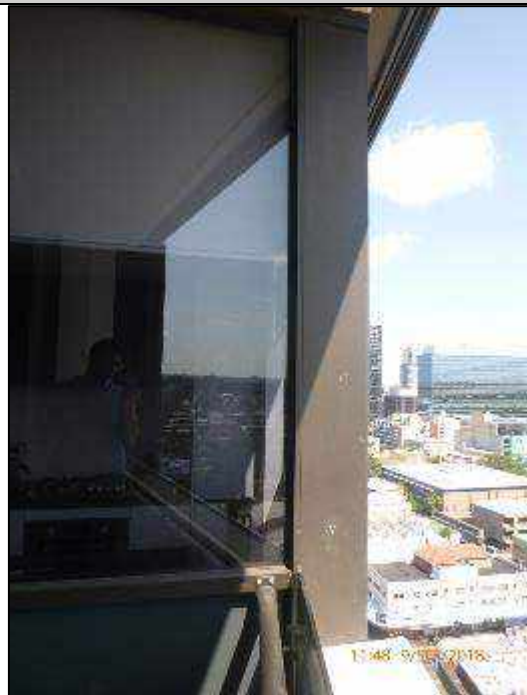
Item	Location	Defect description and Breach	Rectification	Photograph (if applicable)
1682	Balcony sliding door frame	See section 5.7.1	See section 5.7.2

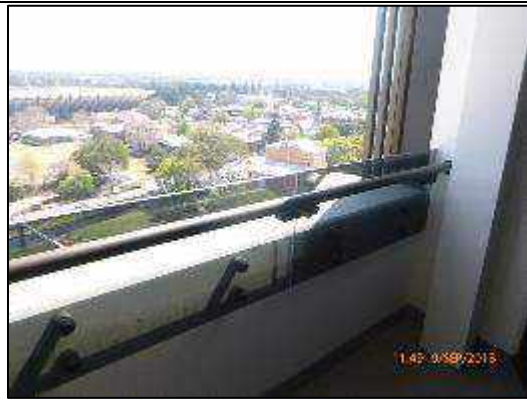
A photograph showing a close-up of a balcony sliding door frame. The frame appears to be made of metal and is set into a concrete wall. The glass of the door is visible, reflecting the interior. The date and time '1:48 9/15/2015' are visible in the bottom right corner of the photo.
1683	Balcony	See section 5.4.1	See section 5.4.2

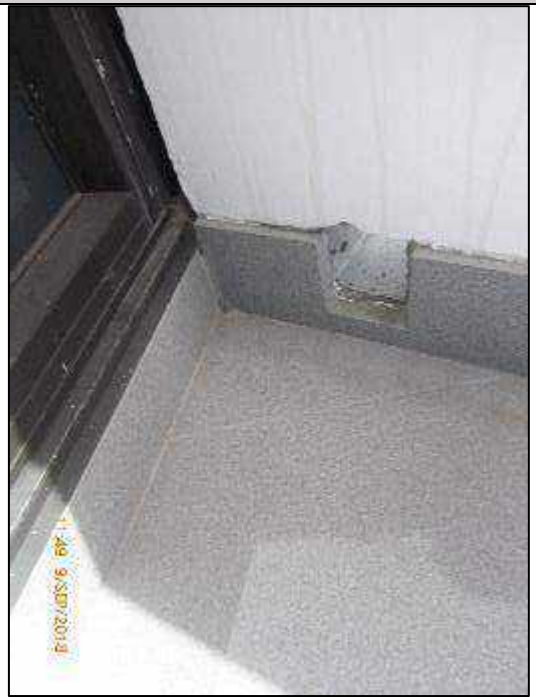
Item	Location	Defect description and Breach	Rectification	Photograph (if applicable)
1684	Balcony	See section 5.15.1	See section 5.15.2

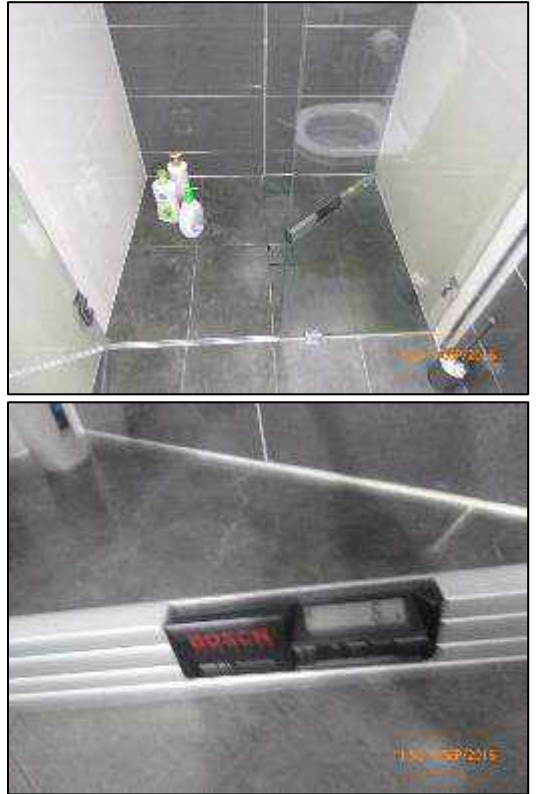
Item	Location	Defect description and Breach	Rectification	Photograph (if applicable)
1685	Main bathroom	See section 5.1.1 Falls (mm); 6/1000	See section 5.1.2

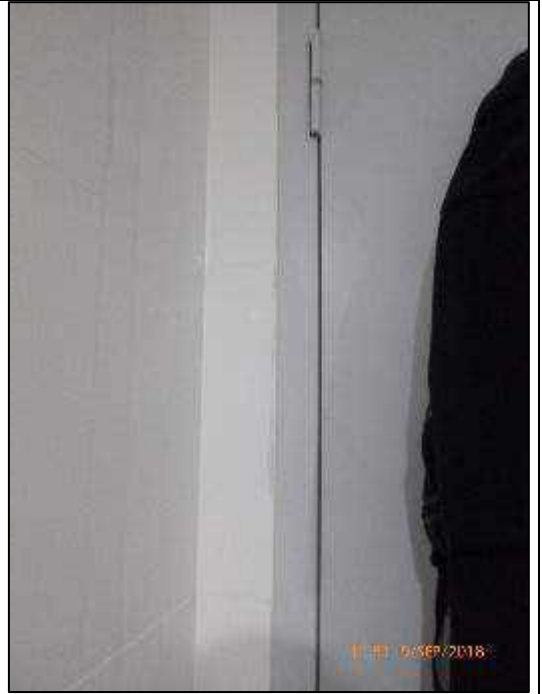
Item	Location	Defect description and Breach	Rectification	Photograph (if applicable)
1686	Wall adjacent to main bathroom door	See section 5.9.1	See section 5.9.2

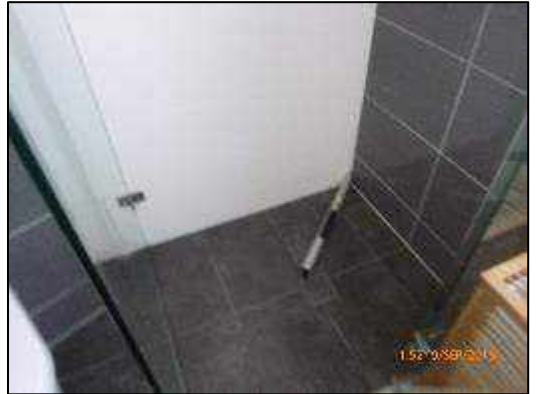
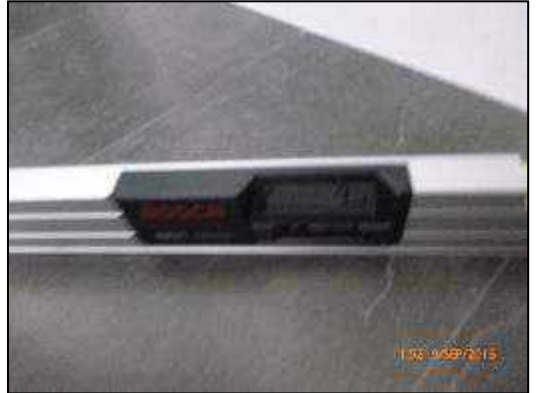
Item	Location	Defect description and Breach	Rectification	Photograph (if applicable)
1687	Main bedroom ensuite	See section 5.1.1 Falls (mm); 7/1000	See section 5.1.2

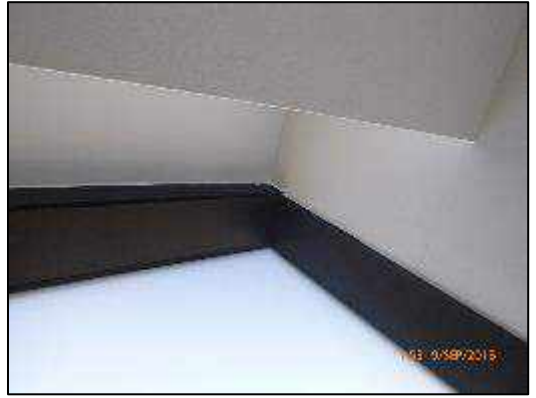
Item	Location	Defect description and Breach	Rectification	Photograph (if applicable)
1688	Main bedroom ensuite window frames	See section 5.9.1	See section 5.9.2

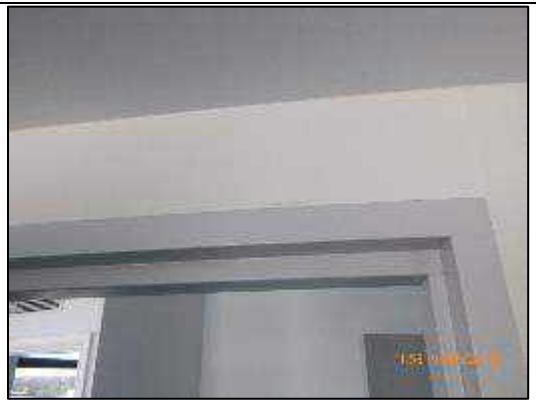
1689	Wall above bedroom ensuite door	See section 5.9.1	See section 5.9.2

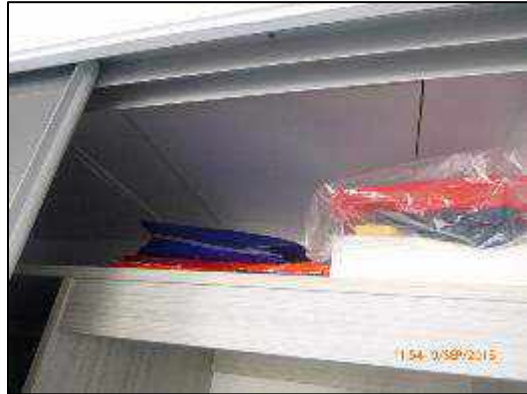
Item	Location	Defect description and Breach	Rectification	Photograph (if applicable)
1690	Main bedroom built in	See section 5.6.1	See section 5.6.2

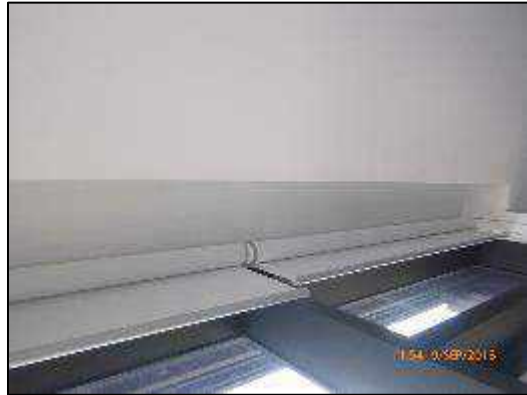
1691	Main bedroom window bulkhead	See section 5.13.1	See section 5.13.2

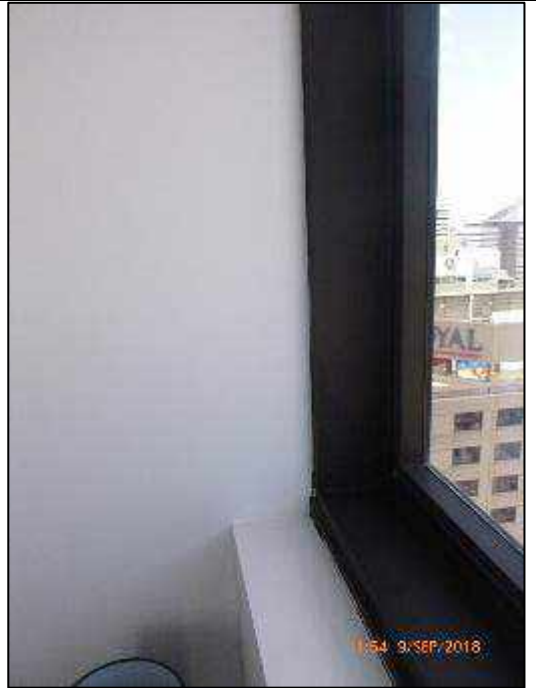
Item	Location	Defect description and Breach	Rectification	Photograph (if applicable)
1692	Main bedroom window frames	See section 5.9.1	See section 5.9.2

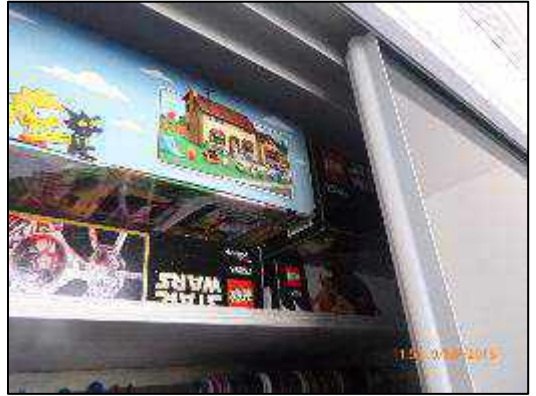
1693	Second bedroom built in	See section 5.6.1	See section 5.6.2

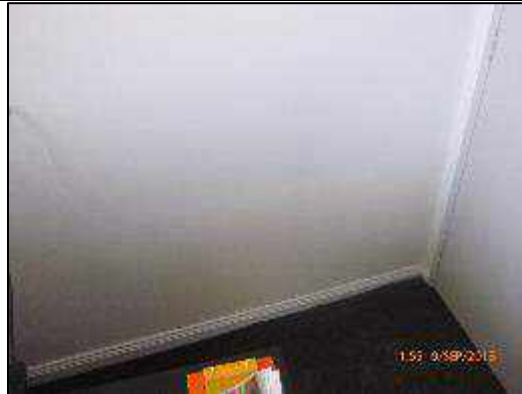
Item	Location	Defect description and Breach	Rectification	Photograph (if applicable)
1694	Second bedroom northern wall	See section 5.13.1	See section 5.13.2

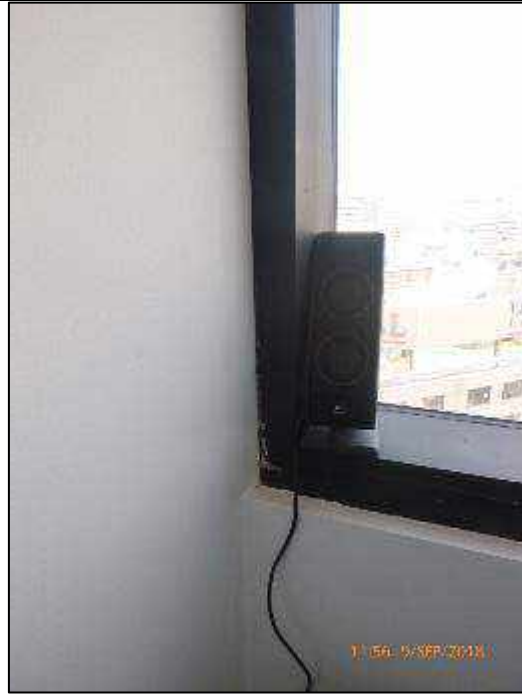
1695	Second bedroom window frames	See section 5.9.1	See section 5.9.2

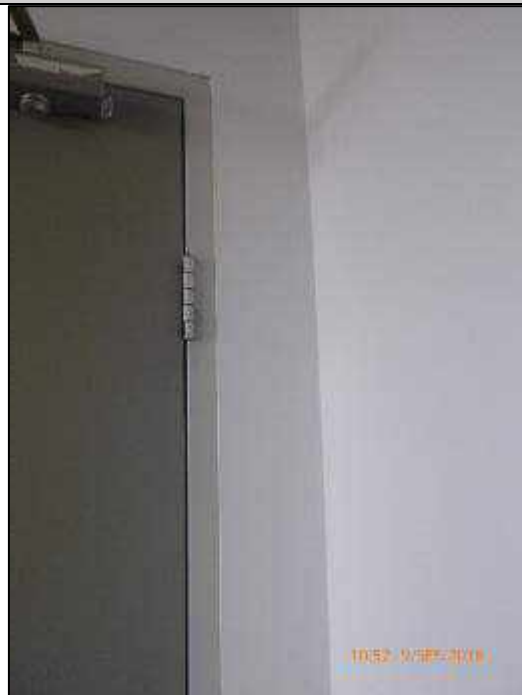
Item	Location	Defect description and Breach	Rectification	Photograph (if applicable)
1698	Wall adjacent to front entry door	See section 5.13.1	See section 5.13.2

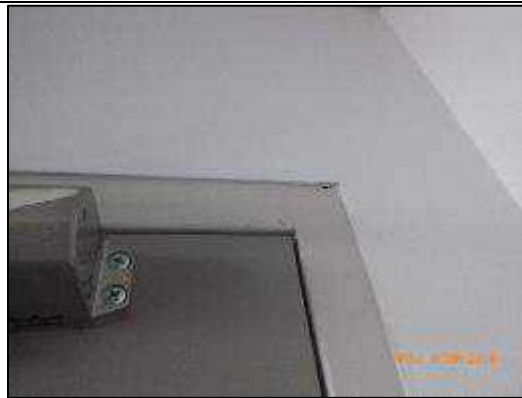
1699	Wall adjacent to front entry door	See section 5.9.1	See section 5.9.2

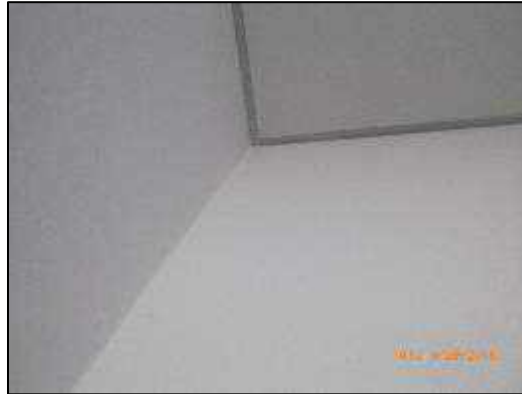
Item	Location	Defect description and Breach	Rectification	Photograph (if applicable)
1700	Lounge room	See section 5.11.1	See section 5.11.2

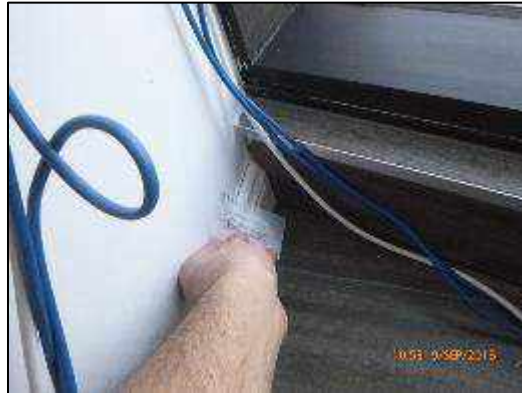
1701	Lounge room eastern wall skirting board	See section 5.14.1 Separation; 1.5mm	See section 5.14.2

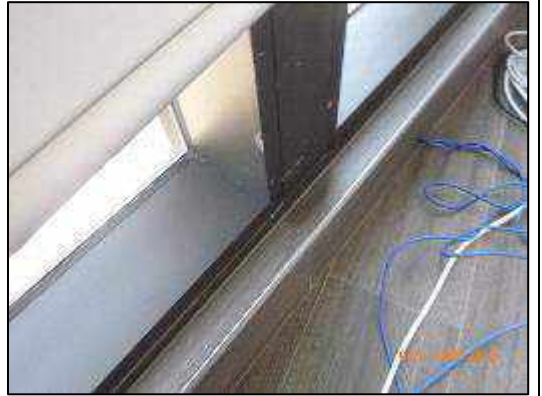
Item	Location	Defect description and Breach	Rectification	Photograph (if applicable)
1702	Lounge room window frames	See section 5.9.1	See section 5.9.2

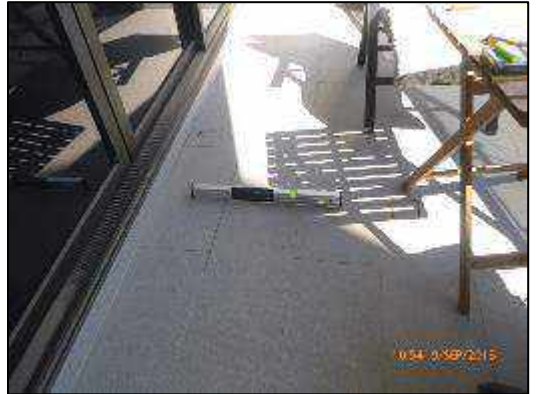
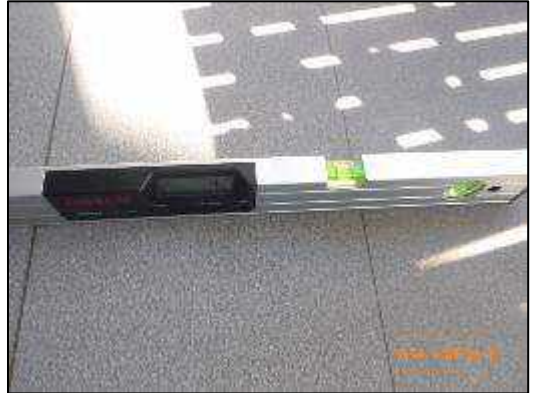
Item	Location	Defect description and Breach	Rectification	Photograph (if applicable)
1703	Balcony	See section 5.2.1 Falls (mm); 4/1000	See section 5.2.2

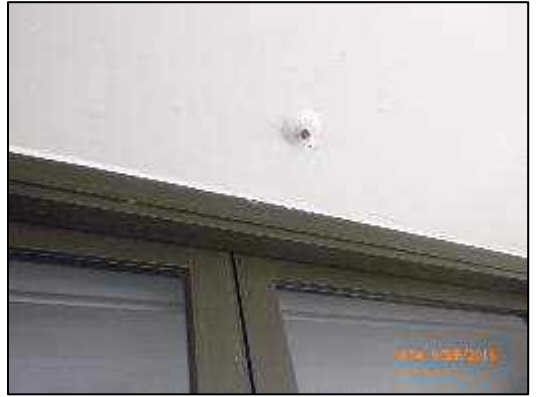
Item	Location	Defect description and Breach	Rectification	Photograph (if applicable)
1704	Balcony sliding door frame	See section 5.9.1	See section 5.9.2

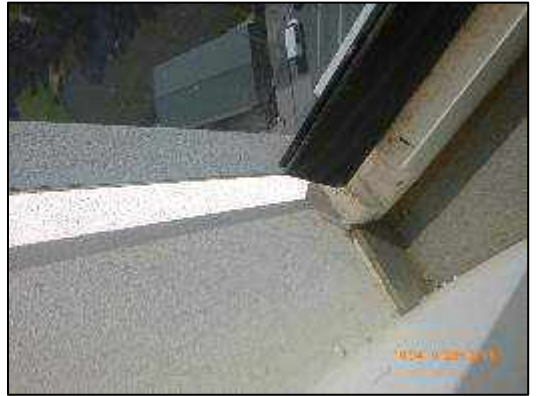
1705	Balcony	See section 5.15.1	See section 5.15.2

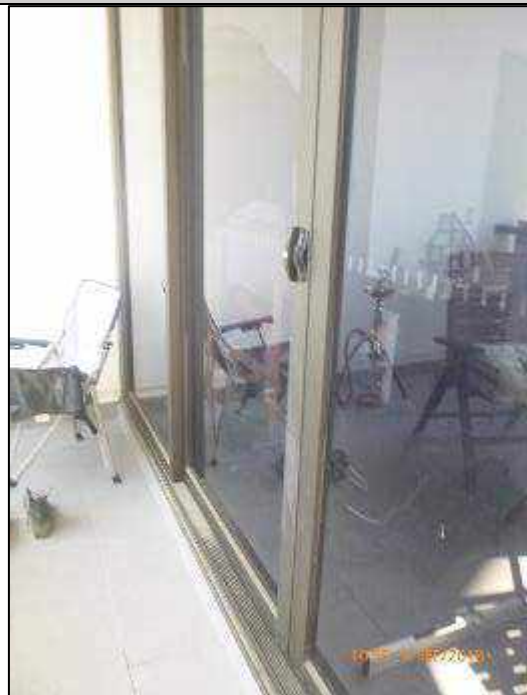
Item	Location	Defect description and Breach	Rectification	Photograph (if applicable)
1706	Balcony sliding door	See section 5.7.1	See section 5.7.2

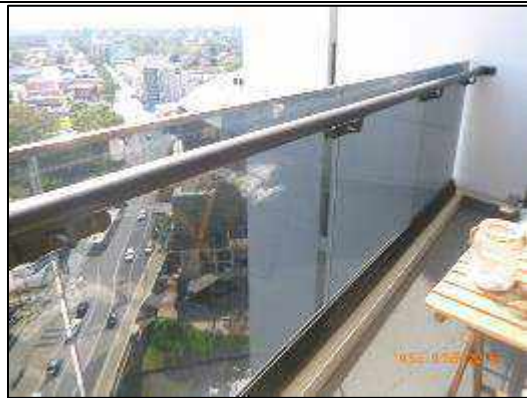
1707	Balcony	See section 5.4.1	See section 5.4.2

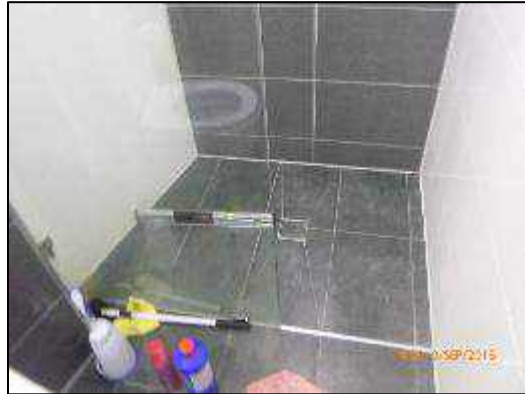
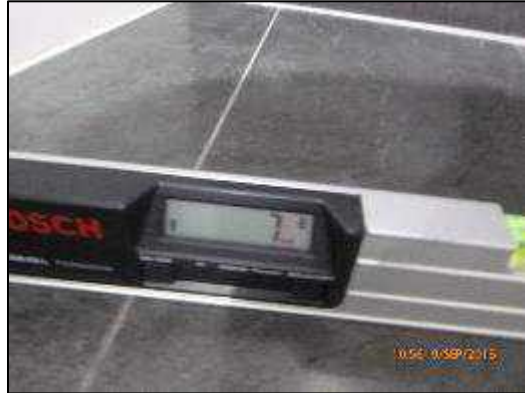
Item	Location	Defect description and Breach	Rectification	Photograph (if applicable)
1708	Main bathroom	See section 5.1.1 Falls (mm); 7/1000	See section 5.1.2

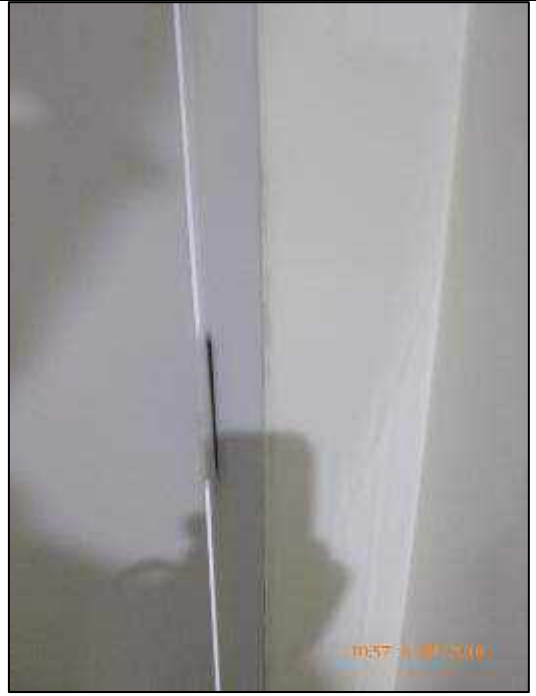
Item	Location	Defect description and Breach	Rectification	Photograph (if applicable)
1709	Wall adjacent to main bathroom	See section 5.9.1	See section 5.9.2

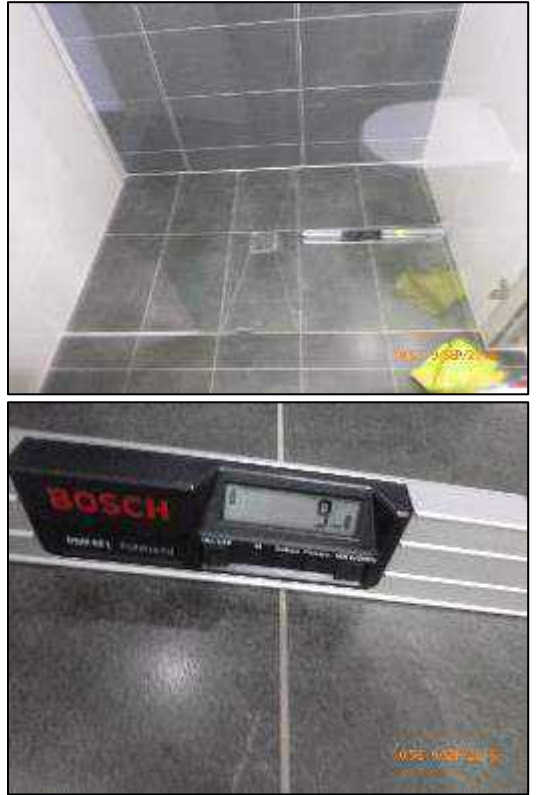
Item	Location	Defect description and Breach	Rectification	Photograph (if applicable)
1710	Main bedroom ensuite	See section 5.1.1 Falls (mm); 9/1000	See section 5.1.2

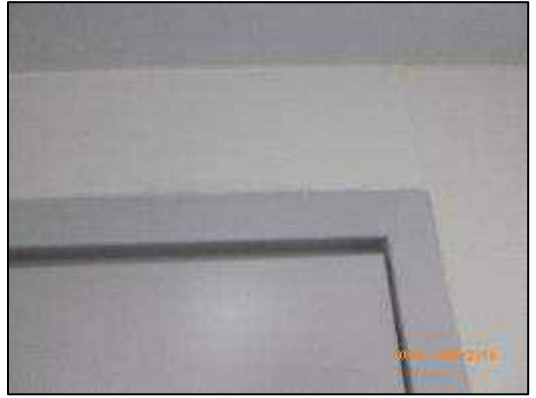
Item	Location	Defect description and Breach	Rectification	Photograph (if applicable)
1711	Wall adjacent to ensuite door	See section 5.9.1	See section 5.9.2

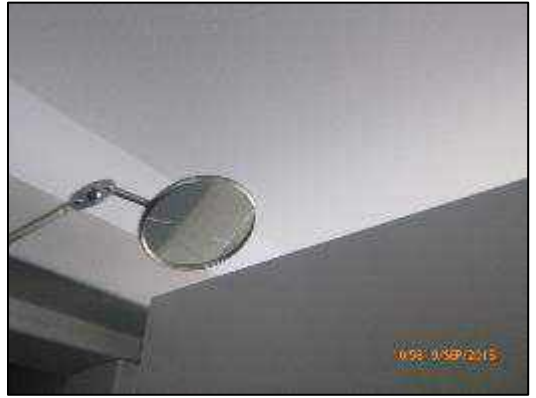
1712	Doors throughout the unit (x4)	See section 5.5.1	See section 5.5.2

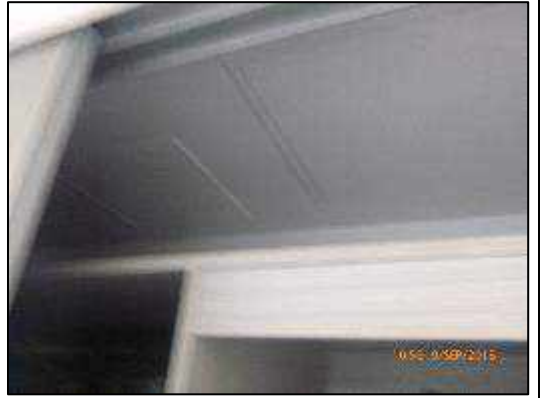
Item	Location	Defect description and Breach	Rectification	Photograph (if applicable)
1713	<i>Second bedroom built in</i>	See section 5.6.1	See section 5.6.2

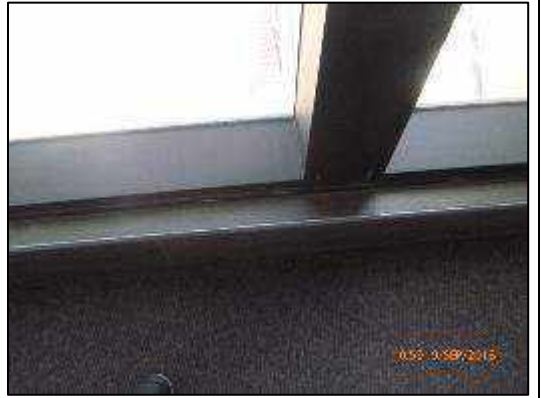
1714	<i>Second bedroom window frames</i>	See section 5.8.1	See section 5.8.2

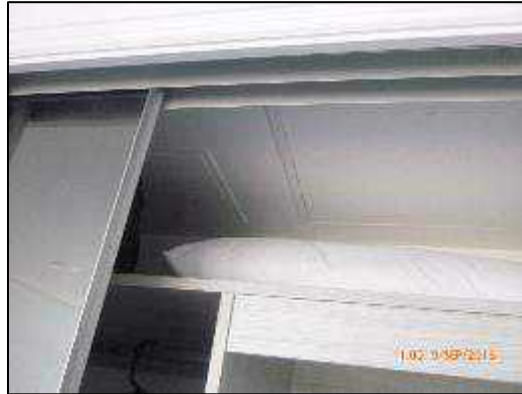
Item	Location	Defect description and Breach	Rectification	Photograph (if applicable)
1715	Main bedroom built in	See section 5.6.1	See section 5.6.2

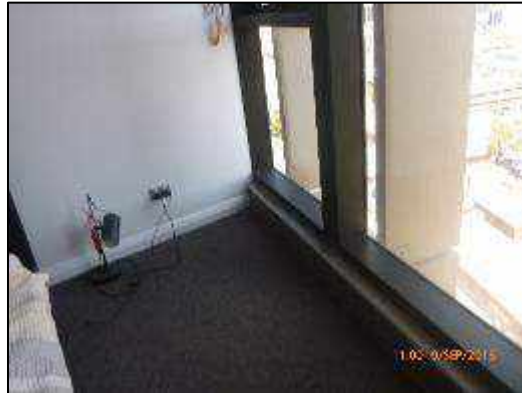
1716	Main bedroom window frames	See section 5.9.1	See section 5.9.2

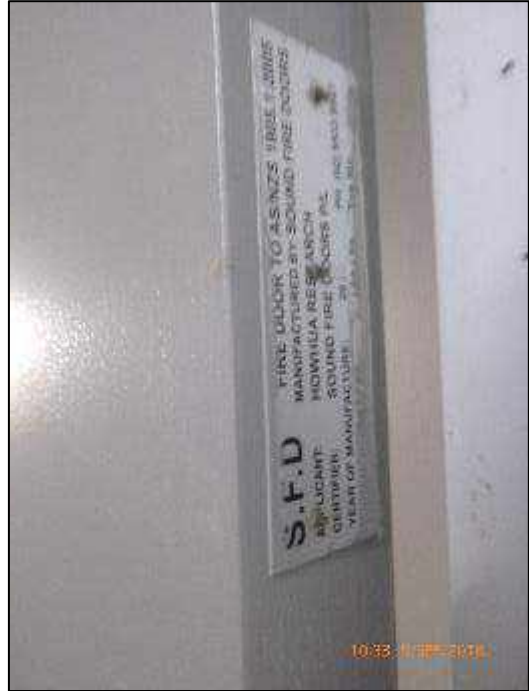
Item	Location	Defect description and Breach	Rectification	Photograph (if applicable)
Unit 1602				
1717	Front entry door	See section 5.12.1	See section 5.12.2

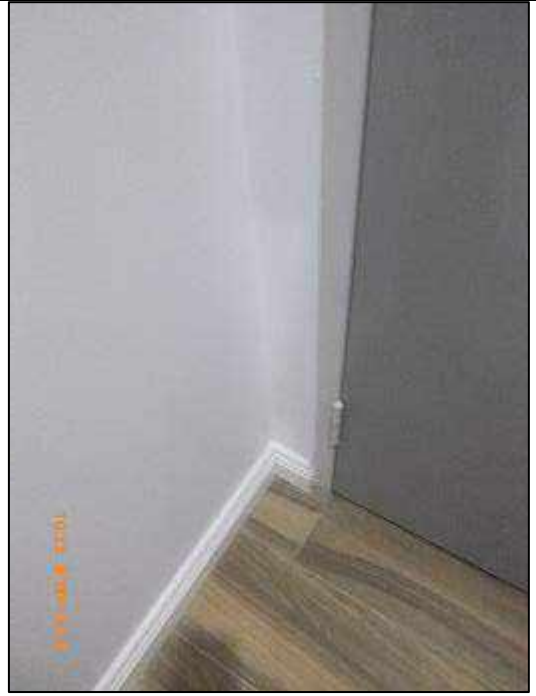
Item	Location	Defect description and Breach	Rectification	Photograph (if applicable)
1718	Wall adjacent to front entry door	See section 5.13.1	See section 5.13.2

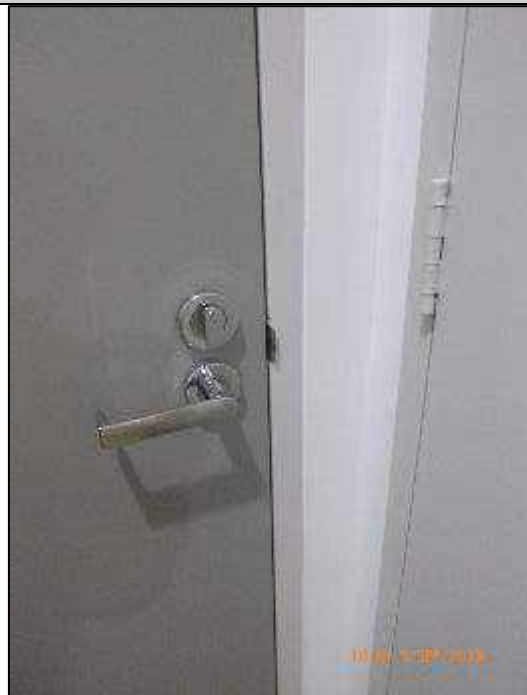
Item	Location	Defect description and Breach	Rectification	Photograph (if applicable)
1719	Wall adjacent to front entry door	See section 5.9.1	See section 5.9.2

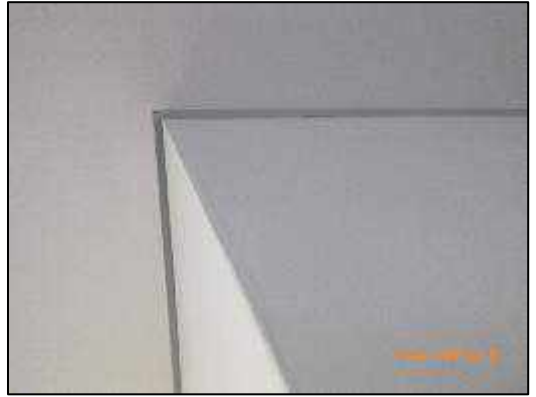
Item	Location	Defect description and Breach	Rectification	Photograph (if applicable)
1721	Lounge room	See section 5.11.1	See section 5.11.2

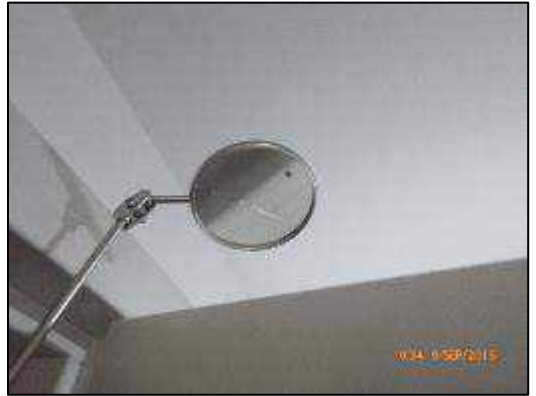
1722	Doors throughout the unit (x3)	See section 5.5.1	See section 5.5.2
