SydneyStrataReport

STRATA REPORT

Client	Church Street Parramatta Property Pty Ltd
Address of property	Unit 3303/330 Church Street, Parramatta, NSW.
Lot	359
Strata Plan	SP 94469
Name of Strata Management Co.	NSW Strata
Telephone Number of Strata Agent	8980 1841
Report Date	15 February 2024

BUILDING DEFECTS REPORT Part 1/2

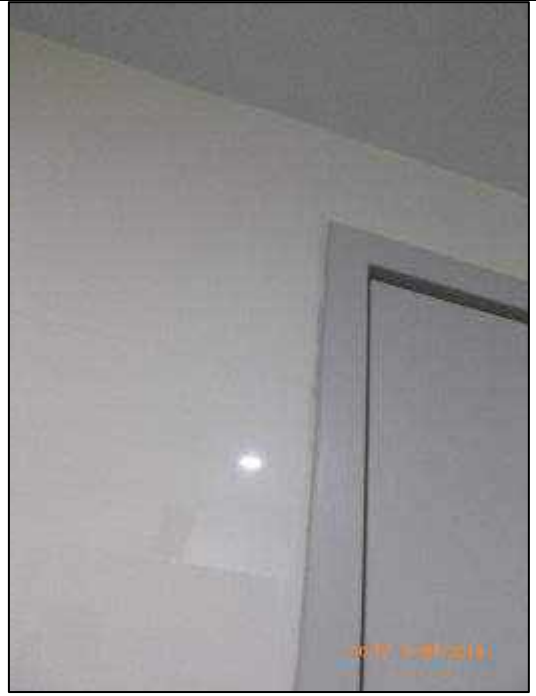
Item	Location	Defect description and Breach	Rectification	Photograph (if applicable)
1723	Wall adjacent to main bathroom door	See section 5.9.1	See section 5.9.2

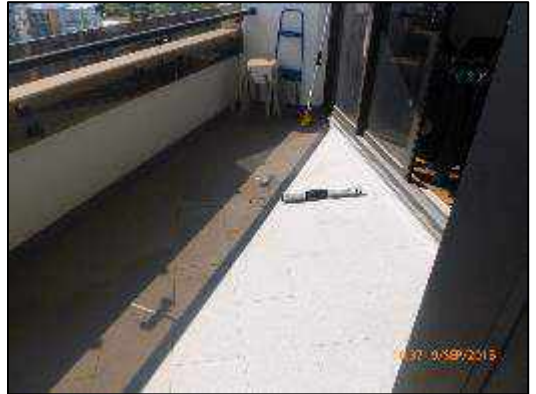
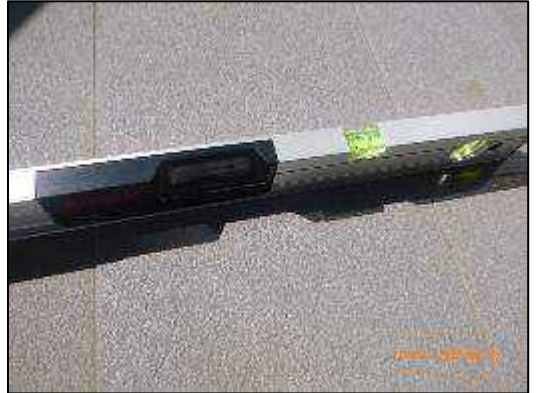
Item	Location	Defect description and Breach	Rectification	Photograph (if applicable)
1724	Balcony	See section 5.2.1 Falls (mm); 3/1000	See section 5.2.2

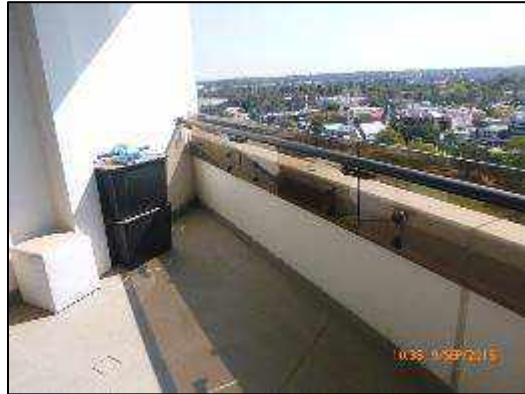
Item	Location	Defect description and Breach	Rectification	Photograph (if applicable)
1725	Balcony	See section 5.4.1	See section 5.4.2

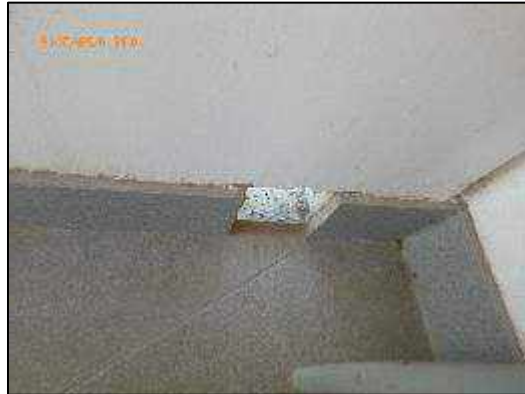
1726	Balcony	See section 5.15.1	See section 5.15.2

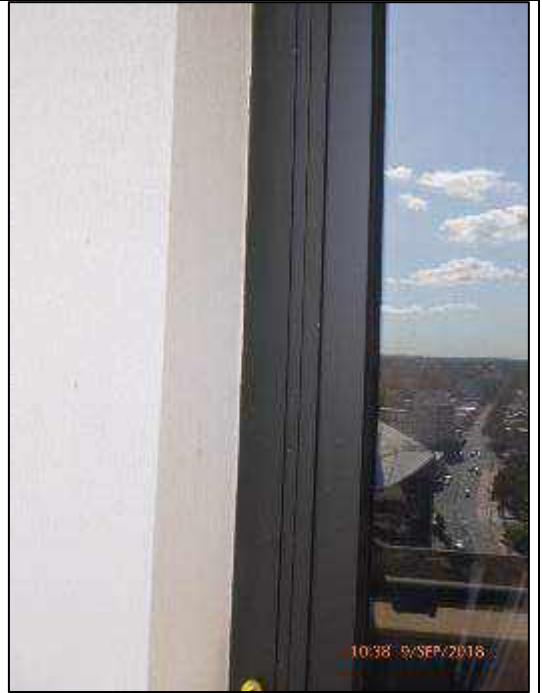
Item	Location	Defect description and Breach	Rectification	Photograph (if applicable)
1727	Balcony sliding door frame	See section 5.9.1	See section 5.9.2

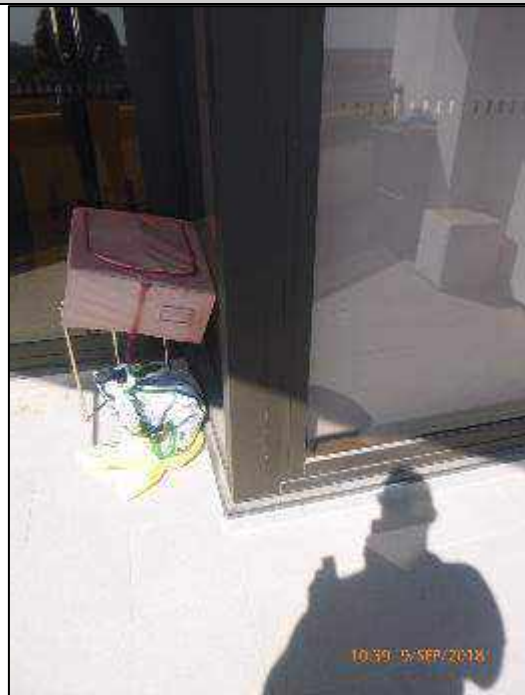
Item	Location	Defect description and Breach	Rectification	Photograph (if applicable)
1728	Balcony sliding door frame	See section 5.7.1	See section 5.7.2

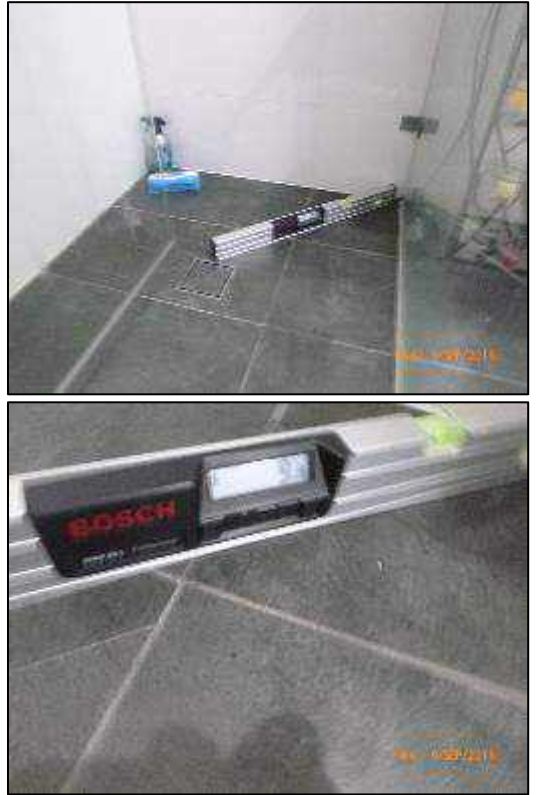
Item	Location	Defect description and Breach	Rectification	Photograph (if applicable)
1729	Main bedroom ensuite	See section 5.1.1 Falls (mm); 9/1000	See section 5.1.2

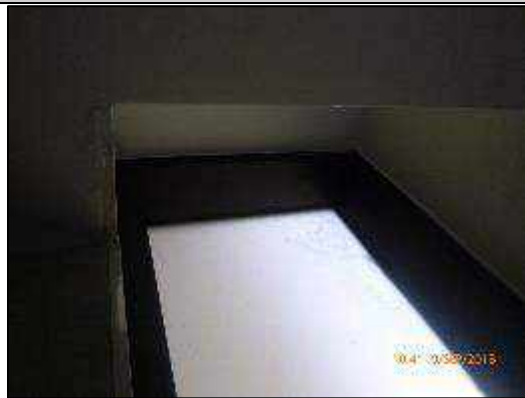
Item	Location	Defect description and Breach	Rectification	Photograph (if applicable)
1730	Main bedroom ensuite ceiling adjacent to window	See section 5.10.1	See section 5.10.2

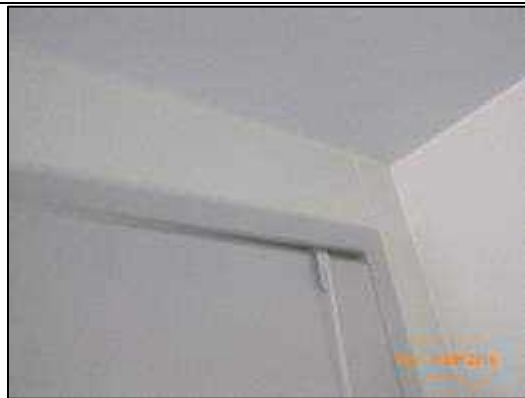
1731	Wall adjacent to ensuite door	See section 5.9.1	See section 5.9.2

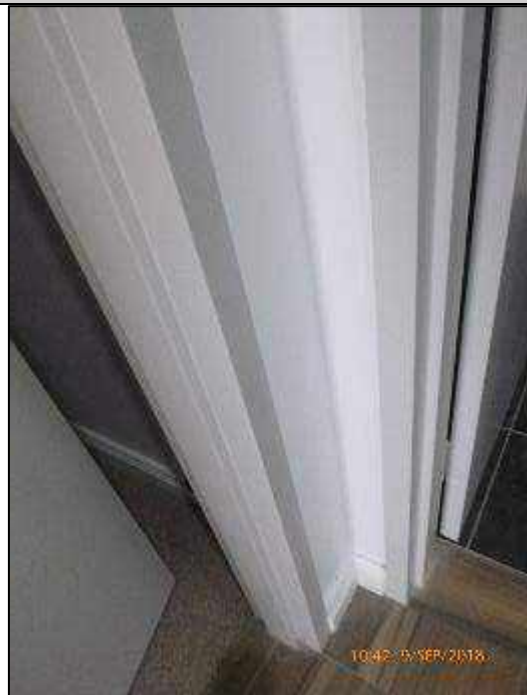
Item	Location	Defect description and Breach	Rectification	Photograph (if applicable)
1732	Wall adjacent to main bathroom door	See section 5.13.1	See section 5.13.2

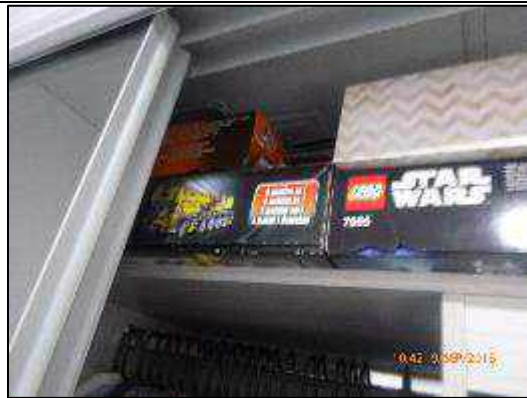
A photograph showing a close-up of a white wall and a white door frame. There is a visible gap or defect where the wall meets the floor. A timestamp '10:42:15 SEP 2018' is visible in the bottom right corner.
1733	Second bedroom built in	See section 5.6.1	See section 5.6.2

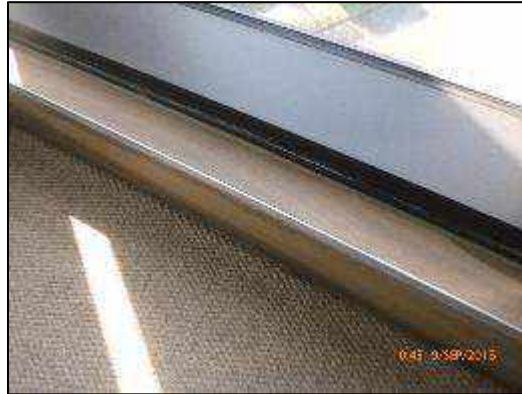
Item	Location	Defect description and Breach	Rectification	Photograph (if applicable)
1734	Second bedroom window frames	See section 5.8.1	See section 5.8.2

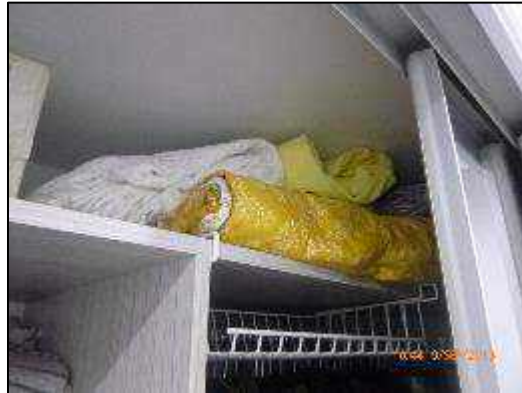
1735	Main bedroom built in	See section 5.6.1	See section 5.6.2

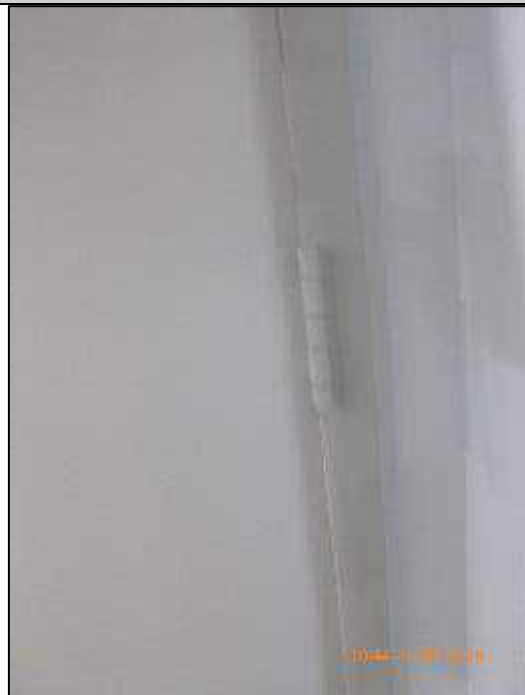
Item	Location	Defect description and Breach	Rectification	Photograph (if applicable)
1736	Wall adjacent to main bedroom door	See section 5.13.1	See section 5.13.2

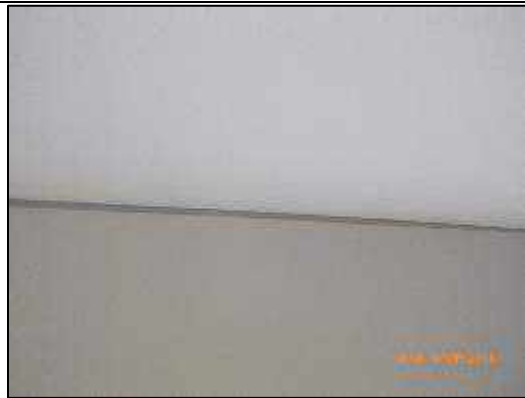
A photograph showing a vertical crack or defect on a light-colored wall. The crack runs vertically down the center of the frame. There is some orange text in the bottom right corner of the photo.
1737	Lounge room	See section 5.11.1	See section 5.11.2

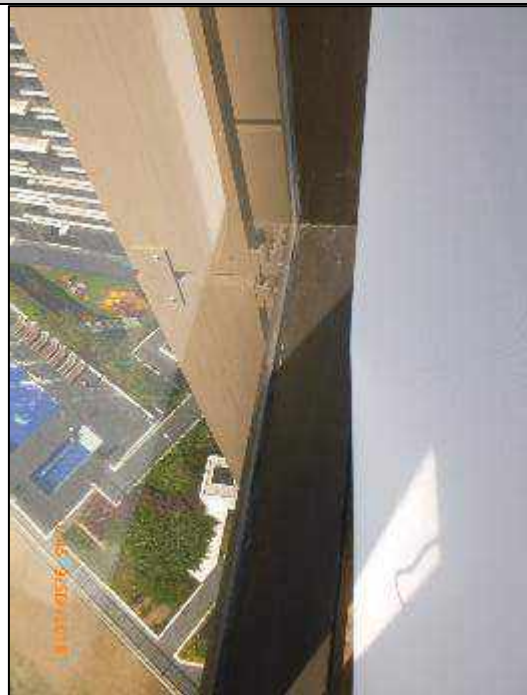
Item	Location	Defect description and Breach	Rectification	Photograph (if applicable)
1738	Lounge room window frames	See section 5.8.1	See section 5.8.2

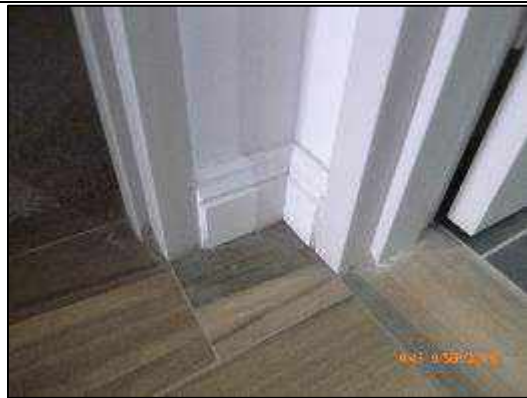
1739	Skirting board adjacent to main bathroom door	See section 5.10.1	See section 5.10.2

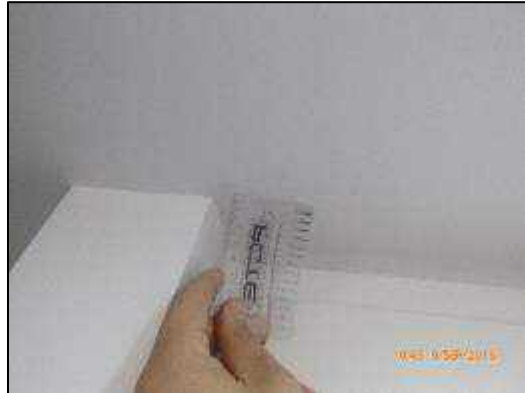
Item	Location	Defect description and Breach	Rectification	Photograph (if applicable)
1740	<i>Ceiling above kitchen cupboards</i>	See section 5.14.1 Separation; 1.5mm	See section 5.14.2

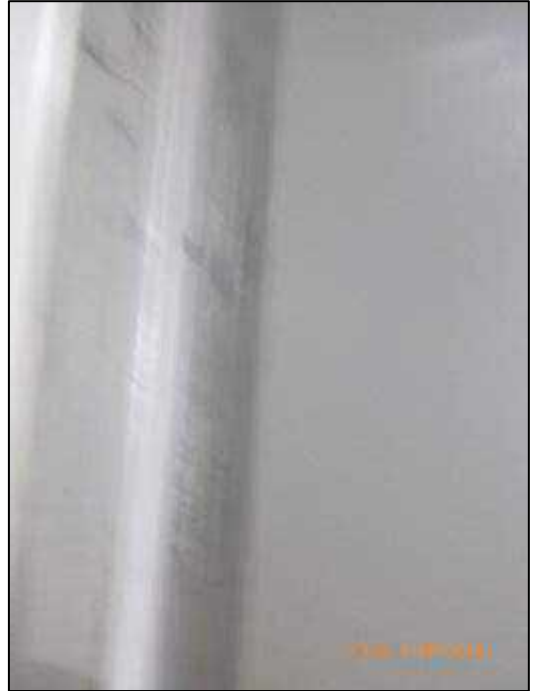
Item	Location	Defect description and Breach	Rectification	Photograph (if applicable)
Unit 1603				
1741	Front entry door	See section 5.12.1	See section 5.12.2

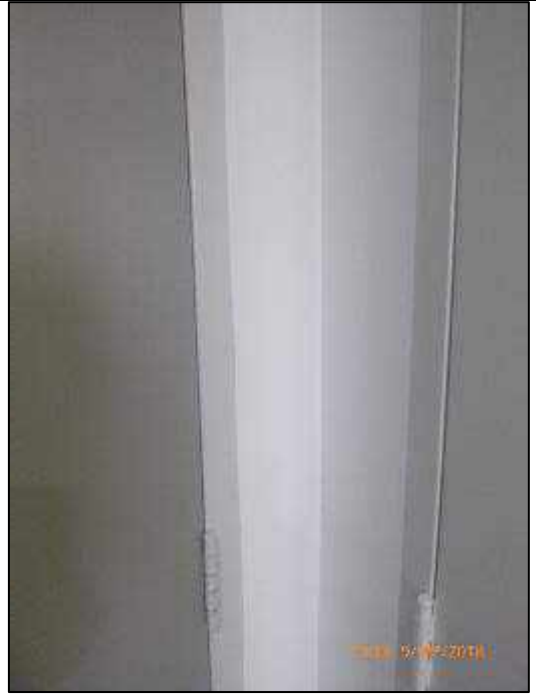
Item	Location	Defect description and Breach	Rectification	Photograph (if applicable)
1742	Wall adjacent to front entry door	See section 5.13.1	See section 5.13.2

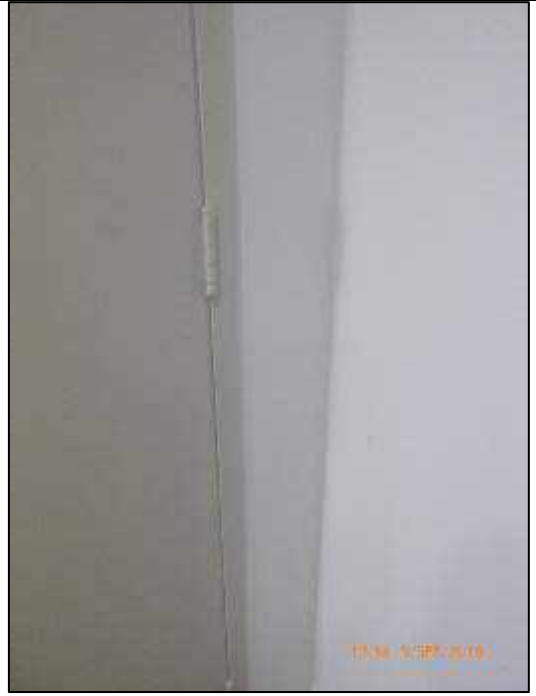
Item	Location	Defect description and Breach	Rectification	Photograph (if applicable)
1743	Wall adjacent to front entry door	See section 5.9.1	See section 5.9.2

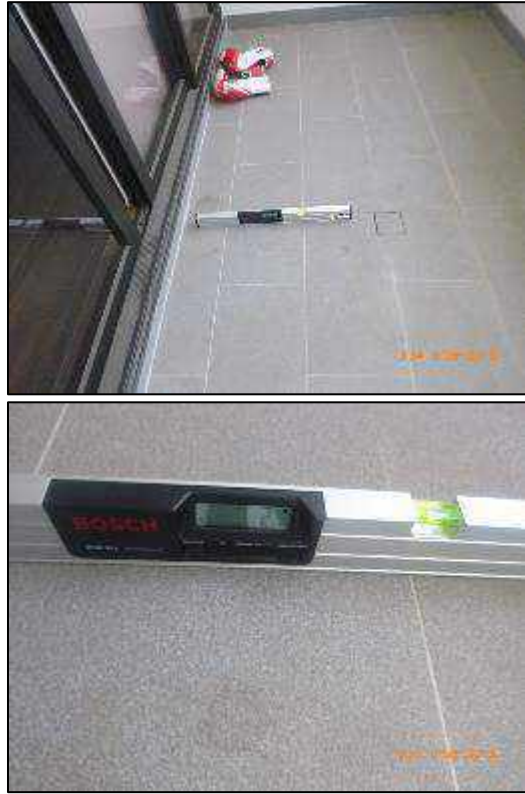
Item	Location	Defect description and Breach	Rectification	Photograph (if applicable)
1744	Balcony	See section 5.2.1 Falls (mm); 2/1000	See section 5.2.2

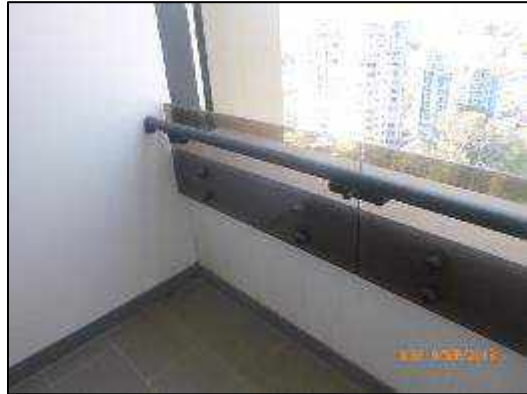
Item	Location	Defect description and Breach	Rectification	Photograph (if applicable)
1745	Balcony	See section 5.4.1	See section 5.4.2

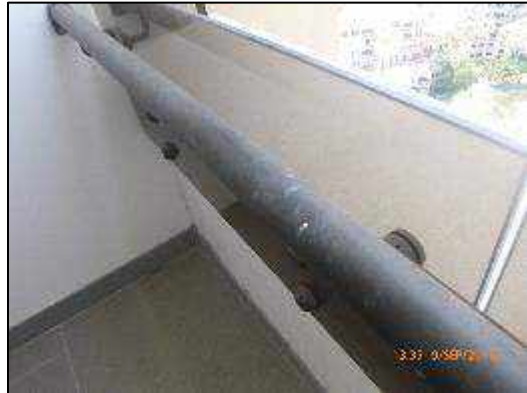
A photograph showing a balcony railing. The railing consists of a dark metal handrail mounted on a white wall. There is a visible gap or defect in the railing assembly. A timestamp '13/07/2015' is visible in the bottom right corner of the photo.
1746	Balcony balustrade rail	See section 5.9.1	See section 5.9.2

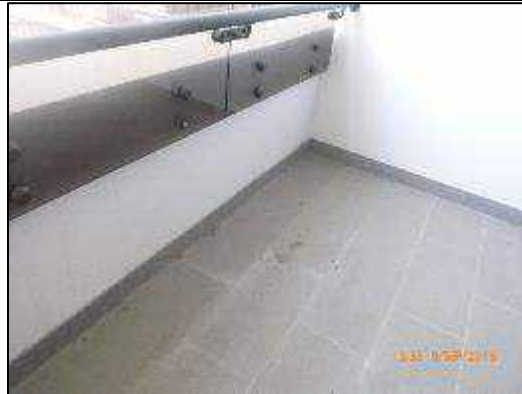
Item	Location	Defect description and Breach	Rectification	Photograph (if applicable)
1747	Balcony	See section 5.3.1	See section 5.3.2

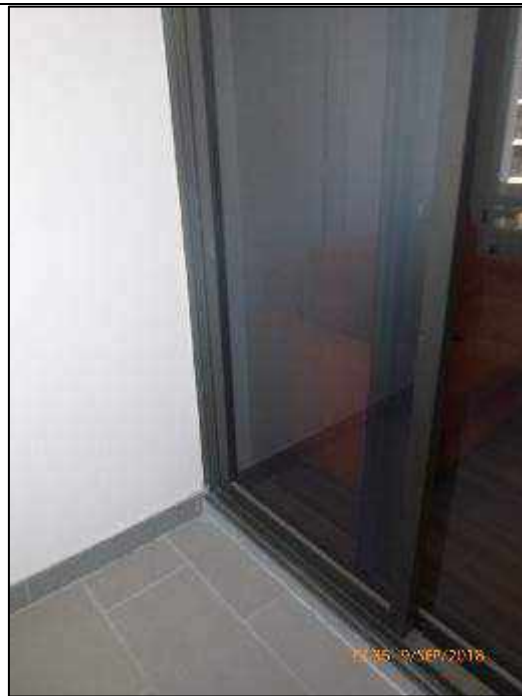
1748	Balcony sliding door frame	See section 5.7.1	See section 5.7.2

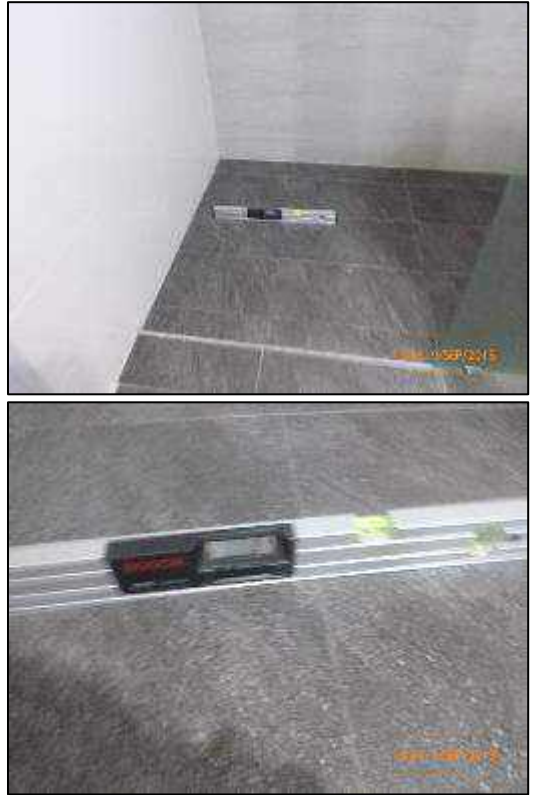
Item	Location	Defect description and Breach	Rectification	Photograph (if applicable)
1749	Main bathroom	See section 5.1.1 Falls (mm); 8/1000	See section 5.1.2

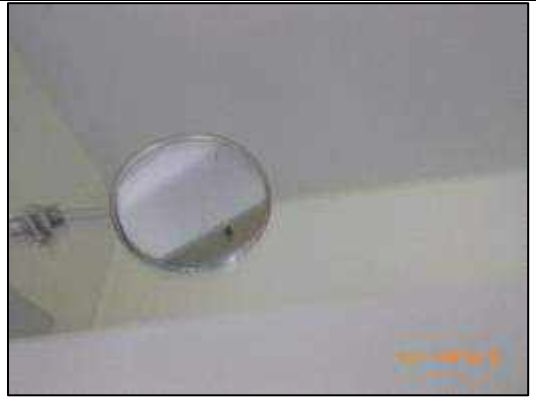
Item	Location	Defect description and Breach	Rectification	Photograph (if applicable)
1750	<i>Doors throughout the unit (x2)</i>	See section 5.5.1	See section 5.5.2

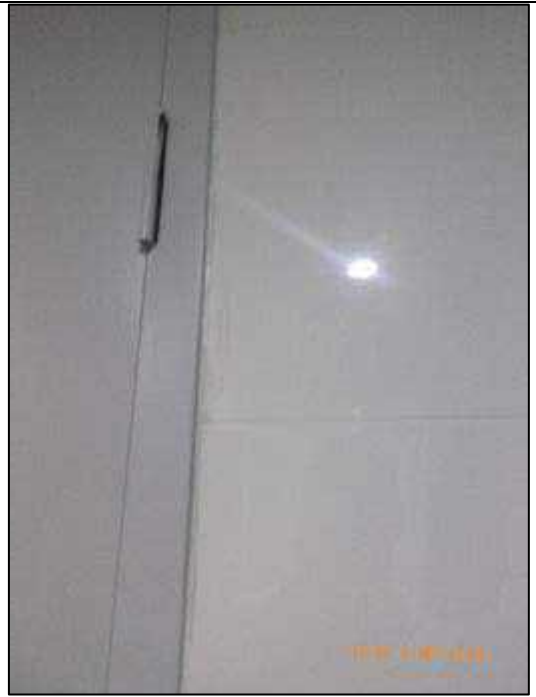
1751	<i>Wall adjacent to main bathroom door</i>	See section 5.9.1	See section 5.9.2

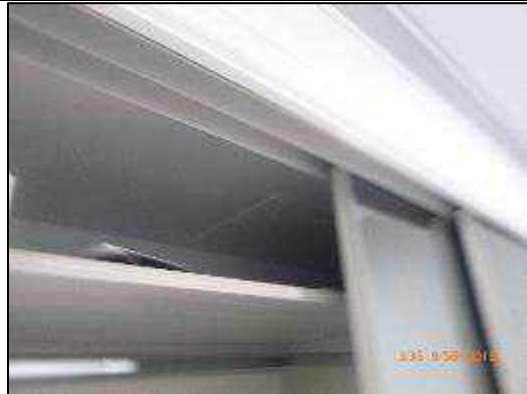
Item	Location	Defect description and Breach	Rectification	Photograph (if applicable)
1752	Main bedroom built in	See section 5.6.1	See section 5.6.2

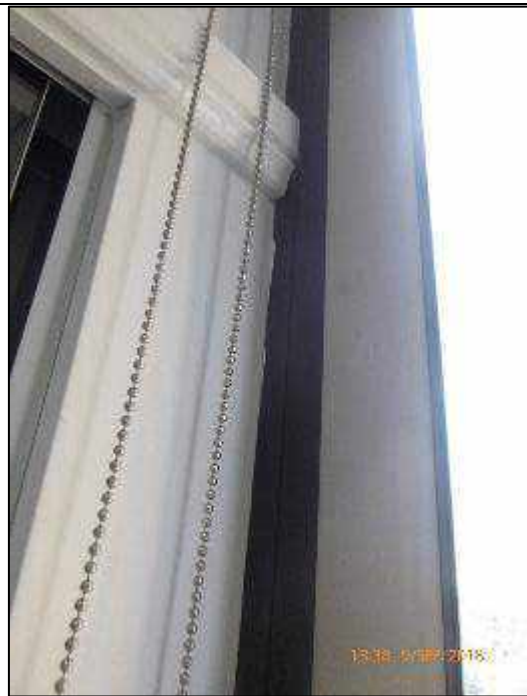
1753	Main bedroom window frames	See section 5.9.1	See section 5.9.2

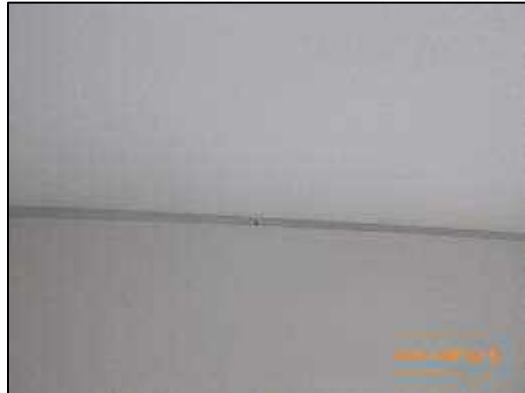
1755	<i>Lounge room</i>	See section 5.11.1	See section 5.11.2

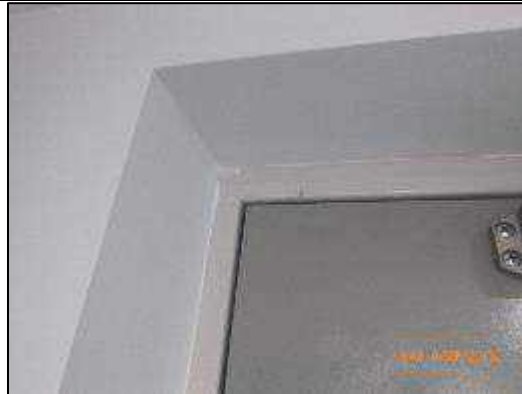
Item	Location	Defect description and Breach	Rectification	Photograph (if applicable)
1757	Wall adjacent to front entry door	See section 5.9.1	See section 5.9.2

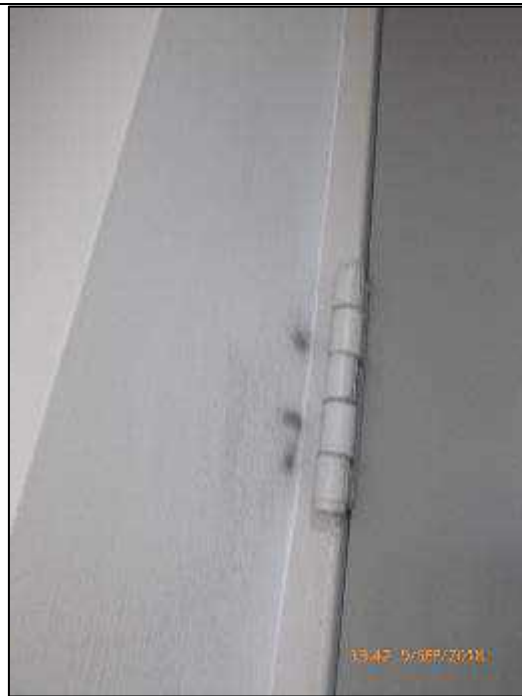
1758	Front entry door	<p>The hinges of the front entry door are leaking.</p> <p>Home Building Act (NSW) 1989</p> <ul style="list-style-type: none"> Part 2C, 18B (a) and (b). <p>This item is a defect as the builder has failed to satisfy implied warranty set out in the Home Building Act 1989 – Section 18B Warranties as to residential building work.</p> <p>(b) a warranty that all materials supplied by the holder or person will be good and suitable for the purpose for which they are used and that, unless otherwise stated in the contract, those materials will be new.</p> <p>Loss Suffered Loss suffered in cost of rectification.</p>	Engage a licenced carpenter to remove faulty door hinges and reinstate with new hinges matching existing in accordance with manufacturers specifications.

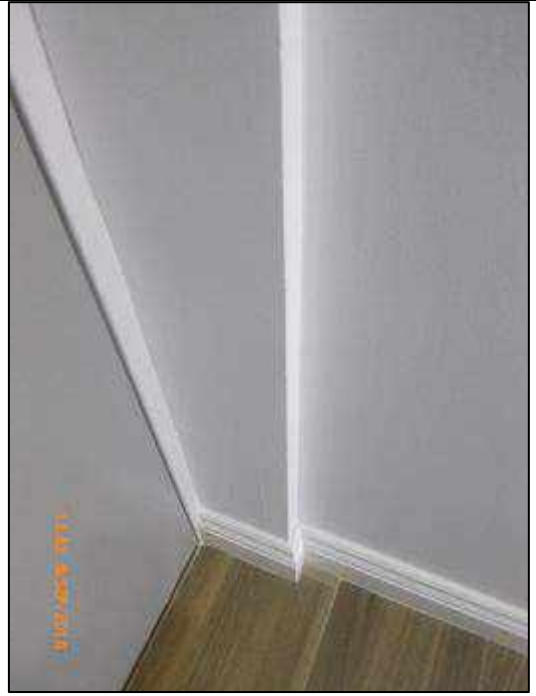
Item	Location	Defect description and Breach	Rectification	Photograph (if applicable)
1759	Wall adjacent to front entry door	See section 5.13.1	See section 5.13.2

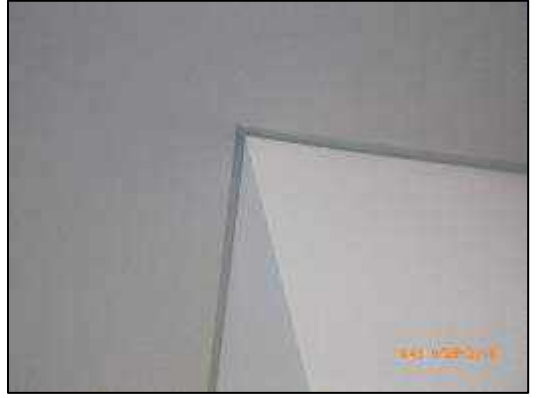
1760	Lounge room	See section 5.11.1	See section 5.11.2

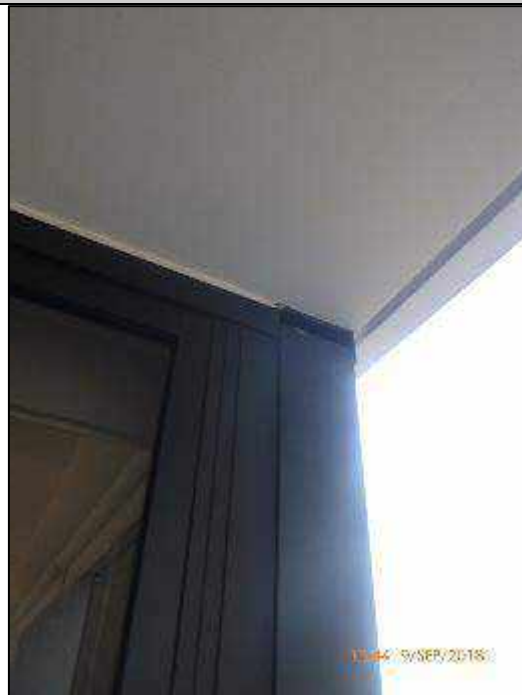
Item	Location	Defect description and Breach	Rectification	Photograph (if applicable)
1762	Balcony sliding door frame	<p>Separation observed between sliding door and ceiling.</p> <p>Home Building Act (NSW) 1989</p> <ul style="list-style-type: none"> Part 2C, 18B (a) and (c). <p>Guide to Standards and Tolerances 2017</p> <p>10.16 Cracking at junctions of dissimilar materials-Cracking at junctions between dissimilar materials is a defect if it is greater than 1 mm or is visible from a normal viewing position.</p> <p>Loss Suffered</p> <p>Loss suffered is cost of rectification.</p>	<ol style="list-style-type: none"> Protect all surrounding areas Apply a bead of flexible sealant to the joint between the sliding door frame and wall As required, all affected surfaces are to be painted with an appropriate paint system to match as close as possible to the existing in accordance with the manufacturer's recommendations and AS2311 – Guide to the painting of buildings. Clean up the work area

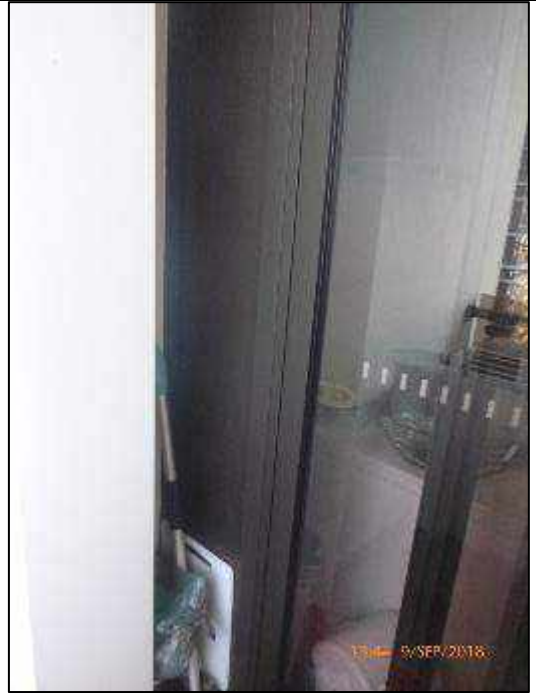
Item	Location	Defect description and Breach	Rectification	Photograph (if applicable)
1763	Balcony sliding door frame	See section 5.7.1	See section 5.7.2

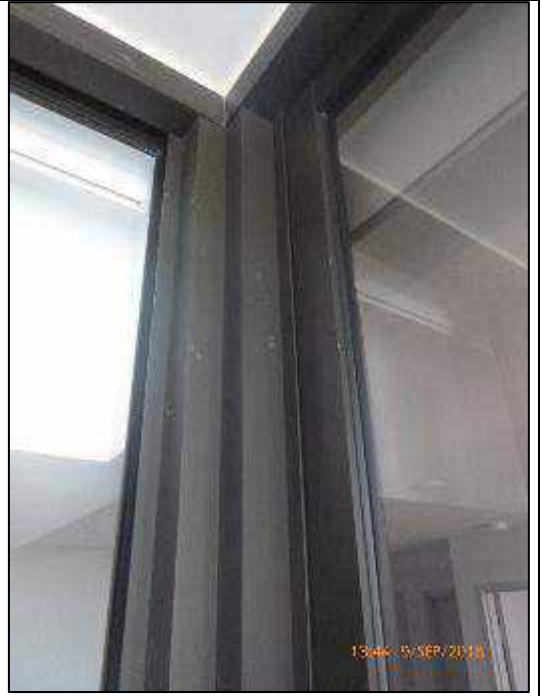
Item	Location	Defect description and Breach	Rectification	Photograph (if applicable)
1764	Balcony sliding door frame	See section 5.9.1	See section 5.9.2

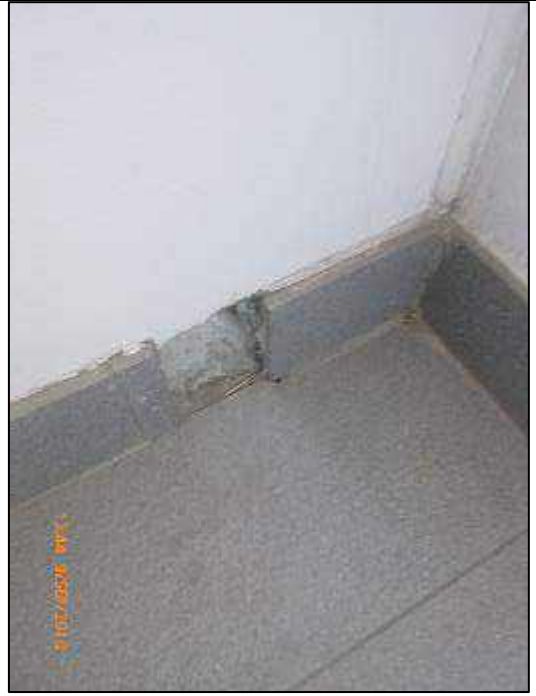
Item	Location	Defect description and Breach	Rectification	Photograph (if applicable)
1765	Balcony	See section 5.15.1	See section 5.15.2

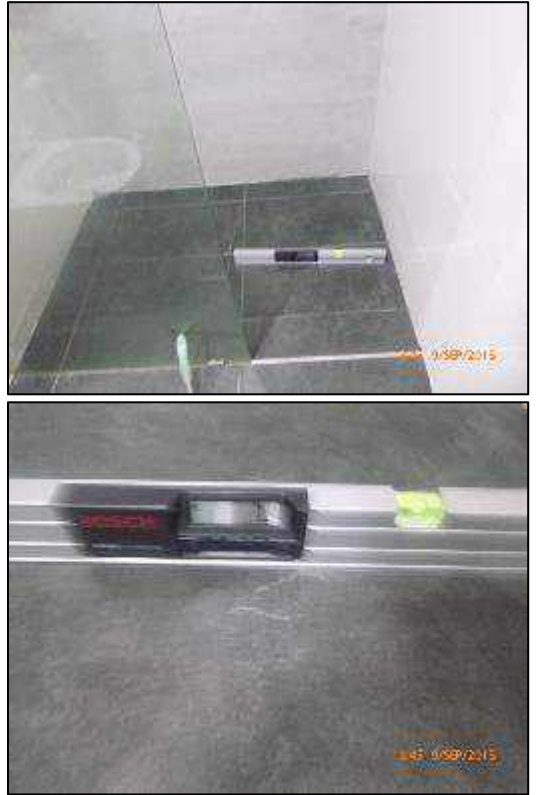
Item	Location	Defect description and Breach	Rectification	Photograph (if applicable)
1766	Main bathroom	See section 5.1.1 Falls (mm); 7/1000	See section 5.1.2

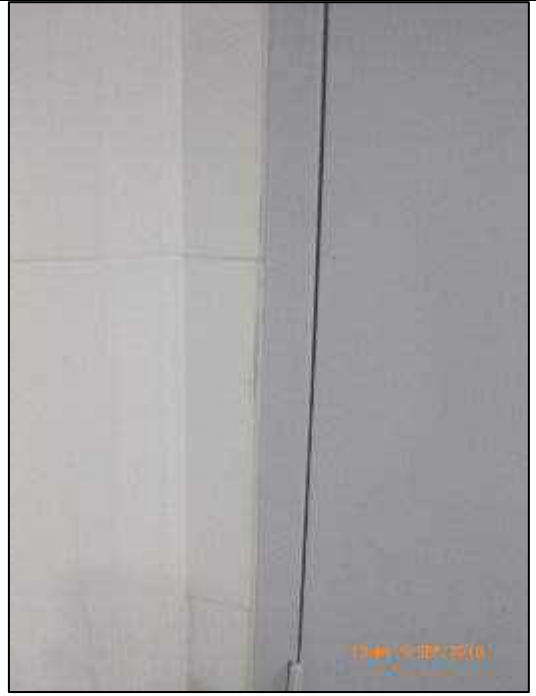
Item	Location	Defect description and Breach	Rectification	Photograph (if applicable)
1767	Wall adjacent to main bathroom door	See section 5.9.1	See section 5.9.2

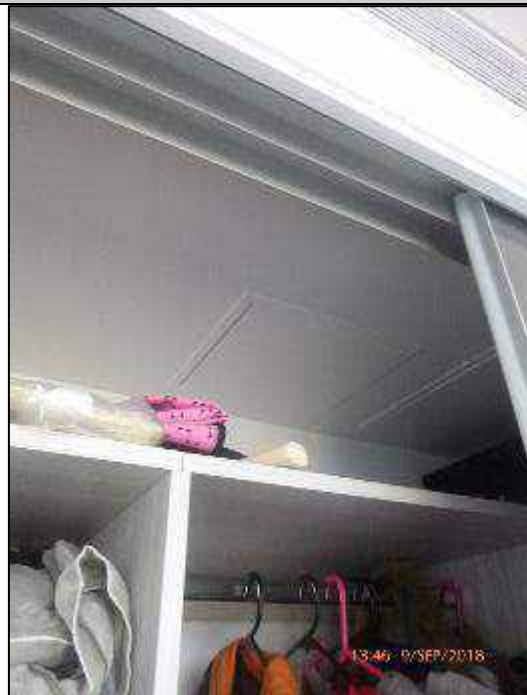
Item	Location	Defect description and Breach	Rectification	Photograph (if applicable)
1768	Main bedroom built in	See section 5.6.1	See section 5.6.2

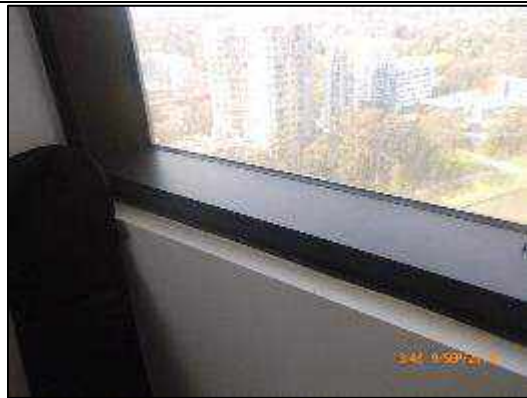
1769	Main bedroom window frames	See section 5.9.1	See section 5.9.2

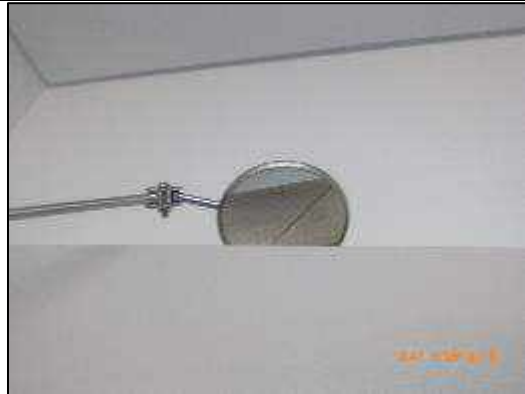
Item	Location	Defect description and Breach	Rectification	Photograph (if applicable)
1770	Doors throughout the unit (x3)	See section 5.5.1	See section 5.5.2

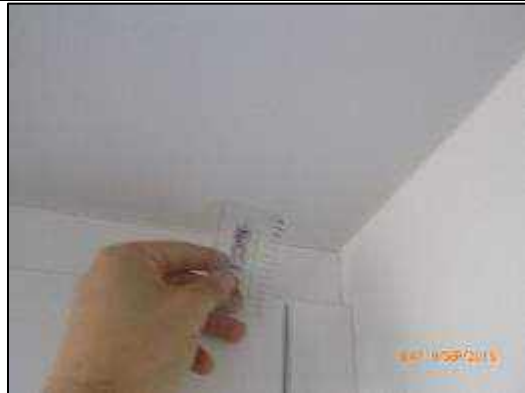
1771	Ceiling above kitchen cupboards	See section 5.14.1 Separation; 1mm	See section 5.14.2

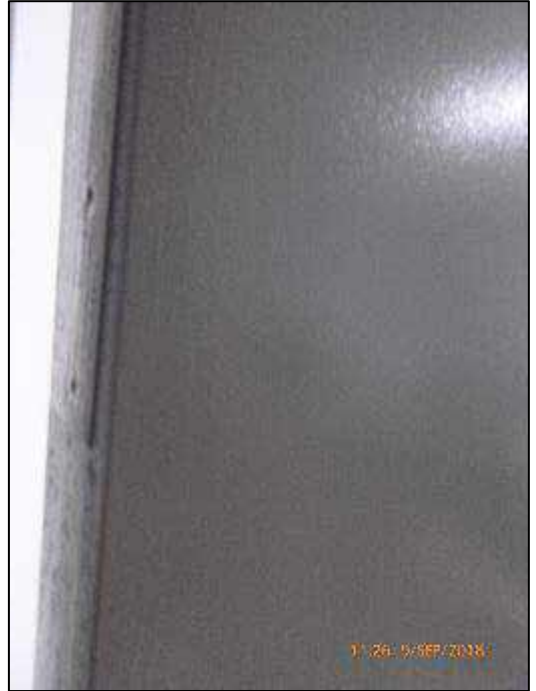
Item	Location	Defect description and Breach	Rectification	Photograph (if applicable)
Unit 1606				
1773	Front entry door	See section 5.12.1	See section 5.12.2

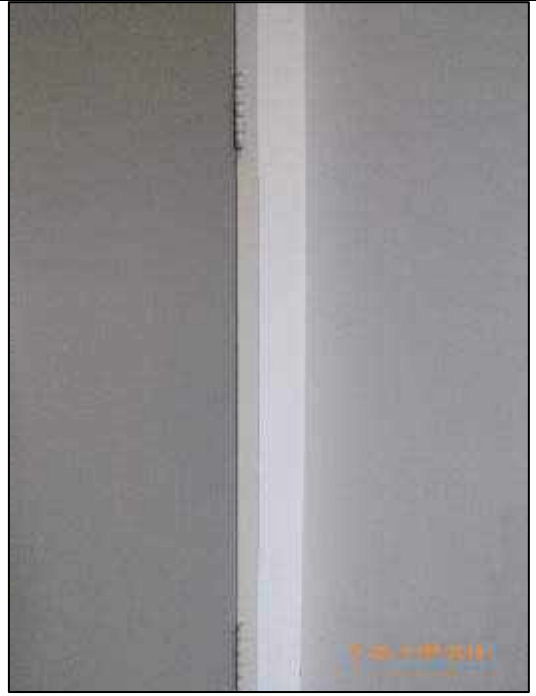
Item	Location	Defect description and Breach	Rectification	Photograph (if applicable)
1774	Wall adjacent to front entry door	See section 5.9.1	See section 5.9.2

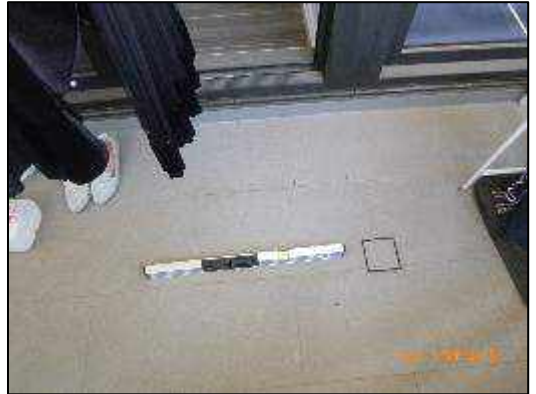
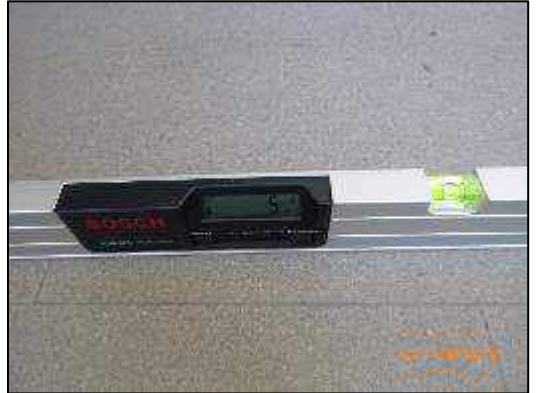
Item	Location	Defect description and Breach	Rectification	Photograph (if applicable)
1776	Balcony	See section 5.2.1 Falls (mm); 5/1000	See section 5.2.2

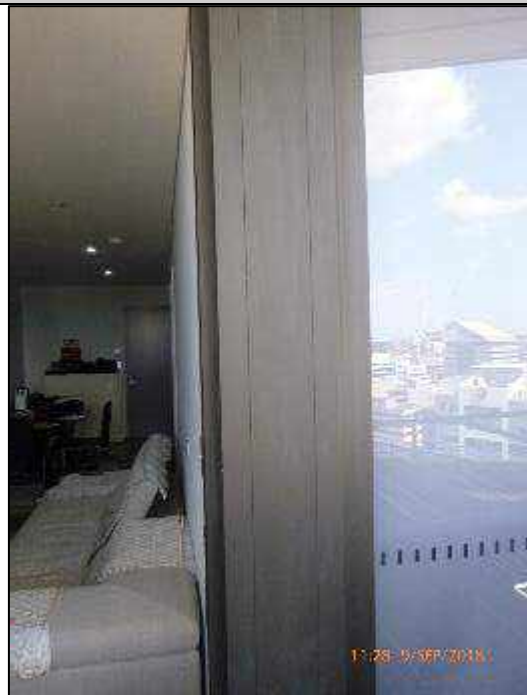
Item	Location	Defect description and Breach	Rectification	Photograph (if applicable)
1777	Balcony sliding door frame	See section 5.7.1	See section 5.7.2

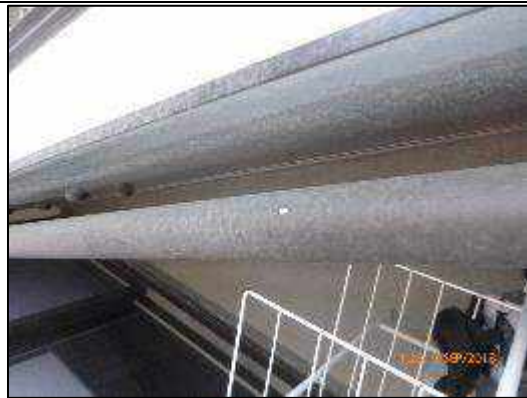
A photograph showing a balcony sliding door frame. The door is partially open, revealing a gap between the frame and the door panel. The view outside shows a building and a clear sky. A timestamp '13:28:59/5/2018' is visible in the bottom right corner.
1778	Balcony balustrade	See section 5.9.1	See section 5.9.2

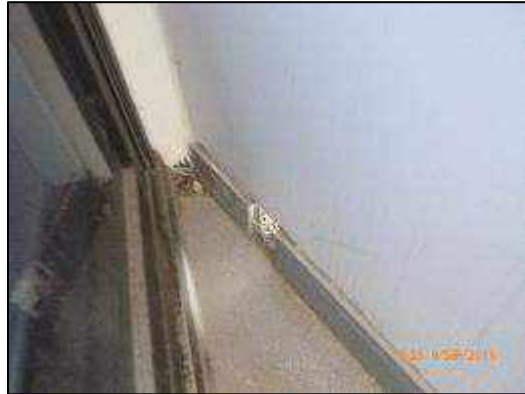
Item	Location	Defect description and Breach	Rectification	Photograph (if applicable)
1779	Balcony	See section 5.15.1	See section 5.15.2

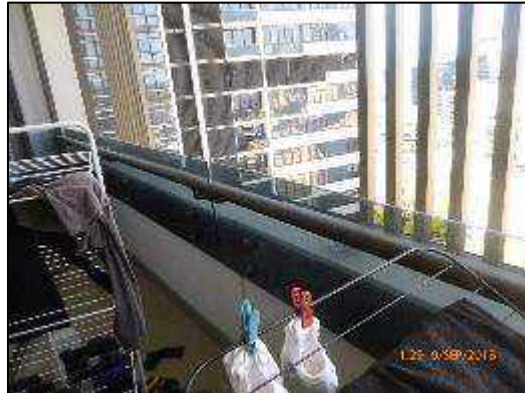
1780	Balcony	See section 5.4.1	See section 5.4.2

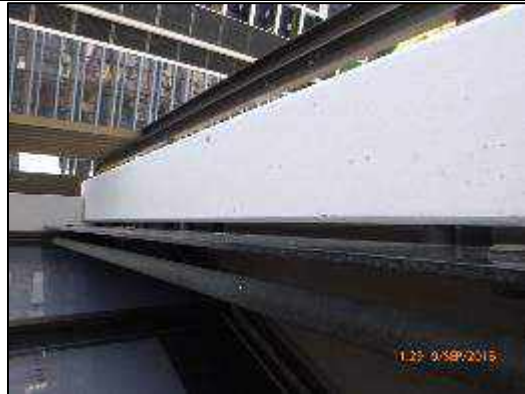
Item	Location	Defect description and Breach	Rectification	Photograph (if applicable)
1781	Balcony façade of balustrade	<p>Construction debris observed on the external façade.</p> <p>Home Building Act (NSW) 1989</p> <ul style="list-style-type: none"> Part 2C, 18B (a) and (c). <p>This is a breach of part (a) of the act because the surface has not been finished in a proper workmanlike manner that would prevent loss of appearance to the surface.</p> <p>Loss Suffered Loss suffered is cost of rectification.</p>	<ol style="list-style-type: none"> 1. Protect all adjoining surfaces. 2. Use a suitable cleaning agent to remove residue and clear debris. 3. Clean up the work area.

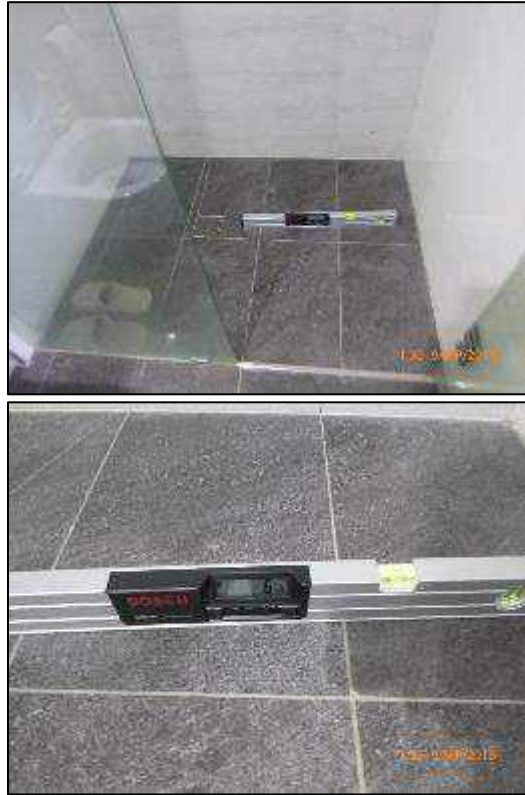
Item	Location	Defect description and Breach	Rectification	Photograph (if applicable)
1782	Main bathroom	See section 5.1.1 Falls (mm); 6/1000	See section 5.1.2

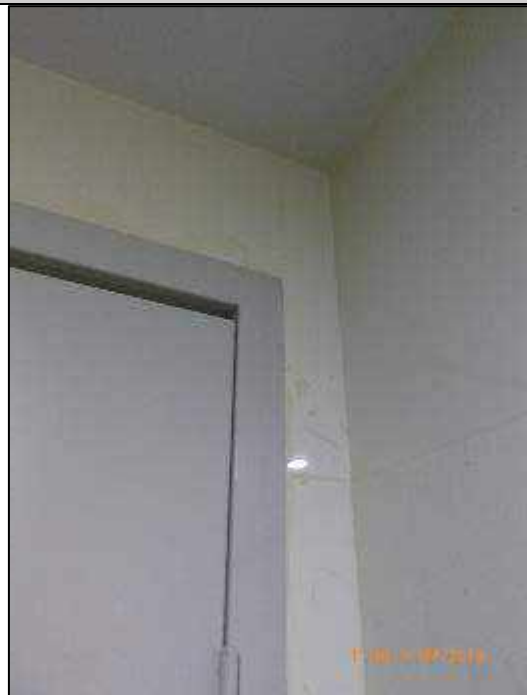
Item	Location	Defect description and Breach	Rectification	Photograph (if applicable)
1783	Wall adjacent to main bathroom door	See section 5.9.1	See section 5.9.2

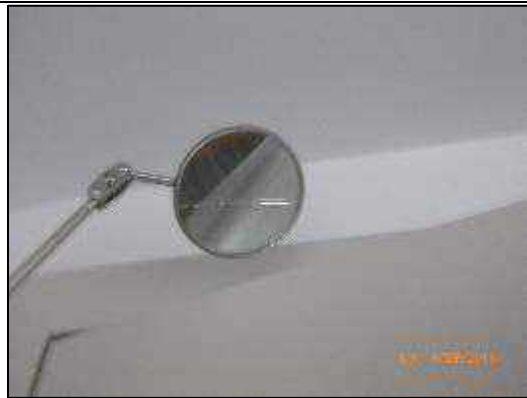
1784	Doors throughout the unit (x3)	See section 5.5.1	See section 5.5.2

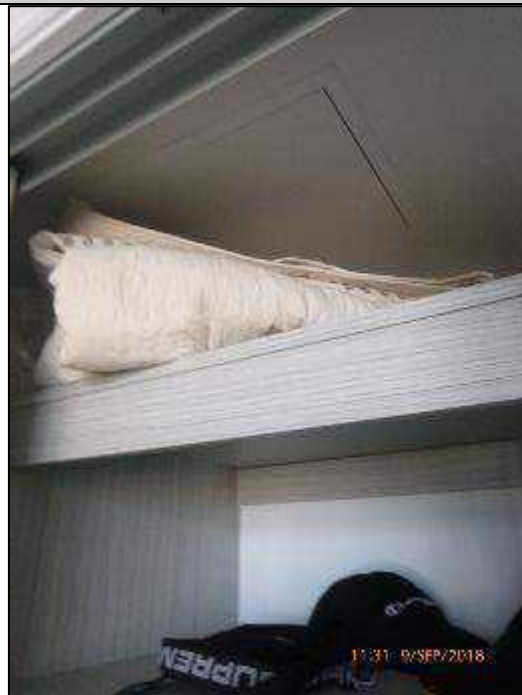
Item	Location	Defect description and Breach	Rectification	Photograph (if applicable)
1785	Main bedroom built in	See section 5.6.1	See section 5.6.2

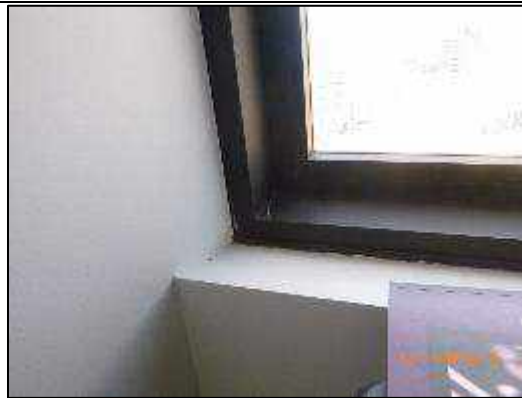
1786	Main bedroom window frames	See section 5.9.1	See section 5.9.2

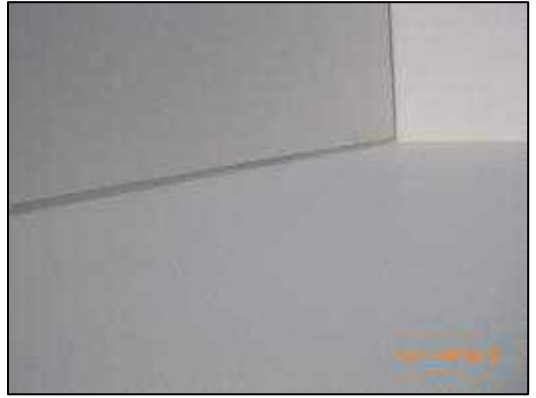
Item	Location	Defect description and Breach	Rectification	Photograph (if applicable)
1787	Lounge room	See section 5.11.1	See section 5.11.2

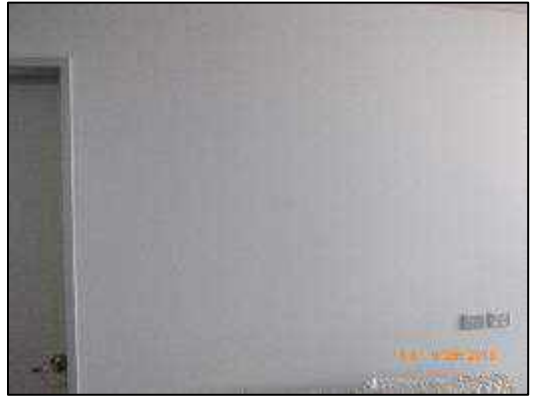
1788	Walls and ceiling throughout the unit	See section 5.10.1	See section 5.10.2

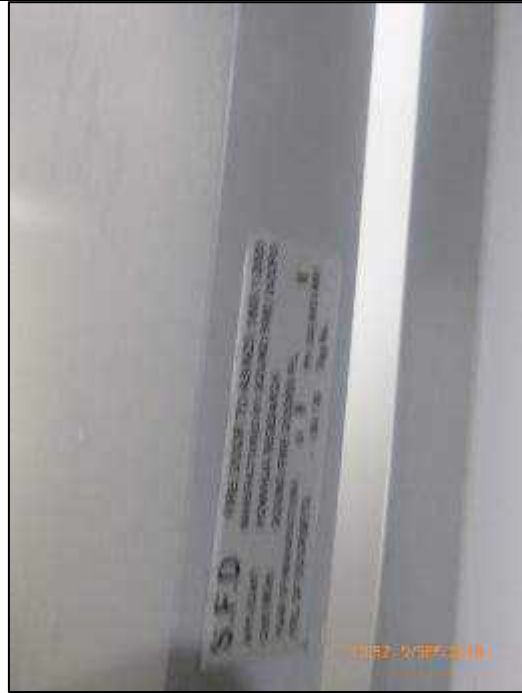
Item	Location	Defect description and Breach	Rectification	Photograph (if applicable)
Unit 1607				
1789	Front entry door	See section 5.12.1	See section 5.12.2

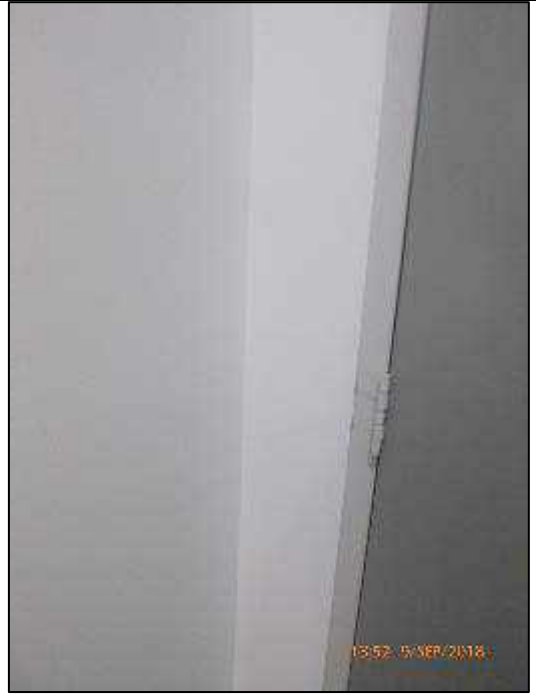
Item	Location	Defect description and Breach	Rectification	Photograph (if applicable)
1790	Wall adjacent to front entry door	See section 5.9.1	See section 5.9.2

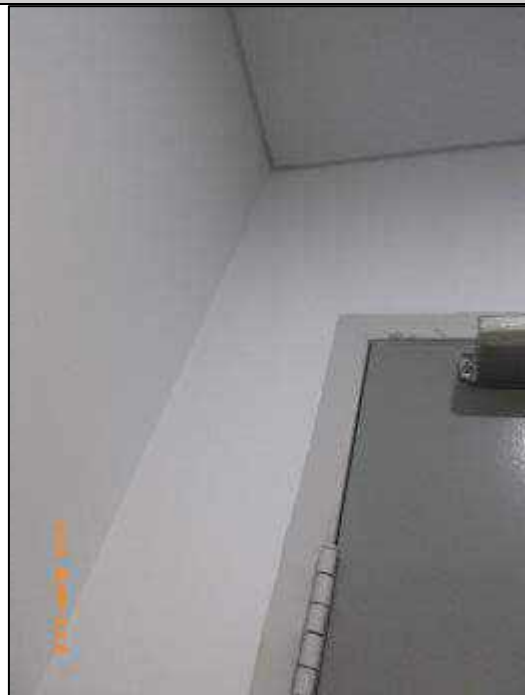
Item	Location	Defect description and Breach	Rectification	Photograph (if applicable)
1791	Wall adjacent to front entry door	See section 5.13.1	See section 5.13.2

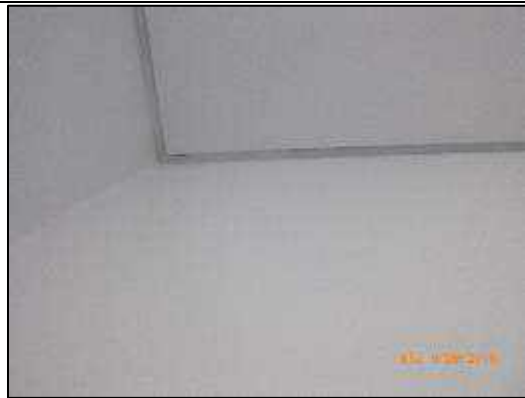
1792	Lounge room	See section 5.11.1	See section 5.11.2
