SydneyStrataReport

STRATA REPORT

Client	Church Street Parramatta Property Pty Ltd
Address of property	Unit 3303/330 Church Street, Parramatta, NSW.
Lot	359
Strata Plan	SP 94469
Name of Strata Management Co.	NSW Strata
Telephone Number of Strata Agent	8980 1841
Report Date	15 February 2024

BUILDING DEFECTS REPORT Part 1/2

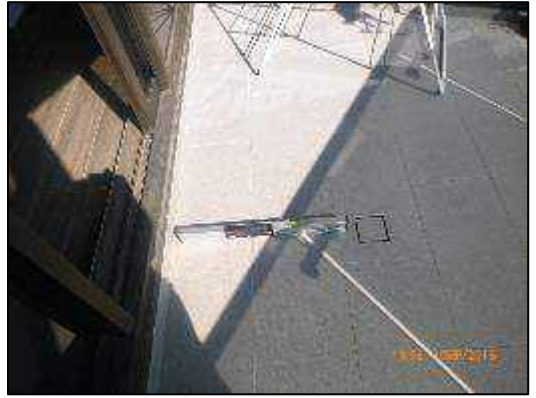
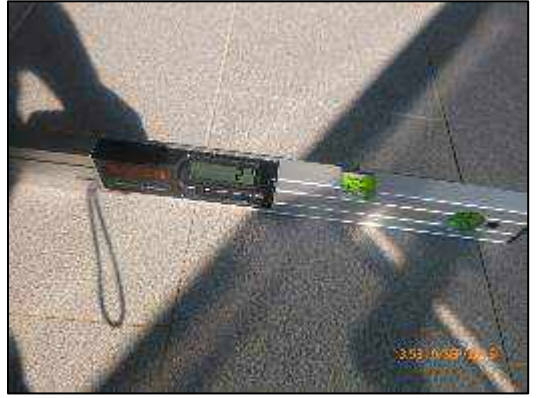
Item	Location	Defect description and Breach	Rectification	Photograph (if applicable)
1793	Balcony	See section 5.1.1 Falls (mm); 2/1000	See section 5.1.2

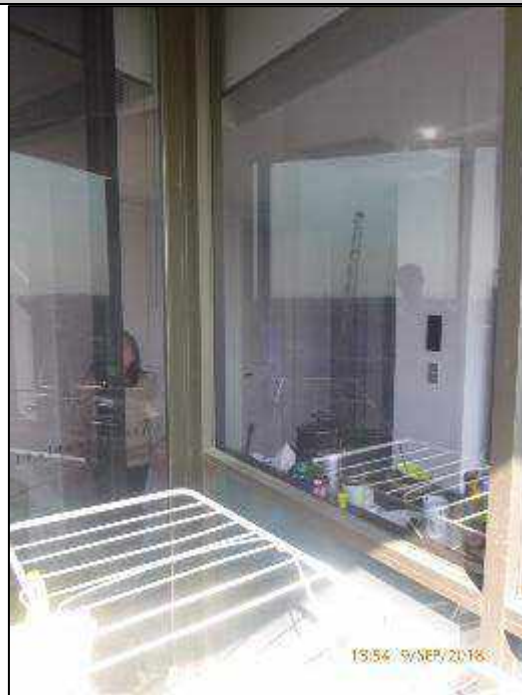
Item	Location	Defect description and Breach	Rectification	Photograph (if applicable)
1794	Balcony sliding door frame	See section 5.7.1	See section 5.7.2

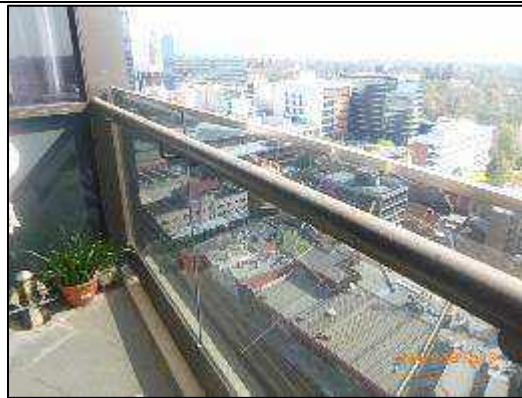
1795	Balcony	See section 5.4.1	See section 5.4.2

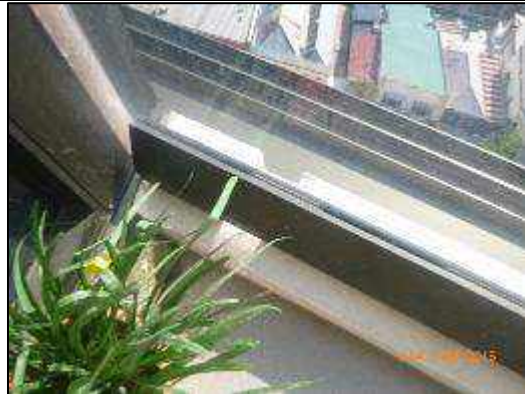
Item	Location	Defect description and Breach	Rectification	Photograph (if applicable)
1796	Balcony	See section 5.3.1	See section 5.3.2

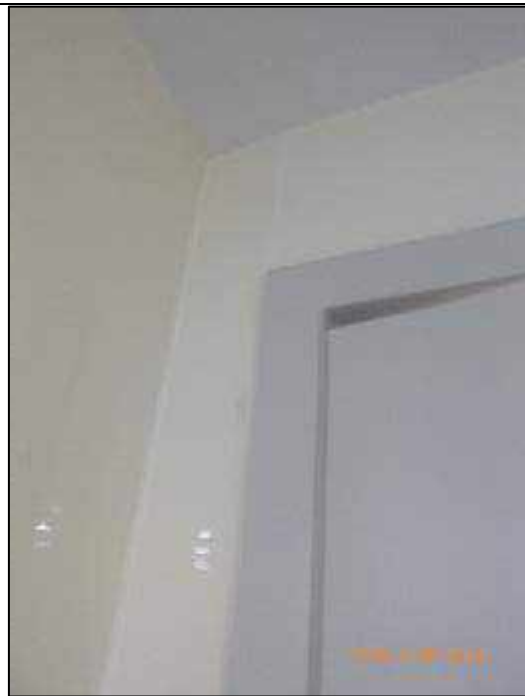
1797	Wall adjacent to main bathroom door	See section 5.9.1	See section 5.9.2

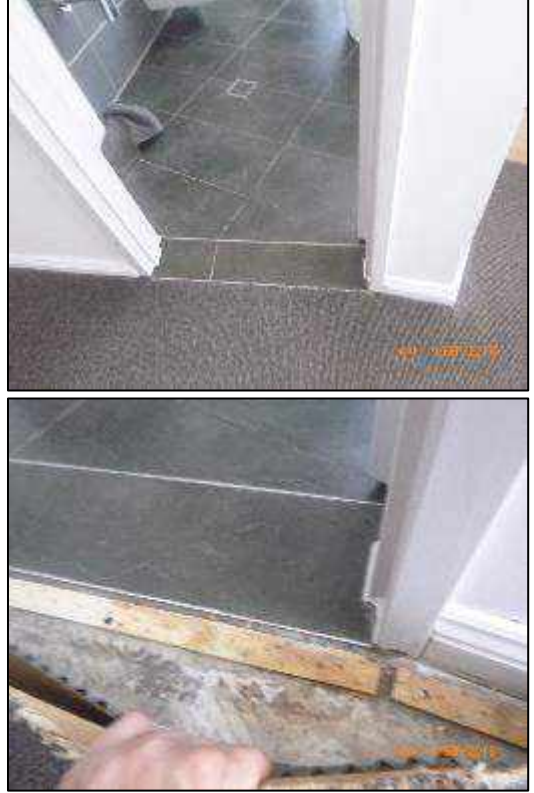
1798	Main bedroom ensuite	<p>Water egress observed from ensuite into main bedroom. High moisture readings measured at entrance to ensuite.</p> <p>Home Building Act (NSW) 1989</p> <ul style="list-style-type: none"> Part 2C, 18B (a), (b) and (c). <p>Building Code of Australia</p> <ul style="list-style-type: none"> Section F Health and Amenity Part F1 Damp and Weatherproofing Sections FO1, FF1.3. <p>This is a breach because the building is not constructed in a manner so as to prevent moisture escaping from the ensuite wet area.</p> <p>Loss Suffered Loss suffered is cost of rectification.</p>	<p>Remove tiles/fixtures within the shower enclosure to allow provision of suitable new waterproofing membrane system to the wet area. Replace tiles and refit shower fixtures on completion of tiling.</p>

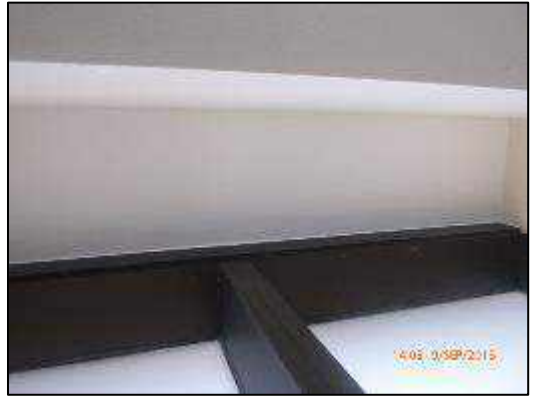
1799	Main bedroom ensuite window frames	See section 5.9.1	See section 5.9.2

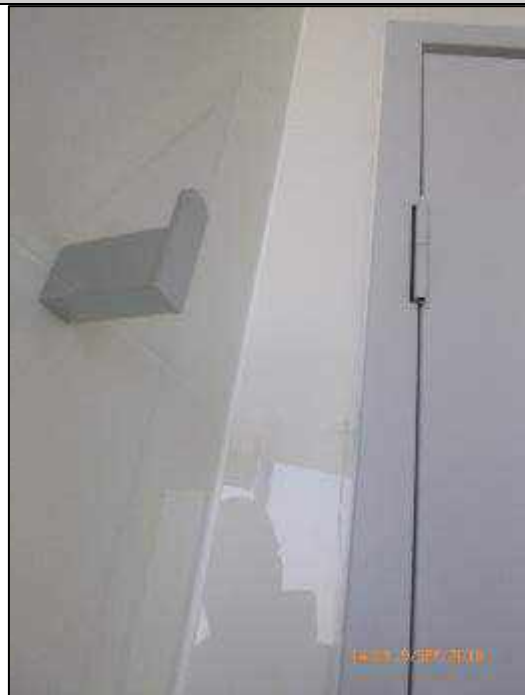
Item	Location	Defect description and Breach	Rectification	Photograph (if applicable)
1800	Wall adjacent to ensuite door	See section 5.9.1	See section 5.9.2

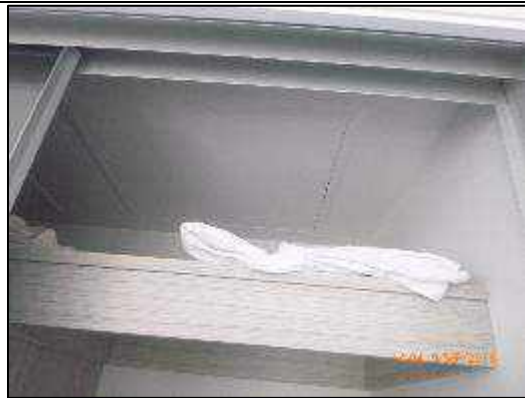
A photograph showing a wall defect near an ensuite door. The wall is light-colored and appears to have a small, dark, rectangular object or hole. The door is visible on the right side of the frame.
1801	Main bedroom built in	See section 5.6.1	See section 5.6.2

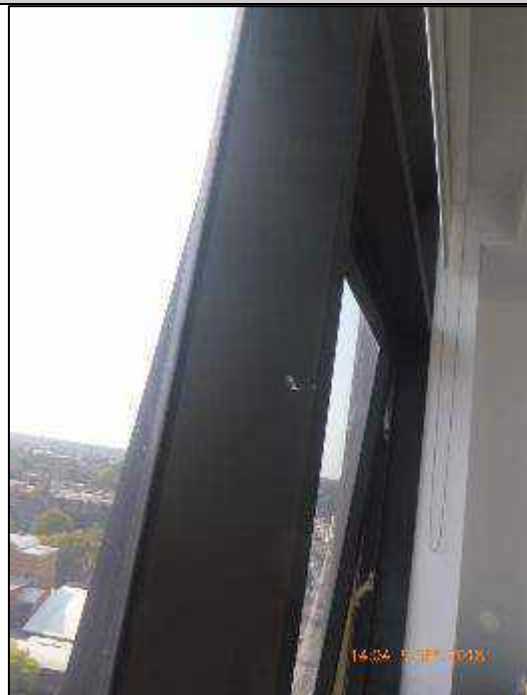
Item	Location	Defect description and Breach	Rectification	Photograph (if applicable)
1802	Main bedroom window frames	See section 5.9.1	See section 5.9.2

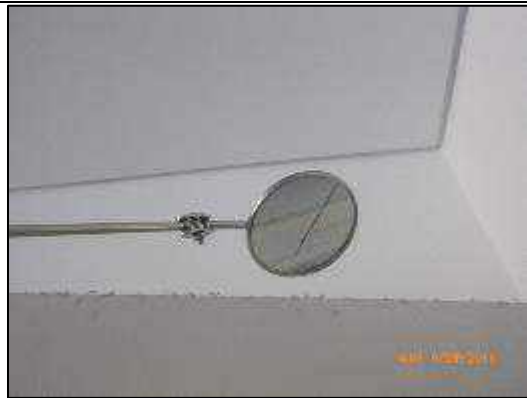
1803	Doors throughout the unit (x3)	See section 5.5.1	See section 5.5.2

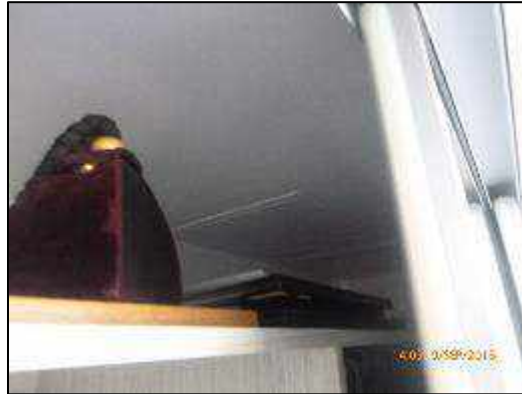
Item	Location	Defect description and Breach	Rectification	Photograph (if applicable)
1804	<i>Second bedroom built in</i>	See section 5.6.1	See section 5.6.2

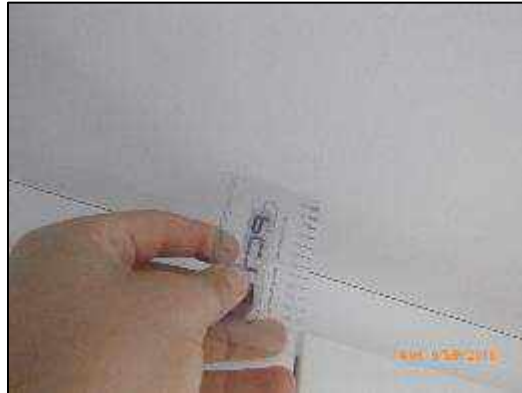
1805	<i>Ceiling above kitchen cupboards</i>	See section 5.14.1 Separation; 1mm	See section 5.14.2

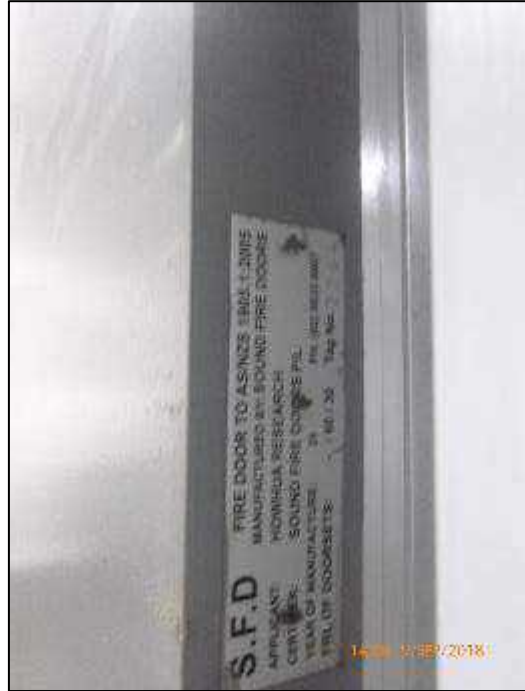
Item	Location	Defect description and Breach	Rectification	Photograph (if applicable)
Unit 1608				
1806	Front entry door	See section 5.12.1	See section 5.12.2

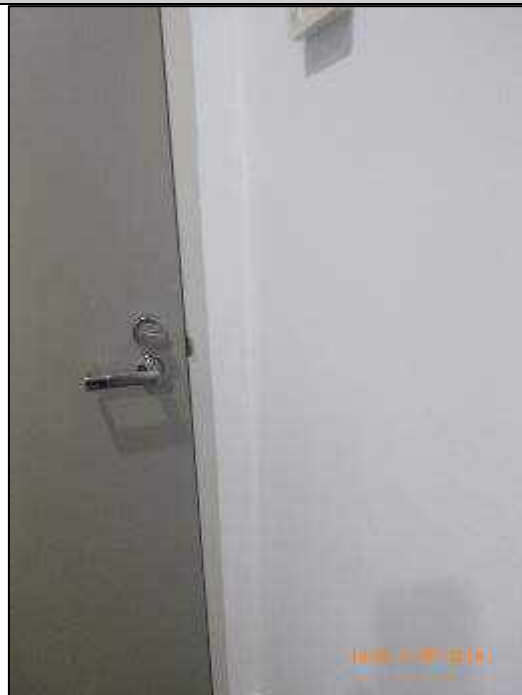
Item	Location	Defect description and Breach	Rectification	Photograph (if applicable)
1807	Wall adjacent to front entry door	See section 5.13.1	See section 5.13.2

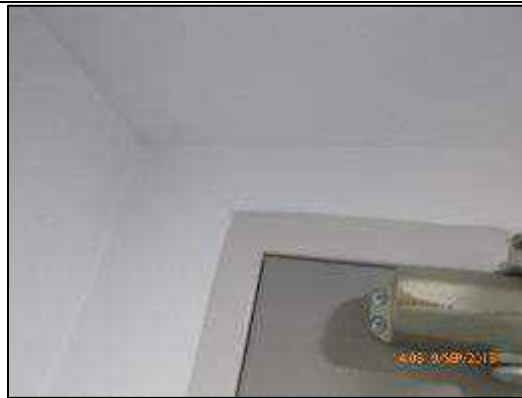
1808	Wall adjacent to front entry door	See section 5.9.1	See section 5.9.2

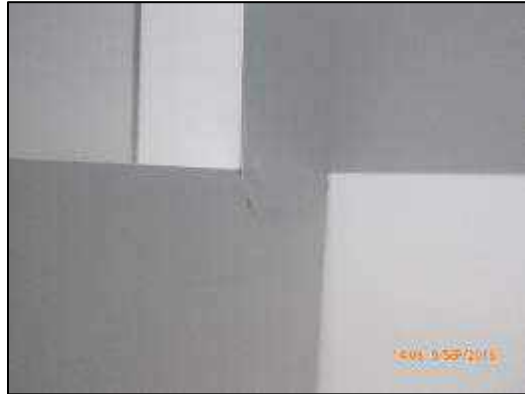
Item	Location	Defect description and Breach	Rectification	Photograph (if applicable)
1809	Kitchen window bulkhead	See section 5.13.1	See section 5.13.2

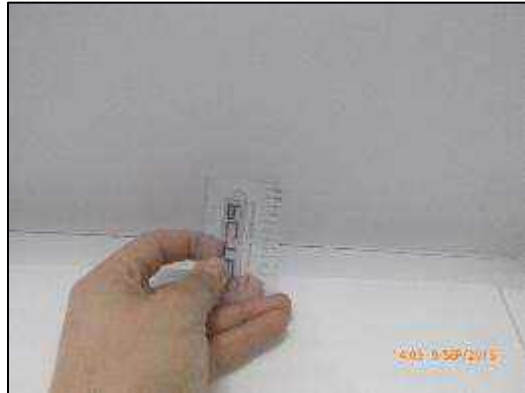
1810	Ceiling above kitchen cupboards	See section 5.14.1 Separation; 1.5mm	See section 5.14.2

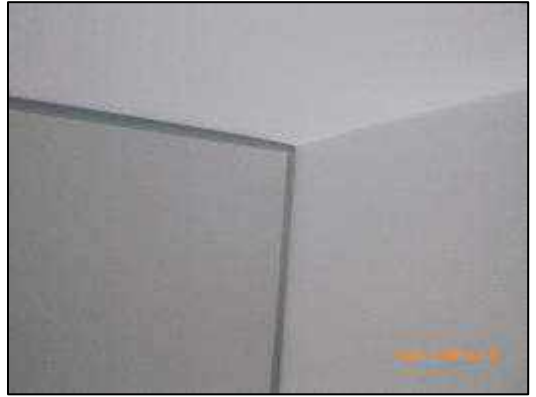
Item	Location	Defect description and Breach	Rectification	Photograph (if applicable)
1811	Lounge room	See section 5.11.1	See section 5.11.2

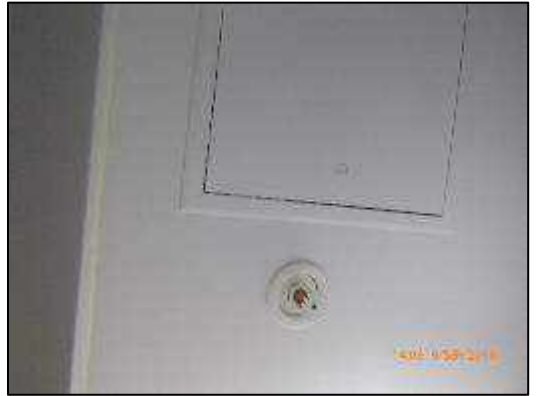
1812	Laundry ceiling	See section 5.10.1	See section 5.10.2

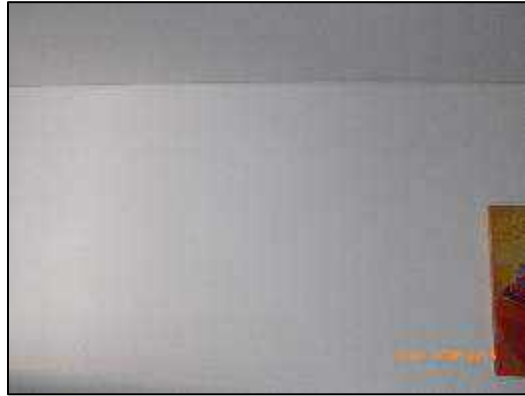
Item	Location	Defect description and Breach	Rectification	Photograph (if applicable)
1813	<i>Walls and ceiling throughout the unit</i>	See section 5.10.1	See section 5.10.2

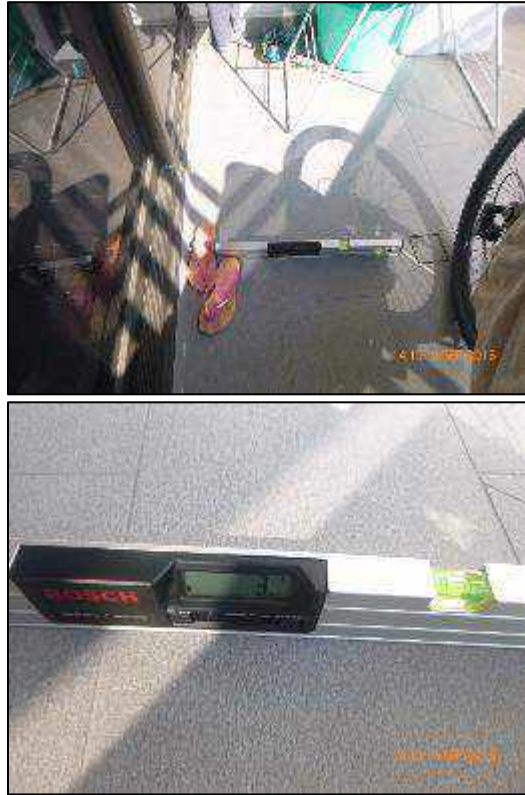
Item	Location	Defect description and Breach	Rectification	Photograph (if applicable)
1814	Balcony	See section 5.1.1 Falls (mm); 3/1000	See section 5.1.2

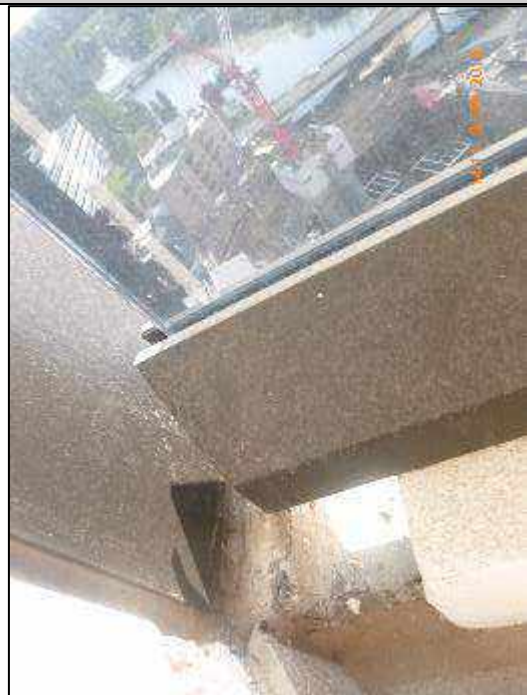
Item	Location	Defect description and Breach	Rectification	Photograph (if applicable)
1815	Balcony	See section 5.15.1	See section 5.15.2

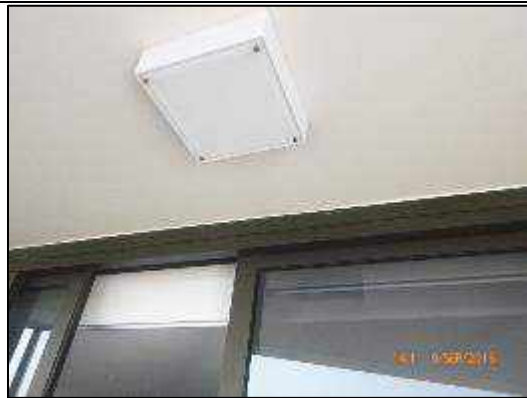
1816	Balcony sliding door frame	See section 5.9.1	See section 5.9.2

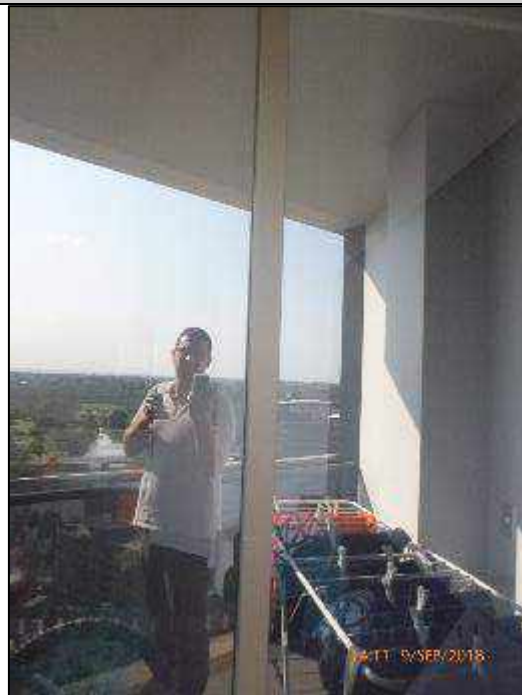
Item	Location	Defect description and Breach	Rectification	Photograph (if applicable)
1817	Balcony sliding door frame	See section 5.7.1	See section 5.7.2

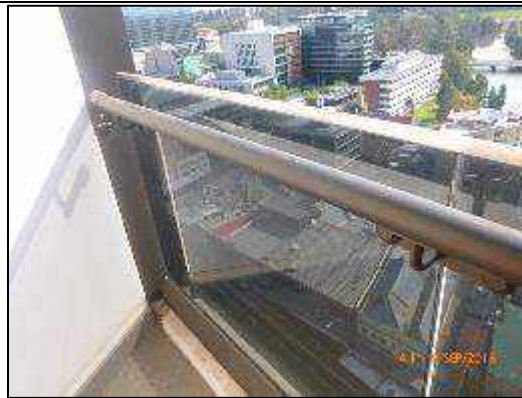
1818	Balcony	See section 5.4.1	See section 5.4.2

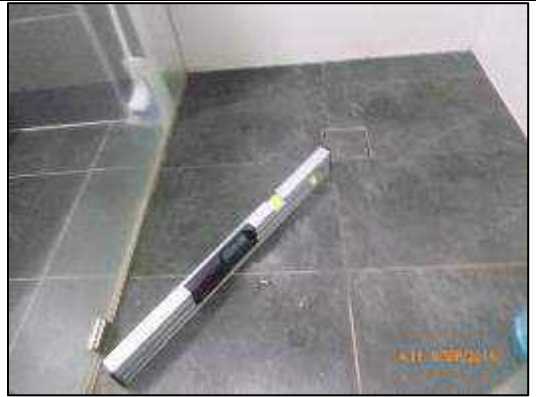
Item	Location	Defect description and Breach	Rectification	Photograph (if applicable)
1819	Main bedroom ensuite	See section 5.1.1 Falls (mm); 6/1000	See section 5.1.2

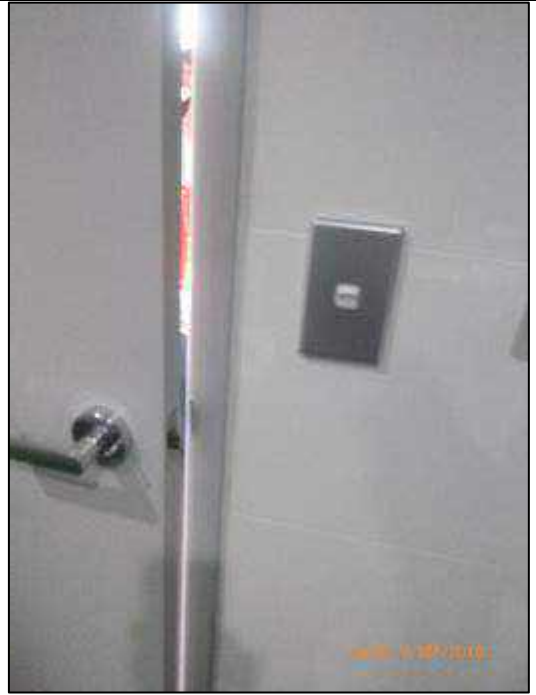
1820	Wall adjacent to ensuite door	See section 5.9.1	See section 5.9.2

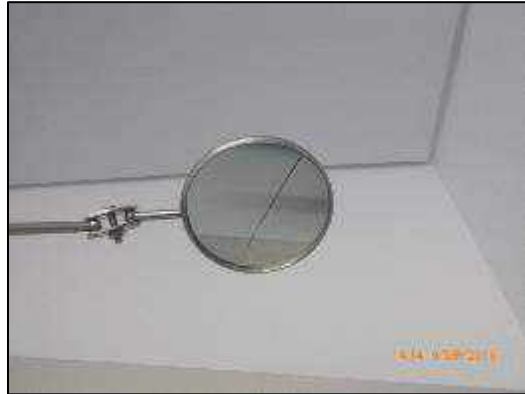
Item	Location	Defect description and Breach	Rectification	Photograph (if applicable)
1821	<i>Doors throughout the unit (x3)</i>	See section 5.5.1	See section 5.5.2

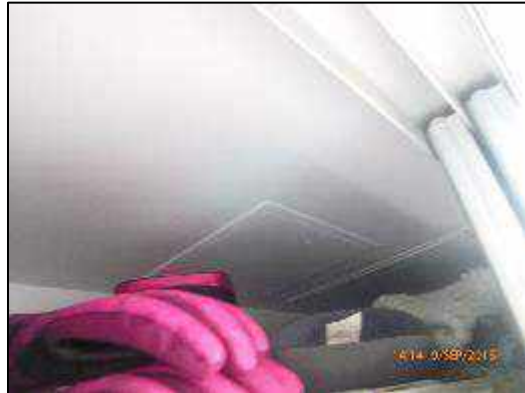
1822	<i>Main bedroom built in</i>	See section 5.6.1	See section 5.6.2

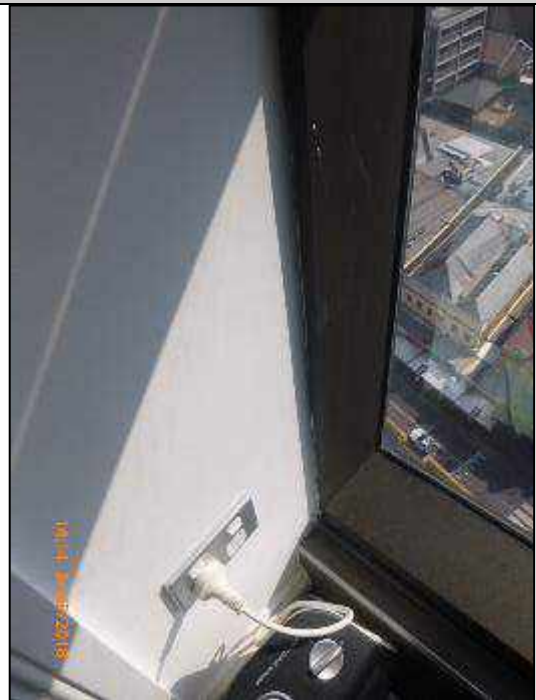
Item	Location	Defect description and Breach	Rectification	Photograph (if applicable)
1823	Main bedroom window frames	See section 5.9.1	See section 5.9.2

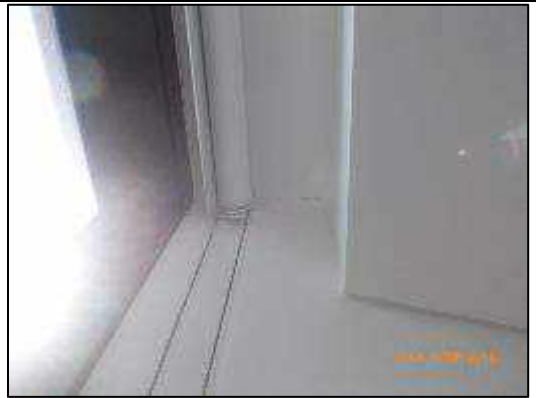
1824	Main bedroom window bulkhead	See section 5.13.1	See section 5.13.2

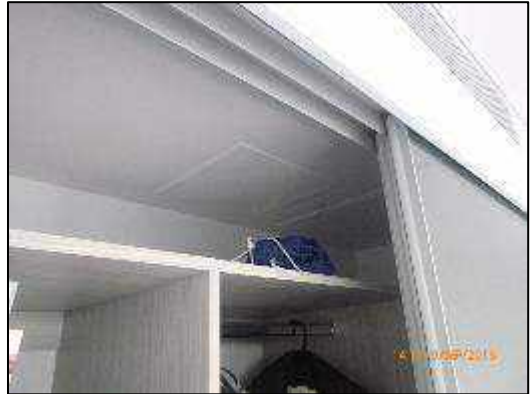
Item	Location	Defect description and Breach	Rectification	Photograph (if applicable)
1825	Second bedroom built in	See section 5.6.1	See section 5.6.2

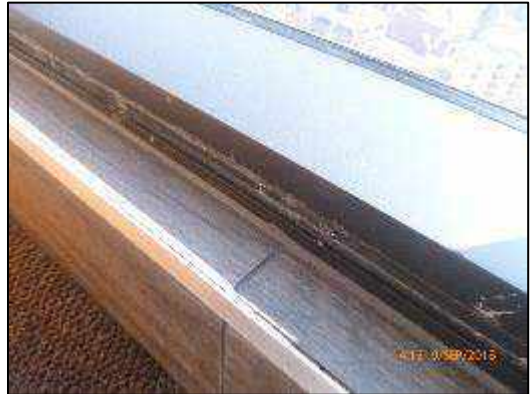
1826	Second bedroom window frames	See section 5.8.1	See section 5.8.2

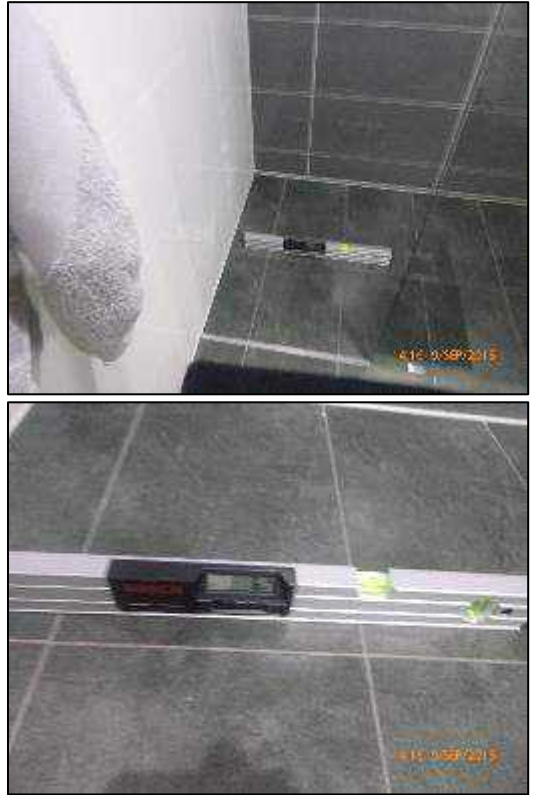
Item	Location	Defect description and Breach	Rectification	Photograph (if applicable)
1827	Main bathroom	See section 5.1.1 Falls (mm); 6/1000	See section 5.1.2

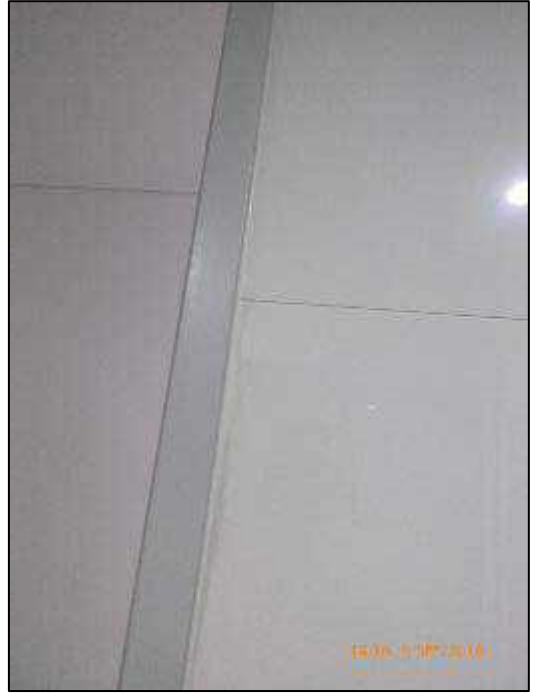
Item	Location	Defect description and Breach	Rectification	Photograph (if applicable)
1828	Wall adjacent to main bathroom	See section 5.9.1	See section 5.9.2

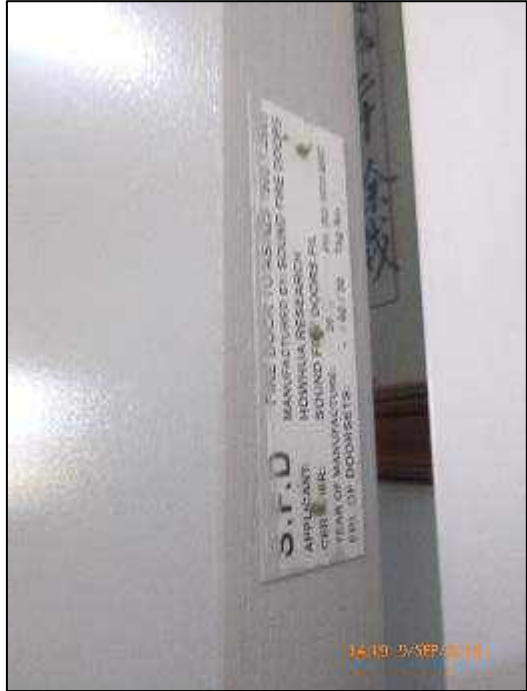
Item	Location	Defect description and Breach	Rectification	Photograph (if applicable)
Unit 1702				
1830	Front entry door	See section 5.12.1	See section 5.12.2

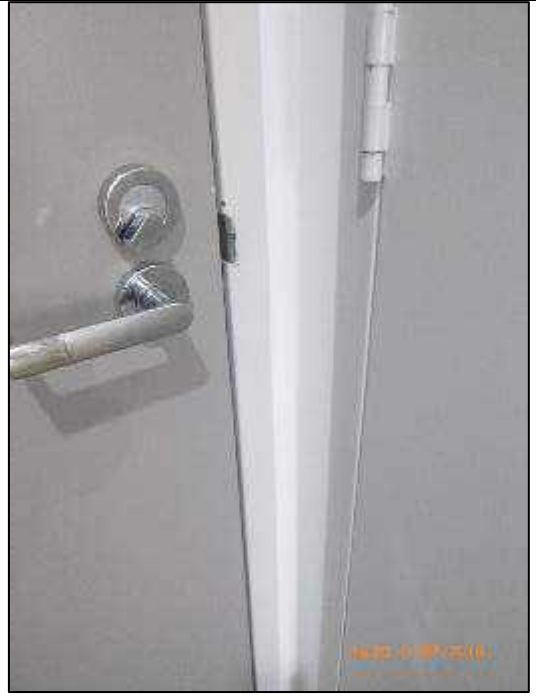
Item	Location	Defect description and Breach	Rectification	Photograph (if applicable)
1831	Wall adjacent to front entry door	See section 5.13.1	See section 5.13.2

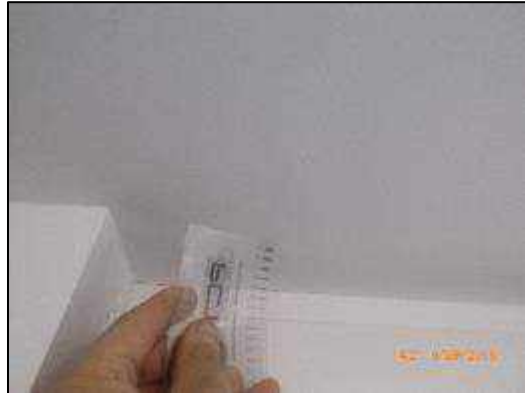
Item	Location	Defect description and Breach	Rectification	Photograph (if applicable)
1834	<i>Ceiling above kitchen cupboards</i>	See section 5.14.1 Separation; 1mm	See section 5.14.2

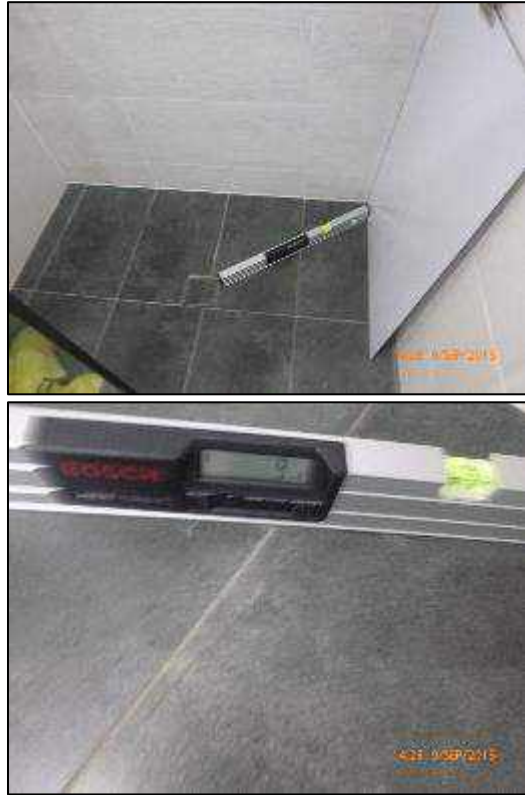
Item	Location	Defect description and Breach	Rectification	Photograph (if applicable)
1835	Main bathroom	See section 5.1.1 Falls (mm); 9/1000	See section 5.1.2

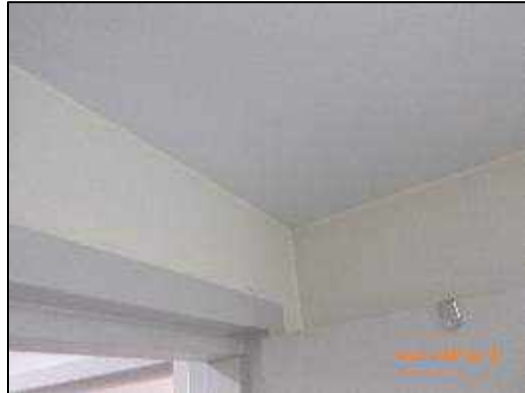
Item	Location	Defect description and Breach	Rectification	Photograph (if applicable)
1836	Wall above main bathroom door	See section 5.9.1	See section 5.9.2

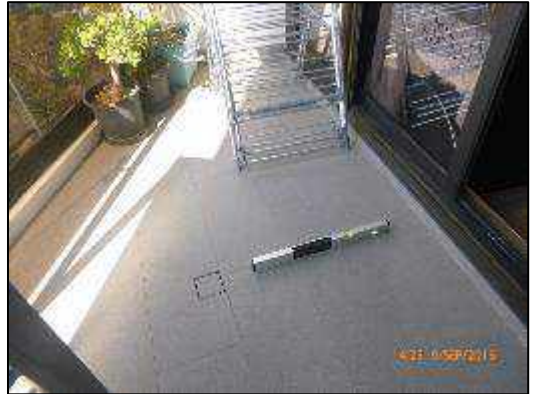
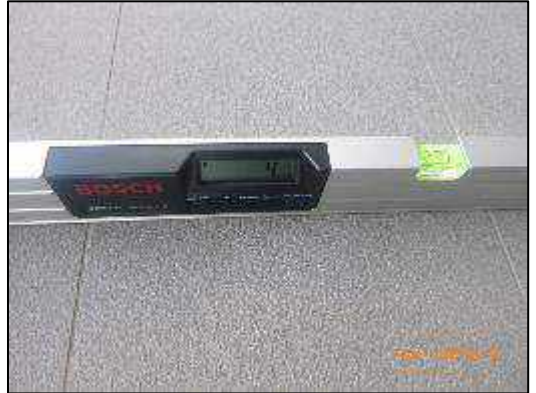
Item	Location	Defect description and Breach	Rectification	Photograph (if applicable)
1837	Balcony	See section 5.2.1 Falls (mm); 4/1000	See section 5.2.2

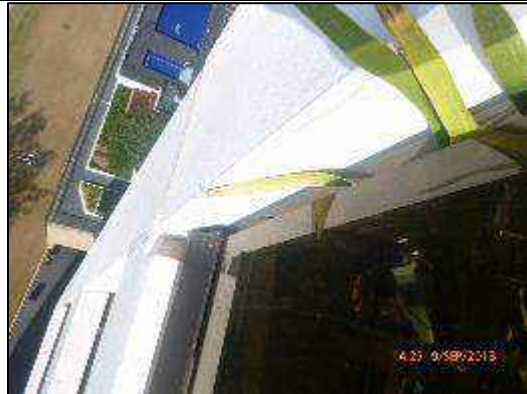
Item	Location	Defect description and Breach	Rectification	Photograph (if applicable)
1838	Balcony	See section 5.15.1	See section 5.15.2

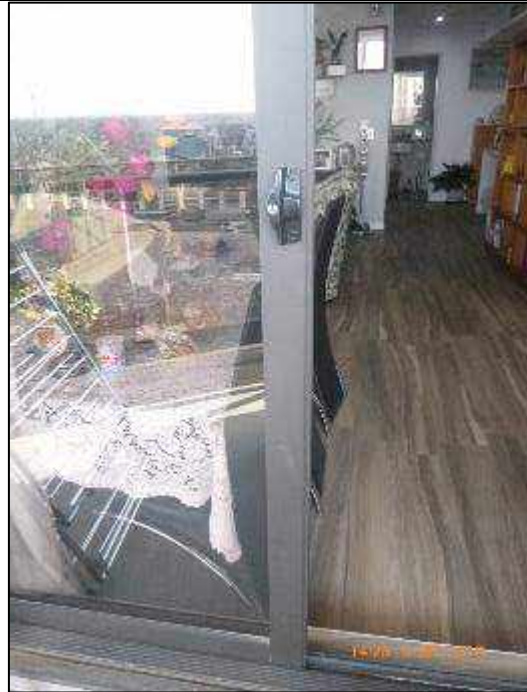
1839	Balcony sliding door frame	See section 5.7.1	See section 5.7.2

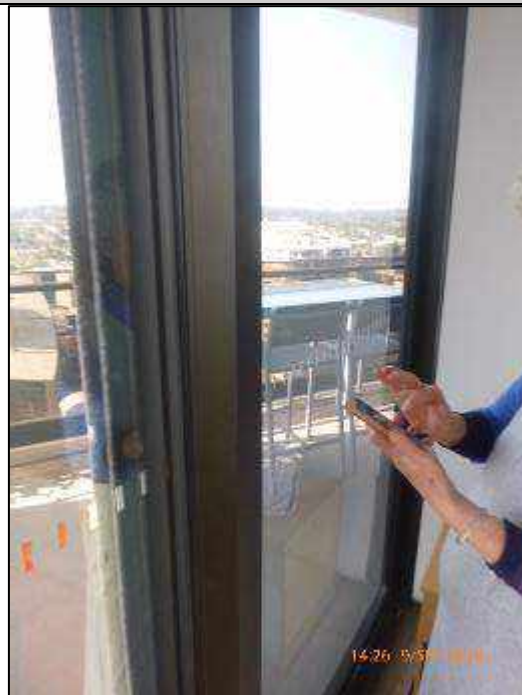
Item	Location	Defect description and Breach	Rectification	Photograph (if applicable)
1840	Balcony sliding door	<p>Resident advised of excessive noise and vibration in sliding door during windy days.</p> <p>Home Building Act (NSW) 1989</p> <ul style="list-style-type: none"> Part 2C, 18B (a) & (c). <p>Loss Suffered Loss suffered is cost of rectification.</p>	Engage a licenced tradesman to reseal door to prevent excessive noise to the unit in accordance with manufacturers specifications.

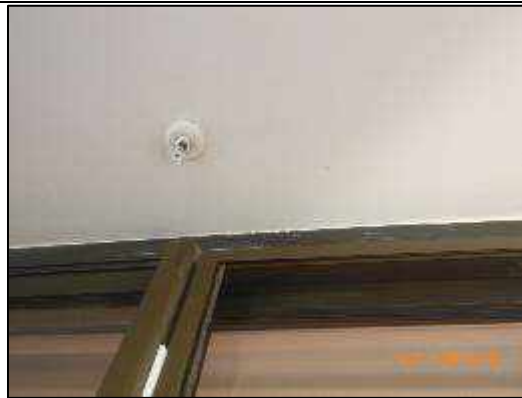
1841	Balcony sliding door frame	See section 5.9.1	See section 5.9.2

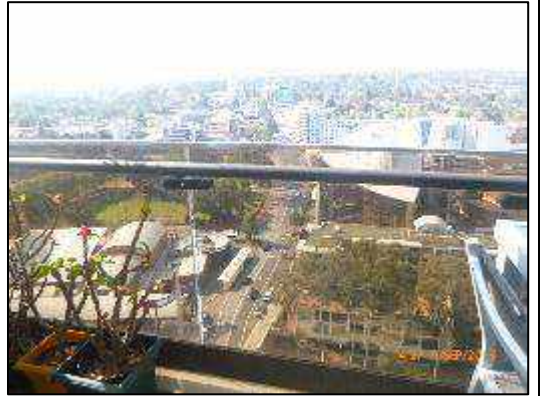
Item	Location	Defect description and Breach	Rectification	Photograph (if applicable)
1842	Balcony	See section 5.4.1	See section 5.4.2

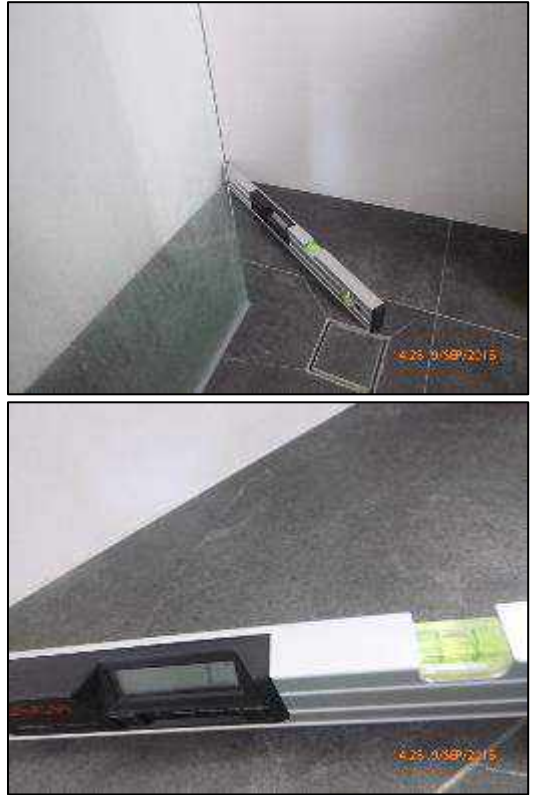
Item	Location	Defect description and Breach	Rectification	Photograph (if applicable)
1843	Main bedroom ensuite	See section 5.1.1 Falls (mm); 1/1000	See section 5.1.2

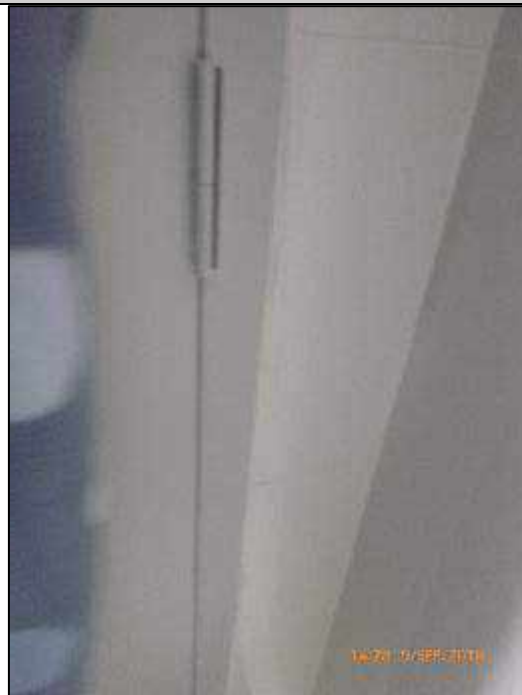
Item	Location	Defect description and Breach	Rectification	Photograph (if applicable)
1844	Wall adjacent to ensuite door	See section 5.9.1	See section 5.9.2

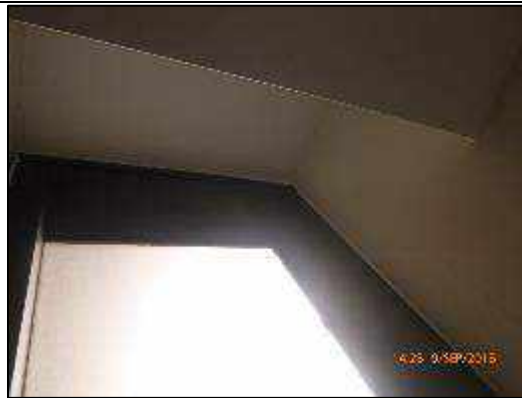
1845	Ensuite bulkhead window	See section 5.13.1	See section 5.13.2

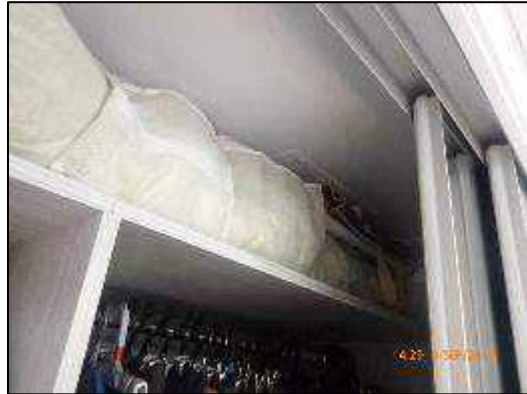
Item	Location	Defect description and Breach	Rectification	Photograph (if applicable)
1846	Main bedroom built in	See section 5.6.1	See section 5.6.2

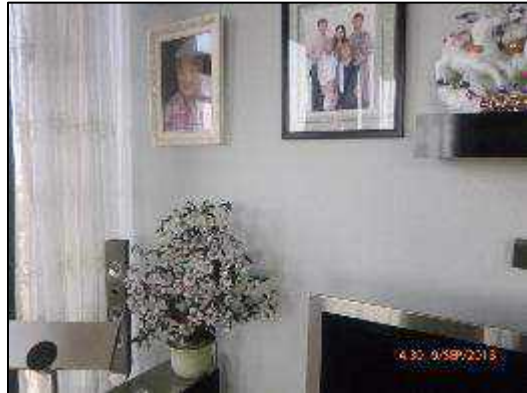
1847	Walls and ceiling throughout the unit.	See section 5.10.1	See section 5.10.2

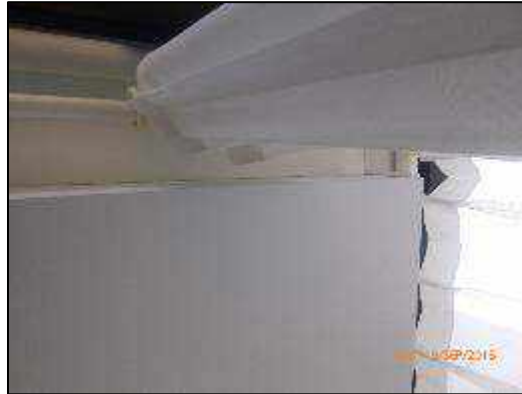
Item	Location	Defect description and Breach	Rectification	Photograph (if applicable)
1848	Lounge room window bulkhead	See section 5.13.1	See section 5.13.2

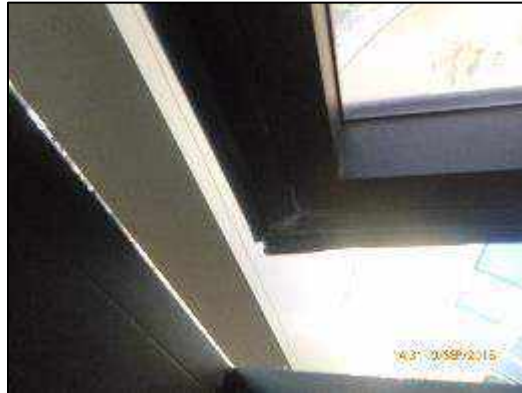
A photograph showing a close-up of a white bulkhead or window frame. There is a visible gap or separation between the bulkhead and the window frame, with some debris or material visible in the gap. A date stamp '14/09/2015' is visible in the bottom right corner.
1849	Lounge room window	<p>Window gasket in lounge room observed to be delaminated.</p> <p>Home Building Act (NSW) 1989</p> <ul style="list-style-type: none"> Part 2C, 18B (a) & (c). <p>Loss Suffered</p> <p>Loss suffered is cost of rectification.</p>	Engage a licenced tradesman to reseal window to prevent excessive noise to the unit in accordance with manufacturers specifications.

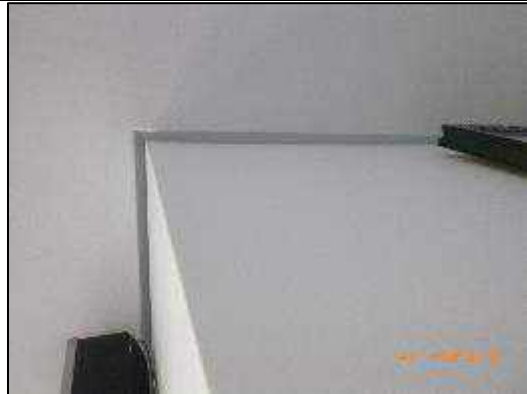
Item	Location	Defect description and Breach	Rectification	Photograph (if applicable)
1850	Lounge room	See section 5.11.1	See section 5.11.2

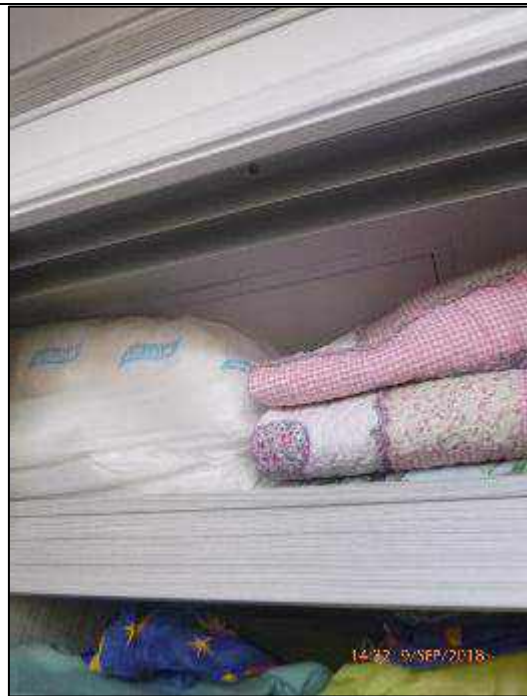
1851	Second bedroom built in	See section 5.6.1	See section 5.6.2

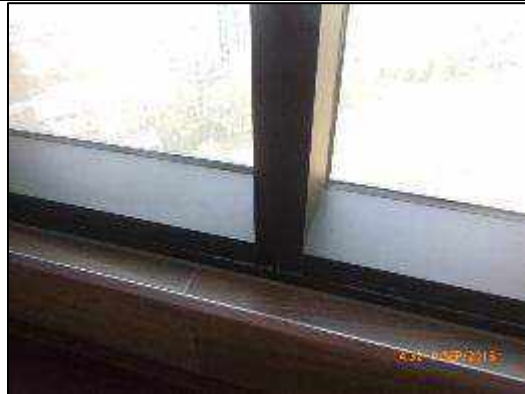
Item	Location	Defect description and Breach	Rectification	Photograph (if applicable)
1852	Second bedroom window frames	See section 5.8.1	See section 5.8.2

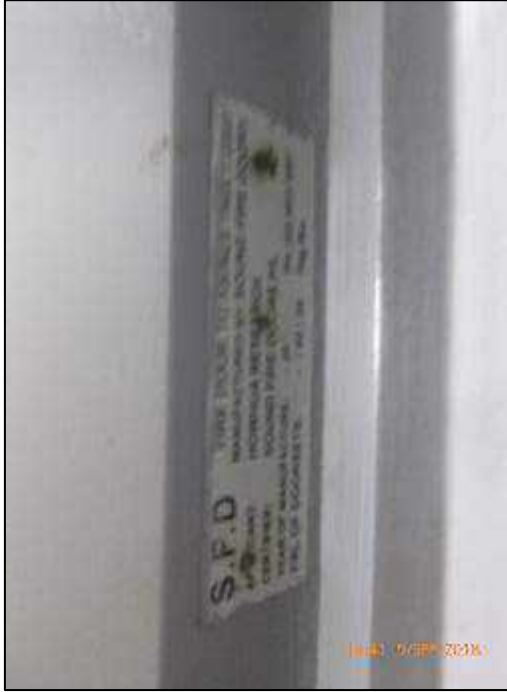
Item	Location	Defect description and Breach	Rectification	Photograph (if applicable)
Unit 1704				
1854	Front entry door	See section 5.12.1	See section 5.12.2

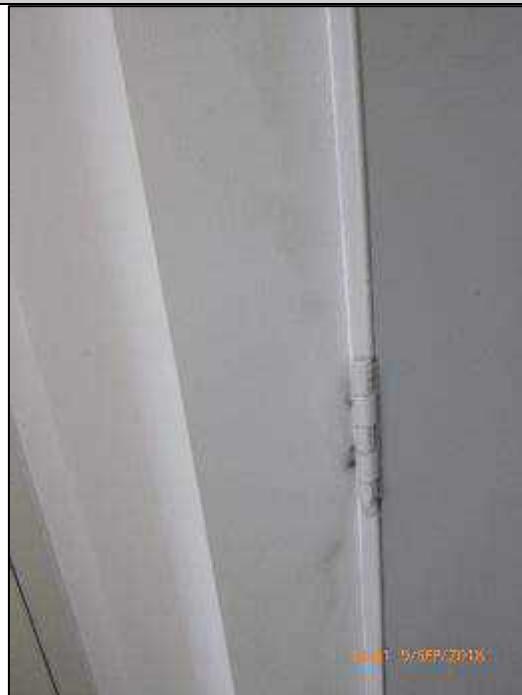
Item	Location	Defect description and Breach	Rectification	Photograph (if applicable)
1855	Front entry door	<p>The hinges of the front entry door are leaking.</p> <p>Home Building Act (NSW) 1989</p> <ul style="list-style-type: none"> Part 2C, 18B (a) and (b). <p>This item is a defect as the builder has failed to satisfy implied warranty set out in the Home Building Act 1989 – Section 18B Warranties as to residential building work.</p> <p>(b) a warranty that all materials supplied by the holder or person will be good and suitable for the purpose for which they are used and that, unless otherwise stated in the contract, those materials will be new.</p> <p>Loss Suffered Loss suffered in cost of rectification.</p>	Engage a licenced carpenter to remove faulty door hinges and reinstate with new hinges matching existing in accordance with manufacturers specifications.

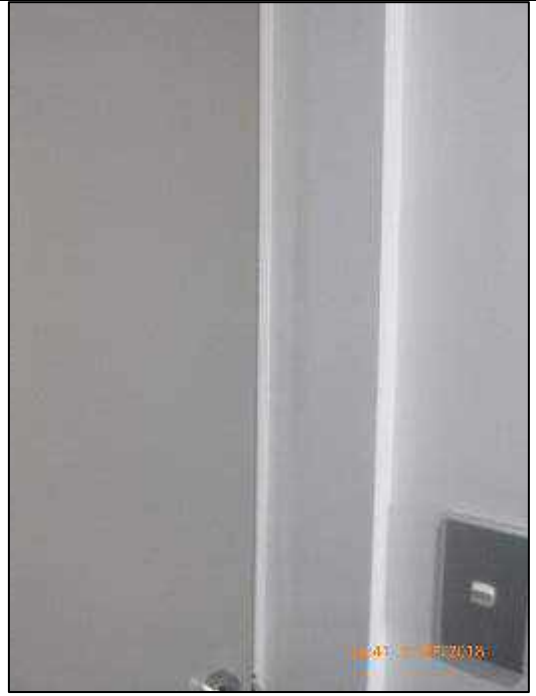
Item	Location	Defect description and Breach	Rectification	Photograph (if applicable)
1856	Wall adjacent to front entry door	See section 5.10.1	See section 5.10.2

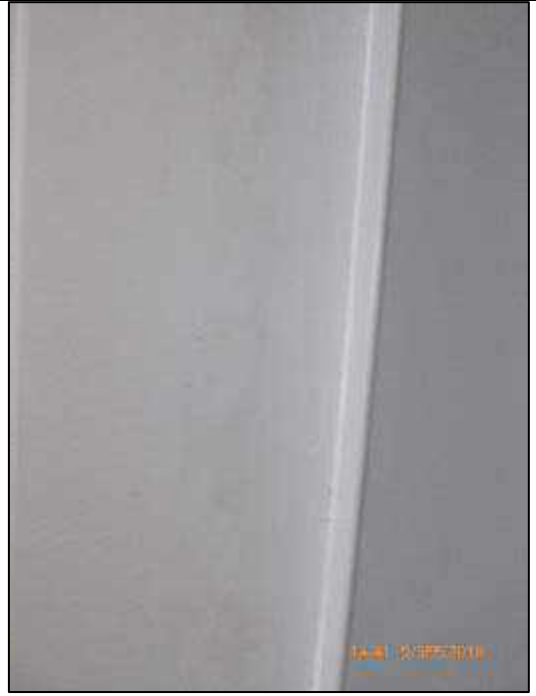
Item	Location	Defect description and Breach	Rectification	Photograph (if applicable)
1857	Wall adjacent to front entry door.	See section 5.13.1	See section 5.13.2

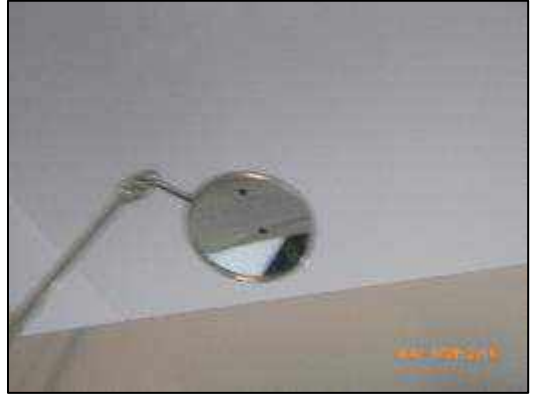
1858	Doors throughout the unit (x3)	See section 5.5.1	See section 5.5.2

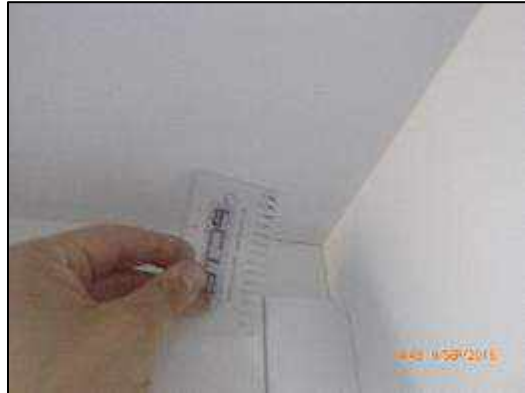
Item	Location	Defect description and Breach	Rectification	Photograph (if applicable)
1859	<i>Ceiling above kitchen cupboards</i>	See section 5.14.1 Separation; 1mm	See section 5.14.2

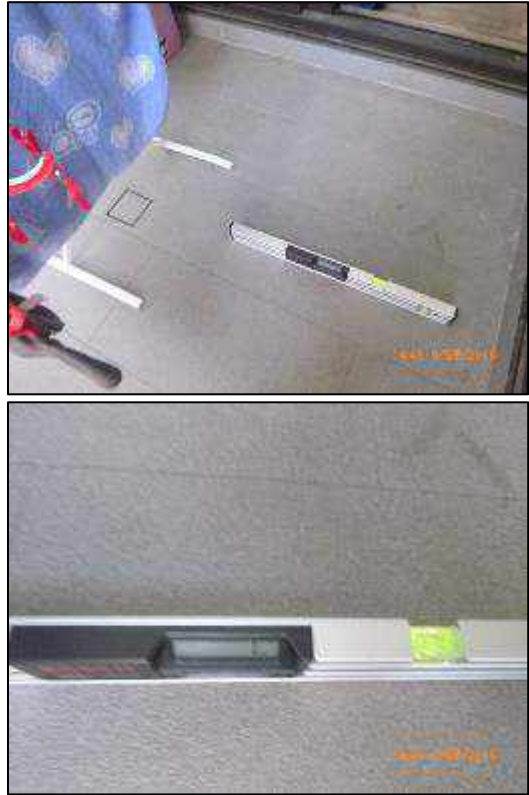
Item	Location	Defect description and Breach	Rectification	Photograph (if applicable)
1860	Balcony	See section 5.2.1 Falls (mm); 1/1000	See section 5.2.2

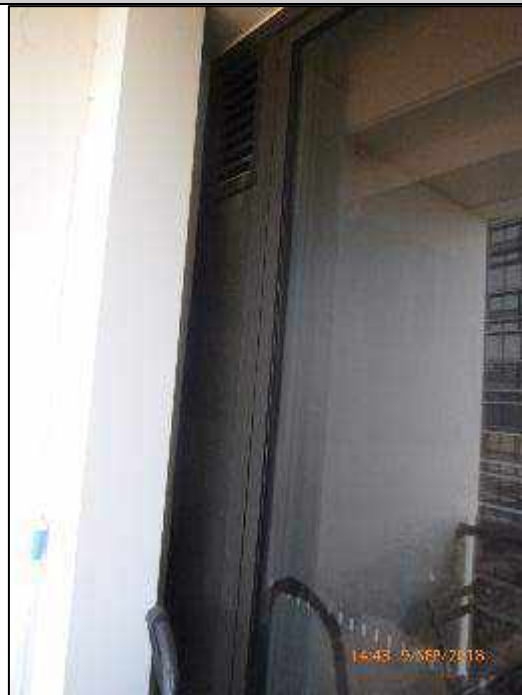
Item	Location	Defect description and Breach	Rectification	Photograph (if applicable)
1861	Balcony sliding door frame	See section 5.7.1	See section 5.7.2

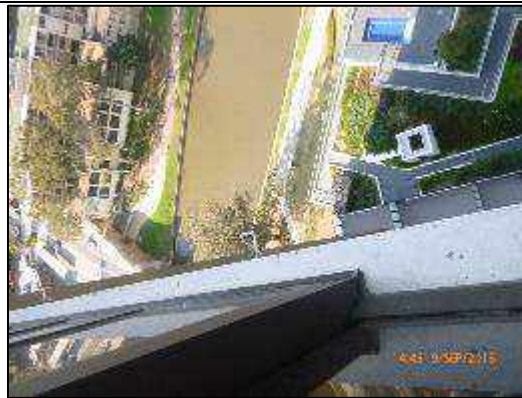
1862	Façade of balcony balustrade	<p>Construction debris observed on the external façade.</p> <p>Home Building Act (NSW) 1989</p> <ul style="list-style-type: none"> Part 2C, 18B (a) and (c). <p>This is a breach of part (a) of the act because the surface has not been finished in a proper workmanlike manner that would prevent loss of appearance to the surface.</p>	<ol style="list-style-type: none"> 1. Protect all adjoining surfaces. 2. Use a suitable cleaning agent to remove residue and clear debris. 3. Clean up the work area.

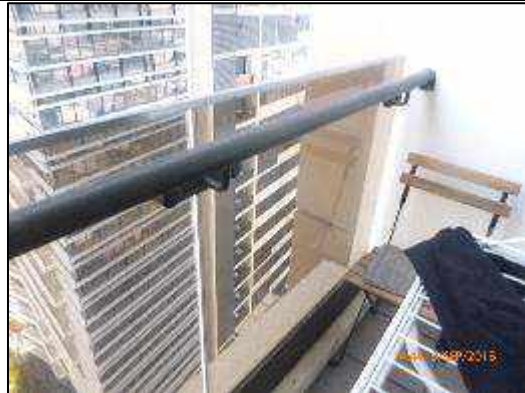
Item	Location	Defect description and Breach	Rectification	Photograph (if applicable)
		Loss Suffered Loss suffered is cost of rectification.		
1863	Balcony	See section 5.4.1	See section 5.4.2

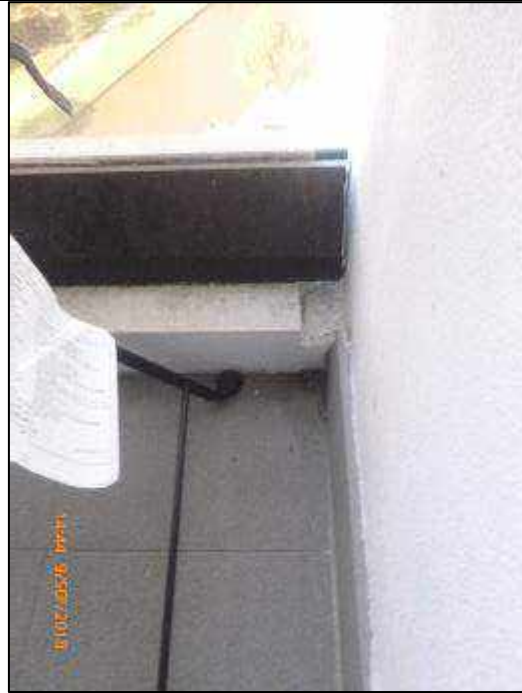
Item	Location	Defect description and Breach	Rectification	Photograph (if applicable)
1864	Balcony	See section 5.15.1	See section 5.15.2

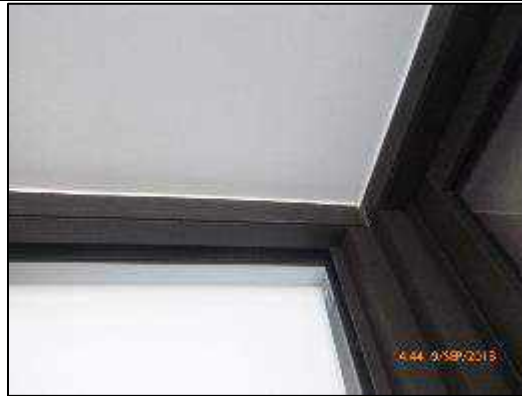
1865	Balcony sliding door frame	See section 5.9.1	See section 5.9.2
