SydneyStrataReport

STRATA REPORT

Client	Church Street Parramatta Property Pty Ltd
Address of property	Unit 3303/330 Church Street, Parramatta, NSW.
Lot	359
Strata Plan	SP 94469
Name of Strata Management Co.	NSW Strata
Telephone Number of Strata Agent	8980 1841
Report Date	15 February 2024

BUILDING DEFECTS REPORT Part 1/2

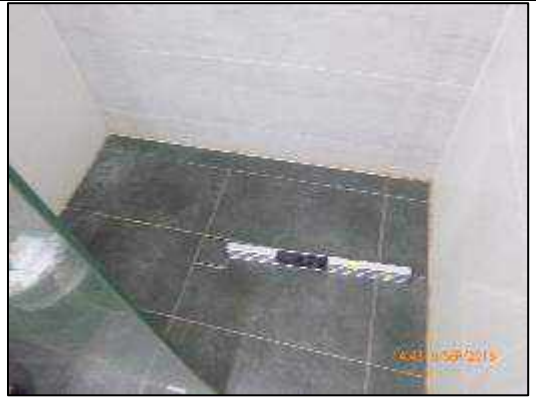
Item	Location	Defect description and Breach	Rectification	Photograph (if applicable)
1866	Main bathroom	See section 5.1.1 Falls (mm); 5/1000	See section 5.1.2

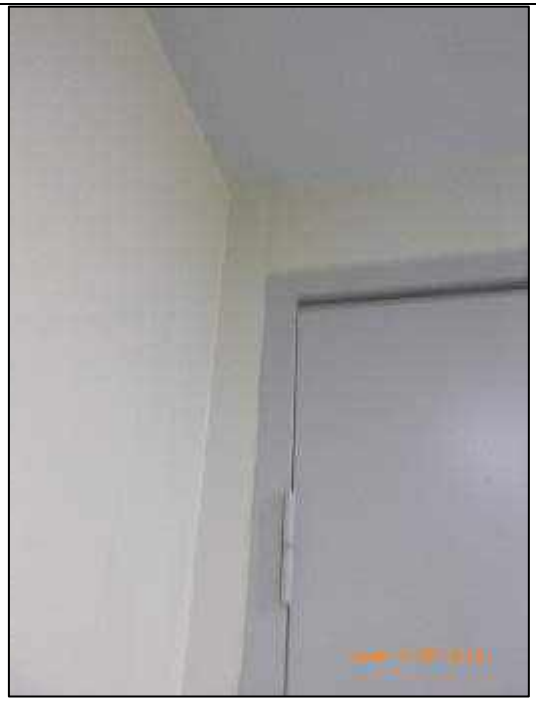
1867	Wall adjacent to main bathroom door	See section 5.9.1	See section 5.9.2

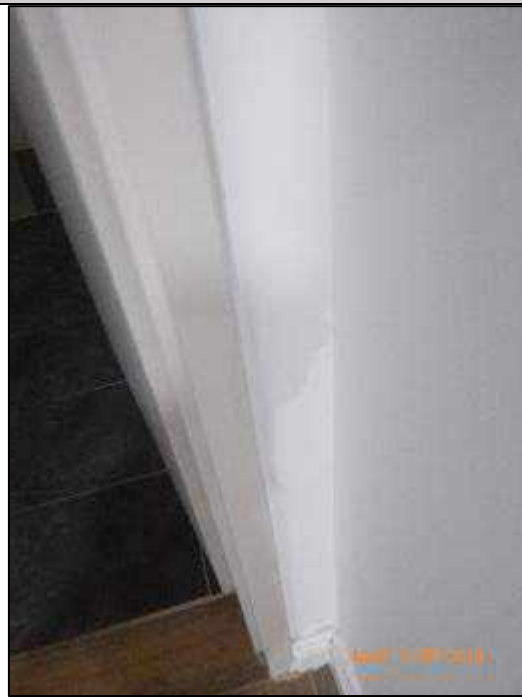
Item	Location	Defect description and Breach	Rectification	Photograph (if applicable)
1868	Wall adjacent to main bathroom door	See section 5.13.1	See section 5.13.2

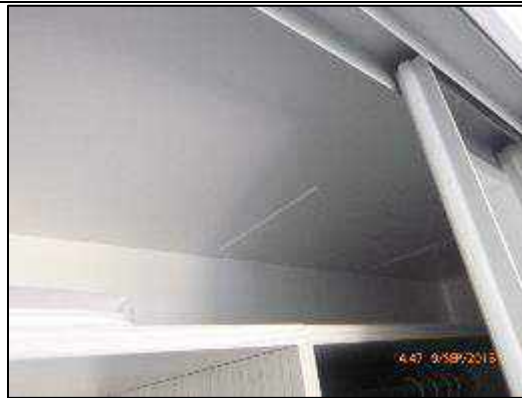
1869	Main bedroom built in	See section 5.6.1	See section 5.6.2

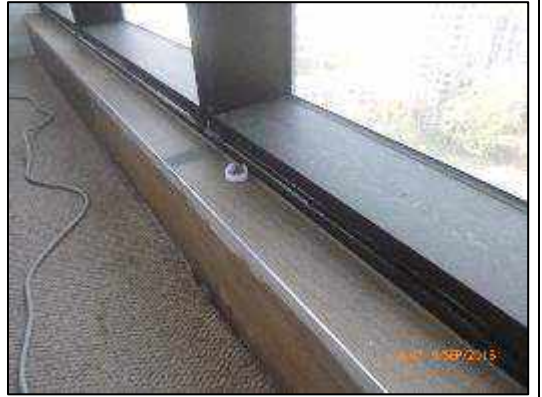
Item	Location	Defect description and Breach	Rectification	Photograph (if applicable)
1870	Main bedroom window frames	See section 5.8.1	See section 5.8.2

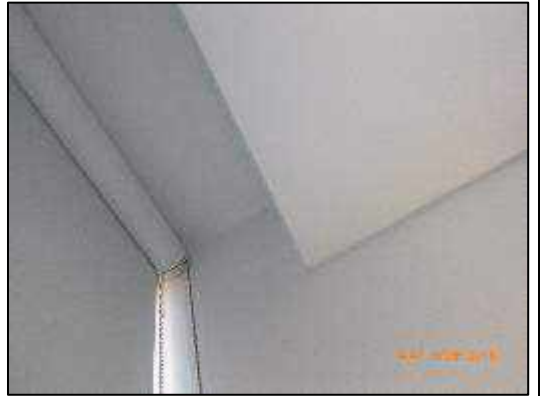
1871	Main bedroom window bulkhead	See section 5.13.1	See section 5.13.2

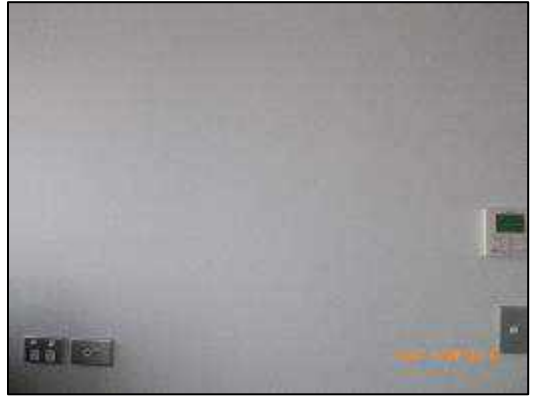
Item	Location	Defect description and Breach	Rectification	Photograph (if applicable)
1872	<i>Walls and ceiling throughout the unit</i>	See section 5.10.1	See section 5.10.2

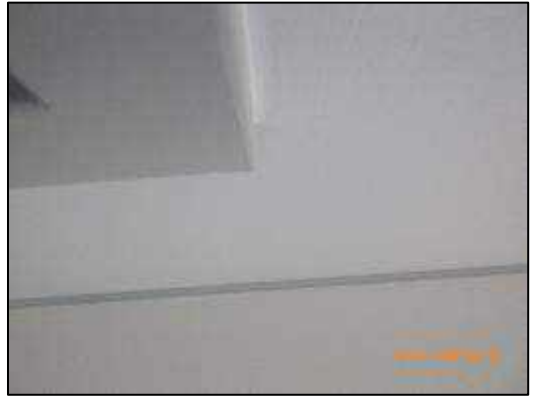
1873	<i>Lounge room</i>	See section 5.11.1	See section 5.11.2

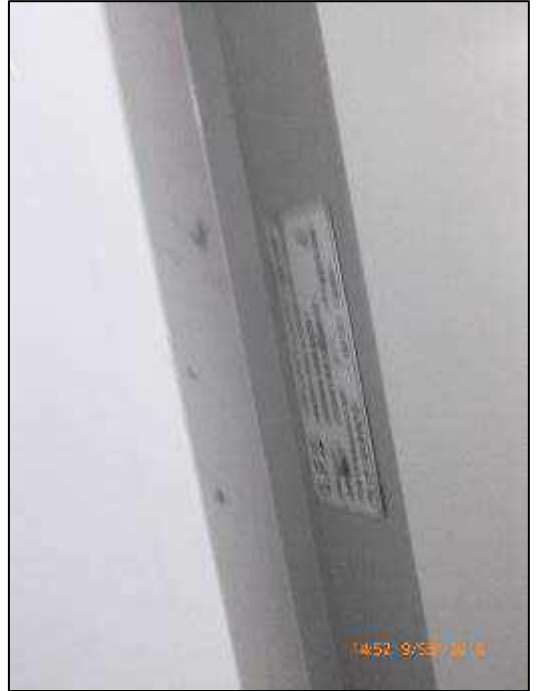
Item	Location	Defect description and Breach	Rectification	Photograph (if applicable)
Unit 1705				
1874	Front entry door	See section 5.12.1	See section 5.12.2

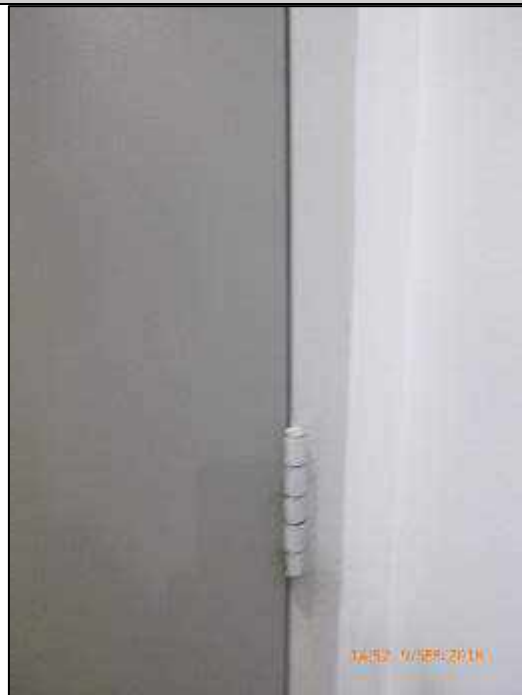
Item	Location	Defect description and Breach	Rectification	Photograph (if applicable)
1875	Front entry door	<p>The hinges of the front entry door are leaking.</p> <p>Home Building Act (NSW) 1989</p> <ul style="list-style-type: none"> Part 2C, 18B (a) and (b). <p>This item is a defect as the builder has failed to satisfy implied warranty set out in the Home Building Act 1989 – Section 18B Warranties as to residential building work.</p> <p>(b) a warranty that all materials supplied by the holder or person will be good and suitable for the purpose for which they are used and that, unless otherwise stated in the contract, those materials will be new.</p> <p>Loss Suffered Loss suffered in cost of rectification.</p>	Engage a licenced carpenter to remove faulty door hinges and reinstate with new hinges matching existing in accordance with manufacturers specifications.

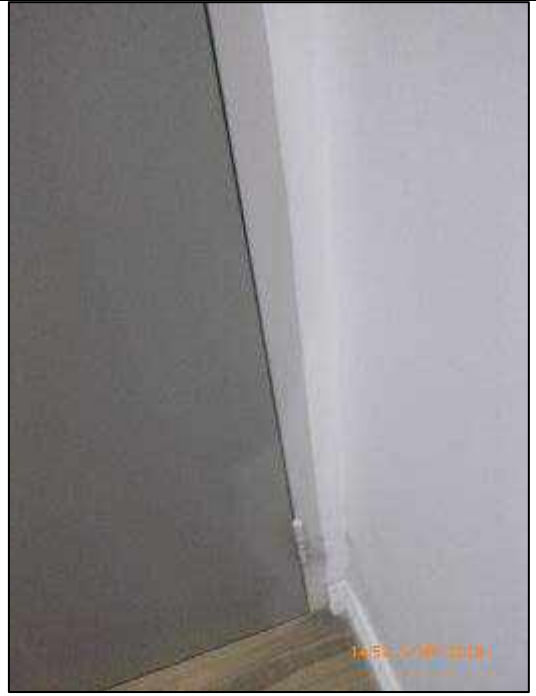
Item	Location	Defect description and Breach	Rectification	Photograph (if applicable)
1876		See section 5.13.1	See section 5.13.2

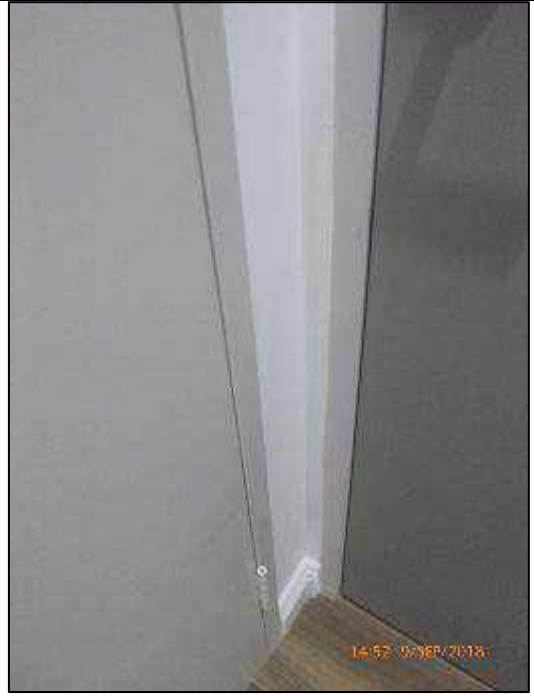
Item	Location	Defect description and Breach	Rectification	Photograph (if applicable)
1877	Wall adjacent to front entry door	See section 5.9.1	See section 5.9.2

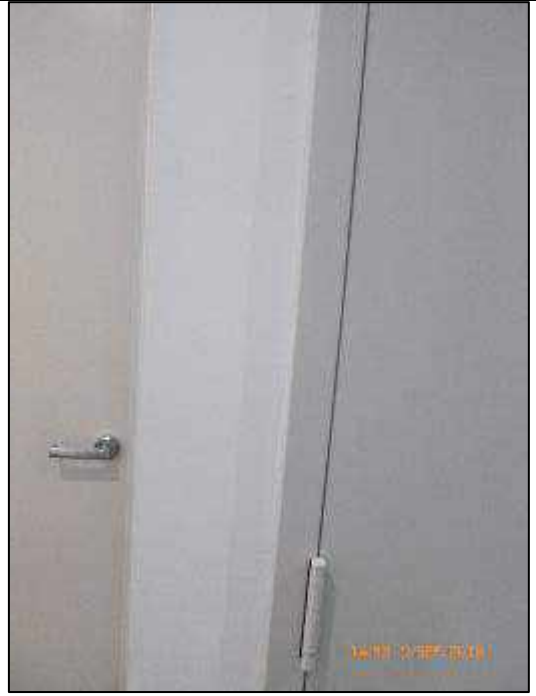
Item	Location	Defect description and Breach	Rectification	Photograph (if applicable)
1878	Wall adjacent to study room door	See section 5.13.1	See section 5.13.2

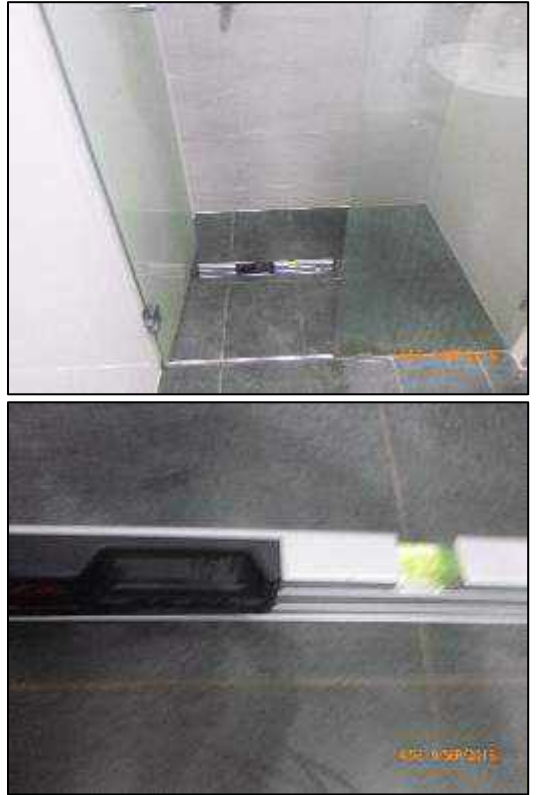
Item	Location	Defect description and Breach	Rectification	Photograph (if applicable)
1879	Main bathroom	See section 5.1.1 Falls (mm); 10/1000	See section 5.1.2

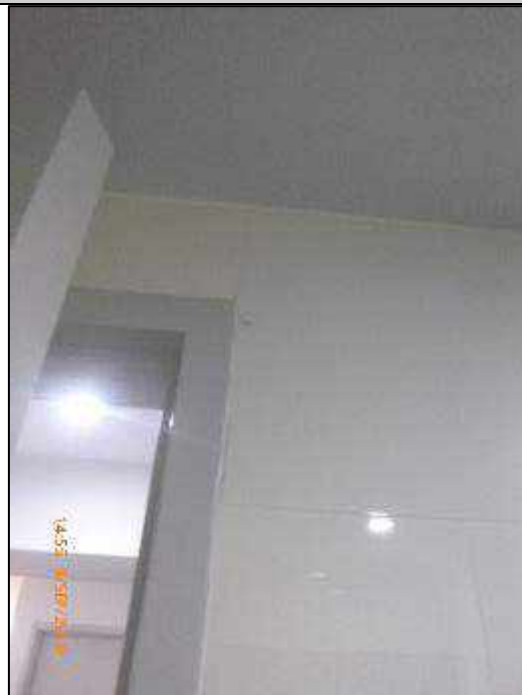
Item	Location	Defect description and Breach	Rectification	Photograph (if applicable)
1880	Wall adjacent to bathroom door	See section 5.9.1	See section 5.9.2

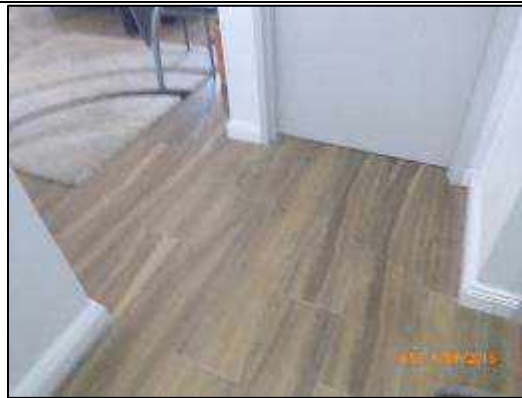
1881	Floor throughout the unit	<p>Paint and sealant staining on floor throughout the unit.</p> <p>Home Building Act (NSW) 1989</p> <ul style="list-style-type: none"> Part 2C, 18B (a) and (c). <p>This is a breach of part (a) of the act because the surface has not been finished in a proper workmanlike manner that would prevent loss of appearance to the surface.</p>	<ol style="list-style-type: none"> 1. Protect all adjoining surfaces. 2. Use a suitable cleaning agent to remove residue and clear debris. 3. Clean up the work area.

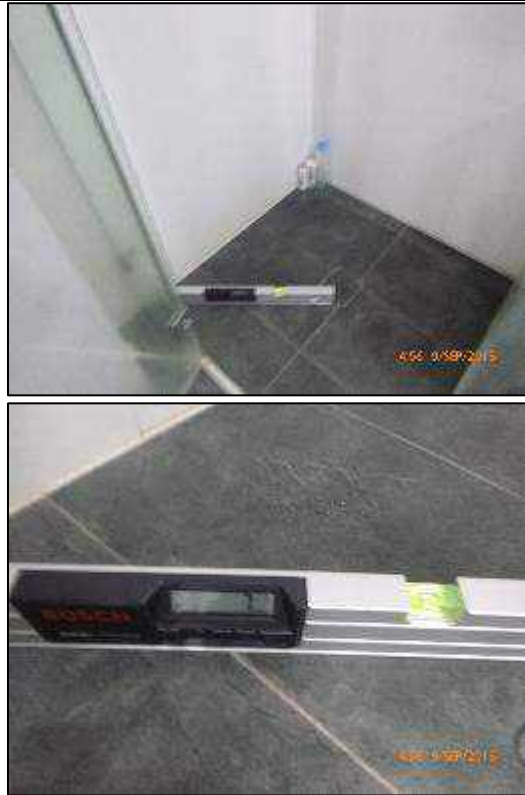
Item	Location	Defect description and Breach	Rectification	Photograph (if applicable)
		Loss Suffered Loss suffered is cost of rectification.		
1882	Main bedroom ensuite	See section 5.1.1 Falls (mm); 7/1000	See section 5.11.2

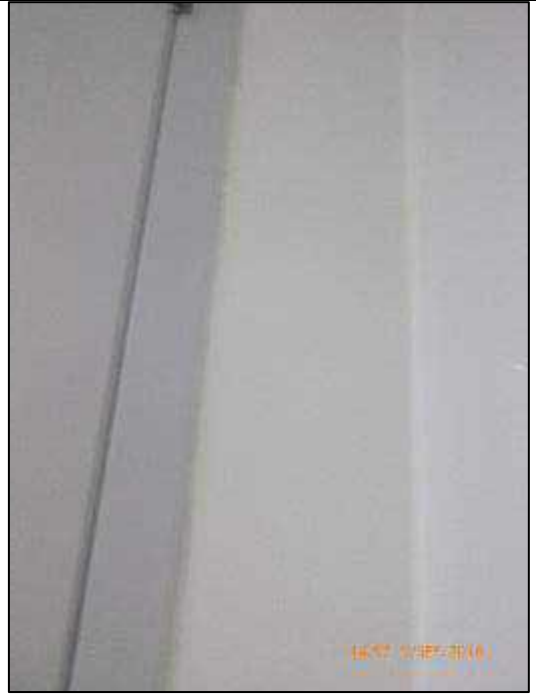
Item	Location	Defect description and Breach	Rectification	Photograph (if applicable)
1883	Wall adjacent to ensuite door	See section 5.9.1	See section 5.9.2

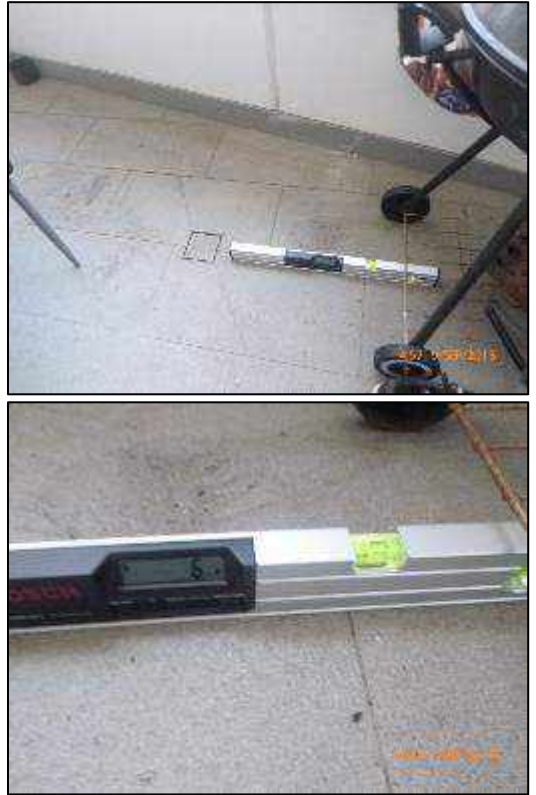
Item	Location	Defect description and Breach	Rectification	Photograph (if applicable)
1884	Balcony	See section 5.2.1 Falls (mm); 6/1000	See section 5.2.2

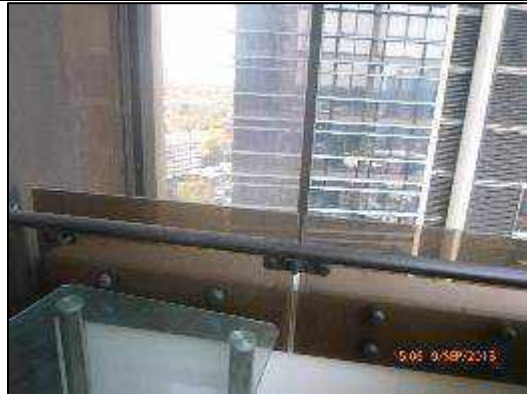
Item	Location	Defect description and Breach	Rectification	Photograph (if applicable)
1885	Balcony	See section 5.4.1	See section 5.4.2

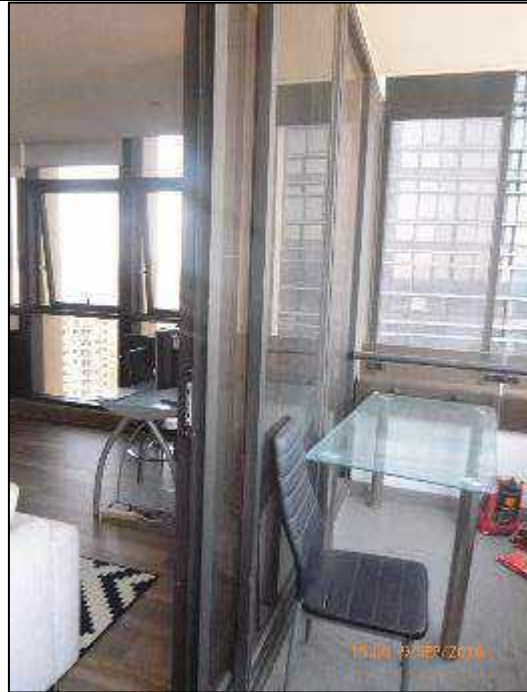
A photograph showing a balcony railing with a glass panel. The railing is made of dark metal. The glass panel is partially visible. The background shows a view of a city with buildings and trees. A timestamp '15.06.2013' is visible in the bottom right corner.
1886	Balcony sliding door frame	See section 5.7.1	See section 5.7.2

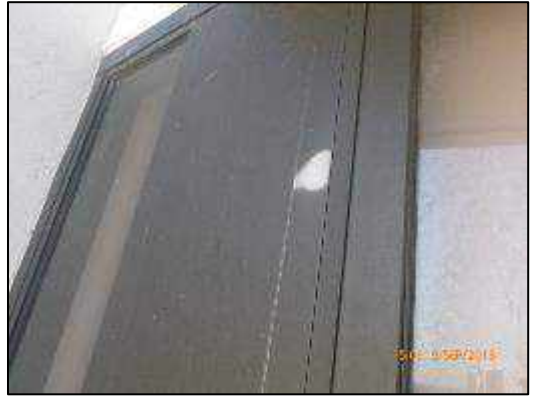
Item	Location	Defect description and Breach	Rectification	Photograph (if applicable)
1887	Balcony sliding door frame	See section 5.9.1	See section 5.9.2

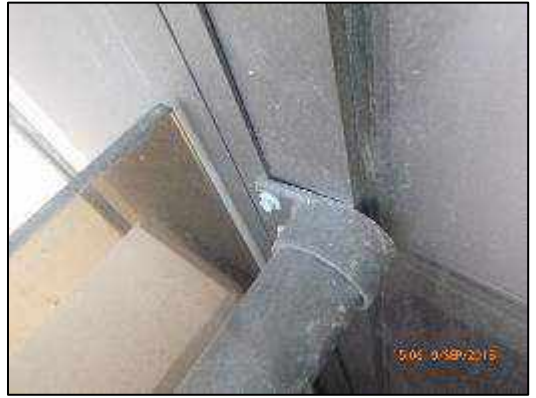
1888	Balcony balustrade rail	See section 5.9.1	See section 5.9.2

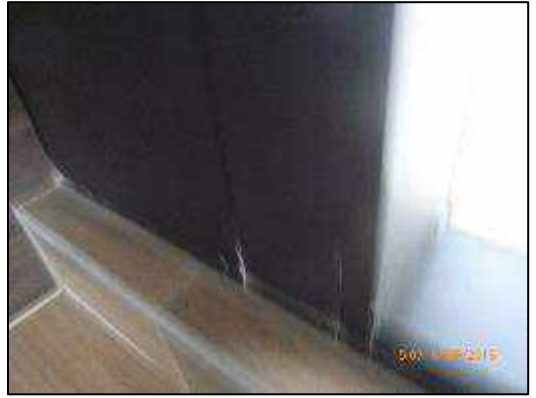
Item	Location	Defect description and Breach	Rectification	Photograph (if applicable)
1889	Lounge room window frames	See section 5.8.1	See section 5.8.2

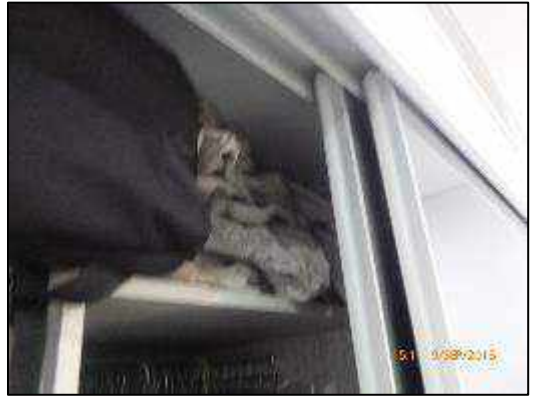
1890	Main bedroom built in	See section 5.6.1	See section 5.6.2

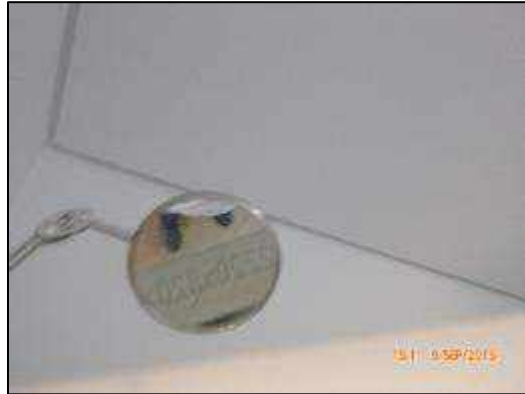
Item	Location	Defect description and Breach	Rectification	Photograph (if applicable)
1891	<i>Doors throughout the unit (x4)</i>	See section 5.5.1	See section 5.5.2

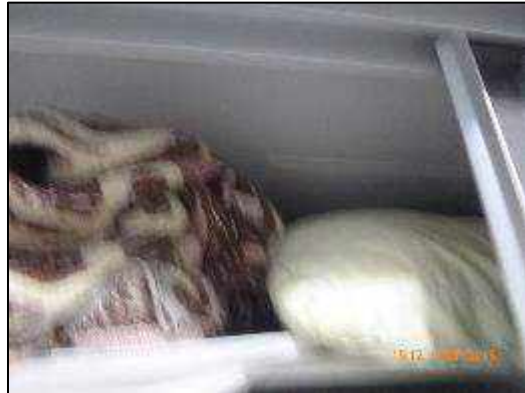
1892	<i>Second bedroom built in</i>	See section 5.6.1	See section 5.6.2

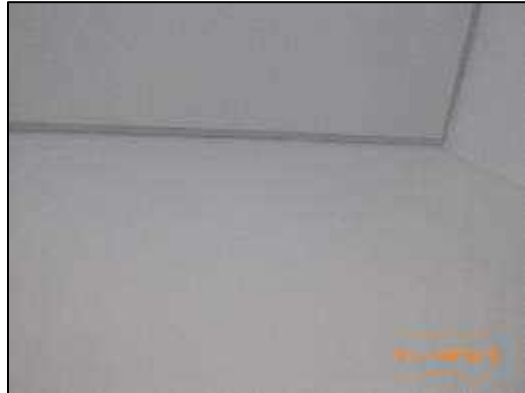
Item	Location	Defect description and Breach	Rectification	Photograph (if applicable)
1893	Lounge room	See section 5.11.1	See section 5.11.2

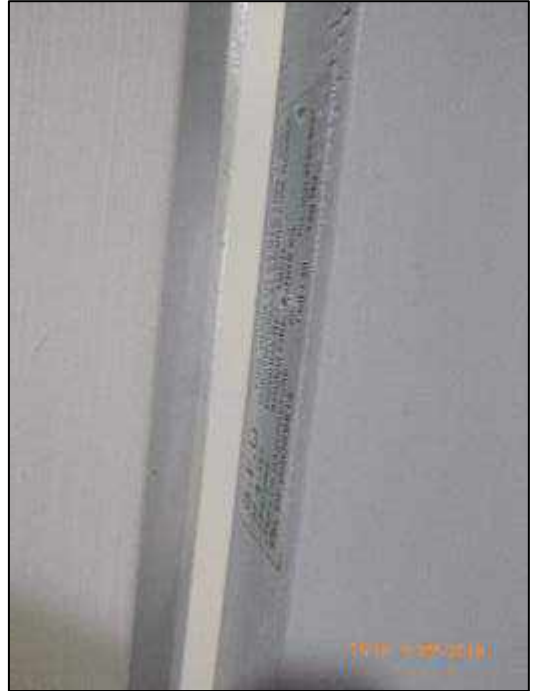
Item	Location	Defect description and Breach	Rectification	Photograph (if applicable)
Unit 1706				
1894	Front entry door	See section 5.12.1	See section 5.12.2

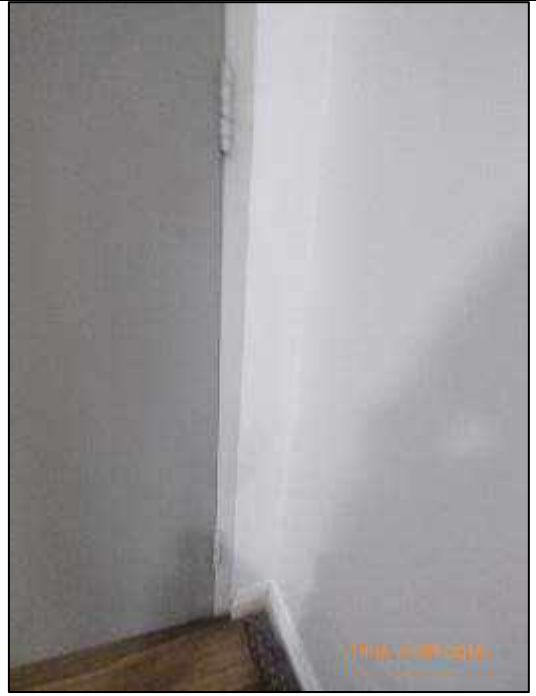
Item	Location	Defect description and Breach	Rectification	Photograph (if applicable)
1895	Wall adjacent to front entry door	See section 5.13.1	See section 5.13.2

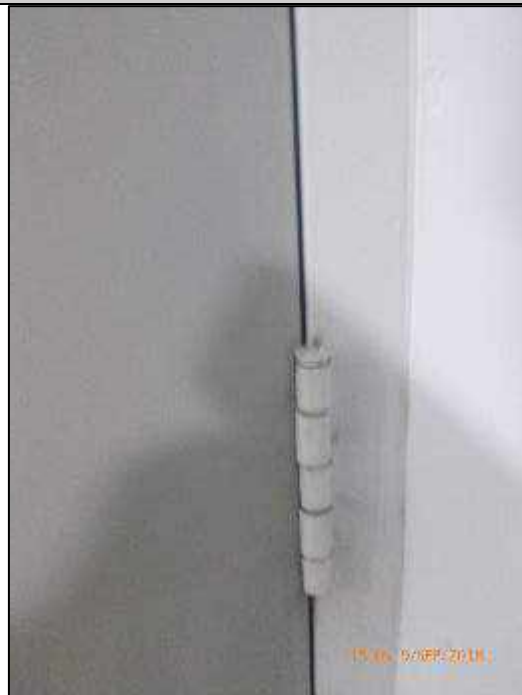
Item	Location	Defect description and Breach	Rectification	Photograph (if applicable)
1896	Front entry door	<p>The hinges of the front entry door are leaking.</p> <p>Home Building Act (NSW) 1989</p> <ul style="list-style-type: none"> Part 2C, 18B (a) and (b). <p>This item is a defect as the builder has failed to satisfy implied warranty set out in the Home Building Act 1989 – Section 18B Warranties as to residential building work.</p> <p>(b) a warranty that all materials supplied by the holder or person will be good and suitable for the purpose for which they are used and that, unless otherwise stated in the contract, those materials will be new.</p> <p>Loss Suffered Loss suffered in cost of rectification.</p>	Engage a licenced carpenter to remove faulty door hinges and reinstate with new hinges matching existing in accordance with manufacturers specifications.

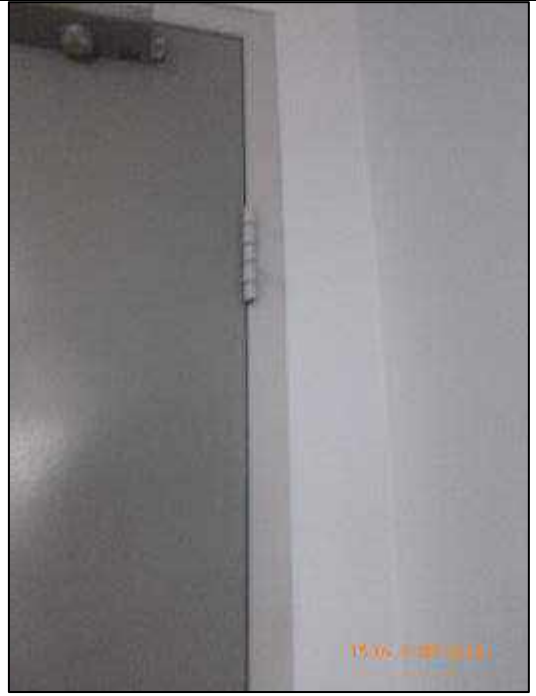
Item	Location	Defect description and Breach	Rectification	Photograph (if applicable)
1897	Wall adjacent to front entry door	See section 5.9.1	See section 5.9.2

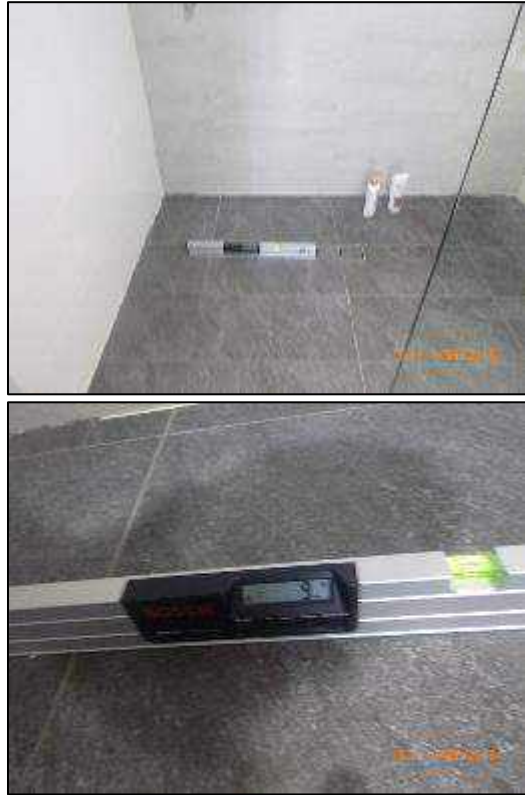
Item	Location	Defect description and Breach	Rectification	Photograph (if applicable)
1898	Main bedroom ensuite	See section 5.1.1	See section 5.1.2

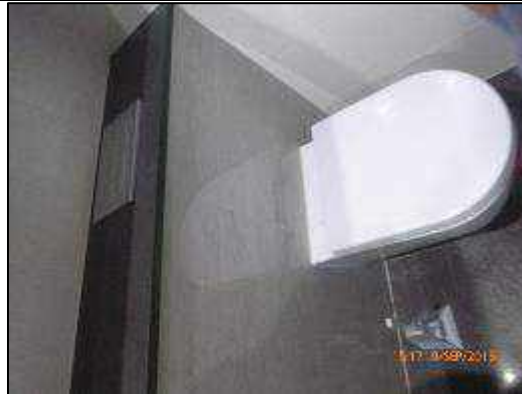
Item	Location	Defect description and Breach	Rectification	Photograph (if applicable)
1899	Main bedroom ensuite	<p>Resident advised that toilet flush was not working.</p> <p>Home Building Act (NSW) 1989</p> <ul style="list-style-type: none"> Part 2C, 18B (a) and (b). <p>This item is a defect as the builder has failed to satisfy implied warranty set out in the Home Building Act 1989 – Section 18B Warranties as to residential building work.</p> <p>(b) a warranty that all materials supplied by the holder or person will be good and suitable for the purpose for which they are used and that, unless otherwise stated in the contract, those materials will be new.</p> <p>Loss Suffered Loss suffered is cost of rectification and loss of amenity.</p>	<ol style="list-style-type: none"> 1. Temporary turn off main water supply to the toilet. 2. Carefully remove the flush from the toilet. 3. Supply and install flush to match existing. 4. Secure the flush to the toilet. 5. Turn on main water supply to toilet.

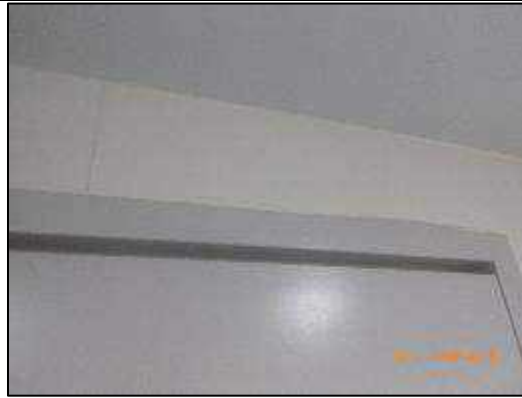
1900	Wall above main bathroom door	See section 5.9.1	See section 5.9.2

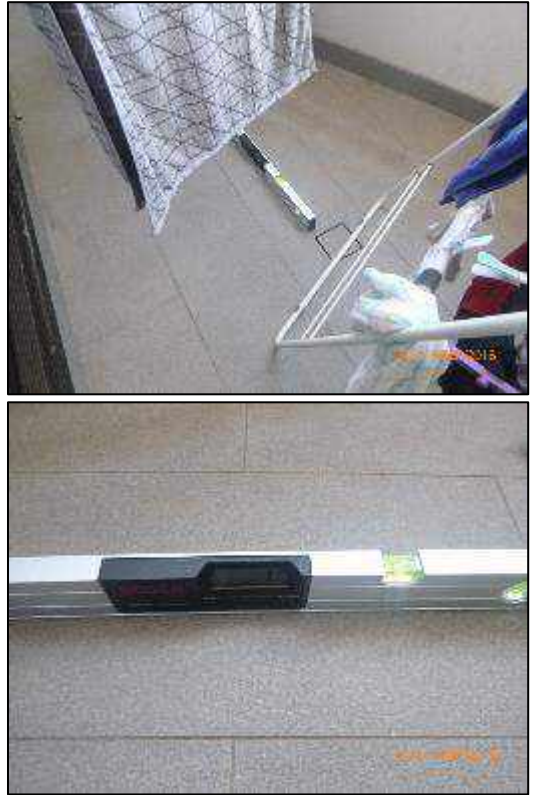
Item	Location	Defect description and Breach	Rectification	Photograph (if applicable)
1901	Balcony	See section 5.1.1 Falls (mm); 1/1000	See section 5.1.2

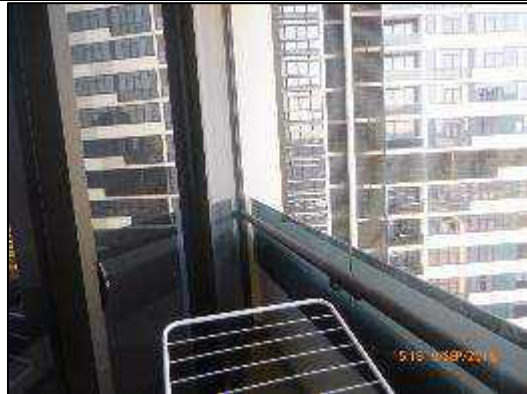
Item	Location	Defect description and Breach	Rectification	Photograph (if applicable)
1902	Balcony	See section 5.4.1	See section 5.4.2

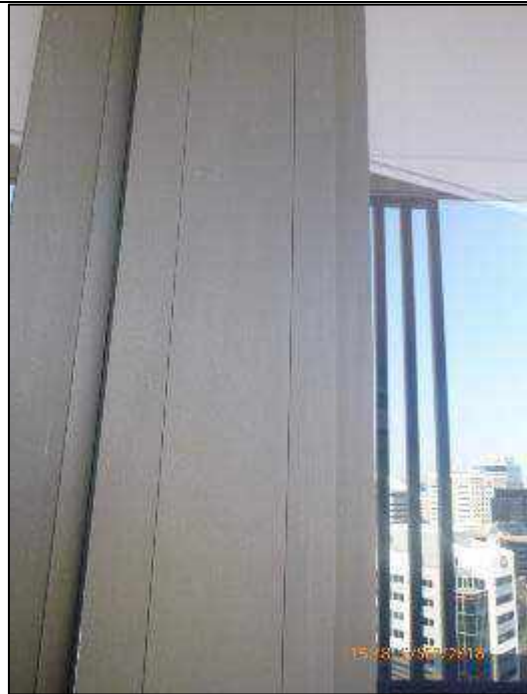
1903	Balcony sliding door frame	See section 5.7.1	See section 5.7.2

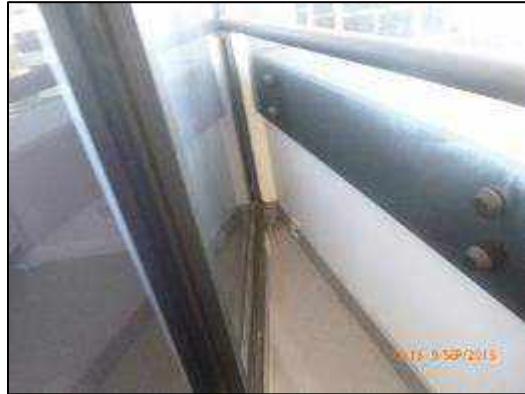
Item	Location	Defect description and Breach	Rectification	Photograph (if applicable)
1904	Balcony	See section 5.15.1	See section 5.15.2

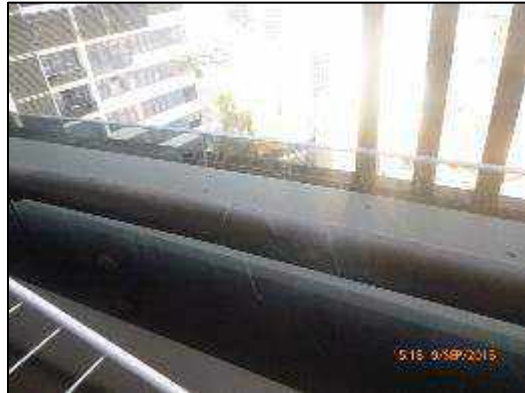
1905	Balcony balustrade rail	See section 5.9.1	See section 5.9.2

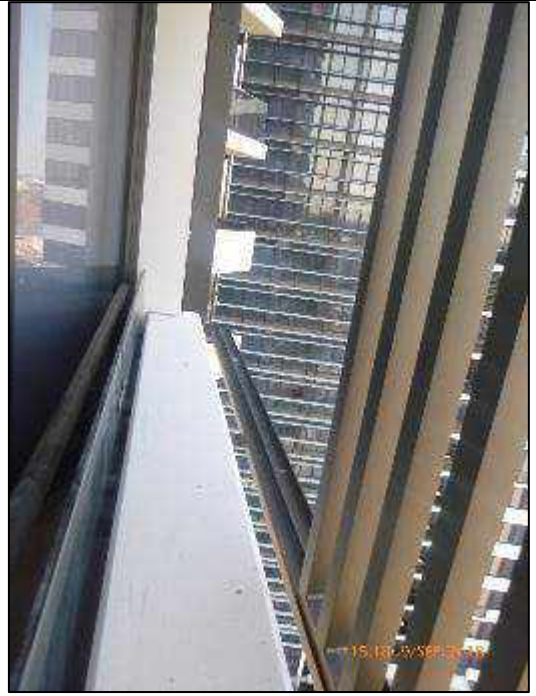
Item	Location	Defect description and Breach	Rectification	Photograph (if applicable)
1906	External balustrade wall	See section 5.10.1	See section 5.10.2

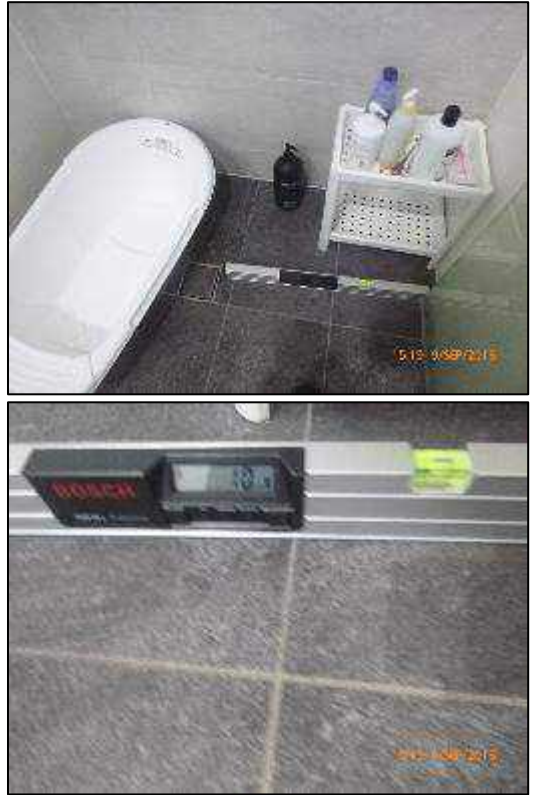
Item	Location	Defect description and Breach	Rectification	Photograph (if applicable)
1907	Main bedroom ensuite	See section 5.1.1 Falls (mm); 10/1000	See section 5.1.2

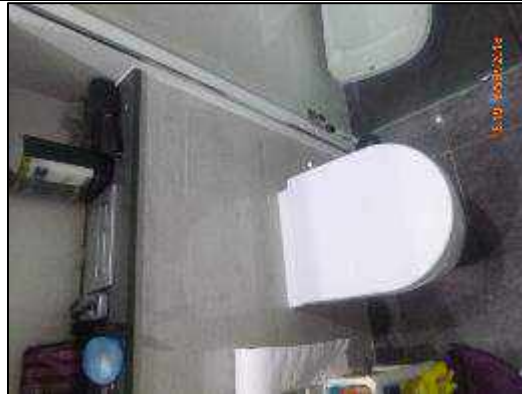
Item	Location	Defect description and Breach	Rectification	Photograph (if applicable)
1908	Main bedroom ensuite	<p>Resident advised that toilet flush was not working.</p> <p>Home Building Act (NSW) 1989</p> <ul style="list-style-type: none"> Part 2C, 18B (a) and (b). <p>This item is a defect as the builder has failed to satisfy implied warranty set out in the Home Building Act 1989 – Section 18B Warranties as to residential building work.</p> <p>(b) a warranty that all materials supplied by the holder or person will be good and suitable for the purpose for which they are used and that, unless otherwise stated in the contract, those materials will be new.</p> <p>Loss Suffered Loss suffered is cost of rectification and loss of amenity.</p>	<ol style="list-style-type: none"> 1. Temporary turn off main water supply to the toilet. 2. Carefully remove the flush from the toilet. 3. Supply and install flush to match existing. 4. Secure the flush to the toilet. 5. Turn on main water supply to toilet.

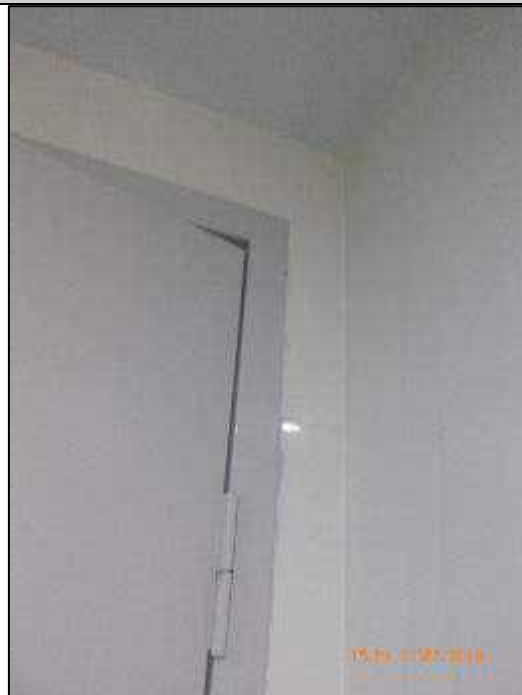
Item	Location	Defect description and Breach	Rectification	Photograph (if applicable)
1909	Wall adjacent to ensuite door	See section 5.9.1	See section 5.9.2

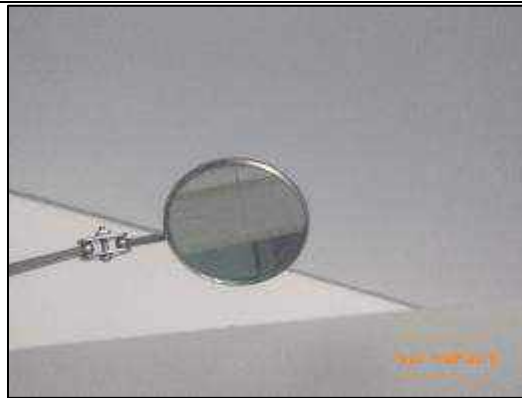
1910	Doors throughout the unit (x3)	See section 5.5.1	See section 5.5.2

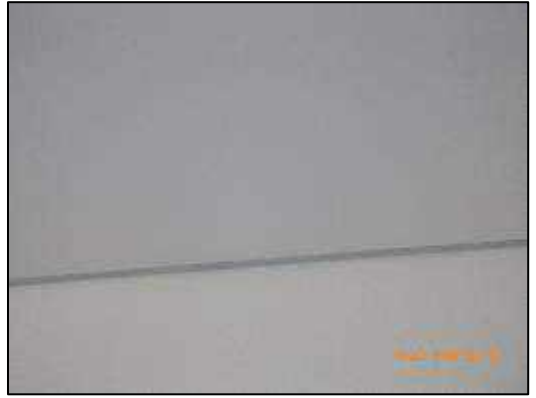
Item	Location	Defect description and Breach	Rectification	Photograph (if applicable)
1911	Lounge room	See section 5.11.1	See section 5.11.2

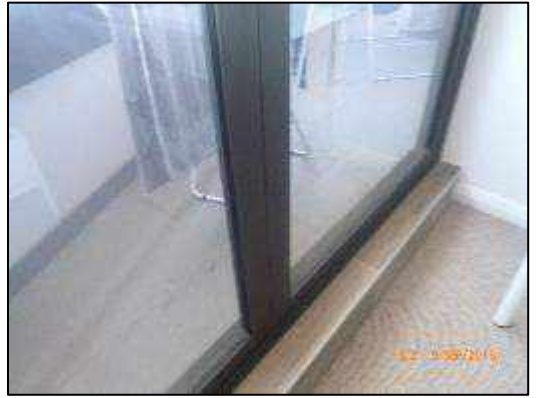
1912	Main bedroom sliding door frame	See section 5.8.1	See section 5.8.2

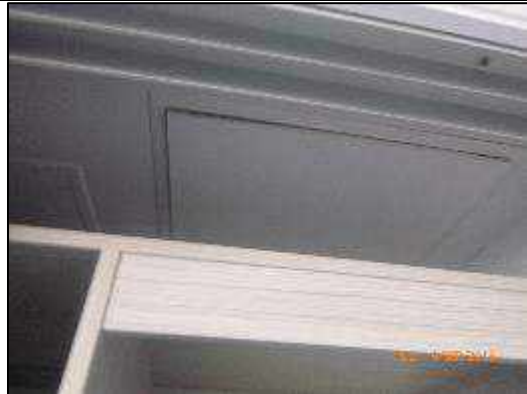
Item	Location	Defect description and Breach	Rectification	Photograph (if applicable)
1913	Main bedroom built in	See section 5.6.1	See section 5.6.2

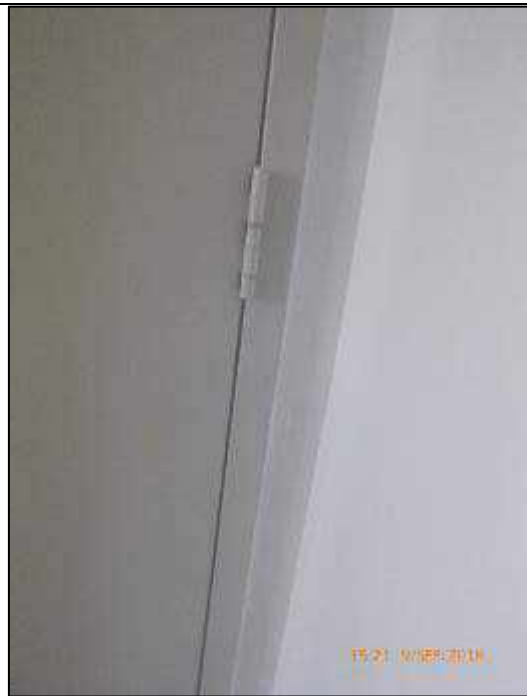
1914	Wall adjacent to main bedroom door	See section 5.13.1	See section 5.13.2

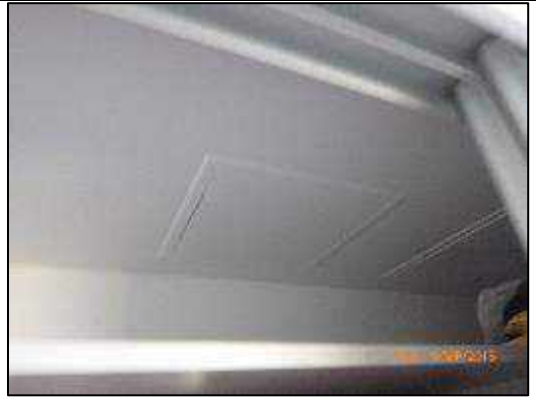
Item	Location	Defect description and Breach	Rectification	Photograph (if applicable)
1915	Second bedroom built in	See section 5.6.1	See section 5.6.2

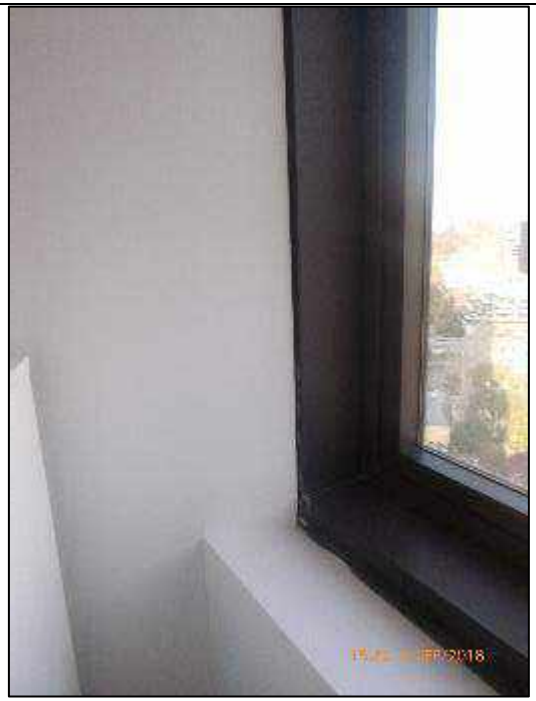
1916	Second bedroom window frames	See section 5.9.1	See section 5.9.2

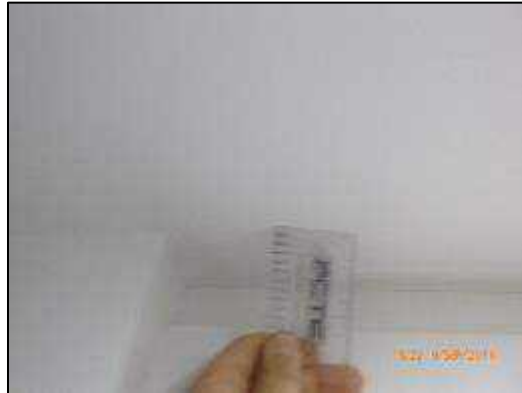
1918	<i>Ceiling above kitchen cupboards</i>	See section 5.14.1 Separation; 1mm	See section 5.14.2

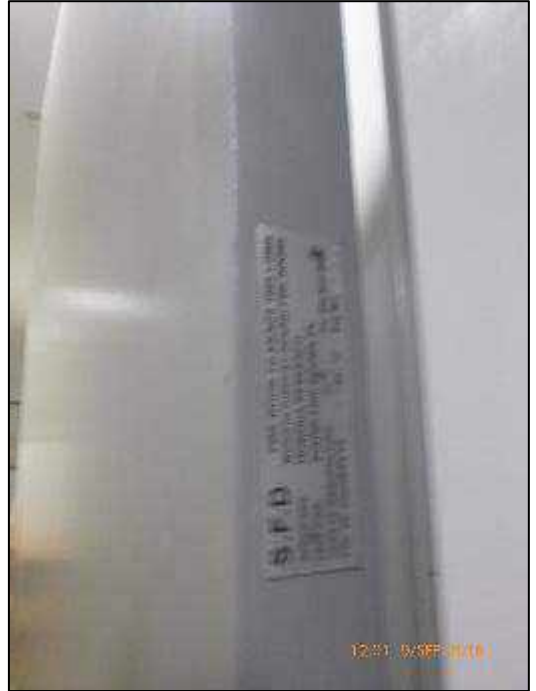
Item	Location	Defect description and Breach	Rectification	Photograph (if applicable)
Unit 1707				
1919	Front entry door	See section 5.12.1	See section 5.12.2

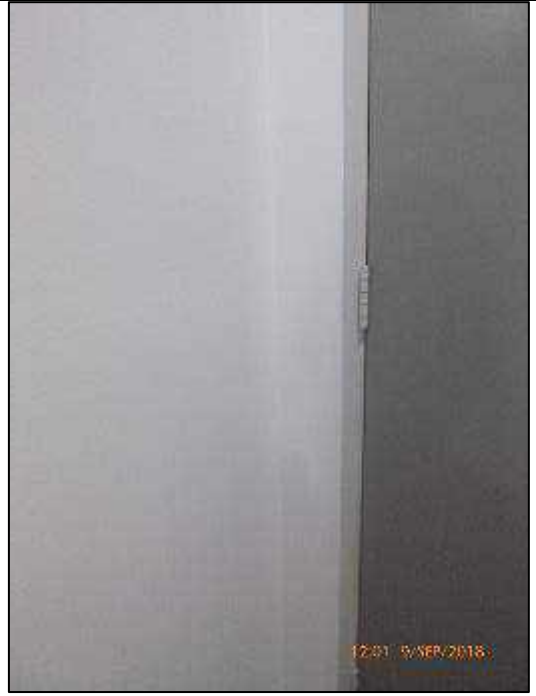
Item	Location	Defect description and Breach	Rectification	Photograph (if applicable)
1920	Wall adjacent to front entry door	See section 5.13.1	See section 5.13.2

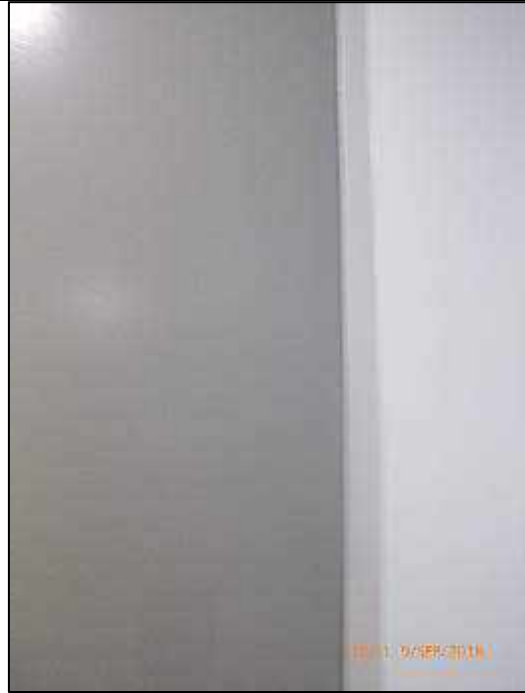
Item	Location	Defect description and Breach	Rectification	Photograph (if applicable)
1921	Wall adjacent to front entry door	See section 5.9.1	See section 5.9.2

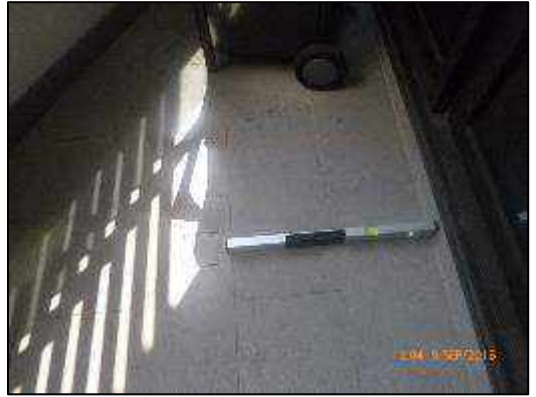
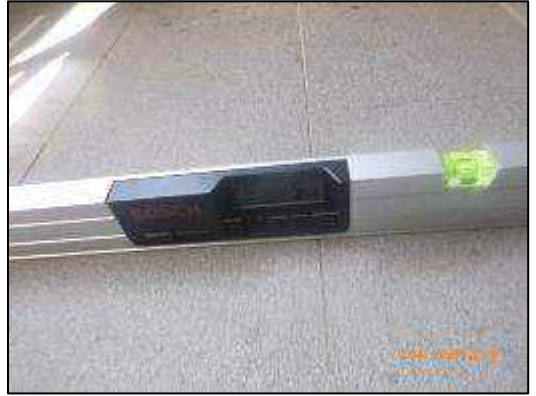
Item	Location	Defect description and Breach	Rectification	Photograph (if applicable)
1922	Balcony	See section 5.2.1 Falls (mm); 5/1000	See section 5.2.2

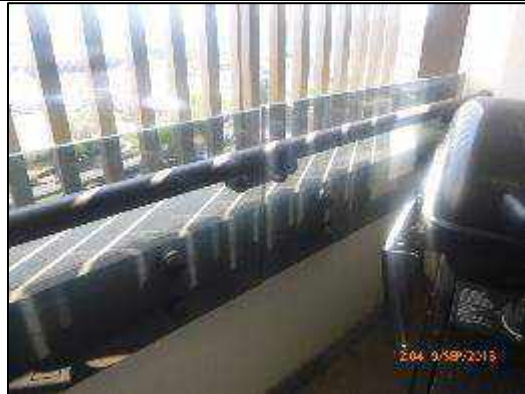
Item	Location	Defect description and Breach	Rectification	Photograph (if applicable)
1923	Balcony	See section 5.4.1	See section 5.4.2

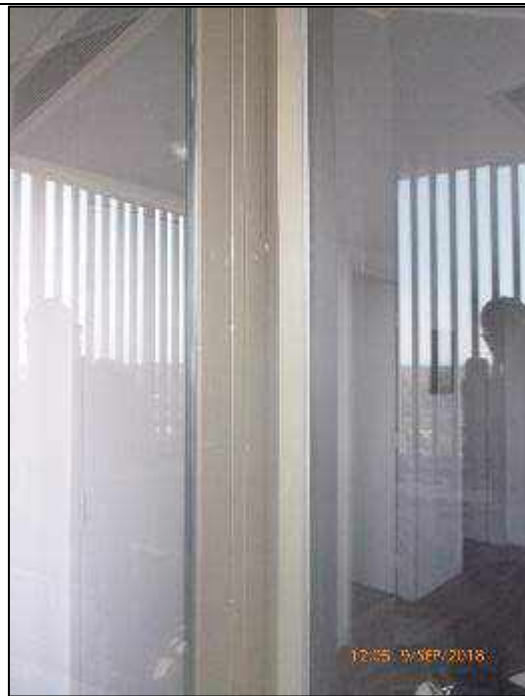
1924	Balcony sliding door frame	See section 5.7.1	See section 5.7.2

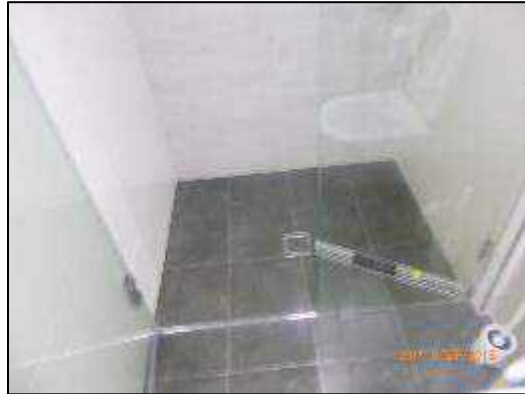
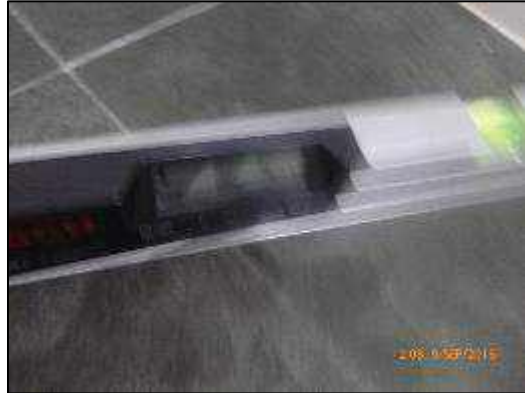
Item	Location	Defect description and Breach	Rectification	Photograph (if applicable)
1927	Main bathroom	See section 5.1.1 Falls (mm); 5/1000	See section 5.1.2

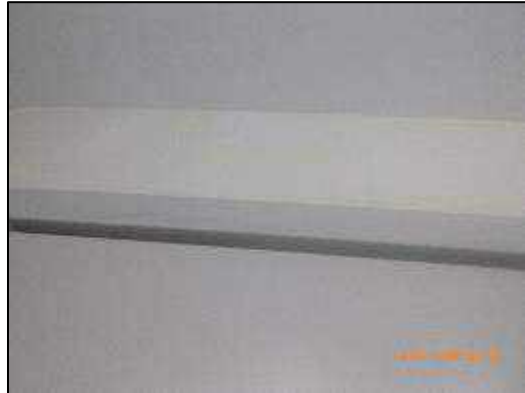
Item	Location	Defect description and Breach	Rectification	Photograph (if applicable)
1928	Wall above main bathroom door	See section 5.9.1	See section 5.9.2

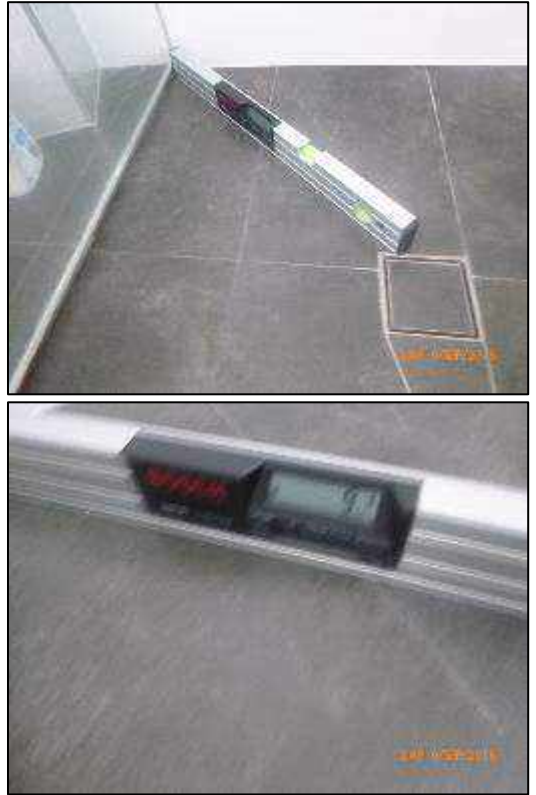
Item	Location	Defect description and Breach	Rectification	Photograph (if applicable)
1929	Main bedroom ensuite	See section 5.1.1 Falls (mm); 9/1000	See section 5.1.2

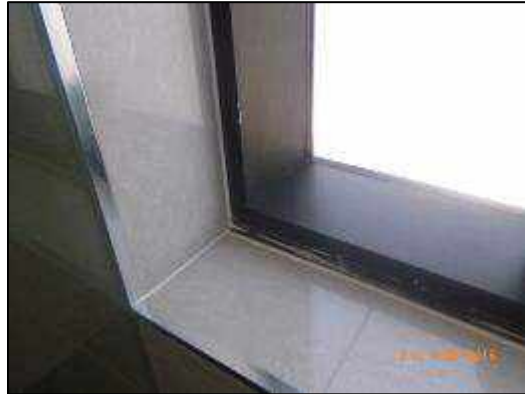
Item	Location	Defect description and Breach	Rectification	Photograph (if applicable)
1930	Main bedroom ensuite window frames	See section 5.9.1	See section 5.9.2

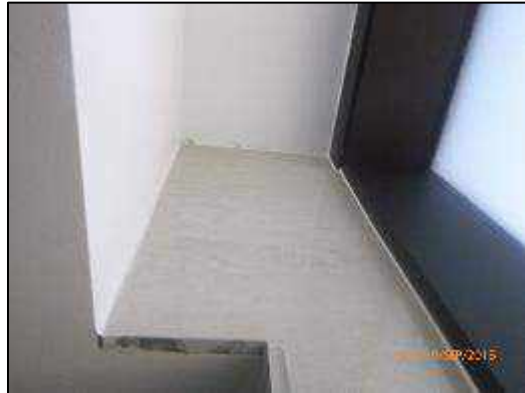
1931	Ensuite bulkhead window	See section 5.13.1	See section 5.13.2

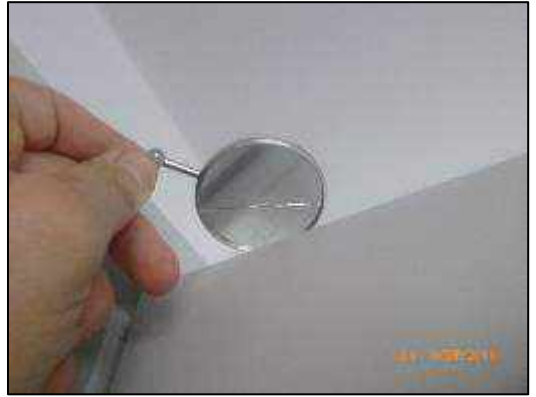
Item	Location	Defect description and Breach	Rectification	Photograph (if applicable)
1932	<i>Doors throughout the unit (x3)</i>	See section 5.5.1	See section 5.5.2

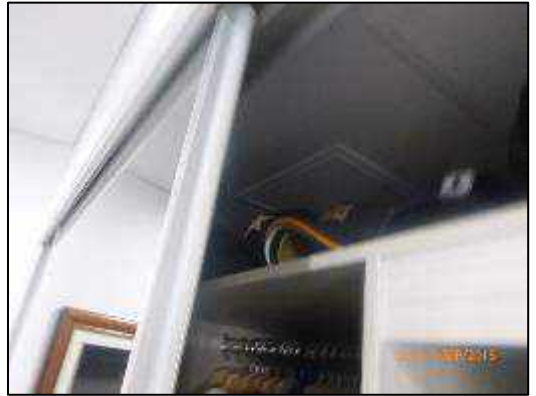
1933	<i>Main bedroom built in</i>	See section 5.6.1	See section 5.6.2
