SydneyStrataReport

STRATA REPORT

Client	Church Street Parramatta Property Pty Ltd
Address of property	Unit 3303/330 Church Street, Parramatta, NSW.
Lot	359
Strata Plan	SP 94469
Name of Strata Management Co.	NSW Strata
Telephone Number of Strata Agent	8980 1841
Report Date	15 February 2024

BUILDING DEFECTS REPORT Part 1/2

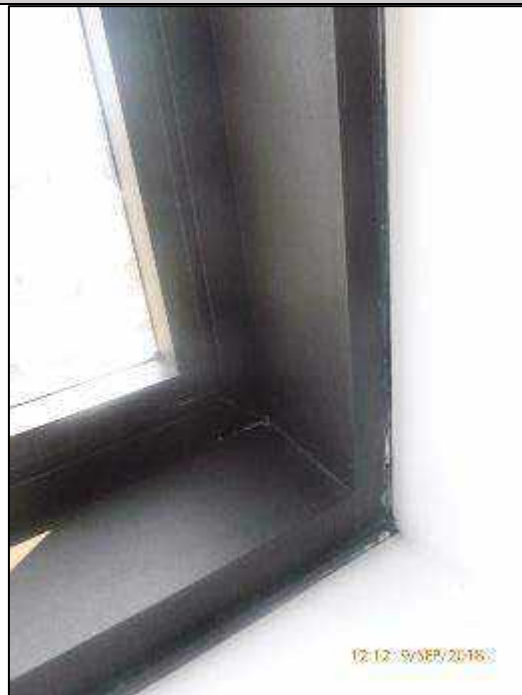
Item	Location	Defect description and Breach	Rectification	Photograph (if applicable)
1934	Main bedroom window frames	See section 5.9.1	See section 5.9.2

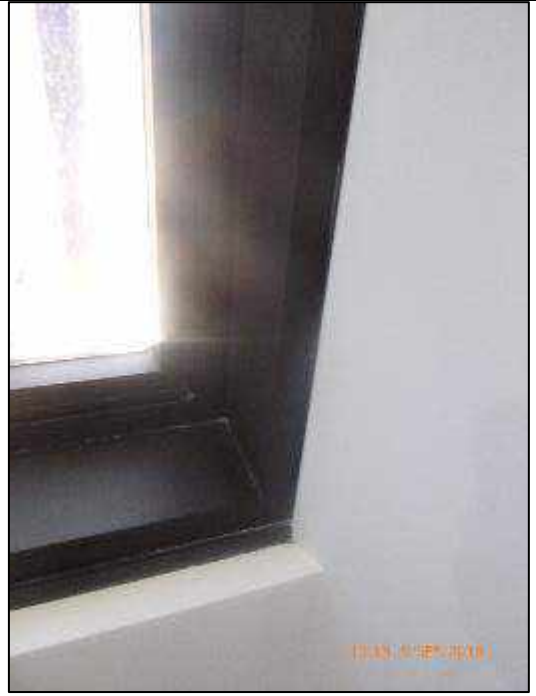
Item	Location	Defect description and Breach	Rectification	Photograph (if applicable)
1936	Second bedroom window frames	See section 5.9.1	See section 5.9.2

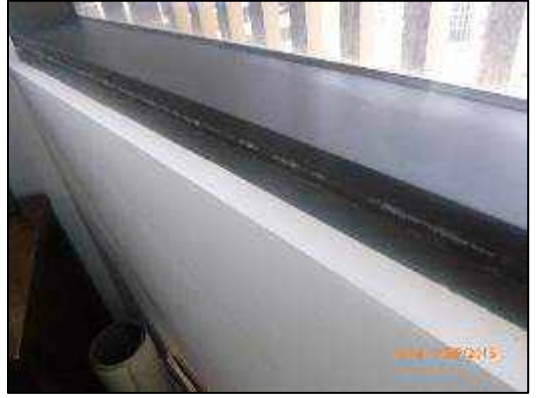
1937	Second bedroom window frames	See section 5.8.1	See section 5.8.2

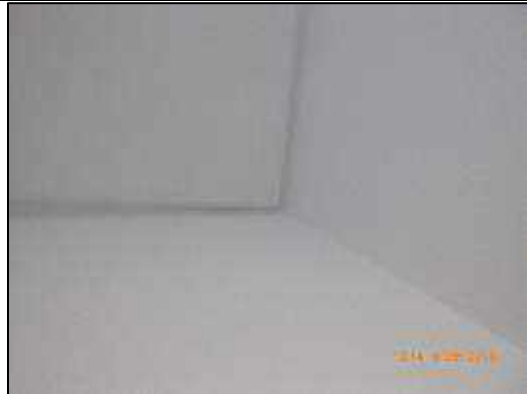
Item	Location	Defect description and Breach	Rectification	Photograph (if applicable)
1938	Lounge room	See section 5.11.1	See section 5.11.2

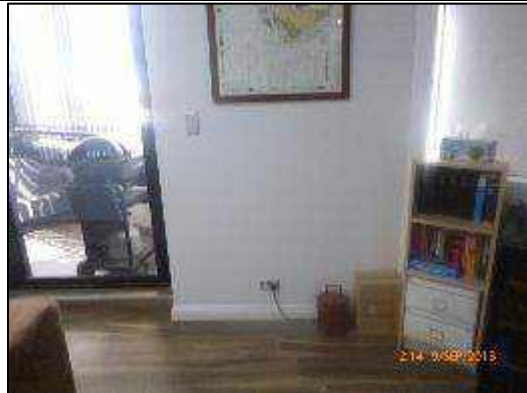
1939	Walls and ceiling throughout the unit	See section 5.10.1	See section 5.10.2

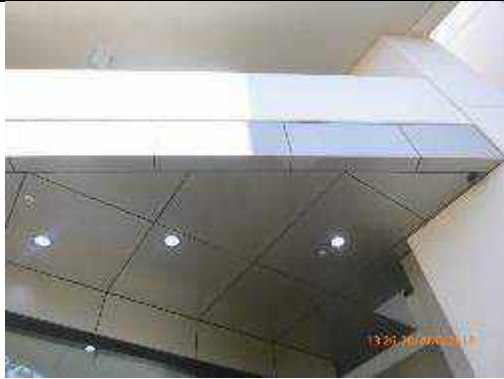
Item	Location	Defect description and Breach	Rectification	Photograph (if applicable)
Common areas – Lobby area				
1941	Soffit of northern entrance	<p>ACP cladding observed on soffit of entrance.</p> <p>Home Building Act (NSW) 1989</p> <ul style="list-style-type: none"> Part 2C, 18B (a) and (c). <p>Loss Suffered Loss suffered is cost of rectification.</p>	Engage a qualified engineer to certify the cladding panels and if required provide a rectification process.

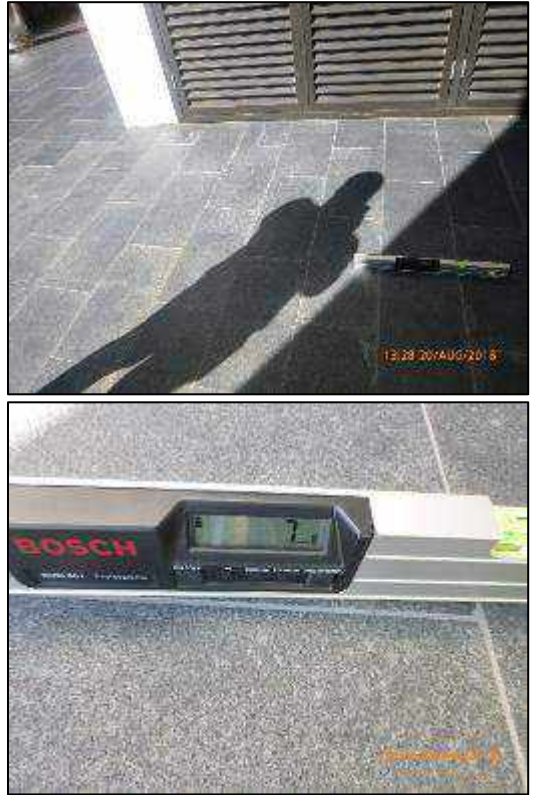
Item	Location	Defect description and Breach	Rectification	Photograph (if applicable)
1942	Northern entrance courtyard area.	See section 5.2.1 Falls (mm); 7/1000	See section 5.2.1

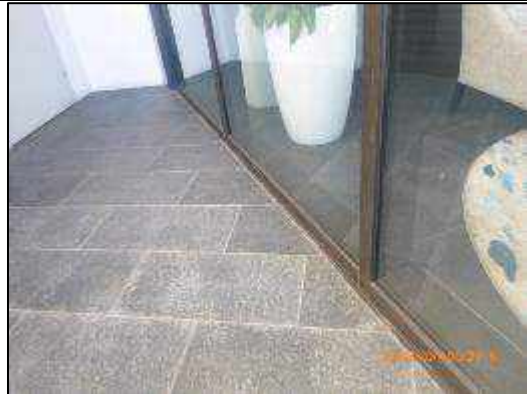
Item	Location	Defect description and Breach	Rectification	Photograph (if applicable)
1943	Northern entrance windows	<p>No hob observed between external and internal areas. No moisture ingress was observed at the time of inspection, however may cause future water ingress into the adjacent area.</p> <p>Home Building Act (NSW) 1989</p> <ul style="list-style-type: none"> Part 2C, 18B (a) and (c). <p>Guide to Standards and Tolerances 2017</p> <ul style="list-style-type: none"> Section 14.6 Decks and balcony freeboard outside windows and doors <p>This is a defect because there is no hob present as intended by the manufacturer' as outlined in Section 14.6 of the Guide to Standards and Tolerances 2017.</p> <p>Loss Suffered Loss suffered is cost of rectification</p>	<ol style="list-style-type: none"> 1. Protect all adjoining surfaces. 2. Remove windows and any surrounding fixtures. 3. Install hob with adequate waterproofing in accordance with manufactures specifications and the BCA. 4. Re-install windows to fit and match existing and seal appropriately. 5. Clean up the work area.

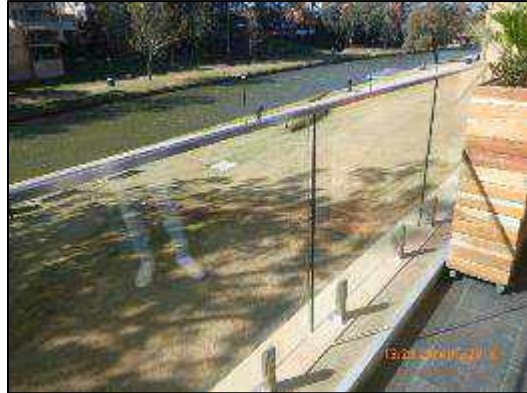
1944	Northern balustrade opposite river.	See section 5.4.1	See section 5.4.1

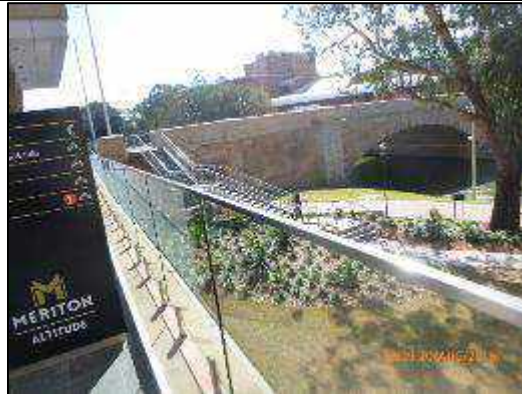
Item	Location	Defect description and Breach	Rectification	Photograph (if applicable)
1945	Northern entrance balustrade opposite river.	<p>Top rail of balustrade was observed to be non-compliant.</p> <p>Home Building Act (NSW) 1989</p> <ul style="list-style-type: none"> Part 2C, 18B (a) and (c). <p>This is a breach of part (a) of the act because the installation of the balustrade will not withhold the required loads and therefore not been installed in a proper workmanlike manner that would prevent falls.</p> <p>Loss Suffered Loss suffered is cost of rectification.</p>	<ol style="list-style-type: none"> 1. Protect all adjoining surfaces surrounding the work area. 2. Appropriately fix balustrade in accordance with AS1170.

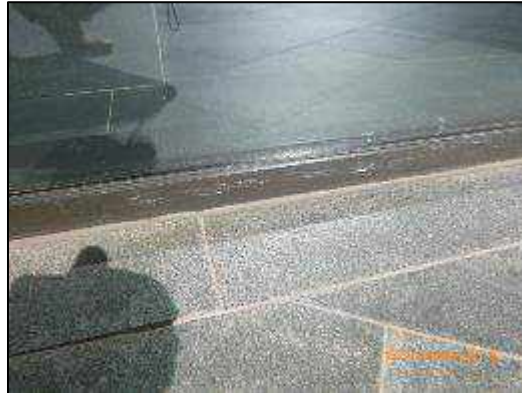
1946	Northern entrance external window frames	See section 5.9.1	See section 5.9.1

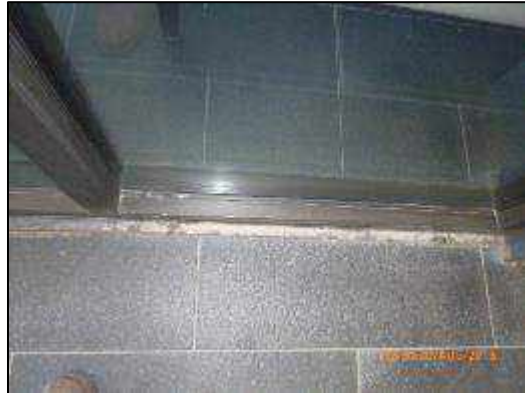
Item	Location	Defect description and Breach	Rectification	Photograph (if applicable)
1947	Northern entrance window frames	See section 5.8.1	See section 5.8.1

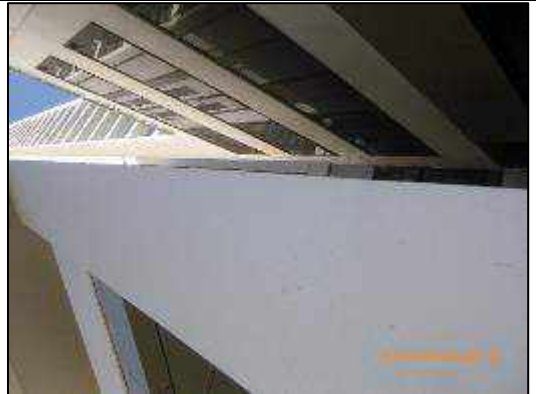
Item	Location	Defect description and Breach	Rectification	Photograph (if applicable)
1949	Southern column adjacent to the building entrance.	<p>Chipped render observed in southern column.</p> <p>Home Building Act (NSW) 1989</p> <ul style="list-style-type: none"> Part 2C, 18B (a) and (c). <p>Guide to Standards and Tolerances 2017</p> <ul style="list-style-type: none"> Crack categories are assessed in accordance with Section 3.02. Cracks are classed as Category 2. Category 2 damage cracks are considered a defect and require repair work. <p>AS2870-2011 Residential footings and slabs</p> <ul style="list-style-type: none"> Crack categories are assessed in accordance with Table C1 <p>CLASSIFICATION OF DAMAGE WITH REFERENCE TO WALLS</p> <ul style="list-style-type: none"> Cracks exceed Category 1 but do not exceed damage Category 2. <p>Loss Suffered</p> <p>Loss suffered is cost of rectification.</p>	<ol style="list-style-type: none"> 1. Protect all surrounding surfaces 2. Remove cracked rendered surfaces to closest architectural line 3. Install suitable flexible sealant 4. Install new render to blend into the existing surface 5. Repaint to match existing using suitable external paint system in accordance with AS2311.

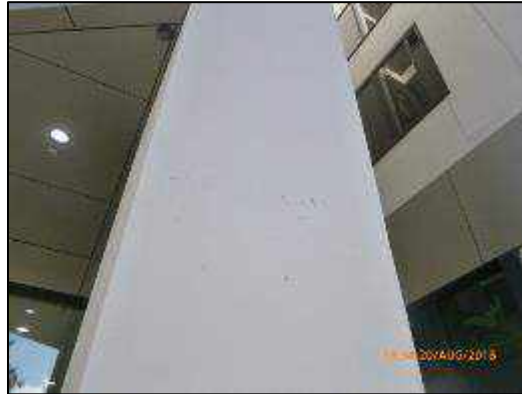
Item	Location	Defect description and Breach	Rectification	Photograph (if applicable)
1950	Western face of building entrance.	See section 5.10.1	See section 5.10.1

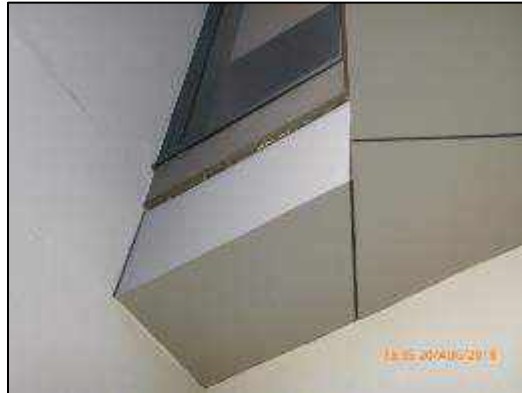
1951	Northern entrance above gas and water meters.	See section 5.10.1	See section 5.10.1

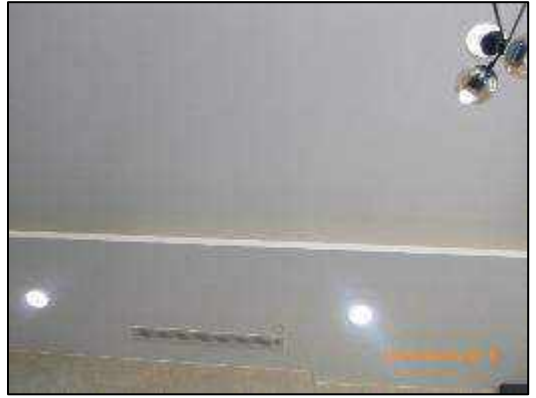
Item	Location	Defect description and Breach	Rectification	Photograph (if applicable)
1952	<i>Throughout the ceiling of the lobby area</i>	See section 5.9.1	See section 5.9.1

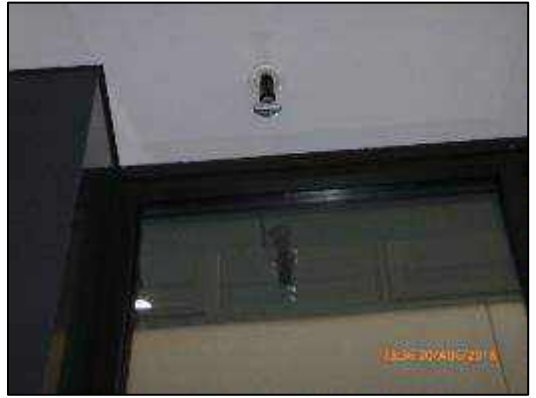
1953	<i>Windows frames of southern wall</i>	See section 5.9.1	See section 5.9.1

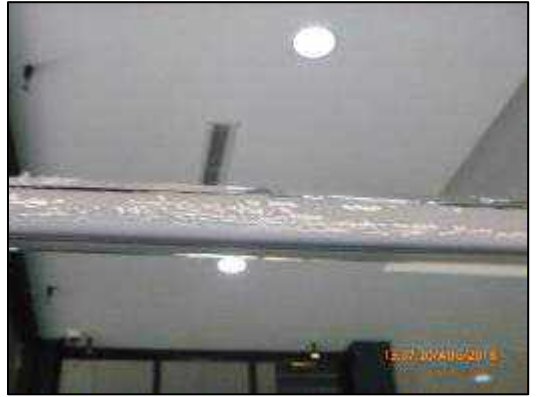
Item	Location	Defect description and Breach	Rectification	Photograph (if applicable)
1954	Window frames in lobby area	See section 5.7.1	See section 5.7.1

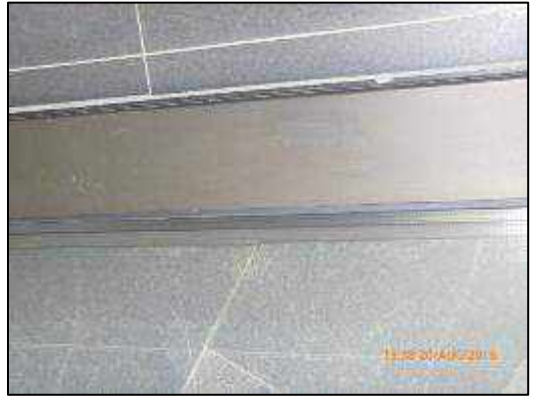
1955	Window frames on northern wall	See section 5.7.1	See section 5.7.1

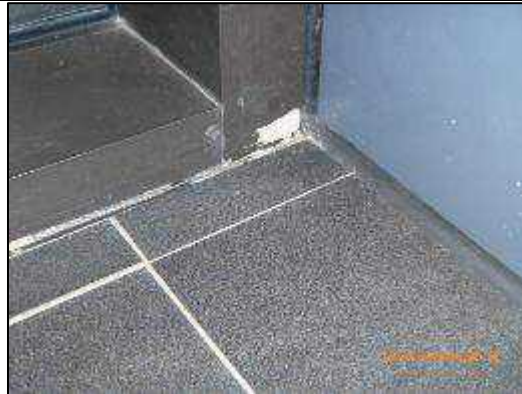
Item	Location	Defect description and Breach	Rectification	Photograph (if applicable)
1956	Window frames on northern wall	See section 5.9.1	See section 5.9.1

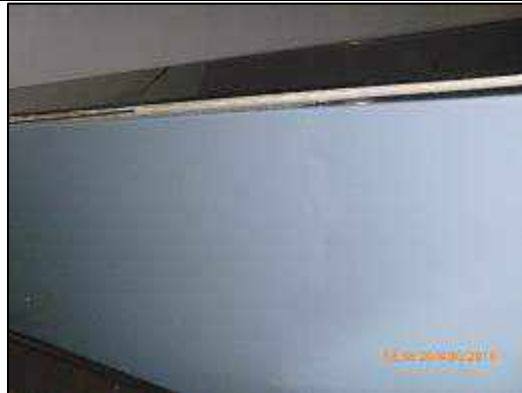
1957	Luca-band panels adjacent to window frames	<p>Discolouration of blue luca-band panel adjacent to window frames.</p> <p>Home Building Act (NSW) 1989</p> <ul style="list-style-type: none"> Part 2C, 18B (a) and (c). <p>This is a breach of part (a) of the act because the installation of the cladding will not withstand the required climatable weather and therefore not been installed in a proper workmanlike manner that would prevent discolouration.</p> <p>Loss Suffered Loss suffered is cost of rectification.</p>	<ol style="list-style-type: none"> 1. Protect all adjoining surfaces surrounding the work area. 2. Appropriately replace the cladding panel in accordance with manufacturers specifications.

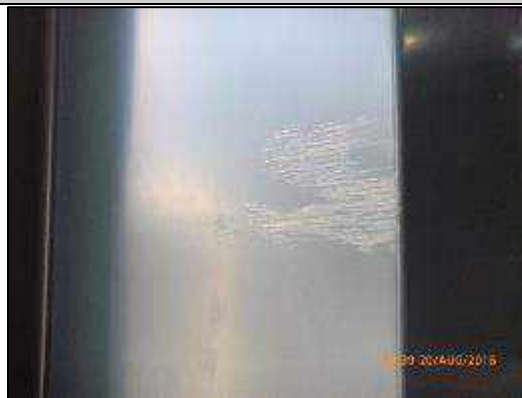
Item	Location	Defect description and Breach	Rectification	Photograph (if applicable)
1958	Wall adjacent to front sliding door	<p>Sealant staining on ACP adjacent to entrance sliding door.</p> <p>Home Building Act (NSW) 1989</p> <ul style="list-style-type: none"> Part 2C, 18B (a) and (c). <p>This is a breach of part (a) of the act because the surface has not been finished in a proper workmanlike manner that would prevent loss of appearance to the surface.</p> <p>Loss Suffered Loss suffered is cost of rectification.</p>	<ol style="list-style-type: none"> 1. Protect all adjoining surfaces. 2. Use a suitable cleaning agent to remove residue and clear debris. 3. Clean up the work area.

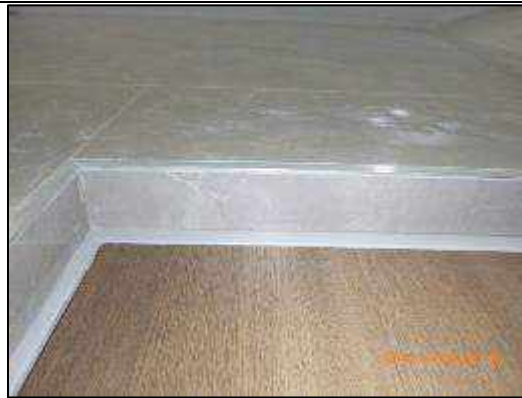
1959	Tiles above telecommunications room	<p>Construction debris observed on tiles above telecommunications room.</p> <p>Home Building Act (NSW) 1989</p> <ul style="list-style-type: none"> Part 2C, 18B (a) and (c). <p>This is a breach of part (a) of the act because the surface has not been finished in a proper workmanlike manner that would prevent loss of appearance to the surface.</p> <p>Loss Suffered Loss suffered is cost of rectification.</p>	<ol style="list-style-type: none"> 1. Protect all adjoining surfaces. 2. Use a suitable cleaning agent to remove residue and clear debris. 3. Clean up the work area.

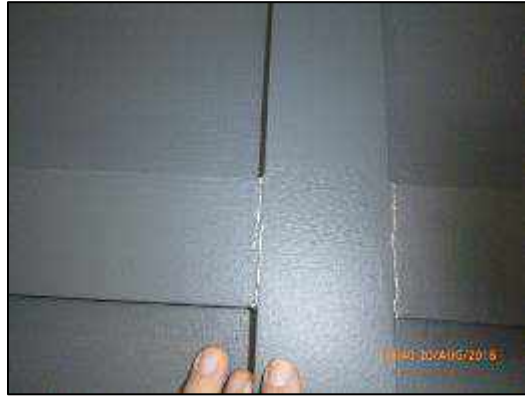
Item	Location	Defect description and Breach	Rectification	Photograph (if applicable)
1960	<i>Southern wall of lobby area</i>	See section 5.10.1	See section 5.10.2

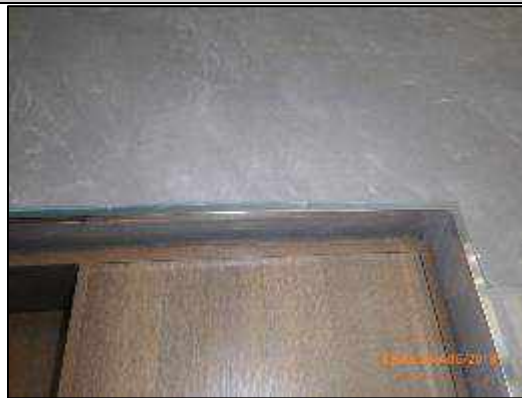
Item	Location	Defect description and Breach	Rectification	Photograph (if applicable)
1962	Cabinetry behind the building manager's desk	<p>Excessive sealant observed around cabinetry.</p> <p>Home Building Act (NSW) 1989</p> <ul style="list-style-type: none"> Part 2C, 18B (a) and (c). <p>This is a breach of part (a) of the act because the surface has not been finished in a proper workmanlike manner that would prevent loss of appearance to the surface.</p> <p>Loss Suffered Loss suffered is cost of rectification.</p>	<ol style="list-style-type: none"> 1. Protect all adjoining surfaces. 2. Use a suitable cleaning agent to remove residue and clear debris. 3. Clean up the work area.

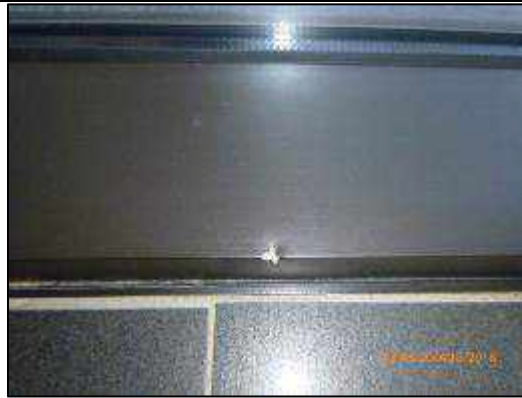
1963	Window frame on eastern wall	<p>Chipped aluminium window frame observed on eastern wall.</p> <p>Home Building Act (NSW) 1989</p> <ul style="list-style-type: none"> Part 2C, 18B (a) and (c). <p>This is a breach of part (a) of the act because the surface has not been finished in a proper workmanlike manner that would prevent loss of appearance to the surface.</p> <p>Loss Suffered Loss suffered is cost of rectification.</p>	<ol style="list-style-type: none"> 1. Protect all adjoining surfaces. 2. Appropriately fix/replace window frame to match existing. 3. Clean up the work area.

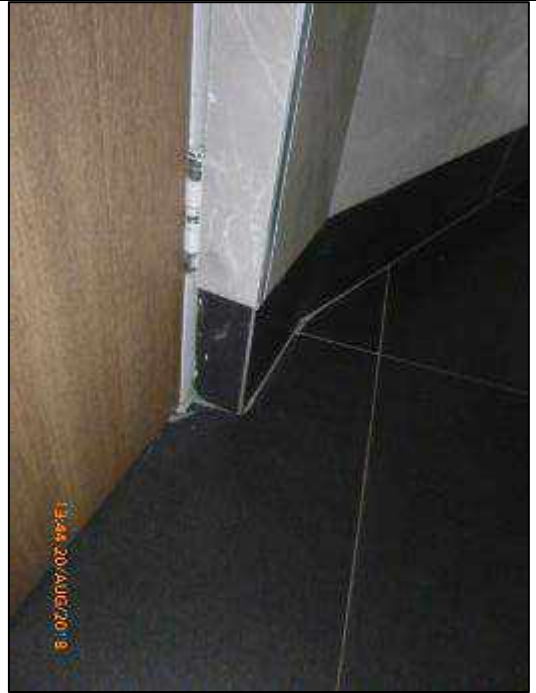
Item	Location	Defect description and Breach	Rectification	Photograph (if applicable)
1964	Wall adjacent to telecommunications room on eastern elevation	See section 5.9.1	See section 5.9.1

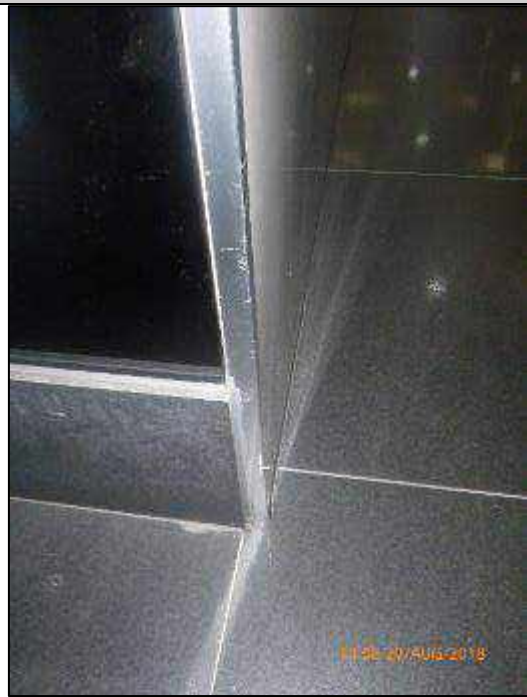
Item	Location	Defect description and Breach	Rectification	Photograph (if applicable)
1965	<i>Tile angle adjacent to lift in lobby area</i>	See section 5.9.1	See section 5.9.1

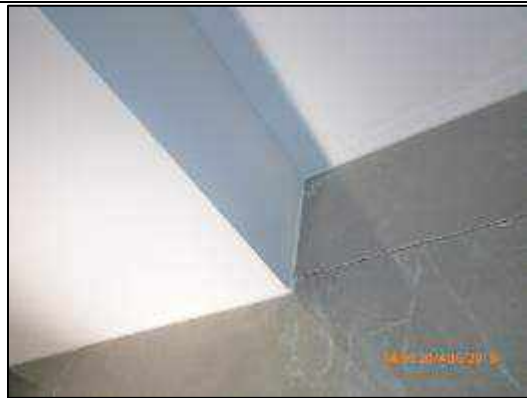
1966	<i>Floor tiles opposite lifts in lobby area</i>	See section 5.9.1	See section 5.9.1

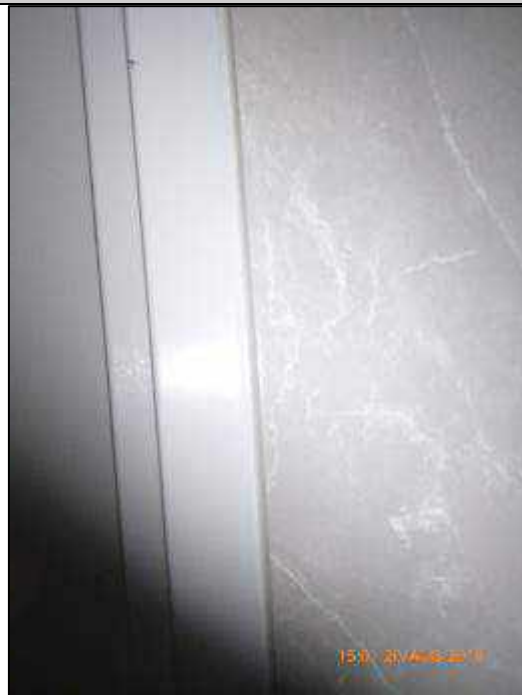
Item	Location	Defect description and Breach	Rectification	Photograph (if applicable)
1967	Eastern wall in lobby area	See section 5.13.1	See section 5.13.1

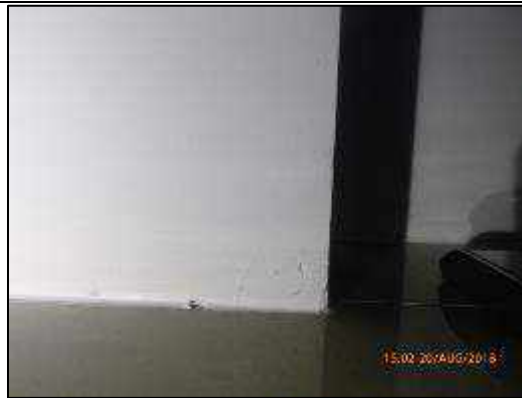
1968	Wall adjacent to southern lift	See section 5.13.1	See section 5.13.1

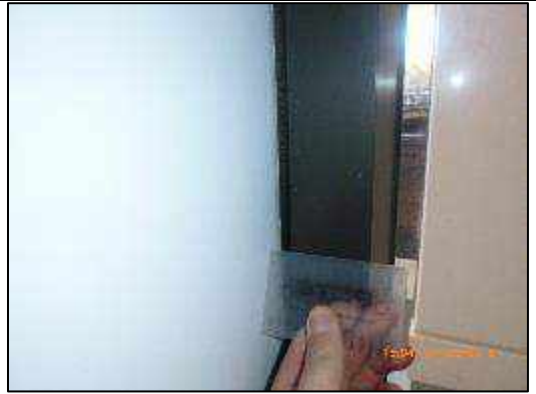
Item	Location	Defect description and Breach	Rectification	Photograph (if applicable)
Common areas – Level 1				
1969	Western end of northern elevation windows frame and wall	See section 5.14.1 Separation; 15mm	See section 5.14.2

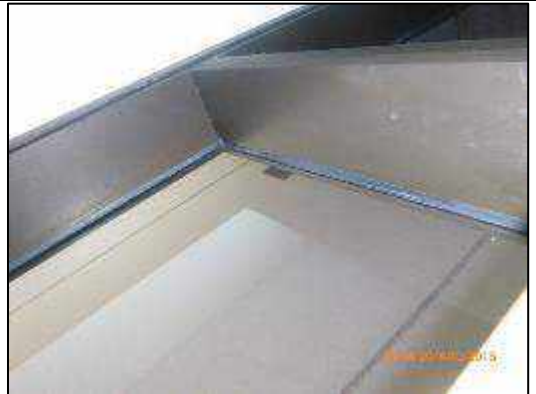
1970	Western elevation window frames	See section 5.7.1	See section 5.7.2

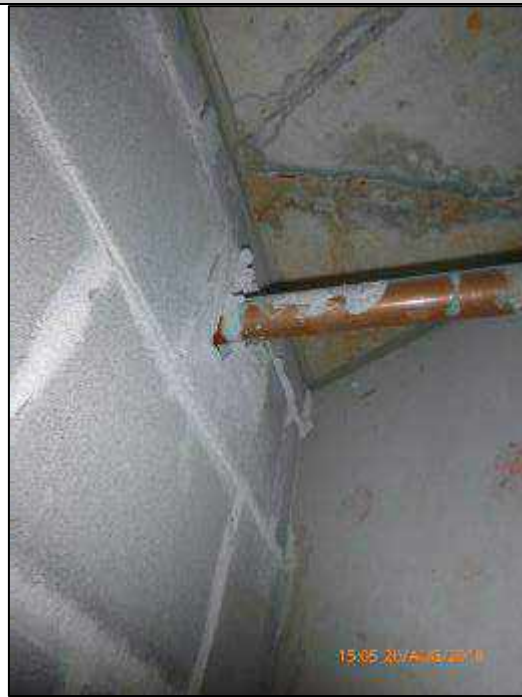
Item	Location	Defect description and Breach	Rectification	Photograph (if applicable)
1971	Fire hose reel room adjacent to room 103	<p>Pipe penetration in fire hose room has not been sealed.</p> <p>Home Building Act (NSW) 1989</p> <ul style="list-style-type: none"> Part 2C, 18B (a), (B) and (c). <p>Building Code of Australia (BCA), Volume 1</p> <ul style="list-style-type: none"> Section C Fire Resistance Part CO1 Performance Requirements CF2 & CP8. <p>This is a breach of the BCA as it requires suitable fire-resistant elements to prevent spread of fire between separate levels</p> <p>Loss Suffered Loss suffered is cost of rectification.</p>	Provide suitable complying fire collars where fitment is achievable or install suitable fire resistant plasterboard enclosure around the pipe penetrations to achieve required fire separation levels and compliance with BCA requirements.

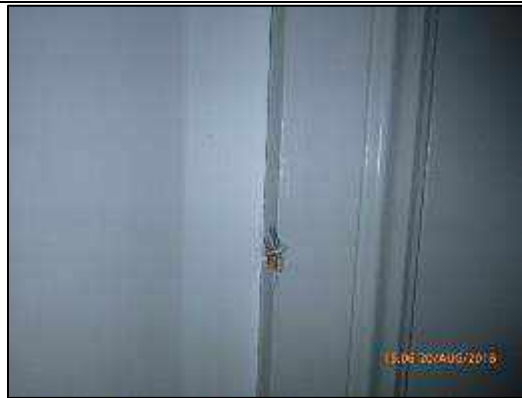
1972	Architrave of data room	<p>Nail penetration has caused chipping of architrave.</p> <p>Home Building Act (NSW) 1989</p> <ul style="list-style-type: none"> Part 2C, 18B (a) and (c). <p>This is a breach of part (a) of the act because the surface has not been finished in a proper workmanlike manner that would prevent loss of appearance to the surface.</p>	<ol style="list-style-type: none"> 1. Protect all adjoining surfaces. 2. Appropriately fix/replace architrave to around door. 3. Repaint to match existing using suitable internal paint system in accordance with AS2311. 4. Clean up the work area.

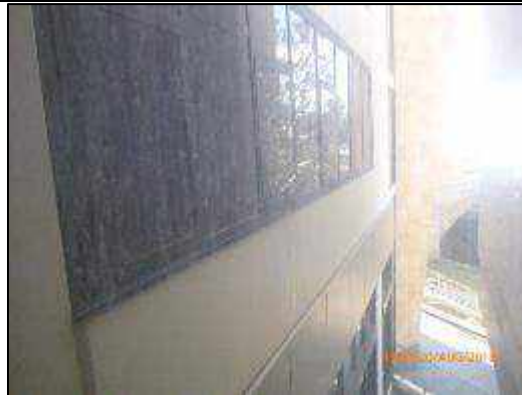
Item	Location	Defect description and Breach	Rectification	Photograph (if applicable)
		<p>Guide to Standards and Tolerances 2017</p> <ul style="list-style-type: none"> Section 13.3 Nail and screw fixings <p>This is a defect because the nail penetration has not been filled as intended by the manufacturer as outlined in Section 13.3 of the Guide to Standards and Tolerances 2017.</p> <p>Loss Suffered Loss suffered is cost of rectification.</p>		
1973	External southern return windows	<p>Construction debris observed on external façade of building.</p> <p>Home Building Act (NSW) 1989</p> <ul style="list-style-type: none"> Part 2C, 18B (a) and (c). <p>This is a breach of part (a) of the act because the surface has not been finished in a proper workmanlike manner that would prevent loss of appearance to the surface.</p> <p>Loss Suffered Loss suffered is cost of rectification.</p>	<ol style="list-style-type: none"> 1. Protect all adjoining surfaces. 2. Use a suitable cleaning agent to remove residue and clear debris. 3. Clean up the work area.

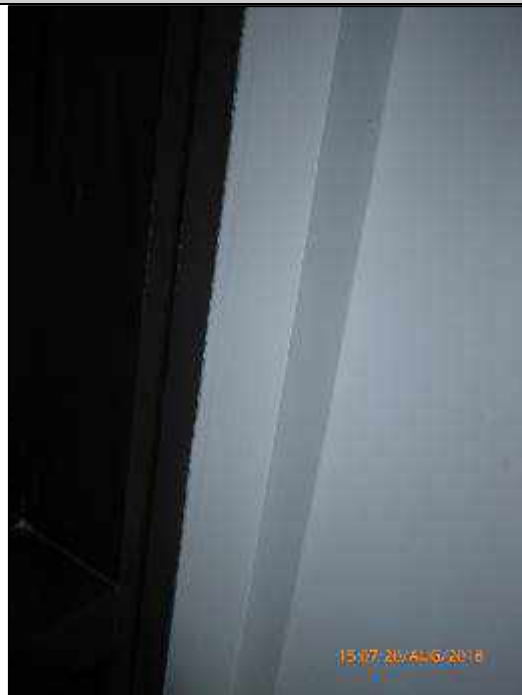
Item	Location	Defect description and Breach	Rectification	Photograph (if applicable)
1974	Window reveal adjacent to room 106	See section 5.10.1	See section 5.10.2

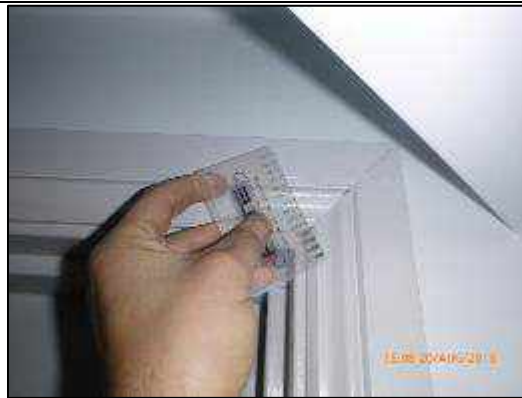
1975	Architrave of room 103	See section 5.14.1 Separation (mm); 1mm	See section 5.14.2

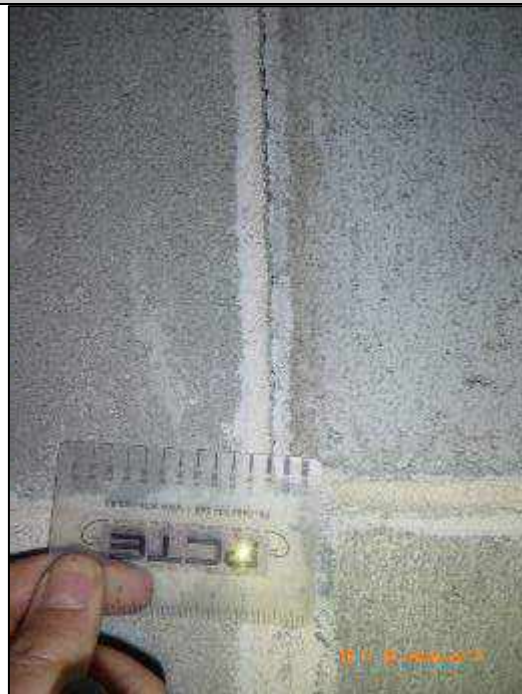
Item	Location	Defect description and Breach	Rectification	Photograph (if applicable)
1976	Northern wall of fire hose reel	<p>1.5mm vertical cracking in blockwork of fire hose reel room.</p> <p>Home Building Act (NSW) 1989</p> <ul style="list-style-type: none"> Part 2C, 18B (a) & (c). <p>Guide to Standards and Tolerances 2017</p> <p>Crack categories are assessed in accordance with Section 3.02.</p> <p>Cracks are classed as exceeding Category 1 but not exceeding Category 2 damage.</p> <p>AS2870-2011 Residential footings and slabs</p> <p>Crack categories are assessed in accordance with Table C1</p> <p>CLASSIFICATION OF DAMAGE WITH REFERENCE TO WALLS</p> <p>Cracks exceed Category 1 but do not exceed damage Category 2.</p> <p>Loss Suffered</p> <p>Loss suffered is cost of rectification.</p>	<ol style="list-style-type: none"> 1. Protect all surrounding surfaces 2. Hold Point Engineer to inspect. 3. Contractor to install Helifix Bars are required 4. Repair area to match existing

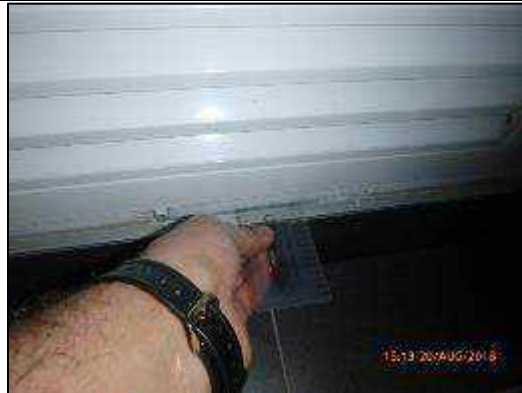
1978	Wall adjacent to entrance of carpark	<p>Junction between tiles and wall has not been sealed.</p> <p>Home Building Act (NSW) 1989</p> <ul style="list-style-type: none"> Part 2C, 18B (a) and (c). <p>Building Code of Australia</p> <ul style="list-style-type: none"> Section F Damp and Weatherproofing Part F1 Damp and Weatherproofing Sections FO1 and FF1.2. <p>This is a breach because the building is not constructed in a manner so as to provide adequate weatherproofing of the building's envelope.</p> <p>Loss Suffered</p> <p>Loss suffered is cost of rectification and potential loss of amenity.</p>	Fit a suitable foam backing rod and apply suitable mastic sealant to weatherproof the joint.

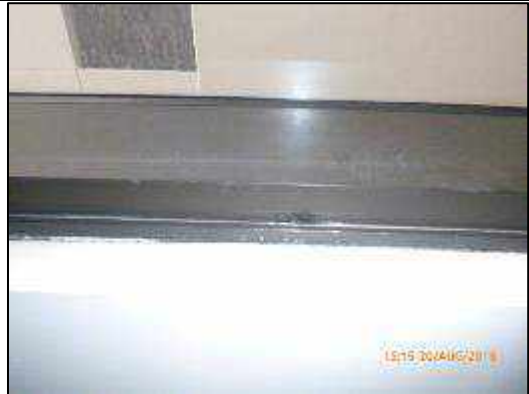
Item	Location	Defect description and Breach	Rectification	Photograph (if applicable)
Common areas – Level 2				
1979	Windows frames adjacent to room 205 on western wall	See section 5.9.1	See section 5.9.2

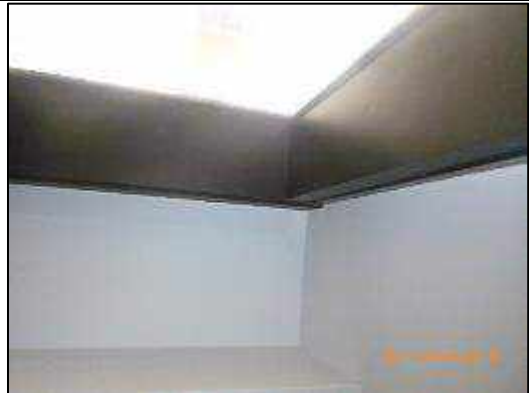
1980	Window bulkhead adjacent to room 205	See section 5.13.1	See section 5.13.2

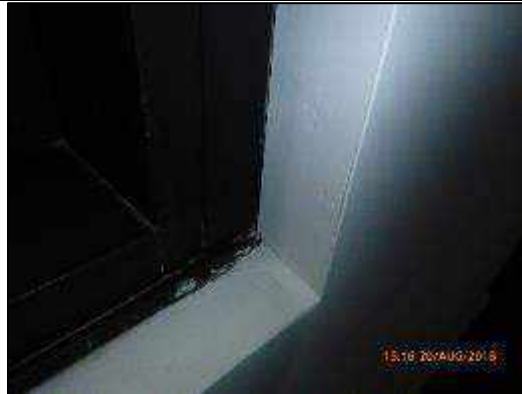
Item	Location	Defect description and Breach	Rectification	Photograph (if applicable)
1981	Windows frames on western wall	See section 5.9.1	See section 5.9.2

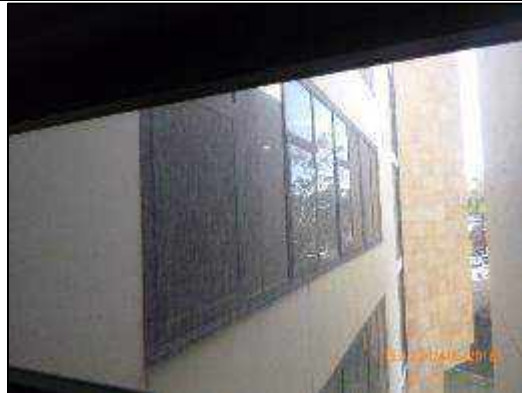
1982	Windows adjacent to room 206	<p>Construction debris observed on external façade of building.</p> <p>Home Building Act (NSW) 1989</p> <ul style="list-style-type: none"> Part 2C, 18B (a) and (c). <p>This is a breach of part (a) of the act because the surface has not been finished in a proper workmanlike manner that would prevent loss of appearance to the surface.</p> <p>Loss Suffered Loss suffered is cost of rectification.</p>	<ol style="list-style-type: none"> 1. Protect all adjoining surfaces. 2. Use a suitable cleaning agent to remove residue and clear debris. 3. Clean up the work area.

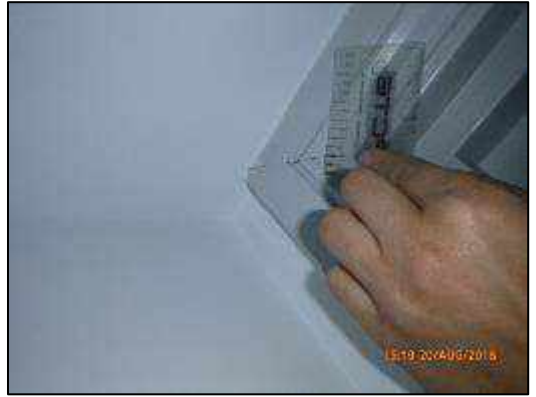
Item	Location	Defect description and Breach	Rectification	Photograph (if applicable)
1983	Architrave of data room door	See section 5.14.1 Separation (mm); 1.5mm	See section 5.14.2

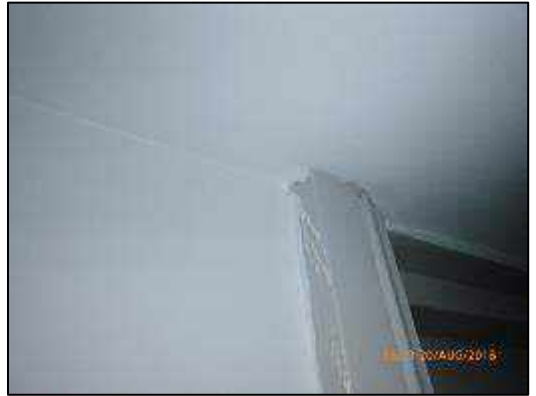
1984	Door frame above room 203	See section 5.9.1	See section 5.9.2

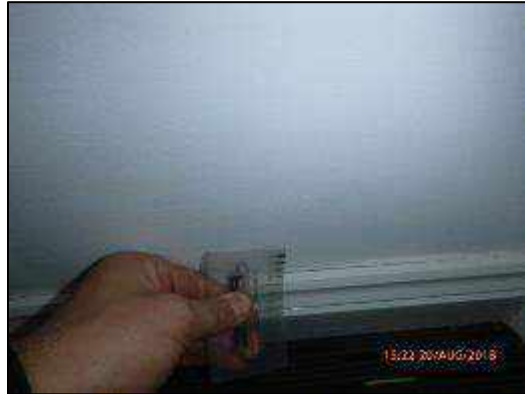
Item	Location	Defect description and Breach	Rectification	Photograph (if applicable)
1985	Skirting board adjacent to fire hose reel room	See section 5.14.1 Separation (mm); 1.5mm	See section 5.14.2

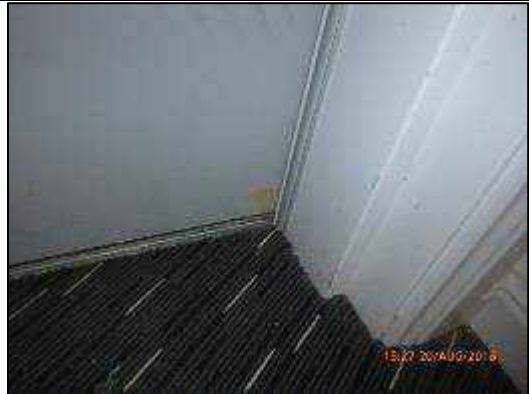
Item	Location	Defect description and Breach	Rectification	Photograph (if applicable)
Common areas – Level 3				
1987	Front entry door of room 304	See section 5.10.1	See section 5.10.2

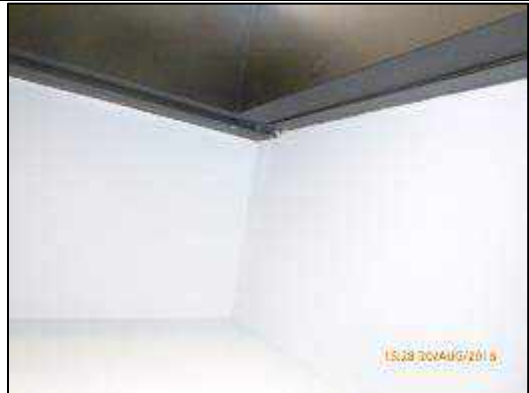
1988	Windows at the northern end of the western wall	See section 5.13.1	See section 5.13.2

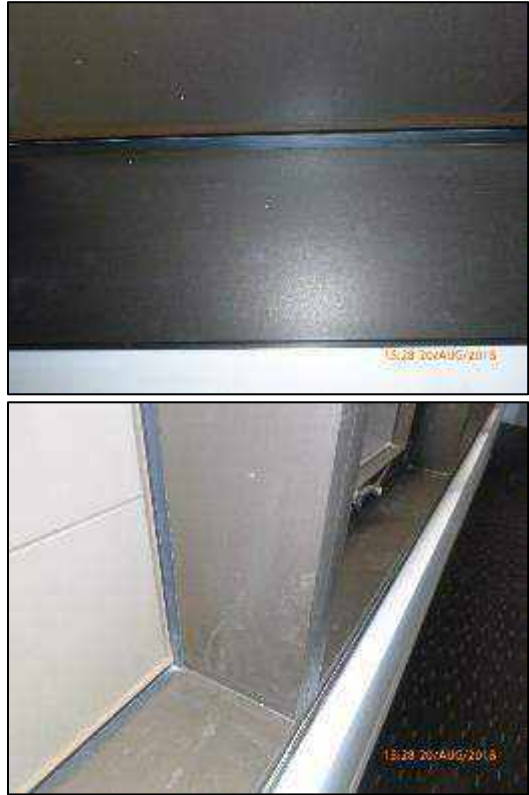
Item	Location	Defect description and Breach	Rectification	Photograph (if applicable)
1989	Windows frames on western wall	See section 5.7.1	See section 5.7.2

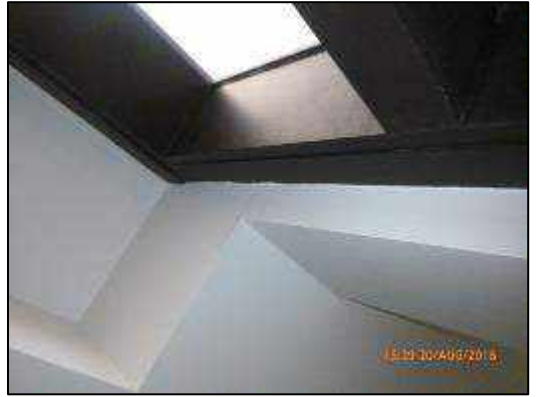
Item	Location	Defect description and Breach	Rectification	Photograph (if applicable)
1990	Western wall window frames adjacent to room 306	See section 5.9.1	See section 5.9.2

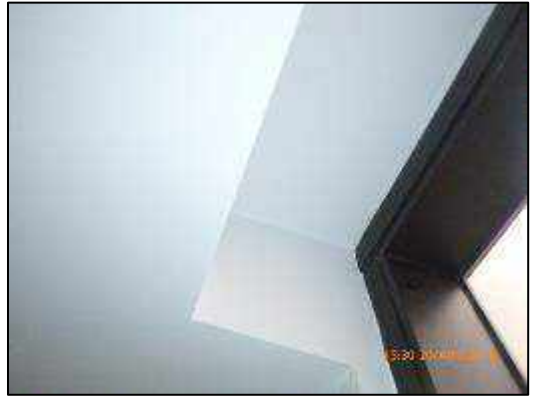
1991	Window bulkhead adjacent to room 306	See section 5.13.1	See section 5.13.2

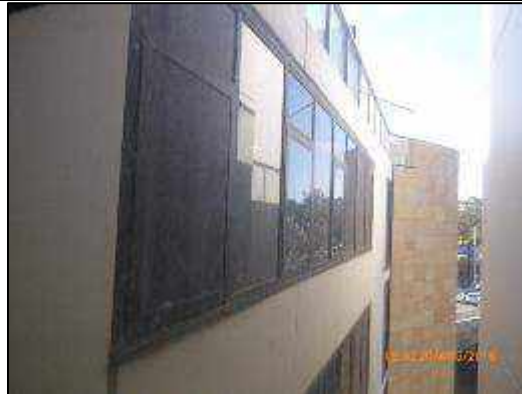
Item	Location	Defect description and Breach	Rectification	Photograph (if applicable)
1992	External façade southern return wall windows	<p>Construction debris observed on external façade of building.</p> <p>Home Building Act (NSW) 1989</p> <ul style="list-style-type: none"> Part 2C, 18B (a) and (c). <p>This is a breach of part (a) of the act because the surface has not been finished in a proper workmanlike manner that would prevent loss of appearance to the surface.</p> <p>Loss Suffered Loss suffered is cost of rectification.</p>	<ol style="list-style-type: none"> 1. Protect all adjoining surfaces. 2. Use a suitable cleaning agent to remove residue and clear debris. 3. Clean up the work area.

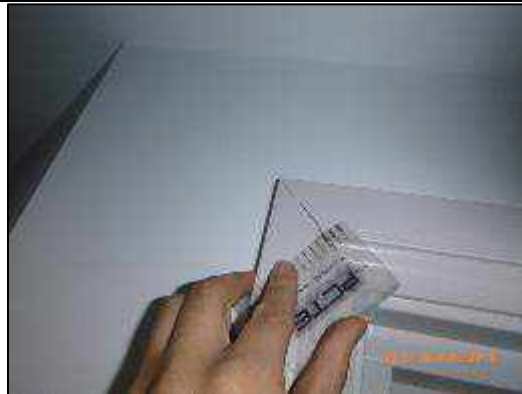
1993	Architrave of room 404	<p>See section 5.14.1</p> <p>Separation; 1.5mm</p>	See section 5.14.2

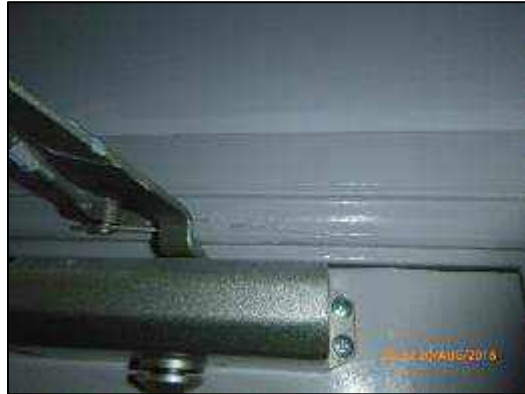
Item	Location	Defect description and Breach	Rectification	Photograph (if applicable)
1994	Exit to carpark door frame	<p>Damaged to door frame as a result of door stopper installation.</p> <p>Home Building Act (NSW) 1989</p> <ul style="list-style-type: none"> Part 2C, 18B (a) and (c). <p>This is a breach of part (a) of the act because the surface has not been finished in a proper workmanlike manner that would prevent loss of appearance to the surface.</p> <p>Loss Suffered Loss suffered is cost of rectification.</p>	<ol style="list-style-type: none"> 1. Protect all adjoining surfaces. 2. Fix/replace architrave damaged by door stop installation. 3. Clean up the work area.

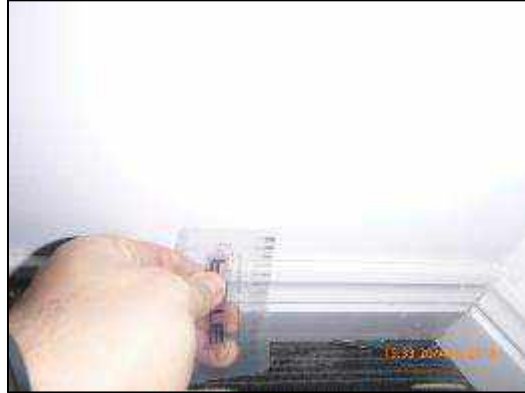
1995	Skirting board adjacent to fire hose reel on northern end	<p>See section 5.14.1</p> <p>Separation; 1.5mm</p>	See section 5.14.2

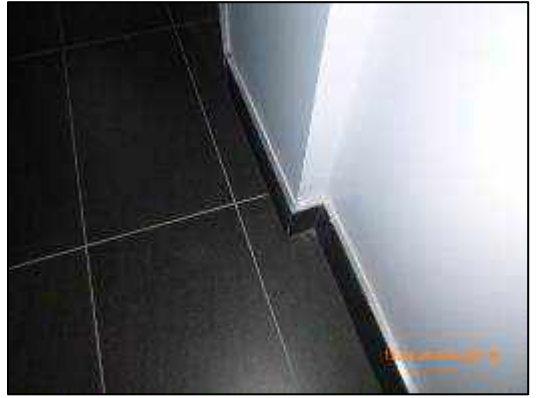
Item	Location	Defect description and Breach	Rectification	Photograph (if applicable)
1996	<i>Return wall to northern lifts</i>	See section 5.13.1	See section 5.13.2

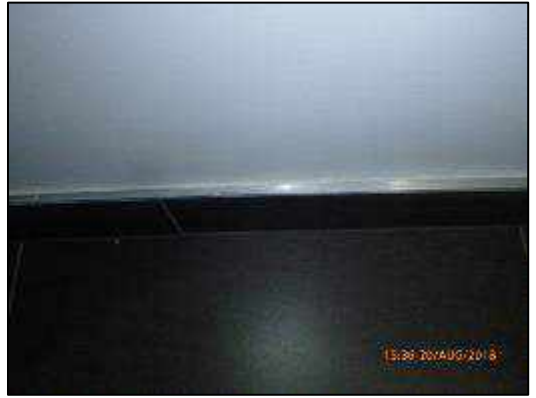
1997	<i>Tile angle of return wall to northern lifts</i>	See section 5.9.1	See section 5.9.2

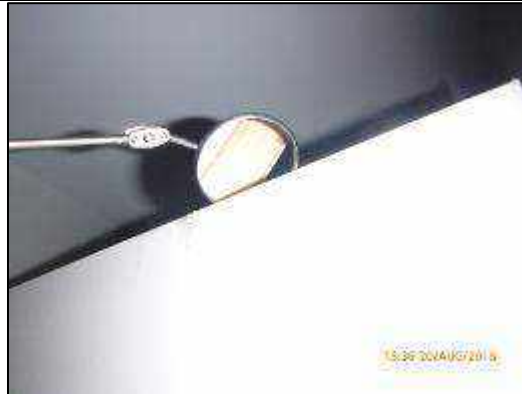
Item	Location	Defect description and Breach	Rectification	Photograph (if applicable)
1998	Door of sprinkler riser room adjacent to carpark entrance	See section 5.5.1	See section 5.5.2

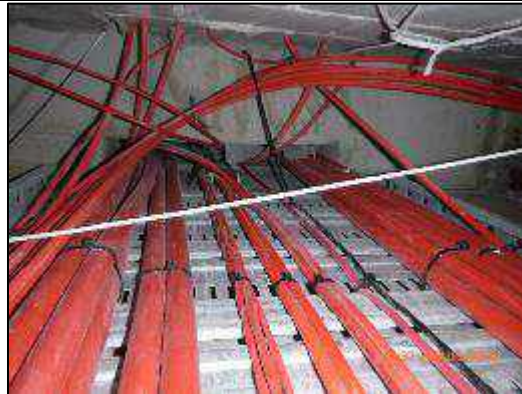
1999	Sprinkler riser room	<p>Conduit penetrations through slab have not been sealed.</p> <p>Home Building Act (NSW) 1989</p> <ul style="list-style-type: none"> Part 2C, 18B (a), (B) and (c). <p>Building Code of Australia (BCA), Volume 1</p> <ul style="list-style-type: none"> Section C Fire Resistance Part CO1 Performance Requirements CF2 & CP8. <p>This is a breach of the BCA as it requires suitable fire resistant elements to prevent spread of fire between separate levels</p> <p>Loss Suffered Loss suffered is cost of rectification.</p>	Provide suitable complying fire collars where fitment is achievable or install suitable fire resistant plasterboard enclosure around the pipe penetrations to achieve required fire separation levels and compliance with BCA requirements.

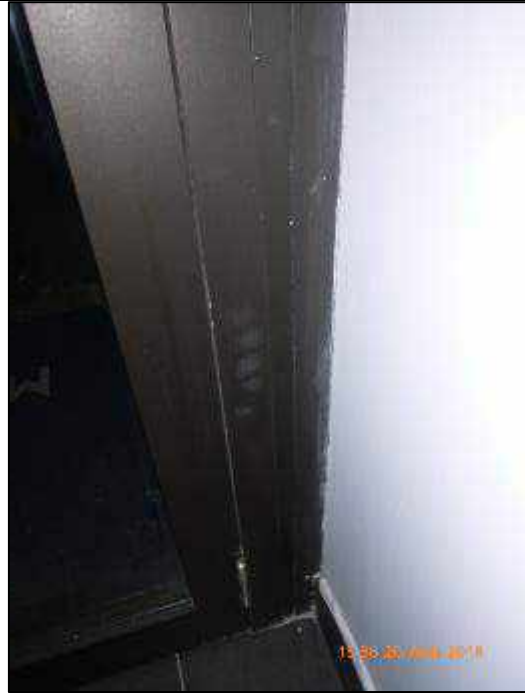
Item	Location	Defect description and Breach	Rectification	Photograph (if applicable)
2000	Door frame of entrance to carpark	See section 5.9.1	See section 5.9.2

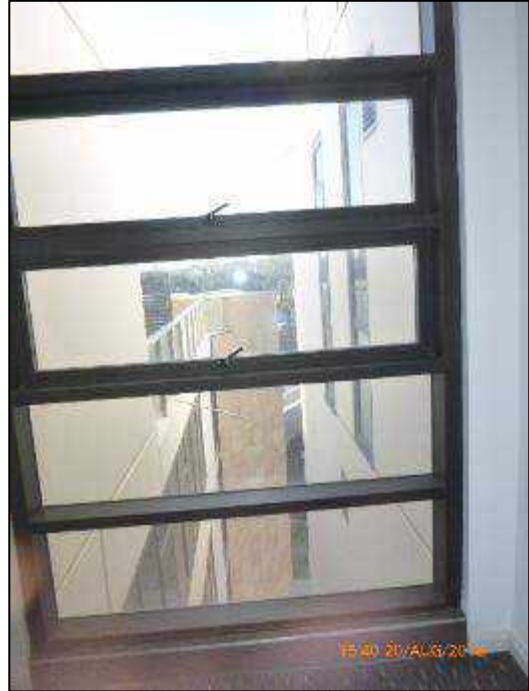
Item	Location	Defect description and Breach	Rectification	Photograph (if applicable)
Common areas – Level 4				
2001	Window frames on northern wall adjacent to room 401	See section 5.8.1	See section 5.8.2

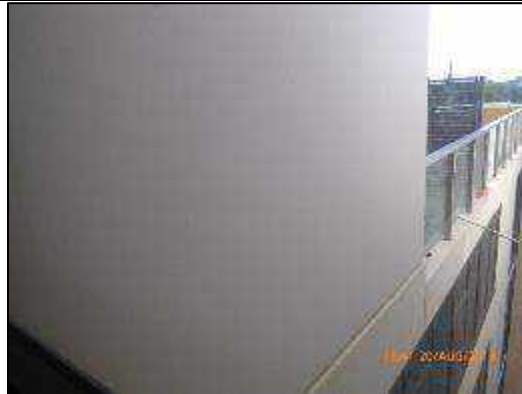
Item	Location	Defect description and Breach	Rectification	Photograph (if applicable)
2002	External façade of building	<p>Construction debris observed on external façade of building.</p> <p>Home Building Act (NSW) 1989</p> <ul style="list-style-type: none"> Part 2C, 18B (a) and (c). <p>This is a breach of part (a) of the act because the surface has not been finished in a proper workmanlike manner that would prevent loss of appearance to the surface.</p> <p>Loss Suffered Loss suffered is cost of rectification.</p>	<ol style="list-style-type: none"> 1. Protect all adjoining surfaces. 2. Use a suitable cleaning agent to remove residue and clear debris. 3. Clean up the work area.

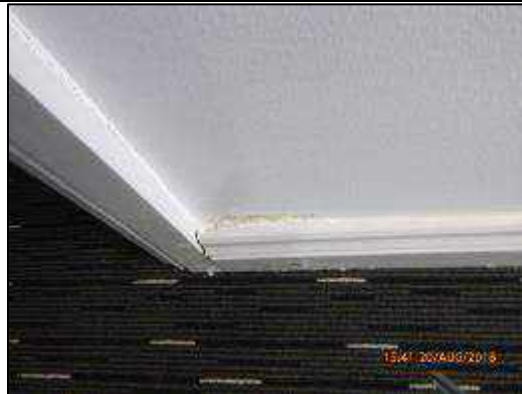
2003	Skirting board adjacent to unit 401	See section 5.10.1	See section 5.10.2

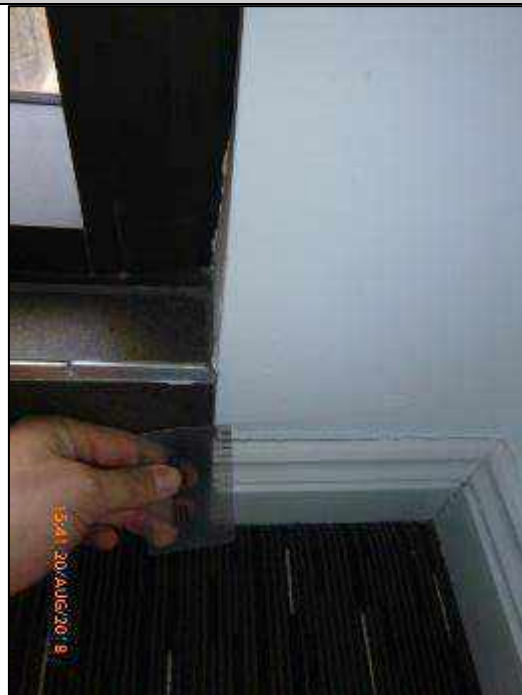
Item	Location	Defect description and Breach	Rectification	Photograph (if applicable)
2004	Skirting board on northern wall adjacent to windows	See section 5.14.1 Separation; 2mm	See section 5.14.2

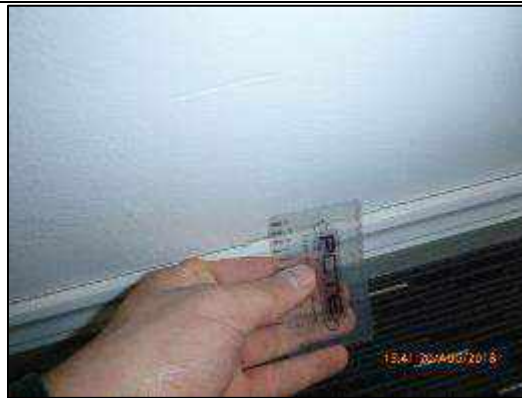
2005	Skirting board along northern and southern walls in hallway	See section 5.14.1 Separation; 2mm	See section 5.14.2

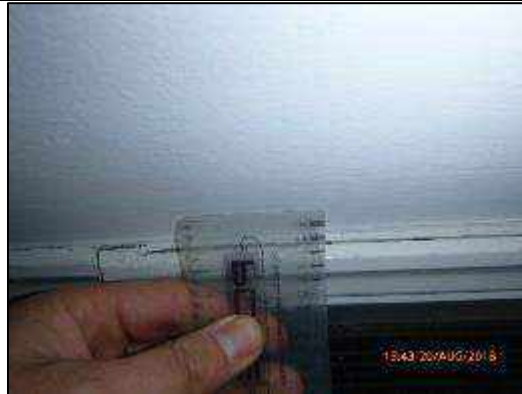
Item	Location	Defect description and Breach	Rectification	Photograph (if applicable)
2006	Eastern wall skirting board adjacent to room 407	See section 5.14.1 Separation; 1.5mm	See section 5.14.2

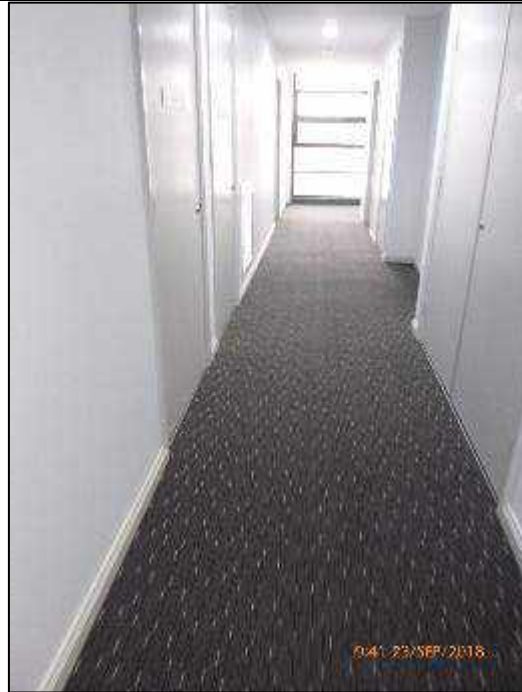
2007	Western hallway lobby	Concrete substrate appears to be not level. Displacement of substrate was measured to be greater than 4mm/2000mm. Home Building Act (NSW) 1989 <ul style="list-style-type: none">Part 2C, 18B (a) and (c). Guide to Standards and Tolerances 2017 <ul style="list-style-type: none">Section 2.8 Levelness of flooring This is a defect because the floor levels exceed the maximum deviation as intended by the manufacturer as outlined in Section 2.8 of the Guide to Standards and Tolerances 2017. Loss Suffered Loss suffered is cost of rectification.	Further investigation required to identify the source of displacement in flooring.
