SydneyStrataReport

STRATA REPORT

Client	Church Street Parramatta Property Pty Ltd
Address of property	Unit 3303/330 Church Street, Parramatta, NSW.
Lot	359
Strata Plan	SP 94469
Name of Strata Management Co.	NSW Strata
Telephone Number of Strata Agent	8980 1841
Report Date	15 February 2024

BUILDING DEFECTS REPORT Part 1/2

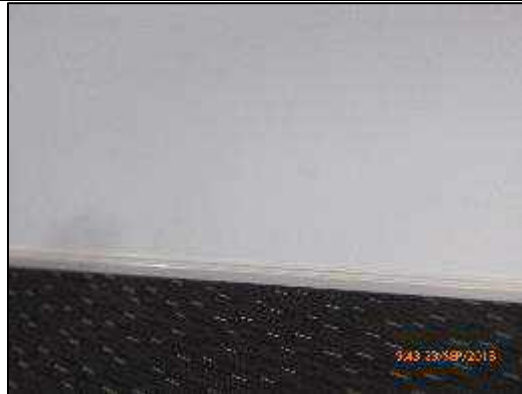
Item	Location	Defect description and Breach	Rectification	Photograph (if applicable)
2008	Western wall adjacent to entrance to pool and gym area	See section 5.13.1	See section 5.13.2

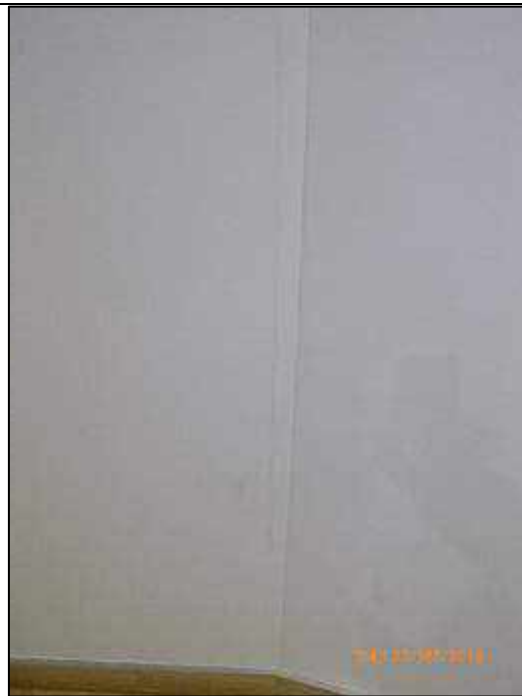
2009	Wall adjacent to female toilet sheet joint	See section 5.14.1 Separation; 1.5mm	See section 5.14.2

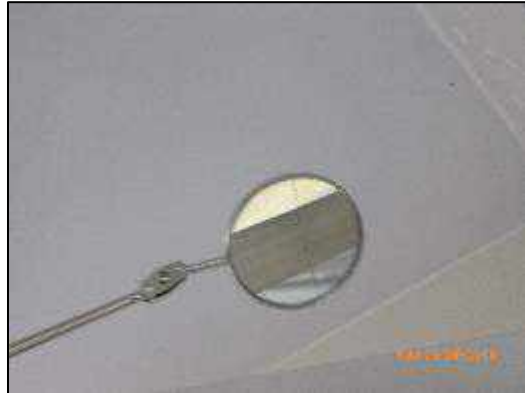
Item	Location	Defect description and Breach	Rectification	Photograph (if applicable)
2010	Door of male toilet outside gym	See section 5.5.1	See section 5.5.2

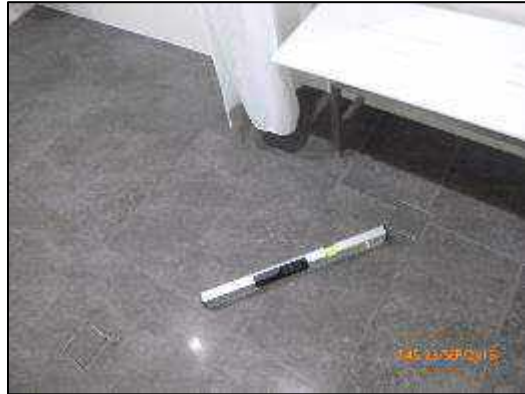
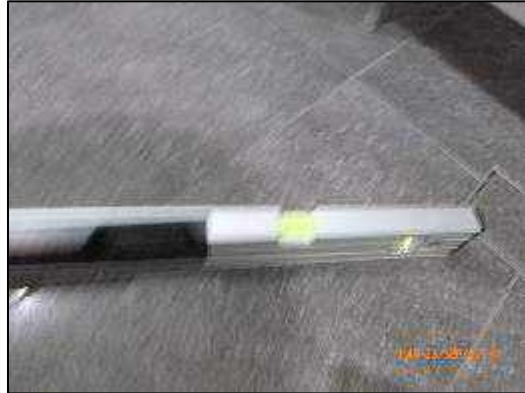
Item	Location	Defect description and Breach	Rectification	Photograph (if applicable)
2011	Male toilet shower recess	See section 5.1.1 Falls (mm); 5/1000	See section 5.1.2

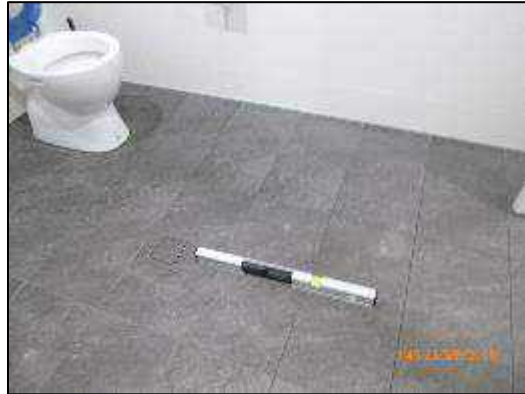
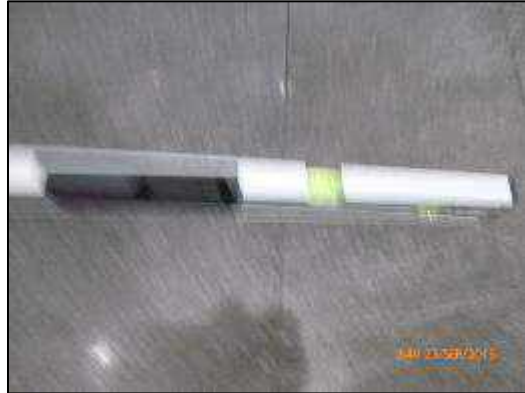
Item	Location	Defect description and Breach	Rectification	Photograph (if applicable)
2012	Male toilet outside shower recess	See section 5.1.1 Falls (mm); 5/1000	See section 5.1.2

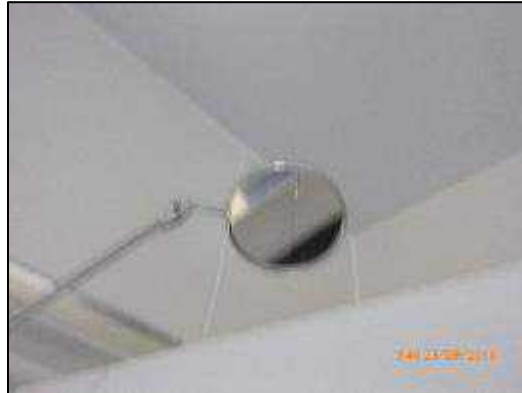
Item	Location	Defect description and Breach	Rectification	Photograph (if applicable)
2013	Door of female toilet outside gym	See section 5.5.1	See section 5.5.2

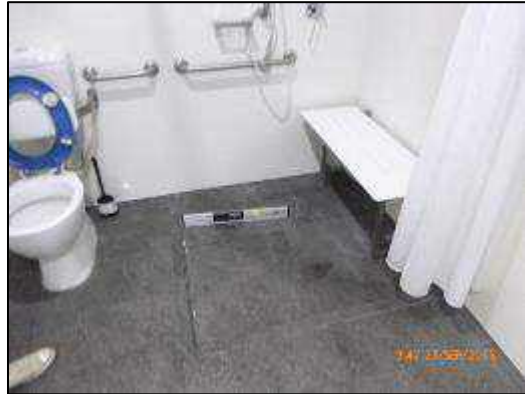
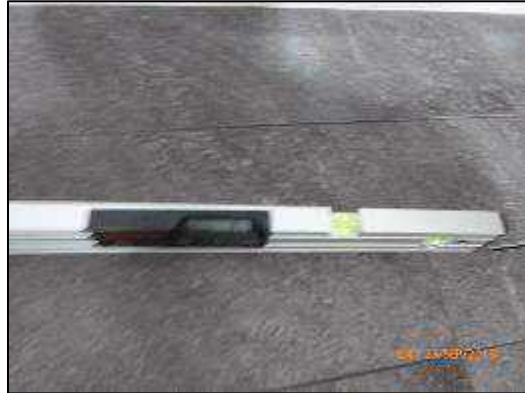
Item	Location	Defect description and Breach	Rectification	Photograph (if applicable)
2014	Female toilet shower recess	See section 5.1.1 Falls (mm); 8/1000	See section 5.1.2

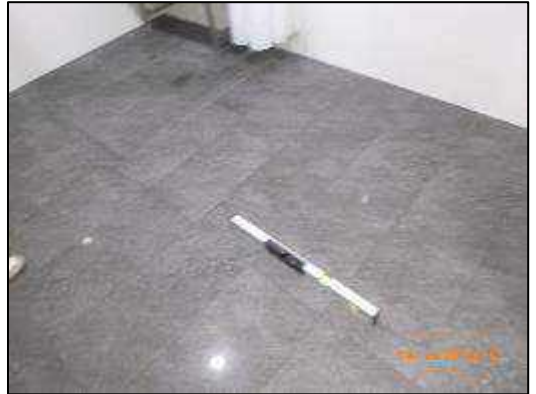
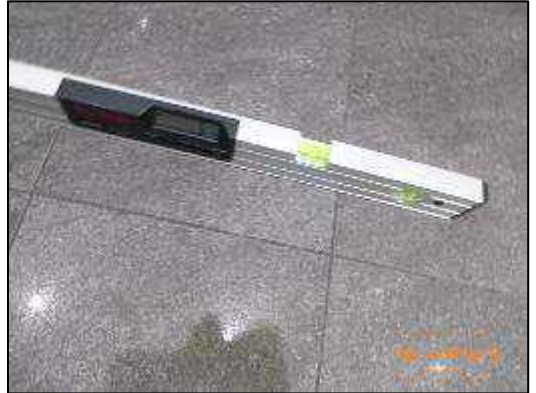
Item	Location	Defect description and Breach	Rectification	Photograph (if applicable)
2015	Female toilet outside shower recess	See section 5.1.1 Falls (mm); 5/1000	See section 5.1.2

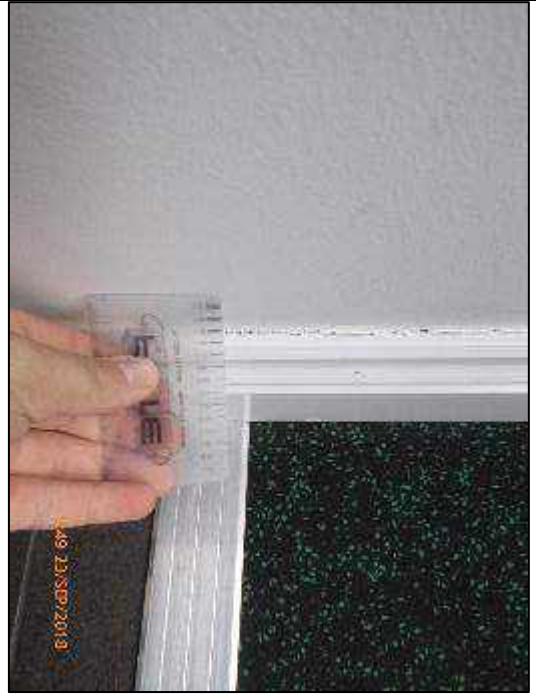
Item	Location	Defect description and Breach	Rectification	Photograph (if applicable)
2016	<i>Eastern wall skirting board in gym</i>	See section 5.14.1 Separation; 1.5mm	See section 5.14.2

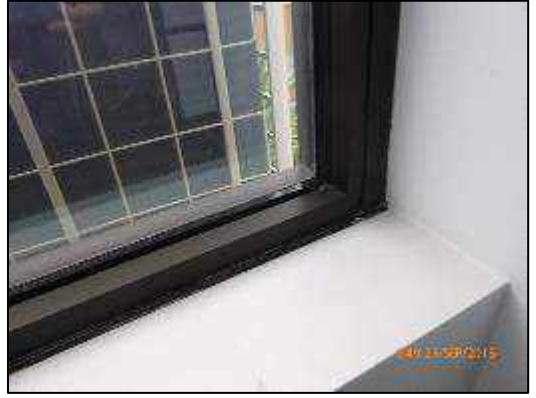
2017	<i>Northern wall window frames in gym</i>	See section 5.9.1	See section 5.9.2

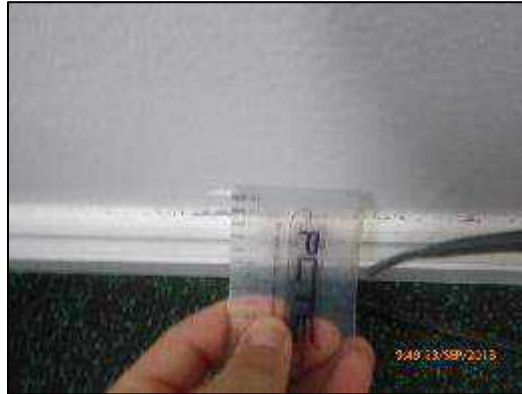
Item	Location	Defect description and Breach	Rectification	Photograph (if applicable)
2018	Northern wall skirting board in gym	See section 5.14.1 Separation; 1.5mm	See section 5.14.2

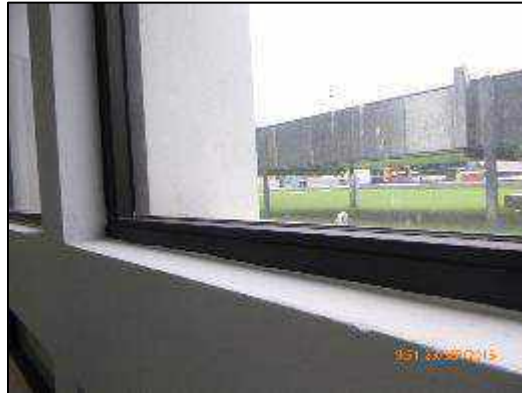
2019	Northern window frames in pool area	See section 5.9.1	See section 5.9.2

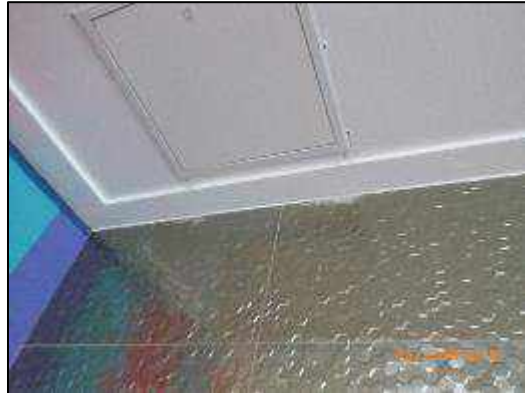
Item	Location	Defect description and Breach	Rectification	Photograph (if applicable)
2020	<i>Tiles on eastern wall</i>	See section 5.9.1	See section 5.9.2

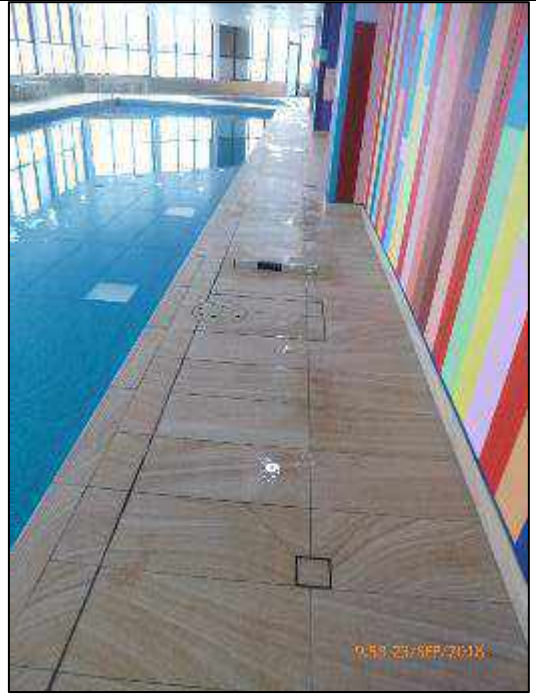
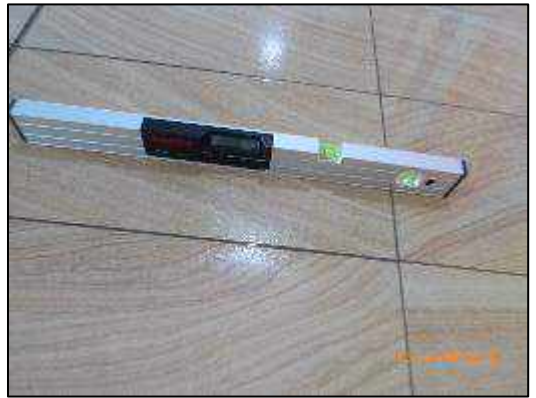
Item	Location	Defect description and Breach	Rectification	Photograph (if applicable)
2021	Perimeter of pool and spa area	See section 5.2.1 Falls (mm); 1/1000	See section 5.2.2

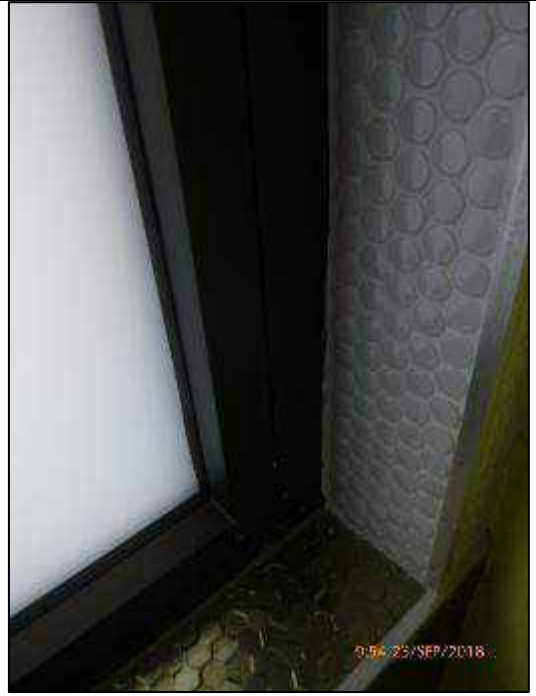
Item	Location	Defect description and Breach	Rectification	Photograph (if applicable)
2022	Windows frames throughout the pool area	See section 5.9.1	See section 5.9.2

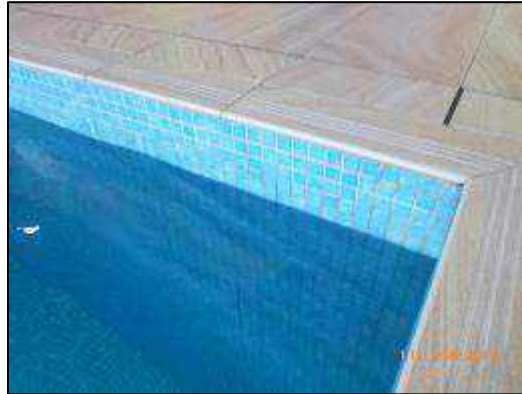
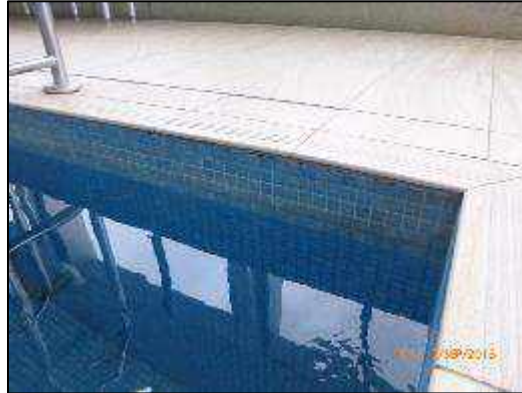
Item	Location	Defect description and Breach	Rectification	Photograph (if applicable)
2023	Pool Tiles	<p>Leeching observed in grout of tiles in pool area.</p> <p>Home Building Act (NSW) 1989</p> <ul style="list-style-type: none"> Part 2C, 18B (a) and (c). <p>Guide to Standards and Tolerances 2017</p> <ul style="list-style-type: none"> Section 12.6 Grouting and joints <p>This is a defect because the grout has not been applied as intended by the manufacturer as outlined in Section 12.6 of the Guide to Standards and Tolerances 2017.</p> <p>Loss Suffered</p> <p>Loss suffered is cost of rectification.</p>	Further investigation required to identify the source of leeching.

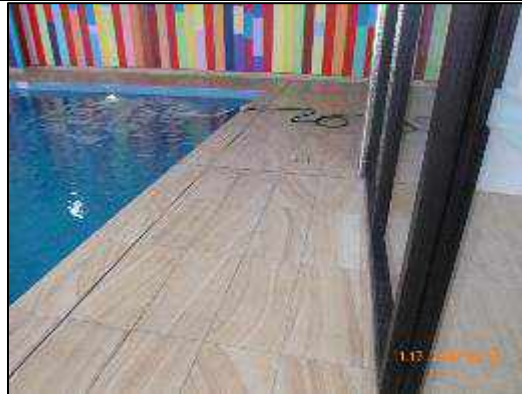
Item	Location	Defect description and Breach	Rectification	Photograph (if applicable)
2024		<p>Excessive staining observed on sandstone tiles surrounding pool area.</p> <p>Home Building Act (NSW) 1989</p> <ul style="list-style-type: none"> Part 2C, 18B (a) and (c). <p>Guide to Standards and Tolerances 2017</p> <ul style="list-style-type: none"> Section 12.2 Floor and wall tiling <p>This is a defect because the sandstone tiles have not been sealed as intended by the manufacturer as outlined in Section 12.2 of the Guide to Standards and Tolerances 2017.</p> <p>Loss Suffered Loss suffered is cost of rectification.</p>	Engage a qualified tradesman to clean and seal the sandstone tiles to prevent excessive staining.

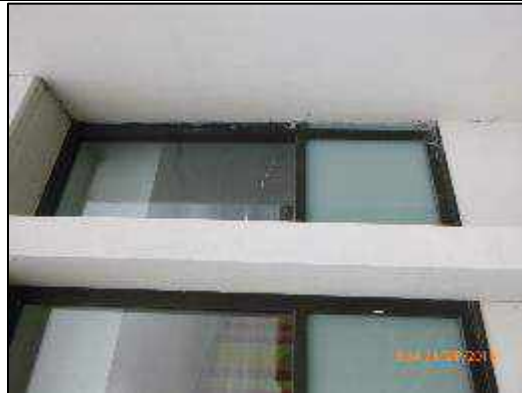
2025	Courtyard outside of pool area	<p>Construction debris observed on external façade of building.</p> <p>Home Building Act (NSW) 1989</p> <ul style="list-style-type: none"> Part 2C, 18B (a) and (c). <p>This is a breach of part (a) of the act because the surface has not been finished in a proper workmanlike manner that would prevent loss of appearance to the surface.</p> <p>Loss Suffered Loss suffered is cost of rectification.</p>	<ol style="list-style-type: none"> 1. Protect all adjoining surfaces. 2. Use a suitable cleaning agent to remove residue and clear debris. 3. Clean up the work area.

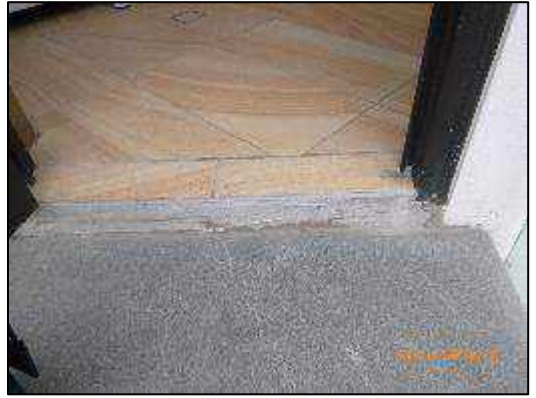
Item	Location	Defect description and Breach	Rectification	Photograph (if applicable)
2026	Step at entrance to courtyard area	See section 5.10.1	See section 5.10.2

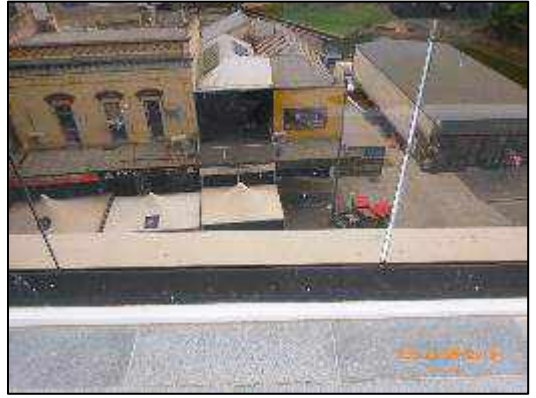
2027	Courtyard balustrade	See section 5.4.1	See section 5.4.2

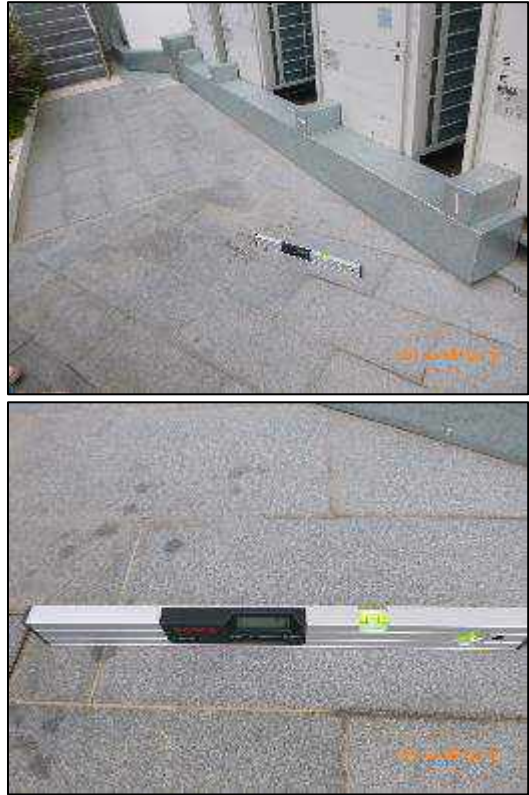
Item	Location	Defect description and Breach	Rectification	Photograph (if applicable)
2028	Courtyard pool area outside	See section 5.2.1 Falls (mm); 7/1000	See section 5.2.2

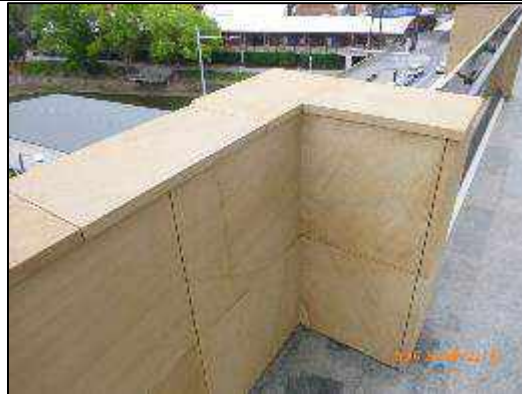
Item	Location	Defect description and Breach	Rectification	Photograph (if applicable)
2029	Courtyard area	<p>Sandstone tiles around perimeter of the building have not been sealed.</p> <p>Home Building Act (NSW) 1989</p> <ul style="list-style-type: none"> Part 2C, 18B (a) and (c). <p>Building Code of Australia</p> <ul style="list-style-type: none"> Section F Damp and Weatherproofing Part F1 Damp and Weatherproofing Sections FO1 and FF1.2. <p>This is a breach because the building is not constructed in a manner so as to provide adequate weatherproofing of the buildings envelope.</p> <p>Loss Suffered</p> <p>Loss suffered is cost of rectification and potential loss of amenity.</p>	Fit a suitable foam backing rod and apply suitable mastic sealant to weatherproof the joint.

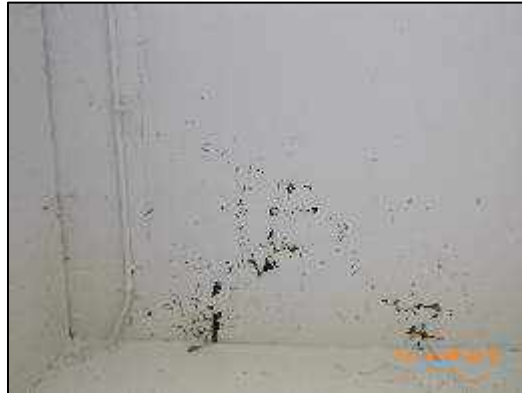
2030	Ceiling above fire exit door.	<p>Honeycombing on soffit of fire exit on eastern side of building.</p> <p>Home Building Act (NSW) 1989</p> <ul style="list-style-type: none"> Part 2C, 18B (a) & (c). <p>AS 3600 – 2009 – Concrete Structures</p> <p>4.10 REQUIREMENTS FOR COVER TO REINFORCING STEEL AND TENDONS</p> <p>4.10.1 General</p> <p>The cover to reinforcing steel and tendons shall be the greatest of the values</p>	<ol style="list-style-type: none"> 1. Protect all surrounding surfaces 2. Break away all drummy concrete 3. Install high-build mortar in accordance with manufacturers recommendation to match existing profile

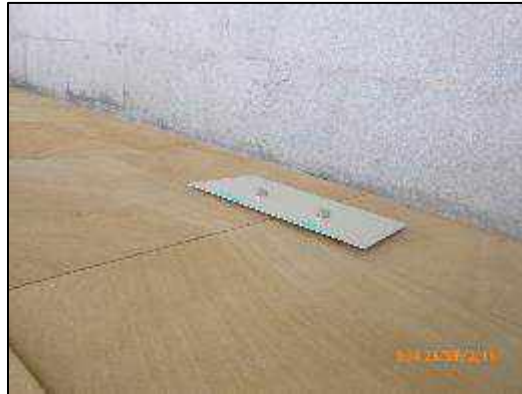
Item	Location	Defect description and Breach	Rectification	Photograph (if applicable)
		<p>determined from Clauses 4.8, 4.10.2 and 4.10.3, as appropriate, unless exceeded by the requirements for fire resistance given in Section 5.</p> <p>Loss Suffered Loss suffered is cost of rectification.</p>		
2031	Courtyard sandstone balustrade	<p>Bolts throughout perimeter creating a step hazard reducing the height of balustrade.</p> <p>Home Building Act (NSW) 1989</p> <ul style="list-style-type: none"> Part 2C, 18B (a) and (c). <p>Building Code of Australia</p> <ul style="list-style-type: none"> Section D Access and Egress D2.16 – Barriers to prevent falls Table 2.16a <p>This is a breach because the building is not constructed in a manner so as to provide safe barriers to prevent falls.</p> <p>Loss Suffered Loss suffered is cost of rectification.</p>	Non-compliant bolts be removed and replaced or modified with a compliant system.

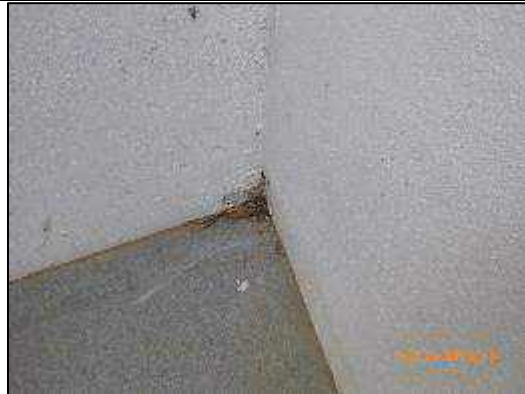
Item	Location	Defect description and Breach	Rectification	Photograph (if applicable)
2032	Rendered balustrade adjacent to air conditioner unit	<p>Missing area of render adjacent to air conditioner unit.</p> <p>Home Building Act (NSW) 1989</p> <ul style="list-style-type: none"> Part 2C, 18B (a) and (c). <p>Guide to Standards and Tolerances 2017</p> <ul style="list-style-type: none"> Crack categories are assessed in accordance with Section 3.02. Cracks are classed as exceeding Category 1. <p>AS2870-2011 Residential footings and slabs</p> <ul style="list-style-type: none"> Crack categories are assessed in accordance with Table C1 CLASSIFICATION OF DAMAGE WITH REFERENCE TO WALLS Cracks exceed Category 1 but do not exceed damage Category 2. <p>Loss Suffered Loss suffered is cost of rectification.</p>	<ol style="list-style-type: none"> 1. Protect all surrounding surfaces 2. Remove cracked rendered surfaces to closest architectural line 3. Install new render to blend into the existing surface 4. Repaint to match existing using suitable external paint system in accordance with AS2311.

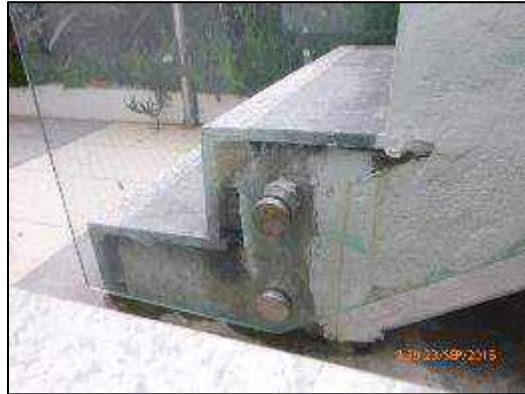
Item	Location	Defect description and Breach	Rectification	Photograph (if applicable)
2033	Courtyard stairs to pool area.	<p>Missing area of render to base of stairs.</p> <p>Home Building Act (NSW) 1989</p> <ul style="list-style-type: none"> Part 2C, 18B (a) and (c). <p>Guide to Standards and Tolerances 2017</p> <ul style="list-style-type: none"> Crack categories are assessed in accordance with Section 3.02. Cracks are classed as exceeding Category 1. <p>AS2870-2011 Residential footings and slabs</p> <ul style="list-style-type: none"> Crack categories are assessed in accordance with Table C1 CLASSIFICATION OF DAMAGE WITH REFERENCE TO WALLS Cracks exceed Category 1 but do not exceed damage Category 2. <p>Loss Suffered Loss suffered is cost of rectification.</p>	<ol style="list-style-type: none"> 1. Protect all surrounding surfaces 2. Remove cracked rendered surfaces to closest architectural line 3. Install new render to blend into the existing surface 4. Repaint to match existing using suitable external paint system in accordance with AS2311.

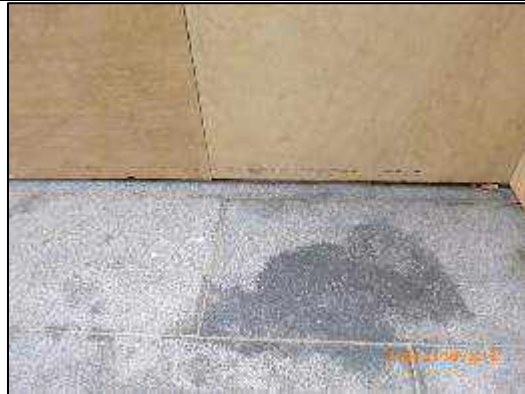
Item	Location	Defect description and Breach	Rectification	Photograph (if applicable)
2034	Courtyard balustrade	<p>Markings on sandstone balustrade on perimeter of courtyard.</p> <p>Home Building Act (NSW) 1989</p> <ul style="list-style-type: none"> Part 2C, 18B (a) and (c). <p>This is a breach of part (a) of the act because the surface has not been finished in a proper workmanlike manner that would prevent loss of appearance to the surface.</p> <p>Loss Suffered Loss suffered is cost of rectification.</p>	<ol style="list-style-type: none"> 1. Protect all adjoining surfaces. 2. Use a suitable cleaning agent to remove residue and clear debris. 3. Clean up the work area.

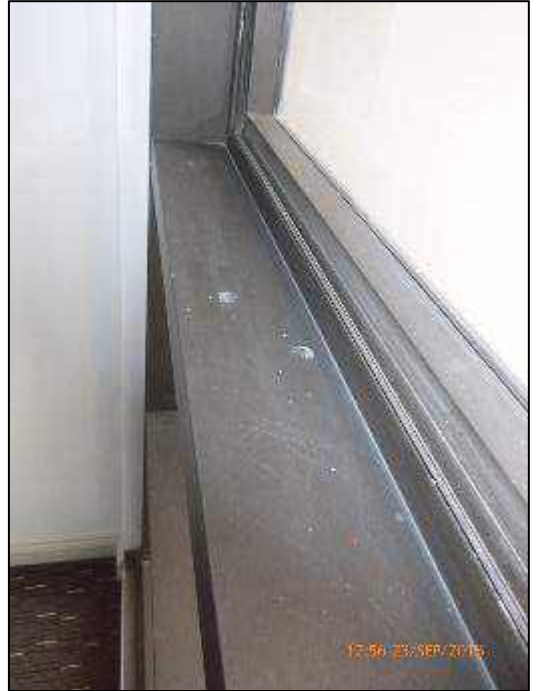
Item	Location	Defect description and Breach	Rectification	Photograph (if applicable)
Common areas – Level 5				
2035	Western elevation window frames	See section 5.7.1	See section 5.7.2

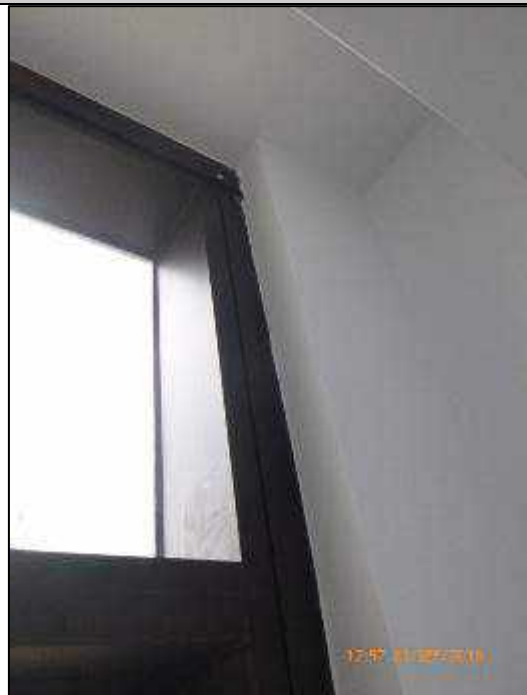
Item	Location	Defect description and Breach	Rectification	Photograph (if applicable)
2036	Western elevation window frames	See section 5.9.1	See section 5.9.2

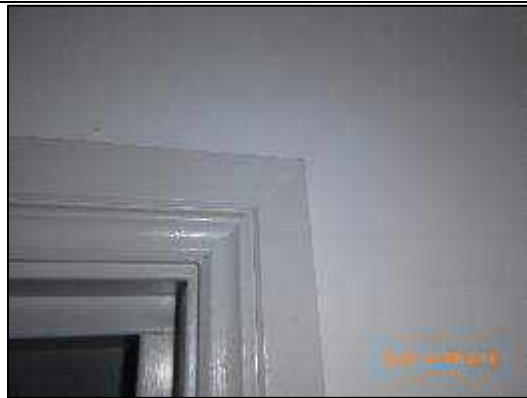
2037	Frames around all entry door to units	See section 5.9.1	See section 5.9.2

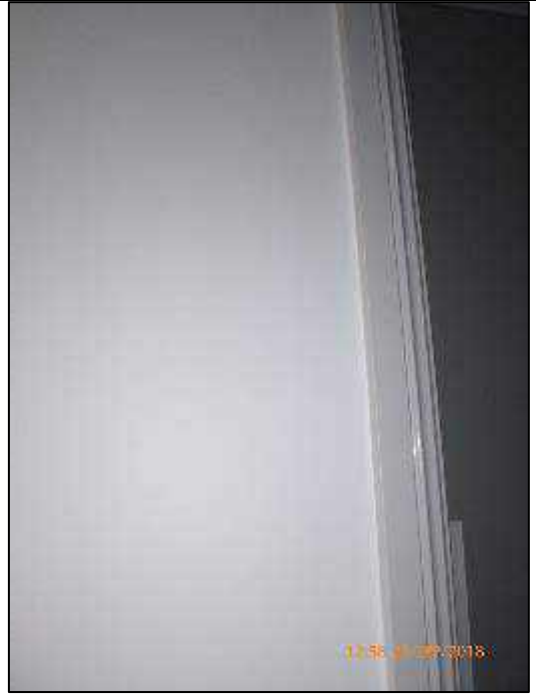
Item	Location	Defect description and Breach	Rectification	Photograph (if applicable)
2038	Throughout level 5 common areas	See section 5.10.1	See section 5.10.2

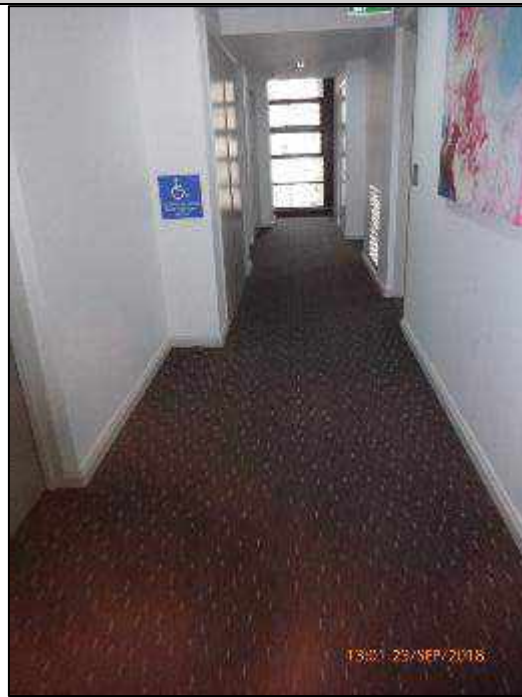
Item	Location	Defect description and Breach	Rectification	Photograph (if applicable)
2039	Level 5 hallway	<p>Concrete substrate appears to be not level. Displacement of substrate was measured to be greater than 4mm/2000mm.</p> <p>Home Building Act (NSW) 1989</p> <ul style="list-style-type: none"> Part 2C, 18B (a) and (c). <p>Guide to Standards and Tolerances 2017</p> <ul style="list-style-type: none"> Section 2.8 Levelness of flooring <p>This is a defect because the floor levels exceed the maximum deviation as intended by the manufacturer as outlined in Section 2.8 of the Guide to Standards and Tolerances 2017.</p> <p>Loss Suffered</p> <p>Loss suffered is cost of rectification.</p>	Further investigation required to identify the source of displacement in flooring.

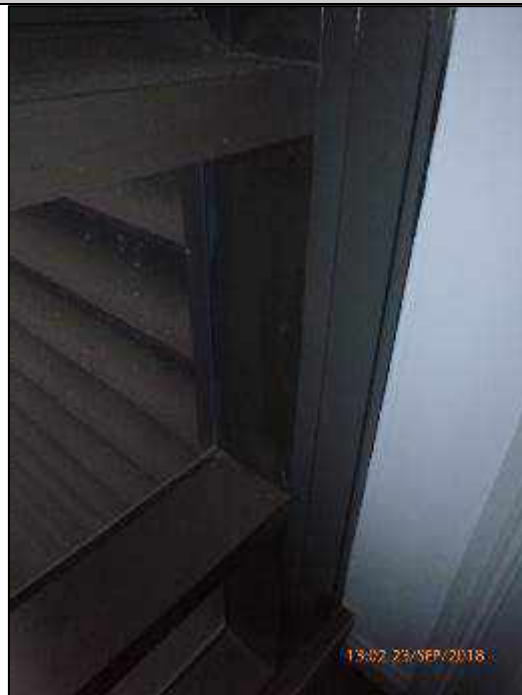
Item	Location	Defect description and Breach	Rectification	Photograph (if applicable)
2040	Northern elevation windows	See section 5.9.1	See section 5.9.2

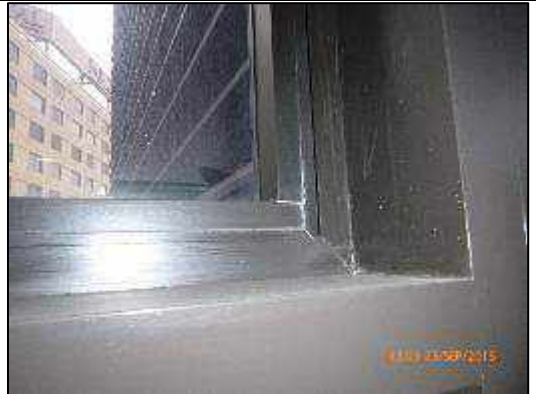
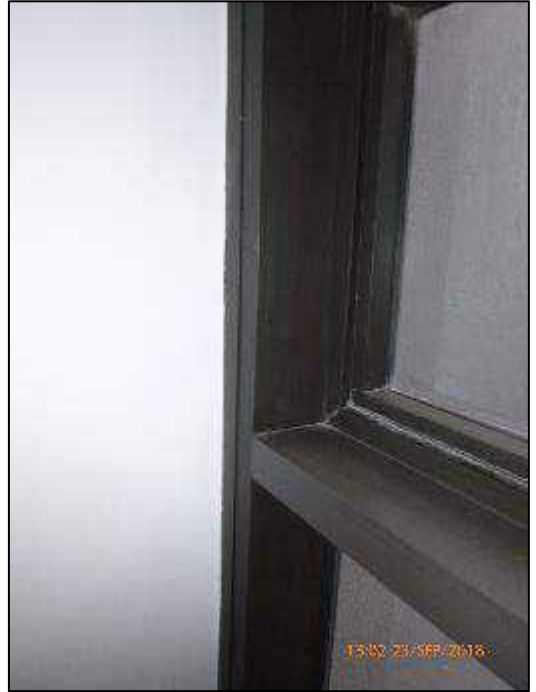
Item	Location	Defect description and Breach	Rectification	Photograph (if applicable)
2041	Northern elevation windows	See section 5.8.1	See section 5.8.2

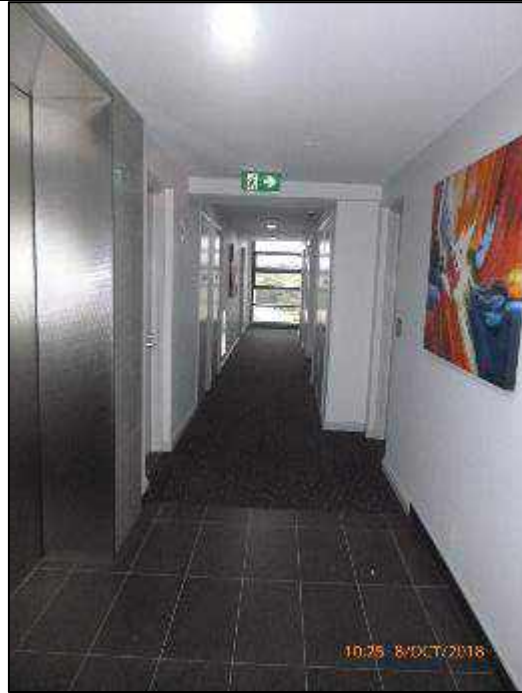
Item	Location	Defect description and Breach	Rectification	Photograph (if applicable)
Common areas – Level 6				
2042	Level 6 Western lobby	<p>Concrete substrate appears to be not level. Displacement of substrate was measured to be greater than 4mm/2000mm.</p> <p>Home Building Act (NSW) 1989</p> <ul style="list-style-type: none"> Part 2C, 18B (a) and (c). <p>Guide to Standards and Tolerances 2017</p> <ul style="list-style-type: none"> Section 2.8 Levelness of flooring <p>This is a defect because the floor levels exceed the maximum deviation as intended by the manufacturer as outlined in Section 2.8 of the Guide to Standards and Tolerances 2017.</p> <p>Loss Suffered</p> <p>Loss suffered is cost of rectification.</p>	Further investigation required to identify the source of displacement in flooring.

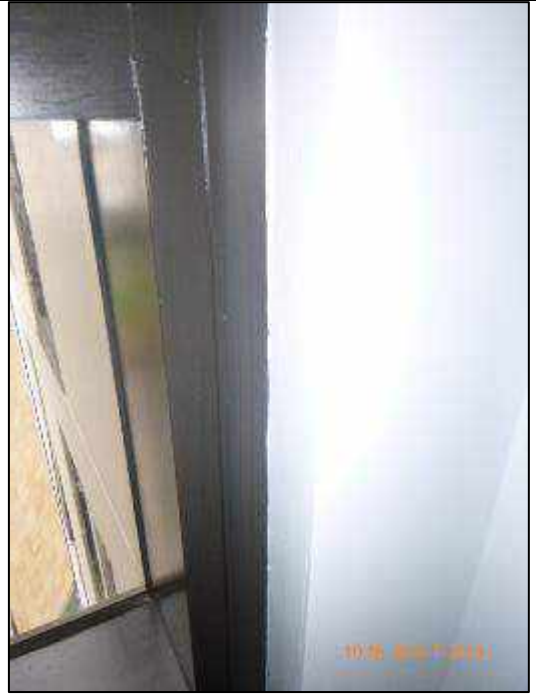
Item	Location	Defect description and Breach	Rectification	Photograph (if applicable)
2043	Western window frames	See section 5.9.1	See section 5.9.2

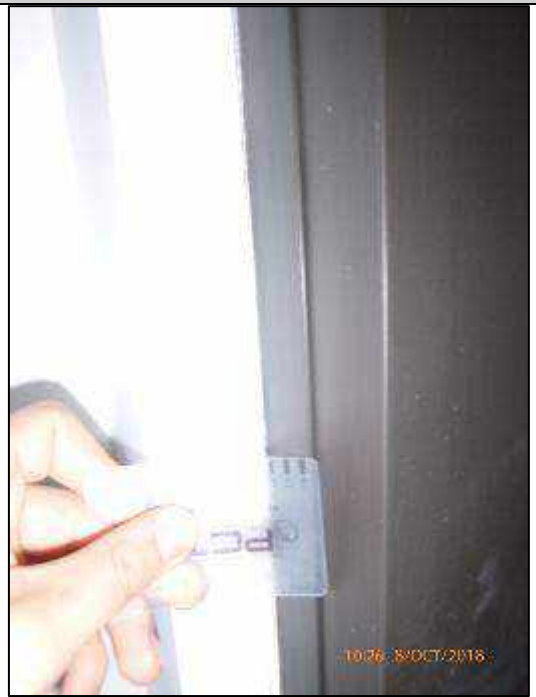
Item	Location	Defect description and Breach	Rectification	Photograph (if applicable)
2044	Southern end of western window frames	See section 5.14.1 Separation; 1.5mm	See section 5.14.2

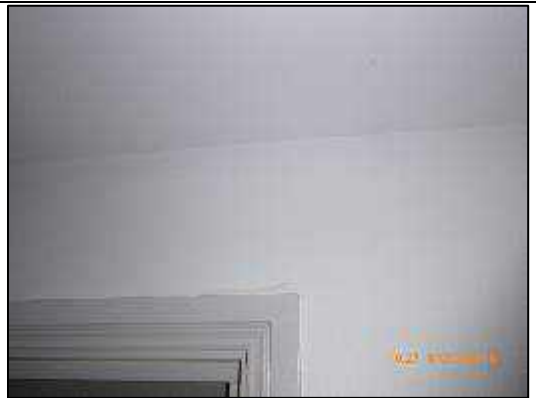
2045	Wall adjacent to door of Unit 602	See section 5.9.1	See section 5.9.2

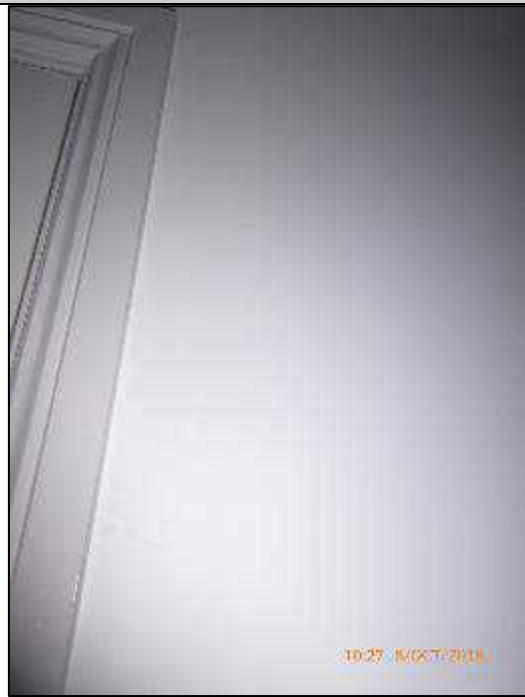
Item	Location	Defect description and Breach	Rectification	Photograph (if applicable)
2046	Wall adjacent to telecommunications room	See section 5.13.1	See section 5.13.2

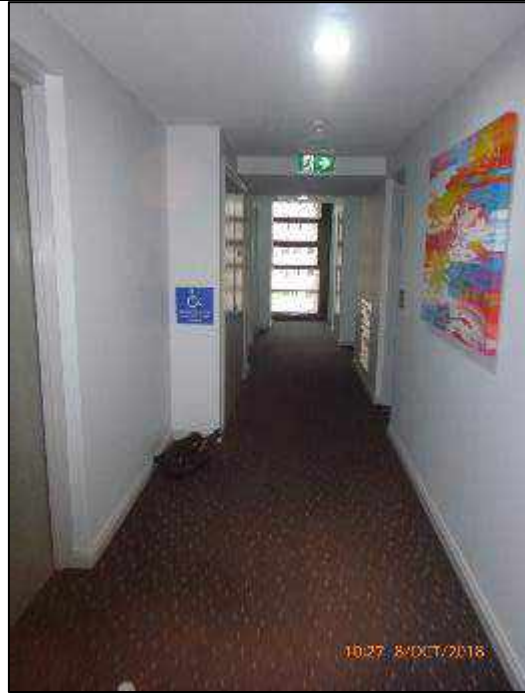
Item	Location	Defect description and Breach	Rectification	Photograph (if applicable)
2047	Level 6 Eastern lobby	<p>Concrete substrate appears to be not level. Displacement of substrate was measured to be greater than 4mm/2000mm.</p> <p>Home Building Act (NSW) 1989</p> <ul style="list-style-type: none"> Part 2C, 18B (a) and (c). <p>Guide to Standards and Tolerances 2017</p> <ul style="list-style-type: none"> Section 2.8 Levelness of flooring <p>This is a defect because the floor levels exceed the maximum deviation as intended by the manufacturer as outlined in Section 2.8 of the Guide to Standards and Tolerances 2017.</p> <p>Loss Suffered</p> <p>Loss suffered is cost of rectification.</p>	Further investigation required to identify the source of displacement in flooring.

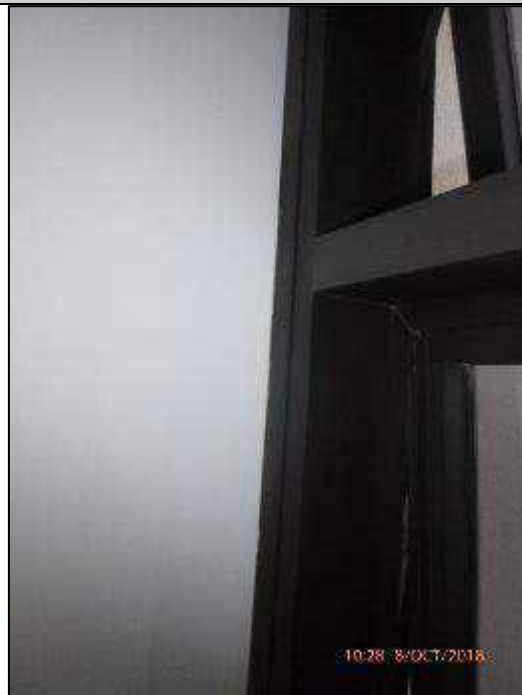
Item	Location	Defect description and Breach	Rectification	Photograph (if applicable)
2048	Eastern window frames	See section 5.9.1	See section 5.9.2

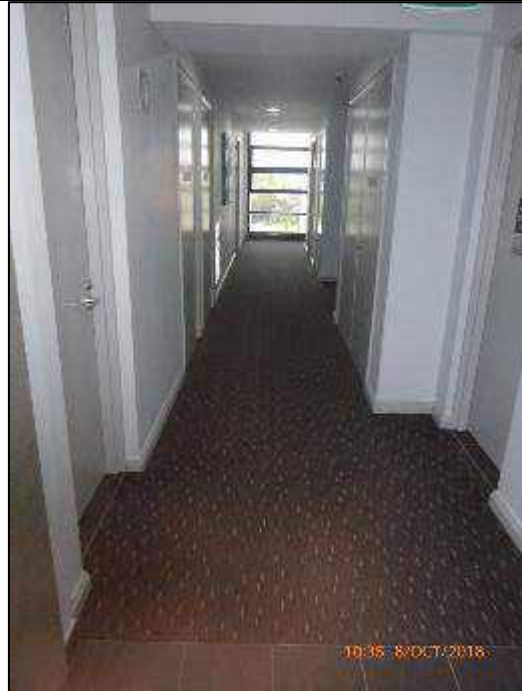
Item	Location	Defect description and Breach	Rectification	Photograph (if applicable)
Common areas – Level 7				
2050	Level 7 Western lobby	<p>Concrete substrate appears to be not level. Displacement of substrate was measured to be greater than 4mm/2000mm.</p> <p>Home Building Act (NSW) 1989</p> <ul style="list-style-type: none"> Part 2C, 18B (a) and (c). <p>Guide to Standards and Tolerances 2017</p> <ul style="list-style-type: none"> Section 2.8 Levelness of flooring <p>This is a defect because the floor levels exceed the maximum deviation as intended by the manufacturer as outlined in Section 2.8 of the Guide to Standards and Tolerances 2017.</p> <p>Loss Suffered</p> <p>Loss suffered is cost of rectification.</p>	Further investigation required to identify the source of displacement in flooring.

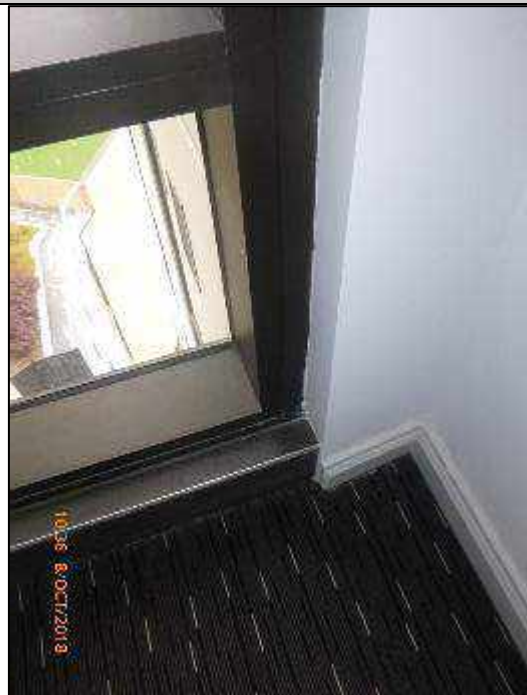
Item	Location	Defect description and Breach	Rectification	Photograph (if applicable)
2051	Western window frames	See section 5.9.1	See section 5.9.2

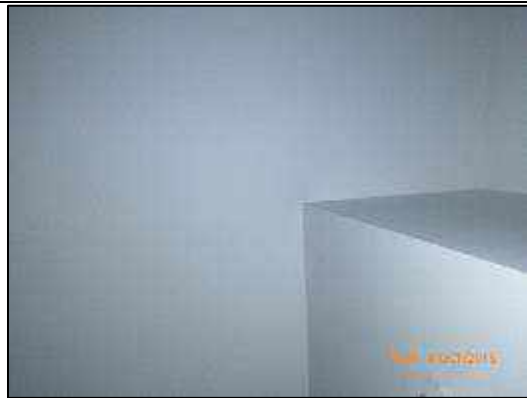
2052	Ceiling adjacent to water meter	See section 5.13.1	See section 5.13.2

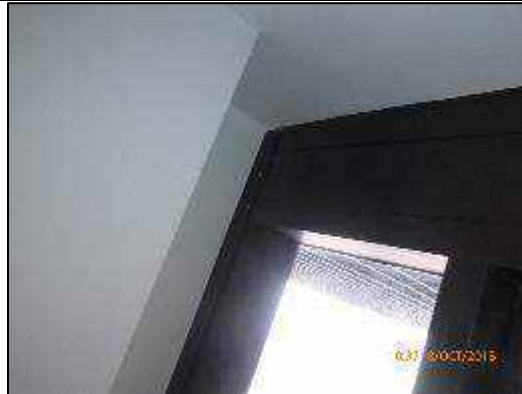
Item	Location	Defect description and Breach	Rectification	Photograph (if applicable)
2053	Eastern window frames	See section 5.9.1	See section 5.9.2

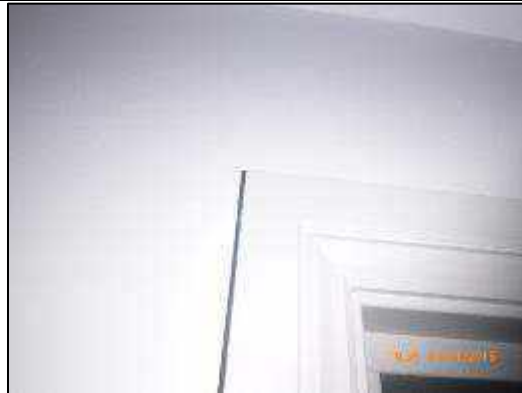
2054	Architraves throughout level 7	<p>Nail fixing in architrave has not been filled prior to painting.</p> <p>Home Building Act (NSW) 1989</p> <ul style="list-style-type: none"> Part 2C, 18B (a) and (c). <p>This is a breach of part (a) of the act because the surface has not been finished in a proper workmanlike manner that would prevent loss of appearance to the surface.</p> <p>Guide to Standards and Tolerances 2017</p> <ul style="list-style-type: none"> Section 13.3 Nail and screw fixings <p>This is a defect because the nail penetration has not been filled as intended by the manufacturer as outlined in Section 13.3 of the Guide to Standards and Tolerances 2017.</p> <p>Loss Suffered</p>	<ol style="list-style-type: none"> 1. Protect all adjoining surfaces. 2. Appropriately fix/replace architrave to around door. 3. Repaint to match existing using suitable internal paint system in accordance with AS2311. 4. Clean up the work area.

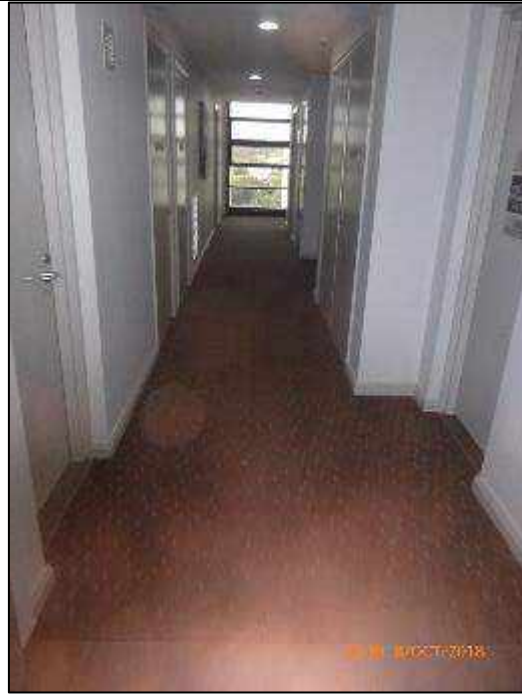
Item	Location	Defect description and Breach	Rectification	Photograph (if applicable)
		Loss suffered is cost of rectification.		
Common areas – Level 8				
2055	Level 8 Western lobby	<p>Concrete substrate appears to be not level. Displacement of substrate was measured to be greater than 4mm/2000mm.</p> <p>Home Building Act (NSW) 1989</p> <ul style="list-style-type: none"> Part 2C, 18B (a) and (c). <p>Guide to Standards and Tolerances 2017</p> <ul style="list-style-type: none"> Section 2.8 Levelness of flooring <p>This is a defect because the floor levels exceed the maximum deviation as intended by the manufacturer as outlined in Section 2.8 of the Guide to Standards and Tolerances 2017.</p> <p>Loss Suffered</p> <p>Loss suffered is cost of rectification.</p>	Further investigation required to identify the source of displacement in flooring.

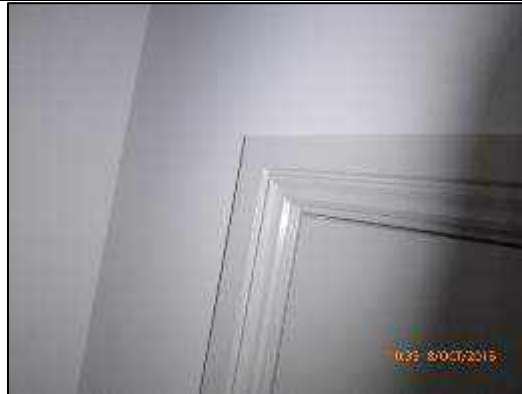
Item	Location	Defect description and Breach	Rectification	Photograph (if applicable)
2056	Architraves throughout level 8	<p>Nail fixing in architrave has not been filled prior to painting.</p> <p>Home Building Act (NSW) 1989</p> <ul style="list-style-type: none"> Part 2C, 18B (a) and (c). <p>This is a breach of part (a) of the act because the surface has not been finished in a proper workmanlike manner that would prevent loss of appearance to the surface.</p> <p>Guide to Standards and Tolerances 2017</p> <ul style="list-style-type: none"> Section 13.3 Nail and screw fixings <p>This is a defect because the nail penetration has not been filled as intended by the manufacturer as outlined in Section 13.3 of the Guide to Standards and Tolerances 2017.</p> <p>Loss Suffered</p> <p>Loss suffered is cost of rectification.</p>	<ol style="list-style-type: none"> 1. Protect all adjoining surfaces. 2. Appropriately fix/replace architrave to around door. 3. Repaint to match existing using suitable internal paint system in accordance with AS2311. 4. Clean up the work area.

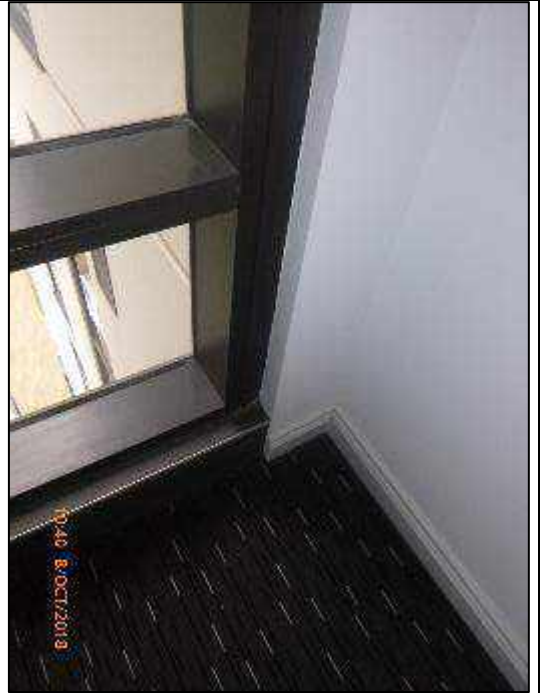
Item	Location	Defect description and Breach	Rectification	Photograph (if applicable)
2057	Western window frames	See section 5.9.1	See section 5.9.2

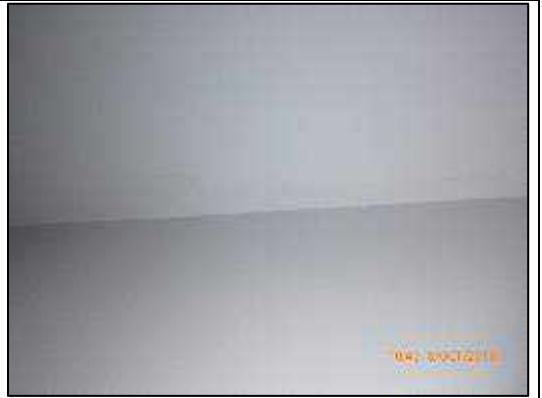
2058	Ceiling between room 801 and telecommunications room	See section 5.10.1	See section 5.10.2

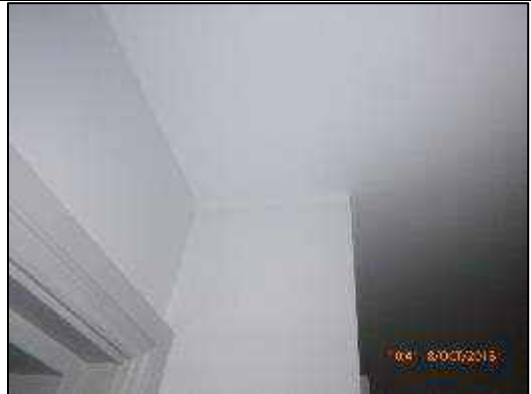
Item	Location	Defect description and Breach	Rectification	Photograph (if applicable)
2059	Wall adjacent to room 805	See section 5.14.1	See section 5.14.2

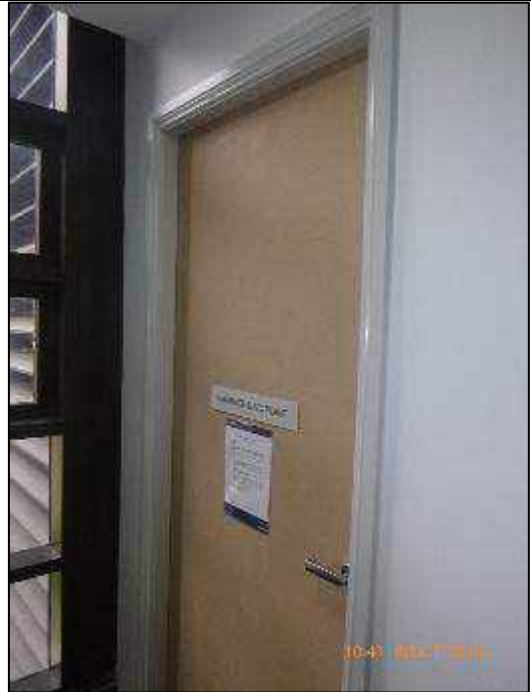
A photograph showing a corner of a room with white walls and a white ceiling. There is a visible defect or gap in the wall near the ceiling. A timestamp '04 OCT 2015' is visible in the bottom right corner of the photo.
2060	Garbage and AC plant room door	See section 5.10.1	See section 5.10.2

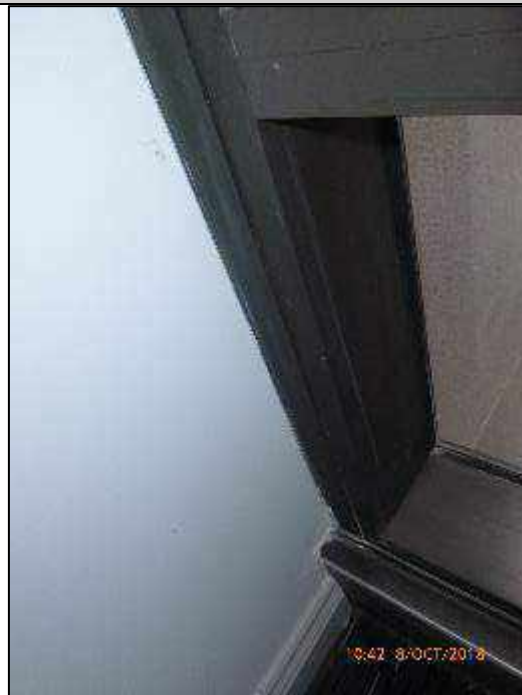
Item	Location	Defect description and Breach	Rectification	Photograph (if applicable)
2061	Eastern window frames	See section 5.9.1	See section 5.9.2

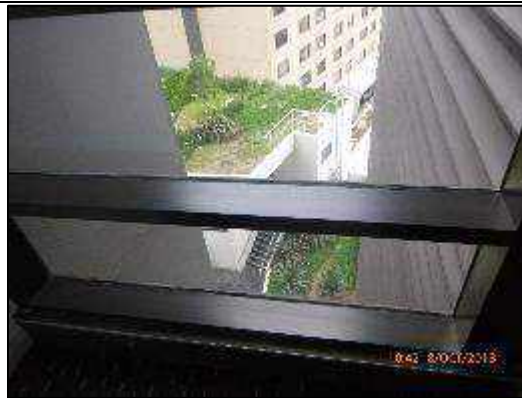
2062	Eastern window frames	See section 5.7.1	See section 5.7.2

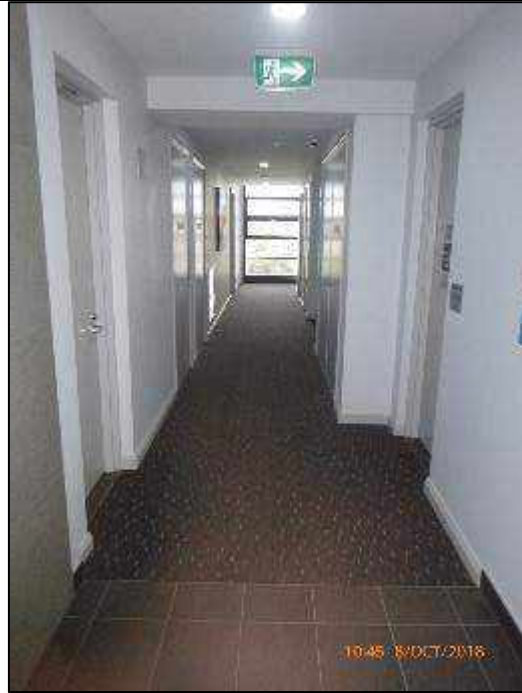
Item	Location	Defect description and Breach	Rectification	Photograph (if applicable)
Common areas – Level 9				
2065	Level 9 Western lobby	<p>Concrete substrate appears to be not level. Displacement of substrate was measured to be greater than 4mm/2000mm.</p> <p>Home Building Act (NSW) 1989</p> <ul style="list-style-type: none"> Part 2C, 18B (a) and (c). <p>Guide to Standards and Tolerances 2017</p> <ul style="list-style-type: none"> Section 2.8 Levelness of flooring <p>This is a defect because the floor levels exceed the maximum deviation as intended by the manufacturer as outlined in Section 2.8 of the Guide to Standards and Tolerances 2017.</p> <p>Loss Suffered</p> <p>Loss suffered is cost of rectification.</p>	Further investigation required to identify the source of displacement in flooring.

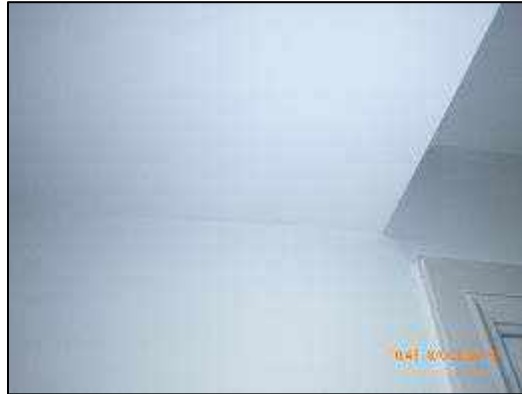
Item	Location	Defect description and Breach	Rectification	Photograph (if applicable)
2066	Ceiling sheet joint adjacent to unit 903 storage room	See section 5.14.1	See section 5.14.2
