SydneyStrataReport

STRATA REPORT

Client	Church Street Parramatta Property Pty Ltd
Address of property	Unit 3303/330 Church Street, Parramatta, NSW.
Lot	359
Strata Plan	SP 94469
Name of Strata Management Co.	NSW Strata
Telephone Number of Strata Agent	8980 1841
Report Date	15 February 2024

BUILDING DEFECTS REPORT Part 1/2

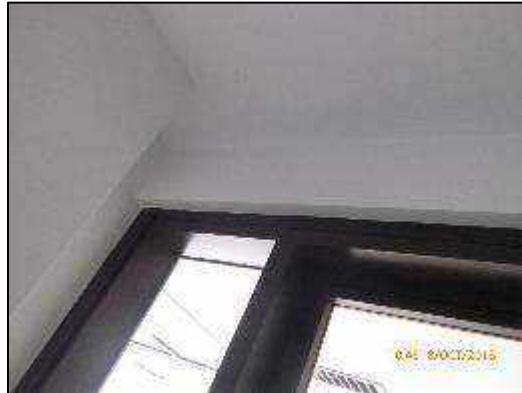
A photograph showing a close-up of a ceiling sheet joint in a storage room. The joint is visible as a horizontal line across the ceiling. A yellow date stamp '04/10/2015' is visible in the bottom right corner of the photo.
2067	Western window frames	See section 5.9.1	See section 5.9.2

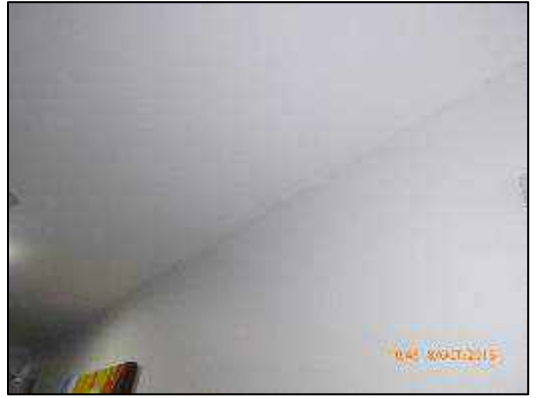
Item	Location	Defect description and Breach	Rectification	Photograph (if applicable)
2068	Wall adjacent to unit 901	See section 5.10.1	See section 5.10.2

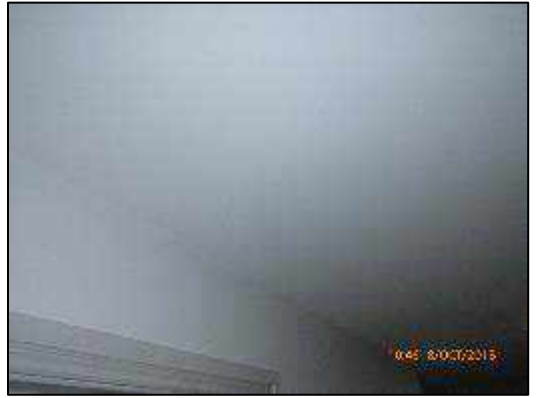
A photograph showing a close-up of a wall surface. A diagonal line of discoloration or staining runs from the bottom left towards the top right. A small portion of a yellow and red striped object is visible in the bottom left corner. A timestamp '045 20/07/2015' is in the bottom right.
2069	Ceiling adjacent to unit 902	See section 5.10.1	See section 5.10.2

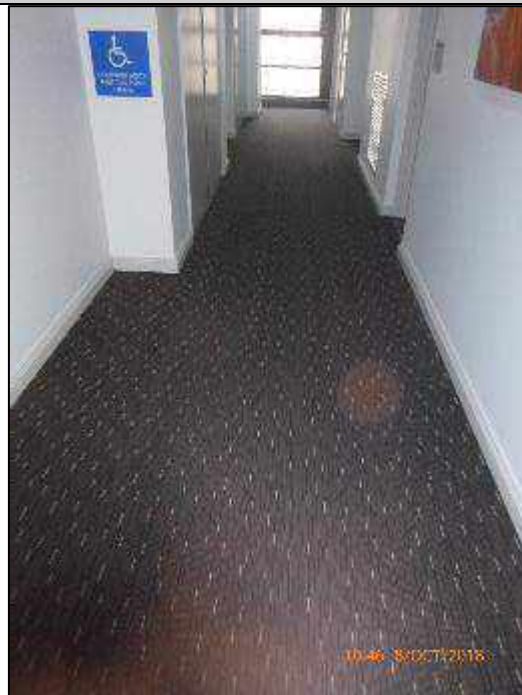
Item	Location	Defect description and Breach	Rectification	Photograph (if applicable)
2070	Level 9 Eastern lobby	<p>Concrete substrate appears to be not level. Displacement of substrate was measured to be greater than 4mm/2000mm.</p> <p>Home Building Act (NSW) 1989</p> <ul style="list-style-type: none"> Part 2C, 18B (a) and (c). <p>Guide to Standards and Tolerances 2017</p> <ul style="list-style-type: none"> Section 2.8 Levelness of flooring <p>This is a defect because the floor levels exceed the maximum deviation as intended by the manufacturer as outlined in Section 2.8 of the Guide to Standards and Tolerances 2017.</p> <p>Loss Suffered</p> <p>Loss suffered is cost of rectification.</p>	Further investigation required to identify the source of displacement in flooring.

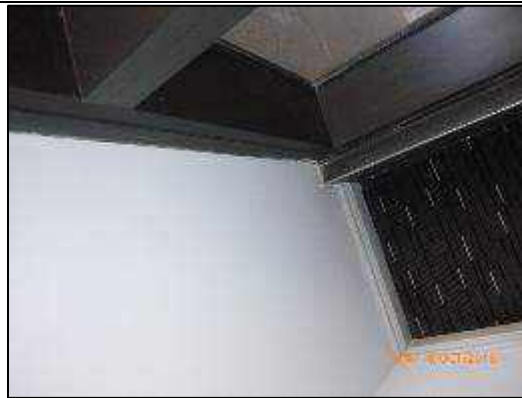
2071	Eastern windows frames	See section 5.9.1	See section 5.9.2

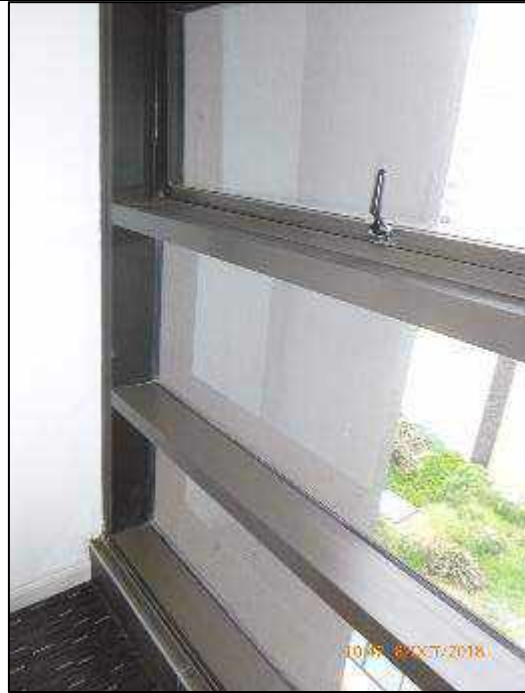
Item	Location	Defect description and Breach	Rectification	Photograph (if applicable)
2072	Eastern window frames	See section 5.7.1	See section 5.7.2

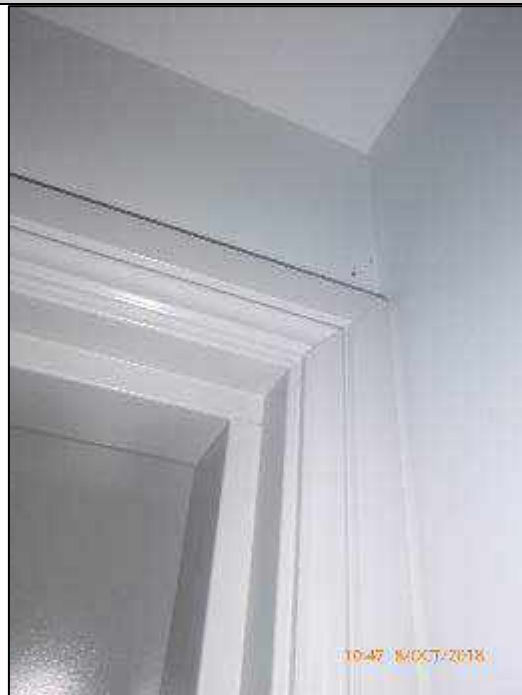
Item	Location	Defect description and Breach	Rectification	Photograph (if applicable)
2073	Architraves throughout level 9	<p>Nail fixing in architrave has not been filled prior to painting.</p> <p>Home Building Act (NSW) 1989</p> <ul style="list-style-type: none"> Part 2C, 18B (a) and (c). <p>This is a breach of part (a) of the act because the surface has not been finished in a proper workmanlike manner that would prevent loss of appearance to the surface.</p> <p>Guide to Standards and Tolerances 2017</p> <ul style="list-style-type: none"> Section 13.3 Nail and screw fixings <p>This is a defect because the nail penetration has not been filled as intended by the manufacturer as outlined in Section 13.3 of the Guide to Standards and Tolerances 2017.</p> <p>Loss Suffered</p> <p>Loss suffered is cost of rectification.</p>	<ol style="list-style-type: none"> 1. Protect all adjoining surfaces. 2. Appropriately fix/replace architrave to around door. 3. Repaint to match existing using suitable internal paint system in accordance with AS2311. 4. Clean up the work area.

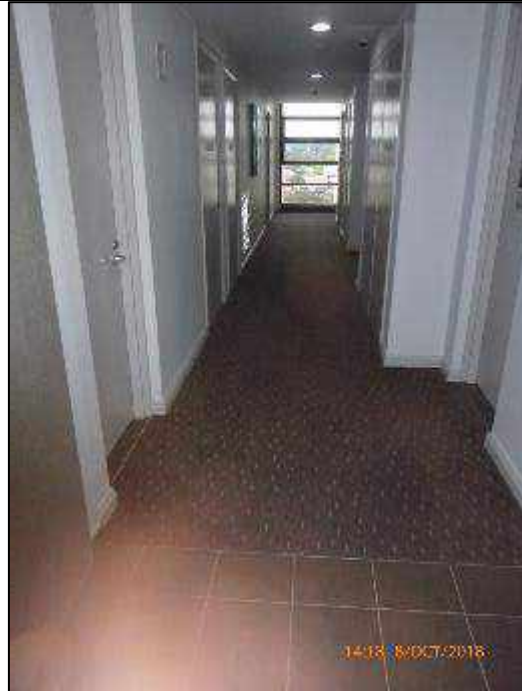
Item	Location	Defect description and Breach	Rectification	Photograph (if applicable)
Common areas – Level 10				
2074	Level 10 western lobby	<p>Concrete substrate appears to be not level. Displacement of substrate was measured to be greater than 4mm/2000mm.</p> <p>Home Building Act (NSW) 1989</p> <ul style="list-style-type: none"> Part 2C, 18B (a) and (c). <p>Guide to Standards and Tolerances 2017</p> <ul style="list-style-type: none"> Section 2.8 Levelness of flooring <p>This is a defect because the floor levels exceed the maximum deviation as intended by the manufacturer as outlined in Section 2.8 of the Guide to Standards and Tolerances 2017.</p> <p>Loss Suffered</p> <p>Loss suffered is cost of rectification.</p>	Further investigation required to identify the source of displacement in flooring.

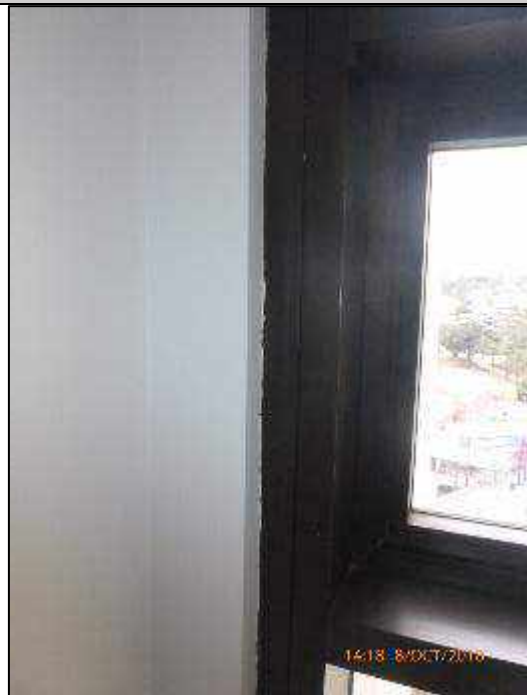
Item	Location	Defect description and Breach	Rectification	Photograph (if applicable)
2075	Western window frames	See section 5.9.1	See section 5.9.2

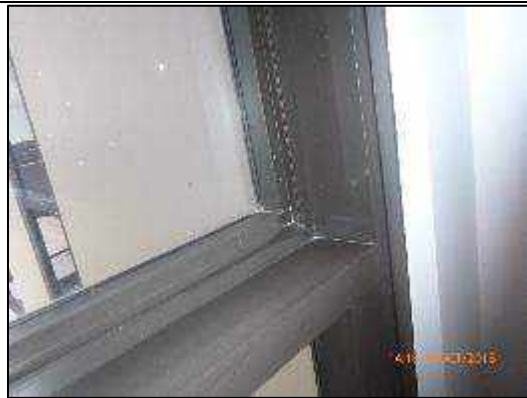
A photograph showing a close-up of a dark-colored window frame. The frame appears to be made of wood or a similar material. There is a visible gap or defect in the frame where it meets the wall. The date and time '14:18:54/06.07.2018' are visible in the bottom right corner of the image.
2076	Western window frames	See section 5.7.1	See section 5.7.2

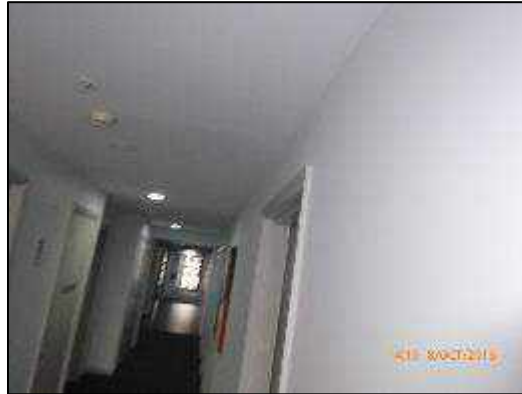
Item	Location	Defect description and Breach	Rectification	Photograph (if applicable)
2077	<i>Southern wall of western lobby</i>	<p>Peaking of plasterboard was observed throughout wall.</p> <p>Home Building Act (NSW) 1989</p> <ul style="list-style-type: none"> Part 2C, 18B (a) and (c). <p>Guide to Standards and Tolerances 2017</p> <ul style="list-style-type: none"> Section 10.18 Peaking in plasterboard <p>This is a defect because the plasterboard was not set as intended by the manufacturer as outlined in Section 10.18 of the Guide to Standards and Tolerances 2017.</p> <p>Loss Suffered</p> <p>Loss suffered is cost of rectification.</p>	<ol style="list-style-type: none"> 1. Protect all adjoining surfaces. 2. Appropriately re-set the affected areas. 3. Repaint to match existing using suitable internal paint system in accordance with AS2311. 4. Clean up the work area.

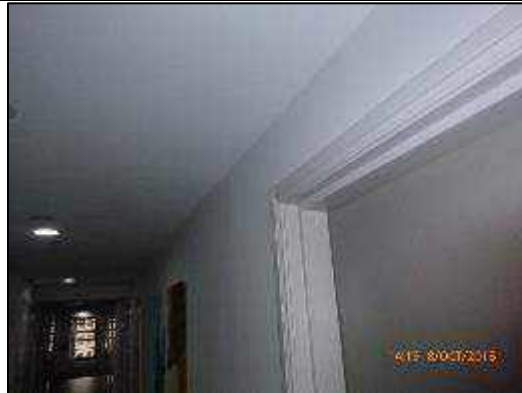
2078	<i>Walls and ceiling throughout Level 10 lobby</i>	See section 5.10.1	See section 5.10.2

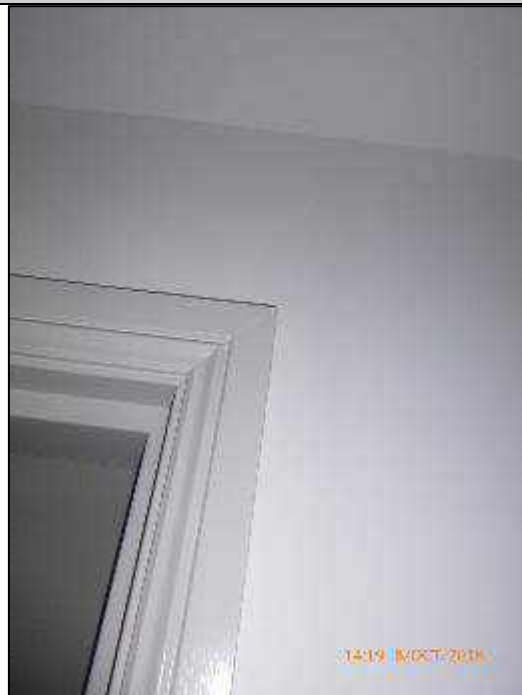
Item	Location	Defect description and Breach	Rectification	Photograph (if applicable)
2079	Architraves throughout level 10	<p>Nail fixing in architrave has not been filled prior to painting.</p> <p>Home Building Act (NSW) 1989</p> <ul style="list-style-type: none"> Part 2C, 18B (a) and (c). <p>This is a breach of part (a) of the act because the surface has not been finished in a proper workmanlike manner that would prevent loss of appearance to the surface.</p> <p>Guide to Standards and Tolerances 2017</p> <ul style="list-style-type: none"> Section 13.3 Nail and screw fixings <p>This is a defect because the nail penetration has not been filled as intended by the manufacturer as outlined in Section 13.3 of the Guide to Standards and Tolerances 2017.</p> <p>Loss Suffered</p> <p>Loss suffered is cost of rectification.</p>	<ol style="list-style-type: none"> 1. Protect all adjoining surfaces. 2. Appropriately fix/replace architrave to around door. 3. Repaint to match existing using suitable internal paint system in accordance with AS2311. 4. Clean up the work area.

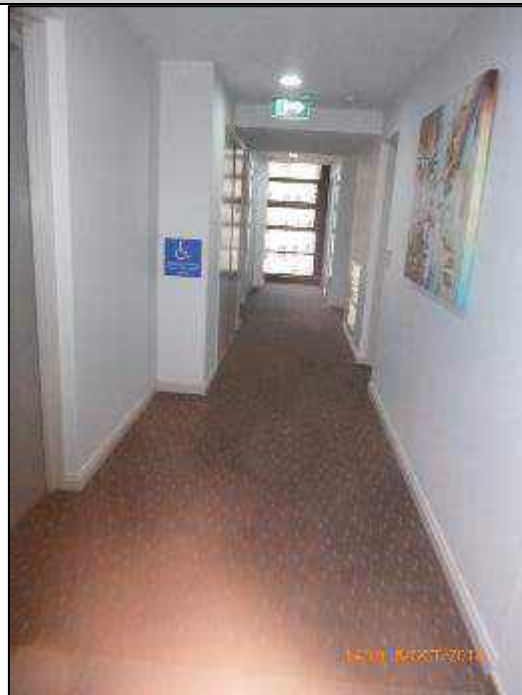
Item	Location	Defect description and Breach	Rectification	Photograph (if applicable)
2080	Level 10 eastern lobby	<p>Concrete substrate appears to be not level. Displacement of substrate was measured to be greater than 4mm/2000mm.</p> <p>Home Building Act (NSW) 1989</p> <ul style="list-style-type: none"> Part 2C, 18B (a) and (c). <p>Guide to Standards and Tolerances 2017</p> <ul style="list-style-type: none"> Section 2.8 Levelness of flooring <p>This is a defect because the floor levels exceed the maximum deviation as intended by the manufacturer as outlined in Section 2.8 of the Guide to Standards and Tolerances 2017.</p> <p>Loss Suffered Loss suffered is cost of rectification.</p>	Further investigation required to identify the source of displacement in flooring.

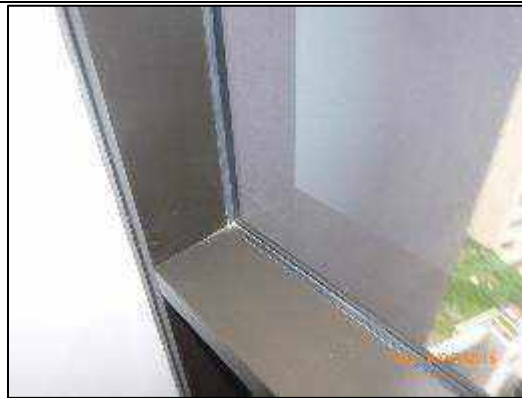
2081	Eastern window frames	<p>Window was observed to be cracked from the outside.</p> <p>Home Building Act (NSW) 1989</p> <ul style="list-style-type: none"> Part 2C, 18B (a) and (c). <p>This is a breach of part (a) of the act because the glass has not been finished in a proper workmanlike manner that would prevent loss of appearance and loss of durability of the building.</p> <p>Loss Suffered</p>	Replace glass panel in window frame to match existing in accordance with manufacturers specifications.

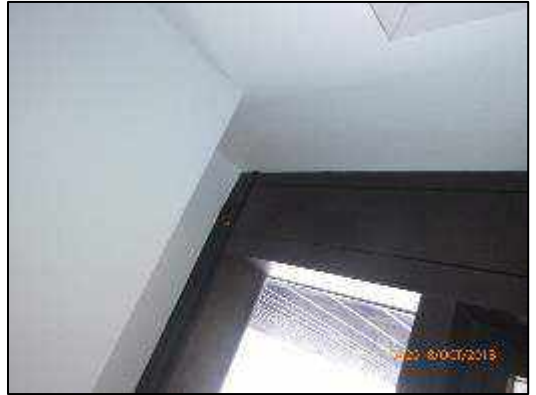
Item	Location	Defect description and Breach	Rectification	Photograph (if applicable)
		Loss suffered is cost of rectification.		
2082	Eastern window frames	See section 5.9.1	See section 5.9.2

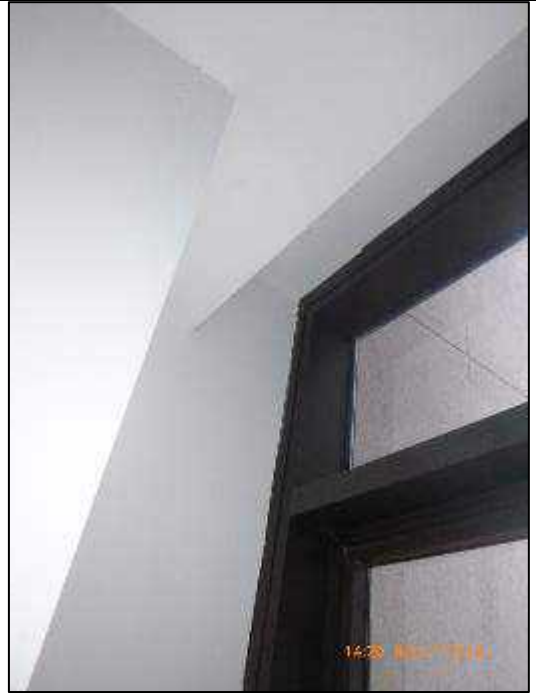
Item	Location	Defect description and Breach	Rectification	Photograph (if applicable)
2083	Eastern window frames	See section 5.7.1	See section 5.7.2

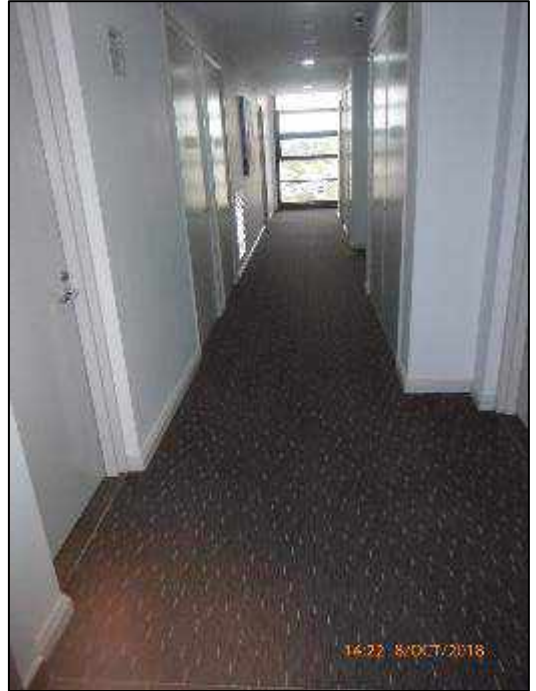
Item	Location	Defect description and Breach	Rectification	Photograph (if applicable)
Common areas – Level 11				
2084	Level 11 western lobby	<p>Concrete substrate appears to be not level. Displacement of substrate was measured to be greater than 4mm/2000mm.</p> <p>Home Building Act (NSW) 1989</p> <ul style="list-style-type: none"> Part 2C, 18B (a) and (c). <p>Guide to Standards and Tolerances 2017</p> <ul style="list-style-type: none"> Section 2.8 Levelness of flooring <p>This is a defect because the floor levels exceed the maximum deviation as intended by the manufacturer as outlined in Section 2.8 of the Guide to Standards and Tolerances 2017.</p> <p>Loss Suffered</p> <p>Loss suffered is cost of rectification.</p>	Further investigation required to identify the source of displacement in flooring.

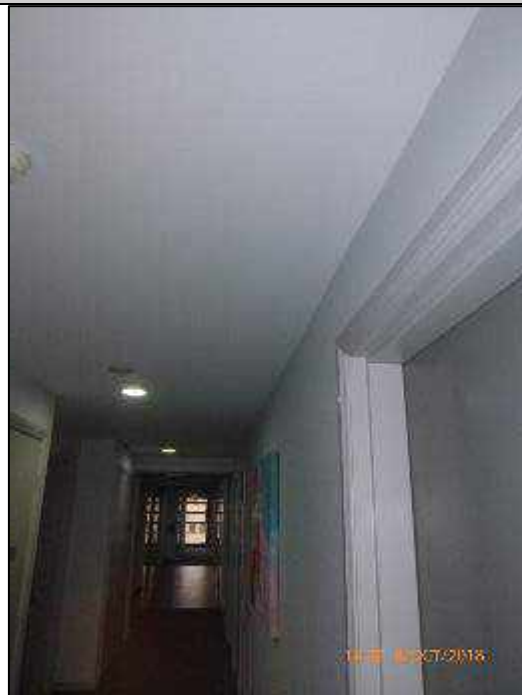
Item	Location	Defect description and Breach	Rectification	Photograph (if applicable)
2085	Throughout level 11 walls	<p>Peaking of plasterboard was observed throughout wall.</p> <p>Home Building Act (NSW) 1989</p> <ul style="list-style-type: none"> Part 2C, 18B (a) and (c). <p>Guide to Standards and Tolerances 2017</p> <ul style="list-style-type: none"> Section 10.18 Peaking in plasterboard <p>This is a defect because the plasterboard was not set as intended by the manufacturer as outlined in Section 10.18 of the Guide to Standards and Tolerances 2017.</p> <p>Loss Suffered</p> <p>Loss suffered is cost of rectification.</p>	<ol style="list-style-type: none"> 1. Protect all adjoining surfaces. 2. Appropriately re-set the affected areas. 3. Repaint to match existing using suitable internal paint system in accordance with AS2311. 4. Clean up the work area.

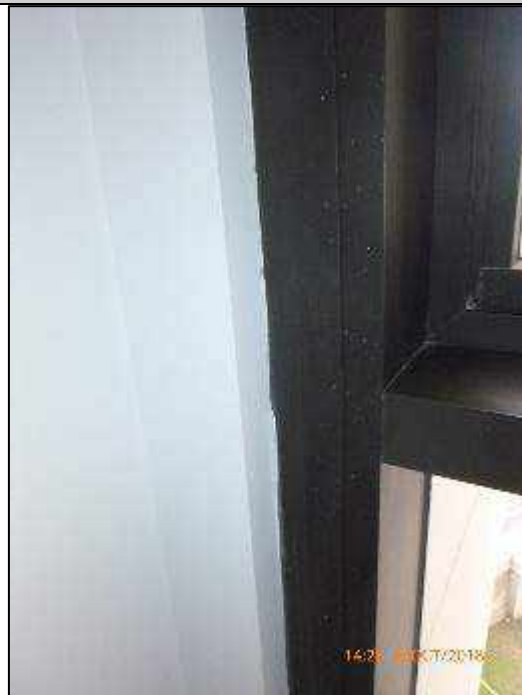
Item	Location	Defect description and Breach	Rectification	Photograph (if applicable)
2087	Western window frames	See section 5.9.1	See section 5.9.2

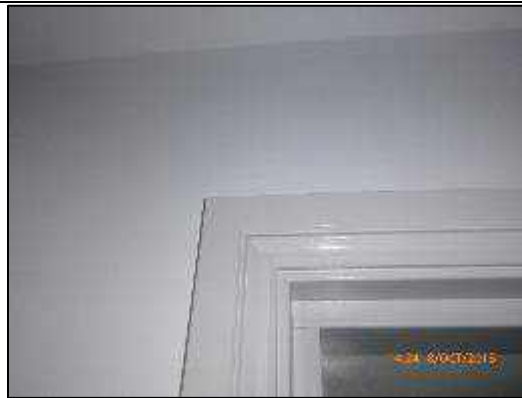
2088	Architraves throughout level 11	<p>Nail fixing in architrave has not been filled prior to painting.</p> <p>Home Building Act (NSW) 1989</p> <ul style="list-style-type: none"> Part 2C, 18B (a) and (c). <p>This is a breach of part (a) of the act because the surface has not been finished in a proper workmanlike manner that would prevent loss of appearance to the surface.</p>	<ol style="list-style-type: none"> 1. Protect all adjoining surfaces. 2. Appropriately fix/replace architrave to around door. 3. Repaint to match existing using suitable internal paint system in accordance with AS2311. 4. Clean up the work area.

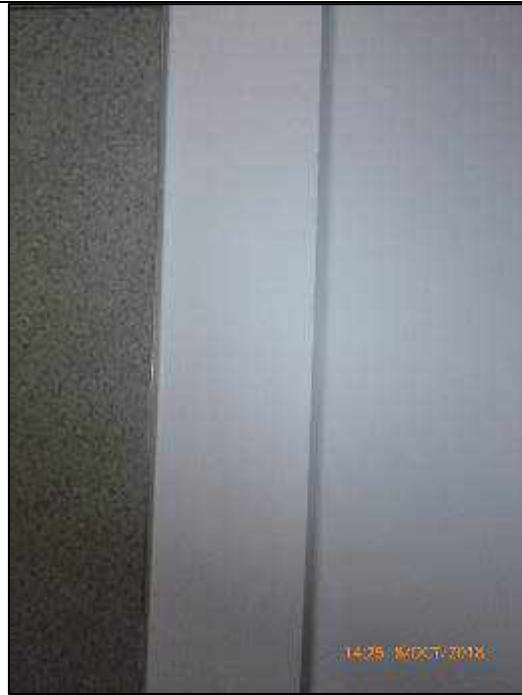
Item	Location	Defect description and Breach	Rectification	Photograph (if applicable)
		Guide to Standards and Tolerances 2017 <ul style="list-style-type: none"> Section 13.3 Nail and screw fixings <p>This is a defect because the nail penetration has not been filled as intended by the manufacturer as outlined in Section 13.3 of the Guide to Standards and Tolerances 2017.</p> <p>Loss Suffered Loss suffered is cost of rectification.</p>		
2089	Throughout level 11 lobby walls	See section 5.10.1	See section 5.10.2

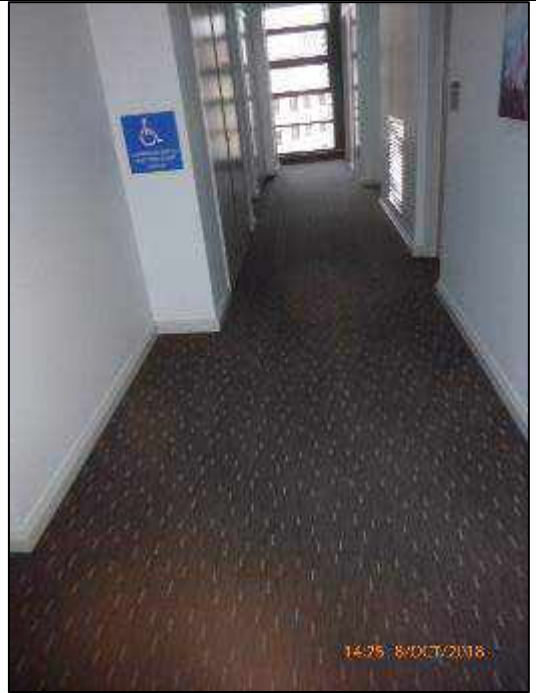
Item	Location	Defect description and Breach	Rectification	Photograph (if applicable)
2090	Level 11 eastern lobby	<p>Concrete substrate appears to be not level. Displacement of substrate was measured to be greater than 4mm/2000mm.</p> <p>Home Building Act (NSW) 1989</p> <ul style="list-style-type: none"> Part 2C, 18B (a) and (c). <p>Guide to Standards and Tolerances 2017</p> <ul style="list-style-type: none"> Section 2.8 Levelness of flooring <p>This is a defect because the floor levels exceed the maximum deviation as intended by the manufacturer as outlined in Section 2.8 of the Guide to Standards and Tolerances 2017.</p> <p>Loss Suffered</p> <p>Loss suffered is cost of rectification.</p>	Further investigation required to identify the source of displacement in flooring.

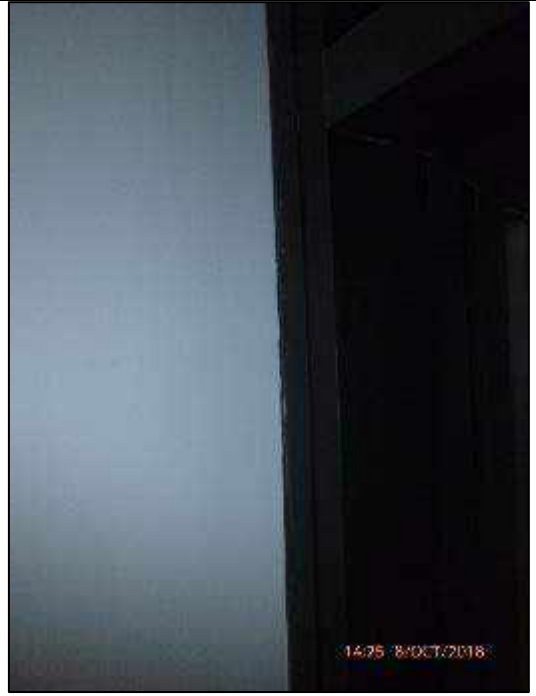
Item	Location	Defect description and Breach	Rectification	Photograph (if applicable)
2091	Eastern window frames	See section 5.9.1	See section 5.9.2

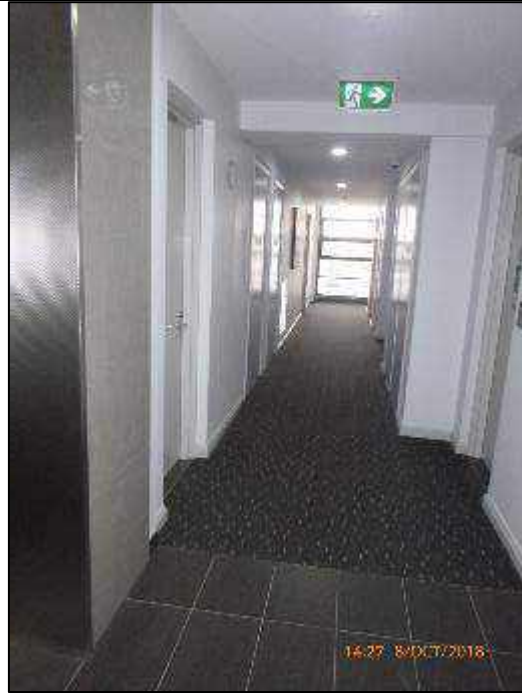
Item	Location	Defect description and Breach	Rectification	Photograph (if applicable)
Common areas – Level 12				
2092	Level 12 western lobby	<p>Concrete substrate appears to be not level. Displacement of substrate was measured to be greater than 4mm/2000mm.</p> <p>Home Building Act (NSW) 1989</p> <ul style="list-style-type: none"> Part 2C, 18B (a) and (c). <p>Guide to Standards and Tolerances 2017</p> <ul style="list-style-type: none"> Section 2.8 Levelness of flooring <p>This is a defect because the floor levels exceed the maximum deviation as intended by the manufacturer as outlined in Section 2.8 of the Guide to Standards and Tolerances 2017.</p> <p>Loss Suffered</p> <p>Loss suffered is cost of rectification.</p>	Further investigation required to identify the source of displacement in flooring.

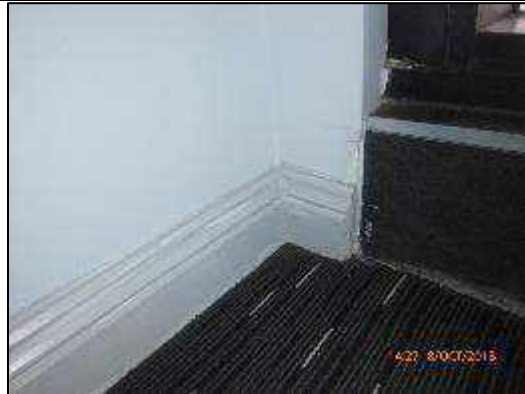
Item	Location	Defect description and Breach	Rectification	Photograph (if applicable)
2093	Skirting boards adjacent to western window frames	See section 5.10.1	See section 5.10.2

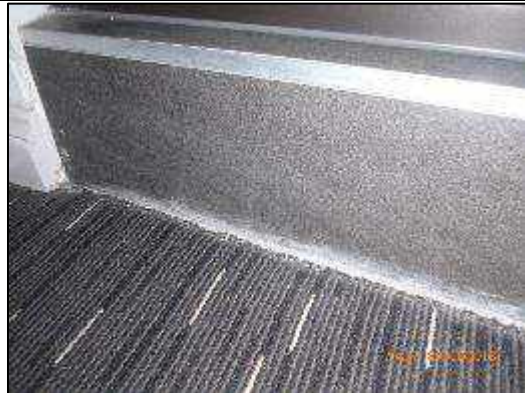
2094	Western window frames	<p>Final clean of grout under western windows has not been undertaken.</p> <p>Home Building Act (NSW) 1989</p> <ul style="list-style-type: none"> Part 2C, 18B (a) and (c). <p>This is a breach of part (a) of the act because the surface has not been finished in a proper workmanlike manner that would prevent loss of appearance to the surface.</p> <p>Loss Suffered</p> <p>Loss suffered is cost of rectification.</p>	<ol style="list-style-type: none"> 1. Protect all adjoining surfaces. 2. Use a suitable cleaning agent to remove residue and clear debris. 3. Clean up the work area.

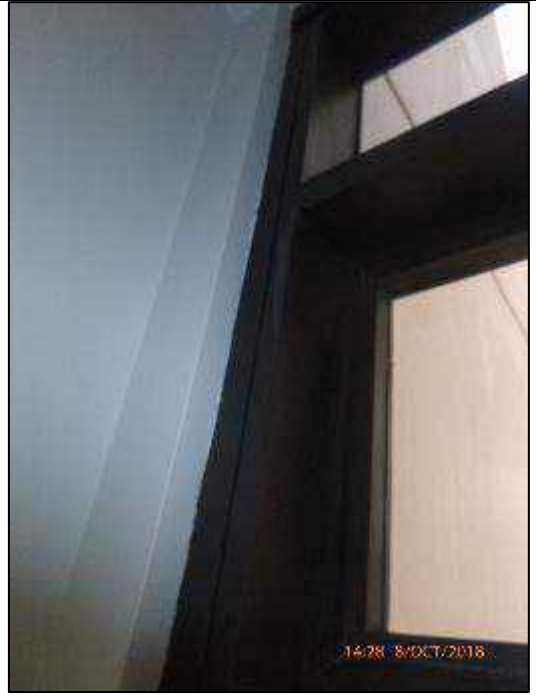
Item	Location	Defect description and Breach	Rectification	Photograph (if applicable)
2095	Western window frames	See section 5.9.1	See section 5.9.2

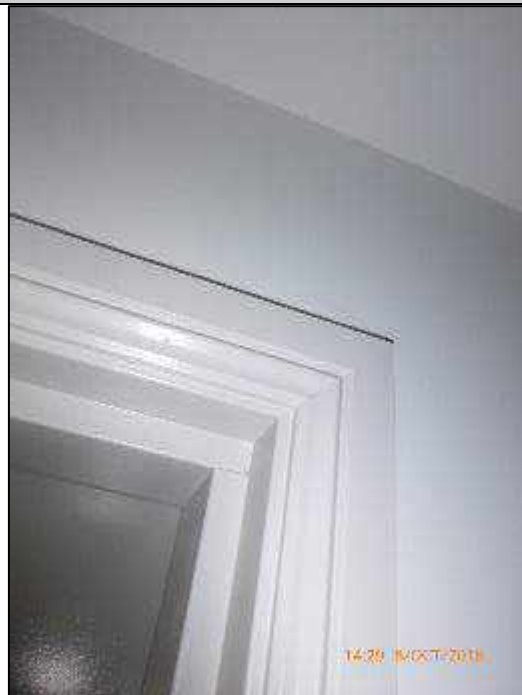
Item	Location	Defect description and Breach	Rectification	Photograph (if applicable)
2096	Architraves throughout level 12	<p>Nail fixing in architrave has not been filled prior to painting.</p> <p>Home Building Act (NSW) 1989</p> <ul style="list-style-type: none"> Part 2C, 18B (a) and (c). <p>This is a breach of part (a) of the act because the surface has not been finished in a proper workmanlike manner that would prevent loss of appearance to the surface.</p> <p>Guide to Standards and Tolerances 2017</p> <ul style="list-style-type: none"> Section 13.3 Nail and screw fixings <p>This is a defect because the nail penetration has not been filled as intended by the manufacturer as outlined in Section 13.3 of the Guide to Standards and Tolerances 2017.</p> <p>Loss Suffered</p> <p>Loss suffered is cost of rectification.</p>	<ol style="list-style-type: none"> 1. Protect all adjoining surfaces. 2. Appropriately fix/replace architrave to around door. 3. Repaint to match existing using suitable internal paint system in accordance with AS2311. 4. Clean up the work area.

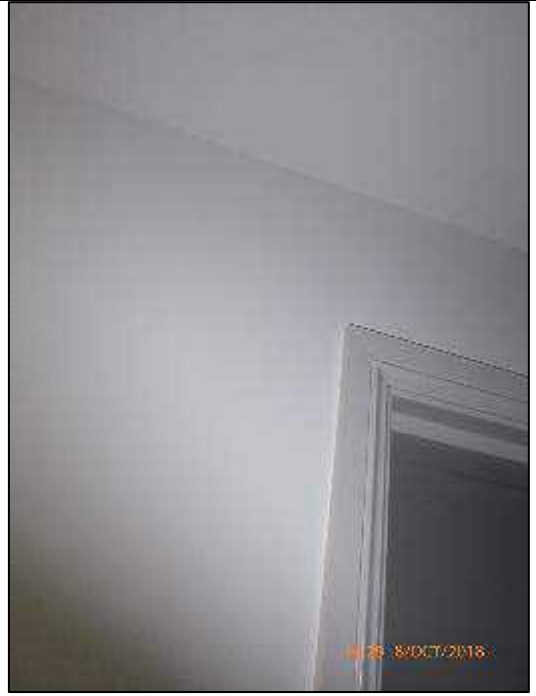
Item	Location	Defect description and Breach	Rectification	Photograph (if applicable)
2097	Wall adjacent to unit 1202	See section 5.13.1	See section 5.13.2

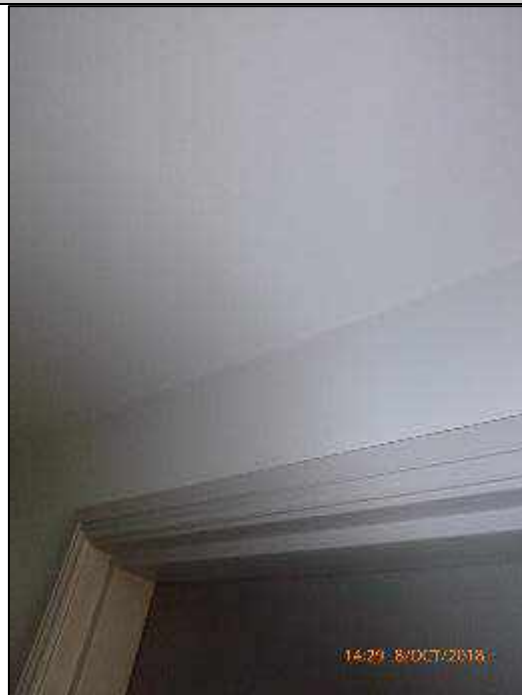
Item	Location	Defect description and Breach	Rectification	Photograph (if applicable)
2098	Wall above unit 1201	<p>Peaking of plasterboard was observed throughout wall.</p> <p>Home Building Act (NSW) 1989</p> <ul style="list-style-type: none"> Part 2C, 18B (a) and (c). <p>Guide to Standards and Tolerances 2017</p> <ul style="list-style-type: none"> Section 10.18 Peaking in plasterboard <p>This is a defect because the plasterboard was not set as intended by the manufacturer as outlined in Section 10.18 of the Guide to Standards and Tolerances 2017.</p> <p>Loss Suffered</p> <p>Loss suffered is cost of rectification.</p>	<ol style="list-style-type: none"> 1. Protect all adjoining surfaces. 2. Appropriately re-set the affected areas. 3. Repaint to match existing using suitable internal paint system in accordance with AS2311. 4. Clean up the work area.

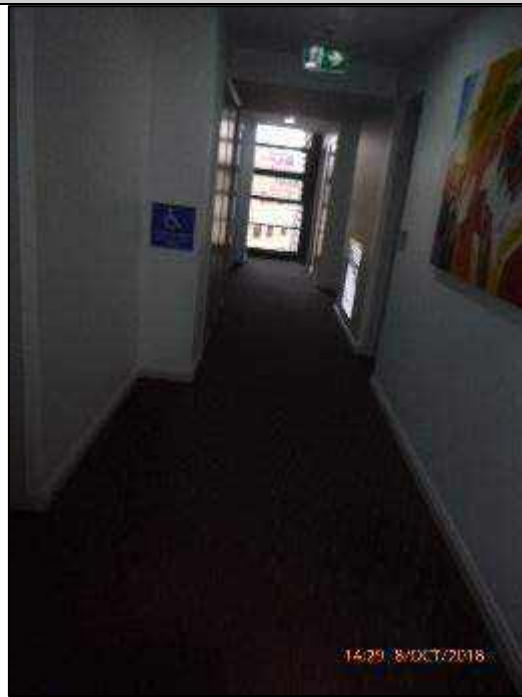
Item	Location	Defect description and Breach	Rectification	Photograph (if applicable)
2099	Level 12 eastern lobby	<p>Concrete substrate appears to be not level. Displacement of substrate was measured to be greater than 4mm/2000mm.</p> <p>Home Building Act (NSW) 1989</p> <ul style="list-style-type: none"> Part 2C, 18B (a) and (c). <p>Guide to Standards and Tolerances 2017</p> <ul style="list-style-type: none"> Section 2.8 Levelness of flooring <p>This is a defect because the floor levels exceed the maximum deviation as intended by the manufacturer as outlined in Section 2.8 of the Guide to Standards and Tolerances 2017.</p> <p>Loss Suffered</p> <p>Loss suffered is cost of rectification.</p>	Further investigation required to identify the source of displacement in flooring.

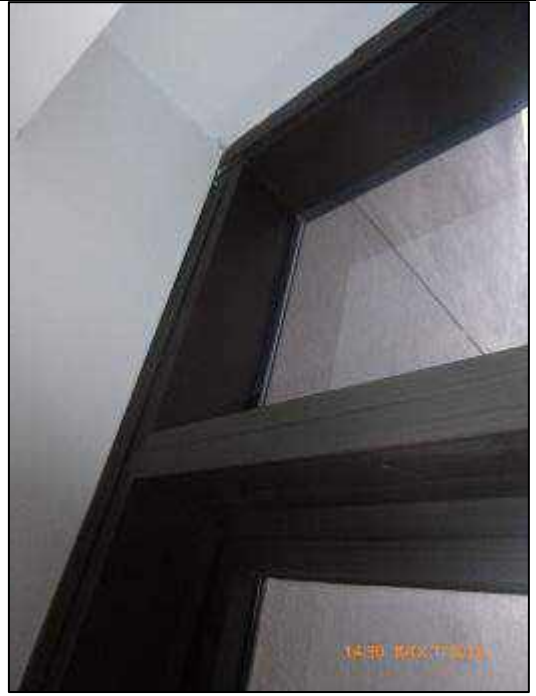
Item	Location	Defect description and Breach	Rectification	Photograph (if applicable)
2100	Eastern window frames	See section 5.9.1	See section 5.9.2

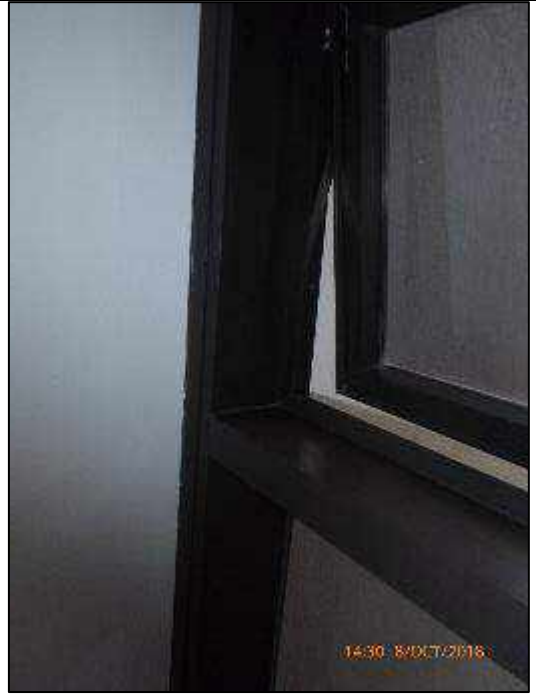
Item	Location	Defect description and Breach	Rectification	Photograph (if applicable)
2101	Wall adjacent to eastern window frames	See section 5.13.1	See section 5.13.2

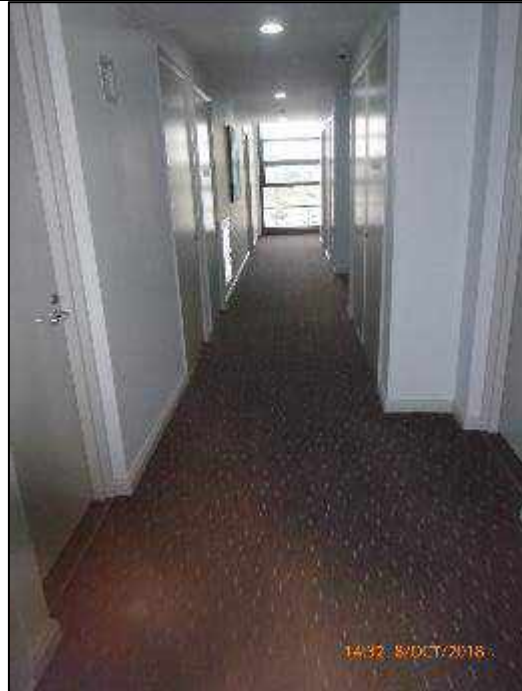
Item	Location	Defect description and Breach	Rectification	Photograph (if applicable)
Common areas – Level 13				
2102	Level 13 western lobby	<p>Concrete substrate appears to be not level. Displacement of substrate was measured to be greater than 4mm/2000mm.</p> <p>Home Building Act (NSW) 1989</p> <ul style="list-style-type: none"> Part 2C, 18B (a) and (c). <p>Guide to Standards and Tolerances 2017</p> <ul style="list-style-type: none"> Section 2.8 Levelness of flooring <p>This is a defect because the floor levels exceed the maximum deviation as intended by the manufacturer as outlined in Section 2.8 of the Guide to Standards and Tolerances 2017.</p> <p>Loss Suffered</p> <p>Loss suffered is cost of rectification.</p>	Further investigation required to identify the source of displacement in flooring.

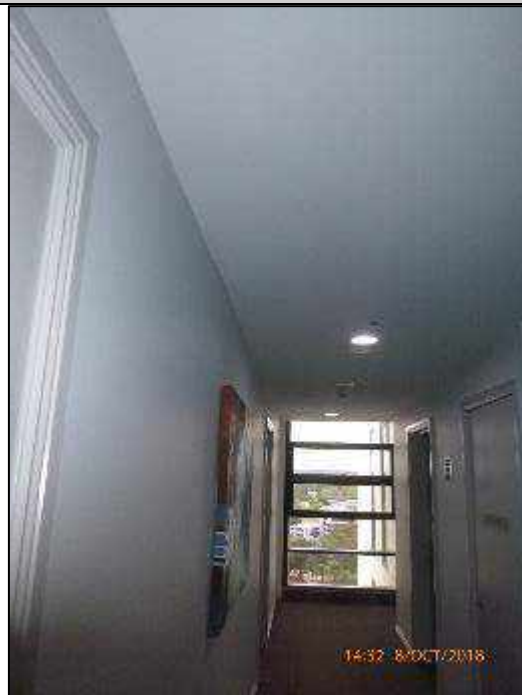
Item	Location	Defect description and Breach	Rectification	Photograph (if applicable)
2103	Walls throughout level 13 lobby	<p>Peaking of plasterboard was observed throughout wall.</p> <p>Home Building Act (NSW) 1989</p> <ul style="list-style-type: none"> Part 2C, 18B (a) and (c). <p>Guide to Standards and Tolerances 2017</p> <ul style="list-style-type: none"> Section 10.18 Peaking in plasterboard <p>This is a defect because the plasterboard was not set as intended by the manufacturer as outlined in Section 10.18 of the Guide to Standards and Tolerances 2017.</p> <p>Loss Suffered</p> <p>Loss suffered is cost of rectification.</p>	<ol style="list-style-type: none"> 1. Protect all adjoining surfaces. 2. Appropriately re-set the affected areas. 3. Repaint to match existing using suitable internal paint system in accordance with AS2311. 4. Clean up the work area.

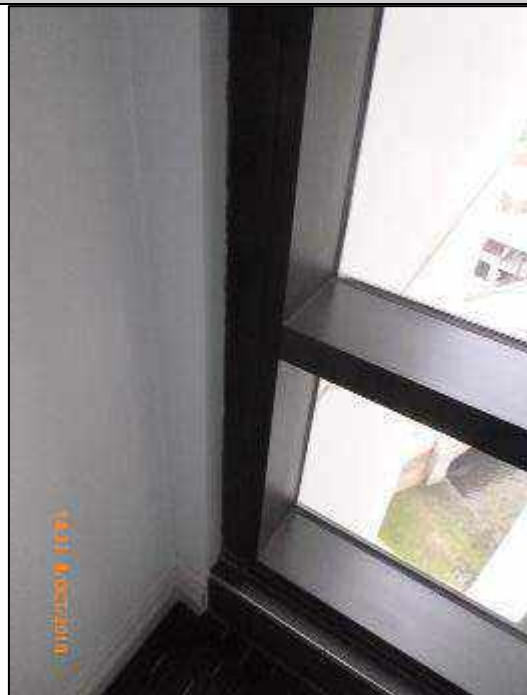
Item	Location	Defect description and Breach	Rectification	Photograph (if applicable)
2104	Western window frames	See section 5.9.1	See section 5.9.2

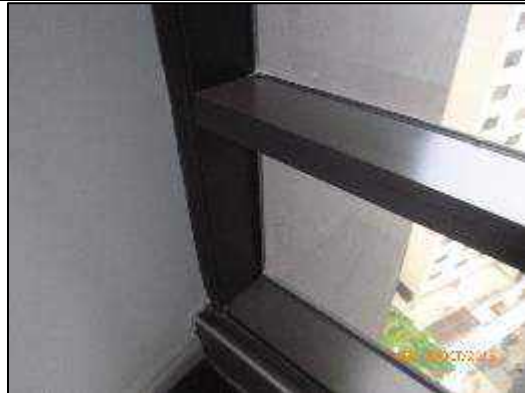
Item	Location	Defect description and Breach	Rectification	Photograph (if applicable)
		Loss Suffered Loss suffered is cost of rectification.		
2109	Eastern window frames	See section 5.9.1	See section 5.9.2

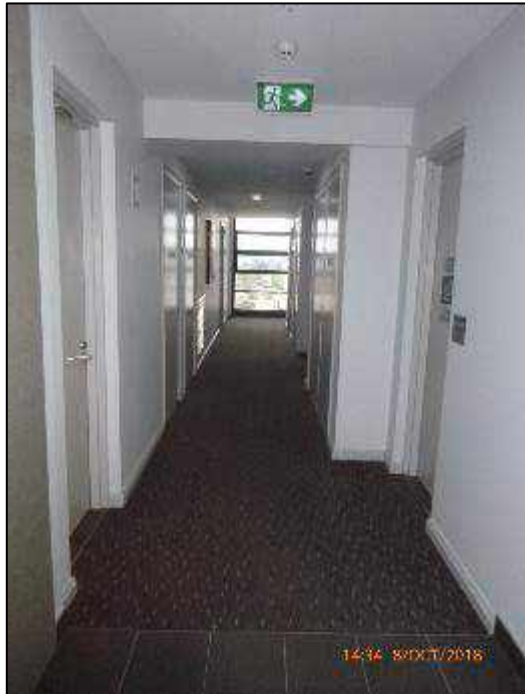
Item	Location	Defect description and Breach	Rectification	Photograph (if applicable)
Common areas – Level 14				
2110	Level 14 western lobby	<p>Concrete substrate appears to be not level. Displacement of substrate was measured to be greater than 4mm/2000mm.</p> <p>Home Building Act (NSW) 1989</p> <ul style="list-style-type: none"> Part 2C, 18B (a) and (c). <p>Guide to Standards and Tolerances 2017</p> <ul style="list-style-type: none"> Section 2.8 Levelness of flooring <p>This is a defect because the floor levels exceed the maximum deviation as intended by the manufacturer as outlined in Section 2.8 of the Guide to Standards and Tolerances 2017.</p> <p>Loss Suffered</p> <p>Loss suffered is cost of rectification.</p>	Further investigation required to identify the source of displacement in flooring.

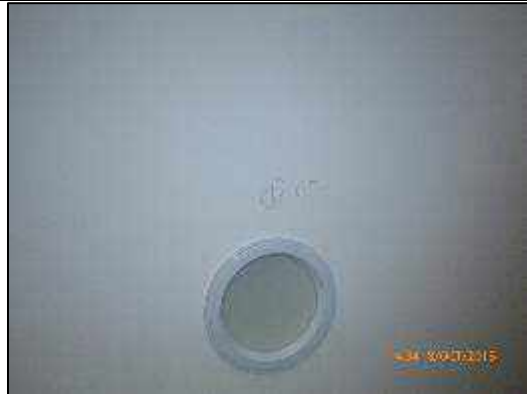
Item	Location	Defect description and Breach	Rectification	Photograph (if applicable)
2111	Ceiling adjacent to unit 1401	See section 5.10.1	See section 5.10.2

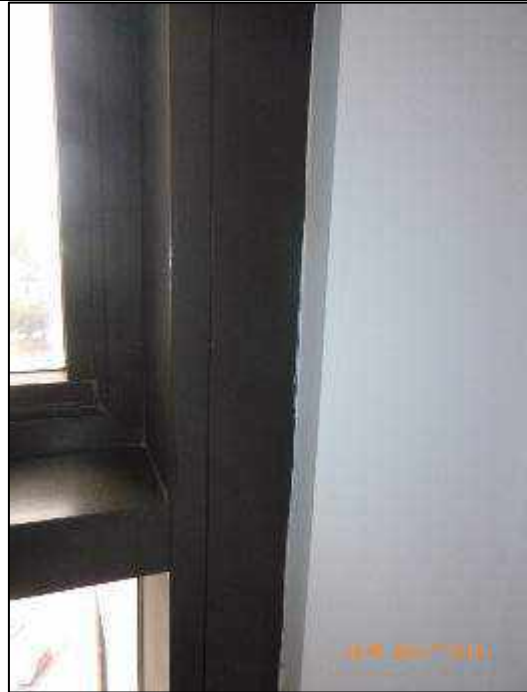
2112	Western window frames	See section 5.9.1	See section 5.9.2

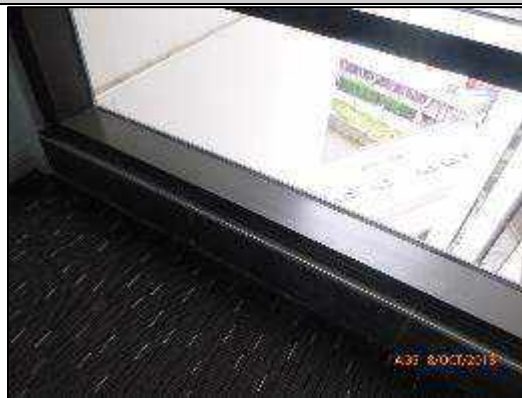
Item	Location	Defect description and Breach	Rectification	Photograph (if applicable)
2113	Western window frames	<p>Final clean of grout under western windows has not been undertaken.</p> <p>Home Building Act (NSW) 1989</p> <ul style="list-style-type: none"> Part 2C, 18B (a) and (c). <p>This is a breach of part (a) of the act because the surface has not been finished in a proper workmanlike manner that would prevent loss of appearance to the surface.</p> <p>Loss Suffered Loss suffered is cost of rectification.</p>	<ol style="list-style-type: none"> 1. Protect all adjoining surfaces. 2. Use a suitable cleaning agent to remove residue and clear debris. 3. Clean up the work area.

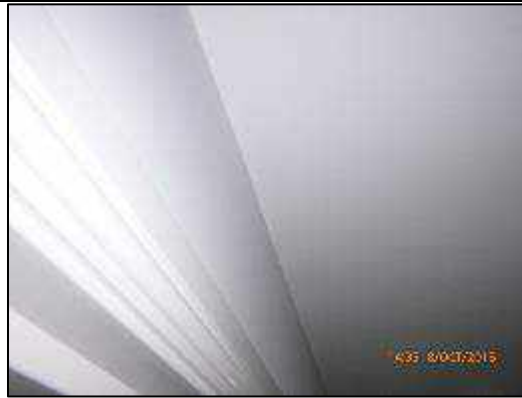
<p>A close-up photograph of a dark window frame. The grout between the frame and the wall is dirty and uneven. A date stamp '4/35 8/01/2015' is visible in the bottom right corner.</p>
2114	Walls and ceiling throughout level 14 lobby	See section 5.10.1	See section 5.10.2

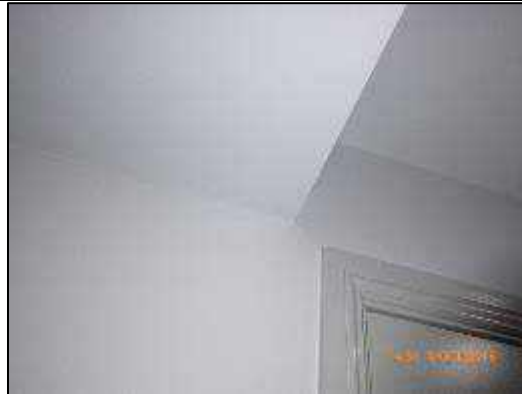
Item	Location	Defect description and Breach	Rectification	Photograph (if applicable)
2115	Wall adjacent to unit 1403	See section 5.14.1	See section 5.14.2

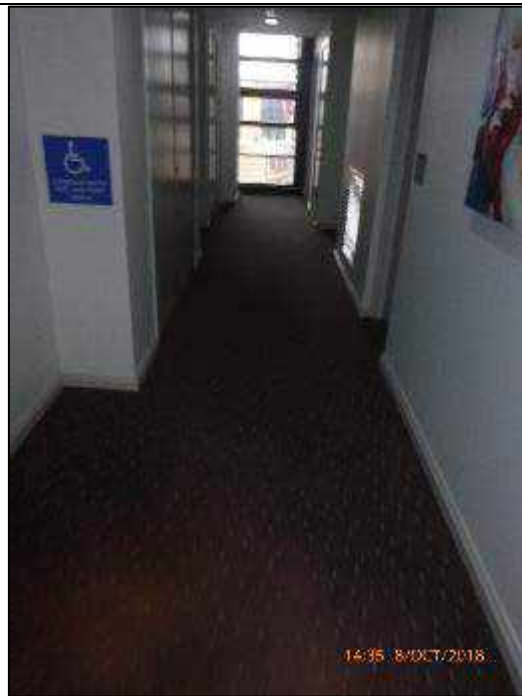
2116	Level 14 eastern lobby	<p>Concrete substrate appears to be not level. Displacement of substrate was measured to be greater than 4mm/2000mm.</p> <p>Home Building Act (NSW) 1989</p> <ul style="list-style-type: none"> Part 2C, 18B (a) and (c). <p>Guide to Standards and Tolerances 2017</p> <ul style="list-style-type: none"> Section 2.8 Levelness of flooring <p>This is a defect because the floor levels exceed the maximum deviation as intended by the manufacturer as outlined in Section 2.8 of the Guide to Standards and Tolerances 2017.</p> <p>Loss Suffered</p> <p>Loss suffered is cost of rectification.</p>	Further investigation required to identify the source of displacement in flooring.

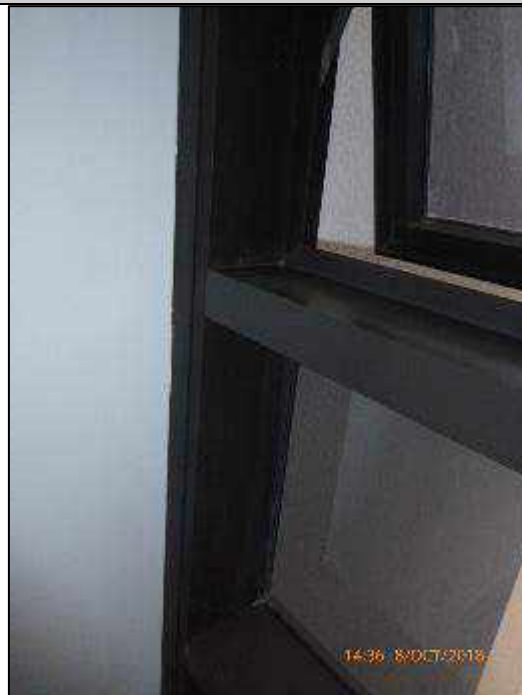
Item	Location	Defect description and Breach	Rectification	Photograph (if applicable)
2117	Eastern window frames	See section 5.9.1	See section 5.9.2

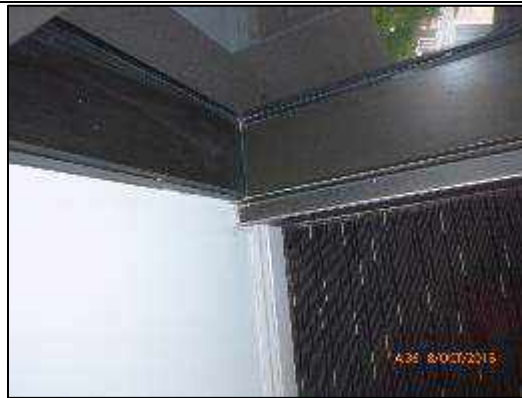
A photograph showing a close-up of a dark-colored window frame. The frame appears to be made of wood or a similar material. There is a visible gap or defect in the frame, possibly where it meets the wall or another part of the frame. The background is a light-colored wall.
2118	Eastern window frames northern elevation	See section 5.13.1	See section 5.13.2

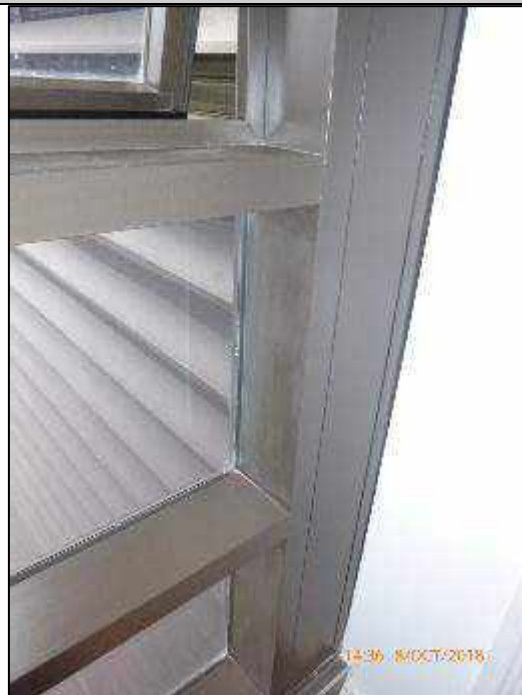
Item	Location	Defect description and Breach	Rectification	Photograph (if applicable)
2119	Eastern window frames	See section 5.7.1	See section 5.7.2

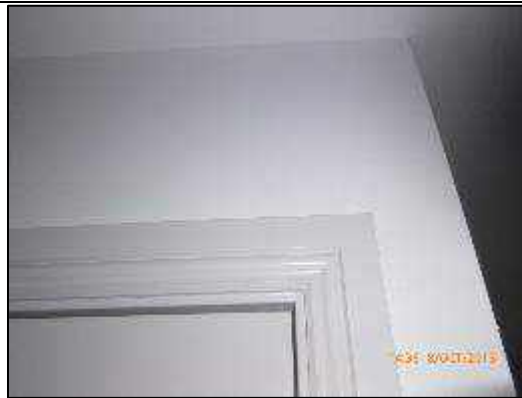
A close-up photograph of a window frame. The frame is made of a light-colored material, possibly wood or composite, and shows signs of wear and discoloration. The glass pane is visible, and the frame appears to be part of a larger window unit.
2120	Architraves throughout level 14	<p>Nail fixing in architrave has not been filled prior to painting.</p> <p>Home Building Act (NSW) 1989</p> <ul style="list-style-type: none"> Part 2C, 18B (a) and (c). <p>This is a breach of part (a) of the act because the surface has not been finished in a proper workmanlike manner that would prevent loss of appearance to the surface.</p>	<ol style="list-style-type: none"> 1. Protect all adjoining surfaces. 2. Appropriately fix/replace architrave to around door. 3. Repaint to match existing using suitable internal paint system in accordance with AS2311. 4. Clean up the work area.

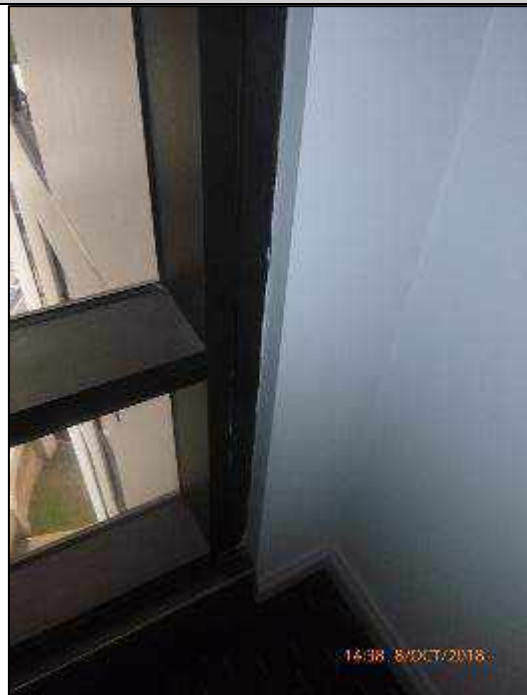
Item	Location	Defect description and Breach	Rectification	Photograph (if applicable)
2122	Western window frames	See section 5.9.1	See section 5.9.2

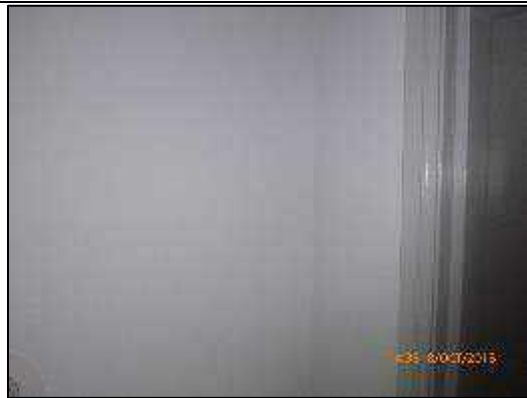
A photograph showing a close-up of a window frame. The frame is dark, and the glass is slightly discolored or dirty. The image is taken from an angle, showing the frame's profile and the glass pane. A timestamp in the bottom right corner reads "14:38 8/OCT/2018".
2123	Wall above unit 1501 sheet joint	See section 5.14.1	See section 5.14.2

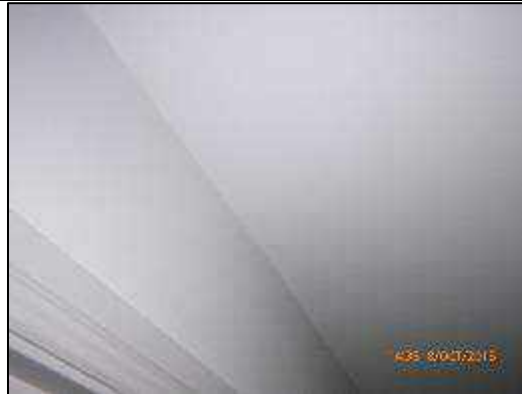
Item	Location	Defect description and Breach	Rectification	Photograph (if applicable)
2124	Walls and ceiling throughout level 15 lobby	See section 5.10.1	See section 5.10.2
