SydneyStrataReport

STRATA REPORT

Client	Church Street Parramatta Property Pty Ltd
Address of property	Unit 3303/330 Church Street, Parramatta, NSW.
Lot	359
Strata Plan	SP 94469
Name of Strata Management Co.	NSW Strata
Telephone Number of Strata Agent	8980 1841
Report Date	15 February 2024

BUILDING DEFECTS REPORT Part 1/2

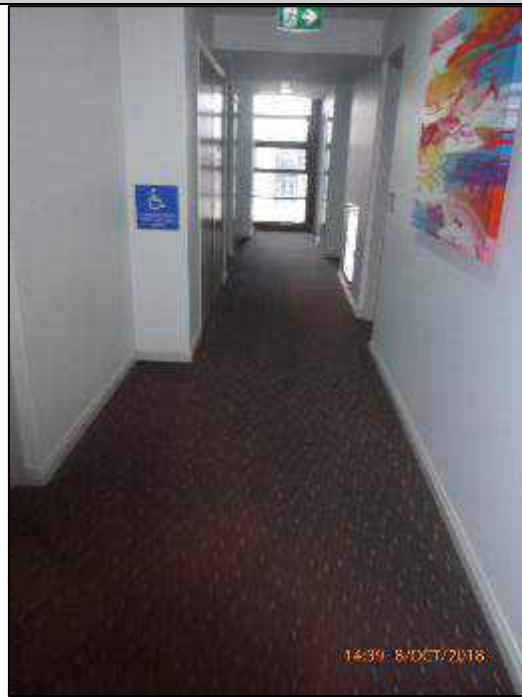
Item	Location	Defect description and Breach	Rectification	Photograph (if applicable)
2126	Level 15 eastern lobby	<p>Concrete substrate appears to be not level. Displacement of substrate was measured to be greater than 4mm/2000mm.</p> <p>Home Building Act (NSW) 1989</p> <ul style="list-style-type: none"> Part 2C, 18B (a) and (c). <p>Guide to Standards and Tolerances 2017</p> <ul style="list-style-type: none"> Section 2.8 Levelness of flooring <p>This is a defect because the floor levels exceed the maximum deviation as intended by the manufacturer as outlined in Section 2.8 of the Guide to Standards and Tolerances 2017.</p> <p>Loss Suffered</p> <p>Loss suffered is cost of rectification.</p>	Further investigation required to identify the source of displacement in flooring.

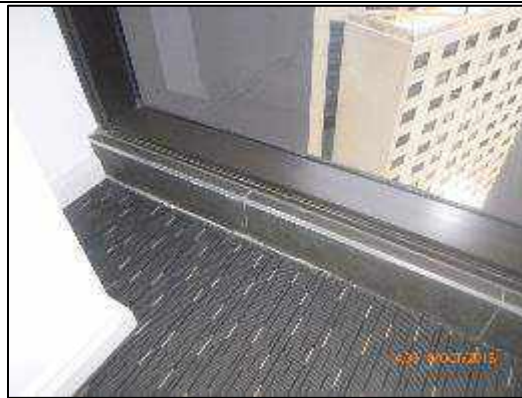
2127	Eastern window frames	<p>Final clean of grout under eastern windows has not been undertaken.</p> <p>Home Building Act (NSW) 1989</p> <ul style="list-style-type: none"> Part 2C, 18B (a) and (c). <p>This is a breach of part (a) of the act because the surface has not been finished in a proper workmanlike manner that would prevent loss of appearance to the surface.</p>	<ol style="list-style-type: none"> 1. Protect all adjoining surfaces. 2. Use a suitable cleaning agent to remove residue and clear debris. 3. Clean up the work area.

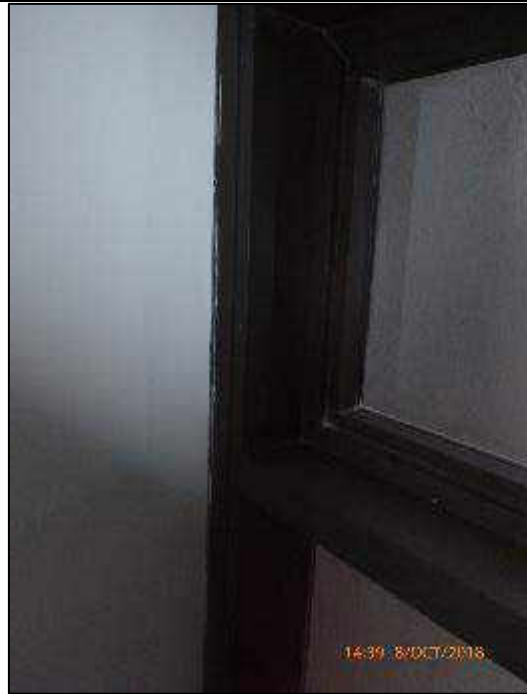
Item	Location	Defect description and Breach	Rectification	Photograph (if applicable)
		Loss Suffered Loss suffered is cost of rectification.		
2128	Eastern window frames	See section 5.9.1	See section 5.9.2

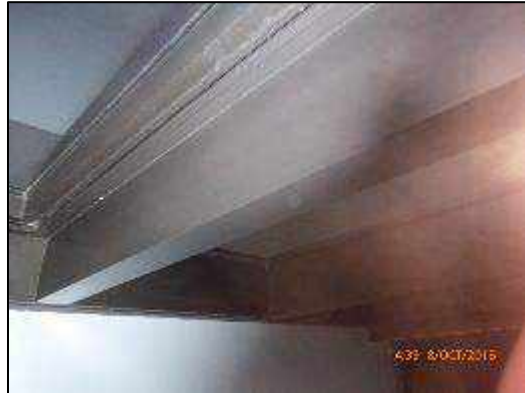
Item	Location	Defect description and Breach	Rectification	Photograph (if applicable)
2129	Eastern window frames	See section 5.7.1	See section 5.7.2

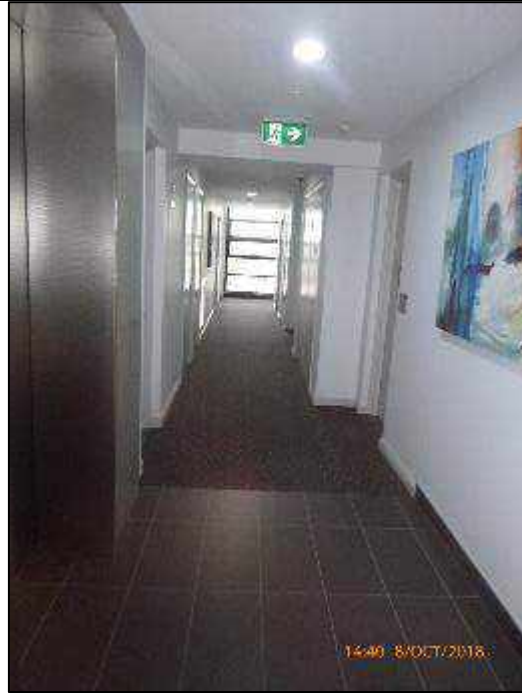
Item	Location	Defect description and Breach	Rectification	Photograph (if applicable)
Common areas – Level 16				
2130	Level 16 western lobby	<p>Concrete substrate appears to be not level. Displacement of substrate was measured to be greater than 4mm/2000mm.</p> <p>Home Building Act (NSW) 1989</p> <ul style="list-style-type: none"> Part 2C, 18B (a) and (c). <p>Guide to Standards and Tolerances 2017</p> <ul style="list-style-type: none"> Section 2.8 Levelness of flooring <p>This is a defect because the floor levels exceed the maximum deviation as intended by the manufacturer as outlined in Section 2.8 of the Guide to Standards and Tolerances 2017.</p> <p>Loss Suffered</p> <p>Loss suffered is cost of rectification.</p>	Further investigation required to identify the source of displacement in flooring.

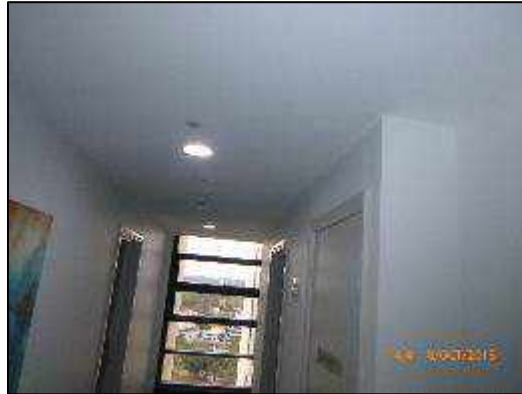
Item	Location	Defect description and Breach	Rectification	Photograph (if applicable)
2131	<i>Walls throughout level 16 lobby</i>	<p>Peaking of plasterboard was observed throughout wall.</p> <p>Home Building Act (NSW) 1989</p> <ul style="list-style-type: none"> Part 2C, 18B (a) and (c). <p>Guide to Standards and Tolerances 2017</p> <ul style="list-style-type: none"> Section 10.18 Peaking in plasterboard <p>This is a defect because the plasterboard was not set as intended by the manufacturer as outlined in Section 10.18 of the Guide to Standards and Tolerances 2017.</p> <p>Loss Suffered</p> <p>Loss suffered is cost of rectification.</p>	<ol style="list-style-type: none"> 1. Protect all adjoining surfaces. 2. Appropriately re-set the affected areas. 3. Repaint to match existing using suitable internal paint system in accordance with AS2311. 4. Clean up the work area.

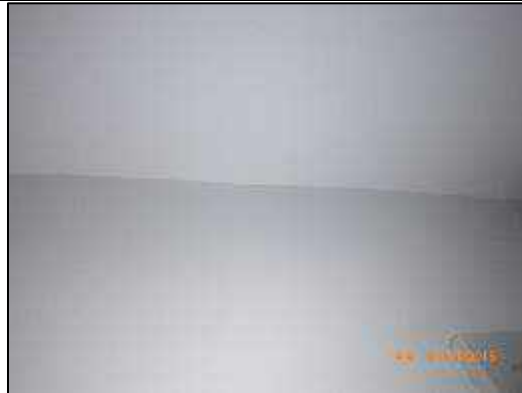
2132	<i>Wall and ceiling junction throughout level 16 lobby</i>	See section 5.10.1	See section 5.10.2

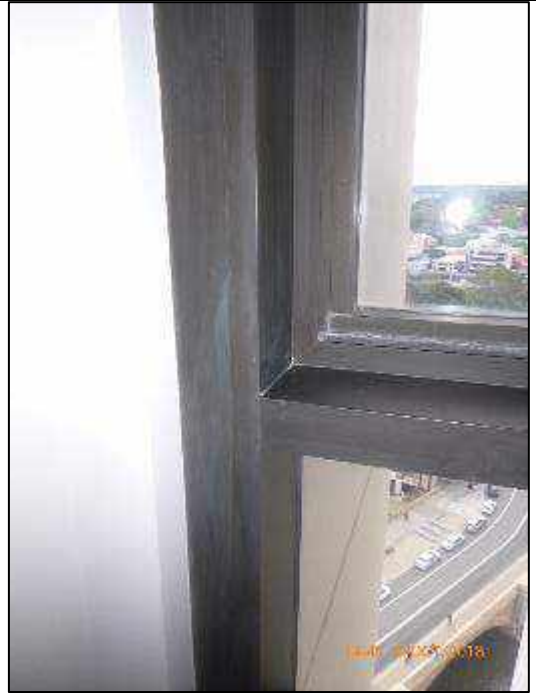
Item	Location	Defect description and Breach	Rectification	Photograph (if applicable)
2133	Western window frames	See section 5.9.1	See section 5.9.2

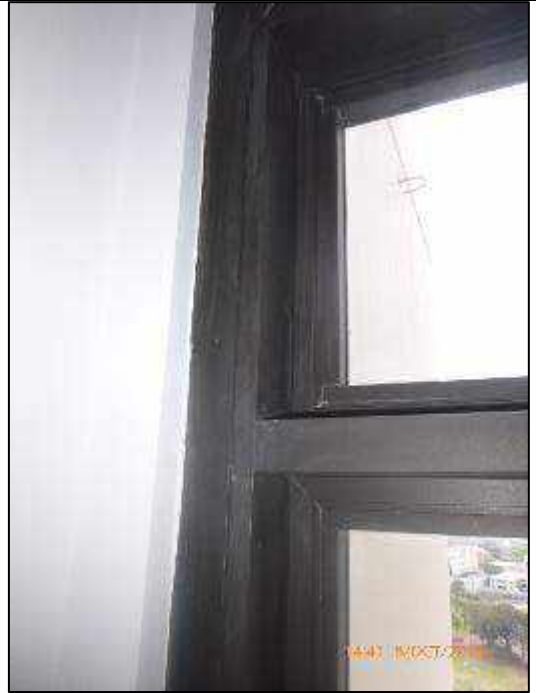
Item	Location	Defect description and Breach	Rectification	Photograph (if applicable)
2134	Western window frames	See section 5.7.1	See section 5.7.2

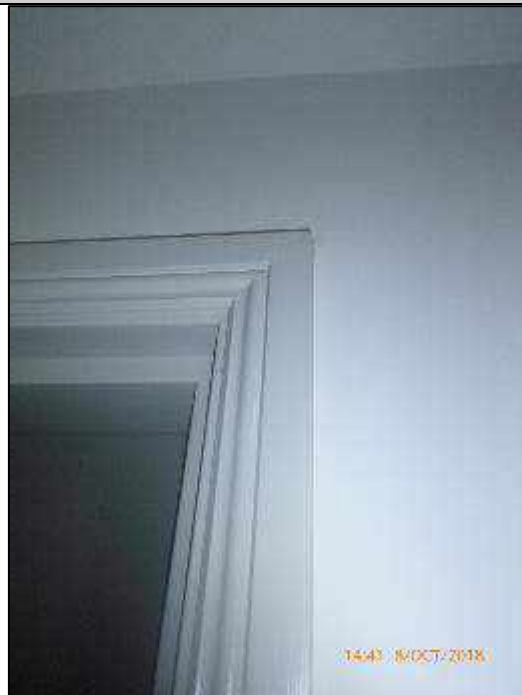
Item	Location	Defect description and Breach	Rectification	Photograph (if applicable)
2135	Architraves throughout level 16	<p>Nail fixing in architrave has not been filled prior to painting.</p> <p>Home Building Act (NSW) 1989</p> <ul style="list-style-type: none"> Part 2C, 18B (a) and (c). <p>This is a breach of part (a) of the act because the surface has not been finished in a proper workmanlike manner that would prevent loss of appearance to the surface.</p> <p>Guide to Standards and Tolerances 2017</p> <ul style="list-style-type: none"> Section 13.3 Nail and screw fixings <p>This is a defect because the nail penetration has not been filled as intended by the manufacturer as outlined in Section 13.3 of the Guide to Standards and Tolerances 2017.</p> <p>Loss Suffered</p> <p>Loss suffered is cost of rectification.</p>	<ol style="list-style-type: none"> 1. Protect all adjoining surfaces. 2. Appropriately fix/replace architrave to around door. 3. Repaint to match existing using suitable internal paint system in accordance with AS2311. 4. Clean up the work area.

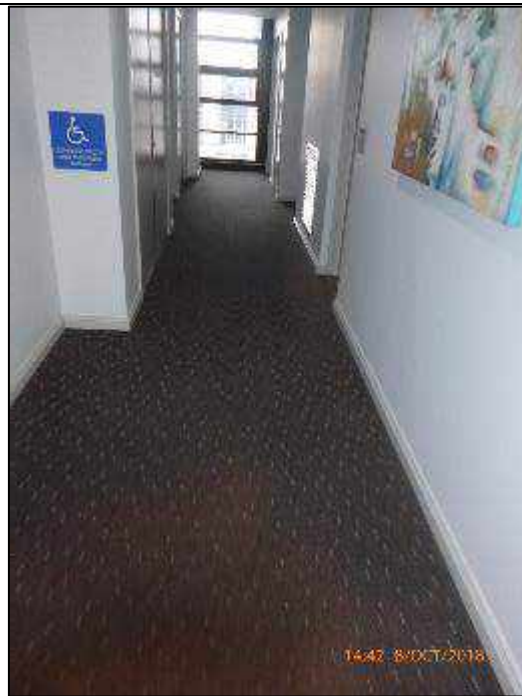
2137	Level 16 eastern lobby	<p>Concrete substrate appears to be not level. Displacement of substrate was measured to be greater than 4mm/2000mm.</p> <p>Home Building Act (NSW) 1989</p> <ul style="list-style-type: none"> Part 2C, 18B (a) and (c). <p>Guide to Standards and Tolerances 2017</p> <ul style="list-style-type: none"> Section 2.8 Levelness of flooring <p>This is a defect because the floor levels exceed the maximum deviation as intended by the manufacturer as outlined in Section 2.8 of the Guide to Standards and Tolerances 2017.</p> <p>Loss Suffered</p> <p>Loss suffered is cost of rectification.</p>	Further investigation required to identify the source of displacement in flooring.

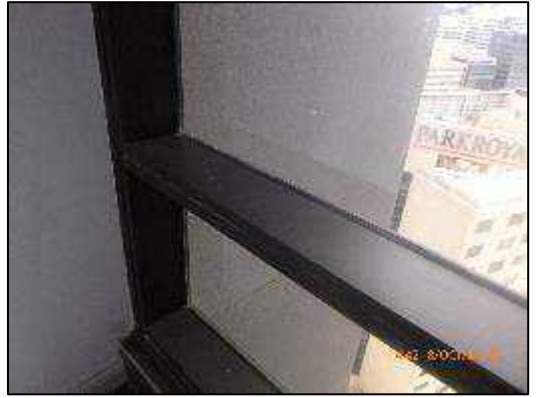
Item	Location	Defect description and Breach	Rectification	Photograph (if applicable)
2138	Eastern window frames	See section 5.8.1	See section 5.8.2

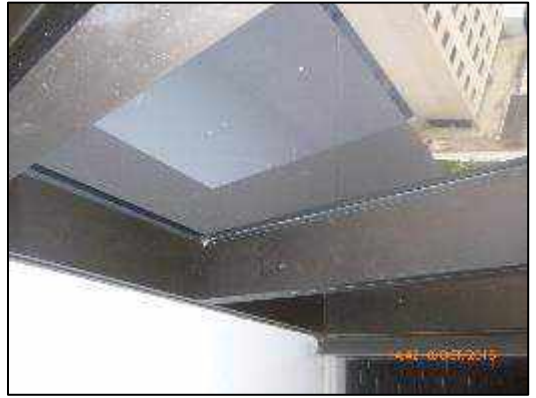
A photograph showing a close-up of a dark-colored window frame. The frame appears to be made of metal or wood and is set into a light-colored wall. The window is slightly open, and a view of a city street with buildings is visible through the glass. The text 'PARKROYAL' is visible on a building in the background. A timestamp '2012/05/24 14:00' is visible in the bottom right corner of the photo.
2139	Eastern window frames	See section 5.7.1	See section 5.7.2

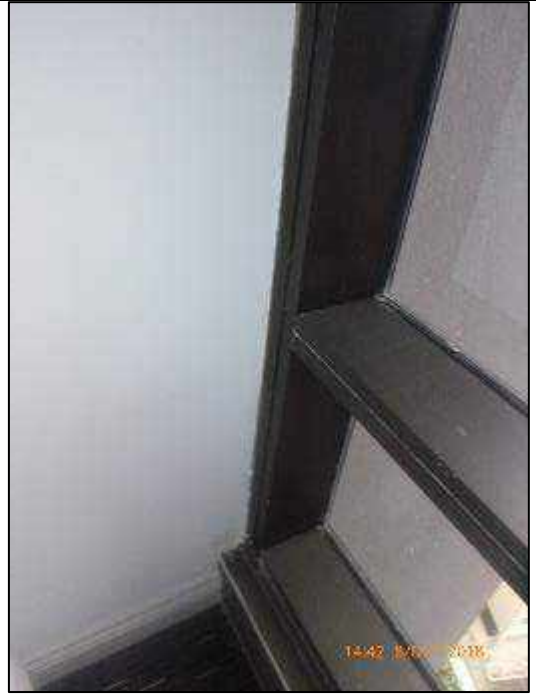
Item	Location	Defect description and Breach	Rectification	Photograph (if applicable)
2140	Eastern window frames northern elevation wall	See section 5.9.1	See section 5.9.2

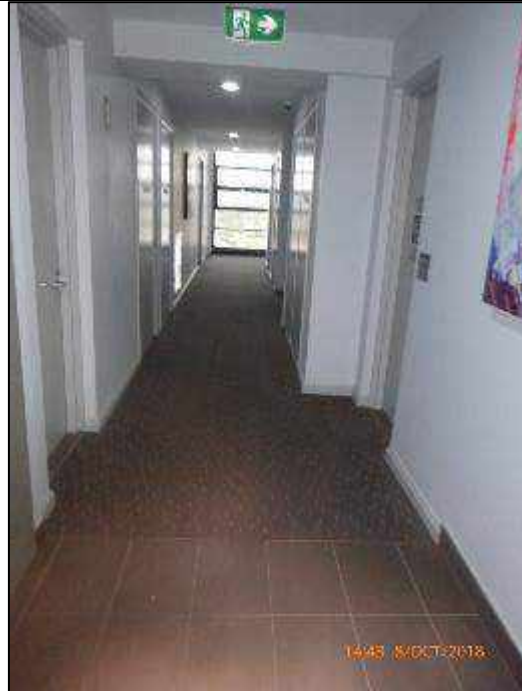
Item	Location	Defect description and Breach	Rectification	Photograph (if applicable)
Common areas – Level 17				
2141	Level 17 western lobby	<p>Concrete substrate appears to be not level. Displacement of substrate was measured to be greater than 4mm/2000mm.</p> <p>Home Building Act (NSW) 1989</p> <ul style="list-style-type: none"> Part 2C, 18B (a) and (c). <p>Guide to Standards and Tolerances 2017</p> <ul style="list-style-type: none"> Section 2.8 Levelness of flooring <p>This is a defect because the floor levels exceed the maximum deviation as intended by the manufacturer as outlined in Section 2.8 of the Guide to Standards and Tolerances 2017.</p> <p>Loss Suffered</p> <p>Loss suffered is cost of rectification.</p>	Further investigation required to identify the source of displacement in flooring.

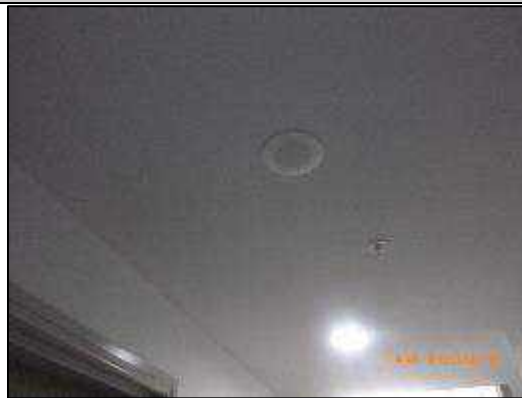
Item	Location	Defect description and Breach	Rectification	Photograph (if applicable)
2142	Ceiling adjacent to unit 1701	<p>Peaking of plasterboard was observed throughout wall.</p> <p>Home Building Act (NSW) 1989</p> <ul style="list-style-type: none"> Part 2C, 18B (a) and (c). <p>Guide to Standards and Tolerances 2017</p> <ul style="list-style-type: none"> Section 10.18 Peaking in plasterboard <p>This is a defect because the plasterboard was not set as intended by the manufacturer as outlined in Section 10.18 of the Guide to Standards and Tolerances 2017.</p> <p>Loss Suffered</p> <p>Loss suffered is cost of rectification.</p>	<ol style="list-style-type: none"> 1. Protect all adjoining surfaces. 2. Appropriately re-set the affected areas. 3. Repaint to match existing using suitable internal paint system in accordance with AS2311. 4. Clean up the work area.

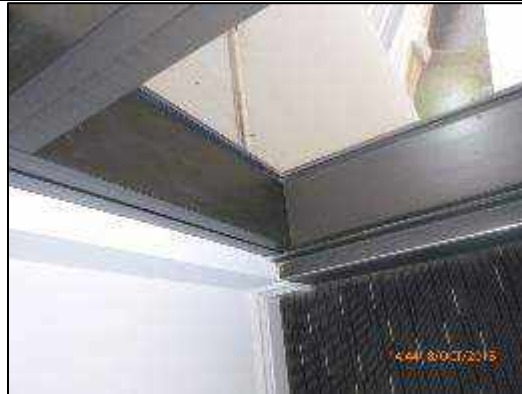
Item	Location	Defect description and Breach	Rectification	Photograph (if applicable)
2145	Wall adjacent to western window frames	See section 5.13.1	See section 5.13.2

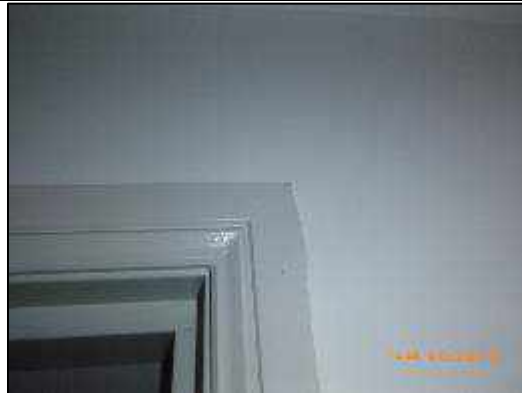
2146	Architraves throughout level 17	<p>Nail fixing in architrave has not been filled prior to painting.</p> <p>Home Building Act (NSW) 1989</p> <ul style="list-style-type: none"> Part 2C, 18B (a) and (c). <p>This is a breach of part (a) of the act because the surface has not been finished in a proper workmanlike manner that would prevent loss of appearance to the surface.</p> <p>Guide to Standards and Tolerances 2017</p> <ul style="list-style-type: none"> Section 13.3 Nail and screw fixings <p>This is a defect because the nail penetration has not been filled as intended by the manufacturer as outlined in Section 13.3 of the Guide to Standards and Tolerances 2017.</p> <p>Loss Suffered</p>	<ol style="list-style-type: none"> 1. Protect all adjoining surfaces. 2. Appropriately fix/replace architrave to around door. 3. Repaint to match existing using suitable internal paint system in accordance with AS2311. 4. Clean up the work area.

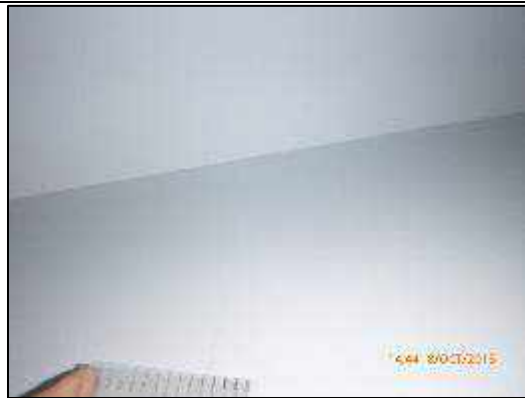
Item	Location	Defect description and Breach	Rectification	Photograph (if applicable)
		Loss suffered is cost of rectification.		
2147	Wall adjacent to telecommunications room	See section 5.14.1 Separation; 1mm	See section 5.14.2

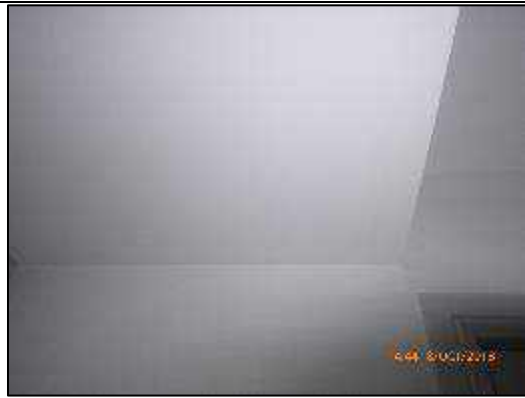
2148	Wall adjacent to unit 1703 storage room sheet joint	See section 5.14.1	See section 5.14.2

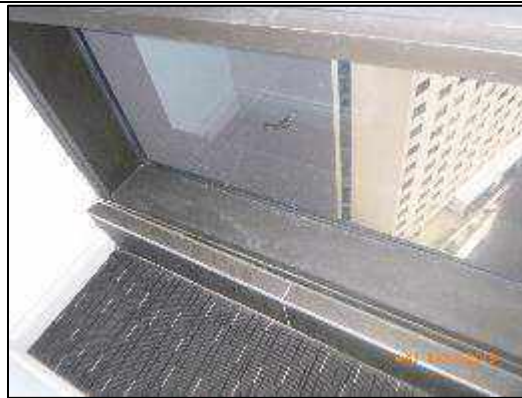
Item	Location	Defect description and Breach	Rectification	Photograph (if applicable)
2149	Level 17 eastern lobby	<p>Concrete substrate appears to be not level. Displacement of substrate was measured to be greater than 4mm/2000mm.</p> <p>Home Building Act (NSW) 1989</p> <ul style="list-style-type: none"> Part 2C, 18B (a) and (c). <p>Guide to Standards and Tolerances 2017</p> <ul style="list-style-type: none"> Section 2.8 Levelness of flooring <p>This is a defect because the floor levels exceed the maximum deviation as intended by the manufacturer as outlined in Section 2.8 of the Guide to Standards and Tolerances 2017.</p> <p>Loss Suffered Loss suffered is cost of rectification.</p>	Further investigation required to identify the source of displacement in flooring.	 
2150	Eastern window frames	See section 5.9.1	See section 5.9.2

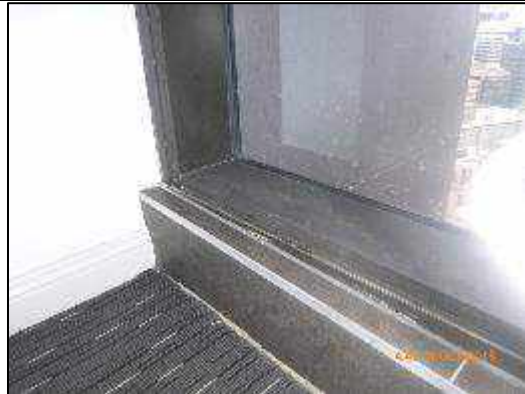
Item	Location	Defect description and Breach	Rectification	Photograph (if applicable)
2151	Eastern window frames	<p>Final clean of grout under eastern windows has not been undertaken.</p> <p>Home Building Act (NSW) 1989</p> <ul style="list-style-type: none"> Part 2C, 18B (a) and (c). <p>This is a breach of part (a) of the act because the surface has not been finished in a proper workmanlike manner that would prevent loss of appearance to the surface.</p> <p>Loss Suffered</p> <p>Loss suffered is cost of rectification.</p>	<ol style="list-style-type: none"> 1. Protect all adjoining surfaces. 2. Use a suitable cleaning agent to remove residue and clear debris. 3. Clean up the work area.

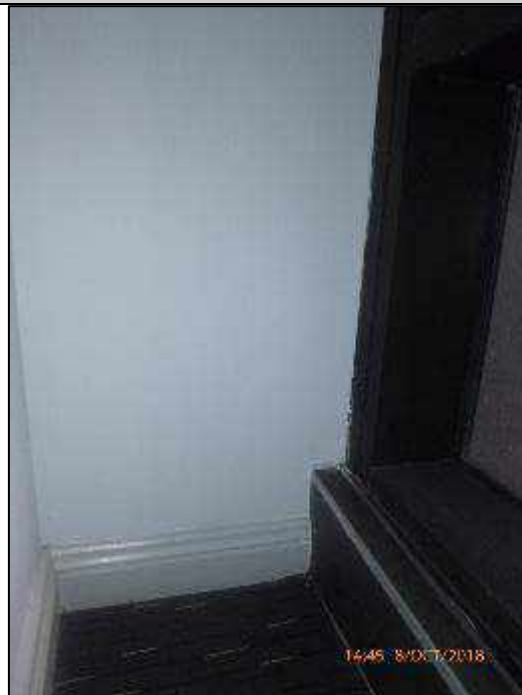
Item	Location	Defect description and Breach	Rectification	Photograph (if applicable)
2152	Wall adjacent of eastern window frames	See section 5.13.1	See section 5.13.2

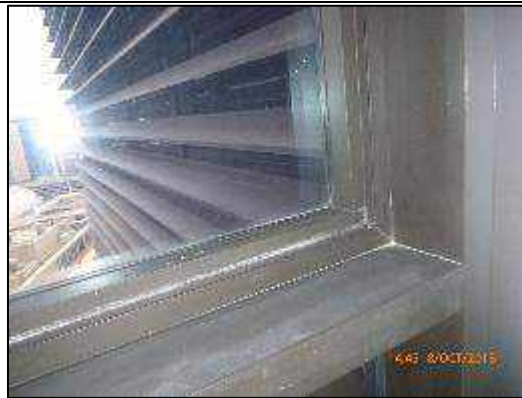
2153	Eastern window frames	See section 5.7.1	See section 5.7.2

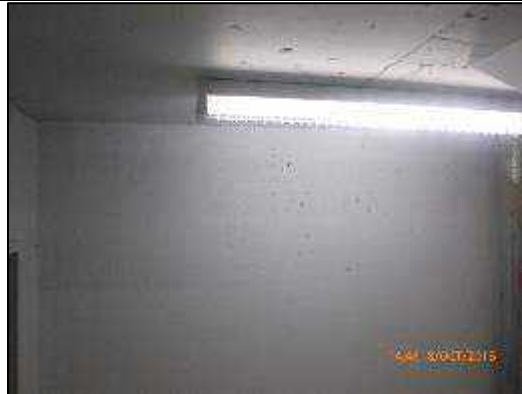
Item	Location	Defect description and Breach	Rectification	Photograph (if applicable)
Common areas – Fire stairs				
2154	Level 17 eastern fire stairs	<p>Honeycombing observed throughout fire stairs</p> <p>Home Building Act (NSW) 1989</p> <ul style="list-style-type: none"> Part 2C, 18B (a) & (c). <p>AS 3600 – 2009 – Concrete Structures</p> <p>4.10 REQUIREMENTS FOR COVER TO REINFORCING STEEL AND TENDONS</p> <p>4.10.1 General</p> <p>The cover to reinforcing steel and tendons shall be the greatest of the values determined from Clauses 4.8, 4.10.2 and 4.10.3, as appropriate, unless exceeded by the requirements for fire resistance given in Section 5.</p> <p>Loss Suffered</p> <p>Loss suffered is cost of rectification.</p>	<ol style="list-style-type: none"> 1. Protect all surrounding surfaces 2. Break away all drummy concrete 3. Install high-build mortar in accordance with manufacturers recommendation to match existing profile

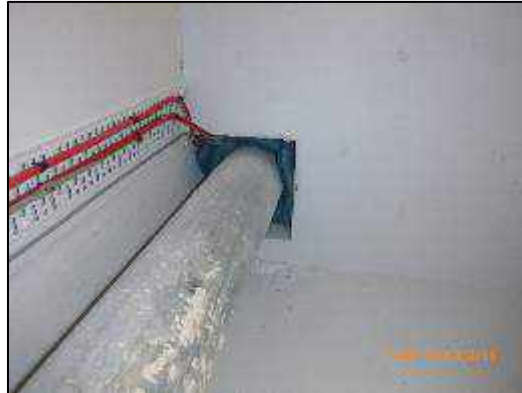
2155	Level 17 eastern fire stairs	<p>Piping penetration through slab.</p> <p>Home Building Act (NSW) 1989</p> <ul style="list-style-type: none"> Part 2C, 18B (a) & (c). <p>Loss Suffered</p> <p>Loss suffered is cost of rectification.</p>	<p>Engage a fire engineer to certify penetration is in accordance with relevant standards.</p>

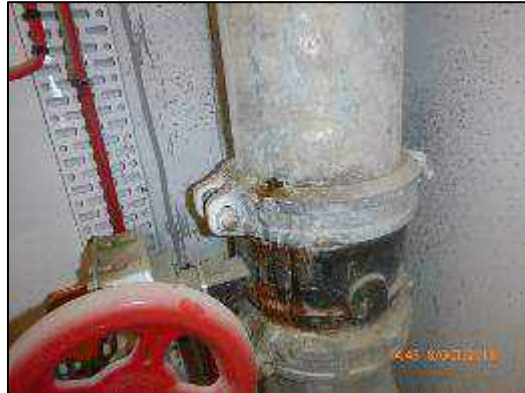
Item	Location	Defect description and Breach	Rectification	Photograph (if applicable)
2156	Level 12 eastern fire stairs	<p>Active leak observed in hydrant pipe.</p> <p>Home Building Act (NSW) 1989</p> <ul style="list-style-type: none"> Part 2C, 18B (a) & (c). <p>Loss Suffered Loss suffered is cost of rectification.</p>	Engage plumber to repair the leak appropriately.

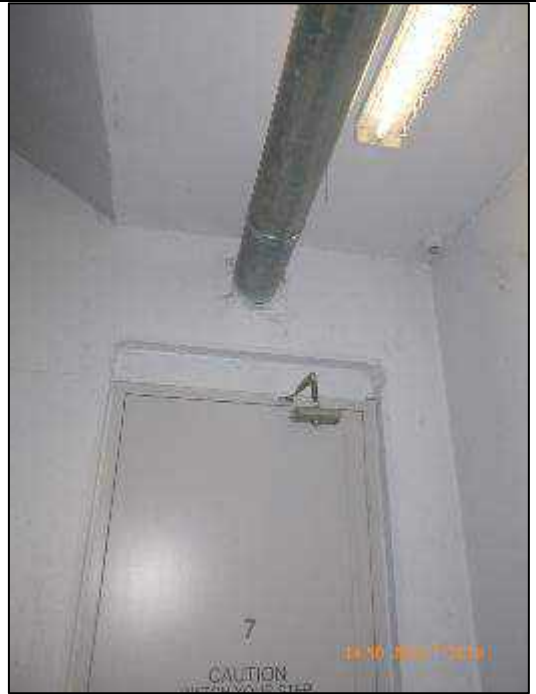
2157	Level 7 eastern fire stairs	<p>Piping penetration through wall.</p> <p>Home Building Act (NSW) 1989</p> <ul style="list-style-type: none"> Part 2C, 18B (a) & (c). <p>Loss Suffered</p> <p>Loss suffered is cost of rectification.</p>	<p>Engage a fire engineer to certify penetration is in accordance with relevant standards.</p>

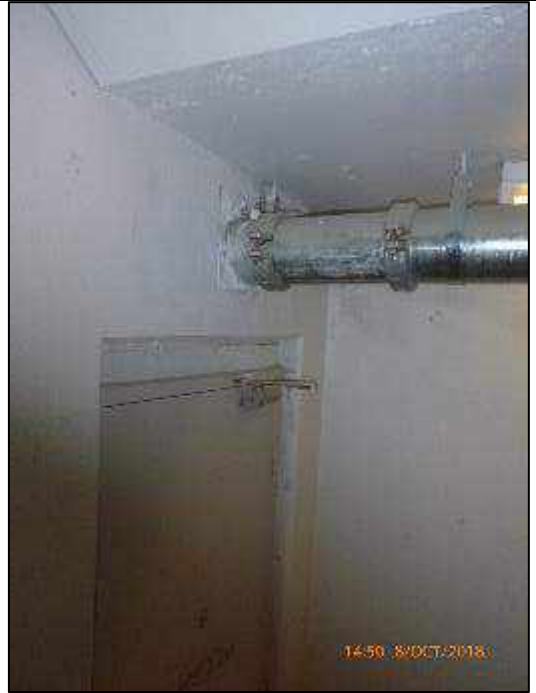
Item	Location	Defect description and Breach	Rectification	Photograph (if applicable)
2158	Level 6 eastern fire stairs	<p>Piping penetration through wall.</p> <p>Home Building Act (NSW) 1989</p> <ul style="list-style-type: none"> Part 2C, 18B (a) & (c). <p>Loss Suffered</p> <p>Loss suffered is cost of rectification.</p>	Engage a fire engineer to certify penetration is in accordance with relevant standards.

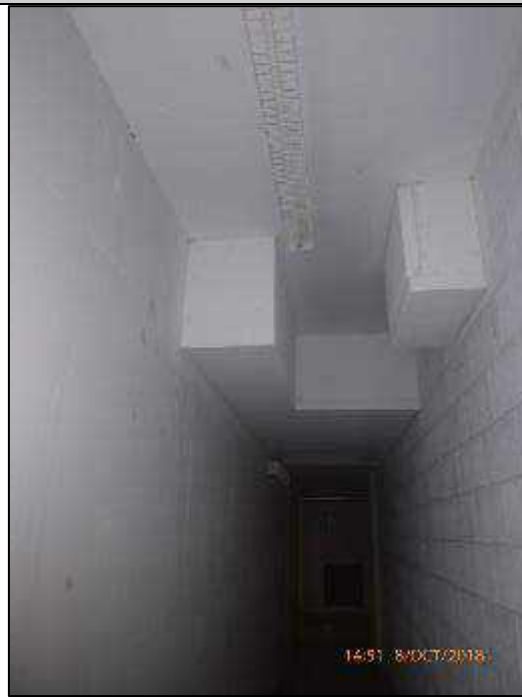
Item	Location	Defect description and Breach	Rectification	Photograph (if applicable)
2159	Level 3 eastern fire stairs	<p>Lights were observed to be non-functional.</p> <p>Home Building Act (NSW) 1989</p> <ul style="list-style-type: none"> Part 2C, 18B (a) and (c). <p>Guide to Standards and Tolerances 2017</p> <ul style="list-style-type: none"> Section 16.1 Electrical <p>This is a defect because the lights do not work as intended by the manufacturer as outlined in Section 16.1 of the Guide to Standards and Tolerances 2017.</p> <p>Loss Suffered</p> <p>Loss suffered is cost of rectification.</p>	Engage an electrician to fix/replace lighting in accordance with fire engineer's specifications.

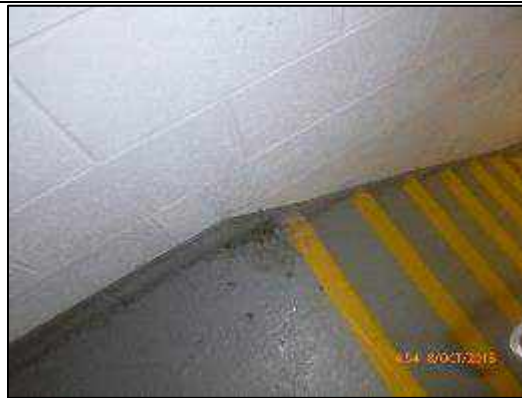
2160	Ground level stair landing in eastern fire stairs	<p>Poorly finished concrete surface observed.</p> <p>Home Building Act (NSW) 1989</p> <ul style="list-style-type: none"> Part 2C, 18B (a) and (c). <p>Guide to Standards and Tolerances 2017</p> <ul style="list-style-type: none"> Section 2.11 Finish to concrete slabs <p>This is a defect because the concrete slab has not been finished as intended by the manufacturer as outlined in Section 2.11</p>	Engage a qualified tradesman to grind back the uneven concrete surface in accordance with AS3600 and manufacturers specifications.

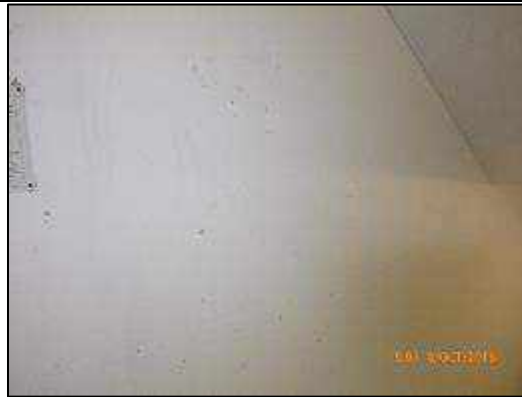
Item	Location	Defect description and Breach	Rectification	Photograph (if applicable)
		<p>of the Guide to Standards and Tolerances 2017.</p> <p>Loss Suffered Loss suffered is cost of rectification.</p>		
2161	Level 17 western fire stairs	<p>Honeycombing observed throughout fire stairs</p> <p>Home Building Act (NSW) 1989</p> <ul style="list-style-type: none"> Part 2C, 18B (a) & (c). <p>AS 3600 – 2009 – Concrete Structures 4.10 REQUIREMENTS FOR COVER TO REINFORCING STEEL AND TENDONS 4.10.1 General The cover to reinforcing steel and tendons shall be the greatest of the values determined from Clauses 4.8, 4.10.2 and 4.10.3, as appropriate, unless exceeded by the requirements for fire resistance given in Section 5.</p> <p>Loss Suffered Loss suffered is cost of rectification.</p>	<ol style="list-style-type: none"> 1. Protect all surrounding surfaces 2. Break away all drummy concrete 3. Install high-build mortar in accordance with manufacturers recommendation to match existing profile

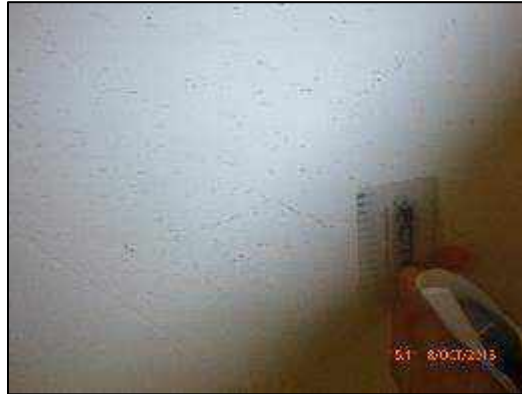
Item	Location	Defect description and Breach	Rectification	Photograph (if applicable)
2162	Level 10 western fire stairs	See section 5.14.1 Separation; 1.5mm	See section 5.14.2

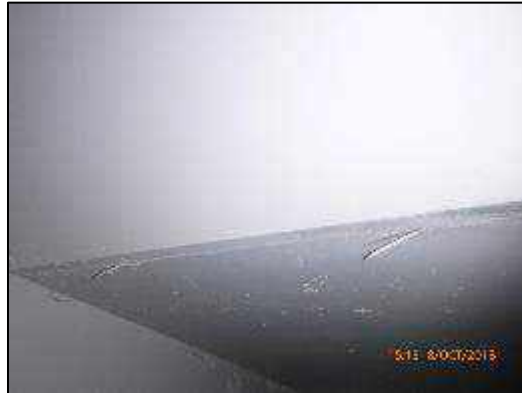
2163	Ground level western fire stairs	Exposed polystyrene boards creating a flammable hazard. Home Building Act (NSW) 1989 <ul style="list-style-type: none">Part 2C, 18B (a), (B) and (c). Building Code of Australia (BCA), Volume 1 <ul style="list-style-type: none">Section C Fire ResistancePart CO1Performance Requirements CP2 & CP7. This is a breach of the BCA as it requires the avoidance of the spread of fire. Loss Suffered Loss suffered is cost of rectification.	Install suitable fire-resistant plasterboard enclosure over the polystyrene boards to achieve required fire resistance and compliance with BCA requirements or remove the polystyrene boards if appropriate.

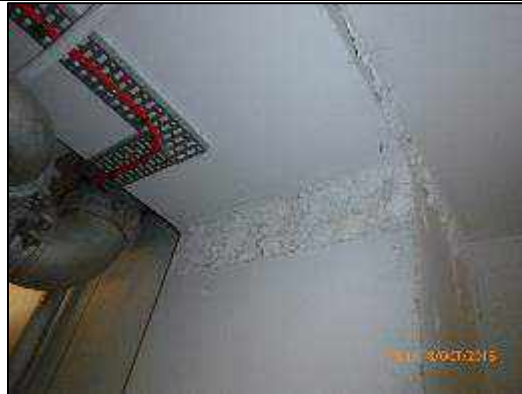
Item	Location	Defect description and Breach	Rectification	Photograph (if applicable)
2164	Ground level western fire stairs	<p>Poorly finished concrete on ground level fire stairs.</p> <p>Home Building Act (NSW) 1989</p> <ul style="list-style-type: none"> Part 2C, 18B (a) & (c). <p>Guide to Standards and Tolerances 2007</p> <p>Crack categories are assessed in accordance with Section 3.02.</p> <p>Cracks are classed as exceeding Category 2.</p> <p>Category 2 damage cracks are considered a defect and require repair work.</p> <p>AS2870-2011 Residential footings and slabs</p> <p>Crack categories are assessed in accordance with Table C1</p> <p>CLASSIFICATION OF DAMAGE WITH REFERENCE TO WALLS</p> <p>Cracks exceed Category 2 damage.</p> <p>Loss Suffered</p> <p>Loss suffered is cost of rectification.</p>	<ol style="list-style-type: none"> 1. Protect all surrounding surfaces 2. Hold Point Engineer to inspect. 3. Contractor to install Helifix Bars are required 4. Repair area to match existing

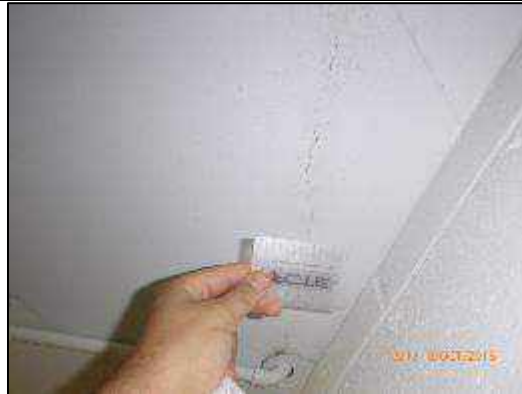
Item	Location	Defect description and Breach	Rectification	Photograph (if applicable)
2165	Ground level western fire stairs adjacent to lighting conduit	See section 5.14.1 Separation; 1mm	See section 5.14.2

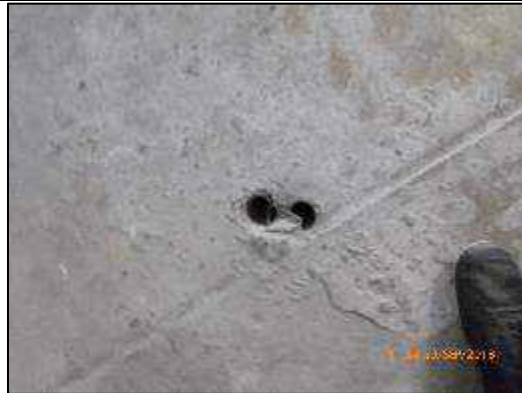
Common areas – P4 carpark				
2166	Soffit of P4 carpark	<p>Embedment left in soffit of slab. Approximately 100 embedments observed throughout P4 carpark.</p> <p>Home Building Act (NSW) 1989</p> <ul style="list-style-type: none"> Part 2C, 18B (a) & (c). <p>AS 3600 – 2009 – Concrete Structures 4.10 REQUIREMENTS FOR COVER TO REINFORCING STEEL AND TENDONS 4.10.1 General The cover to reinforcing steel and tendons shall be the greatest of the values determined from Clauses 4.8, 4.10.2 and 4.10.3, as appropriate, unless exceeded by the requirements for fire resistance given in Section 5.</p> <p>Loss Suffered</p>	<ol style="list-style-type: none"> 1. Protect all surrounding surfaces 2. Remove corroded embedment 3. Break away all drummy concrete 4. Install high-build mortar in accordance with manufacturers recommendation to match existing profile

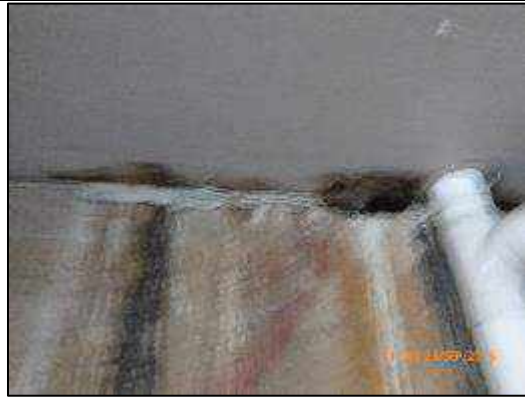
Item	Location	Defect description and Breach	Rectification	Photograph (if applicable)
		Loss suffered is cost of rectification.		
2167	P4 carpark wall	See section 5.14.1 Separation; 2mm	See section 5.14.2

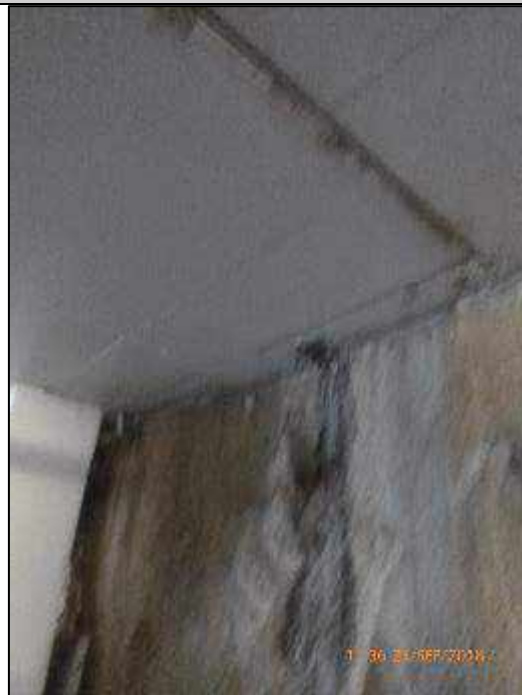
Item	Location	Defect description and Breach	Rectification	Photograph (if applicable)
2168	P4 carpark soffit of slab	<p>Uneven concrete surface on soffit above carpark of unit 407. Displacement of substrate was measured to be greater than 3mm/2000mm.</p> <p>Home Building Act (NSW) 1989</p> <ul style="list-style-type: none"> Part 2C, 18B (a) and (c). <p>Guide to Standards and Tolerances 2017</p> <ul style="list-style-type: none"> Section 3.04 Tolerances in masonry construction. <p>This is a defect because the soffit levels exceed the maximum deviation as intended by the manufacturer as outlined in Section 3.04 of the Guide to Standards and Tolerances 2017.</p> <p>Loss Suffered Loss suffered is cost of rectification.</p>	Engage a qualified tradesman to grind back the uneven concrete surface in accordance with AS3600 and manufacturers specifications.

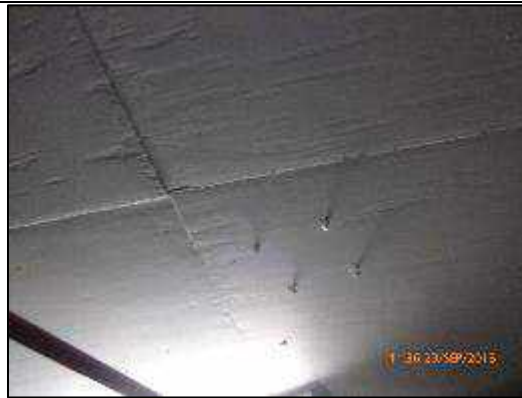
2169	P4 carpark soffit of slab	<p>Construction debris observed in soffit of slab adjacent to carpark 407.</p> <p>Home Building Act (NSW) 1989</p> <ul style="list-style-type: none"> Part 2C, 18B (a) and (c). <p>This is a breach of part (a) of the act because the surface has not been finished in a proper workmanlike manner that would prevent loss of appearance to the surface.</p>	<ol style="list-style-type: none"> 1. Protect all adjoining surfaces. 2. Use a suitable cleaning agent to remove residue and clear debris. 3. Clean up the work area.

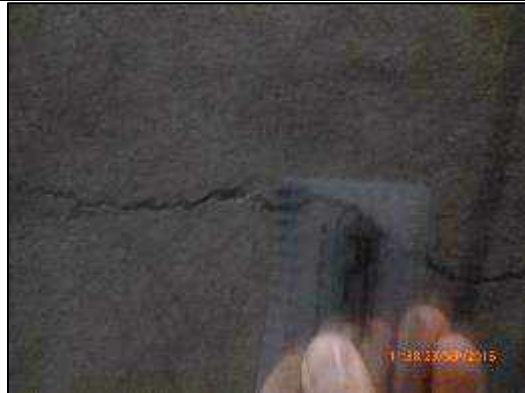
Item	Location	Defect description and Breach	Rectification	Photograph (if applicable)
		Loss Suffered Loss suffered is cost of rectification.		
2170	Wall adjacent to sprinkler above fire hydrant room.	See section 5.14.1 Separation; 1mm	See section 5.14.2

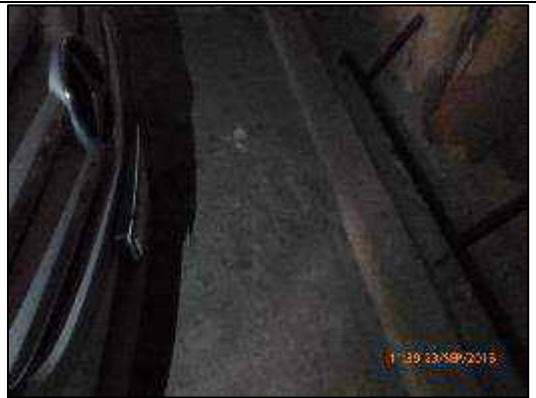
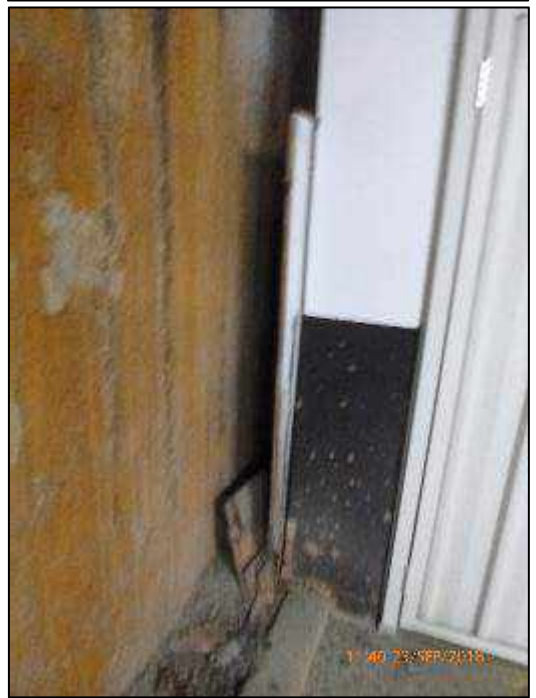
2171	Perimeter of P4 carpark	<p>Exposed reinforcement observed throughout perimeter of P4 carpark.</p> <p>Home Building Act (NSW) 1989</p> <ul style="list-style-type: none"> Part 2C, 18B (a) & (c). <p>AS 3600 – 2009 – Concrete Structures</p> <p>4.10 REQUIREMENTS FOR COVER TO REINFORCING STEEL AND TENDONS</p> <p>4.10.1 General</p> <p>The cover to reinforcing steel and tendons shall be the greatest of the values determined from Clauses 4.8, 4.10.2 and 4.10.3, as appropriate, unless exceeded by the requirements for fire resistance given in Section 5.</p> <p>Loss Suffered</p> <p>Loss suffered is cost of rectification.</p>	<ol style="list-style-type: none"> 1. Protect all surrounding surfaces 2. Remove corroded embedment 3. Break away all drummy concrete 4. Install high-build mortar in accordance with manufacturers recommendation to match existing profile

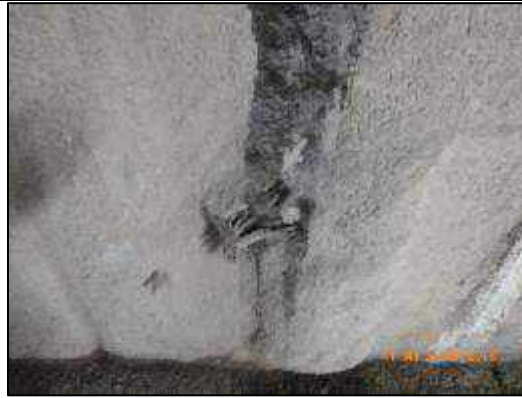
2172	Western wall of P4 carpark adjacent to fire exit stairs.	<p>No fire collar observed on piping through blockwork.</p> <p>Home Building Act (NSW) 1989</p> <ul style="list-style-type: none"> Part 2C, 18B (a), (B) and (c). <p>Building Code of Australia (BCA), Volume 1</p> <ul style="list-style-type: none"> Section C Fire Resistance Part CO1 Performance Requirements CF2 & CP8. <p>This is a breach of the BCA as it requires suitable fire resistant elements to prevent spread of fire between separate levels</p> <p>Loss Suffered Loss suffered is cost of rectification.</p>	Provide suitable complying fire collars where fitment is achievable or install suitable fire resistant plasterboard enclosure around the pipe penetrations to achieve required fire separation levels and compliance with BCA requirements.

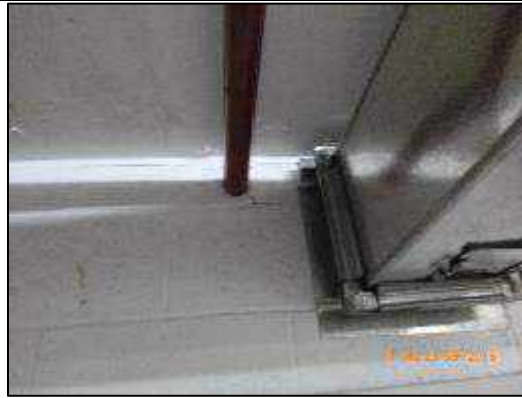
Item	Location	Defect description and Breach	Rectification	Photograph (if applicable)
2173	Concrete floor surface between car spots 306 and 3703.	<p>Poorly finished concrete surface observed.</p> <p>Home Building Act (NSW) 1989</p> <ul style="list-style-type: none"> Part 2C, 18B (a) and (c). <p>Guide to Standards and Tolerances 2017</p> <ul style="list-style-type: none"> Section 2.11 Finish to concrete slabs <p>This is a defect because the concrete slab has not been finished as intended by the manufacturer as outlined in Section 2.11 of the Guide to Standards and Tolerances 2017.</p> <p>Loss Suffered</p> <p>Loss suffered is cost of rectification.</p>	Engage a qualified tradesman to grind back the uneven concrete surface in accordance with AS3600 and manufacturers specifications.

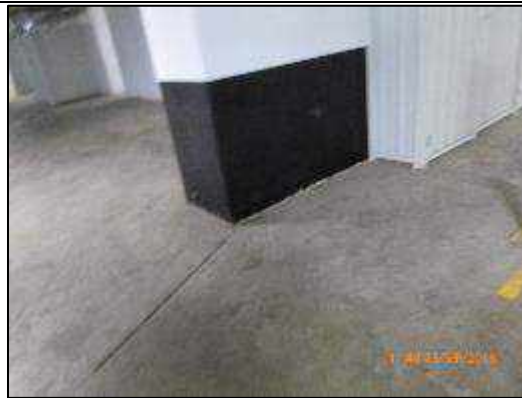
Item	Location	Defect description and Breach	Rectification	Photograph (if applicable)
		<p>of the Guide to Standards and Tolerances 2017.</p> <p>Loss Suffered Loss suffered is cost of rectification.</p>		
2176	Concrete floor surface at shed for units 904 and 1104.	<p>Poorly finished concrete surface observed.</p> <p>Home Building Act (NSW) 1989</p> <ul style="list-style-type: none"> Part 2C, 18B (a) and (c). <p>Guide to Standards and Tolerances 2017</p> <ul style="list-style-type: none"> Section 2.11 Finish to concrete slabs <p>This is a defect because the concrete slab has not been finished as intended by the manufacturer as outlined in Section 2.11 of the Guide to Standards and Tolerances 2017.</p> <p>Loss Suffered Loss suffered is cost of rectification.</p>	Engage a qualified tradesman to grind back the uneven concrete surface in accordance with AS3600 and manufacturers specifications.

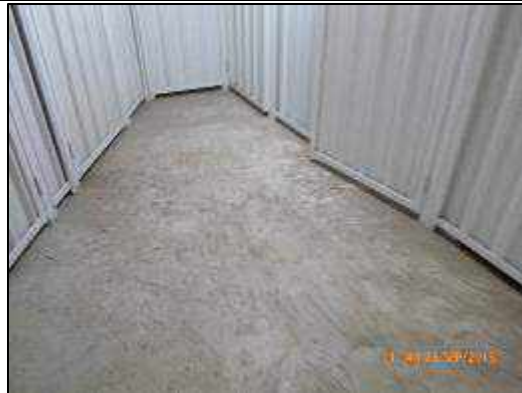
Item	Location	Defect description and Breach	Rectification	Photograph (if applicable)
2179	P4 carpark soffit of slab in unit 2008.	<p>Epoxy crack injection residue left in soffit of slab.</p> <p>Home Building Act (NSW) 1989</p> <ul style="list-style-type: none"> Part 2C, 18B (a) and (c). <p>This is a breach of part (a) of the act because the surface has not been finished in a proper workmanlike manner that would prevent loss of appearance to the surface.</p> <p>Loss Suffered</p> <p>Loss suffered is cost of rectification.</p>	<ol style="list-style-type: none"> 1. Protect all adjoining surfaces. 2. Use a suitable cleaning agent to remove residue and clear debris. 3. Clean up the work area.

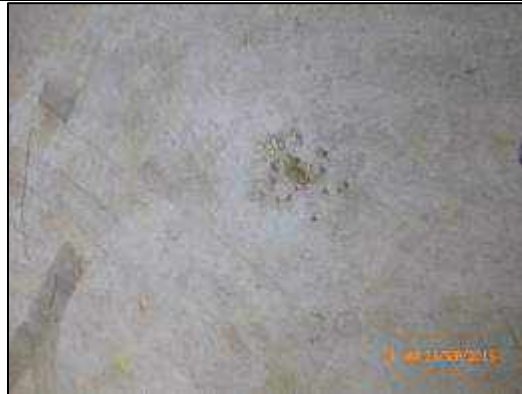
2180	Soffit of slab above carpark 1106.	<p>Uneven concrete surface on soffit above carpark of unit 1106. Displacement of substrate was measured to be greater than 3mm/2000mm.</p> <p>Home Building Act (NSW) 1989</p> <ul style="list-style-type: none"> Part 2C, 18B (a) and (c). <p>Guide to Standards and Tolerances 2017</p> <ul style="list-style-type: none"> Section 3.04 Tolerances in masonry construction. <p>This is a defect because the soffit levels exceed the maximum deviation as intended by the manufacturer as outlined in Section 3.04 of the Guide to Standards and Tolerances 2017.</p>	<p>Engage a qualified tradesman to grind back the uneven concrete surface in accordance with AS3600 and manufacturers specifications.</p>

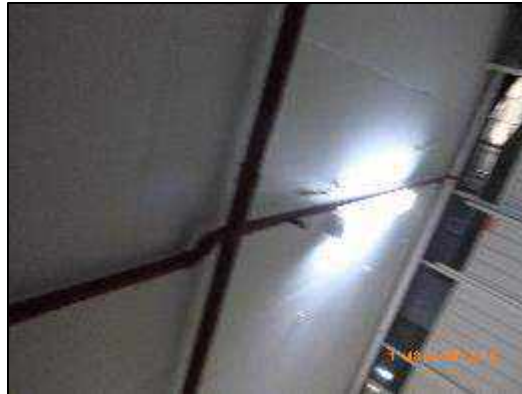
Item	Location	Defect description and Breach	Rectification	Photograph (if applicable)
		Loss Suffered Loss suffered is cost of rectification.		
2181	Cage of carpark 1707	<p>Corroded embedments observed in cage of carpark 1707.</p> <p>Home Building Act (NSW) 1989</p> <ul style="list-style-type: none"> Part 2C, 18B (a) & (c). <p>AS 3600 – 2009 – Concrete Structures</p> <p>4.10 REQUIREMENTS FOR COVER TO REINFORCING STEEL AND TENDONS</p> <p>4.10.1 General</p> <p>The cover to reinforcing steel and tendons shall be the greatest of the values determined from Clauses 4.8, 4.10.2 and 4.10.3, as appropriate, unless exceeded by the requirements for fire resistance given in Section 5.</p> <p>Loss Suffered Loss suffered is cost of rectification.</p>	<ol style="list-style-type: none"> 1. Protect all surrounding surfaces 2. Remove corroded embedment 3. Break away all drummy concrete 4. Install high-build mortar in accordance with manufacturers recommendation to match existing profile

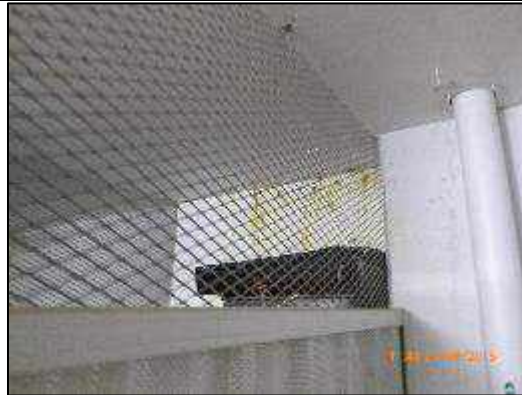
Item	Location	Defect description and Breach	Rectification	Photograph (if applicable)
2182	Perimeter wall of P4 carpark	<p>Corroded embedments throughout the perimeter of P4 carpark wall. Approximately 200 embedments observed.</p> <p>Home Building Act (NSW) 1989</p> <ul style="list-style-type: none"> Part 2C, 18B (a) & (c). <p>AS 3600 – 2009 – Concrete Structures</p> <p>4.10 REQUIREMENTS FOR COVER TO REINFORCING STEEL AND TENDONS</p> <p>4.10.1 General</p> <p>The cover to reinforcing steel and tendons shall be the greatest of the values determined from Clauses 4.8, 4.10.2 and 4.10.3, as appropriate, unless exceeded by the requirements for fire resistance given in Section 5.</p> <p>Loss Suffered</p> <p>Loss suffered is cost of rectification.</p>	<ol style="list-style-type: none"> 1. Protect all surrounding surfaces 2. Remove corroded embedment 3. Break away all drummy concrete 4. Install high-build mortar in accordance with manufacturers recommendation to match existing profile

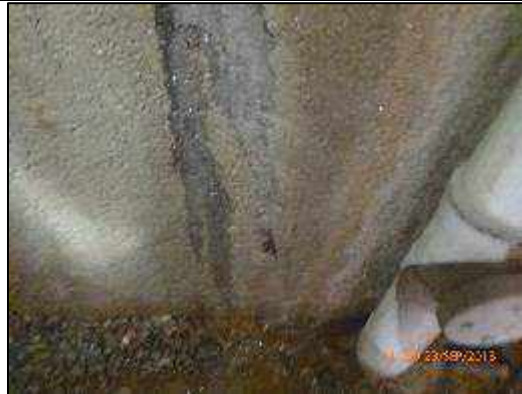
Item	Location	Defect description and Breach	Rectification	Photograph (if applicable)
2183	P4 carpark storage cage	<p>Uncontrolled water ingress into cage of carpark 1505.</p> <p>Home Building Act (NSW) 1989</p> <ul style="list-style-type: none"> Part 2C, 18B (a) and (c). <p>Building Code of Australia</p> <ul style="list-style-type: none"> Section F Damp and Weatherproofing Part F1 Damp and Weatherproofing Sections FO1 and FF1.2. <p>This is a breach because the building is not constructed in a manner so as to provide adequate weatherproofing of the buildings envelope.</p> <p>Loss Suffered</p> <p>Loss suffered is cost of rectification and potential loss of amenity.</p>	<ol style="list-style-type: none"> 1. Remove the existing failed waterproofing membrane from the source of the water to bare substrate. 2. Apply a new NCC BCA compliant waterproof membrane after leveling the concrete substrate. 3. Provide waterproofing certification. 4. Make good damaged area.

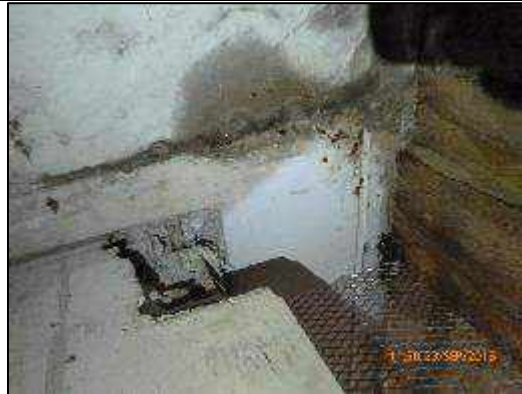
Item	Location	Defect description and Breach	Rectification	Photograph (if applicable)
2185	Storage cages of P4 carpark	<p>Missing concrete section in column between cages of units 2005 and 1505.</p> <p>Home Building Act (NSW) 1989</p> <ul style="list-style-type: none"> Part 2C, 18B (a) & (c). <p>Guide to Standards and Tolerances 2017</p> <p>Crack categories are assessed in accordance with Section 3.02.</p> <p>Cracks are classed as exceeding Category 2 damage.</p> <p>Category 2 damage cracks are considered a defect and require repair work.</p> <p>AS2870-2011 Residential footings and slabs</p> <p>Crack categories are assessed in accordance with Table C1</p> <p>CLASSIFICATION OF DAMAGE WITH REFERENCE TO WALLS</p> <p>Cracks exceed Category 2 damage.</p> <p>Loss Suffered</p> <p>Loss suffered is cost of rectification.</p>	<ol style="list-style-type: none"> 1. Protect all surrounding surfaces 2. Hold Point Engineer to inspect. 3. Contractor to install Helifix Bars as required. 4. Repair area to match existing

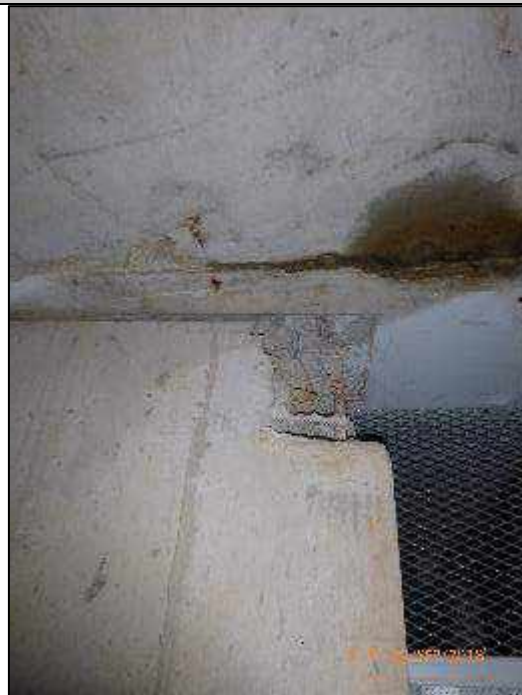
2186	Throughout carpark	P4	<p>Construction debris observed on columns of P4 carpark.</p> <p>Home Building Act (NSW) 1989</p> <ul style="list-style-type: none"> Part 2C, 18B (a) and (c). <p>This is a breach of part (a) of the act because the surface has not been finished in a proper workmanlike manner that would prevent loss of appearance to the surface.</p> <p>Loss Suffered Loss suffered is cost of rectification.</p>	<ol style="list-style-type: none"> 1. Protect all adjoining surfaces. 2. Use a suitable cleaning agent to remove residue and clear debris. 3. Clean up the work area.
