SydneyStrataReport

STRATA REPORT

Client	Church Street Parramatta Property Pty Ltd
Address of property	Unit 3303/330 Church Street, Parramatta, NSW.
Lot	359
Strata Plan	SP 94469
Name of Strata Management Co.	NSW Strata
Telephone Number of Strata Agent	8980 1841
Report Date	15 February 2024

BUILDING DEFECTS REPORT Part 1/2

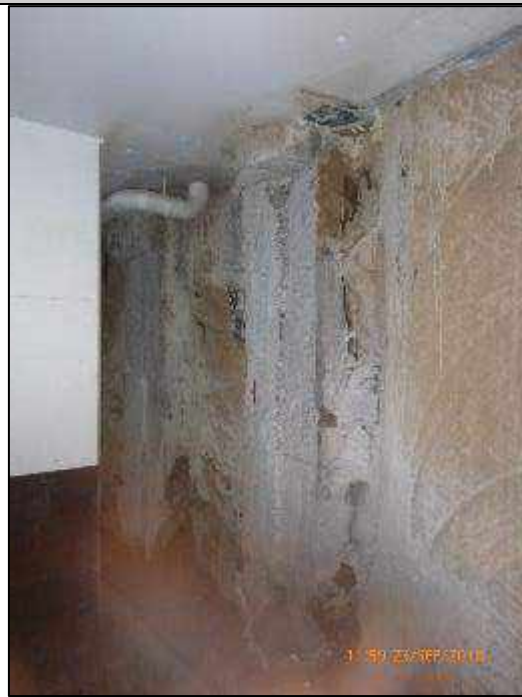
Item	Location	Defect description and Breach	Rectification	Photograph (if applicable)
2187	Throughout P4 carpark	<p>Formwork plywood boards have been left throughout P4 carpark walls. Approximately 15 boards observed throughout the carpark.</p> <p>Home Building Act (NSW) 1989</p> <ul style="list-style-type: none"> Part 2C, 18B (a) and (c). <p>This is a breach of part (a) of the act because the surface has not been finished in a proper workmanlike manner that would prevent loss of appearance to the surface.</p> <p>Loss Suffered Loss suffered is cost of rectification.</p>	<ol style="list-style-type: none"> 1. Protect all adjoining surfaces. 2. Use a suitable cleaning agent to remove residue and clear debris. 3. Clean up the work area.

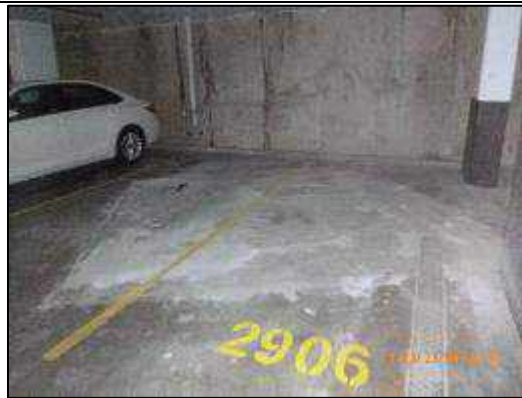
2188	P4 carpark flooring in unit 2906 carpark.	<p>Poorly finished concrete surface in carpark of unit 2906.</p> <p>Home Building Act (NSW) 1989</p> <ul style="list-style-type: none"> Part 2C, 18B (a) and (c). <p>Guide to Standards and Tolerances 2017</p> <ul style="list-style-type: none"> Section 2.11 Finish to concrete slabs <p>This is a defect because the concrete slab has not been finished as intended by the manufacturer as outlined in Section 2.11</p>	Engage a qualified tradesman to grind back the uneven concrete surface in accordance with AS3600 and manufacturers specifications.

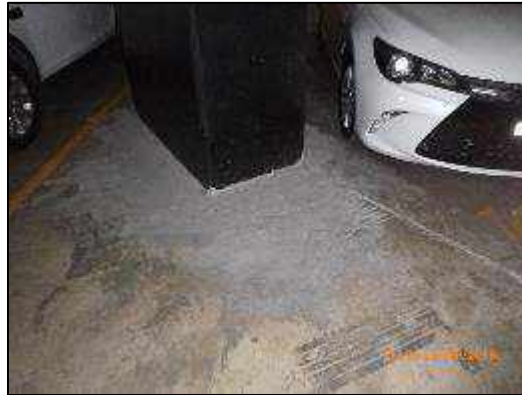
Item	Location	Defect description and Breach	Rectification	Photograph (if applicable)
		<p>of the Guide to Standards and Tolerances 2017.</p> <p>Loss Suffered Loss suffered is cost of rectification.</p>		
2189	P4 carpark flooring column base	<p>Poorly finished concrete base of column between carpark 1404 and 1307.</p> <p>Home Building Act (NSW) 1989</p> <ul style="list-style-type: none"> Part 2C, 18B (a) and (c). <p>Guide to Standards and Tolerances 2017</p> <ul style="list-style-type: none"> Section 2.11 Finish to concrete slabs <p>This is a defect because the concrete slab has not been finished as intended by the manufacturer as outlined in Section 2.11 of the Guide to Standards and Tolerances 2017.</p> <p>Loss Suffered Loss suffered is cost of rectification.</p>	Engage a qualified tradesman to grind back the uneven concrete surface in accordance with AS3600 and manufacturers specifications.

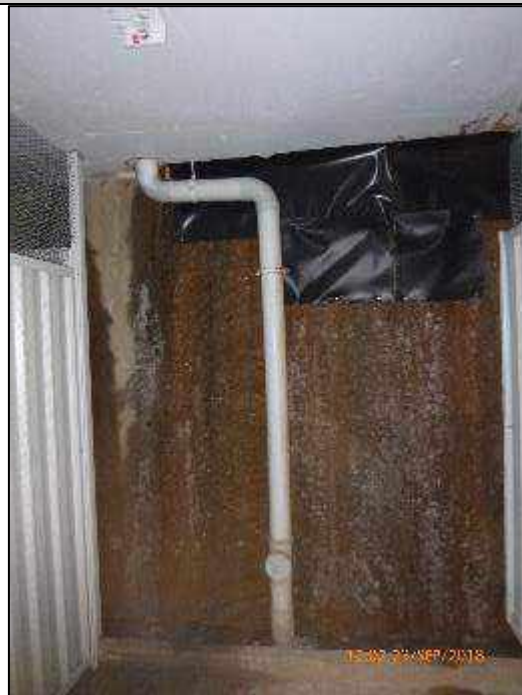
Item	Location	Defect description and Breach	Rectification	Photograph (if applicable)
2190	Soffit above carpark 1305.	<p>Water ingress in soffit causing concrete spalling above unit 1305.</p> <p>Home Building Act (NSW) 1989</p> <ul style="list-style-type: none"> Part 2C, 18B (a) and (c). <p>AS 4654 – 2012 Waterproofing membranes for external use</p> <p>Falls in finishes shall ensure water drains to the drainage outlet. Water shall not be retained on the finished surface with the exception of residual water remaining due to surface tension.</p> <p>The fall shall be in the structural substrate, or formed by a screed over the structural substrate.</p> <p>NOTE: Falls for surface drainage should be no flatter than 1 in 100.</p> <p>Guide to Standards and Tolerances 2017</p> <ul style="list-style-type: none"> Section 14.7 Ponding on waterproof decks and balconies/ <p>This is a defect because 'water ponds or does not drain' as outlined in Section 14.7 of the Guide to Standards and Tolerances 2017.</p>	<ol style="list-style-type: none"> 1. Remove existing tiles and screed in wet areas above drainage pipe. 2. Remove waterproofing back to bare concrete; 3. Apply suitable waterproofing with correct penetration, drainage, upturns and wall opening detailing. 4. Apply graded sand and cement screed with moisture retarder, achieve minimum fall requirements as per the B.C.A and AS 4654; 5. Waterproof over bedding before retiling; 6. Seal appropriately around all slab penetrations; 7. Apply tiles to screed with adequate quantity of adhesive to ensure sound bond; 8. Clean and make good.

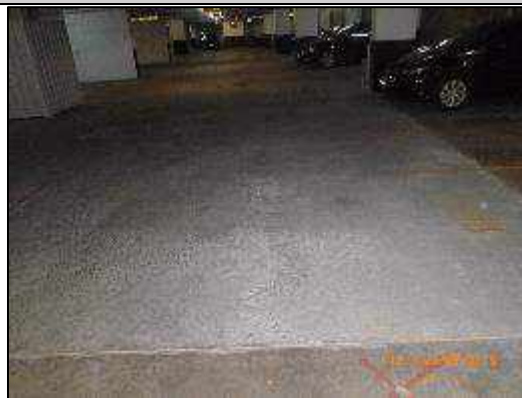
Item	Location	Defect description and Breach	Rectification	Photograph (if applicable)
2191	P4 carpark flooring	<p>Poorly finished concrete surface between carparks 1406 and 1306.</p> <p>Home Building Act (NSW) 1989</p> <ul style="list-style-type: none"> Part 2C, 18B (a) and (c). <p>Guide to Standards and Tolerances 2017</p> <ul style="list-style-type: none"> Section 2.11 Finish to concrete slabs <p>This is a defect because the concrete slab has not been finished as intended by the manufacturer as outlined in Section 2.11 of the Guide to Standards and Tolerances 2017.</p> <p>Loss Suffered Loss suffered is cost of rectification.</p>	Engage a qualified tradesman to grind back the uneven concrete surface in accordance with AS3600 and manufacturers specifications.

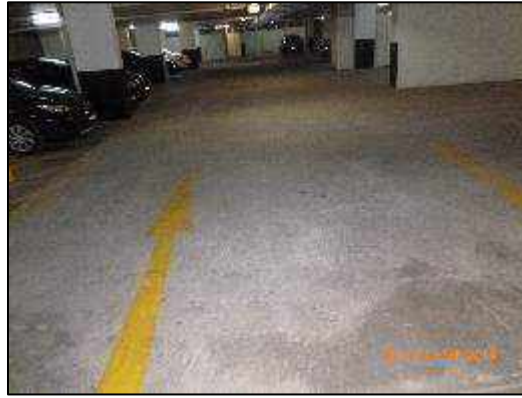
2192	Throughout carpark P4	<p>Dusting of surface throughout P4 carpark.</p> <p>Home Building Act (NSW) 1989</p> <ul style="list-style-type: none"> Part 2C, 18B (a) and (c). <p>This is a breach of part (a) of the act because the surface has not been finished in a proper workmanlike manner that would prevent loss of appearance to the surface.</p> <p>Loss Suffered Loss suffered is cost of rectification.</p>	<ol style="list-style-type: none"> 1. Protect all adjoining surfaces. 2. Use a suitable cleaning agent to remove residue and clear debris. 3. Clean up the work area.

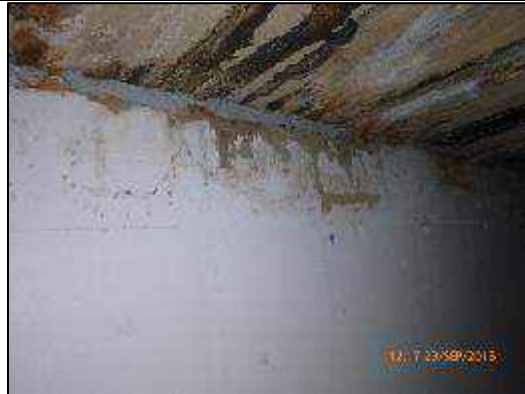
Item	Location	Defect description and Breach	Rectification	Photograph (if applicable)
2193	Soffit above carpark 1206.	<p>Staining of soffit adjacent to carpark 1206.</p> <p>Home Building Act (NSW) 1989</p> <ul style="list-style-type: none"> Part 2C, 18B (a) and (c). <p>This is a breach of part (a) of the act because the surface has not been finished in a proper workmanlike manner that would prevent loss of appearance to the surface.</p> <p>Loss Suffered</p> <p>Loss suffered is cost of rectification.</p>	<ol style="list-style-type: none"> 1. Protect all adjoining surfaces. 2. Use a suitable cleaning agent to remove residue and clear debris. 3. Clean up the work area.

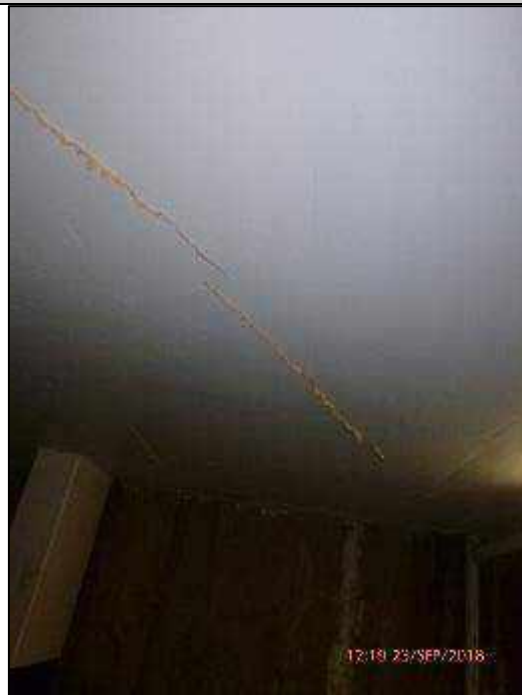
Item	Location	Defect description and Breach	Rectification	Photograph (if applicable)
2194	P4 carpark soffit of slab	<p>Epoxy injection residue left in soffit above carpark of unit 2101.</p> <p>Home Building Act (NSW) 1989</p> <ul style="list-style-type: none"> Part 2C, 18B (a) and (c). <p>This is a breach of part (a) of the act because the surface has not been finished in a proper workmanlike manner that would prevent loss of appearance to the surface.</p> <p>Loss Suffered Loss suffered is cost of rectification.</p>	<ol style="list-style-type: none"> 1. Protect all adjoining surfaces. 2. Use a suitable cleaning agent to remove residue and clear debris. 3. Clean up the work area.

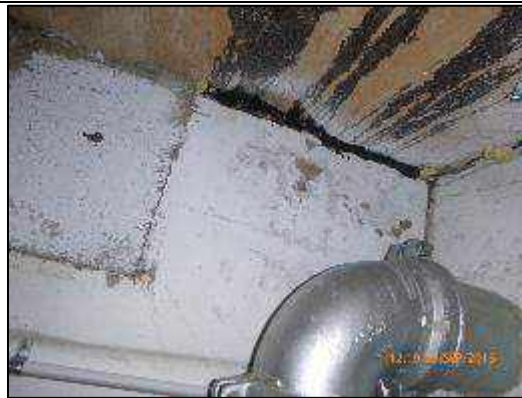
2195	Soffit adjacent to P4 fire stairs	<p>Staining of soffit adjacent to P4 fire stairs on western elevation.</p> <p>Home Building Act (NSW) 1989</p> <ul style="list-style-type: none"> Part 2C, 18B (a) and (c). <p>This is a breach of part (a) of the act because the surface has not been finished in a proper workmanlike manner that would prevent loss of appearance to the surface.</p>	<ol style="list-style-type: none"> 1. Protect all adjoining surfaces. 2. Use a suitable cleaning agent to remove residue and clear debris. 3. Clean up the work area.

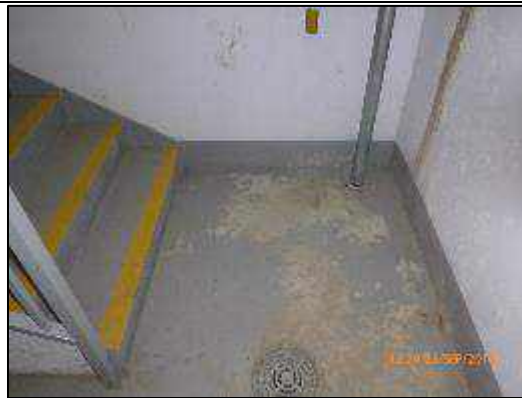
Item	Location	Defect description and Breach	Rectification	Photograph (if applicable)
		Loss Suffered Loss suffered is cost of rectification.		
2196	Western P4 fire stairs	Poorly finished concrete surface observed. Home Building Act (NSW) 1989 <ul style="list-style-type: none"> Part 2C, 18B (a) and (c). Guide to Standards and Tolerances 2017 <ul style="list-style-type: none"> Section 2.11 Finish to concrete slabs This is a defect because the concrete slab has not been finished as intended by the manufacturer as outlined in Section 2.11 of the Guide to Standards and Tolerances 2017. Loss Suffered Loss suffered is cost of rectification.	Engage a qualified tradesman to grind back the uneven concrete surface in accordance with AS3600 and manufacturers specifications.

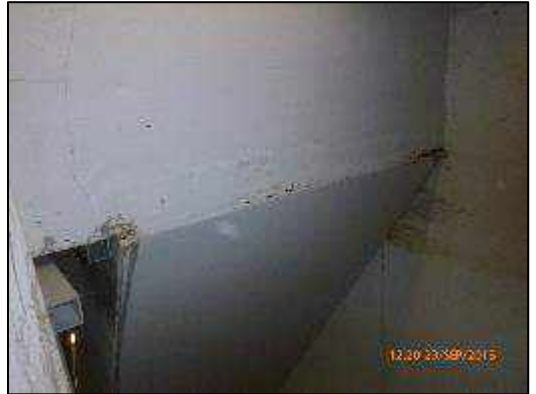
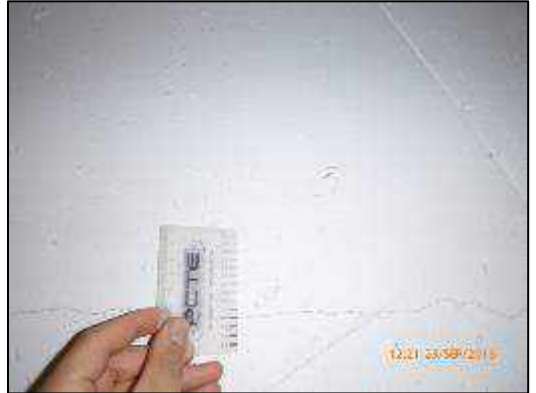
Item	Location	Defect description and Breach	Rectification	Photograph (if applicable)
2197	Western wall of P4 fire stairs	See section 5.14.1 Separation; 1mm	See section 5.14.2

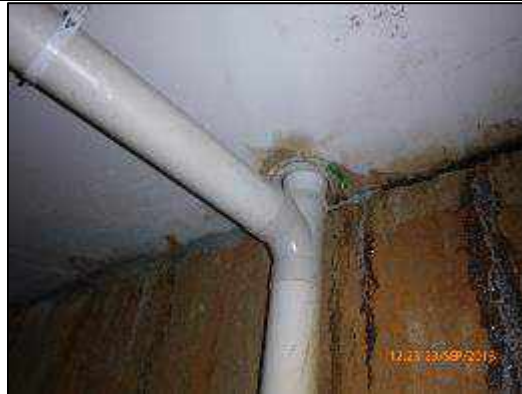
Item	Location	Defect description and Breach	Rectification	Photograph (if applicable)
2198	Drainage pipe in carpark 901	<p>Water penetration observed around drainage pipe in carpark of unit 901.</p> <p>Home Building Act (NSW) 1989</p> <ul style="list-style-type: none"> Part 2C, 18B (a) and (c). <p>AS 4654 – 2012 Waterproofing membranes for external use</p> <p>Falls in finishes shall ensure water drains to the drainage outlet. Water shall not be retained on the finished surface with the exception of residual water remaining due to surface tension.</p> <p>The fall shall be in the structural substrate, or formed by a screed over the structural substrate.</p> <p>NOTE: Falls for surface drainage should be no flatter than 1 in 100.</p> <p>Guide to Standards and Tolerances 2017</p> <ul style="list-style-type: none"> Section 14.7 Ponding on waterproof decks and balconies/ <p>This is a defect because 'water ponds or does not drain' as outlined in Section 14.7 of the Guide to Standards and Tolerances 2017.</p>	<ol style="list-style-type: none"> 1. Remove existing tiles and screed in wet areas above drainage pipe. 2. Remove waterproofing back to bare concrete; 3. Apply suitable waterproofing with correct penetration, drainage, upturns and wall opening detailing. 4. Apply graded sand and cement screed with moisture retarder, achieve minimum fall requirements as per the B.C.A and AS 4654; 5. Waterproof over bedding before retiling; 6. Seal appropriately around all slab penetrations; 7. Apply tiles to screed with adequate quantity of adhesive to ensure sound bond; 8. Clean and make good.

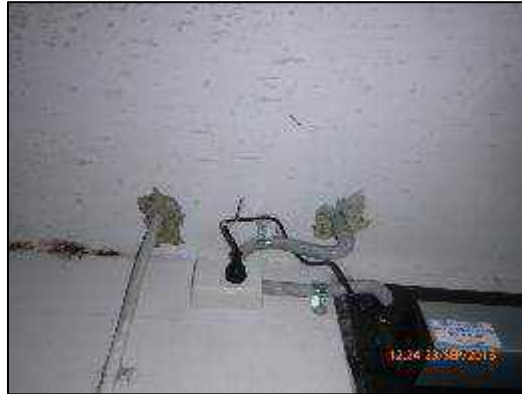
Item	Location	Defect description and Breach	Rectification	Photograph (if applicable)
2199	Soffit adjacent to eastern firestairs	<p>Conduit piping has no fire collar on eastern fire stairs.</p> <p>Home Building Act (NSW) 1989</p> <ul style="list-style-type: none"> Part 2C, 18B (a), (B) and (c). <p>Building Code of Australia (BCA), Volume 1</p> <ul style="list-style-type: none"> Section C Fire Resistance Part CO1 Performance Requirements CF2 & CP8. <p>This is a breach of the BCA as it requires suitable fire-resistant elements to prevent spread of fire between separate levels</p> <p>Loss Suffered Loss suffered is cost of rectification.</p>	Provide suitable complying fire collars where fitment is achievable or install suitable fire resistant plasterboard enclosure around the pipe penetrations to achieve required fire separation levels and compliance with BCA requirements.

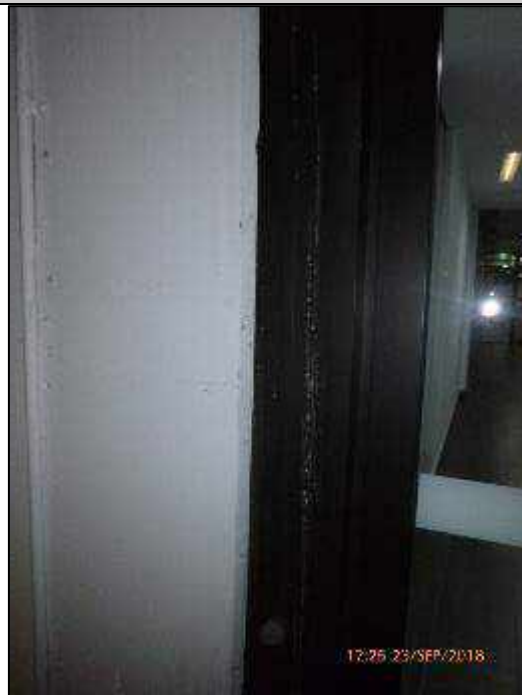
Item	Location	Defect description and Breach	Rectification	Photograph (if applicable)
2200	Eastern fire stairs door of P4	See section 5.9.1	See section 5.9.2

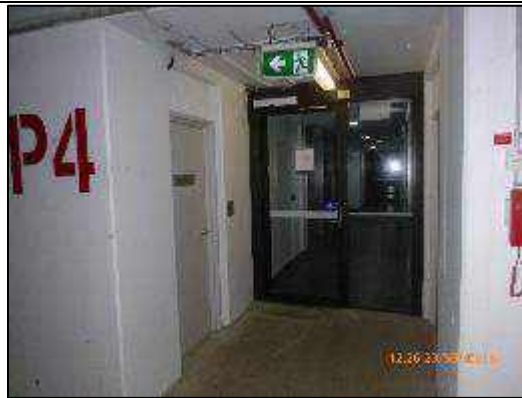
A photograph showing a dark, possibly black, fire stairs door in a hallway. The door is slightly ajar, and the interior of the stairs is visible. A timestamp '12:25 23/SEP/2018' is visible in the bottom right corner.
2201	Western end of elevators	<p>Excessive noise observed at entrance to western end of elevators indicating doors have not been adequately sealed.</p> <p>Home Building Act (NSW) 1989</p> <ul style="list-style-type: none"> Part 2C, 18B (a), (B) and (c). <p>Loss Suffered Loss suffered is cost of rectification.</p>	Engage a licenced tradesman to reseal door to prevent excessive noise to the area in accordance with manufacturers specifications.

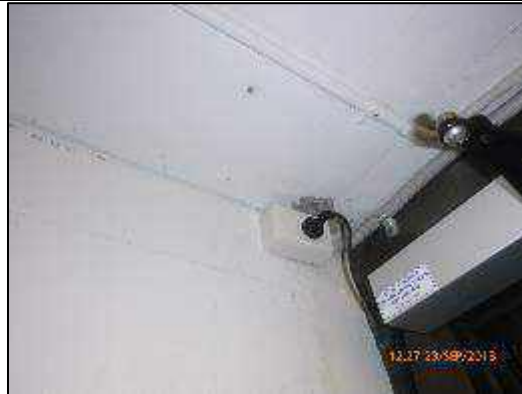
Item	Location	Defect description and Breach	Rectification	Photograph (if applicable)
2202	Soffit above entrance door to firestairs.	<p>Conduit penetration has no fire collar.</p> <p>Building Code of Australia (BCA), Volume 1</p> <ul style="list-style-type: none"> • Section C Fire Resistance • Part CO1 • Performance Requirements CF2 & CP8. <p>This is a breach of the BCA as it requires suitable fire-resistant elements to prevent spread of fire between separate levels</p> <p>Loss Suffered Loss suffered is cost of rectification.</p>	Provide suitable complying fire collars where fitment is achievable or install suitable fire resistant plasterboard enclosure around the pipe penetrations to achieve required fire separation levels and compliance with BCA requirements.

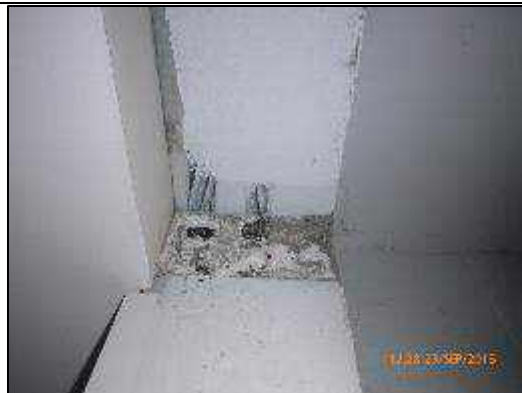
2203	Soffit above unit 408 storage cage.	<p>Poor finish to entrance of unit 408 storage cage.</p> <p>Home Building Act (NSW) 1989</p> <ul style="list-style-type: none"> • Part 2C, 18B (a) & (c). <p>Guide to Standards and Tolerances 2017</p> <p>Crack categories are assessed in accordance with Section 3.02. Cracks are classed as exceeding Category 2 damage. Category 2 damage cracks are considered a defect and require repair work.</p>	<ol style="list-style-type: none"> 1. Protect all surrounding surfaces 2. Hold Point Engineer to inspect. 3. Contractor to install Helifix Bars as required. 4. Repair area to match existing

Item	Location	Defect description and Breach	Rectification	Photograph (if applicable)
		<p>AS2870-2011 Residential footings and slabs</p> <p>Crack categories are assessed in accordance with Table C1</p> <p>CLASSIFICATION OF DAMAGE WITH REFERENCE TO WALLS</p> <p>Cracks exceed Category 2 damage.</p> <p>Loss Suffered</p> <p>Loss suffered is cost of rectification.</p>

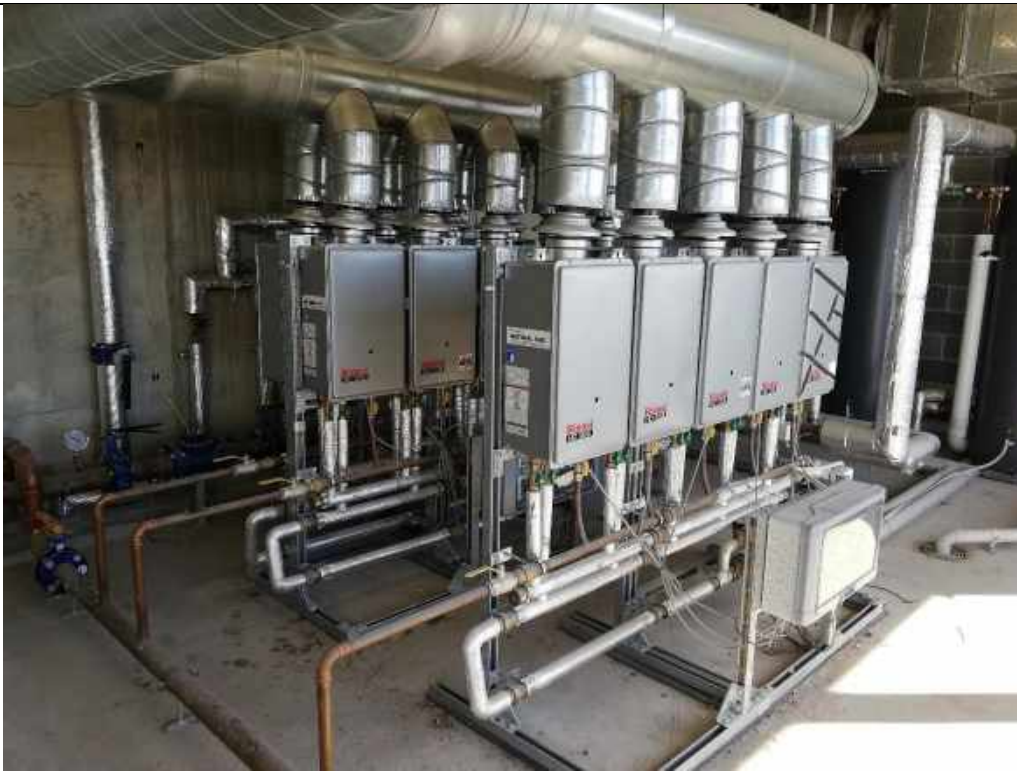
ITEM	3
Photo 3

Photo 3 comment	The domestic hot water systems were assessed on the temperature delivery of hot water. It was witnessed the hot water plant was producing hot water at 60 Degrees Celsius, which is an acceptable temperature

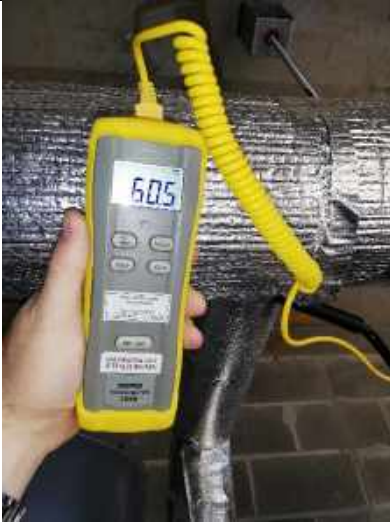
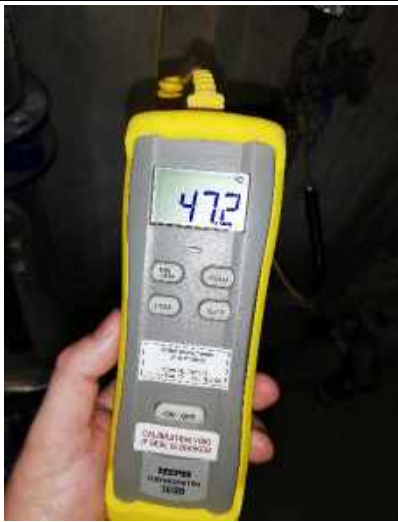
ITEM	4
Photo 4 Comments

Photo 4 Comments	The hot water flow and return temps were recorded to have a loss of 13.3 degrees Celsius. This variance is on the limits of being inefficient (subject to the time if day) but given the size of the system this would appear acceptable.
