# SydneyStrataReport

## STRATA REPORT

Client	Infinity Property Agents
Address of property	Unit 107/361-362 Military Road, Mosman, NSW.
Lot	13
Strata Plan	SP 92834
Name of Strata Management Co.	Executive Strata
Telephone Number of Strata Agent	1300 984 186
Report Date	22 April 2020

Mixed Use Residential Apartment at  
363 Military Road,  
Mosman, NSW

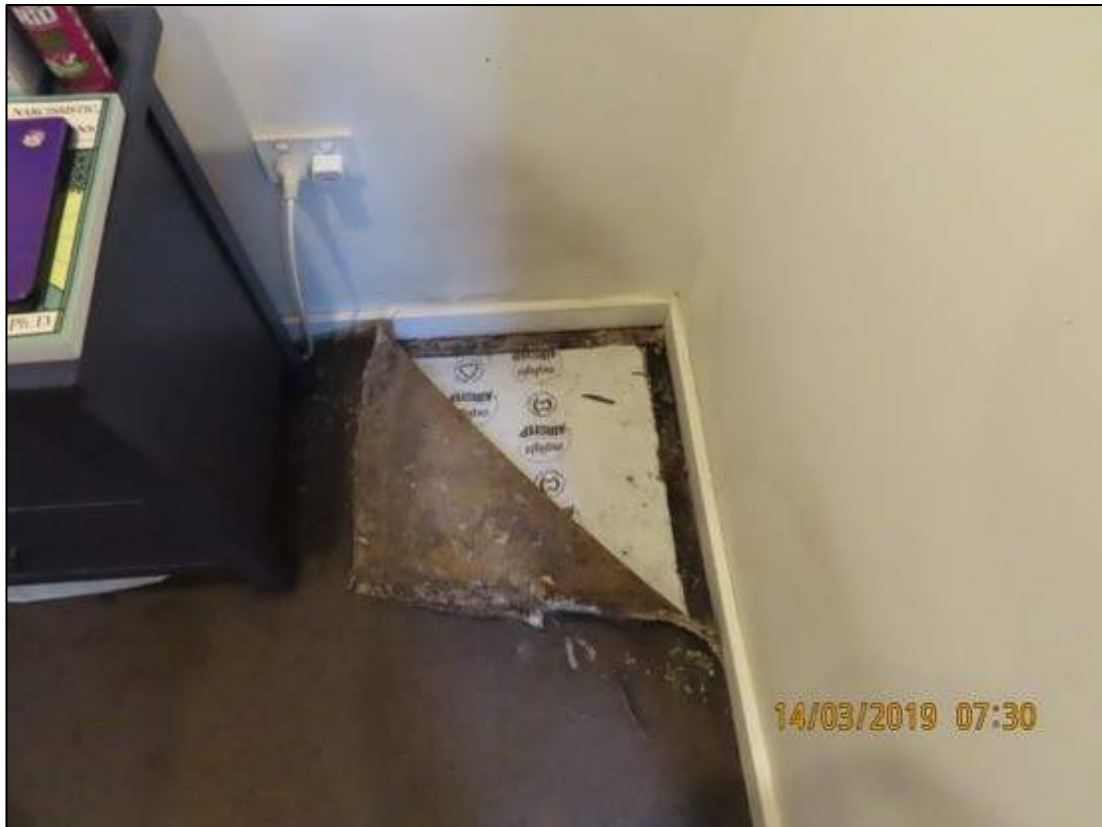
**Photograph 1:** Showing mould growth and water staining to smooth edge of carpet adjacent to courtyard sliding door of Bedroom 1 in Unit 4.

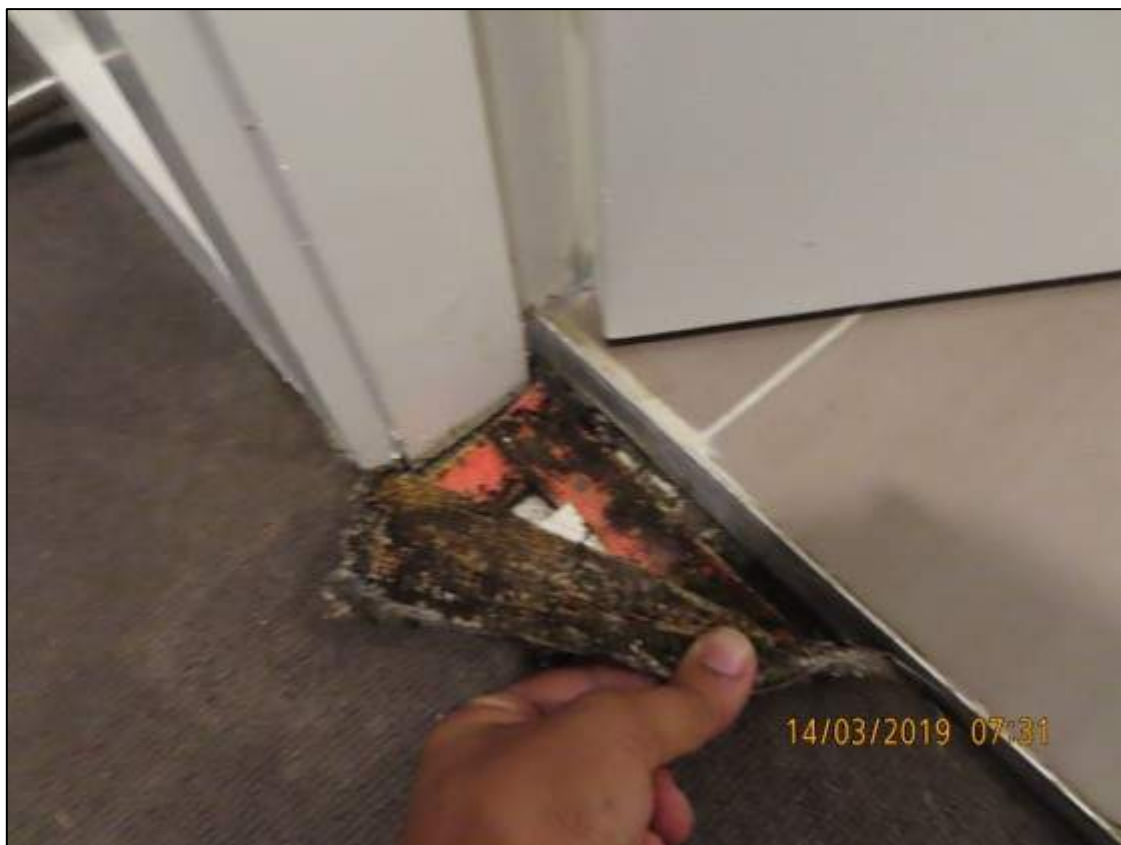
**Photograph 2:** Showing water staining to the smooth edge of carpet adjacent to threshold of Ensuite of Unit 4.

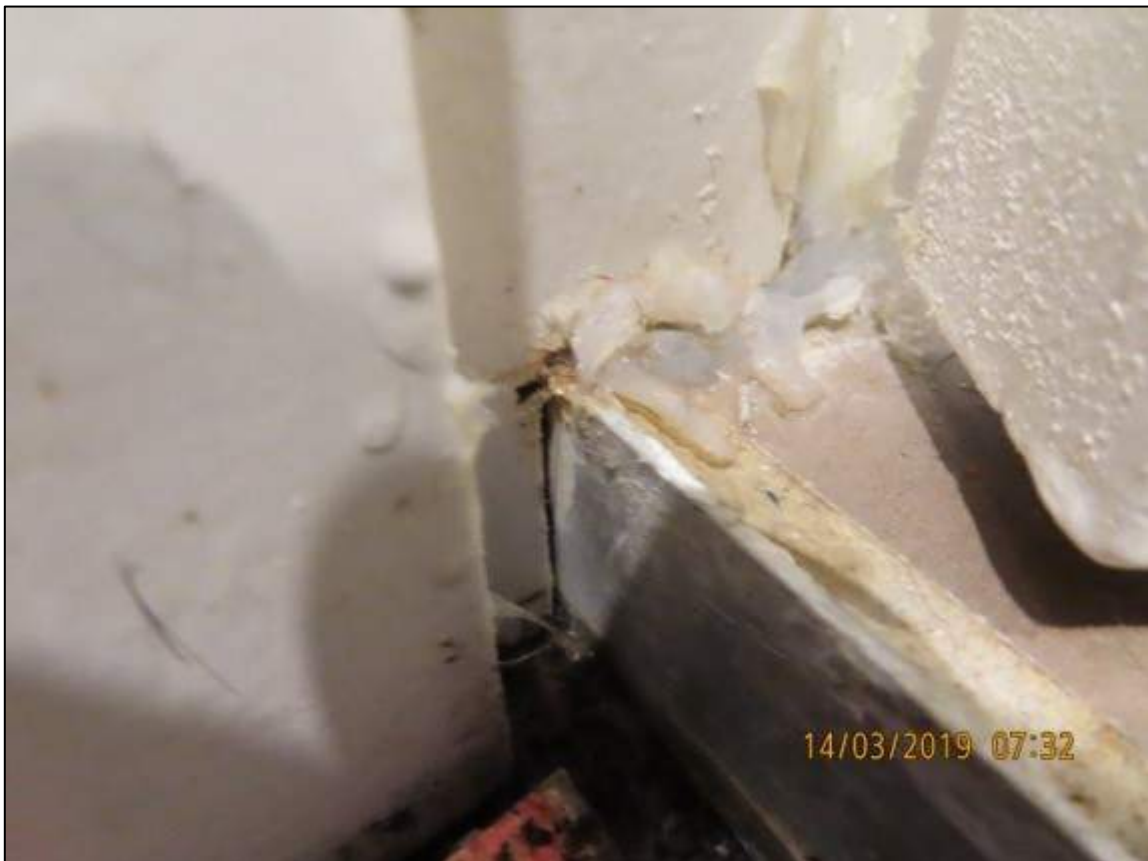
**Photograph 4:** Showing application of sealant to the threshold of Ensuite in Unit 4.

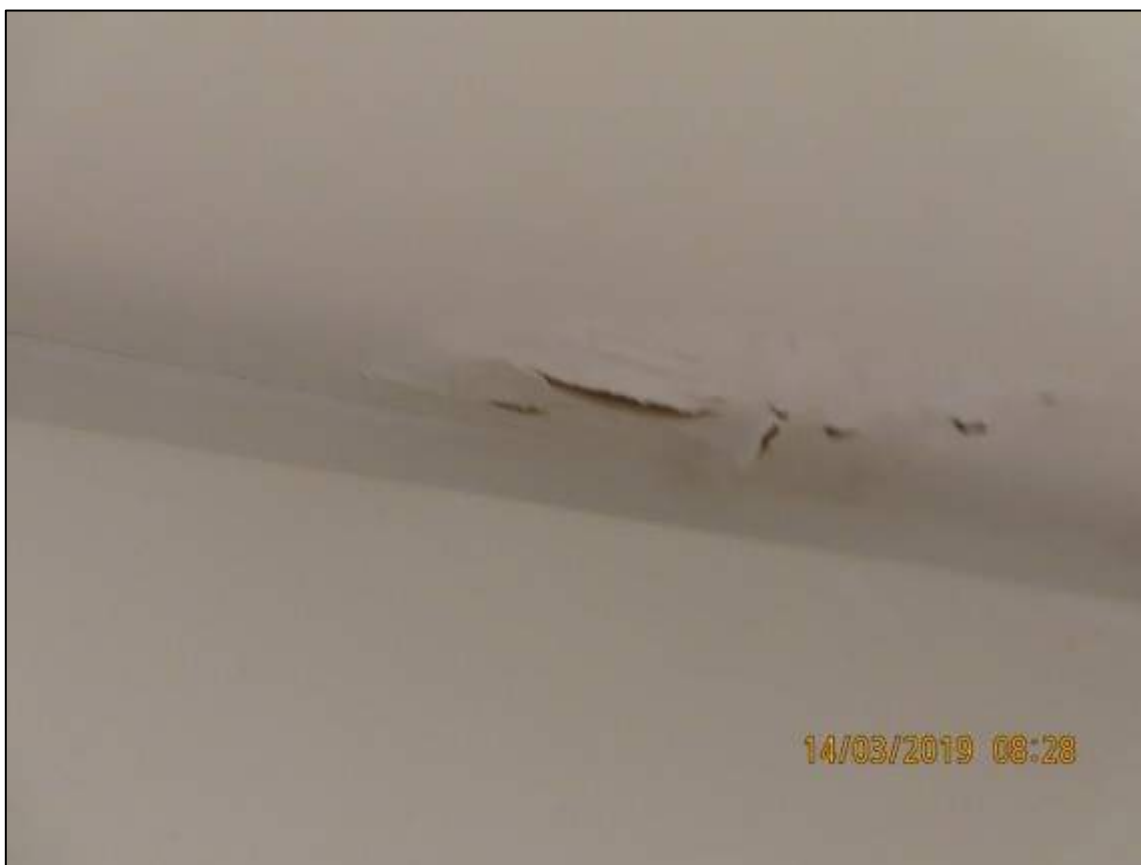
**Photograph 11:** Showing blistering plasterboard to access hatch in the Kitchen of Unit 8.

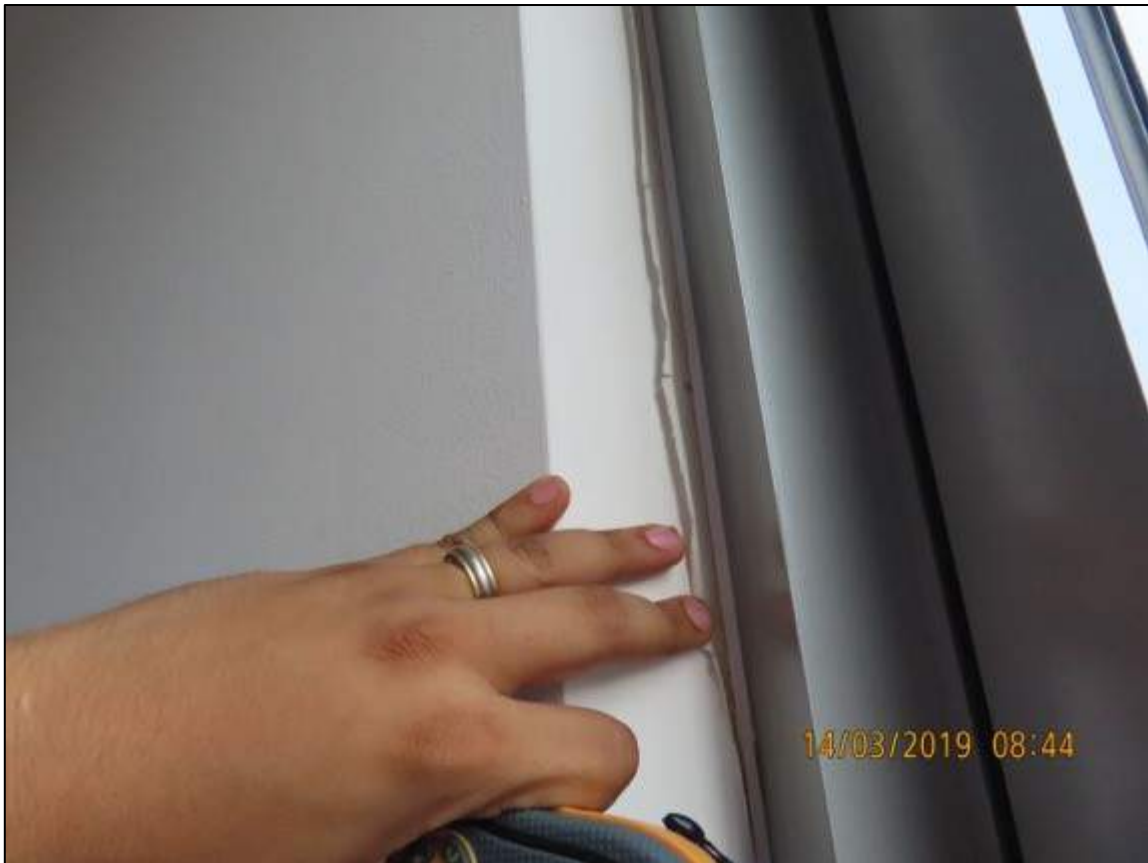
**Photograph 18:** Showing delamination of plasterboard adjacent to Enclosed balcony window of Unit 13.

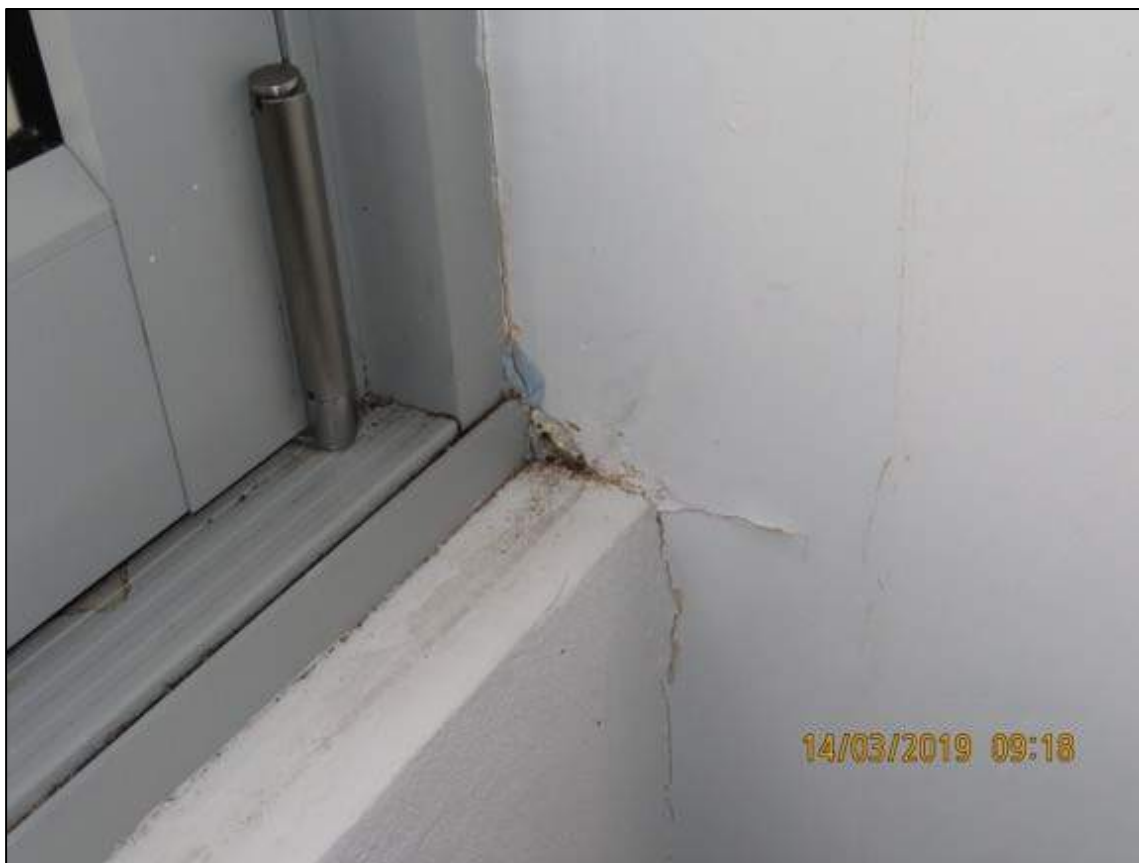
**Photograph 22:** Showing water damage adjacent to base of Enclosed Balcony windows of Unit 15.

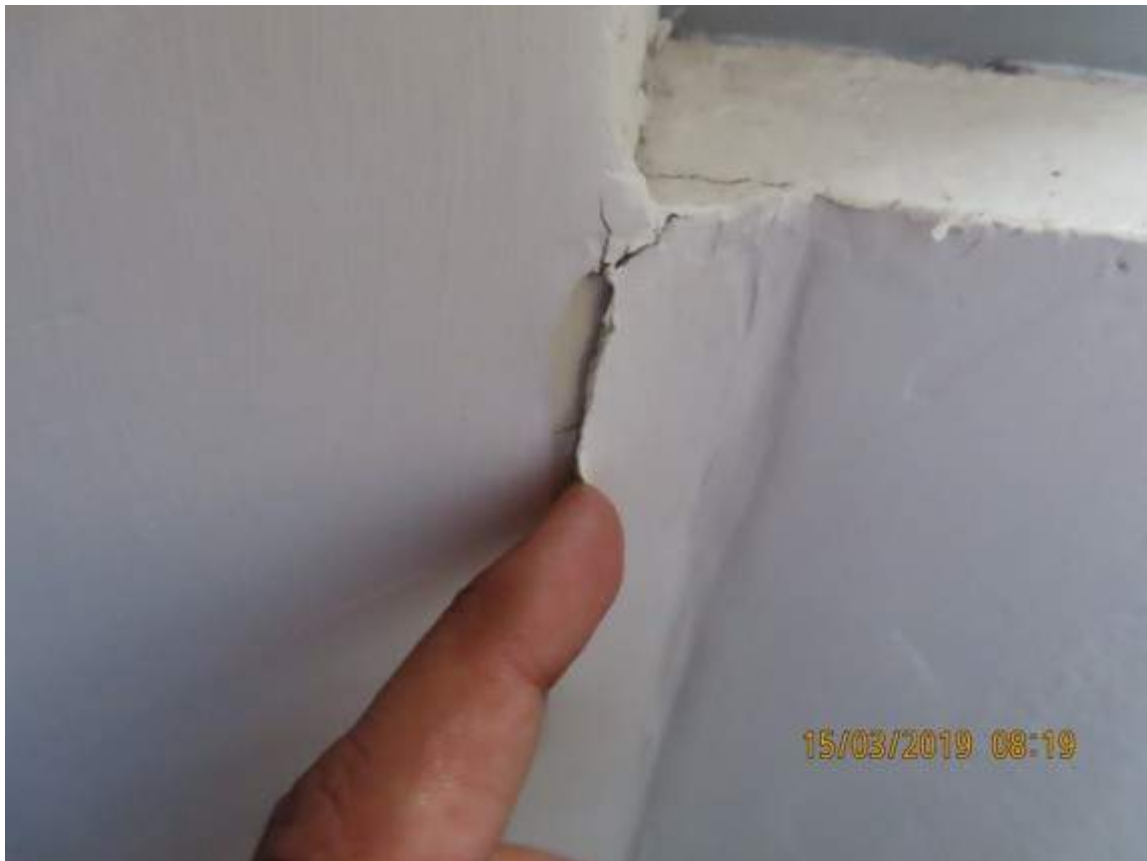
**Photograph 44:** Showing delaminating plasterboard below Enclosed Balcony windows of Unit 28.

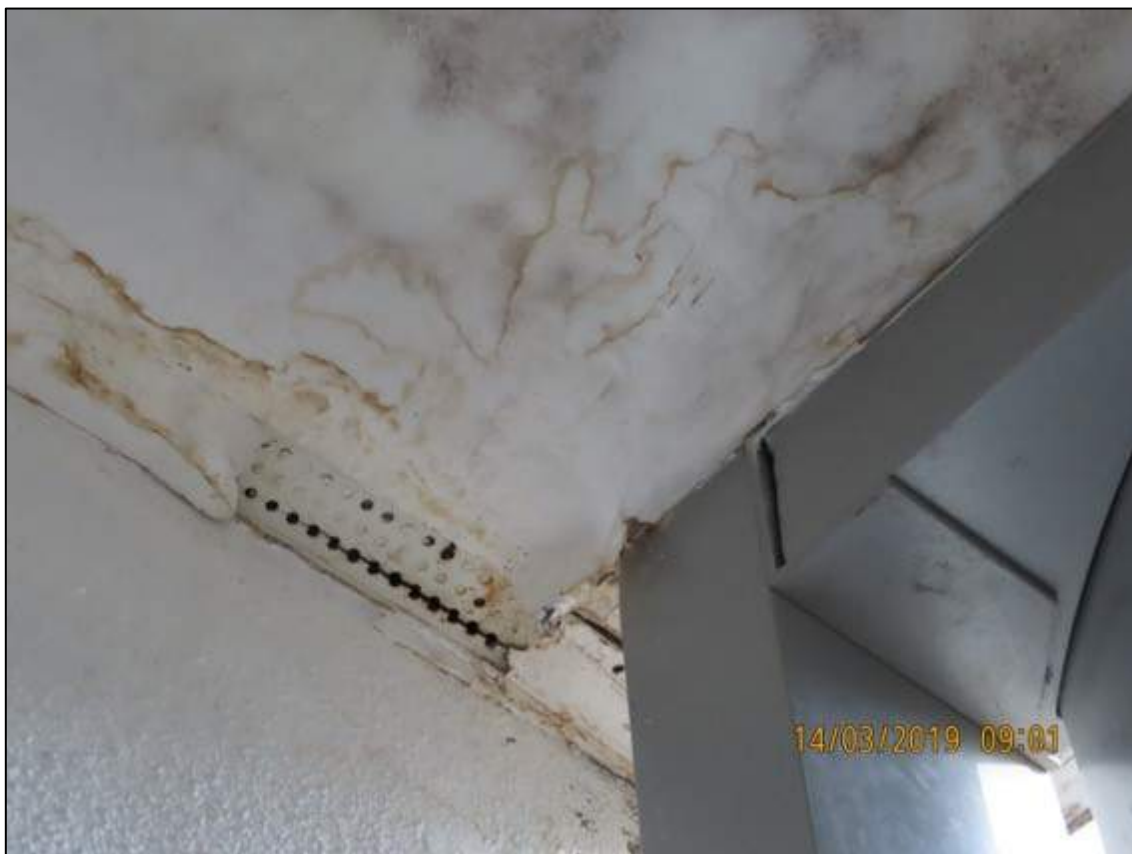
**Photograph 49:** Showing further view of water damage to plasterboard ceiling opposite to Unit 14.

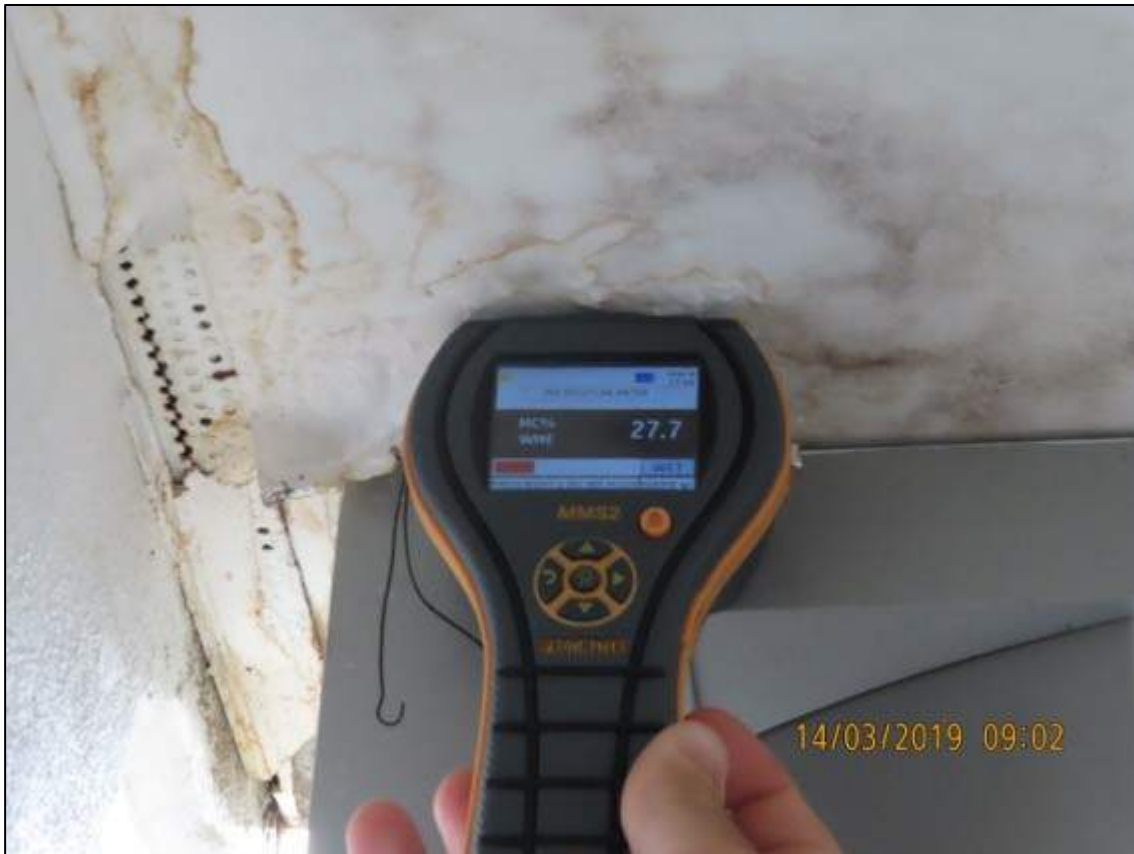
**Photograph 50:** Showing elevated moisture readings to plasterboard ceiling opposite to Unit 14.

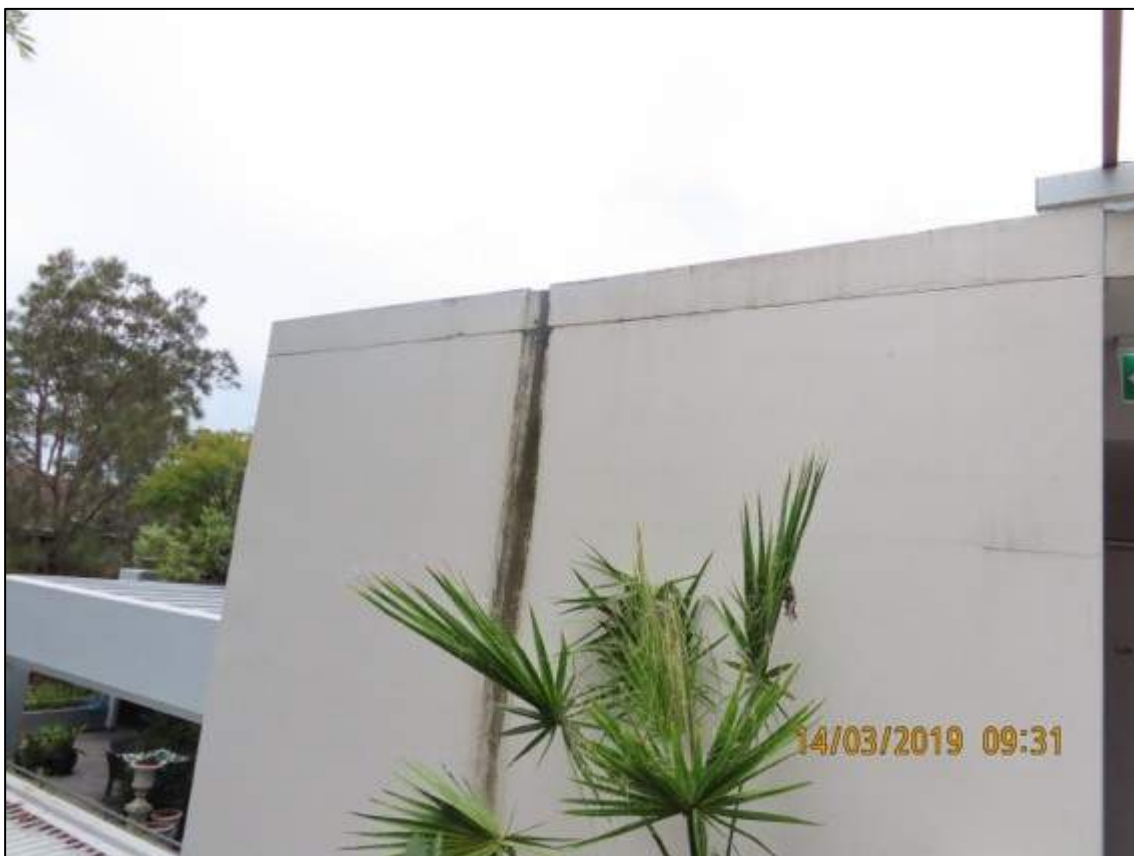
**Photograph 51:** Showing water staining to facades emanating from rooftop.

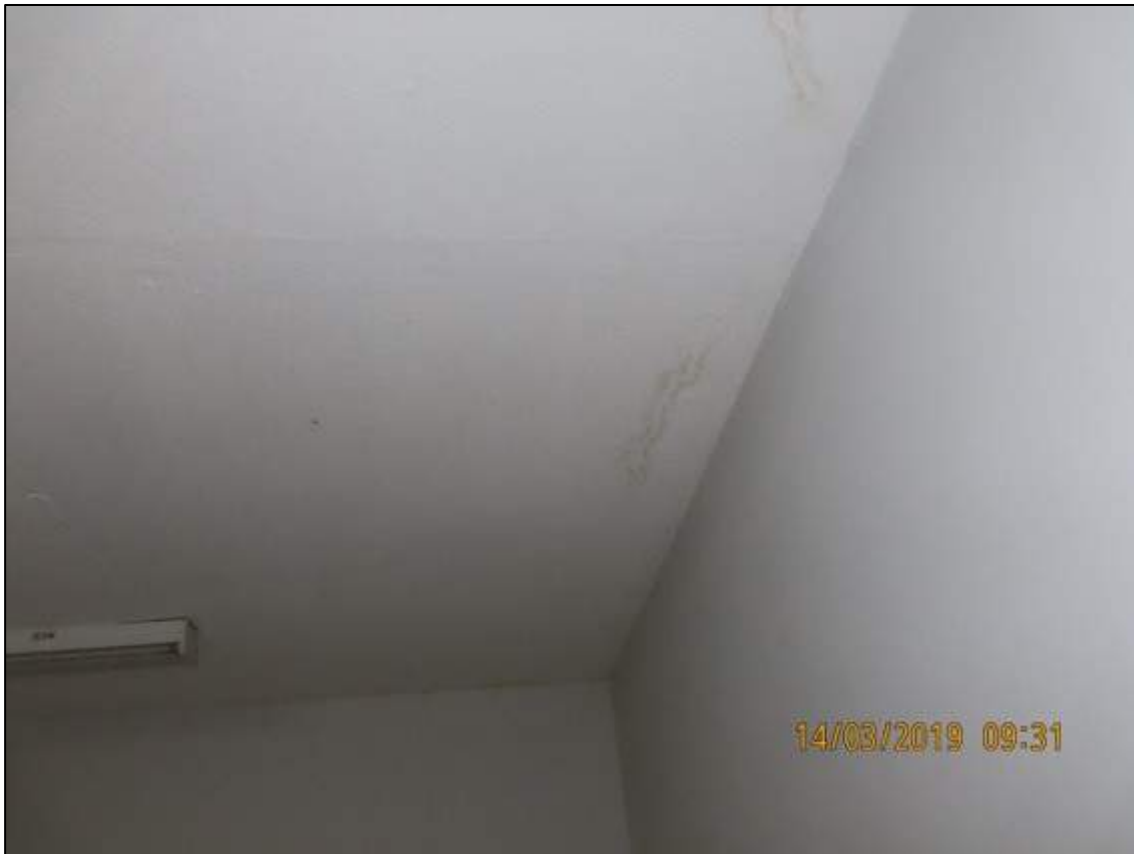
**Photograph 52:** Showing water staining to soffit of Level 3 southern fire stairs.

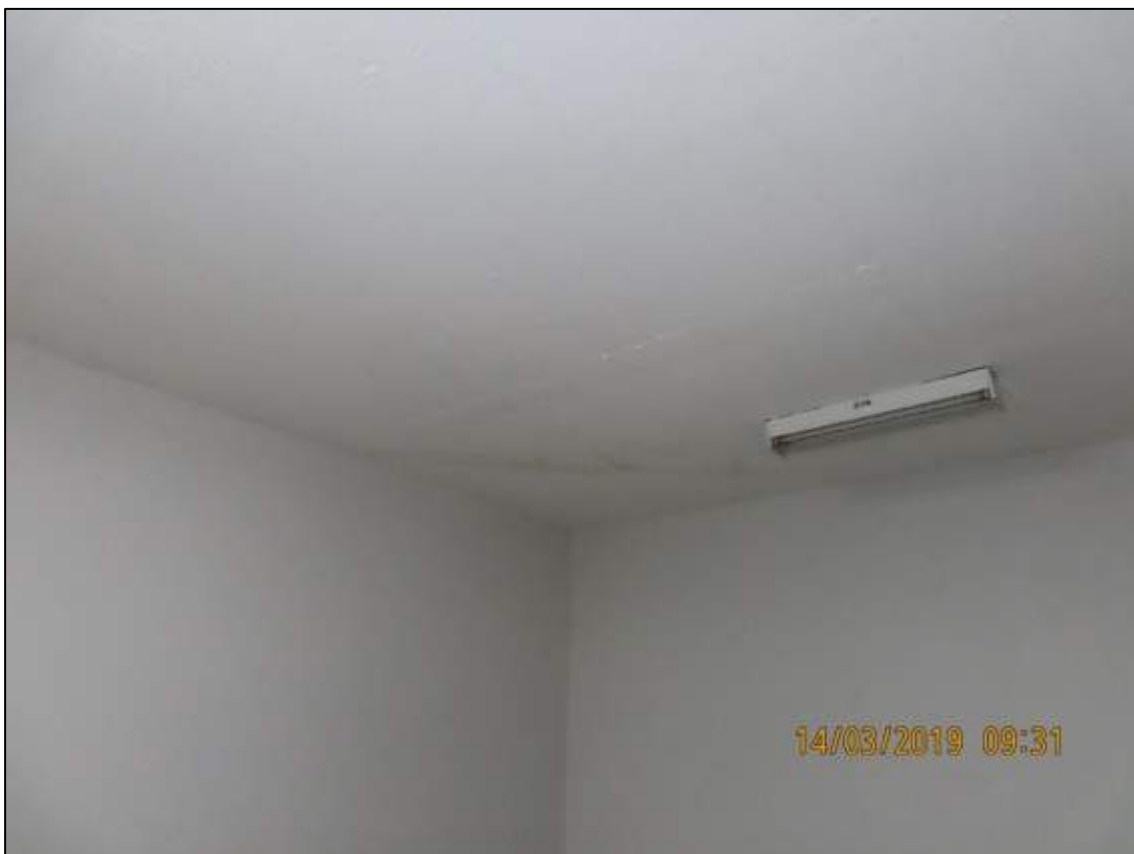
**Photograph 53:** Showing further view of water staining to soffit of Level 3 southern fire stairs.

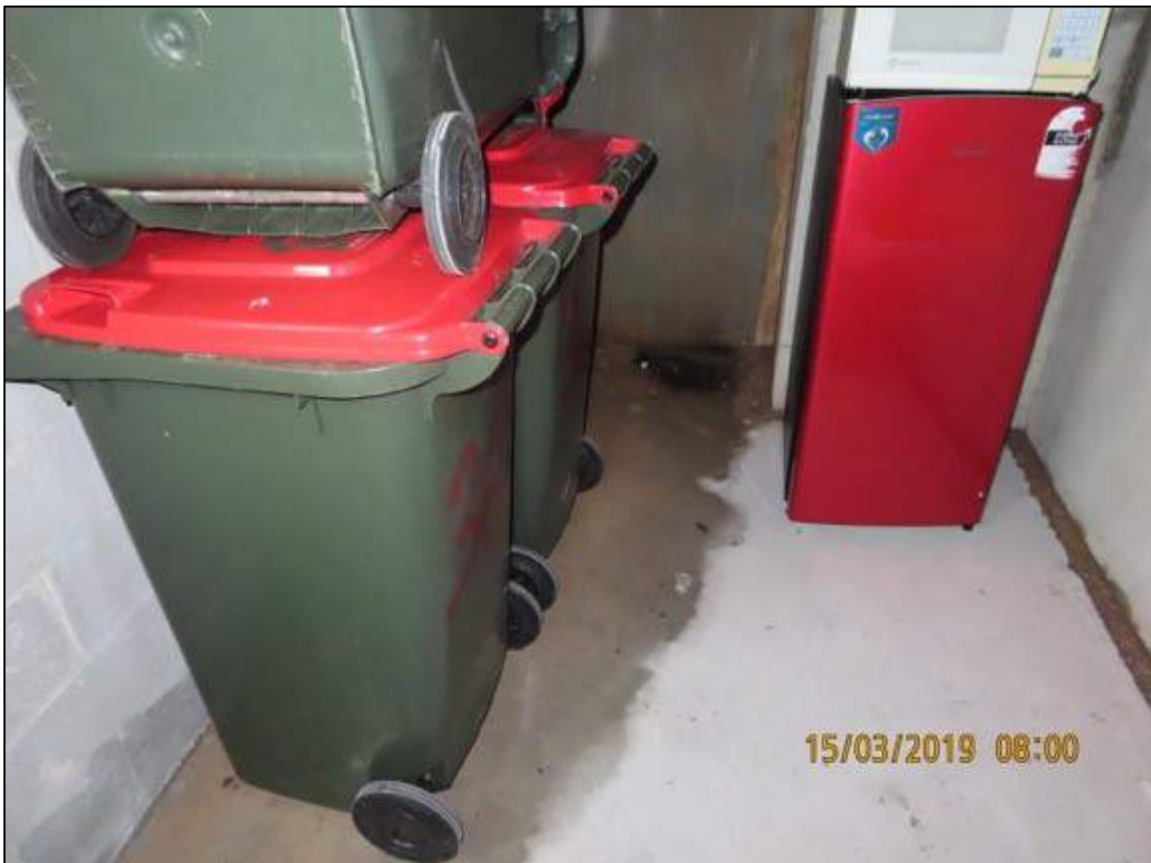
**Photograph 57:** Showing ponding of water opposite northern fire stairs entry of Level 3 basement.

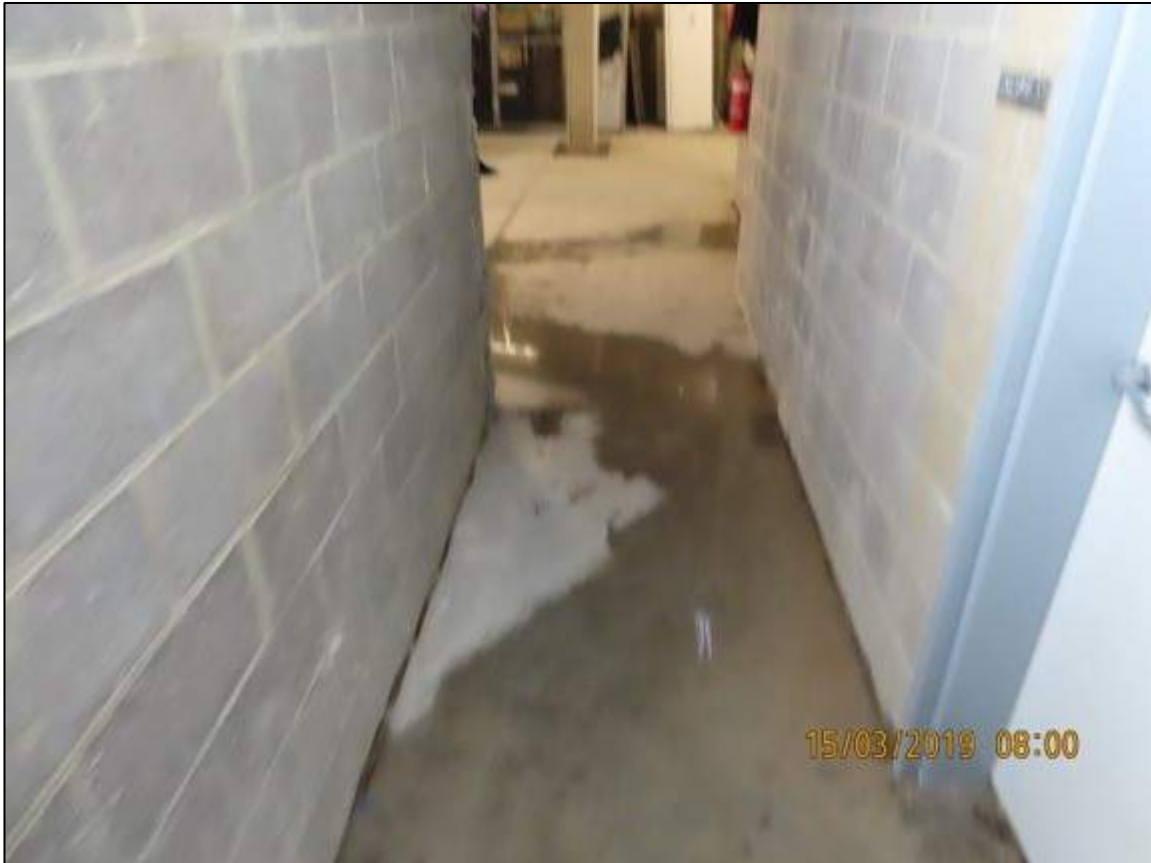
**Photograph 58:** Showing further view of water ponding opposite northern fire stairs entry of Level 3 basement.

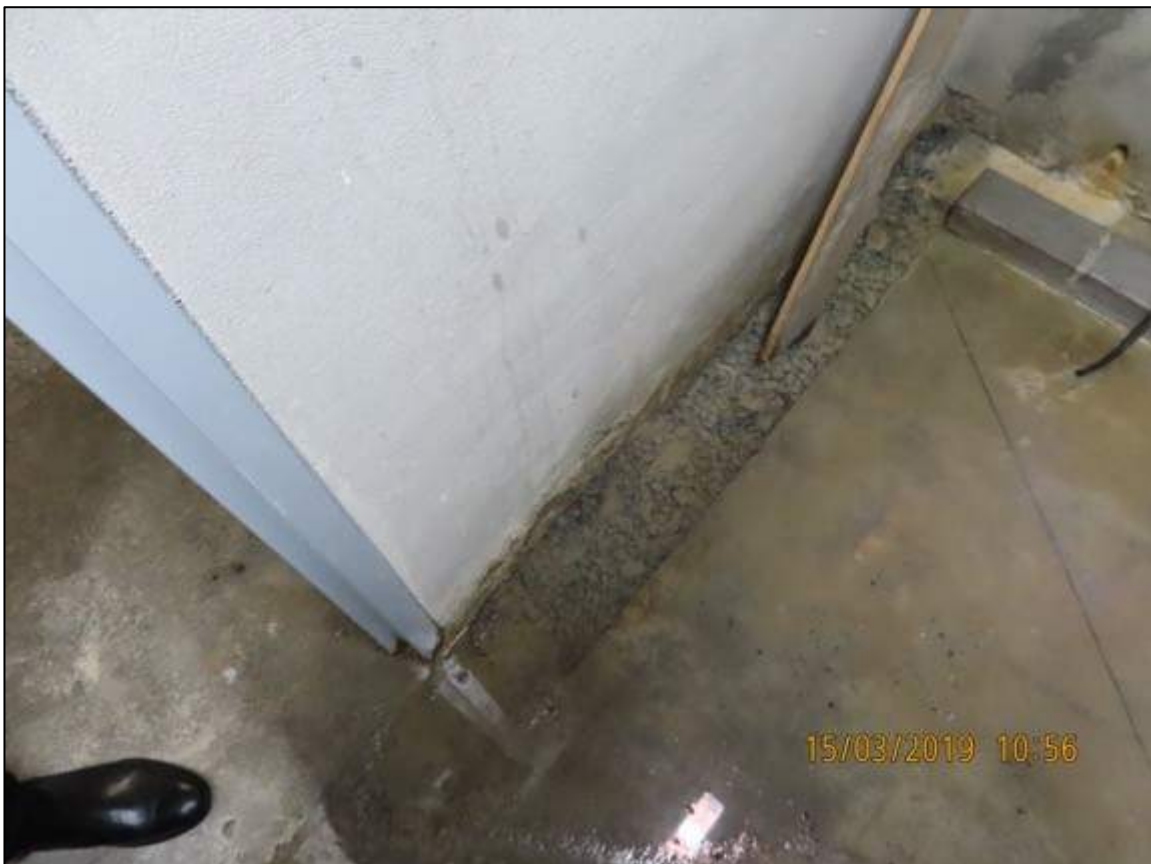
**Photograph 61:** Showing overflow of water in perimeter hob in northern fire stairs on Level 3 basement.

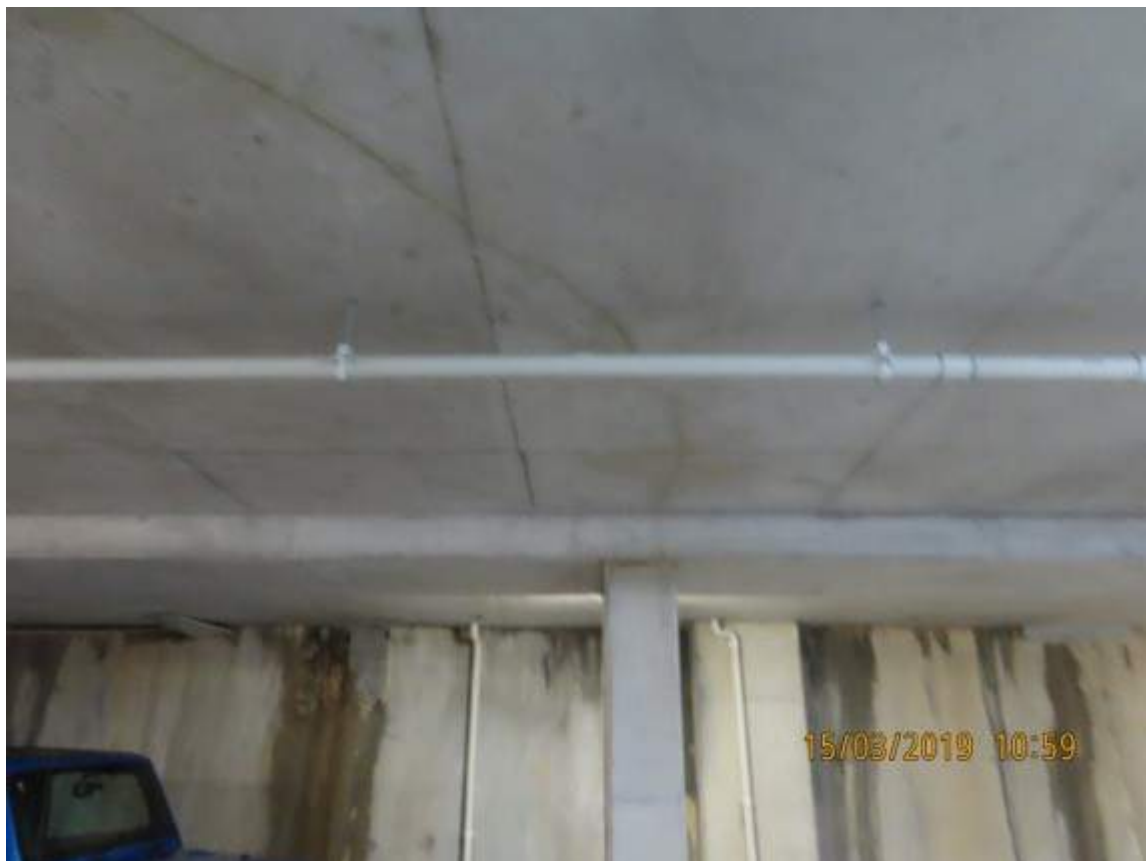
**Photograph 63:** Showing efflorescence emanating from cracking to soffit above car spaces 27 and 28.

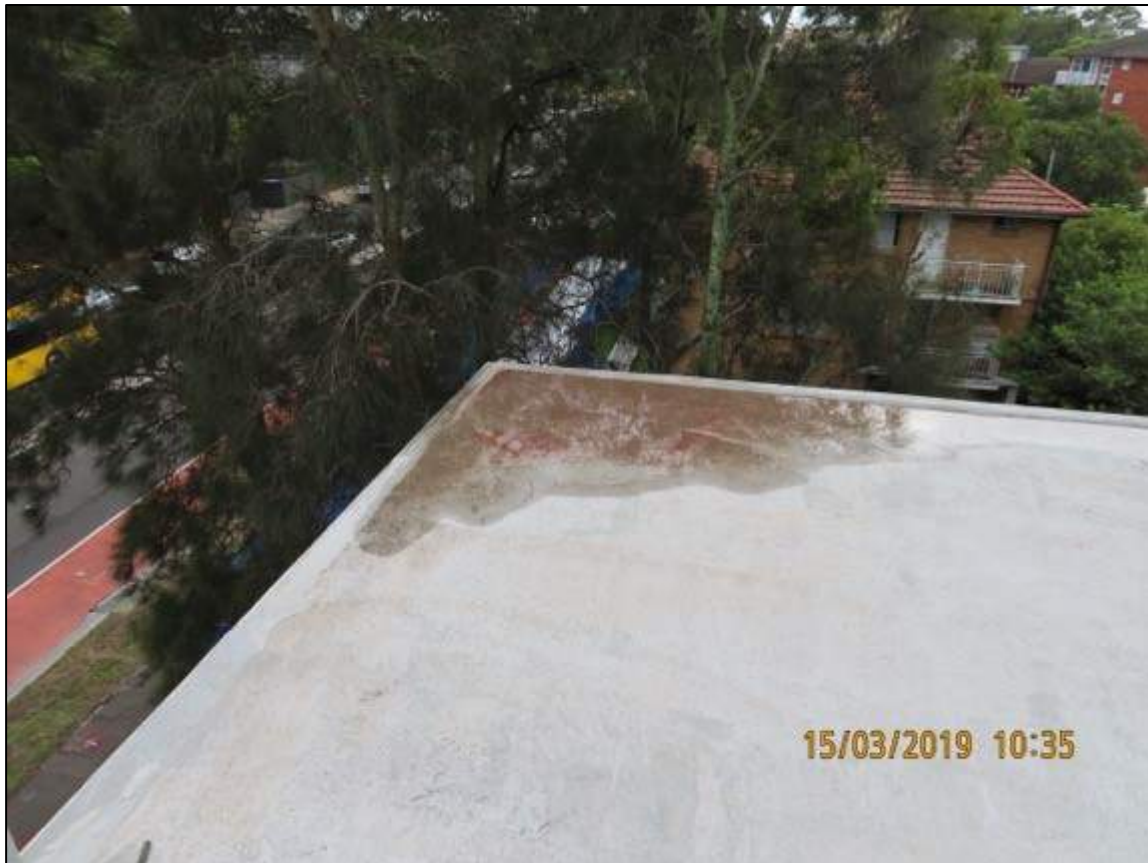
**Photograph 68:** Showing ponding water to exposed area of rooftop.

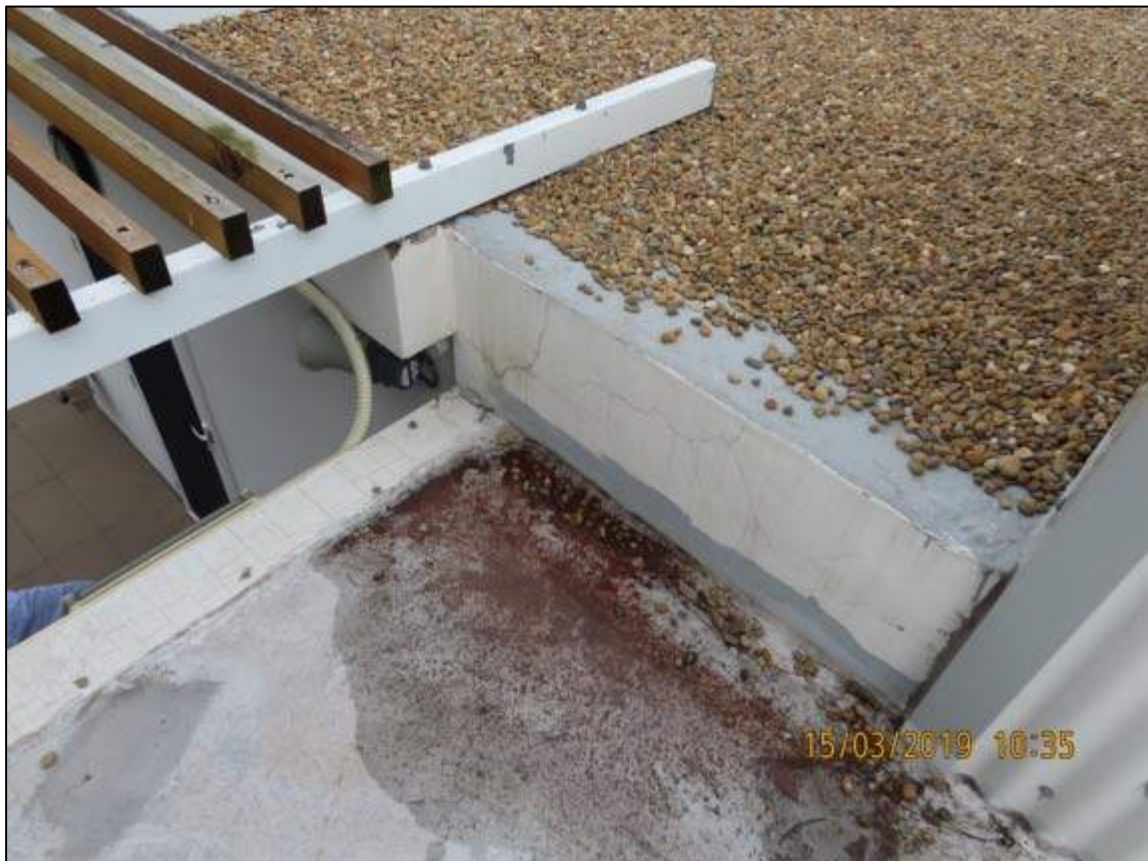
**Photograph 69:** Showing ponding water adjacent to ballast rooftop.

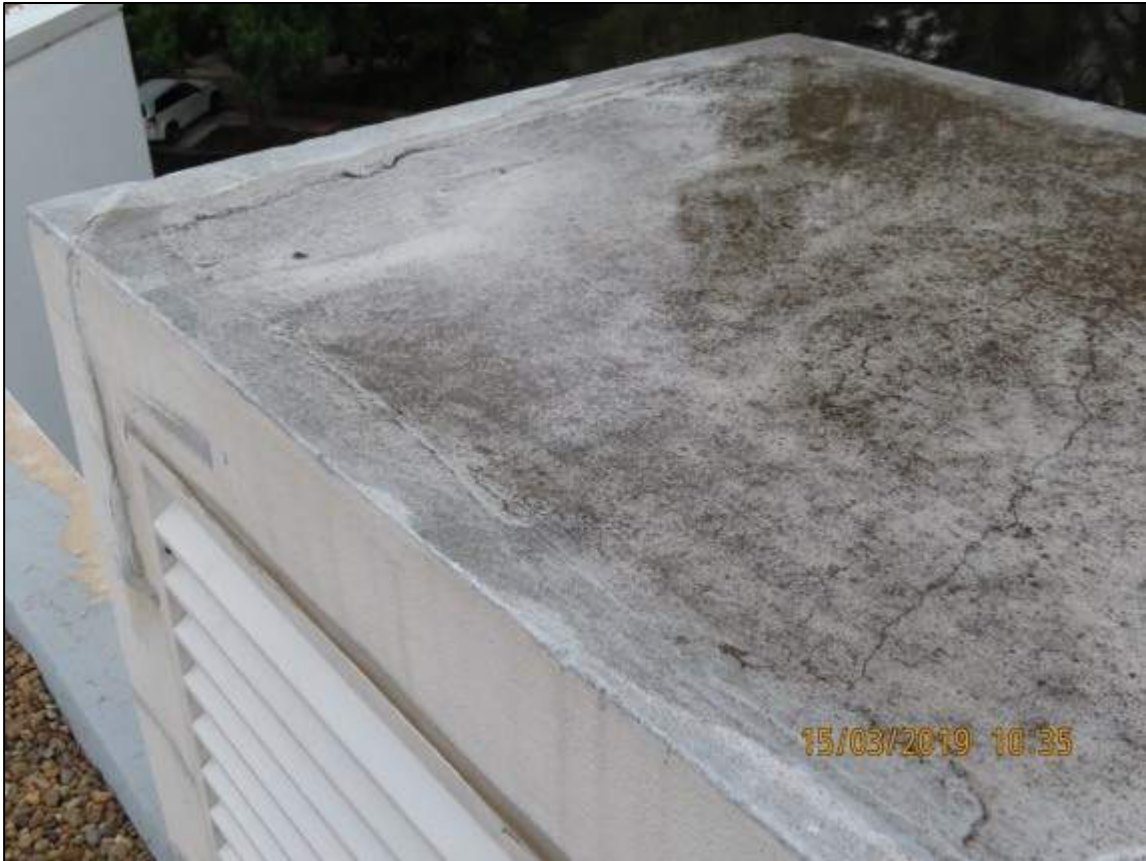
**Photograph 70:** Showing ponding water to exposed area of rooftop.

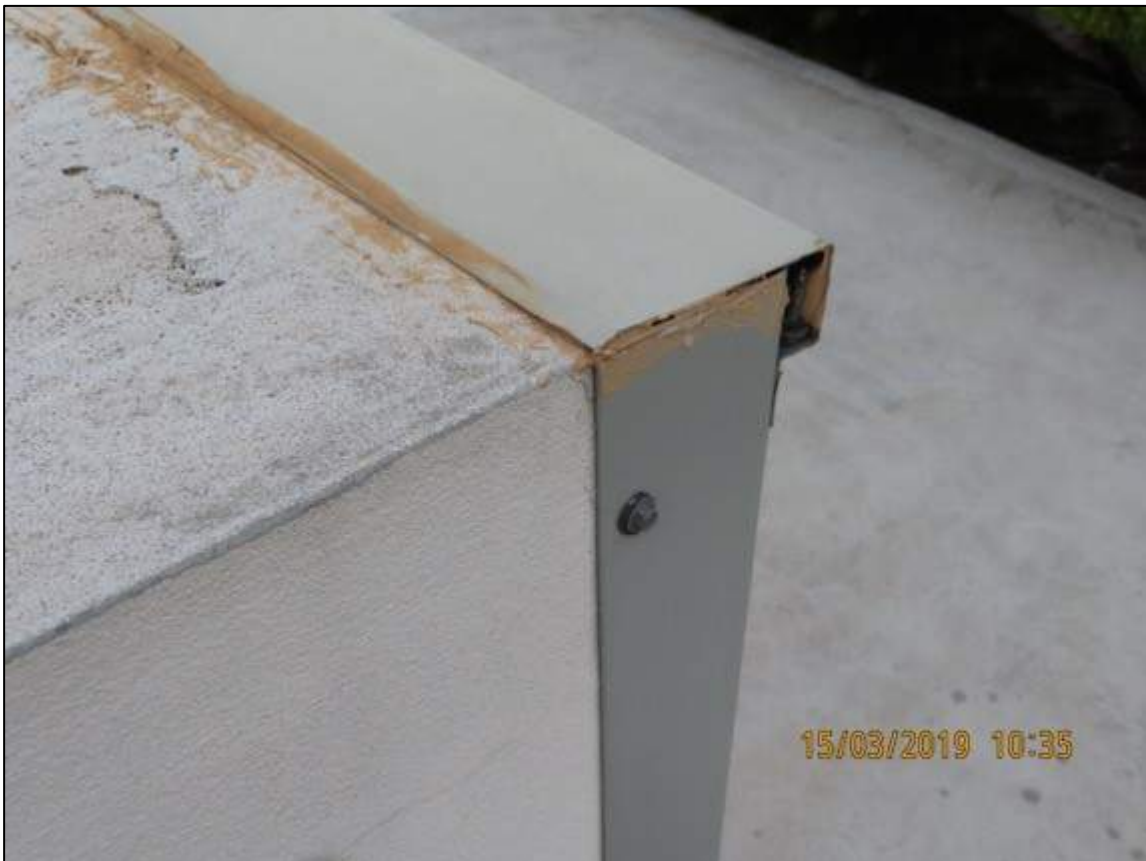
**Photograph 71:** Showing application of sealant to rooftop perimeter capping.

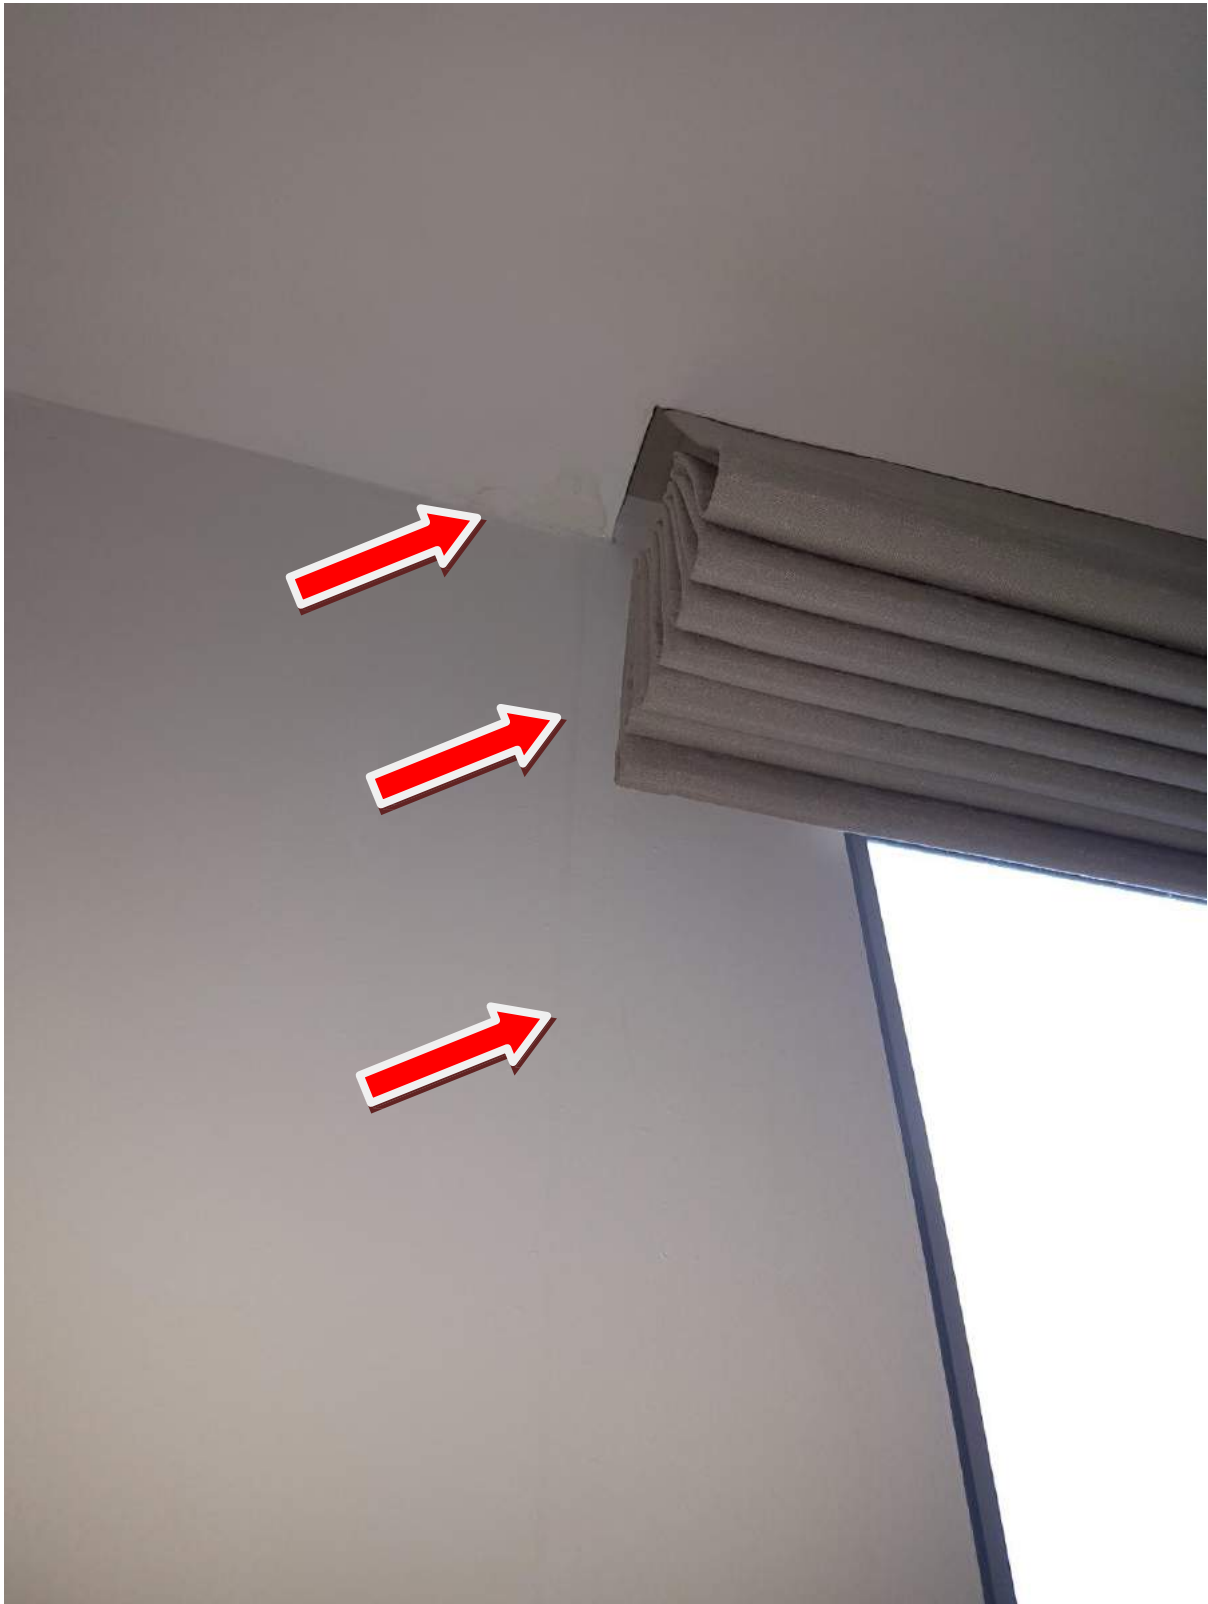
Water is seeping in from the top of the window frame and making its way down.

Recommended that; further inspection is required. Above unit 15 to view the window seal externally.
