# SydneyStrataReport

## STRATA REPORT

Client	Infinity Property Agents
Address of property	Unit 107/361-362 Military Road, Mosman, NSW.
Lot	13
Strata Plan	SP 92834
Name of Strata Management Co.	Executive Strata
Telephone Number of Strata Agent	1300 984 186
Report Date	22 April 2020

Mixed Use Residential Apartment at  
363 Military Road,  
Mosman, NSW

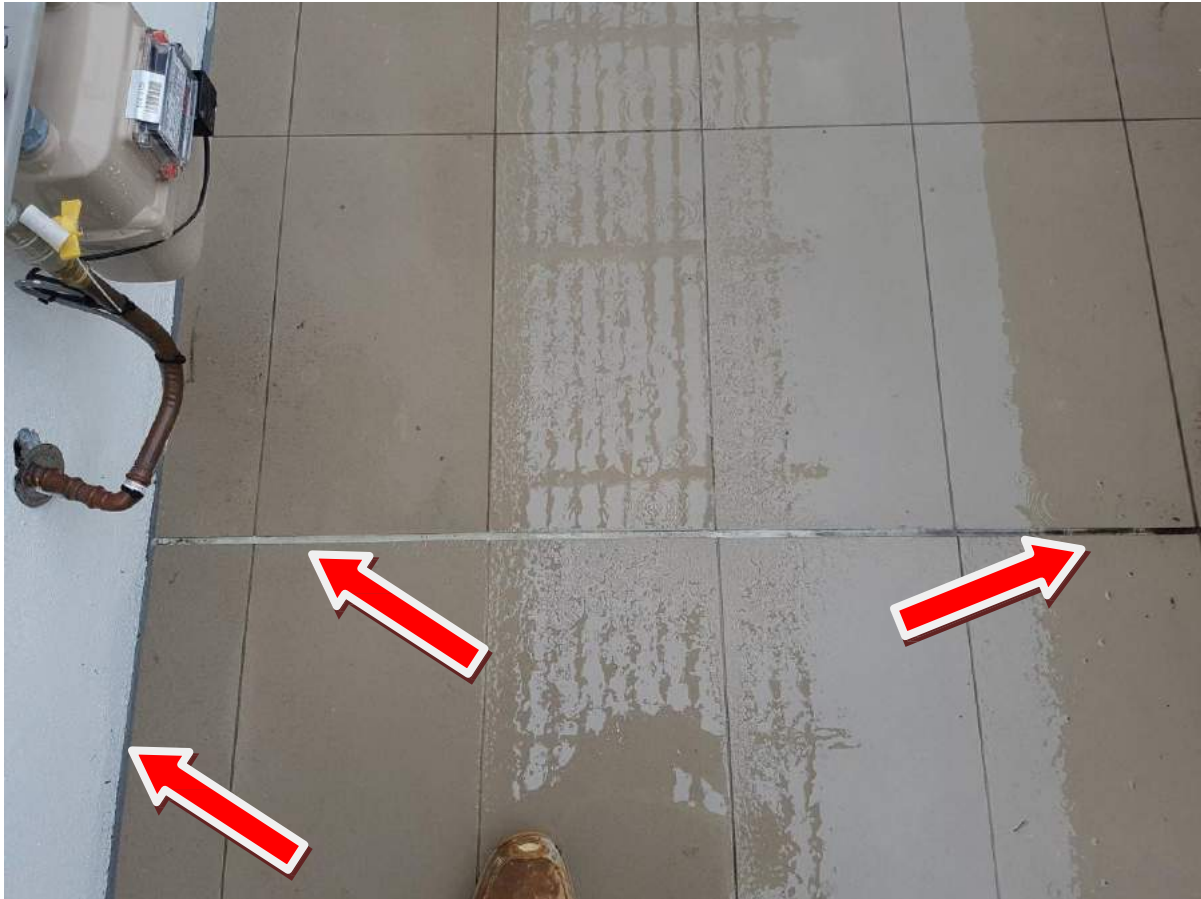
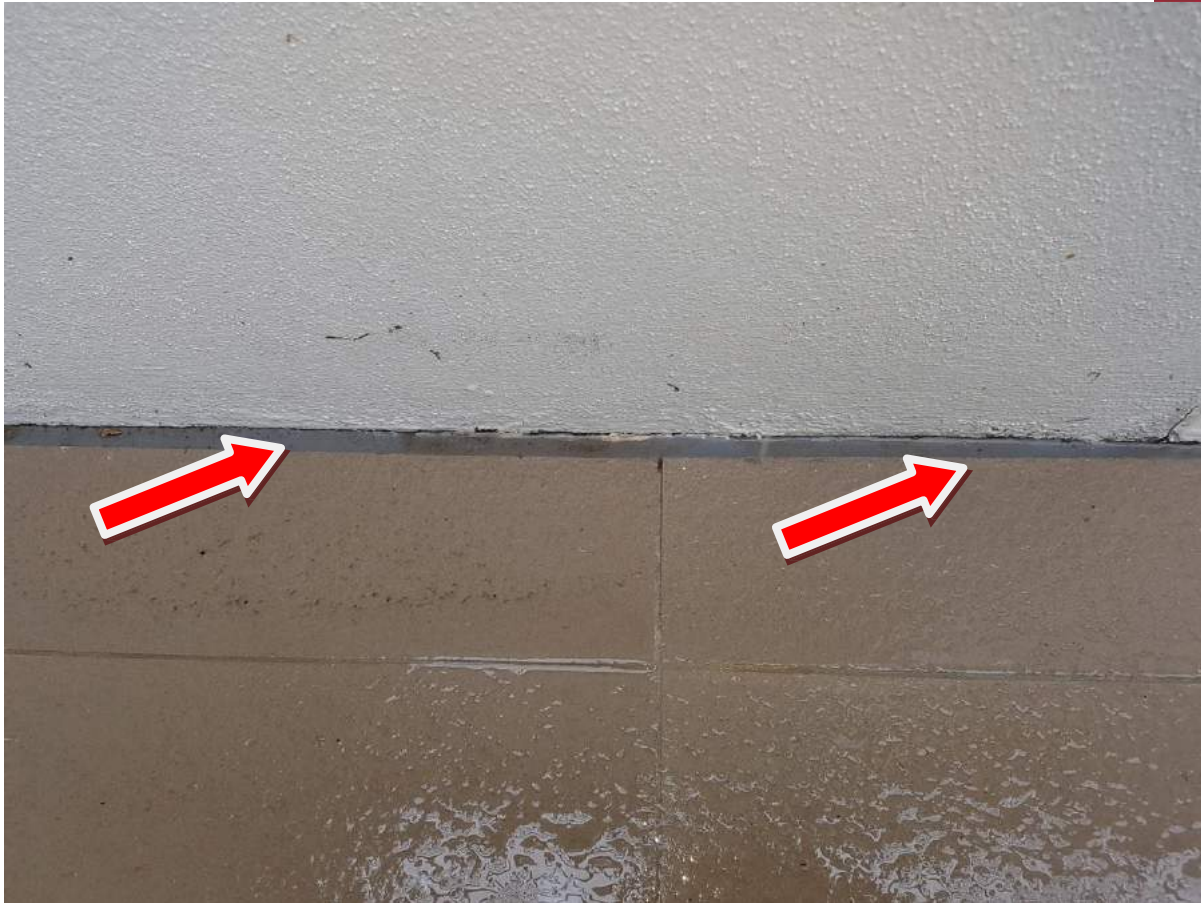
Expansion joints  
require re-caulking  
due to poor  
preparation and  
caulking

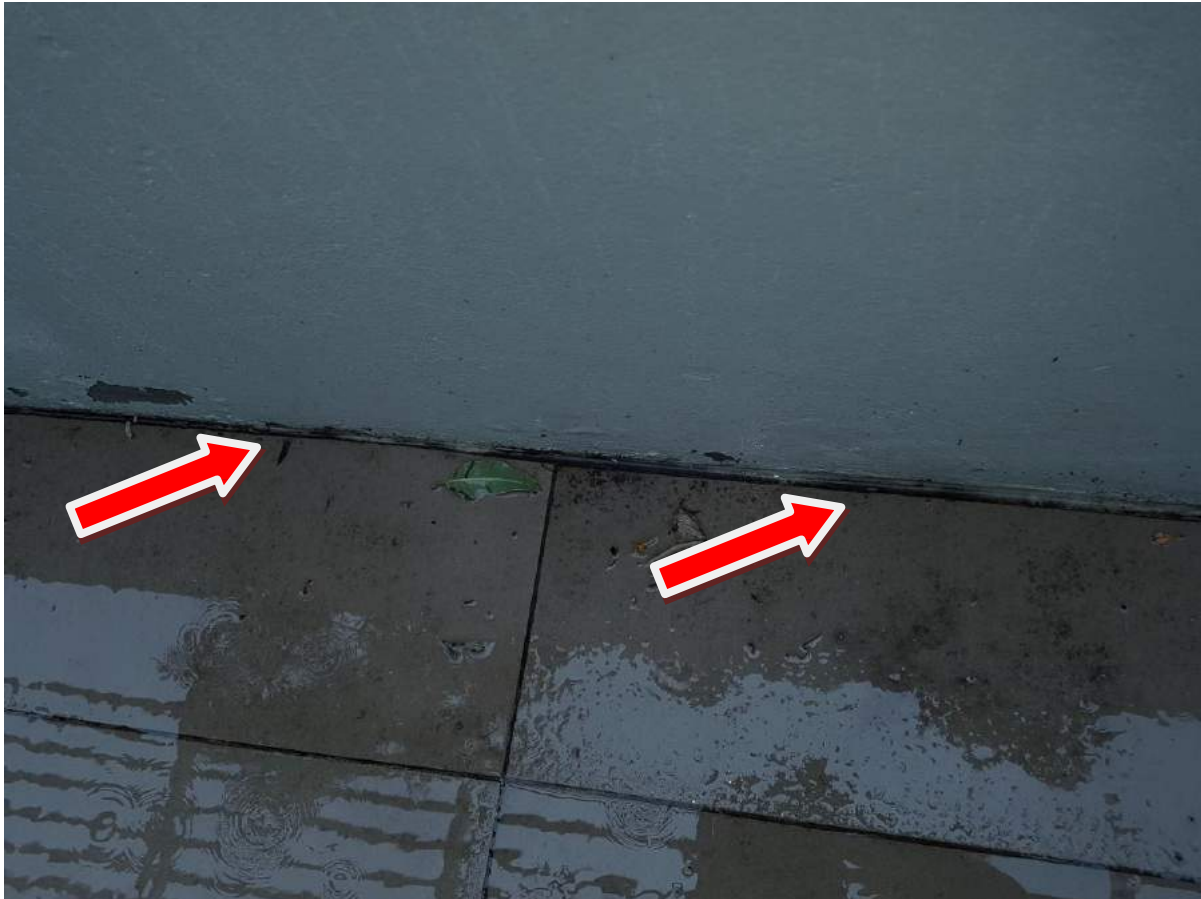
Expansion joints  
require re-caulking  
due to poor  
preparation and  
caulking

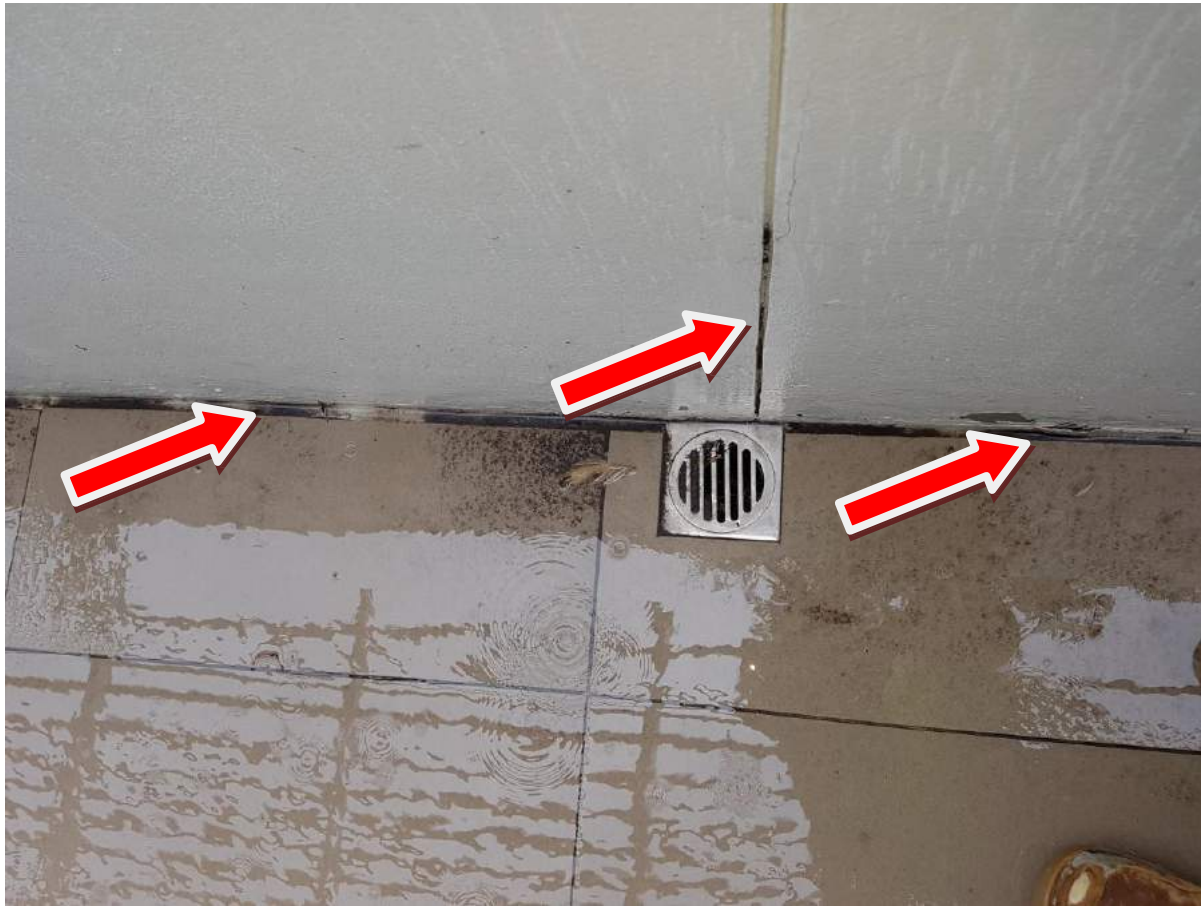
Expansion joints  
require re-caulking  
due to poor  
preparation and  
caulking

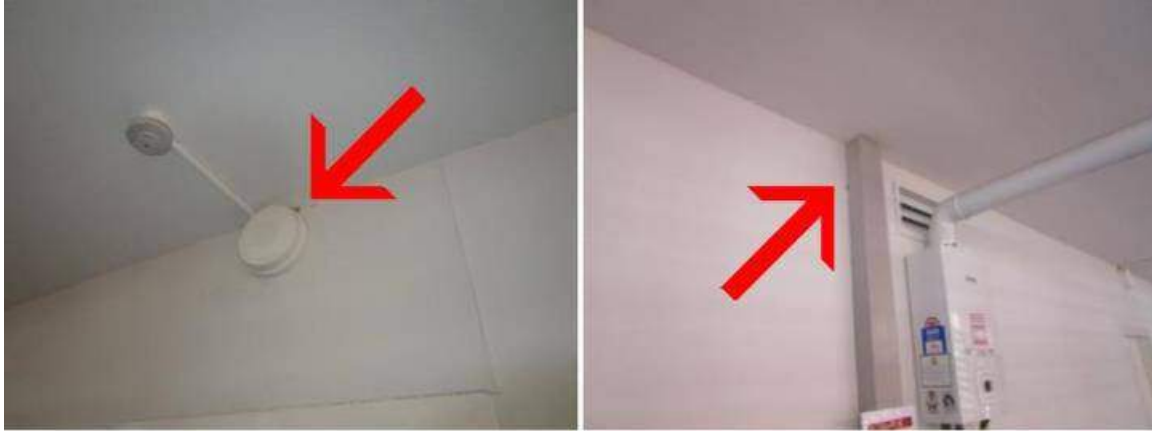
The condition of the walls is generally fair. Defective or poor surfaces were noted to wall materials and will require repair. Some minor maintenance is required to internal wall surfaces. Adjacent to Units 8, 10 and 13.

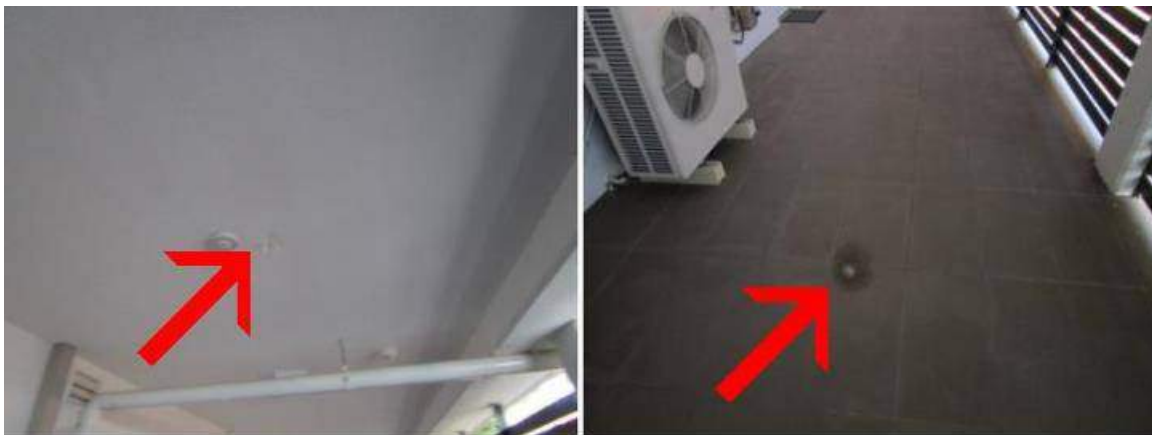
The condition of the ceilings is generally fair. Evidence of current water penetration through ceiling/concrete soffit. Recommend further investigation and rectification .

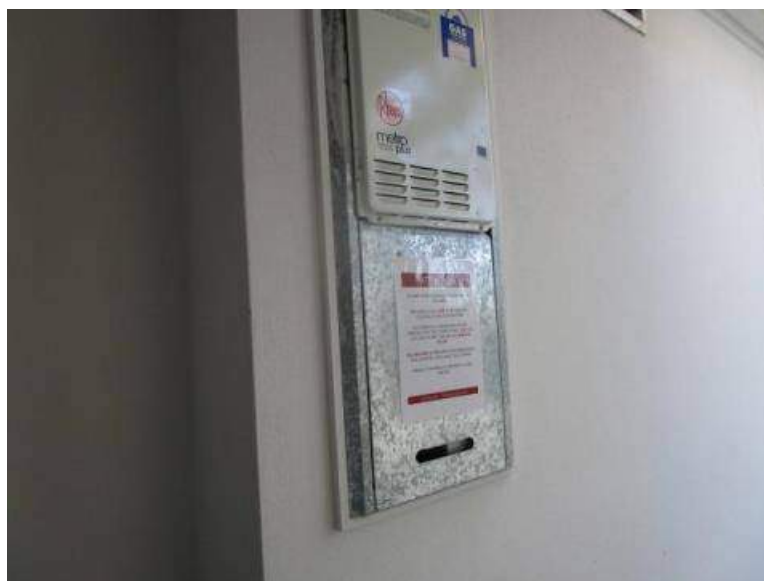
The condition of the walls is generally fair. Defective or poor surfaces were noted to wall materials and will require repair. Adjacent to Unit 24.

Gas hotwater service reveal requires painting for an acceptable finish.

A licensed Plasterer should be called to make a further evaluation and repairs or rectification as needed. A licensed Painter should be called to make a further evaluation and repairs or rectification as needed.

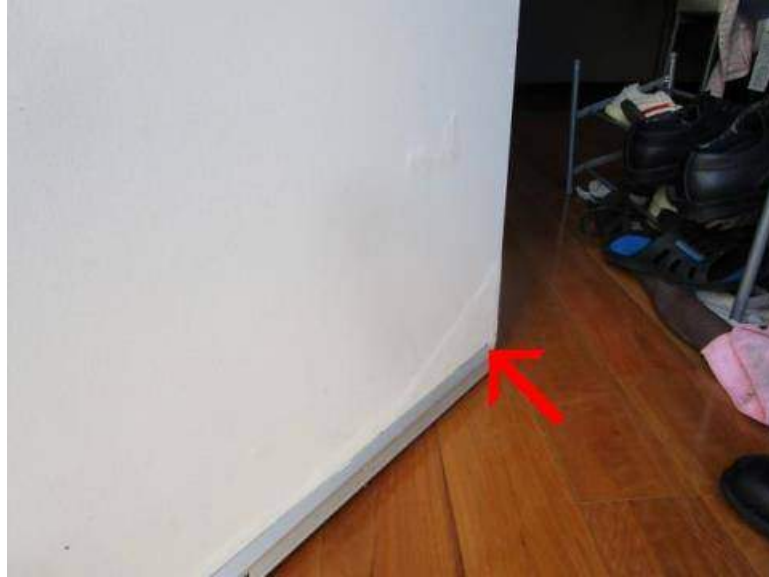
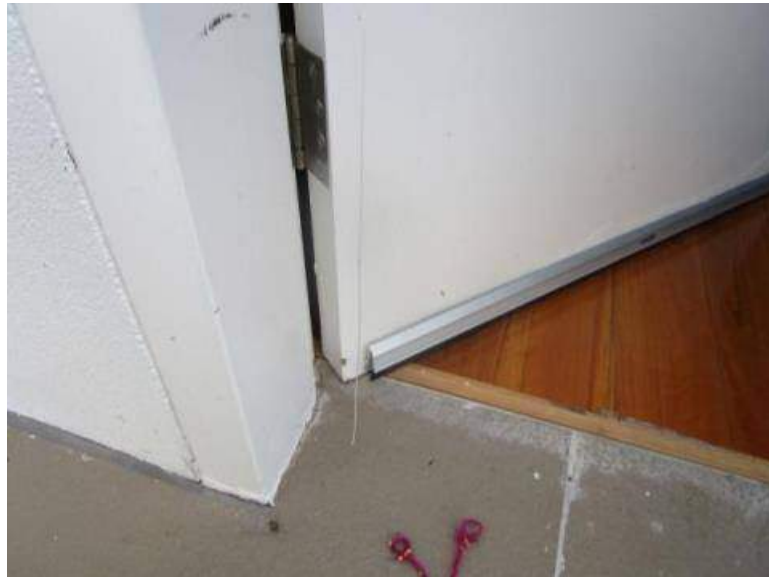
The condition of the doors is generally fair. The condition of the door hardware is generally good. Water damage was noted to all unit entry doors and will require repair or replacement.

Door weather seals appear to be inadequate, potential resultant water damage to internal flooring, recommend rectification.

A licensed Building Contractor should be called to make a further evaluation and repairs or rectification as needed.

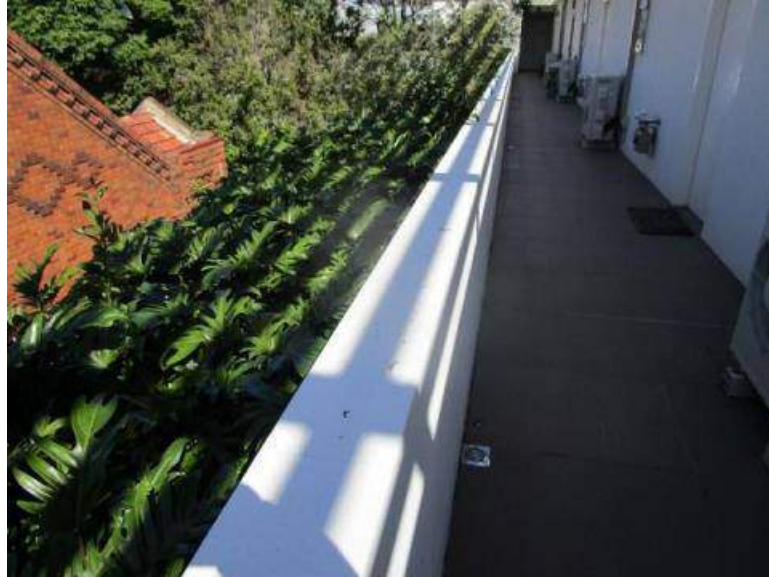
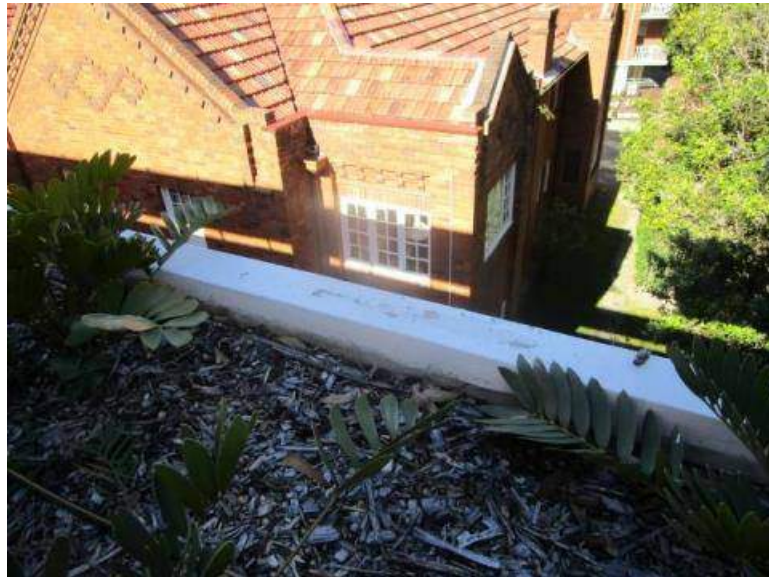
Paintwork to masonry balustrade is deteriorating, recommend rectification.

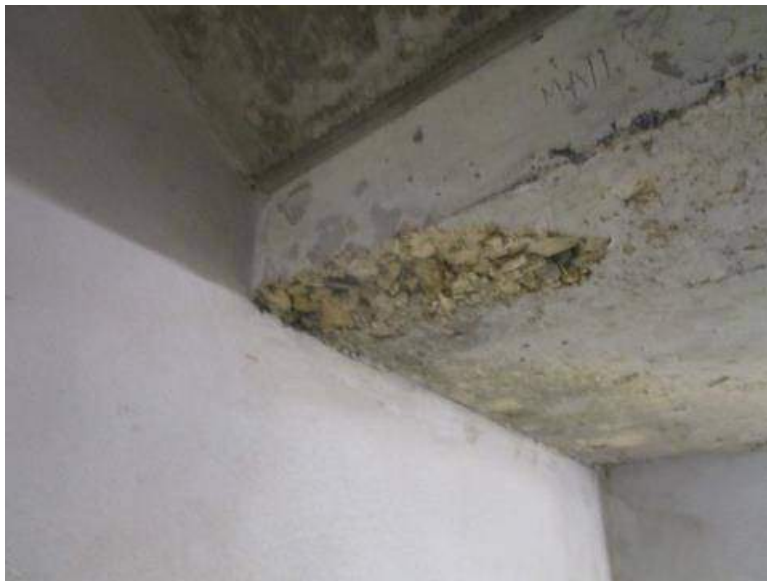
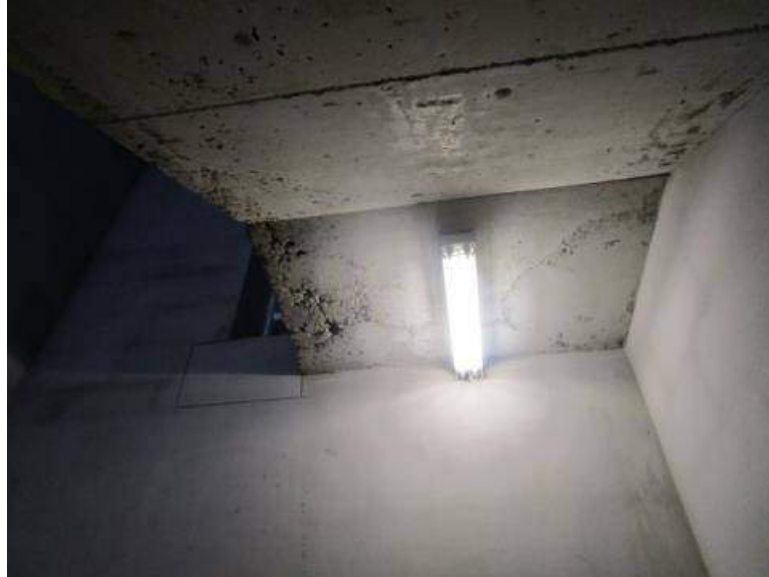
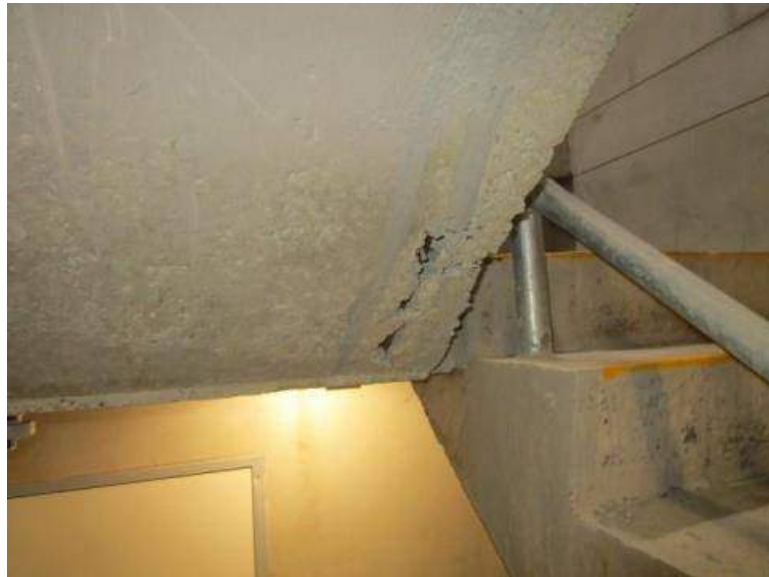
Defective surface was noted to reinforced concrete stair and carriage slab exposing reinforcement steel, recommend rectification.

A licensed Building Contractor should be called to make a further evaluation and repairs or rectification as needed.

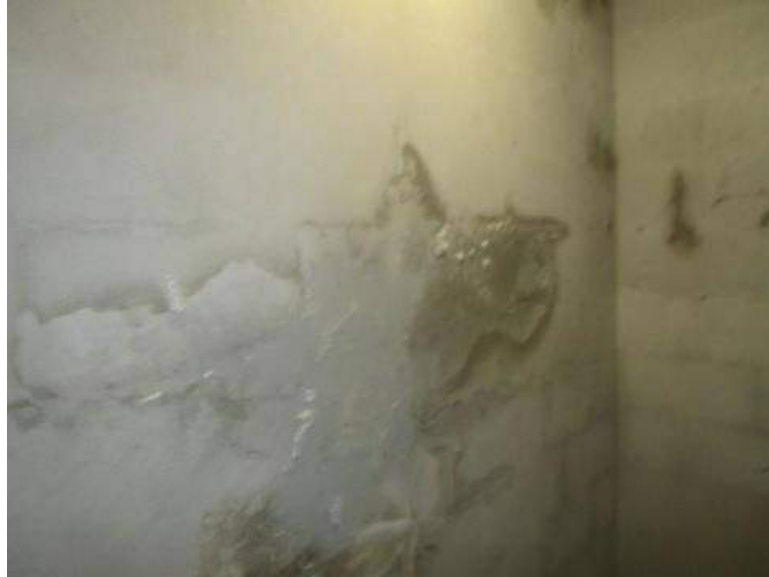
The condition of the walls is generally fair. Defective or poor surfaces were noted to wall materials and will require repair. Efflorescence is noted to the face of masonry wall. This is when a white powdery deposit forms on the surface of bricks, masonry or concrete. This is caused by crystallisation and subsequent dehydration of soluble salts contained in the mortar or wall materials. Recommend the area be cleaned to remove efflorescence.

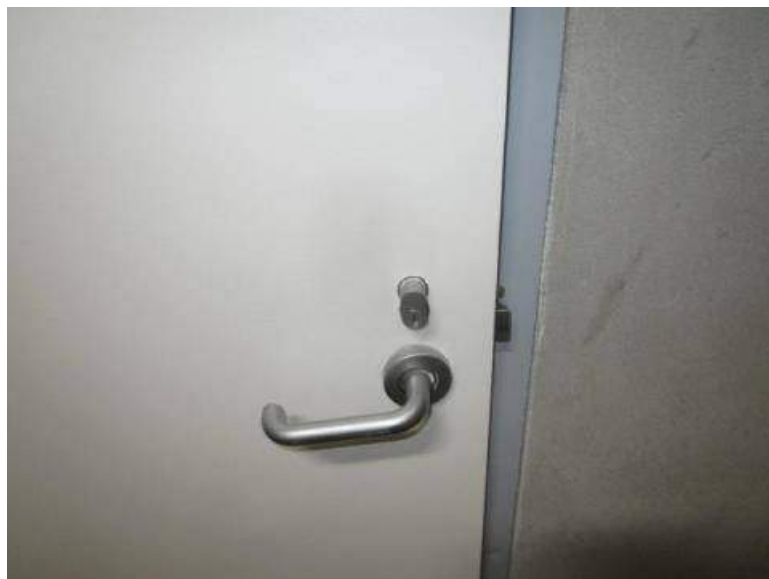
The condition of the doors is generally fair. The condition of the door hardware is generally fair. Some repairs or maintenance will

be required. Escutcheon plate to level one door should be fitted.

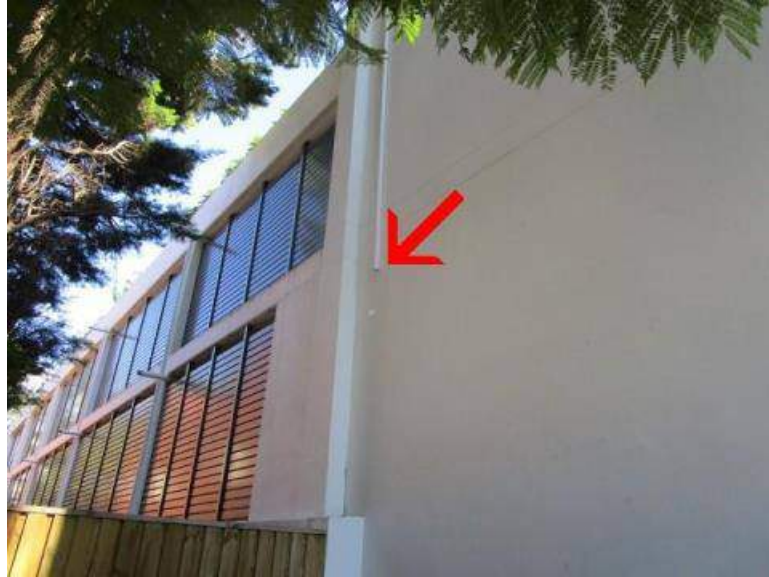
Some downpipes appear to be missing. These should be installed.

A licensed Roof Plumber should be called to make a further evaluation and repairs or rectification as needed.

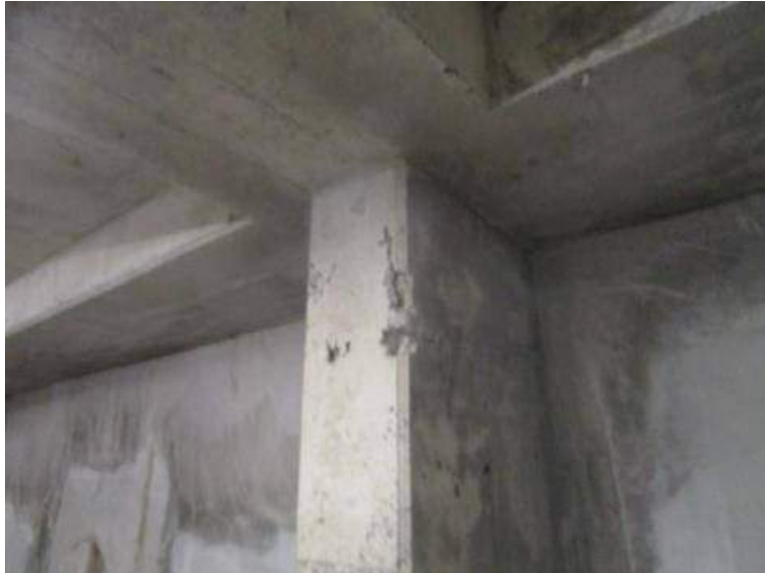
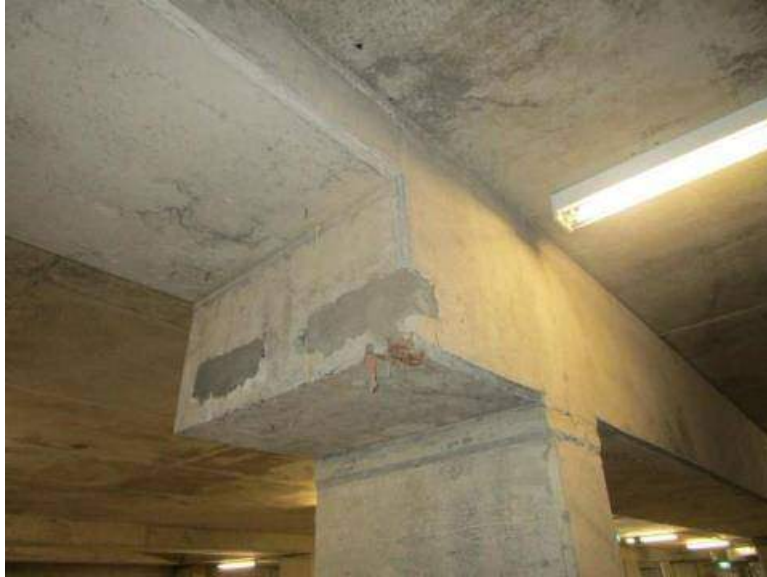
The condition of the walls is generally fair. Defective surface to reinforced concrete columns beam soffit, recommend rectification.

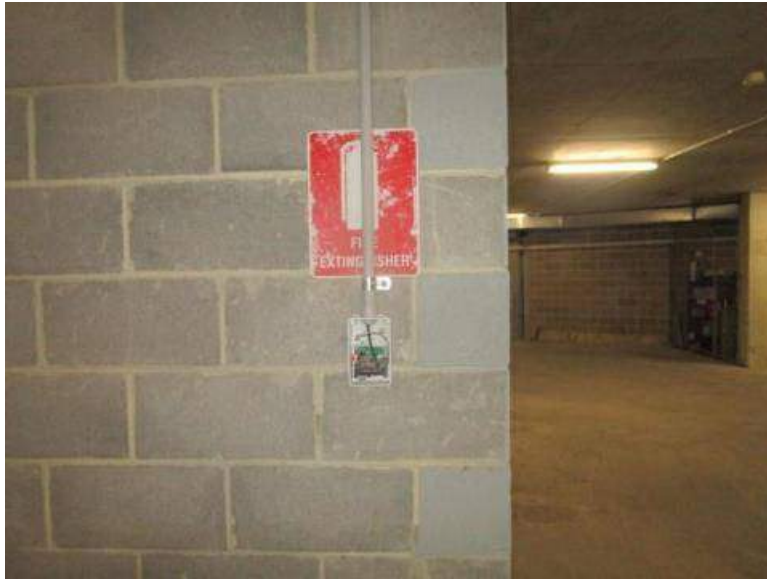
The condition of the walls is generally fair. Cover plate to electrical box is required.
